**DETAILED STUDY OF THE  
7 JUNE 2008 LANDSLIDE  
ON SLOPE NO. 11SE-A/C502  
AT PAK FUK ROAD,  
NORTH POINT**

**GEO REPORT No. 289**

**Fugro Scott Wilson Joint Venture**

**GEOTECHNICAL ENGINEERING OFFICE  
CIVIL ENGINEERING AND DEVELOPMENT DEPARTMENT  
THE GOVERNMENT OF THE HONG KONG  
SPECIAL ADMINISTRATIVE REGION**

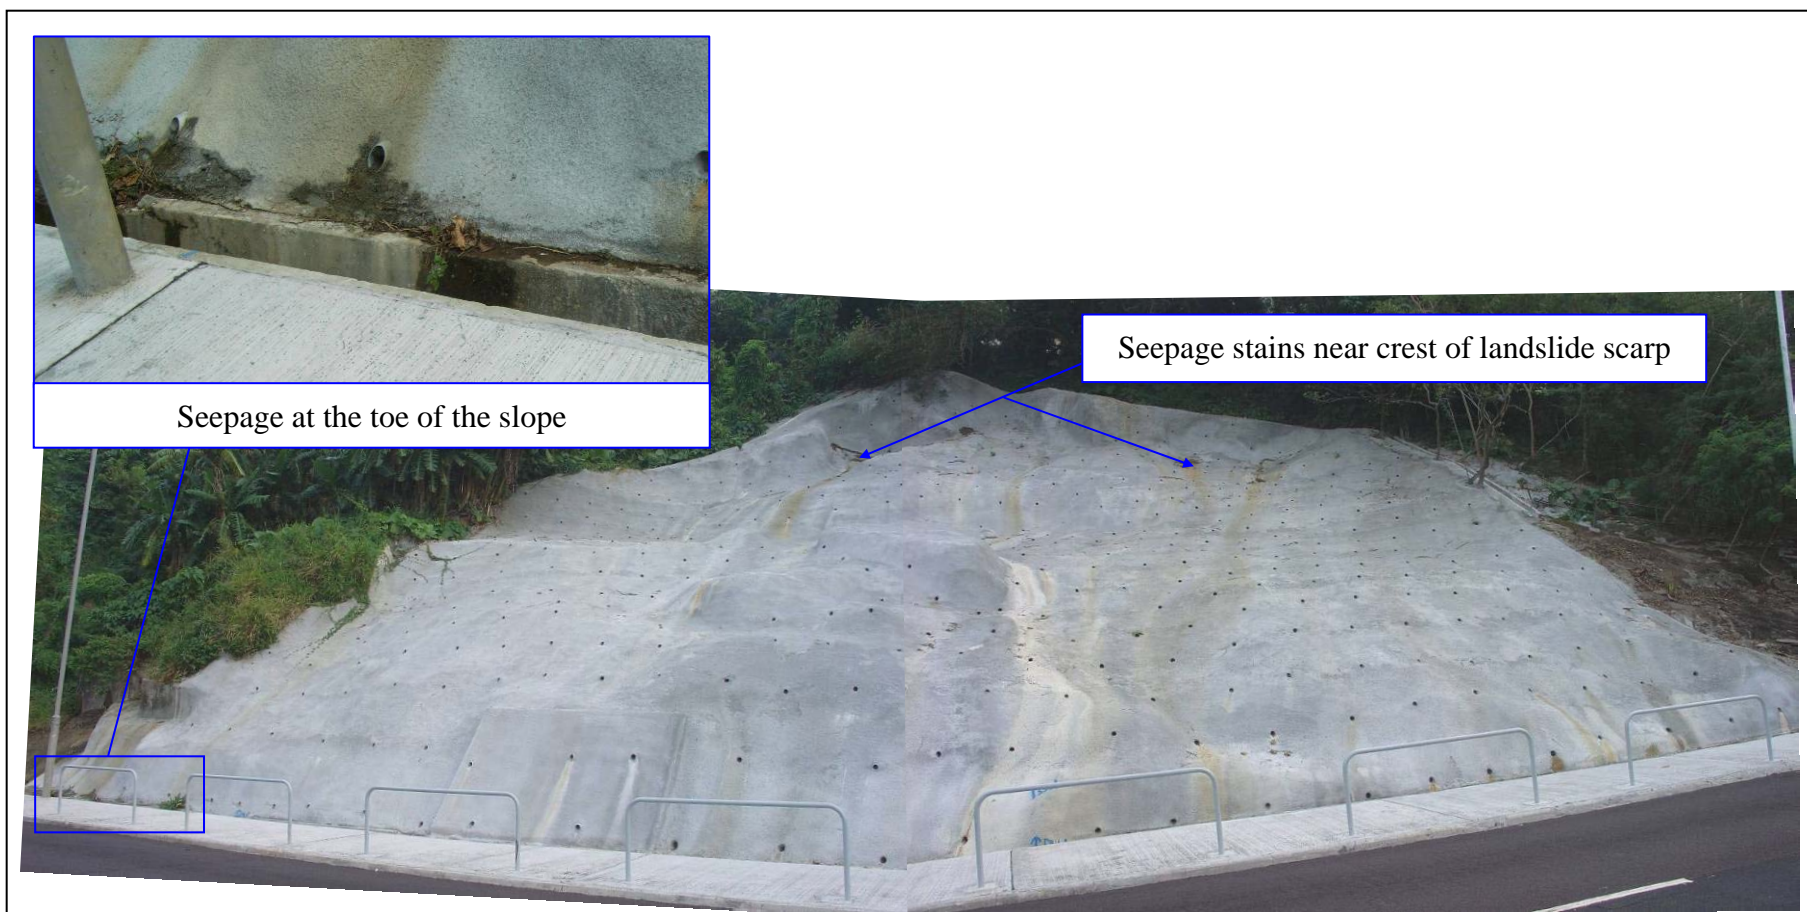
Moreover, signs of seepage from weepholes and scaffolding supports in the shotcrete cover were noted between November 2008 and November 2009, predominantly over the western flank of the main scarp and the central part of the basal slip plane where the kaolin-rich zone was present (Figure 14 and Plate 31).

Plate 31 - Seepage Stains on the Shotcreted Landslide Scar  
(Photograph taken on 18 November 2008)

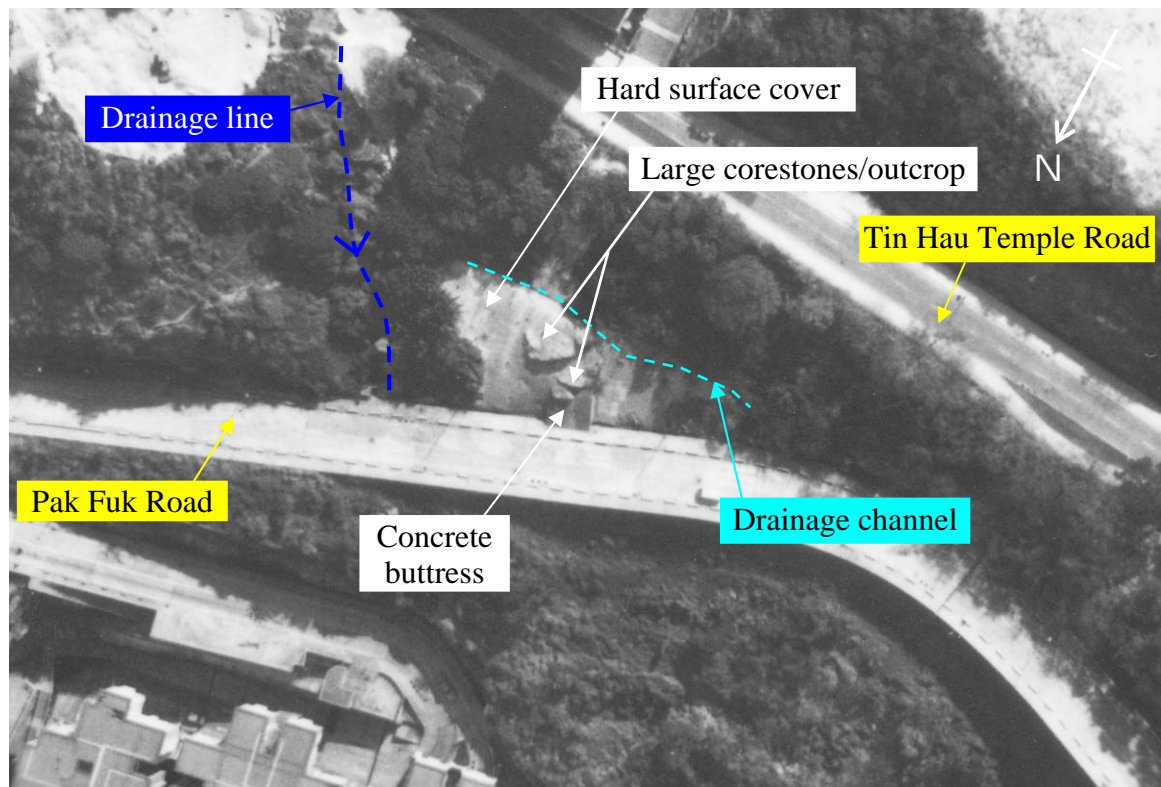
Following the 1983 landslide, urgent repair works were carried out by the then Highways Office (HO). The works comprised the provision of a chunam cover to the trimmed landslide scar and a concrete buttress at the slope toe to support some boulders. The extent of the chunam cover, as well as the concrete buttress, can be seen in the November 1983 and January 1984 aerial photographs (Plate A2 in Appendix A).

Plate A2 – Hard Surface Cover Noted in the 1984 Aerial Photograph  
(Aerial Photograph No. 53362 taken on 27 January 1984)
