**REVIEW OF THE
21 AUGUST 2005 LANDSLIDE
INCIDENT ON SLOPES AT THE
SHING MUN CATCHWATER
TSO KUNG TAM
TSUEN WAN**

GEO REPORT No. 291

Halcrow China Limited

**This report is largely based on GEO Landslide Study Report
No. LSR 12/2009 produced in December 2009**

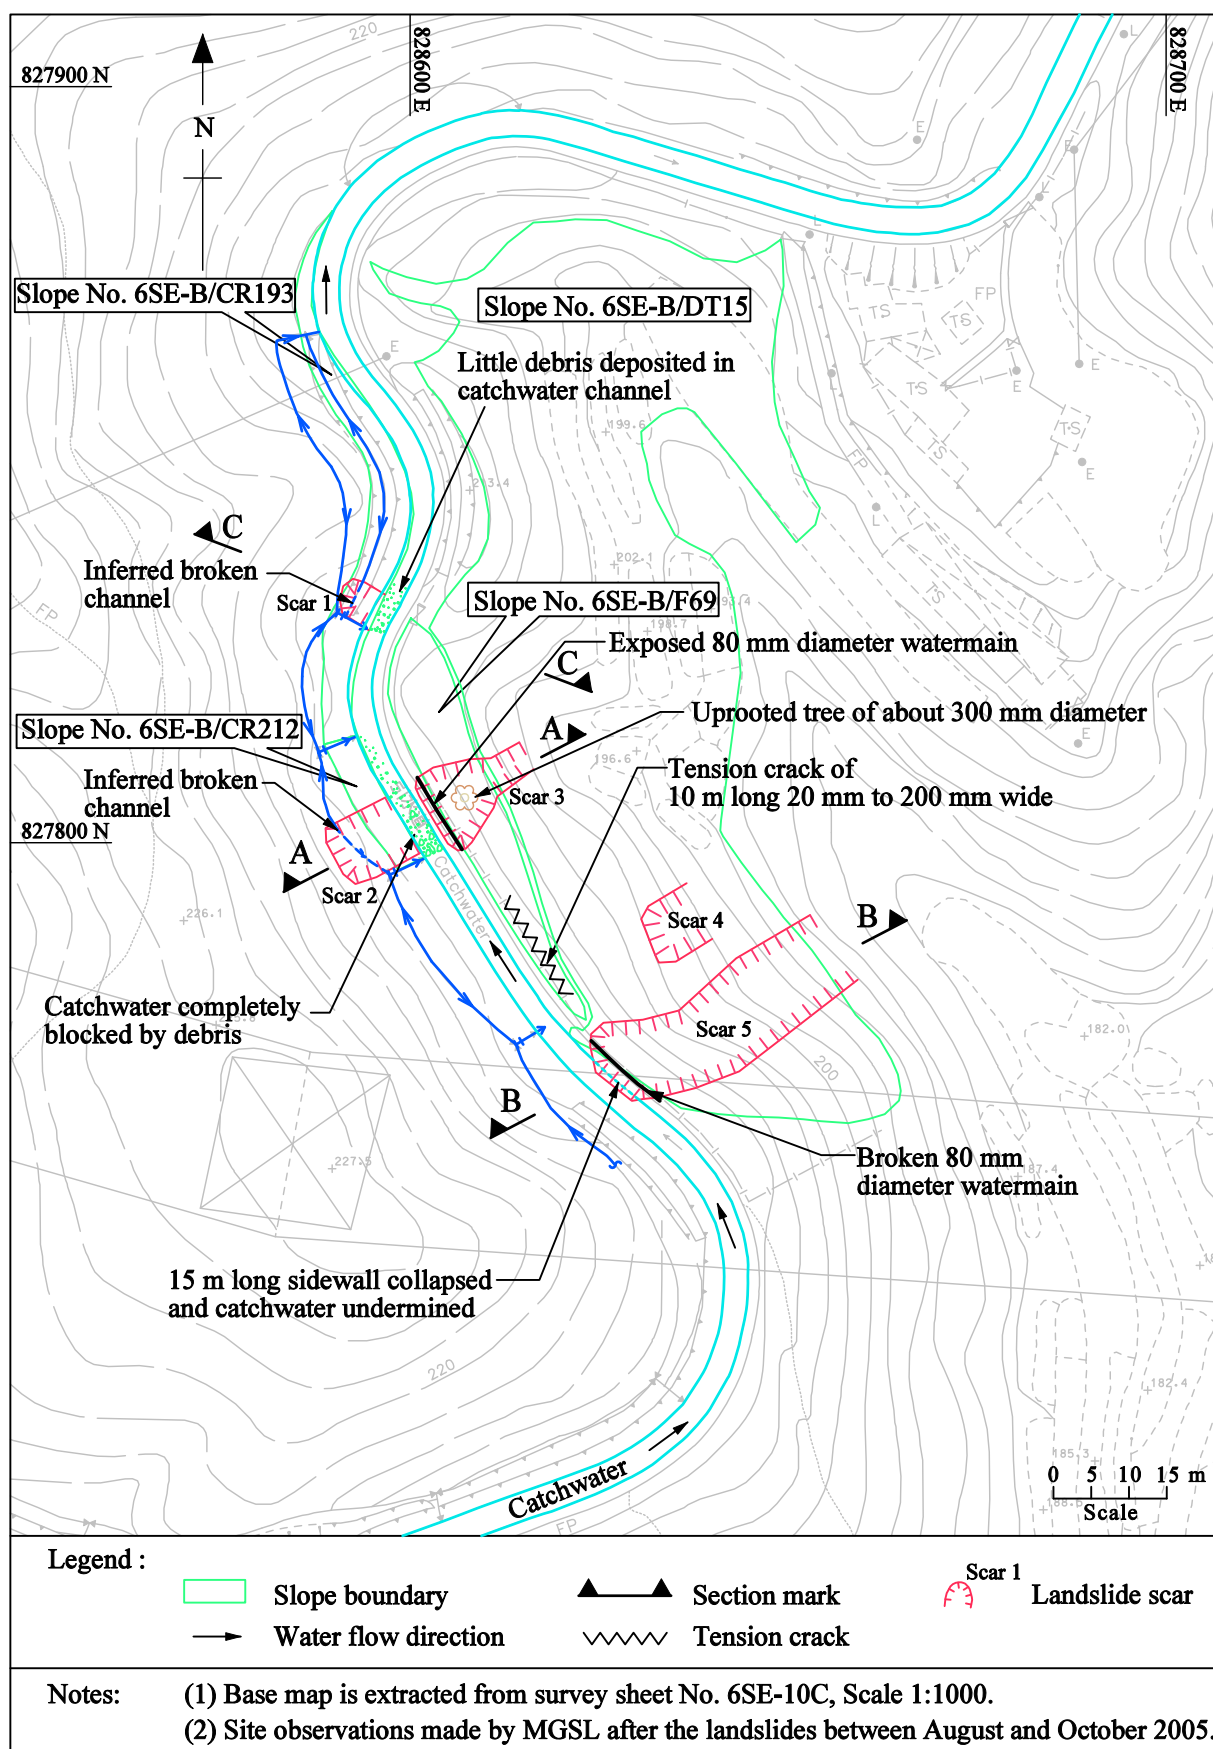
Figure 4 - Site Observations in the Vicinity of the 21 August 2005 Landslide Site

The landslide involved a total of five failure scars (Figure 4). Scar 1 was located at the middle portion of slope No. 6SE-B/CR193 just above its concrete toe wall. The failure volume was about 6 m³ (Plate 2). The landslide debris was deposited in the catchwater

Located about 30 m to the southeast of Scar 3, at the southern end of slope No. 6SE-B/F69, was a tension crack which ran along the crest of the slope. The tension crack measured about 10 m long and 20 mm to 200 mm wide (Figure 4 and Plate 5). About 20 m to the east (downhill) of the tension crack was another washout scar (Scar 4). Scar 4 was located at the southern portion of slope No. 6SE-B/DT15 (Plate 6). The failure volume was about 100 m³.

Adjacent to the south of the tension crack was the largest landslide scar (Scar 5), which was located at the southern end of slope No. 6SE-B/DT15 (Figure 4). The failure volume was about 900 m³. The base of the scar dipped at about 15° to 20°. The average depth of the main scarp was about 12 m (Figure 6 and Plate 7). A section of about 15 m long catchwater sidewall together with a section of adjoining concrete access road above the back scarp had been washed away (Plate 7). The catchwater channel at this location was also undermined and the scar was flanked by cultivated land near the slope crest (Plates 6 and 8). At the time of inspection, a large quantity of water was still cascading over the collapsed section of the catchwater channel into the failure scar (Plate 8) and most of the debris from the scar had been washed away. A fresh watermain of about 80 mm in diameter (possibly the same as that exposed in Scar 3) was uncovered. The watermain was broken, probably due to the landslide.

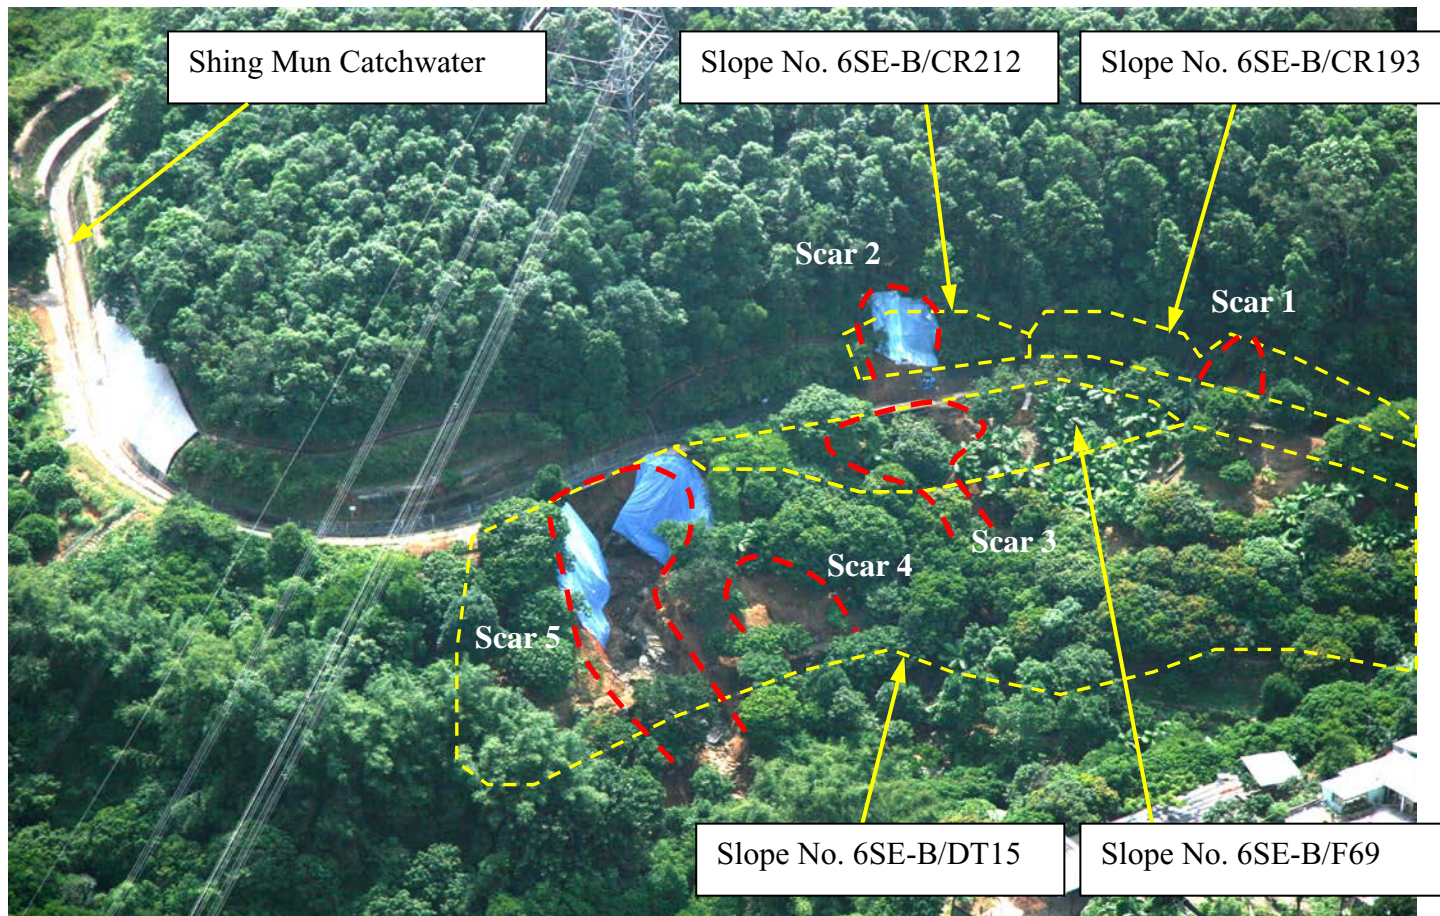
Plate 1 - Oblique Aerial View of Shing Mun Catchwater and Landslide Scars (Photograph taken on 7 September 2005 by MGSL)

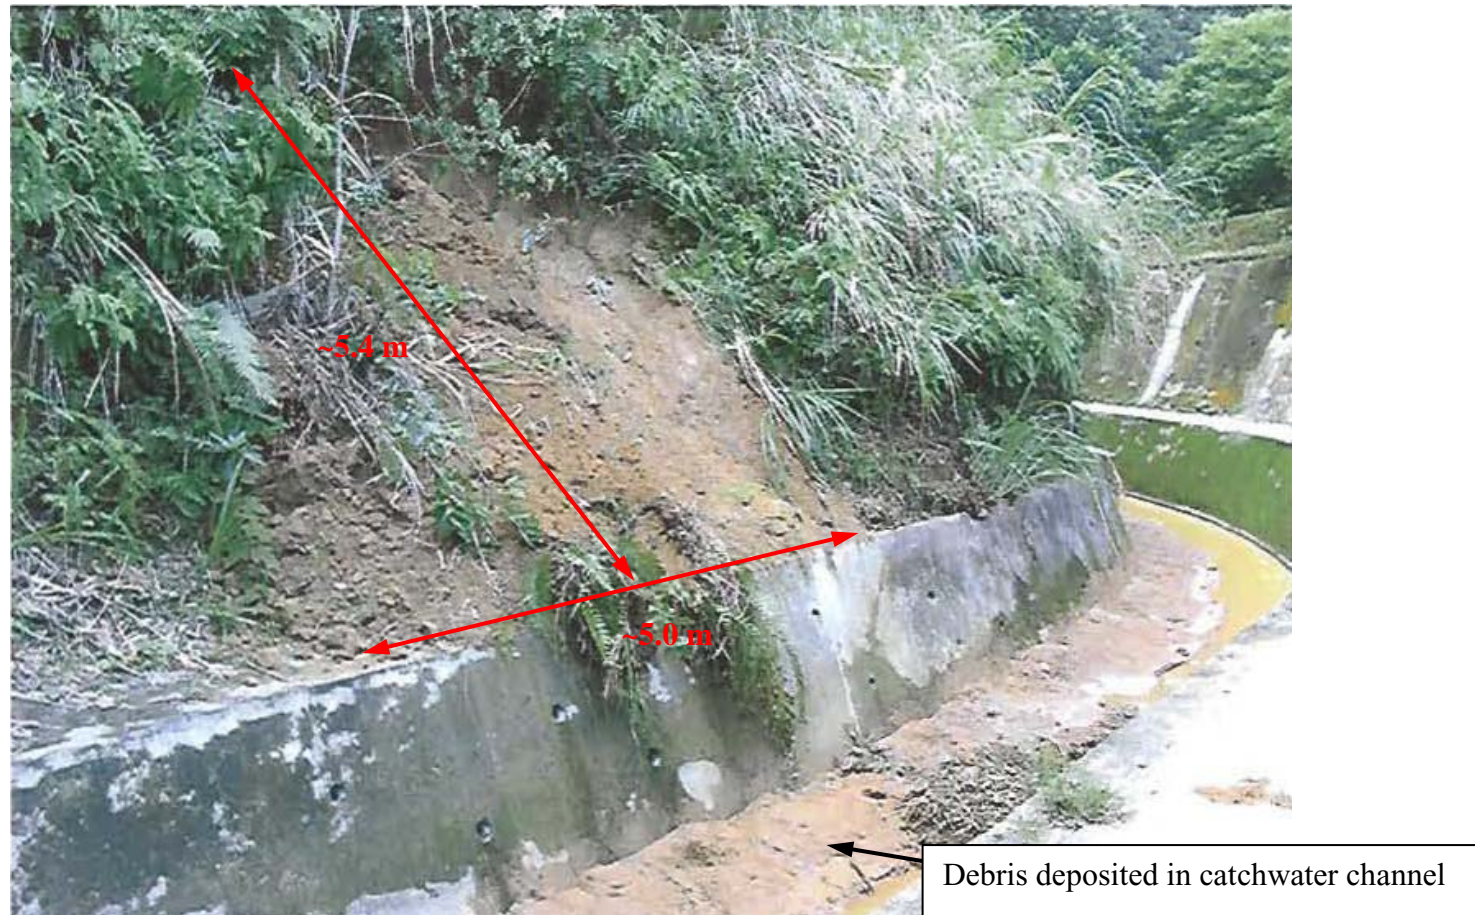
The relatively shallow landslides that occurred on the two old, steep soil cut slopes Nos. 6SE-B/CR193 and 6SE-B/CR212 (Scars 1 and 2) were likely triggered by slope saturation and transient build-up of water pressure as a result of infiltration and possible subsurface flow due to water ingress from the drainage lines in the proximity under heavy rainfall (Section 5.1). This would have led to a subsequent reduction in the shear strength of the groundmass. Post-failure site inspection revealed that both failures occurred immediately below the junctions of the slope crest U-channels where there was no provision of catchpits (Figure 2). Overspilling at these particular locations could have occurred during prolonged heavy rainfall, resulting in additional water ingress in the groundmass below.

Plate 2 - Landslide Scar 1 on Slope No. 6SE-B/CR193 (Photograph taken on 22 August 2005 by MGSL)

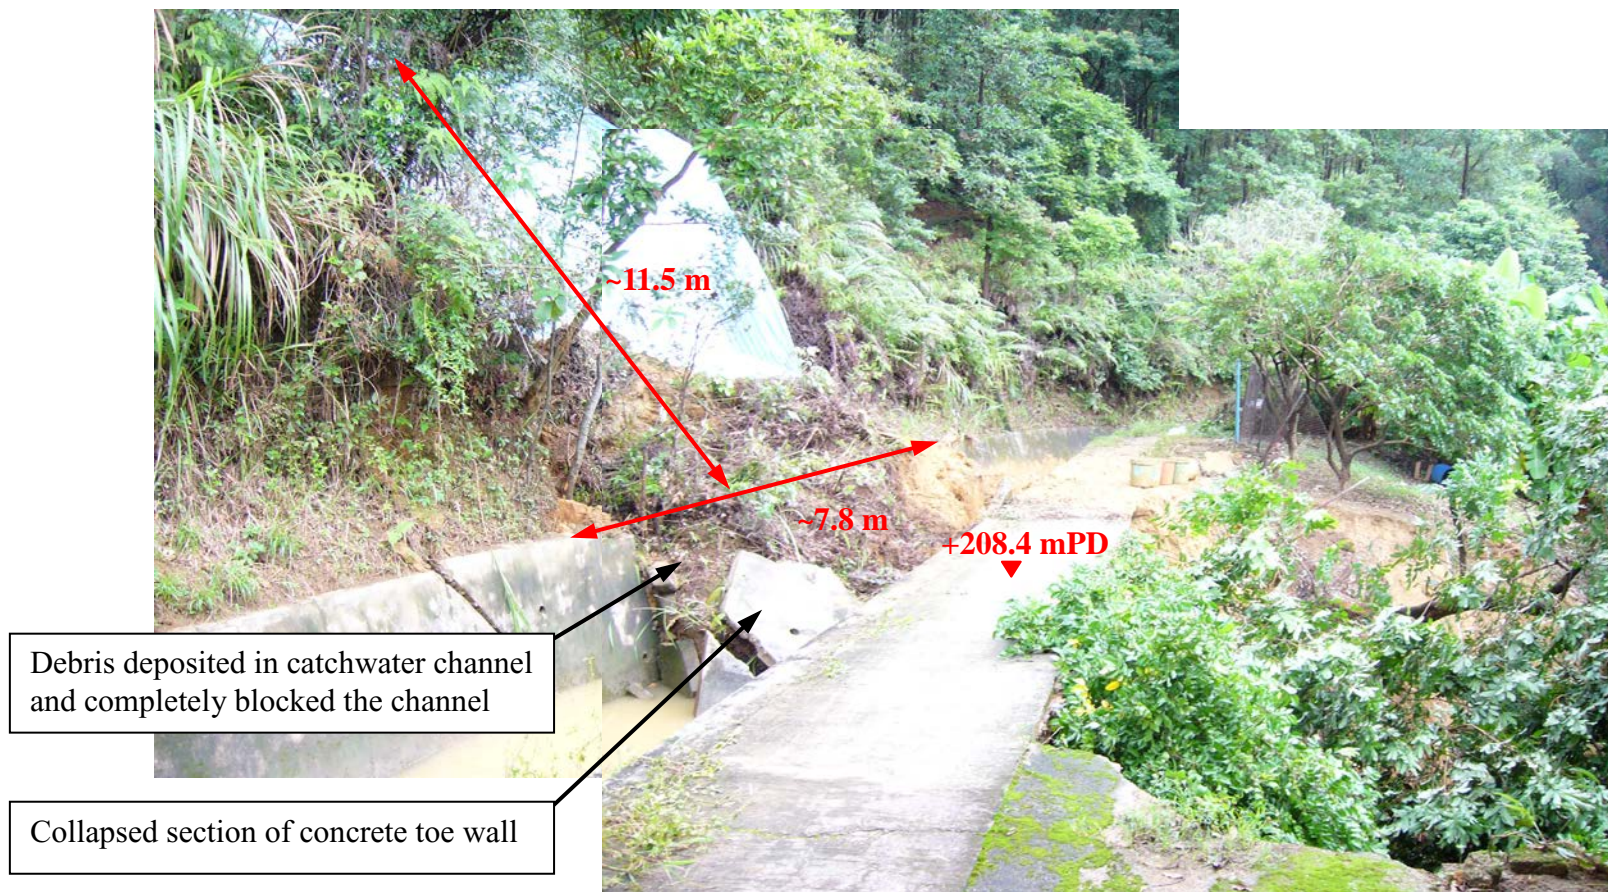
The landslide debris from Scar 2 at slope No. 6SE-B/CR212 was deposited in the catchwater below and blocked the water flow. As the catchwater might have reached its full capacity due to the prolonged rainfall, the blockage would have led to an uncontrolled overbank flow across the adjacent concrete access road, where the elevation is lower than the outlet invert level (208.8 mPD) of the overflow weir, OW1, upstream. The uncontrolled overflow would have caused severe erosion on the vegetated surface of slope No. 6SE-B/F69 below the access road (i.e. Scar 3), undermining the road in the process and resulting in the formation of a deep scar and a tension crack in the slope crest (Plates 4 and 5).

Plate 3 - Landslide Scar 2 on Slope No. 6SE-B/CR212 (Photograph taken on 22 August 2005 by MGSL)

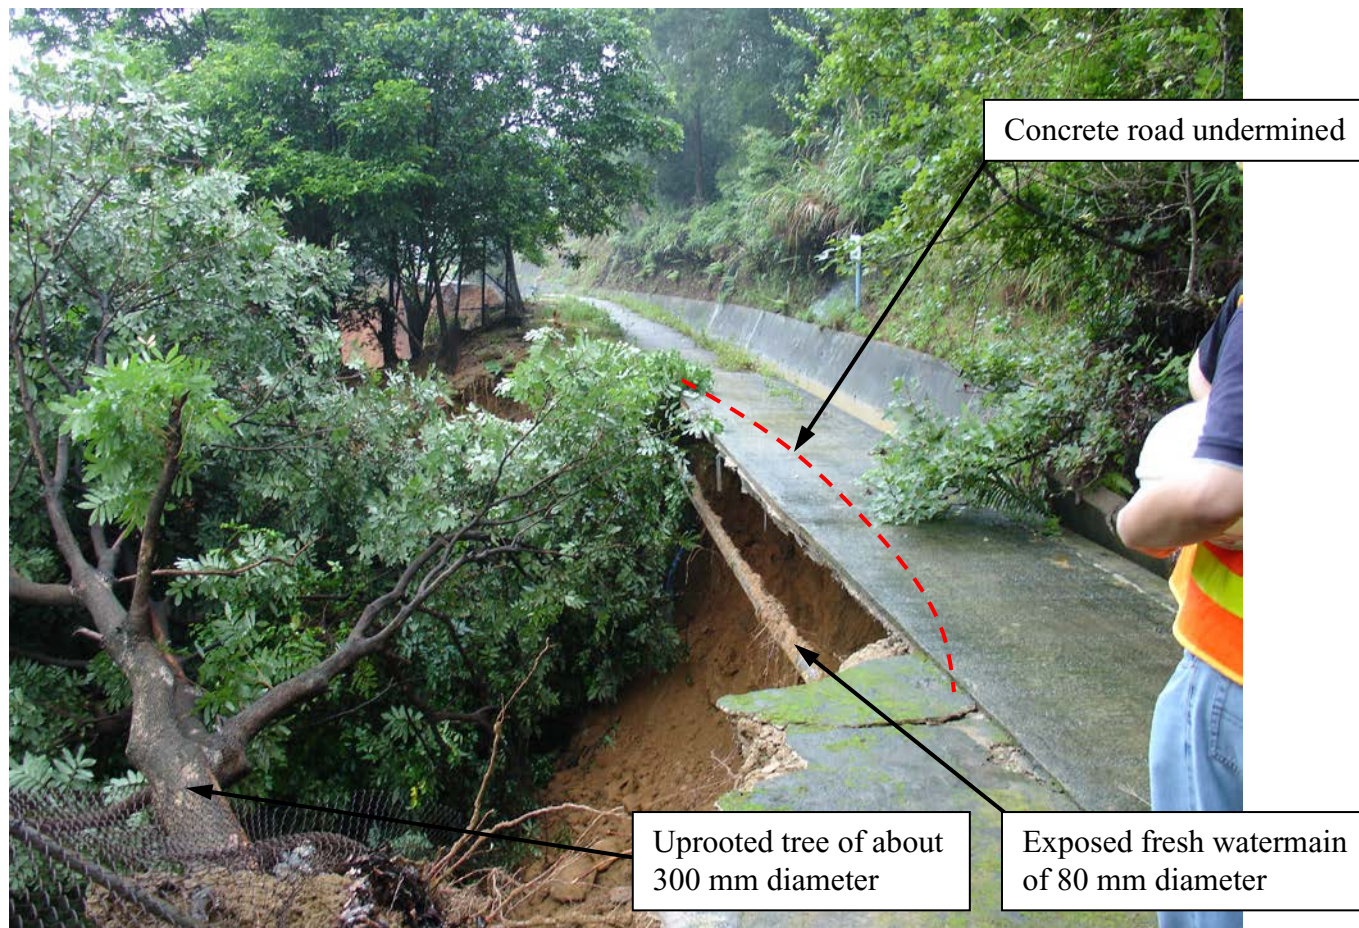
Across the catchwater channel on the downhill side of Scar 2 was Scar 3 which was located at the crest of slope No. 6SE-B/F69. The scar was probably the result of a washout failure due to uncontrolled overbank flow from the blocked catchwater channel. The failure volume was about 100 m³. A section of the concrete road above the backscarp was severely undermined. A fresh watermain of about 80 mm in diameter was also exposed (Figure 5 and Plate 4).

Plate 4 - Washout Scar 3 on Slope No. 6SE-B/F69 (Photograph taken on 21 August 2005 by HyD)

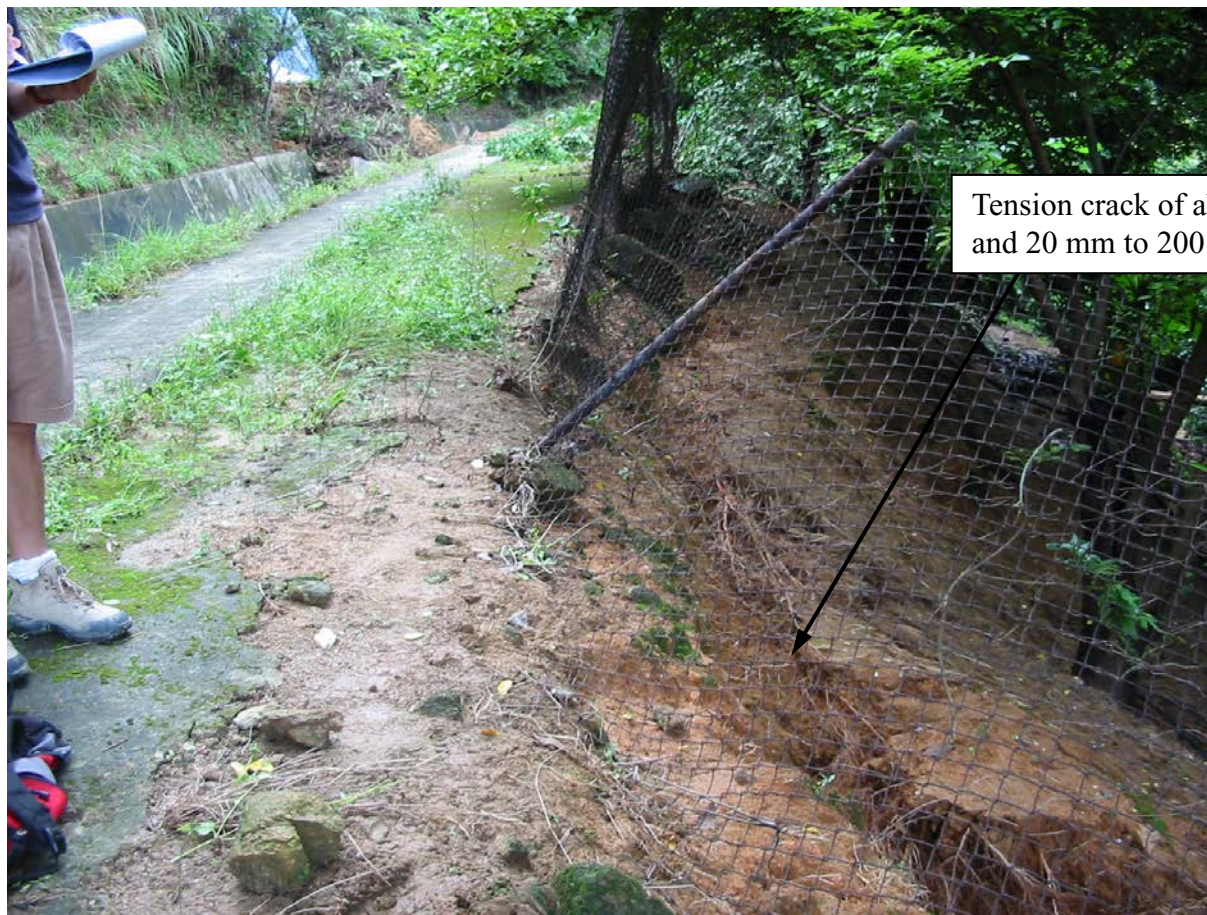
Tension crack of about 10 m long
and 20 mm to 200 mm wide

Plate 5 - Tension Crack at Crest of Slope No. 6SE-B/F69 (Photograph taken on 21 August 2005 by MGSL)

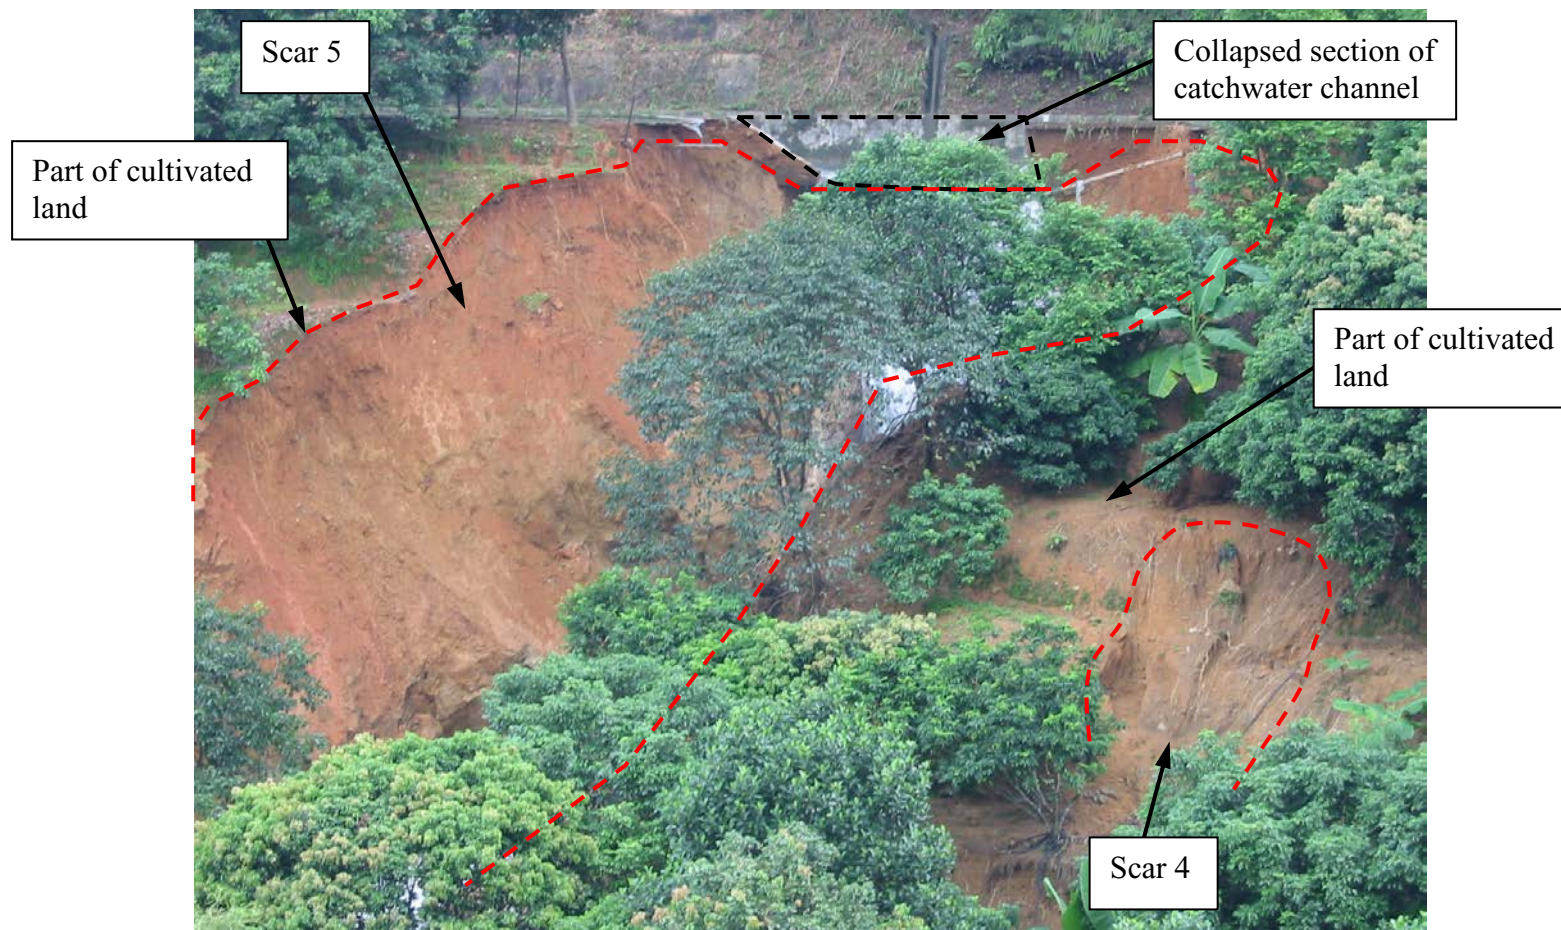
The August 2005 incident involved 2 failure locations (Scars 4 and 5) on slope No. 6SE-B/DT15. Both failures were located on a relatively steep part of the DT feature with a history of instability and where unauthorised cultivation had taken place prior to the failure. The cultivation could have made the slope more vulnerable to water ingress under heavy rainfall. The landslides were also located near a broad local depression with possible subsurface flow towards the landslide location. Given the adverse site setting, the failure at this location is not unexpected under the severe rainfall. The 'initial' failure at Scar 5 could have severed the 80 mm diameter fresh watermain at the crest of the landslide scar, discharging water onto the failed area and subsequently undermined a section of the adjacent catchwater channel. This might have eventually led to the collapse of the catchwater sidewall. The damaged catchwater would have released a large amount of water onto the failed area, resulting in extensive erosion and formation of a large failure scar.

Plate 6 - Scar 4 and Scar 5 on Slope No. 6SE-B/DT15 (Photograph taken on 21 August 2005 by MGSL)

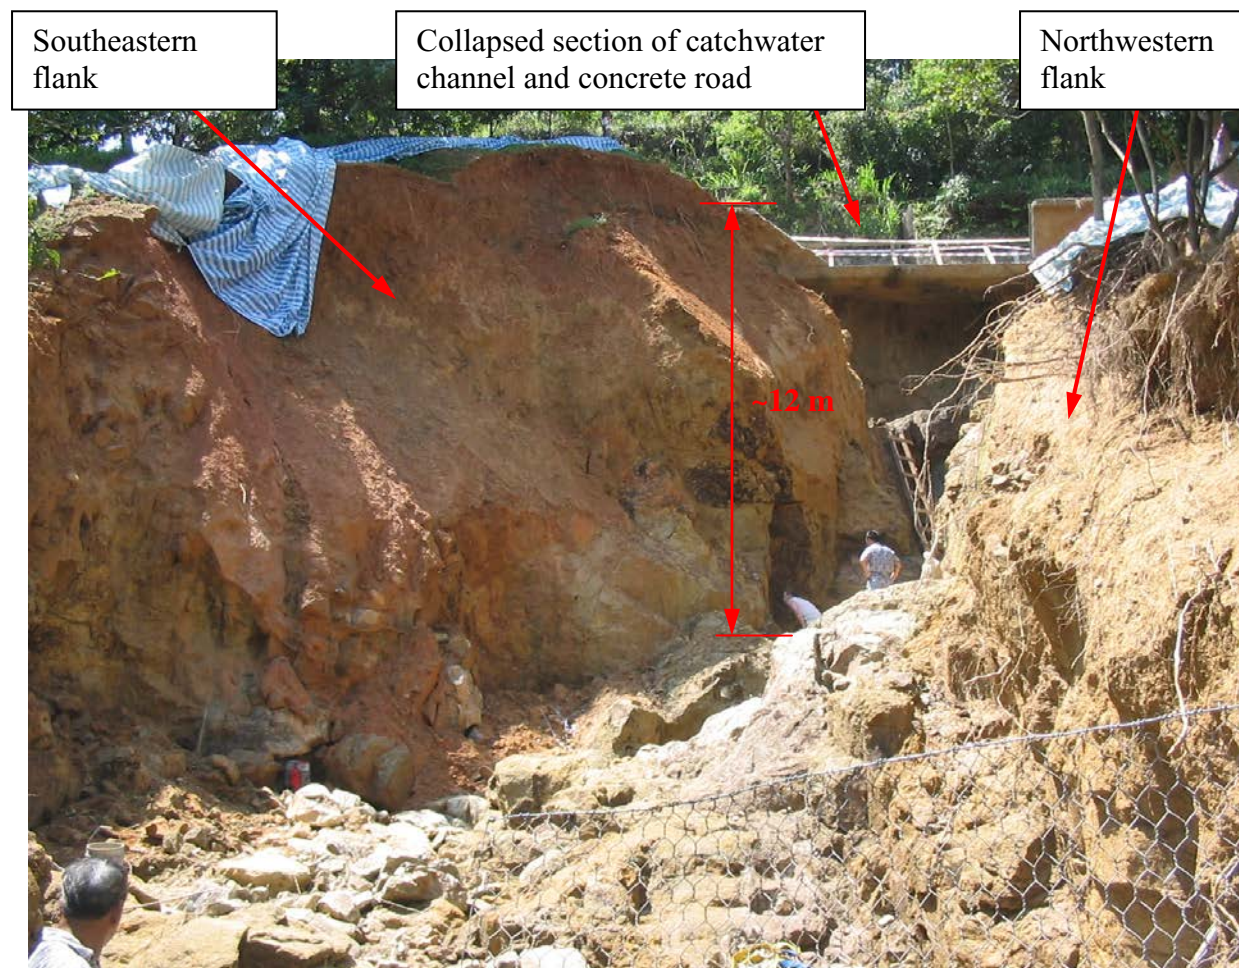
Plate 7 - General View of Scar 5 from Toe (Photograph taken on 16 September 2005 by MGSL)

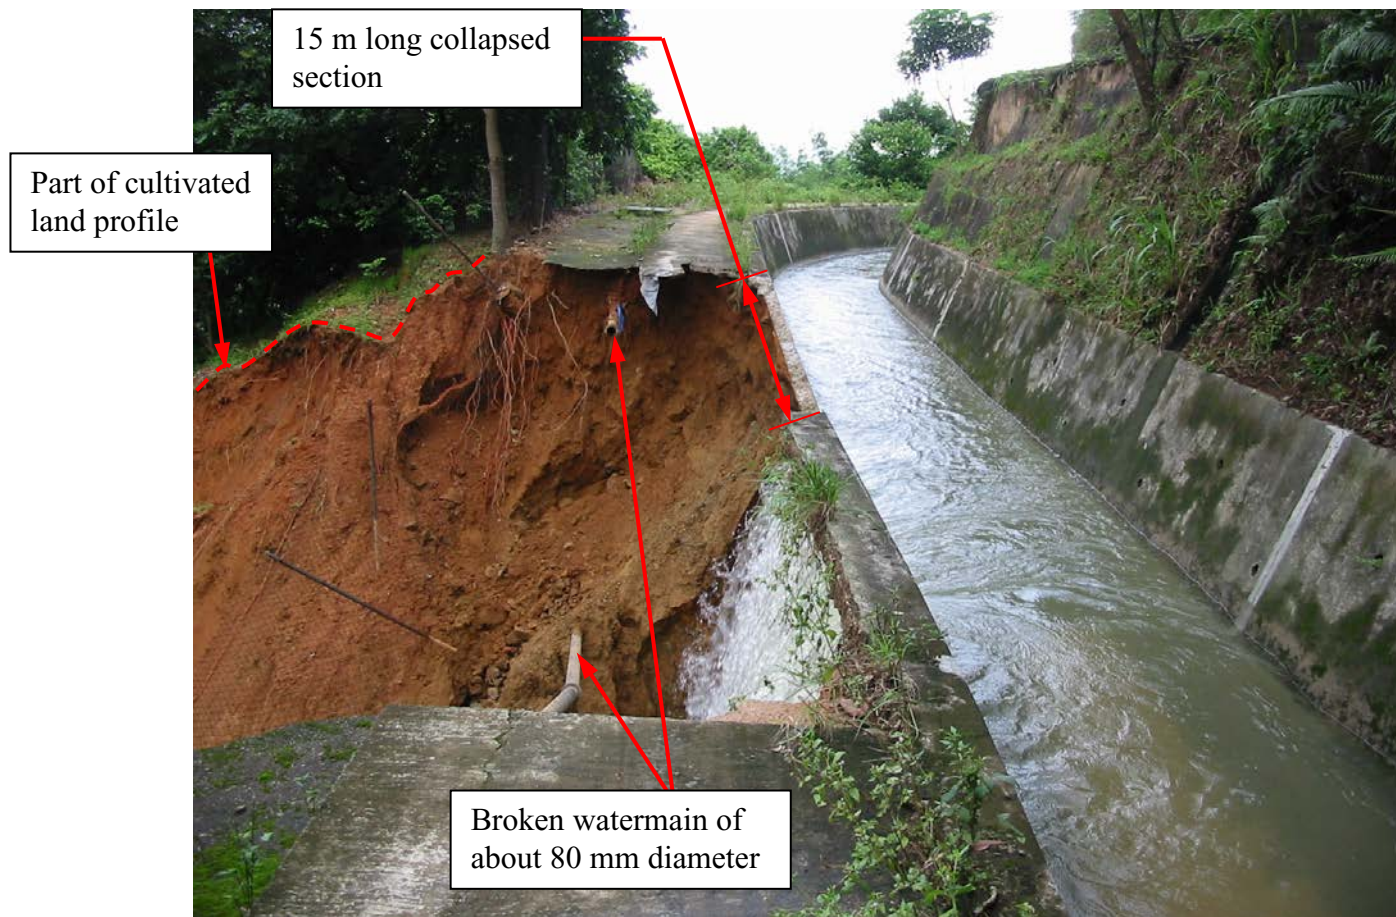
Plate 8 - Water Cascading Over Collapsed Section of Catchwater (Photograph taken on 21 August 2005 by MGSL)

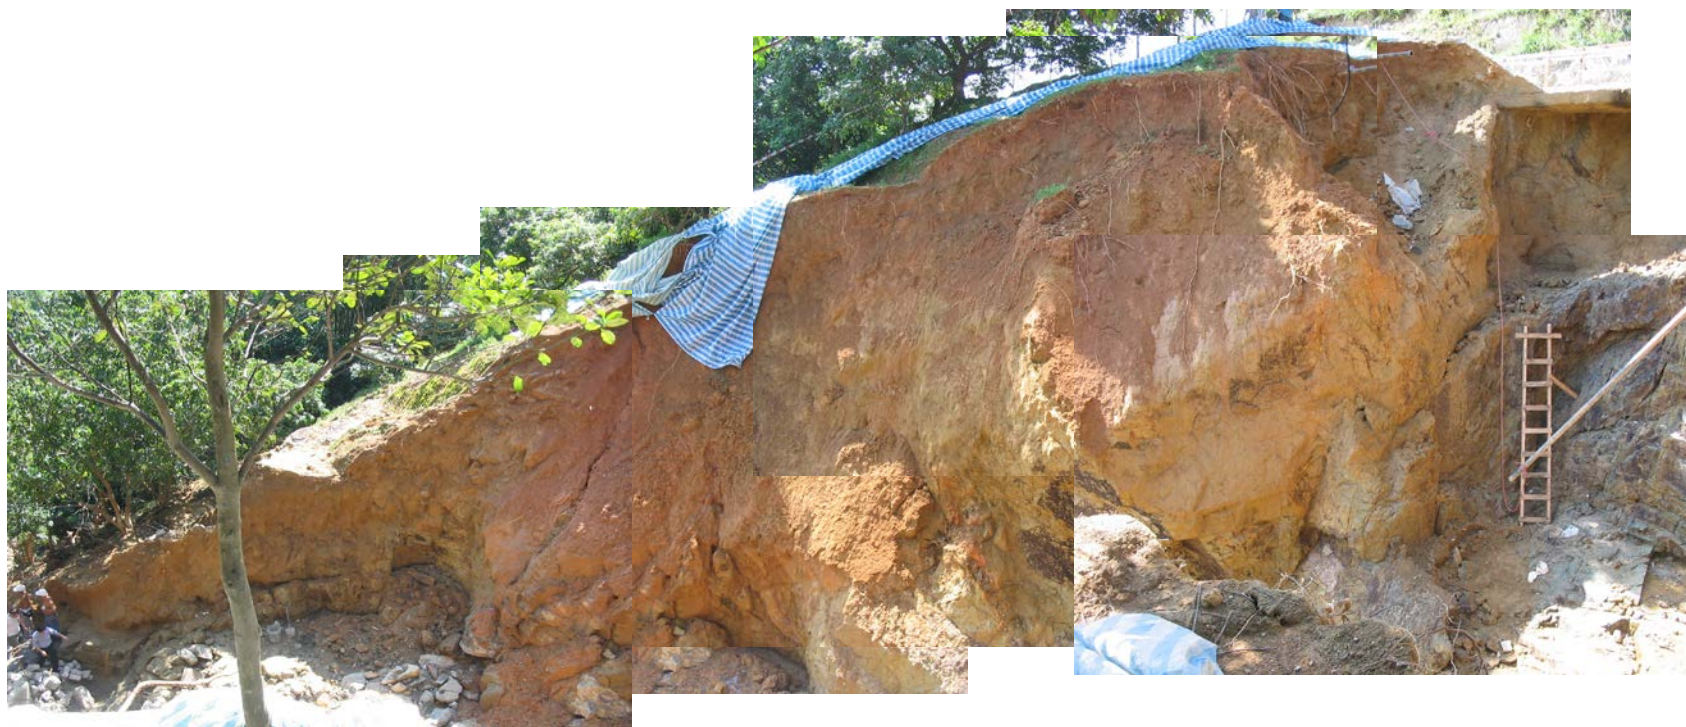
Plate 9 - General View of Southeastern Flank of Scar 5 (Photograph taken on 16 September 2005 by MGSL)
