**DETAILED STUDY OF
THE 15 SEPTEMBER 2006
DISTRESS ABOVE
SLOPE NO. 6NE-B/C44 AT
33A2 SHEK TONG TSUEN,
TA SHEK WU, PAT HEUNG**

GEO REPORT No. 293

AECOM Asia Company Limited

**GEOTECHNICAL ENGINEERING OFFICE
CIVIL ENGINEERING AND DEVELOPMENT DEPARTMENT
THE GOVERNMENT OF THE HONG KONG
SPECIAL ADMINISTRATIVE REGION**

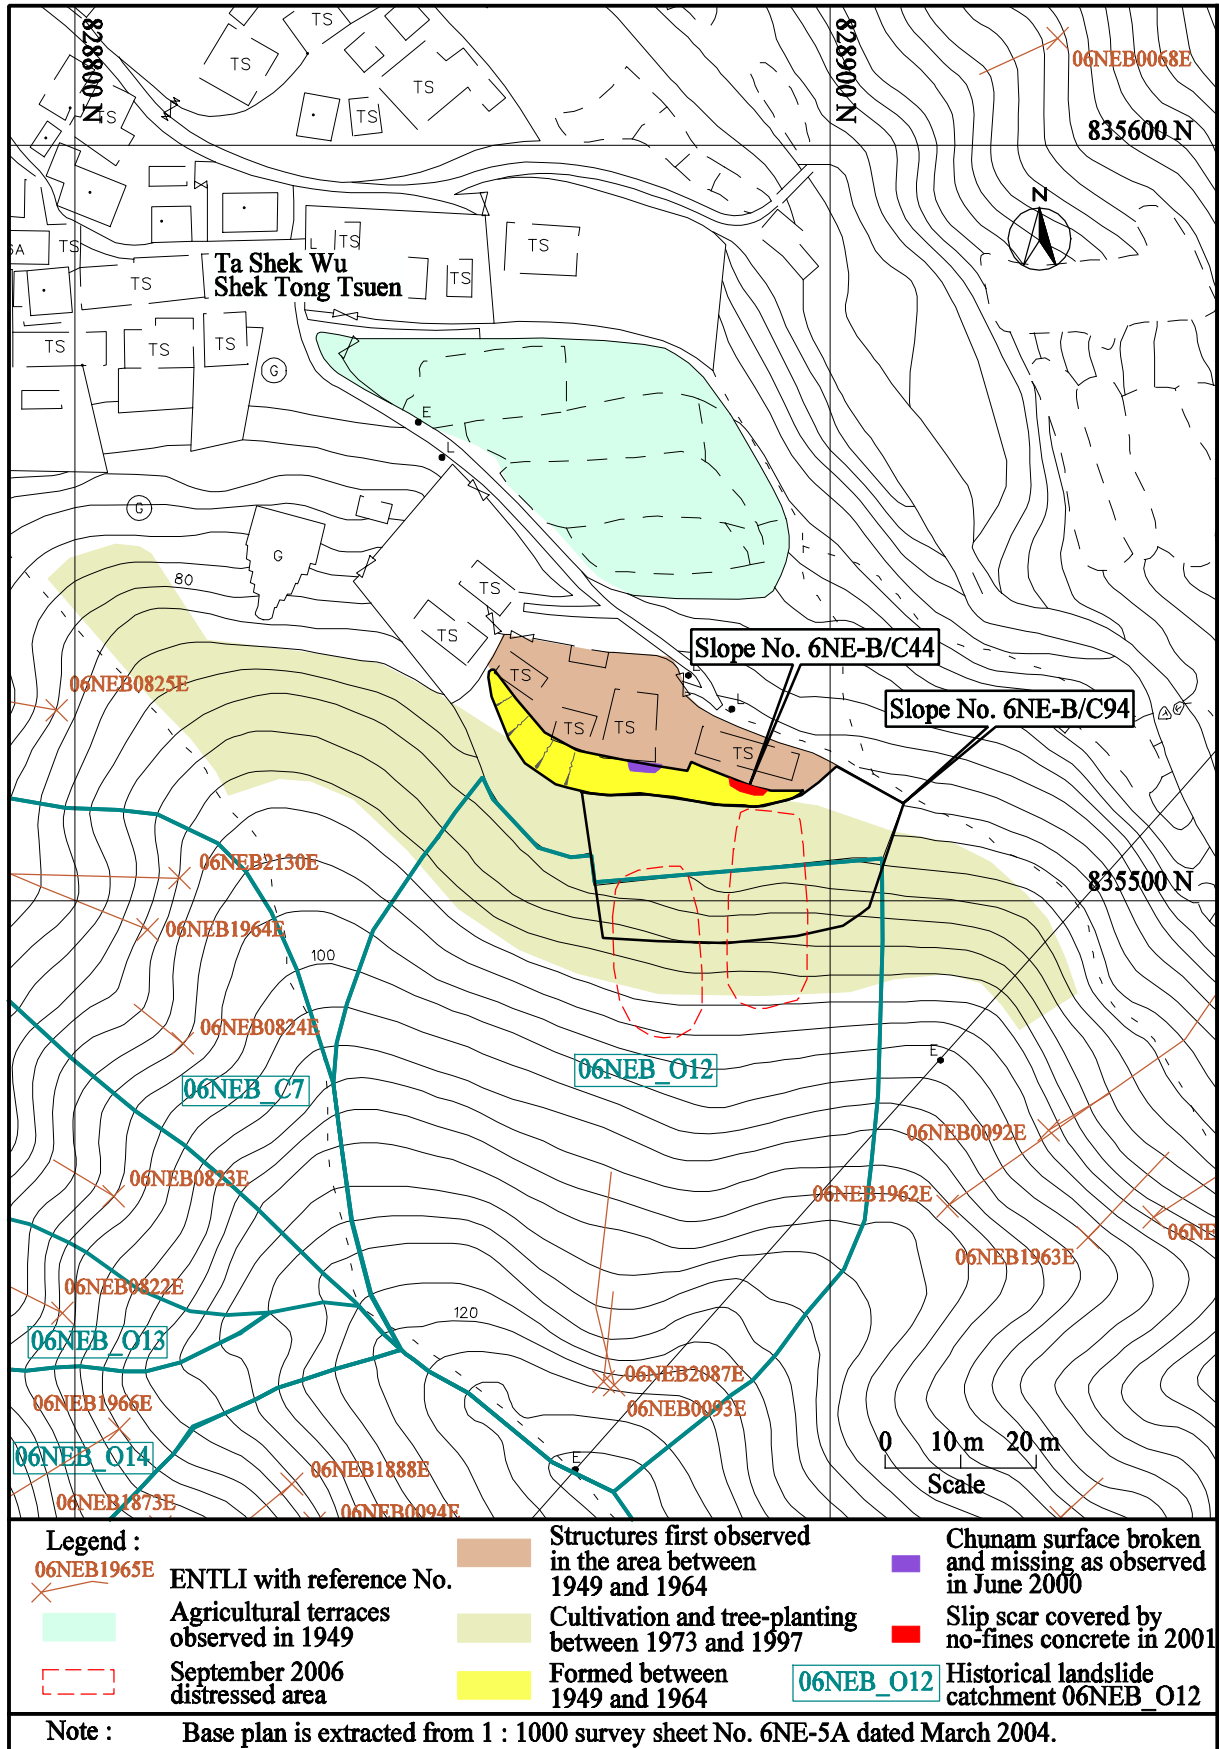
Figure 5 - Site History and Past Instabilities

In June 2000, MGSL carried out the New Priority Classification System (NPCS) data updating exercise for slope No. 6NE-B/C44 under Agreement No. CE 3/2000. During the inspection by MGSL, a large portion of the chunam surface behind the 2-storey residential structure was found to be broken or missing (Figure 5).

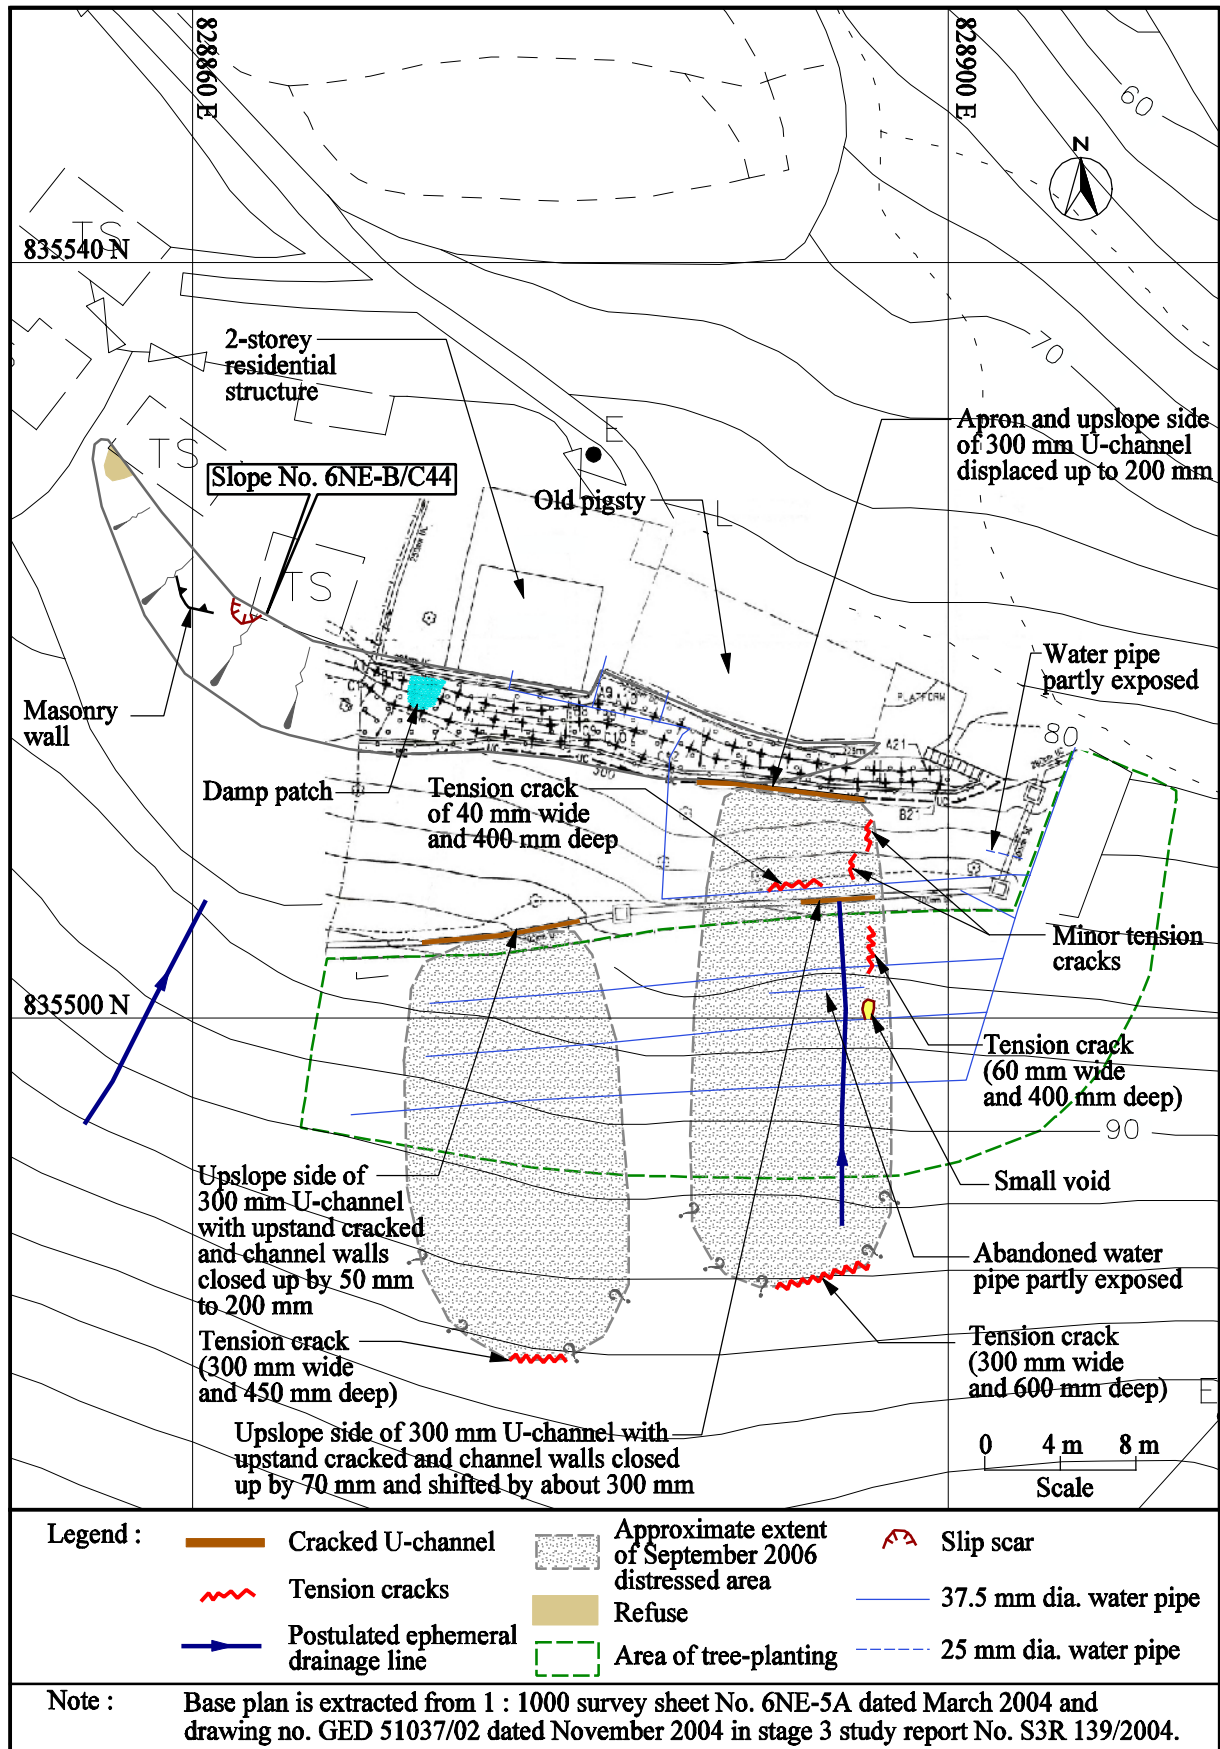
Figure 6 - Post-failure Observations by AECOM in September 2006

AECOM first inspected the site on 26 September 2006, following the report of the distress. The U-channel above and at the crest of the eastern portion of slope No. 6NE-B/C44 had deformed and cracked at three locations, above a pigsty and a 2-storey residential structure. Tension cracks were also observed on the hillside above, after clearance of the vegetation. No signs of distress were observed on the cut slope portion upgraded in 2005 under the LPM Programme. The locations of the signs of distress are shown in Figure 6. Details are summarized below.

Cracks on the surface of the sloping ground in the vicinity of the above cracked U-channel sections were also observed (Figure 6) during the inspection in September 2006. These cracks appeared to be recent and were running in directions approximately parallel or normal to the crest line of the slope. Plate 10 shows one of the tension cracks which was about 40 mm wide located at the downslope side of the upper 300 mm U-channel. The deformations of the two sections of U-channel, together with the cracks on the slope surface, suggest the presence of a wider distressed area extending into the hillside above the cut slope. The distressed area was estimated to be about 9 m wide. Part of the area further above the hillside was later cleared (Section 7.2), and a 300 mm wide and 600 mm deep tension crack was observed at about 20 m south of the upper 300 mm U-channel in November 2007 (Figure 6 and Plate 11). This tension crack was within the colluvium and the material was partly discoloured, suggesting the material might have been exposed for some time.

No signs of distress were observed on slope No. 6NE-B/C44. A network of water pipes was found in the area above and on the slope surface (Figure 6). No major seepage was

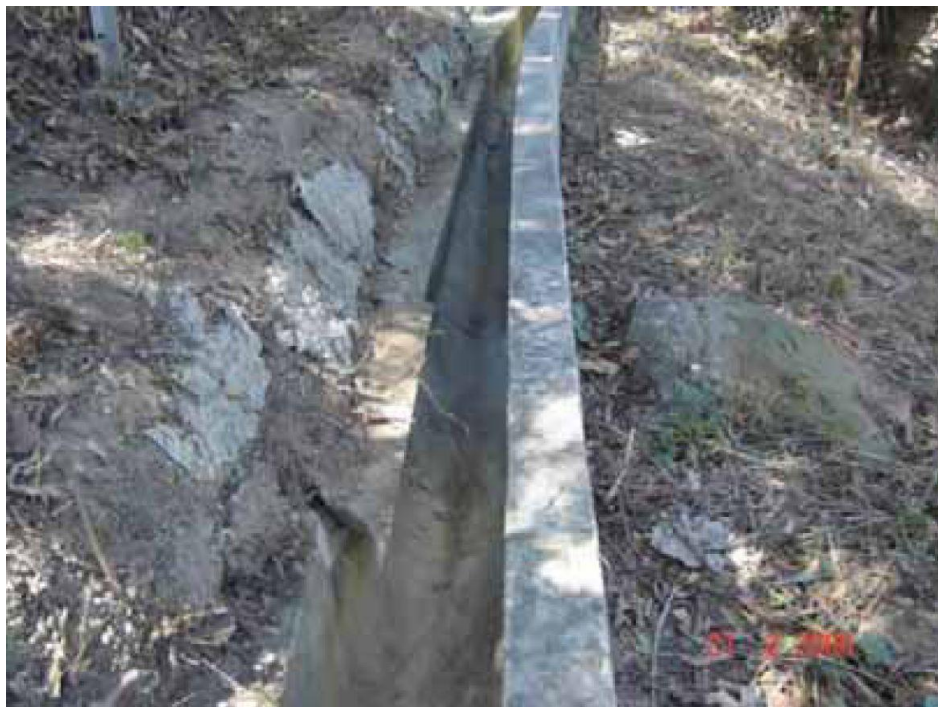
Routine Maintenance Inspections (RMI) of slope No. 6NE-B/C44 were undertaken by LandsD's consultants in 2002, 2003, 2005 and 2006. No sign of distress or seepage was observed, except that during the RMI of January 2006, cracking was noted at the top edge of the upper 300 mm U-channel (Plate 4, Figures 6 and 10). The salient observations made are summarized in Appendix B. The cracked channel was repaired in February 2006. This section of the channel was located at the lower edge of the eastern distressed area and was identified to have subsequently cracked and deformed in September 2006 (Plate 12, Figures 6 and 10).

Plate 4 - Cracked Upper 300 mm U-channel of Slope
No. 6NE-B/C44 (Photograph taken by OAP on
21 February 2006)

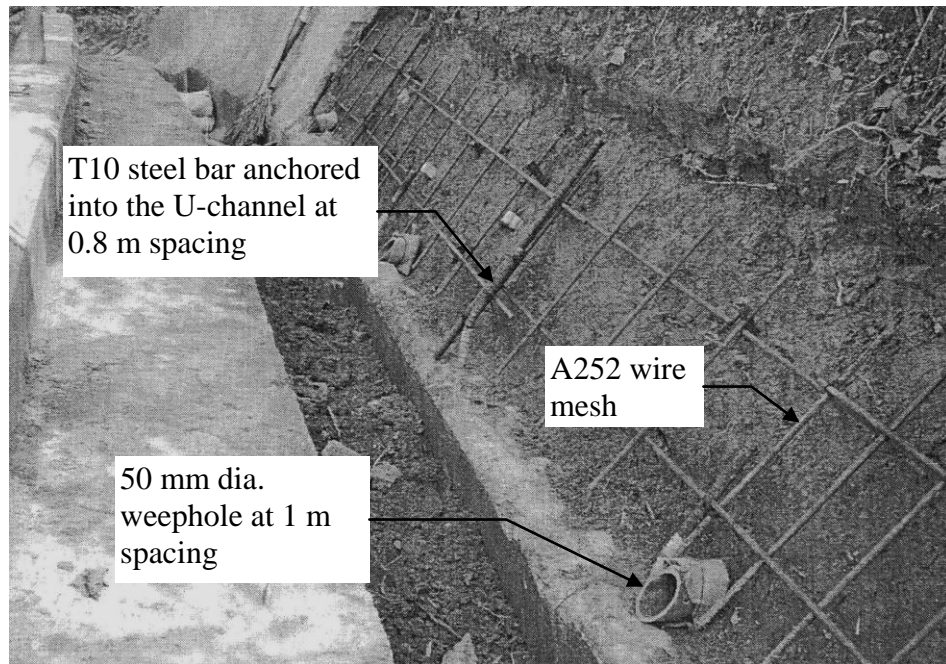
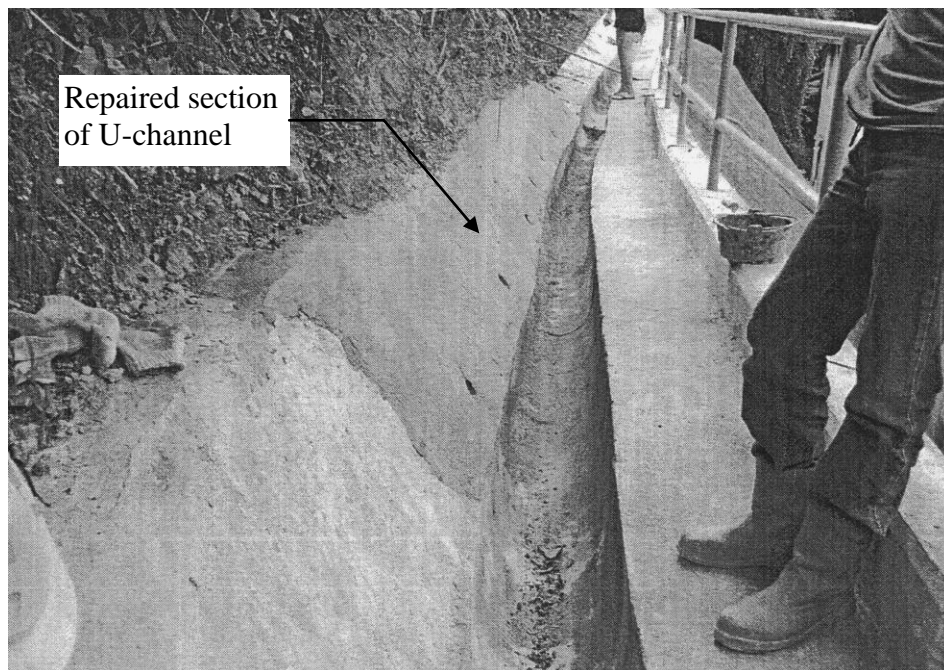
In September 2005, about five months after the completion of the upgrading works, cracks were observed on the aprons of the 300 U-channel at the slope crest. The cracked section of the apron was reconstructed by mid-October 2005 (Plates 5 and 6). The location of the cracks coincides with the eastern distressed area observed in September 2006.

Plate 5 - Repair of Cracked U-channel along the Crest of Slope No. 6NE-B/C44 Looking Southeast
(Photograph taken by LandsD on 3 October 2005)

Plate 6 - Repair of Cracked U-channel along the Crest of Slope No. 6NE-B/C44 Looking West
(Photograph taken by LandsD on 3 October 2005)

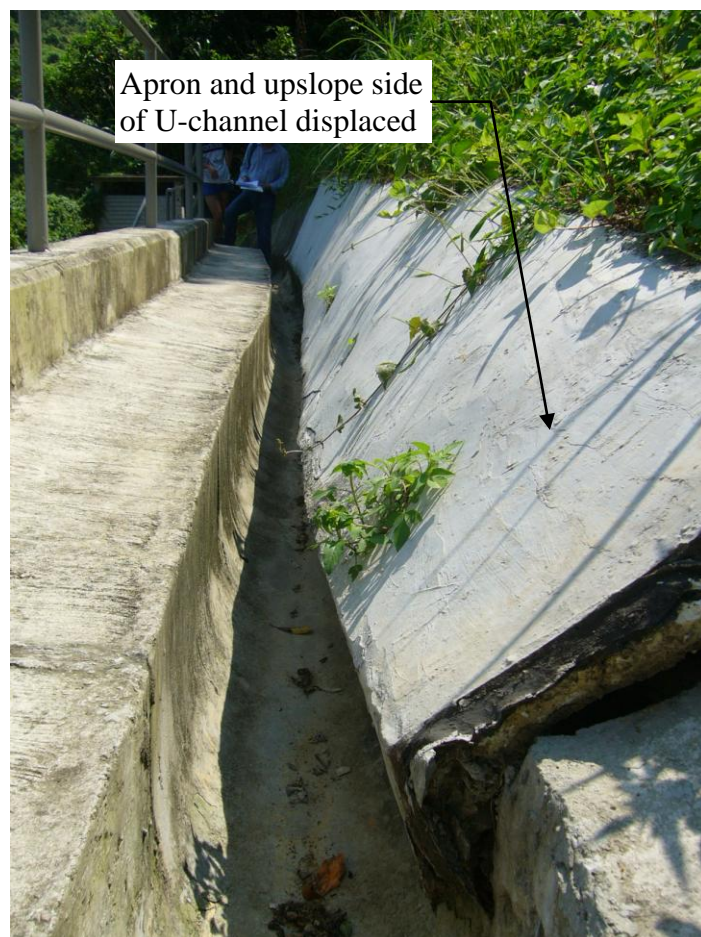
Near the abandoned pigsty, an approximately 9 m long section of the 300 mm wide and 300 mm deep U-channel at the crest of the cut slope had deformed. The apron and uphill side of the channel had cracked and displaced by up to 200 mm (Plate 7). The U-channel was clear of any blockage at the time of the inspection. A 4 m long section of the upper 300 mm wide U-channel was also observed to have deformed and shifted outward in the downslope direction by some 300 mm (Plate 8). Based on a photograph taken in the 2003 RMI (Plate 9), the alignment of this section of the U-channel was straight at that time. This U-channel was also clear of any blockage at the time of inspection.

Plate 7 - View of the Displaced 300 mm U-channel
along the Crest of Slope No. 6NE-B/C44
(Photograph taken on 26 September 2006)

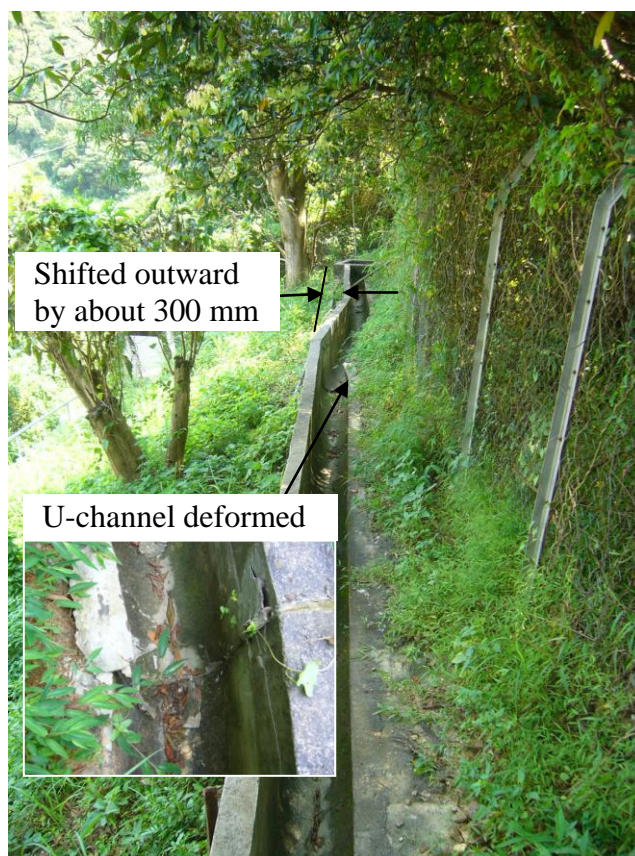
Plate 8 - Deformed Upper 300 mm U-channel near the Eastern End of Slope No. 6NE-B/C44 Looking East (Photograph taken on 26 September 2006)

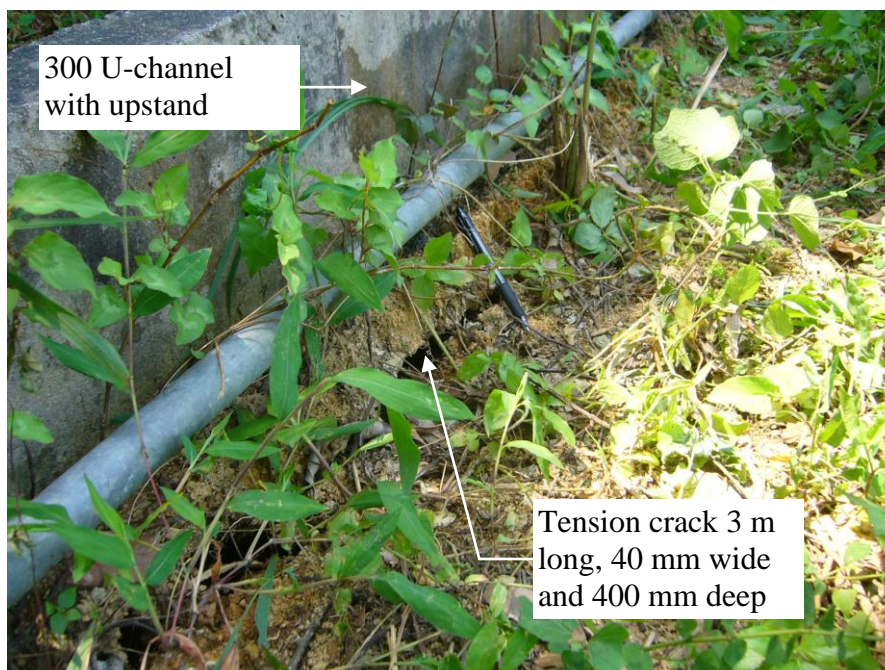
Plate 10 - Tension Crack on Downslope Side of the Upper 300 mm U-channel
(Photograph taken on 26 September 2006)

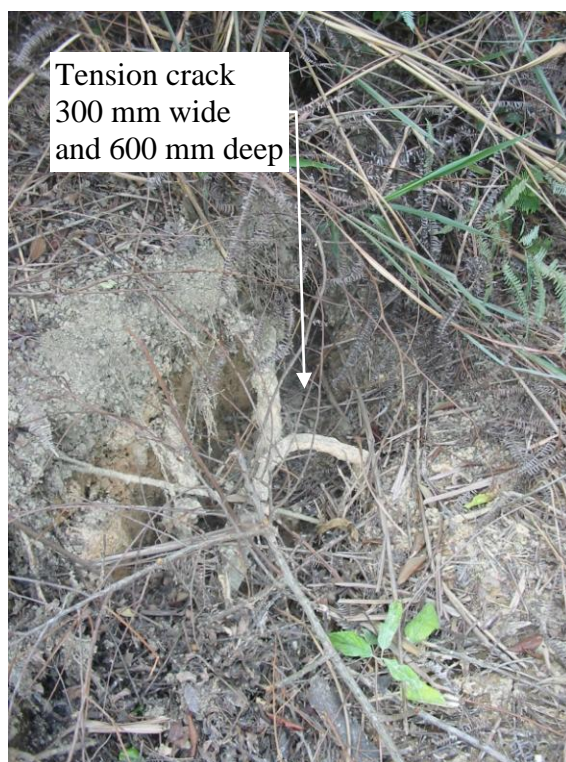
Plate 11 - Tension Crack on Area above Slope No. 6NE-B/C44
(Photograph taken on 19 November 2007)

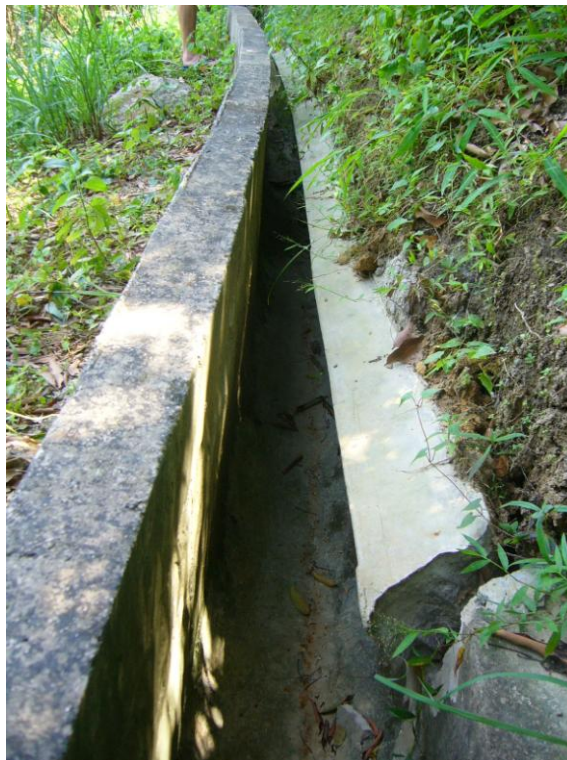
On the hillside behind the 2-storey residential structure (Figure 6) to the southwest of the pigsty was another section of the upper 300 mm U-channel that was cracked and deformed by up to about 200 mm (Plate 12). The affected section of the channel was about 10 m long. The U-channel was clear of any blockage at the time of inspection. The distressed area was estimated to be about 10 m wide. A 300 mm wide and 450 mm deep tension crack was observed about 22 m above the upper U-channel in the November 2007 inspection (Figure 6 and Plate 13). Partly discoloured material was also observed in this tension crack.

Plate 12 - Deformed Upper 300 mm U-channel
(Photograph taken on 26 September 2006)

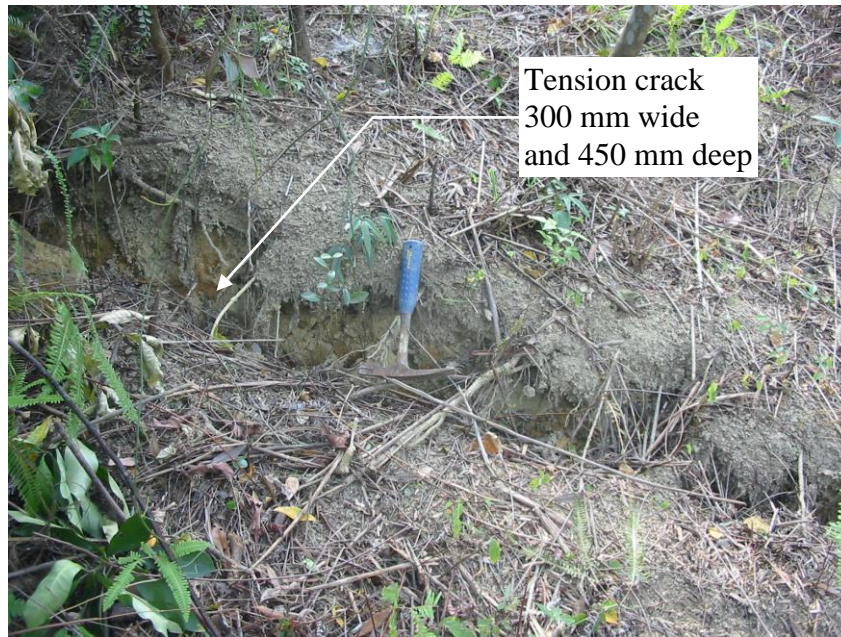
The site may have been subject to deterioration given the presence of recent and relict landslides as well as tension cracks in the hillside above. The tension cracks were probably pre-existing as evidenced by the partly discoloured infill material observed. Presence of such tension cracks would have increased infiltration and water ingress into the near-surface ground mass during heavy rainfall, further destabilising the ground.

Plate 13 - Tension Crack on Area above Slope No. 6NE-B/C44
(Photograph taken on 19 November 2007)

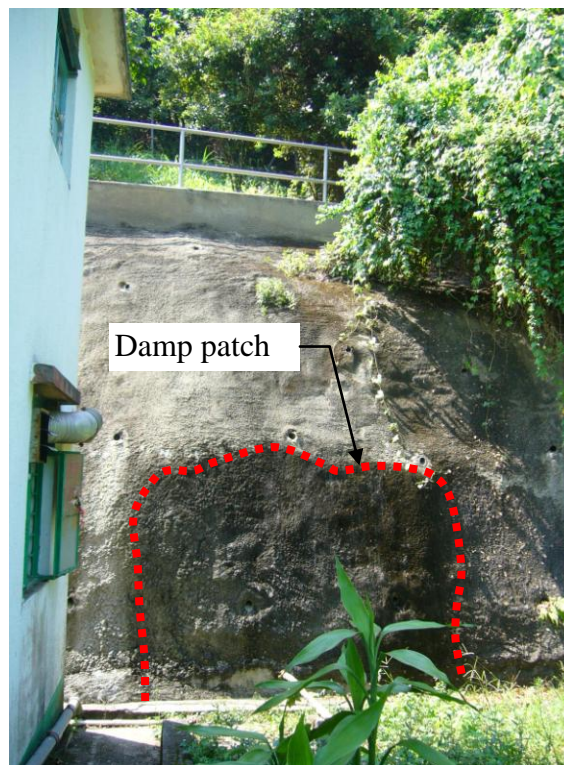
observed although a damp patch was visible on the shotcrete surface (Figure 6 and Plate 14). Some discolouring of the shotcrete surface was also observed, which might be associated with previous seepages (Plate 15).

Plate 14 - Damp Patch on Shotcrete Surface
(Photograph taken on 26 September 2006)

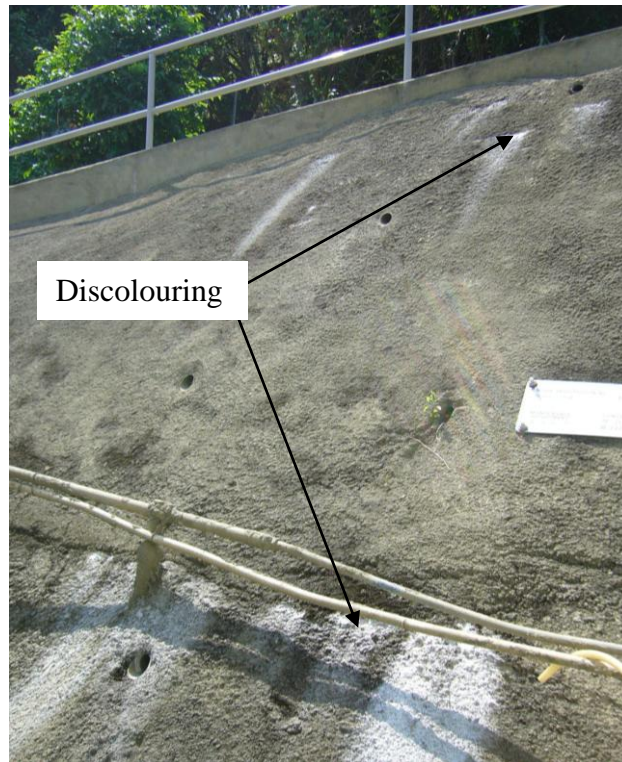
Plate 15 - Discolouring on Shotcrete Surface
(Photograph taken on 26 September 2006)

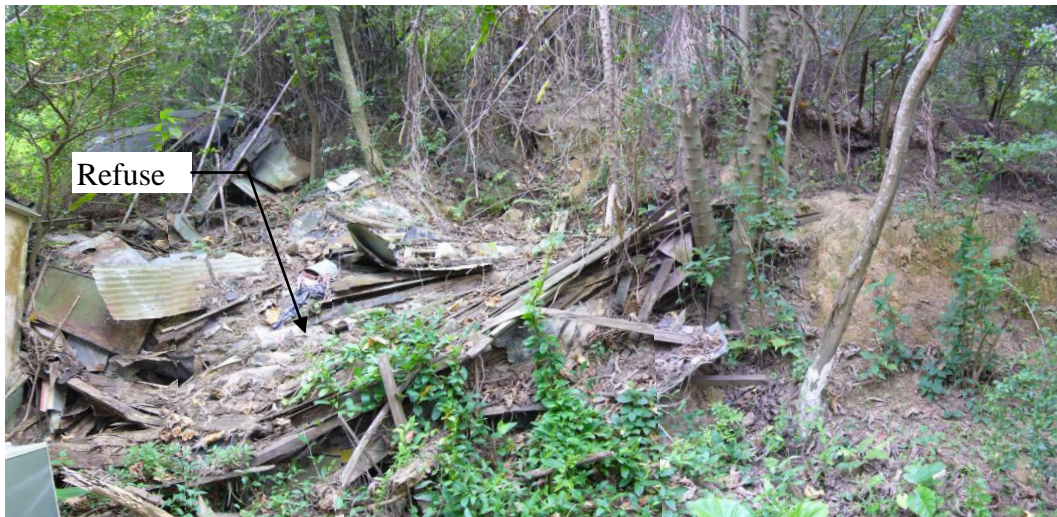
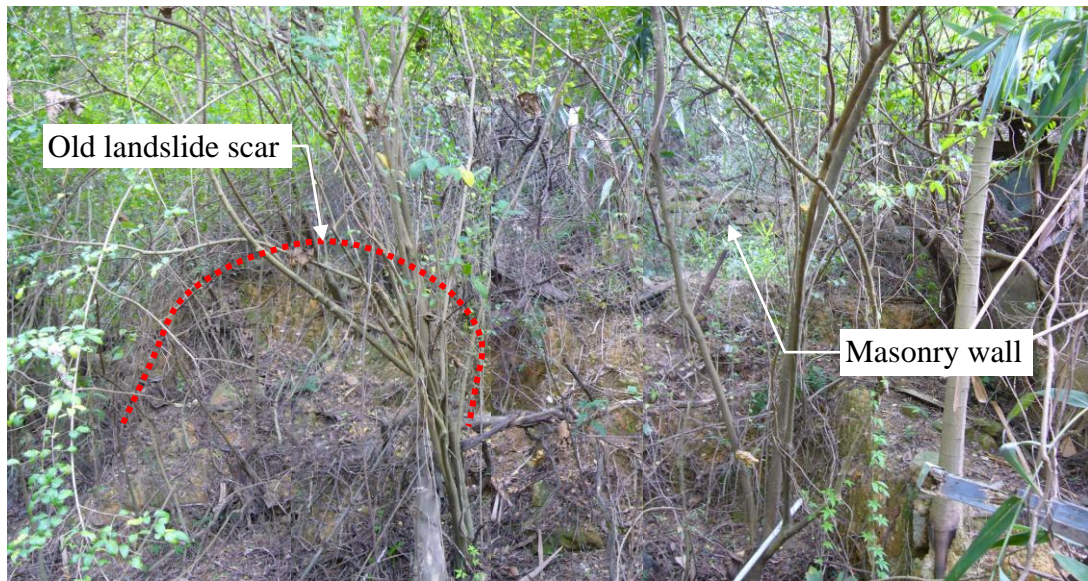
The western portion of slope No. 6NE-B/C44, which was not upgraded under the LPM Programme, was inspected although access was limited owing to the presence of dense vegetation cover and refuse (Figure 6, Plates 16 and 17). The slope is up to 5 m high, with a slope angle of about 40° to 50°. The slope profile is relatively irregular, with a masonry wall of about 1 m high present on the slope. An old landslide scar measured about 2 m wide, 2 m long and 0.5 m deep was also observed (Figure 6 and Plate 17). An abandoned structure was observed at the toe of this portion of the slope (Plate 18).

Plate 16 - View of the Western End of Slope No. 6NE-B/C44
Looking Southwest (Photograph taken on
9 May 2007)

Plate 17 - General View of the Western Portion of Slope
No. 6NE-B/C44 Looking Southwest (Photograph
taken on 9 May 2007)

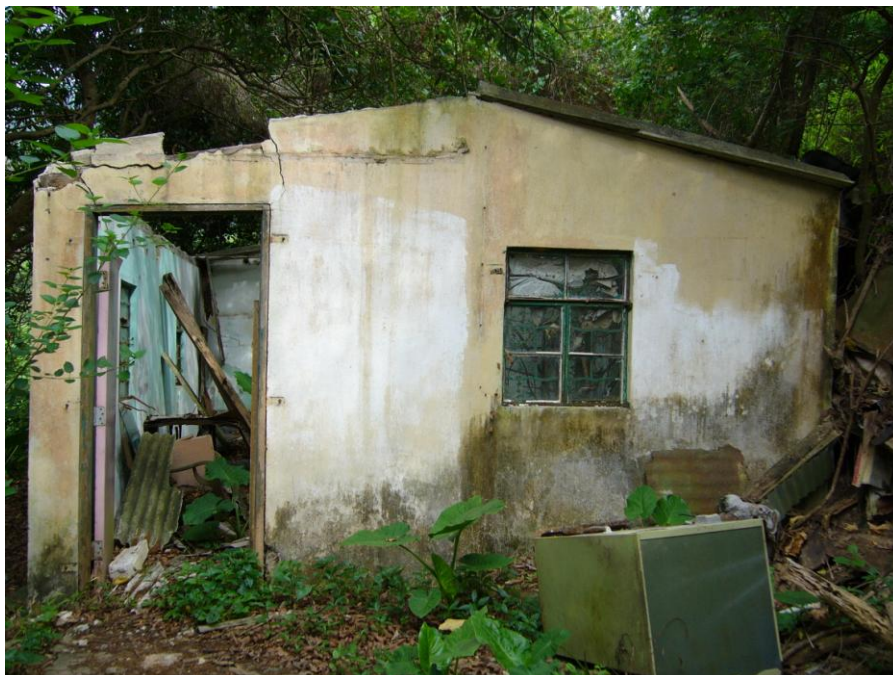
Plate 18 - Ruin at Toe of Western Portion of Slope No. 6NE-B/C44
(Photograph taken on 9 May 2007)
