Review of the June 2008 Landslide on Soil-nailed Slope No. 7NE-A/C167 at Ting Kok Road Tai Po

GEO Report No. 295

C.L.H. Lam

**Geotechnical Engineering Office
Civil Engineering and Development Department
The Government of the Hong Kong
Special Administrative Region**

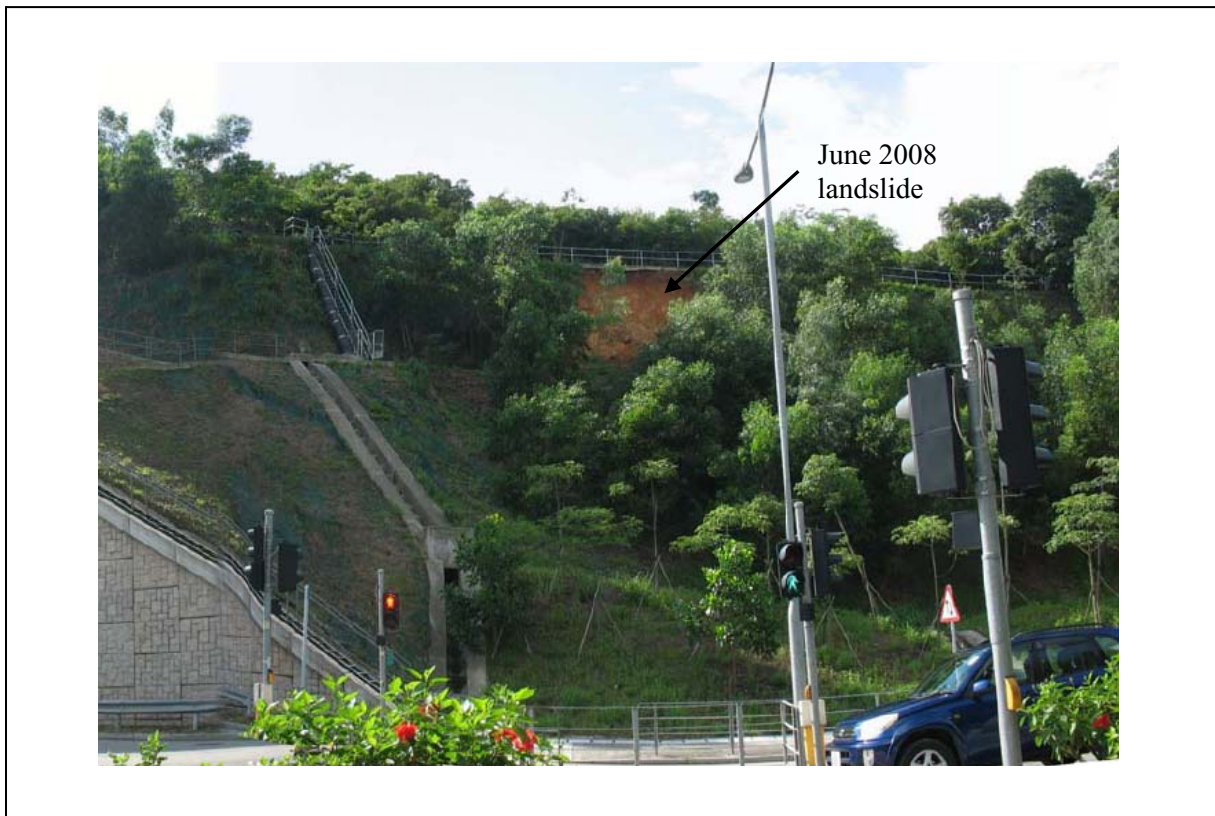
A landslide incident (Incident No. 2008/06/0320) involving a soil-nailed cut slope No. 7NE-A/C167 located along Ting Kok Road, Tai Po (Figure 1.1) was reported on 12 June 2008. The landslide probably occurred on 7 June 2008 at the upper batter of the cut slope, with a failure volume of about 20 m³. The debris was largely deposited on the berm immediately below the landslide scar, exposing four soil nail heads. The landslide did not result in any casualties or road closure.

Figure 1.1 General View of the June 2008 Landslide at Slope No. 7NE-A/C167 (Photograph taken on 11 June 2008)

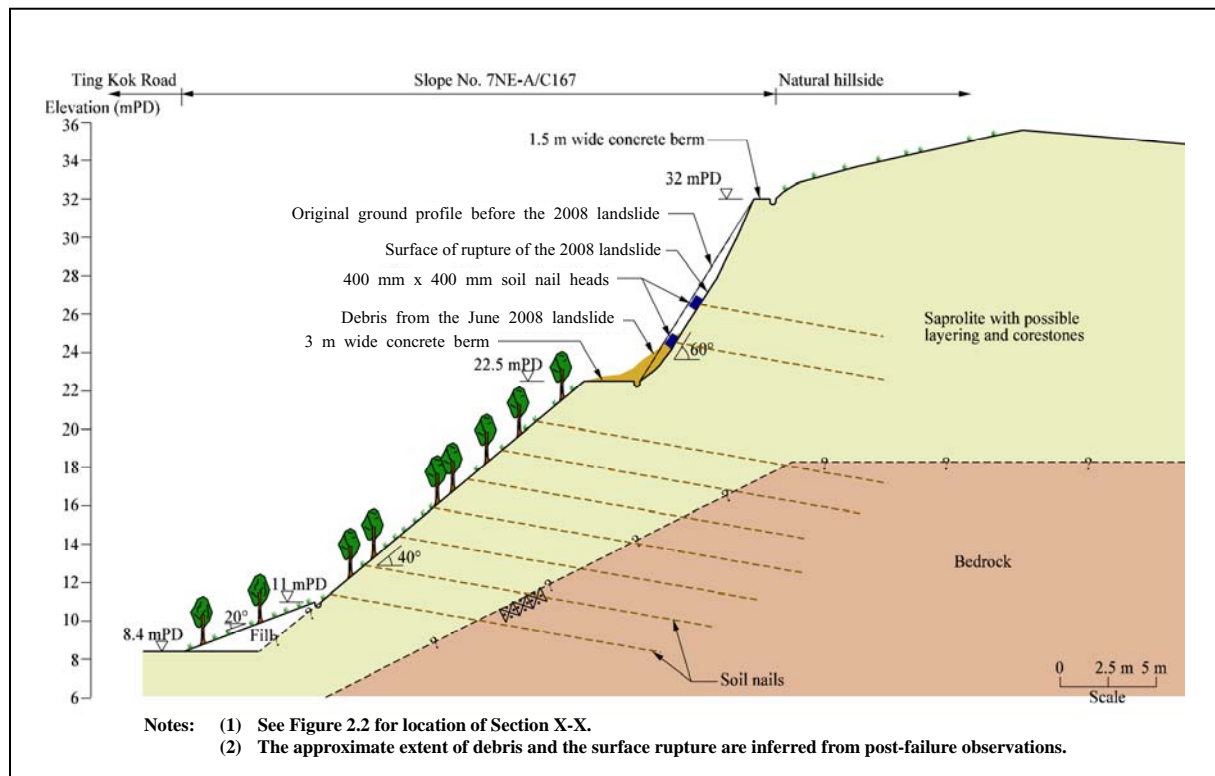
Figure 2.3 Geological Section X-X through the Landslide Scar

The slope works were completed in July 2006. Based on the as-built record, a 2.6 m high fill body was provided at the toe of the slope (Figure 2.3), probably as additional toe support. In December 2006, the GEO issued a checking certificate (Ref. No. GEO/ME042/2006) for the slope.

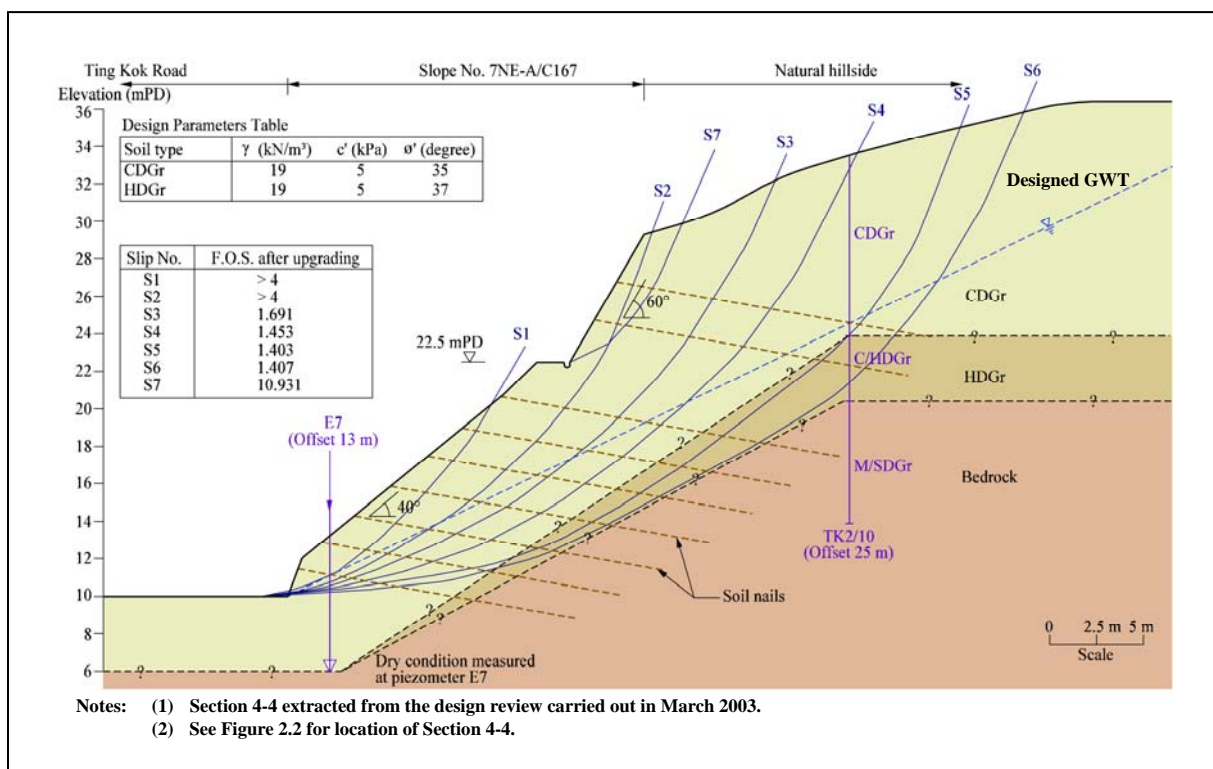
In February 2003, during construction, discrepancy was found between the slope profile formed and that required in the design. A design review was subsequently conducted and a stability check was also carried out in March 2003, taking into account that the slope angle of the upper batter had increased from 52° to 60° (Figure 4.2). The groundwater table was assumed at 3 m above bedrock (i.e. about 10 m below ground level) for a 10-year return period rainfall. No perched water table was modelled in the analysis. The review confirmed that no changes to the details of soil nails were necessary, as the calculated minimum FoS was found adequate. It was considered that there was no major design change and hence the design amendment to the slope profile was not submitted to the GEO for vetting.

Figure 4.2 Revised Design Geological Section 4-4

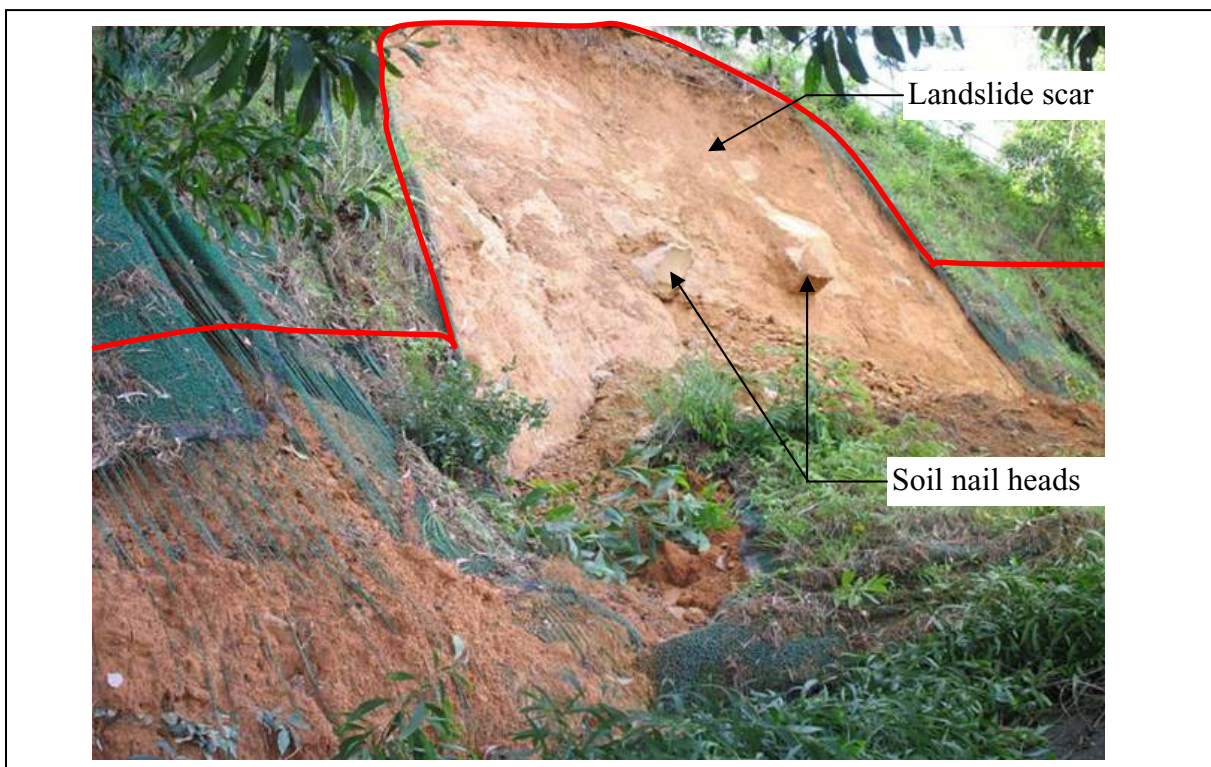
The landslide was shallow, comprising a central portion and two “wings”. The central portion of the landslide measured about 8 m wide by 7 m long, up to 0.5 m deep. The detached portions on both sides (i.e. the “wings”) measured about 5 m wide by 4.5 m long (Figures 2.2 and 5.1). The total failure volume was about 20 m³.

Figure 5.1 View of the Landslide Scar (Photograph taken on 11 June 2008)

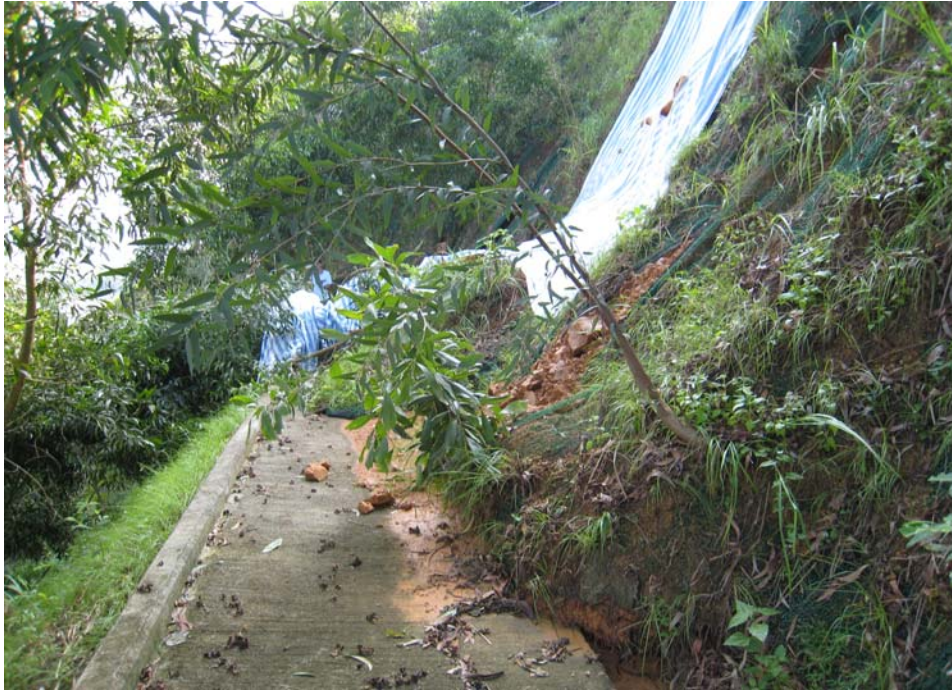
Debris from the central portion of the landslide was largely deposited on the berm immediately below (Figure 5.2), while debris detached from the sides was mostly retained by the erosion control mat present (Figures 5.3 and 5.4). No wire mesh was provided on the top of the erosion control mat. The debris comprised yellowish brown, sandy clayey SILT of completely to highly decomposed granodiorite, with occasional cobble-sized fragments of moderately decomposed granodiorite (Figure 5.4).

Figure 5.2 Side View of the Landslide and Slope Berm (Photograph taken on 19 June 2008)

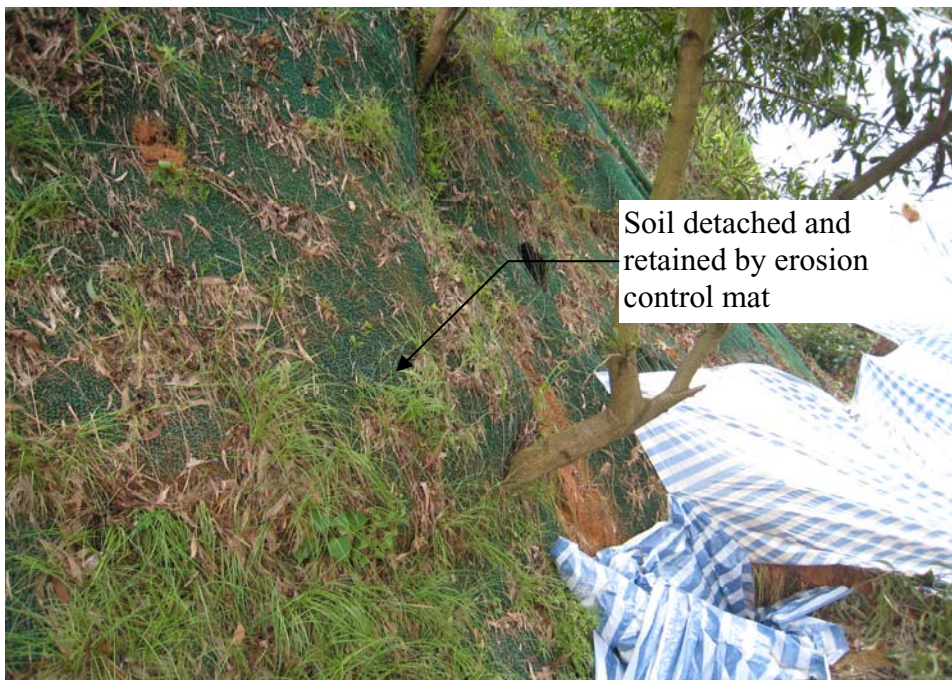
Figure 5.3 View of the Minor Detachment on the West (Photograph taken on 19 June 2008)

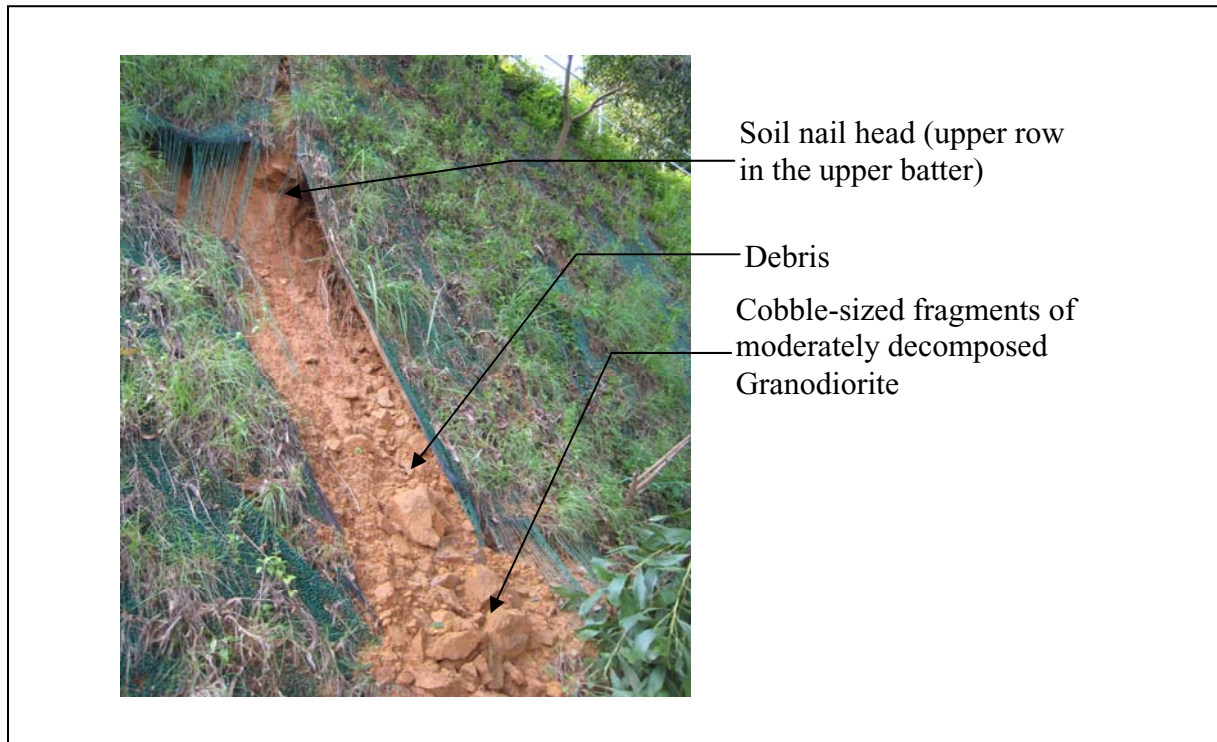
Figure 5.4 View of the Minor Detachment on the East (Photograph taken on 19 June 2008)

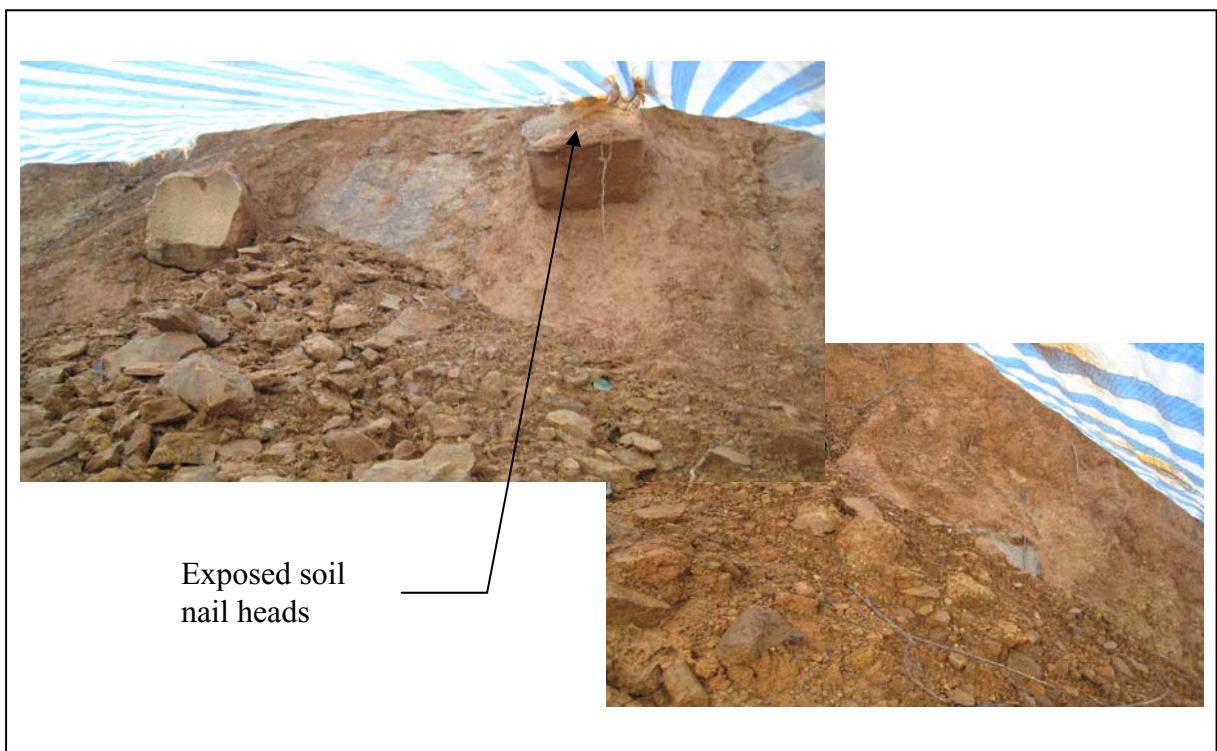
Four soil-nail heads of 400 mm x 400 mm were exposed on the landslide scar (Figures 2.2 and 5.5). No damage to the exposed soil nail heads was observed during the post-failure inspection on 19 June 2008. Above the nail heads, the landslide scar involved a 4 m high unsupported portion of the cut slope, immediately below the crest channel (Figure 5.6).

Figure 5.5 View of the Exposed 400 mm x 400 mm Soil Nail Heads (Photograph taken on 19 June 2008)

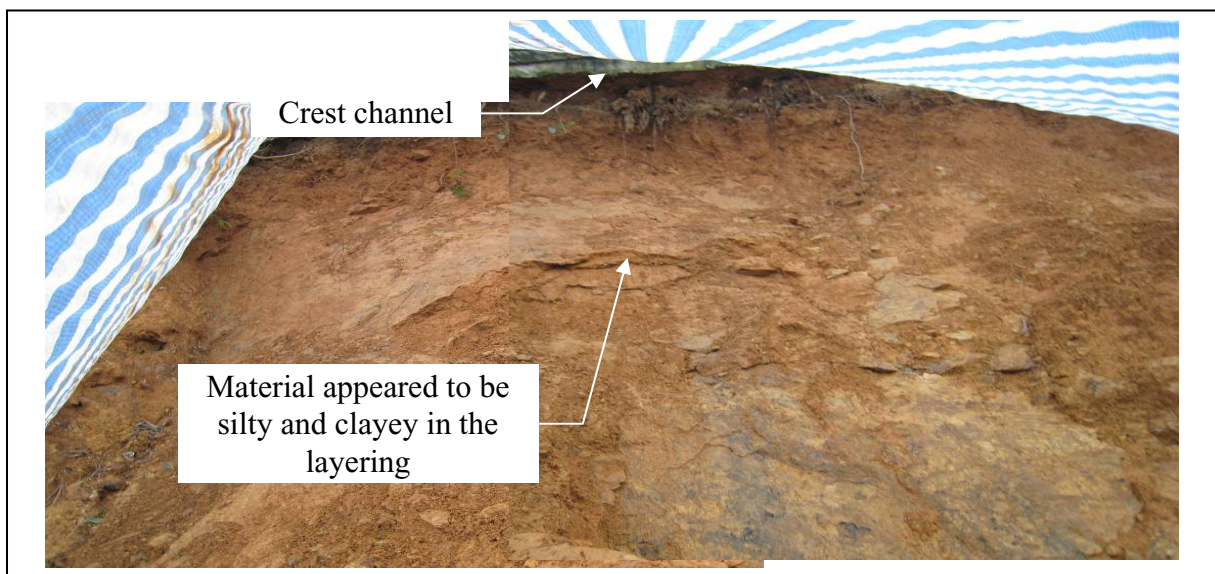
Figure 5.6 View of Layering at the Landslide Scarp (Photograph taken on 19 June 2008)

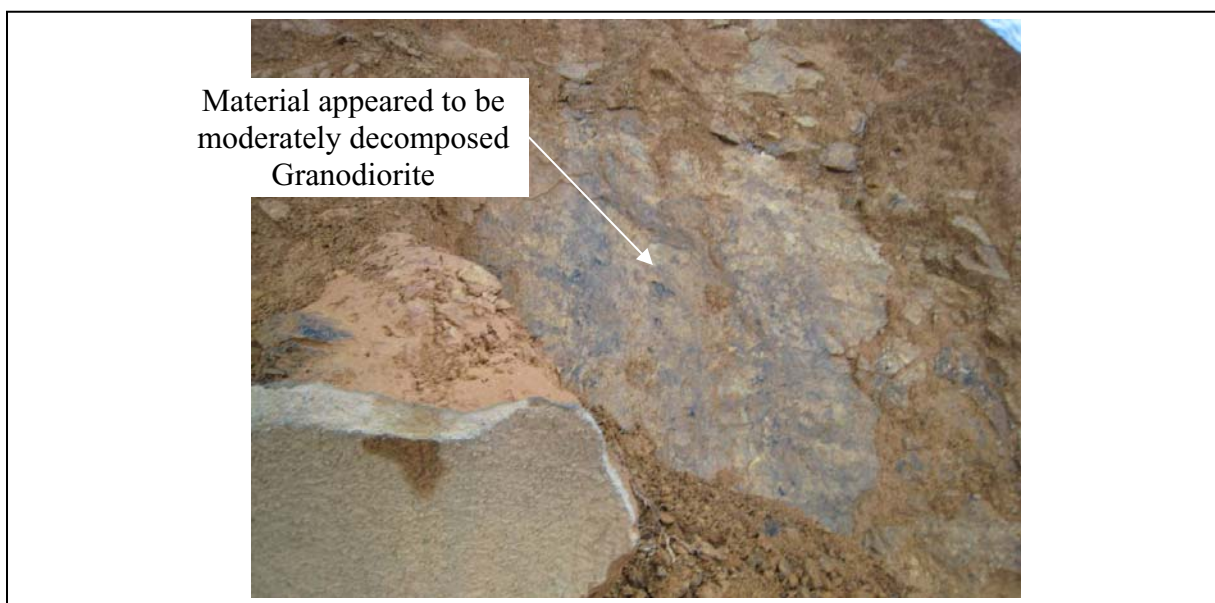
The rupture surface mainly ran along the near surface CDGr. A relict joint plane measuring about 3 m wide and 1 m long was observed on the central portion of the landslide scar, in-between the exposed nail heads (Figures 5.5 to 5.7). The dip angle/orientation of the joint is 58/165, which is sub-parallel to the 60° slope. The joint could have daylighted on the slope surface prior to the failure. A portion of the joint plane exposed moderately decomposed granodiorite (MDGr), which could be part of a corestone (Figure 5.7). Some layering with similar dipping and orientation was observed at the landslide scarp (Figure 5.6), which could be an extension of the relict joint exposed at the central portion of the landslide. The lateral extent of the relict joint is uncertain as the debris detached from both sides was retained in place by the erosion control mat at the time of inspection.

Figure 5.7 Close-up View of the Joint Plane Exposed between the Nail Heads (Photograph taken on 19 June 2008)
