**REVIEW STUDY OF THE
7 JUNE 2008 LANDSLIDE
ON SLOPE NO. 11NE-A/C351
AND THE NATURAL HILLSIDE
ABOVE SHATIN PASS ROAD,
TSZ WAN SHAN**

GEO REPORT No. 302

AECOM Asia Company Limited

**This report is largely based on GEO Landslide Study Report
No. LSR 4/2010 produced in August 2010**

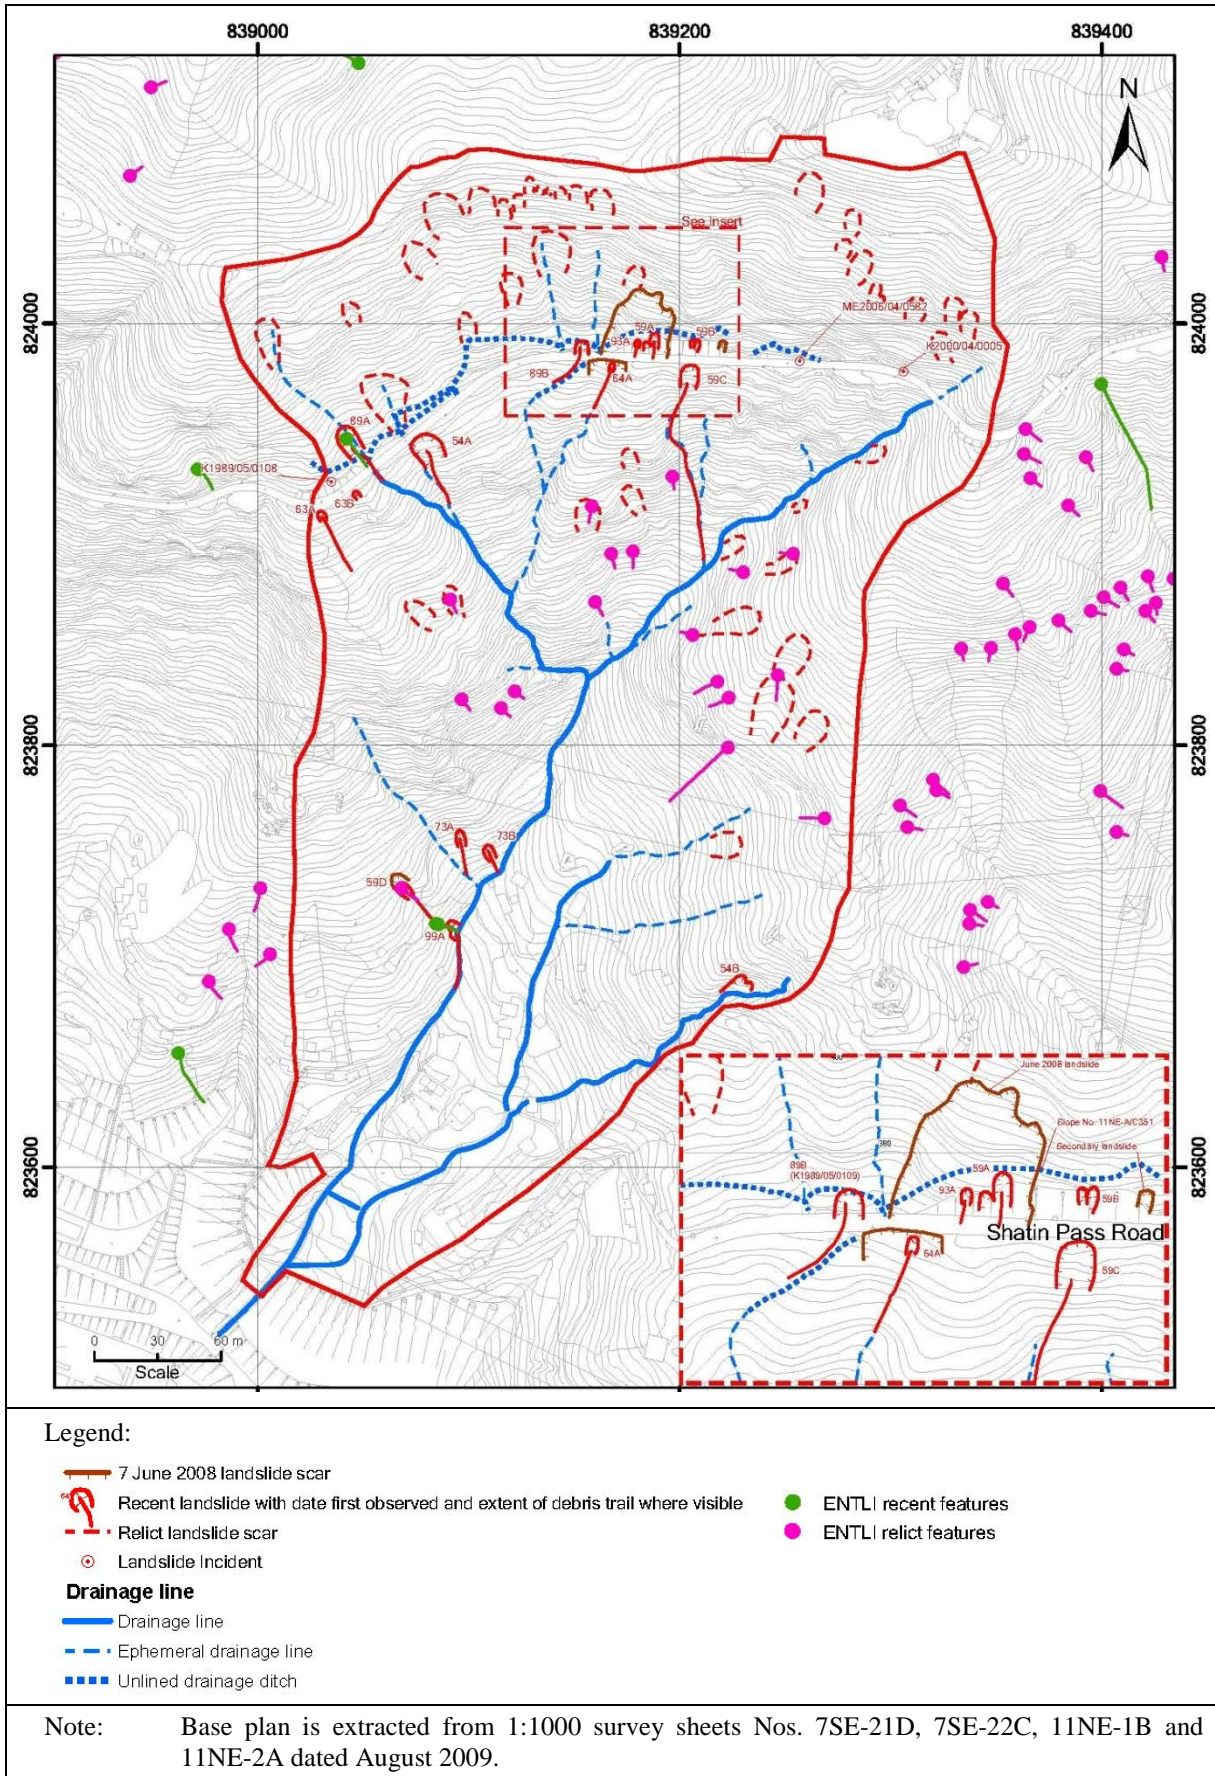
Figure 4 - Drainage Lines and Past Instabilities

The 1959 aerial photographs show two landslides (labelled 59A and 59B on Figure 4) at the western end of slope No. 11NE-A/C351. Landslide No. 59A is located within the 7 June 2008 landslide. The main scarp of the failure extends above the cut slope to the unlined drainage ditch above (Plate A4). Another failure is also visible some 30 m southeast of the 7 June 2008 landslide, and is located on the hillside below Shatin Pass Road (labelled 59C on Figure 4).

In the 1964 aerial photograph a minor failure is visible within the pocket of possibly fill materials below the 7 June 2008 landslide (labelled 64A on Figure 4). The debris entered the ephemeral drainage line DF1, with a runout distance of about 10 m. The debris flow resulting from the 7 June 2008 landslide occurred along this ephemeral drainage line, which is referred to as “CDF1” in Figure 5.

Landslide Incident No. K89/5/109 (Plate A7) was observed on the 1989 aerial photographs and labelled as 89B on Figure 4. This incident occurred adjacent to the 7 June 2008 landslide (Plates 19 and 20). The failure volume was about 15 m³ based on the incident record.

Another minor failure was observed within the source area of the 7 June 2008 landslide on the 1993 aerial photograph and is labelled 93A on Figure 4. The scarp of the failure appeared to have terminated along the unlined drainage ditch above the cut slope.

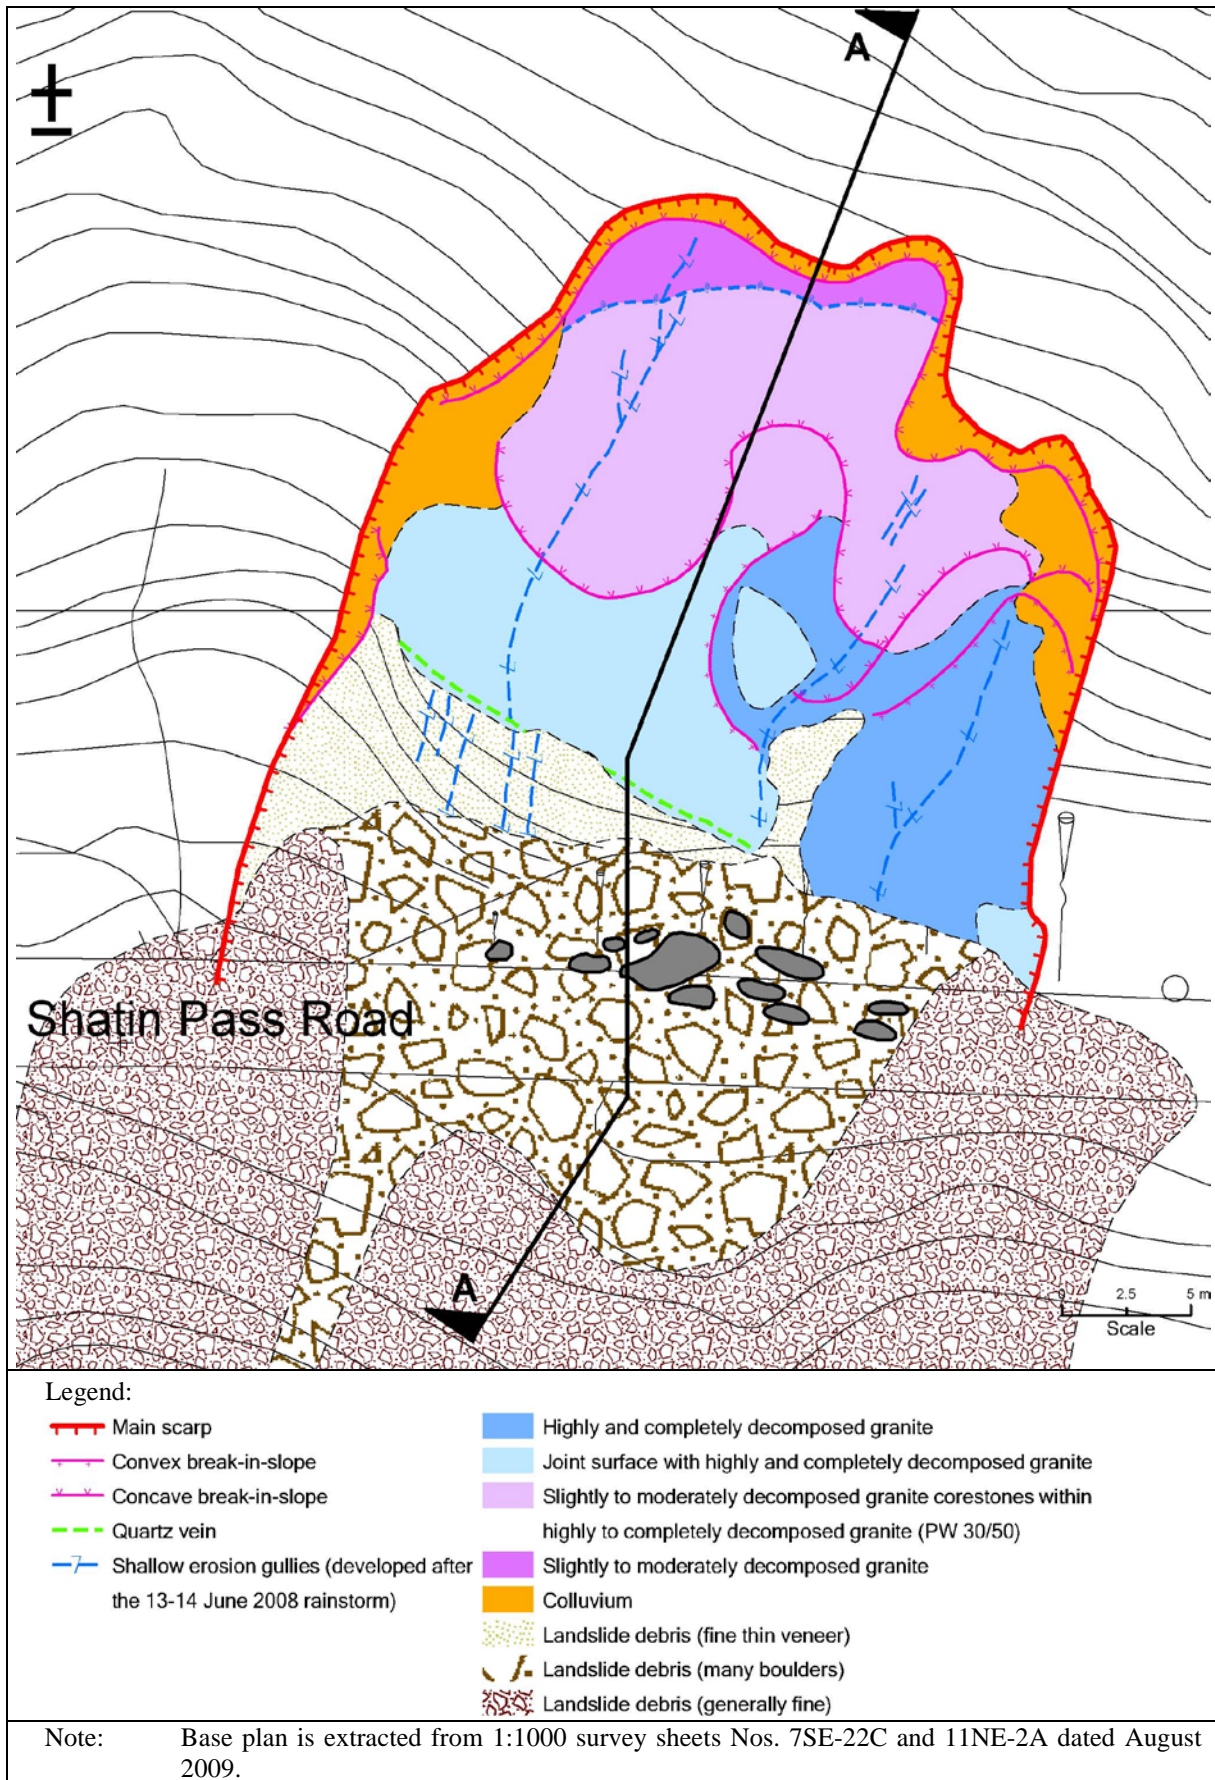
Figure 8 - Plan of Source Area

The crown of the 7 June 2008 landslide is located at about 25 m above the western end of slope No. 11NE-A/C351 (or about 35 m above Shatin Pass Road, Figures 8 and 9). The landslide involved an open hillslope failure. The failure scar measures about 30 m wide and 35 m long, with an average depth of about 5 m. The total detached volume is about 3,500 m³. The inspection on 10 June 2008 at Shatin Pass Road observed that the debris appeared relatively dry, containing a 2 to 3 m thick layer of mainly cobbles and boulders (Plates 21 and 22) overlying another layer of fine debris.

On the western half of the scar, an adversely orientated relict sheeting joint (40° - 50° / 200), at about 5 to 8 m below ground, was observed on the middle and lower part of the rupture surface (Figure 8, Plate 21). A persistent quartz vein was visible along the lower section of the sheeting joint (Plate 25). An elongated depression was present at the centre of the landslide scar, exposing another sheeting joint (Plate 24). A further sheeting joint, probably a continuation of that observed on the western and middle parts, was exposed at the lower eastern side of the rupture surface (Plate 22). The main failure on 7 June 2008, likely occurred along this laterally persistent, adversely orientated relict sheeting joint.

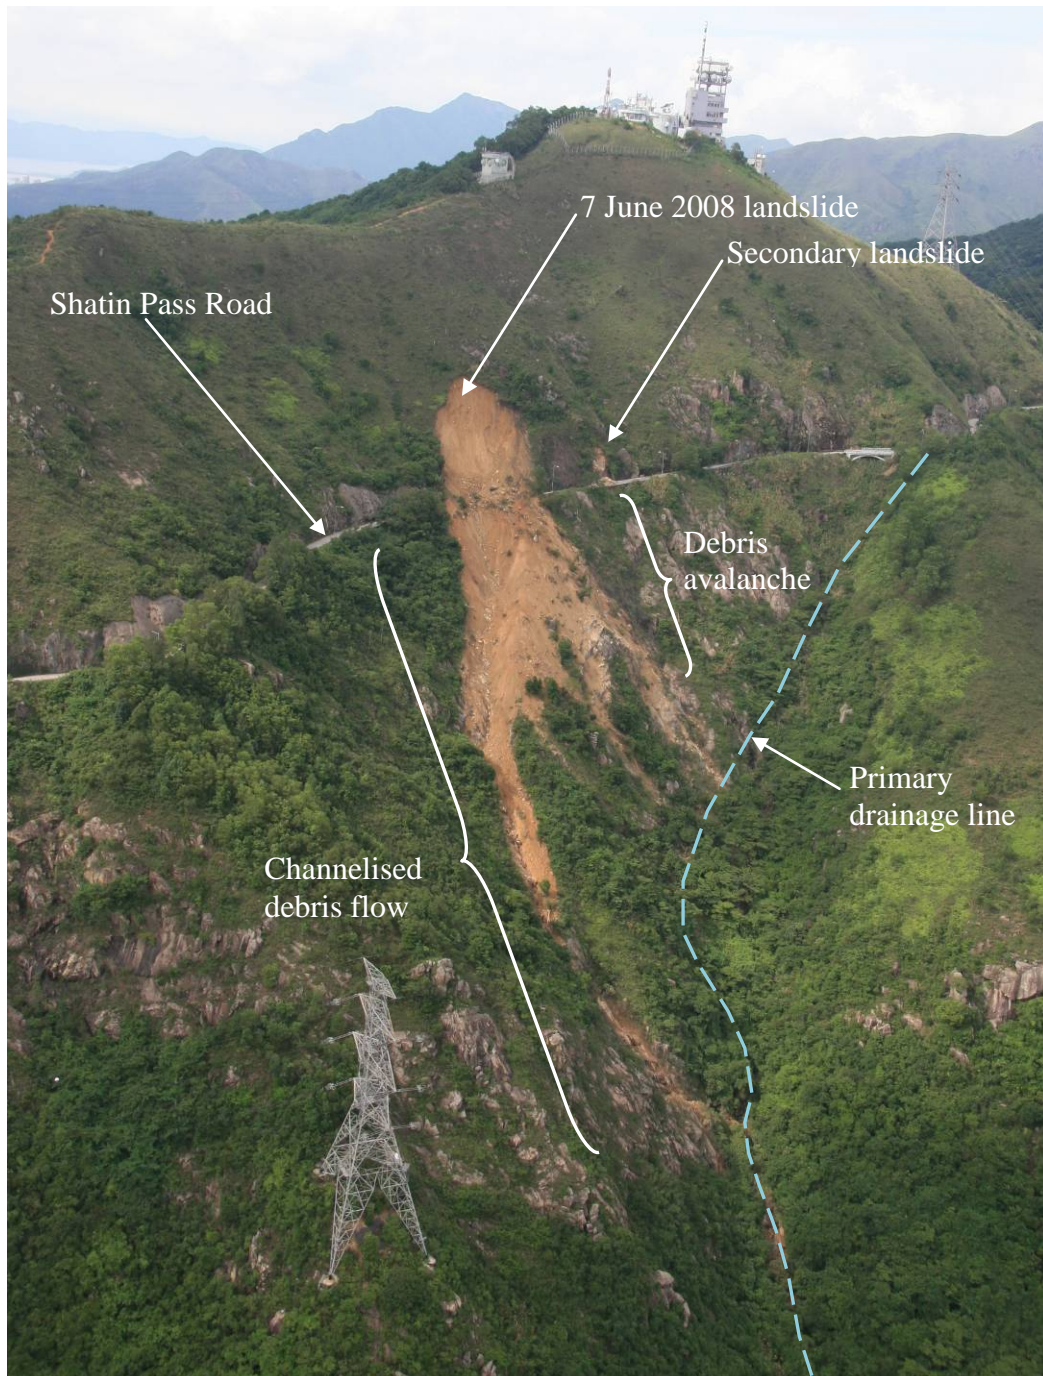
Plate 1 - Oblique Aerial View of the Landslide Site
(Photograph taken on 9 June 2008)

The landslide involved the western portion of a registered cut slope No. 11NE-A/C351 and the natural hillside above, with a total displaced volume (terminology after Cruden & Varnes, 1996) of about 3,500 m³ (Plates 1 and 2). Majority of the debris was deposited on the hillside and some in the primary drainage line. Another minor landslide with a failure volume of about 6 m³ (Secondary landslide, Figure 1) occurred on the middle portion of slope No. 11NE-A/C351, which was also reported in the incident. This landslide investigation report focuses on the larger landslide.

The 7 June 2008 landslide was first observed by the security officer of Tsz Ching Estate at 12:05 pm. The landslide involved the western portion of cut slope No. 11NE-A/C351 and the natural terrain above. The failure volume was about 3,500 m³, of which about 1,500 m³ came to rest on Shatin Pass Road. The remaining (about 2,000 m³) continued downslope, with about 1,200 m³ travelled as debris avalanche and deposited over a large area of the hillside below Shatin Pass Road. The rest travelled along an ephemeral drainage line (labelled DF1, Figure 2) below the road (Plate 1).

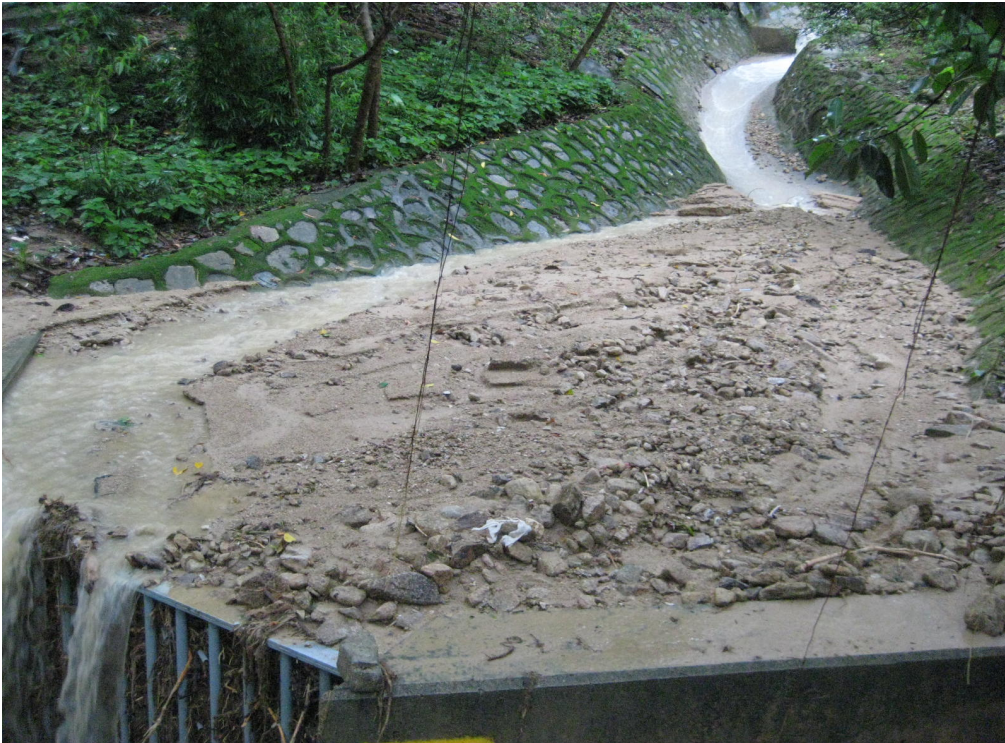
Plate 4 - Record Photograph from DSD Showing Blockage at the Rock Trap above Slope No. 11NE-A/C300 at Tsz Ching Estate (Photograph taken on 13 June 2008)

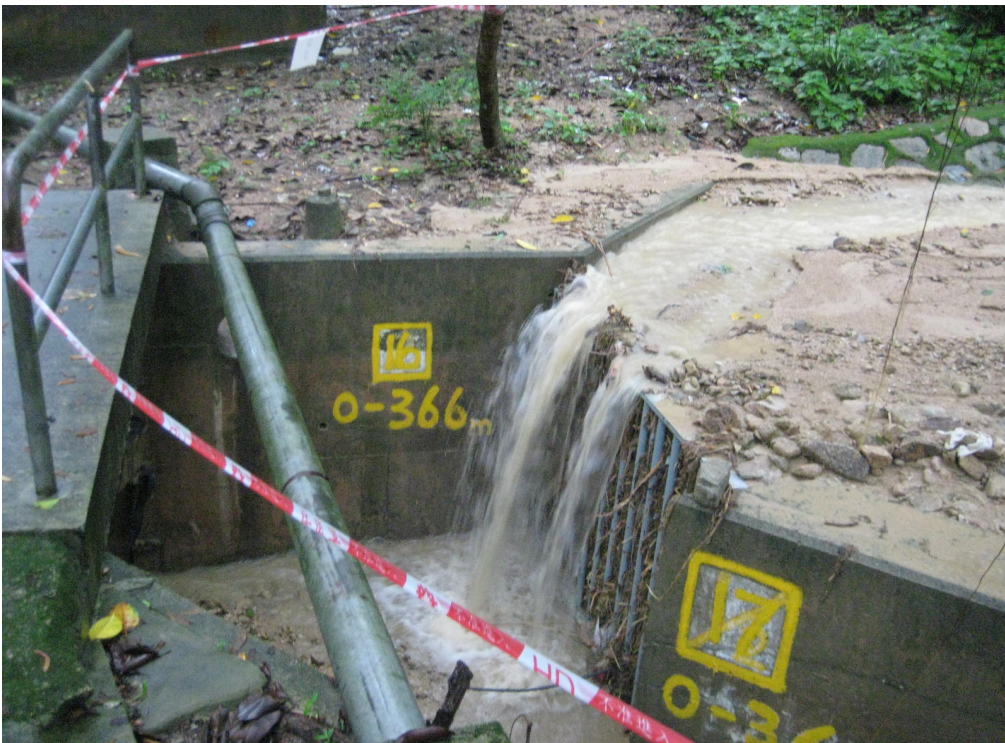
Plate 5 - Record Photograph from DSD Showing Overflow of the Rock Trap above Slope No. 11NE-A/C300 at Tsz Ching Estate (Photograph taken on 13 June 2008)

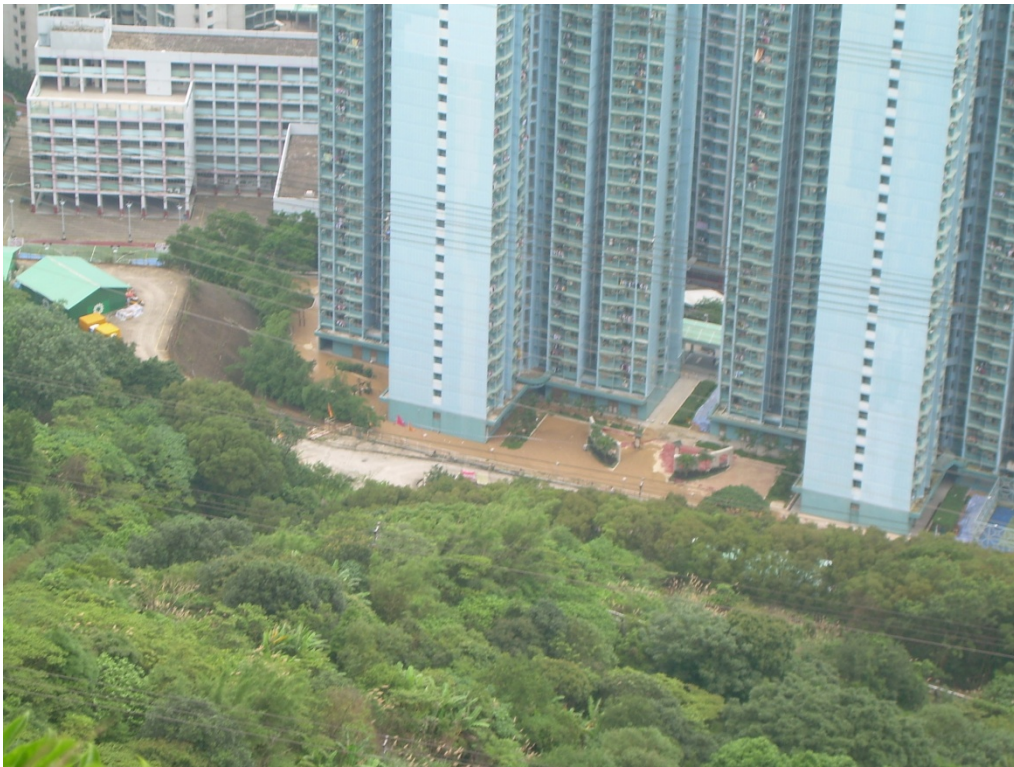
Plate 6 - General View of Outwash Debris within Tsz Ching Estate
(Photograph taken on 9 June 2008)

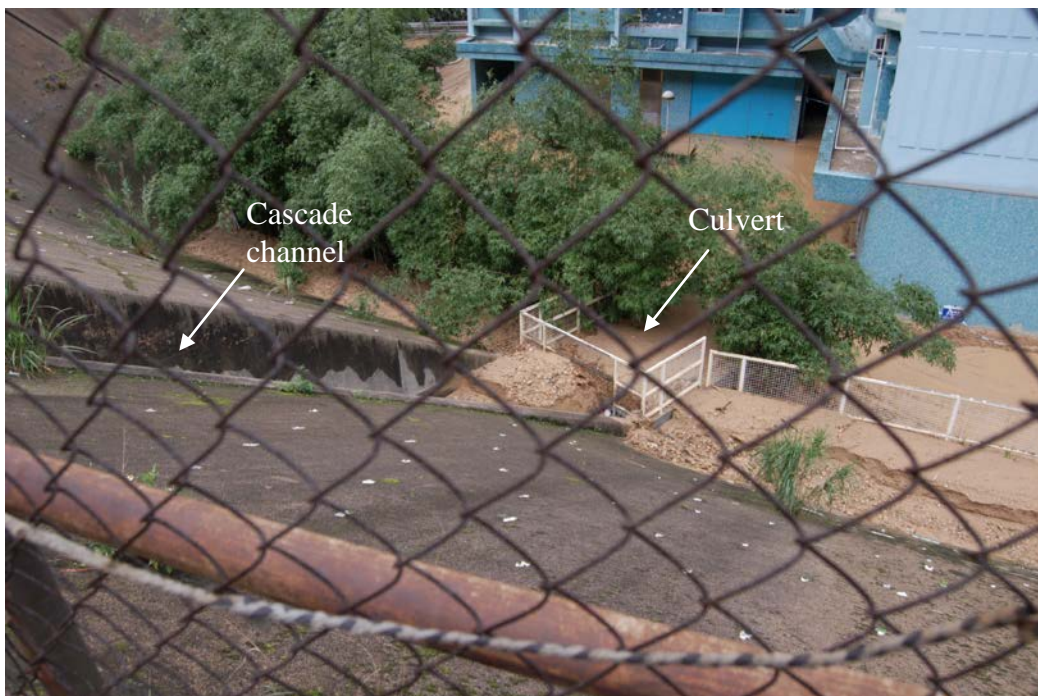
Plate 7 - Debris Outwash Accumulated behind Fence above Tsz Ching Estate
(Photograph taken on 10 June 2008)

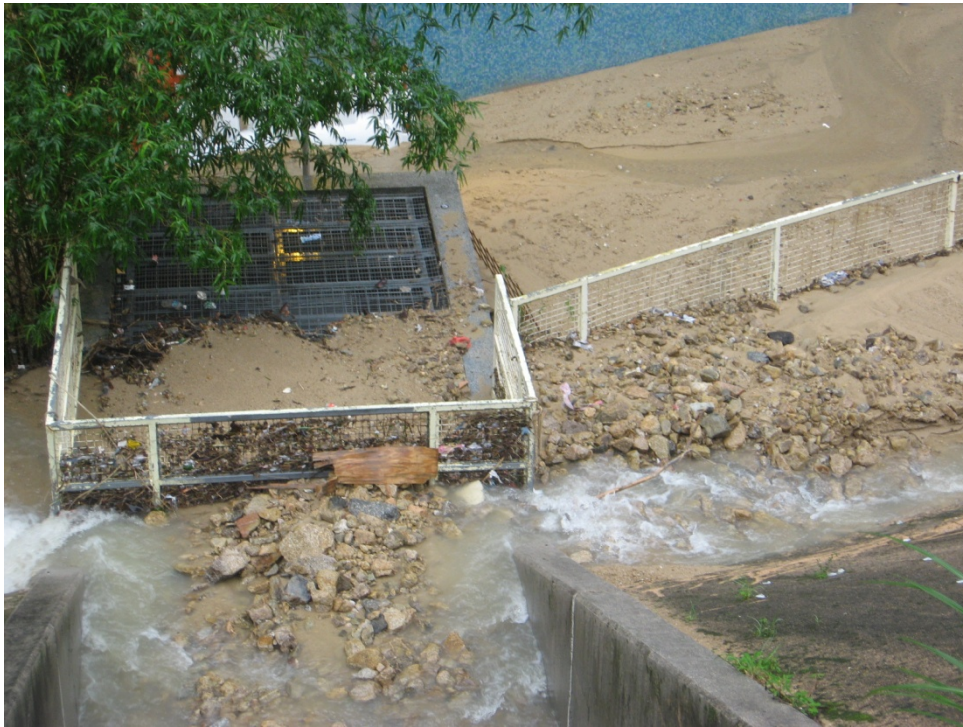
Plate 12 - Debris Outwash Accumulated behind Fence above Tsz Ching Estate after the 12 July 2008 Rainstorm
(Photograph taken on 12 July 2008)

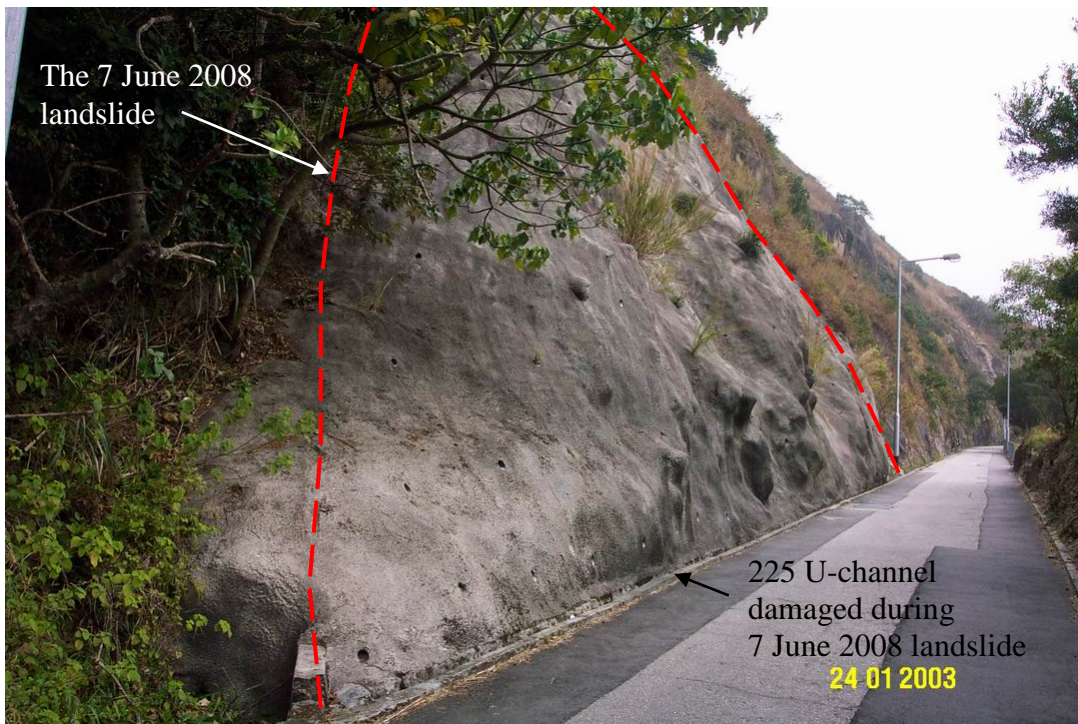
The slope has been subjected to routine maintenance inspections (RMI) and Engineer Inspections (EI) since 2001 (Plates 16 and 17). Potential unstable boulders and localized fractured zone were observed in several occasions. However, no seepage was noted, probably due to the presence of the newly applied shotcrete (Section 5.2). Available records show that routine maintenance works as well as preventive maintenance works including provision of wire mesh on the rock slope portion, shotcreting, and installation of pattern rock dowels were carried out after the inspections.

Plate 16 - Record Photograph from 2003 RMI Showing the 7 June 2008 Landslide Looking East (Photograph taken on 24 January 2003)

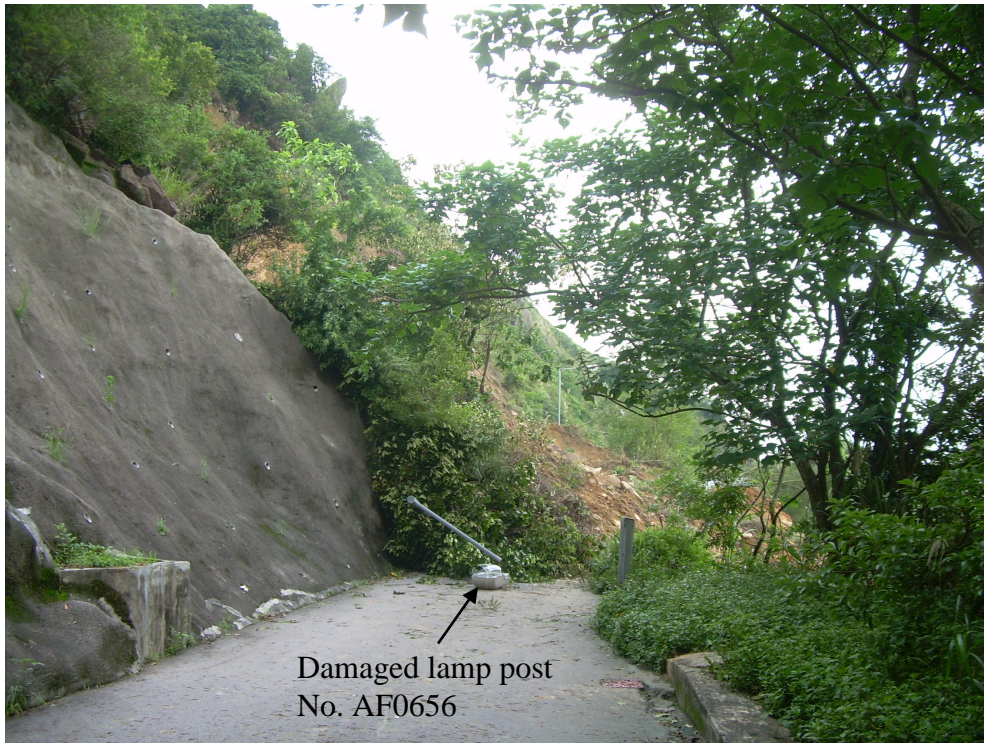
Damaged lamp post
No. AF0656

Plate 18 - View of Landslide Debris and Damaged Lamp Post at Shatin Pass Road (Photograph taken on 9 June 2008)

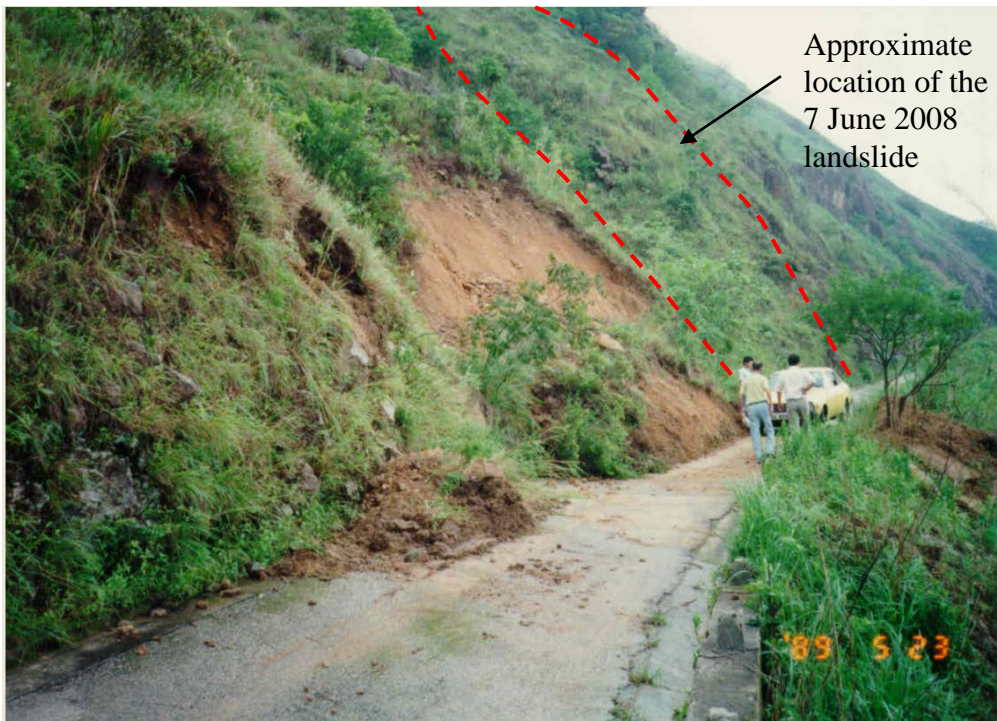
Plate 19 - Record Photograph of Landslide Incident No. K89/5/109
(Photograph taken on 23 May 1989)

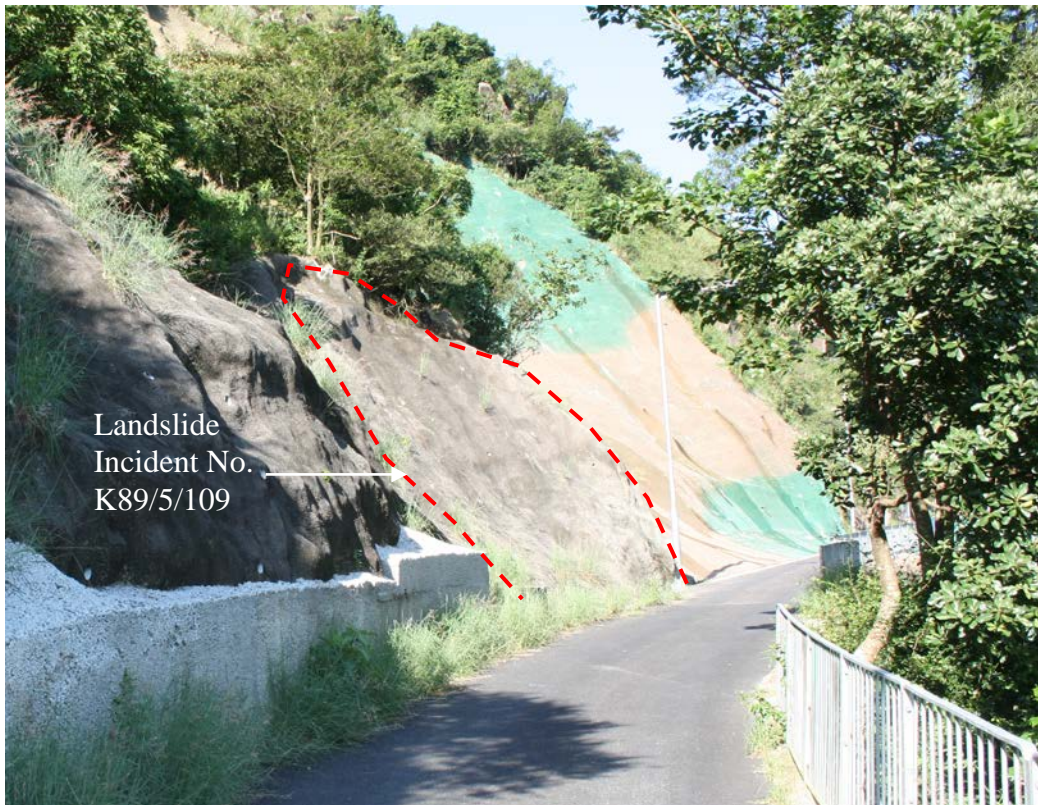
Plate 20 - Recent Photograph Showing the Shotcrete Covered Scar from Landslide Incident No. K89/5/109 (Photograph taken on 24 August 2009)

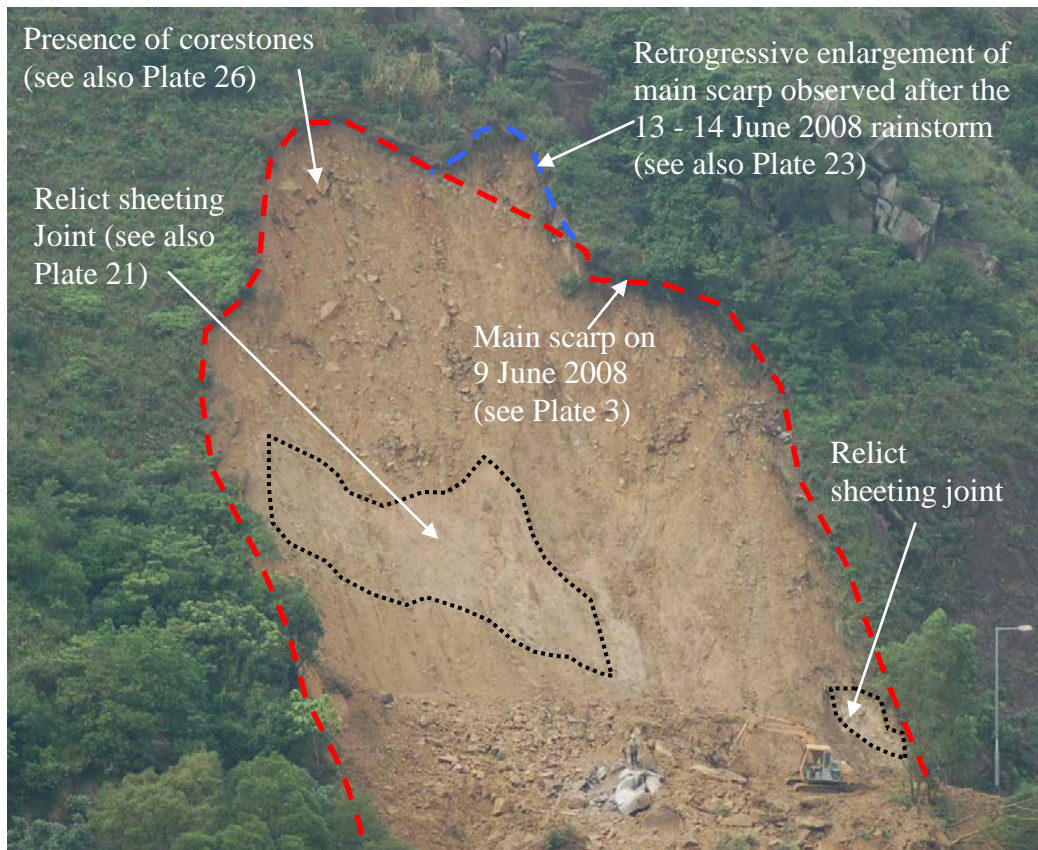
Plate 22 - Oblique Aerial View of the Landslide Site Showing Secondary Enlargement of Main Scarp after the 14 June 2008 Rainstorm (Photograph taken on 16 June 2008)

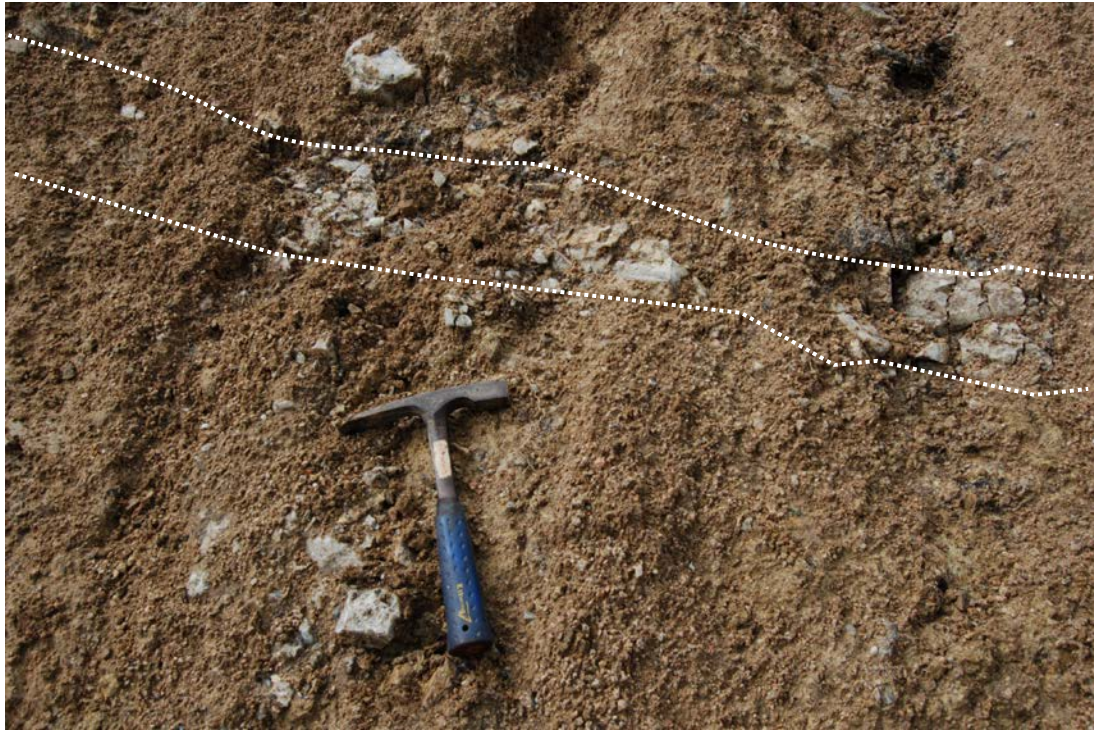
Plate 25 - Close-up View of the Quartz Vein Exposed in the Lower Portion of the Source Area (Photograph taken on 10 June 2008)

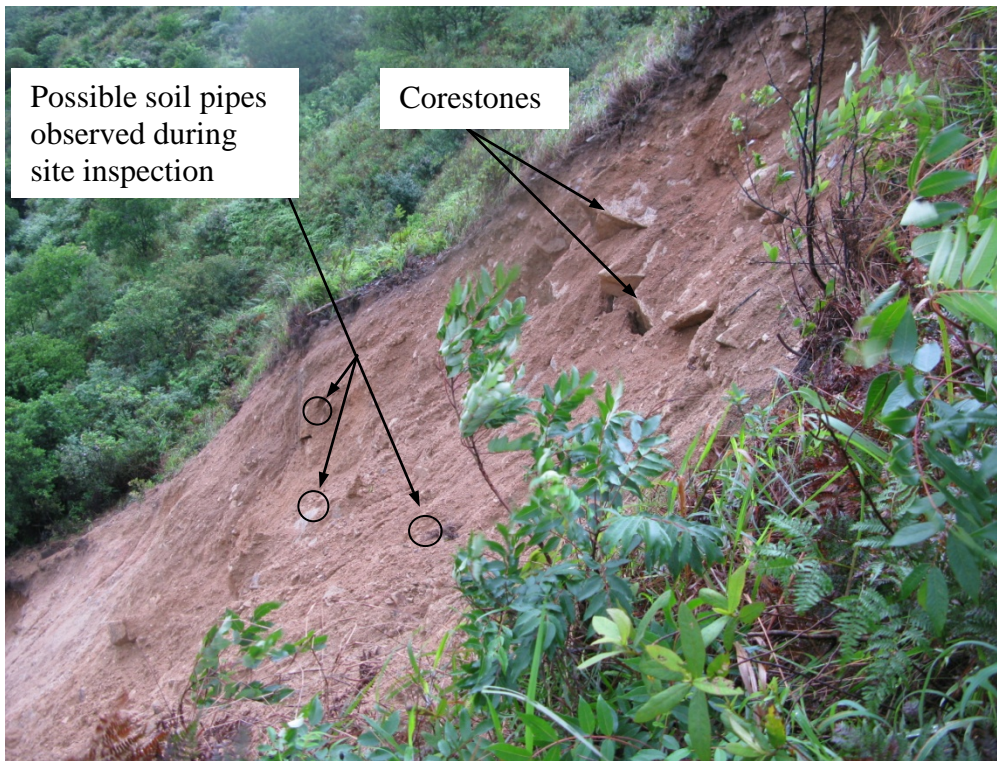
Plate 26 - Possible Soil Pipes and Presence of Corestones Exposed on Surface of Rupture (Photograph taken on 26 June 2008)

Three possible soil pipes were observed in the upper part of the scar in the highly to completely decomposed granite (Plate 26), which may indicate the possibility of preferential sub-surface flow toward the landslide site. Dense reeds (hydrophilic vegetation), which requires good supply of water from the ground, are present on the area immediately above the northeast corner of the 7 June 2008 landslide (Plates 23 and 27).

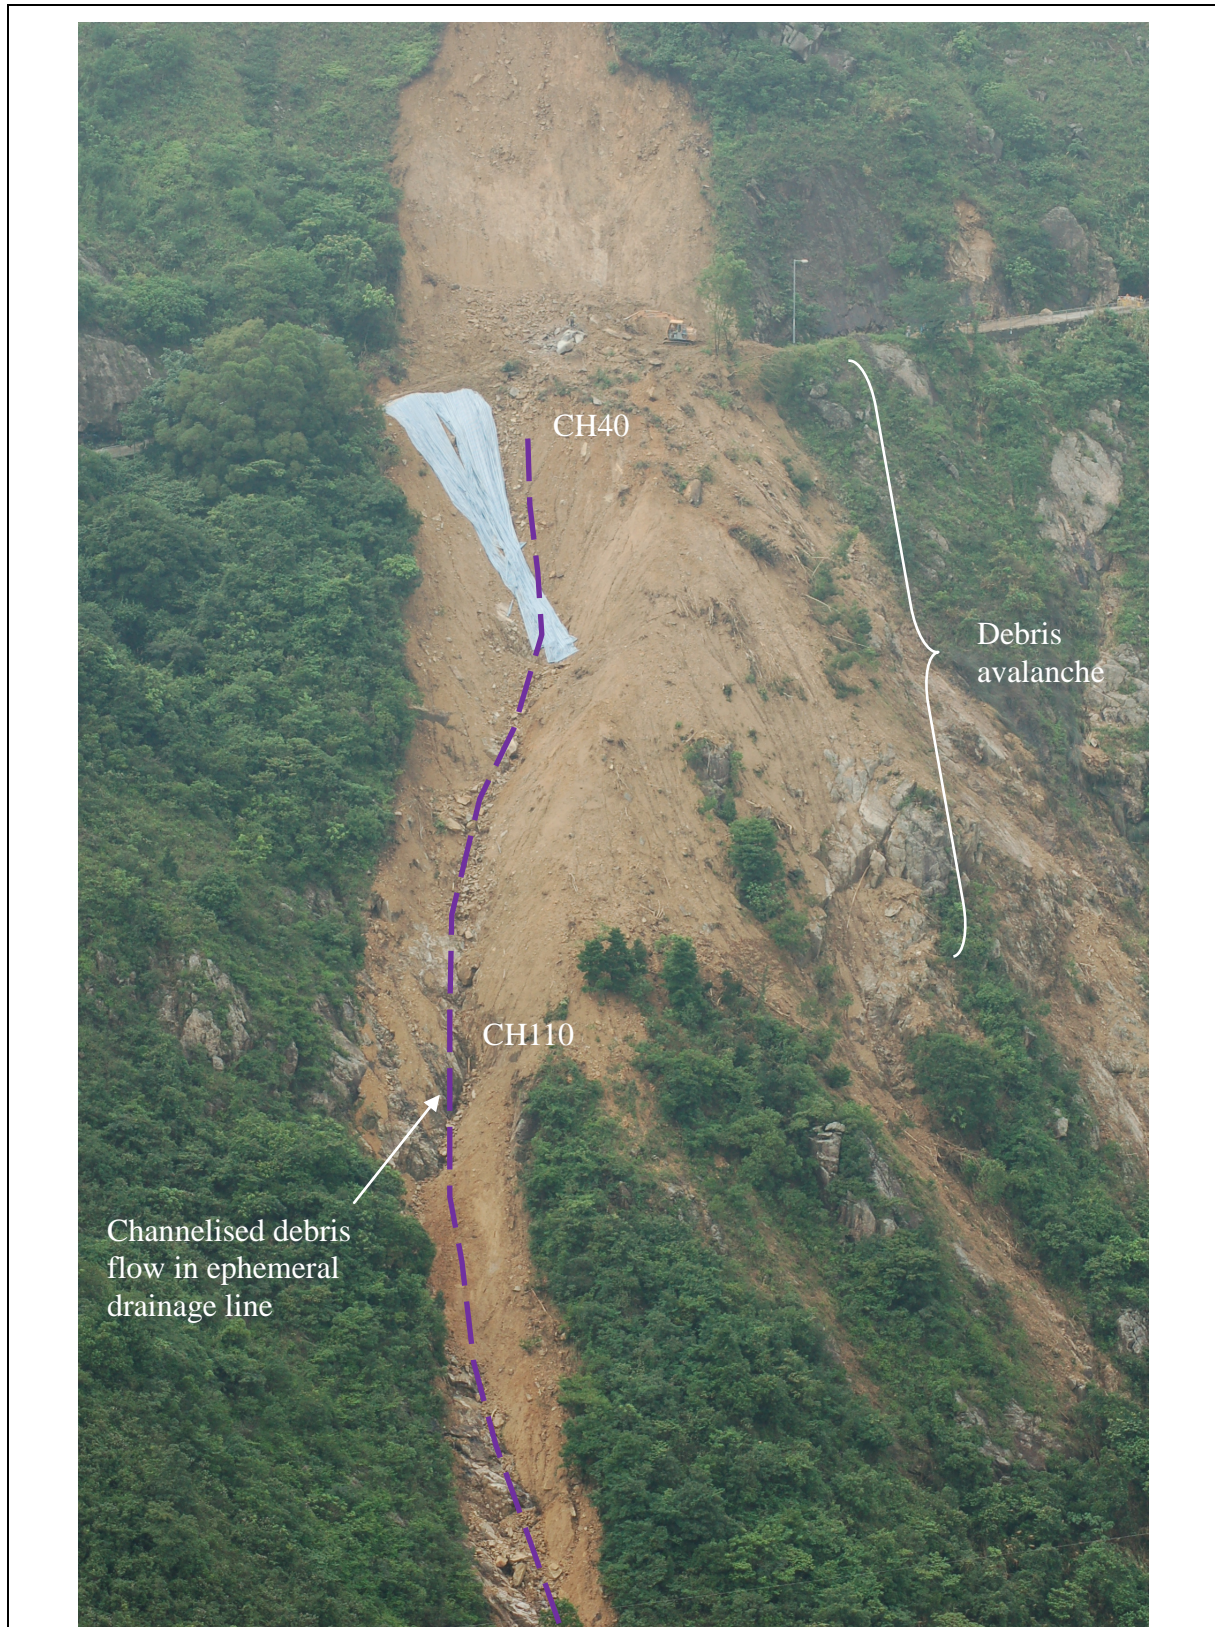
Plate 28 - Oblique Aerial View of the Upper Channelised Debris Flow Path (Photograph taken on 16 June 2008)

Of the 3,500 m³ landslide debris, about 850 m³ might have entered an ephemeral drainage line DF1 below Shatin Pass Road, and developed into a channelised debris flow (Figure 7, Plates 28 and 29). The upper part of the drainage line is sloping at about 30° but is not particularly incised (Figures 5 and 10, Plate 28), with a channelisation ratio³ (CR) of about 5. Not much depletion into the colluvium substrate was observed along the channel streambed or side slope.

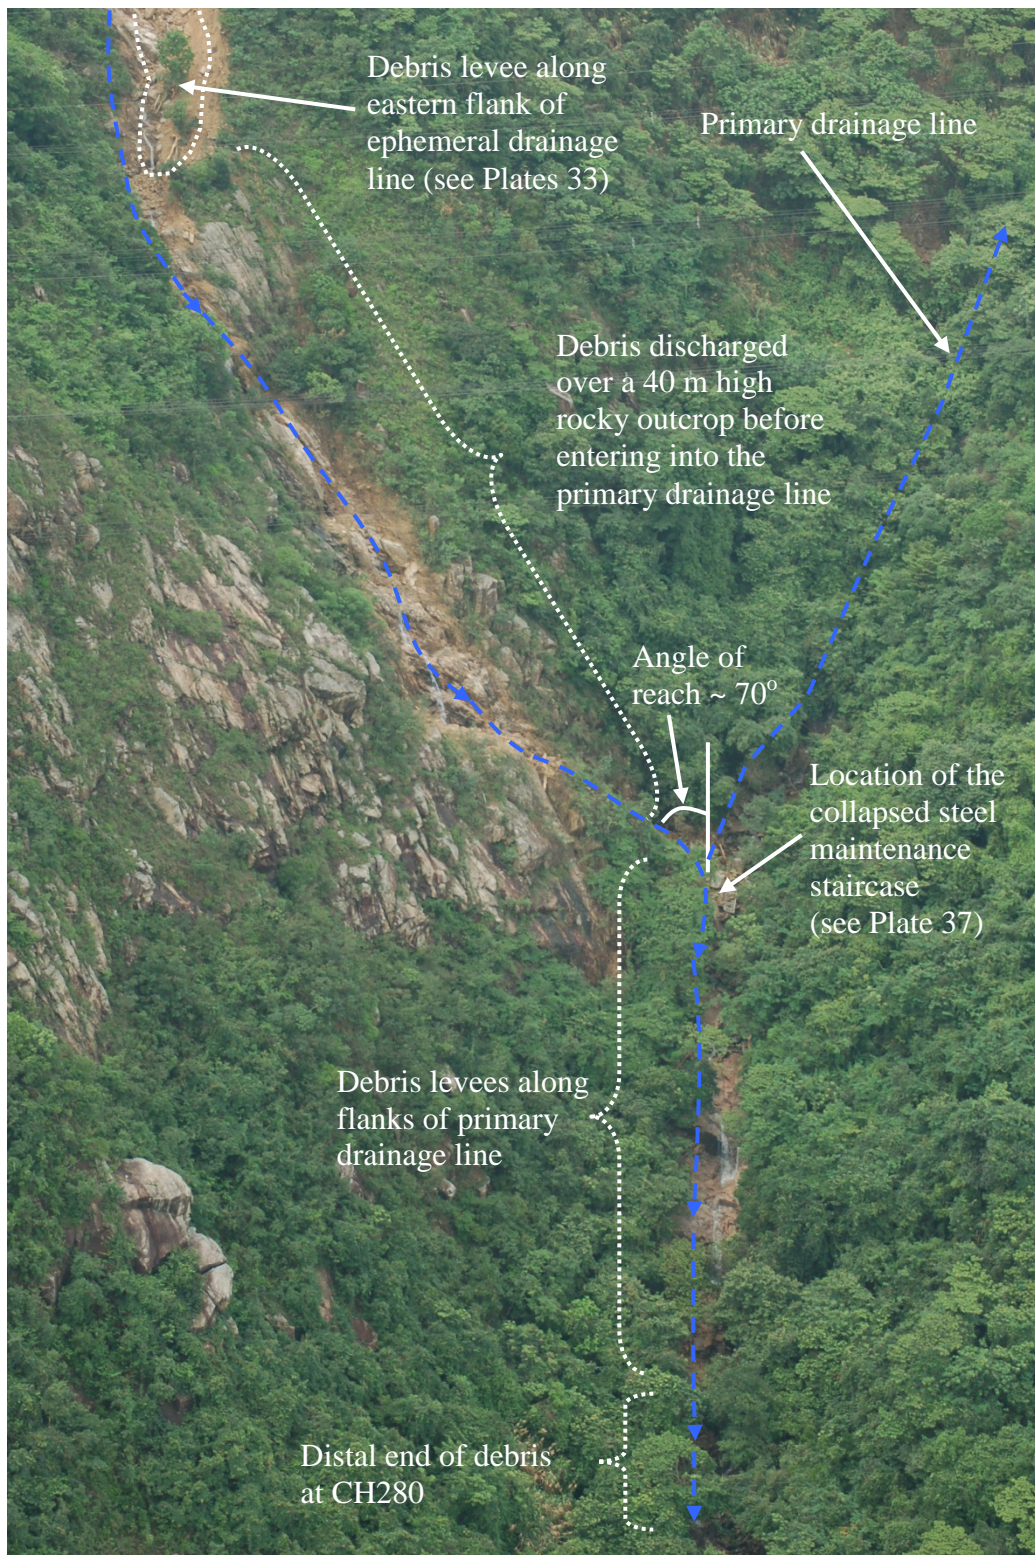
Plate 29 - Oblique Aerial View of the Lower Channelised Debris Flow Path
(Photograph taken on 16 June 2008)

At about CH170, the drainage line reached the edge of a series of rock steps from a pegmatite intrusion (Plate 34). At this point, the drainage line turns abruptly from southwest to southeast (Plate 35). The active volume was about 350 m³. Deposits of material oversplashed from the passage of the debris flow were noted at this location. However, no super-elevated deposits were observed (Plate 36). Beyond this point, the debris dropped abruptly over the rocky outcrop before entering the primary drainage line at about CH230, with an angle of entry of about 70° (Plate 29). Debris deposition between CH180 and CH230 was generally minimal.

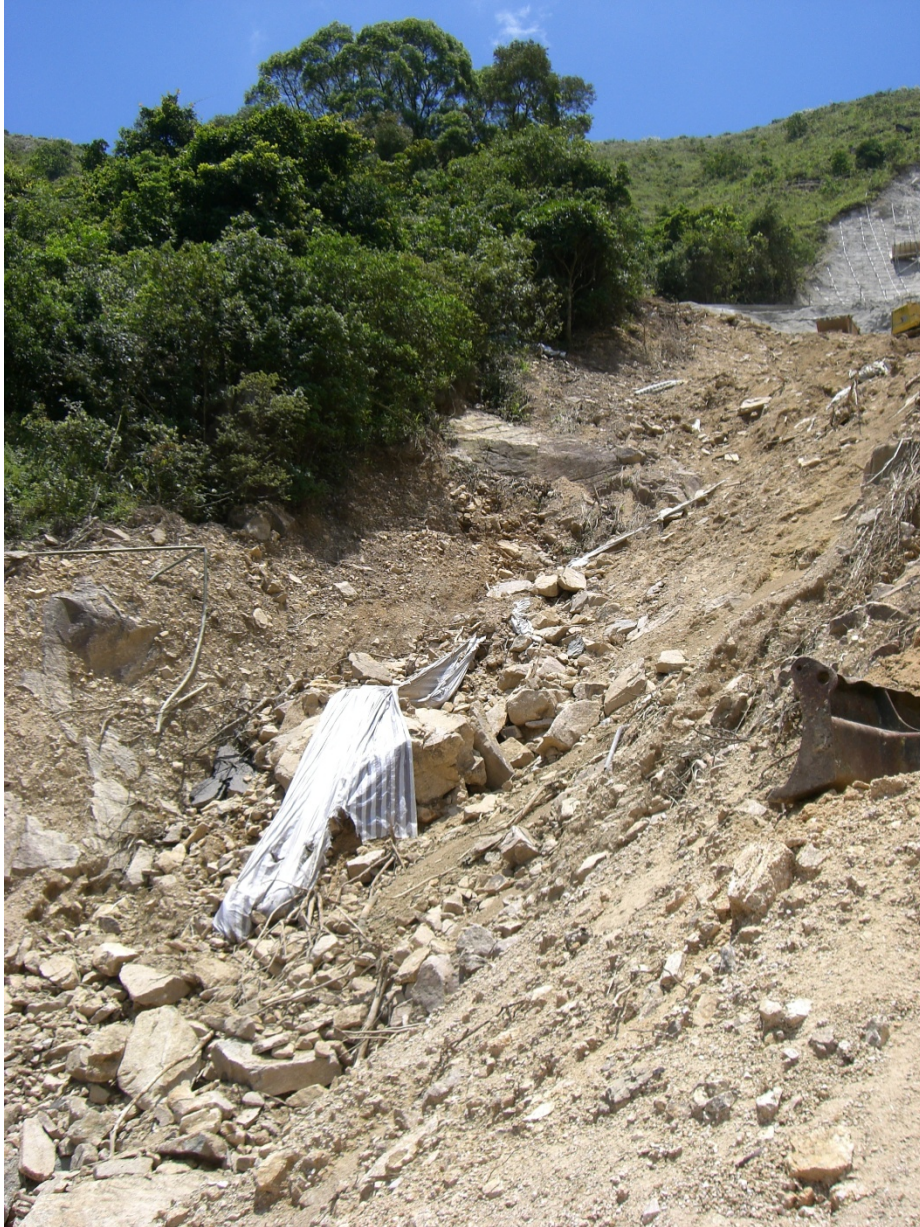
Plate 30 - View of the Upper Channelised Debris Flow Path
(Photograph taken on 23 July 2008)

along this part of the drainage line (Plate 30). Some debris deposited on the eastern spur of the channel was washed down along a poorly defined channel (or topographical depression, i.e. DT2) near CH80 (Figure 5). Minimal debris deposition was observed further along the drainage line between CH80 to CH110 where the channel bed is on rock outcrop (Plate 31) with a gradient of about 45°.
