**REVIEW STUDY OF THE
7 JUNE 2008 LANDSLIDE
ON SLOPE NO. 11NE-A/C351
AND THE NATURAL HILLSIDE
ABOVE SHATIN PASS ROAD,
TSZ WAN SHAN**

GEO REPORT No. 302

AECOM Asia Company Limited

**This report is largely based on GEO Landslide Study Report
No. LSR 4/2010 produced in August 2010**

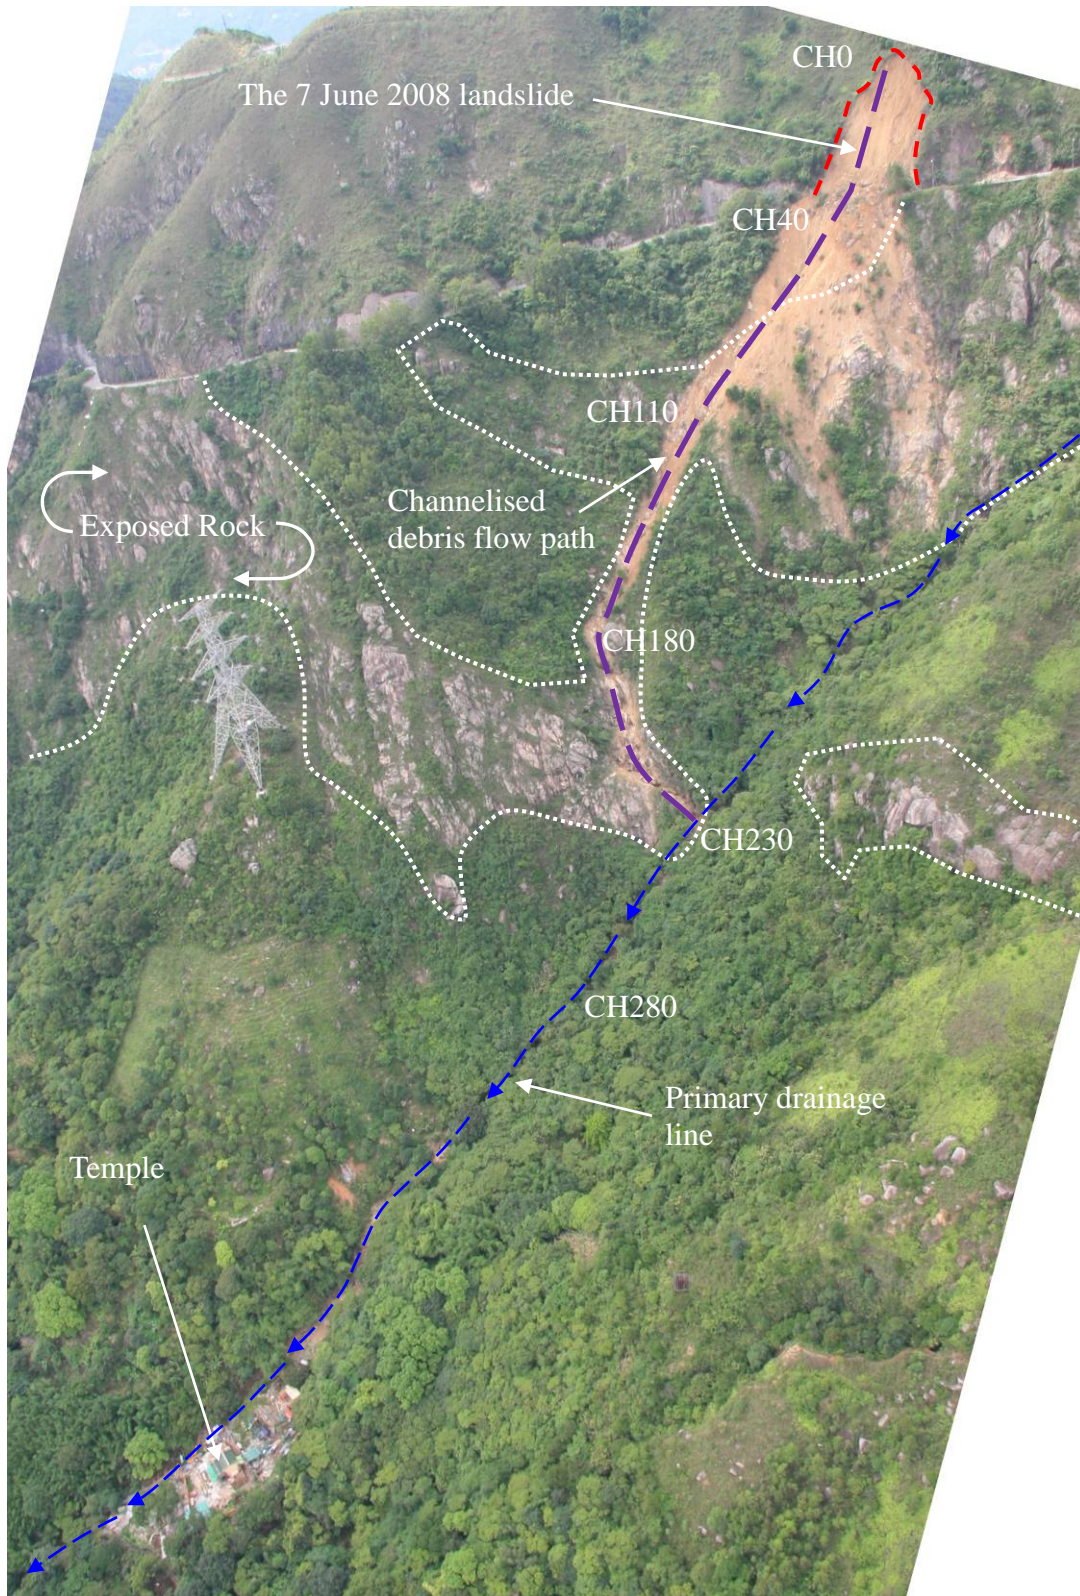
Plate 31 - Oblique Aerial View of the Debris Trails and Surrounding Terrain
(Photograph taken on 9 June 2008)

According to the information supplied by the Water Supplies Department (WSD), a 100 mm diameter fresh water main running along the outer edge of Shatin Pass Road was not damaged as a result of the incident. However, part of a slope toe 225 mm U-channel on Shatin Pass Road (Plate 16), a steel access ladder (Plate 17) and a lamp post (Plate 18) at the western boundary of the failed cut slope, were destroyed. In addition, a temple located near the outlet of the primary drainage line was temporarily evacuated (Figure 2, Plate 31).

along this part of the drainage line (Plate 30). Some debris deposited on the eastern spur of the channel was washed down along a poorly defined channel (or topographical depression, i.e. DT2) near CH80 (Figure 5). Minimal debris deposition was observed further along the drainage line between CH80 to CH110 where the channel bed is on rock outcrop (Plate 31) with a gradient of about 45°.

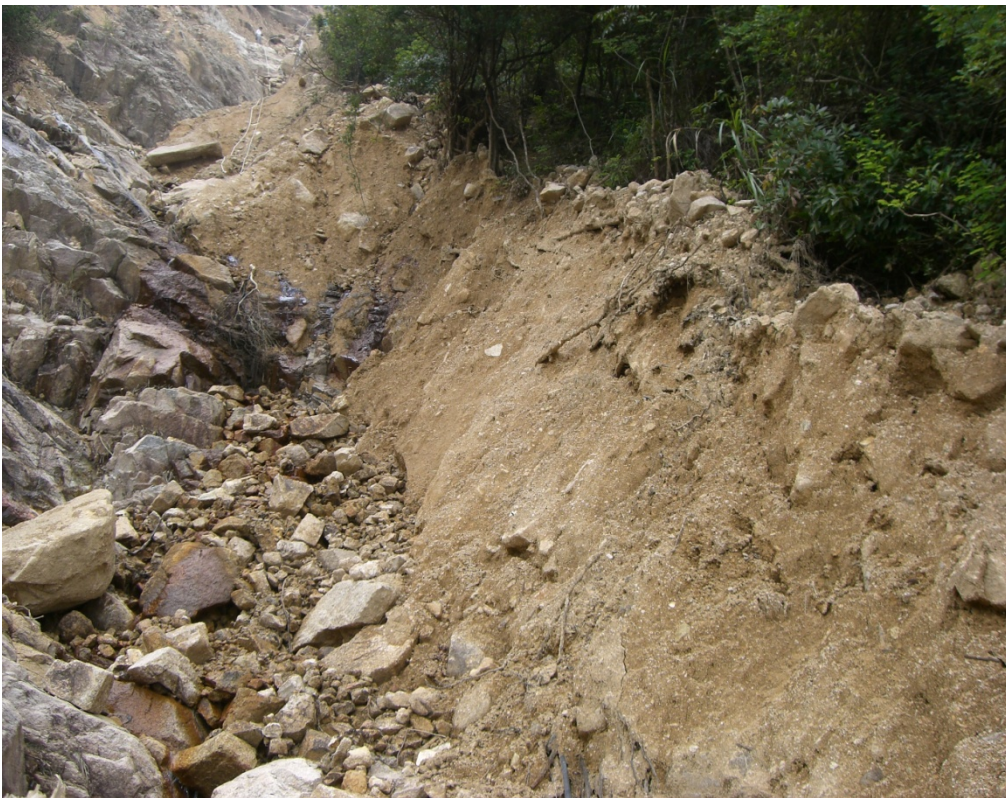
Plate 33 - Debris within Channelised Debris Flow Path at about CH170
(Photograph taken on 29 July 2008)

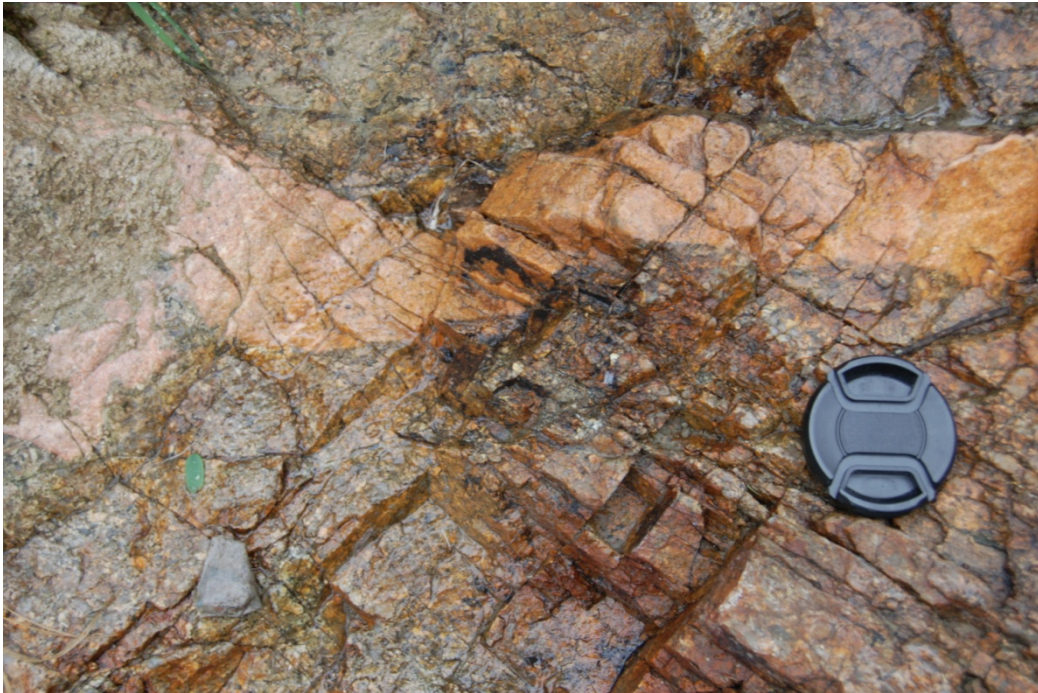
Plate 34 - Prominent Pegmatite Intrusion near CH170
(Photograph taken on 6 January 2010)

At about CH170, the drainage line reached the edge of a series of rock steps from a pegmatite intrusion (Plate 34). At this point, the drainage line turns abruptly from southwest to southeast (Plate 35). The active volume was about 350 m³. Deposits of material oversplashed from the passage of the debris flow were noted at this location. However, no super-elevated deposits were observed (Plate 36). Beyond this point, the debris dropped abruptly over the rocky outcrop before entering the primary drainage line at about CH230, with an angle of entry of about 70° (Plate 29). Debris deposition between CH180 and CH230 was generally minimal.

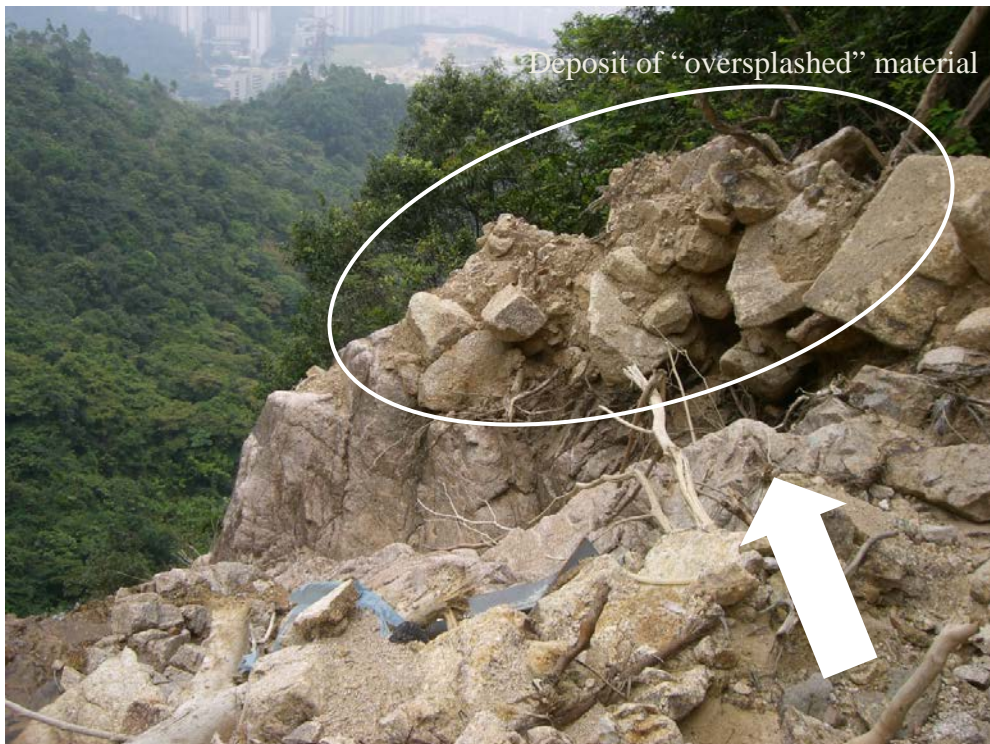
Plate 36 - Deposit of "Oversplashed" Debris at about CH170
(Photograph taken on 29 July 2008)

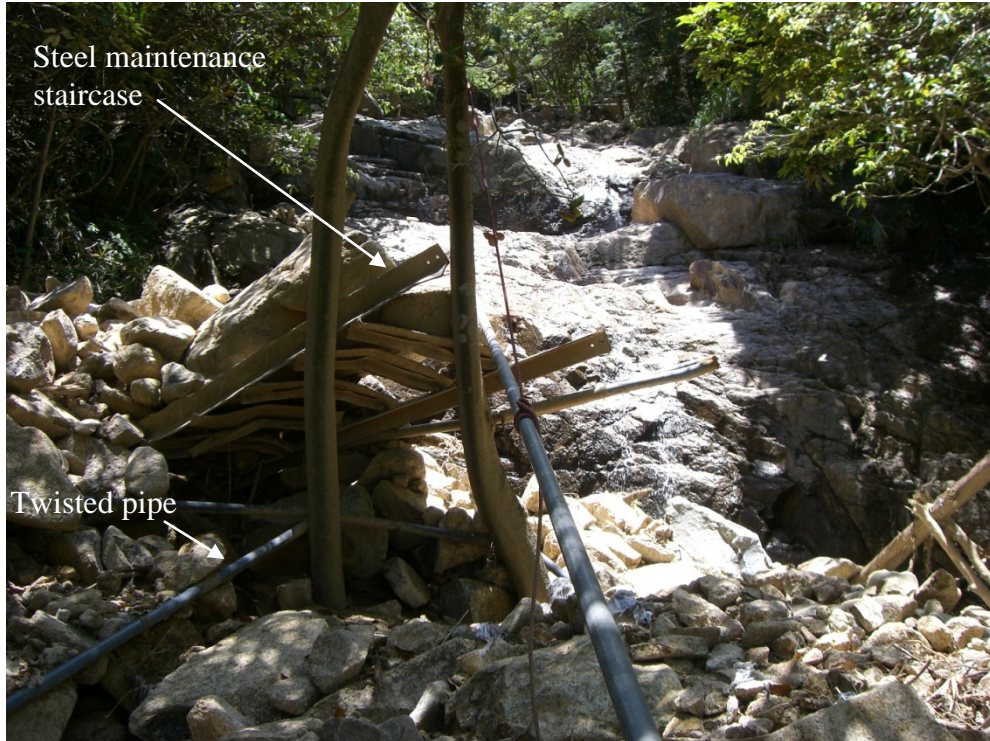
The debris entered the primary drainage line at CH230, where the channel is open and about 7 to 10 m wide, with a CR ratio over 7. It was estimated that about 200 m³ of the debris was deposited at CH230. The remaining 150 m³ would have travelled further downstream before terminating at about CH280, where the channel gradient is reduced to about 18°. The location of the distal end is consistent with field observations as stated below. The surrounding vegetation below CH280 was not damaged. Also, an existing steel water pipe that ran along the primary drainage line was only damaged by the landslide at locations upstream of CH280 (Plate 37), whereas no damage was observed on the pipe downstream of CH280 (Plate 38).

Plate 37 - Upstream View of Primary Drainage Line at about CH280
(Photograph taken on 28 October 2009)

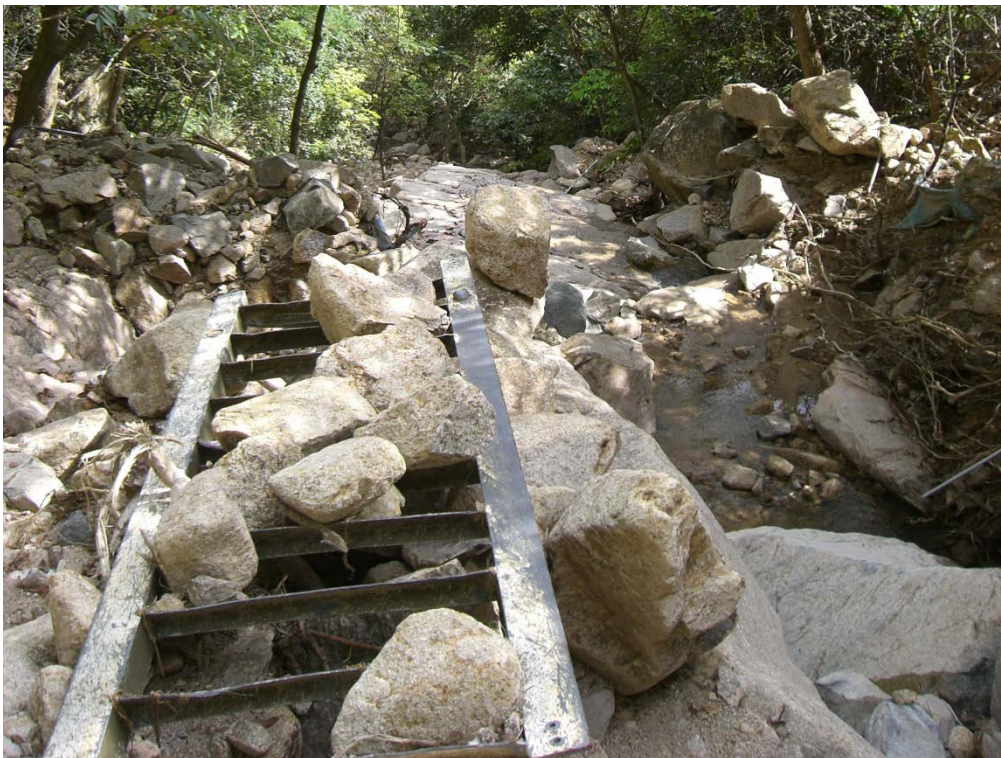
Plate 39 - View of Collapsed Section of Steel Maintenance Staircase of
Slope No. 11NE-A/C351 at Primary Drainage Line at about CH250
(Photograph taken on 23 July 2008)

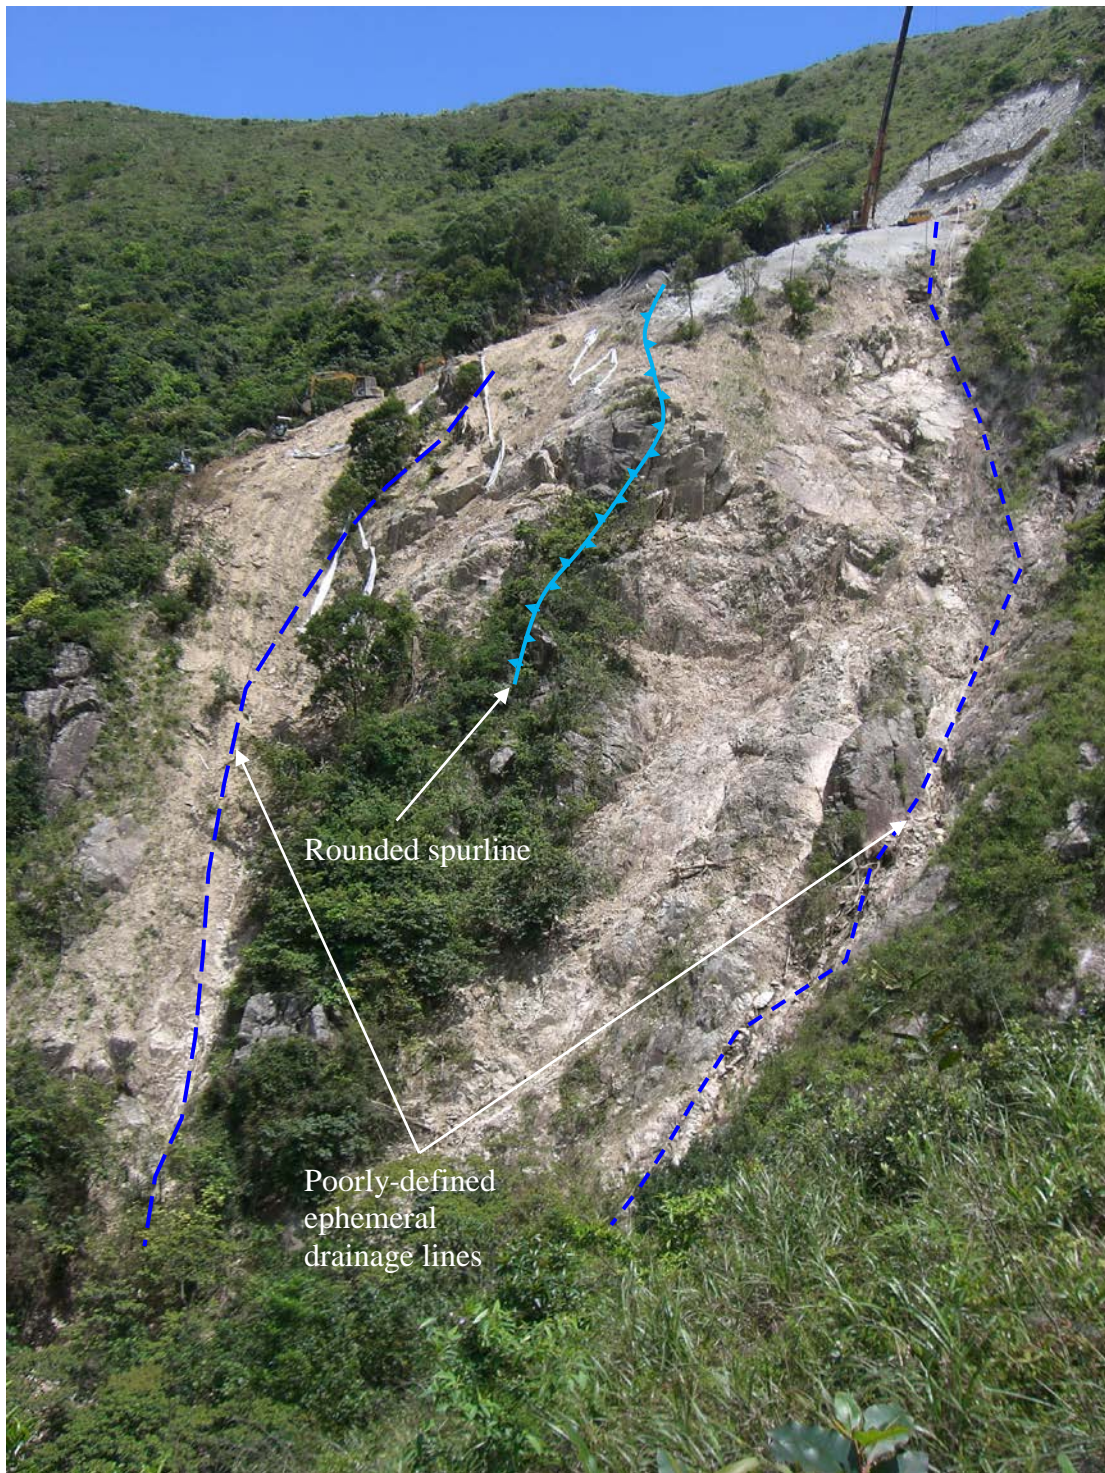
Plate 40 - Debris Travelled along Poorly-Defined Ephemeral Drainage Lines towards the Primary Drainage Line (Photograph taken on 23 July 2008)

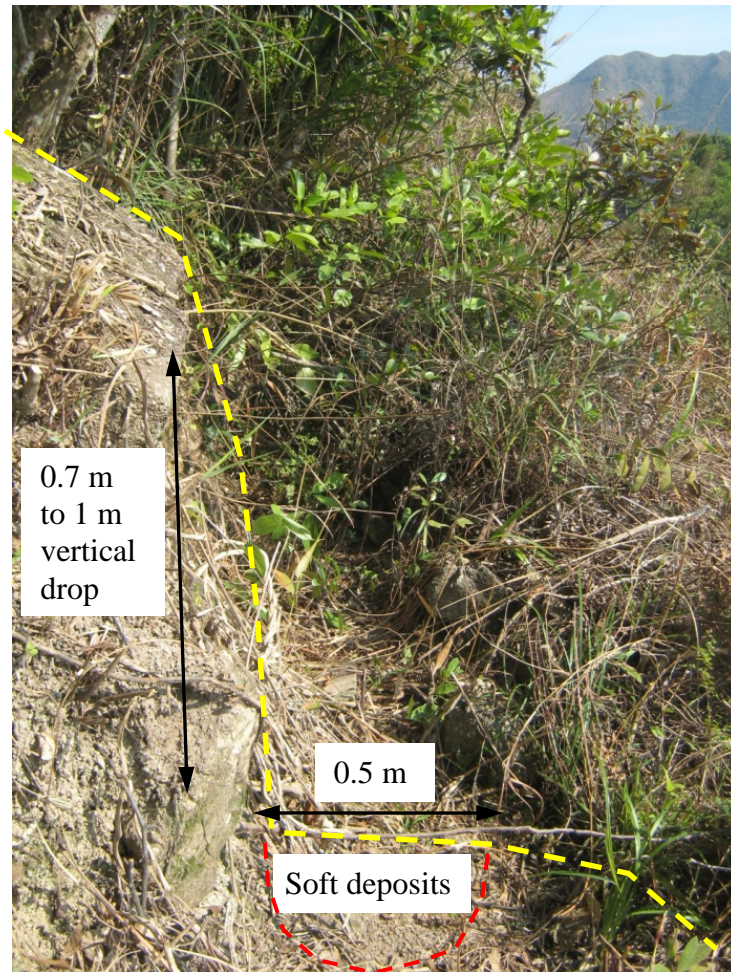
Plate 42 - Vertical Drop Observed at the Crest of Slope No. 11NE-A/C351 after Vegetation Clearance (Photograph taken on 21 January 2010)

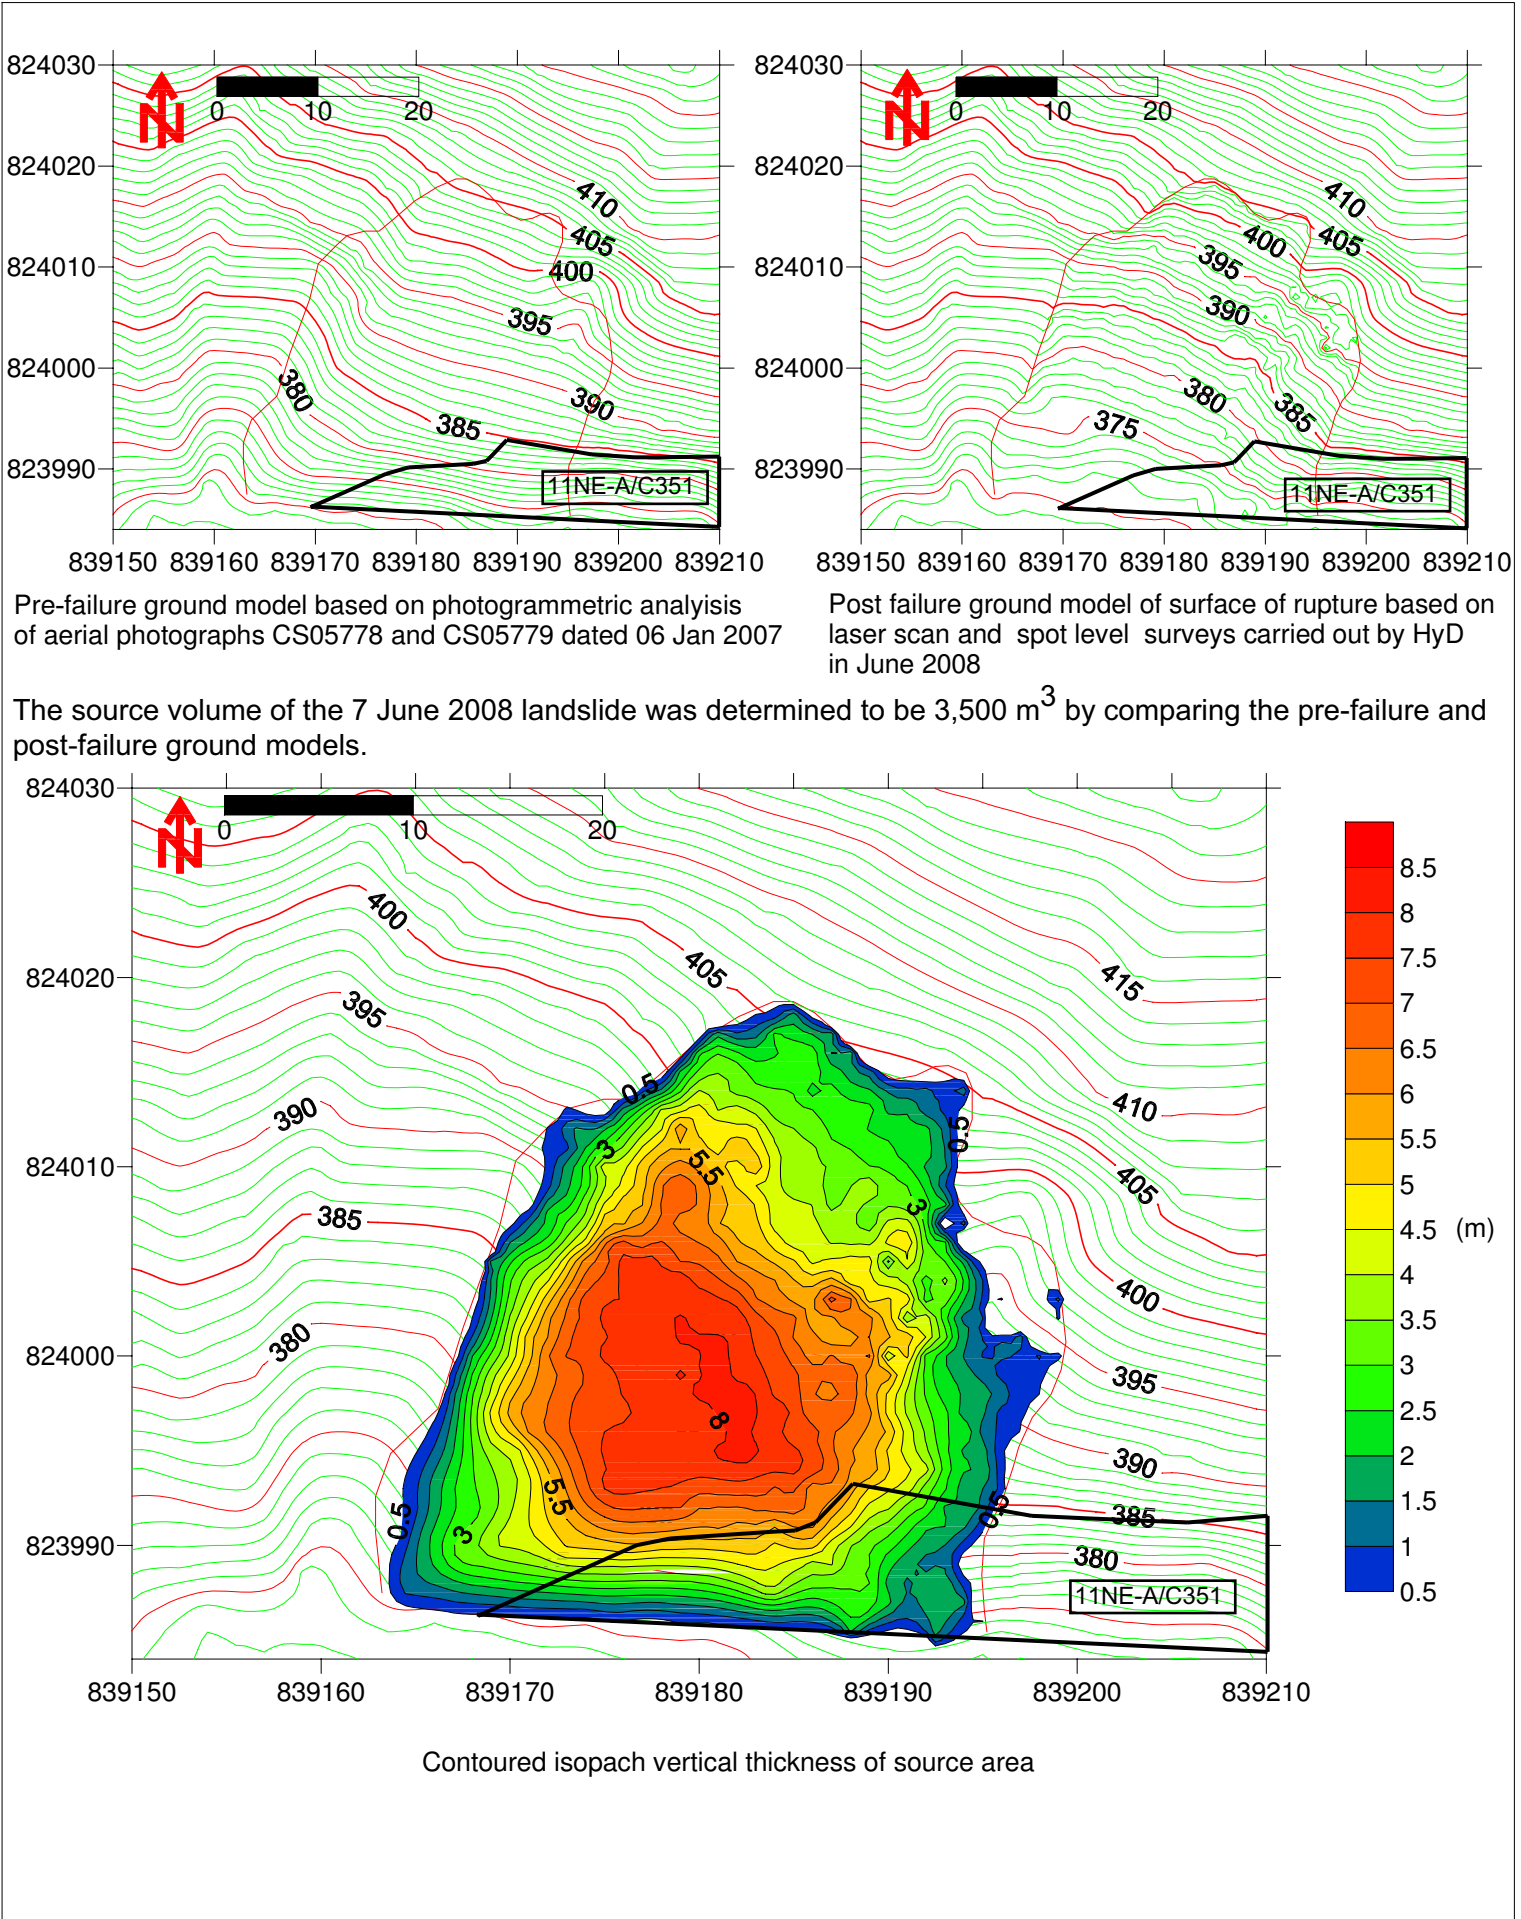
Figure B1 - Source Volume Determination

The failure volume of the 7 June 2008 landslide was found to be about 3,500 m³, based on the difference in ground profiles before and after the failure. The pre-failure ground profile is estimated by photogrammetric analysis of 2007 aerial photographs. The post-failure ground profile is determined by conventional topographic survey. Further details are given in Appendix B.
