# **Review of Landslides in 2011**

**GEO Report No. 306**

**Geotechnical Engineering Office  
Civil Engineering and Development Department  
The Government of the Hong Kong  
Special Administrative Region**

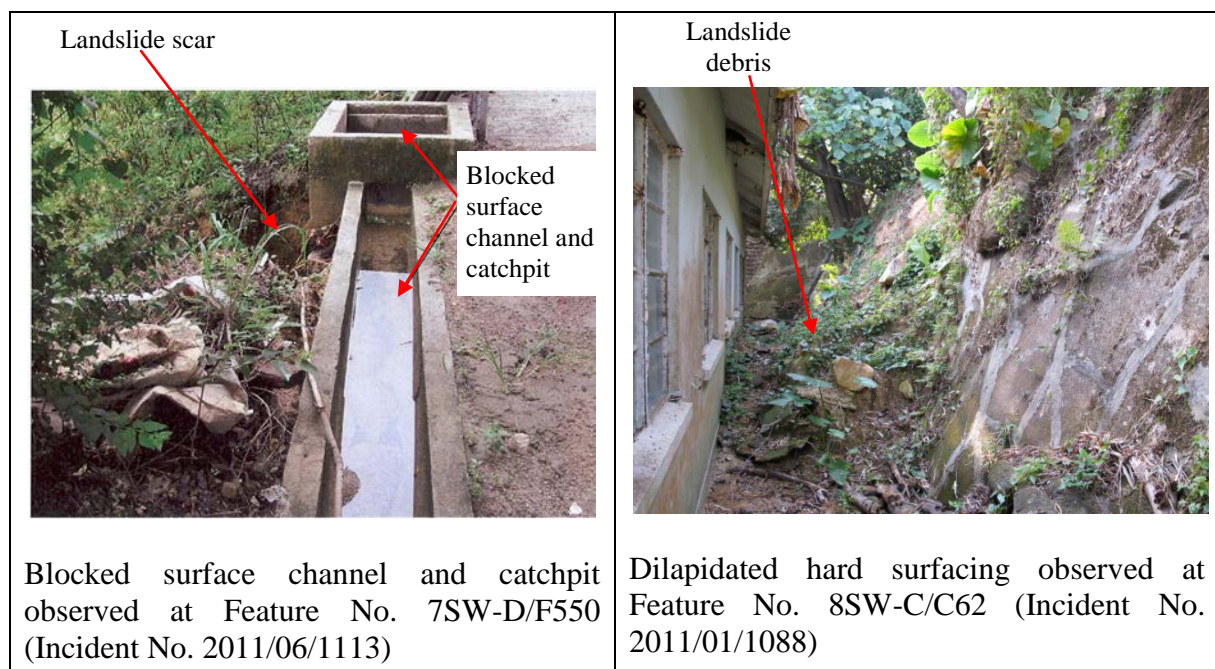
**Figure 3.3 Examples of Inadequate Slope Maintenance**

Inadequate slope maintenance such as blockage of surface drainage and inadequate hard surface protection (see examples in Figure 3.3) was assessed to be a key contributory factor in 11 landslides. It contributed to about 23% (i.e. 11 out of 47) of the landslides on registered man-made slopes. This annual percentage remains on a high side in recent years (from 23% to 32% between 2009 and 2010), compared with the annual average of about 13% in the mid-2000s. All the 11 landslides were minor failures, of which three occurred on engineered slopes (i.e. Slope Nos. 11NW-B/C37, 7SW-D/F550 and 11SE-A/C10). Of these 11 landslides, seven occurred on government slopes and two on private slopes. The remaining two incidents occurred on slope features with mixed maintenance responsibility of government/private, where one occurred on the private portion and the other occurred on the government portion of the slopes. The relevant maintenance parties have been informed of the incidents and advised to take appropriate follow-up action.

The above diagnosis re-affirms the importance of regular slope maintenance. It also serves as a reminder that even an engineered slope is liable to failure without adequate maintenance.
