Preliminary Back Analysis of Open Hillside Landslide Impacting on a Flexible Rockfall Barrier at Jordan Valley

GEO Report No. 308

**Geotechnical Engineering Office
Civil Engineering and Development Department
The Government of the Hong Kong
Special Administrative Region**

**Failure of Boulder Fence No. 11NE-A/ND8
above Slope No. 11NE-A/C872 near Choi Wan Road and Jordan Valley**

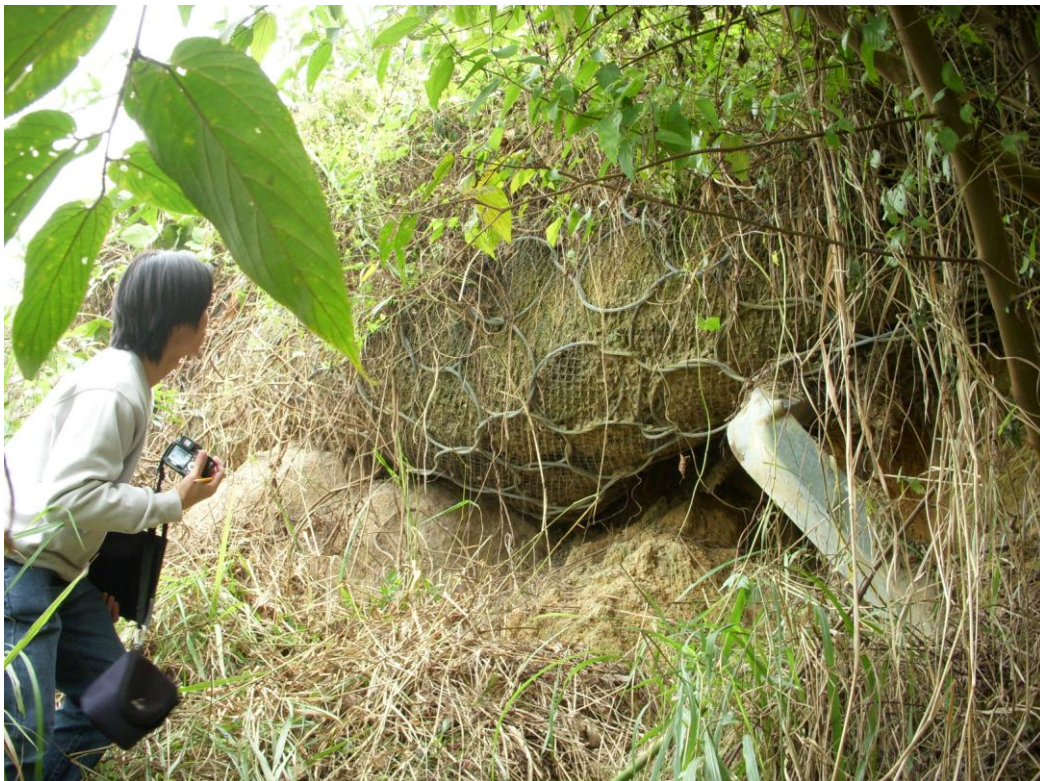
Figure 2.2 Close Inspection to the Ring Net

Site inspections by the LIC were carried out in December 2009 and April 2010. The Standards & Testing Division joined the inspection in April 2010. It was observed that landslide debris struck Post P1 and two ring net panels spanning across Posts P2-P1 and Posts P1-P15 (see Figure 2.1). The debris was largely retained by the barrier. There were no noticeable signs of overflow or marks left behind by a large amount of debris passing through the ring net. Close inspection of the ring net indicated that landslide debris, including fine grains, was arrested by the barrier (see Figure 2.2). Post P1 was severely damaged by debris impact. No signs of damage to Post P2 were evident. Post P15, which was located at the southern end of the barrier, was not subject to any direct impact by the landslide debris. However, Post P15 had bent and failed. It was also observed during the inspections that the energy dissipation devices attached to the uphill cable ropes of the barrier had not been mobilised, and no tensile failure of any cable ropes was apparent. Details of the site observations are presented in an inspection note prepared by the LIC. The inspection note is reproduced in Appendix A.

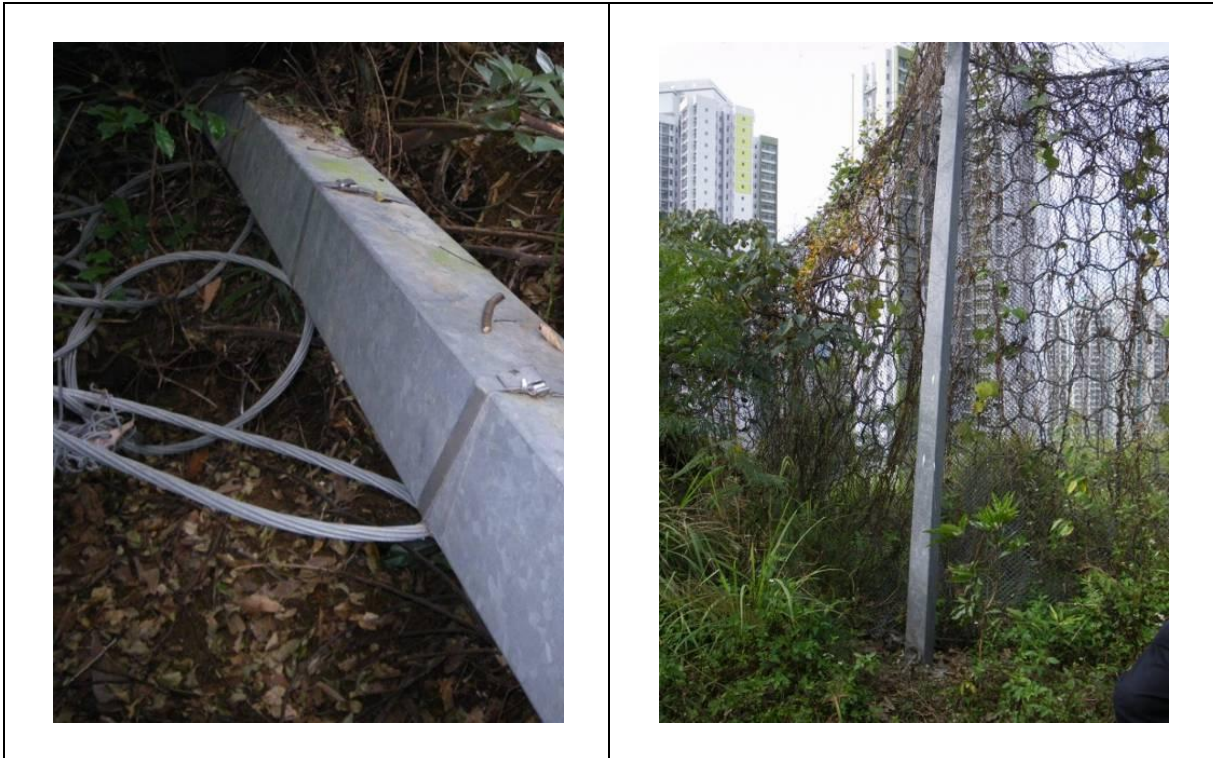
Figure 2.3 Photograph of Post P15

It is noteworthy that the construction details of Post P15 are different from the intermediate Posts P1 and P2. The ring net was attached to Post P15 by about nine layers of stainless steel bands (see Figure 2.3), whereas Posts P1 and P2 were not tied to any ring net (see Figure 2.4).

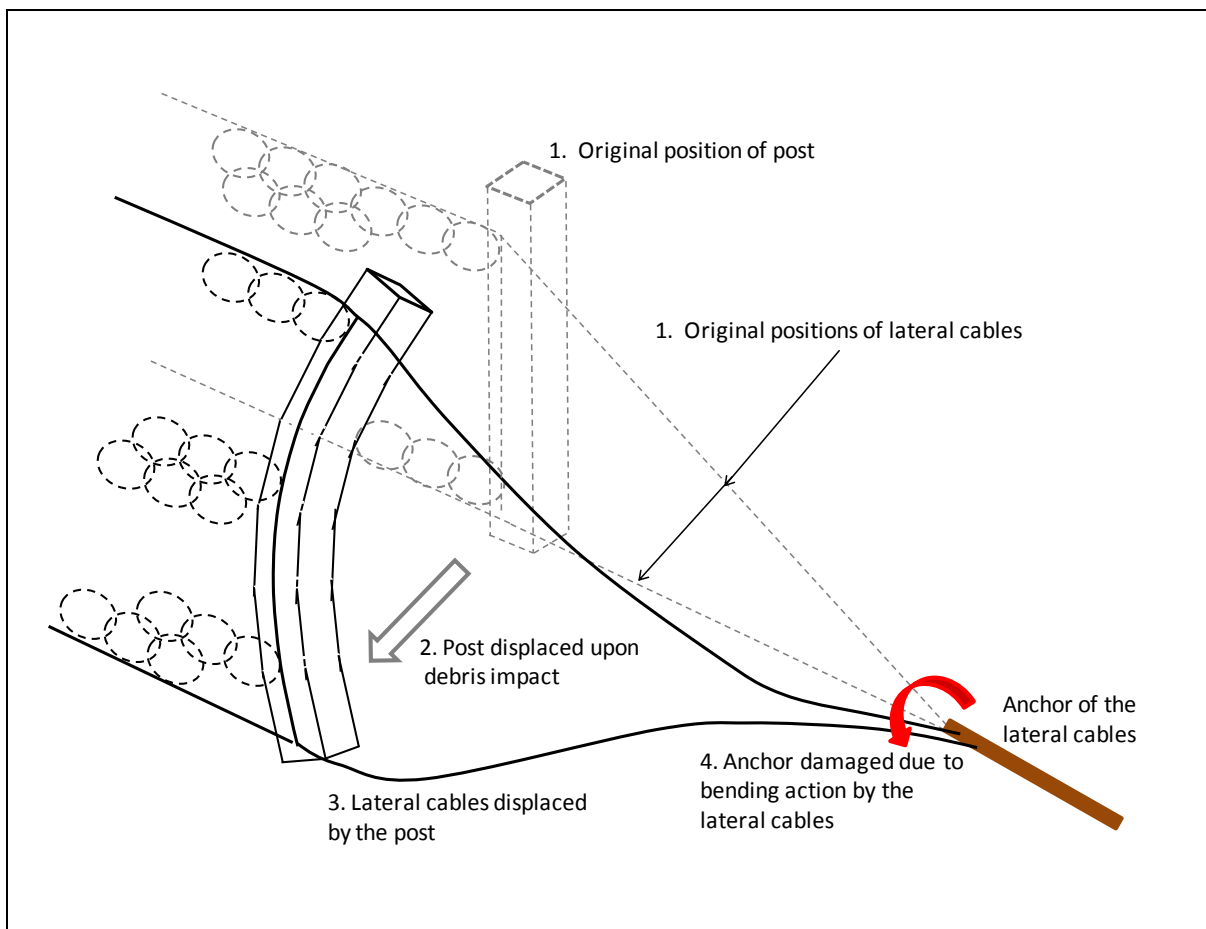
Figure 6.2 Bending of Lateral Anchor

With reference to item (e) regarding failure of post foundation, it is noteworthy that the foundation of Post P15 was displaced along the direction of debris impact by about 1 m. This displacement direction is perpendicular to the lateral cable, which resulted in bending actions on the ground anchor of the lateral cable. This probably caused the damage in the grout core of the anchor as observed on site (see Figure 6.2). Therefore, displacement of the posts, depending on the direction of the displacement, could have implications on anchor foundations of the lateral cables.

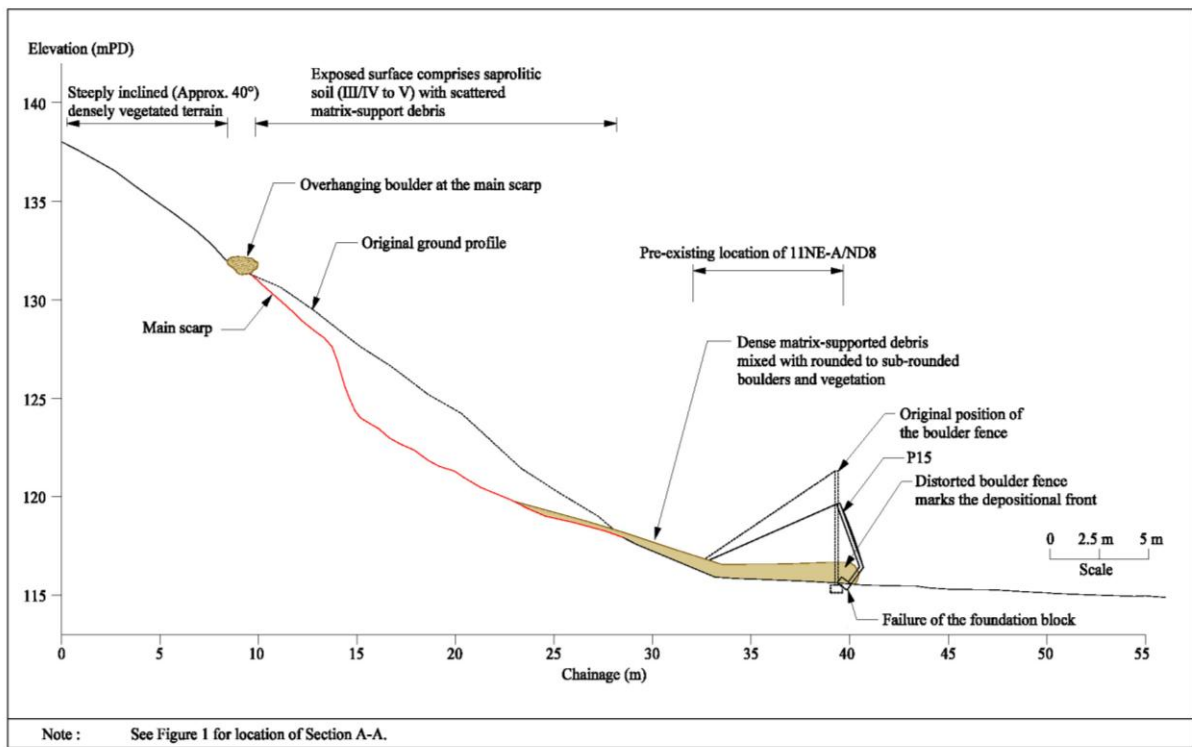
Figure 3 Section A-A through the Damaged End Post No. P15

- 5.3 There is no sign of direct impact of debris on the end post No. P15. Large forward displacement of the end post No. P15 due to the landslide debris would have resulted in a significant shear force on the lateral anchor (which acts almost perpendicular to the direction of the movement of the post), leading to bending of the anchor and local failure

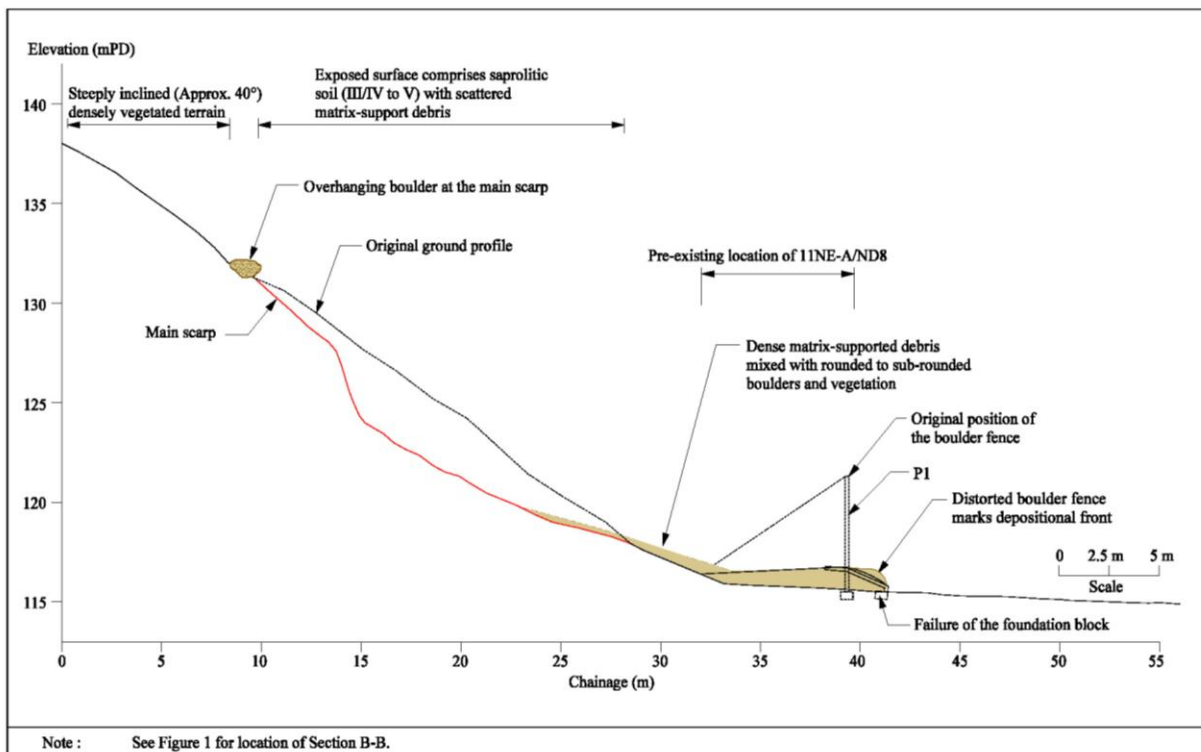
Figure 4 Section B-B through the Damaged Post No. P1

- 4.1 The debris was contained by the first and second span of the boulder fence (Figure 1). The netting of the first and second span, together with the intermediate post (i.e. post No. P1), was pushed forward by the debris and displaced up to 2.2 m in the downslope direction (Figure 4). Post No. P1 was severely deformed (Plate 5). The other components of the system, which have been damaged as a result of the incident, included side post No. P15 in the south (Figure 3 and Plate 6) and the lateral anchor connected to post No. 15 (Plate 8). No apparent signs of damage or movement were observed on Post 2.

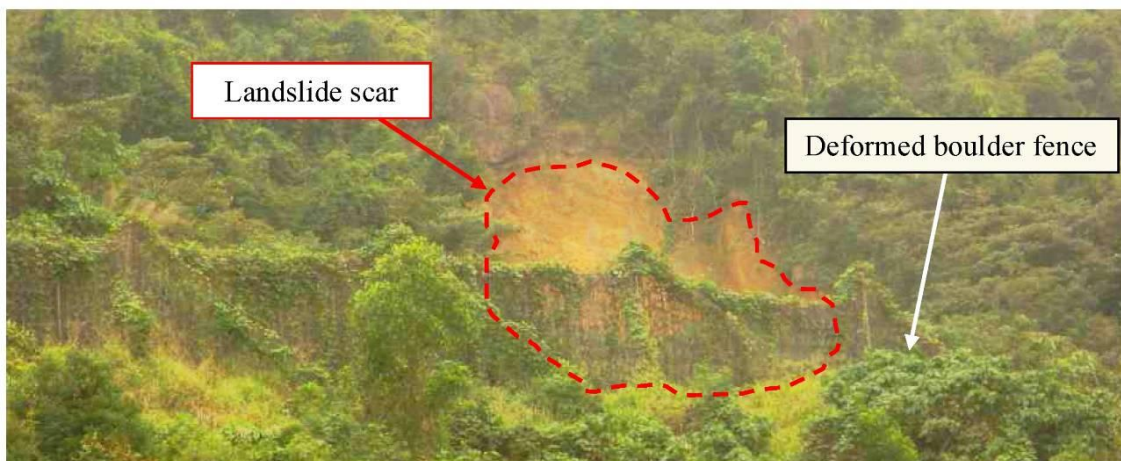
- 1.1 The open hillslope failure (Incident No. LI/2009/12/2001) occurred on a west-facing hillside above Slope No. 11NE-A/C872 (Figure 1 and Plate 1). The failure volume was about 110 m³. The landslide debris damaged an approximately 10 m section of boulder fence No. 11NE-A/ND8 (Plates 2 and 3).

Plate 2 – General View of the Landslide

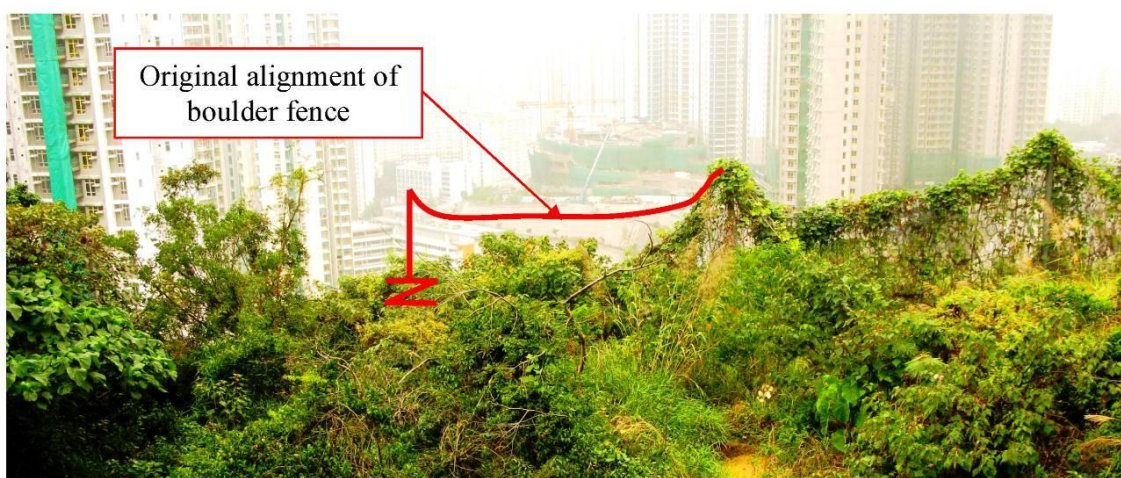
Plate 3 – View of Boulder Fence from the Landslide Source Area

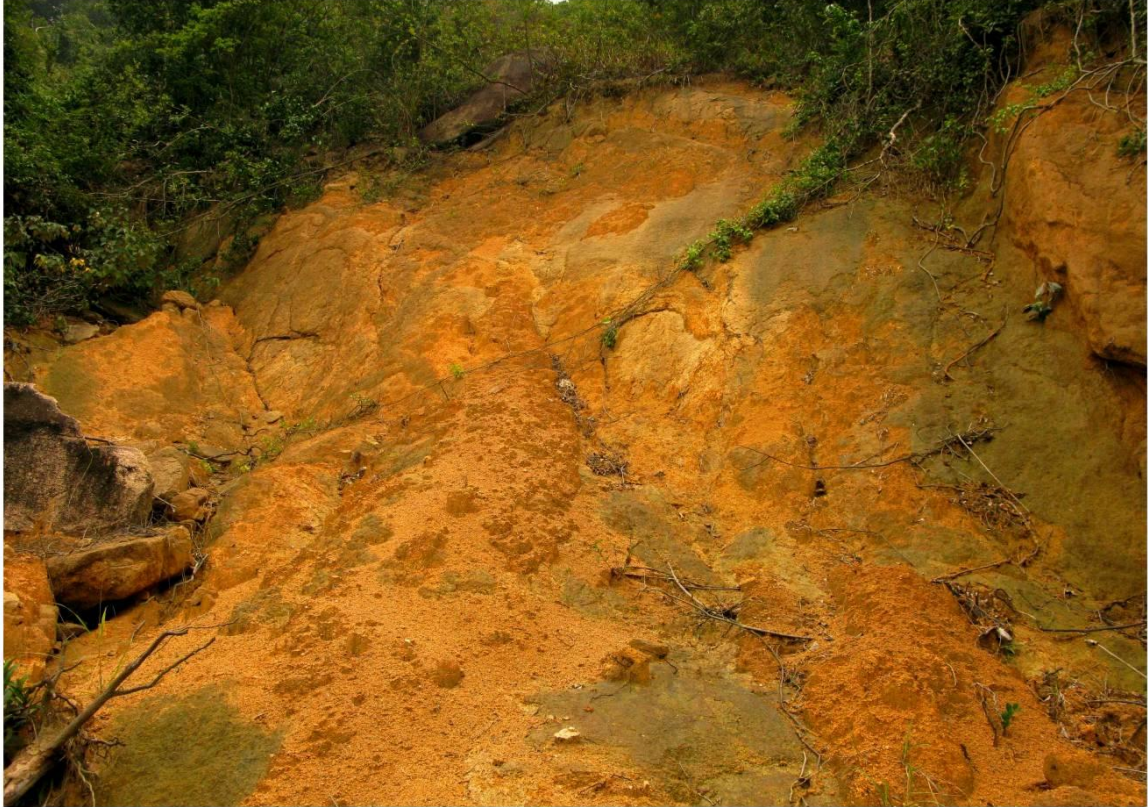
- 2.1 The open hillslope failure occurred below an area of exposed rock outcrop with overhanging boulders. The scar measured approximately 18 m long by 10 m wide, up to 3.5 m deep (Figures 2 to 4). The displaced volume is about 110 m³.
- 2.2 The upper portion of the source area comprises predominately saprolitic terrain, and is steeply inclined (> 50°) with adverse dipping joints (Figure 2 and Plate 4).
- 2.3 The lower portion of the source area comprises predominately matrix-supported debris overlying saprolite. The debris was dry at the time of inspection in December 2009. After the debris was removed, it can be seen that the lower portion of the landslide source area is sloping at 30° to 40°.

Plate 4 – Upper Portion of the Landslide Source Area

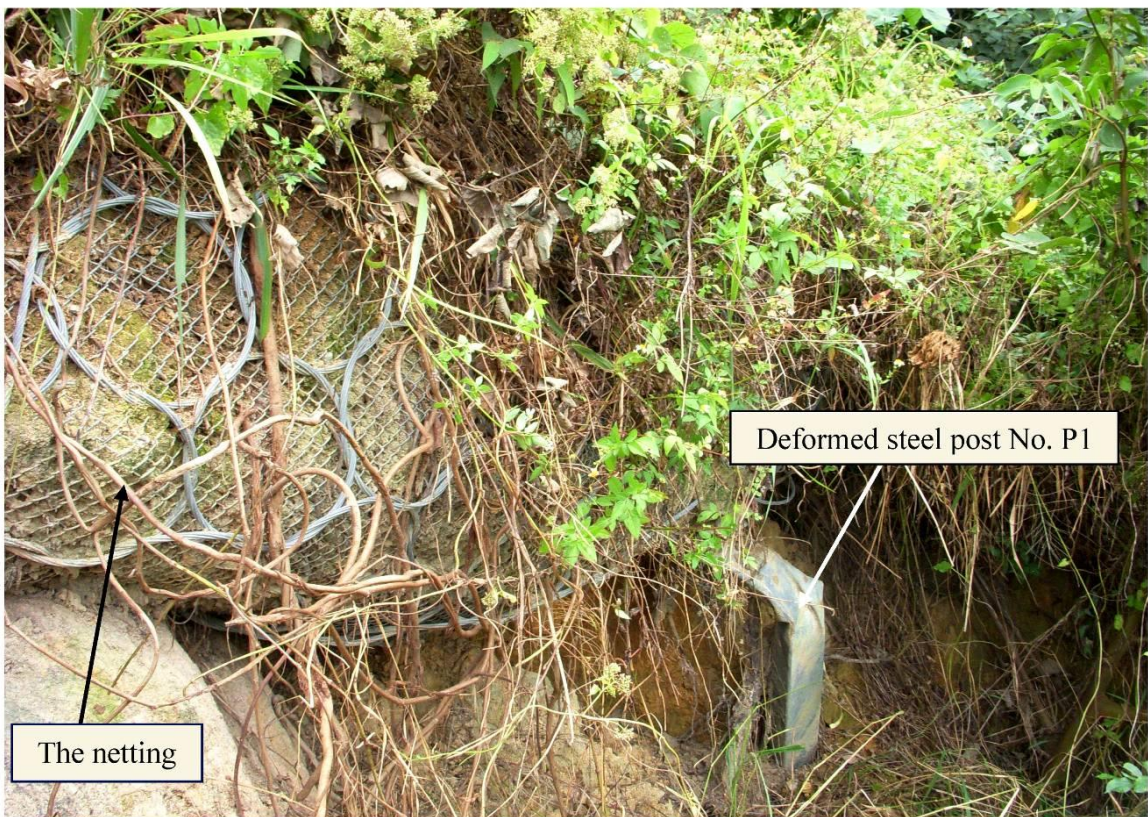
Field observations indicated that the landslide debris was largely retained by the flexible rockfall barrier. However, it was found that Post P1 was severely deformed and had failed (see Plate 5 in Appendix A). End Post P15 was also damaged, although there was no signs of direct debris impact on this post (see Figure 3 and Plate 6 in Appendix A). It is worthwhile to examine the possible structural behaviour of the flexible barrier subject to debris impact in this landslide, which may shed some light on the possible failure mechanism of the barrier posts.

- 5.1 Although the landslide debris severely damaged post No. P1 and pushed it some 2 m forward, the brake cable connecting post No. P1 and the uphill anchor did not appear to have extended significantly. This suggests that the impact energy of the debris has largely been absorbed by the deformation of the netting.

Plate 5 – Steel Post No. P1 was Pushed Forward Together with the Netting

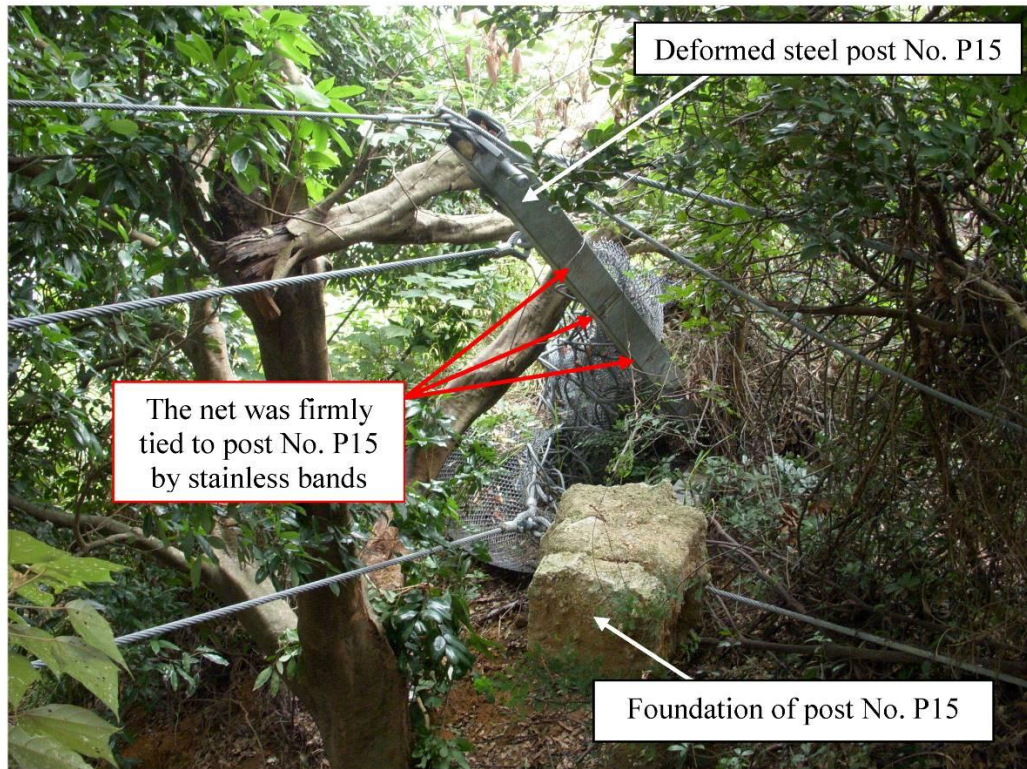
- 4.2 The deformed steel posts are shown in Plates 5 to 7. The foundations of Posts Nos. P1 and P15 also failed.
- 4.3 The head of the lateral anchor (connected to post No. P15) displaced about 1 m (Plate 8), leading to failure of the front part (about 0.9 m) of the grout (Plate 9). The half bent plate connected to the anchor head (Figure 8) remained intact. The extension ropes in the braking system were frayed and extended slightly (Plates 10 and 11). No significant lateral displacement of Post 1 was observed (Plate 5).

Plate 6 – Deformed End Post No. P15 and its Foundation

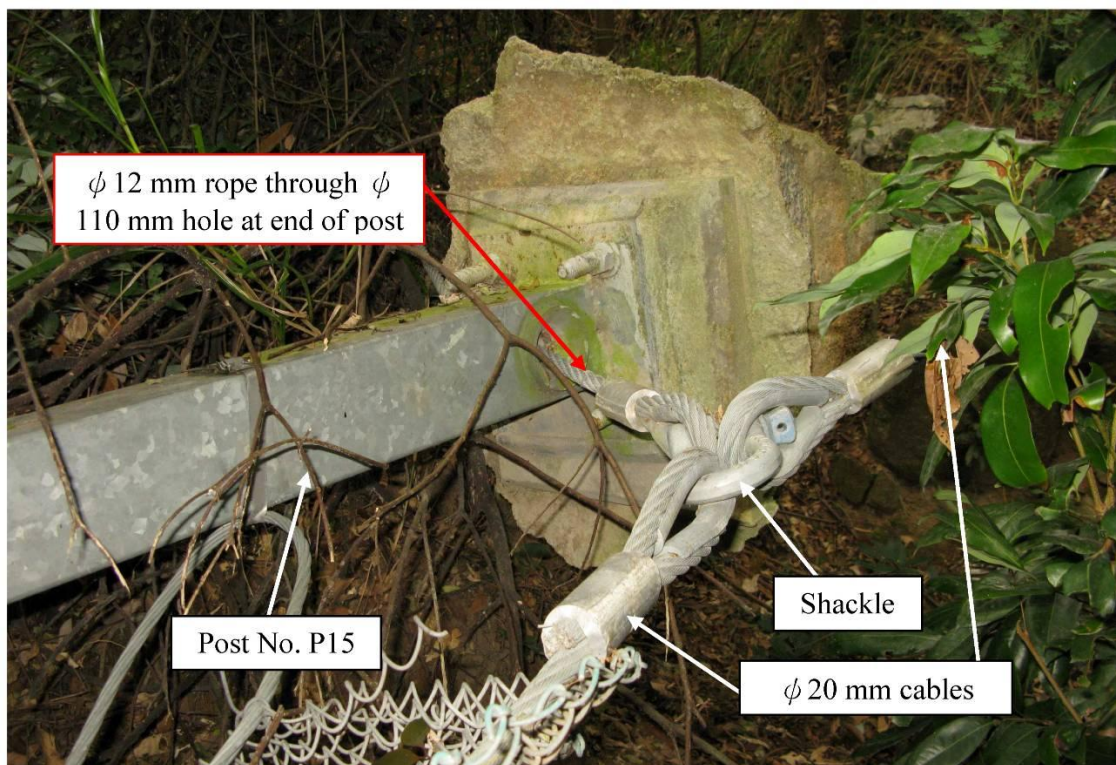
Plate 7 – Connection of Post No. P15 and its Foundation Block

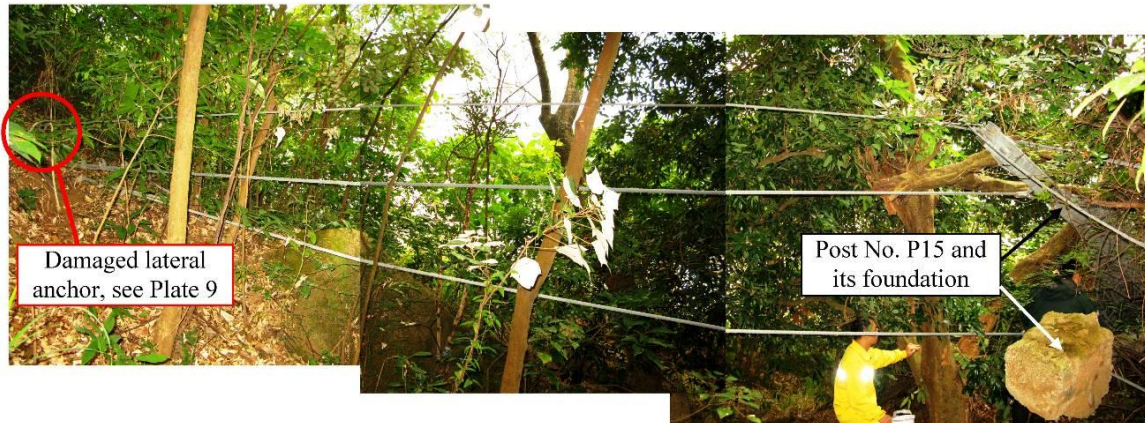
Plate 8 – Location of Lateral Anchor

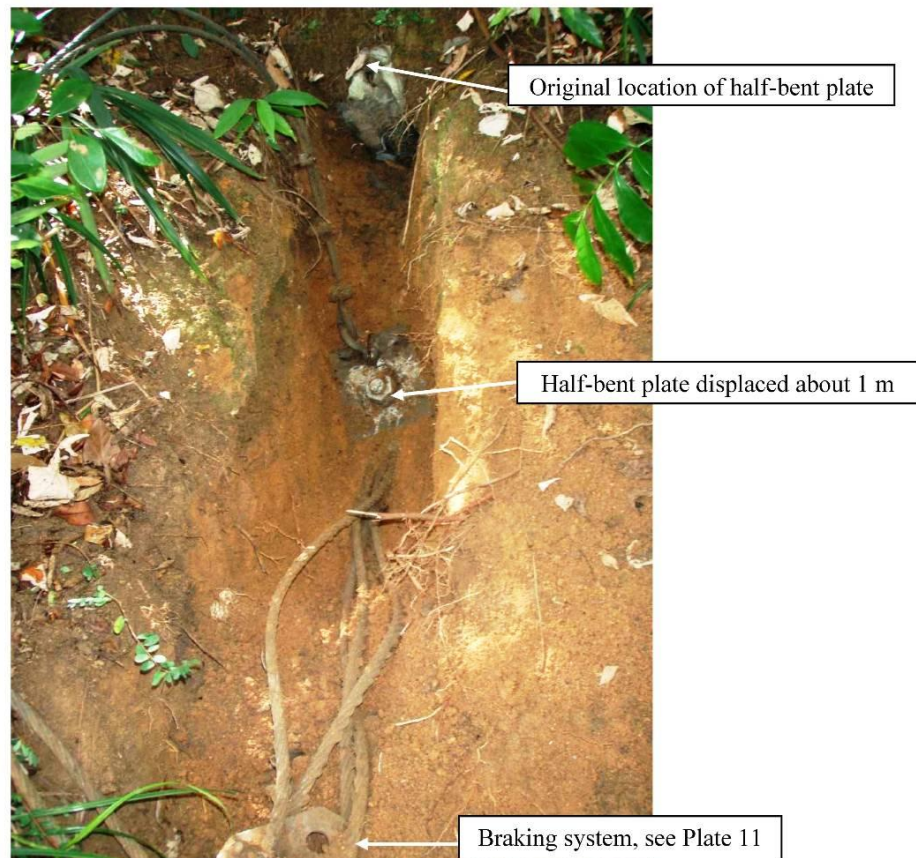
Plate 9 – Anchor Bent Leading to Failure of the Front Part of Grout Block

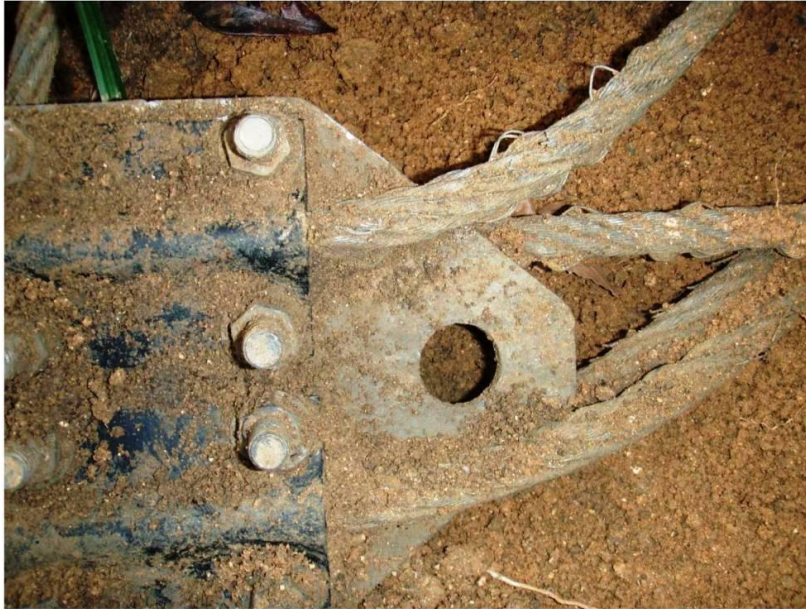
Plate 10 – Frayed Ropes Connected to the Braking System of the Lateral Anchor

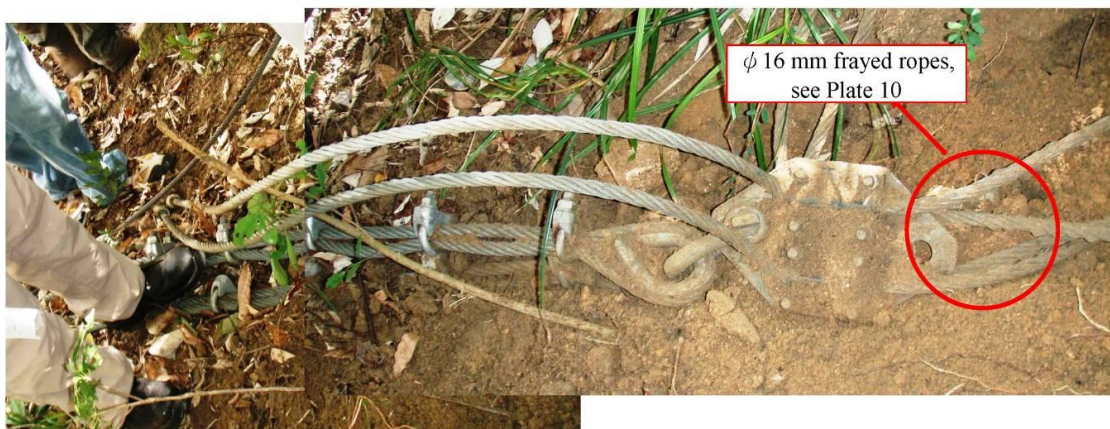
Plate 11 – Ropes Might Have Been Extended Slightly at the Monobloc Brake Connected to the Lateral Anchor

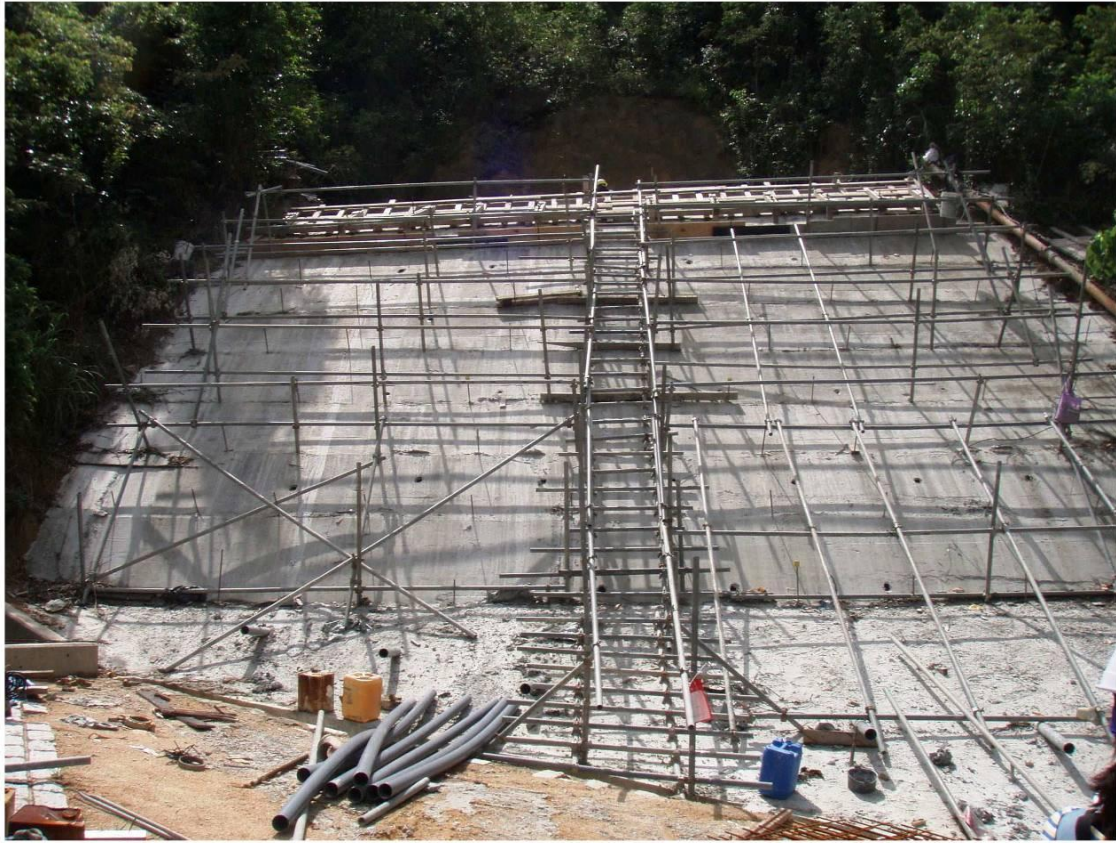
Plate 12 – Remedial Works for the Landslide Scar

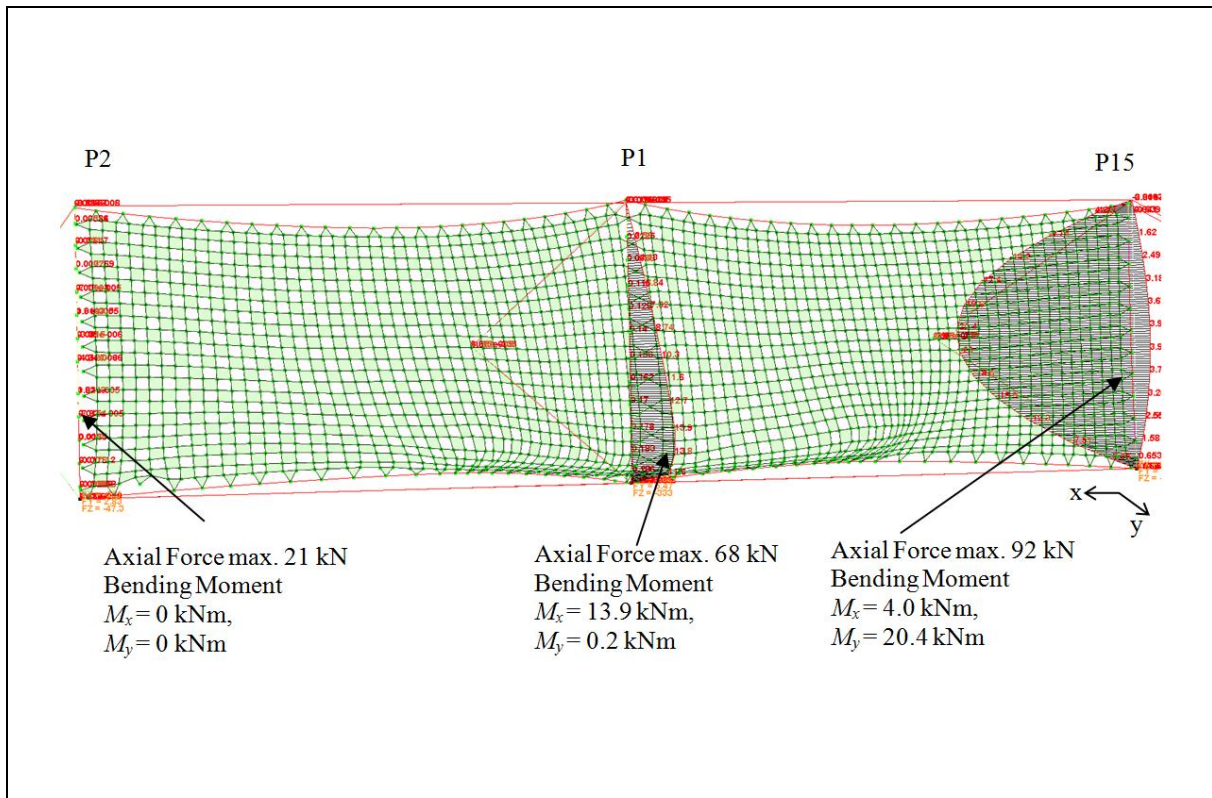
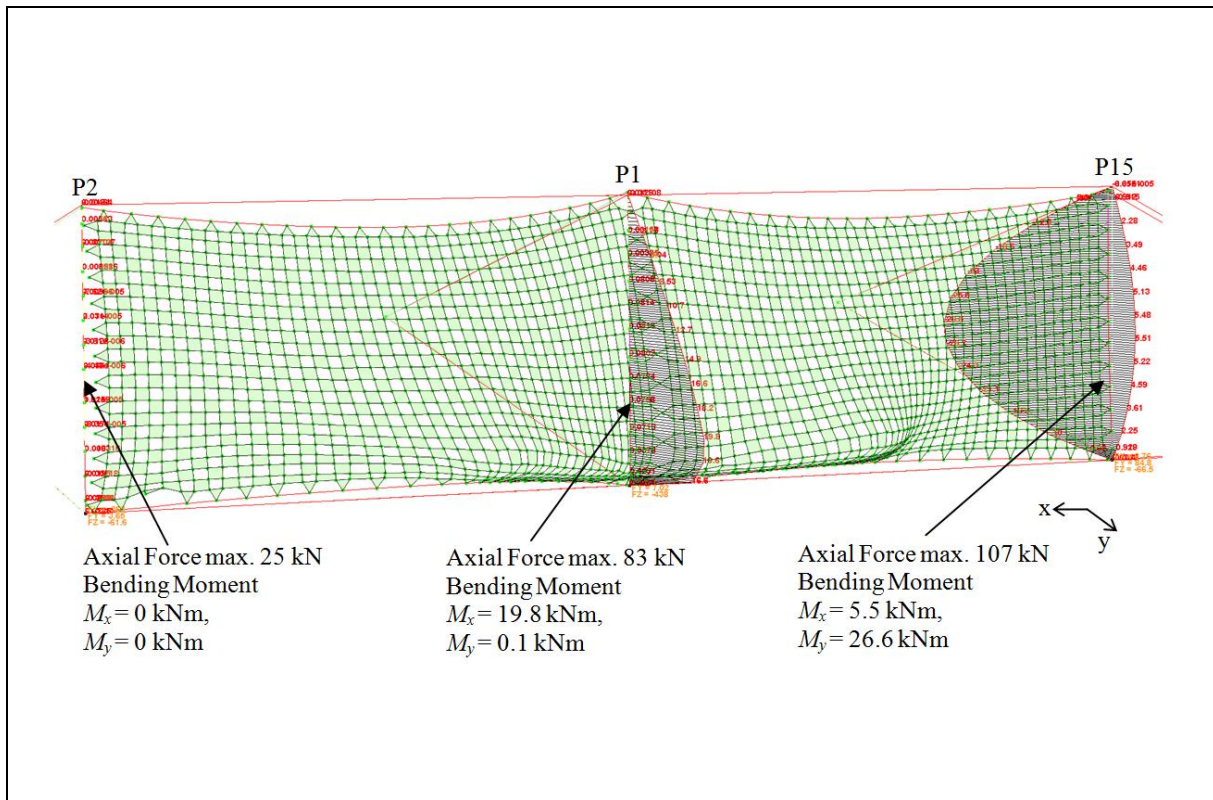
Based on the site inspections, Posts P1 and P15 failed but not P2. The back analysis shows that both Posts P1 and P15 fail when the applied UDP is increased to 50 kPa. The large bending moment in P1 is induced by the UDP directly acting on the post, and the bending moment in P15 is induced by the lateral deformation of ring nets attached to the post. Failure of both P1 and P15 is due to the combined actions of bending moment and the axial compression load. The combined actions could have resulted in buckling failure of the posts. This may explain the reason for the failure of P15, which was not subject to direct hit by the landslide debris. The shear forces induced in the posts were found to be small and not critical.

Figure B5 Bending Moment Diagrams of the Posts under UDP of 50 kPa

Figure B7 Bending Moment Diagrams of the Posts under UDP of 66 kPa
