# **Review of Landslides in 2012**

**GEO Report No. 312**

**R.W.H. Lee, J.C.W. Leung & D.O.K. Lo**

**Geotechnical Engineering Office  
Civil Engineering and Development Department  
The Government of the Hong Kong  
Special Administrative Region**

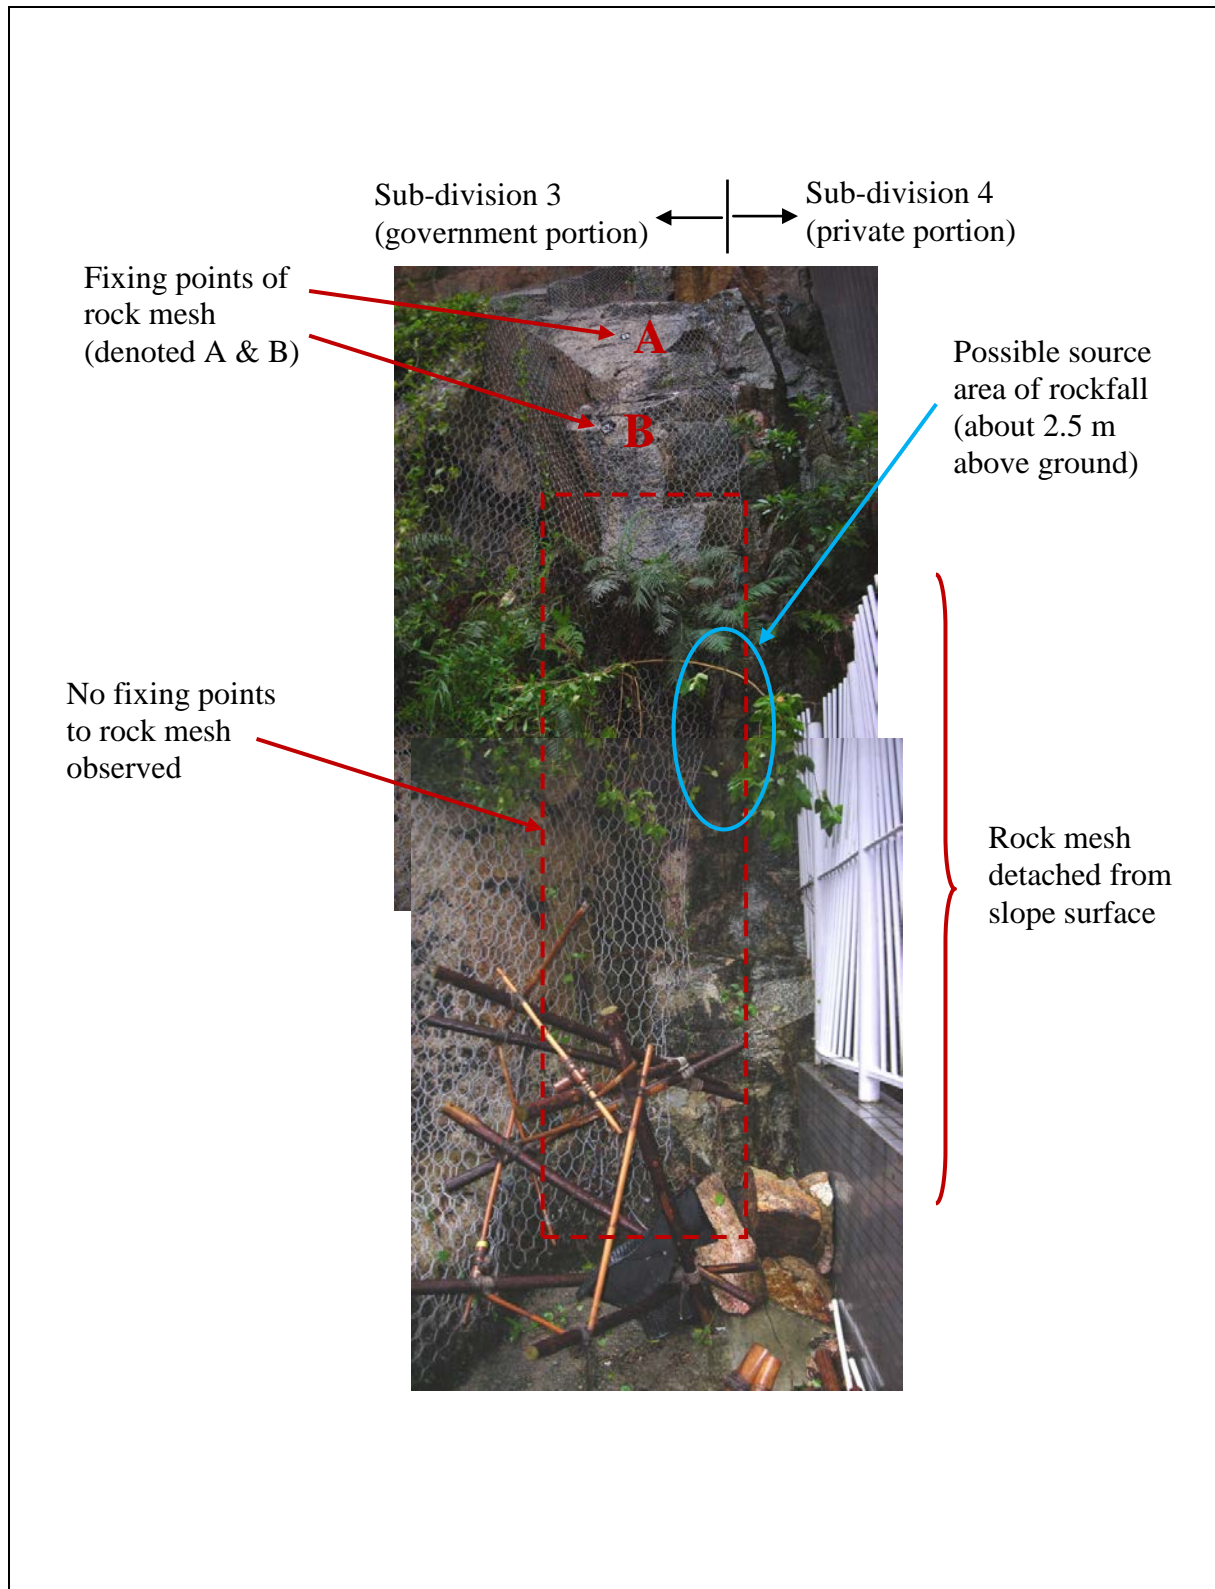
Seven landslides involved minor rockfalls. One of the incidents involved a debris volume of 3 m<sup>3</sup> on Slope No. 7NW-D/C240 (Incident No. 2012/05/1011AD), where the debris was successfully retained by the rock mesh. The slope was upgraded in 2003. This incident was not regarded as an engineered slope failure in accordance with GEO Technical Guidance Note No. 10 (GEO, 2009c). On the other hand, Incident No. 2012/07/1200 occurred at a slope with rock mesh netting, but at the rockfall location the rock mesh was detached from the slope surface and hence unable to retain the dislodged rock blocks. It was observed that the rock surface was rugged and the rock mesh did not follow closely the profile of the rock cut surface. In addition, the designed spacing of the fixing points (i.e. 3 m c/c) for the rock mesh at the rockfall location was not met and no fixing points could be found at the bottom part of the mesh (Figure 4.2).

**Figure 4.2 Detached Rock Mesh Netting at Slope No. 11SE-A/C84 near Mansion Street, Quarry Bay (Incident No. 2012/07/1200)**
