Interim Review on Long-term Monitoring of Corrosion of Soil Nails

GEO Report No. 334

**Geotechnical Engineering Office
Civil Engineering and Development Department
The Government of the Hong Kong
Special Administrative Region**

This report presents an interim review on long-term monitoring of corrosion of soil nails. It summaries the findings of the soil nail exhumation exercises between 2010 and 2013, which are part of the study on long-term monitoring of corrosion of soil nails.

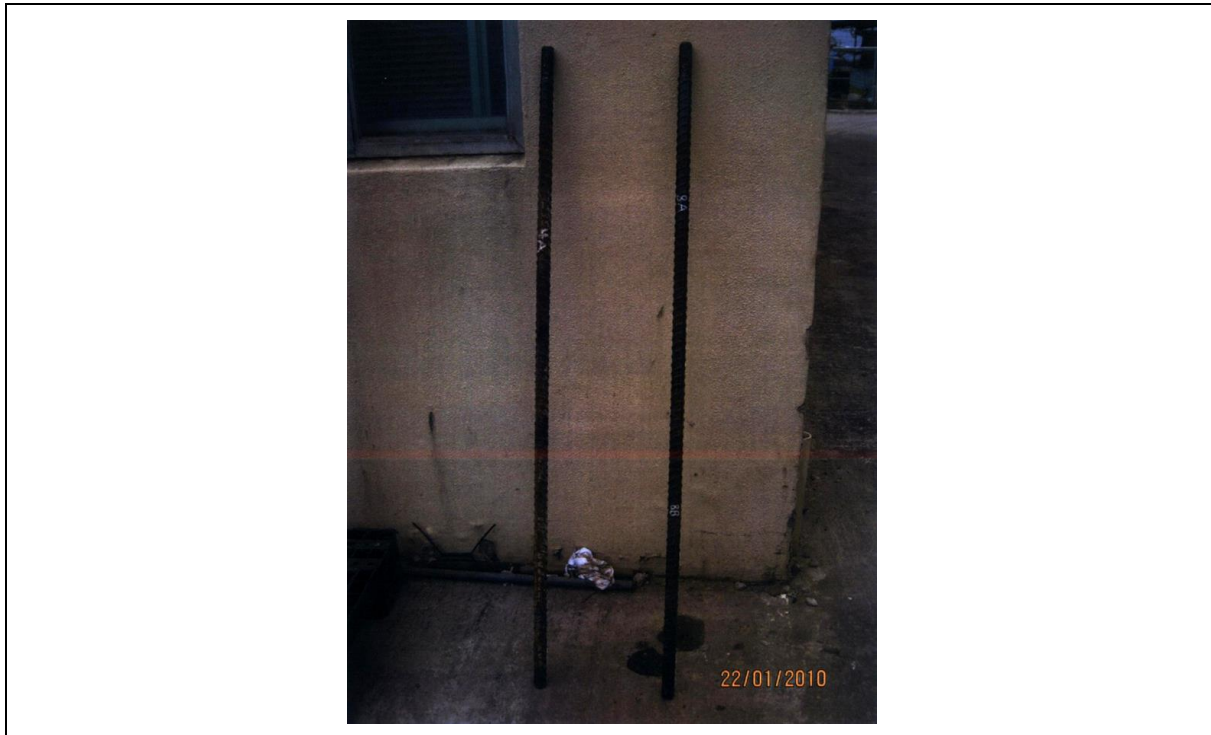
- (a) According to the laboratory test results on soil aggressivity, the site was classified as “non-aggressive” in accordance with Table 4.1 of Geoguide 7 (GEO, 2008).
- (b) The two exhumed sacrificial soil nails were plain steel bars installed in direct contact with the ground. Extensive surface corrosion was observed on the nail bars while no pitting corrosion was spotted (Figure 4.1).
- (c) The results of the tensile tests showed that the yield stress of the two rusty plain steel bars was about 10% greater than its characteristic strength of 460 MPa. The allowable tensile strength of the rusty steel bars was considered not affected by their corrosion condition.

Figure 4.1 Example of Sacrificial Soil Nails with Extensive Surface Corrosion at Slope No. 11SW-D/C2089 at the Hong Kong Stadium

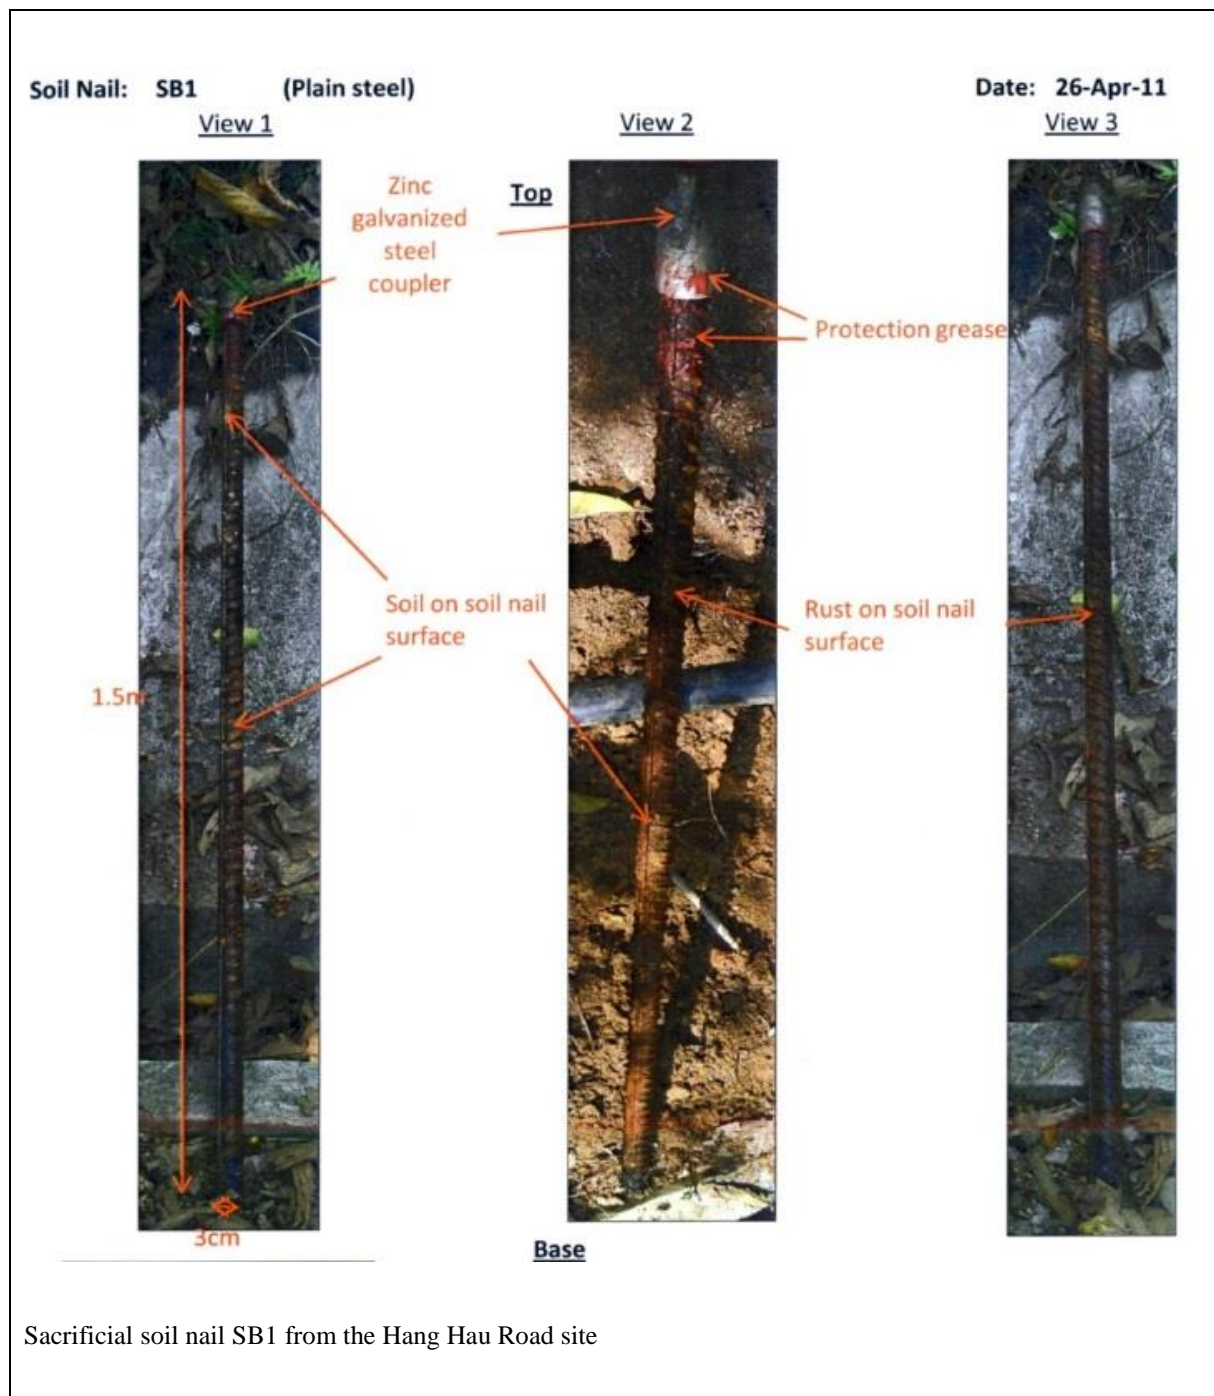
- (b) For the two plain steel bars installed in direct contact with the ground (i.e. SB1 and SB4 at the Hang Hau Road site), extensive sign of corrosion was observed on the surface (Figure 4.2). No pitting corrosion was observed by means of visual inspection. They were not examined further at the laboratory, e.g. cutting into short lengths for inspection of the cross sections.

Figure 4.2 Example of Sacrificial Soil Nails with Extensive Surface Corrosion in Exhumation Exercise in 2011

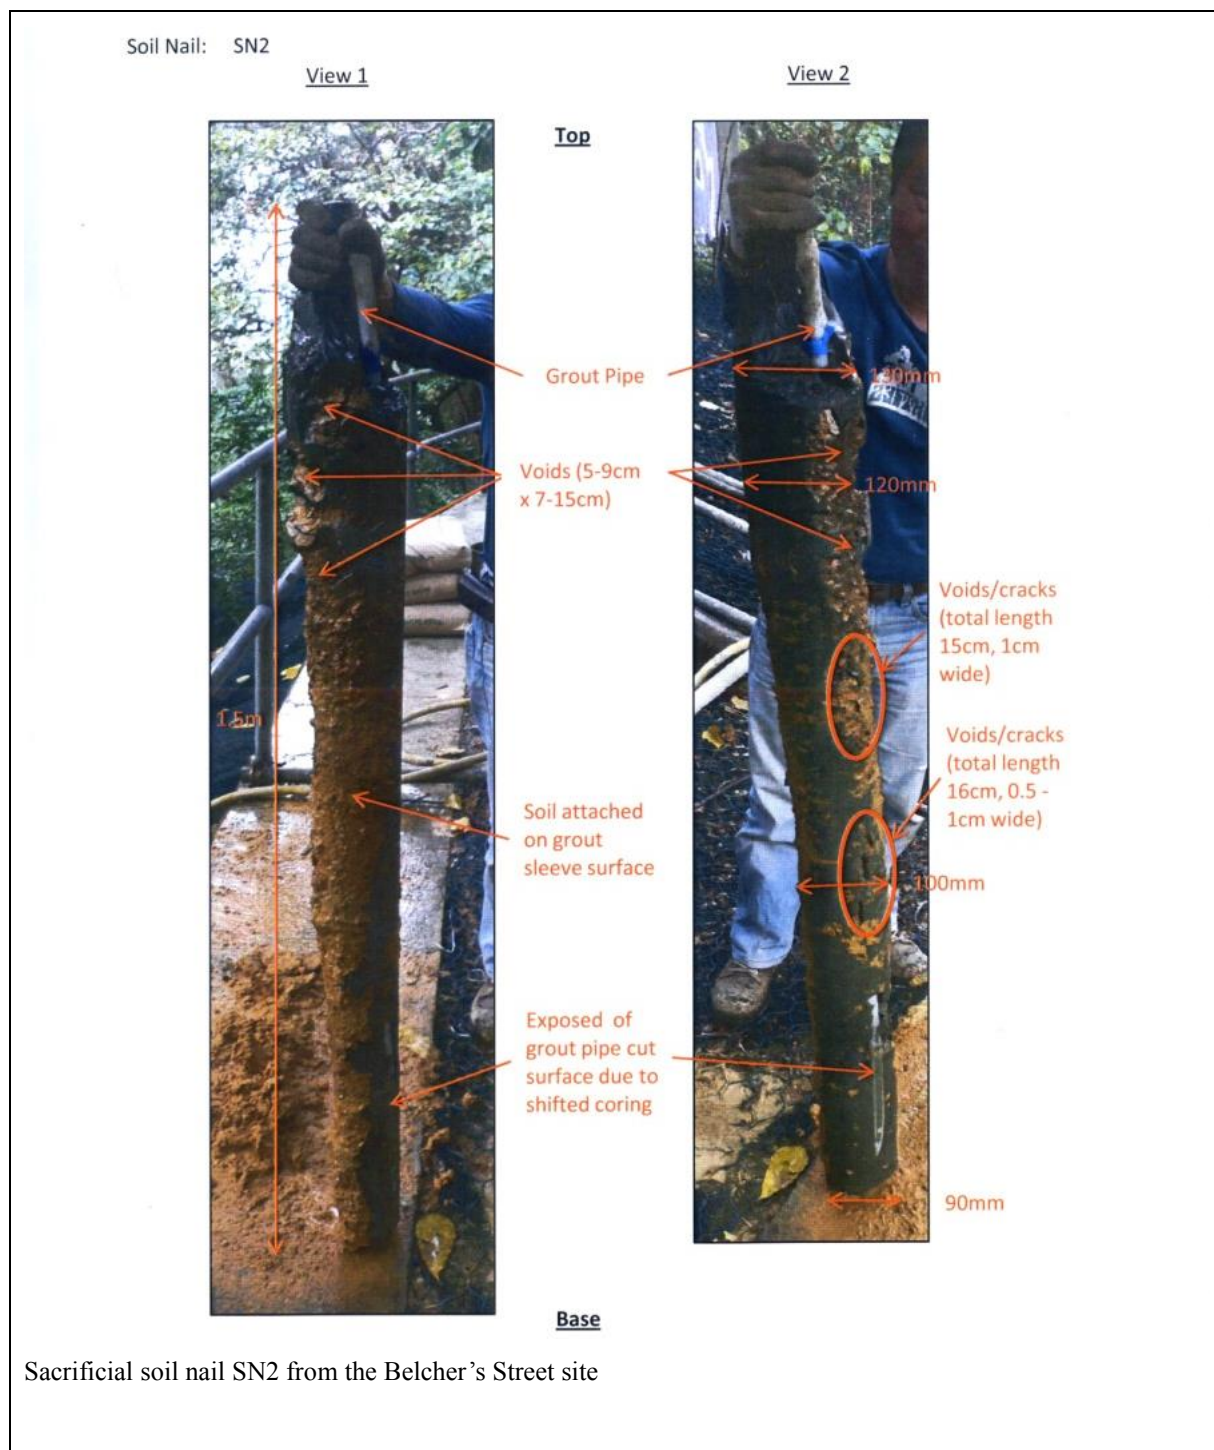
at the Hang Hau Road site) were exhumed with the grout sleeves fully or partially preserved. Different extent of defects, in terms of voiding and cracking of the grout sleeves, were identified on the grout covers of these six nails (Figure 4.3), possibly due to poor workmanship during grouting. The grout cover of the soil nail SN4 at Hang Hau Road site was completely crushed during coring (Figure 4.4).

Figure 4.3 Example of Voids and Cracks on Grout Sleeves in Exhumation Exercise in 2011

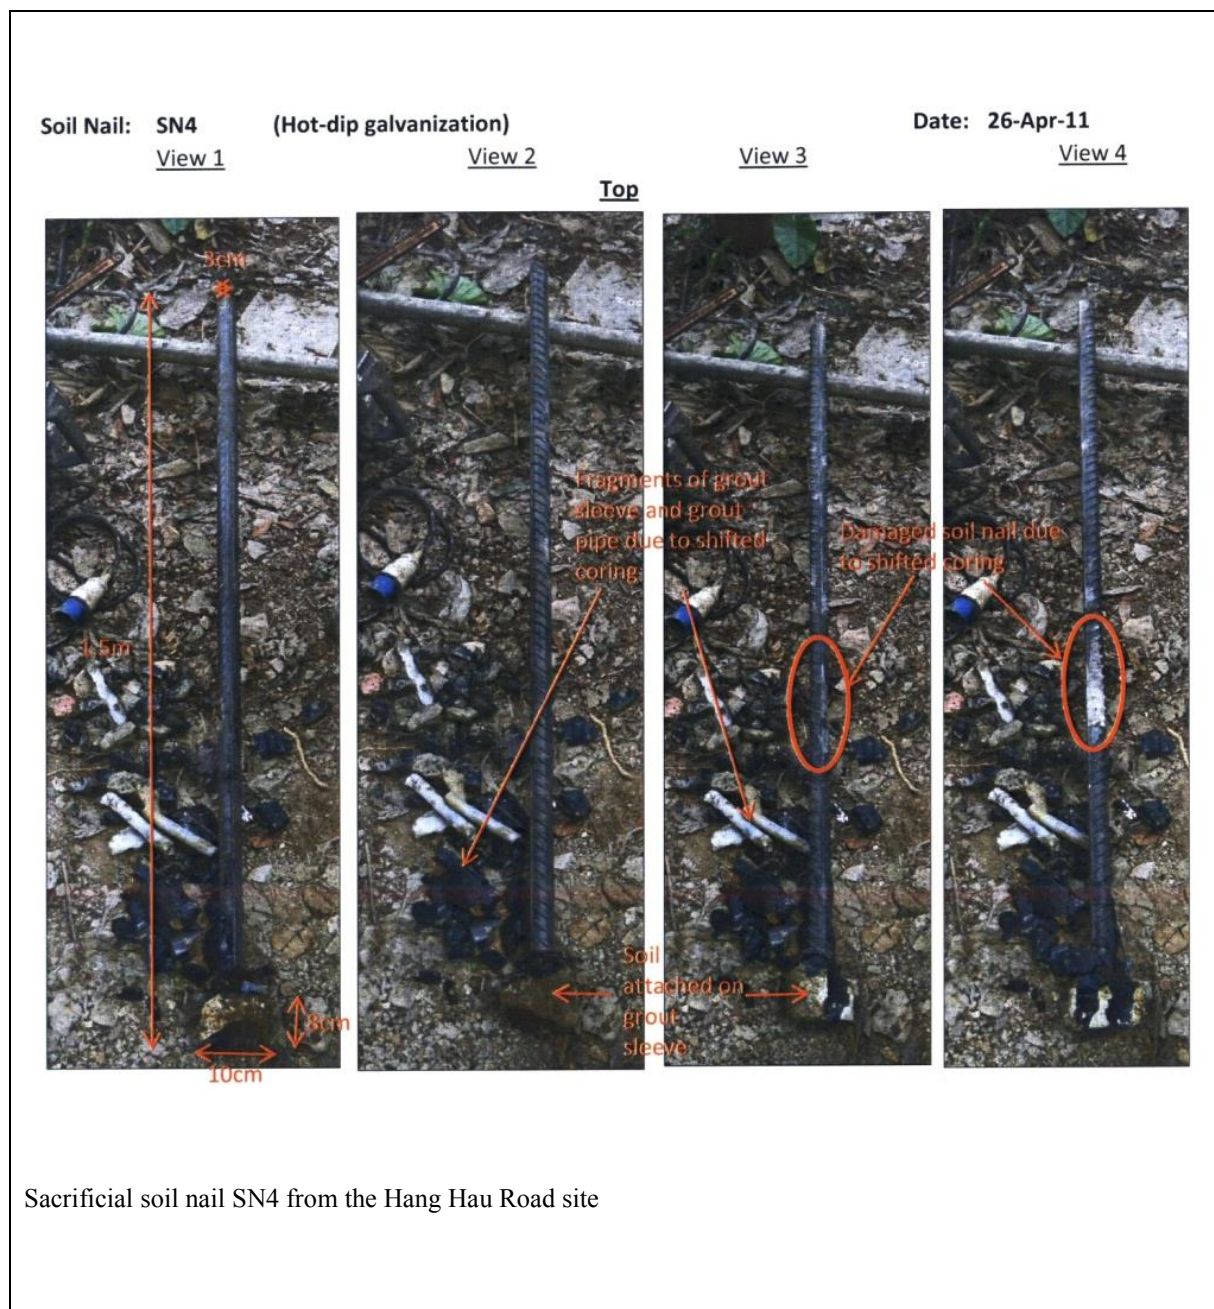
Figure 4.4 Example of Completely Crushed Grout Sleeves in Exhumation Exercise in 2011

Coring was employed for the exhumation of the soil nails. Some difficulties were encountered during the course of the exhumation works which affected those nails with grout sleeve. As a result, the grout sleeve of some soil nails were completely/partially damaged. The difficulties were diagnosed to have primarily related to hard ground materials encountered, coupled with inefficient equipments and/or insecure support of the drilling rig during coring. To overcome such difficulties, it is essential to verify the ground materials in which the nails are embedded and to ensure a stable and efficient coring. It is recommended that a trial core should be carried out before the exhumation of soil nails at each of the nail exhumation sites, or adjacent to any nail location in which the nature of the ground materials is in doubt, to test the suitability of the coring equipment deployed and the adequacy of support for the coring rig at such ground conditions.

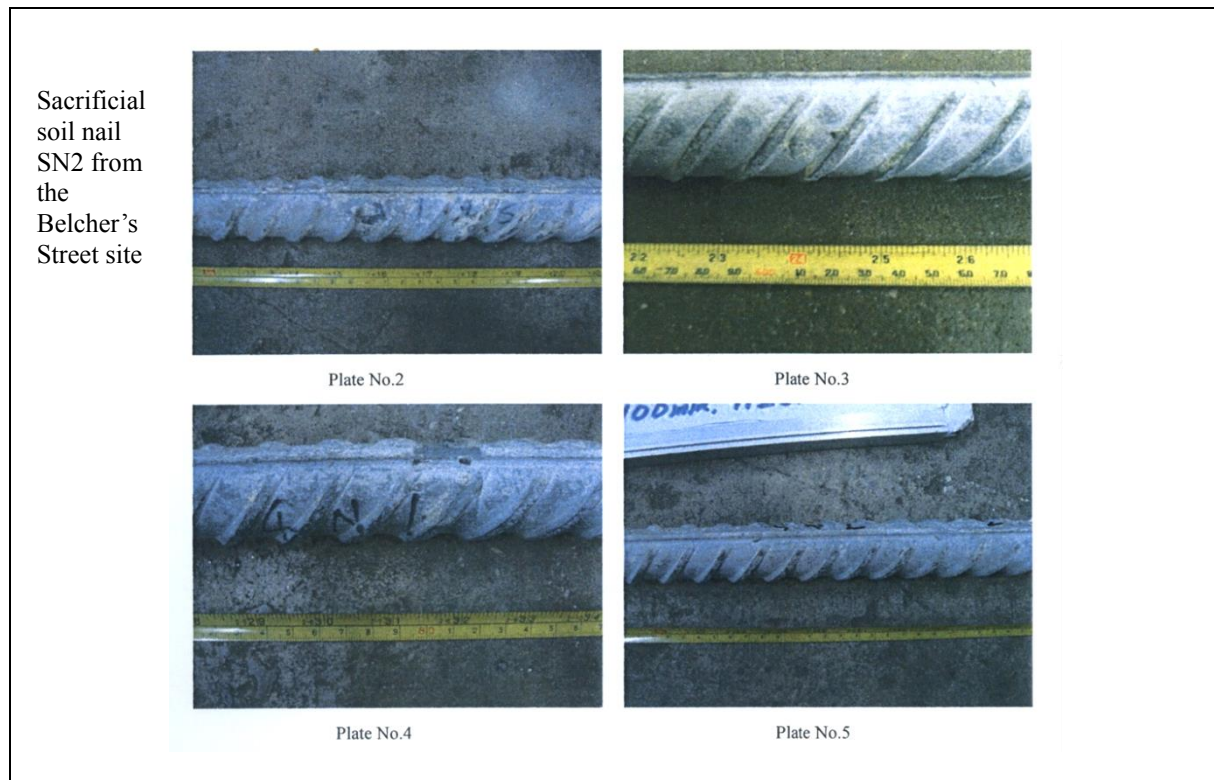
Figure 4.5 Example of Surface Conditions of Hot-dip Galvanized Soil Nails with Grout Sleeves in Exhumation Exercise in 2011

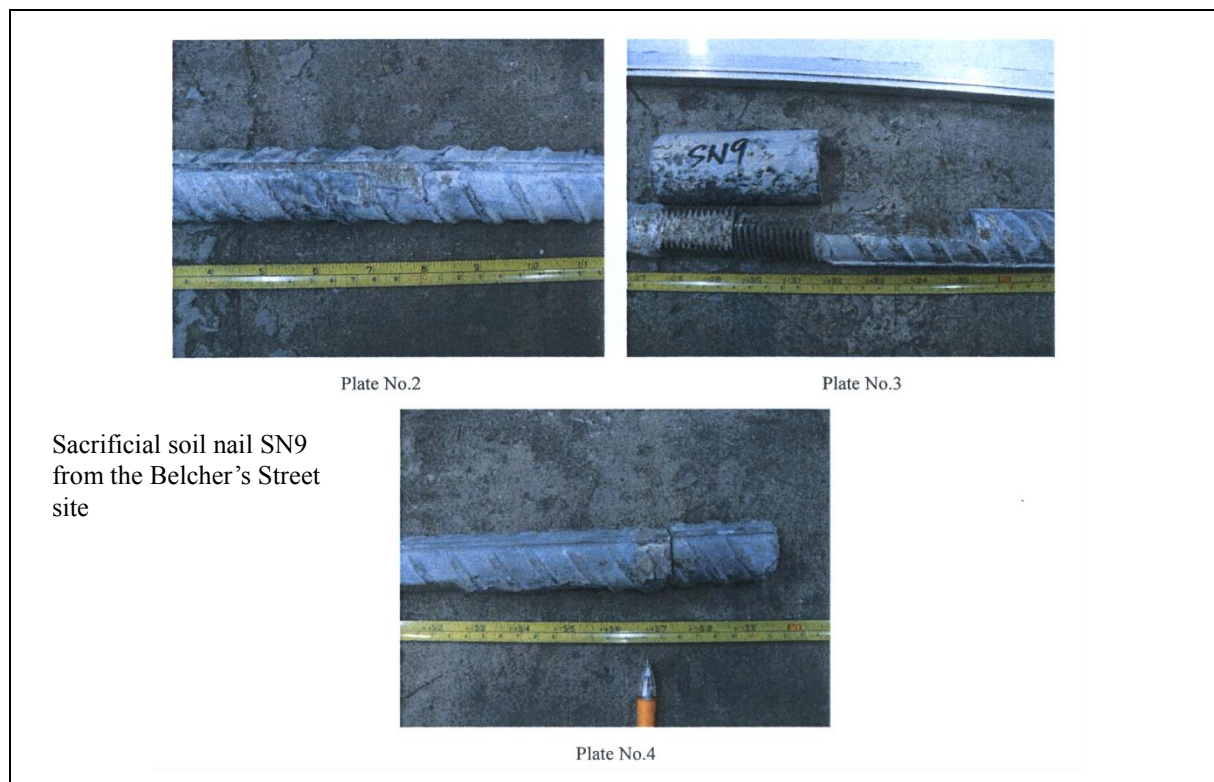
- (e) For the two nails with provisions of couplers (both were zinc-galvanised and grout-protected) (i.e. SN9 at the Belcher's Street site and SN7 at the Hang Hau Road site), mild surface corrosion was observed on the exposed threaded sections of the nail bars, while no major sign of corrosion was noted on the zinc-galvanised nail bars or couplers (Figure 4.6).

Figure 4.6 Example of Surface Conditions of Couplers in Exhumation Exercise in 2011

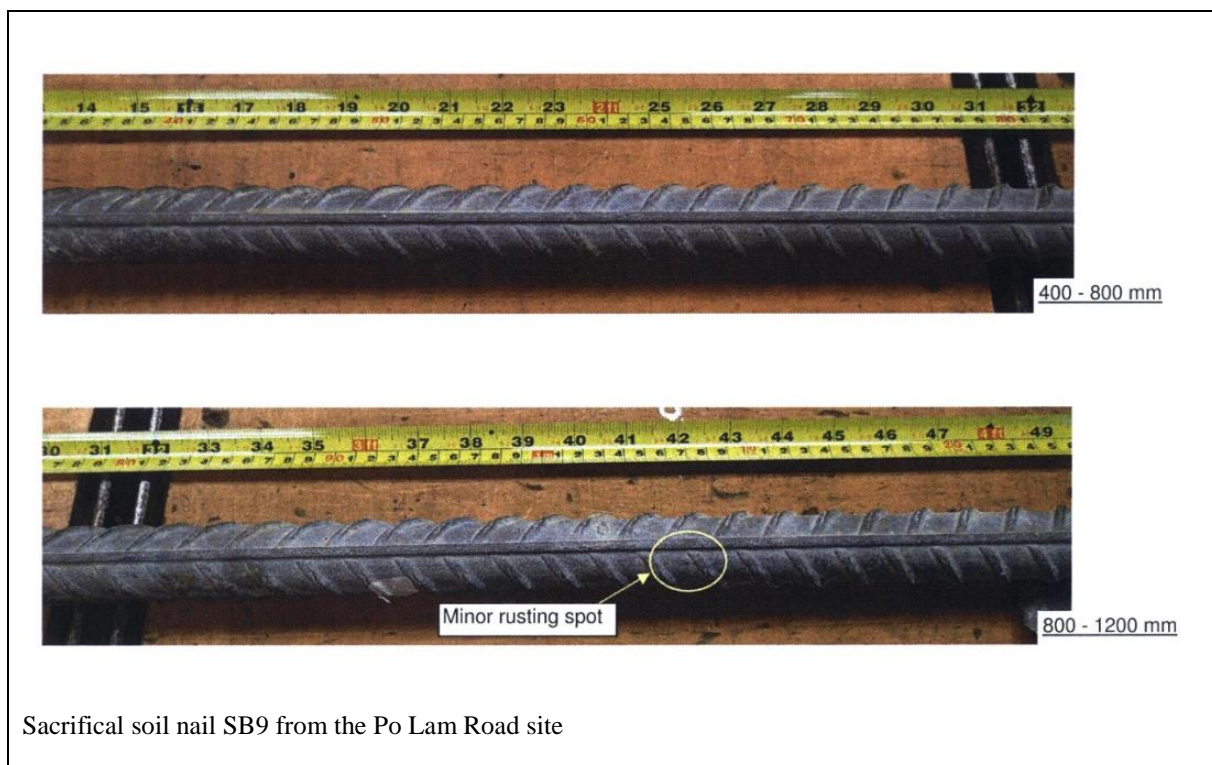
- (b) Out of the six exhumed soil nails that were in direct contact with the ground (i.e. SB1, SB5, SB9, SB11, SB13 and SB16 at the Po Lam Road site), four were protected with either hot-dip galvanization (i.e. SB9 and SB11) or epoxy coating (i.e. SB13 and SB16). The soil nails with hot-dip galvanization showed no significant signs of corrosion (Figure 4.7). For the two soil nails protected with epoxy coating, no signs of damage of the protective coating were observed (Figure 4.8). The remaining two plain steel samples (i.e. SB1 and SB5) displayed extensive surface corrosion. Pitting corrosion was spotted at one single location (measured 2 mm in depth) on one of the two plain steel bars (Figure 4.9). The estimated rate of pitting corrosion of the soil nail at the “aggressive” site is about 0.25 mm/year (i.e. 2 mm depth of possible pitting corrosion after 8 years of the nail installation), which is in order of the similar assessment for Hong Kong conditions (Shiu & Cheung, 2003).

Figure 4.7 Example of Sacrificial Hot-dip Galvanized Soil Nails with No Significant Signs of Surface Corrosion in Exhumation Exercise in 2013

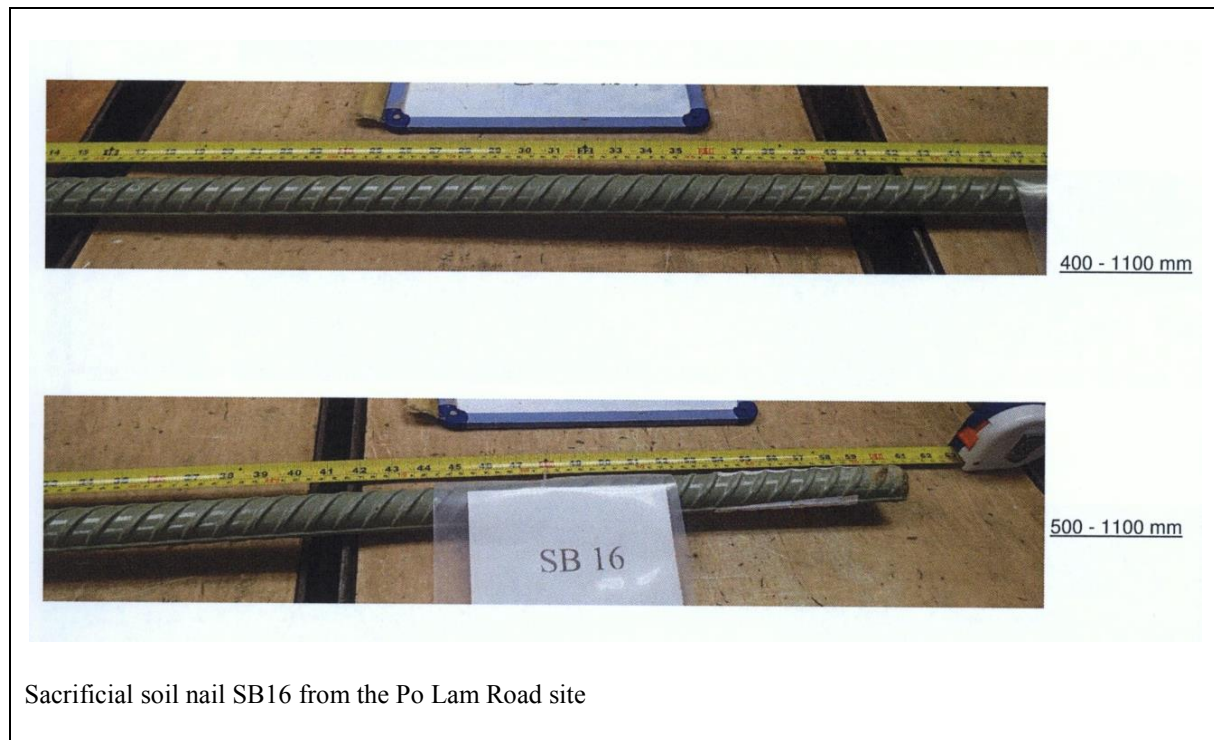
Figure 4.8 Example of Sacrificial Epoxy Coated Soil Nails with No Signs of Damage of Protective Coating in Exhumation Exercise in 2013

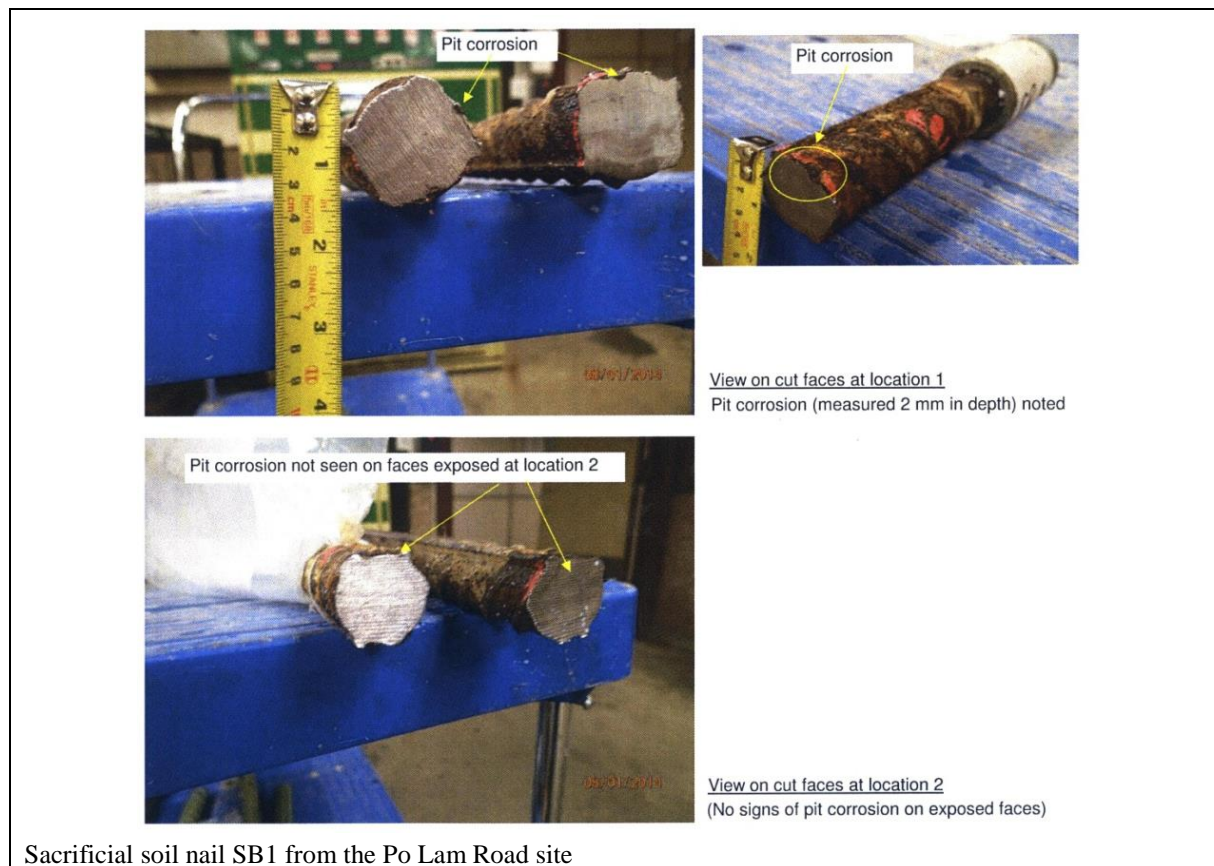
Figure 4.9 Example of Pitting Corrosion on Soil Nails in Exhumation Exercise in 2013

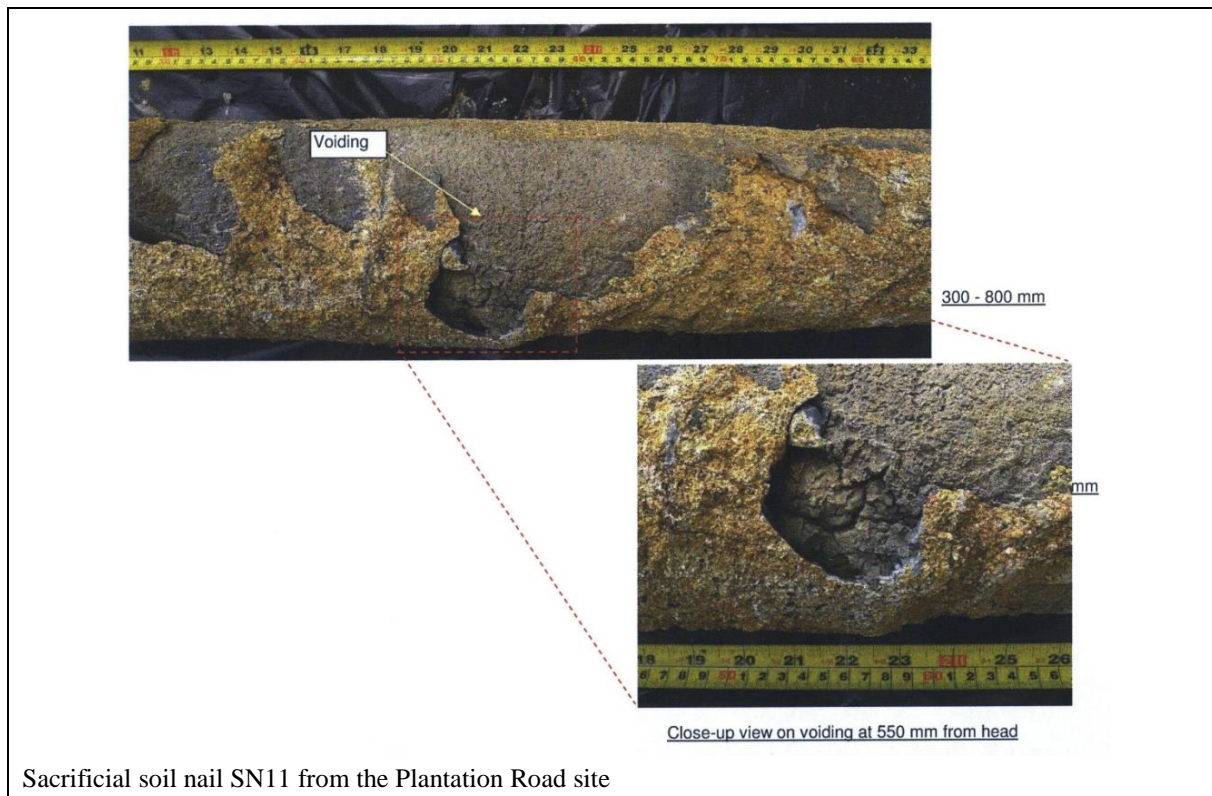
- (c) The seven exhumed soil nails with grout sleeve (i.e. SN1, SN4, SN7 and SN9 at the Po Lam Road site; SN1, SN6 and SN11 at the Plantation Road site) were all protected with either hot-dip galvanization (SN1, SN4, SN7 at the Po Lam Road site and SN1, SN6 at the Plantation Road site) or epoxy coating (SN9 at the Po Lam Road site and SN11 at the Plantation Road site). Out of the seven soil nails, six were exhumed with the grout sleeves fully or partially preserved (i.e. SN4, SN7 and SN9 at the Po Lam Road site; SN1, SN6 and SN11 at the Plantation Road site). Different extent of defects, in terms of voiding and cracking of the grout sleeves, were identified on the grout covers of these six nails (Figure 4.10), possibly due to poor workmanship during grouting. The grout cover of one soil nail (i.e. SN1 at Po Lam Road site) was completely crushed during coring (Figure 4.11).

Figure 4.10 Example of Voids and Cracks on Grout Sleeve in Exhumation Exercise in 2013

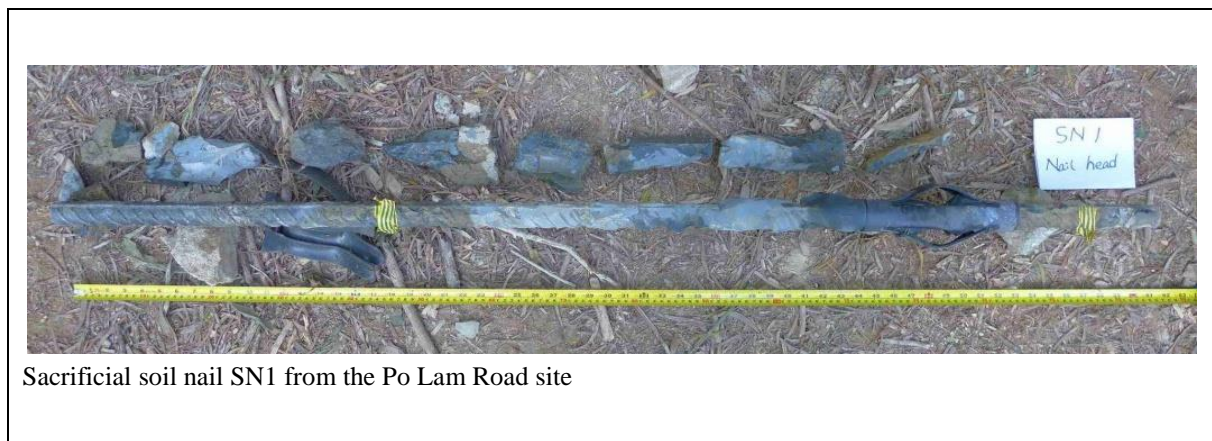
Figure 4.11 Example of Completely Crushed Grout Sleeve in Exhumation Exercise in 2013

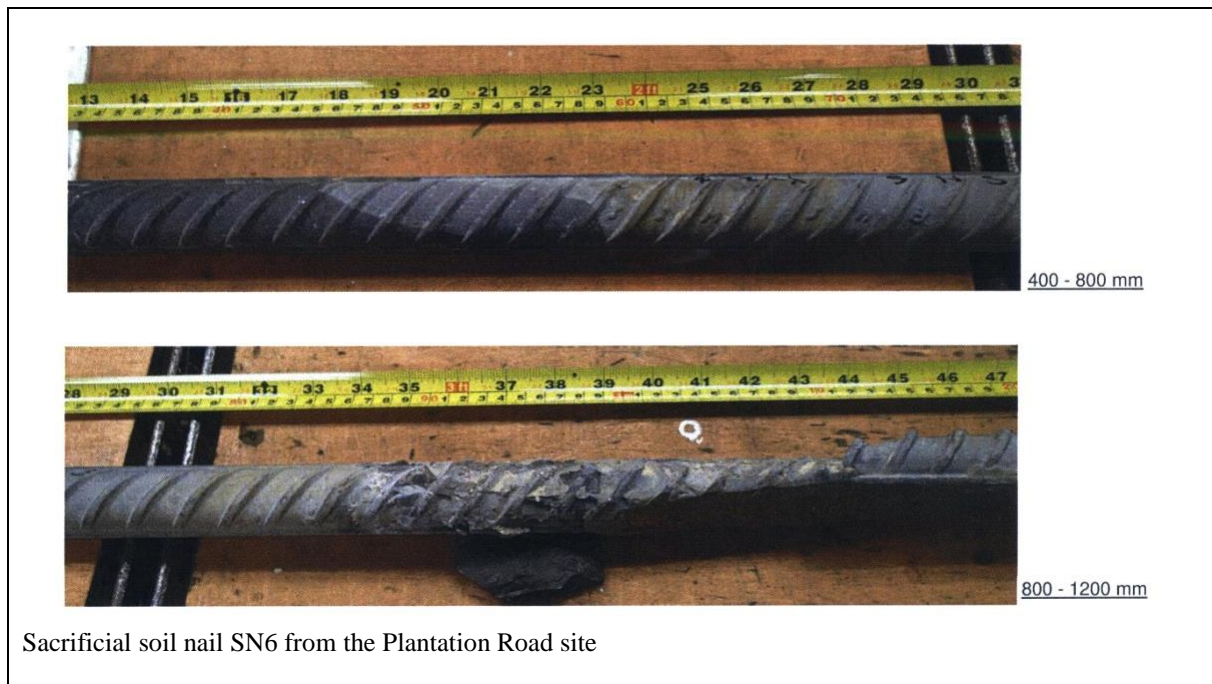
- (d) One sample of grout sleeve was collated from each of the six exhumed soil nails with the grout sleeves preserved for carbonation tests. According to the laboratory results, none of the six samples showed sign of carbonation. The zinc coating thickness of the five hot-dip galvanized steel bars with grout sleeve were also greater than 85 μm for a minimum zinc coating weight of 610 g/m^2 (HKSARG, 2006). All the seven soil nails with grout protection showed no significant signs of corrosion (Figure 4.12).

Figure 4.12 Example of Surface Conditions of Hot-dip Galvanized Soil Nails with Grout Sleeve in Exhumation Exercise in 2013

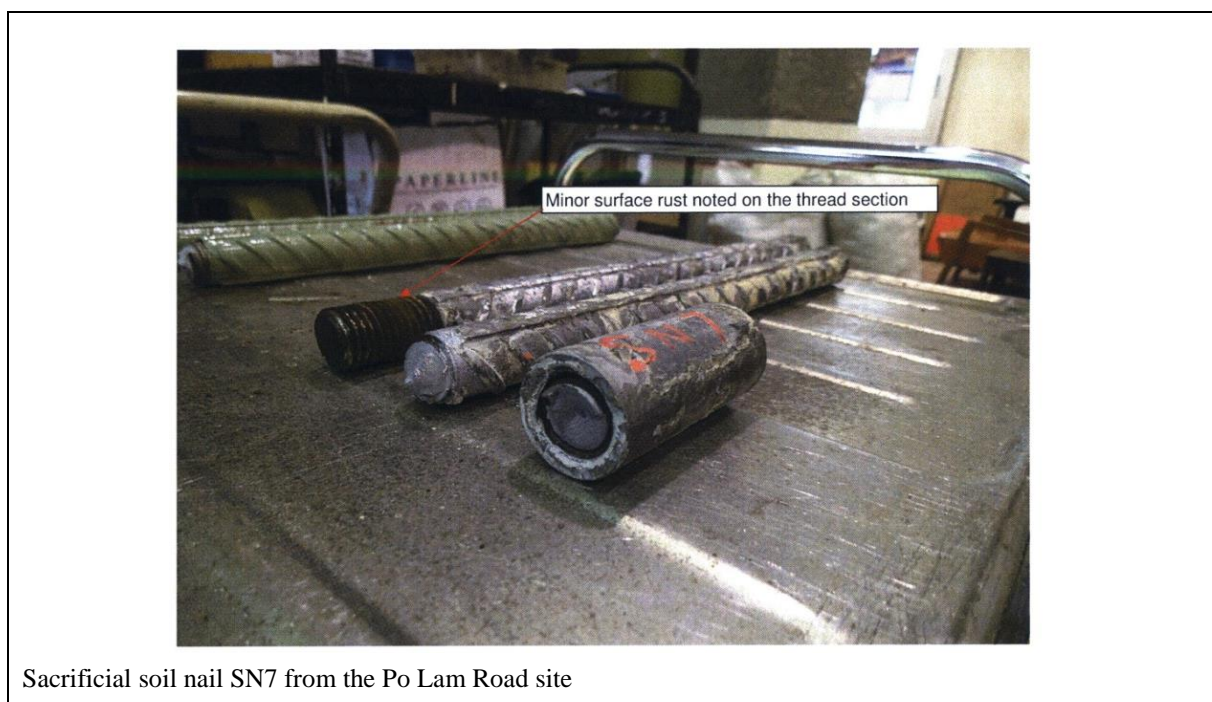
- (e) For the two nails with provisions of couplers (i.e. SN7 (zinc-galvanized, grout-protected) at the Po Lam Road site and SN11 (epoxy-coated, grout-protected) at the Plantation Road site), mild surface corrosion was observed on the exposed threaded sections of the nail bars, while no major sign of corrosion were noted on the zinc-galvanised nail bars or

couplers (Figure 4.13).

Figure 4.13 Example of Surface Conditions of Couplers in Exhumation Exercise in 2013
