**Detailed Study of the 21 May 2016
Landslide on the Natural Hillside
above Slope No. 8SE-A/F34
at Sai Kung Sai Wan Road, Sai Kung**

GEO Report No. 336

AECOM Asia Company Limited

**Geotechnical Engineering Office
Civil Engineering and Development Department
The Government of the Hong Kong
Special Administrative Region**

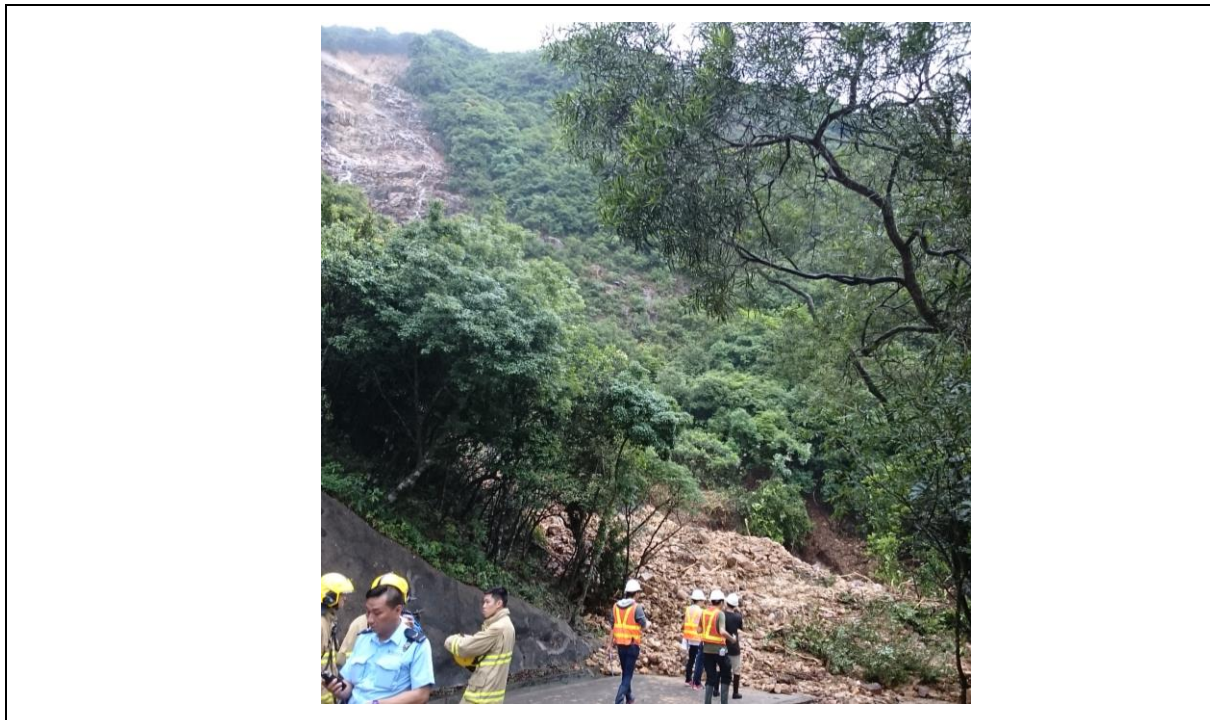
Figure 1.3 View of the Debris Deposited on Sai Kung Sai Wan Road Resulting in Complete Road Blockage
(Photograph taken on 21 May 2016 by GEO Emergency Duty Officer)

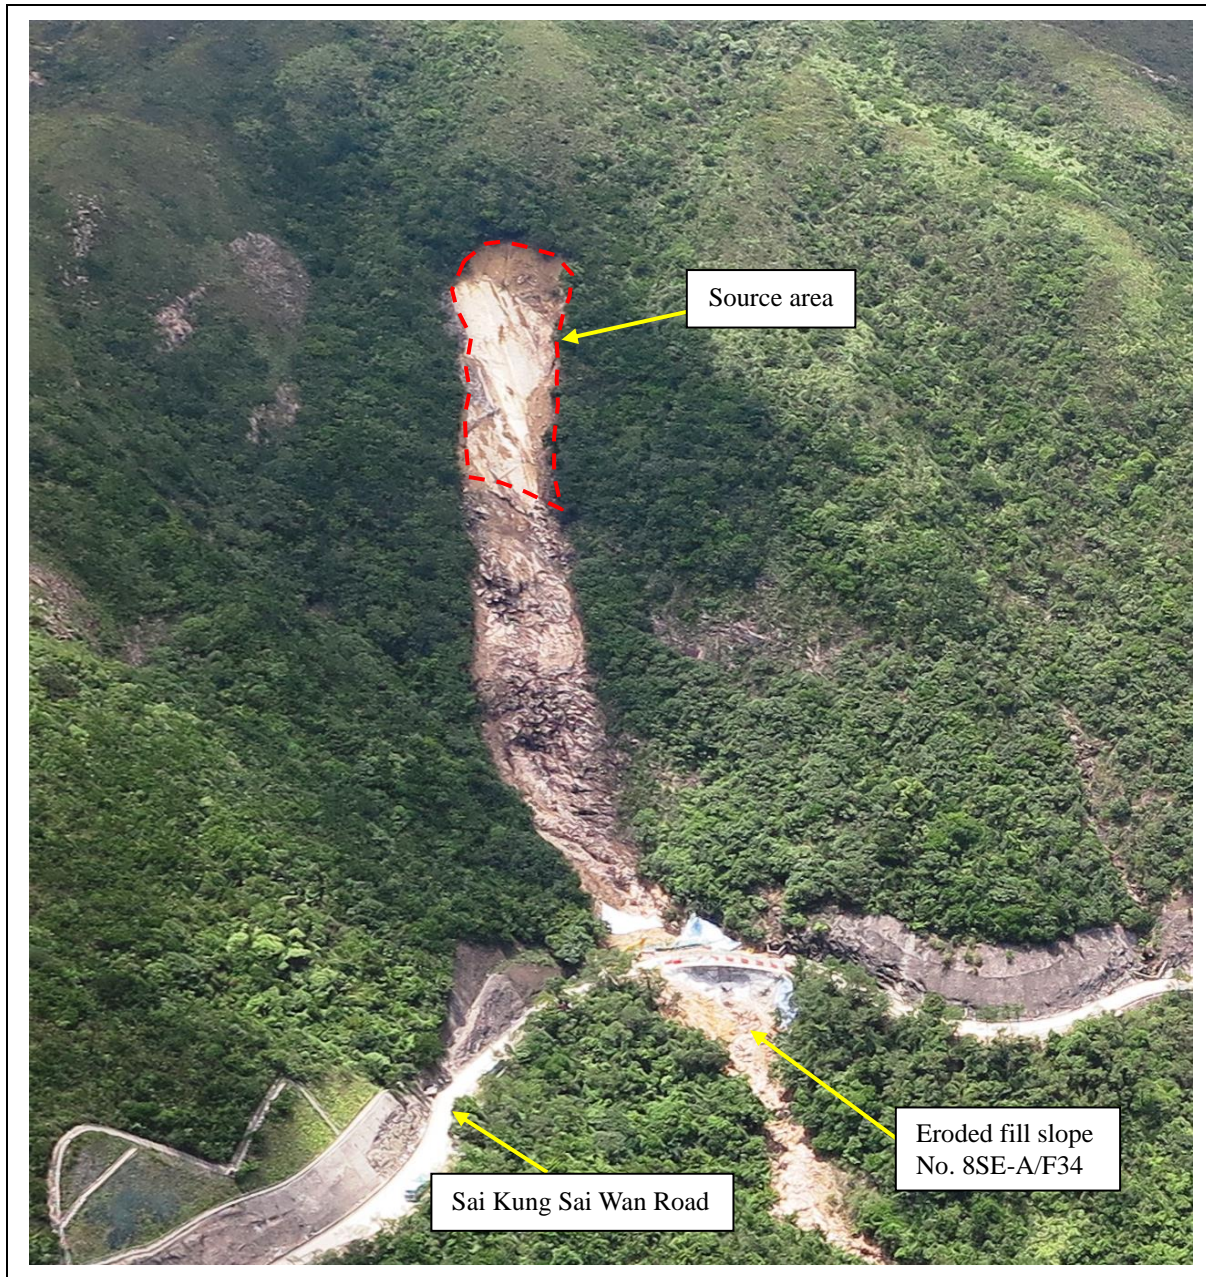
Figure 1.5 View of the Source Area and Upper Debris Trail of the Landslide
(Photograph taken on 30 May 2016)

The hillside adjacent to the source area is generally densely vegetated with tall shrubs and mature trees and is inclined at an angle of about 35° to 45° (Figure 1.5). Locally, rock outcrops in linear bands cross the study area and this is typically characterised by an increase in local slope angle and decrease in vegetation.

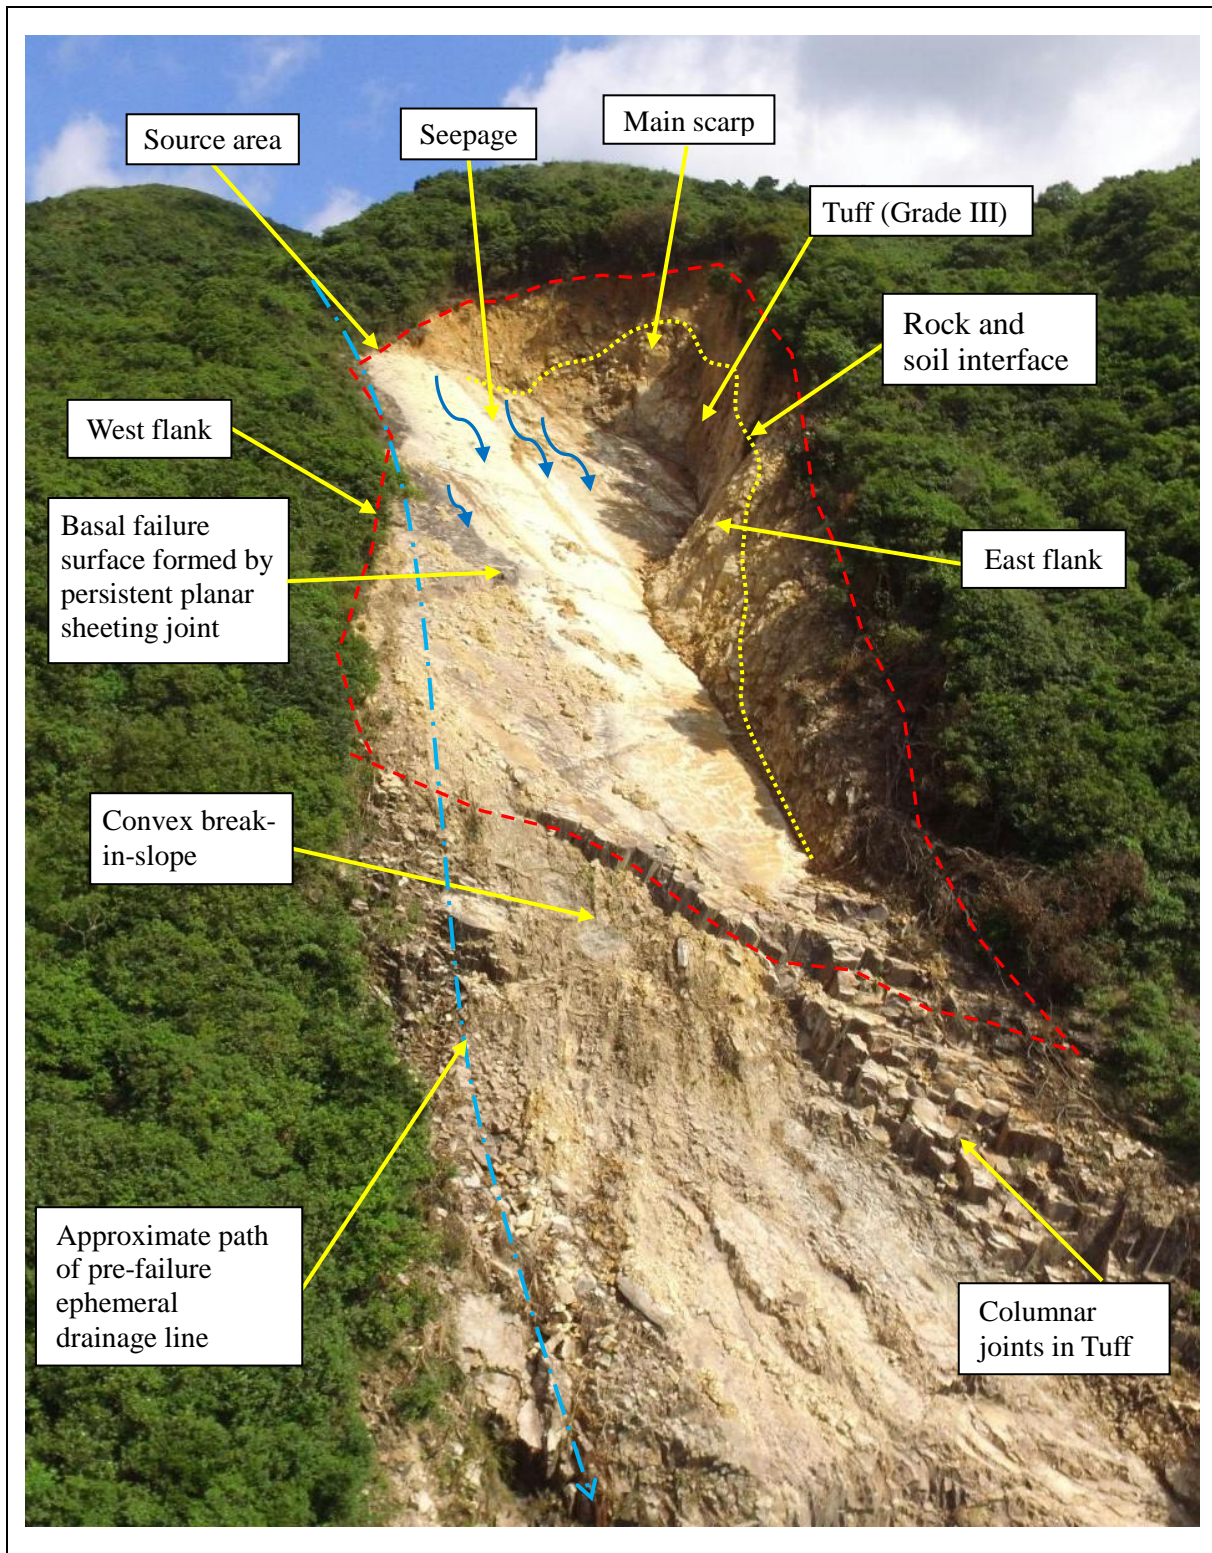
The landslide was a structurally controlled, translational rock slide with a distinctive, planar, basal failure surface (Figure 4.3). The crown of the source area is located at about 250 mPD and the dimensions of the source area are 18 m in width, 60 m in length and 12 m maximum in depth. A plan of the source area is shown in Figure 4.1 and longitudinal and transverse sections are shown in Figure 4.2. The total volume of detached material from the source is estimated at about 2,100 m³ based on field measurements and comparison between pre-failure LiDAR survey data and post-failure photogrammetric topographic survey data obtained by unmanned aerial vehicle (UAV). Images of the actual source area topography and estimated detached material thickness are shown in Figure 4.4.

Figure 4.3 View of the Source Area and Upper Debris Trail
(Photograph taken on 22 May 2016)

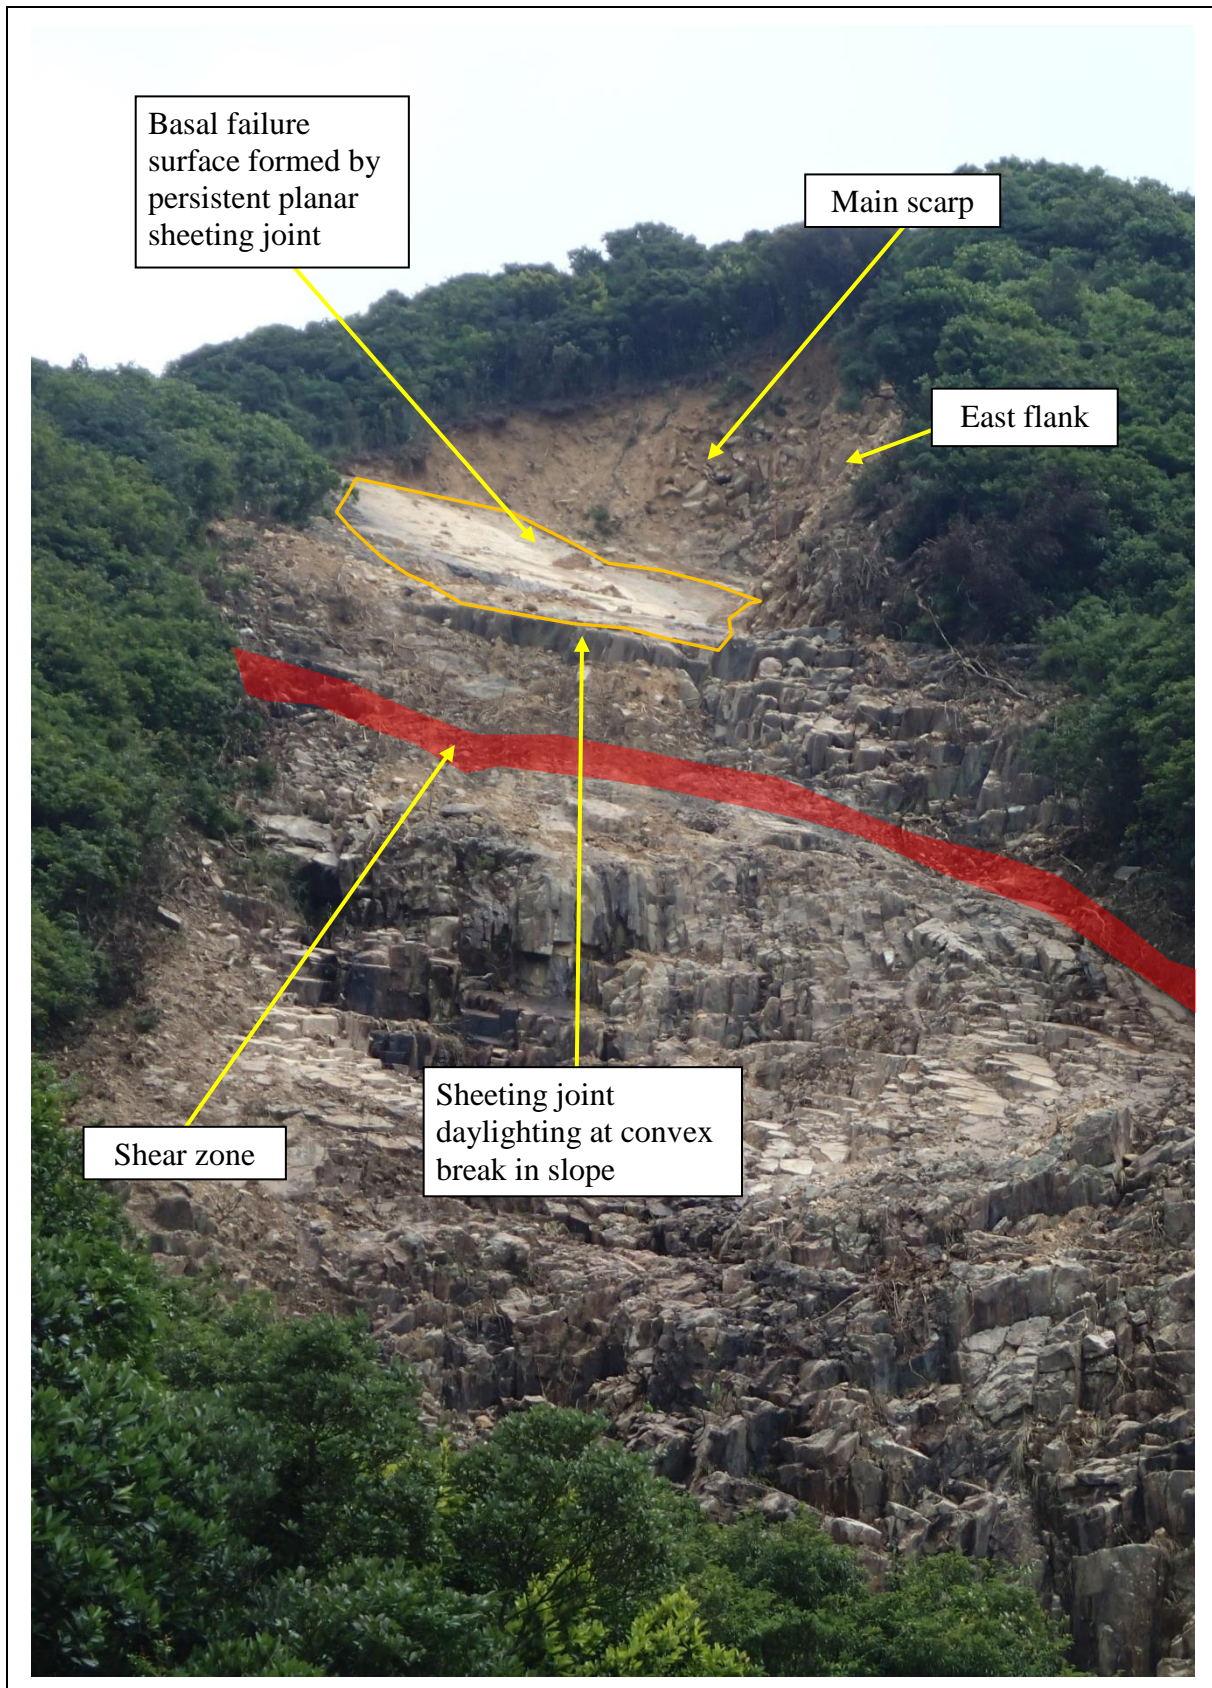
Although the source floor is generally planar, some local, minor steps in the profile were observed (Figures 4.1 and 4.6). Near the base of the source floor, adjacent to the east flank, the dip angle of the surface reduces significantly to around 10° to 15° (Figure 4.7), and this joint orientation was observed to extend laterally eastwards into the adjacent hillside. Immediately below this area there is a convex break-in-slope which allows the sheeting joint to daylight (Figure 4.3). The break-in-slope is probably caused by local weakening of the rock mass along an E-W trending shear zone observed traversing the landslide below the source floor (Figure 4.5).

Figure 4.5 View of the Source Area and Upper Debris Trail Showing Asymmetric Source Profile (Photograph taken on 31 May 2016)

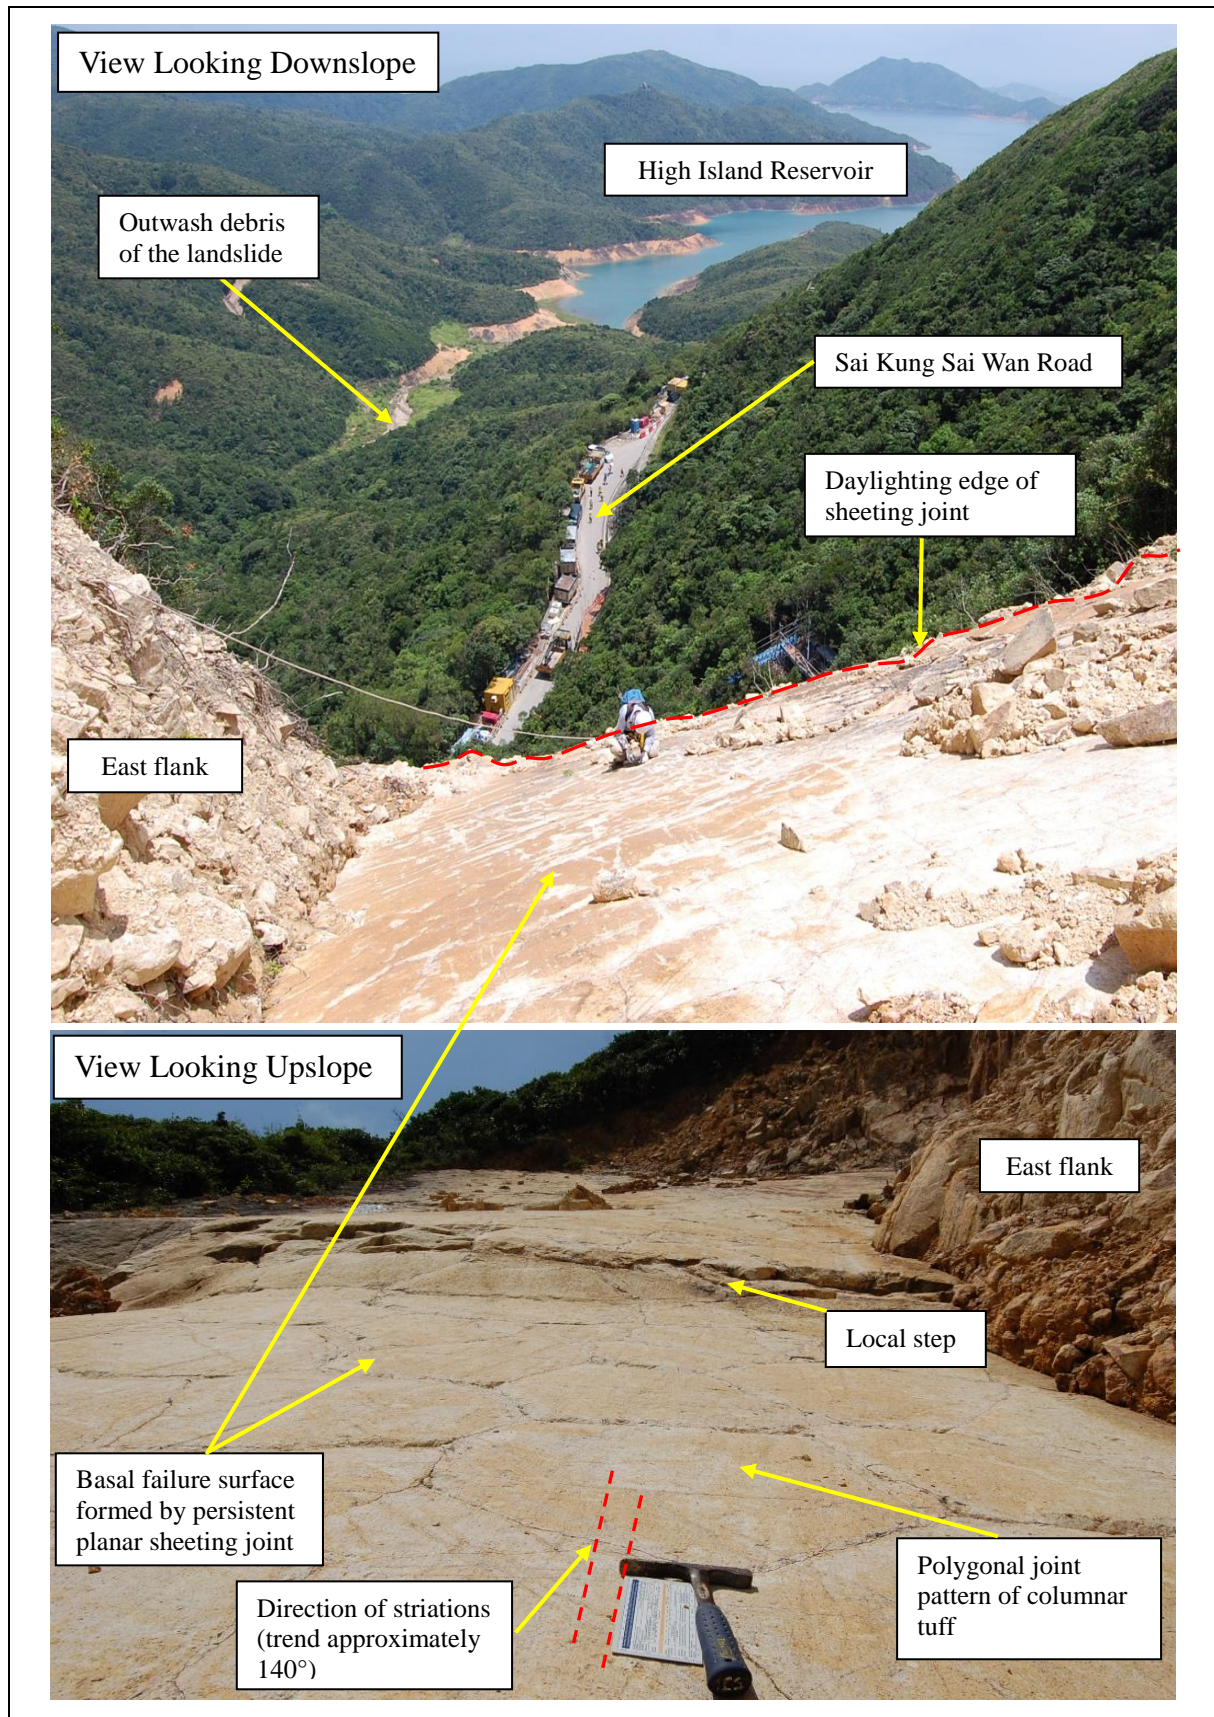
The source floor is formed from a persistent, planar sheeting joint (providing a basal failure plane) inclined at approximately 34° to 40°, and with an easterly dip direction (average 100°) such that the source floor dips across the source area as well as downslope giving an asymmetric morphology in transverse section, and with the sheeting joint probably extending into the adjacent hillside (Figures 4.2 and 4.5). This asymmetry gives the source area a wedge failure-type geometry with a steep (70°) scarp at the east flank up to 12 m in height, but with no scarp at all on the west flank of the source area. The exposed sheeting joint forming the source floor comprises moderately decomposed tuff with a distinctive polygonal joint pattern observed on the surface (Figure 4.6), where the columnar jointing in the tuff has been truncated. No infilling was observed on the joint surface, although thin iron and manganese oxide coating was observed locally. Elsewhere the tuff has typically weathered to an off-white colour. Distinctive striations were locally observed with a trend of approximately 140° (Figure 4.6) which is parallel to the direction of landslide movement but not the dip direction of the source floor. This suggests that the striations were formed during failure and not as part of any pre-failure incremental movement. The origin of the sheeting joint is considered to be related to stress relief.

Figure 4.6 View Upslope and Downslope of the Persistent Planar Sheeting Joint Forming the Basal Surface of Rupture (Photograph taken on 26 July 2016)

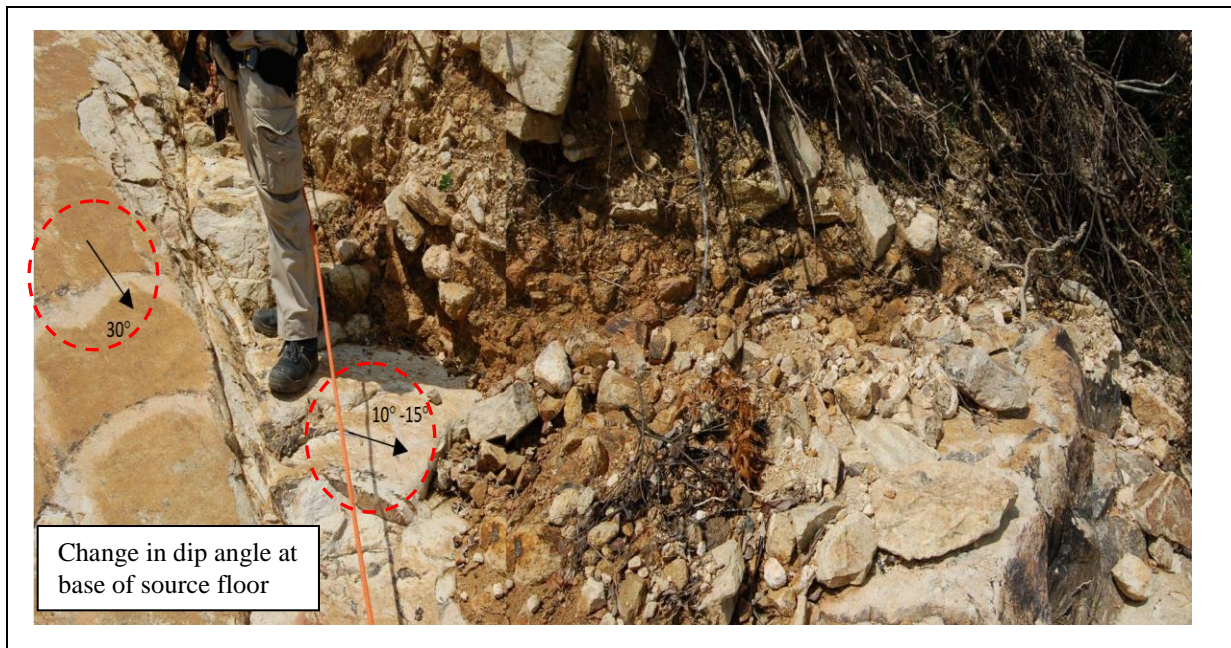
Figure 4.7 View of the Base of Source Floor Showing Sharp Decrease in Dip Angle (Photograph taken on 26 July 2016)

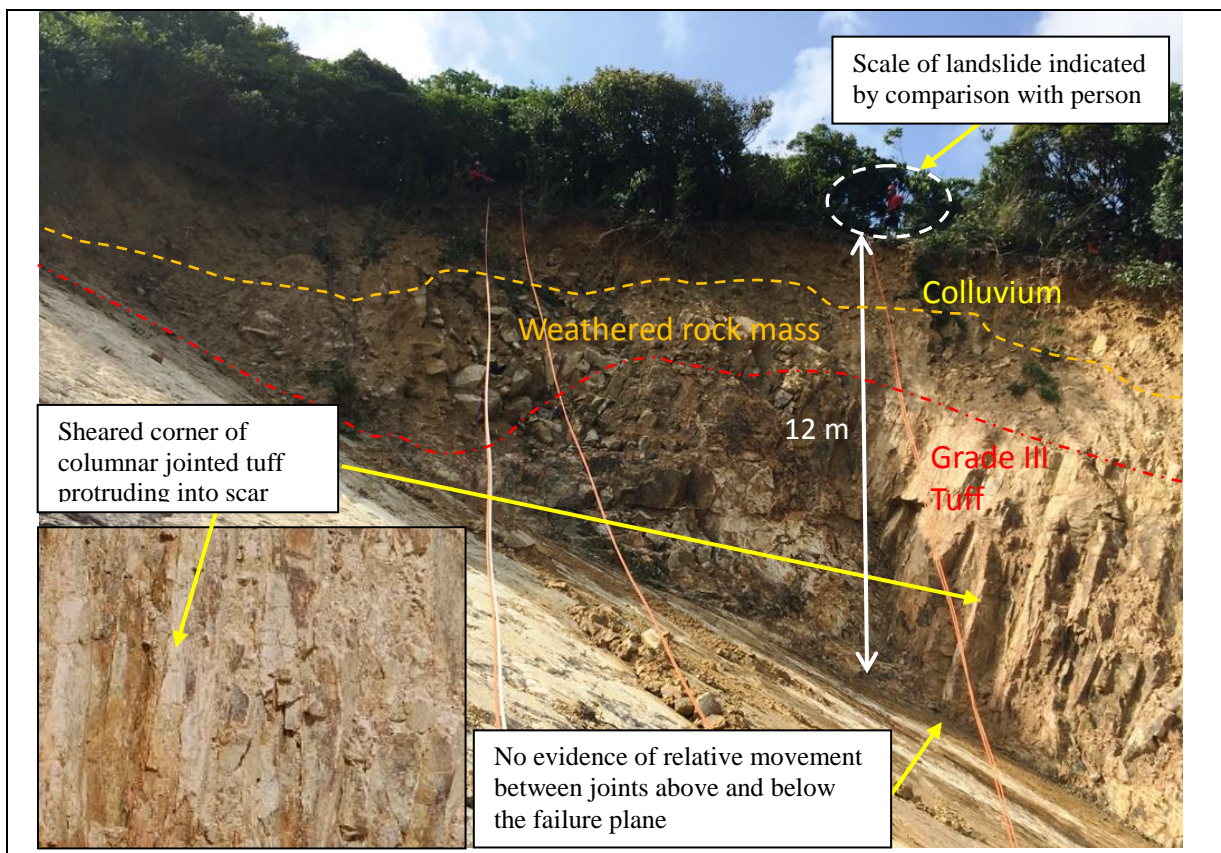
Figure 4.8 View Looking Northeast of the Source Floor, Main Scarp and Upper Part of East Flank Showing Geological Profile (Photograph taken on 31 May 2016)

The columns of tuff have a toppling orientation (inclined approximately 70° into the slope) and evidence of minor dilation of sub-vertical joints was observed, however, as these dilated joints are only exposed in the east flank, they are constrained from toppling failure into the source area. Observations of adjacent joints in the basal failure plane and the columnar joints exposed in the east flank, found no evidence of any relative movement (Figure 4.8) which would suggest pre-failure or post-failure movement.

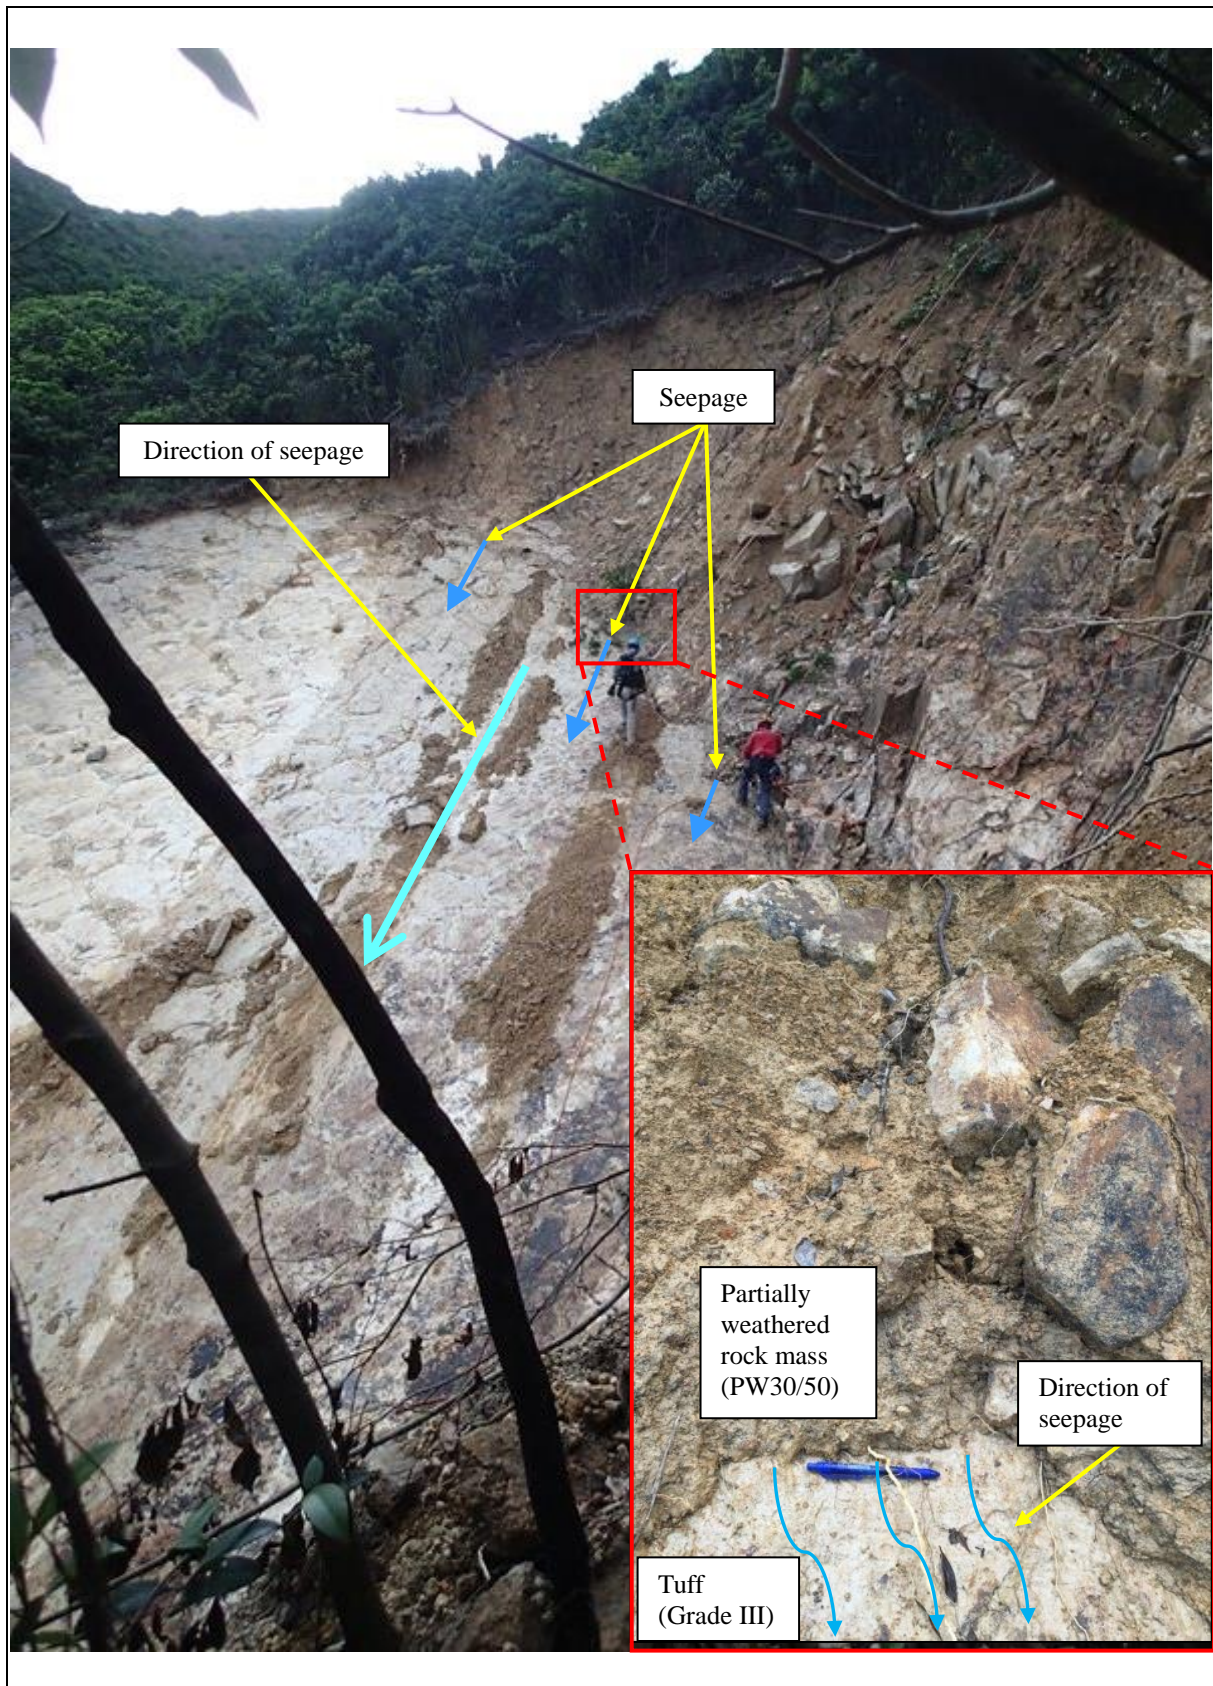
Seepage was observed from the base of the main scarp along the intersection with the sheeting joint failure plane (Figure 4.9). The seepage was minor but fairly consistent when observed several times over a period of three months after the landslide, suggesting that the seepage is not likely to be a short-term response to intense rainfall events. Seepage water was flowing across the source floor towards the base of the east flank. As the intersection of the east flank and the sheeting joint is extremely narrow to tight, surface water was observed draining directly along the surface downslope.

Figure 4.9 View Upslope of the Main Scarp and Upper Source Floor Showing Seepage (Photograph taken on 31 May 2016)

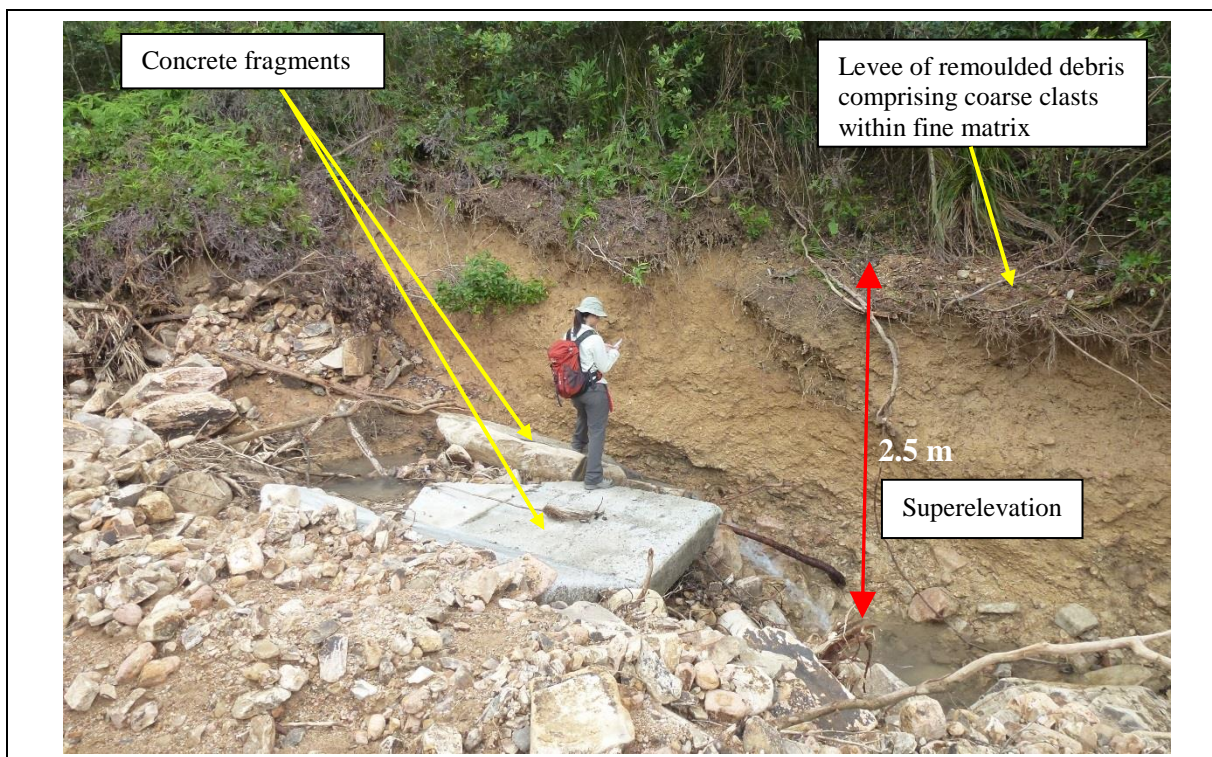
Figure 4.15 View of Superelevation at CH273 Where a Sharp Bend in the Drainage Line Occurs (Photograph taken on 14 June 2016)

Superelevation marks were observed at two locations at bends in the debris trail, at Chainage 273 and Chainage 300, indicating elevation differences of 2.5 m and 1.0 m respectively.

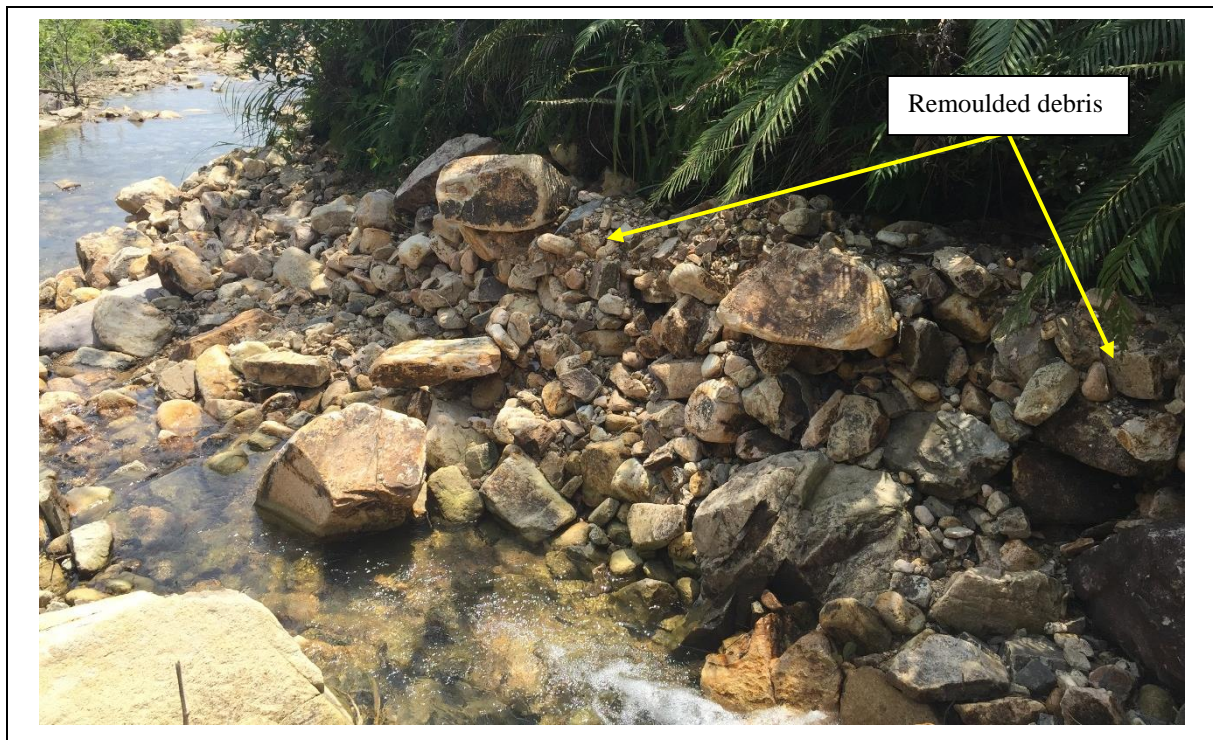
Figure 4.21 View at around CH560 of Remoulded Debris Forming Levees on Top of the Flank (Photograph taken on 14 September 2016)

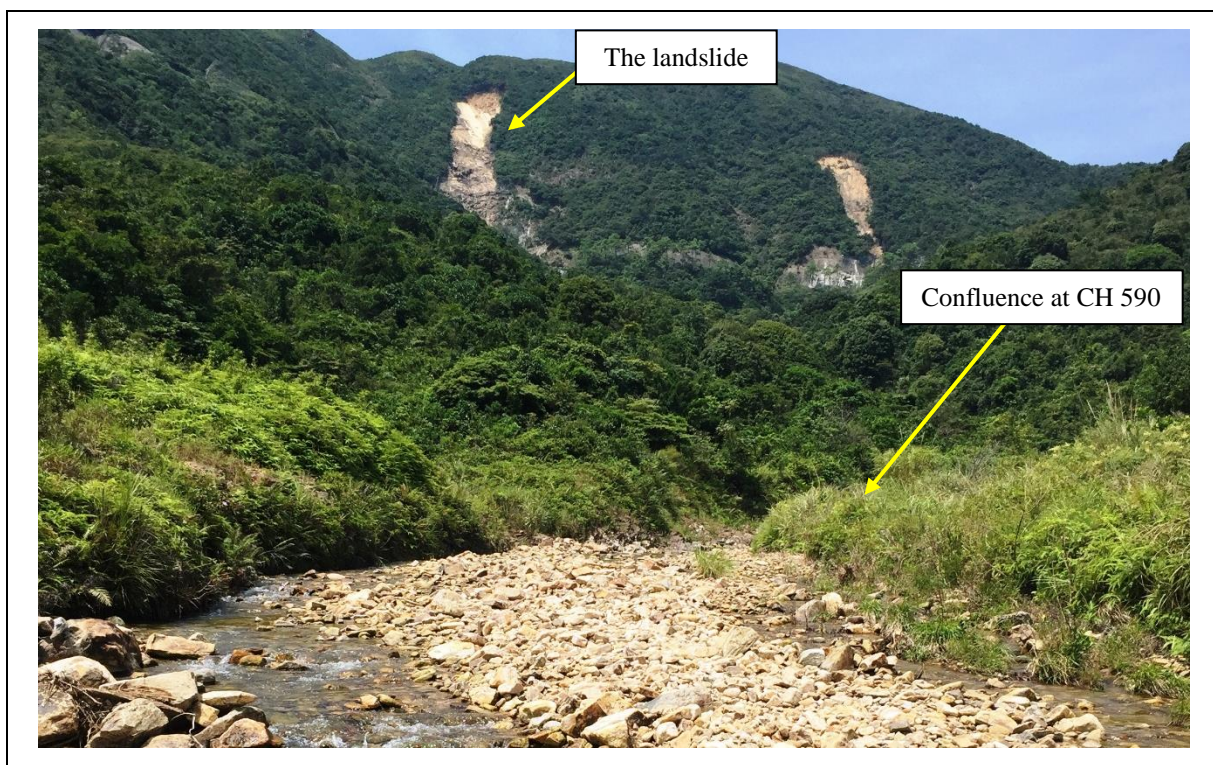
After Chainage 560, intermittent coarse clastic and sand deposits could still be observed within the drainage line all the way to High Island Reservoir but appear sorted or washed and have probably been moved or remobilized by post-failure fluvial processes rather than landslide processes. While most of the coarse boulder-sized material was deposited before Chainage 560, the more dilute, sediment charged flow (i.e. debris flood) may have continued (Hung, 2002). At Chainage 590 there is a confluence with another major drainage line (Figure 2.2) which would have added considerable discharge during the rainstorm (Figure 4.22).

Figure 4.22 View of Outwash Deposits and Upslope from CH630 to CH710 (Photograph taken on 14 September 2016)

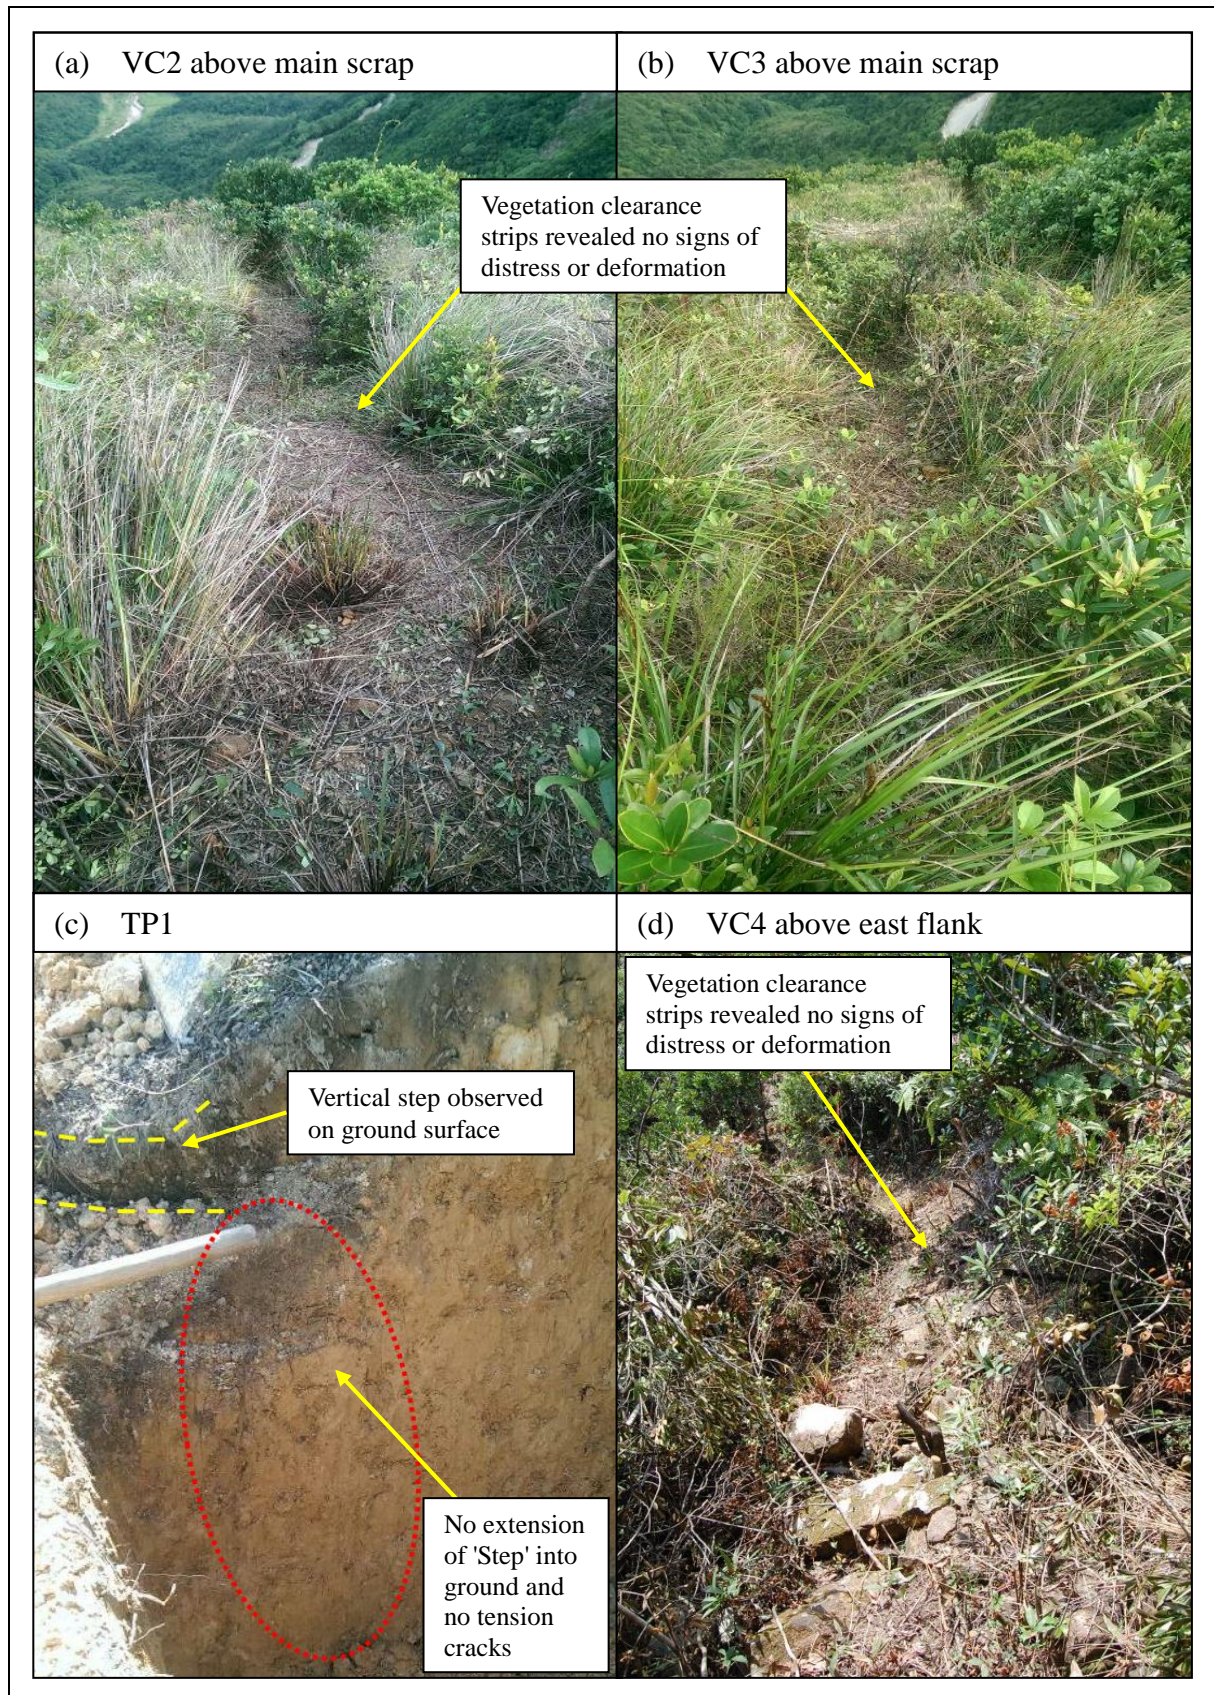
The vegetation clearance strips were carried out 60 m above the main scarp (Nos. VC1 to VC3) and 40 m adjacent to the east flank (Nos. VC4 to VC6). Vegetation was cut down to soil surface so that any distress, such as tension cracks or deformation, significant enough to be manifested on the ground surface could be observed. However, no signs of distress were observed from the hillside above the main scarp or adjacent to the east flank (Figure 5.4).

Trial pit TP1 was excavated to investigate the 400 mm vertical step, suspected to be a relict tension crack, above the main scarp. The trial pit was excavated to 3 m depth and exposed 0.45 m of colluvium, underlain by 0.35 m of residual soil, which became very stiff, completely decomposed tuff (clayey silt) until termination at the base. However, no evidence of any tension crack, disturbance or dilation could be observed in the exposed soil faces below the step (Figure 5.4).

Figure 5.4 View of GI Works including Vegetation Clearance Strips and Trial Pit
(Photograph taken on 6 and 13 October 2016)

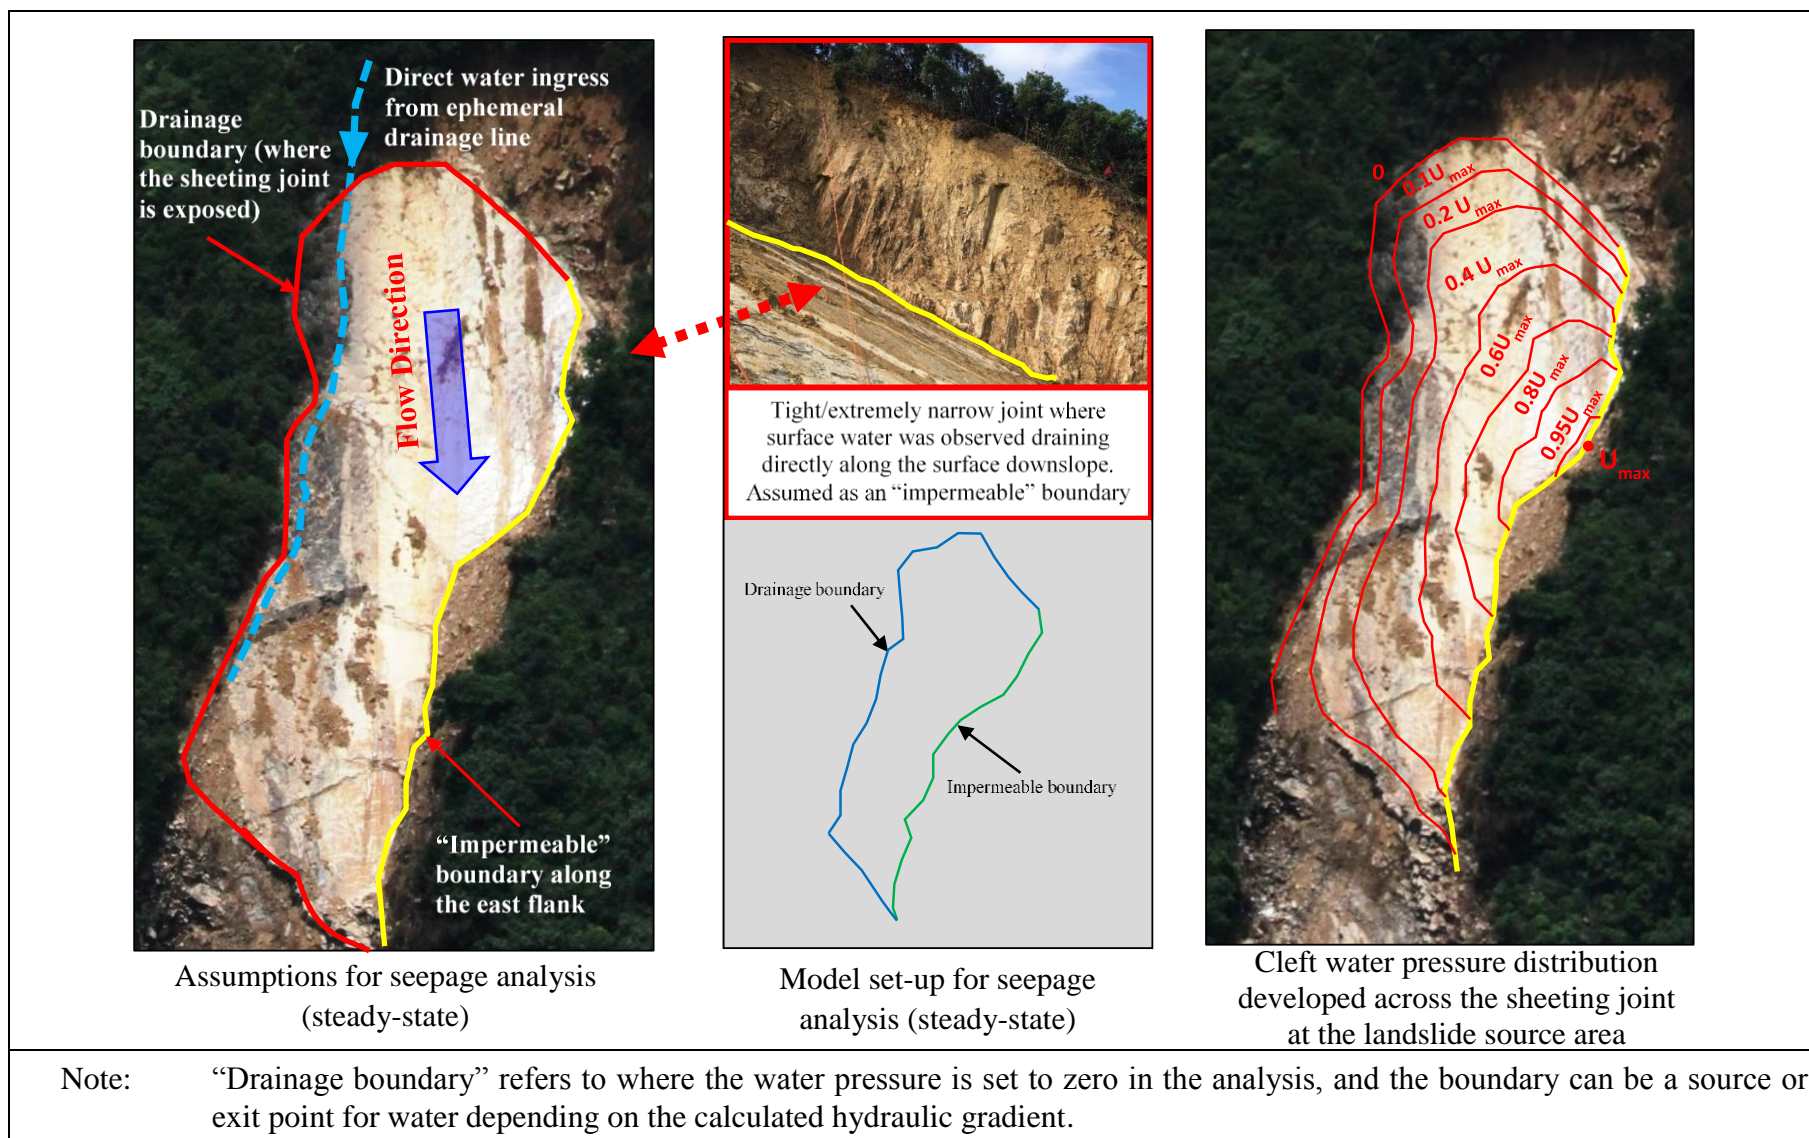
Figure 8.2 Seepage Analysis (Steady State) at Time of Failure

Given the scale and geological setting of the landslide, cleft water pressure was likely to have developed within the planar sheeting joint at the time of failure. Based on the findings from the post-landslide inspections (see Section 4.3), direct water ingress from the ephemeral drainage line at the west flank of the source area and direct infiltration over the entire hillside were two possible water sources for the development of cleft water pressure (Figure 8.1).
