**Detailed Study of the 21 May 2016
Landslide on the Natural Hillside
above Slope No. 8SE-A/F34
at Sai Kung Sai Wan Road, Sai Kung**

GEO Report No. 336

AECOM Asia Company Limited

**Geotechnical Engineering Office
Civil Engineering and Development Department
The Government of the Hong Kong
Special Administrative Region**

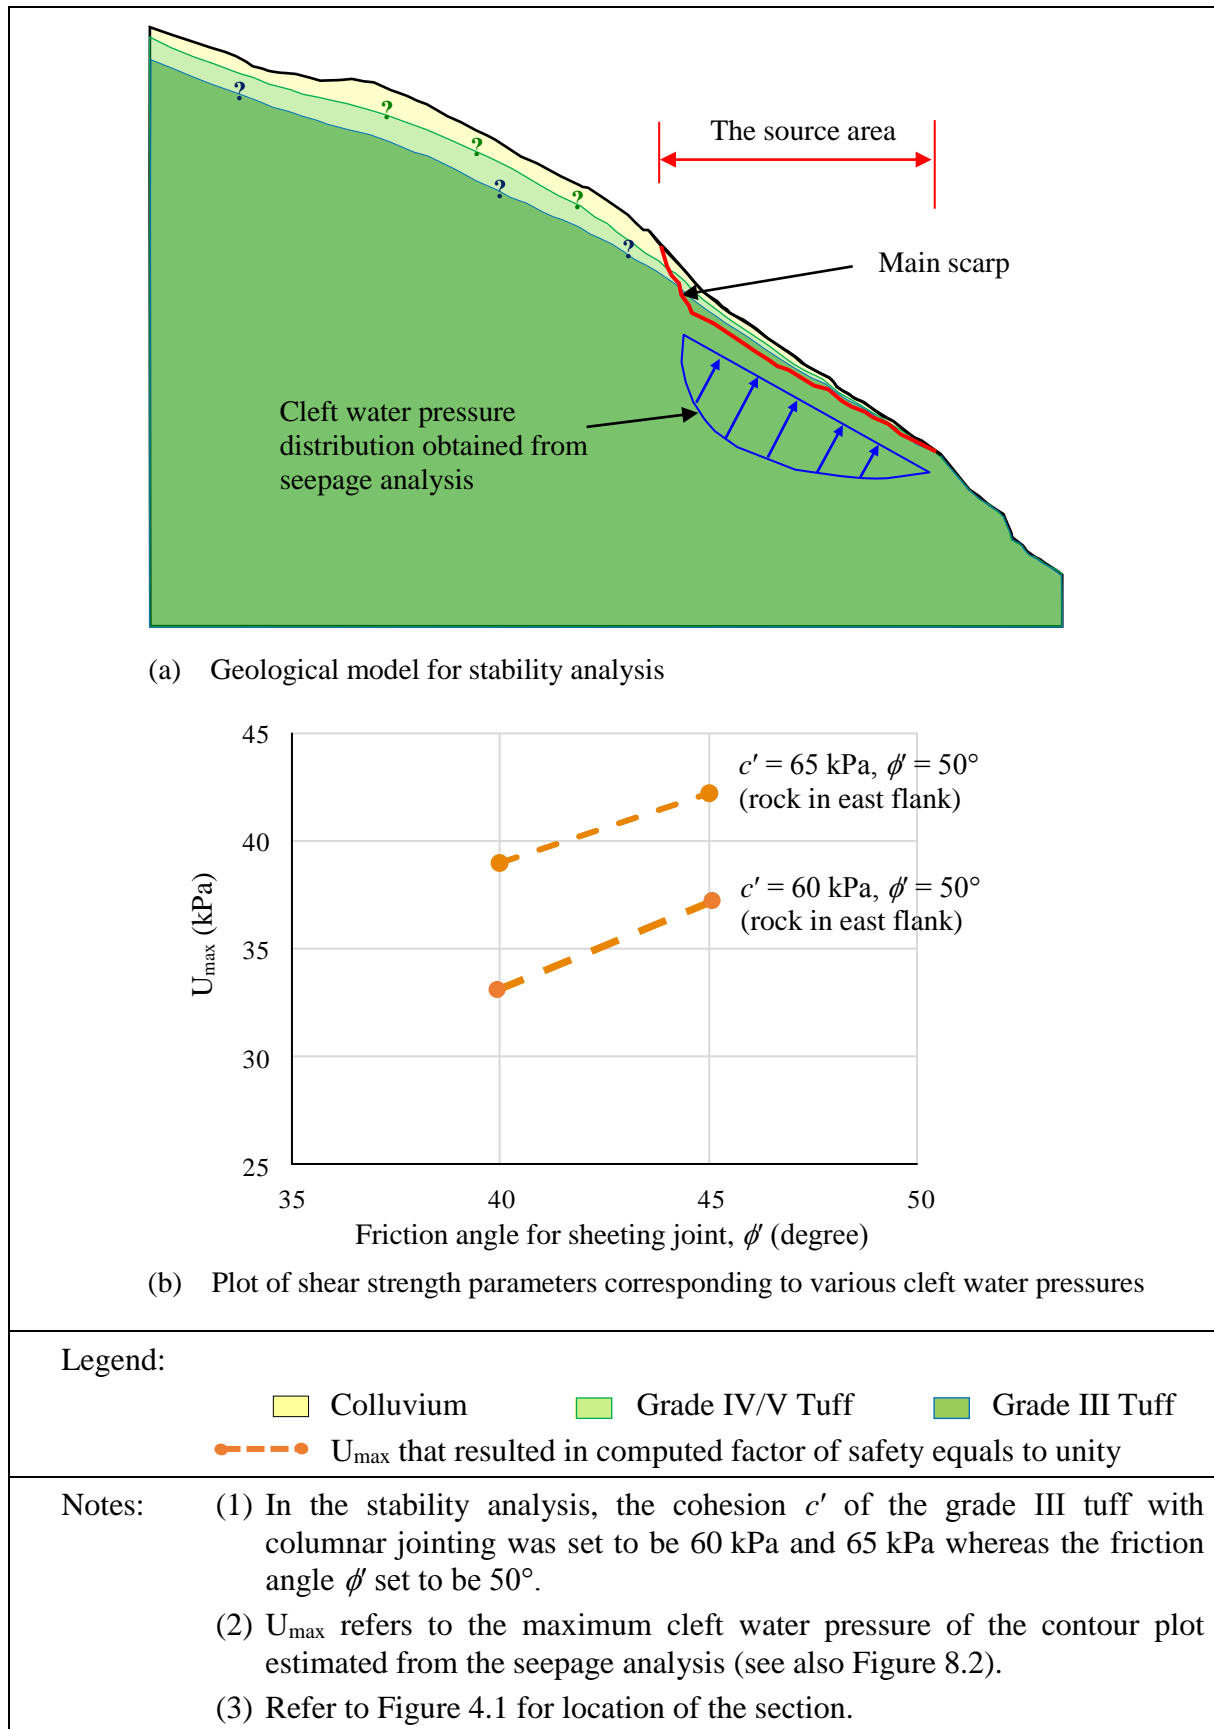
Figure 8.3 Results of Stability Analysis (Back Analysis of the Landslide)

The wedge failure geometry defines a basal sliding plane along the sheeting joint in tuff rock and a secondary side release surface along the east flank comprising columnar persistent surface without any infilling materials. Under these joint conditions, a typical

range of shear strength parameters $c' = 0$ kPa and ϕ varying between 40° and 45° were adopted for the purpose of the stability analyses, which is consistent with local rock slope engineering practice.
