Review of Landslides in 2019

GEO Report No. 350

V.S.F. Kong, R.C.T. Wai & R.W.H. Lee

**Geotechnical Engineering Office
Civil Engineering and Development Department
The Government of the Hong Kong
Special Administrative Region**

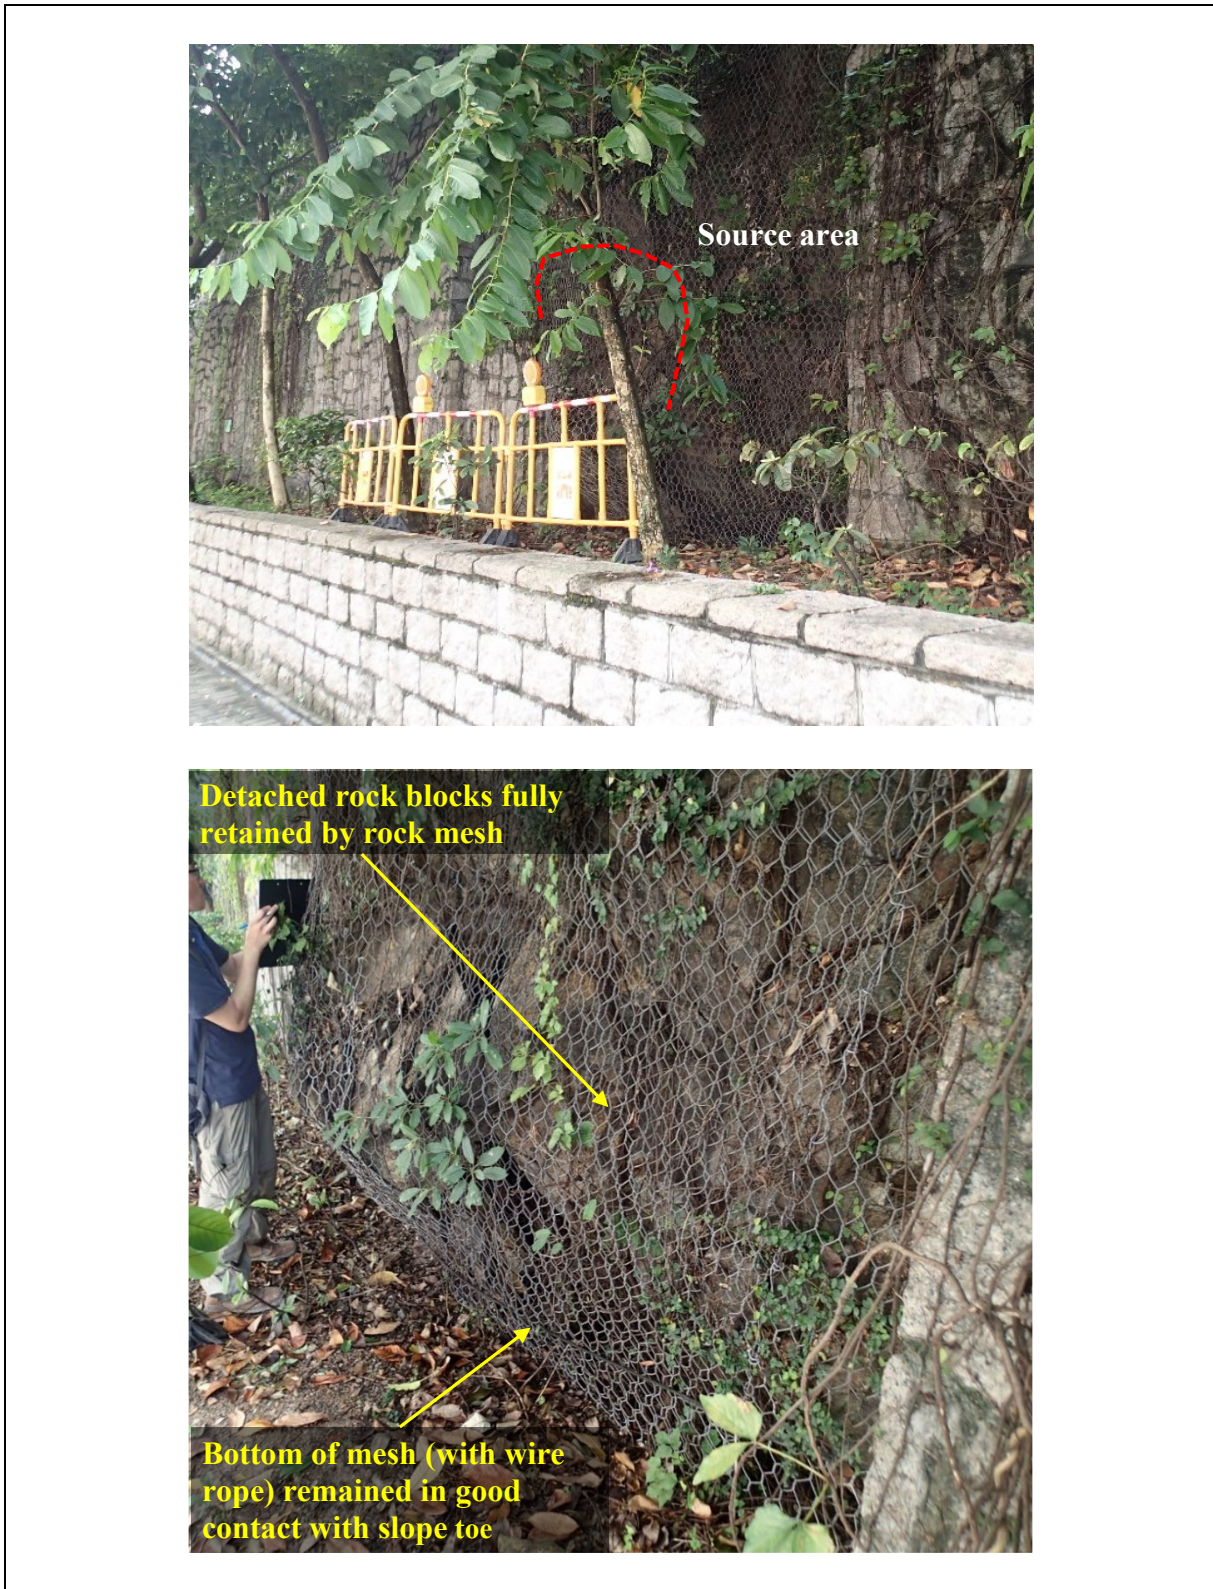
The other two minor rockfall incidents involved rock cut covered with rock mesh. One with a number of detached rock blocks fully retained by the rock mesh (Figure 4.2). The failure might be associated with the development of cleft water pressure within the adversely orientated rock joints. The bottom of the rock mesh was secured with a wire rope and remained in good contact with the slope toe. This incident was not regarded as a failure in accordance with GEO Technical Guidance Note No. 10 (GEO, 2014). Another one involved the fallen out of a detached rock block from the bottom of rock mesh (Figure 4.3). The rock block was detached years ago and trapped by the rock mesh at the slope toe. One day in 2019, the detached rock block dislodged from behind the rock mesh and deposited at the edge of the carriageway, probably caused by the deterioration of slope conditions exacerbated by root wedging action.

Figure 4.2 Incident at Castle Peak Road, Sham Tseng with Rockfall Debris Fully Retained by Rock Mesh (Incident No. 2019/08/2482)

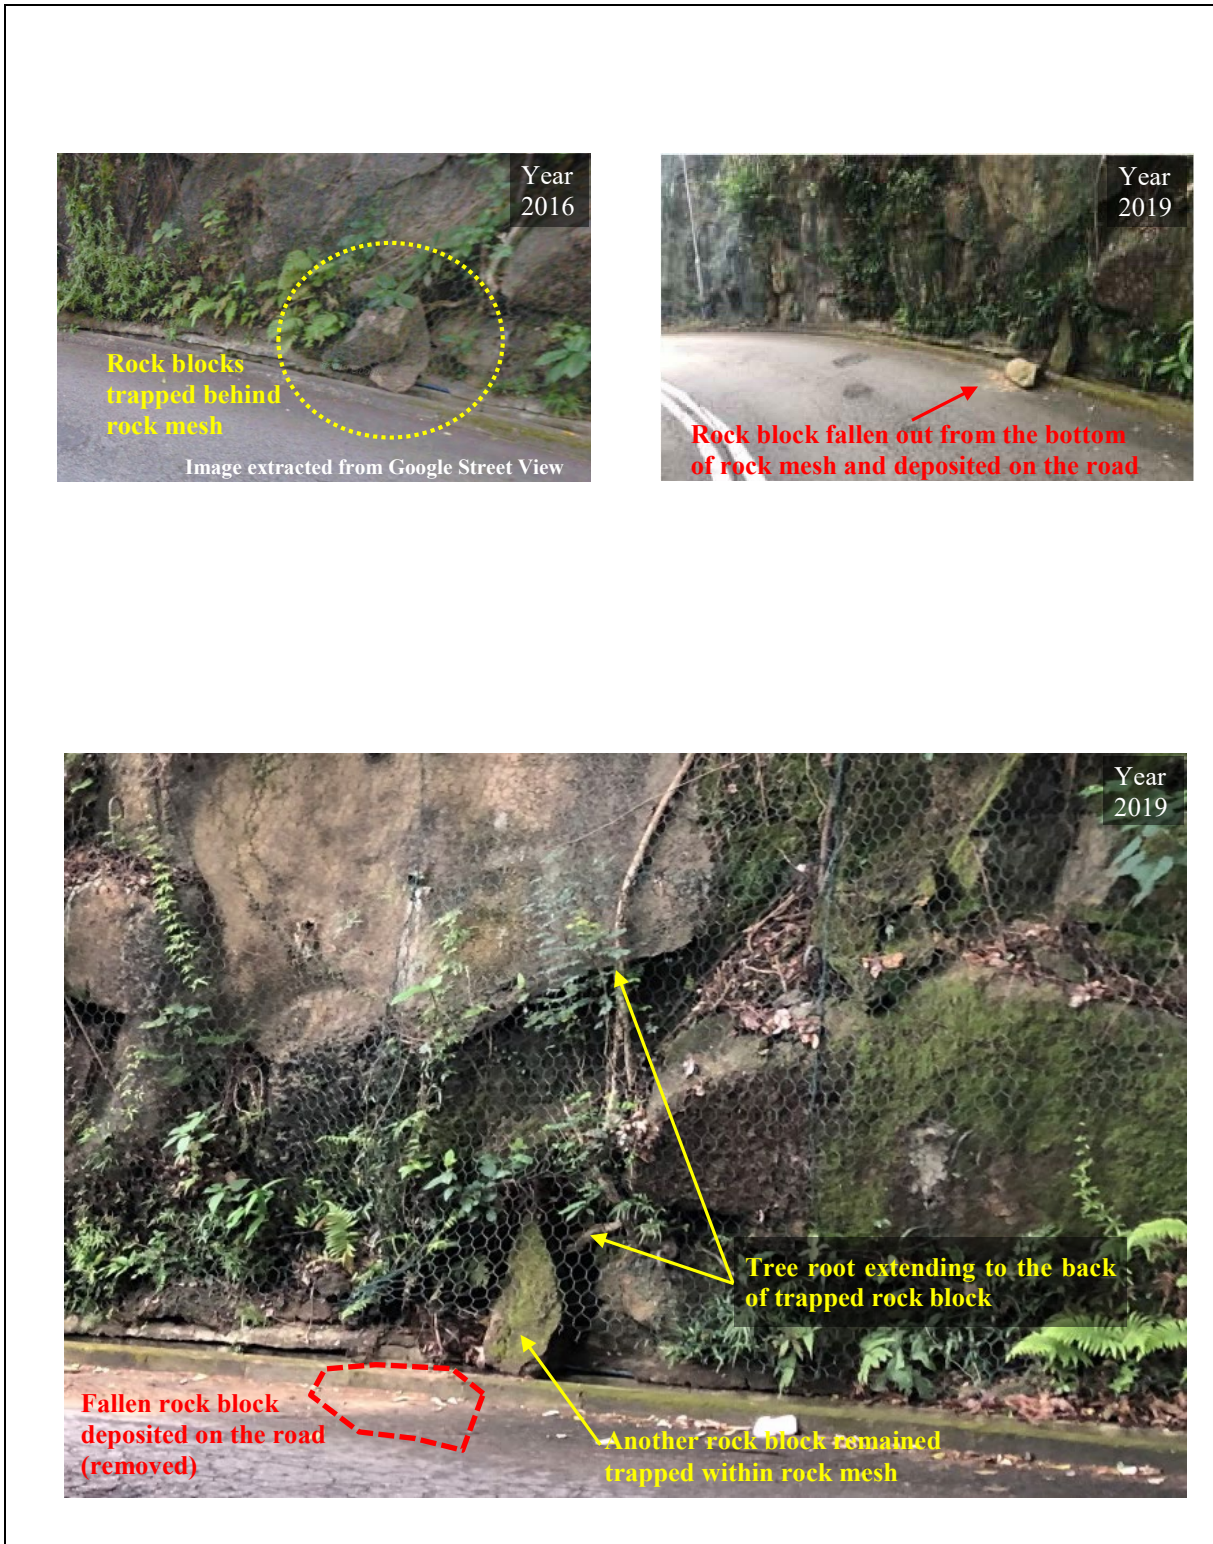
These two incidents reveal the difference in performance in the retaining of detached rock blocks by rock mesh. In both incidents, it is noted that the fixing details of rock mesh comply with the prevailing construction standards at the time of the slope works. The provision of a wire rope at the bottom of rock mesh was first introduced as a standard detail in 2002, giving rise to the difference in fixing of the rock meshes at the two slopes. The incidents highlight that rock blocks trapped at the slope toe are liable to fall out of rock mesh for those without a bottom wire rope. Robustness of fixing details, e.g. provision of a bottom wire rope, is important to ensure the reliability of the rock mesh protection which would contribute to guard against any possible adverse consequences from rockfall incidents.

Figure 4.3 Incident at the Junction of Tai Hang Road and Mount Butler Road with a Detached Rock Block Fallen out of Rock Mesh (Incident No.2019/05/2438)
