一九九七年八月三日  
呈祥道山泥傾瀉事件報告  
**REPORT ON THE  
CHING CHEUNG ROAD  
LANDSLIDE OF  
3 AUGUST 1997**

土力工程處報告系列第 78 號  
GEO REPORT No. 78

合樂亞洲顧問公司  
Halcrow Asia Partnership Ltd.

香港特別行政區政府  
土木工程署  
土力工程處  
**GEOTECHNICAL ENGINEERING OFFICE  
CIVIL ENGINEERING DEPARTMENT  
THE GOVERNMENT OF THE HONG KONG  
SPECIAL ADMINISTRATIVE REGION**

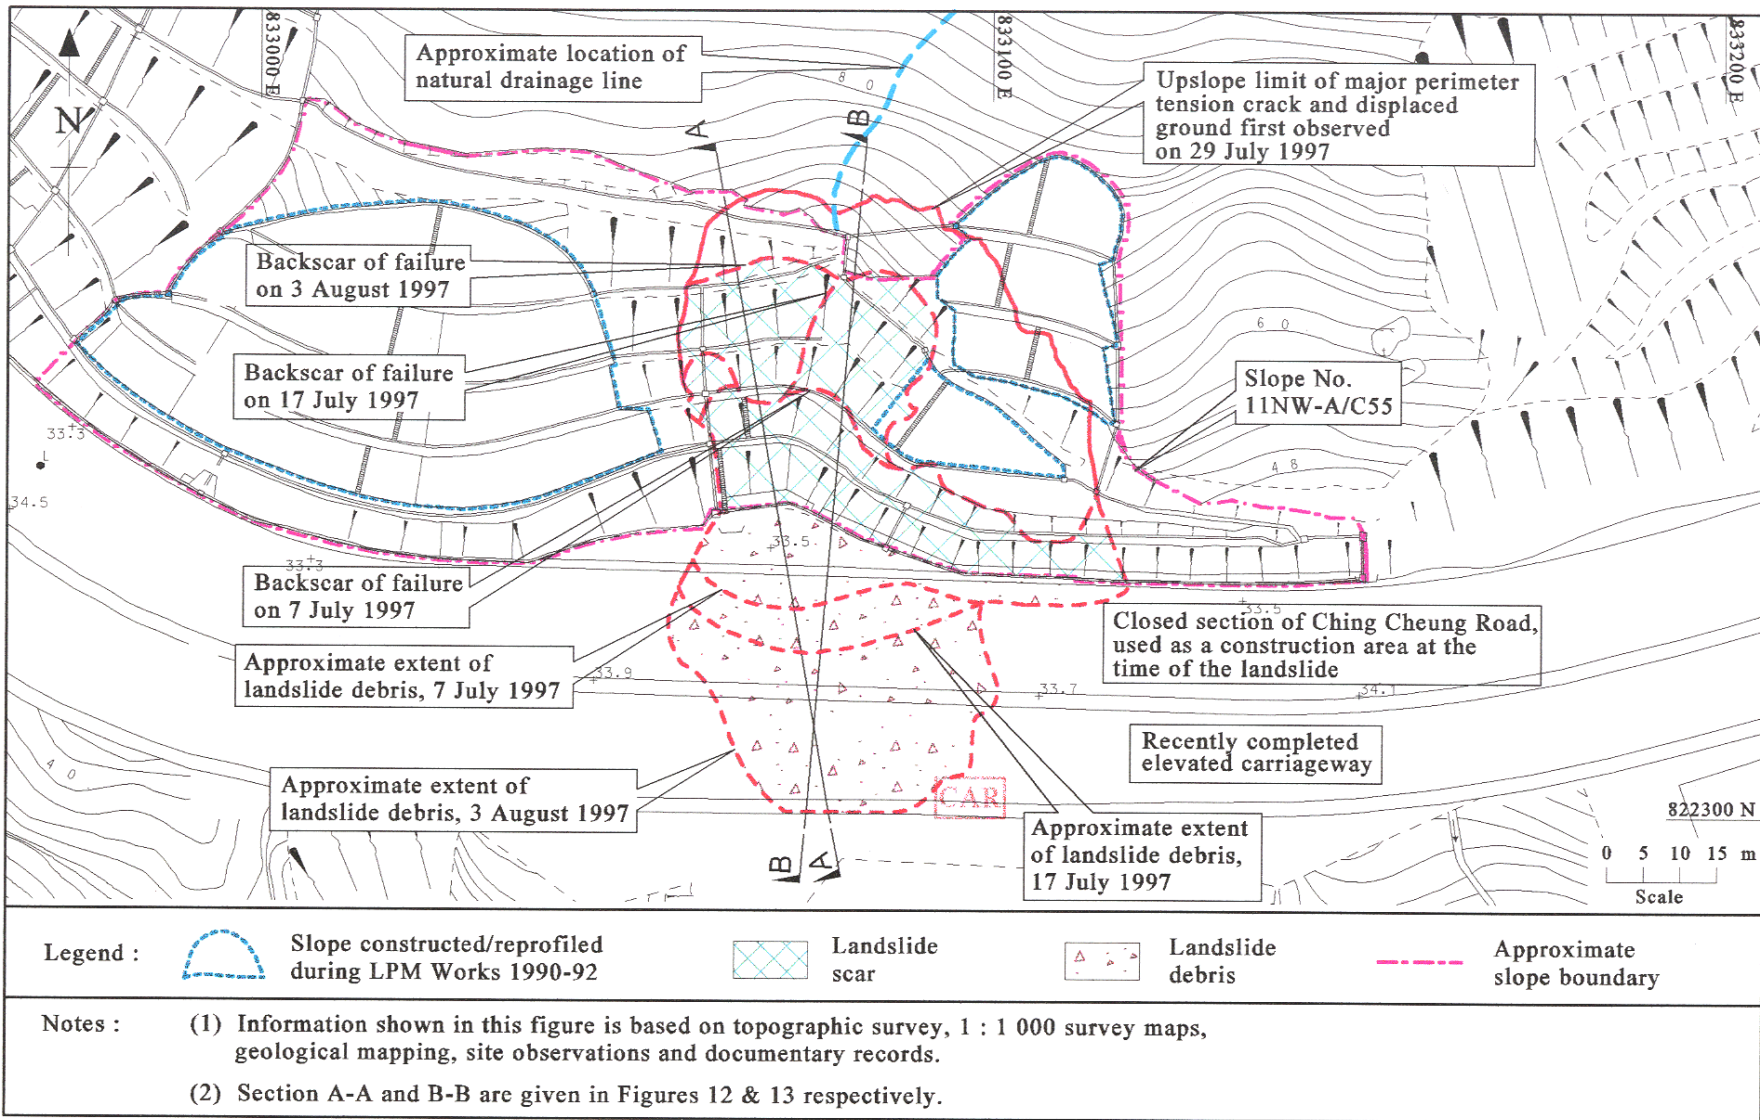
Figure 2 - Plan of the Landslide

The first failure occurred at about 9:00 a.m. on 7 July 1997 and caused the collapse of an estimated volume of 500 m<sup>3</sup> of soil from the lower part of the central eastern portion of the cut slope (Figure 2 and Plate 3). The debris just encroached onto the closed section of Ching Cheung Road. The observed failure scar was confined to the lower two batters, and affected a 52 m length of slope that extended up to 15 m above Ching Cheung Road. The upper portion of the cut slope was heavily vegetated, which made inspection of the slope above the observed failure difficult. The exposed failure surface was apparently shallow but variable in depth, typically less than 2 m. The majority of the displaced material originated from the western portion of the failure within the concave section of the slope, with generally only minor surficial failure in the east. The eastern limit of the failure was defined by an erosion gully which developed beneath the location where several surface channels met at a catchpit.

The second failure occurred at about 3:00 p.m. on 17 July 1997 and involved an estimated volume of 700 m<sup>3</sup> of soil from the concave section of slope immediately above the western part of the earlier failure (Figure 2 and Plate 4). The failure debris run-out was again confined to the closed section of Ching Cheung Road. The failure reached up to 30 m above the road and affected about a 30 m length of slope, comprising two distinct failure scars. The larger scar formed a bowl-shaped depression, some 15 m wide, lying beneath the line of the truncated natural drainage line. The maximum vertical depth of the depression was estimated at 5 m. A similar shaped but smaller scar lay to the west. Located at the head of the larger scar was a severed outflow channel from a catchpit where several surface channels converged, including the channel connected to the truncated natural drainage line. Notable gully erosion in the floor of the scar indicated water flow. A severed surface channel was also present at the head of the smaller scar.

On 29 July 1997, upon clearance of vegetation from the slope, an area of extensive cracking and displacement was identified above the earlier failures (Figure 2 and Plate 5). The area of distress encompassed the earlier failures, with its lateral extent on the lower batter slopes coincident with the extent of the 7 July failure. The distressed ground involved a plan area of about 1800 m<sup>2</sup> that extended slightly above the full height of the cut slope below the natural drainage line and up to 52 m wide.

A major perimeter tension crack encompassed the area of distressed ground (Figure 2). Measurement of ground displacement at points along the tension crack on 30 July 1997 indicated a maximum vertical downward movement of up to 2.5 m and a horizontal downslope movement of up to 1 m at the upslope margin of the tension crack (Plate 5). Along the western and northern boundaries the tension crack appeared fresh. However, observations recorded on 30 July 1997 possibly indicated an earlier phase of movement. Locally, a loose infill of topsoil was observed within a splay of the tension crack, and along the eastern section of the tension crack the surface was stained, indicating that it may have been exposed for some time. Furthermore, within the upper western section a small area of shotcrete surfacing, from

A private car travelling along the west-bound elevated carriageway of Ching Cheung Road was caught in the debris and pushed onto the southern parapet fence (Figure 2). The driver was uninjured and released himself from the vehicle. Ching Cheung Road remained closed for the clear-up operations and during emergency repair works to the failed slope. During the works further movement within the head of the failure occurred with some minor slippage of material. The road was fully re-opened on 24 August 1997.

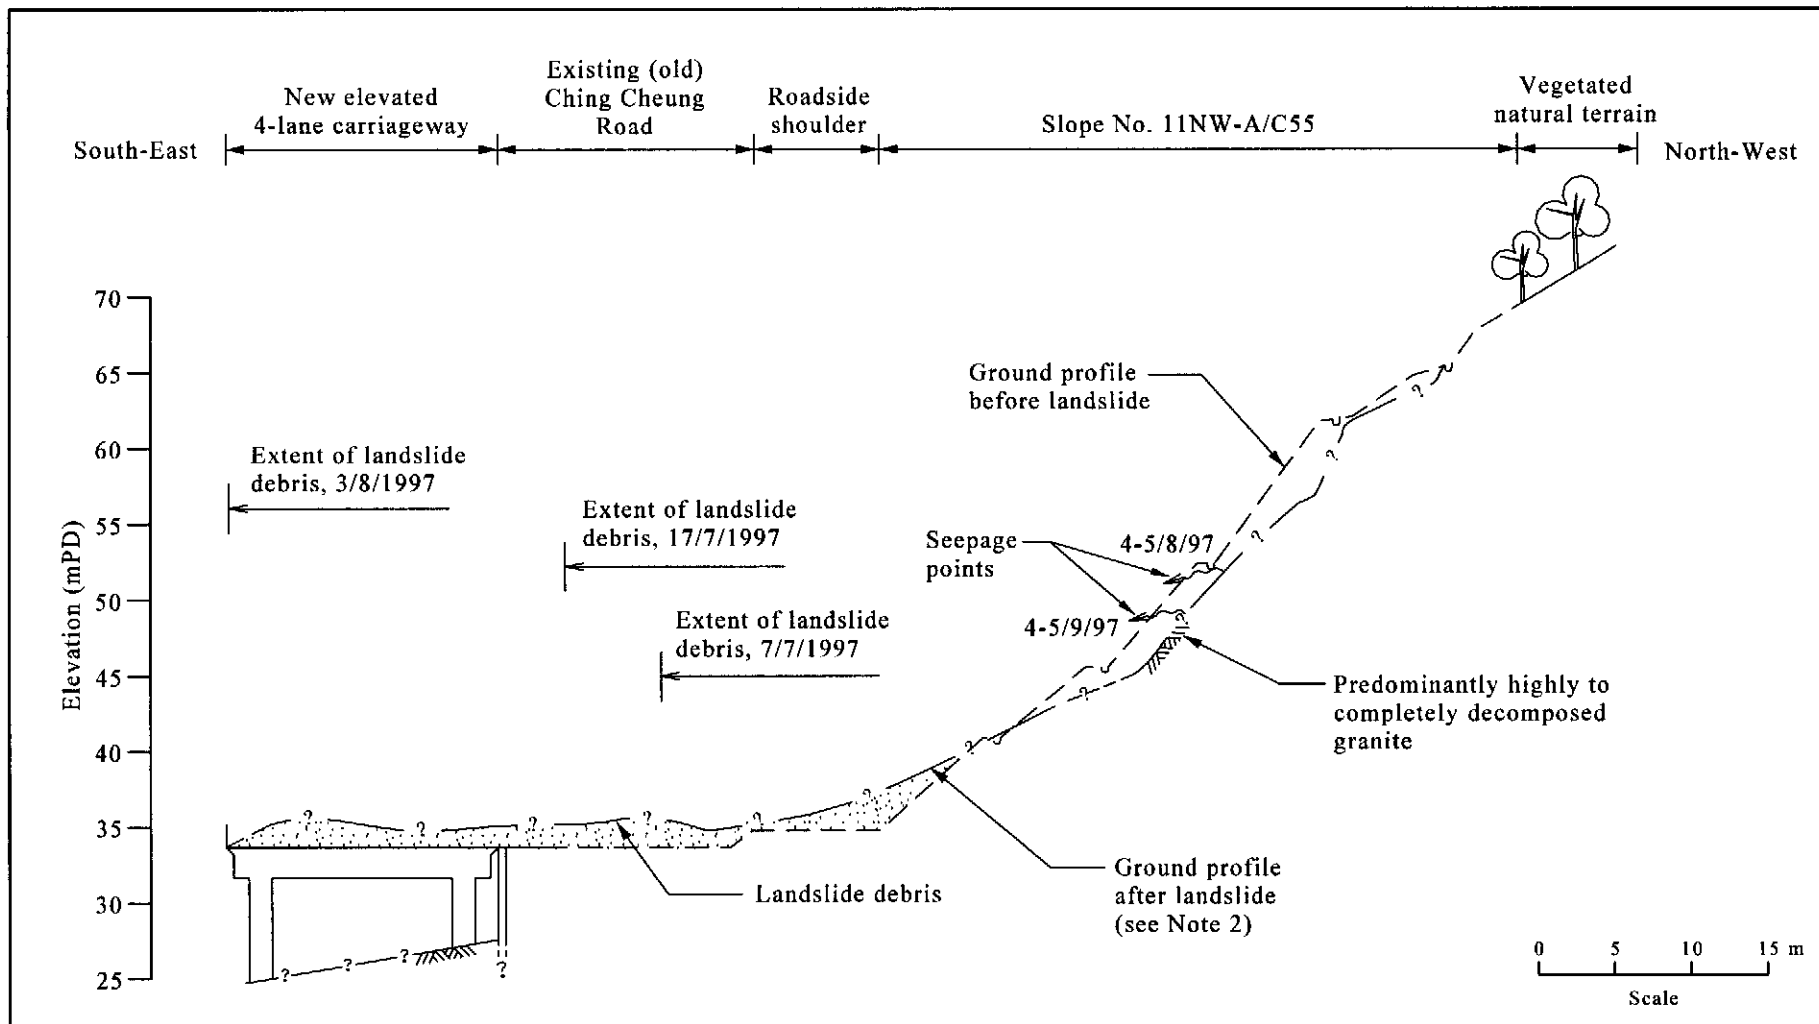
Figure 3 - Typical Cross-section Through the Landslide

The mobility of the landslide was assessed by measuring the inclination of the line joining the distal end of the debris with the crest of the landslide scar (Figure 3). The smaller the angle the greater the debris mobility. According to Wong & Ho (1996) this angle is generally greater than 30° for typical rain-induced landslides on cut slopes. The angle measured on site for the 3 August 1997 failure at Ching Cheung Road was 20°, indicating greater debris mobility than commonly observed. The greater mobility might be attributable in part to the ponding of water on the enclosed section of Ching Cheung Road.

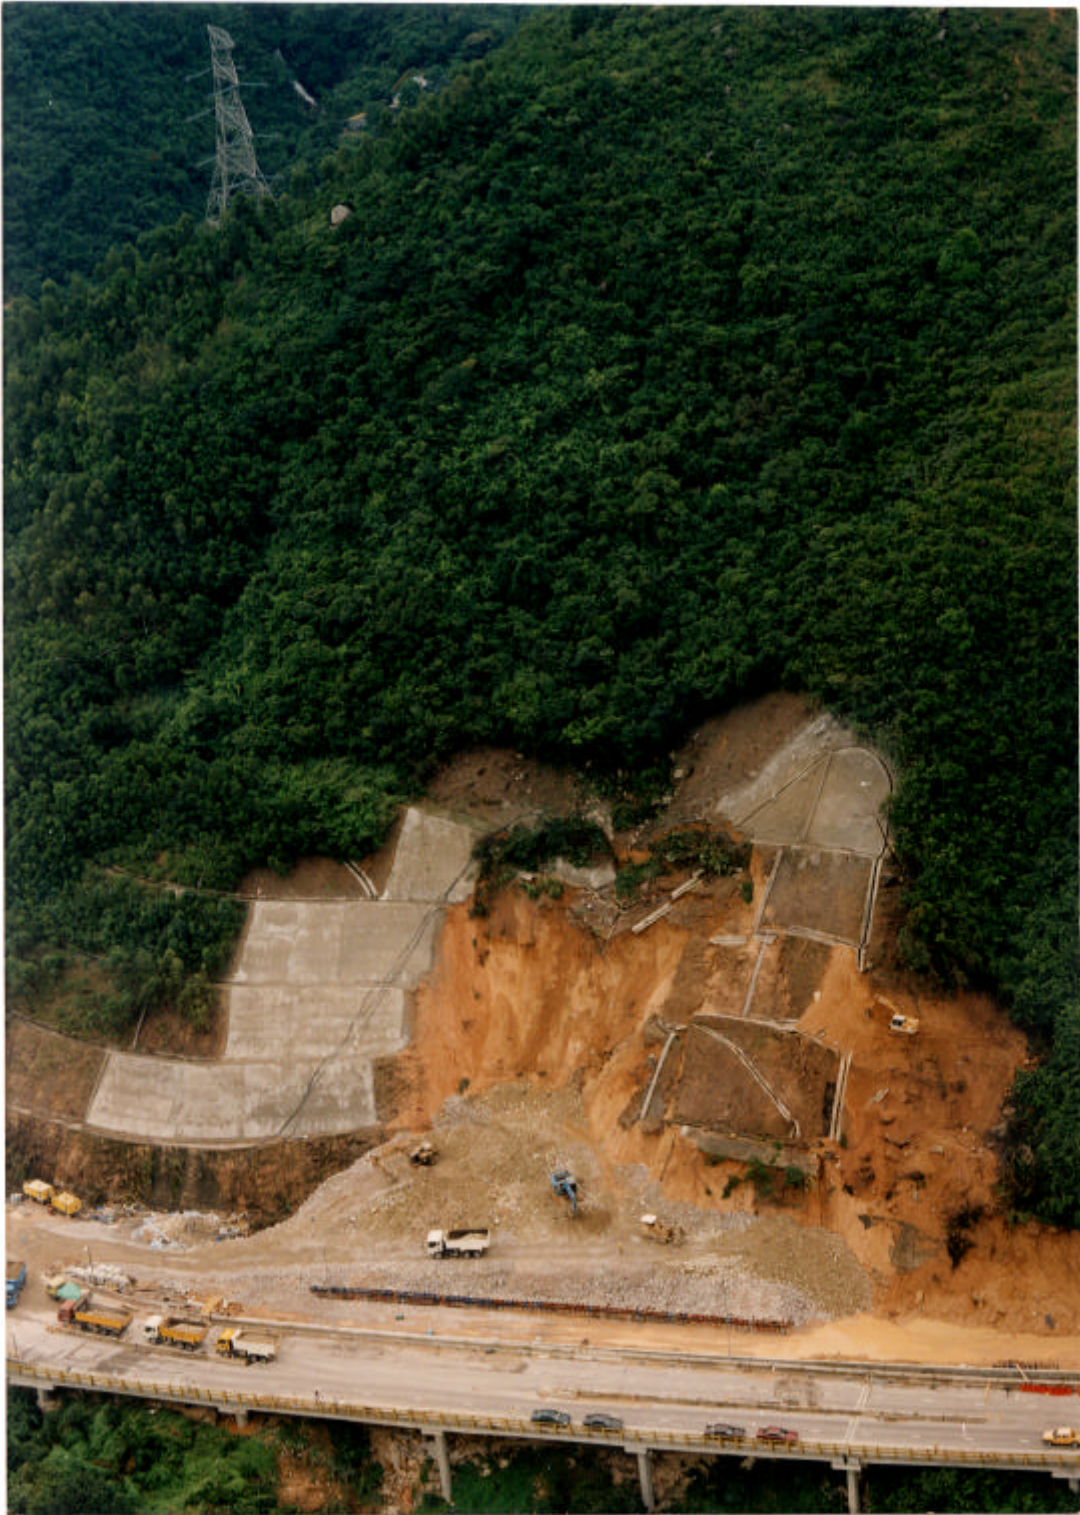
At 11:15 a.m. on Sunday 3 August 1997, a landslide occurred on a roadside cut slope above Ching Cheung Road, east of Butterfly Valley, Kowloon (Figure 1). The landslide debris completely blocked a 50 m section of Ching Cheung Road (Plate 1), trapping a private car travelling on the westbound carriageway. The driver of the car freed himself and was uninjured. The road was subsequently closed to enable clearance of debris and the implementation of urgent repair works to the slope.

Plate 1 - View of 3 August 1997 Landslide (Photograph Taken on 8 August 1997)

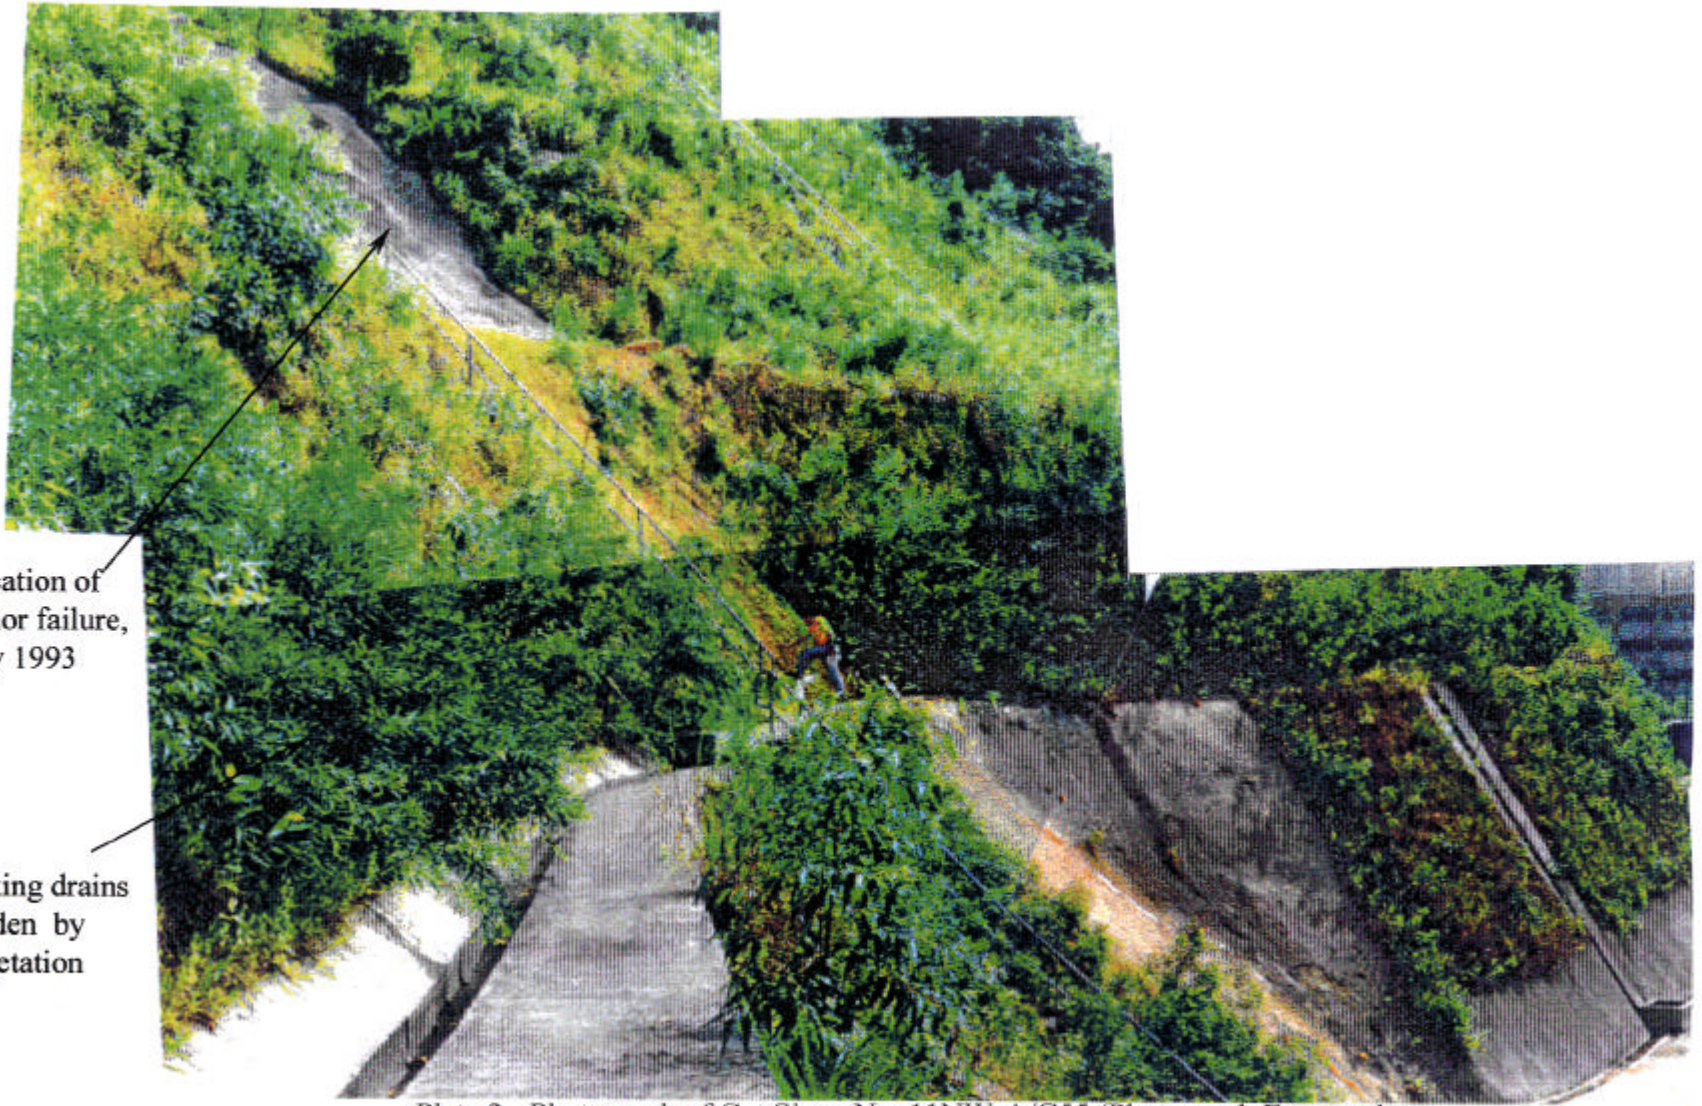
Prior to the recent failures, the slope geometry comprised two to six batter slopes with a total vertical height ranging from 12 m to 47 m. The slope inclination to the horizontal varied, but was typically  $45^{\circ}$  to  $50^{\circ}$ . The slope covering included vegetation with localised shotcreting. A photograph taken of the slope on 15 September 1993 shows the condition of the central portion of the slope (Plate 2).

Following completion of the LPM works, a minor failure occurred in 1993 on the third batter of the slope within the area which failed in 1997. This failure was inspected by the GEO who recommended shotcreting of the scar. No major modification of the slope has been made since 1993. Inspections of the slope in September 1993 by GEO and in December 1995 by consultants engaged by HyD reported "partly blocked" and "moderate cracking" of surface channels. It was also reported that "weepholes" were blocked with vegetation. Some minor routine maintenance works including "clear drainage channels", "repair cracked/damaged channels" and "unblock weepholes" were recommended. "Engineer Inspections carried out every 3 year(s)" were also recommended by the consultants. The maintenance works were completed by HyD in January 1997. Based on the 1995 inspection findings, HyD recommended the slope to LPMC in May 1996, along with 1009 other slopes, for inclusion in the LPM Programme. The slope was not selected because works had been carried out previously under the LPM Programme.

Location of  
minor failure,  
July 1993

Raking drains  
hidden by  
vegetation

Plate 2 - Photograph of Cut Slope No. 11NW-A/C55 (Photograph Extracted from GCD2/A1/11NW-A/C55 And Taken on 15 September 1993)

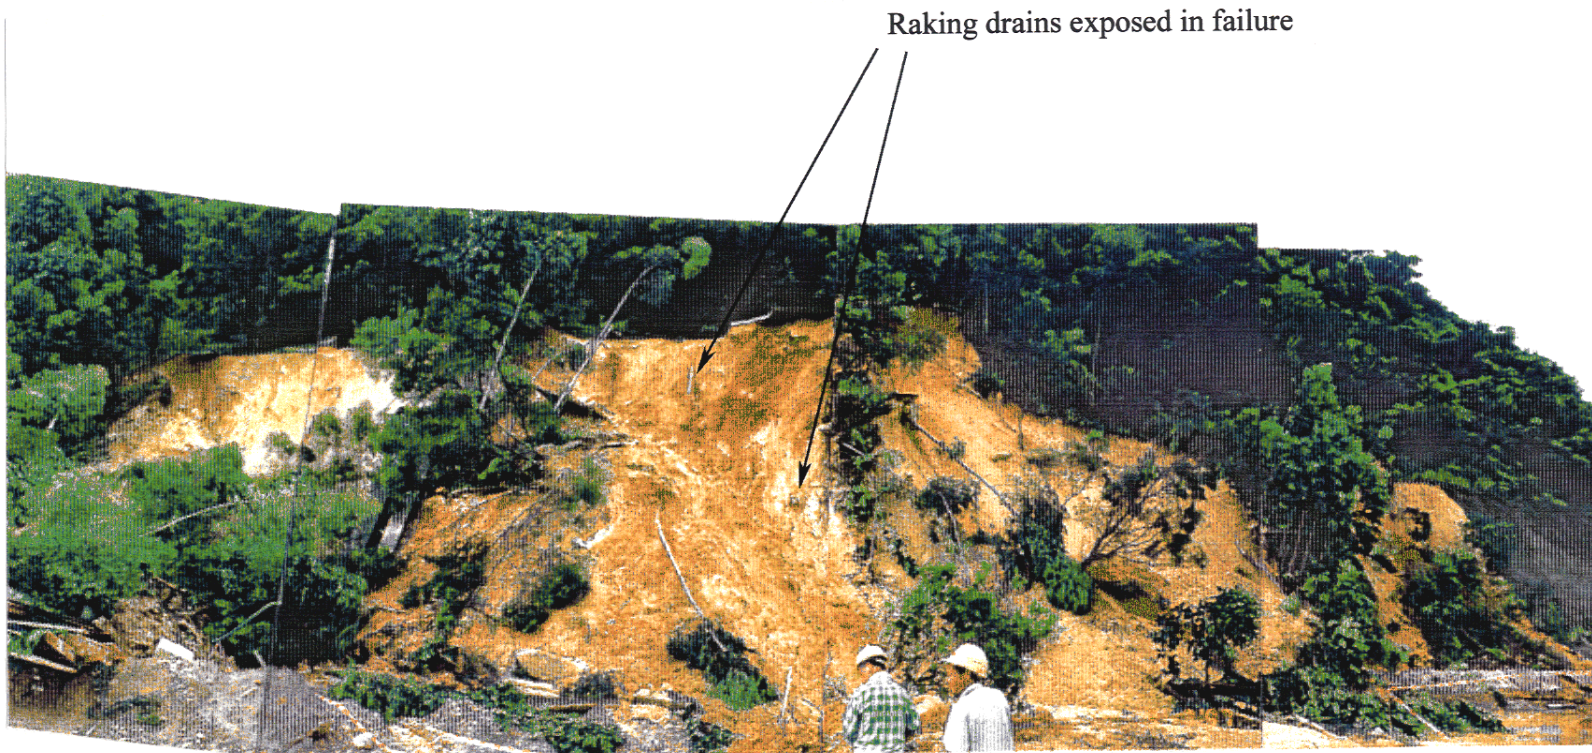
Raking drains exposed in failure

Plate 3 - Photograph of 7 July 1997 Failure (Photograph Taken on 9 July 1997)

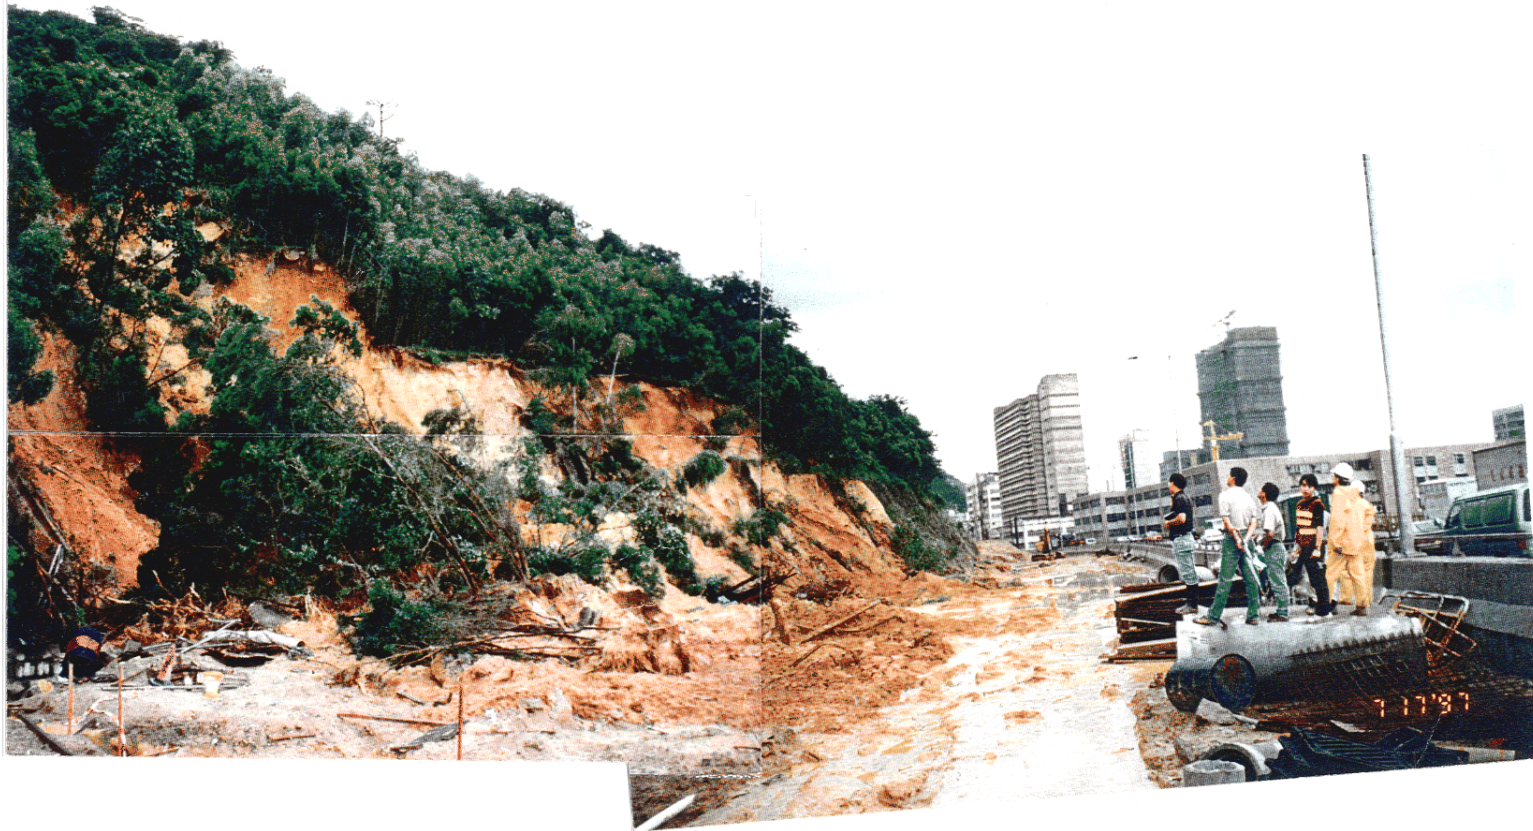
Plate 4 - Photograph of 17 July 1997 Failure (Photograph Taken on 17 July 1997)

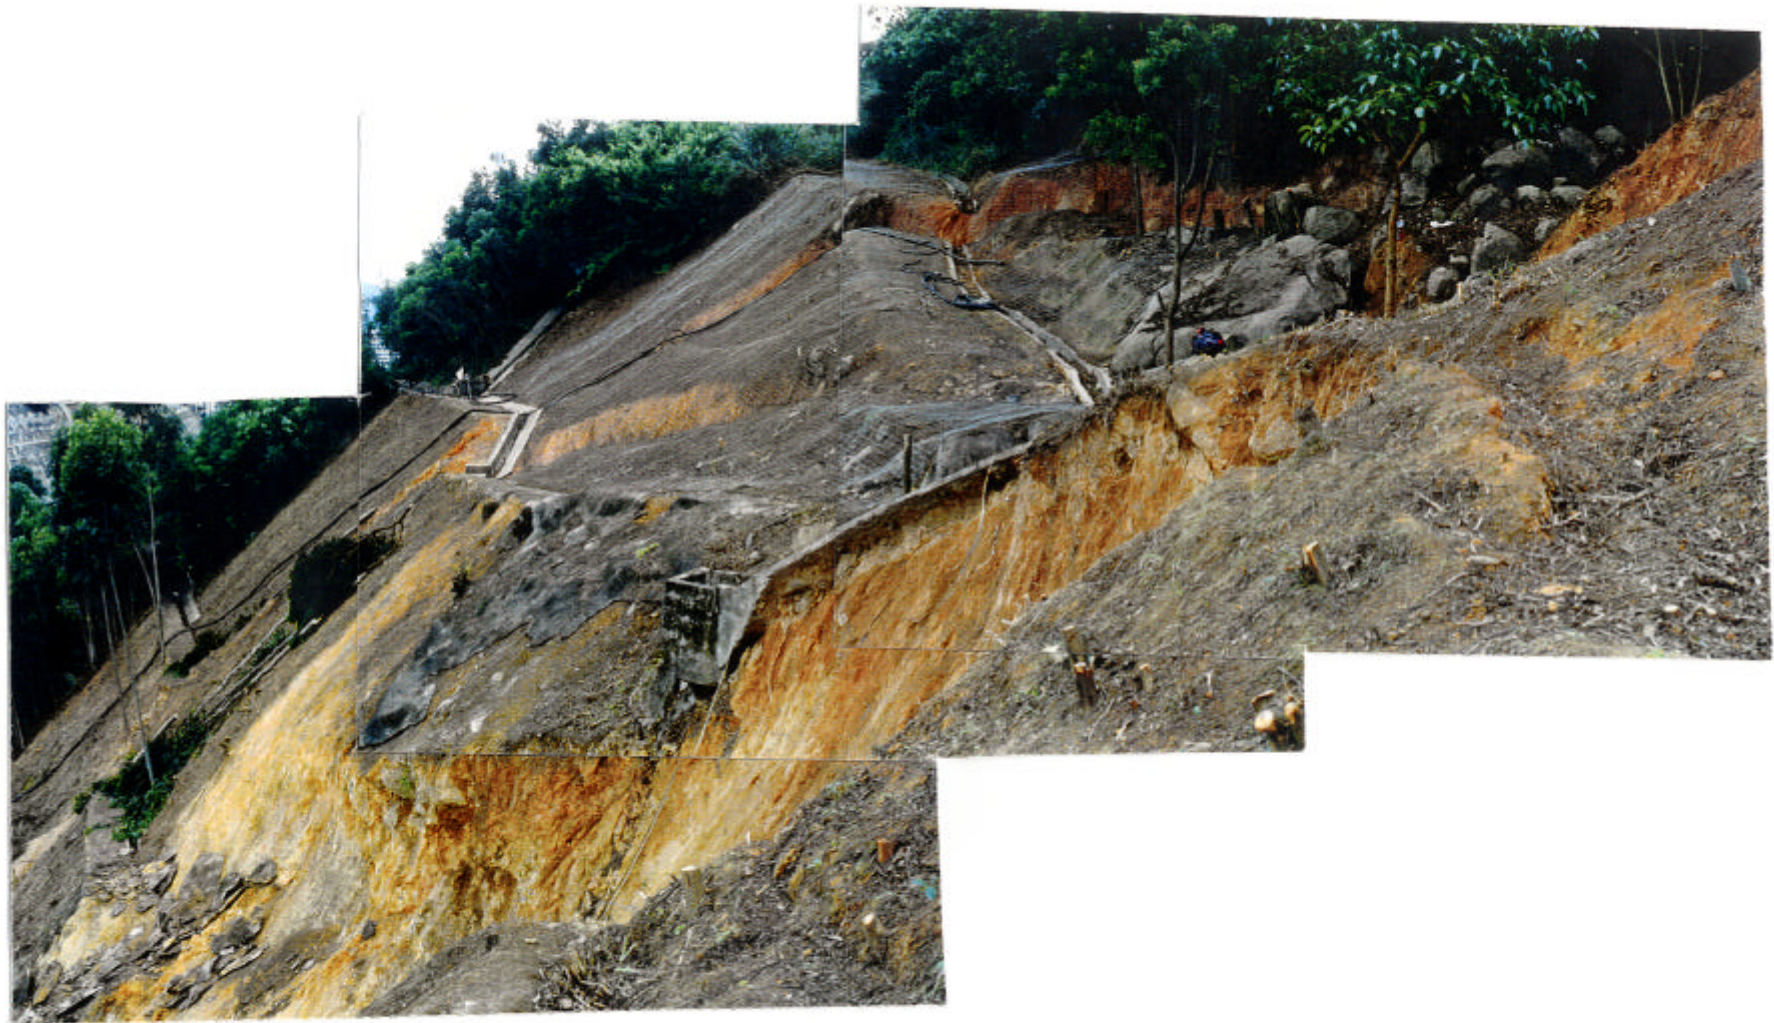
Plate 5 - View of Extensively Cracked and Displaced Ground (Photograph Taken on 30 July 1997)

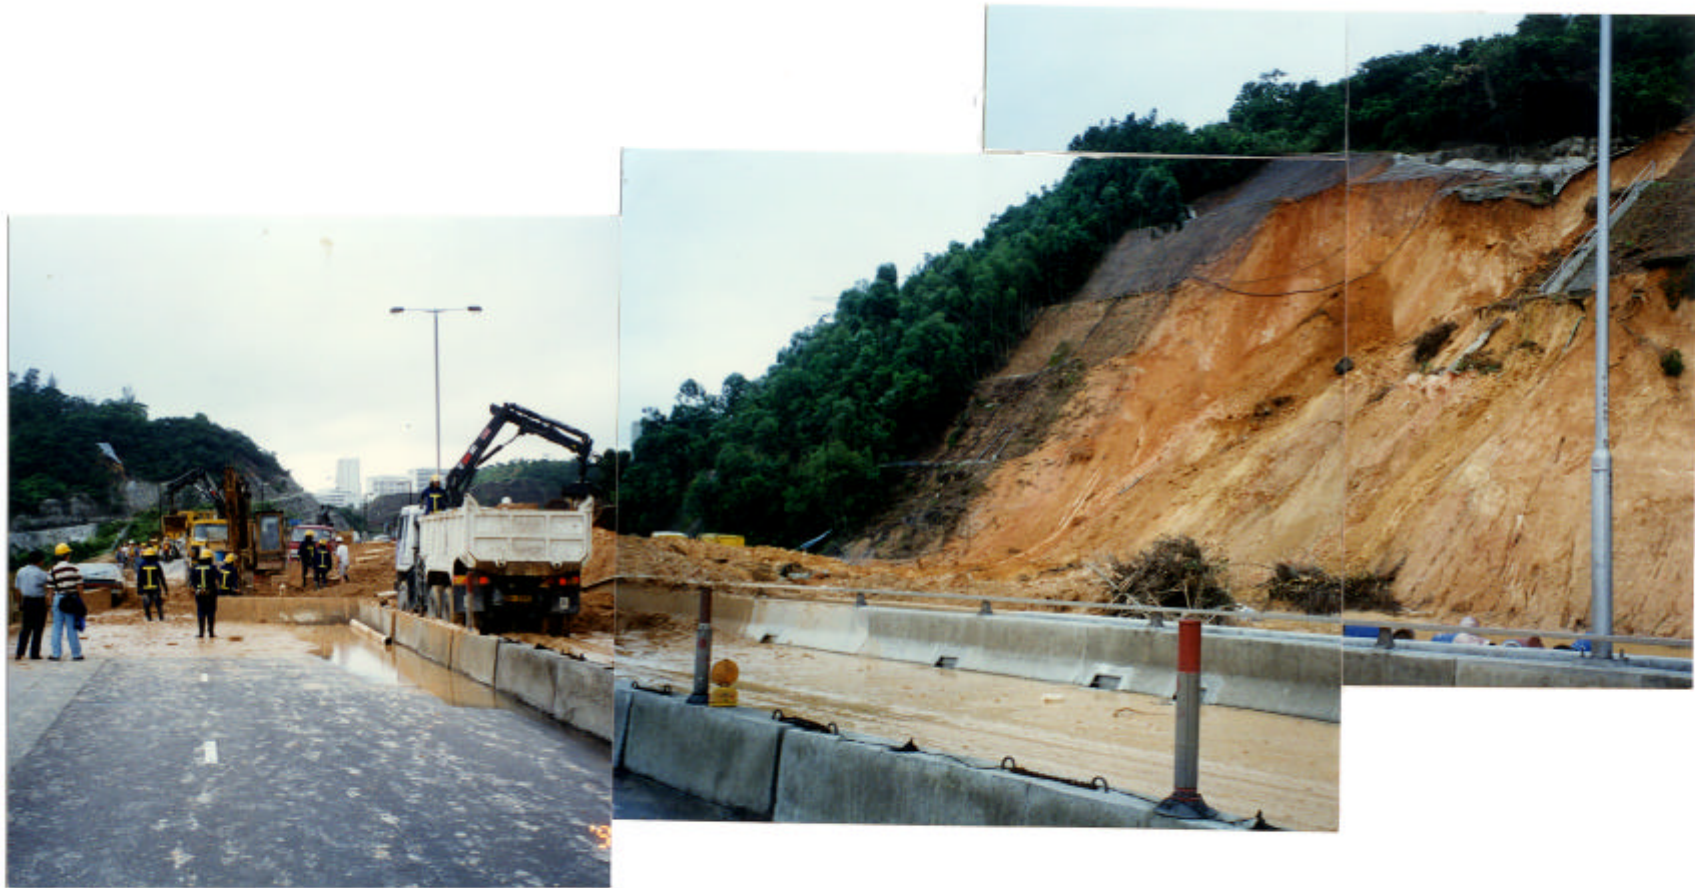
The third failure resulted in the complete blockage of Ching Cheung Road. Based on an eye-witness account, the landslide occurred at 11:15 a.m. on 3 August 1997. A photograph taken during the clear-up operations, a few hours after the failure, is shown in Plate 6. The estimated failed volume of mobilised soil material was 2000 m<sup>3</sup>.

Plate 6 - View of 3 August 1997 Landslide from Ching Cheung Road (Photograph Taken on 3 August 1997)

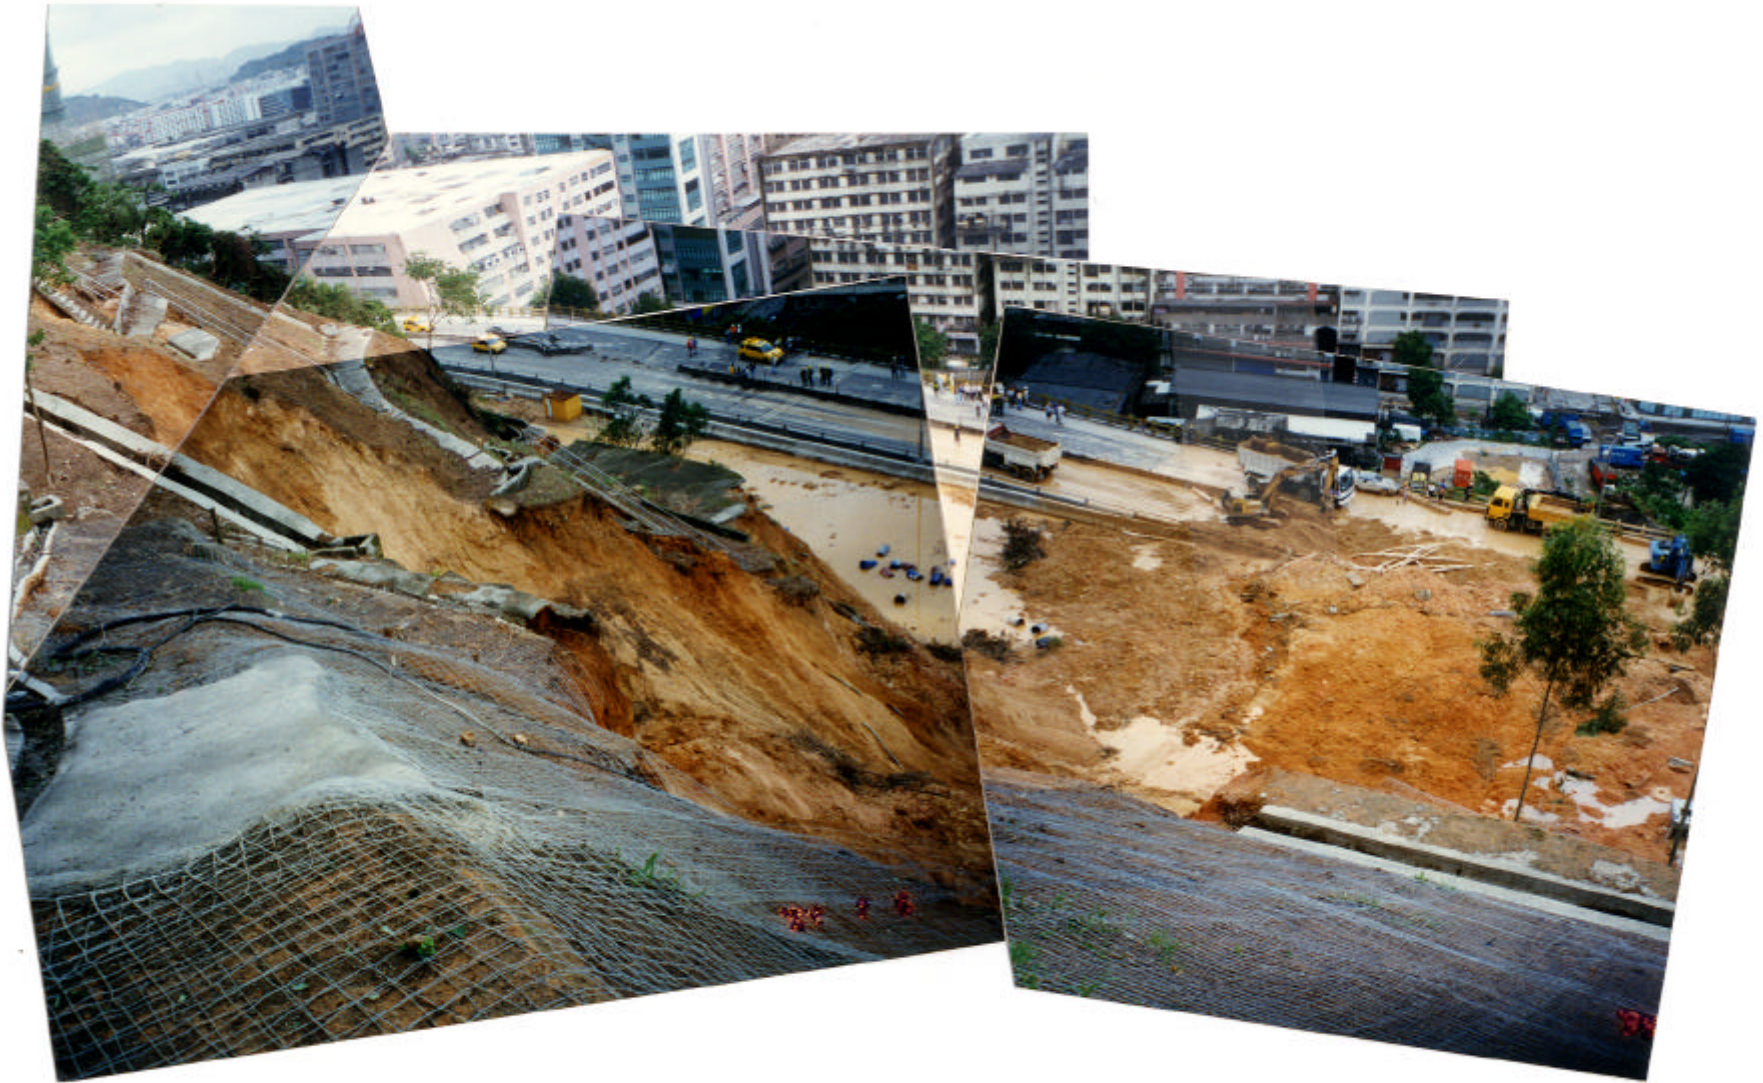
Plate 7 - View of 3 August 1997 Landslide from Cut Slope No. 11NW-A/C55 (Photograph Taken on 3 August 1997)

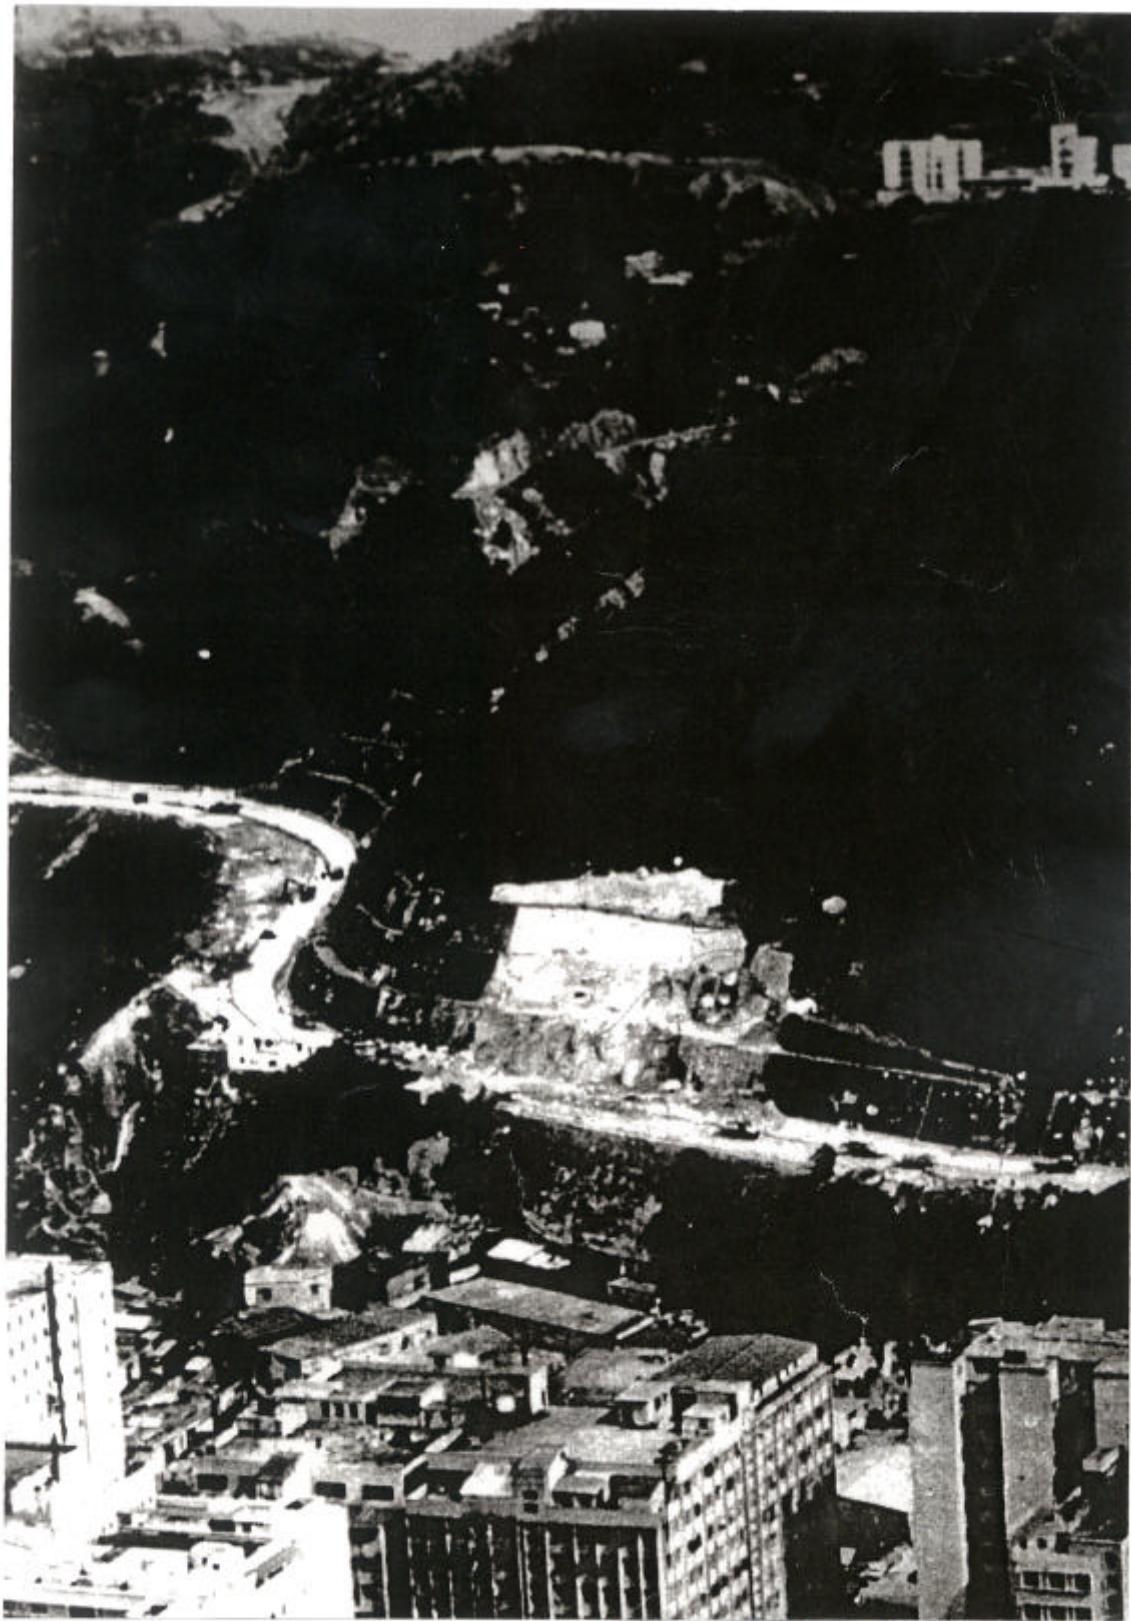
A major landslide occurred in the cut slope in 1972 during the widening works of Ching Cheung Road (Plate 8). The failure volume was reported to be about 7,500 m<sup>3</sup> (Maunsell, 1973a). Remedial works involved cutting back the slope at the same gradient as in the original cutting, but during this process, further movements occurred (Plate 9). Subsequent monitoring recorded horizontal displacement of up to 21 mm, concentrated within the lowest batter at a location corresponding to the central section of the 1997 failure. The slope was eventually stabilised by the installation of 151 raking drains up to 16 m long in the lower two batters. It was reported by Maunsell (1973b) that 70% to 80% of the drains intercepted groundwater, in that they drained water continuously following installation, particularly those at the centre of the failure area. The maximum recorded rate of outflow for any one drain-hole was about 38 litres per hour. The slope apparently remained stable for the following ten years.

Plate 8 - View of 1972 Failure (Photograph Extracted from Figure 1 of Maunsell, 1972)

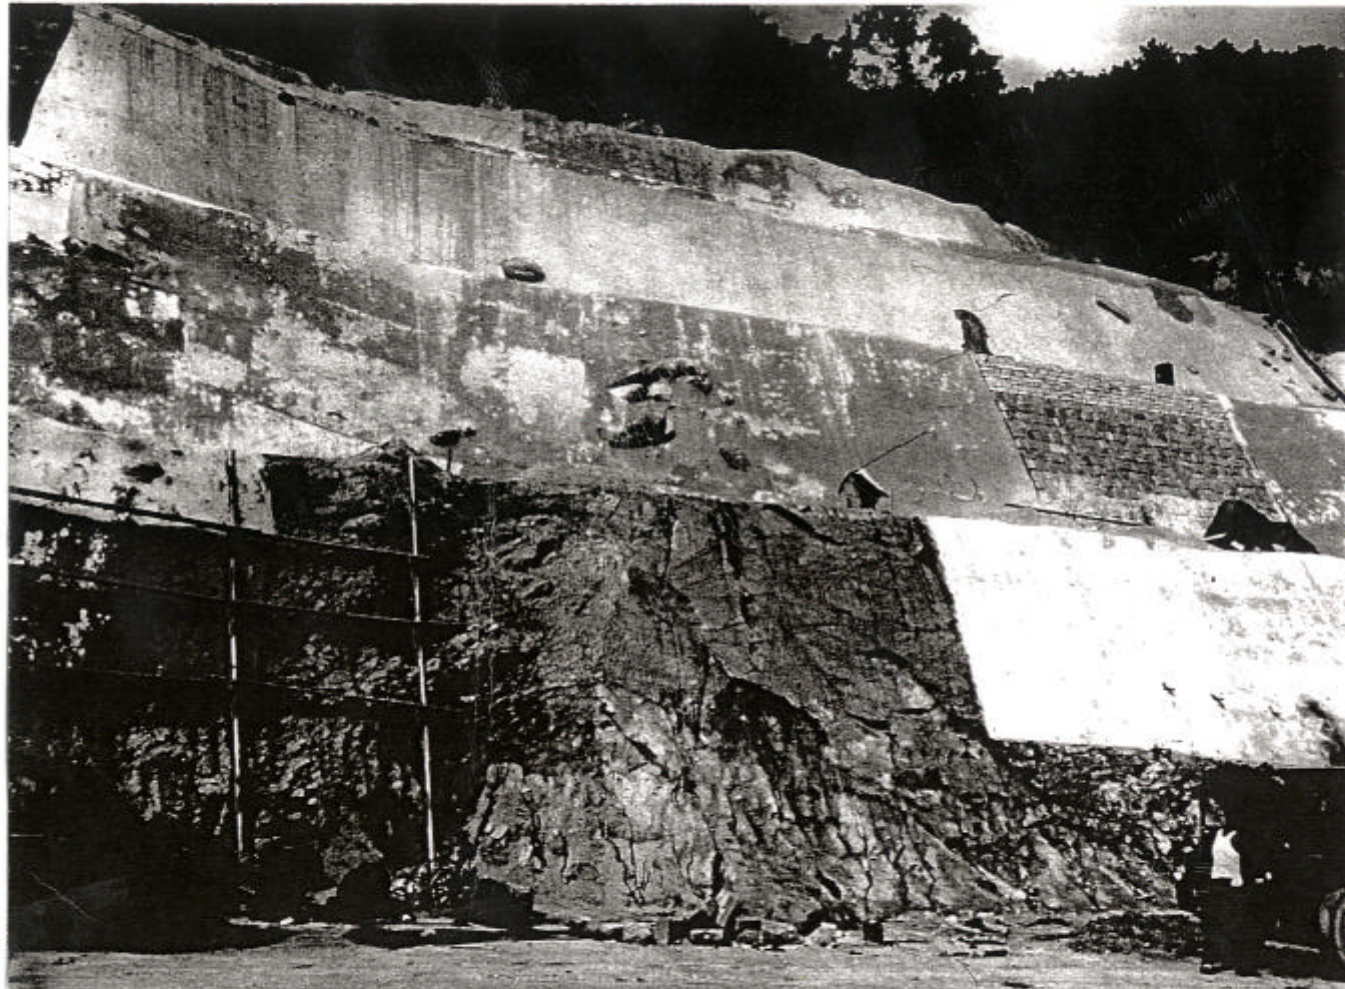
Plate 9 - View of Remedial Works Following 1972 Failure  
(Photographs Extracted from Figures 2 - 4 of Maunsell, 1972)

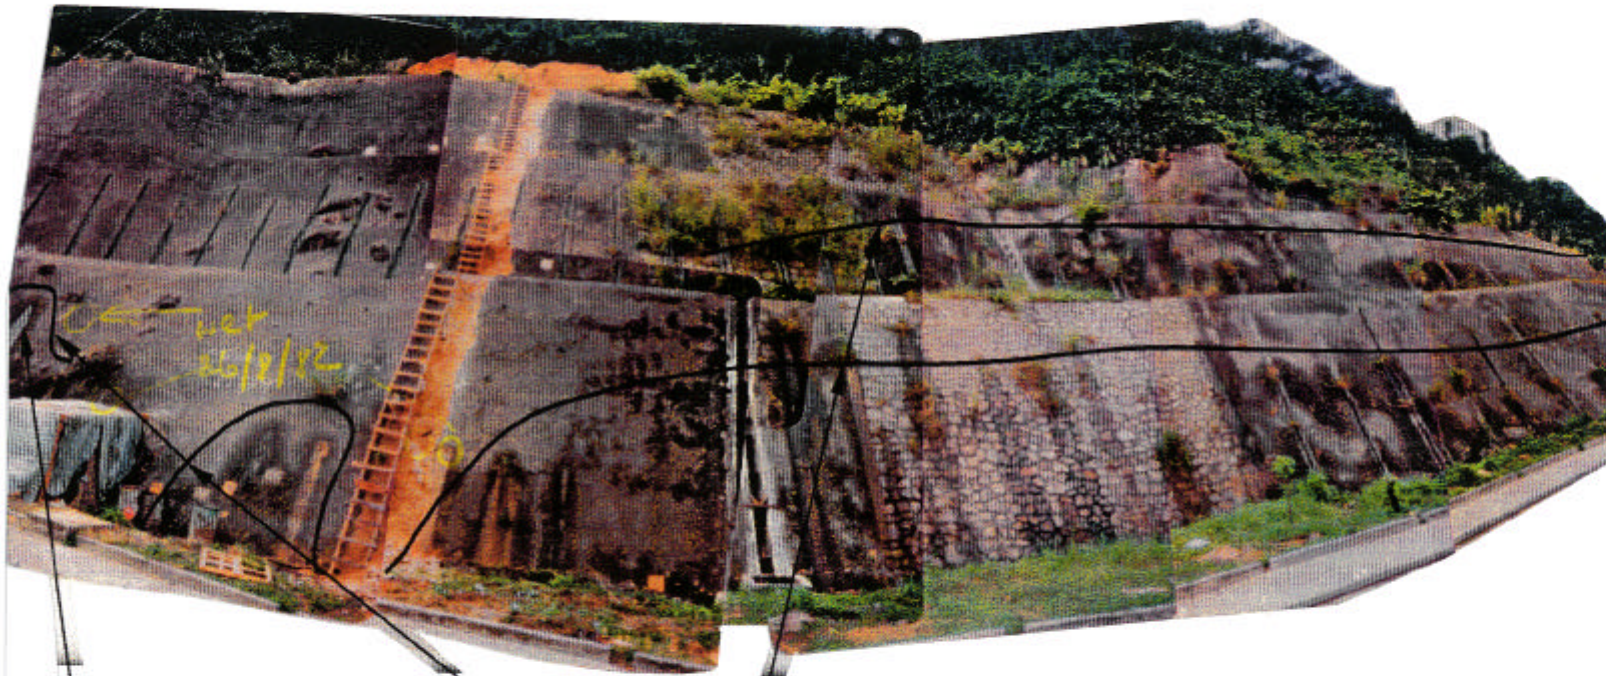
Heavy flow

Approximate limits of observed seepage, 6 September 1982

Plate 10 - View of 1982 Failure (Photograph Extracted from CHASE File, GCO, 1982b)
