一九九七年八月三日  
呈祥道山泥傾瀉事件報告  
**REPORT ON THE  
CHING CHEUNG ROAD  
LANDSLIDE OF  
3 AUGUST 1997**

土力工程處報告系列第 78 號  
GEO REPORT No. 78

合樂亞洲顧問公司  
Halcrow Asia Partnership Ltd.

香港特別行政區政府  
土木工程署  
土力工程處  
**GEOTECHNICAL ENGINEERING OFFICE  
CIVIL ENGINEERING DEPARTMENT  
THE GOVERNMENT OF THE HONG KONG  
SPECIAL ADMINISTRATIVE REGION**

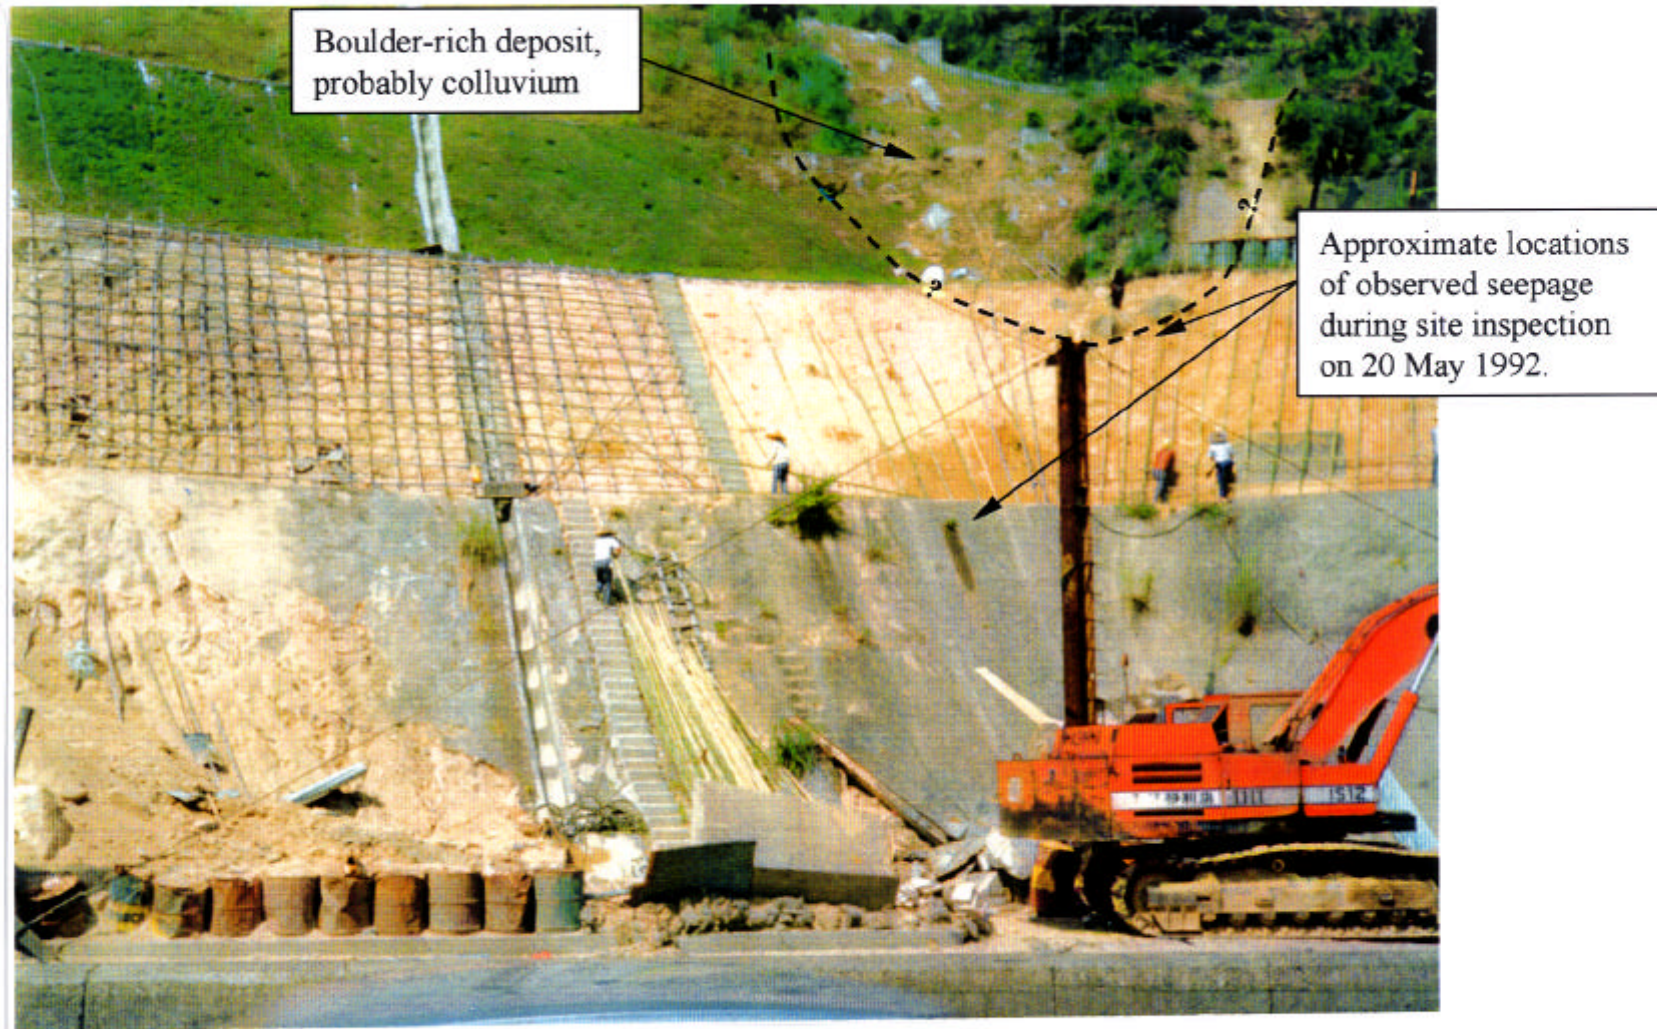
Plate 11 - Photograph of Central Section of Slope No. 11NW-A/C55 During LPM Works  
(Photograph Taken on 4 October 1991)

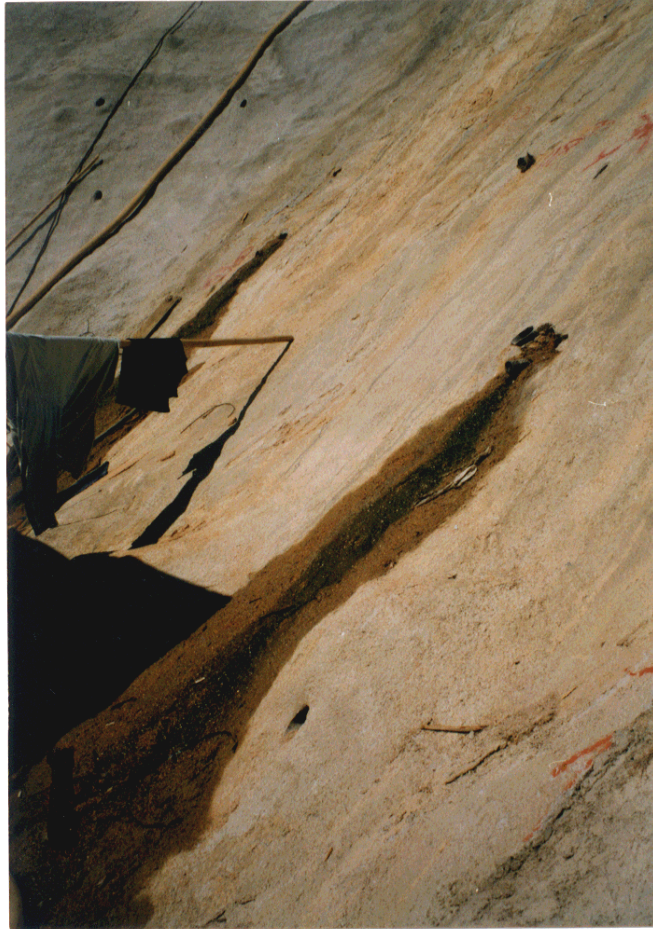
Plate 12 - Photograph Showing Water Flowing from Raking  
Drains Installed at Mid-height of the Landslide  
Backscar (Photograph Taken on 8 January 1997)
