二零零五年八月二十日
芙蓉山村山泥傾瀉事件報告
山泥傾瀉調查結果
**REPORT ON THE LANDSLIDE
AT FU YUNG SHAN TSUEN
OF 20 AUGUST 2005
FINDINGS OF THE LANDSLIDE
INVESTIGATION**

土力工程處報告系列第277號
GEO REPORT No. 277

茂盛土力工程顧問有限公司
Maunsell Geotechnical Services Ltd.

**GEOTECHNICAL ENGINEERING OFFICE
CIVIL ENGINEERING AND DEVELOPMENT DEPARTMENT
THE GOVERNMENT OF THE HONG KONG
SPECIAL ADMINISTRATIVE REGION**

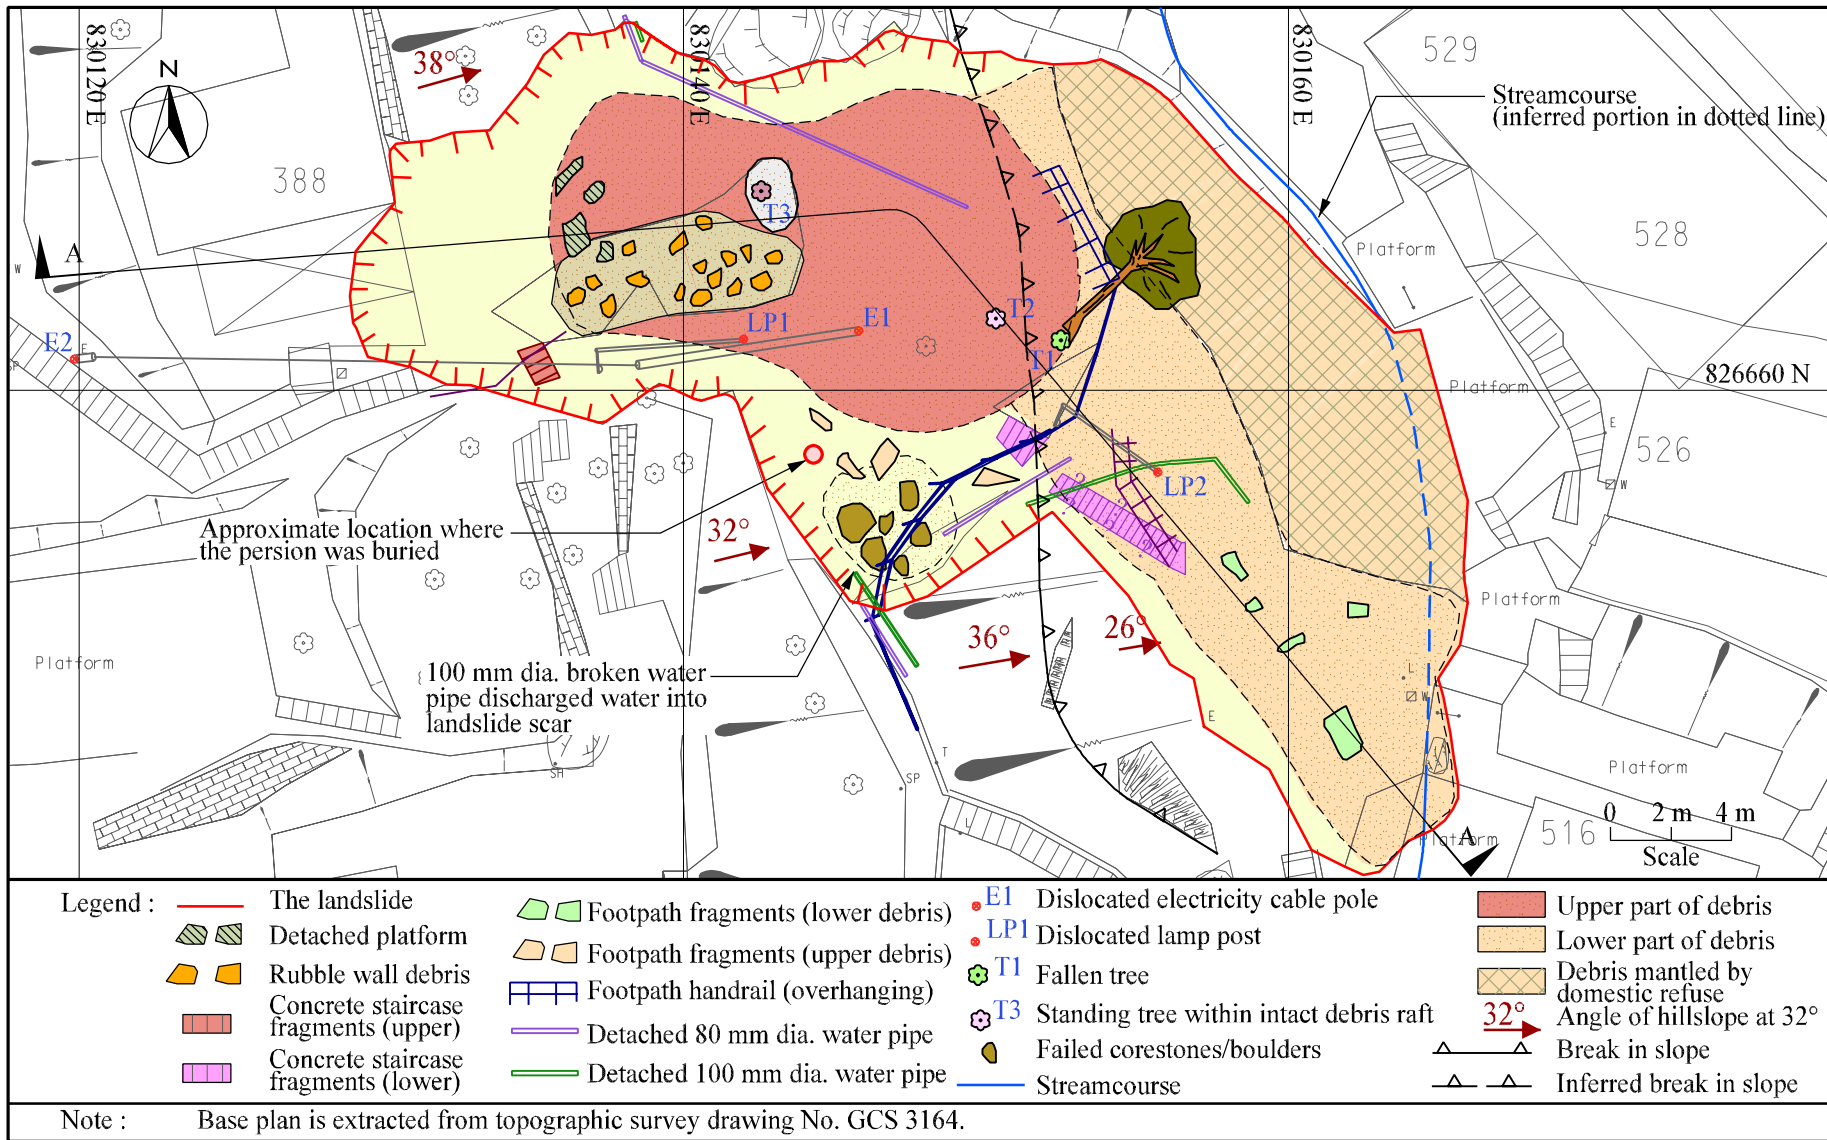
Figure 3 - Plan of the Landslide

According to witnesses' accounts (including residents of Fu Yung Shan Tsuen, firemen, police officers and GEO inspection engineers), records from the Hong Kong Police Force (HKPF) and post-failure field observations, the August 2005 landslide occurred in successive phases between about 5:25 p.m. and 6:30 p.m. on 20 August 2005 (see Section 7). The failure occurred on a hillside that has been disturbed locally by past human activities (Section 2). The landslide scar is about 45 m in length (on plan), 18 m in width (maximum),

with a maximum depth of about 4 m, giving a total failure volume of about 400 m³. The overall travel distance of the landslide debris is about 20 m (Figure 3). The main scarp of the landslide is about 10 m wide, 7 m high and inclined at an angle between 50° and 65° (Plates 5 & 12). Following the landslide, only the main scarp was exposed and the remainder of the landslide scar was covered by landslide debris. No adverse geological structures (such as relict joints, low strength infill, etc.) could be observed in the main scarp. No seepage or any other evidence of water flow was observed in the main scarp during the inspection in the morning of 21 August 2005. However, the exposed materials were notably wet and appeared to be saturated.

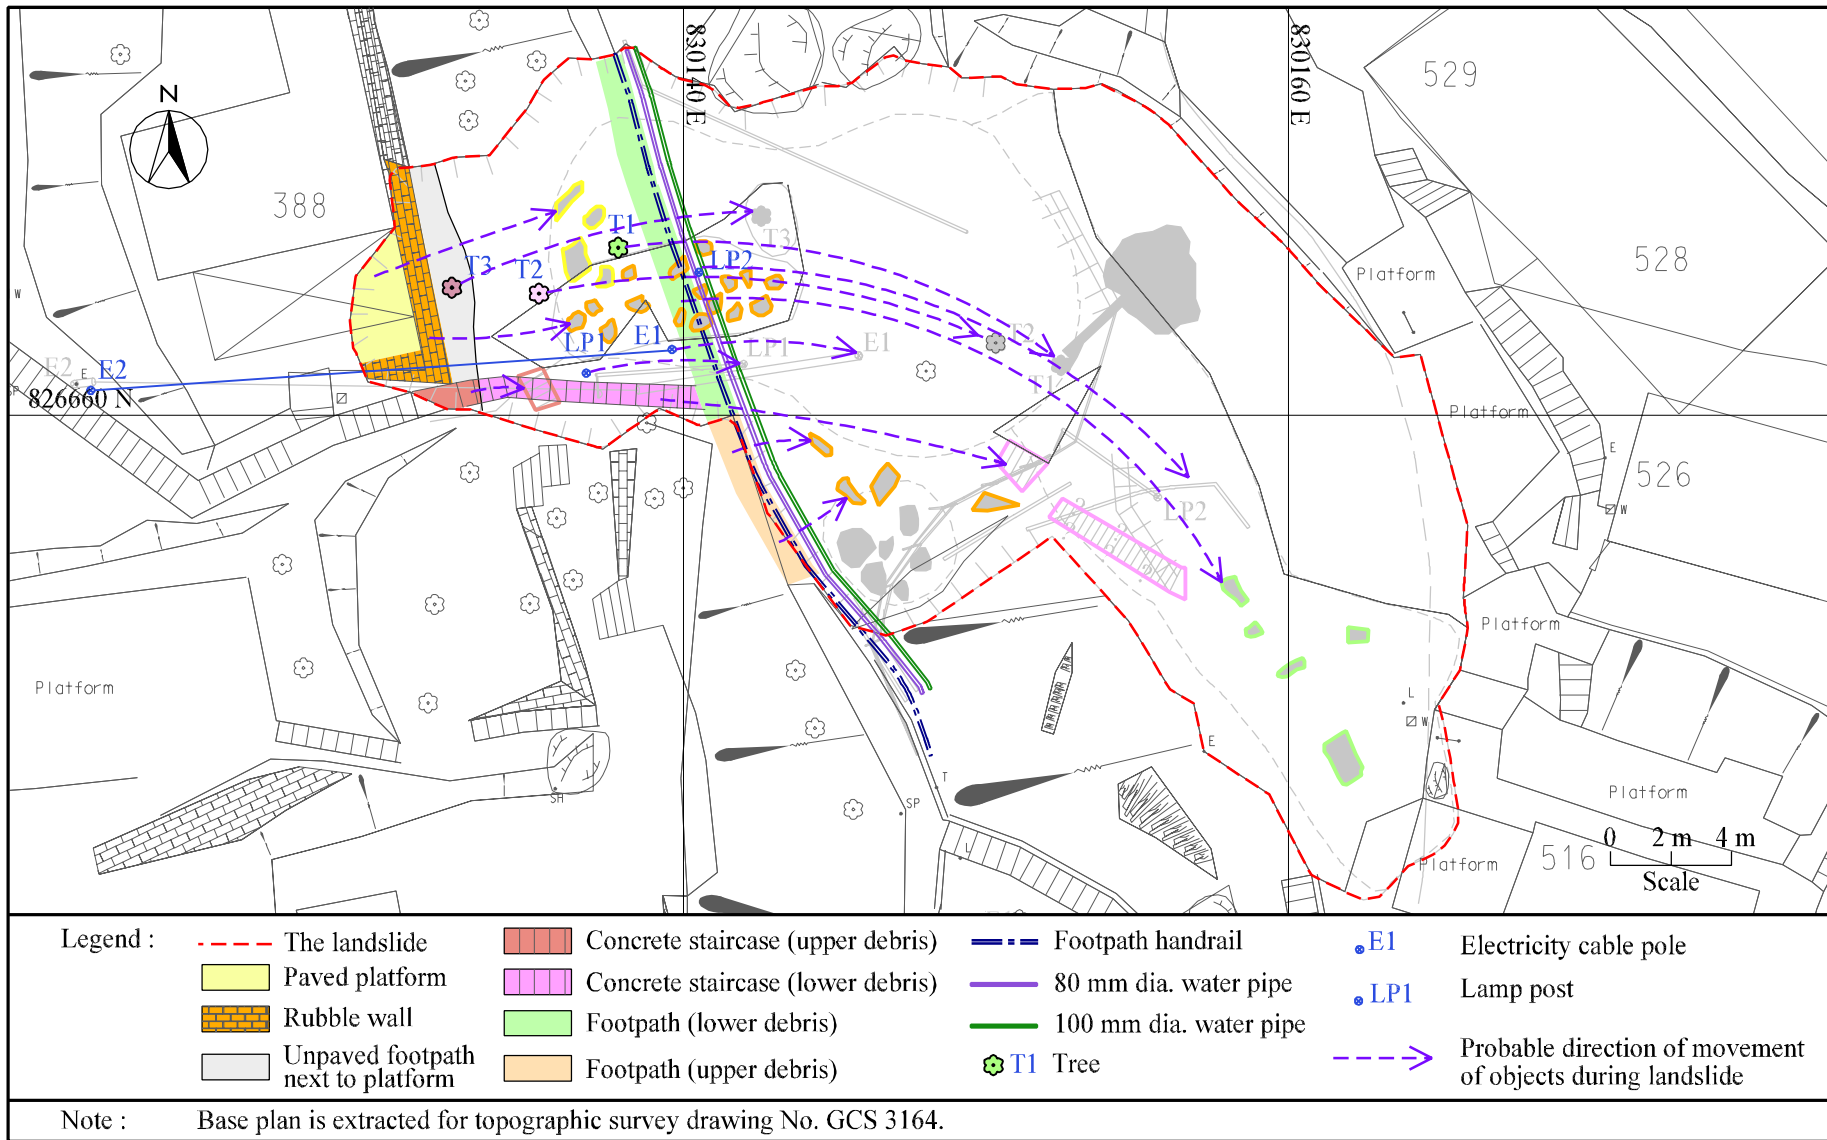
Figure 5 - Debris Mobility from Post-failure Observations and Eye-witnesses' Accounts

The movement pattern of the landslide debris (based on the locations of objects as mapped within the debris, the original locations of which were known), including the failed materials and footpath and stairway fragments, fallen trees and broken utilities, etc. (Figure 5),

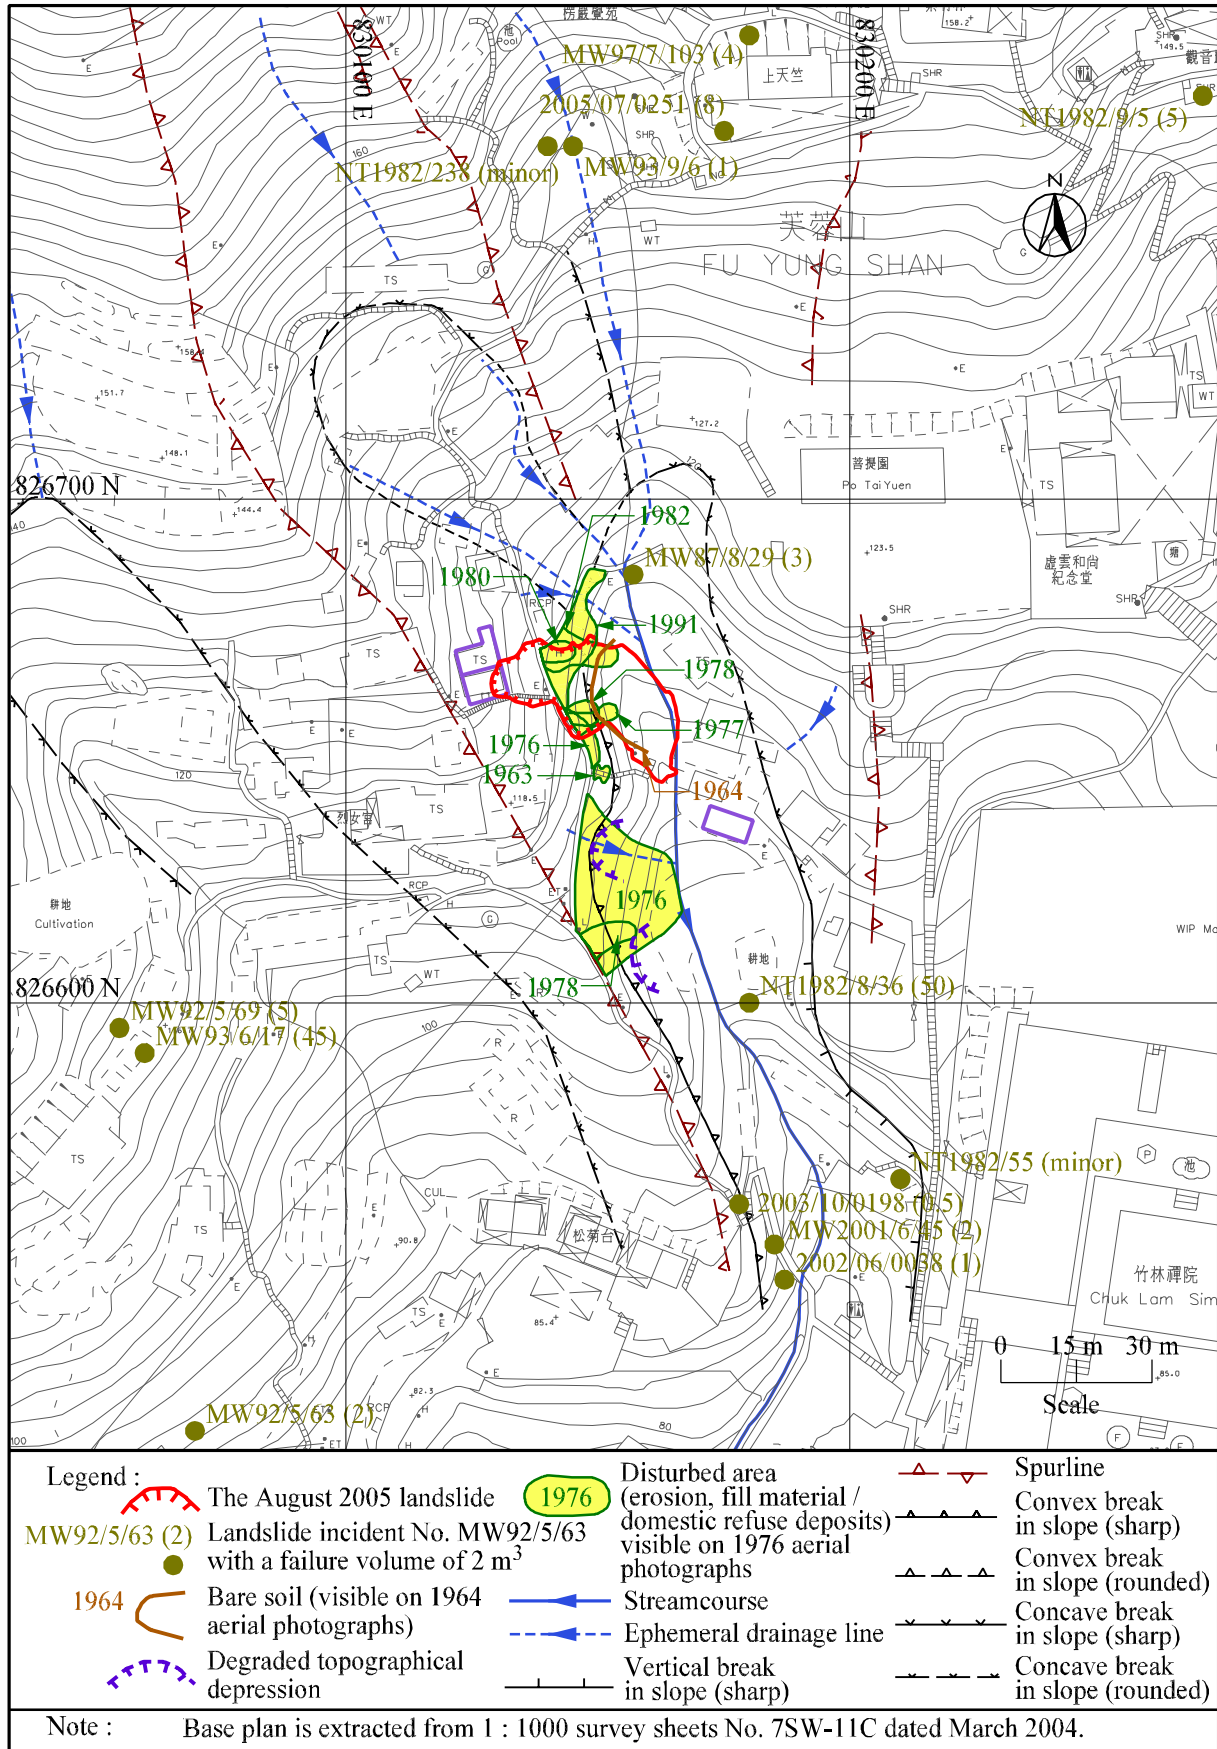
Figure 6 - Past Instabilities and Geomorphology

There are no records of any previous reported landslides in the immediate vicinity of the August 2005 landslide, according to GEO's database of reported landslides, Natural Terrain Landslide Inventory (NTLI), Large Landslide Database (LLD) and the Enhanced NTLI data maintained by the GEO. The nearest recorded landslide incident (a minor landslide on the hillside below a footpath, with a failure volume of about 3 m³) is about 20 m to the north of the landslide site (see Appendix A and Figure 6).

From a review of the 1964 aerial photographs, a possible area of local instability or a man-made excavation is indicated near the toe of the location of the August 2005 landslide. Two degraded topographical depressions, which are inferred to be relict landslides, are located about 30 m to the south of the landslide (Figure 6).

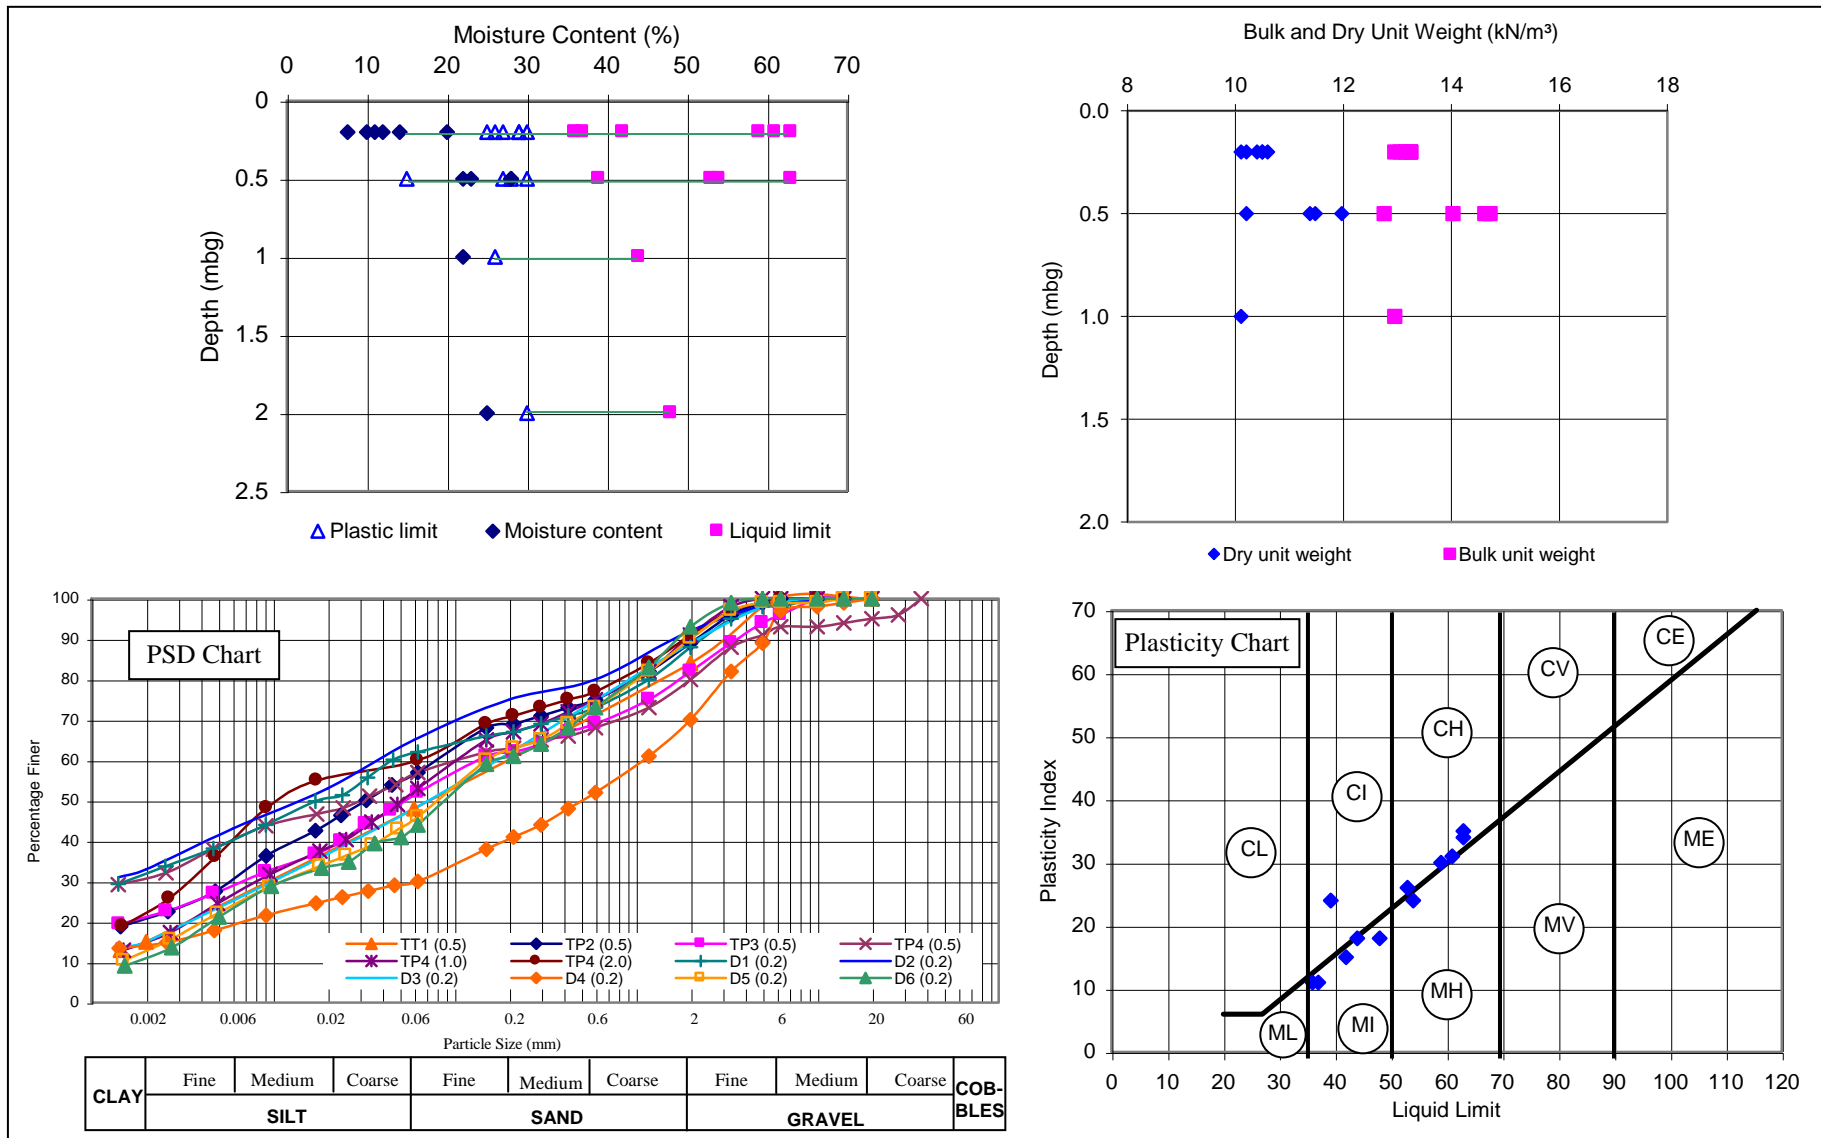
Figure 14 - Geotechnical Properties of Landslide Debris

A series of laboratory tests were conducted at the Public Works Central Laboratory (PWCL) and the Hong Kong University of Science and Technology (HKUST) on samples retrieved during the ground investigation. The tests included moisture content tests, particle size distribution (PSD), Atterberg limits tests, chemical tests on soil and water samples, single stage isotropically consolidated undrained triaxial compression tests (referred to as CIU tests), consolidation tests, direct shear box tests, and stress path tests (with increasing pore water pressure at a constant deviator stress, referred to as 'constant q' tests). The tests were carried out in accordance with Geospec 3 (GEO, 2001). A summary of the laboratory test results is presented in Figures 14 to 16.

The average fines (i.e. silt and clay) content of the landslide debris was found to be 52%, with a range of 30% to 65%, whilst that of the colluvium and CDGd was 49% and 36% respectively, with ranges of 8% to 66% for colluvium and 19% to 62% for CDGd. The plasticity index of the fines of CDGd ranged from 7% to 20%, and the liquid limit ranged from 38% to 49%. The plasticity index of the fines of colluvium ranged from 14% to 37%, and the liquid limit ranged from 42% to 66%. The plasticity index of the fines of the landslide debris ranged from 11% to 35%, and the liquid limit ranged from 36% to 63%. The CDGd comprises slightly gravelly sandy clayey silt, sandy silt, sandy clayey silt, silty gravelly sand and silty sand. The silt in CDGd are predominantly intermediate plastic silt (Figure 15). The colluvium comprises sandy clay, sandy silt, gravelly sandy silt and occasionally gravelly sands. Highly plastic clay and silt were encountered in colluvium

The average dry and bulk unit weights of the landslide debris as determined from sand replacement tests are 10.7 kN/m^3 and 13.4 kN/m^3 respectively, with ranges of 10.1 kN/m^3 to 12 kN/m^3 obtained for the dry unit weight and 12.8 kN/m^3 to 14.7 kN/m^3 for the bulk unit weight. The dry unit weight of colluvium as determined from sand replacement tests ranged from 11 kN/m^3 to 14.6 kN/m^3 , with an average value of 12.9 kN/m^3 . The dry unit weight of CDGd as determined from undisturbed samples ranged from 13 kN/m^3 to 14.9 kN/m^3 , with an average value of 14.1 kN/m^3 .

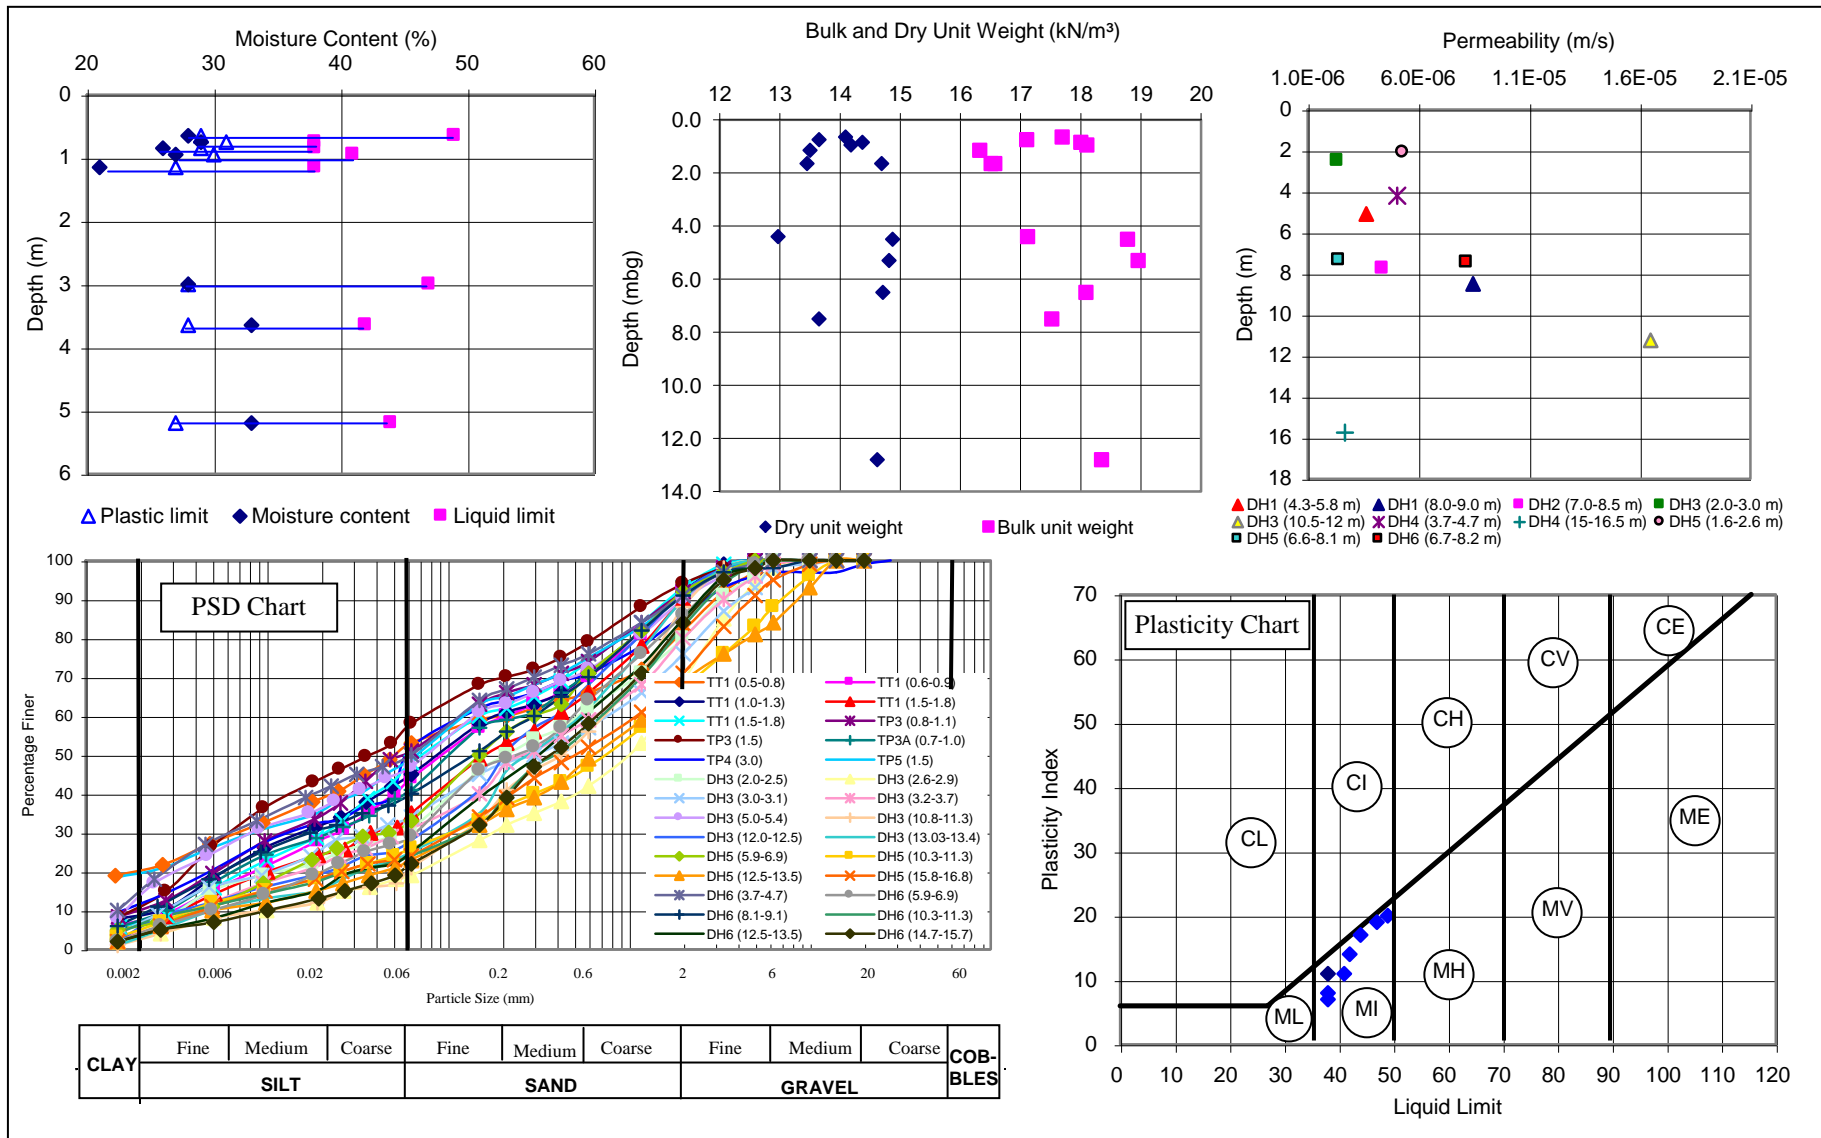
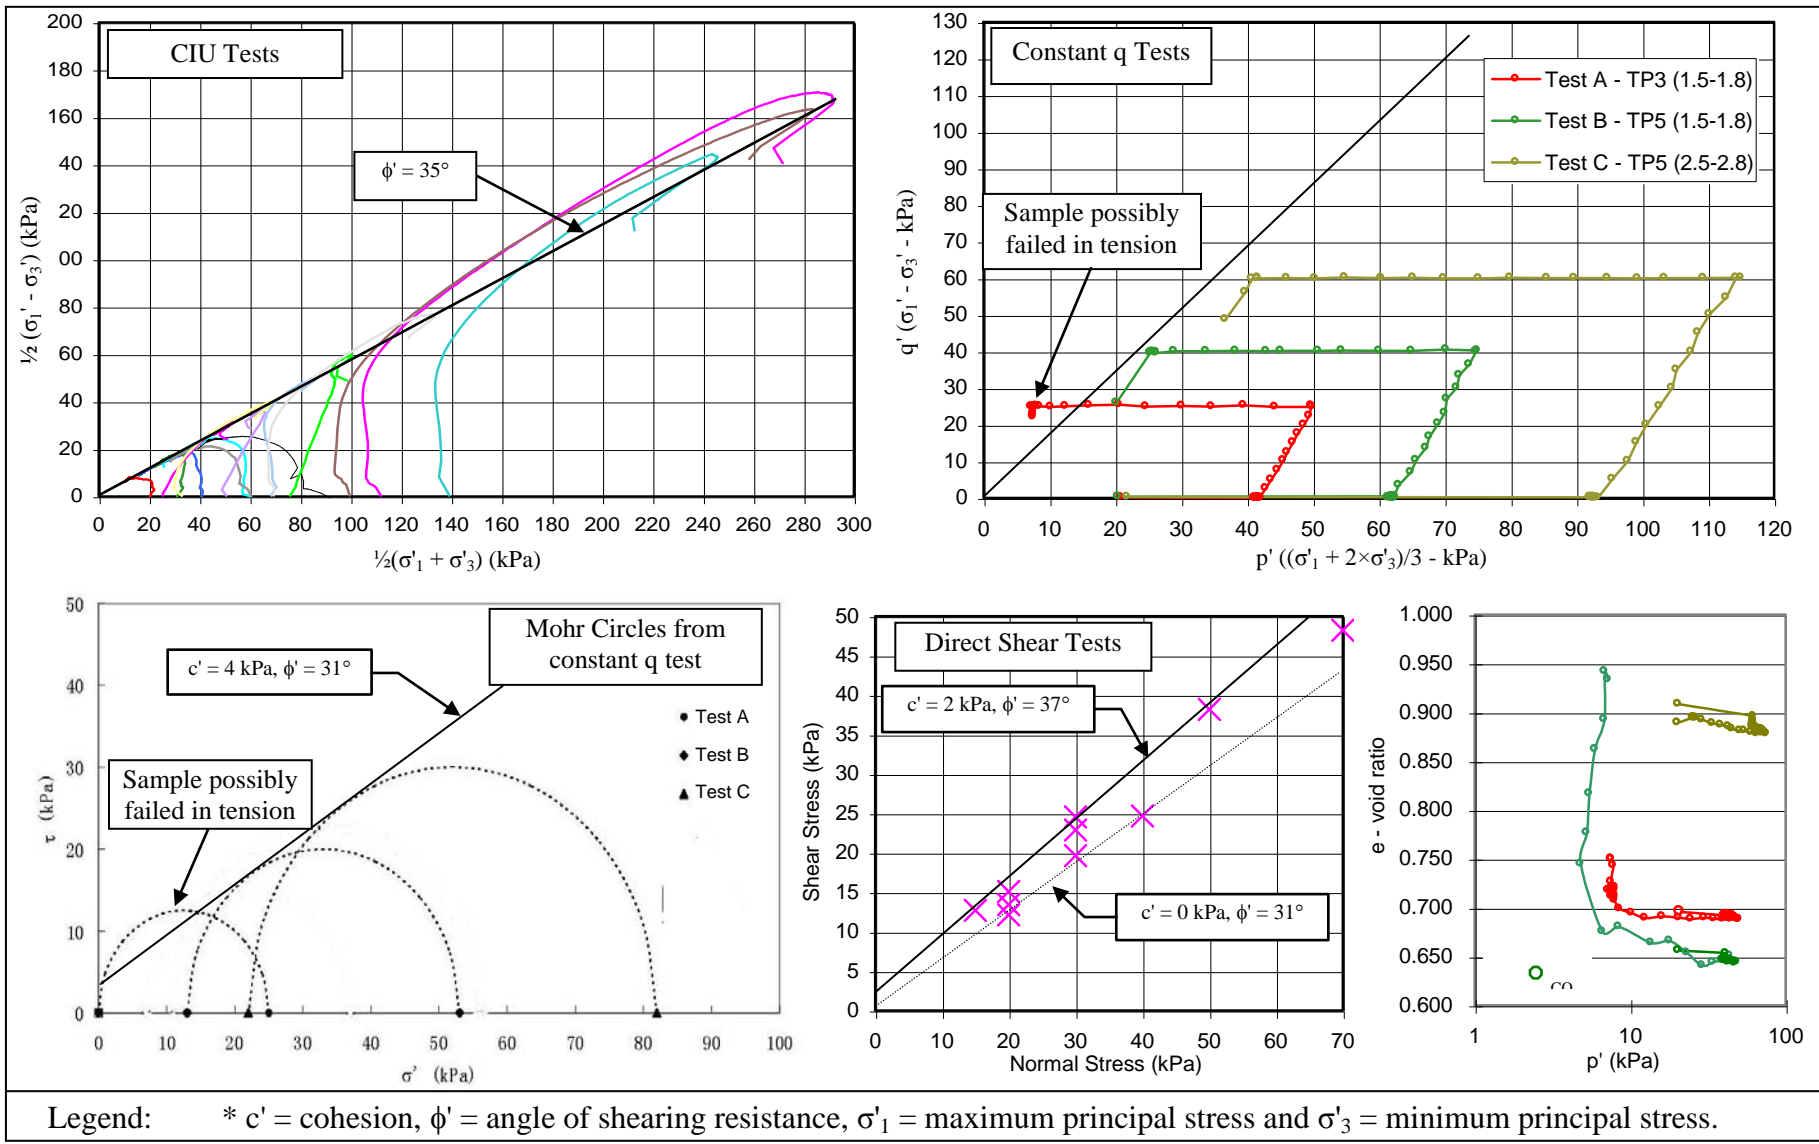
Figure 15 - Geotechnical Properties of Completely Decomposed Granodiorite (Sheet 1 of 2)

The shear strength properties of CDGd and colluvium were assessed by CIU tests and constant q tests. Direct shear box tests were also undertaken on the failure surface using specimens prepared from block samples retrieved from the trial pits. The test results are summarised in Figures 15 and 16 respectively.

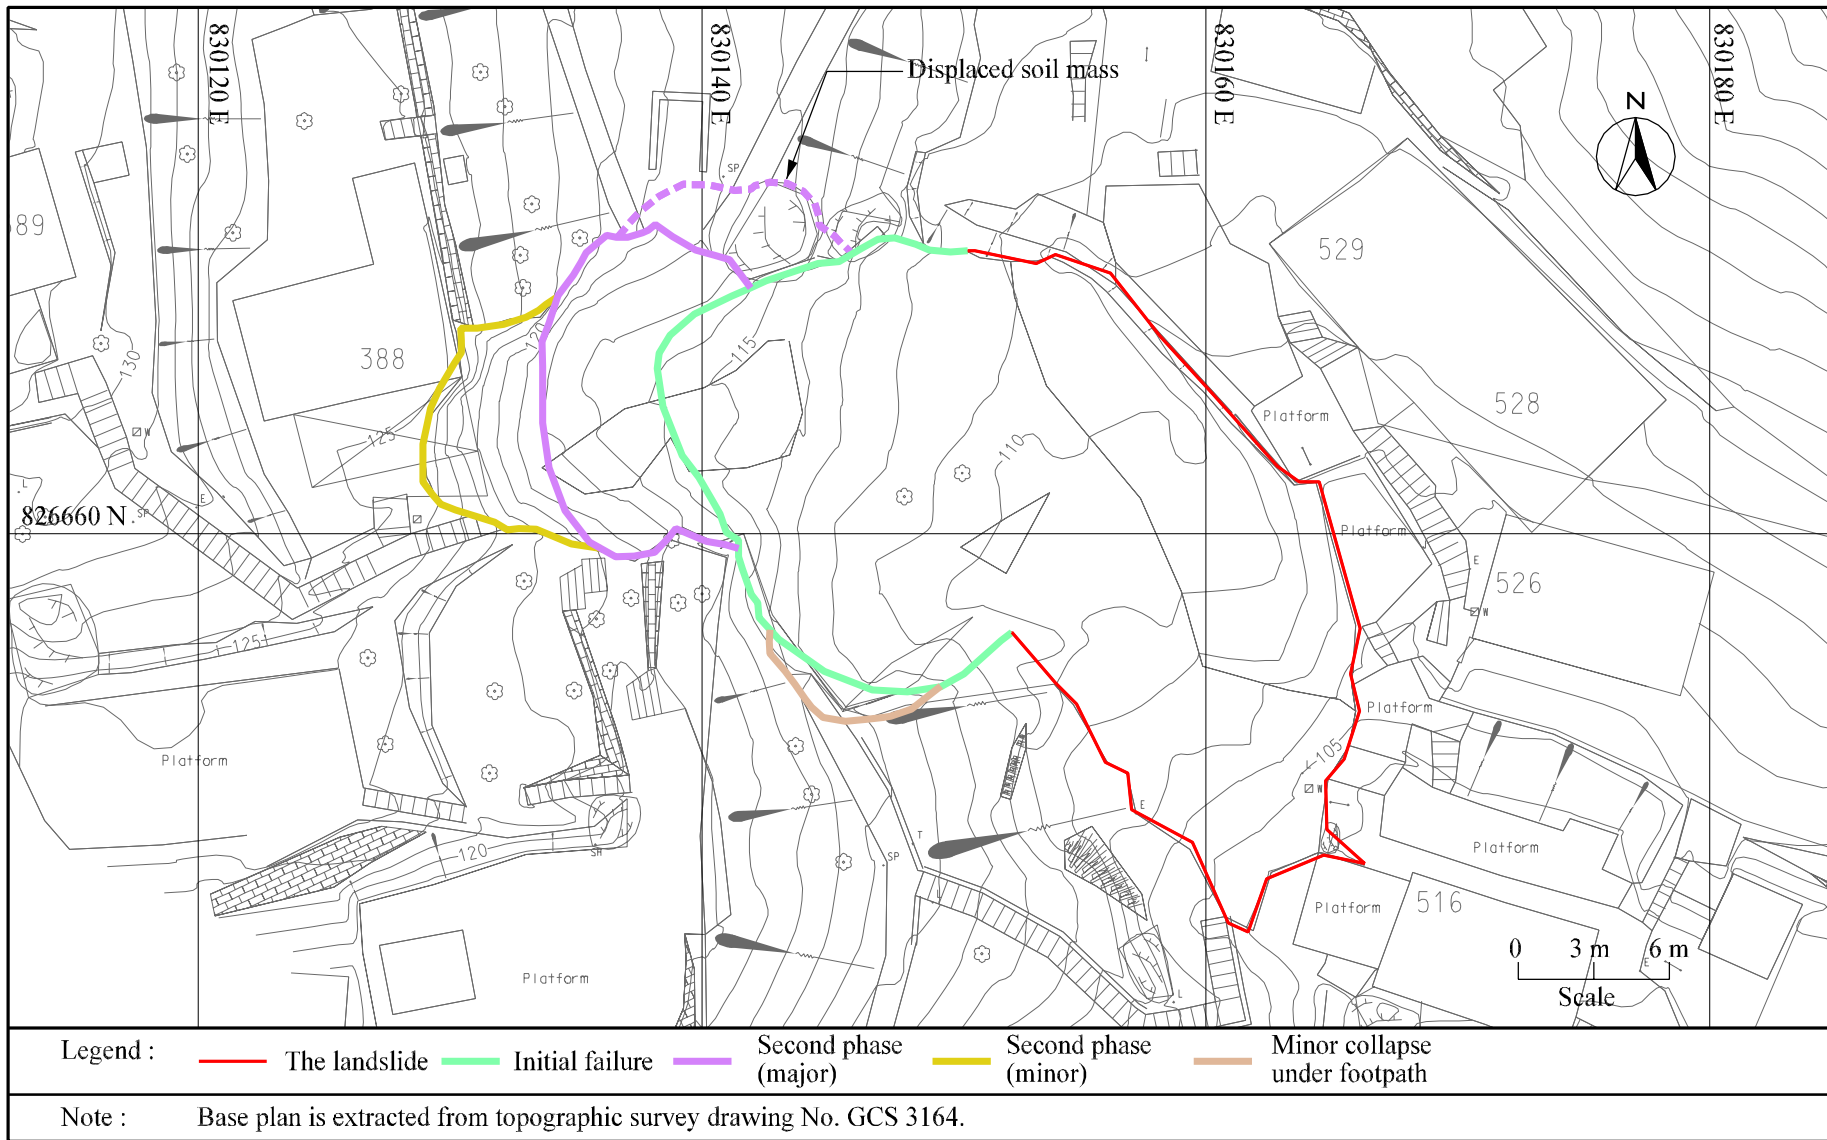
Figure 19 - Probable Sequence of Failure

A further minor detachment involved the failure and extension of the flank of the main scarp around the south side of the footpath (Figure 19), which might have been influenced by the water discharging from the broken water main.

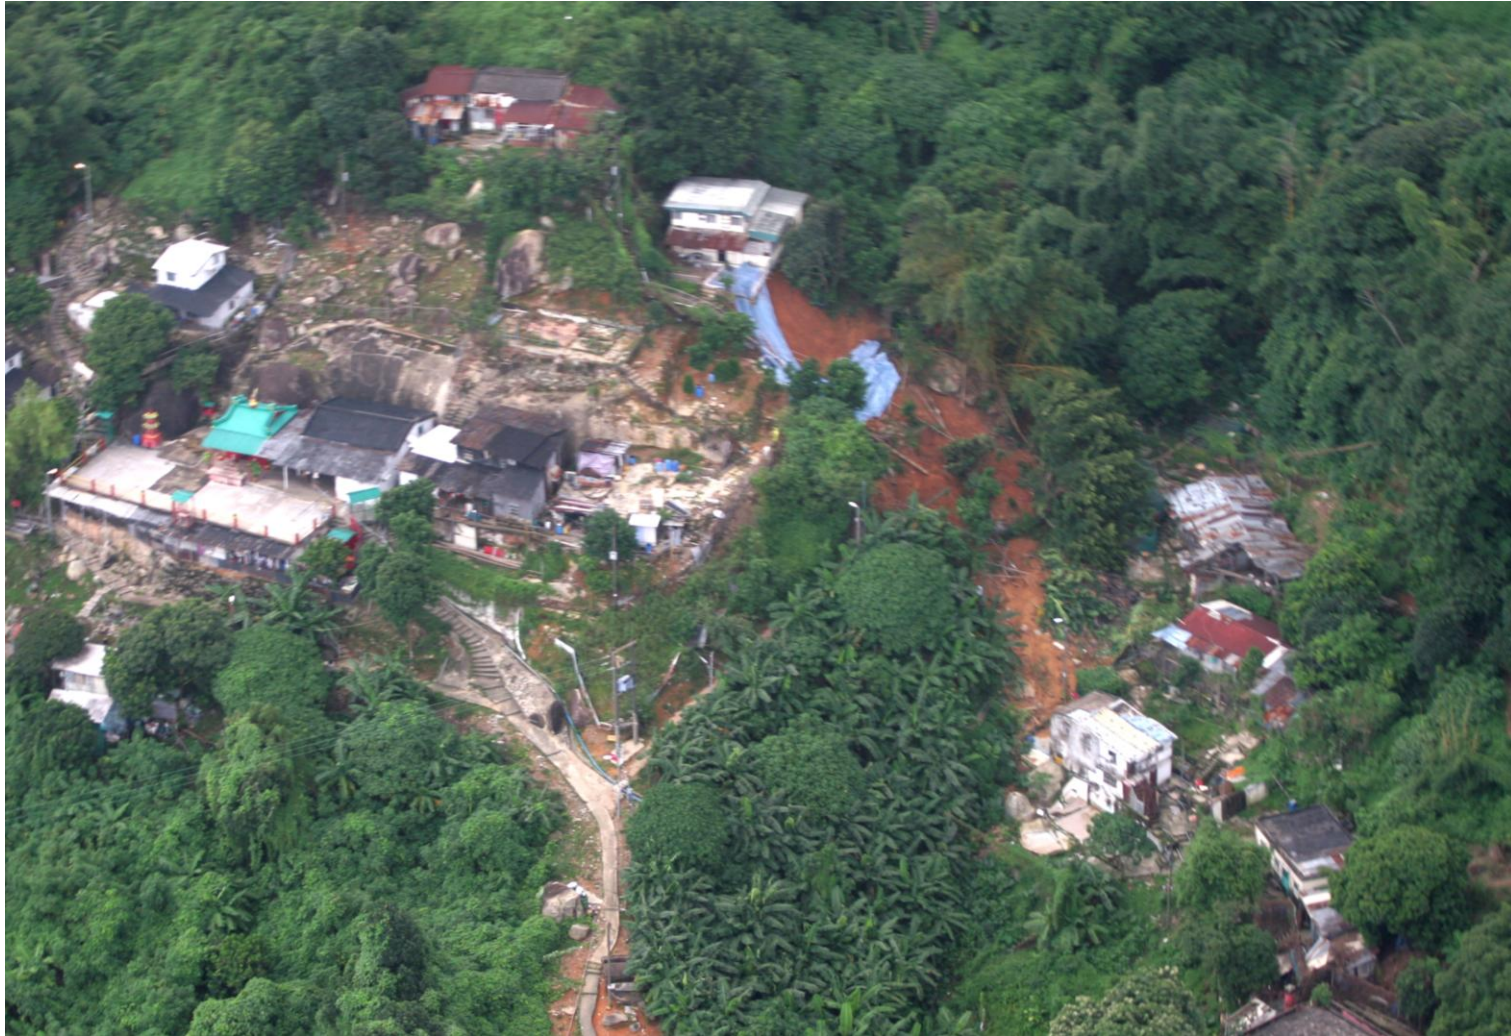
A paved platform, covered by cement screed with a few old minor cracks, and a two-storey registered squatter structure (as registered by the Housing Department (HD) under their 1982 Squatter Structure Survey) are located at the crest of the August 2005 landslide (Plate 4). The platform is supported by a 2.5 m high dry-packed random rubble wall (Figure 2 and Plate 5), which is not registered in the Government's Slope Catalogue, as the wall does not meet the registration criteria in terms of its height (i.e. < 3 m high). The registered squatter structure at the crest (with squatter control survey No. RTW/4A/388, hereinafter referred to as squatter structure No. 388) comprises steel frames, plywood walls and a corrugated sheet roof. A cut slope up to 3.5 m high and inclined at about 60° is located behind squatter structure No. 388 (Plate 6). Further above the cut is a cluster of single-storey, flimsy registered squatter structures (with squatter control survey Nos. RTW/4A/389, 391-393, hereinafter referred to as squatter structures Nos. 389, 391-393) (Plate 7). Some vacant platforms (formerly occupied by other squatter structures), which are partly paved and partly used for cultivation of fruit trees, are located above and to the southwest of the landslide site (Figure 2 and Plate 1). A number of large boulders were observed on the hillside between these platforms and squatter structures Nos. 389, 391-393 (Plate 1).

Plate 1 - Oblique Aerial View of the 20 August 2005 Landslide
(Photograph taken on 22 August 2005)

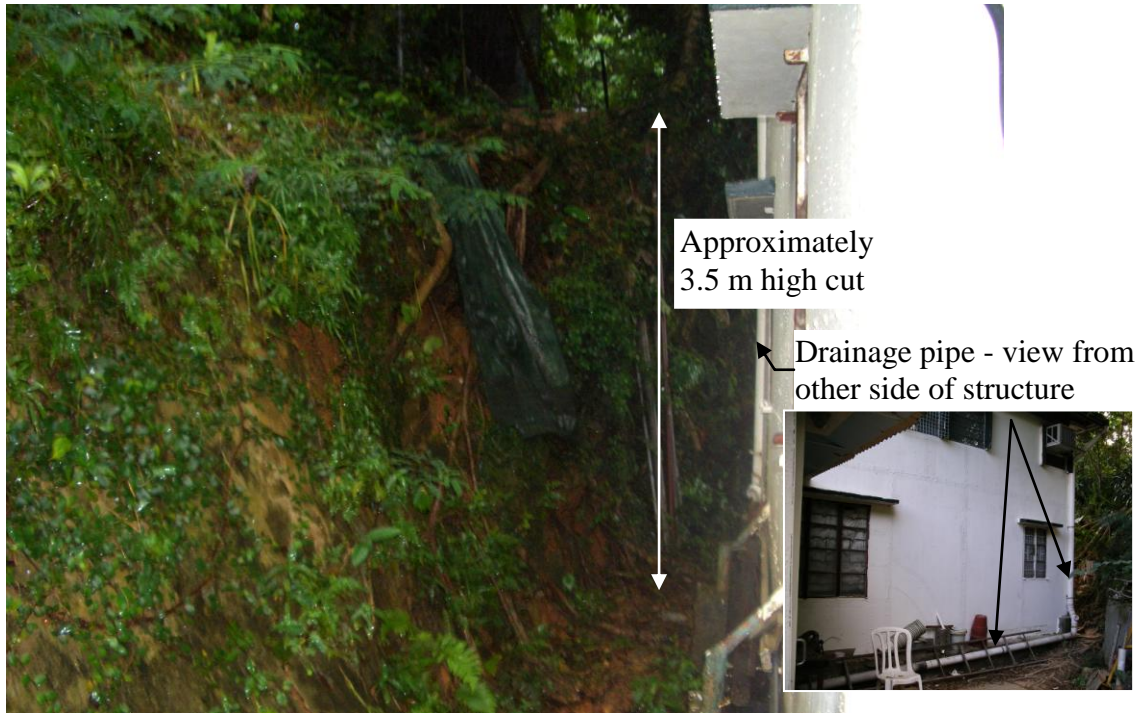
Plate 6 - Drainage Pipe and the Cut Slope behind Registered Squatter Structure No. RTW/4A/388
(Photograph taken on 21 August 2005)

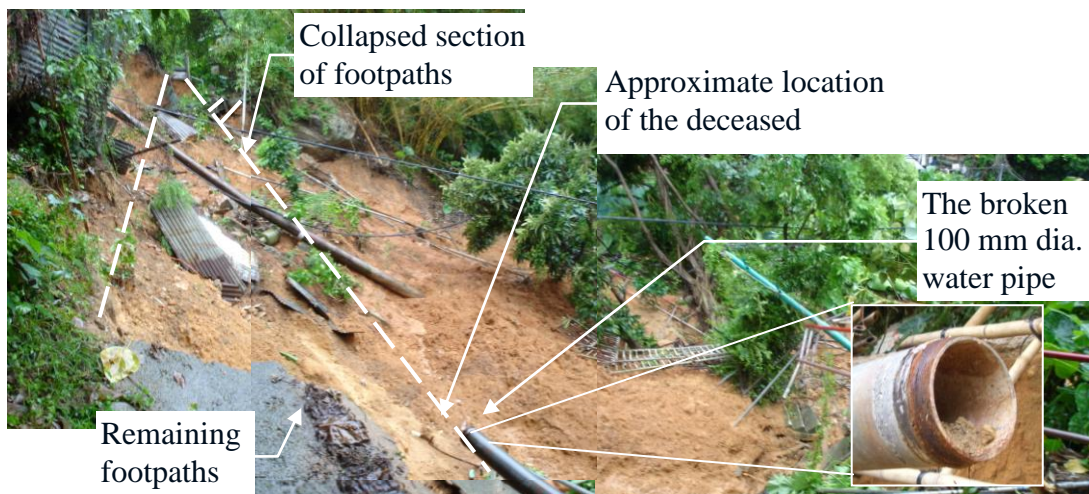
A 15 m long section of the footpath that traversed about the mid-height of the August 2005 landslide scar, and a 10 m long section of the stairway leading from the footpath to the squatter structures above collapsed during the landslide (Plate 13). The utilities in the vicinity of the landslide were damaged, including two water pipes, three electric poles, two telephone cable poles and two street lamps (with cable conduits and poles) (Plate 14). The landslide debris stopped in front of squatter structure No. 516, partly covering the streamcourse (Plate 15). Some fine debris (outwash material) was washed down the streamcourse for another 150 m but no damage was caused.

Plate 13 - The Collapsed Footpath and the Broken
100 mm Diameter Water Pipe
(Photograph taken on 21 August 2005)

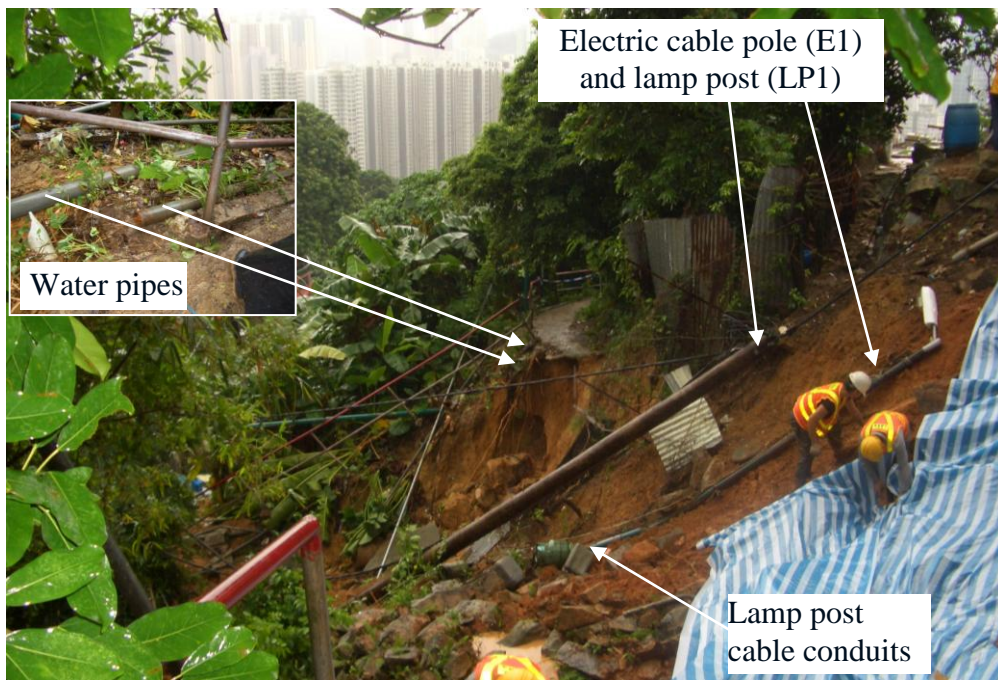
Plate 14 - View of the Damaged Utilities
(Photograph taken on 21 August 2005)

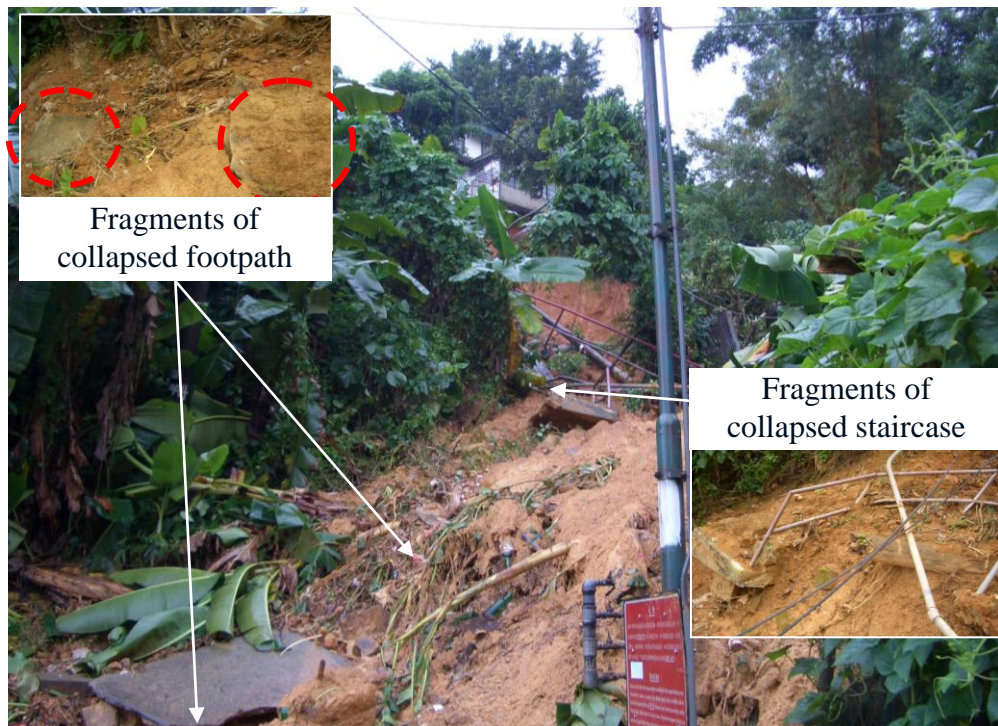
The lower part of the landslide debris trail mainly comprises reddish brown to yellowish brown sandy clay/silt, concrete fragments and handrails of the footpath and stairway, some fallen trees and damaged utilities (Plate 15). Lamp post LP2 was found to lie beneath a section of the footpath handrail, both of which were originally alongside the footpath (Plate 17). Domestic refuse (comprising decomposing organic matter and fibrous materials, plastic bags, bottles, tin cans, broken household/electrical appliances, wood, etc.) was observed to be mixed with soil debris and to have been piled up against the fence along the lower eastern part of the debris trail near the toe adjacent to the streamcourse (the area was fenced off by the residents for the purpose of cultivation) to a height of about 2.5 m (Plate 18). The domestic refuse appeared to have been pushed towards the fence by the landslide debris.

Plate 15 - View of the Lower Part of the Landslide
Debris near the Toe of the Landslide
(Photograph taken on 21 August 2005)

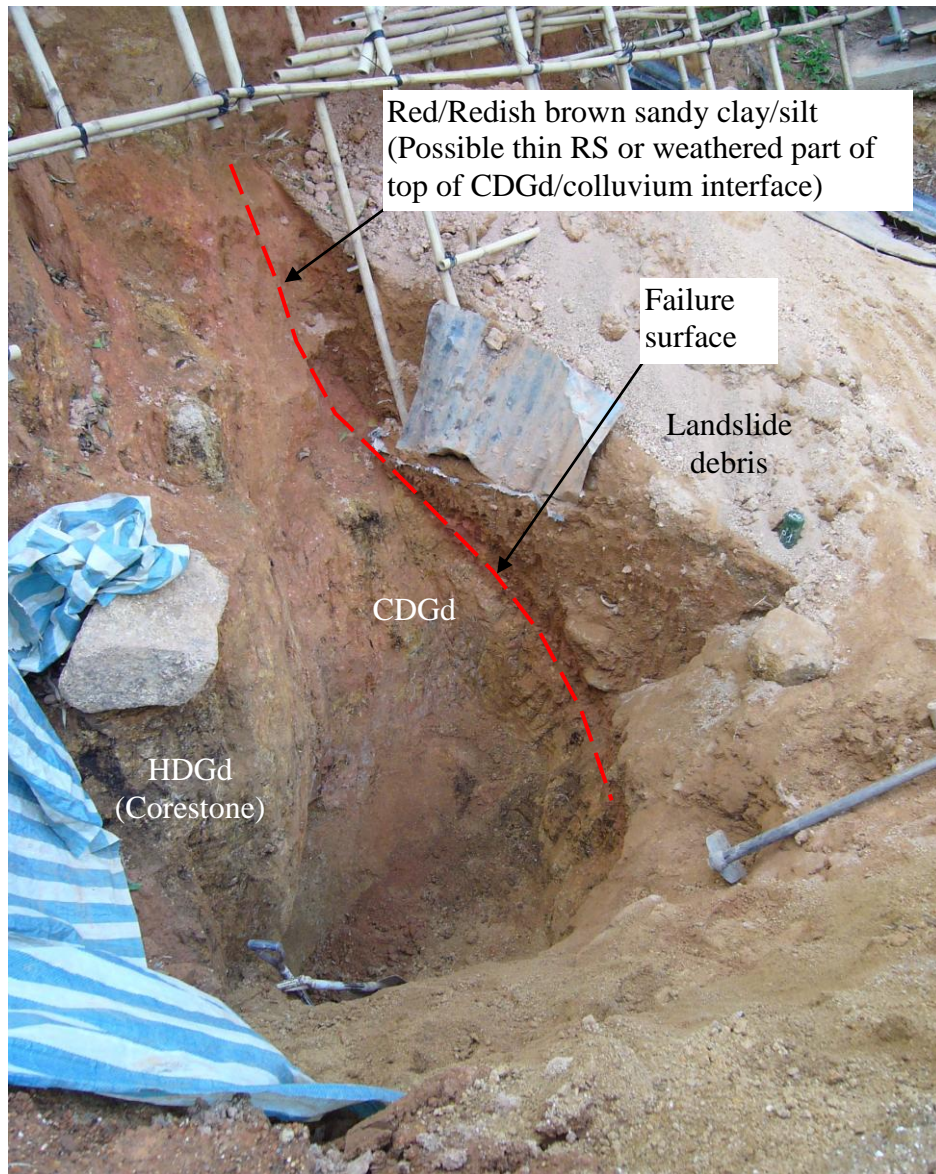
The failure surface was only exposed in the trial pits within the landslide scar (Plate 22) and typically comprised about 20 mm of grey/brown sandy silt/clay, which locally includes a narrow zone (approximately 0.5 m) of sheared and layered soil, best exposed in trial pit No. TP3 (Plate 23). The failure surface is located predominantly within CDGd. Locally, a zone of sheared/disturbed material was observed in trial pit No. TP3 to extend about 200 mm into the CDGd. The material on the failure surface was observed to be notably wet following the landslide and had a disturbed or remoulded appearance. No other evidence of relative movement, such as slickensiding, could be seen. Where there is a zone of sheared and layered soil, the failure surface was generally located near the base of the sheared zone (Plate 23).

Plate 22 - The Failure Surface Exposed in Trial Trench TT1
(Photograph taken on 22 September 2005)
