二零零五年八月二十日
芙蓉山村山泥傾瀉事件報告
山泥傾瀉調查結果
**REPORT ON THE LANDSLIDE
AT FU YUNG SHAN TSUEN
OF 20 AUGUST 2005
FINDINGS OF THE LANDSLIDE
INVESTIGATION**

土力工程處報告系列第277號
GEO REPORT No. 277

茂盛土力工程顧問有限公司
Maunsell Geotechnical Services Ltd.

**GEOTECHNICAL ENGINEERING OFFICE
CIVIL ENGINEERING AND DEVELOPMENT DEPARTMENT
THE GOVERNMENT OF THE HONG KONG
SPECIAL ADMINISTRATIVE REGION**

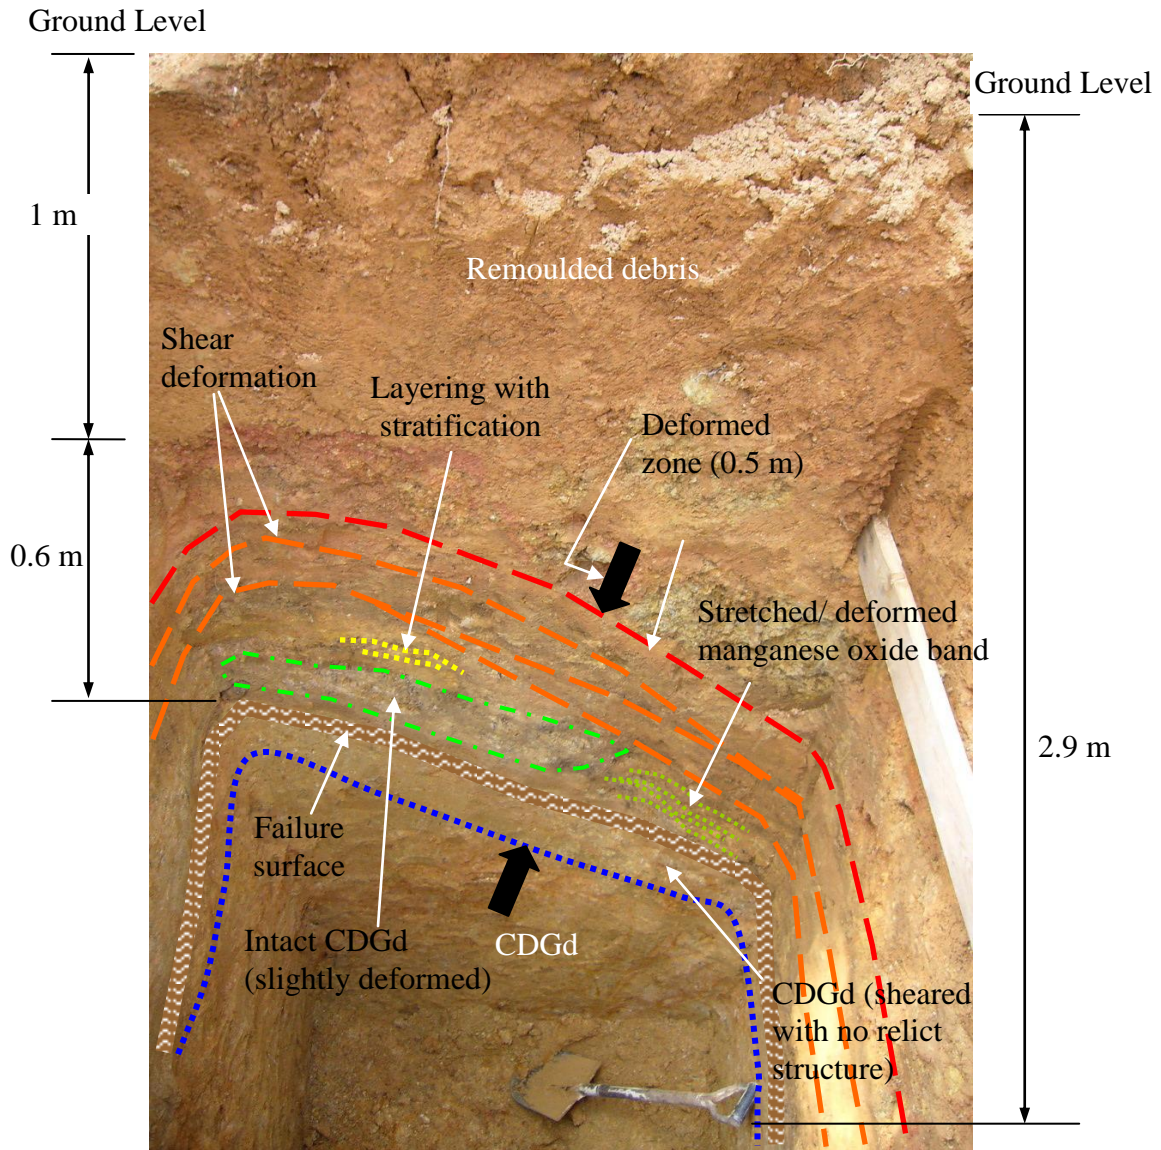
The failure surface was only exposed in the trial pits within the landslide scar (Plate 22) and typically comprised about 20 mm of grey/brown sandy silt/clay, which locally includes a narrow zone (approximately 0.5 m) of sheared and layered soil, best exposed in trial pit No. TP3 (Plate 23). The failure surface is located predominantly within CDGd. Locally, a zone of sheared/disturbed material was observed in trial pit No. TP3 to extend about 200 mm into the CDGd. The material on the failure surface was observed to be notably wet following the landslide and had a disturbed or remoulded appearance. No other evidence of relative movement, such as slickensiding, could be seen. Where there is a zone of sheared and layered soil, the failure surface was generally located near the base of the sheared zone (Plate 23).

Plate 23 - The Failure Surface and Deformed Zone
Exposed in Trial Pit TP3
(Photograph taken on 22 September 2005)

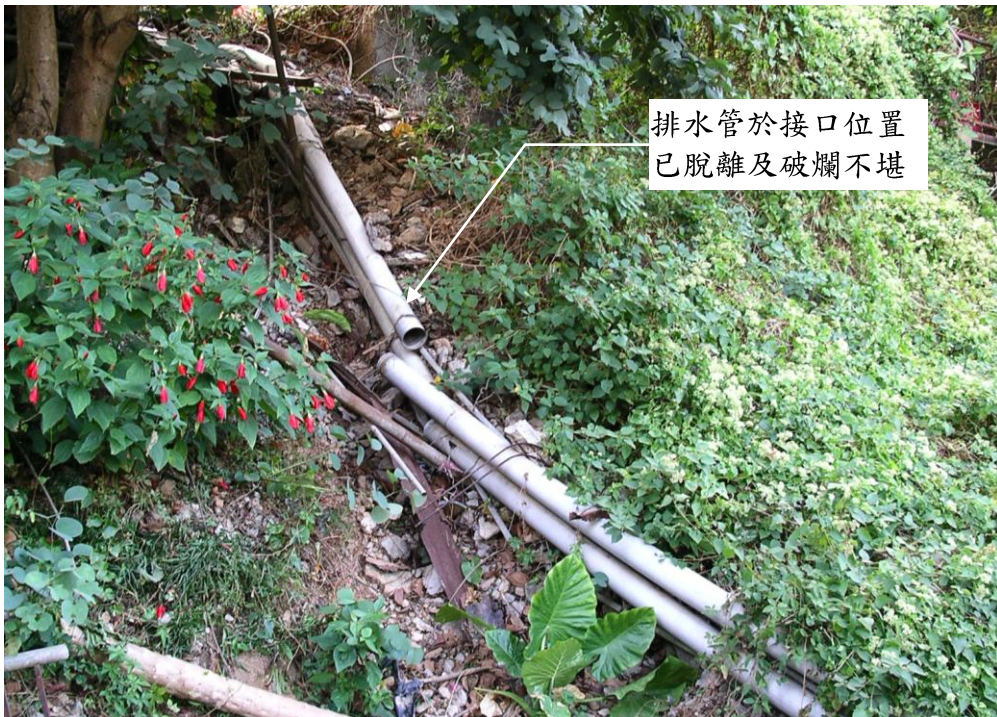
照片 11 - 伸延自登記寮屋編號RTW/4A/389, 391-393 的聚氯乙烯排水管
(照片攝於二零零五年十二月六日)

排水管於接口位置
已脫離及破爛不堪
