一九九五年八月十三日
深灣道山泥傾瀉事件報告
**REPORT ON THE
SHUM WAN ROAD LANDSLIDE
OF 13 AUGUST 1995**

土力工程處報告系列第178號
GEO REPORT No. 178

黎佐賢爵士及土力工程處
Sir John Knill & Geotechnical Engineering Office

**VOLUME 1:
INDEPENDENT REVIEW
OF THE INVESTIGATION
BY THE GEOTECHNICAL
ENGINEERING OFFICE**

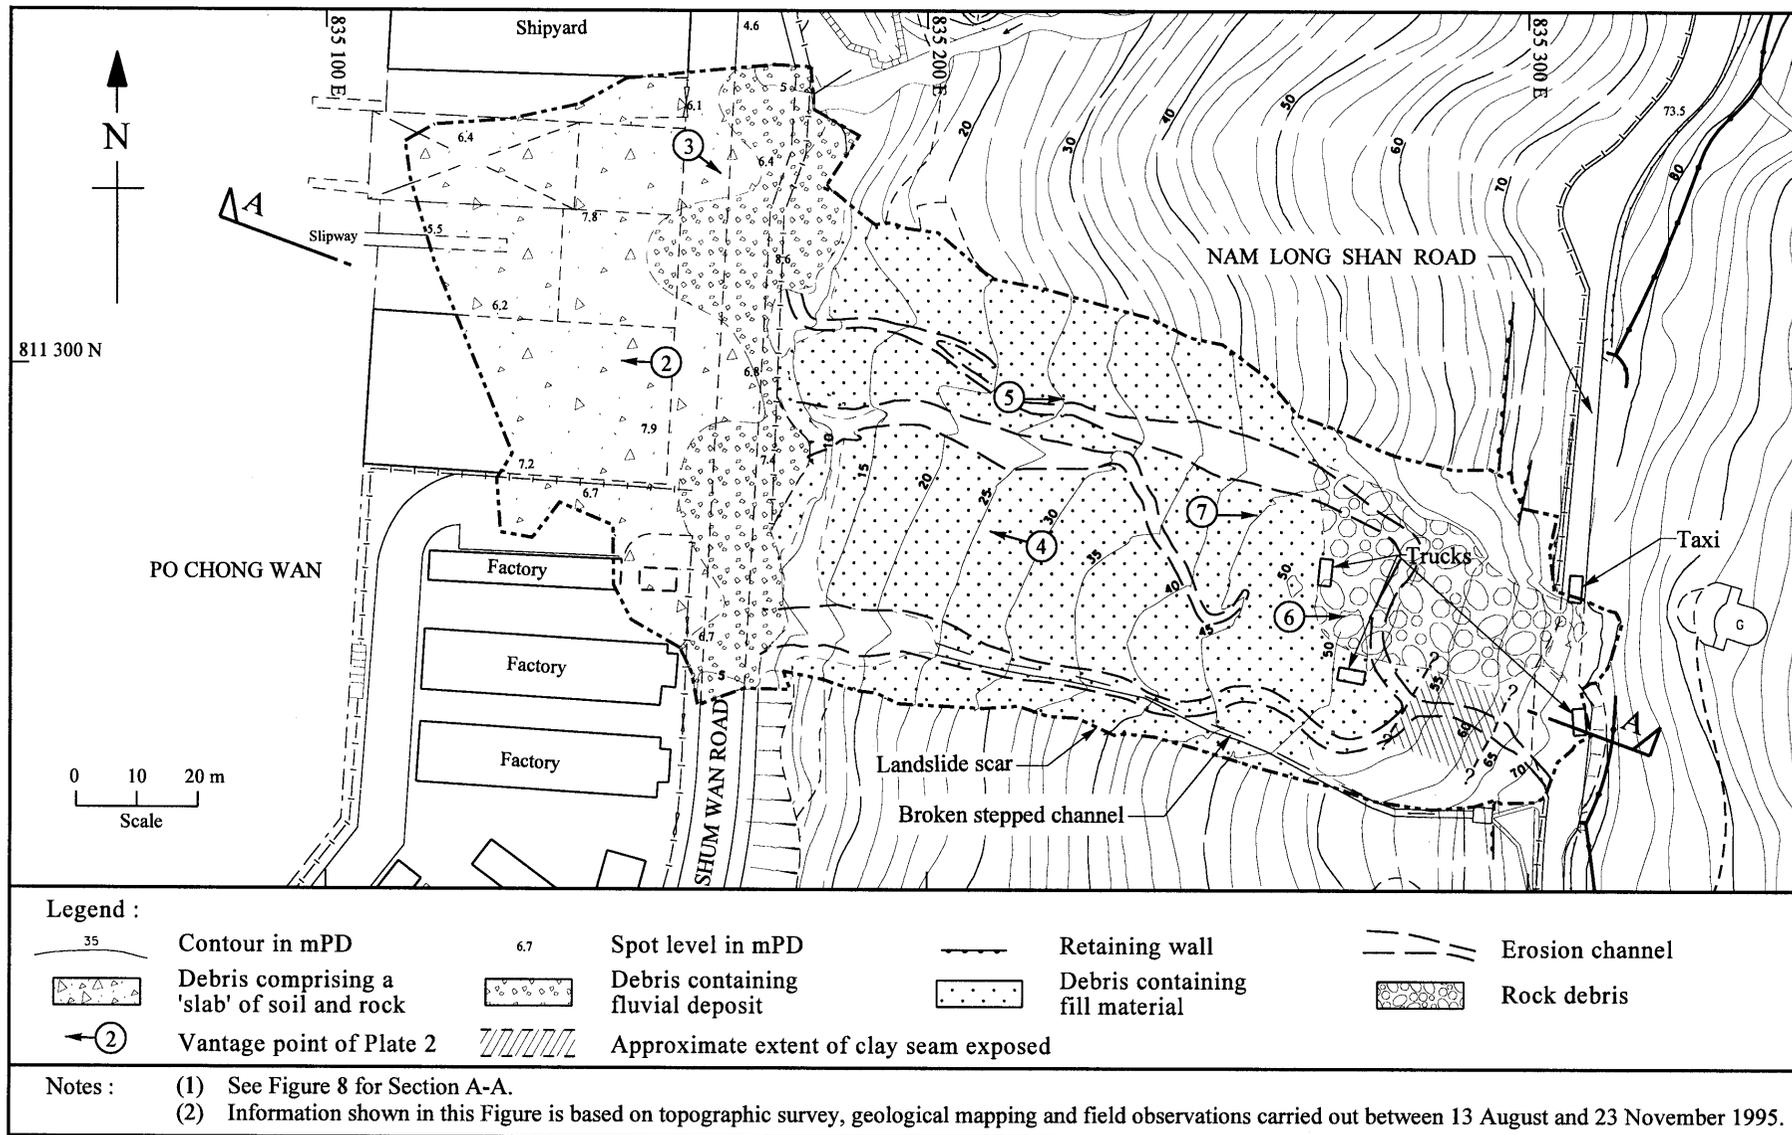
Figure 7 - Plan of the Landslide

The 1.2 m wide stepped-channel carrying water down the hillside between Nam Long Shan Road and Shum Wan Road was partly broken and buried by debris after the landslide (Figure 7). The condition of the broken portion of the stepped-channel before the landslide cannot be ascertained. However, a witness who walked part way up the stepped-channel one week before the landslide did not see any blockage of the channel. Some 20 m portion of the stepped-channel adjacent to the concave scar remained intact and clear after the landslide.

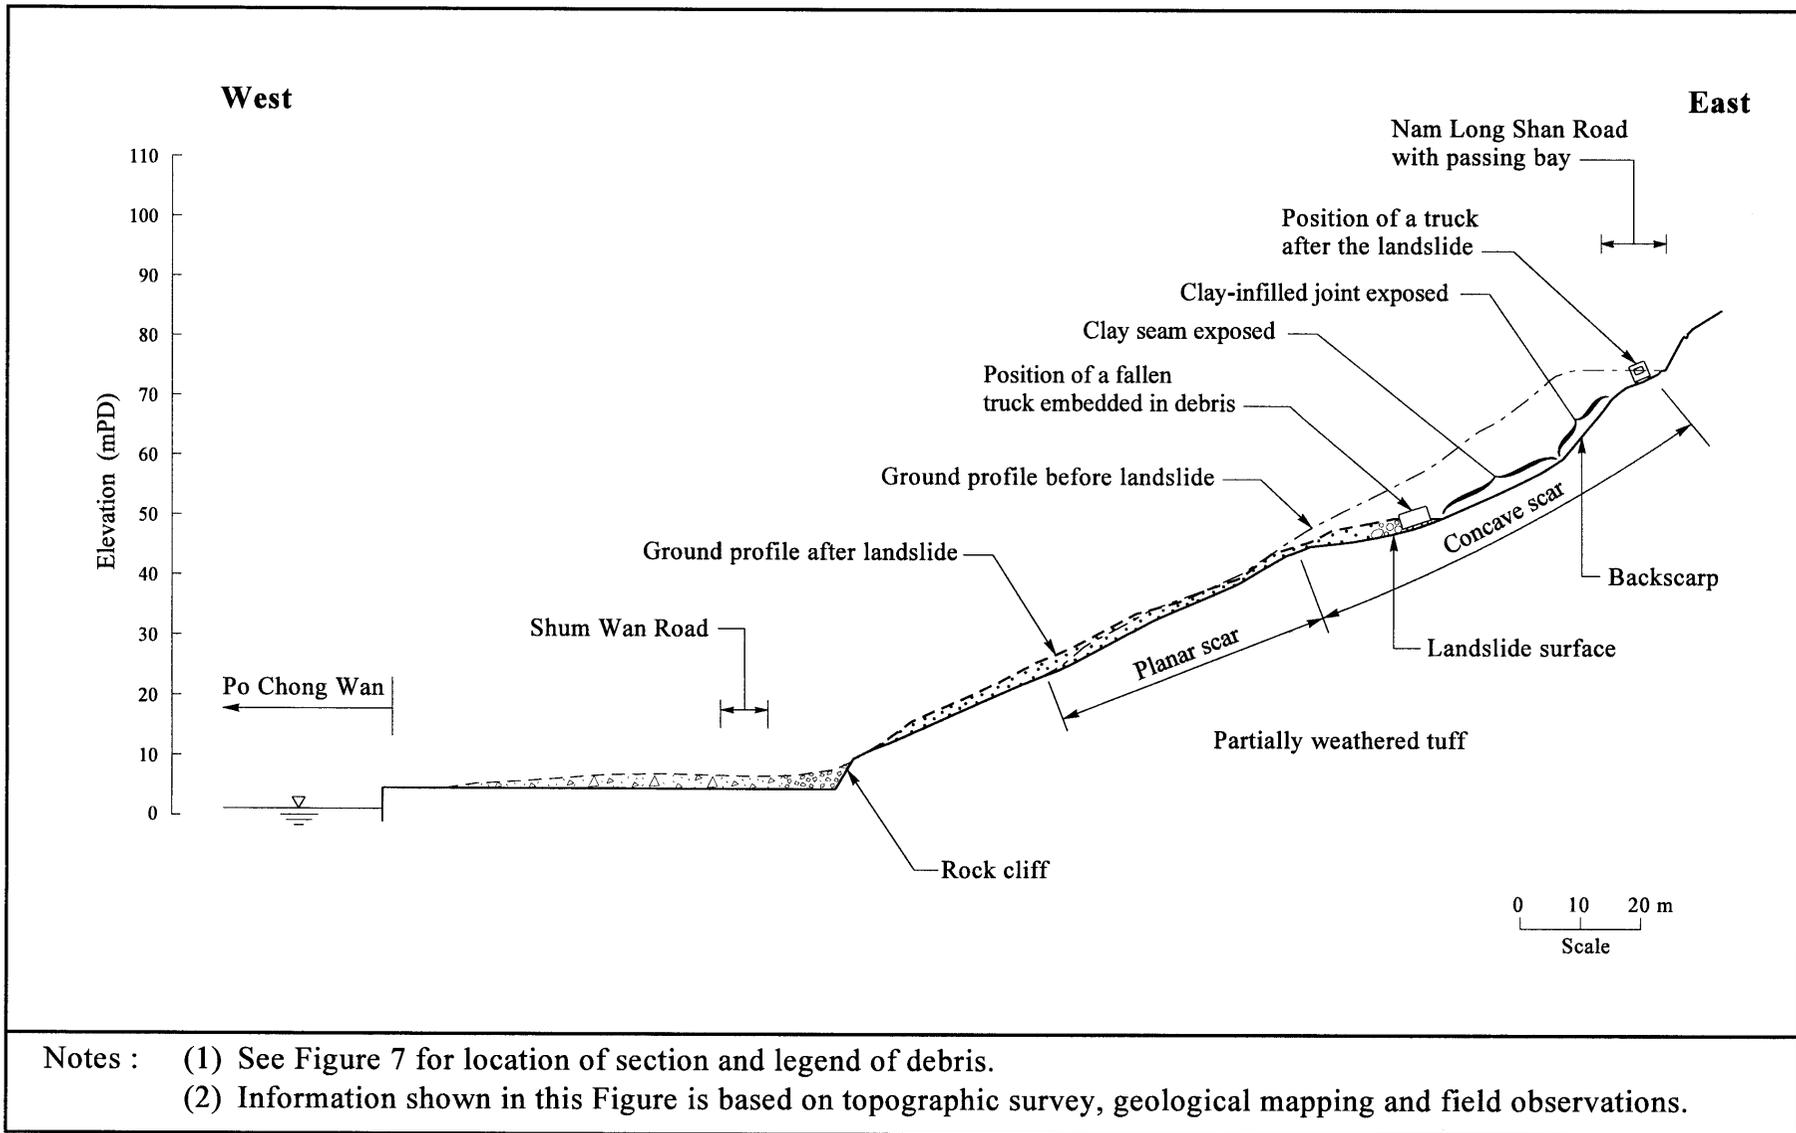
Figure 8 - Section A-A through the Landslide

The landslide resulted in a 70 m high scar, with a width varying from about 50 m just below Nam Long Shan Road to about 90 m above Shum Wan Road. The upper part of the landslide surface (Figure 8) was concave in shape and was up to about 12 m in depth below the pre-failure ground surface. The lower part of the landslide surface was planar and was 2 to 3 m below the pre-failure ground surface.

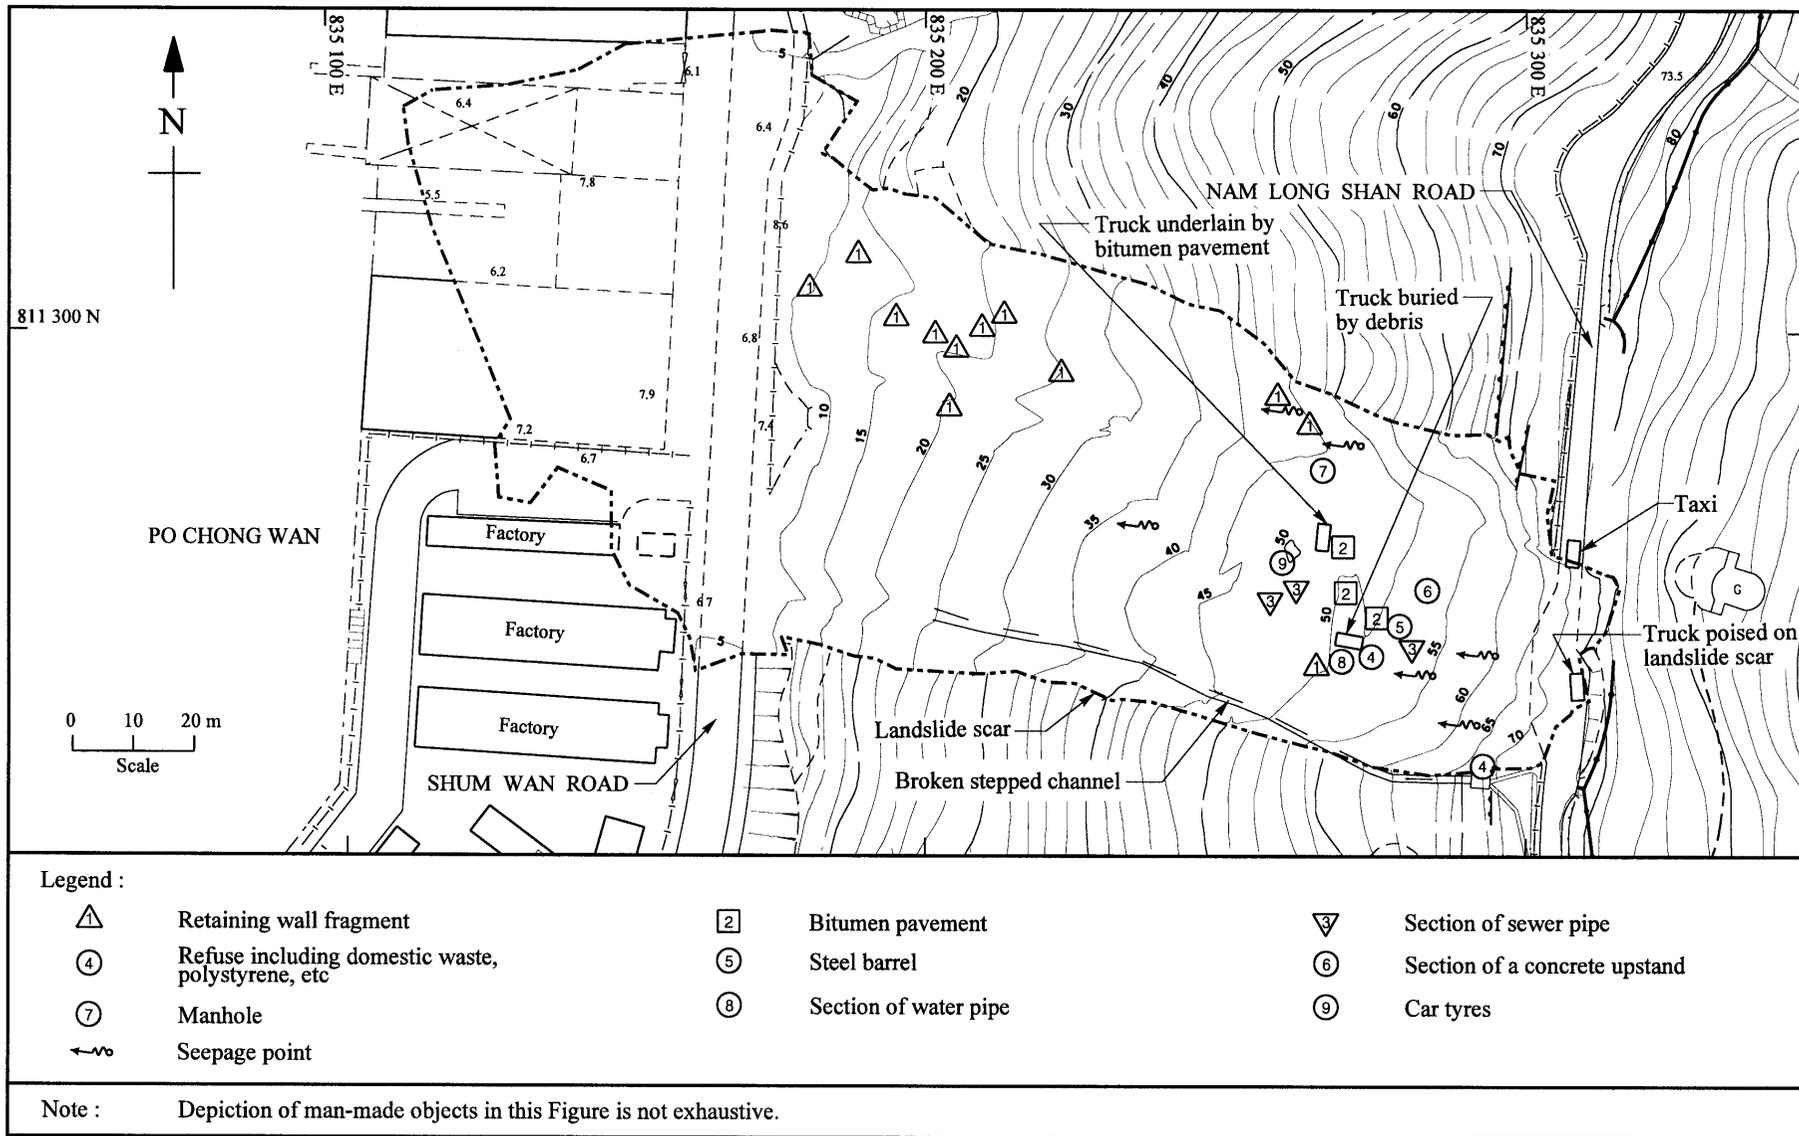
Figure 9 - Locations of Man-made Objects and Seepage Points

During the investigation of the landslide, persistent water seepage from the ground was observed at a number of points on the landslide scar (Figures 9 & 11). The elevations of the seepage points at mid-height of the failed hillside (35 to 50 m above Principal Datum) are compatible with the groundwater levels recorded in boreholes nearby and are considered to be a surface expression of the base groundwater level. The groundwater levels at these locations are about 1 to 3 m below the pre-failure ground surface.

The segregation of concrete retaining wall fragments in the landslide debris from other man-made objects from Nam Long Shan Road, including the fallen trucks and pieces of bituminous pavement and sewer (Figure 9), is best explained by a minor failure of the fill embankment below the passing bay before the main landslide (Figure 13(a)). The minor failure could either have been a shallow slip in the fill or erosion of the fill surface. Although signs of such erosion can be seen on the surface of the fill embankment in aerial photographs taken in 1988 and 1991, a shallow slip might also have been possible. However, sufficient evidence could not be found to establish the nature of the failure. The intense rainfall from 11 p.m. on 12 August to 3 a.m. on 13 August triggered this first failure.

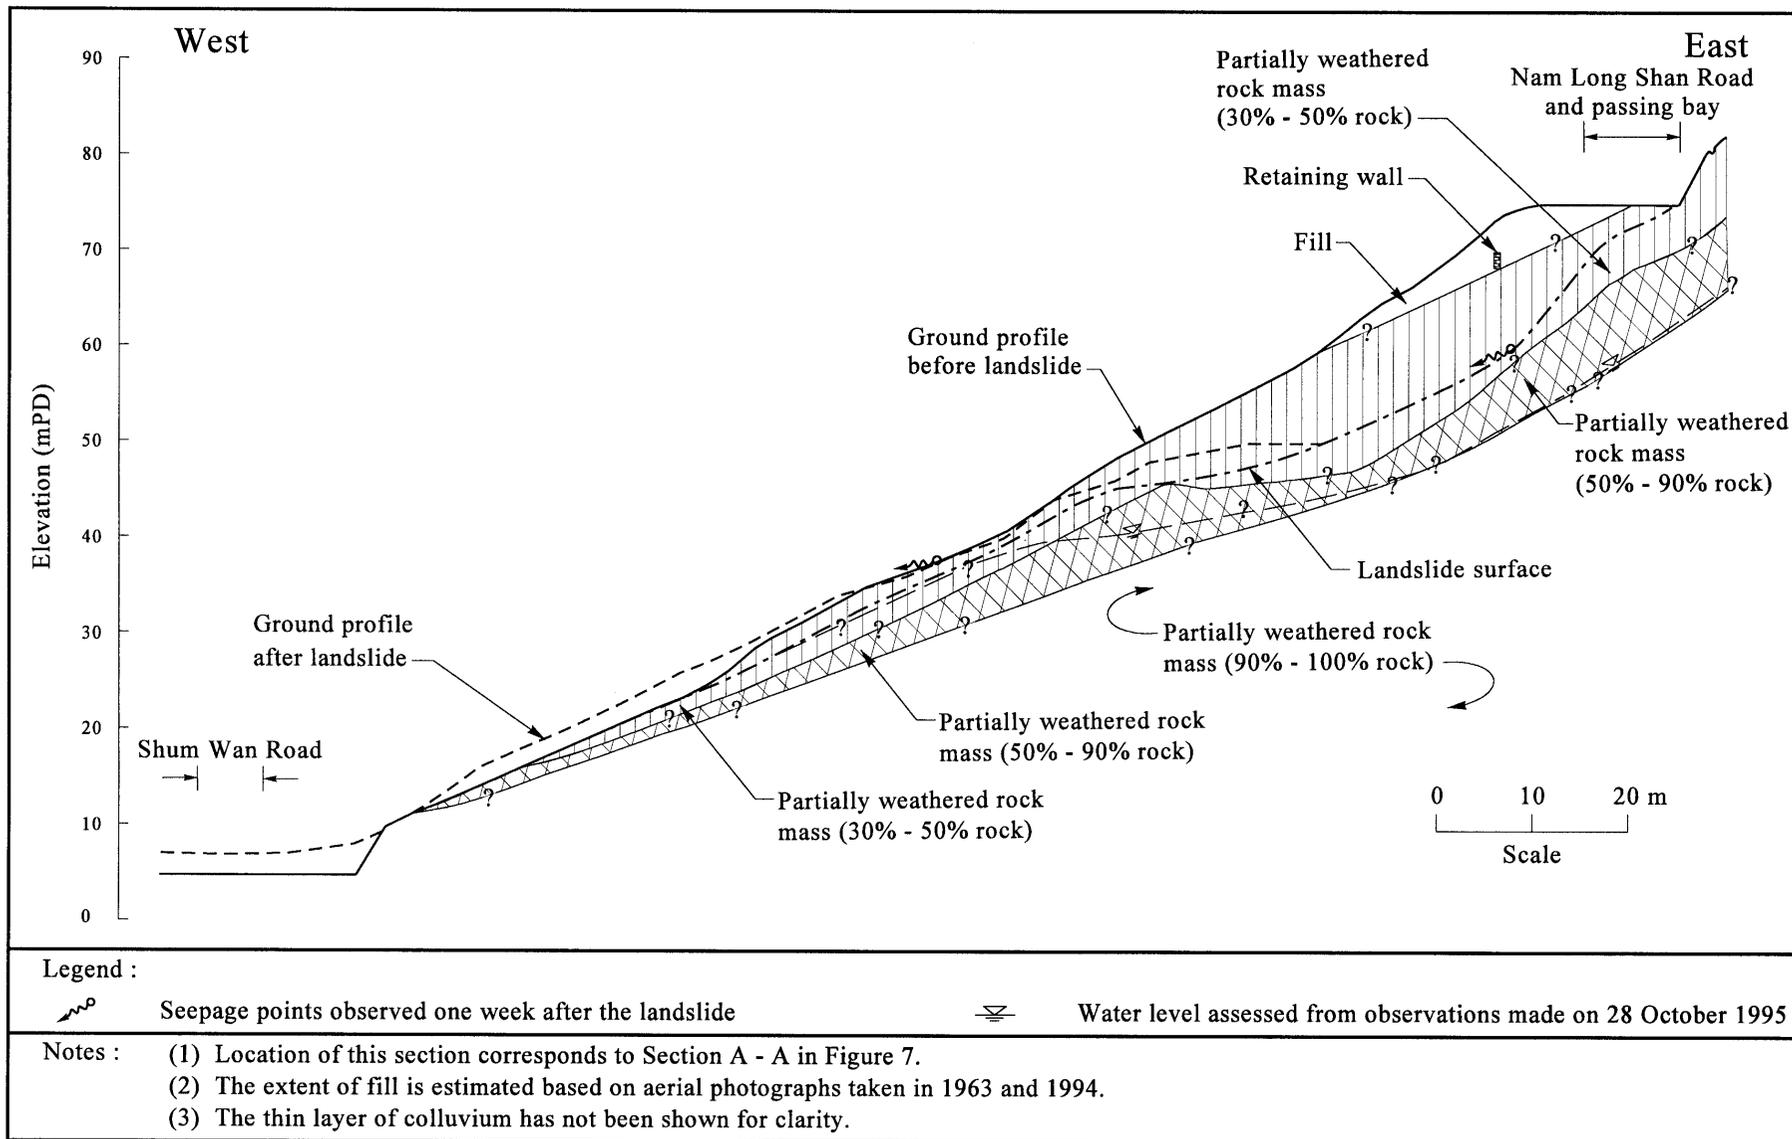
Figure 11 - Geological Section of the Site before the Landslide

The ground investigation also showed that the base groundwater level within the concave scar was about 5 m below the landslide surface. However, seepage was observed from the ground in the concave scar just above the exposed clay seam (Figures 9 & 11). This seepage persisted for about one week after the landslide and reappeared after subsequent rainstorms. This suggests the presence of a transient perched water condition.

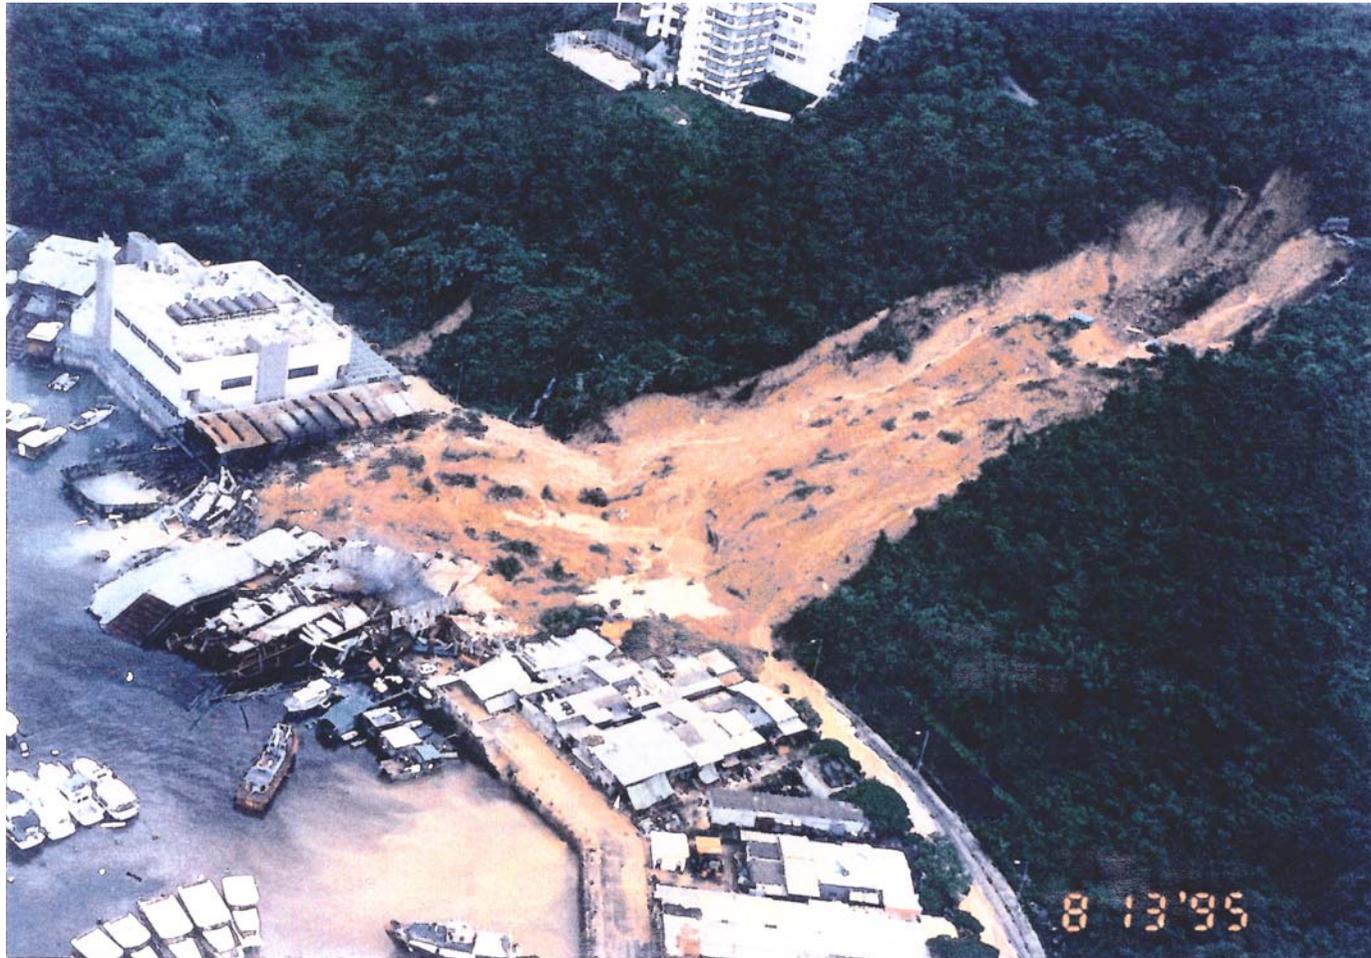
Plate 1 - The Landslide on 13 August 1995

At about 4:00 a.m. on 13 August 1995, a landslide took place at the hillside above Shum Wan Road, Aberdeen (Plate 1 & Figure 1), causing the collapse of a 30 m long section of Nam Long Shan Road. The landslide debris crossed Shum Wan Road and damaged three shipyards and a factory near the seafront. The landslide resulted in two fatalities, and five other people were injured.

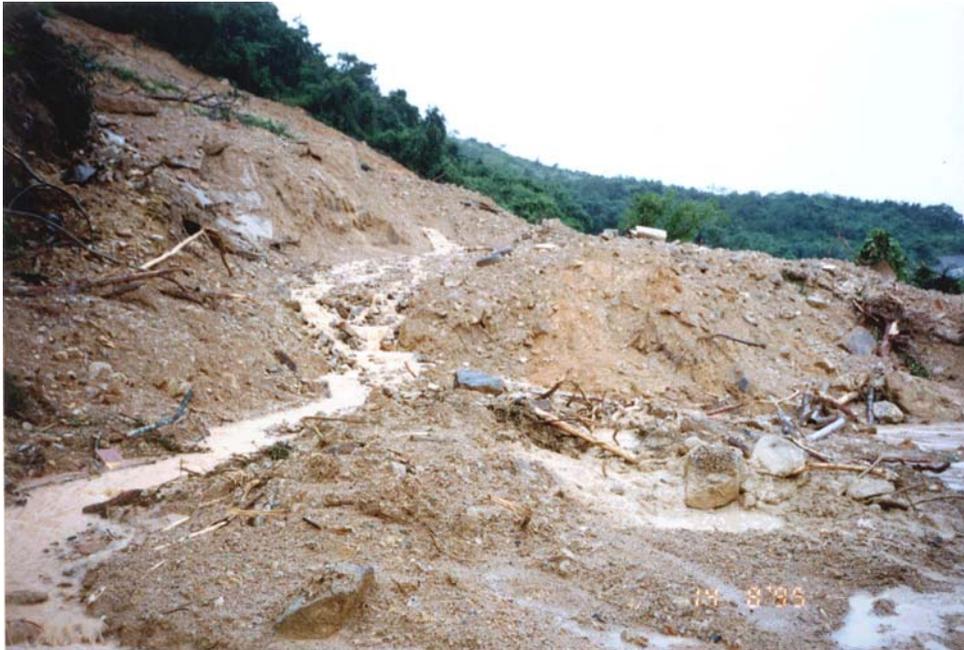
Plate 3 - Deposits at the Toe of the Failed Hillside

The debris in the space between the 'slab' debris and the hillside comprised mainly a very soft or loose fluvial deposit of clay, silt, sand, gravel and some cobbles and boulders (Plate 3). The debris was generally about 2 m thick.

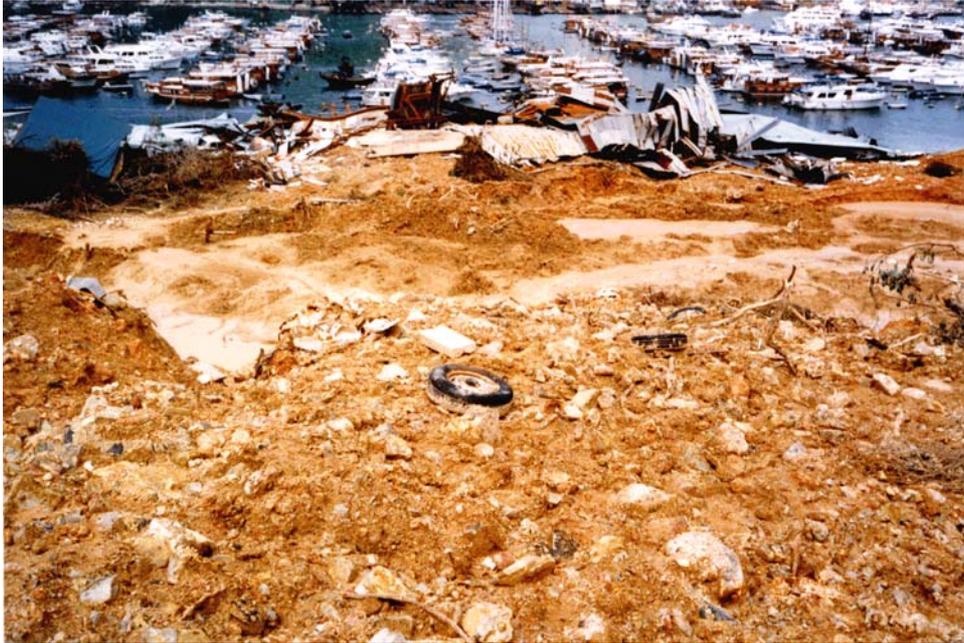
Plate 4 - Debris with Fill Material and Refuse on Landslide Scar

The planar part of the landslide surface was generally covered by soil debris up to about 3 m thick. The soil debris was up to about 5 m thick within the concave scar. The debris included fill material and refuse, such as bottles, polystyrene, car tyres and construction waste (Plate 4). Other man-made objects, including concrete retaining wall fragments, broken pieces of bituminous pavement, sections of 225 mm diameter earthenware pipes, 100 mm diameter galvanised iron water pipes and concrete slabs, were also found (Figure 9). It was noted that most of the concrete retaining wall fragments (Plate 5) were deposited in the lower planar scar, whereas the pieces of bituminous pavement (Plate 6) were all within the upper concave scar.
