一九九五年八月十三日
柴灣翡翠道山泥傾瀉事件報告
**REPORT ON THE
FEI TSUI ROAD LANDSLIDE
OF 13 AUGUST 1995**

土力工程處報告系列第188號
GEO REPORT No. 188

黎佐賢爵士及土力工程處
Sir John Knill & Geotechnical Engineering Office

**VOLUME 1:
INDEPENDENT REVIEW
OF THE INVESTIGATION
BY THE GEOTECHNICAL
ENGINEERING OFFICE**

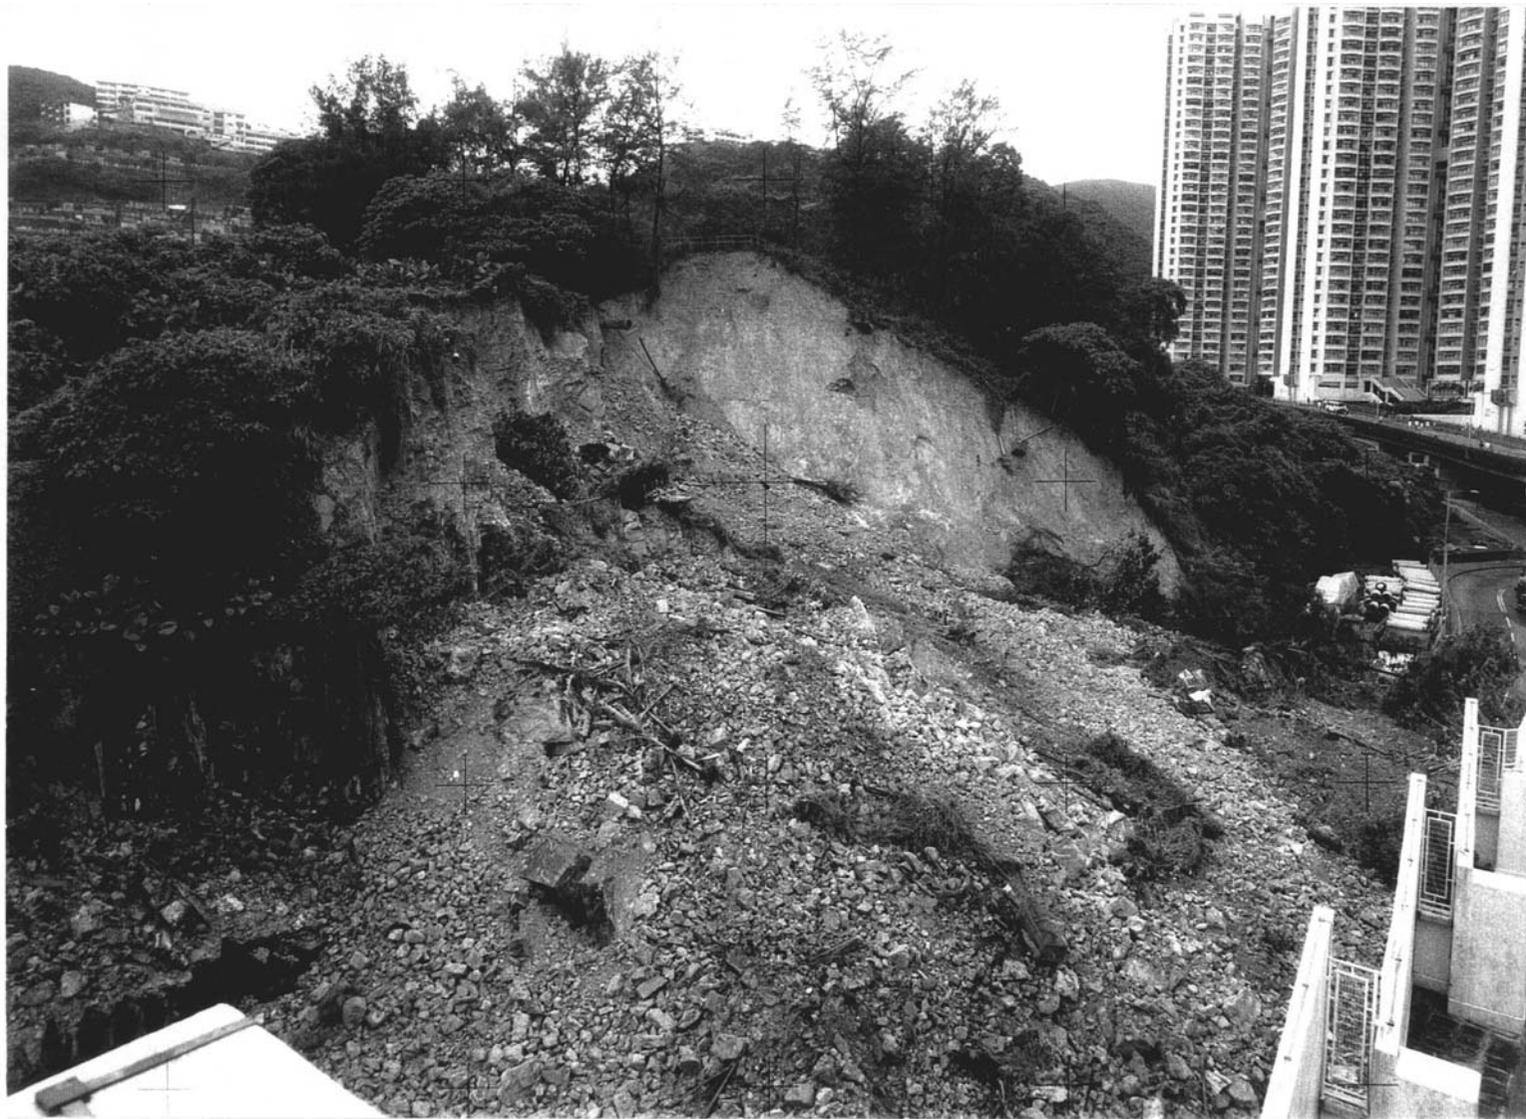
A truncated 24-inch diameter underground salt water main was exposed near the crest of the landslide scar (Plate 1 & Figure 2). Another truncated underground water main, which is 6 inches in diameter, was also exposed near the crest of the back scarp at about 4 m to the east of the truncated 24-inch water main (Figure 5). Witnesses observed that water was discharging from the 24-inch water main onto the landslide area on the morning of 13 August after the failure. The witnesses interviewed by the GEO, however, did not report having noticed the presence of the truncated 6-inch water main.

Plate 1 - Photograph of the Landslide Taken in the Morning of 13 August 1995 (See Figure 21 for Location)

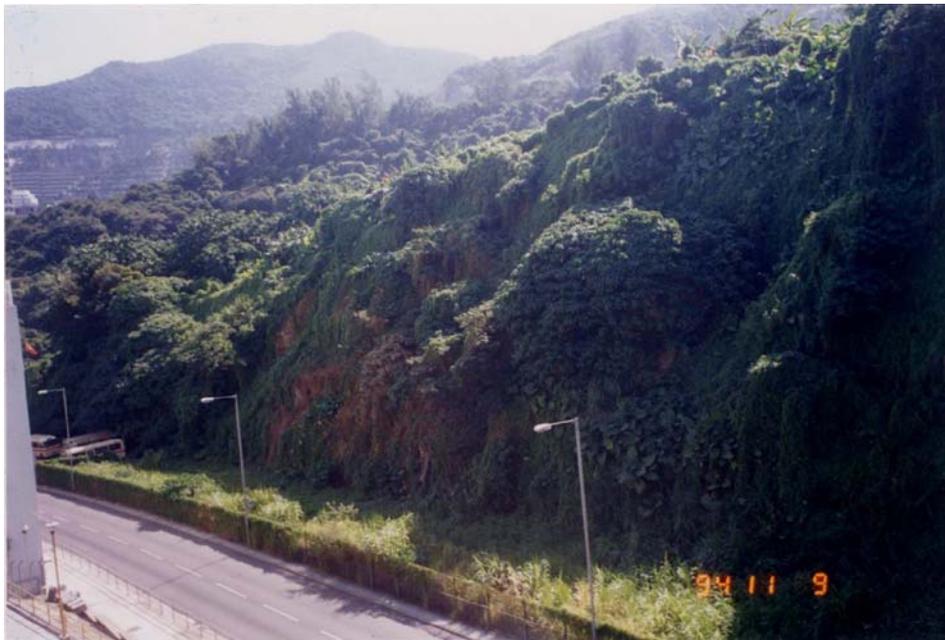
Government to prepare the Catalogue of Slopes in 1977. Before the landslide, the cut slope inclined towards the north at an average angle of about 60° to the horizontal, with a maximum height of about 27 m. Rock was exposed at the lower part of the cut slope, and the upper portion was covered with chunam. A photograph of the cut slope taken after its formation in mid-1970s, which shows the condition of the rock face and the chunamed slope surface at the time, is shown in Plate 2. Photographs of the site taken in 1994 show that the cut face was covered extensively by unplanned vegetation (Plate 3).

Plate 3 - Photograph of Cut Slope No. 11SE-D/C42 Taken on 9 November 1994
(See Figure 21 for Location)

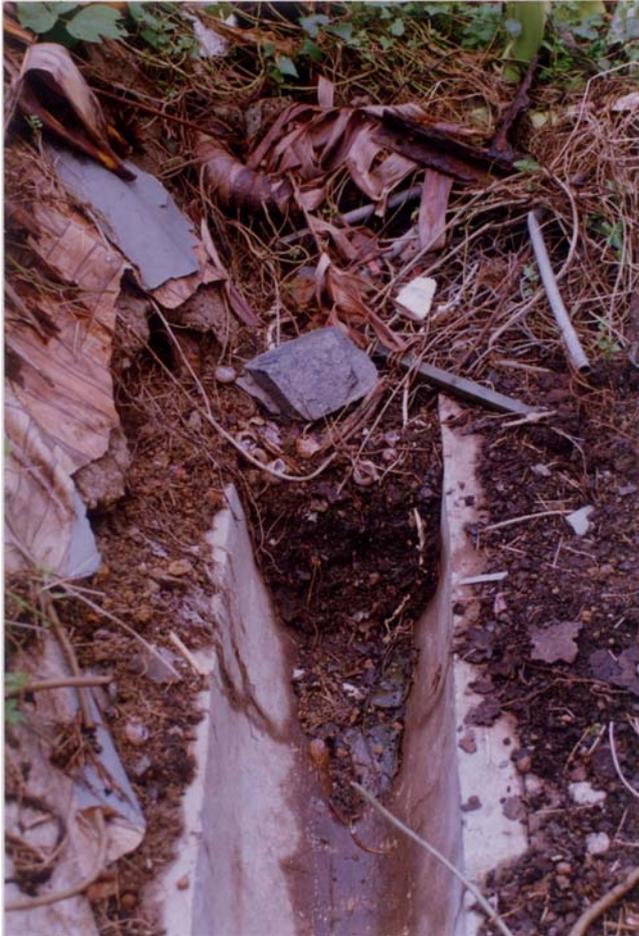
The probable layout of the surface drainage system of the site, as interpreted from the available documentary records and site observations after the landslide, is shown in Figure 3. It was found from inspections after the landslide that the surface drainage channels on the unfailed section of the cut slope to the east of the landslide were blocked by humus and black-stained silty soil (Plate 4). The crest channel on the cut slope to the west of the landslide was partly filled with fallen leaves and silty soil, to a depth of about 20 mm.

Plate 4 - Blocked Surface
Drainage Channel on
the Unfailed Section
of the Cut Slope
(Photograph Taken on
10 October 1995. See
Figure 21 for Location)

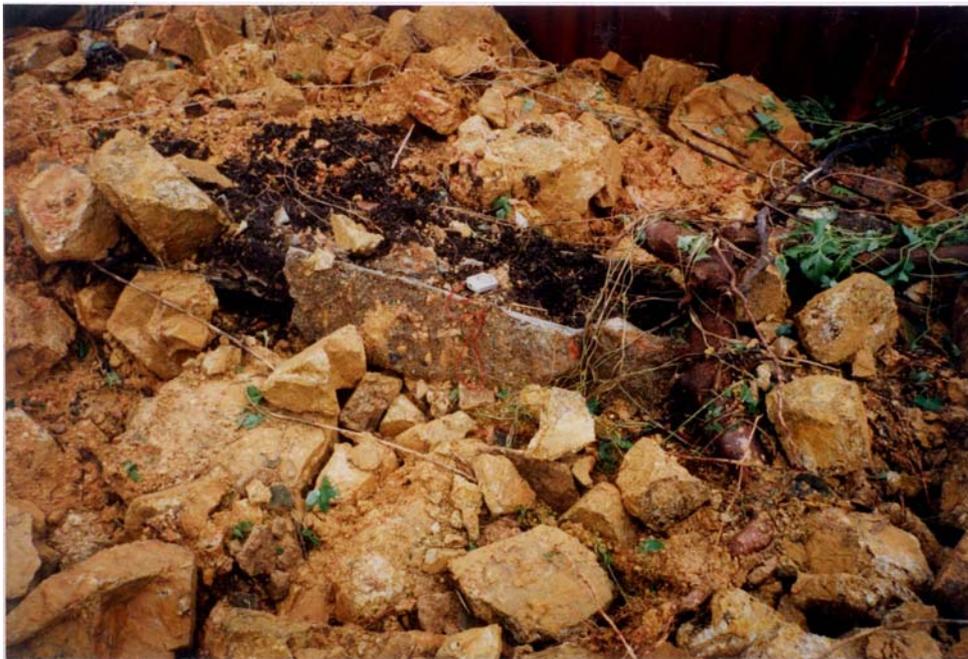
The landslide debris comprised predominantly coarse gravel-size to boulder-size joint-bound blocks of moderately and highly decomposed tuff in a matrix of clayey silty fine sand to sandy clayey silt, together with some man-made materials (Figure 5). The latter included sections of 24-inch and 6-inch diameter asbestos cement pipes, broken pieces of concrete surface channel, broken sections of a masonry wall, concrete blocks and catchpits, chain-link fencing, galvanized iron pipes, cables and damaged lamp posts. Many of the broken channels were filled with humus and black-stained soil (Plate 5), which indicates that they had been blocked for some time before the landslide.

Plate 5 - Blocked Surface Drainage Channel in the Landslide Debris (Photograph
Taken on 13 August 1995. See Figure 21 for Location)

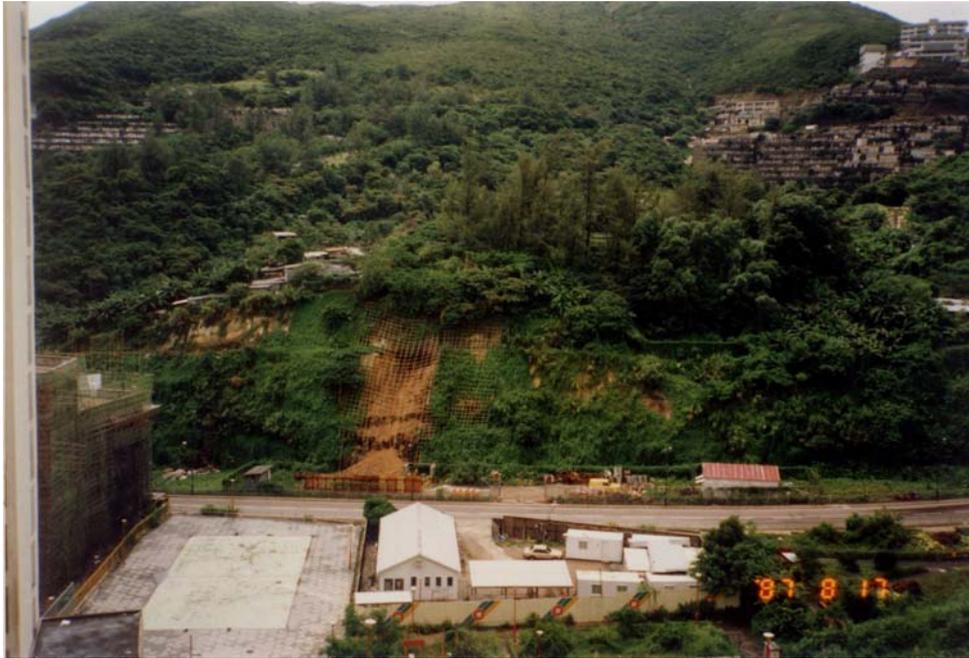
Two landslides, which occurred in 1987 (Plate 6) and in 1993 (Plate 7), with failure volumes of about 50 m³ and 30 m³ respectively, were reported to the Geotechnical Control Office (GCO) (renamed GEO in 1991). In each incident, the landslide occurred at the upper part of the cut slope, and the base of the failure daylighted at about 10 m above the level of Fei Tsui Road. The landslide debris came to rest in the flat open space in front of the slope, except that some windows of the Baptist Church were reported to have been damaged by small pieces of fly rock in the 1993 landslide.

Plate 6 - View of the 1987 Landslide (Photograph Taken on 17 August 1987.
See Figure 21 for Location)

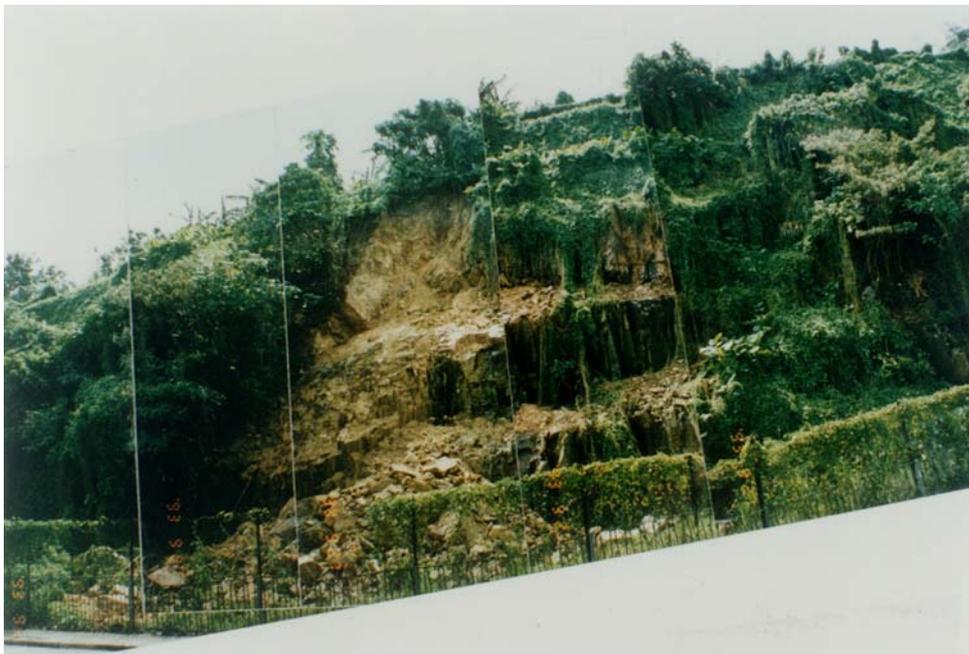
Plate 7 - View of the 1993 Landslide (Photograph Taken on 27 September 1993.
See Figure 21 for Location)

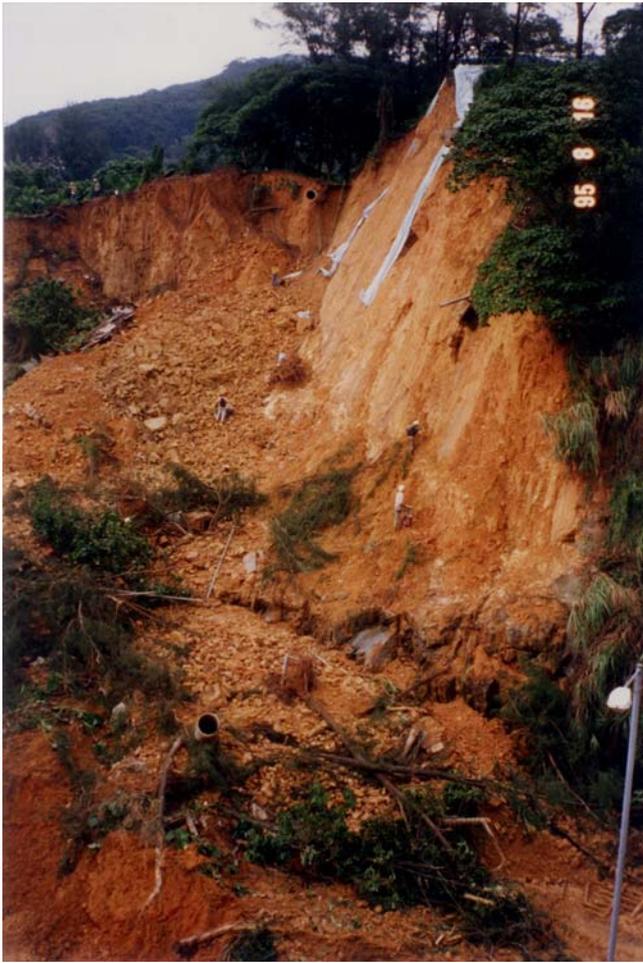
Plate 8 - Weathered Rock Joints
Forming the Back Scarp
of the Landslide
(Photograph Taken on
19 August 1995. See
Figure 21 for Location)

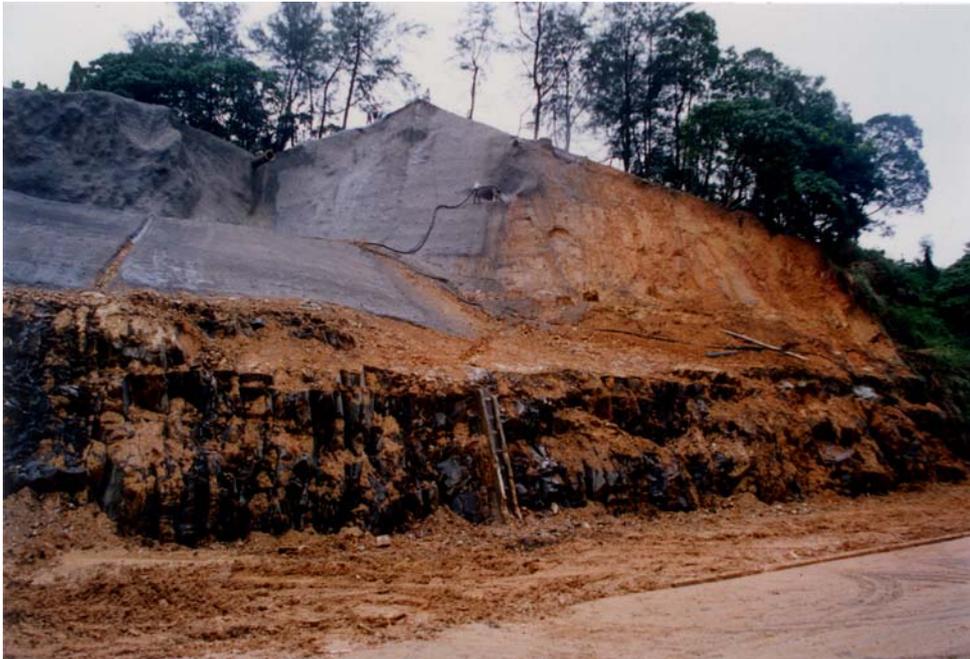
Plate 9 - Rock Face below the Base of the Landslide (Photograph Taken on
31 August 1995. See Figure 21 for Location)

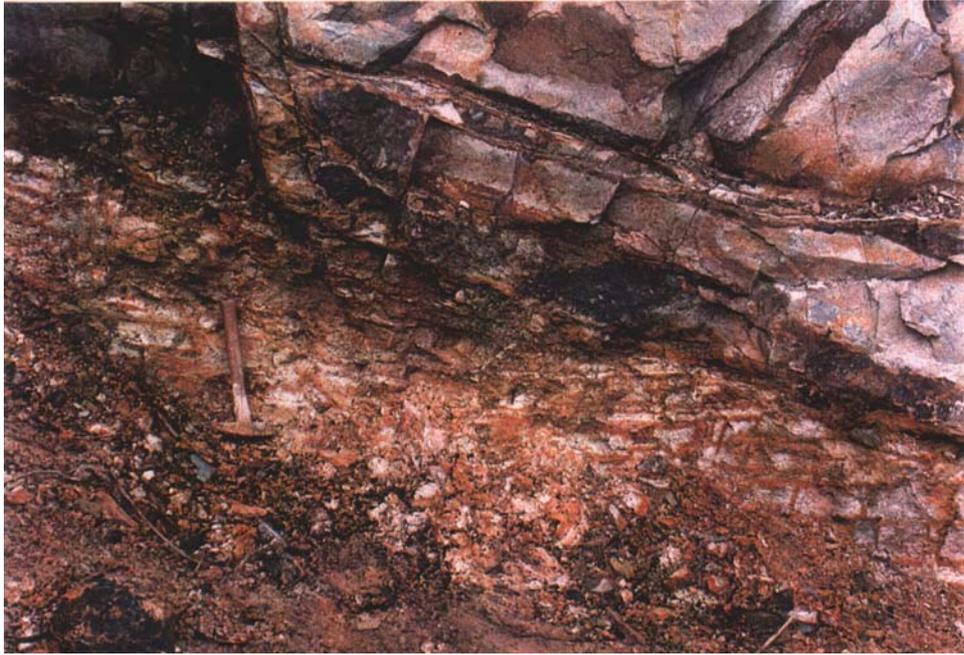
Plate 10 - Kaolinite-rich Altered Tuff at the Unfailed Portion of the Cut Slope to the East of the Landslide (Photograph Taken on 8 October 1995. See Figure 21 for Location)

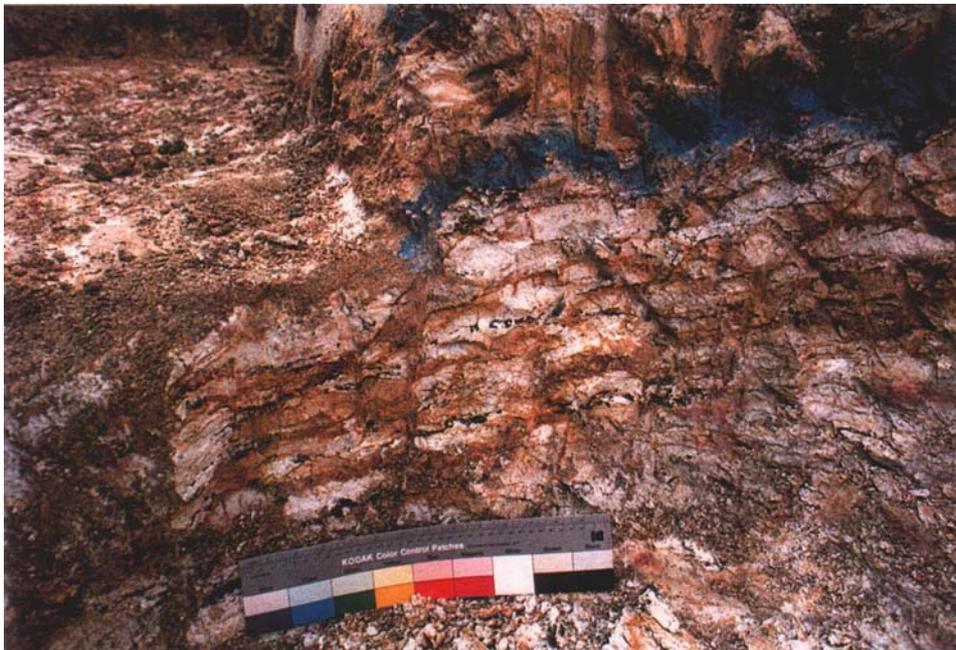
Plate 11 - Kaolinite-rich Altered Tuff at the Central Part of the Base of the Landslide (Photograph Taken on 20 October 1995. See Figure 21 for Location)

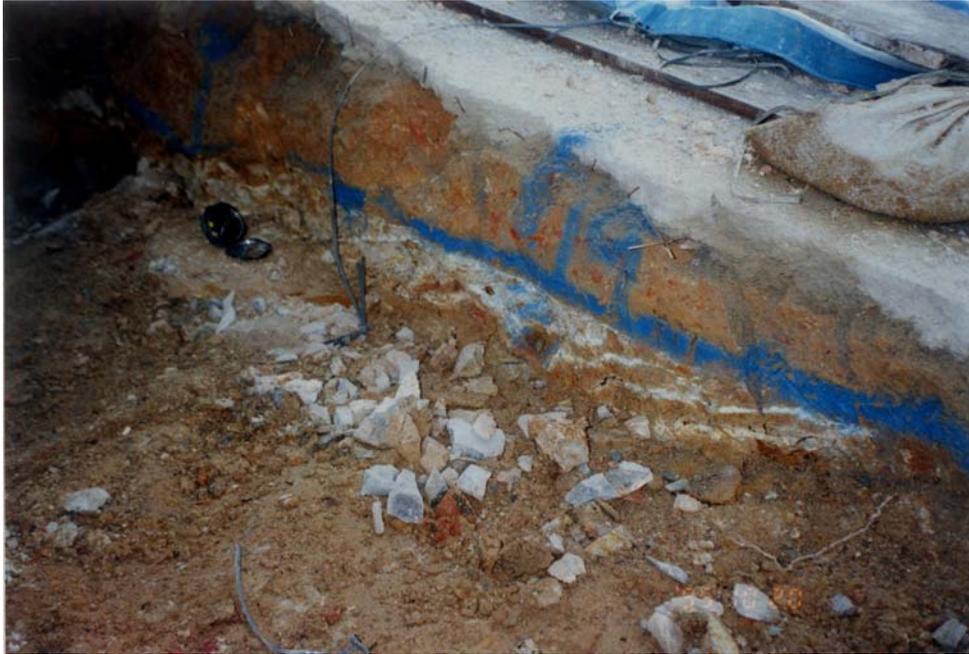
Plate 12 - Remnants of Kaolinite-rich Altered Tuff at the Western Toe of the Landslide
(Photograph Taken on 20 October 1995. See Figure 21 for Location)

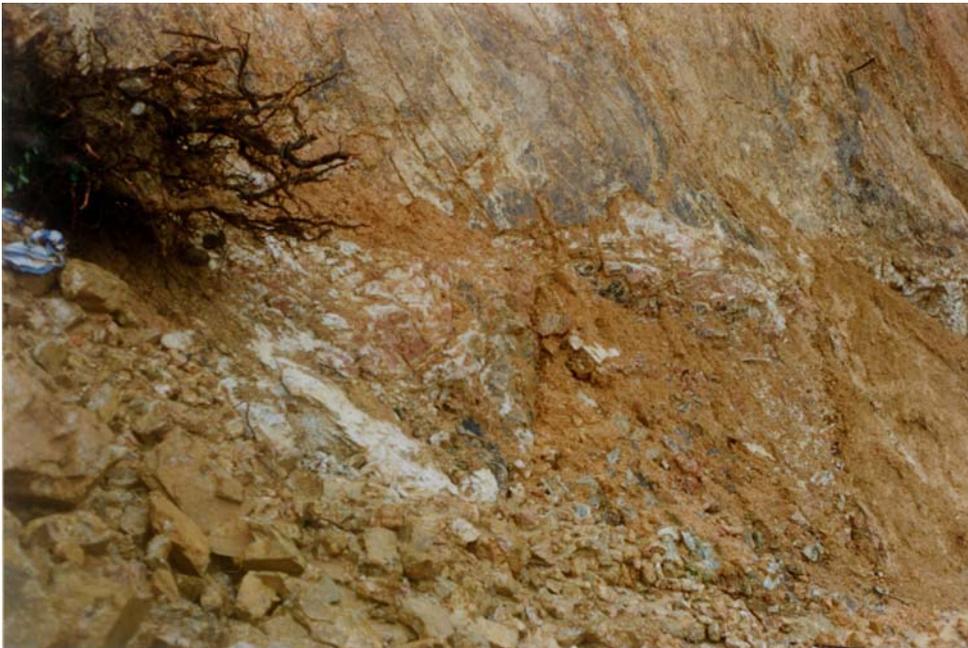
Plate 13 - The 'Diffuse' Layer at the Western Back Scarp (Photograph Taken on
14 August 1995. See Figure 21 for Location)

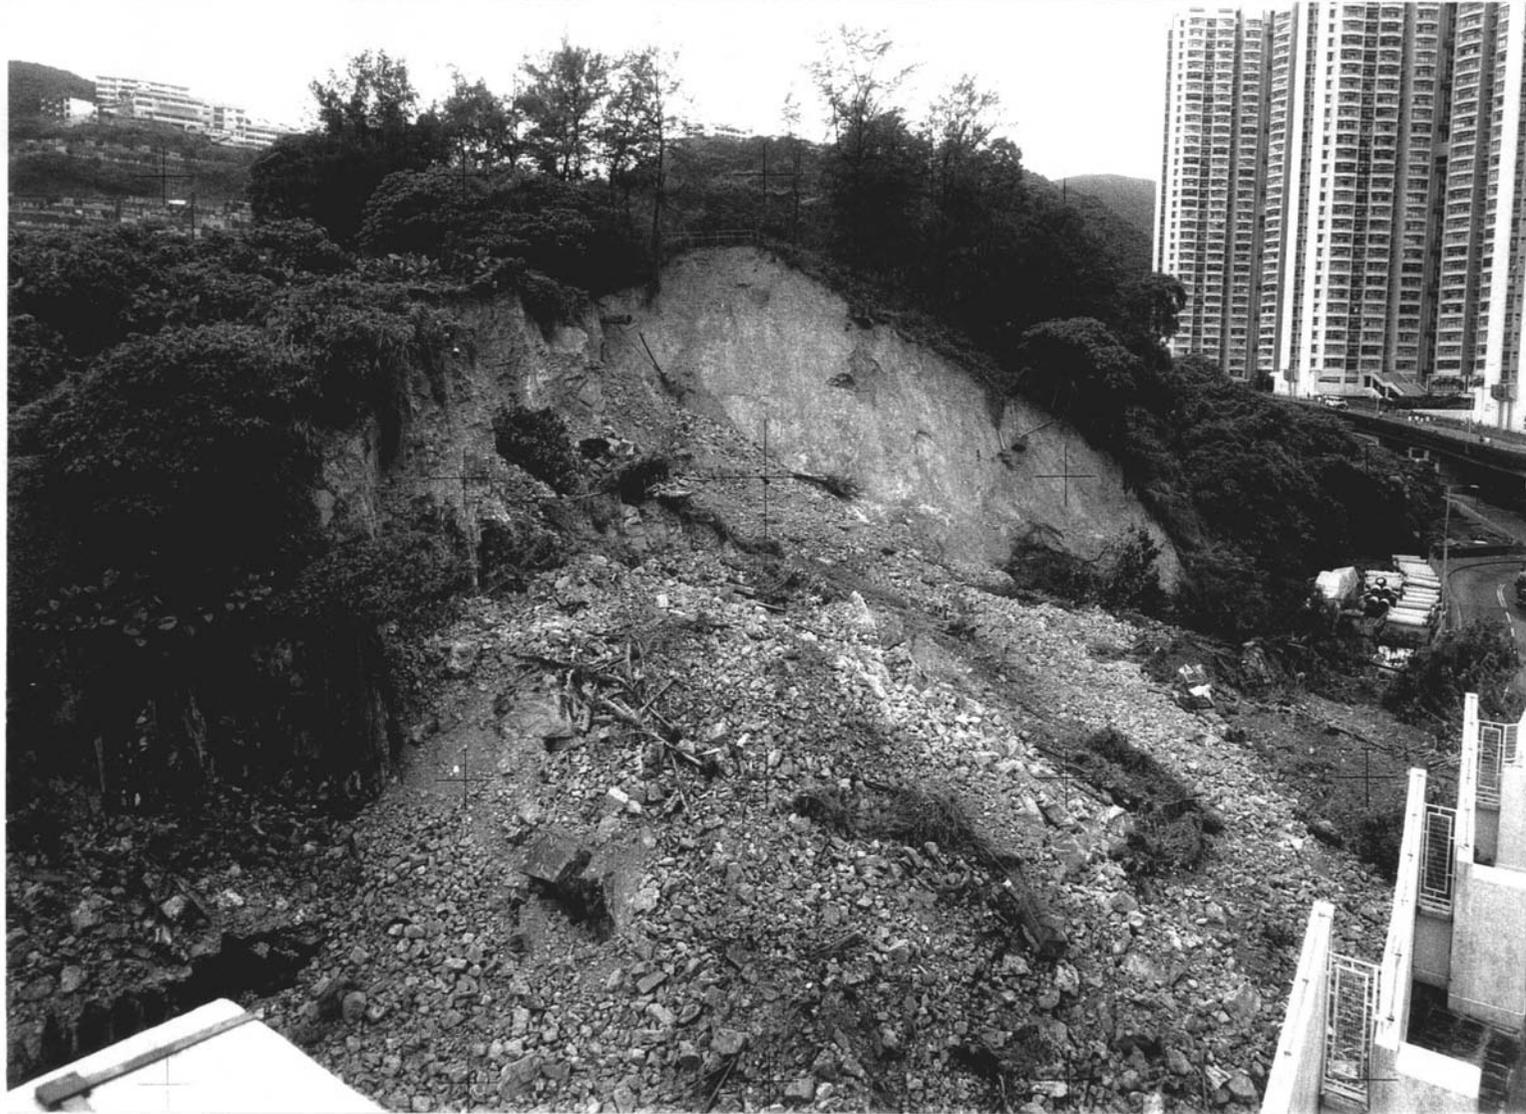
照片1 - 一九九五年八月十三日早上攝得的山泥傾瀉照片(其位置見圖21)

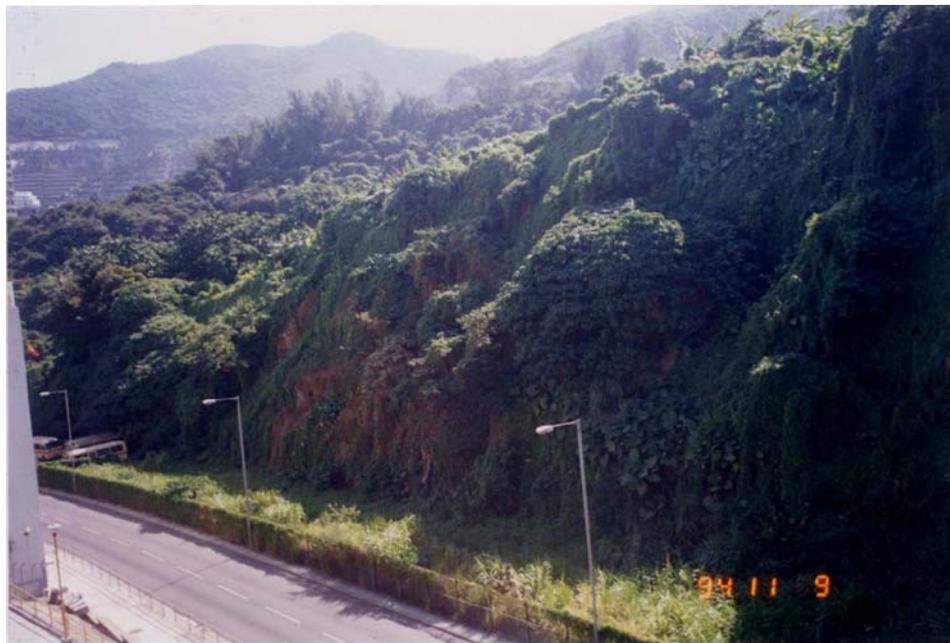
照片3 - 一九九四年十一月九日攝得的編號11SE-D/C42削坡照片
(其位置見圖21)

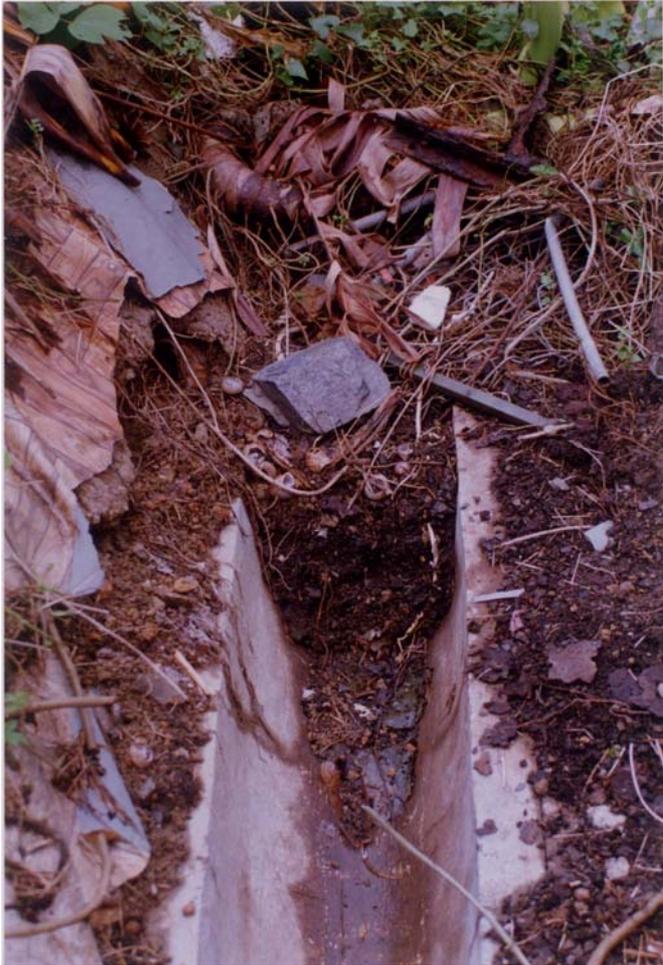
照片4 - 削坡未崩塌部份
的淤塞地面排水渠
(一九九五年十月十日
拍攝。其位置見圖21)

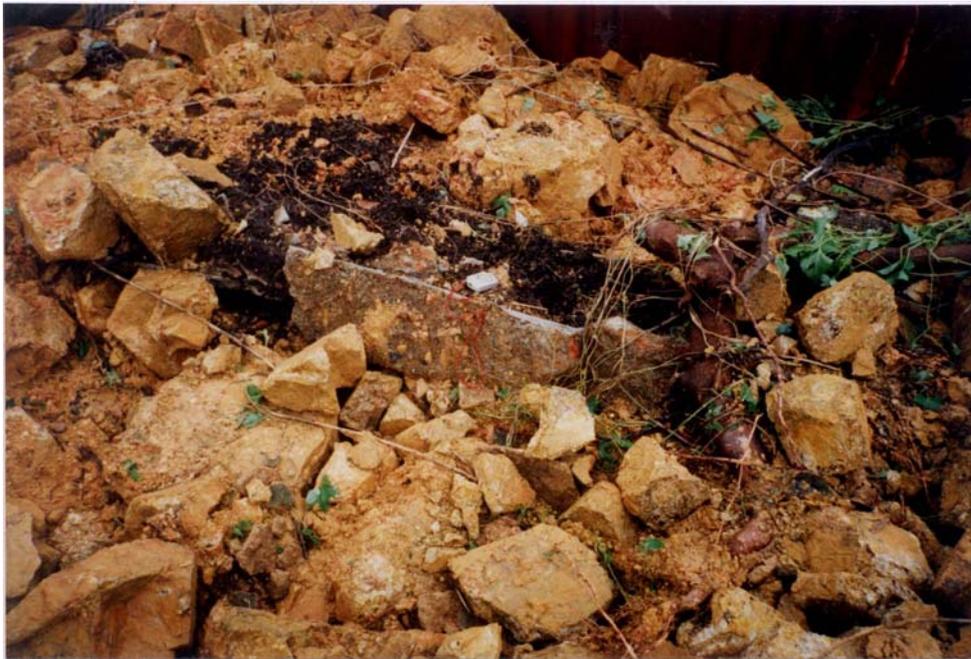
照片5 - 山泥傾瀉泥石中的淤塞地面排水渠
(一九九五年八月十三日拍攝。其位置見圖21)

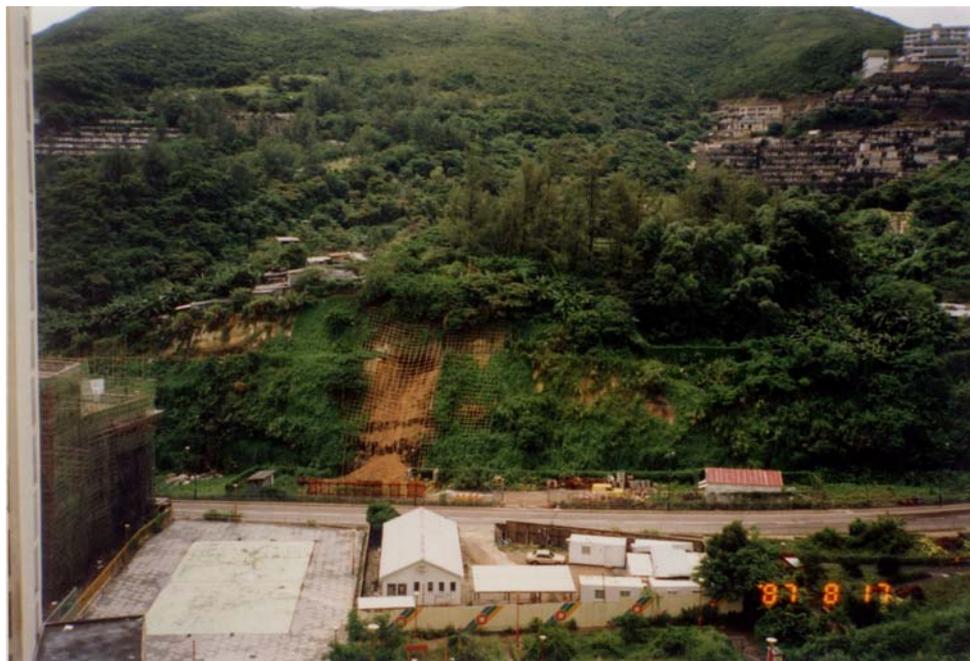
照片6 - 一九八七年山泥傾瀉的景象
(一九九五年八月十七日拍攝。其位置見圖21)

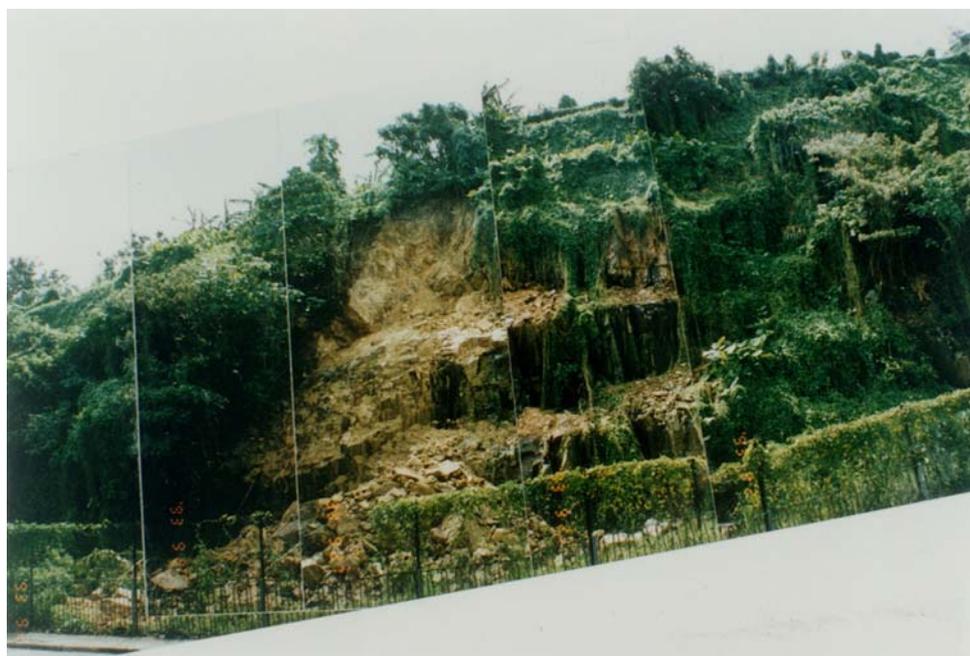
照片7 - 一九九三年山泥傾瀉的景象
(一九九三年九月二十七日拍攝。其位置見圖21)

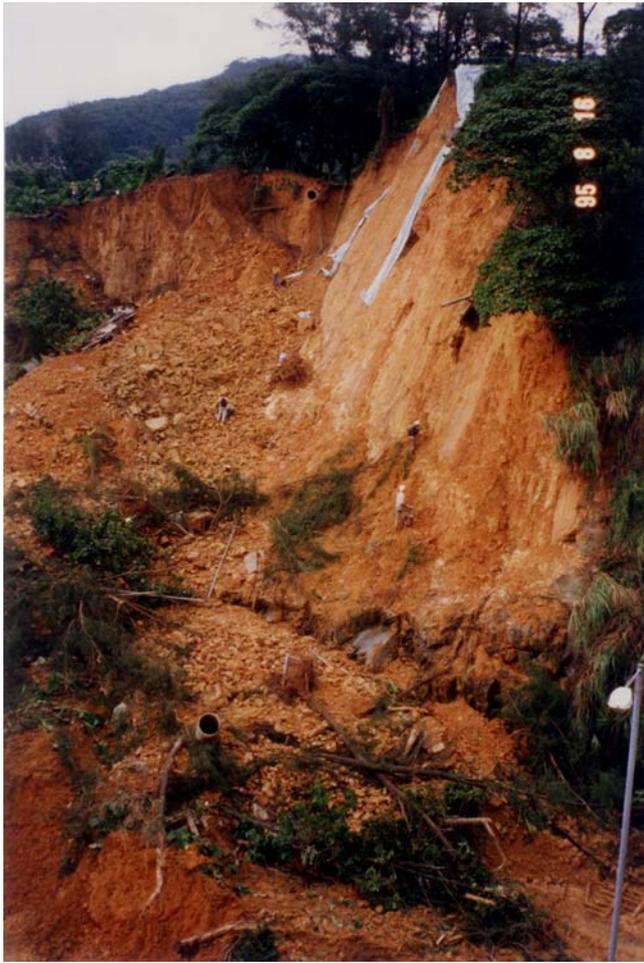
照片8 - 形成山泥傾瀉滑坡崖
的風化岩石節理
(一九九五年八月十九日
拍攝。其位置見圖21)

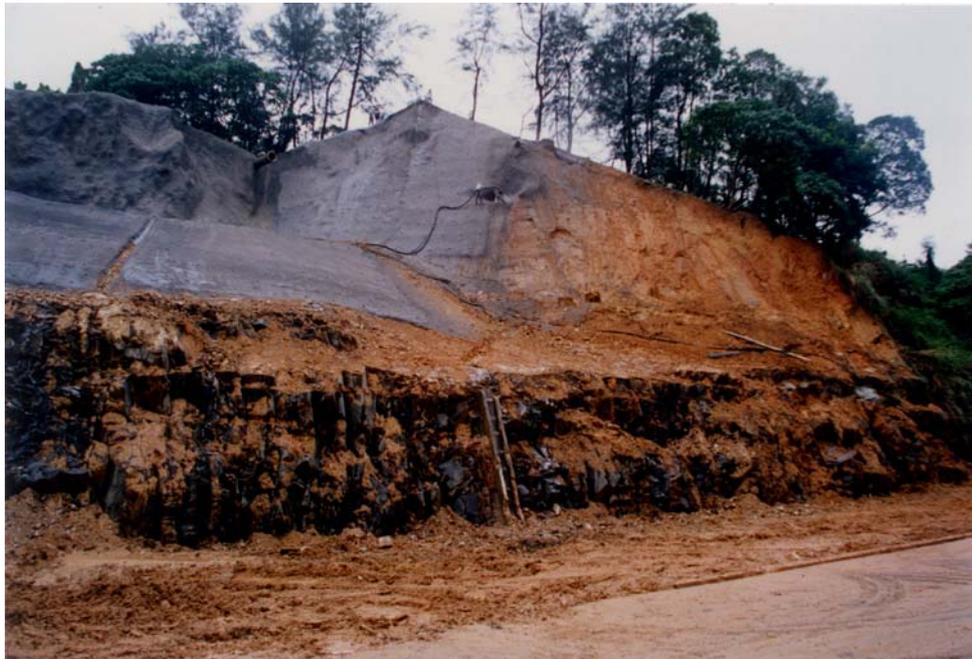
照片9 - 山泥傾瀉底部下面的岩石面
(一九九五年八月三十一日拍攝。其位置見圖21)

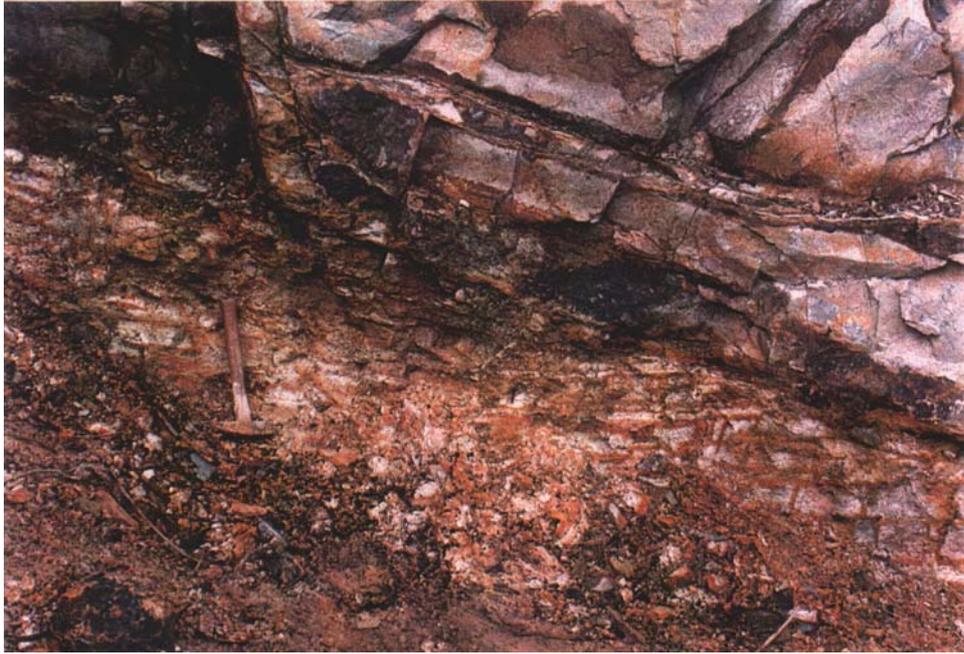
照片10 - 於山泥傾瀉東面，未崩塌削坡內，含豐富高嶺石的蝕變凝灰岩
(一九九五年十月八日拍攝。其位置見圖21)

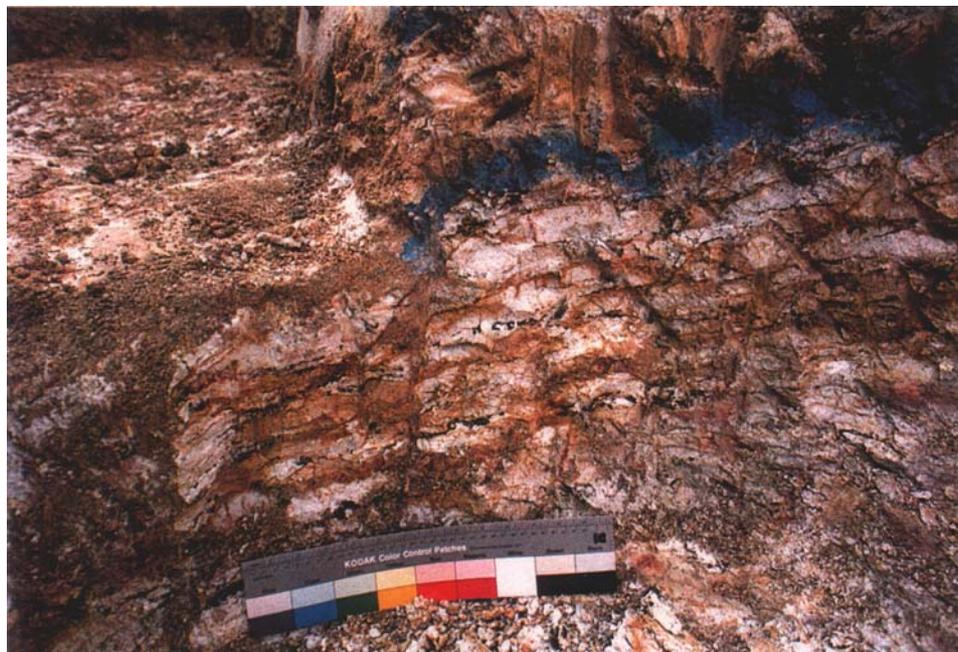
照片11 - 於山泥傾瀉底部中間部份，含豐富高嶺石的蝕變凝灰岩
(一九九五年十月二十日拍攝。其位置見圖21)

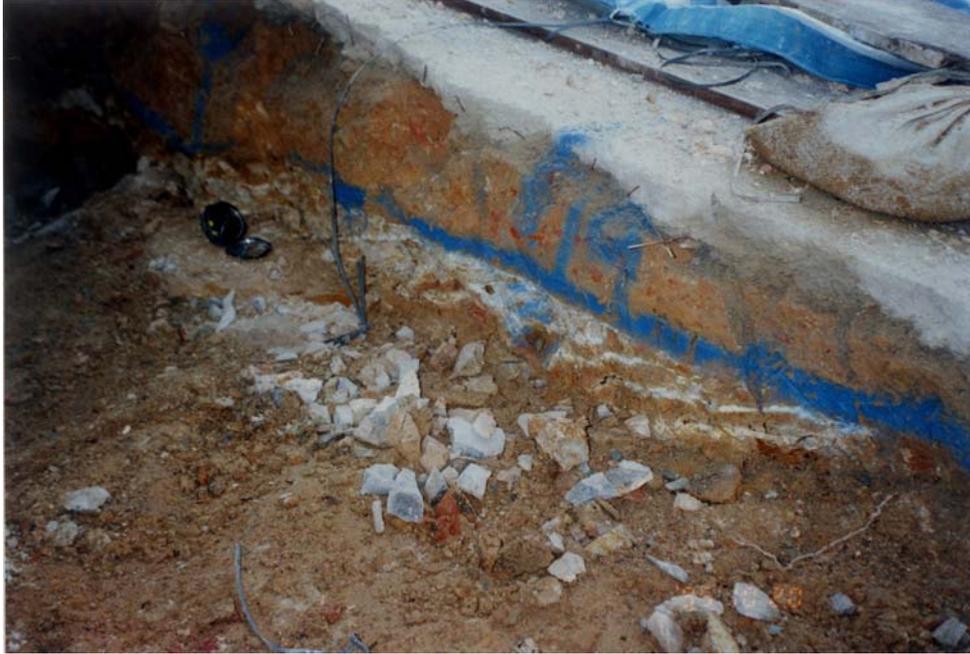
照片12 - 於山泥傾瀉西面，崩塌殘痕最前端，含豐富高嶺石的蝕變凝灰岩剩餘部份
(一九九五年十月二十日拍攝。其位置見圖21)

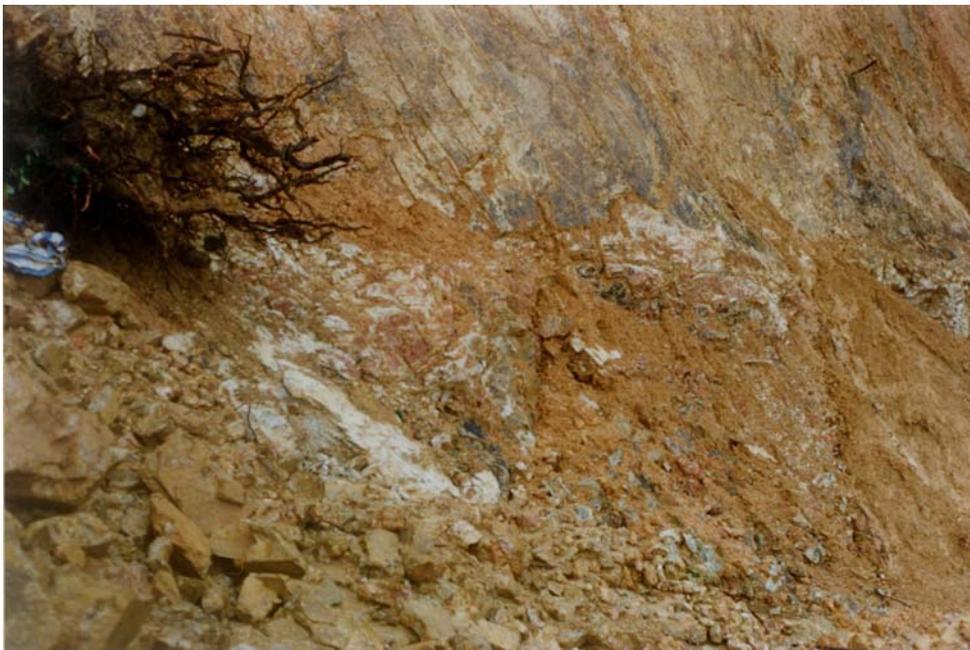
照片13 - 西面滑坡崖的「分散」岩層
(一九九五年八月十四日拍攝。其位置見圖21)
