# **Study of Geological and Morphological Controls on the Occurrence of Natural Terrain Landslide Clusters in Selected Catchments in Hong Kong**

**GEO Report No. 362**

**Geotechnical Engineering Office  
Civil Engineering and Development Department  
The Government of the Hong Kong  
Special Administrative Region**

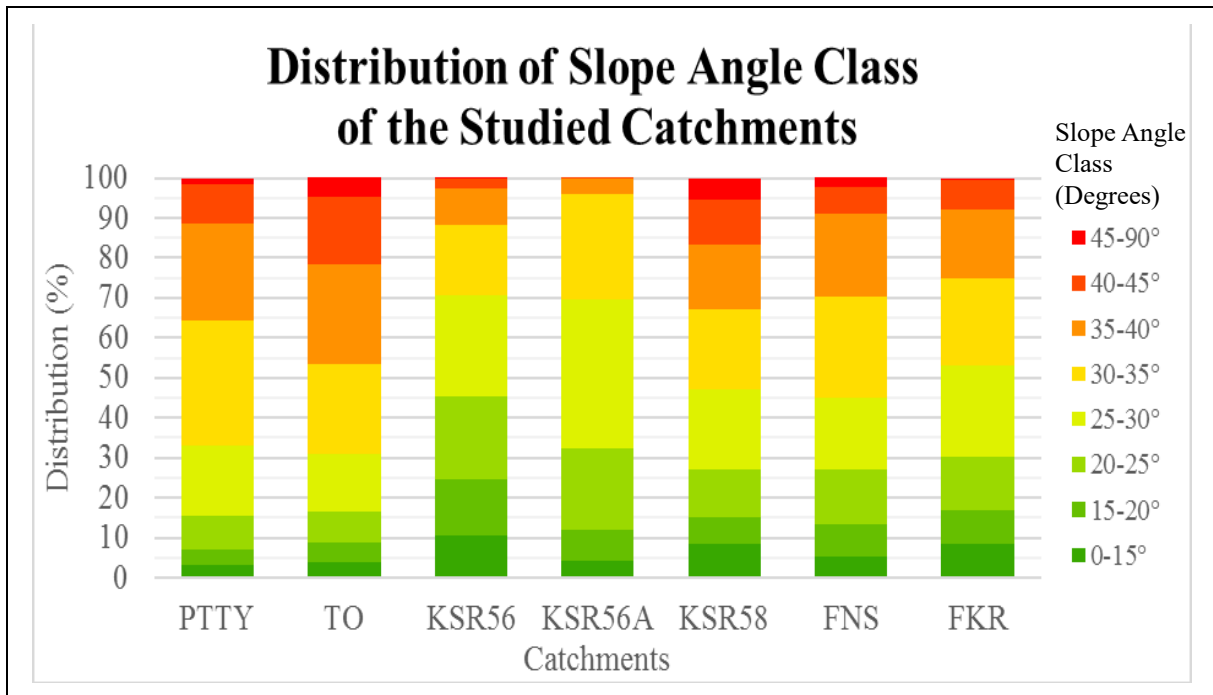
**Figure 2.2 Slope Angle Distribution of the Catchments**

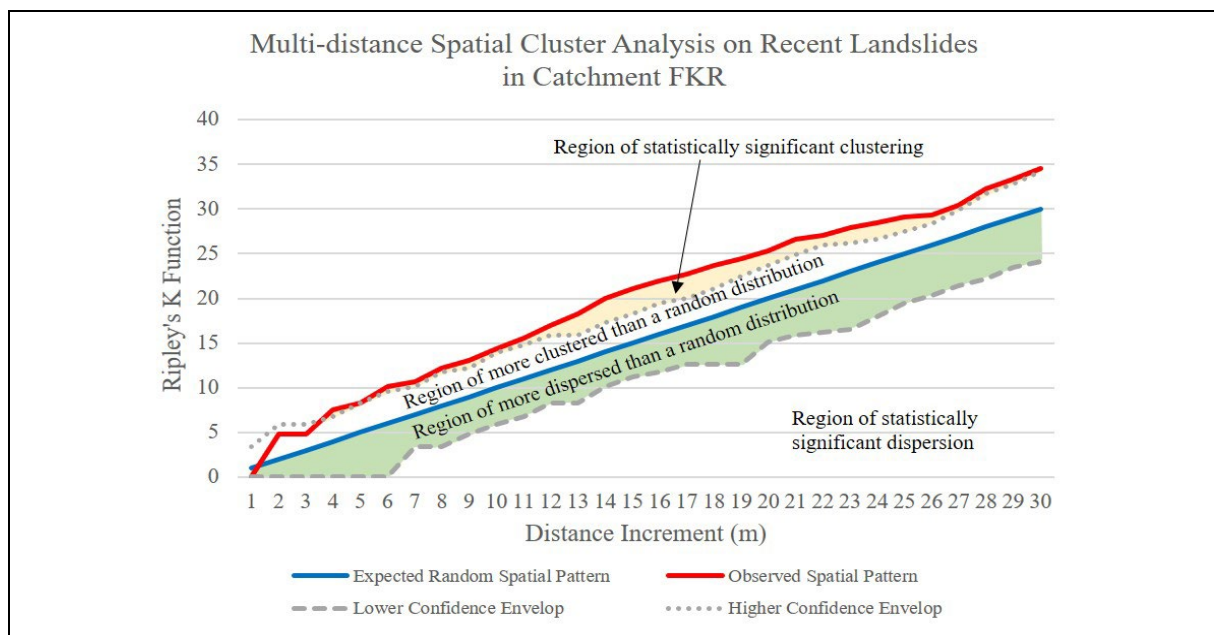
Figure 4.1 shows the output diagram from ArcGIS of the analytical result for catchment FKR, for illustration purpose. Apart from determining the observed K-values of the feature of interest (i.e. landslides for this study), the tool also computes the expected K-values for random spatial distribution at different distances (blue line in Figure 4.1), with the lower and upper confidence envelopes (grey, dashed lines in Figure 4.1). The red line in Figure 4.1 indicates the observed K-values and the result suggested that for catchment FKR, spatial clustering of recent landslides starting from 4 m is statistically significant.

**Figure 4.1 An Example of the Output of Multi-Distance Spatial Cluster Analysis on Recent Landslides in Catchment FKR**

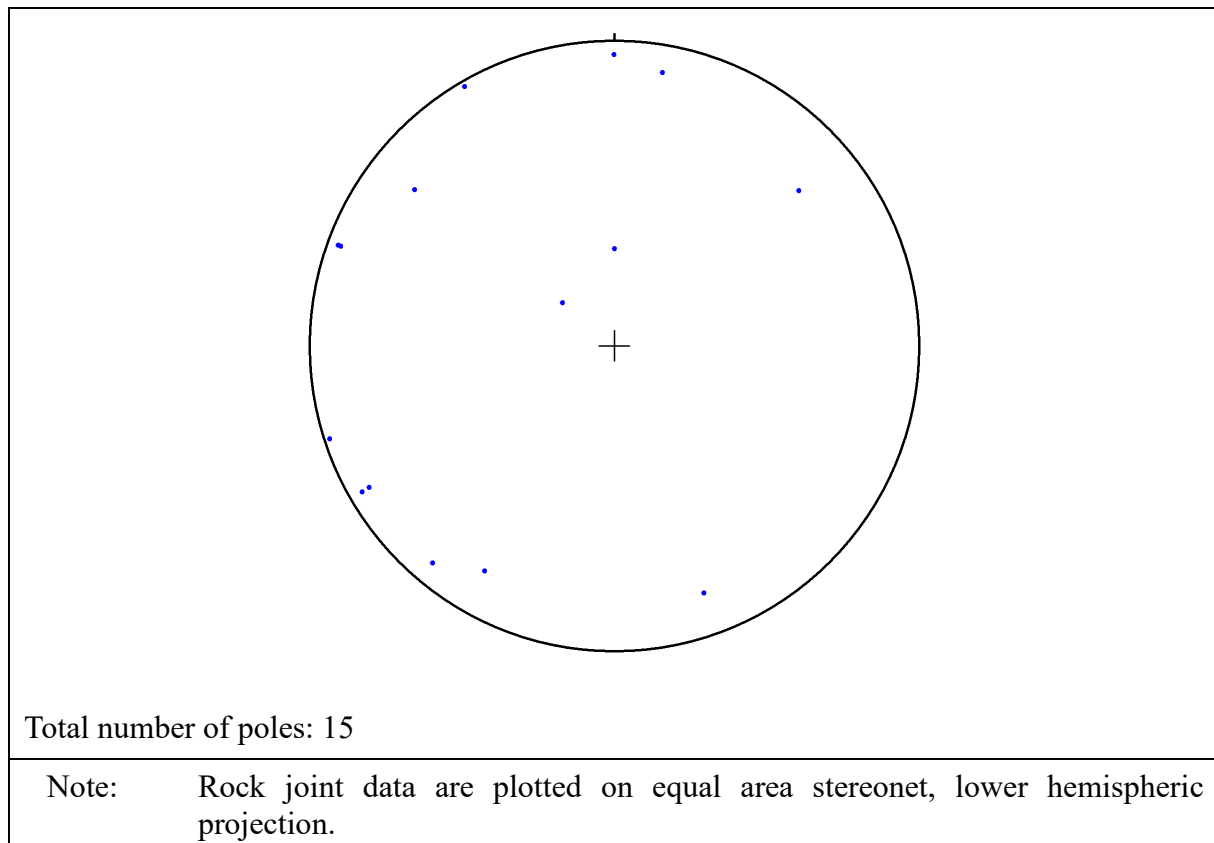
Slightly-decomposed to completely-decomposed coarse ash tuff and fine ash tuff (Grades II to V) and their residual soil (Grade VI) were reported in the drillholes and trial pits. A total of 15 nos. measurements on relict joints were recorded in four trial pits (TPB2, TPB4, TPB5 and TPB7, all in GIU Report No. 61235), the dip angles and dip directions of which are presented as poles on a stereonet in Figure D2.2. Among these four trial pits, kaolin-infilling in the relict joints were reported in TPB5, and quartz veins were reported in TPB5 and TPB7 dipping at  $62^{\circ}/284^{\circ}$ ,  $80^{\circ}/142^{\circ}$  and  $75^{\circ}/070^{\circ}$ .

**Figure D2.2 Equal Area Stereonet of Measurements on Relict Joints in the GI Stations in the Study Area.**

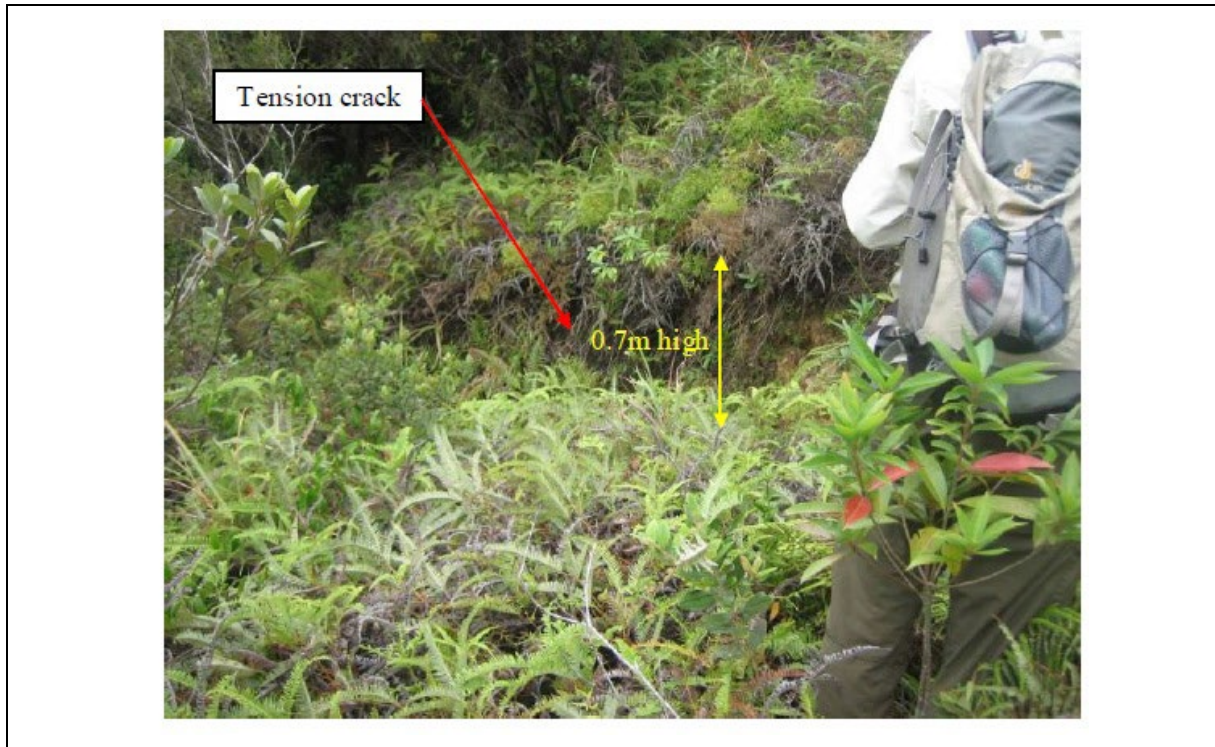
**Plate D4.1 Tension Crack Extending towards the East Flank of Landslide ID No. 135 in Catchment 56A in this Study**

AECOM (2015)'s field observations regarding the recent landslides within the Study Area are summarised as follows. Highly-decomposed tuff (HDT) and moderately-decomposed tuff (MDT) have been found in the source areas of several landslides. Structurally-controlled rupture surface along joint surface was also recorded (Plates D4.1 to D4.6). Where mapping was carried out, AECOM (2015) recorded at least two types of rupture surfaces, namely the interface between colluvium and CDT/HDT (e.g. recent ENTLI No. 13NWB2178E, Plate D4.7) and within colluvium (e.g. Landslide ID No. 135). In addition, tension crack (about 5 m long, 0.2 m wide and with a vertical displacement of 0.7 m) and soil pipes were also reported. Regarding debris, intact displaced debris rafts have been reported at Landslide ID No. 135 (Plate D4.8) and below recent ENTLI No. 13NWB2704E.

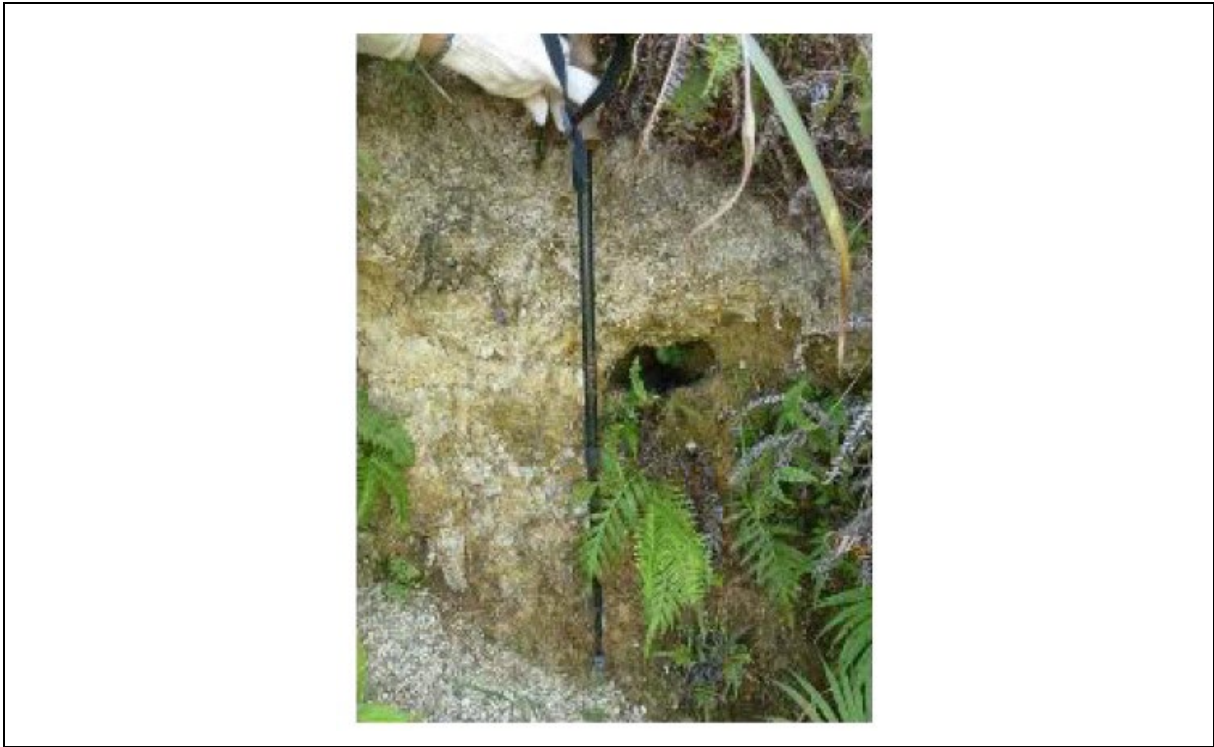
**Plate D4.3 Soil Pipe (0.2 m in dia. And 0.5 m deep) observed on the Scarp of Landslide Recent ENTLI No. 13NWB2013E (Landslide ID No. 51 in Catchment KSR56)**

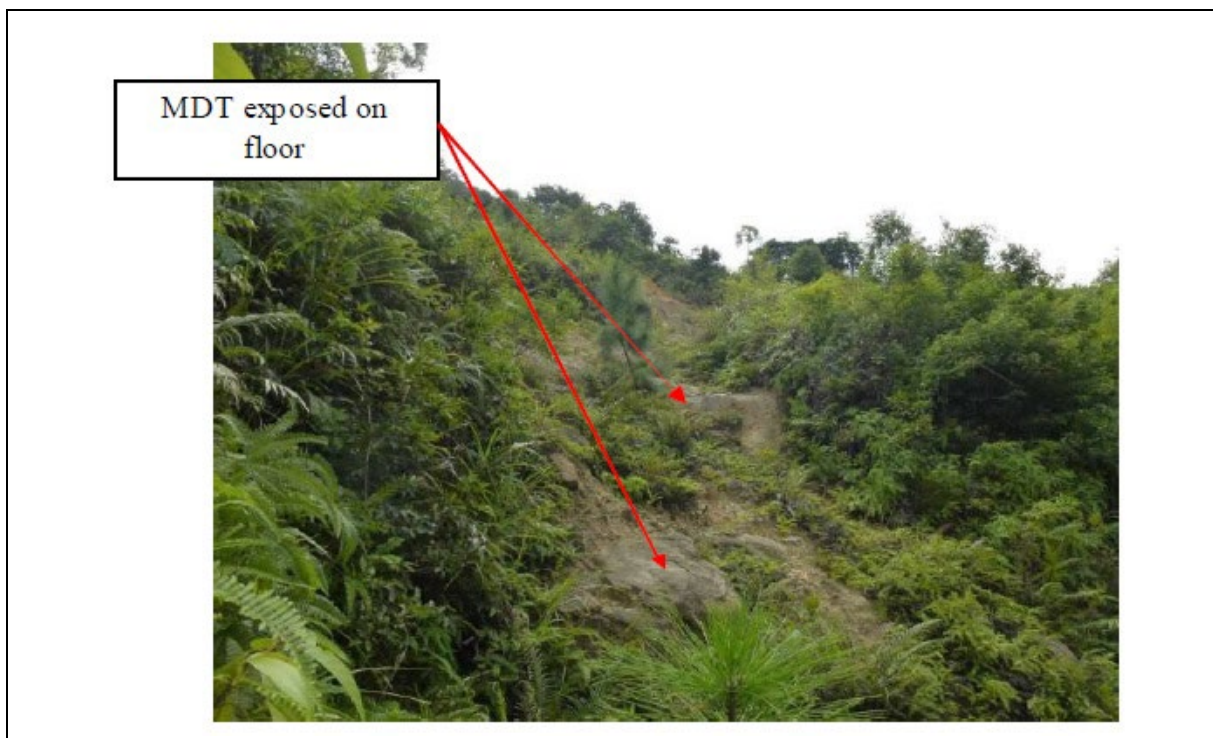
**Plate D4.6 Exposed MDT at the Floor of Recent ENTLI No. 13NWB2703E (Landslide ID No. 80 in Catchment KSR56)**

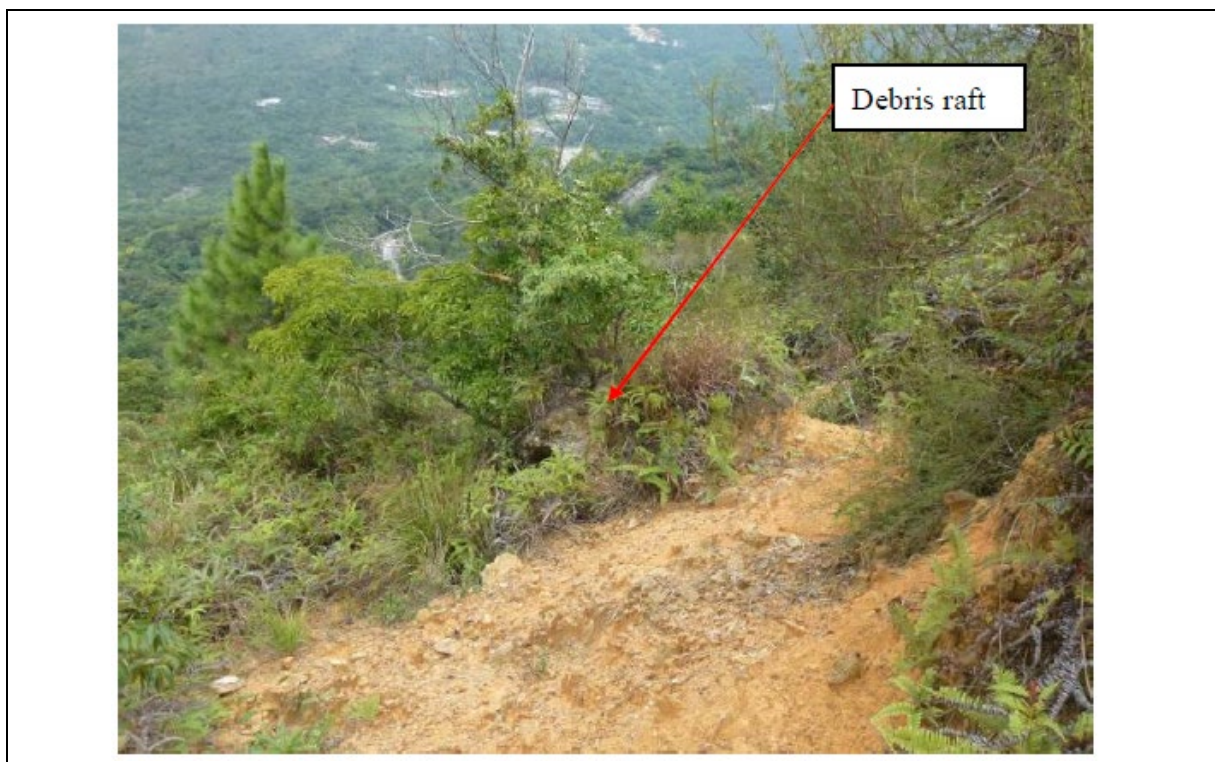
**Plate D4.8 Displaced Intact Debris Raft on Recent Landslide ID No. 135 in Catchment KSR56A**

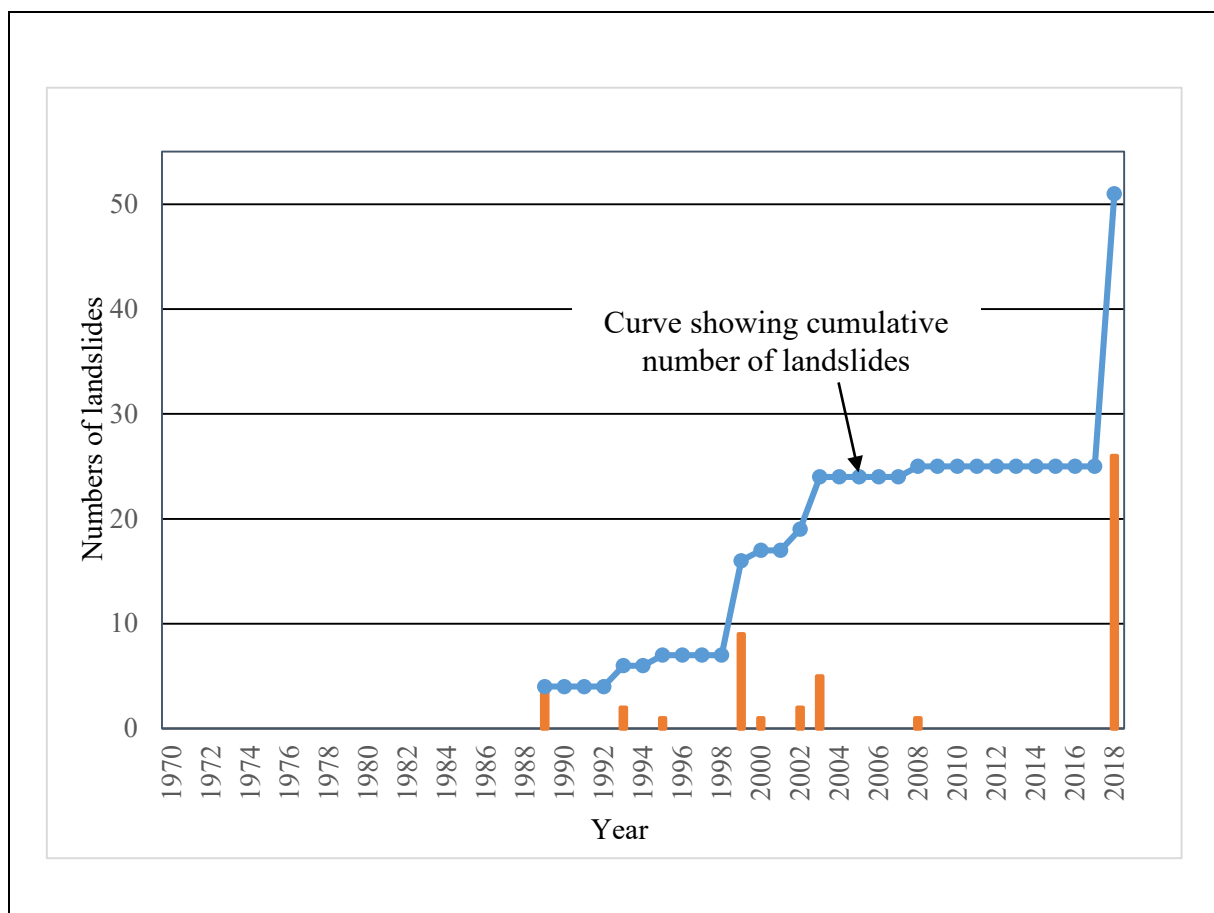
**Figure E4.2** Numbers of Recent Landslides in Catchment FKR between years 1970 and 2018
