Study of Geological and Morphological Controls on the Occurrence of Natural Terrain Landslide Clusters in Selected Catchments in Hong Kong

GEO Report No. 371

**Geotechnical Engineering Office
Civil Engineering and Development Department
The Government of the Hong Kong
Special Administrative Region**

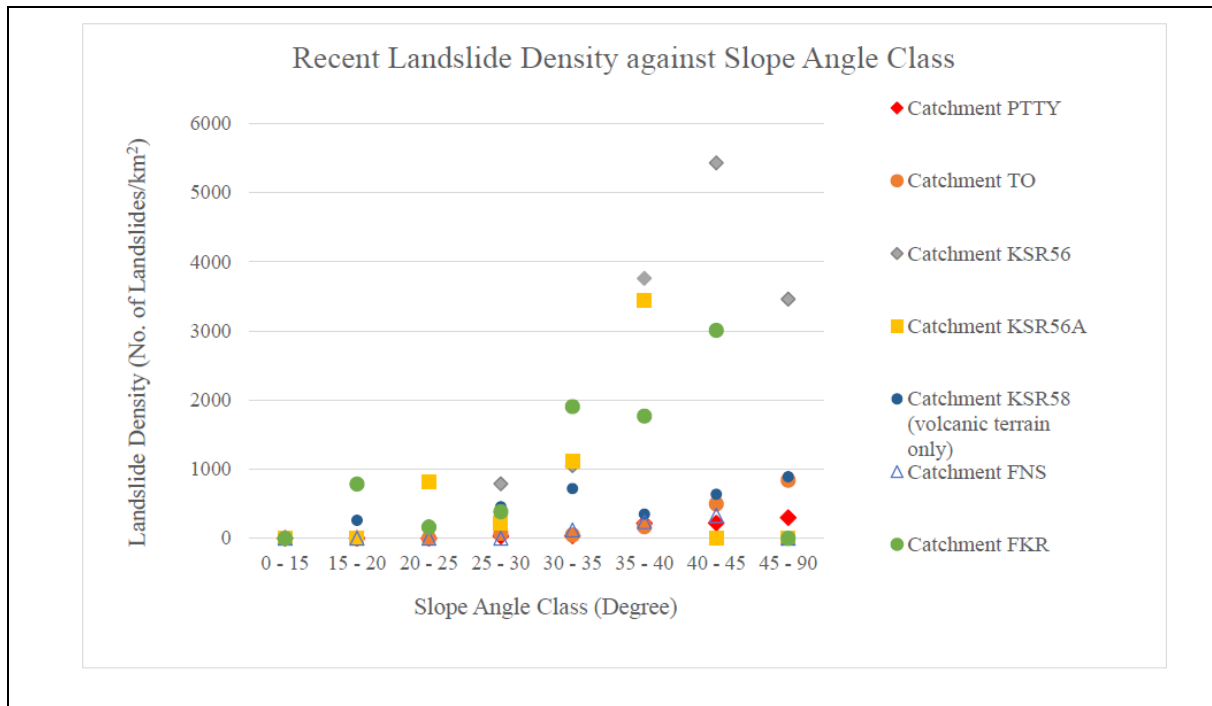
Figure 3.1 Distribution of Recent Landslide Density in Each Slope Angle Class

In general, landslide density increases with increasing slope angle classes for all catchments, except that no landslide was found on terrain with gradient $> 40^\circ$ or no terrain area has slope angle $\geq 45^\circ$ in catchment KSR56A and decreased in landslide densities at slope angle class of 45-90° in catchments KSR56, FNS and FKR. Lo et al (2015) suggested that under the same rainfall and slope angle classes, areas underlain by sedimentary rocks are generally as susceptible to landslide activities as the areas underlain by volcanic rocks in territory-wide. Among the six study catchments, only catchments KSR58 and TO are underlain by both volcanic and sedimentary rocks. Our analysis shows that the landslide densities in areas underlain by sedimentary rocks are as susceptible to landslide activities as in volcanic terrains in catchment TO. In particular, the landslide density in areas underlain by sedimentary rocks at slope angle class of 45-90° is one order of magnitude higher than the one in areas underlain by volcanic rocks. However, for catchment KSR58, no landslide occurred in areas underlain by the tuffaceous sedimentary rocks, which are present at the upper most part of the catchment.

About half of the relict landslides in catchments PTTY, TO, KSR58 and FNS occurred on slopes at slope gradient > 35°. Relict landslides in catchments KSR56 and KSR56A tend to occur at gentler slope (i.e. only about 33% and 17% of landslides at slopes at gradient > 35°). Over 70% of recent landslides were found at slope with gradient > 35° in catchments PTTY, TO and FNS. About 18-53% of recent landslides in catchments KSR56, KSR56A and KSR58 occurred at slope gradient > 35°. Figure 3.1 shows a summary of slope angle distribution of recent landslides in each catchment.

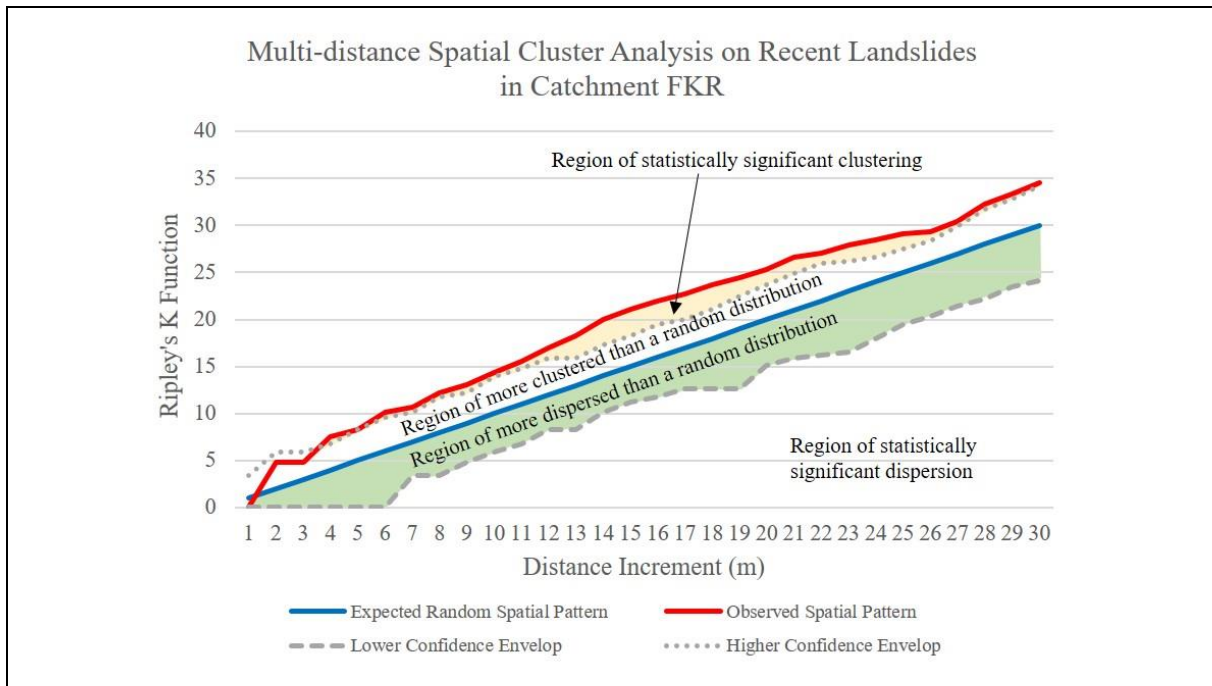
Figure 4.1 An Example of the Output of Multi-distance Spatial Cluster Analysis on Recent Landslides in Catchment FKR

Figure 4.1 shows the output diagram from ArcGIS of the analytical result for catchment FKR, for illustration purpose. Apart from determining the observed K-values of the feature of interest (i.e. landslides for this study), the tool also computes the expected K-values for random spatial distribution at different distances (blue line in Figure 4.1), with the lower and upper confidence envelopes (grey, dashed lines in Figure 4.1). The red line in Figure 4.1 indicates the observed K-values and the result suggested that for catchment FKR, spatial clustering of recent landslides starting from 4 m is statistically significant.

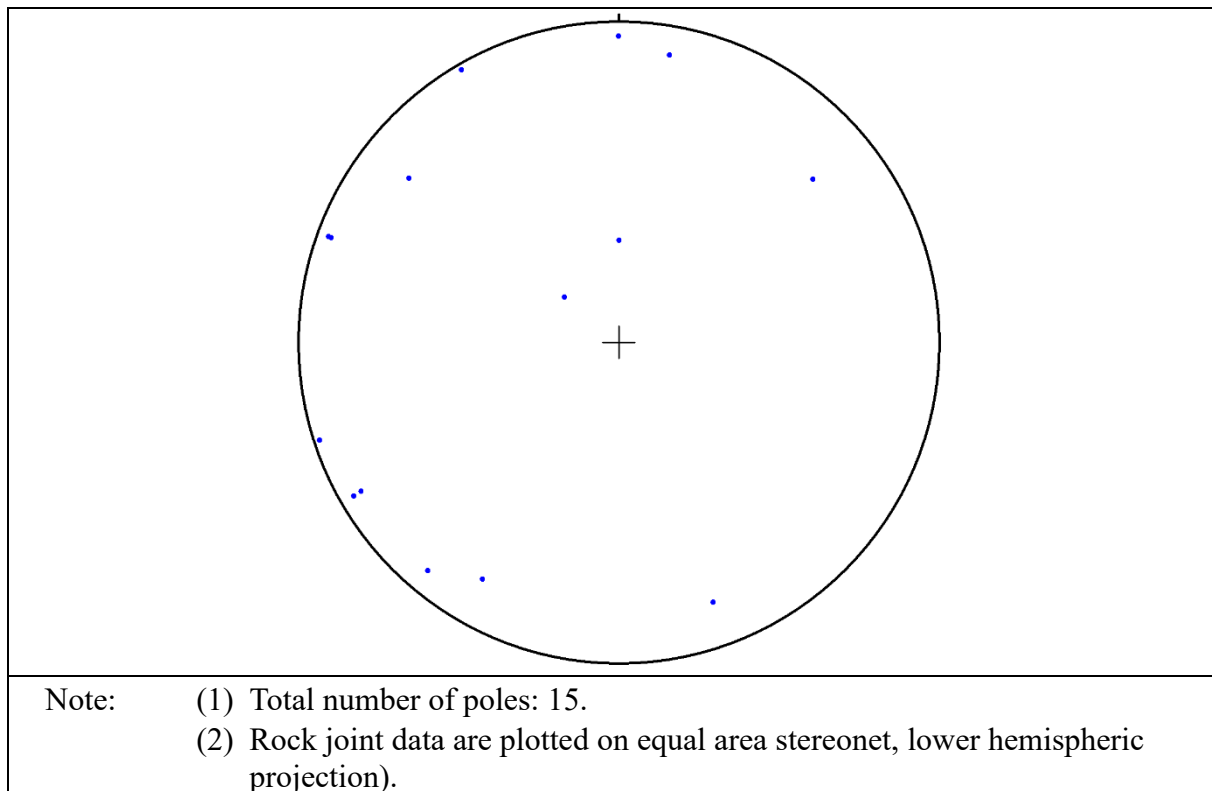
Figure D2.2 Equal Area Stereonet of Measurements on Relict Joints in the GI Stations in the Study Area

Slightly-decomposed to completely-decomposed coarse ash tuff and fine ash tuff (Grades II to V) and their residual soil (Grade VI) were reported in the drillholes and trial pits. A total of 15 nos. measurements on relict joints were recorded in four trial pits (TPB2, TPB4, TPB5 and TPB7, all in GIU Report No. 61235), the dip angles and dip directions of which are presented as poles on a stereonet in Figure D2.2. Among these four trial pits, kaolin-infilling in the relict joints were reported in TPB5, and quartz veins were reported in TPB5 and TPB7 dipping at $62^{\circ}/284^{\circ}$, $80^{\circ}/142^{\circ}$ and $75^{\circ}/070^{\circ}$.
