ENGINEERING GEOLOGICAL PRACTICE IN HONG KONG

GEOTECHNICAL ENGINEERING OFFICE
Civil Engineering and Development Department
The Government of the Hong Kong
Special Administrative Region

First published, March 2007

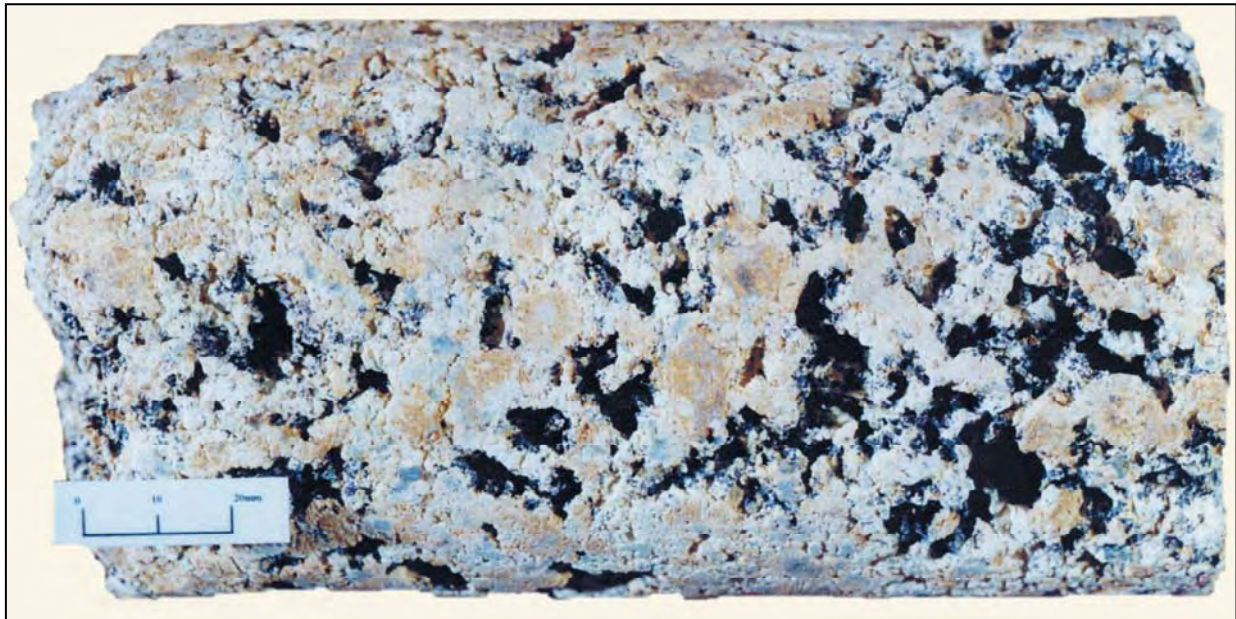
Figure 4.3.4 – Kaolinised granite core from the 1997 Ville de Cascade landslide site at Fo Tan (HAPL, 1998a)

Kaolinisation results from the alteration of feldspars and has a similar occurrence to, but more pronounced effect than, chloritisation. Figure 4.3.4 shows a granite core sample which contains many pits and voids resulting from kaolinisation and dissolution of the feldspar crystals. Until the mid-1990s it was considered that any significant, laterally-persistent concentrations of kaolin were formed as a result of hydrothermal alteration. More recently, Campbell & Parry (2002), GEO (2004i) and Parry *et al.* (2004a) suggest most near-surface, kaolin-rich zones are related to weathering. However, hydrothermal kaolin

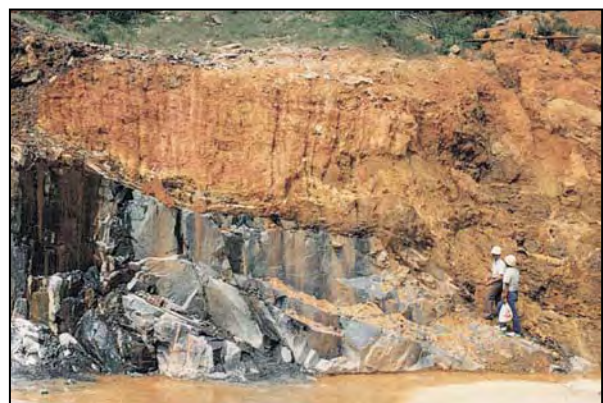
Figure 4.4.5 – Sharply-defined rockhead with little corestone development in volcanic rock. A possible kaolin-rich zone lies directly above rockhead (Fyfe et al., 2000)

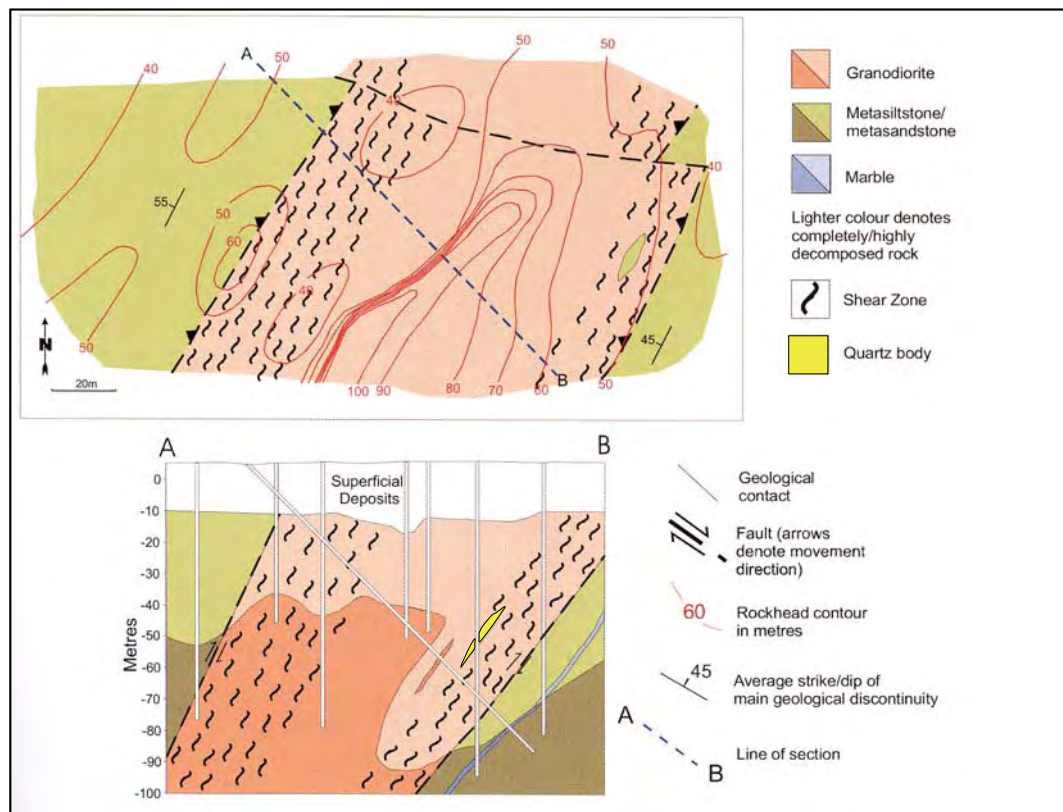
Figure 4.4.9 – Schematic geological map and section developed from borehole data and local geological knowledge showing highly variable rockhead surface (Fletcher, 2004)

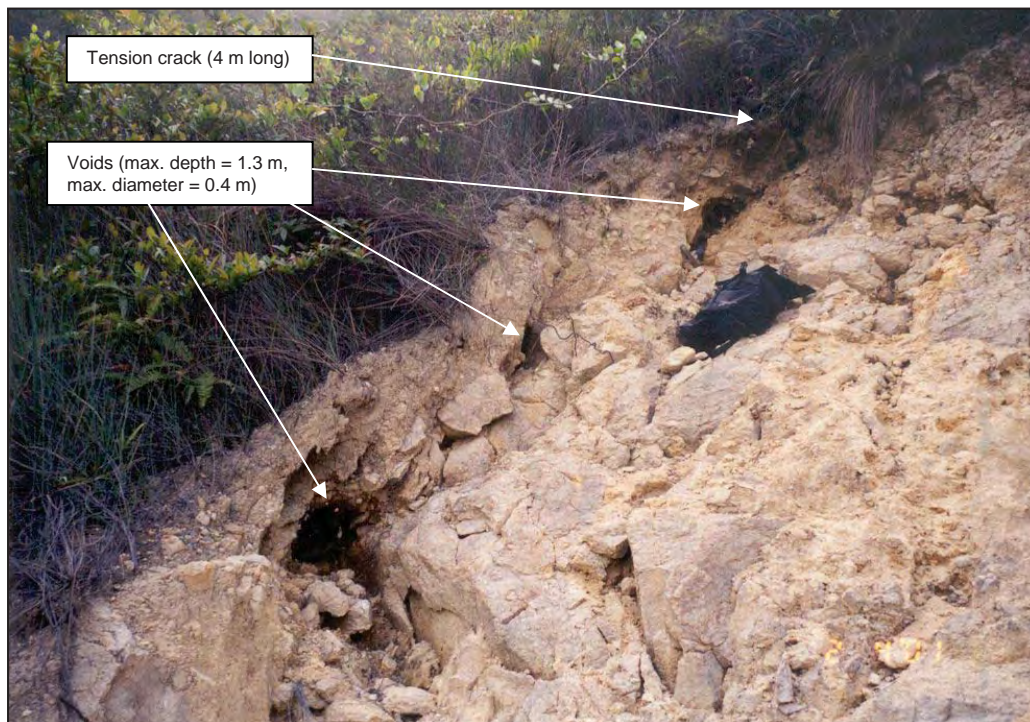
Figure 4.4.13 – Voids/soil pipes at the colluvium/bedrock interface in a landslide scar

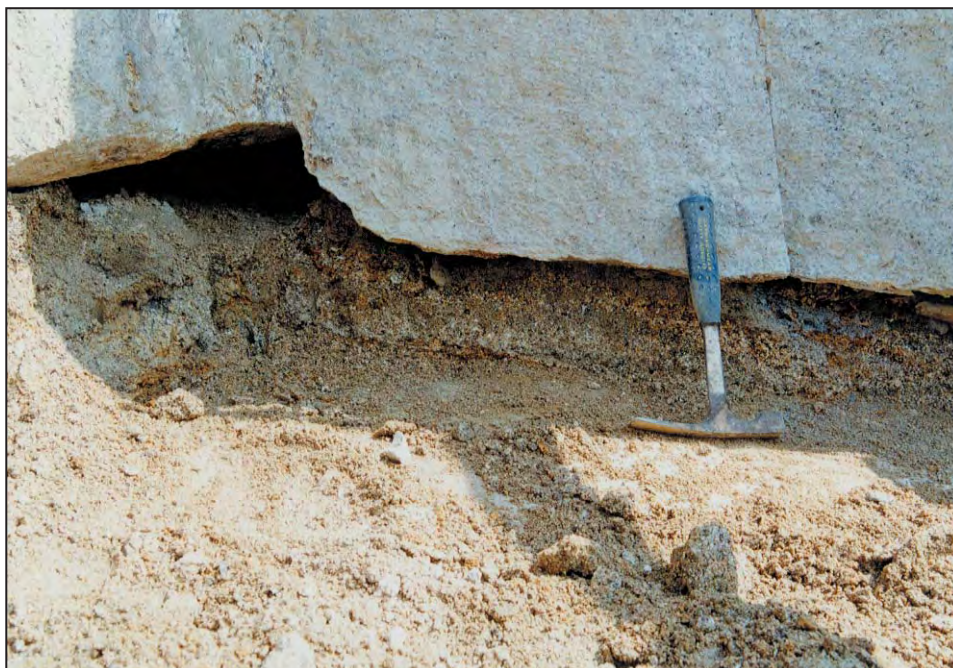
Figure 4.4.14 – Bedded granular material infilling sheeting joint

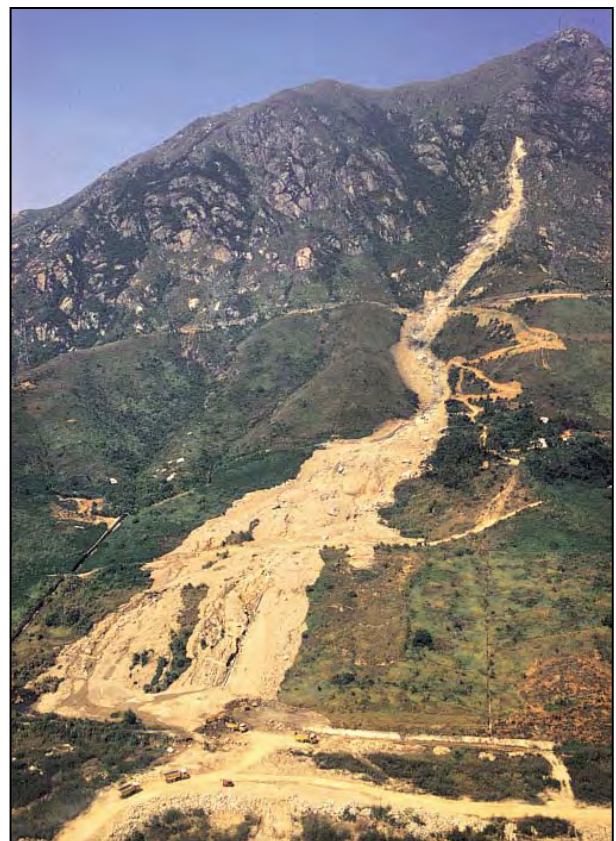
Figure 4.5.3 – The 1990 Tsing Shan debris flow

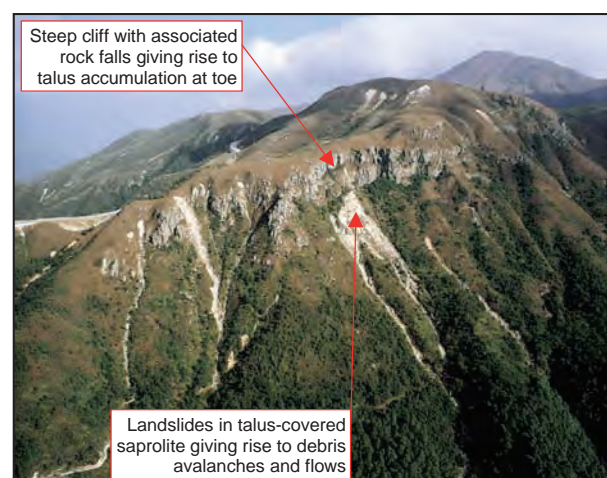
Figure 4.5.5 – Debris avalanches and debris flows below steep cliff near Ngong Ping, Lantau

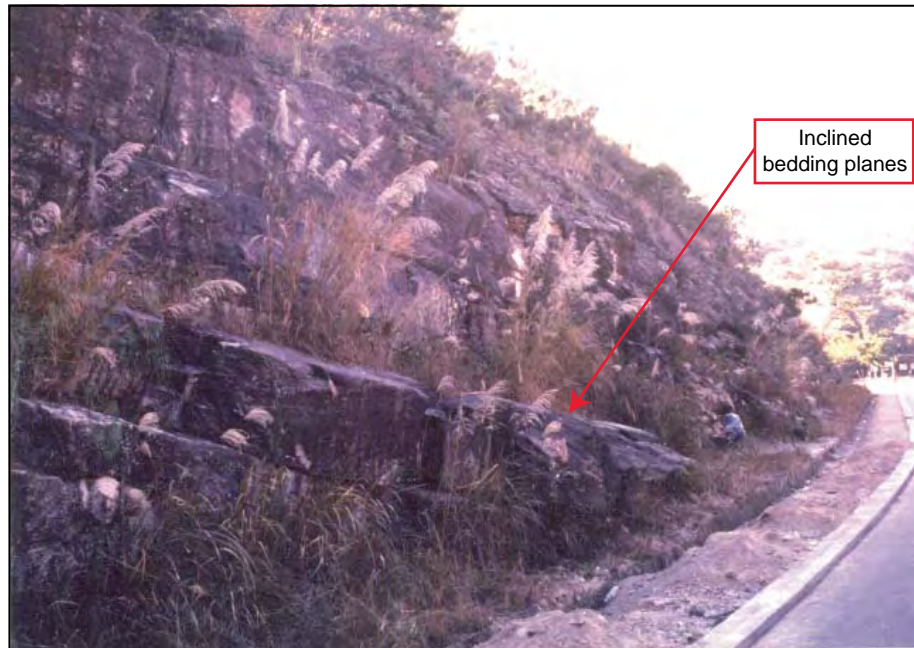
Figure 5.6.2 – Orientation of bedding planes in sandstone of the Pat Sin Leng Formation, at Wu Kau Tang Road (Irfan & Cipullo, 1988)

The ground investigation showed the cut slope is formed of sandstone, which was conglomeratic near the toe of the slope, becoming finer grained upslope. Occasional thin interbeds of mudstone are present, with the general dip being about 21° towards the road. A thin (<1.5m) layer of colluvium was present. Tension cracks were noted above both the cut slope and in the natural terrain. Two types of failure mechanism were noted, namely, the formation of a shear surface at the boundary of the colluvium and weathered sandstone, and slipping along polished, clay-infilled bedding planes. In the bedding plane-controlled failure a steeply dipping joint set, striking sub-parallel to the slope, acted as the rear release surface to the failure and may have allowed the build-up of cleft water pressure (Figure 5.6.3).

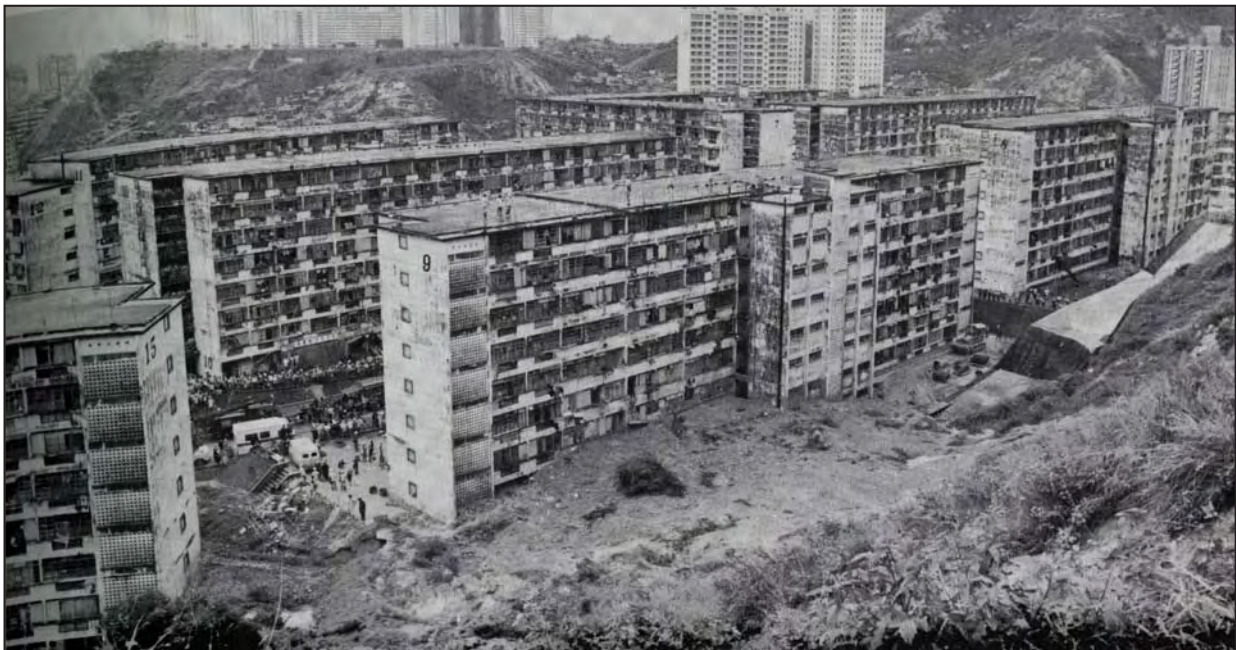
Figure 5.9.2 – View of the fill slope failure at Sau Mau Ping Estate in 1976

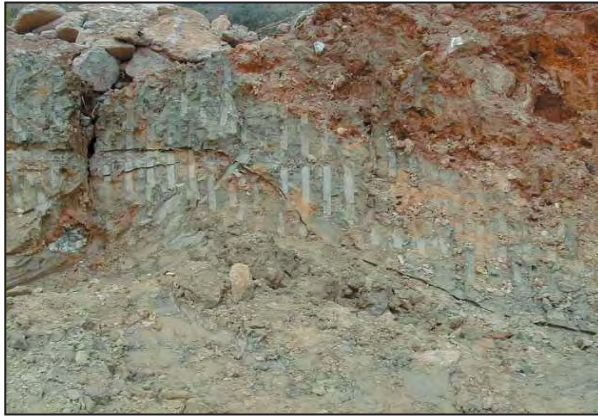
Figure 6.3.11 – Undulating Type 2 shear surface within completely decomposed andesite (photograph by N.P. Koor)

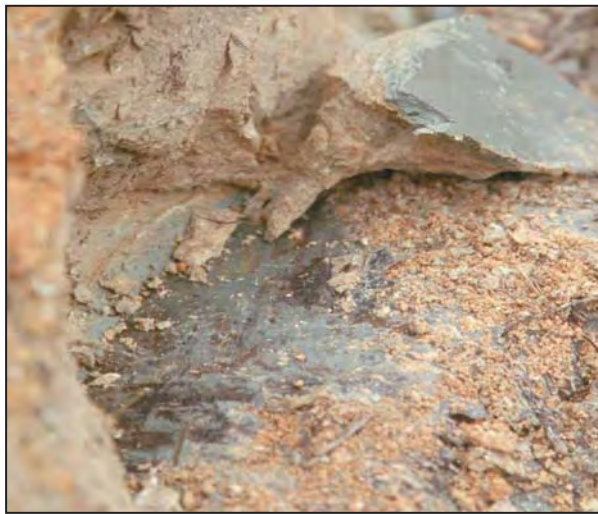
Figure 6.3.12 – Close-up of a Type 2 shear surface with polished and slickensided surfaces and grey clay infill (photograph by N.P. Koor)

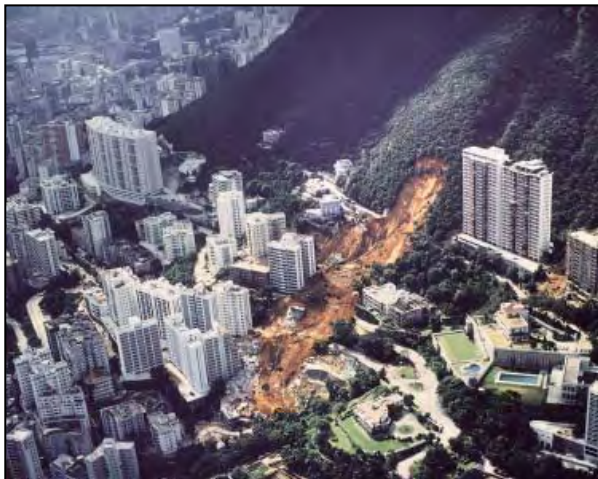
Figure 6.4.1 – 1972 Po Shan Road landslide

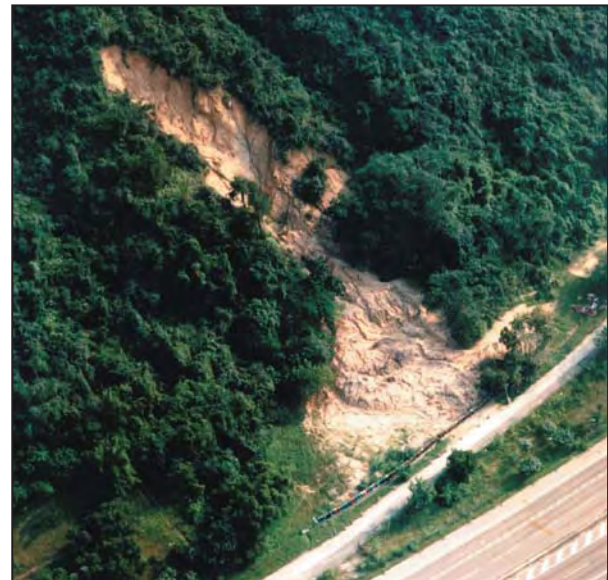
Figure 6.4.3 – 1997 Ma On Shan Road landslide

The landslide involved the displacement of about 2,800 m³ of natural materials and the mobilisation of about 300 m³ of fill on the platform below the cut slope (Figures 6.4.3 and 6.4.4; HAPL, 1999). The hillside contains many relict landslides and incised drainage lines, suggesting an adverse geomorphological

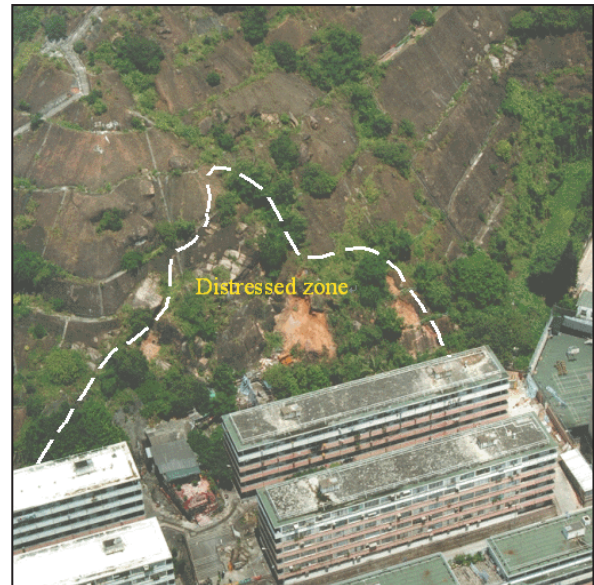
Figure 6.4.5 – 1999 Shek Kip Mei Landslide

The zone of distress comprised about 6,000 m³ of material (Figure 6.4.5; FMSW, 2000). Investigation of the landslide revealed:

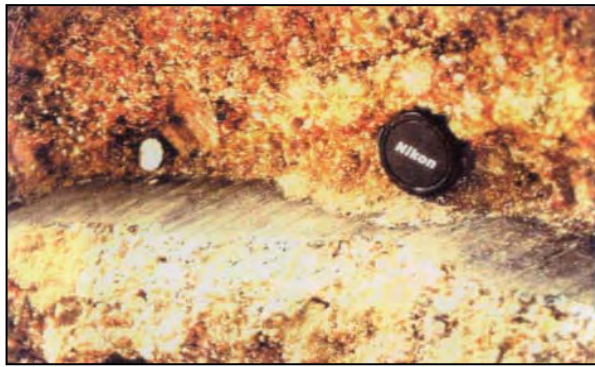
Figure 6.4.7 – Laterally persistent discontinuity infilled with slickensided kaolin and manganese oxide deposits at the toe of the Shek Kip Mei landslide (FMSW, 2000)

- a possible relict landslide scar at the site of the 1999 area of distress (inferred from API),
- a zone of infilled tension cracks which extended up the slope beneath the chunamed surface including areas where no obvious signs of distress were noted at the surface (Figure 6.4.6),
- a 10 mm thick, low angle, kaolin and manganese-oxide infilled, slickensided planar discontinuity that extended for at least 60 m across the toe of

the cut slope and marked the basal rupture surface of the southern part of the 1999 area of distress (Figure 6.4.6 and Figure 6.4.7), and

surfaces and groundwater flow paths/responses. Although the true significance of the 10 mm thick, laterally persistent discontinuity near the toe of the slope might have been difficult to ascertain from a ground investigation involving only a few drillholes, awareness of previous relict instability and detailed mapping of the slope face during excavation would have increased the probability of recognizing the importance of this feature.

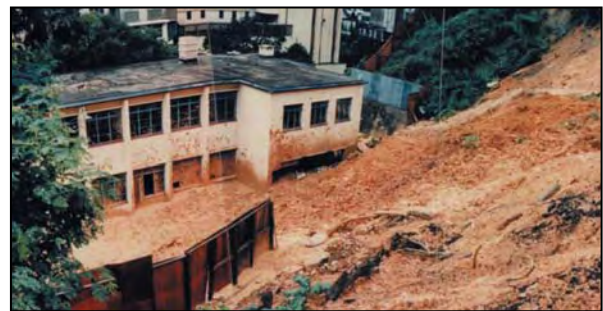
Figure 6.4.8 – 1988 landslide at Island Road School (Irfan, 1989)

These landslides were described in detail by Irfan (1989, 1994b). The main landslide (Figure 6.4.8) involved about 800 m³ of material. There had been much previous instability (Figure 6.4.9), with many landslips associated with an old borrow area dating back to at least 1924. Significant regression of the backslope of the borrow area had also occurred between 1924 and 1949.

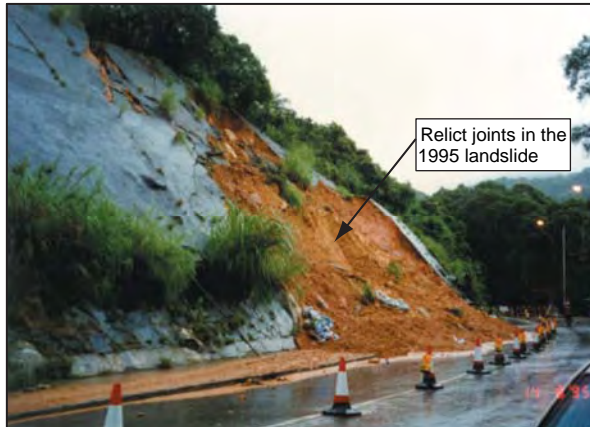
Figure 6.4.13 – 1995 landslide at Sai Sha Road with relict joints (Wong, 1997)

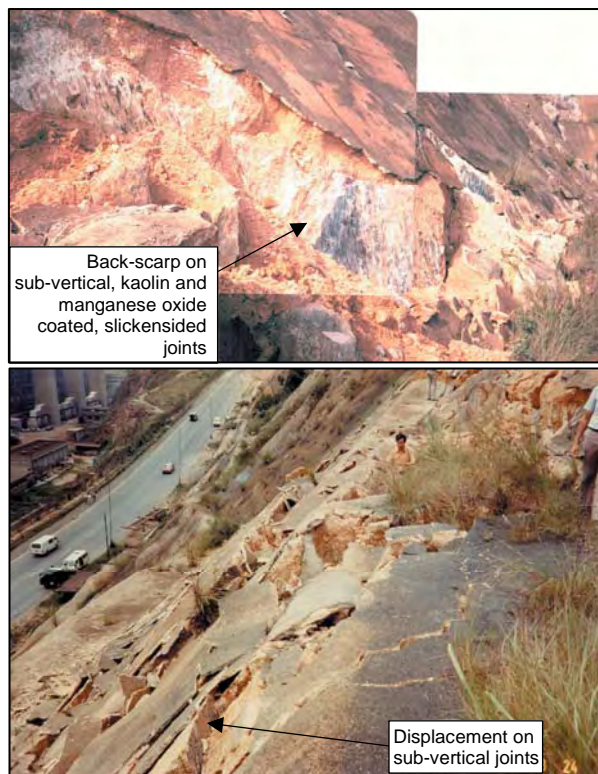
Figure 6.4.17 – Distressed ‘Pepco’ slope in 1982

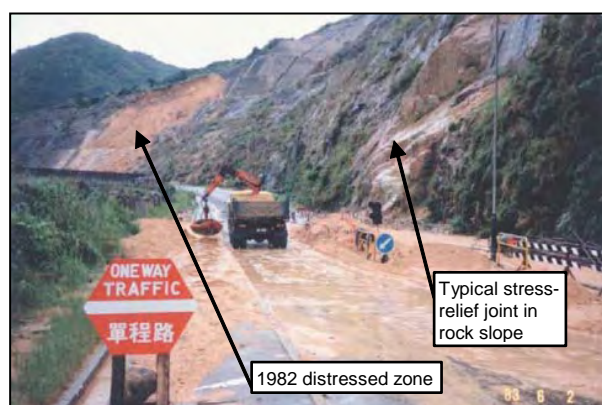
Figure 6.4.18 – Outwash from complete failure of the 1982 distressed zone of the ‘Pepco’ slope blocking Tsing Yi Road in 1983 following heavy rain (Choot, 1993b)

in 1983, leading to substantial disintegration and almost complete detachment of the distressed zone as shown in Figure 6.4.18.

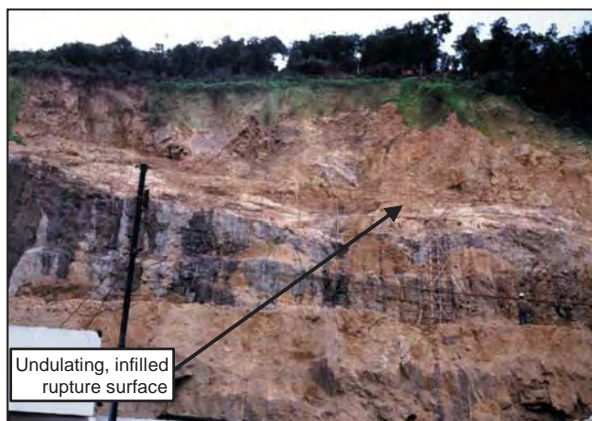
Figure 6.4.19 – 1982 South Bay Close landslide scar (Hencher, 1983b)

This landslide, described by Hencher (1983b) and Clover (1986), occurred in a steep volcanic rock cutting during heavy rain. About 3,800 m³ of moderately and highly decomposed rock failed on a very persistent, undulating discontinuity which dipped out of the slope face at an average angle of about 28° (Figure 6.4.19). A further 700 m³ of adjacent material failed on the same discontinuity during another rainstorm in the same year.

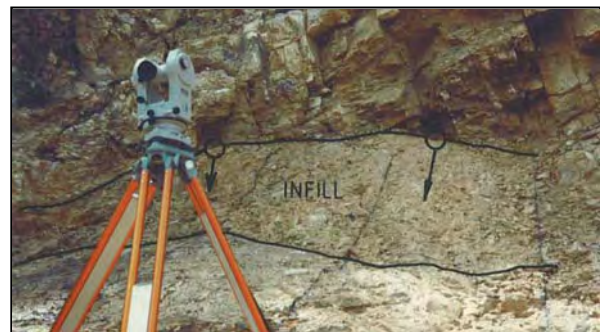
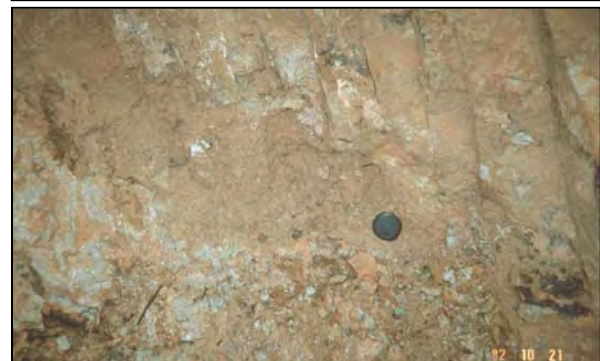
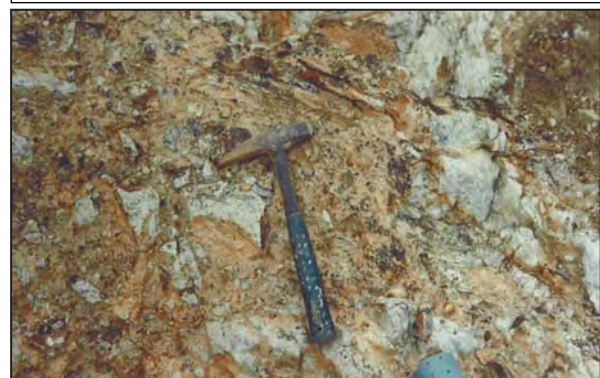
700 mm thick infill along rupture surface overlain by highly to moderately decomposed tuff with soil pipes that flowed with water for several days after the failure (indicated by arrows)

Completely to highly decomposed tuff fragments in a silt/clay matrix overlain by very closely jointed moderately decomposed tuff

Local area of tuff fragments in a clay matrix

Figure 6.4.20 – Variable appearance of the infill along the rupture surface of the South Bay Close landslide (Hencher, 1983b)

and consisted of moderately decomposed gravel fragments in a matrix of sand and silt with pockets of light brown and pink clay (Figure 6.4.20).

The infill was highly variable and was thought to be tectonically disturbed, although no associated slickensides are noted in the above-mentioned references. Hencher (1983b) notes that a continuous broken zone of weathered material was also found in better quality rock at a deeper level. Figure 5 of Hencher (1983b) shows thick tree roots penetrating a loosely interlocked rock mass which may indicate previous movement.

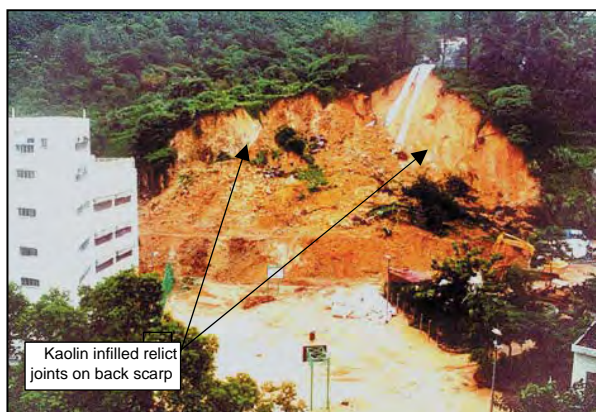
Figure 6.4.22 – 1995 Fei Tsui Road landslide

About 14,000 m³ of highly and completely decomposed tuff failed along a laterally persistent, kaolin-rich seam dipping between 10° and 20° out of the slope (GEO, 1996a,b). Extensive, steeply-dipping, kaolin infilled relict joints formed the back-scarp to the landslide (Figures 6.4.22 and 6.4.23). Details of the kaolin-rich altered tuff layer and the slickensided relict joints in the back-scarp are shown in Figure 6.4.24.

Shear box testing on the kaolin rich tuff layer yielded average and lower-bound shear strength parameters of $c' = 0$, $\phi' = 29^\circ$ and $c' = 0$, $\phi' = 22^\circ$ respectively. Back analysis of the landslide indicated that a perched water table only 2m above the rupture surface yielded a factor of safety of 1.0 if the operative angle of friction on the kaolin seam was assumed to be 28°.

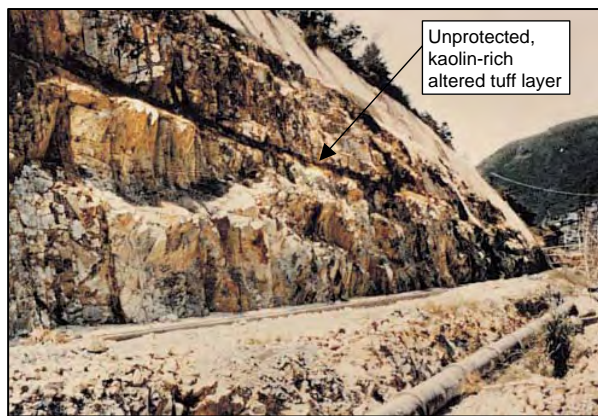
Figure 6.4.25 – Location of the 1995 Fei Tsui Road landslide in 1977 (B&P, 1977)

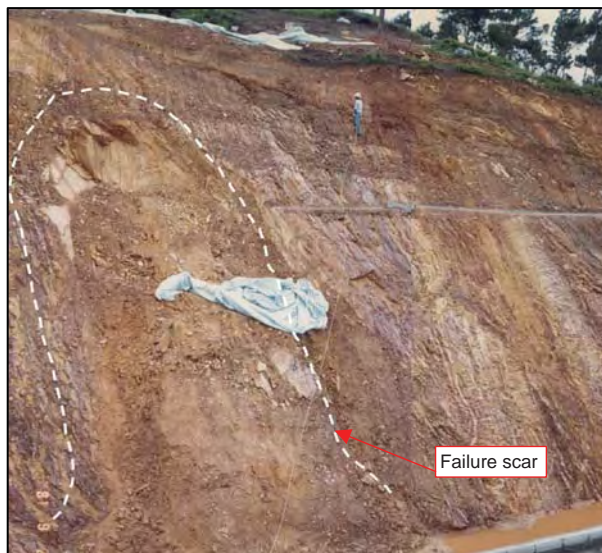
Figure 6.4.29 – 1981 failure on undulating foliation planes plunging steeply towards cutting at Lin Ma Hang Road

more intensively weathered and weaker than had been described in 1981, and adversely orientated, undulating and dilated, foliation fabrics were seen to control the basal shear surface in the slope. The landslide was probably the result of reactivation and enlargement of the relict landslide, exacerbated by progressive dilation of the very weak, intensely foliated rock mass due to excavation of the cutting, tension crack development and ingress of surface water.

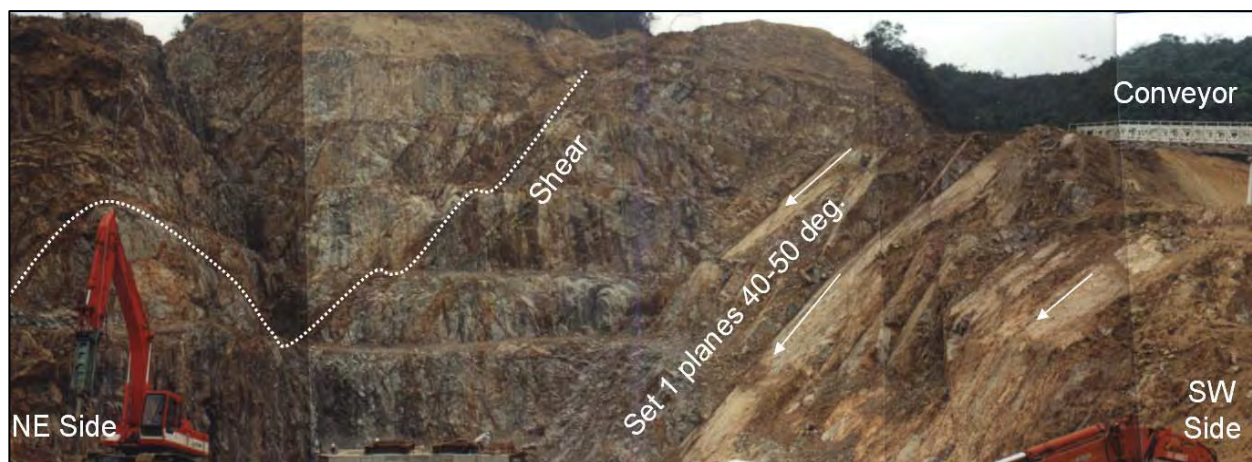
Figure 6.4.32 – Initial ‘box-cut’ of Ting Kau cutting showing continuous shear and persistent Set 1 joint planes (photograph by J.W. Tattersall)

At an early stage during construction, an excavation was made at the northwest end of the cutting which helped to clarify the geological structure. This revealed a continuous shear plane that would intersect the southwest face at an acute angle, and persistent, shallow-dipping joints (Set 1) that were potentially adverse for stability (Figure 6.4.32). Consequently, the southwest slope was re-designed with 20 m high benches at 48° with nominal 4 m wide berms, forming an overall slope angle of 42° (Figure 6.4.33).

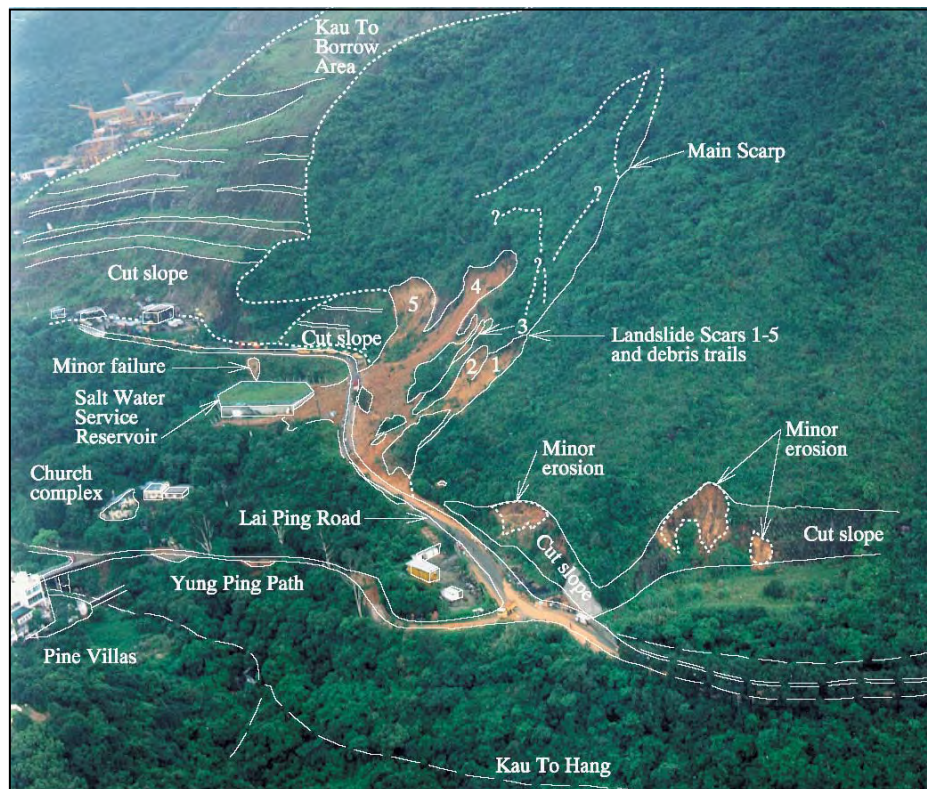
Figure 6.4.38 – 1997 shallow failures at Lai Ping Road and location of main scarp of older landslide (Sun & Campbell, 1999)

Investigations carried out after the 1997 landslide indicated that some piezometers responded rapidly to rainfall, with groundwater rises of about 10 m during rainstorms. The investigations also showed that a depression in rockhead tended to concentrate groundwater flow into the zone of distress and increased the relative groundwater levels above rockhead.

Voids and possible soil pipes or sheared zones were encountered in the investigation drillholes (Figures 6.4.39 and 6.4.40). A large soil pipe was

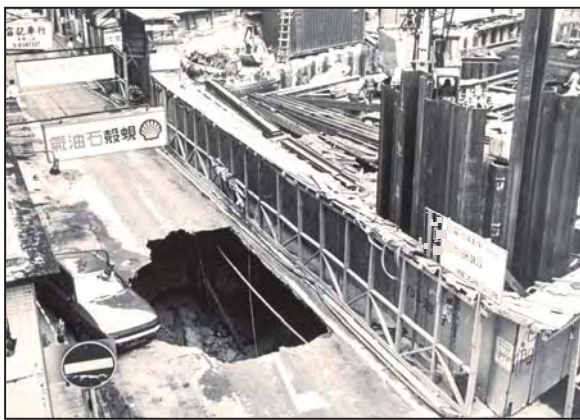
Figure 6.6.1 – Collapse of road due to boulders preventing adequate embedment of sheet piles retaining adjacent excavation

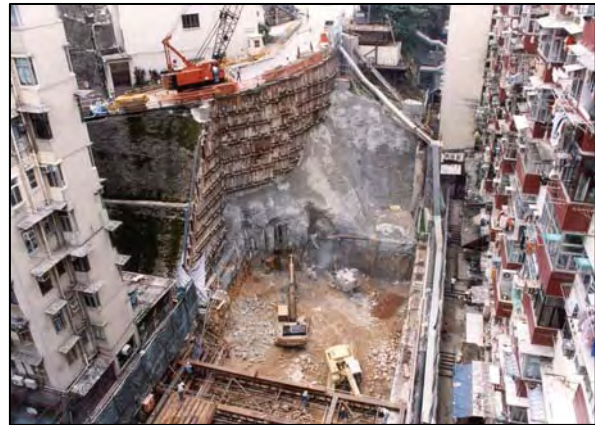
Figure 6.6.2 – Initial excavations for the MTRC North Point plant building

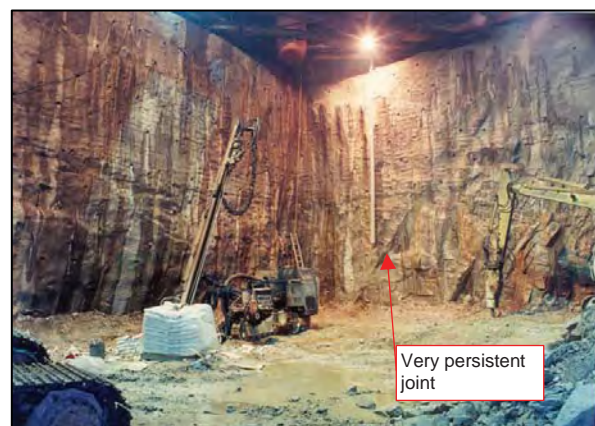
Figure 6.6.3 – MTRC North Point plant building during excavation showing limited support and occasional very persistent joints

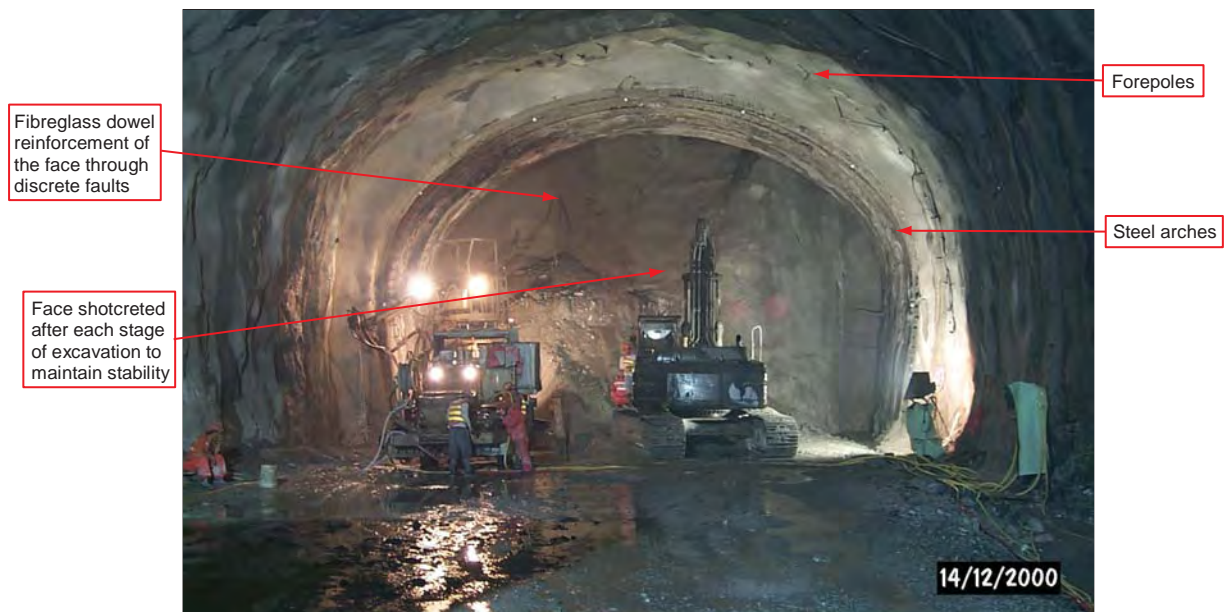
Figure 6.7.11 – Full face excavation, face reinforcement and forepoling during construction (photograph by Nishimatsu-Dragages Joint Venture)

face reinforcement and concrete-lagged steel arches were only required to span across the major zones of weakness (see Figure 6.7.11).
