**REPORT ON
THE RAINSTORM OF
8 MAY 1992**

GEO REPORT No. 22

**GEOTECHNICAL ENGINEERING OFFICE
CIVIL ENGINEERING DEPARTMENT
HONG KONG**

**This report was originally produced in October 1992
as GEO Special Project Report No. SPR 12/92**

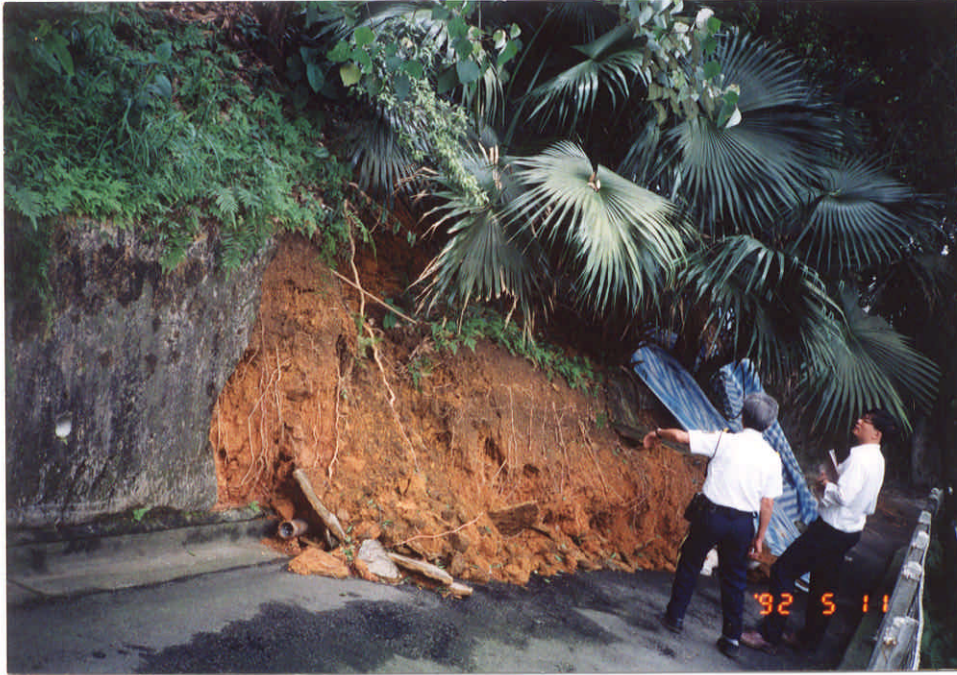
Plate 1 - 12 Severn Road, Mount Gough (Incident HK 5/1)

Negative No. I9221614 Taken on : 11-5-92
Description : Failure of a soil cut slope affecting a private access.

In total, 151 soil cut slope failures were reported, forming 43% of all incidents. Five of these failures were major. Examples of soil cut slope failures are shown in Plates 1 (Incident HK 5/1), 2 (Incident HK 5/3), 11 (Incident HK 5/26), 12 (Incident HK 5/33), 17 and 18 (Incident HK 5/39), 28 (Incident K 5/8), 32 (Incident MW 5/16), 33 (Incident MW 5/17), 34 (Incident MW 5/45), 35 (Incident MW 5/46), 36 (Incident 5/47), 38 (Incident ME 5/1), 39 (Incident ME 5/16) and 42 (Incident ME 5/32). Two failures (HK 5/104 and HK 5/139) are described in more detail in Sections 4.8 and 4.9 respectively.

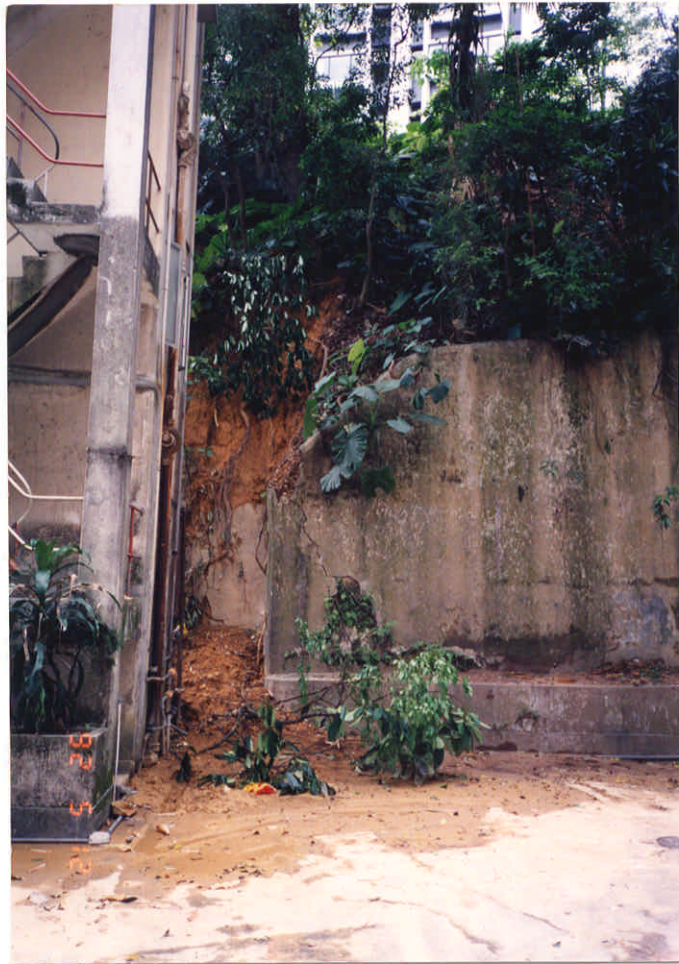
Plate 2 -
78-80 MacDonnell Road, The Peak
(Incident HK 5/3)

Description :
Failure of a soil cut slope affecting a building lot.

There were 65 incidents affecting building lots, six of which were major. Incidents in this category killed two people and injured five (all were casualties of one incident, HK 5/8), and resulted in the temporary evacuation of 23 buildings in part or in total. Examples are shown in Plates 2 (Incident HK 5/3), 3-8 (Incident HK 5/8), 13-16 (Incident HK 5/38), 20 (Incident HK 5/50), 37 (Incident MW 5/67), 39 (Incident ME 5/16) and 41 (Incident ME 5/31). Four incidents (HK 5/8, HK 5/38, HK 5/59 and HK 5/139) are described in more detail in Sections 4.2, 4.4, 4.6, and 4.9 respectively.

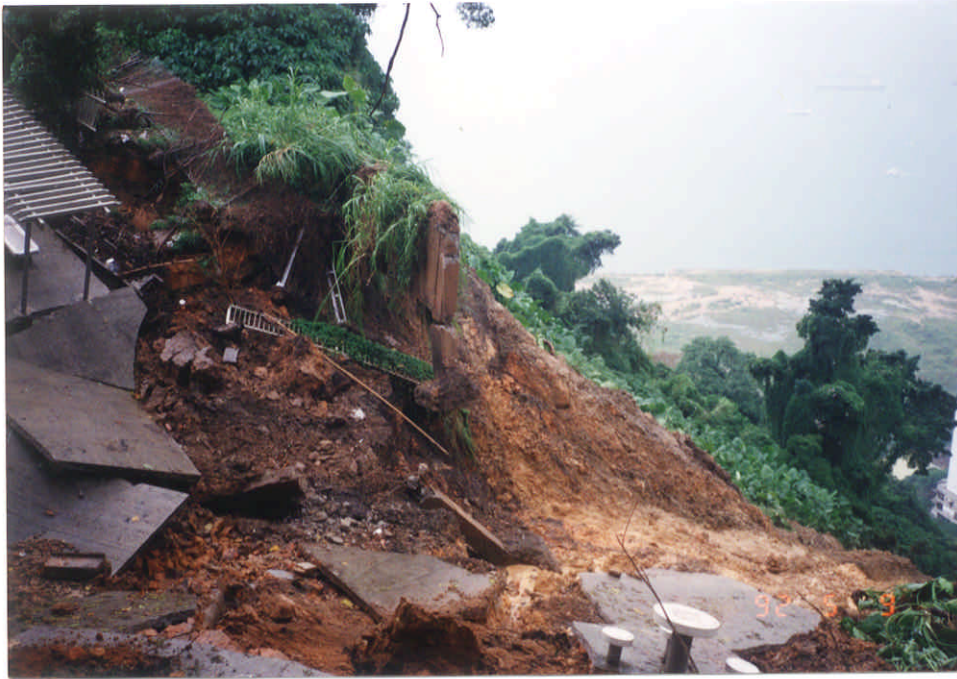
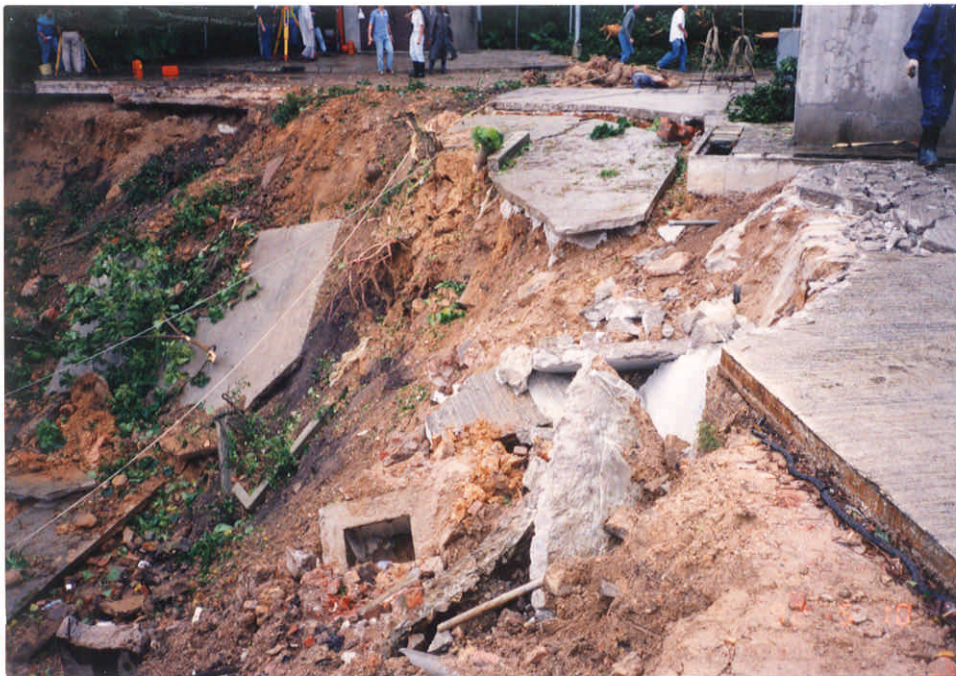
Plates 3 & 4 - Baguio Villas, Victoria Road, Pokfulam (Incident HK 5/8)

Description : Major failure of a retaining wall and a fill platform (about 3500 cu m).
Two dead, five injured. Edge of fill platform illustrated.

(Major debris flow resulting from the failure of an old retaining wall and the subsequent liquefaction of loose fill. Two deaths. Plates 3 to 8.)

The failure began at about 1400 hrs on 8 May when the central part of the masonry retaining wall collapsed during heavy rain which started at about 1340 hrs. This initial failure released about 700 cu m of fill material into the

The total volume of material involved in these failures was about 3500 cu m. A detailed report on the Baguio landslide may be found in GEO (1992).

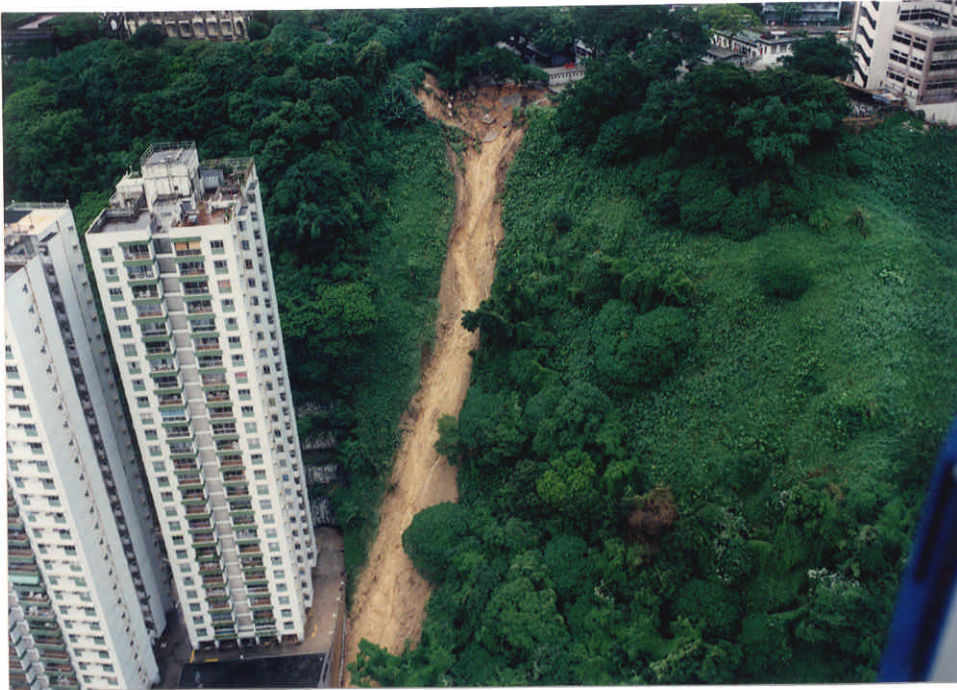
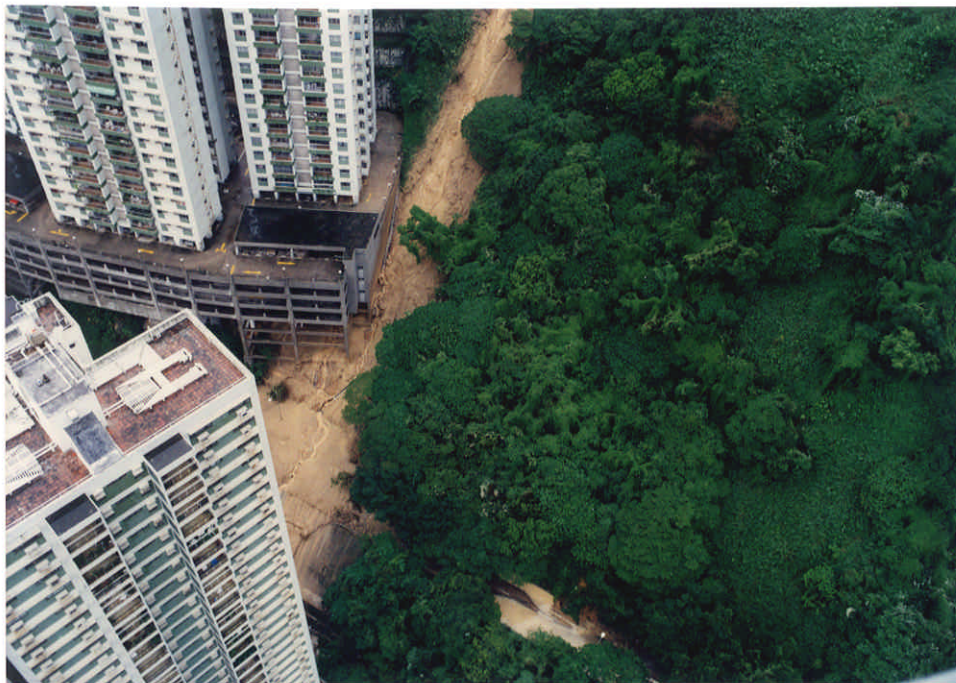
Description : Major failure of a retaining wall and a fill platform (about 3500 cu m).
Two dead, five injured. Blocks 26 and 44 illustrated.

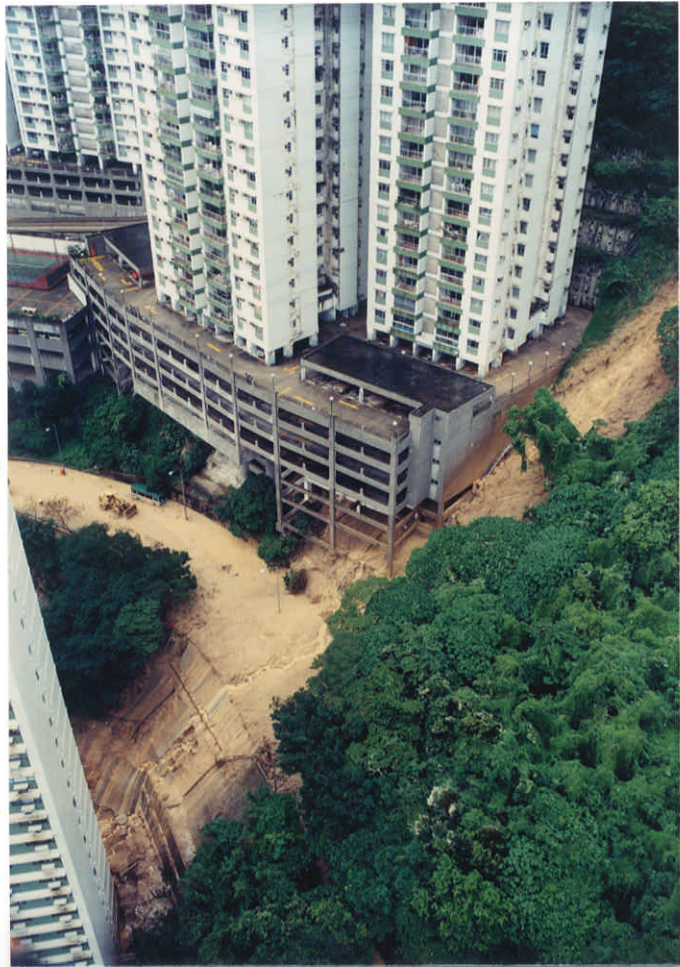
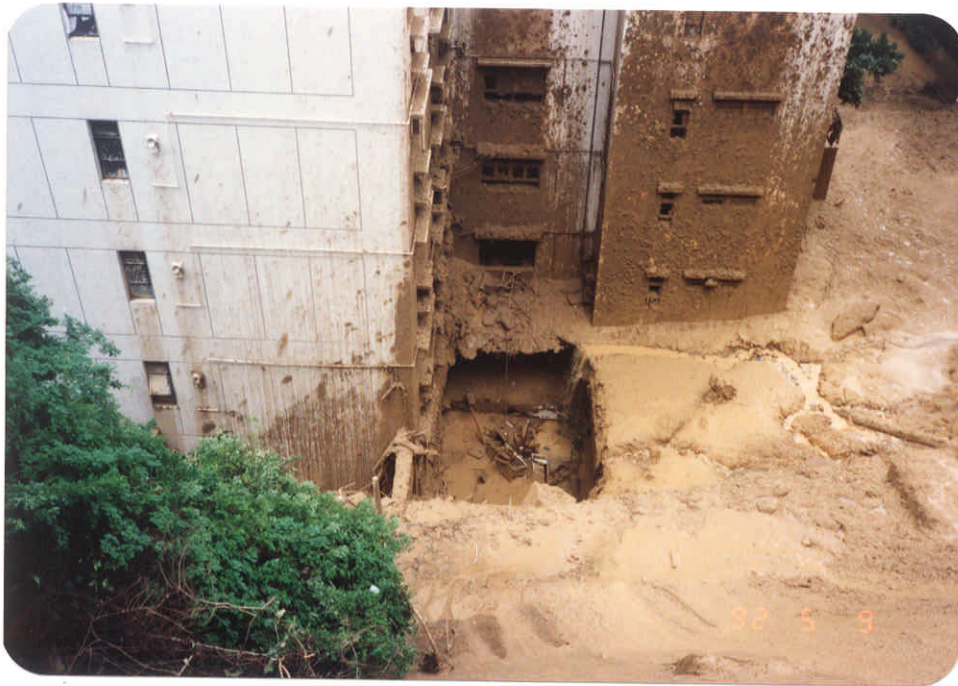
Plate 7 & 8 - Baguio Villas, Victoria Road, Pokfulam (Incident HK 5/8)

Negative No. I92210I03 Taken on : 9-5-92
Description : Major failure of a retaining wall and a fill platform (about 3500 cu m).
Two dead, five injured. Block 44 illustrated.

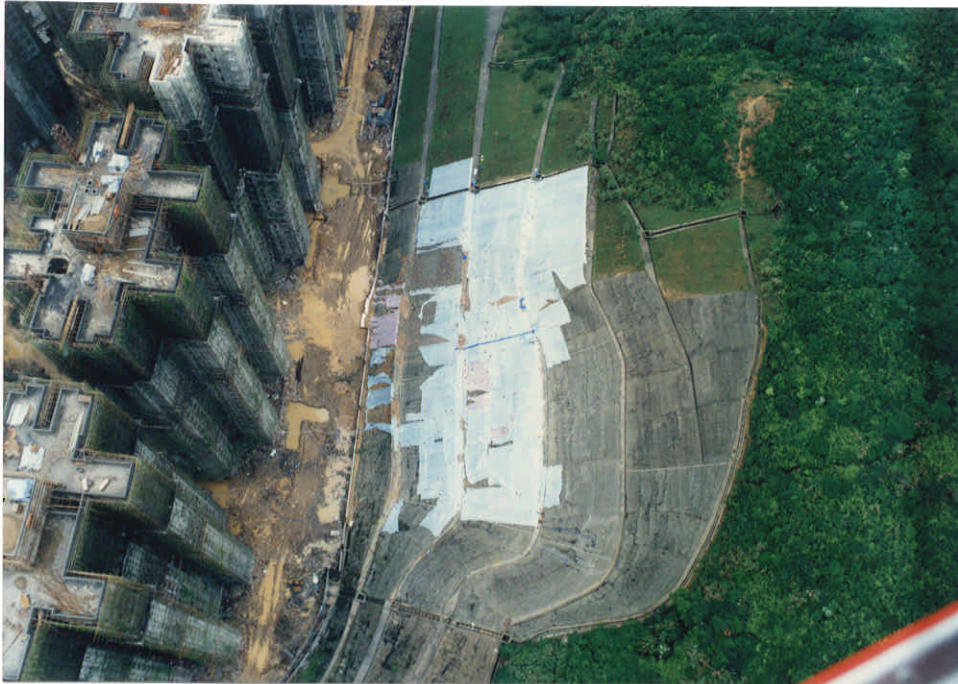
Description : Major failure of a soil/rock cut slope (about 100 cu m).

4.3 Incident HK 5/18, Siu Sai Wan Private Sector Participation Scheme Site
(Continuing major failure of a soil cut slope, affecting a construction site. Plates 9 and 10.)

This site, which has a history of instability and at which a previous major failure occurred in April 1992, was being investigated by the GEO when the rainstorm of 8 May triggered further movement. The failures at this site are relatively deep-seated and slow moving, with the failed mass remaining on the slope. The GEO investigation suggests that the failures may be associated with deep weathering of hydrothermally altered volcanic rock (tuff), coupled with a complex groundwater regime. The failure of 8 May caused damage to chunam, concrete berm slabs and U-channels.

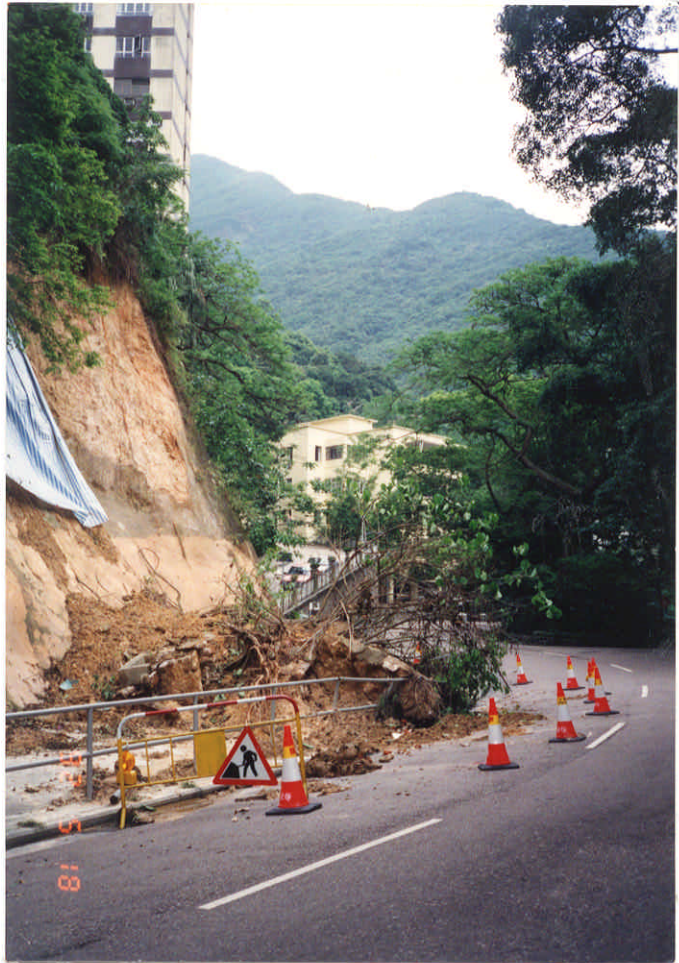
Plate 11 -
92 Pokfulam Road, Kennedy Town
(Incident HK 5/26)

Description :
Failure of a soil cut slope resulting
in the blockage of a pedestrian
pavement and the partial blockage of
one road lane.

A total of 70 incidents affected pedestrian pavements, three of which were major. Examples are shown in Plates 11 (Incident HK 5/26), 13 to 16 (Incident HK 5/38), 25 (Incident HK 5/152), 29 (Incident MW 5/3), 30 and 31 (Incident MW 5/12), 32 (Incident MW 5/16) and 40 (Incident ME 5/22). Three incidents (HK 5/38, HK 5/140 and MW 5/3) are described in more detail in Sections 4.4, 4.10 and 4.12 respectively.

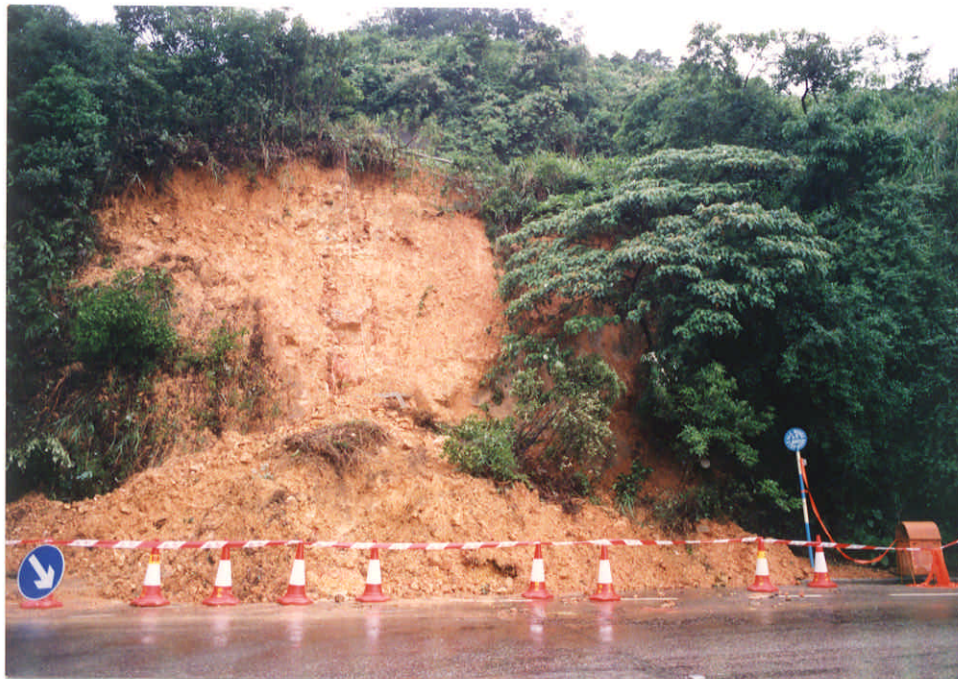
Plate 12 - Junction of Stubbs Road and Peak Road, The Peak (Incident HK 5/33)

Negative No. I9220816 Taken on : 8-5-92
Description : Failure of a soil cut slope resulting in the blockage of one road lane.

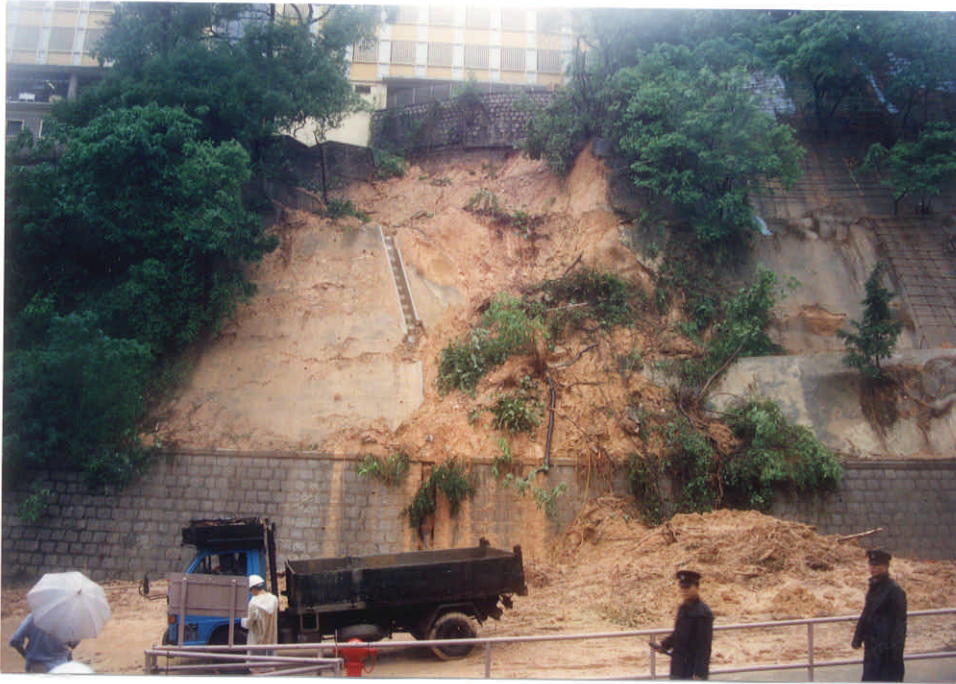
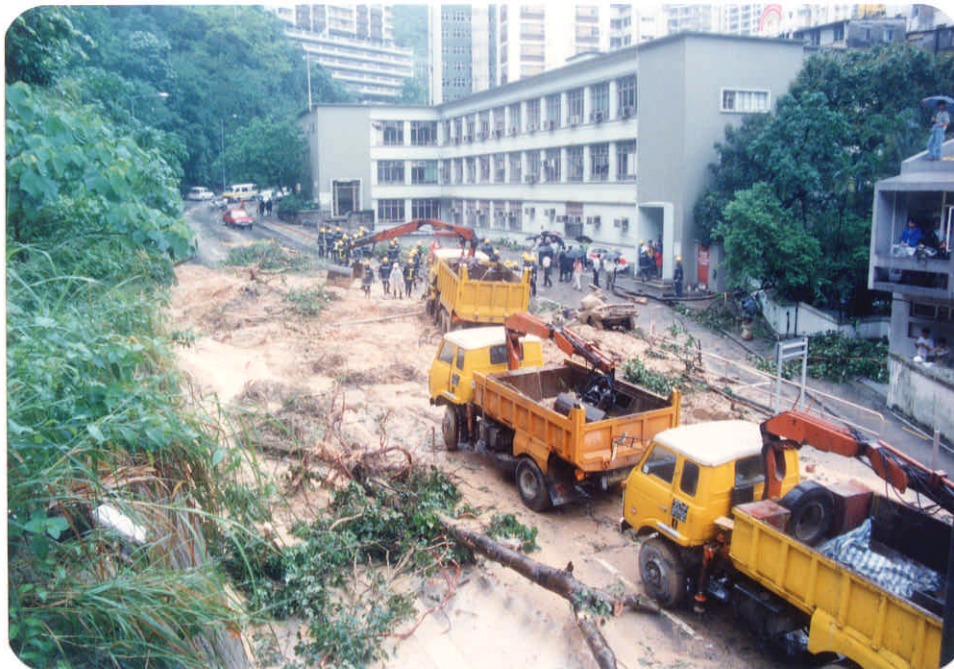
Plates 13 & 14 - Kennedy Road, below Wah Yan College, Happy Valley
(Incident HK 5/38)

Description : Major failure of a fill slope (about 500 cu m). One dead, three lanes of Kennedy Road blocked.

4.4 Incident HK 5/38, Kennedy Road, below Wah Yan College, Happy Valley
(Major failure of a fill slope. One death. Plates 13 to 16.)

At about 0810 on 8 May, fill at the crest of a 24 m high soil cut slope failed during heavy rain. The debris, about 500 cu m, struck a passing car and killed the motorist inside. Three lanes of Kennedy Road were blocked while Wan Chai Clinic and parts of Wah Yan College were closed.

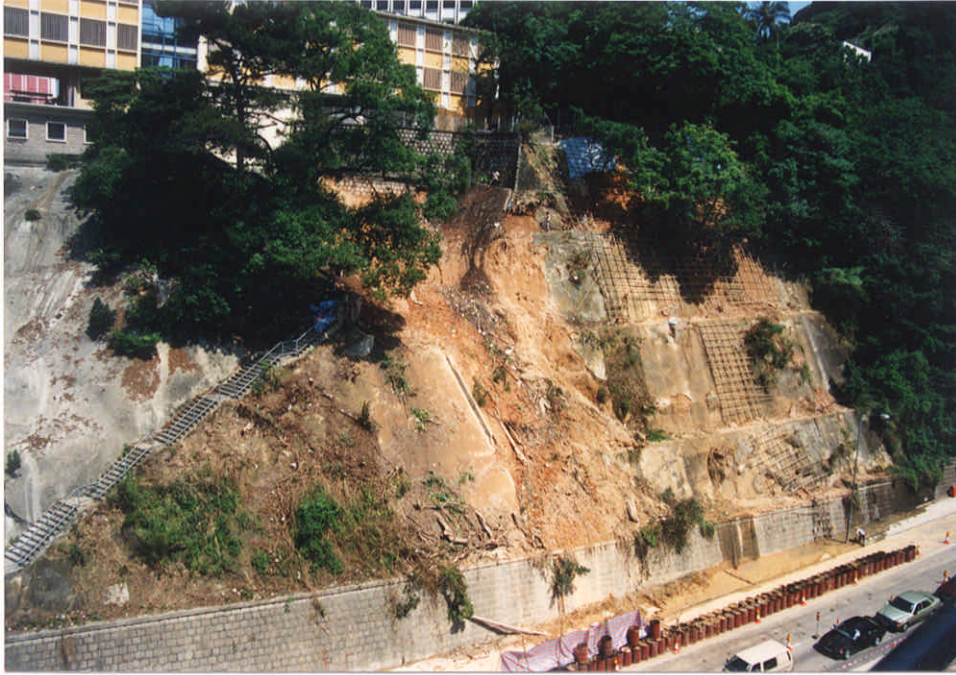
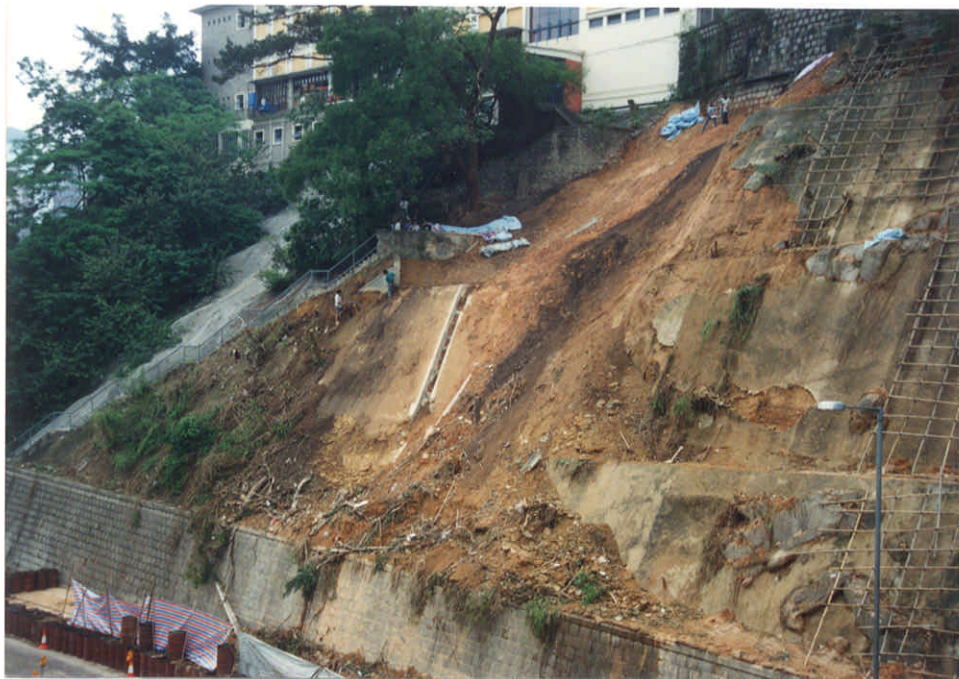
Plates 15 & 16 - Kennedy Road, below Wah Yan College, Happy Valley
(Incident HK 5/38)

Description : Major failure of a fill slope (about 500 cu m). One dead, three lanes of Kennedy Road blocked.

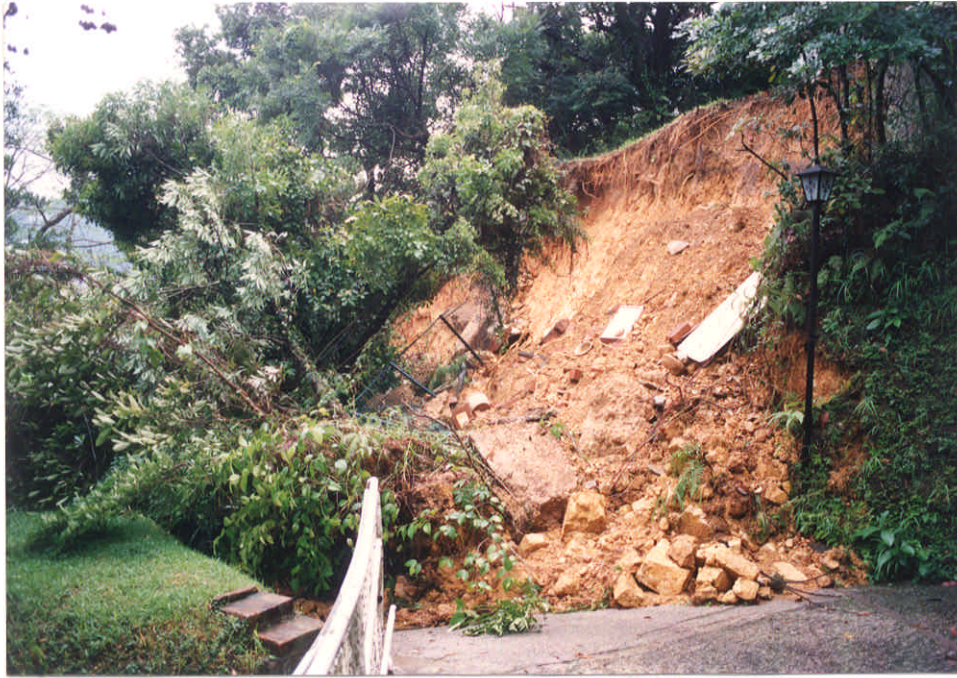
Plate 17 - 9 Middle Gap Road, Wan Chai Gap (Incident HK 5/39)

Negative No. I9220814 Taken on : 9-5-92
Description : Failure of a soil cut slope resulting in the blockage of a private access.

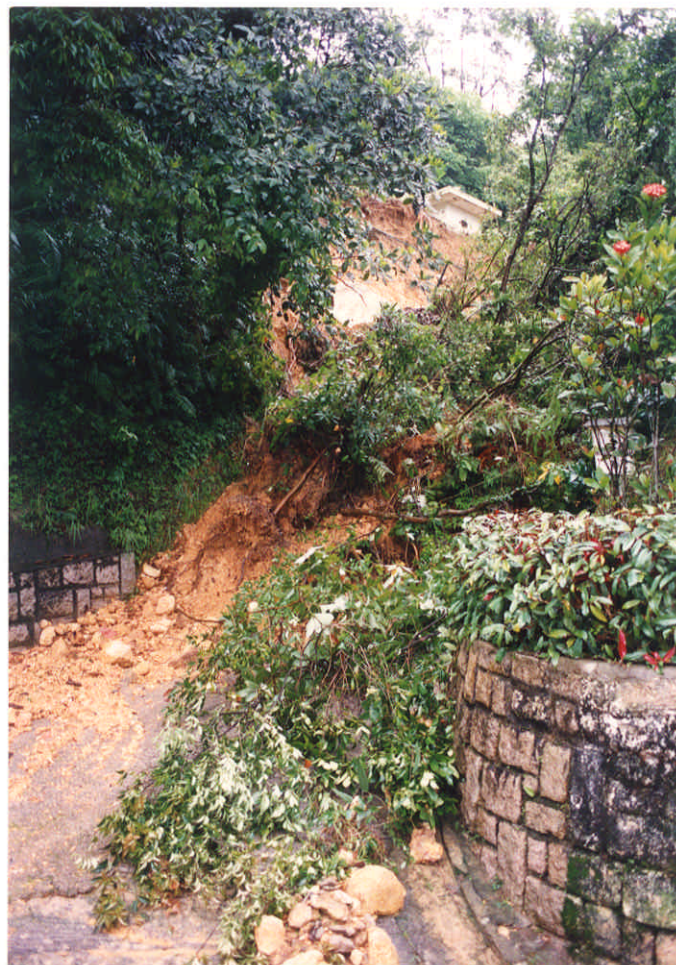
Plate 19 -
15-38 Mount Kellett Road, Mount
Kellett (Incident HK 5/48)

Description :
Failure of a soil/rock cut slope
resulting in the blockage of two road
lanes.

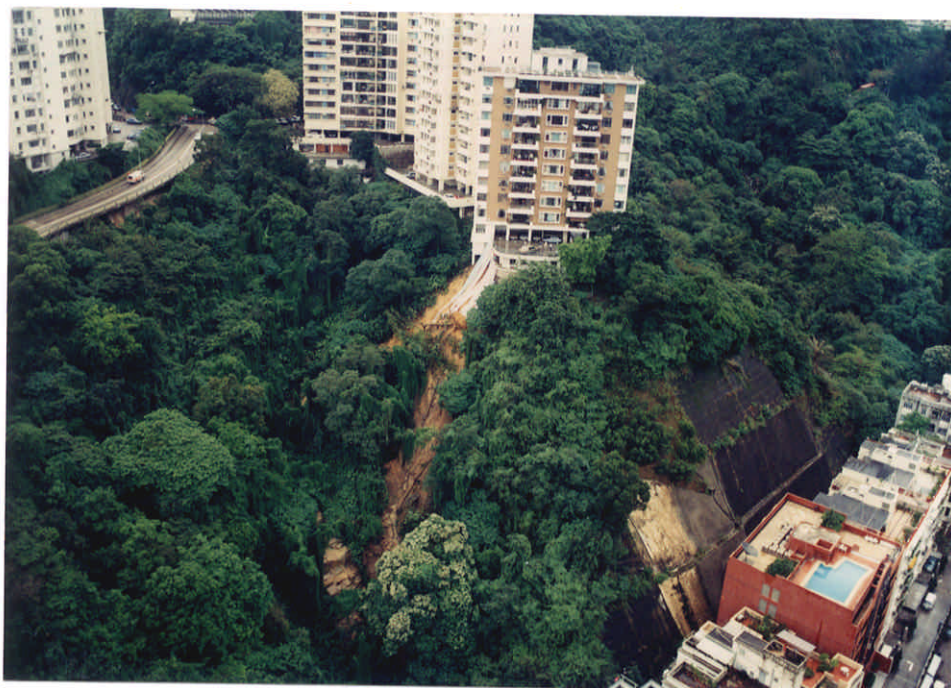
Plate 20 - Below 156 Tai Hang Road, So Kon Po (Incident HK 5/50)

Negative No. 14602 Taken on : 9-5-92
Description : Major failure of a fill slope (about 100 cu m).

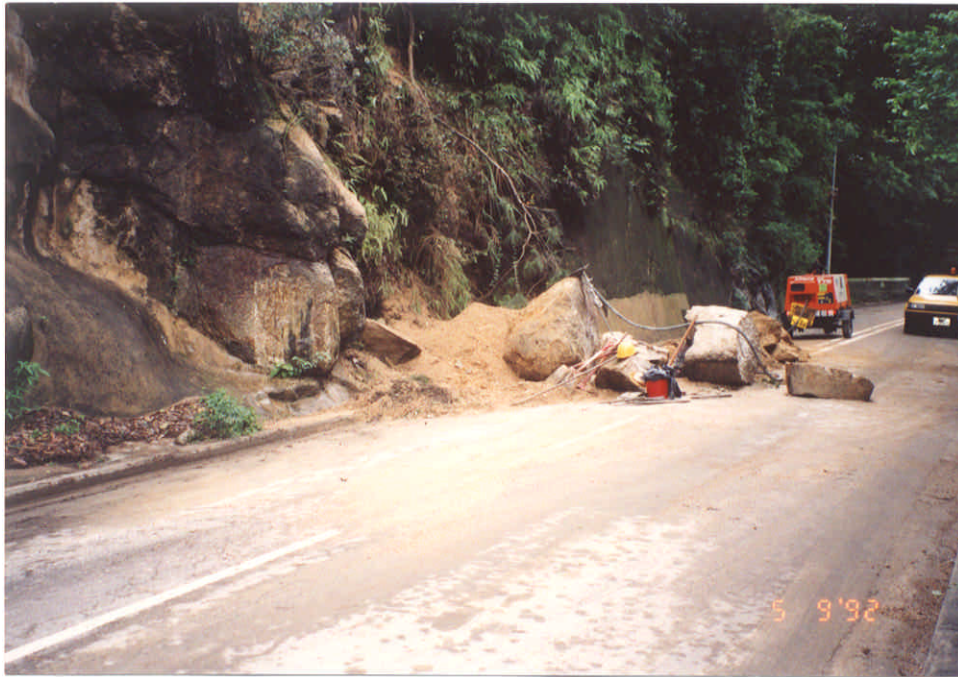
Plate 21 - Tai Hang Road, Jardine's Lookout (Incident HK 5/55)

Negative No. I9224802 Taken on : 9-5-92
Description : Failure of a soil/rock cut slope resulting in the blockage of two road lanes.

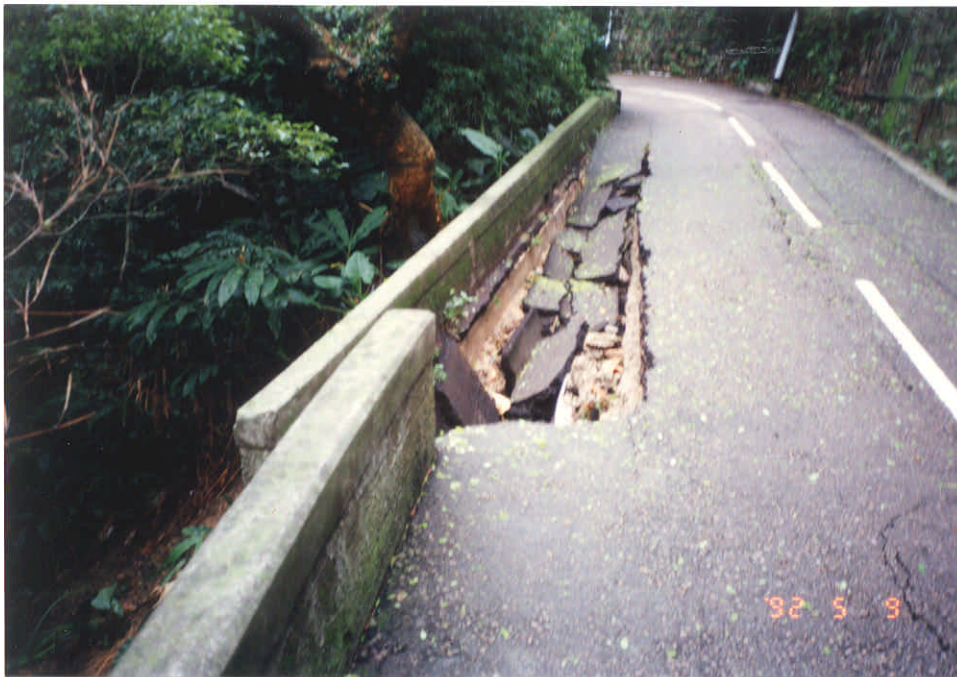
Plate 22 - Below 5 Coombe Road, Magazine Gap (Incident HK 5/70)

Negative No. A9206704 Taken on : 9-5-92
Description : Major failure of a retaining wall resulting in ground subsidence and the closure of two road lanes.

- 4.7 Incident HK 5/70, below 5 Coombe Road, Magazine Gap
(Major failure of a retaining wall resulting in subsidence and the closure of two lanes of the road. Plate 22.)

On 8 May, a 20 m length of retaining wall on the downslope side of Coombe Road failed and moved about 1 m downslope. Both lanes of the road were closed. Localised surface failures were noted on the slope below the retaining wall, together with a broken water pipe which may have contributed to the failure.

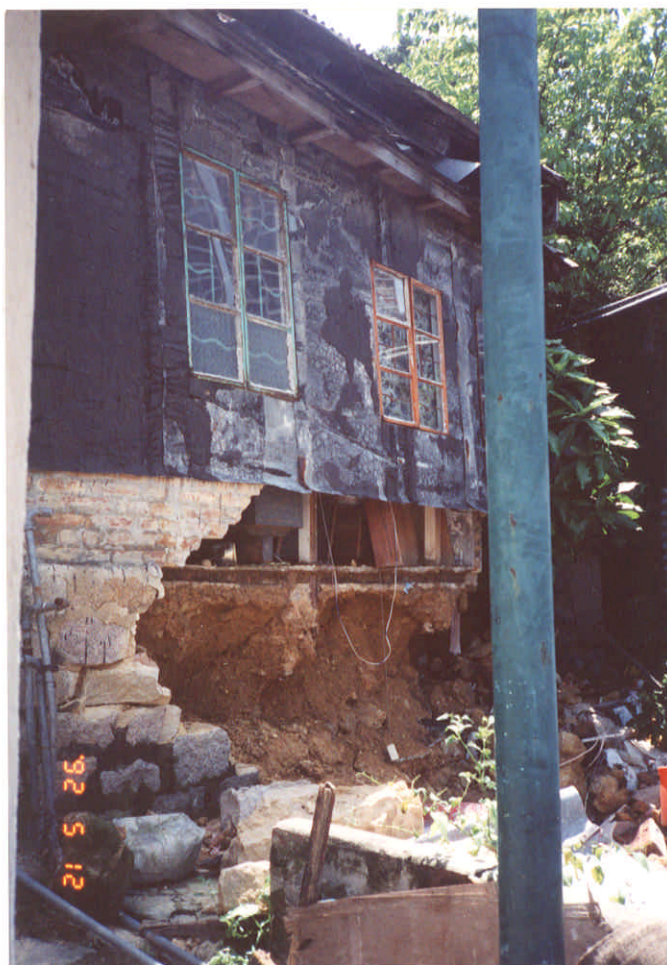
Plate 24 -
Hut No. 1977, Pokfulam Village
(Incident HK 5/98)

Description :
Failure of a retaining wall resulting
in the permanent evacuation of nine
huts.

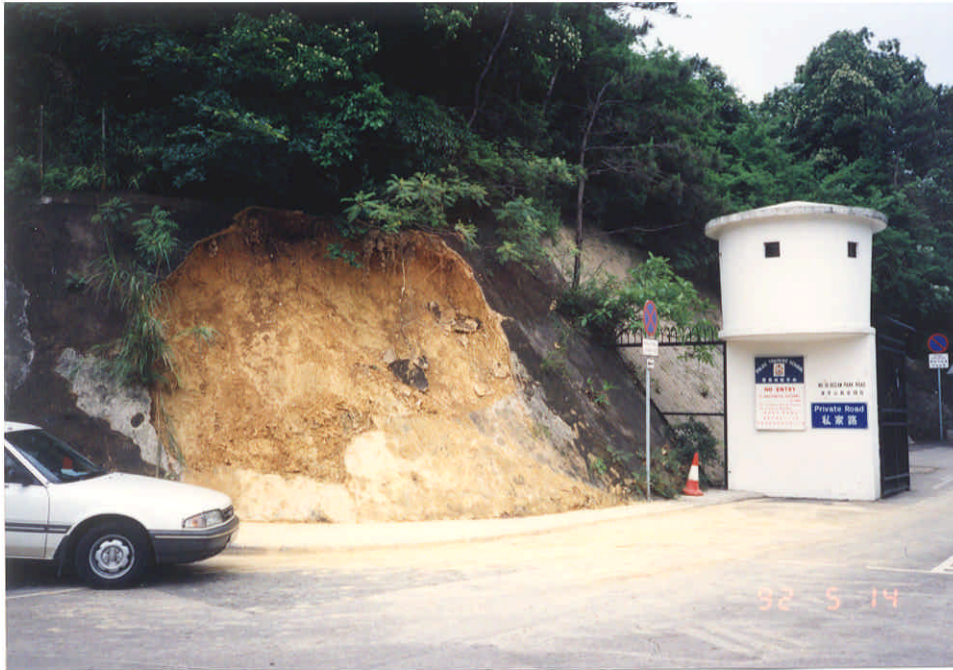
Plate 25 - Ocean Park Road, Wong Chuk Hang (Incident HK 5/152)

Negative No. I9224212A Taken on : 14-5-92
Description : Failure of a soil/rock cut slope affecting a pedestrian pavement.

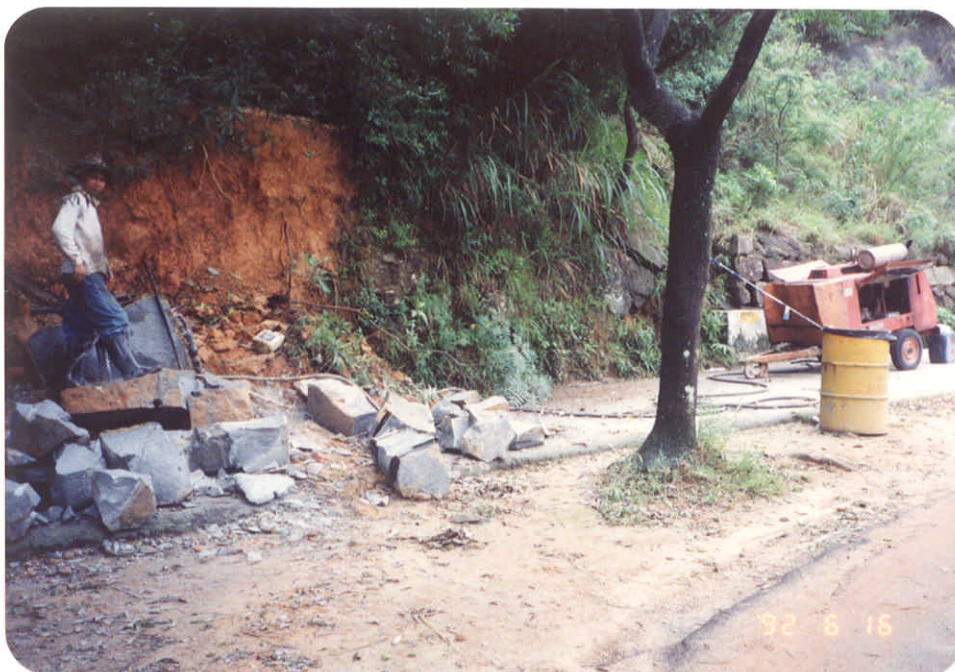
Plate 26 - Aberdeen SW Service Reservoir (Incident HK 6/2)

Negative No. I9235707 Taken on : 16-6-92
Description : Rock/boulder fall affecting a footpath.

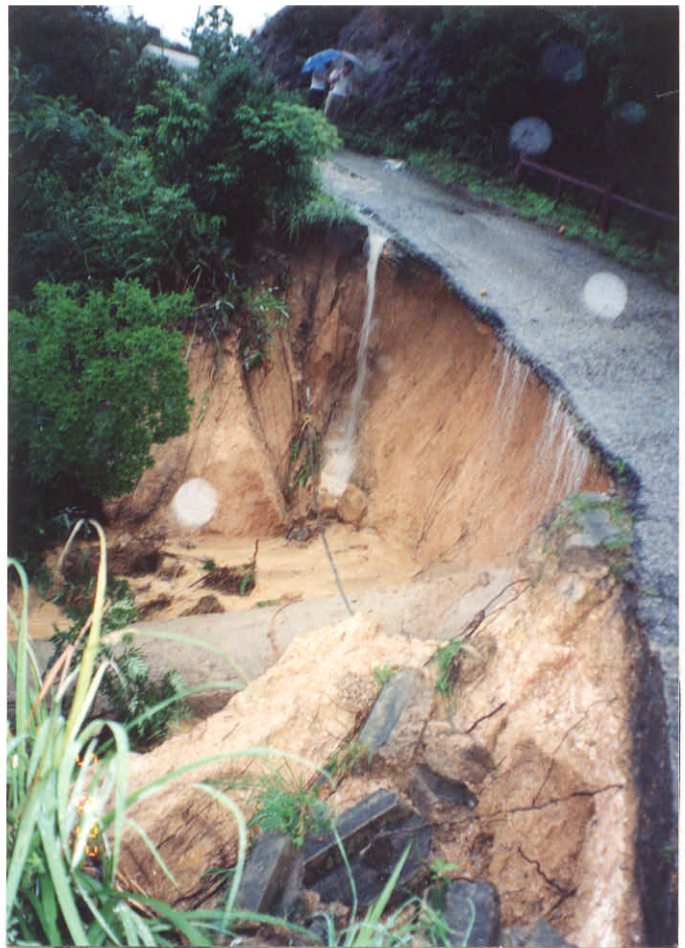
Plate 27 -
Jat's Incline above Fung Shing Street
(Incident K 5/6)

Description :
Major failure of a fill slope (about
65 cu m) resulting in road closure.

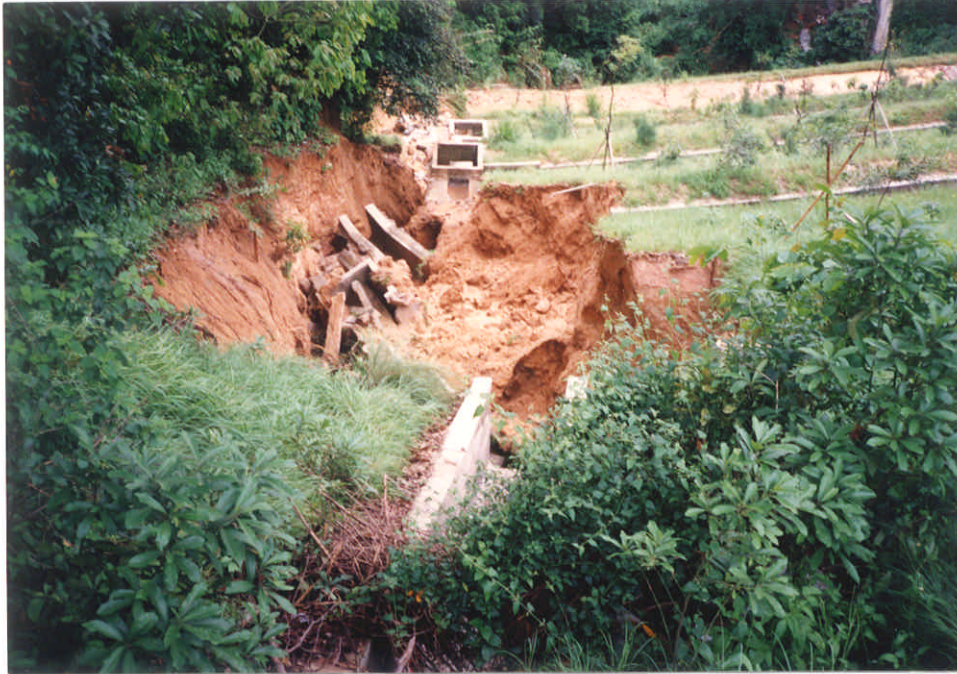
Plate 29 - Tai Po Road Near Carlton Hotel, Kowloon (Incident MW 5/3)

Negative No. MW9210505 Taken on : 9-5-92
Description : Major failure of a fill slope (over 50 cu m) resulting in the closure of one road lane.

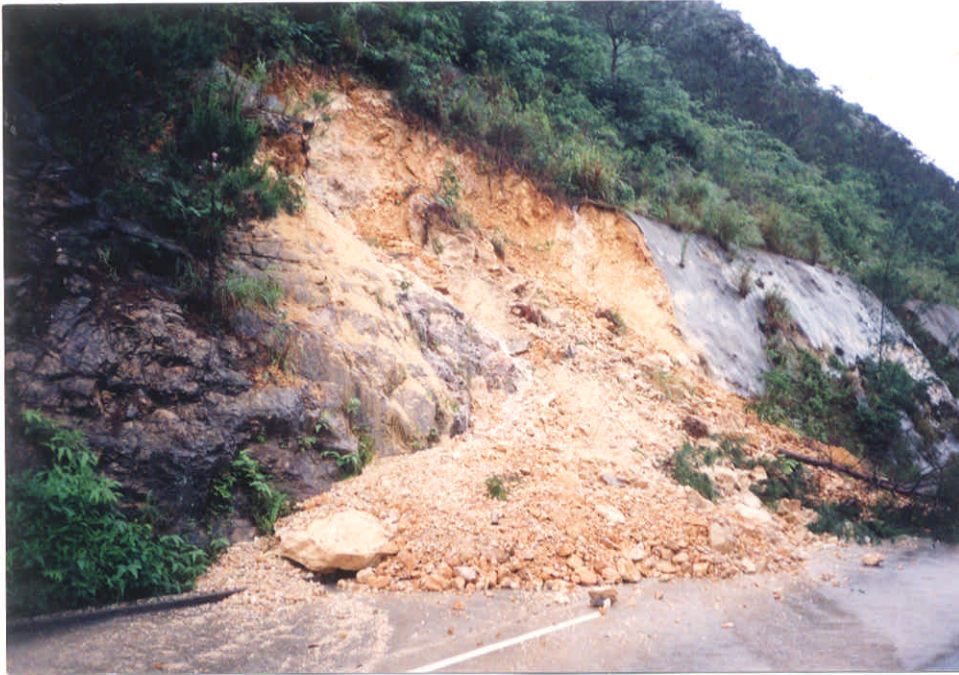
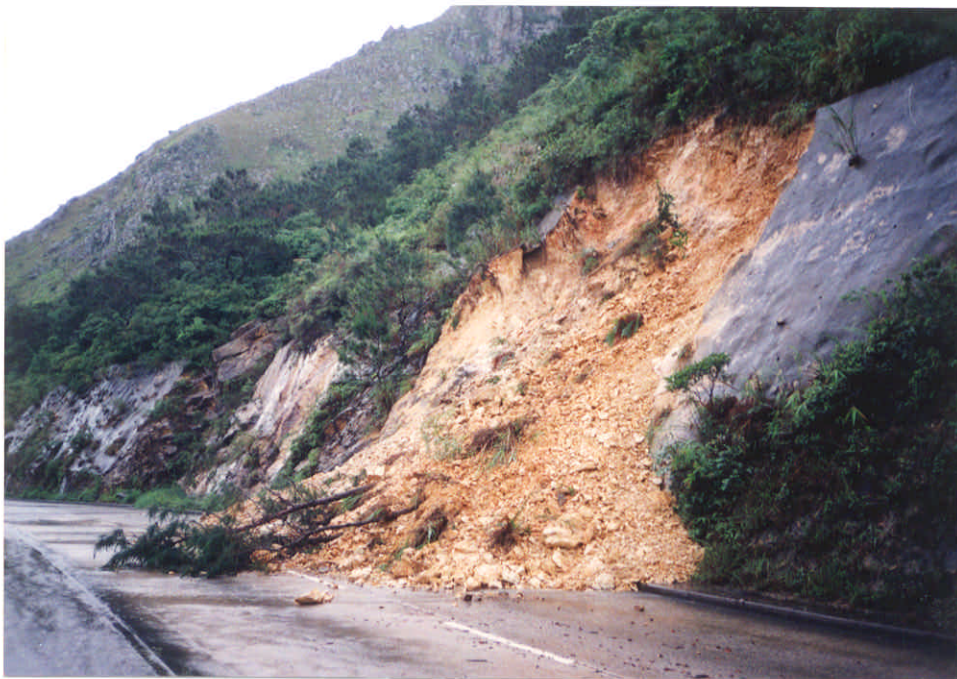
Plates 30 & 31 - Tai O Road, near MS 12¾ , Lantau Island (Incident MW 5/12)

Description : Failure of a soil/rock cut slope resulting in the blockage of a pedestrian pavement and one road lane.

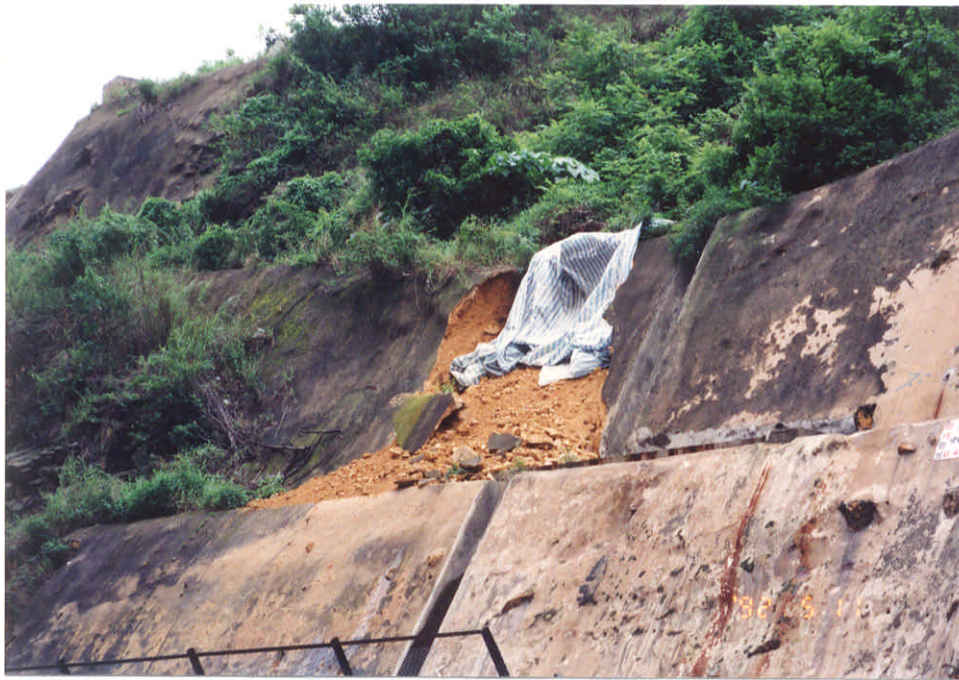
Plate 32 - Kwai Fuk Road, Kwai Chung (Incident MW 5/16)

Negative No. MW9210806 Taken on : 11-5-92
Description : Failure of a soil cut slope affecting a pedestrian pavement.

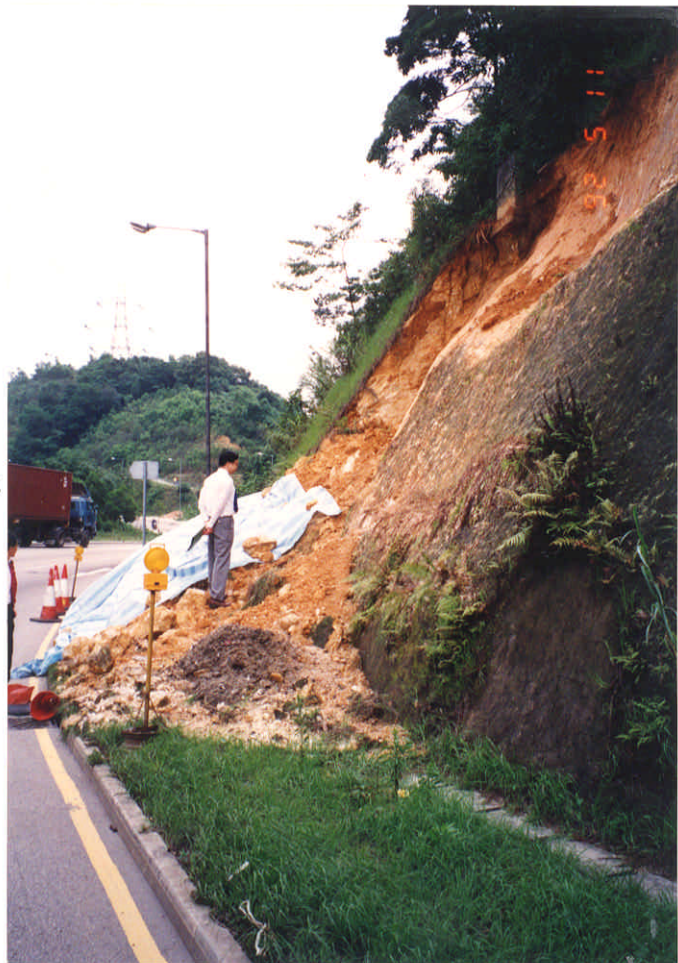
Plate 33 -
Piper's Hill, Shatin
(Incident MW 5/17)

Description :
Failure of a soil cut slope affecting a road.

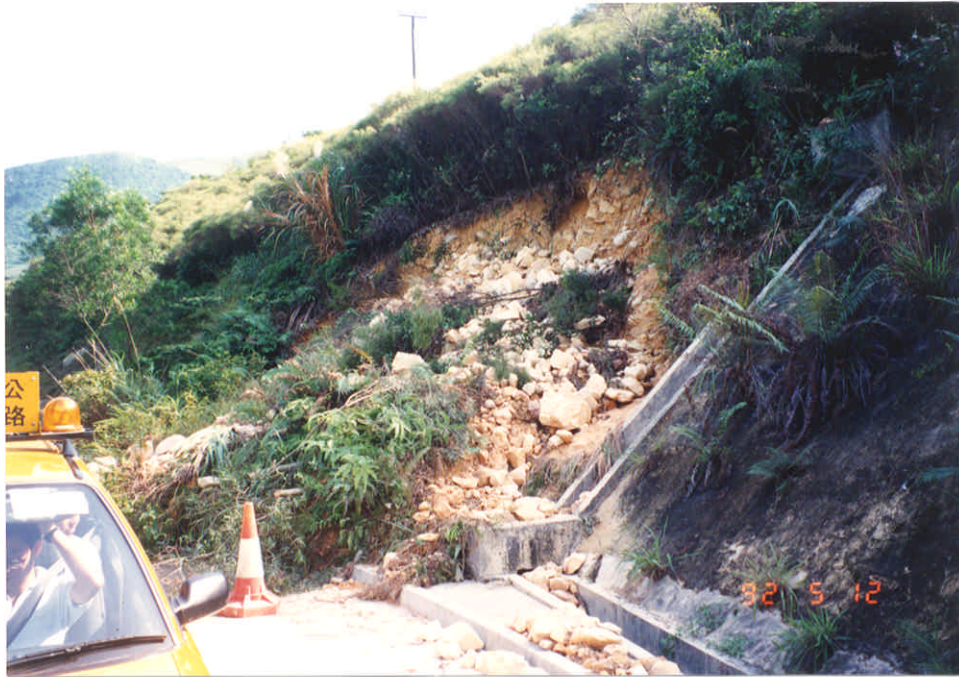
Plate 34 - Sham Wat Road, Lantau Island (Incident MW 5/45)

Negative No. MW9211524 Taken on : 12-5-92
Description : Failure of a soil cut slope resulting in the partial blockage of a road.

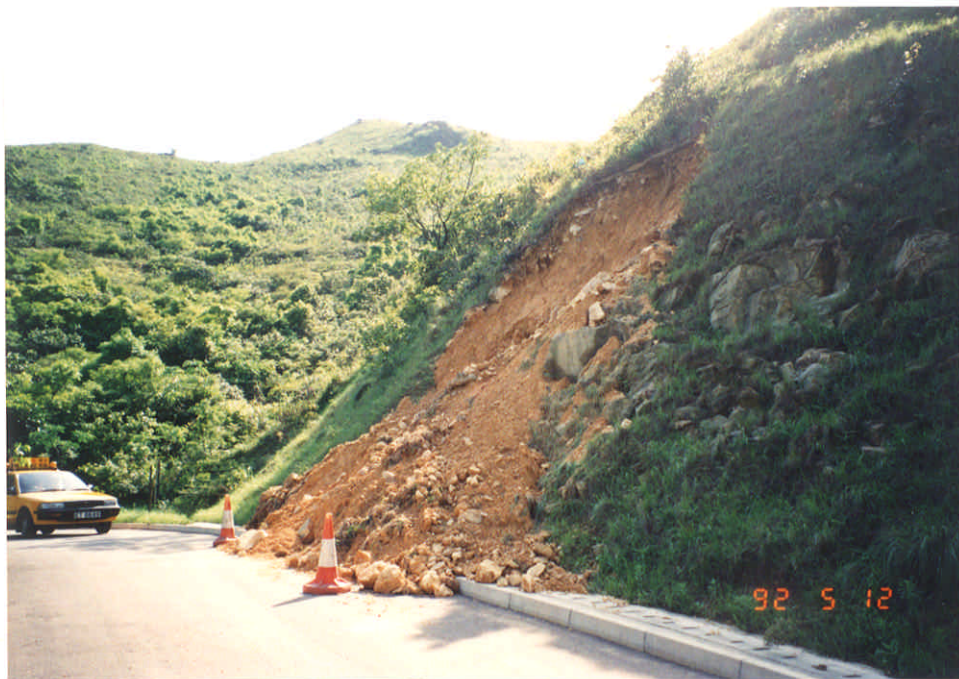
Plate 35 - Sham Wat Road, Lantau Island (Incident MW 5/46)

Negative No. MW9211519 Taken on : 12-5-92
Description : Failure of a soil cut slope resulting in the partial blockage of a road.

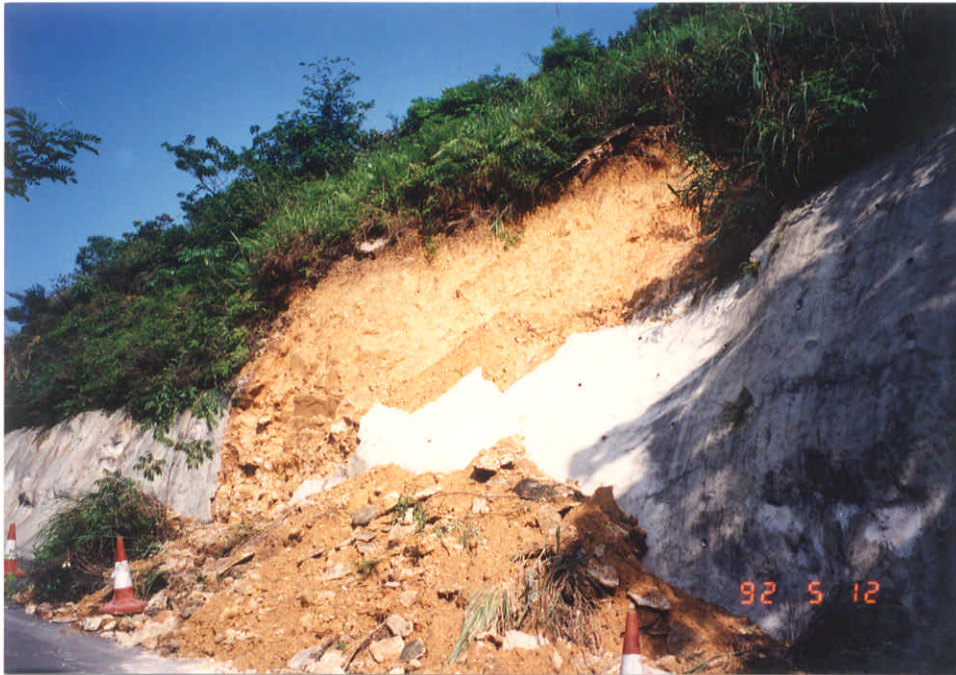
Plate 36 - Sham Wat Road, Lantau Island (Incident MW 5/47)

Negative No. MW9211521 Taken on : 12-5-92
Description : Failure of a soil cut slope resulting in the partial blockage of a road.
