**REPORT ON
THE RAINSTORM OF
8 MAY 1992**

GEO REPORT No. 22

**GEOTECHNICAL ENGINEERING OFFICE
CIVIL ENGINEERING DEPARTMENT
HONG KONG**

**This report was originally produced in October 1992
as GEO Special Project Report No. SPR 12/92**

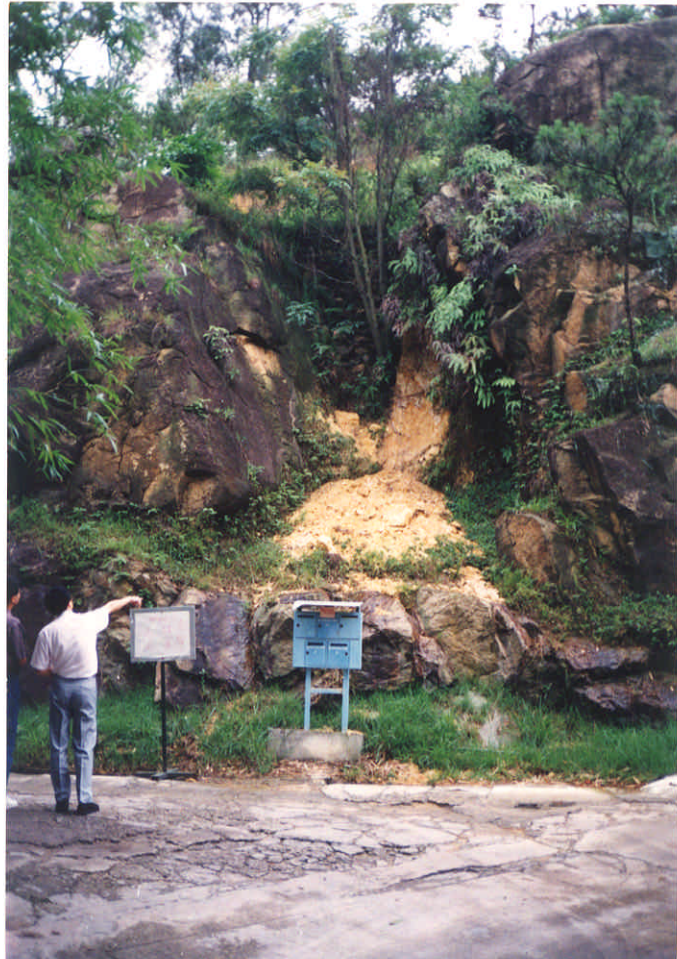
Plate 37 -
Tai Lam Correctional Institution
(Incident MW 5/67)

Description :
Failure of a rock cut slope affecting
a private access.

Seven failures in rock cut slopes were reported, forming 2% of all incidents. None of these failures were major. An example of a rock cut slope failure is shown in Plate 37 (Incident MW 5/67).

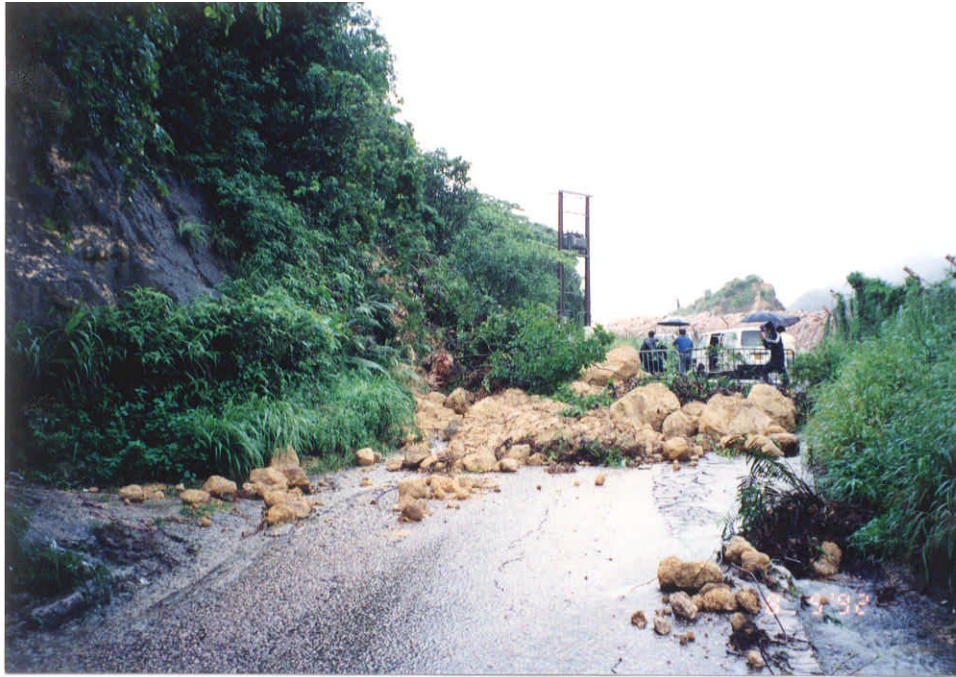
Plate 38 - Anderson Road, Sau Mau Ping (Incident ME 5/1)

Negative No. ME9218819 Taken on : 8-5-92
Description : Failure of a soil cut slope resulting in the blockage of one road lane.

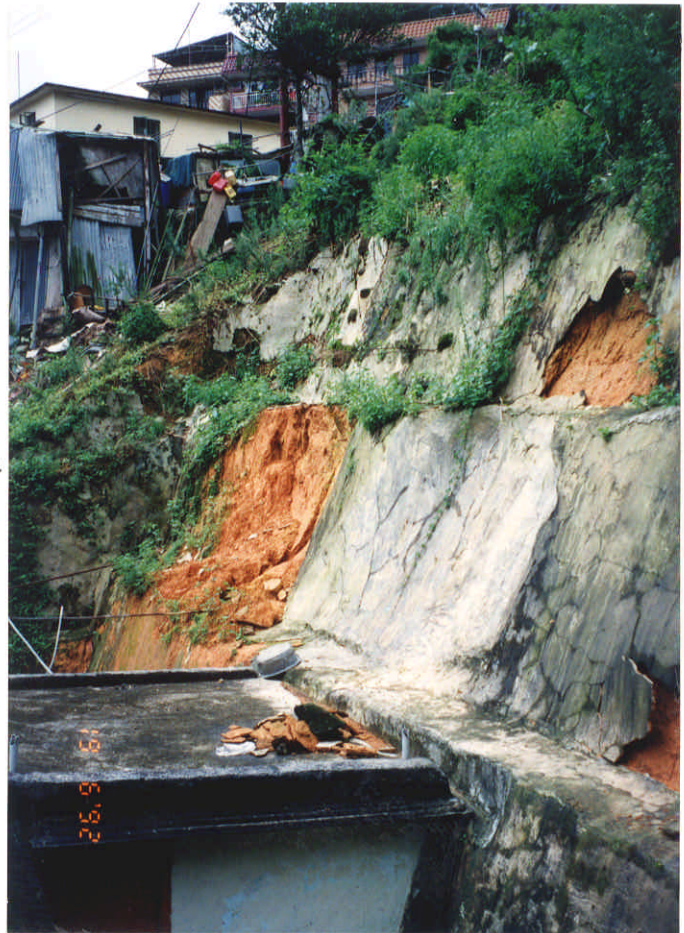
Plate 39 -
42 Tui Hoi Village, Sai Kung
(Incident ME 5/16)

Description :
Failure of a soil cut slope affecting a
building lot.

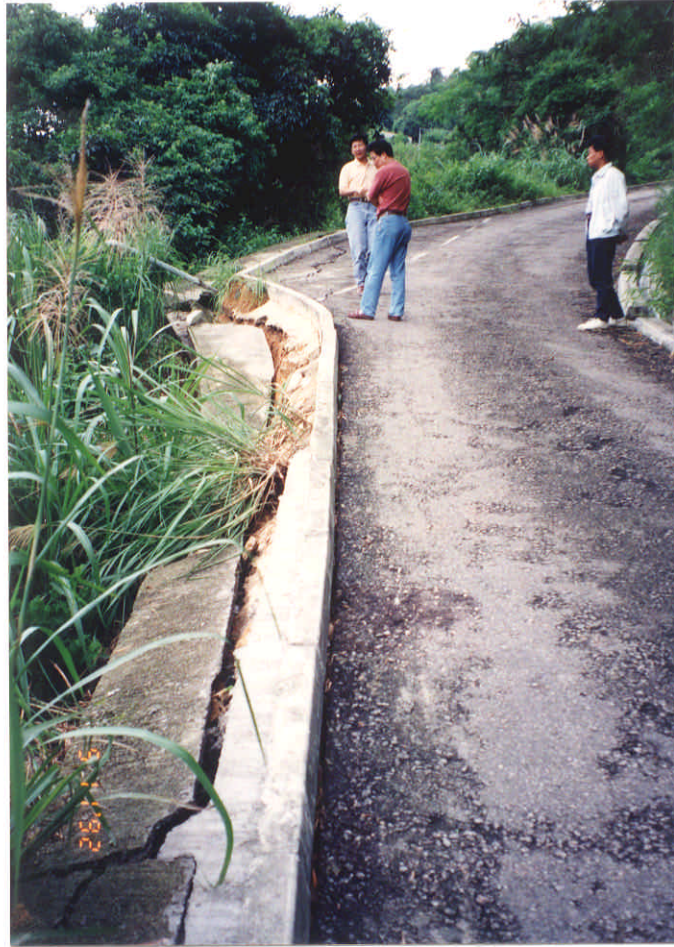
Plate 40 - Wong Chuk Yeung, Fo Tan, Shatin (Incident ME 5/22)

Negative No. ME9218018 Taken on : 11-5-92
Description : Subsidence failure affecting a pedestrian pavement.

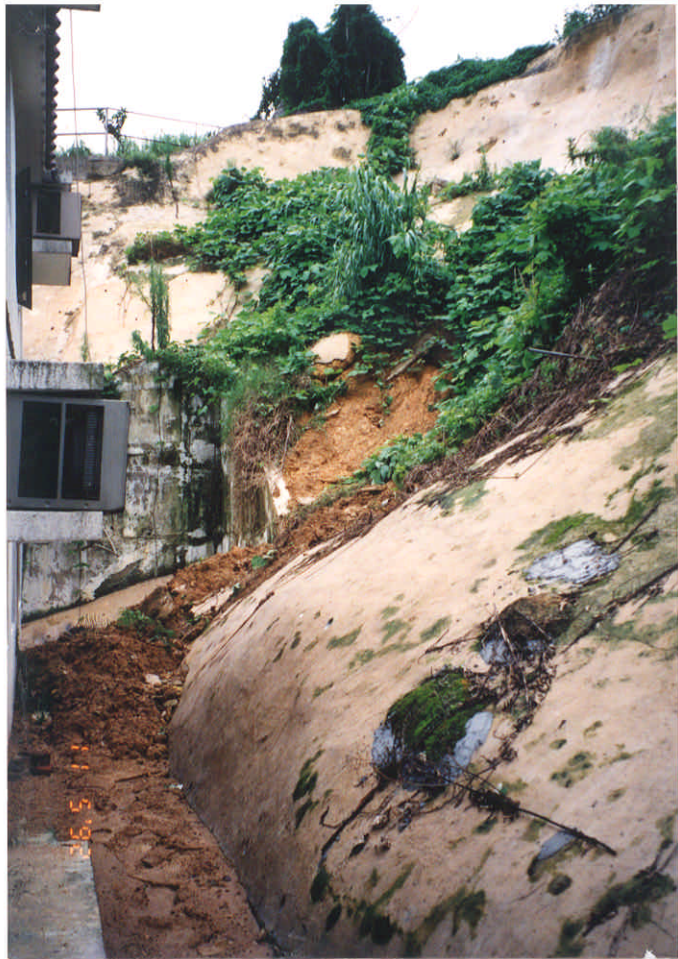
Plate 41 -
Huts 37A and 38A, Tai Lam Lin,
Shatin (Incident ME 5/31)

Description :
Washout failure affecting a building
lot.

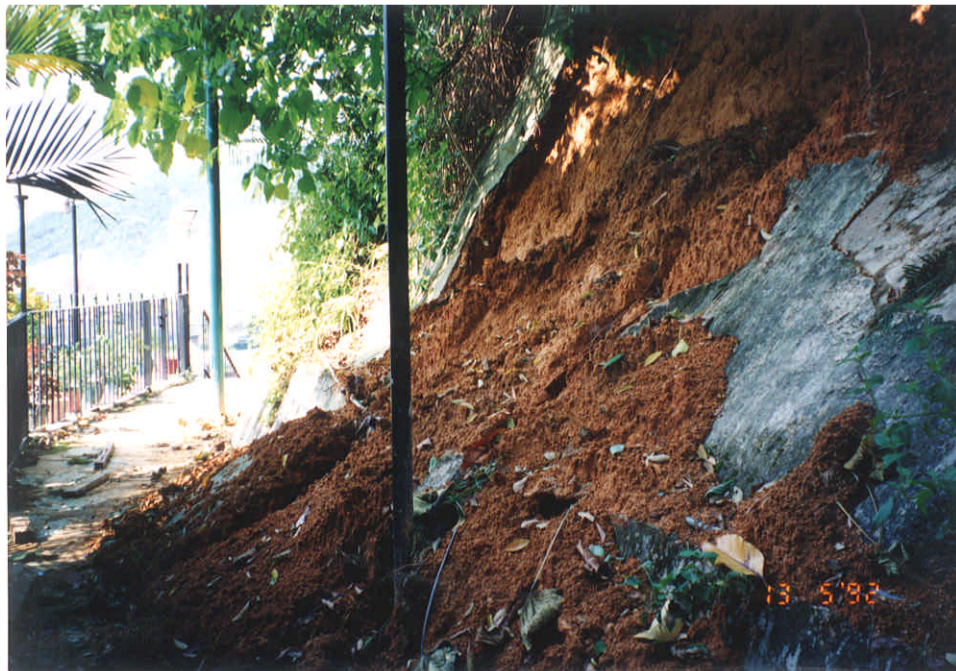
Plate 42 - 20 Ngau Pai Sha Village, Shatin (Incident ME 5/32)

Negative No. ME9219421 Taken on : 13-5-92
Description : Failure of a soil cut slope affecting a private access.
