SKIN FRICTION ON PILES AT THE NEW PUBLIC WORKS CENTRAL LABORATORY

GEO REPORT No. 38

J. Premchitt, I. Gray & K.K.S. Ho

This GEO Report consists of two Special Project Reports on skin friction on piles at the new public works central laboratory.

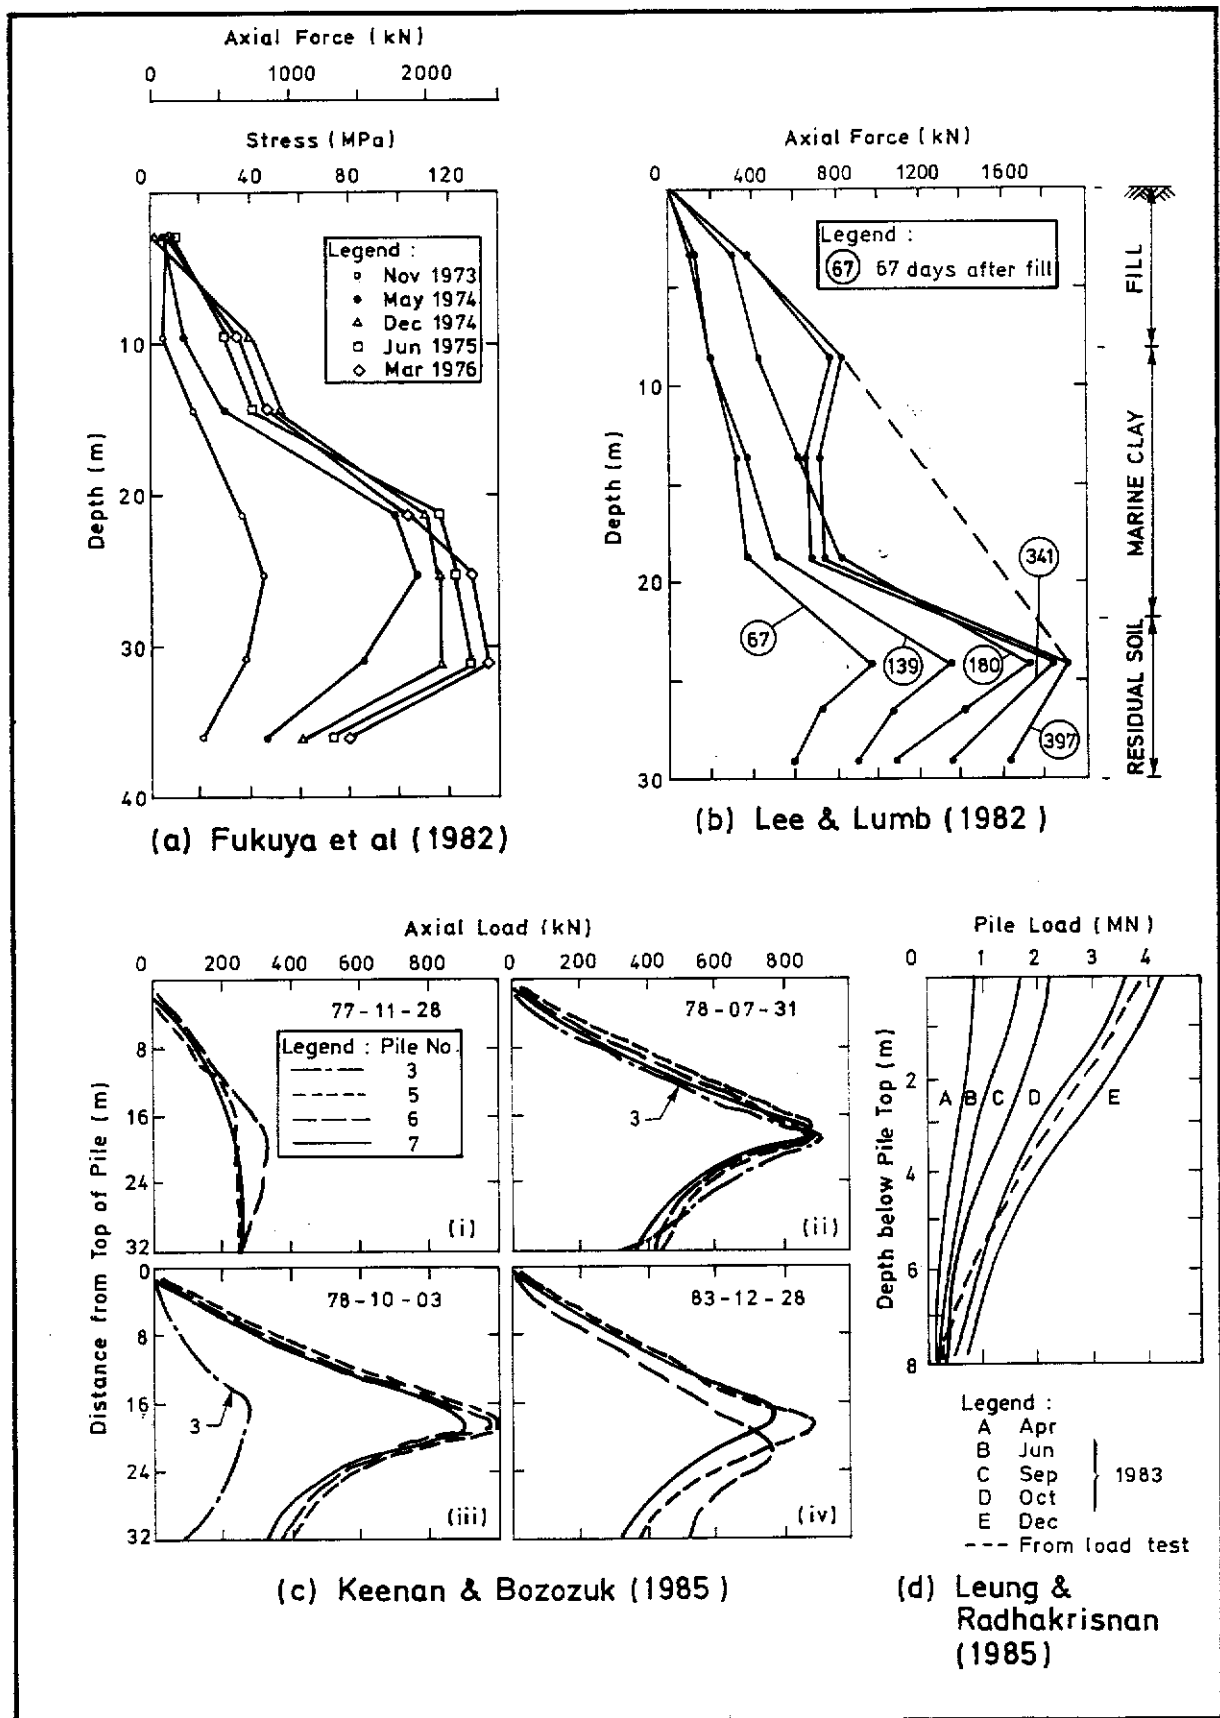
Figure 3 - Previous Studies on Long Term Changes in Strain/Force Distribution in Piles: (a) to (c) Negative Skin Friction, (d) Construction Loads

Leung & Radhakhrisnan (1985) monitored the performance of working bored piles supporting a 42 storey building under construction in Singapore. The piles were formed in weathered siltstone. Figure 3(d) shows load distributions in a pile at various stages of construction, as well as those measured during the pile load test. The load test results were similar to those obtained from building loads but there was a notable difference near the pile toe. The building load, developing over several months, apparently caused higher end bearing force than that which had occurred during the short term pile load test.

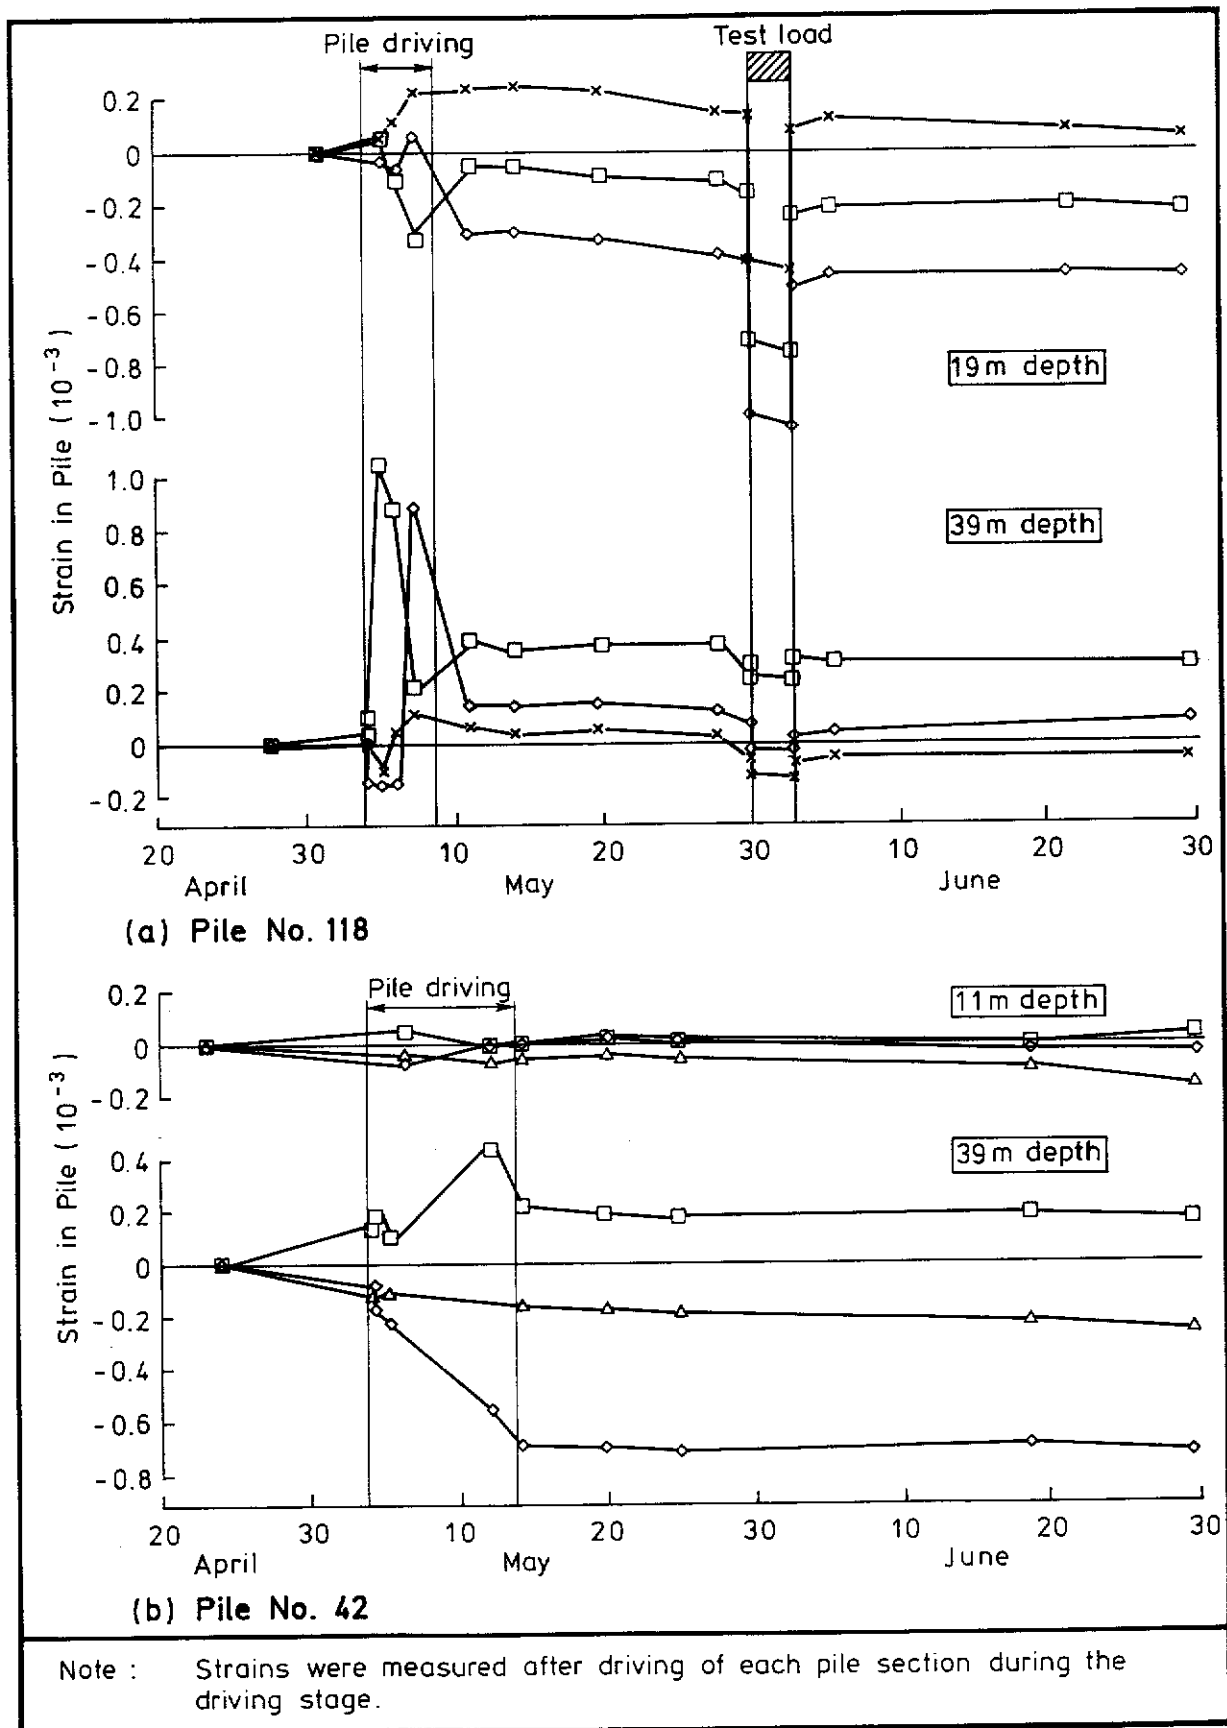
Figure 9 - Results from Strain Monitoring at Three Positions in Piles Nos. 118 & 42 over a Two Month Period

The strains were measured before and after driving of pile sections, and once every fortnight for two months after completion of driving. Typical results are illustrated in Figure 9. In each plot, the measured strains at the three gauge positions at a particular depth are shown. The strains were set to zero after casting of the piles. Hence, the strains reported in this section were additional to the strains induced by prestressing. It could be seen that large strains occurred after driving of each pile section, up to 1000 microstrains in the bottommost section. Some strains remained 'locked in' after completion of all driving. These residual strains were different at different gauge positions. The average of these strains at each depth was the axial strain, and the difference between each strain and the average was the bending strain. Relevant formulae are given in Appendix C.

Most of the pile sections had compressive residual axial strains, up to a value of about 200 microstrains. A few pile sections showed tensile residual axial strains (see Section 2.2.3) of less than 100 microstrains. The magnitudes of these strains varied in a random manner with depth, but the top pile sections generally had smaller residual strains. The maximum residual bending strains at these gauge positions were about 200 microstrains, corresponding to estimated locked-in moments greater than 100 kN-m. The random occurrence of axial and bending strains could be due to the driving process, in which the pile was not a single continuous member but consisted of about five sections driven at different times and in somewhat different positions relative to the driving machine.

Figure 9a shows the strain changes caused by test loading on pile no. 118. The strain changes were almost the same at the three gauge positions at each depth. The changes were smaller at greater depth. The load test results are discussed in the next section. The residual strains remained the same before and after test loading. Apparently, the strains at 19 m depth showed increasing compression with time. However, it was noted that the kentledge (almost 6000 kN) was left on the ground near this pile for several weeks before removal, and this may have caused the observed strains. No other piles showed similar strain changes. Therefore, it was concluded that no significant negative skin friction occurred at this site during the two month period.

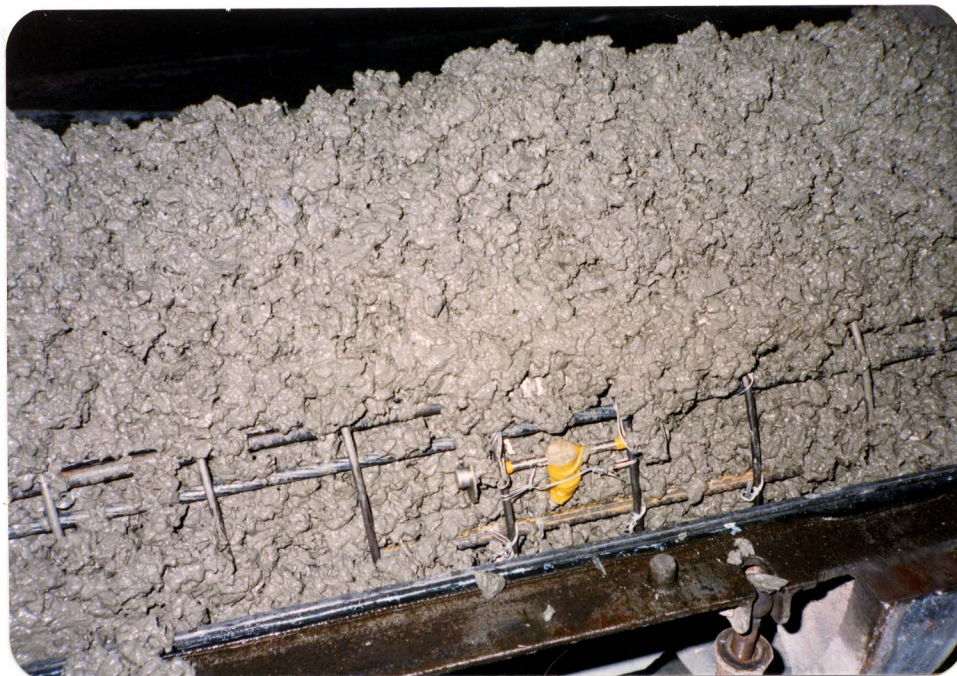
Plate 2 - Concrete Poured into the Pile Mould

The manufacturing processes are described as follows. The steel reinforcement is first placed in the lower half of a longitudinally split mould, and fresh concrete poured into the mould. After placing the upper part of the mould, the reinforcement is prestressed to give a prestress in the finished section of 5.25 MPa. The mould is then spun to create a centrifugal force of up to 35 g, forcing the concrete against the mould, and forming a central hollow. The pile is steam cured, removed from the mould and put into an autoclave at 194°C and 13 bar pressure. These operations are illustrated in Plates 2 to 5. The entire process takes less than one week. Pile sections are fabricated in lengths of 8 and 12 m. Steel end-plates permit on site welded connections between pile sections.
