# **HONG KONG RAINFALL AND LANDSLIDES IN 1993**

**GEO REPORT No. 43**

**GEOTECHNICAL ENGINEERING OFFICE  
CIVIL ENGINEERING DEPARTMENT  
HONG KONG**

**This report was originally produced in December 1994  
as GEO Special Project Report No. SPR 12/94**

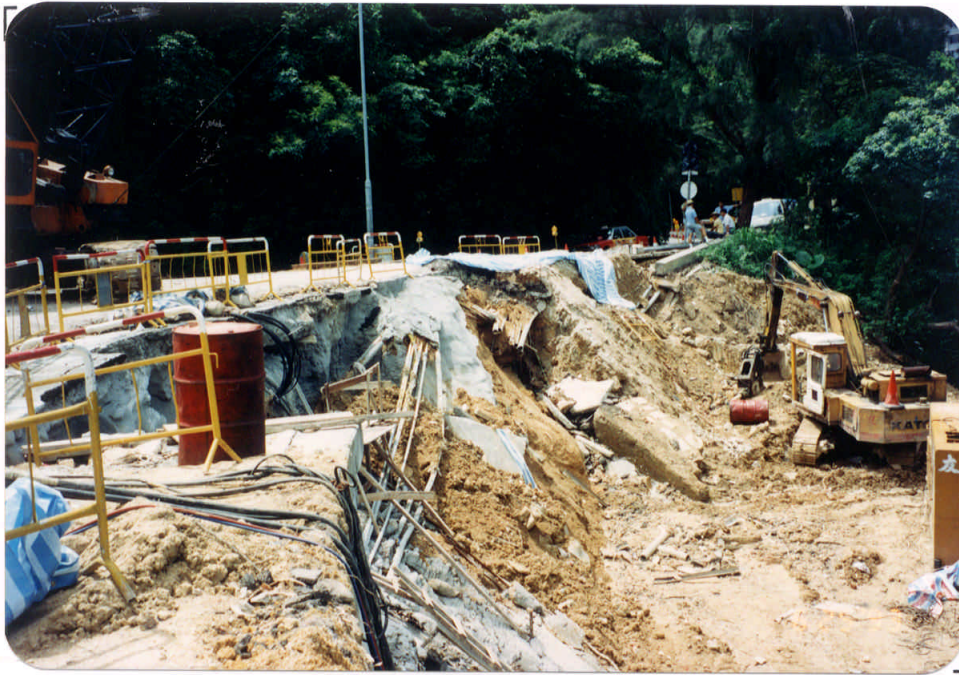
Plate 1 : Negative No. I9327211 Taken on : 25-6-93

Description : Major failure of a retaining wall and fill slope (about 100 m<sup>3</sup>) leading to the closure of one lane of road and pedestrian pavement.

Plates 1 & 2 - Junction of Repulse Bay Road, Black's Link and Wong Nai Chung Gap Road (Incident HK 6/4)

There were 38 fill slope failures, forming 4.6% of all landslide incidents reported. Ten of these failures were major, viz. incidents HK 6/3, HK 6/4 (Plates 1 and 2), HK 6/14, HK 6/19, MW 5/13, MW 6/53 (Plate 11), MW 9/19 (Plates 23 and 24), MW 11/72, MW SP/31 and MW SP/273 (Plate 32).

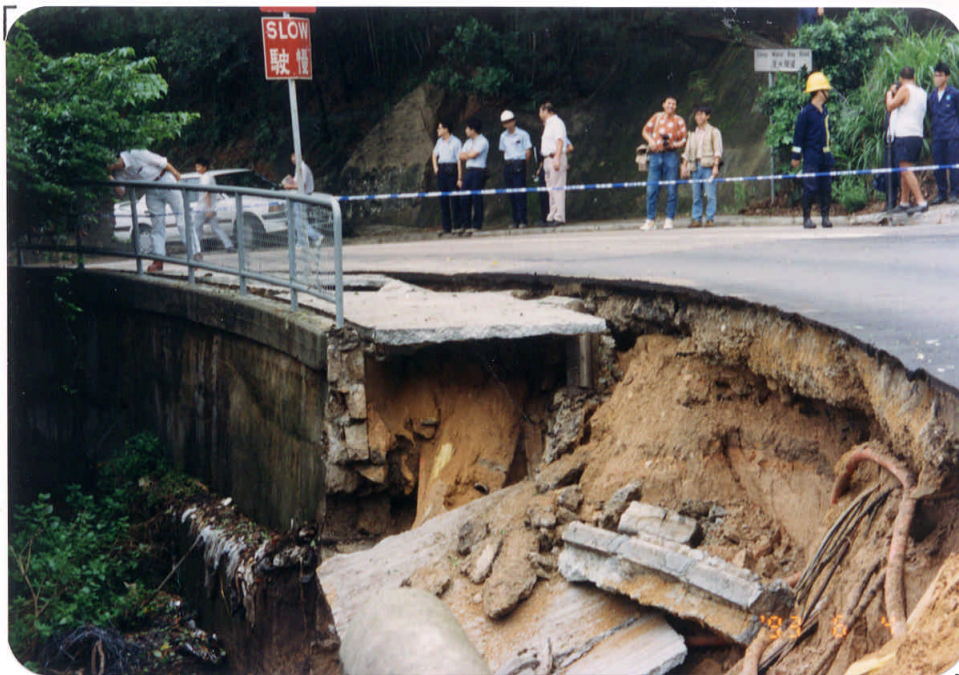
Plate 2 : Negative No. I9323709 Taken on : 4-6-93

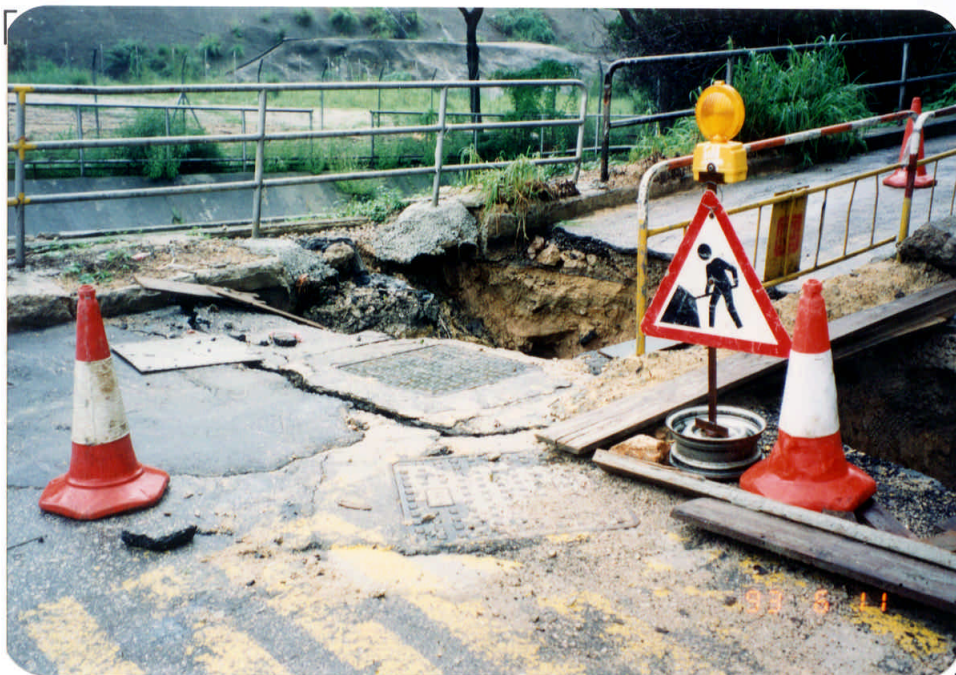
Plate 3 - Next to Nullah, Jordan Valley Road South, Ngau Tau Kok  
(Incident K 6/2)

Description : Subsidence of a road (about 4 m<sup>3</sup>) resulting in road closure.

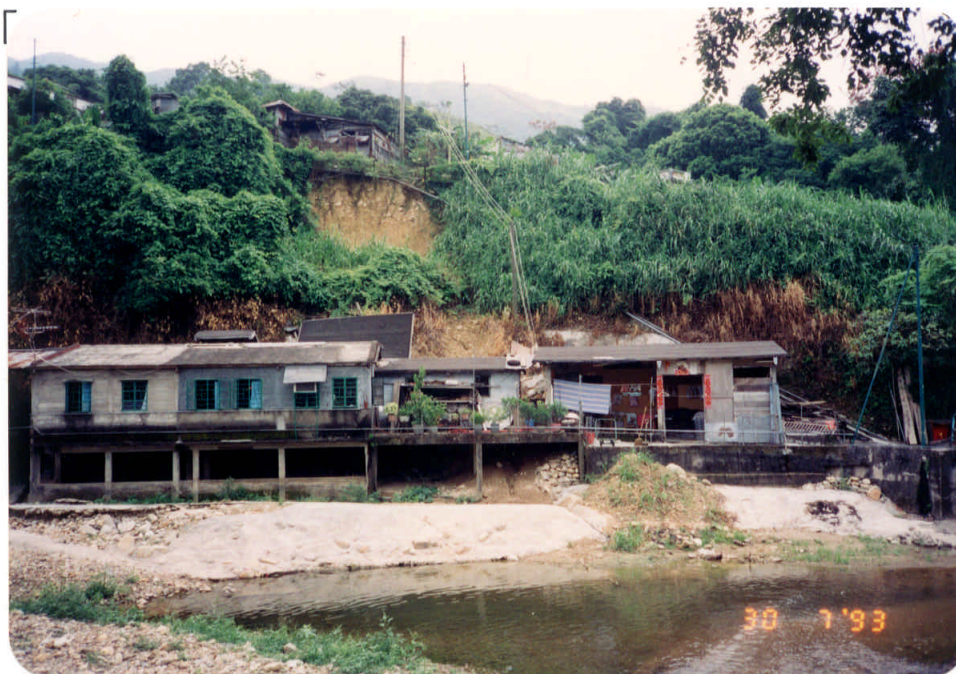
Plate 4 - No. 1, Ngau Kwu Leng Village, Lam Tsuen, Tai Po (Incident ME 6/2)

Description : Failure of a natural slope (about 45 m<sup>3</sup>) resulting in the permanent evacuation of fifteen huts.

Ninety four natural slope failures were reported, forming 11.4% of all incidents. Eleven of these failures were major: Incidents ME 9/18 (Plates 18 and 19), ME 10/15, MW 6/18 (Plates 9 and 10), MW 11/48, MW SP/32 (Plates 28 and 29), MW SP/135, MW SP/201 (Plate 30), MW SP/203, MW SP/204, MW SP/258 (Plate 31) and MW SP/274. Plate 4 also shows a failure of this type.

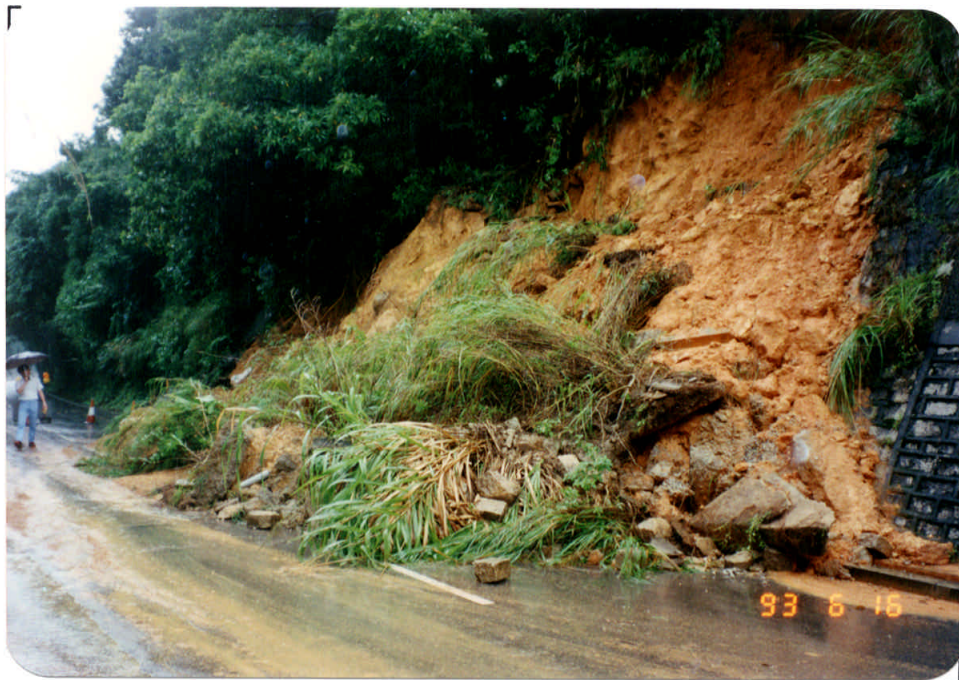
Plate 5 - Near Long Keng, Sai Sha Road, Sai Kung, Slope No. 8SW-A/C3 & C4 (Incident ME 6/11)

Description : Major failure of a soil/rock cut slope (about 83 m<sup>3</sup>) resulting in the closure of a road.

There were 61 soil/rock cut slope failures reported, six of which were major (ME 6/11, ME 6/19, ME 9/21, MW 6/14, MW 9/9 and MW SP/232). Failures of this type are shown in Plates 5, 7, 8, 21 and 22.

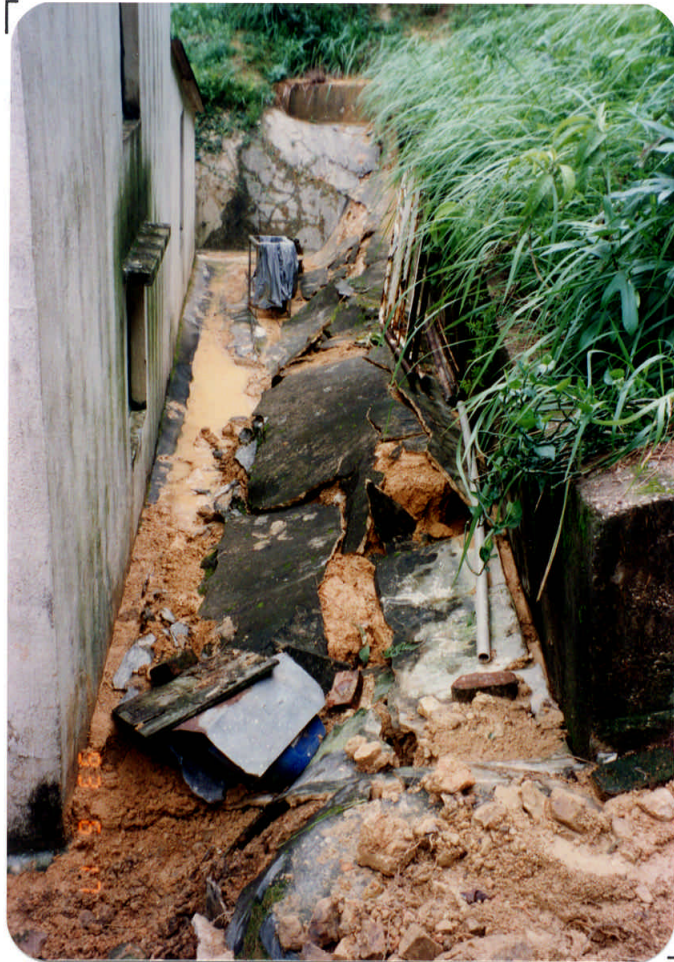
Plate 6 - Behind House Nos. 64-65, Wai Sum Village, Clear Water Bay Road, Mang Kung Uk, Sai Kung (Incident ME 6/21)

Description : Major failure of a soil cut slope (about 300 m<sup>3</sup>) leading to the blockage of a backlane.

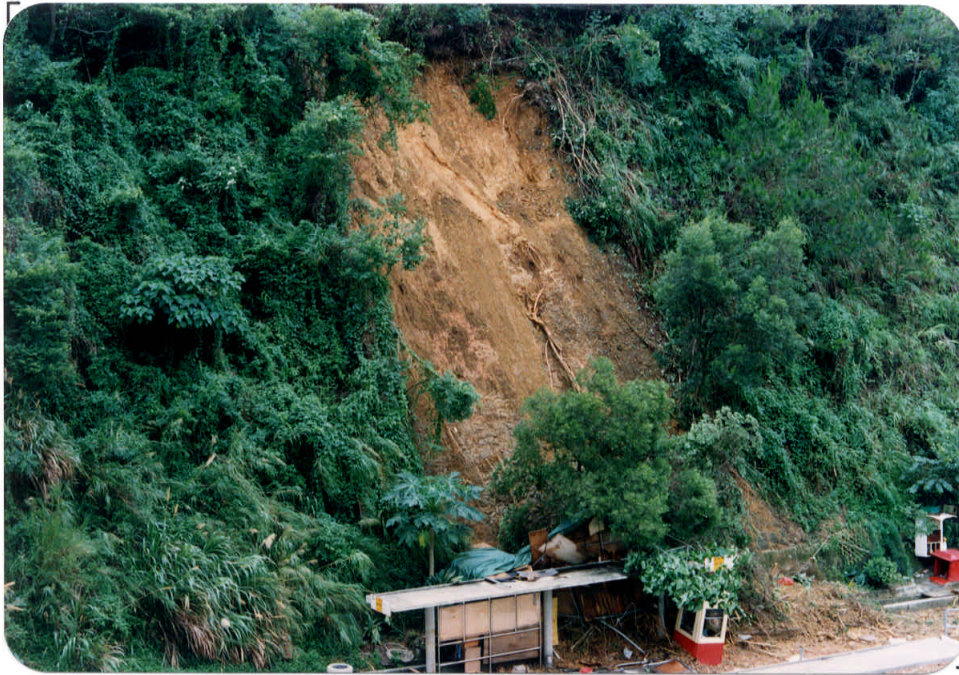
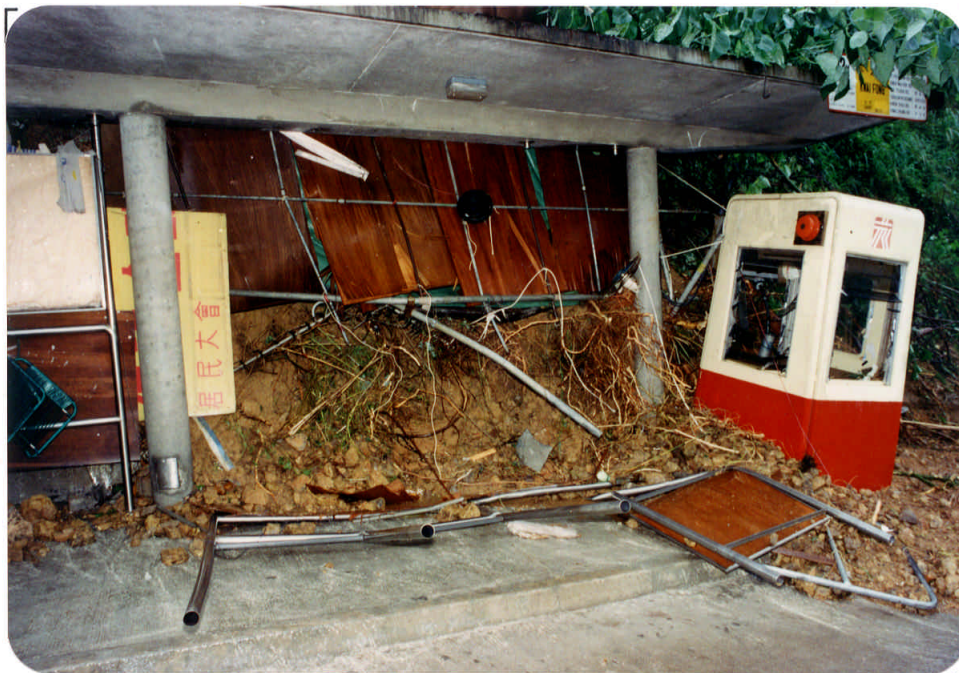
Plates 7 & 8 - Adjacent to Cheung Shan Estate Bus Terminus, Tsuen Wan,  
Slope No. 7SW-C/C128 (Incident MW 6/14)

Description : Major failure of a soil/rock cut slope (about 50 m<sup>3</sup>). One dead and five injured. Pedestrian pavement was closed.

(Date : 16 June 1993. Major failure of a soil/rock cut slope resulting in one fatality and injuries to five people. Plates 7 and 8.)

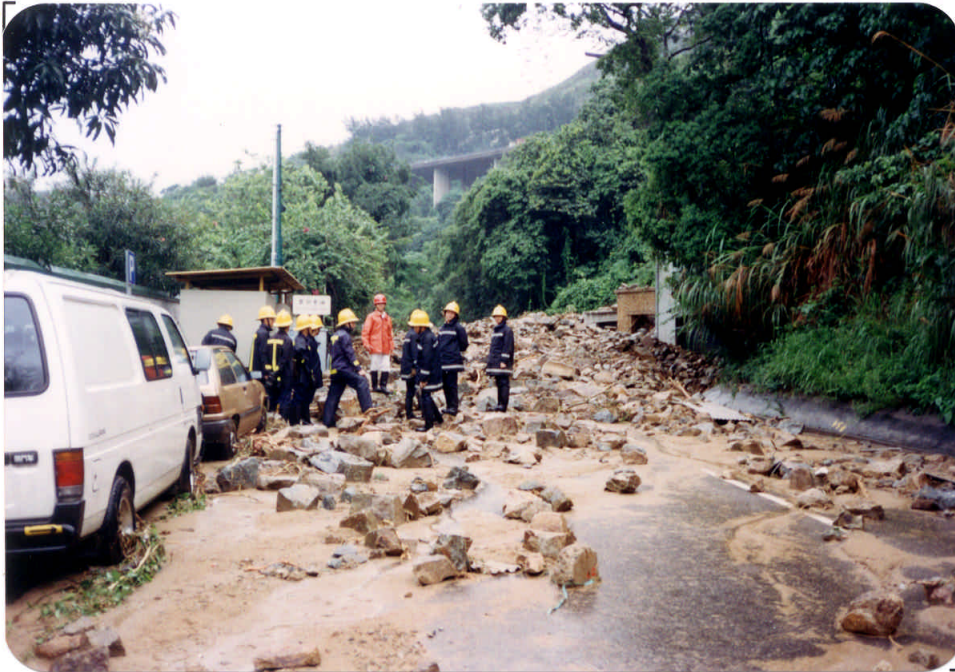
Plate 9 : Negative No. MW9311901 Taken on : 16-6-93

Description : Major failure of a natural slope (about 500 to 1000 m<sup>3</sup>) resulting in the blockage of a road and a carpark.

Plates 9 & 10 - Behind Ting Kau Carpark, Castle Peak Road, Tsuen Wan (Incident MW 6/18)

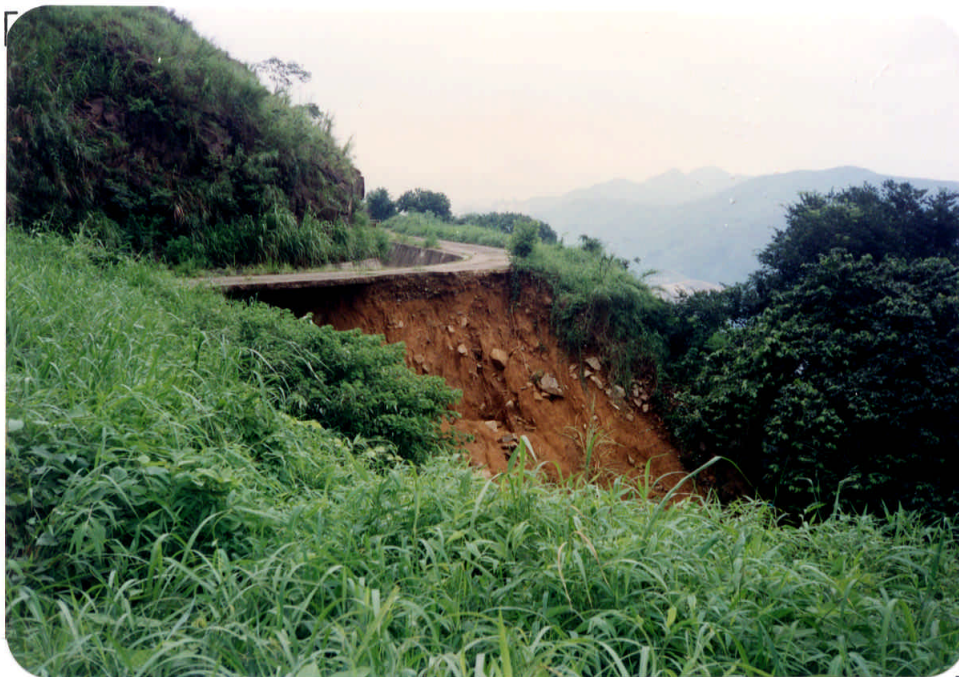
Plate 11 - Tai Lam Chung Catchwater CH 4680, Tai Lam Chung (Incident MW 6/53)

Description : Major failure of a fill slope (about 1000 m<sup>3</sup>) leading to the closure of an access road.

(Date : 16 June 1993. Major failure of a fill slope resulting in temporary closure of Castle Peak Road. Plate 11.)

The failure occurred at about 16:20 hrs on 16 June after intense rainfall on the same day. The landslide occurred at a fill slope along an access road within the Tai Lam Chung catchwater. The failure volume was about 1000 m<sup>3</sup>. The slipped materials travelled some 200 m down to Castle Peak Road. This resulted in the blockage of Castle Peak Road. The failure was probably caused by prolonged rainfall and water infiltration.

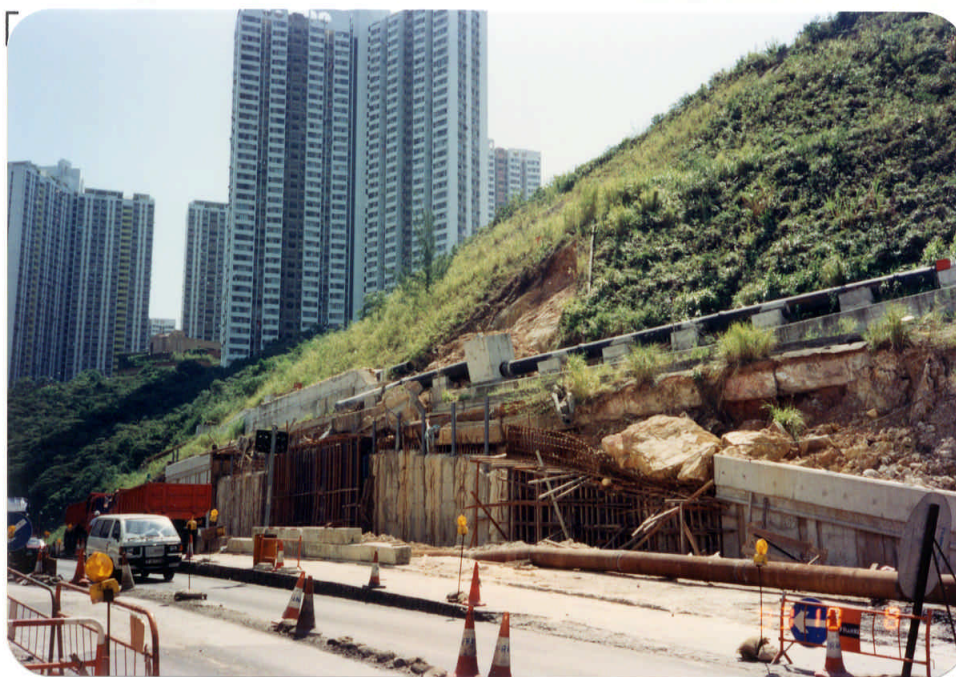
Plate 12 - Opposite Fire Station, and above Caisson Wall No. CW3, Ap Lei Chau Bridge Road, Ap Lei Chau (Incident HK 9/6)

Description : Major failure of a rock cut slope (about 100 m<sup>3</sup>) resulting in the closure of one road lane and pedestrian pavement.

Six failures in rock cut slopes were reported, two (HK 9/6 and K 9/17) of which were major. Failures of this type are shown in Plates 12 and 16.

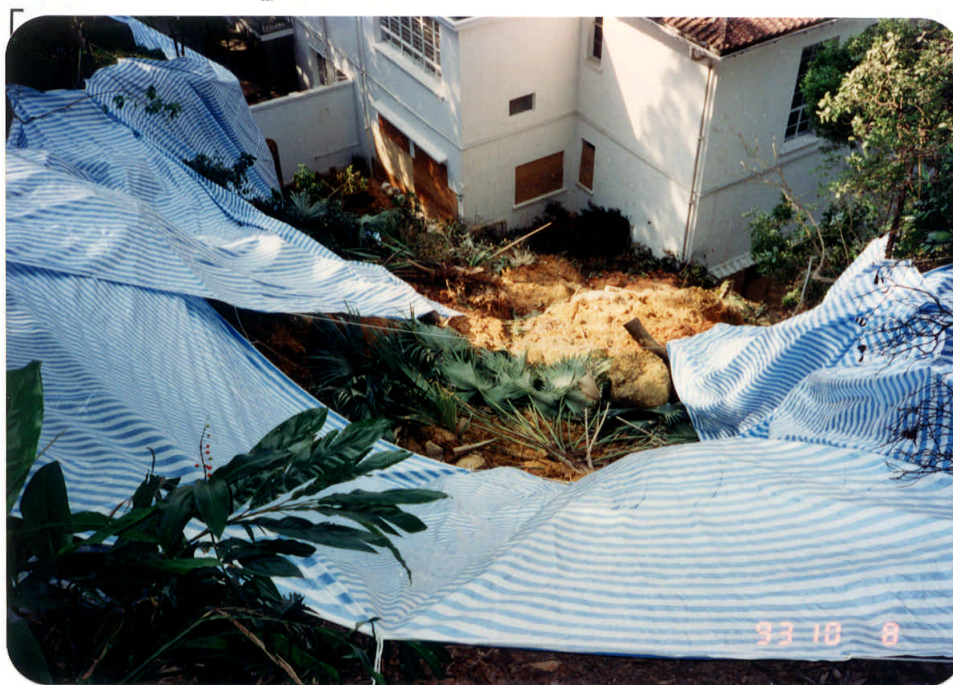
Plate 13 - Behind 8 Severn Road, Mount Gough (Incident HK 9/28)

Description : Major failure of a soil cut slope (about 115 m<sup>3</sup>) resulting in the evacuation of flats.

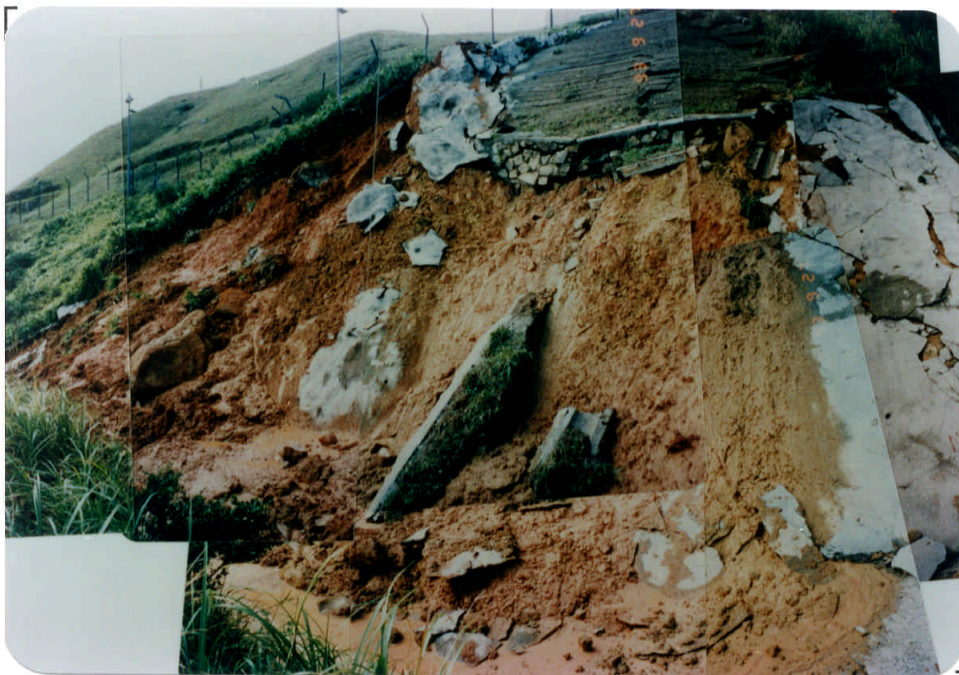
Plate 14 - Near Jat's Incline, Fei Ngo Shan Road, Kowloon Peak  
(Incident K 9/2)

Description : Major failure of a soil cut slope (about 1000 m<sup>3</sup>) resulting in the closure of a road.

(Date : 27 September 1993. Major failure of a soil cut slope and a minor rubble wall resulting in the closure of a road. Plate 14.)

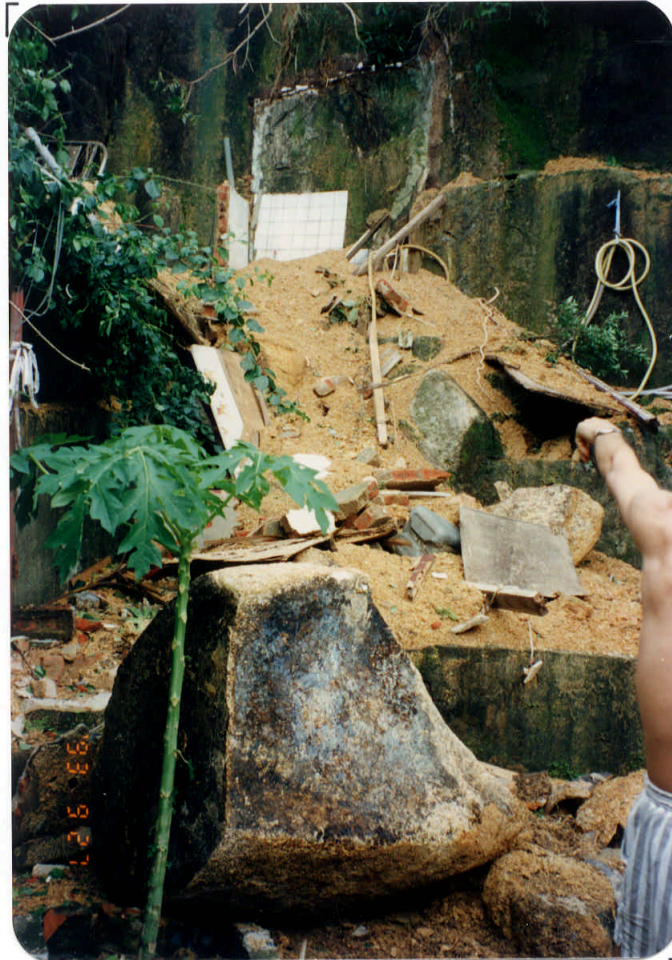
Plate 15 - Behind Hut No. 32B1, On Sai Lee Tsuen, Lei Yue Mun (Incident K 9/6)

Description : Boulder fall from a natural slope ( $1.8 \text{ m}^3$ ) resulting in the temporary evacuation of one hut.

There were 41 cases of rock and boulder falls, forming 5.0% of all landslide incidents reported. None of these failures was major. Example of failures of this type is shown in Plate 15.

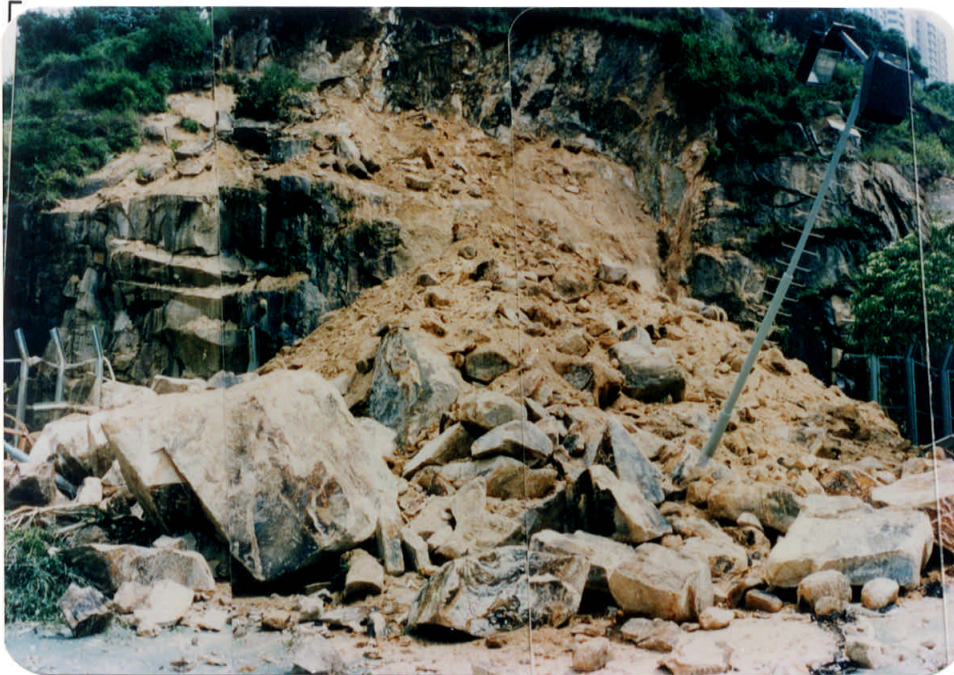
Plate 16 - Behind Tennis Courts of Hiu Ming Street Playground, Hiu Ming Street,  
Sau Mau Ping, Slope No. 11NE-D/C45 (Incident K9/17)

Description : Major failure of a rock cut slope (about 200 m<sup>3</sup>) leading to the closure of tennis courts.

(Date : 26 September 1993. Major failure of a rock cut slope resulting in closure of two tennis courts. Plate 16.)

At about 18:00 hrs on 26 September, a failure occurred in a rock cut slope (No. 11NE-D/C-45) adjacent to two tennis courts, near Hui Ming Street, Sau Mau Ping, Kwun Tong. The portion of slope failed was located at about 10 m above the ground and the failure scar covered an area of about 12 m by 4 m. The fallen material bulked to about 200 m<sup>3</sup> debris. This resulted in closure and fenced-off of the tennis courts. The probable cause of the failure was mainly due to infiltration and possibly the blockage of inaccessible drainage channels as a result of lack of maintenance.

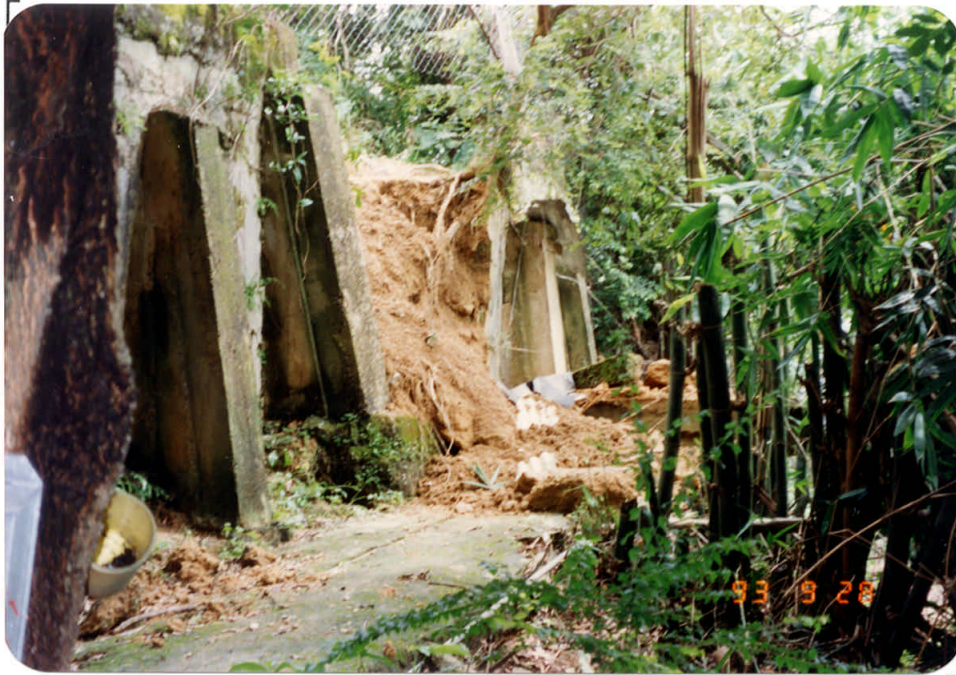
Plate 17 - Front of House No. 175, Ha Wo Che Village, Shatin (Incident ME 9/17)

Description : Failure of a retaining wall (about 2 m<sup>3</sup>) leading to the blockage of a footpath.

There were 25 reported incidents related to retaining walls or walls having earth materials piled up behind them, forming 3.0% of all incidents reported. None of these failures were major. Examples of this type of failure are shown in Plates 17 and 27.

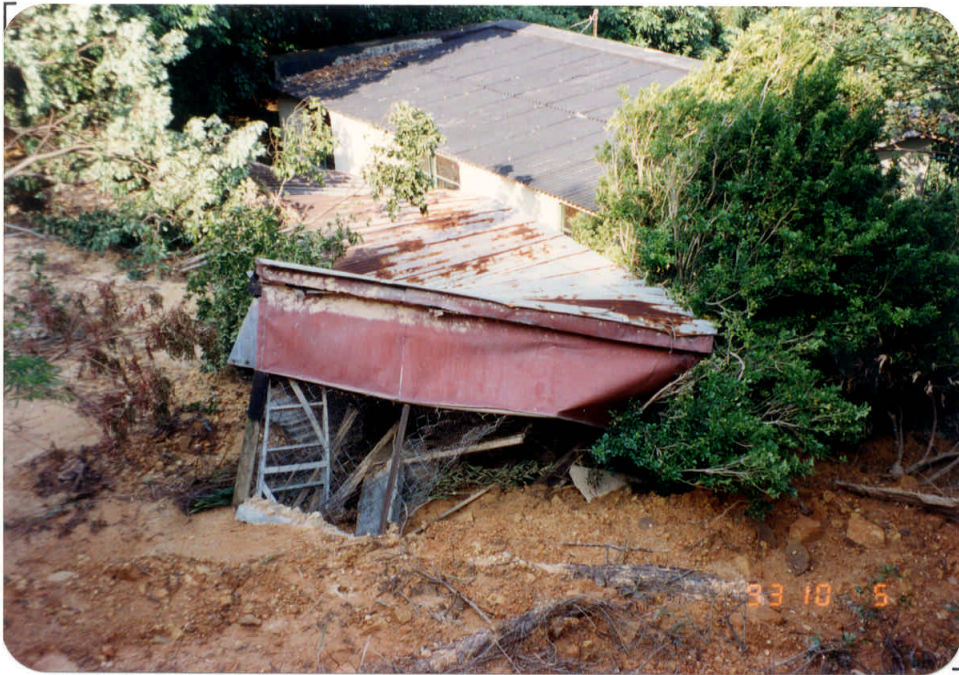
Plate 18 : Negative No. ME9367411 Taken on : 5-10-93

(Date : 26 September 1993. Major failure of a natural slope resulting in permanent evacuation of three huts. Plates 18 and 19.)

Plates 18 & 19 - Behind Huts  
RTP/TTW/190-192, Miu Keng,  
Tai Tong Wu, Sha Tau Kok  
(Incident ME 9/18)

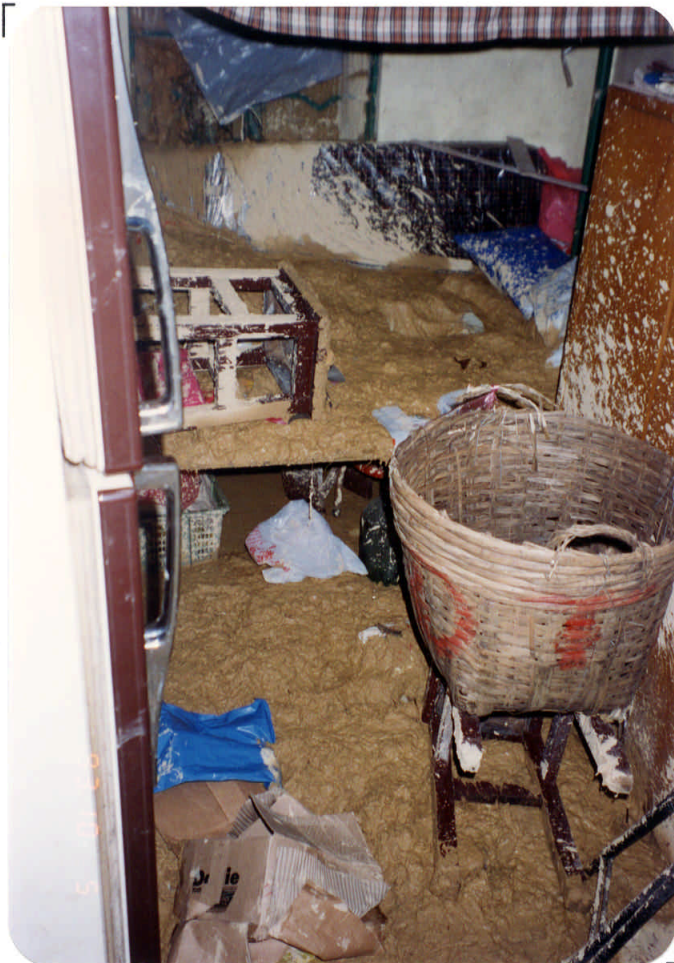
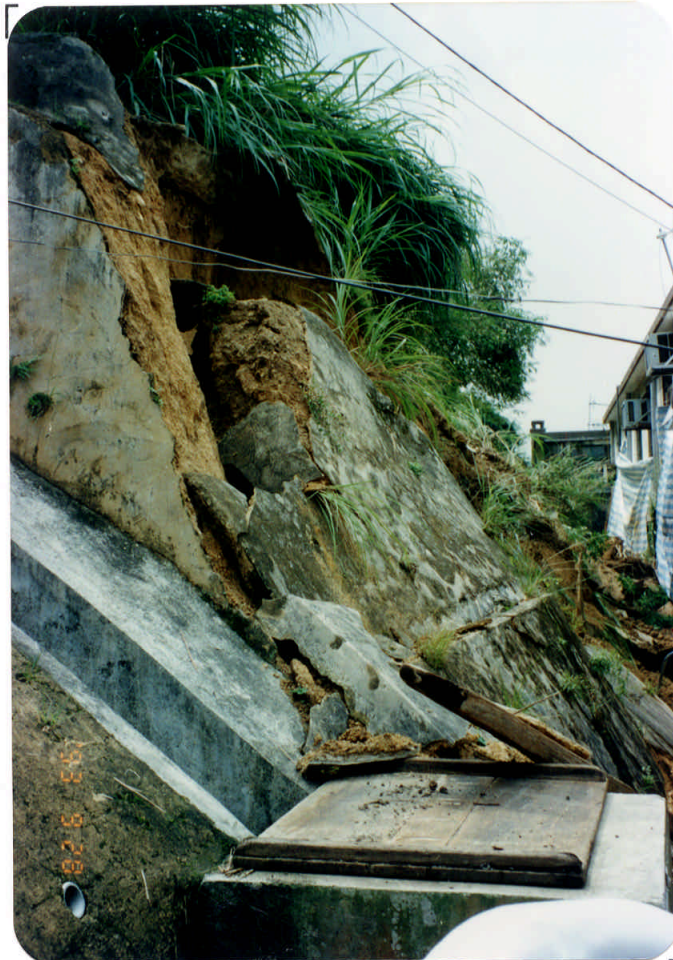
The failure occurred on 26 September after intense rainfall during the previous few days. The natural slope was located behind the huts RTP/TTW/190-192 of Miu Keng, Tai

Tong Wu, Sha Tau Kok. The portion of slope that failed was about 30 m high. The debris damaged and pushed a chicken shed forward by 4 m. Some of the debris also run into huts at the slope toe. As a result, three huts were permanently evacuated. The slipped materials amounted to 300 m<sup>3</sup>. The cause of the failure was mainly due to erosion.

The failures which affected squatter areas led to the permanent evacuation of 151 squatter huts and the temporary evacuation of 53 huts in total (Table 6). Most of these evacuations resulted from failures of natural and soil cut slopes. A number of evacuations were also caused by retaining wall failures and rock or boulder falls. Examples of failures which affected squatter areas are shown in Plates 4, 15, 18 and 19, and incident ME 9/18 (Plates 18 and 19) is discussed in Section 4.4.

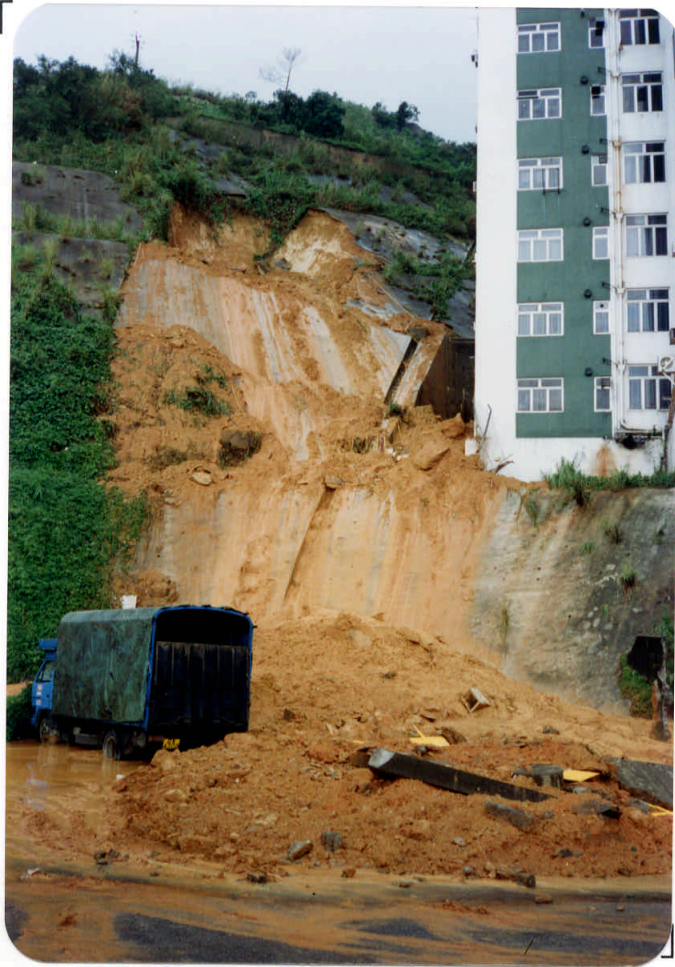
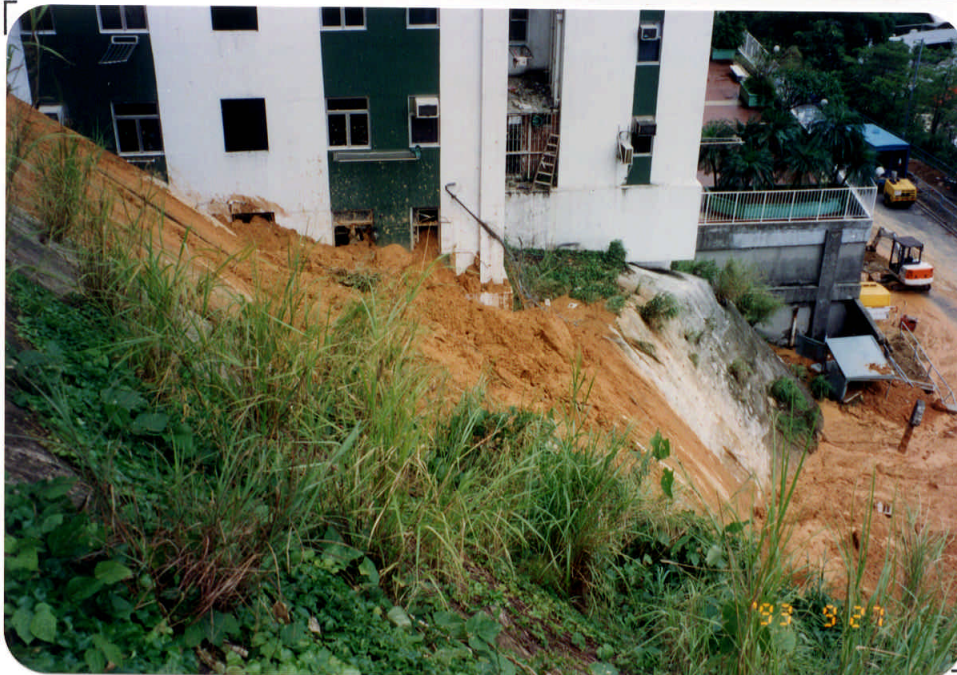
Plate 22 : Negative No. SP9311011 Taken on : 27-9-93

(Date : 27 September 1993. Major failure of a soil/rock cut slope resulting in the temporary evacuation of 24 flats and the damage of a gas main. Plates 21 and 22.)

The failure occurred at about 5:45 hrs on 27 September after the prolonged rainfall during the period between 23 and 27 September. The landslide occurred at the fourth batter of a soil/rock cut slope (No. 6SE-D/CR87) near Block F of Allway Gardens, Tsuen Wan. The whole cut slope was about 45 m high and was covered with chunam. The failure scar covered an area of about 10 m by 16 m. Part of the landslide debris entered two flats of Block F at Allway Gardens. Twenty-four flats in Block F were immediately evacuated. Among the flats affected, closure orders were subsequently served to fifteen flats. None was reported to have been injured in the incident. The debris also covered an area of about 50 m<sup>2</sup> on On Yat Street. The slipped material was estimated to be about 200 to 250 m<sup>3</sup> in volume. Gas leakage from a gas main ruptured in the landslide was also reported. The failure was likely the result of prolonged rainfall and the presence of pre-existing tension cracks and relict joints in the soil.

Description : Major failure  
of a soil/rock cut slope  
(about 200-250 m<sup>3</sup>) leading  
to the evacuation of 15 flats,  
the blockage of a cul-de-sac and  
the damage of gas installation.

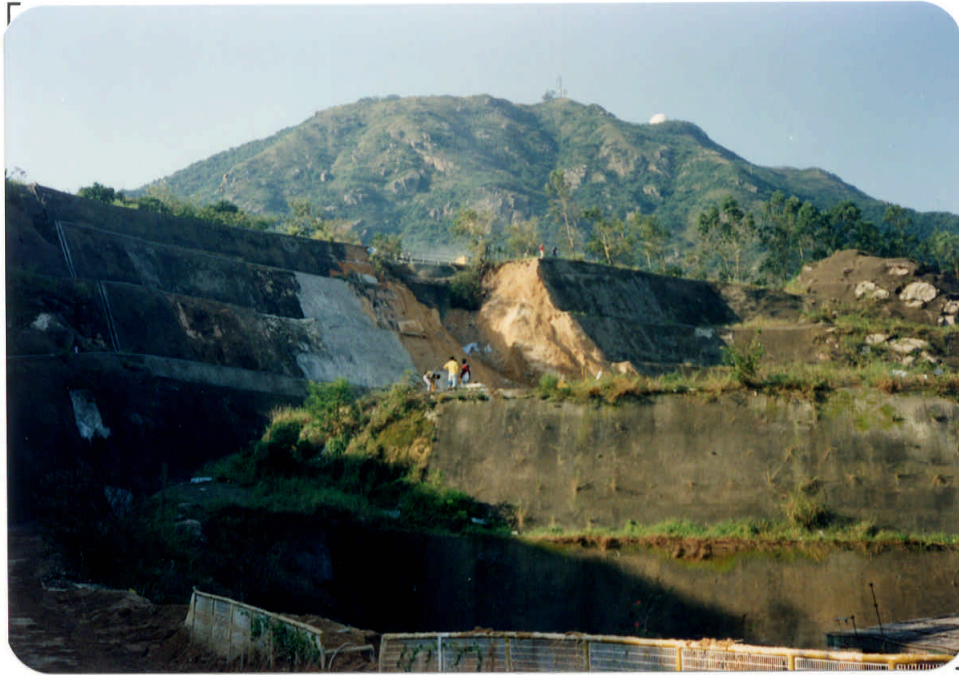
Plate 23 : Negative No. MW9324825 Taken on : 28-9-93

(Date : 27 September 1993. Major failure of a fill/soil cut slope resulting in the closure of a road. Plates 23 and 24.)

Description : Major failure of a fill and soil cut slope (about 2600 m<sup>3</sup>) leading to the closure of one road lane and pedestrian pavement.

Plates 23 & 24 - Below Lung Cheung Road and behind Cornwall Street Abandoned Temporary Housing Area, Kowloon Tong, Slope Nos. 11NW-B/C146 & F33 (Incident MW 9/19)

There were eight incidents affecting construction sites of which two were major. The two major incidents are HK 9/6 (Plate 12) and MW 9/19 (Plates 23 and 24). Incident MW 9/19 is discussed in Section 4.8 of this report.

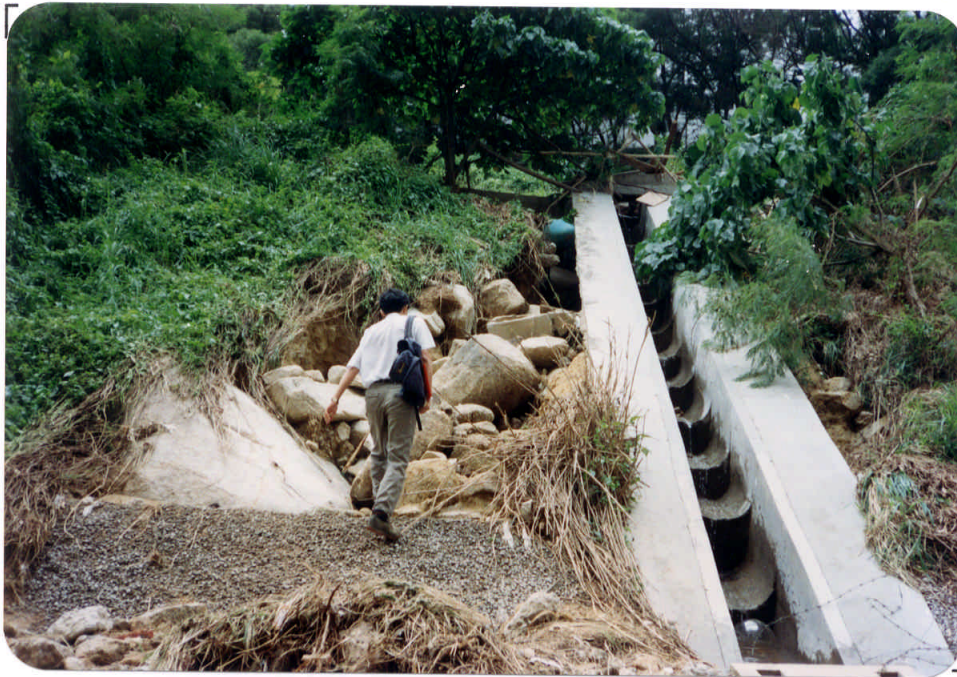
Plate 25 : Negative No. MW9330108 Taken on : 8-11-93

(Date : 5 November 1993. Severe flooding in Alpine Garden and major erosion of soil cut slopes severely affecting the traffic flow of two roads. Plates 25 and 26.)

Description : Major failure of a soil cut slope (about 500 to 1000 m<sup>3</sup>) affecting the building lot, carpark, road and pedestrian pavement.

Plates 25 & 26 - Alpine Garden, NV350, Castle Peak Road, Tuen Mun  
(Incident MW 11/4)

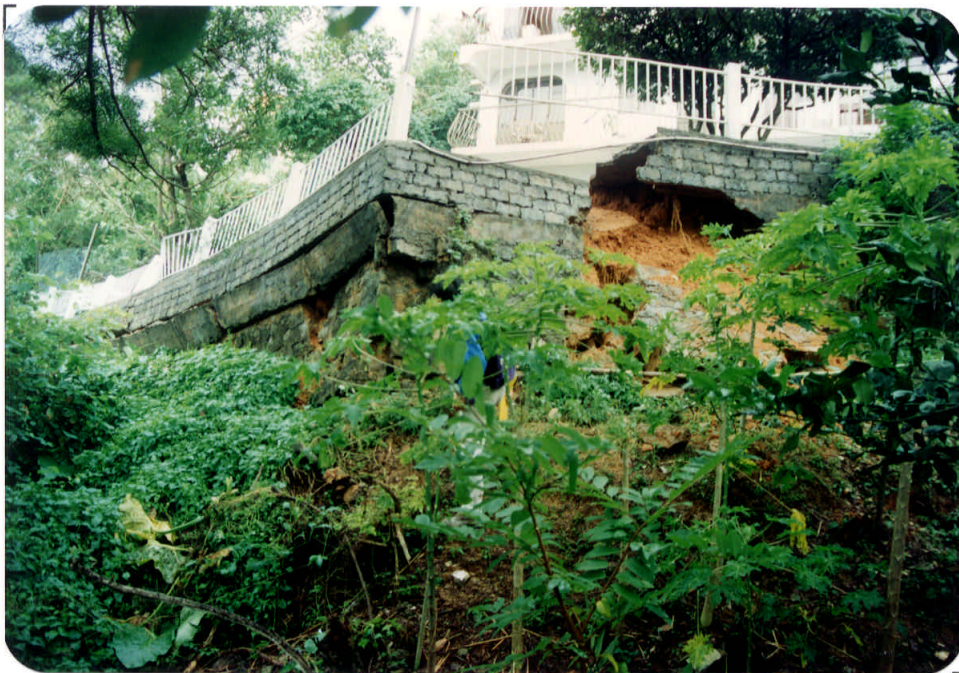
Plate 27 : Negative No. SP9314207 Taken on : 6-11-93

Description : Failure of a retaining wall (about 30 m<sup>3</sup>) affecting the yard area of a building.

Plate 27 - Fu Kong Shan, South Lantau Road, Lantau (Incident MW SP/26)

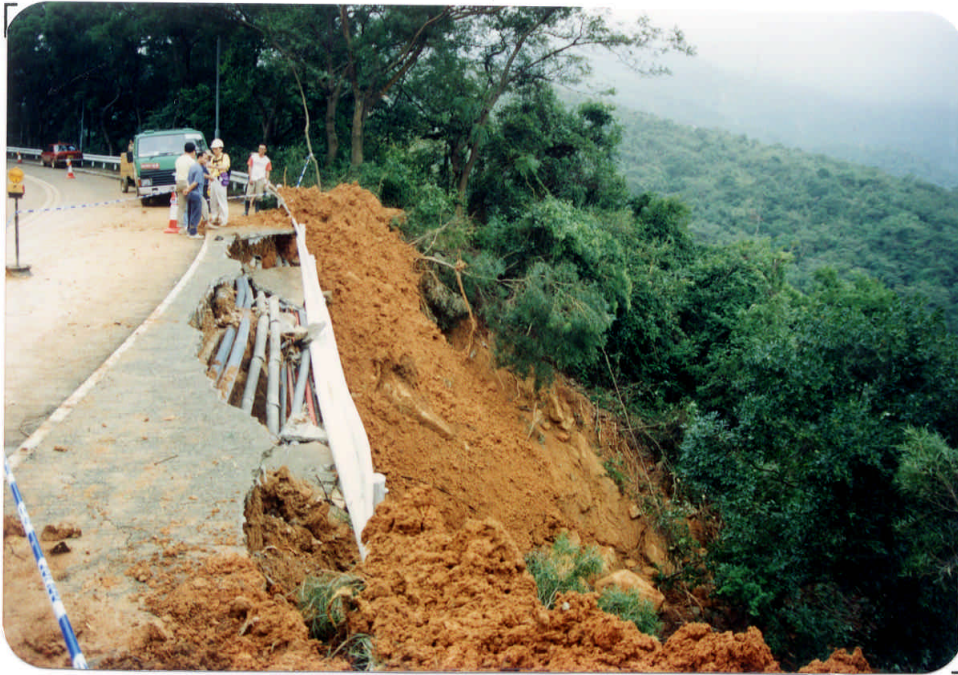
Plate 28 : Negative No. SP9314301 Taken on : 6-11-93

Description : Major failure of a natural slope (about 245 m<sup>3</sup>) resulting in the closure of one road lane and pedestrian pavement.

Plates 28 & 29 - Nam Shan, South Lantau Road, Lantau (Incident MW SP/32)

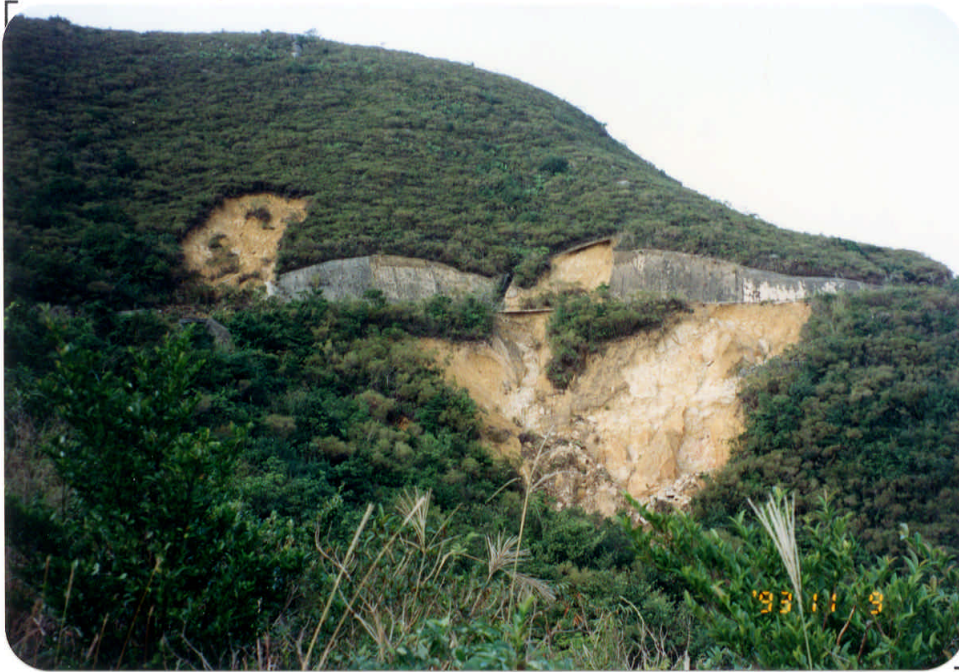
Plate 30 : Negative No. SP9315606 Taken on : 9-11-93

Description : Major failure of a natural slope (about 422 m<sup>3</sup>) resulting in the closure of an access road.

Plate 30 - Near Sham Wat Road, Lantau (Incident MW SP/201)

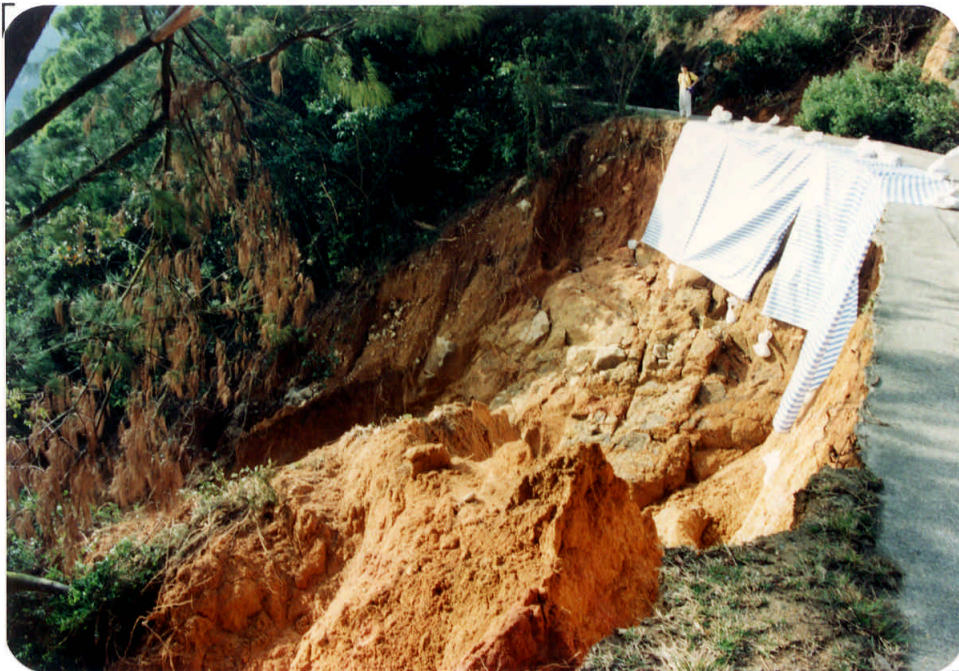
Plate 31 : Negative No. SP9314503 Taken on : 6-11-93

Description : Major failure of a natural slope (about 450 m<sup>3</sup>) leading to the closure of an access road and affecting buildings in Tong Fuk, Lantau.

Plate 31 - Near CH 154, Lantau Trail, Tong Fuk, Lantau (Incident MW SP/258)

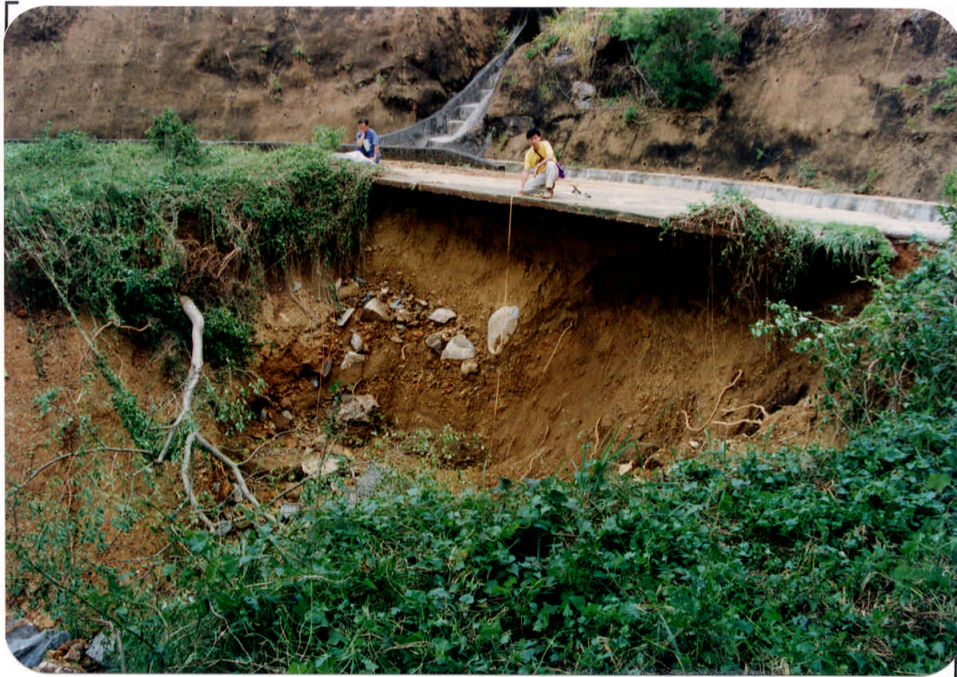
Plate 32 : Negative No. SP9314333 Taken on : 6-11-93

Description : Major failure of a fill slope affecting an access road

Plates 32 - Lantau Trail, Cheung Sha, Lantau, Slope No. 13NE-B/FR21  
(Incident MW SP/273)

Incidents affecting catchwaters and reservoirs were dealt with separately by the Water Supplies Department. There were 100 reported cases of slope failure which affected catchwaters and culverts, nineteen of which were major. The nineteen major cases are MW SP/130, MW SP/162, MW SP/170, MW SP/177, MW SP/181, MW SP/203, MW SP/209, MW SP/211, MW SP/212, MW SP/213, MW SP/215, MW SP/216, MW SP/218, MW SP/219, MW SP/232, MW SP/238, MW SP/249, MW SP/257 and MW SP/259. All of the cases took place in the New Territories. An example of these failures is shown in Plate 32.
