HONG KONG RAINFALL AND LANDSLIDES IN 1994

GEO REPORT No. 54

**GEOTECHNICAL ENGINEERING OFFICE
CIVIL ENGINEERING DEPARTMENT
HONG KONG**

**This report was originally produced in October 1995
as GEO Special Project Report No. SPR 5/95**

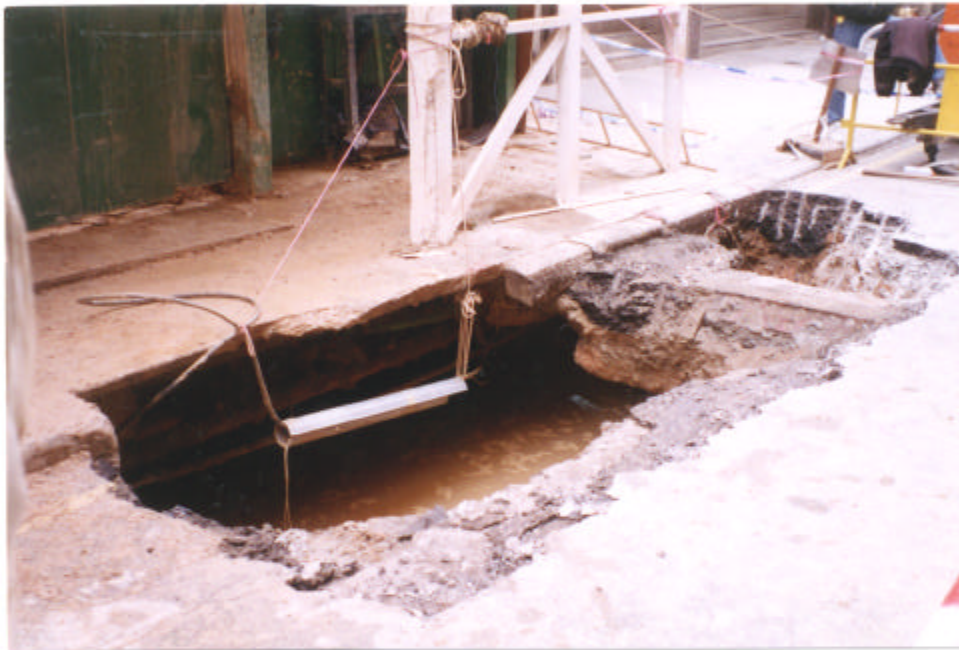
Plate 1 - Wing Lok Street, Sheung Wan (Incident HK 2/1)

Description : Ground subsidence (about 30 m³) resulting in the temporary evacuation of a building and the closure of a road.

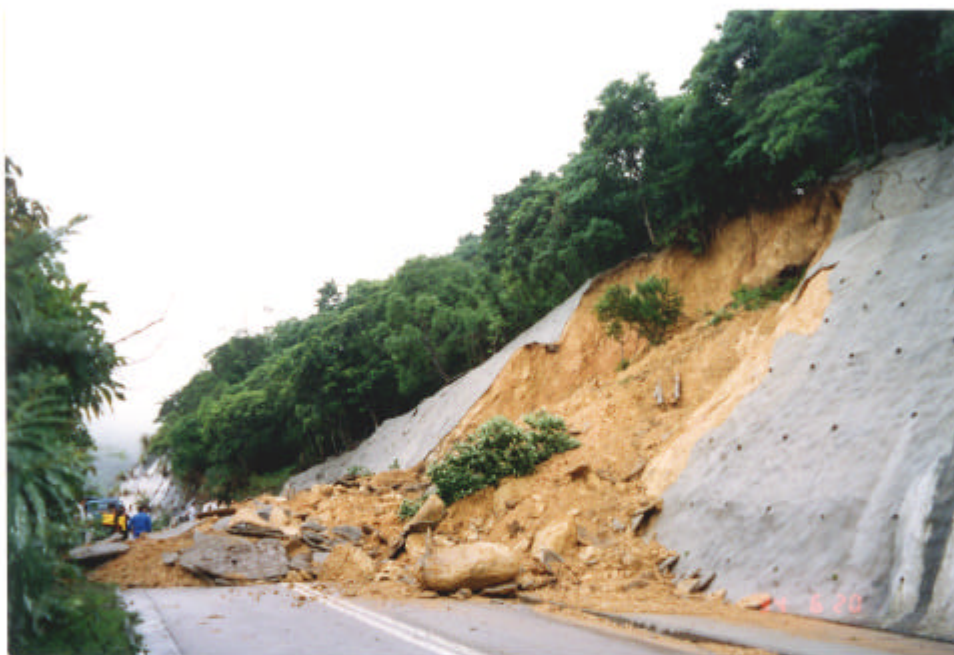
Plate 2 - Pak Tam Road near Uk Tau, Sai Kung, Slope No. 8NW-D/C3
(Incident ME 6/2)

Description : Major failure of a soil cut slope (about 80 m³) resulting in the closure of one lane of a road.

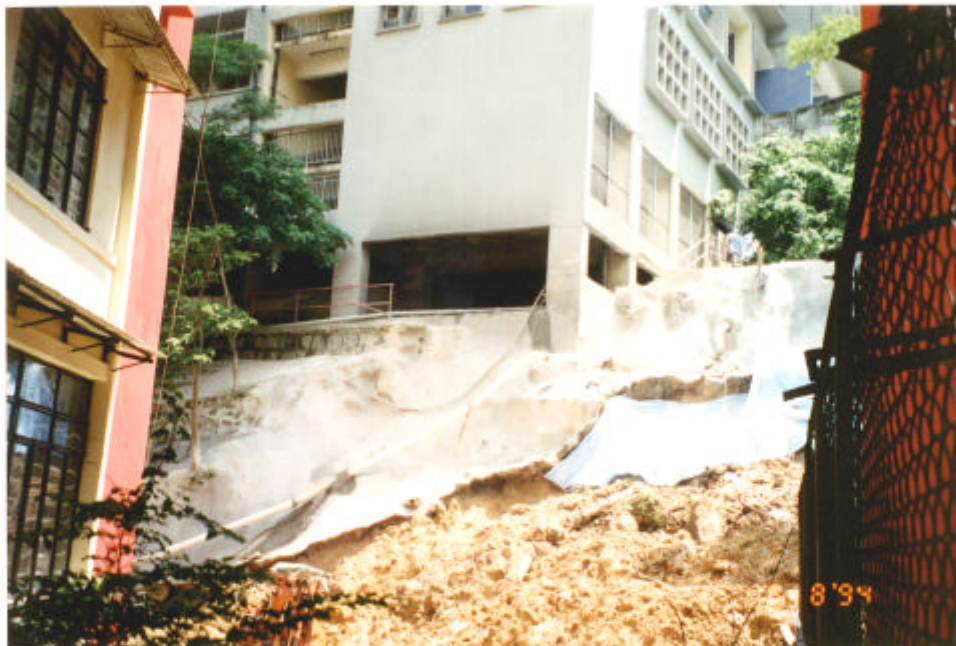
Plate 3 - Island Garden, Chai Wan Road, Shau Kei Wan,
Slope No. 11SE-B/CR79 (Incident HK 7/33)

At about 4:15 p.m. on 24 July, about 200 m^3 of soil slipped down from a soil cut slope (No. 11SE-B/CR79) during a heavy rainstorm, possibly as a result of continuous infiltration and erosion to the slope. The landslide scar measured 7 m high by 20 m wide, and part of the footing foundation which supported St. Basil's School behind the crest was exposed. Residential blocks of Island Garden at the slope toe were affected by the slipped debris, and six flats were temporarily closed.

Description : Major failure of a soil cut slope (about 200 m³) resulting in the evacuation of 6 flats.

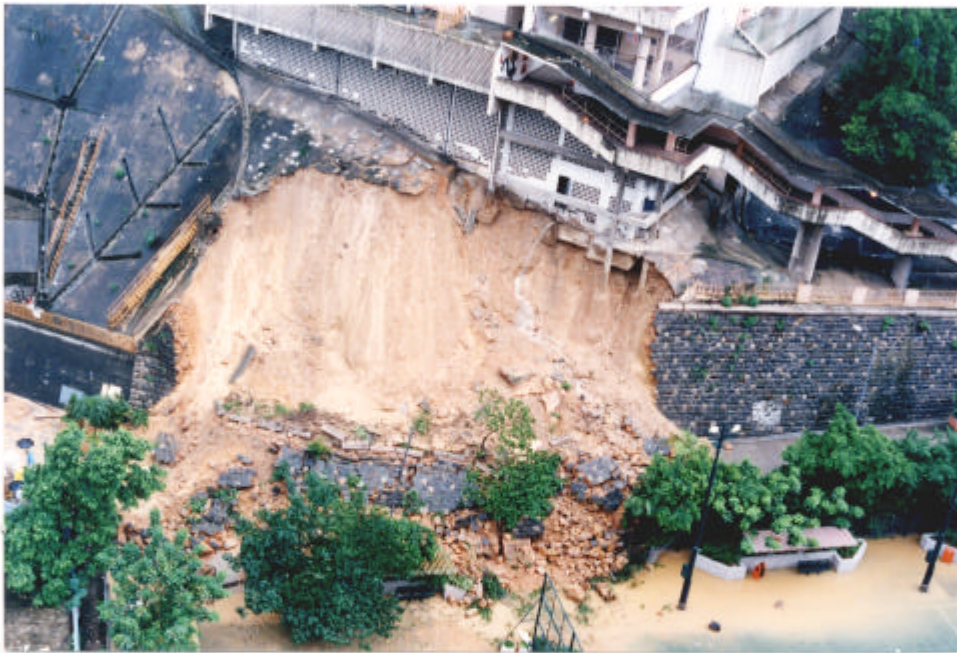
Plate 4 - Kwun Lung Lau, Kennedy Town, Wall No. 11SW-A/R309
(Incident HK 7/37)

At about 8:53 p.m. on 23 July, a landslide occurred below Block D at Kwun Lung Lau, Kennedy Town, following a period of heavy rain. The ground that failed comprised a portion of an old masonry wall (No. 11SW-A/R309) and the slope below Block D. The landslide scar measured 14 m high and 28 m wide. The average depth of debris was about 3 m, with a maximum depth of 6 m. About 1 000 m³ of debris were released in the landslide, comprising mainly soil, fragments of chunam, blocks of masonry and trees. A footpath in front of the masonry wall was buried by the landslide debris, resulting in five fatalities and injuries to three people.

Detailed investigation conducted by the GEO after the landslide found that the failure was triggered by the substantial saturation of the soil behind the wall, which was appreciably thinner than the usual for walls of this type. Leakages from defective underground water carrying services were the principal sources of the water. The prolonged and heavy rainfall preceding the landslide played a contributory part in resulting in a significant quantity of water having entered the ground, initially through the defective stormwater drainage system.

Description : Major failure of a masonry wall and a cut slope (about 1 000 m³).
Five dead, three injuries and two blocks were evacuated.

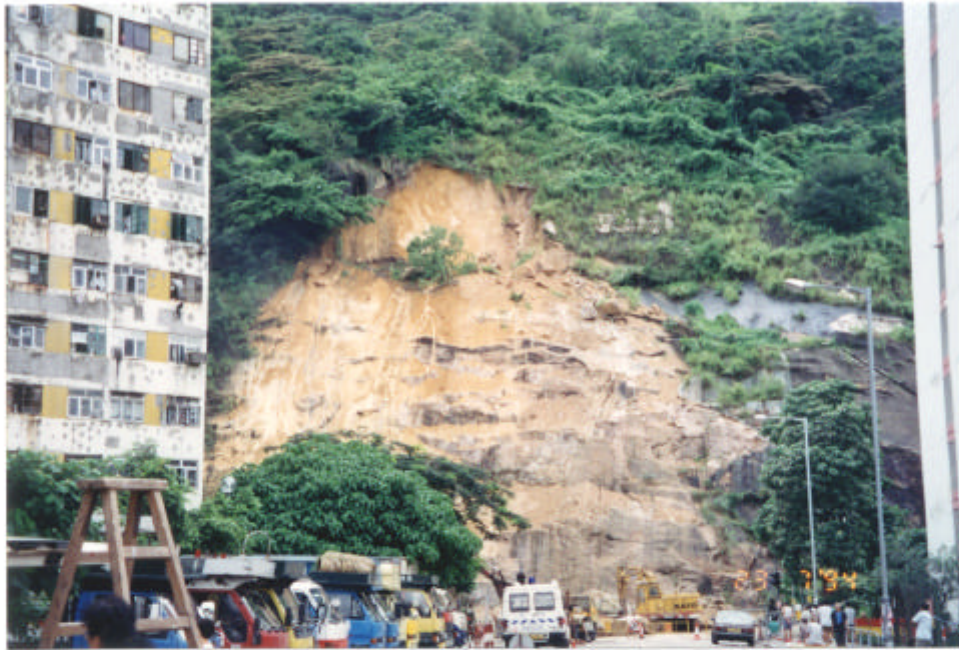
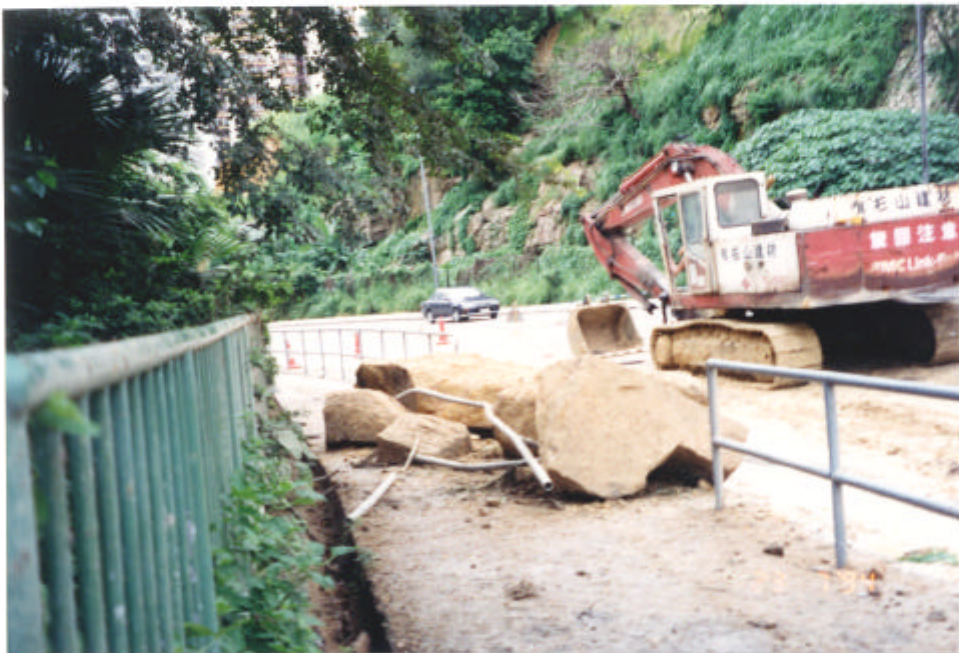
Plates 5 & 6 - Sau Mau Ping Road opposite Blocks 35 & 40, Sau Mau Ping,
Slope No. 11NE-D/C4 (Incident K 7/11)

The failure occurred at about 12:45 p.m. on 23 July after the prolonged rainfall during the previous day. The soil/rock cut slope (No. 11NE-D/C4) was located at the junction of Sau Mau Ping Road and Sau Ming Road. The landslide occurred at the upper portion of a 35 m high cut slope which was partly covered by chunam. The failed portion was located at about 30 m above the ground and the failure scar was about 4 m high by 20 m wide. The volume of failure was about 150 m³. The landslide debris comprising soil and large boulders slipped down onto Sau Mau Ping Road and damaged a taxi travelling along the road. This resulted in the closure of all the four lanes of Sau Mau Ping Road. The failure was probably caused by heavy infiltration during prolonged rainfall. Poor maintenance of the chunam slope cover could have contributed to the failure.

Description : Major failure of a soil/rock cut slope (about 150 m³) damaging a taxi and leading to the closure of a road.

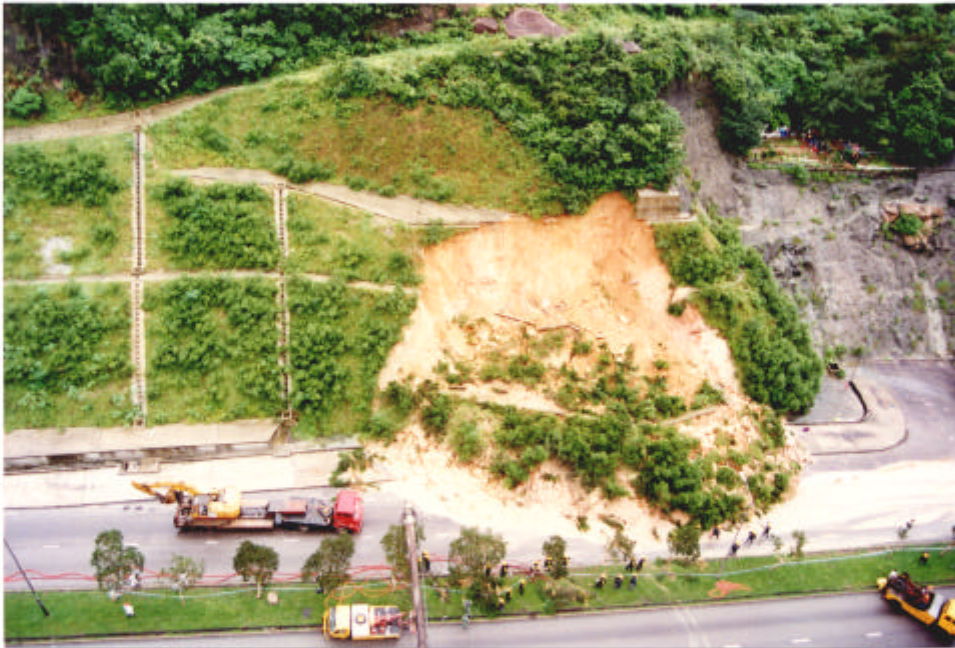
Plate 7 - New Clear Water Bay Road opposite Choi Wan Estate,
Slope No. 11NE-A/C63 (Incident K 7/14)

At about 6:00 a.m. on 25 July, a landslide occurred at a soil cut slope (No. 11NE-A/C63) along New Clear Water Bay Road opposite Choi Wan Estate. The slope was about 25 m high and covered by vegetation. The portion that failed was about 25 m high and 40 m wide. About 800 m^3 material slipped onto the New Clear Water Bay Road, covering three lanes of the road. This resulted in the closure of New Clear Water Bay Road. The failure was probably due to infiltration resulted from the prolonged and heavy rain in the previous few days.

Description : Major failure of a soil cut slope (about 800 m³) resulting in the closure of a road.

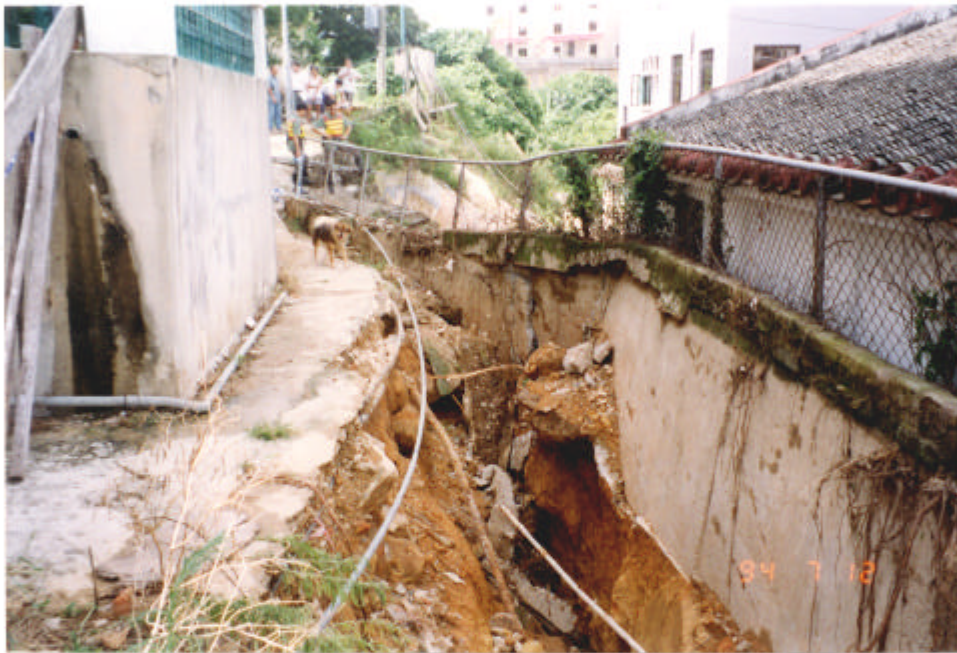
Plate 8 - House No. 45, Sheung Sze Wan Village, Sai Kung (Incident ME 7/3)

Description : Major failure of a retaining wall (about 80 m³) resulting in the evacuation of three flats.

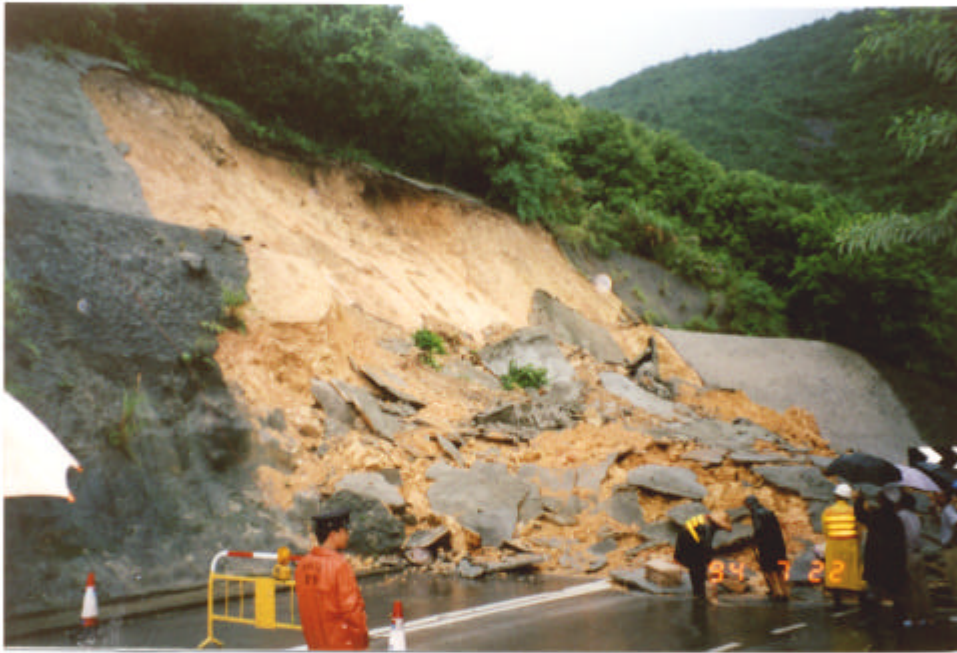
Plate 9 - Sai Sha Road near Kei Ling Ha Lo Wai, Sai Kung,
Slope No. 8NW-C/C14 (Incident ME 7/4)

At about 7:00 a.m. on 22 July, a soil cut slope (No. 8NW-C/C14) along Sai Sha Road near Kei Ling Ha Lo Wai failed. The cut slope was about 11 m high and was covered by shotcrete before the failure. The failure scar covered an area of 8 m high by 20 m wide. About 260 m³ of soil were dislodged and spread over Sai Sha Road. One lane of the road was closed as a result of the failure. The probable cause of the failure was rise in pore water pressure as a result of increased seepage along relict joints in the soil during heavy rain.

Description : Major failure of a soil cut slope (about 260 m³) leading to the closure of a road.

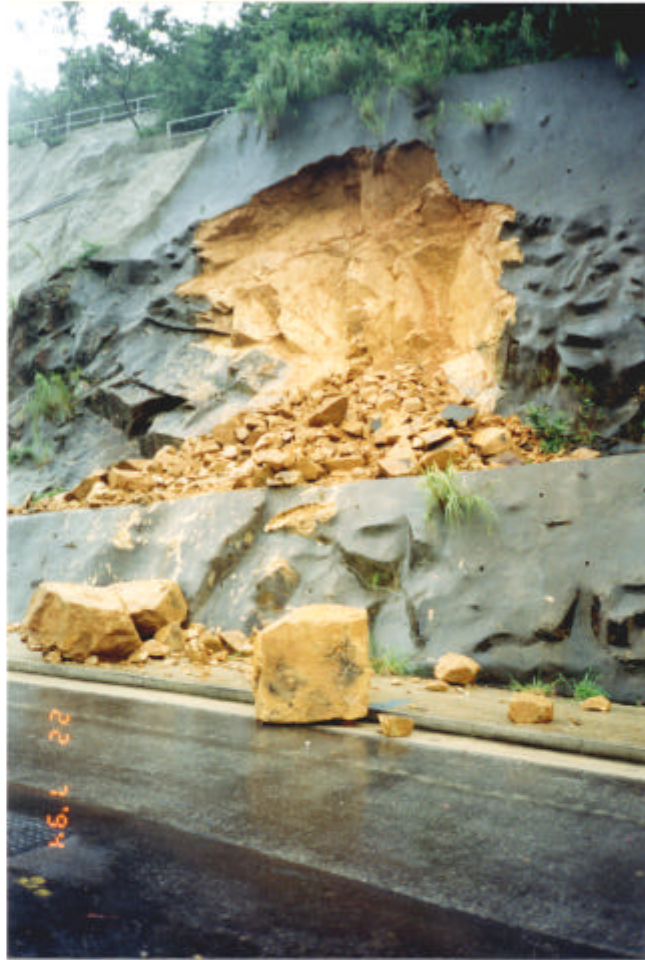
Plate 10 - Lai Ping Road near Chinese University, Shatin,
Slope No. 7NE-C/C78 (Incident ME 7/15)

Description : Rock fall (15 m^3) from a cut slope blocking one lane of a road.

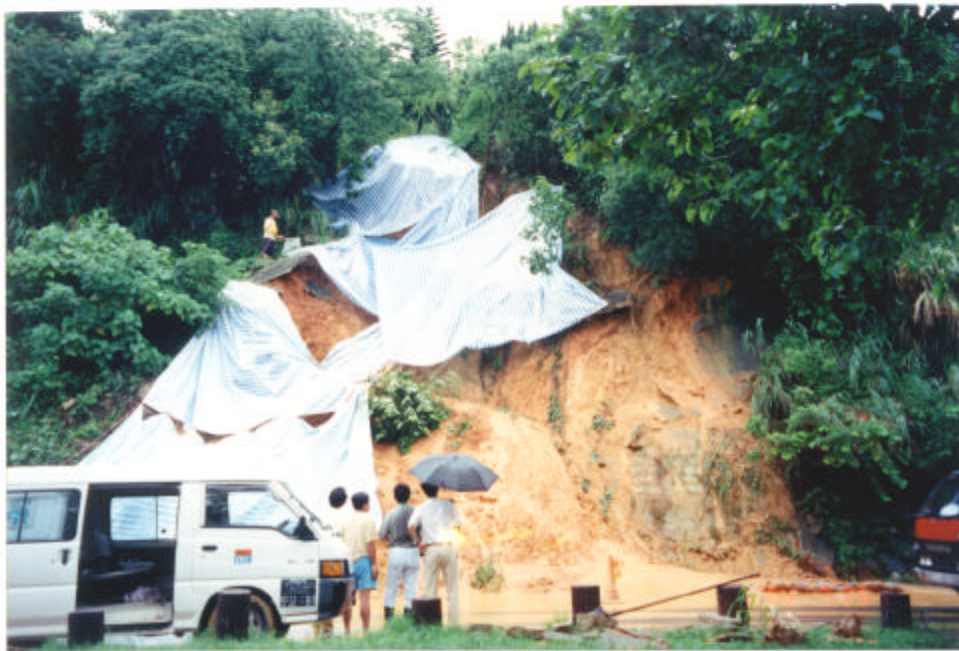
Plate 11 - Tai Mong Tsai Road near Hopes Villa, Sai Kung,
Slope No. 8SW-A/C20 (Incident ME 7/27)

The landslide occurred at 2:00 p.m. on 24 July during intense rain at a slope along Tai Mong Tsai Road near Hopes Villa, Tai Wan. The failure involved a road-side cut slope (No. 8SW-A/C20) and the natural slope above it. Before the failure, the cut slope was covered by chunam and stone-pitching while the natural slope was covered by heavy vegetation. The

cut slope had a gradient of 50° to 70° and that of the natural slope was about 30° . The failure scar was about 16 m high and 45 m wide, with a maximum depth of failure of 5 m. The slipped material was mainly colluvium and was estimated to have a volume of 1000 m^3 , blocking both lanes of Tai Mong Tsai Road. The failure was likely due to heavy infiltration and erosion resulted from prolonged and intense rainfall.

Description : Major failure of a soil cut/natural slope (about 1 000 m³) resulting in the closure of a road.

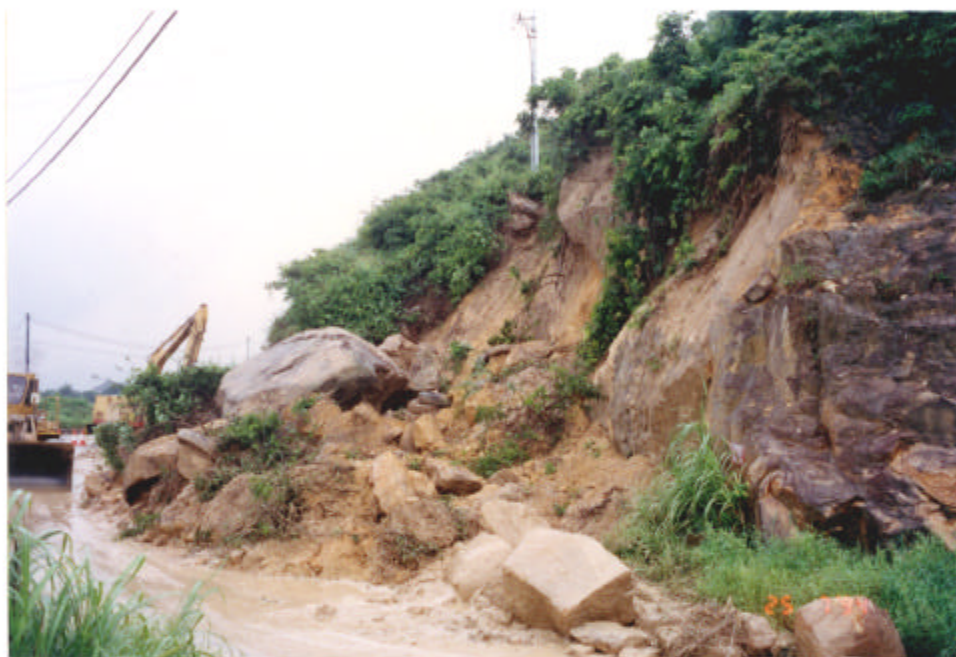
Plate 12 - Anderson Road near Anderson Road Quarry, Sai Kung,
Slope No. 11NE-D/C164 (Incident ME 7/31)

Description : Major failure of a soil/rock cut slope (about 80 m³) leading to the closure of a road.

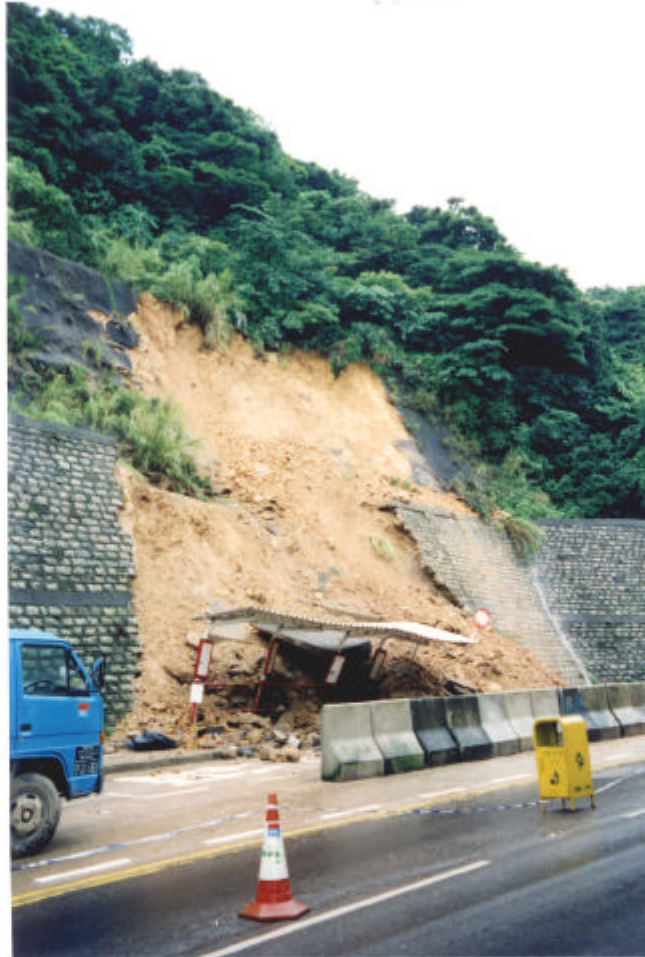
Plate 13 - Clear Water Bay Road near Pik Uk Tsuen, Sai Kung,
Slope No. 11NE-B/C144 (Incident ME 7/32)

Description : Major failure of a soil cut slope (about 60 m³) damaging a bus shelter and resulting in the closure of one lane of a road and a pedestrian pavement.

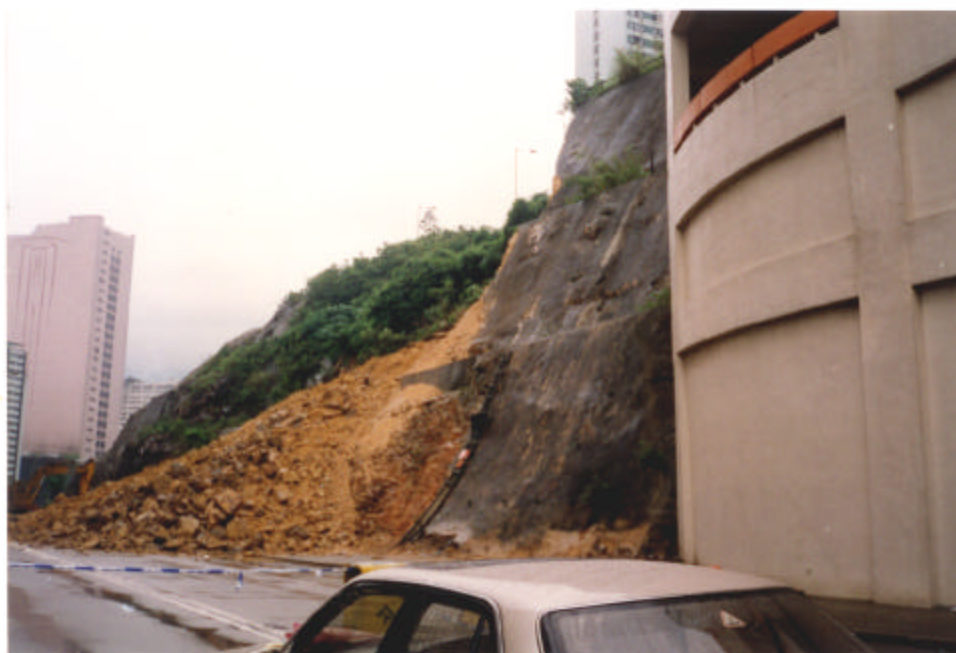
Plate 14 - Kwai Fuk Road near Chun Shing Building, Kwai Chung,
Slope No. 7SW-C/C281 (Incident MW 7/10)

Description : Major failure of a soil/rock cut slope (about 200 m³) blocking 4 lanes of a road.

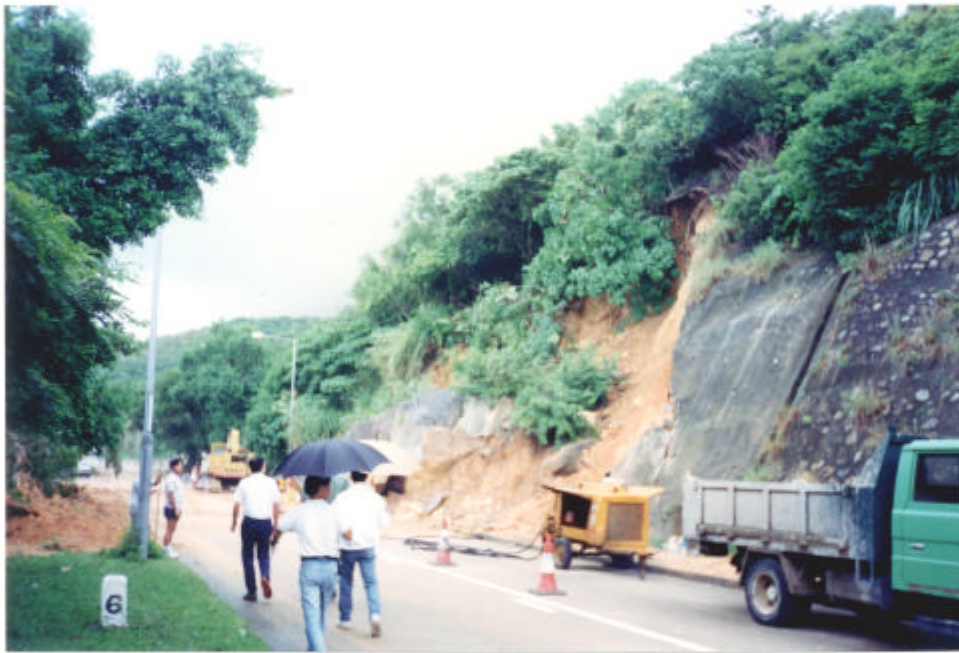
Plate 15 - Milestone 6, South Lantau Road, Lantau Island,
Slope No. 13NE-B/C9 (Incident MW 7/25)

Description : Major failure of a soil/rock cut slope (about 250 to 300m³) resulting in the closure of two lanes of a road and a pedestrian pavement.

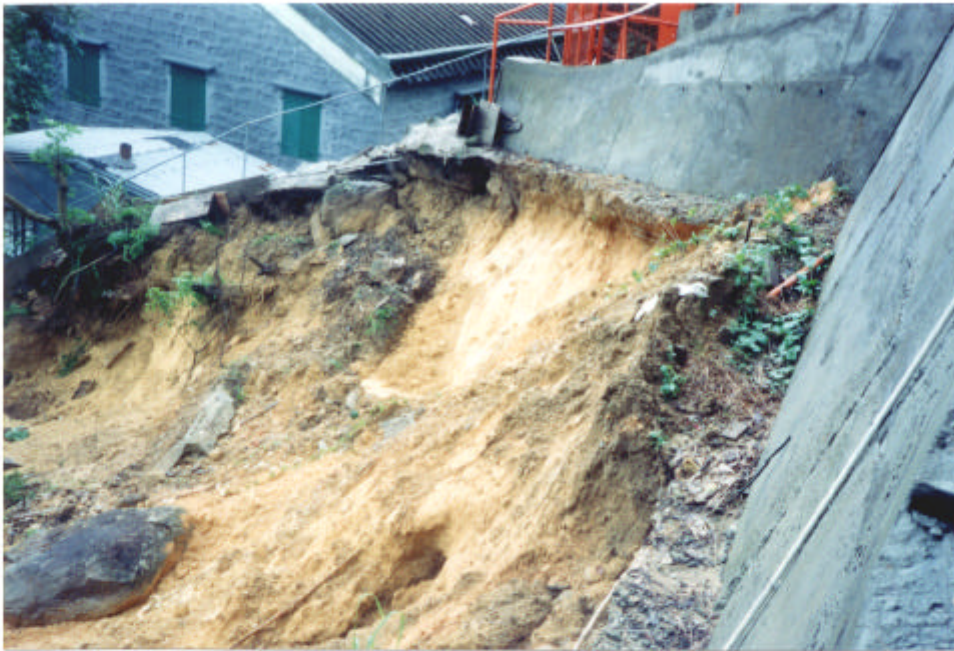
Plates 16 & 17 - Structure
S/GPA1/31,
Luk Wo, Lantau Island,
(Incident MW 7/26)

Description : Failure of a
natural slope (about 40 m³)
resulting in the evacuation
of a house.

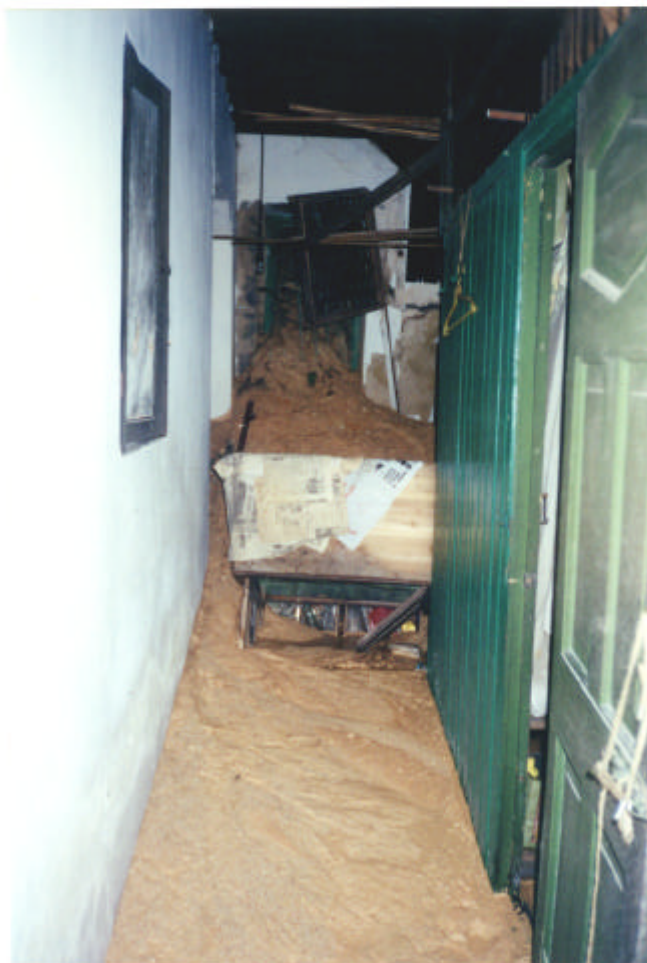
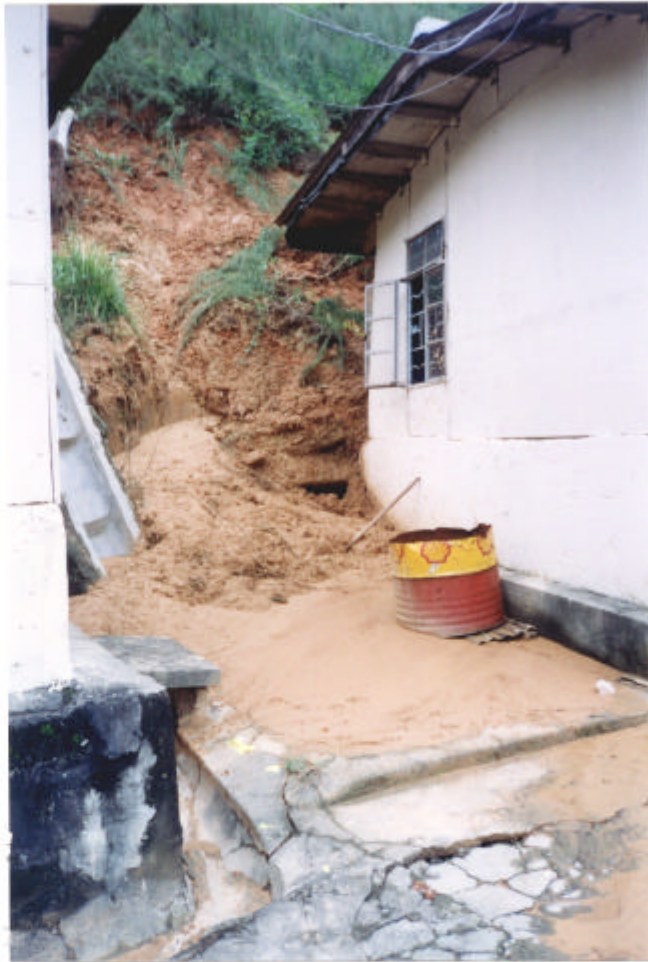
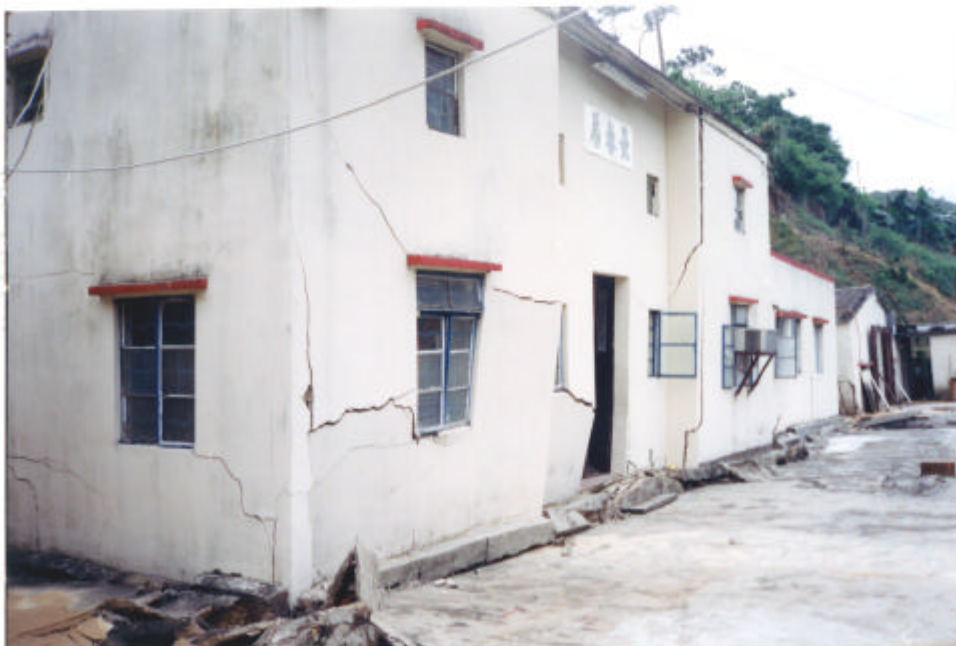
Plates 18 & 19 - No. 19 Sung Shan New Village, Yuen Long (Incident MW 7/44)

Description : Failure of a
cut slope (about 40 m³)
resulting in the evacuation
of one house and the blockage
of a road.

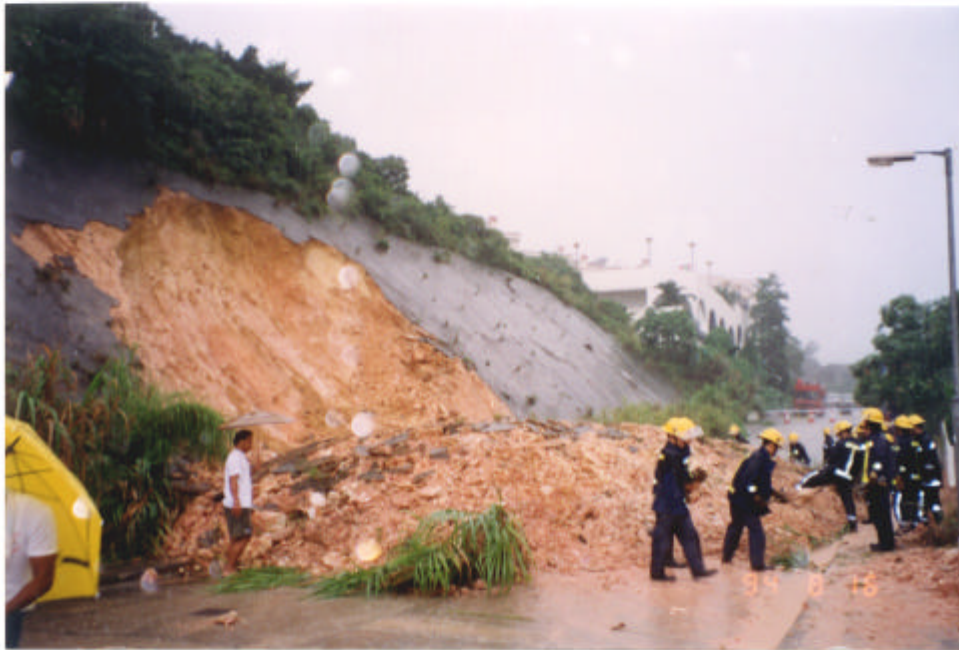
Plate 20 - Ah Kung Wan Road, Sai Kung (Incident ME 8/22)

Description : Major failure of a soil cut slope (about 240 m³) resulting in the evacuation of 4 houses and the blockage of a road.

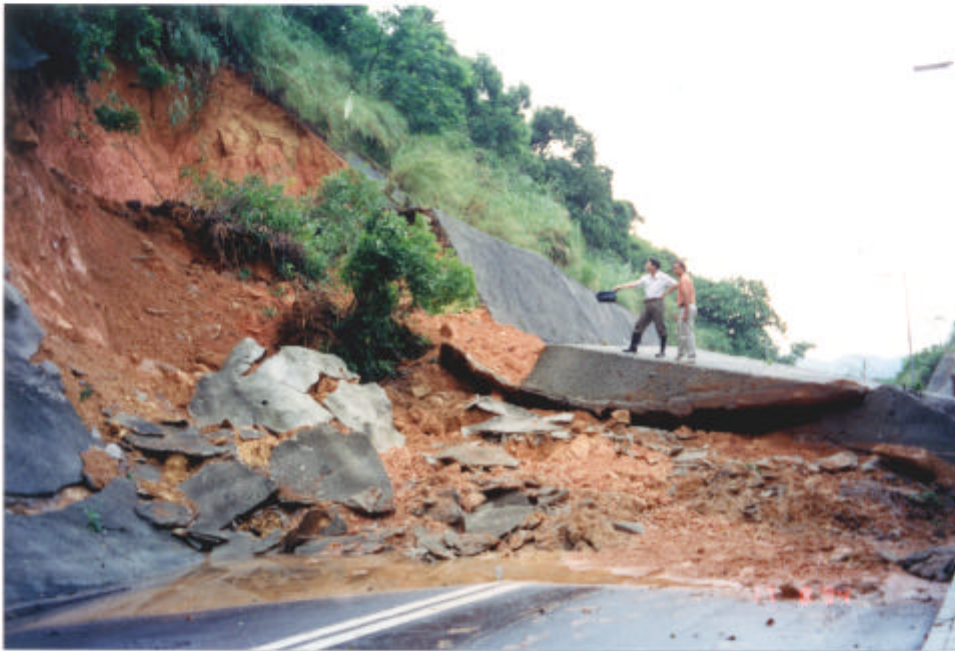
Plate 21 - Sai Sha Road near Long Keng, Sai Kung, Slope No. 8SW-A/C4
(Incident ME 8/24)

Description : Major failure of a soil cut slope (about 200 m³) leading to the closure of a road.

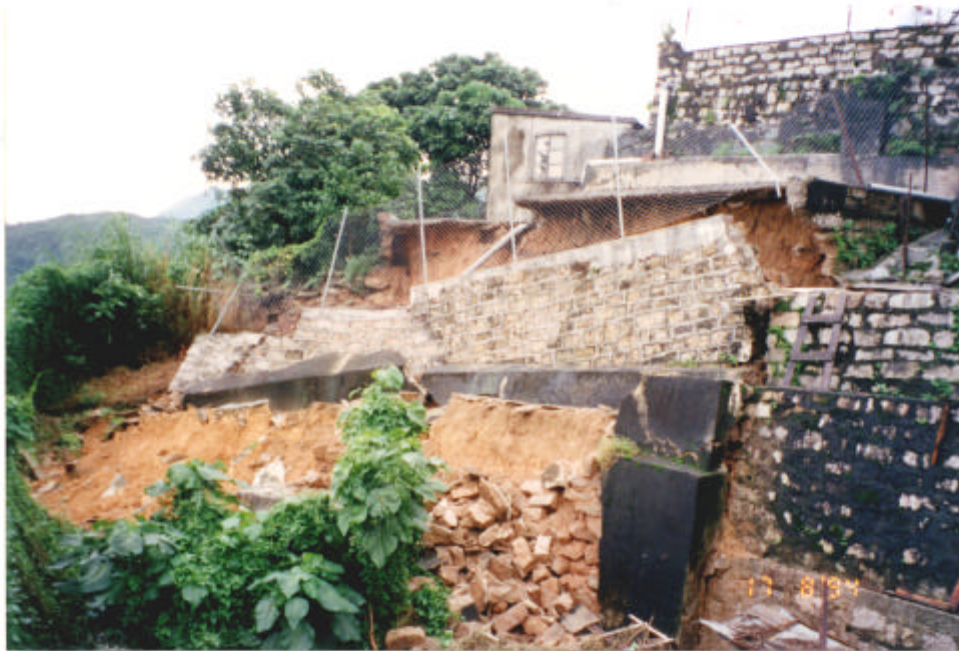
Plate 22 - O Long Village, Sai Kung (Incident ME 8/28)

Description : Major failure of a masonry retaining wall (about 50 m³) resulting in the temporary evacuation of 2 huts.

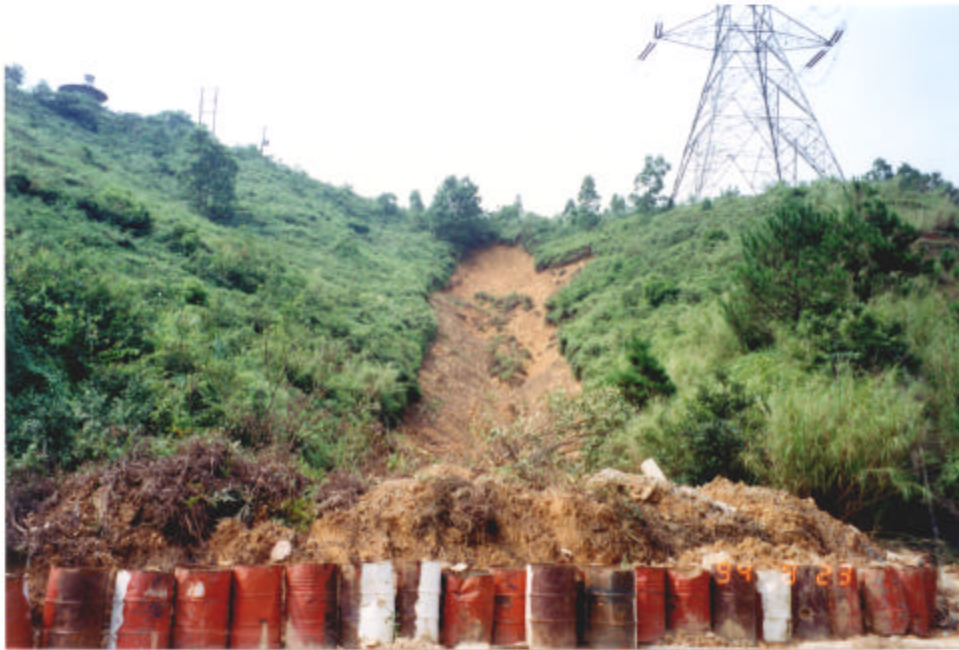
Plate 23 - Lin Ma Hang Road, Man Kam To (Incident ME 8/32)

Description : Major failure of a natural slope (about 100 m³) leading to the closure of one lane of a road.

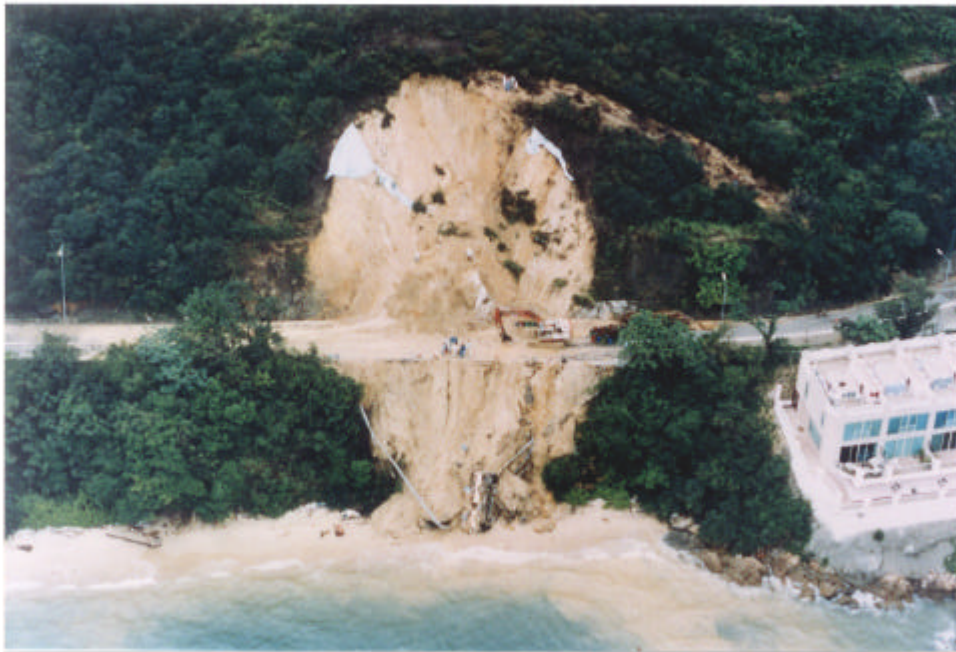
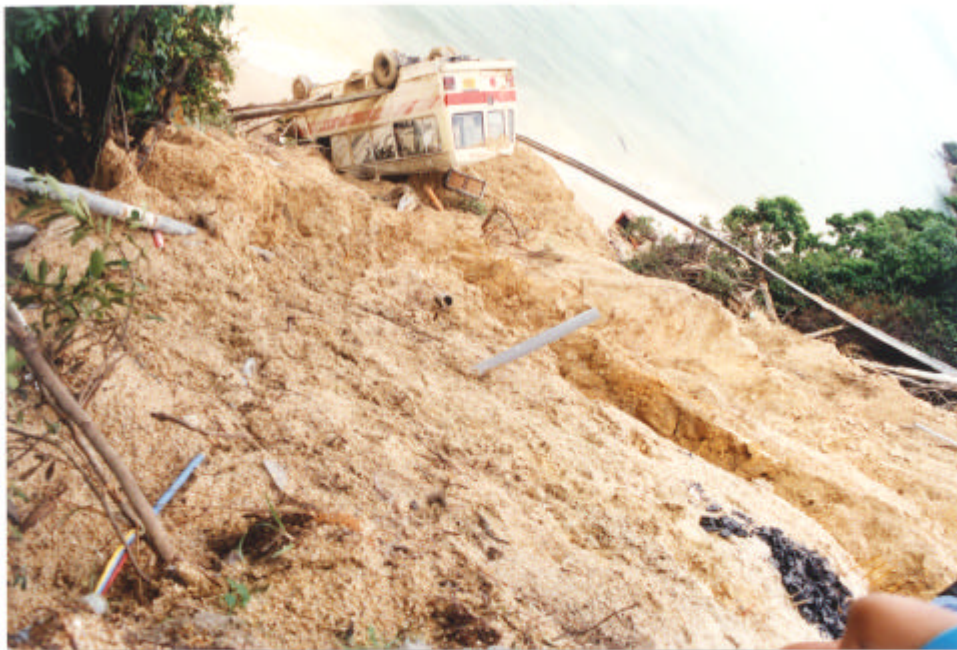
Plates 24 & 25 - Milestone 14½, Castle Peak Road, Tsing Lung Tau
(Incident MW 8/3)

Shortly before 7:00 a.m. on 23 July, a minor landslide occurred at the cut slope. The failure occurred between a cut slope in rock at the west and a no-fines concrete wall with a stone-pitching facing at the east. The volume of failure was approximately 20 m³.

Description : Major failure of a soil cut/natural slope (about 1 000 m³). One dead, 17 injuries and the blockage of a road.

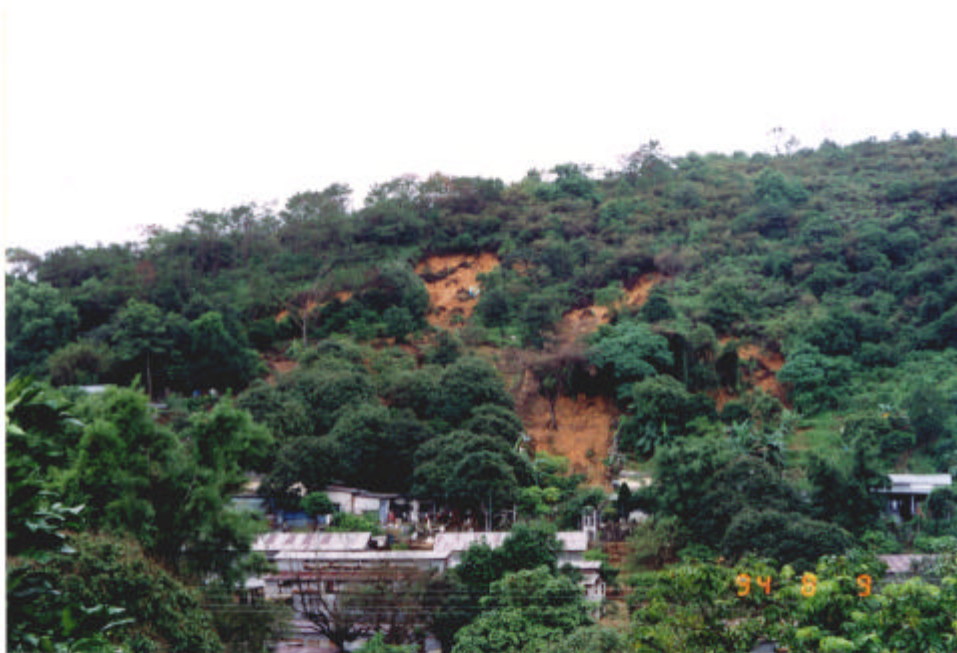
Plate 26 - Kwu Tung Hang Tsuen, Sheung Shui (Incident MW 8/24)

The landslide occurred at about 4:00 p.m. on 6 August at a slope behind Ki Lun Tsuen, Kwu Tung after the intense rain in the morning. The failure occurred in a natural slope which had a gradient of about 27° and an average height of about 50 m. The failure involved three slip scars in an area of about 80 m wide and 15 m high, with an estimated failure volume of about 200 m^3 . The maximum depth of failure was about 2 m. Many boulders, with size up to 1.3 m in diameter, were found in the landslide debris. Some of the landslide debris entered the backyard of the squatter huts located at the toe of the slope. A total of 30 huts were permanently evacuated subsequent to the failure. The failure was probably triggered by infiltration during heavy rain.

Description : Major failure of a natural slope (about 200 m³) resulting in the permanent evacuation of 30 huts.

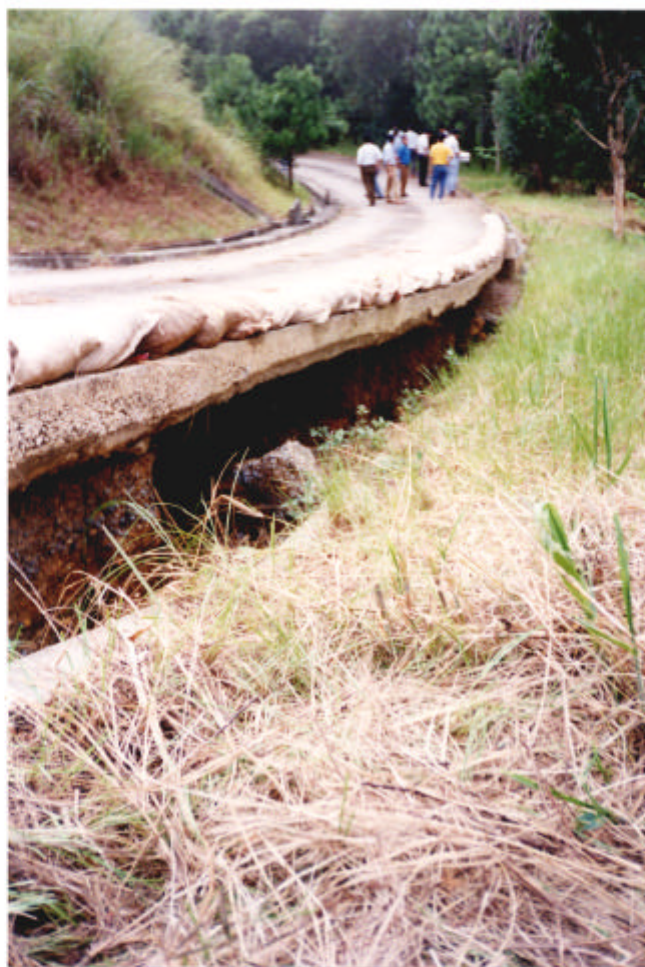
Plate 27 - Table Hill Service Reservoir, Sheung Shui (Incident MW 8/50)

Description : Major failure of a soil cut slope (about 200 m³) affecting an access road.

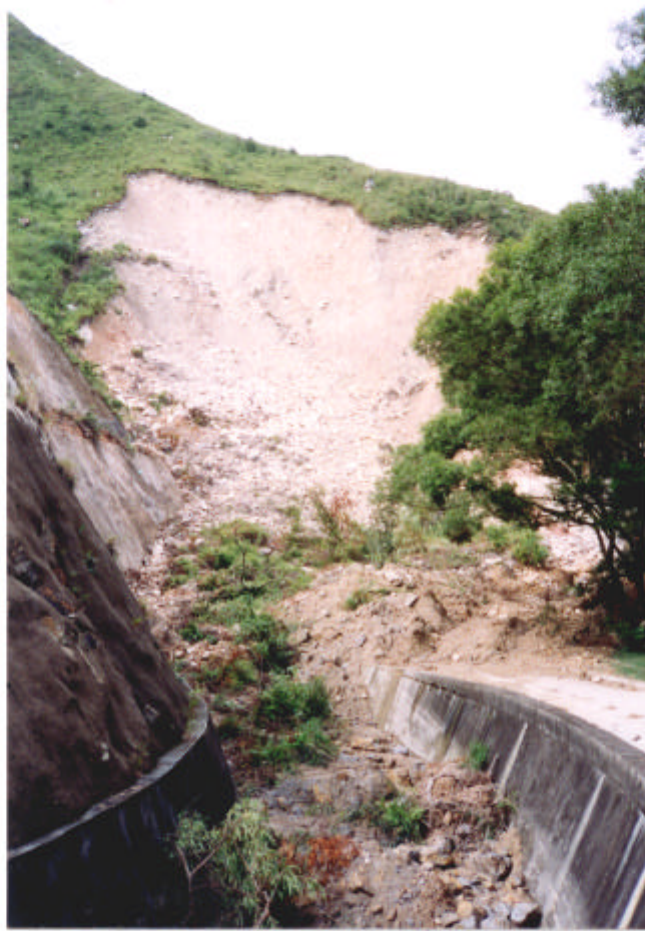
Description : Major failure of a soil cut slope (about 300 m³) blocking the catchwater.
