**STUDY OF RAINFALL
INDUCED LANDSLIDES ON
NATURAL SLOPES IN THE
VICINITY OF TUNG CHUNG
NEW TOWN, LANTAU ISLAND**

GEO REPORT No. 57

**GEOTECHNICAL ENGINEERING OFFICE
CIVIL ENGINEERING DEPARTMENT
THE GOVERNMENT OF THE HONG KONG
SPECIAL ADMINISTRATIVE REGION**

**This report was originally produced in July 1996
as GEO Special Project Report No. SPR 4/96**

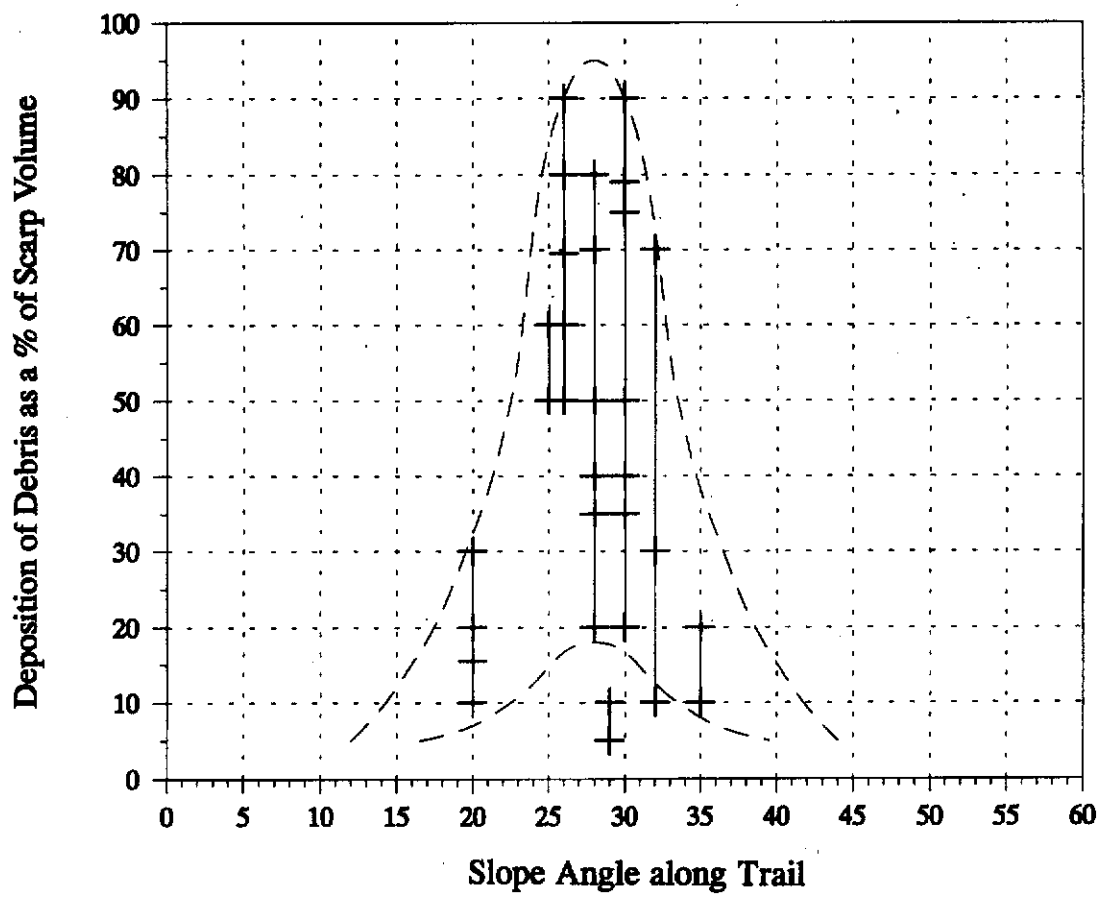
Figure 5 - Slope Angle vs Deposition Volume (as % of Main Scarp Volume)

Examination of the field data indicates that most debris deposition occurs on slope angles in a wide range of 8° to 40° (Table 9, and Figure 5). The wide variation is considered due to the wide range in magnitude of the events studied and the variation in landslide debris transport mechanisms and landslide types observed. Some are *unconstrained* involving only deposition from simple debris flows whilst others are *constrained* and are associated with channelised debris flows. The limited data from the study area indicates that a lower bound angle for deposition is 8° with channel confinement or 10° without channel confinement. In general however, *unconstrained* landslides are more likely to deposit on steeper slope angles. Figure 5 shows that for most *unconstrained* landslides the maximum (i.e. 90%) deposition of debris, as a percentage of the source (main scarp) volume, occurs in slope angles from 26° to 30°. A typical range of slope angles for deposition of at least 30% or more of the debris from the main scarp volume is from 20° to 36°.

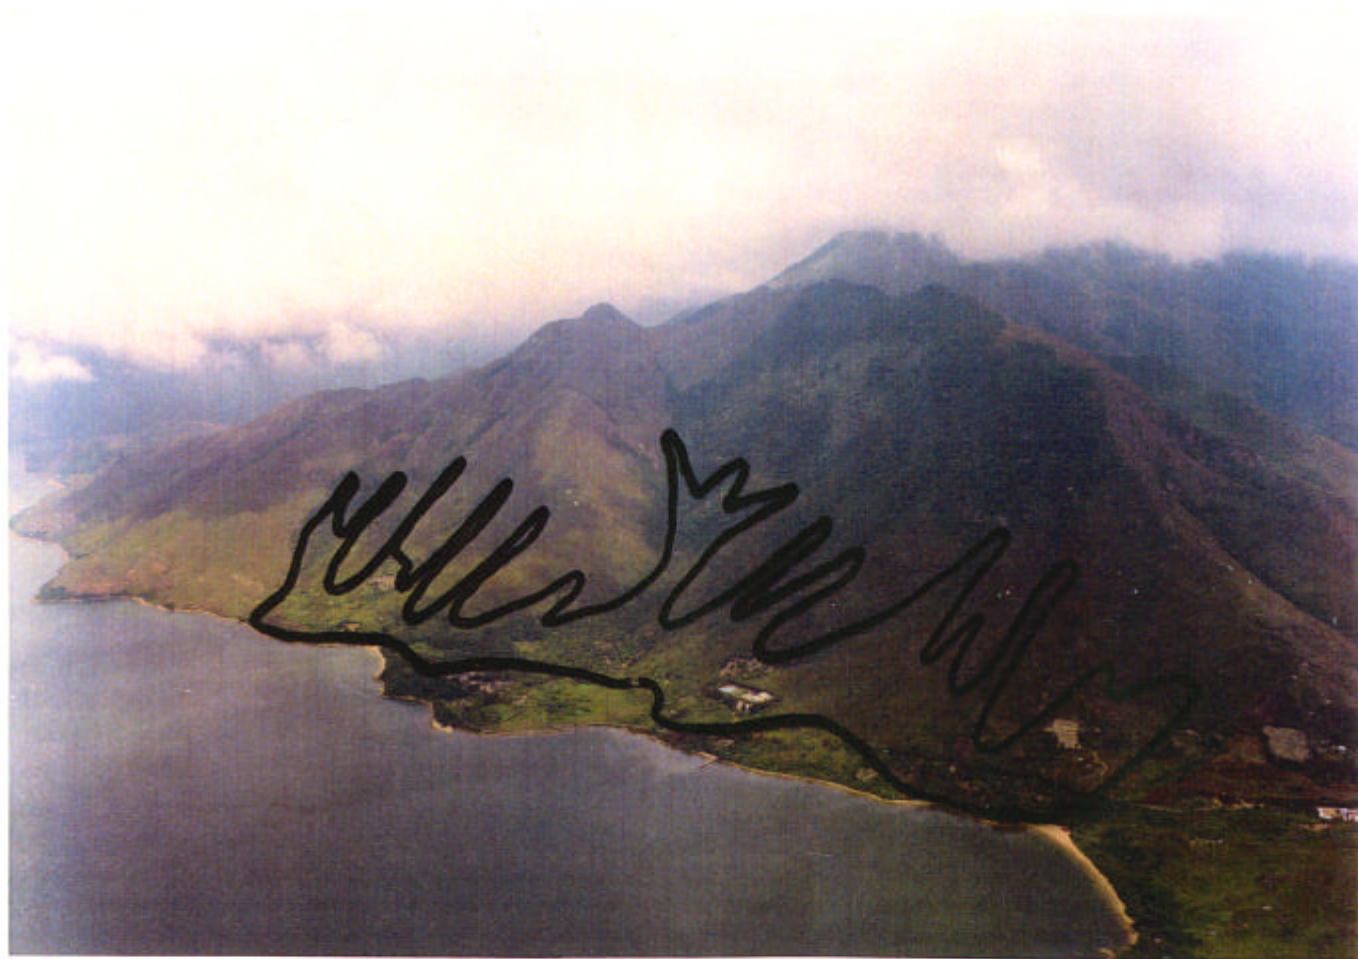
Negative No. PS 695/13

Plate 5 - Large Area of Colluvium on the North Facing Slopes of Pok To Yan

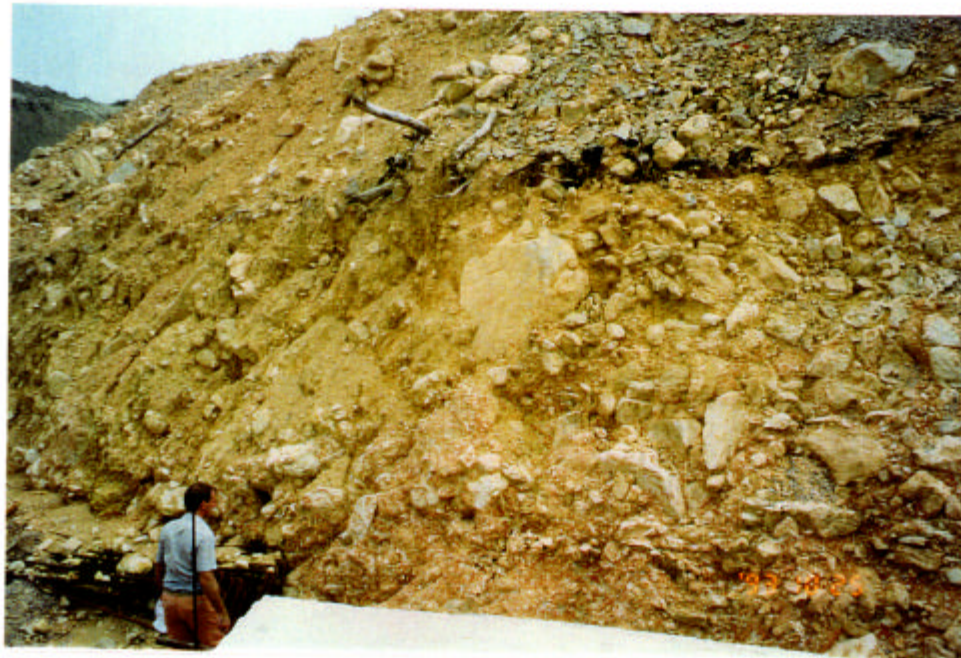
Negative No. TP 224/17

Plate 6 - Exposure of Colluvium Along Feeder Road P2 in Tung Chung New Town Development Area, Phase 1

Town access road Phase 1 area below Pok To Yan (Plate 6) demonstrate the wide grading of the material comprising these deposits. The colluvium observed in exposures typically consists of cobbles and boulders, of primarily feldsparphyric rhyolite with some tuff, in a matrix of mottled reddish brown and yellowish brown gravelly, sandy, slightly clayey silt. The cobbles and boulders are typically subangular and moderately to highly decomposed with a patina up to 50 mm thick. Test pits excavated into this material (Plate 7 and Table 2) indicate bulk insitu density of 2.2-2.3 Mg/m³ for the overall deposit using the water replacement method and 1.7 Mg/m³ for the matrix using the sand replacement method (with insitu moisture content in the range 10.7-16.6%). The mottled nature, relative high density of the deposit and presence of a patina on the coarse materials indicates that the colluvium is of intermediate age, which is equivalent to Class 2 using the definitions from the Mid Levels Area study (GCO 1982). Isolated lobes of younger (Class 3) colluvium were also noted across this site and are characterised by a less compact structure of the matrix and the colour being light yellowish brown (Plate 8).

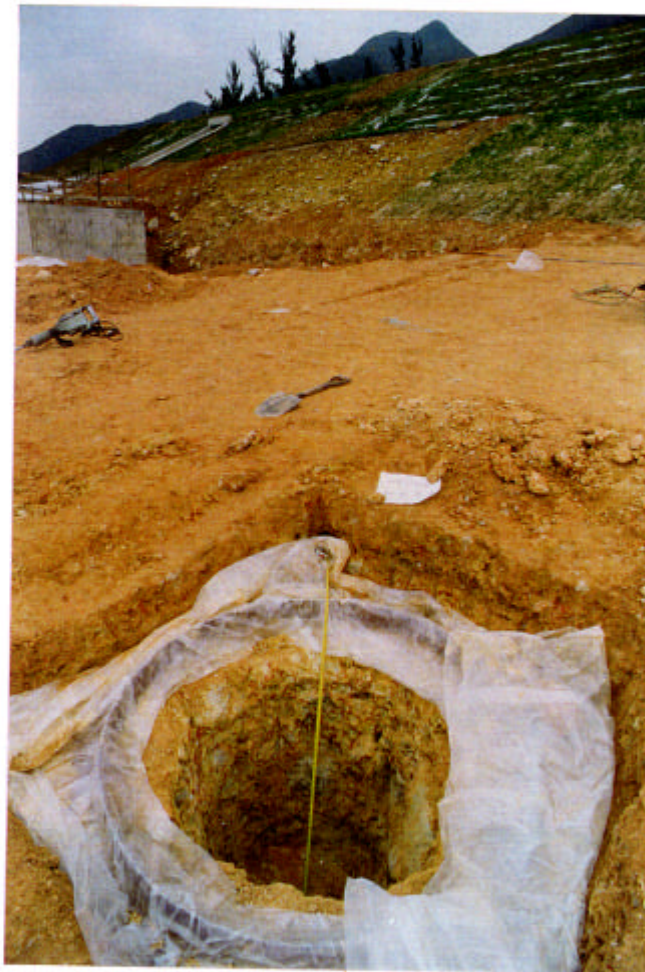
Negative No. EG 93/84/28

Plate 7 - Test Pit Excavated into Colluvium to Determine Insitu Density by
Water Replacement Method

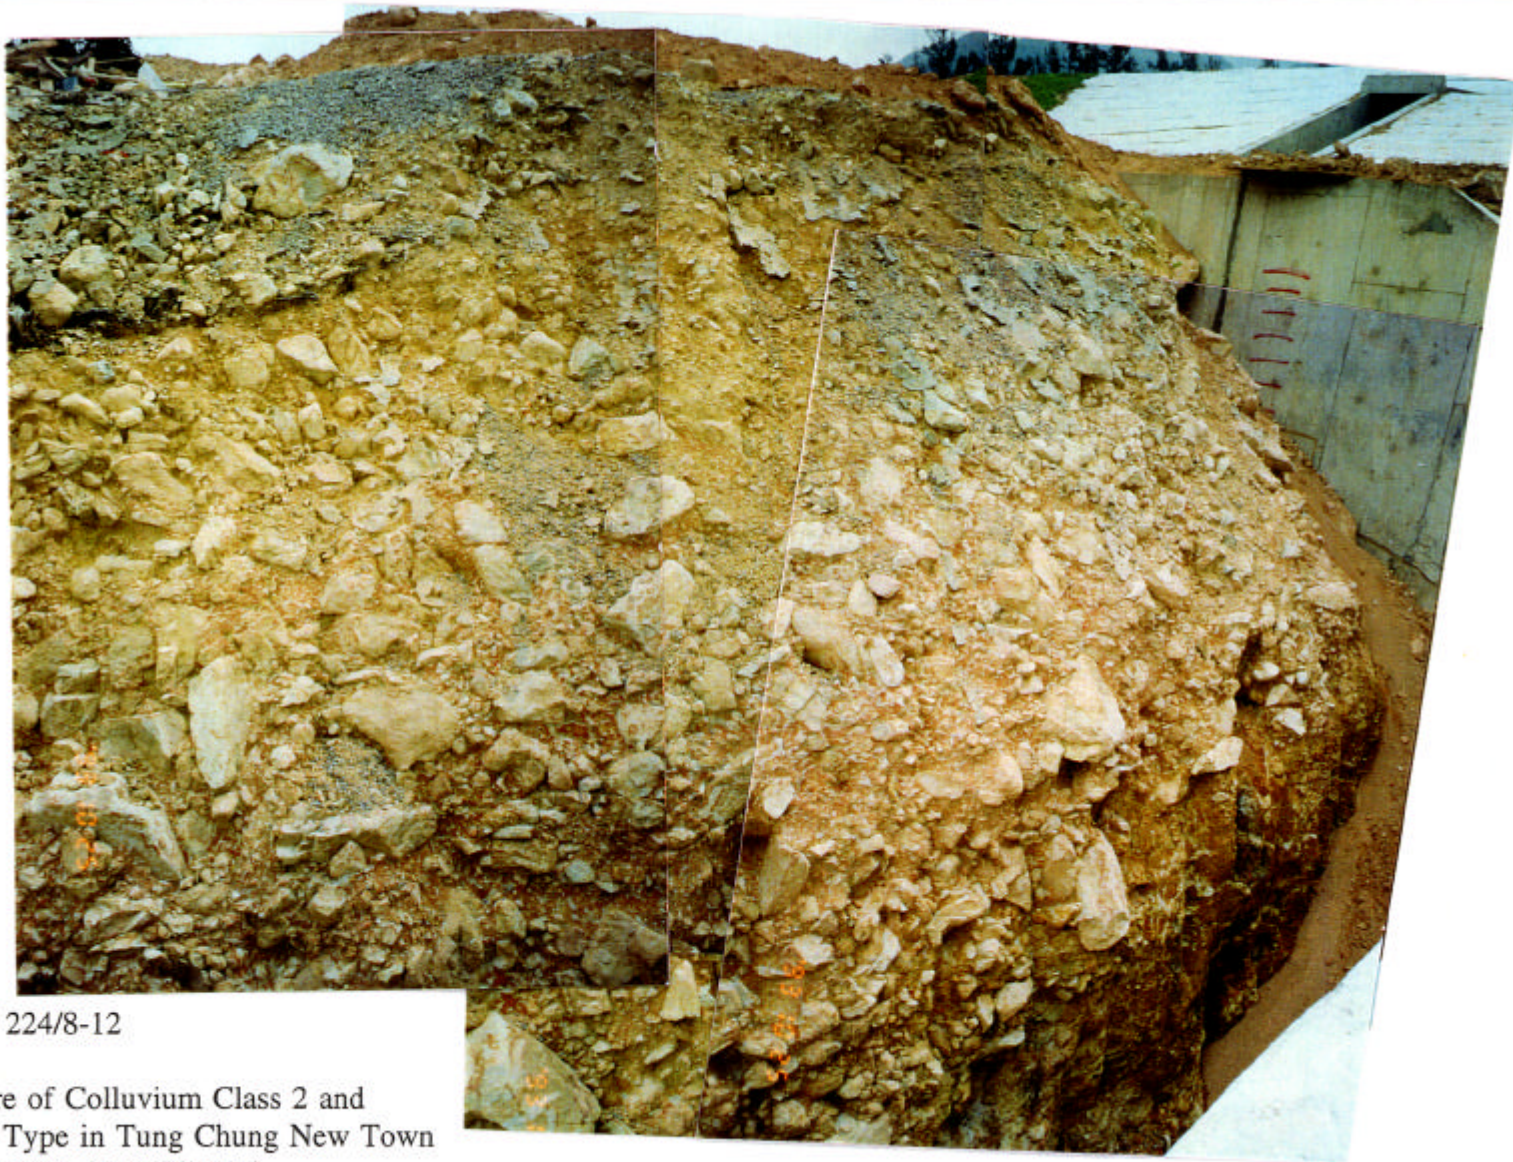
Negative No. TP 224/8-12

Plate 8 - Exposure of Colluvium Class 2 and
Class 3 Type in Tung Chung New Town
Development Area, Phase 1

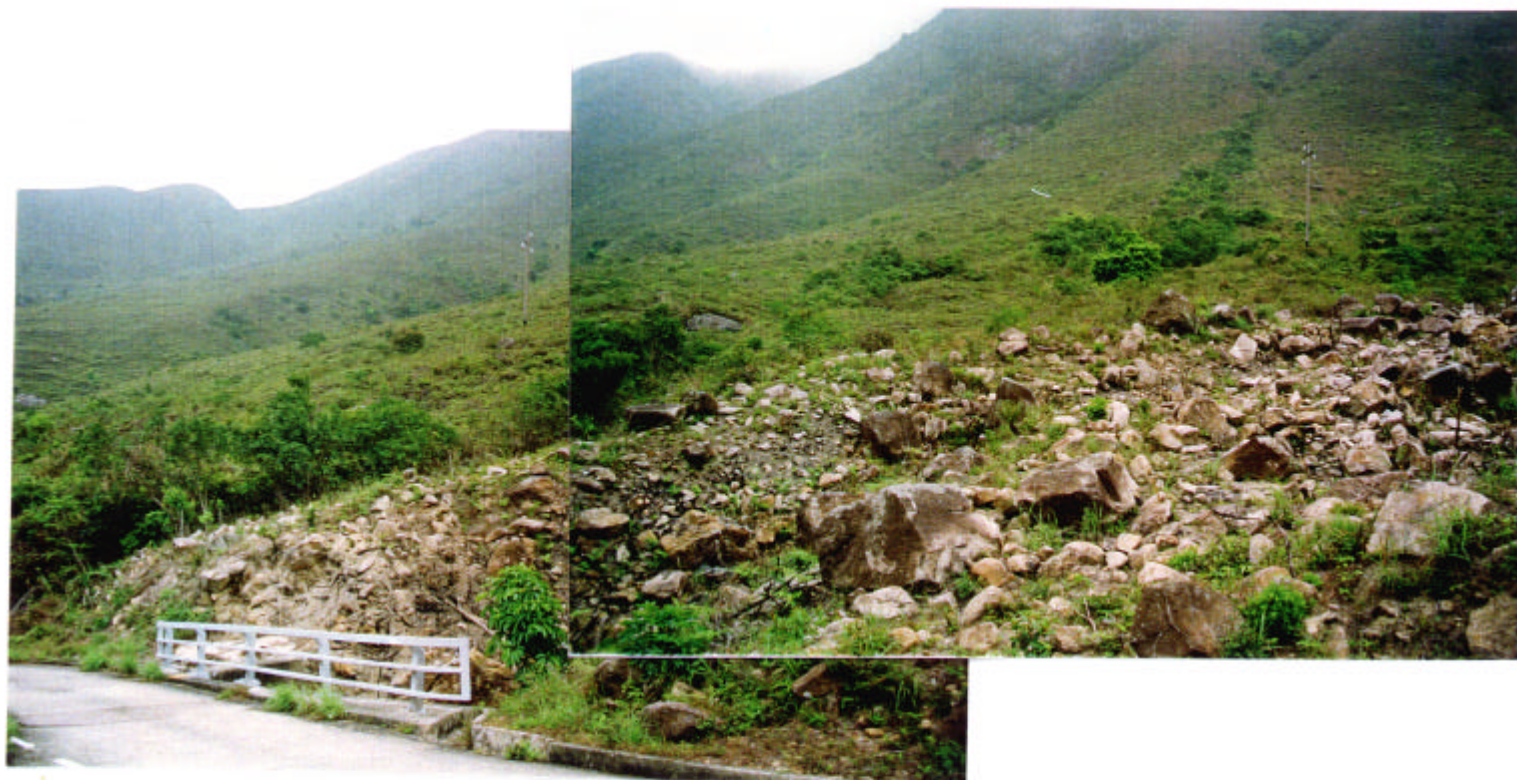
Negative No. EG 91/26/00-1

Plate 9 - Bouldery Surface on Natural Slope Indicative of Colluvium

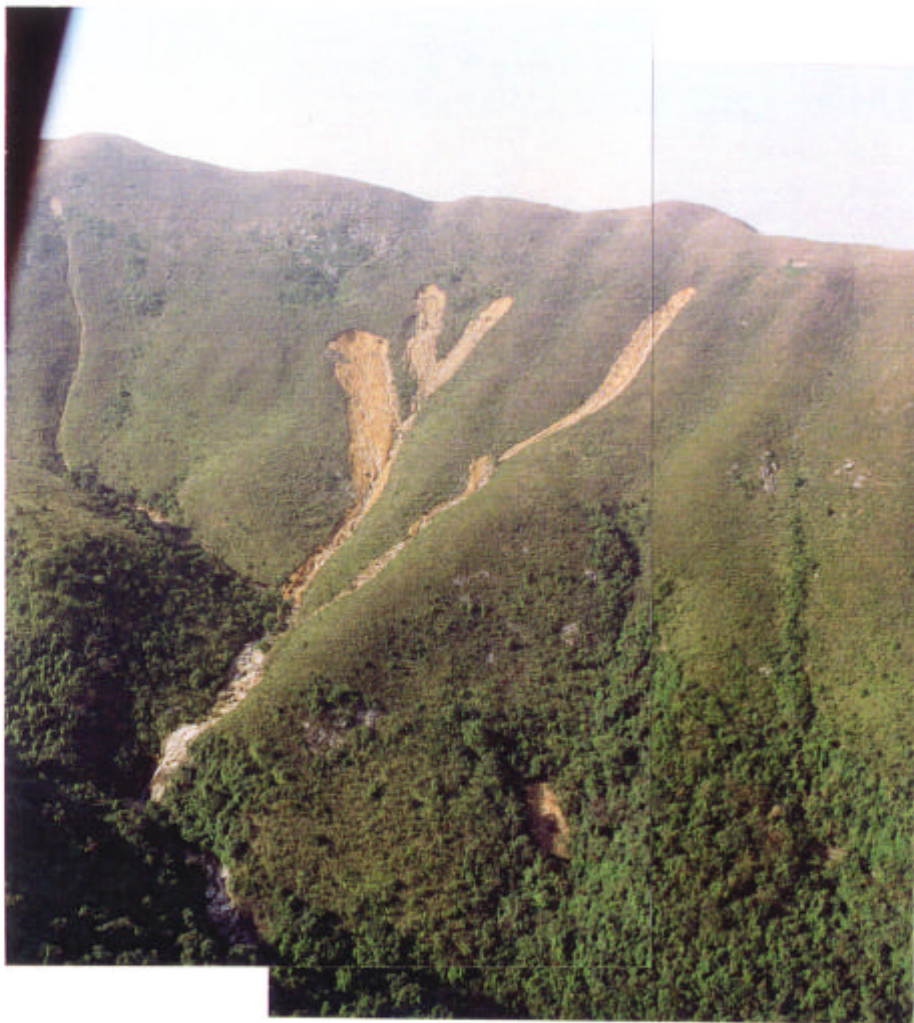
Negative No. EG 93/86/16-17

Plate 10 - Scarps Typically Formed on Steep Slopes close to the
Catchment Boundary

The sources are generally high up within the catchment close to the catchment divide (Plate 10) on steep slopes ($30^\circ - 40^\circ$). Following the parent landslide, the displaced material will generally become significantly disaggregated forming an elongated trail of *debris* below the source (*debris flow*). However a few landslides were observed where the displaced material has remained relatively intact within the elongated trail (*debris slide*).

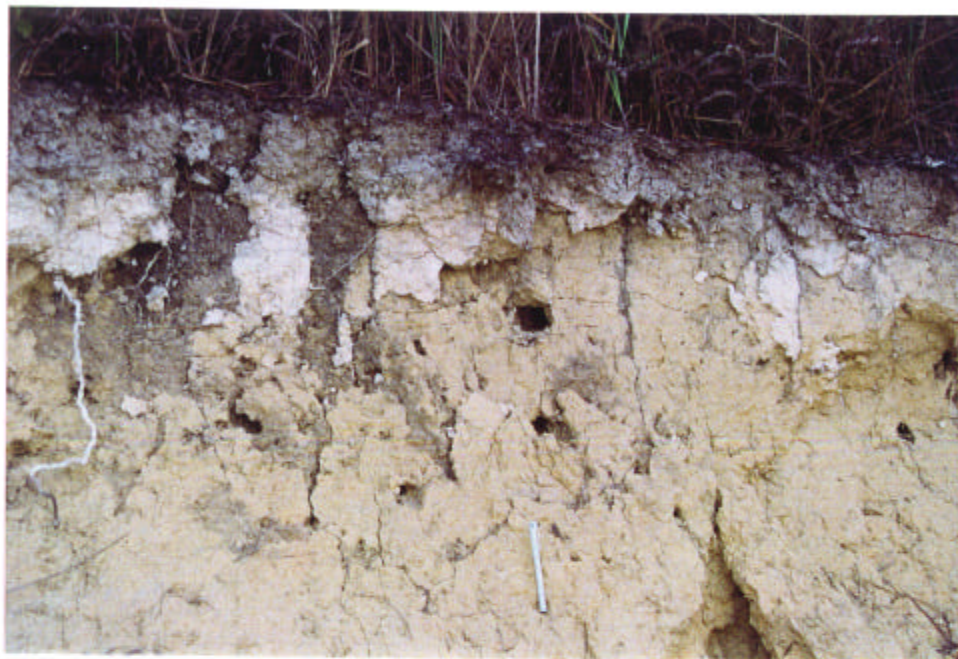
Negative No. EG 94/05/9

Plate 11 - Piping in Main Scarp within Residual Soil

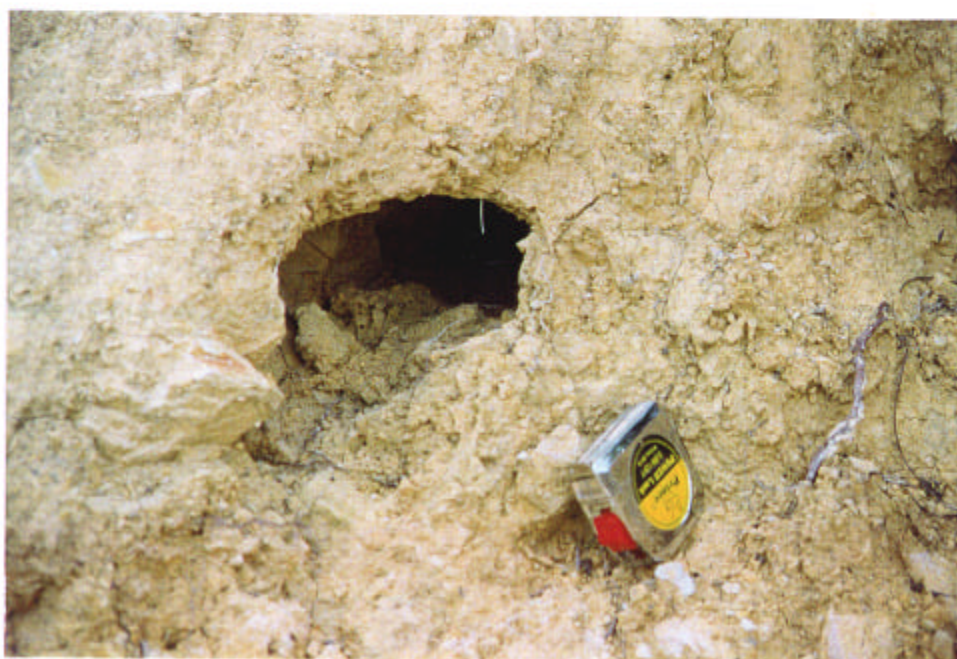
Negative No. EG 93/86/34

Plate 12 - Piping in Main Scarp within Colluvium

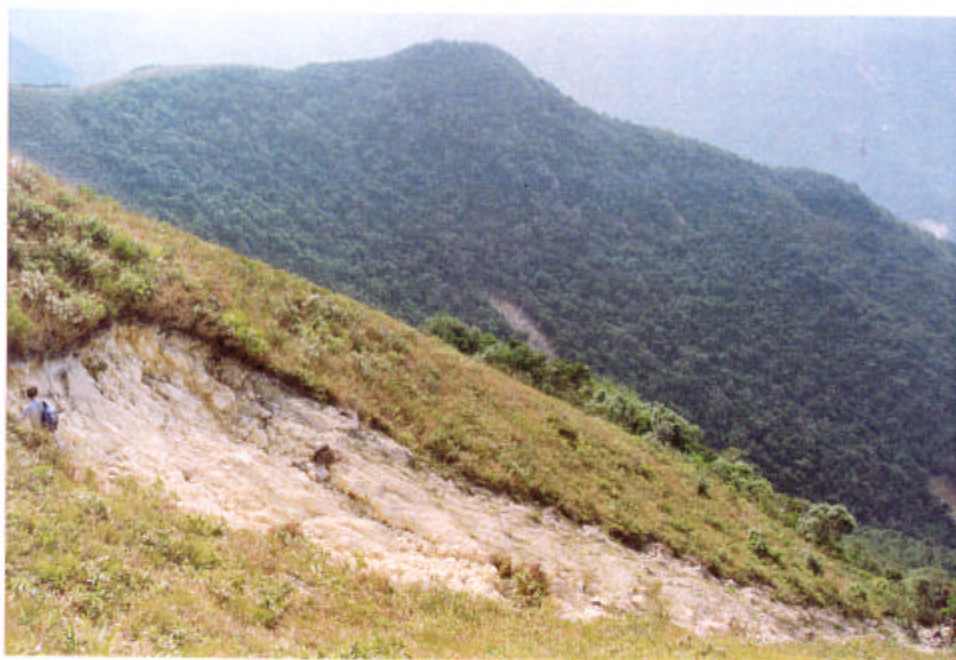
Negative No. EG 94/06/22

Plate 13 - Typical Main Scarp formed in Colluvium with no Debris on Surface of Rupture

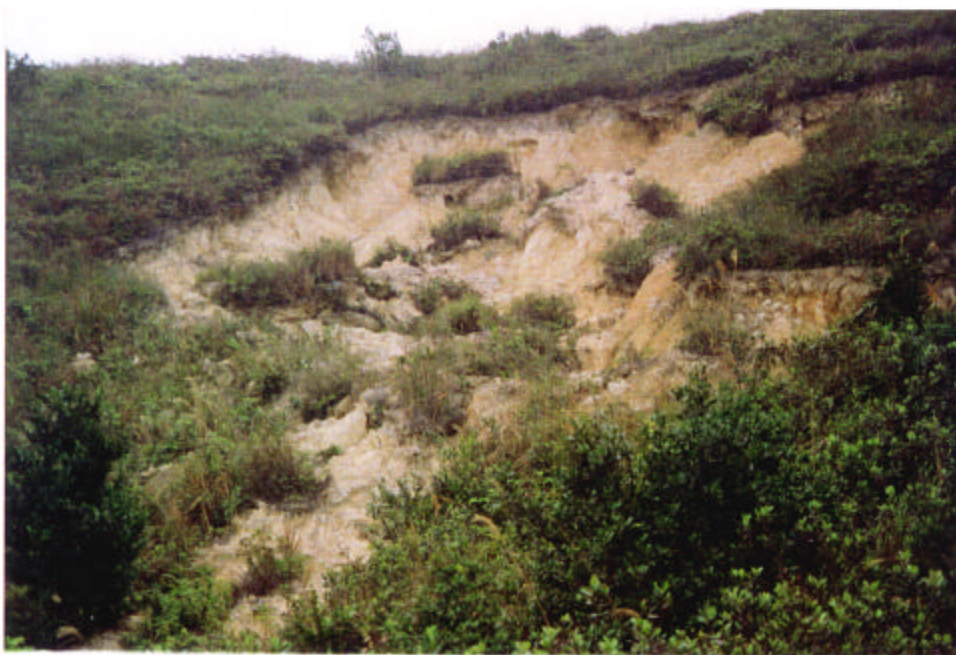
Negative No. EG 94/05/18

Plate 14 - Main Scarp with Minor Disaggregation of the Displaced Material and most of the Debris Remaining on Surface of Rupture

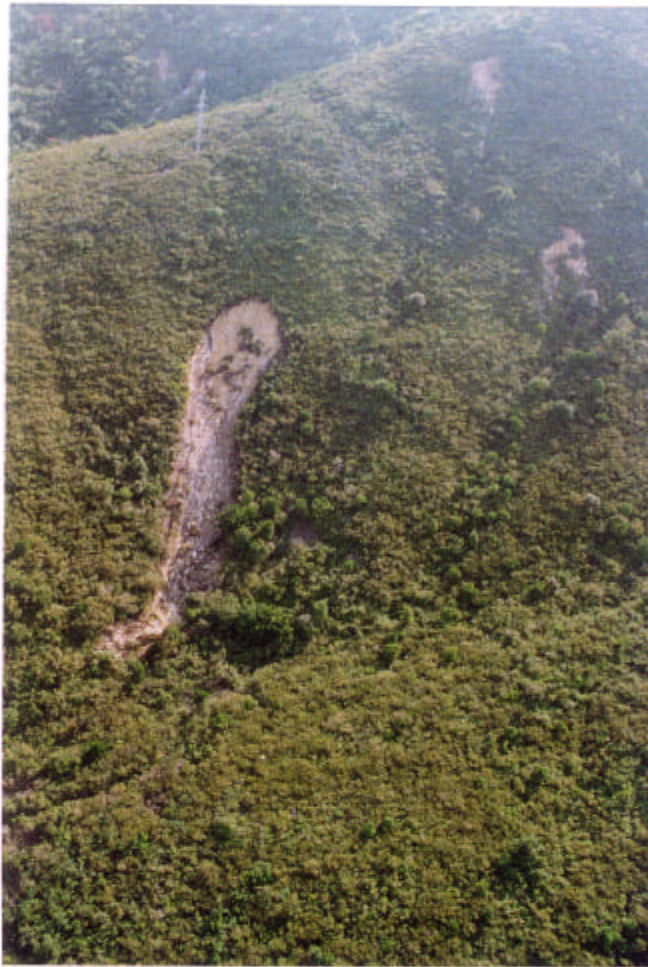
Negative No. EG 93/86/13

Plate 15 - Landslide Showing
Typical Deposition of
Debris along Trail

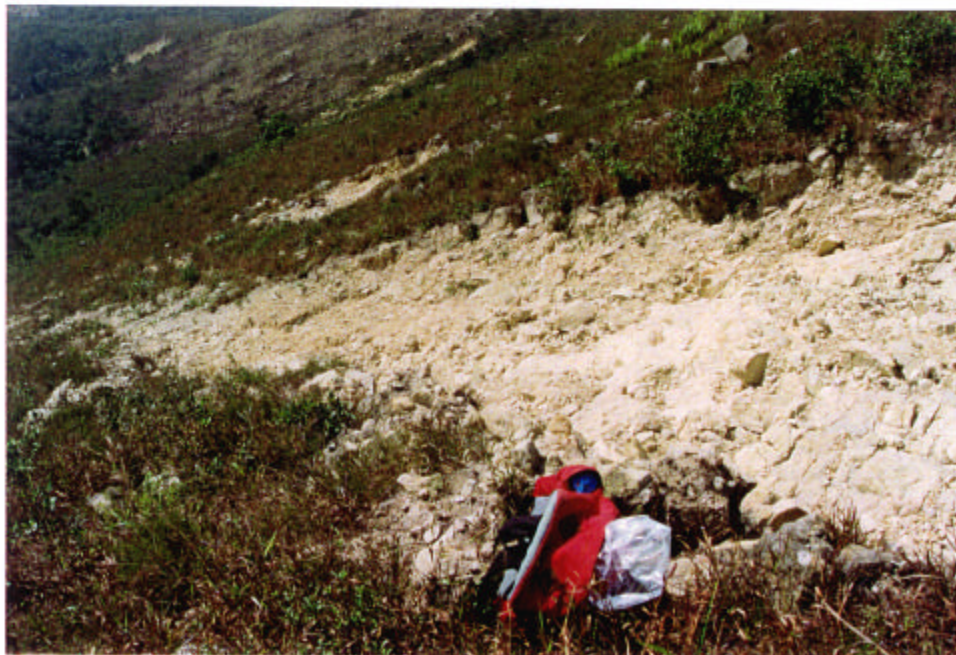
Negative No. EG 94/07/14

Plate 16 - Landslide Showing Typical Erosion along Trail

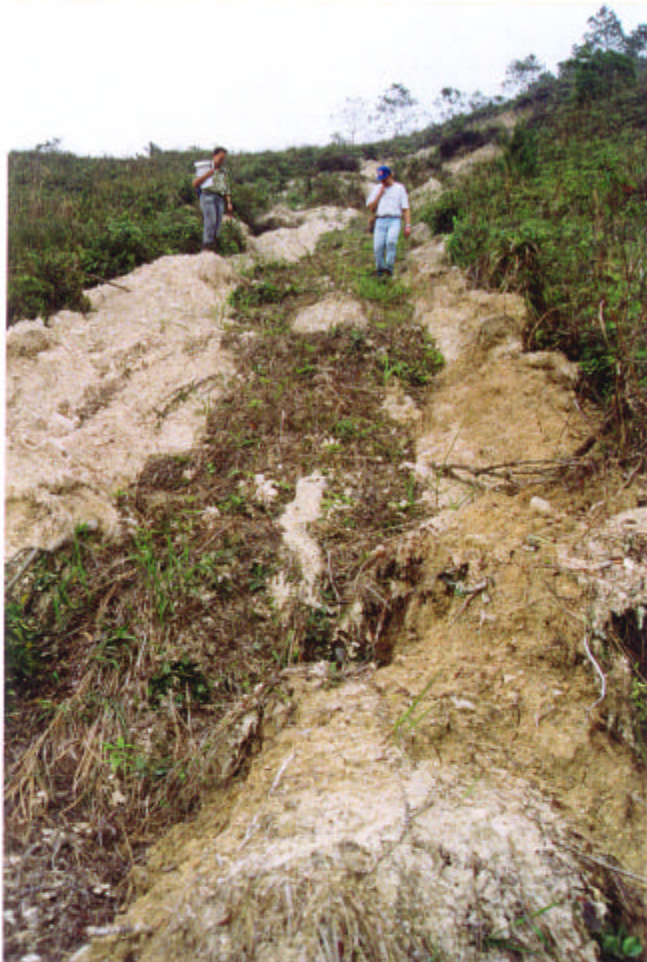
Negative No. EG 94/05/17

Plate 17 - Landslide Showing
Typical Outwash
along Trail

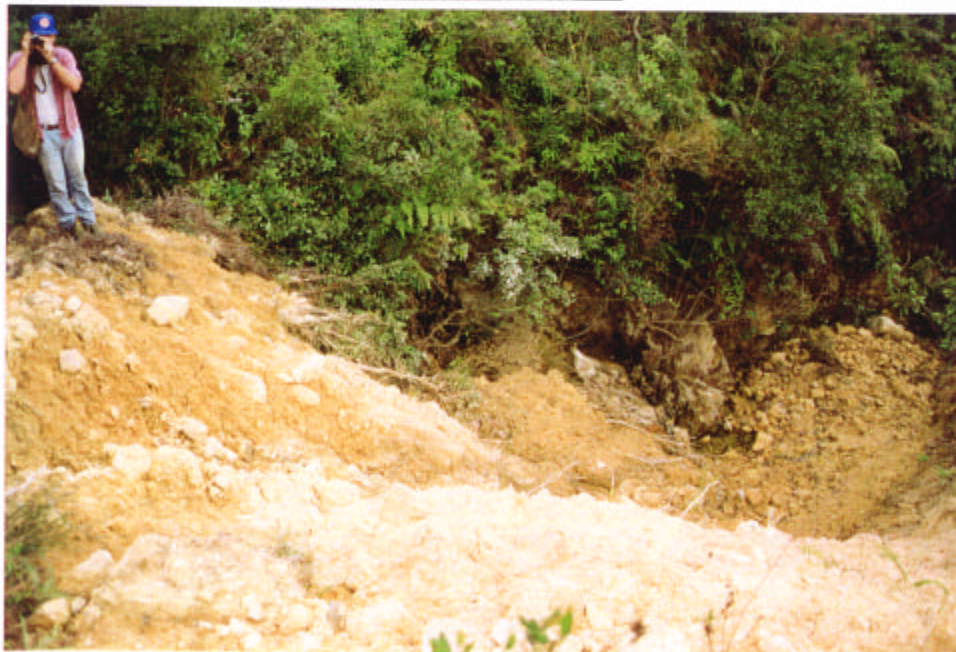
Negative No. EG 94/05/34

Plate 18 - Landslide Showing Typical Terminated Deposition (Constrained Landslide)
along Trail

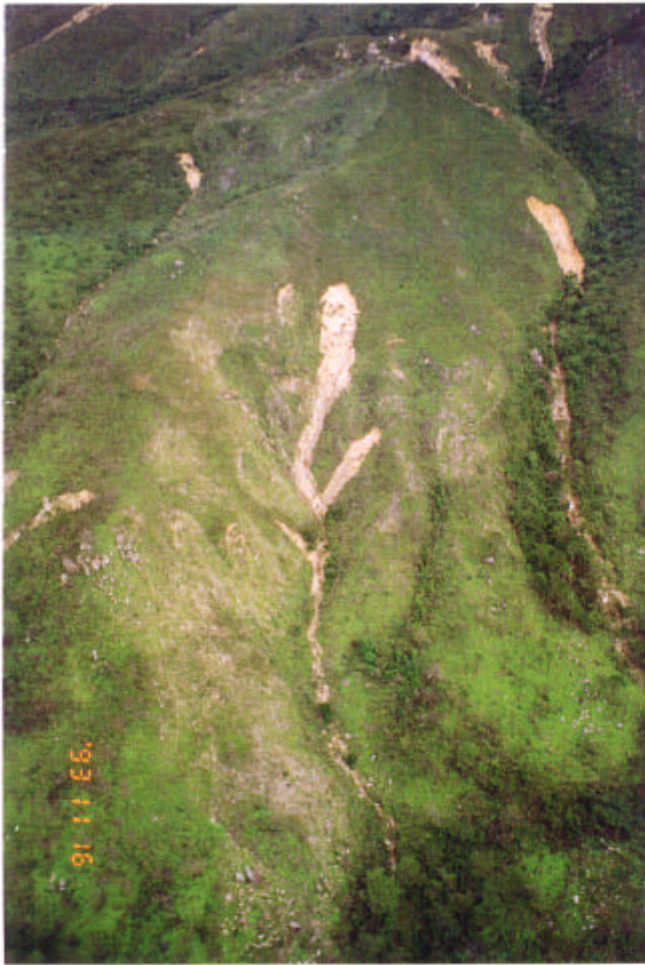
Negative No. TP 239/8

Plate 19 - Example of a
Typical Channelised
Debris Flow
Landslide

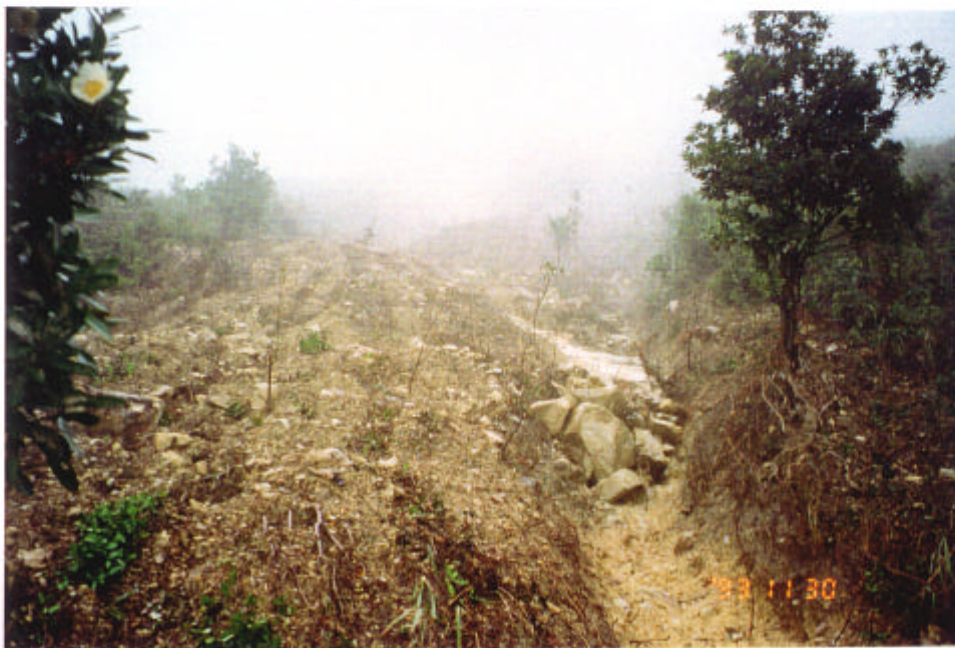
Negative No. TP 248/17

Plate 20 - Channel Downcut through Debris. Note also the flattened
Vegetation at the Sides due to Hyper-Concentrated Flows

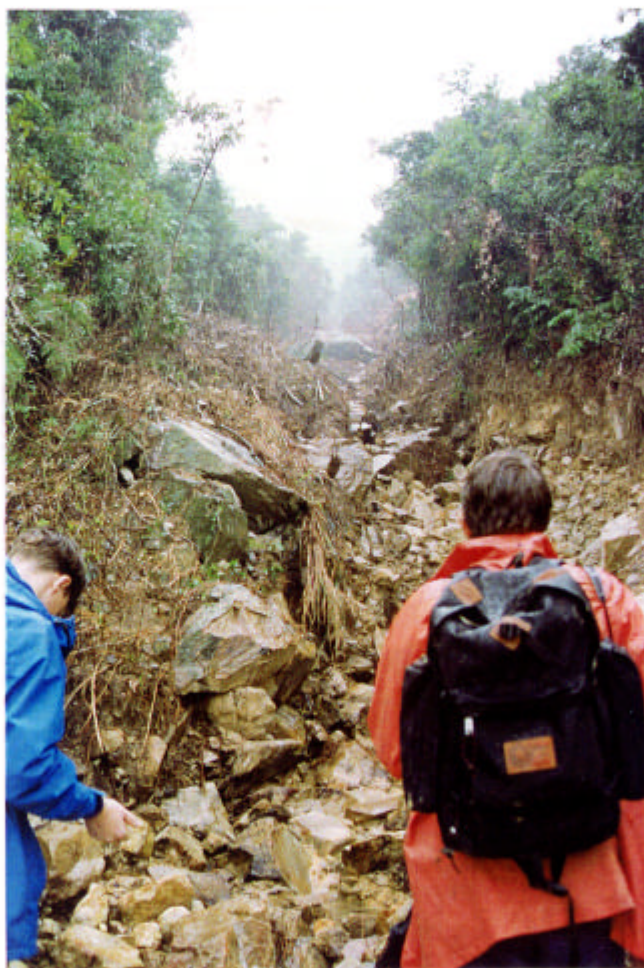
Negative No. EG 93/81/23

Plate 21 - Flattened Vegetation at the Sides of Channelised Debris Flow due to Hyper-Concentrated Flows

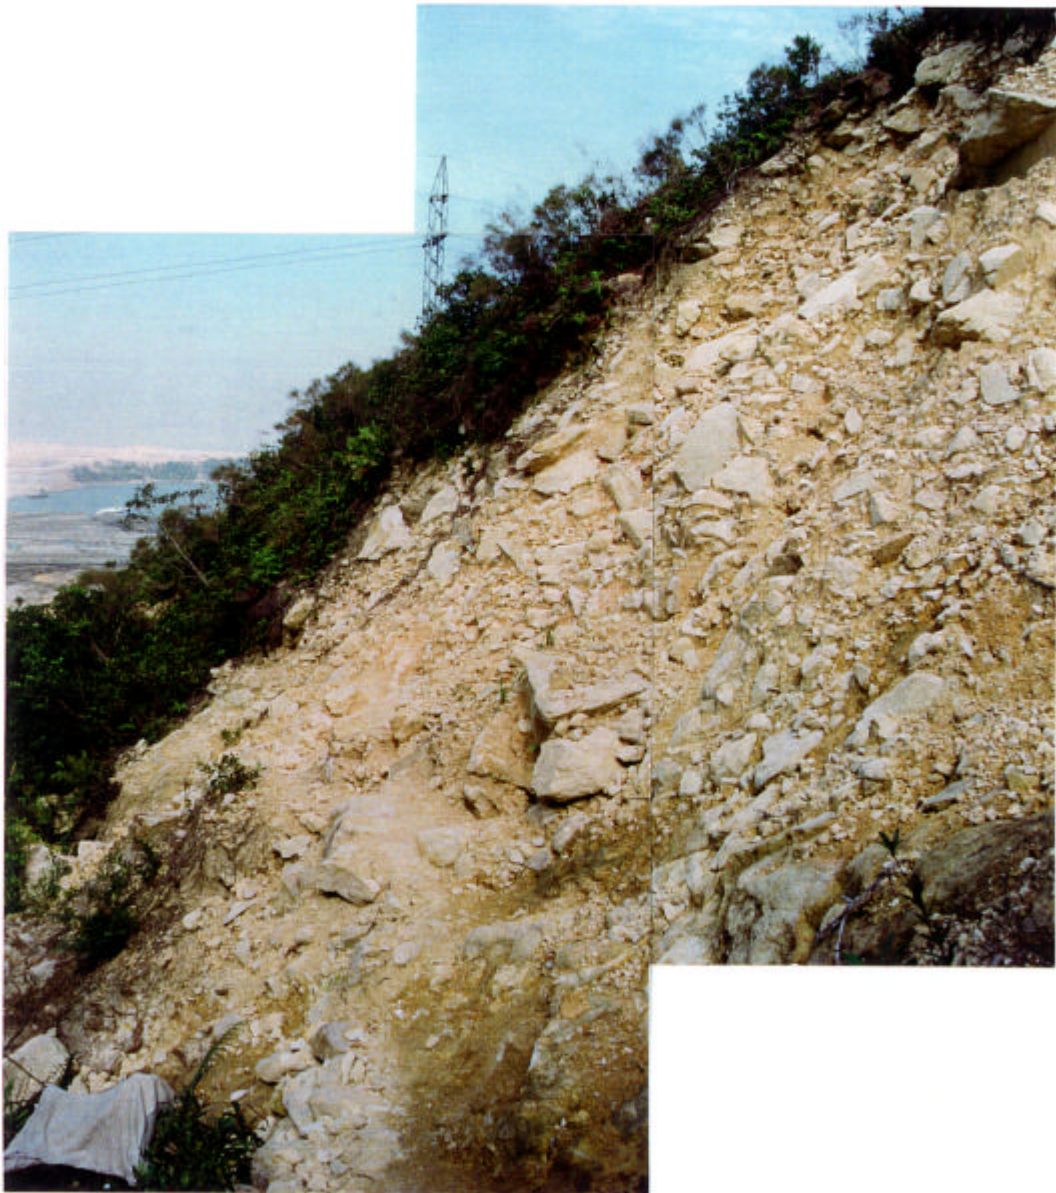
Negative No. EG 93/79/1-2

Plate 22 - Scarp of Gully Side Slide in Class 1 Colluvium

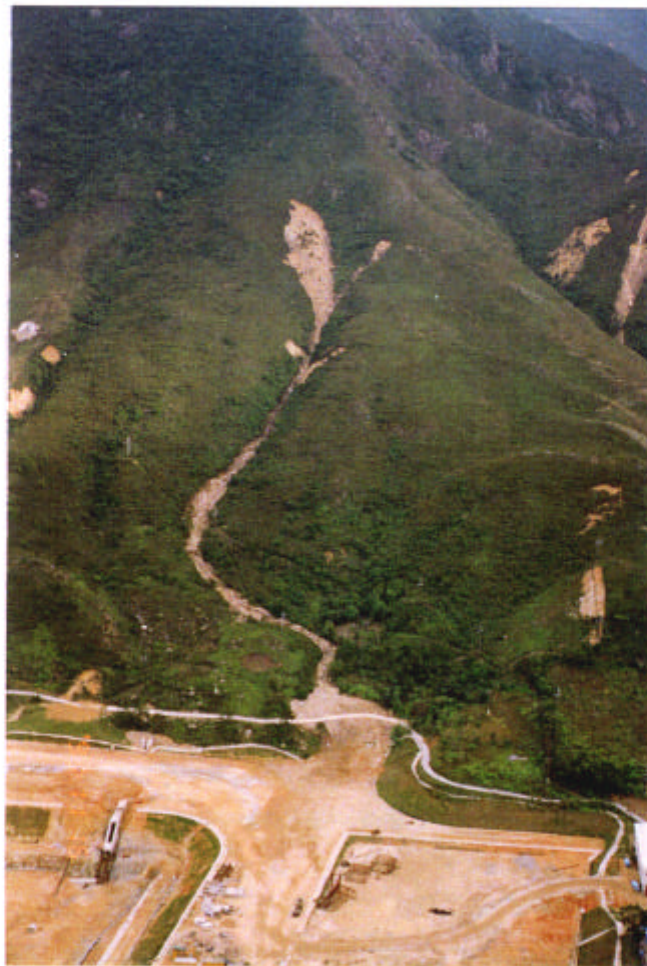
Negative No. TP 239/12

Plate 23 - Overall View of the Landslide (5A/2) that produced a Landslide Trail Runout Extending into the Tung Chung New Town Development Area, Phase 1

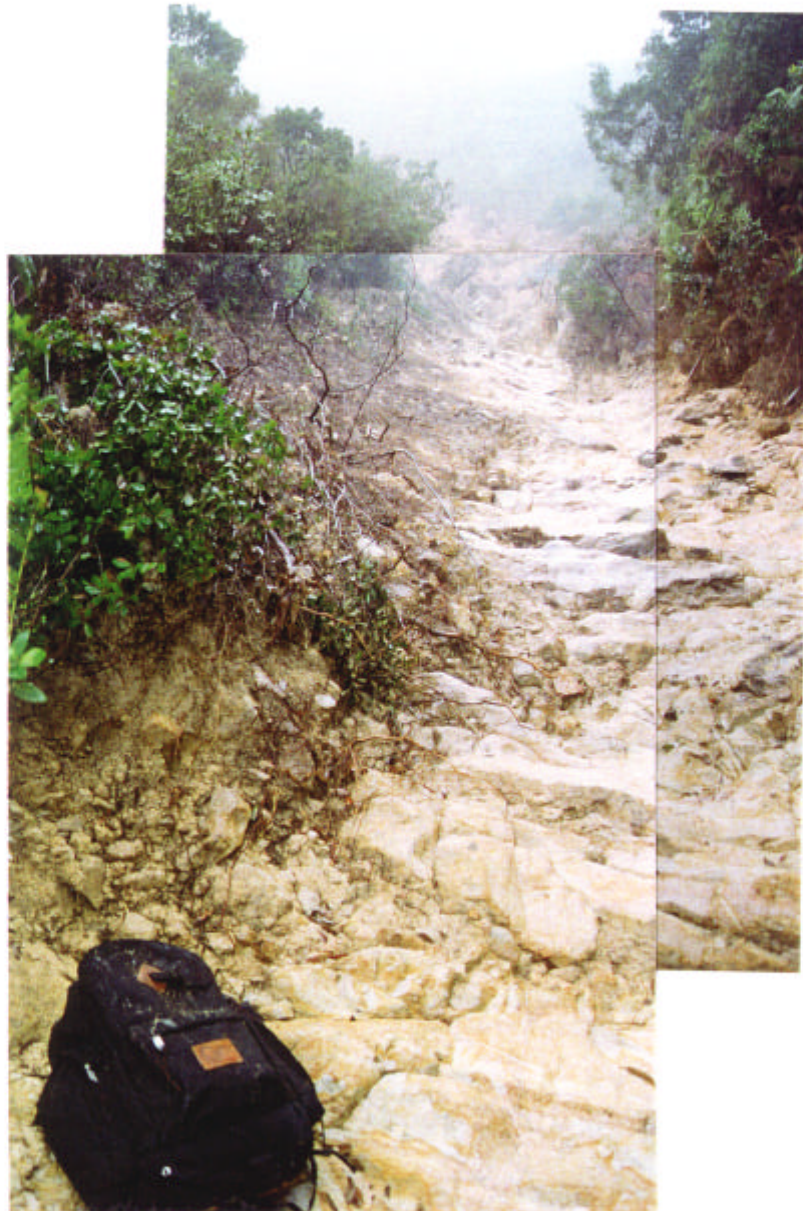
Negative No. EG 93/81/29-30

Plate 25 - Erosion of Bedrock in the Trail Associated with Landslide 5A/2

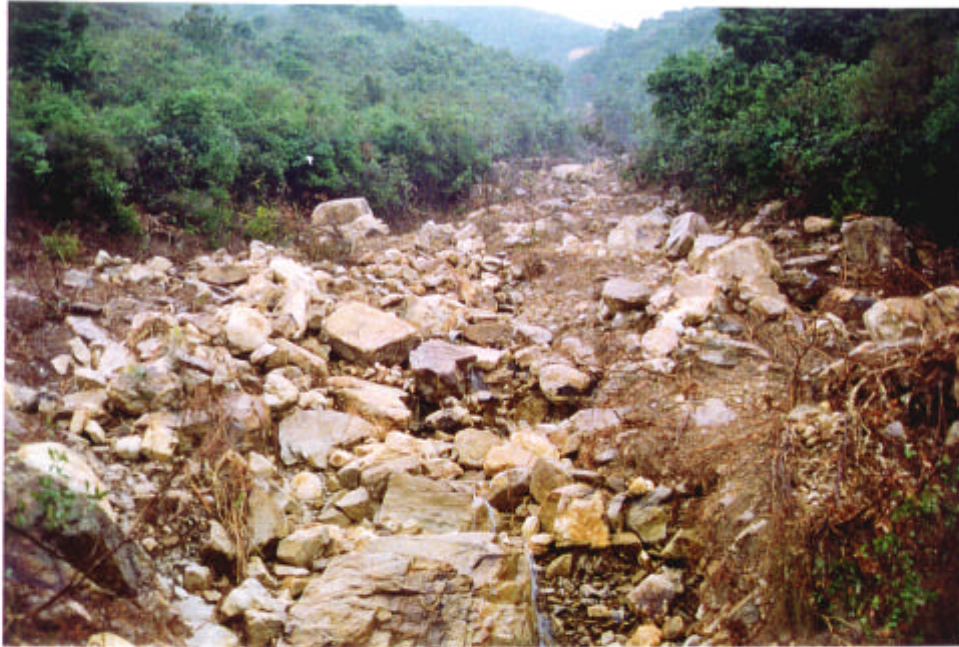
Negative No. EG 93/81/22

Plate 26 - Main Deposition Zone along Trail Associated with Landslide 5A/2

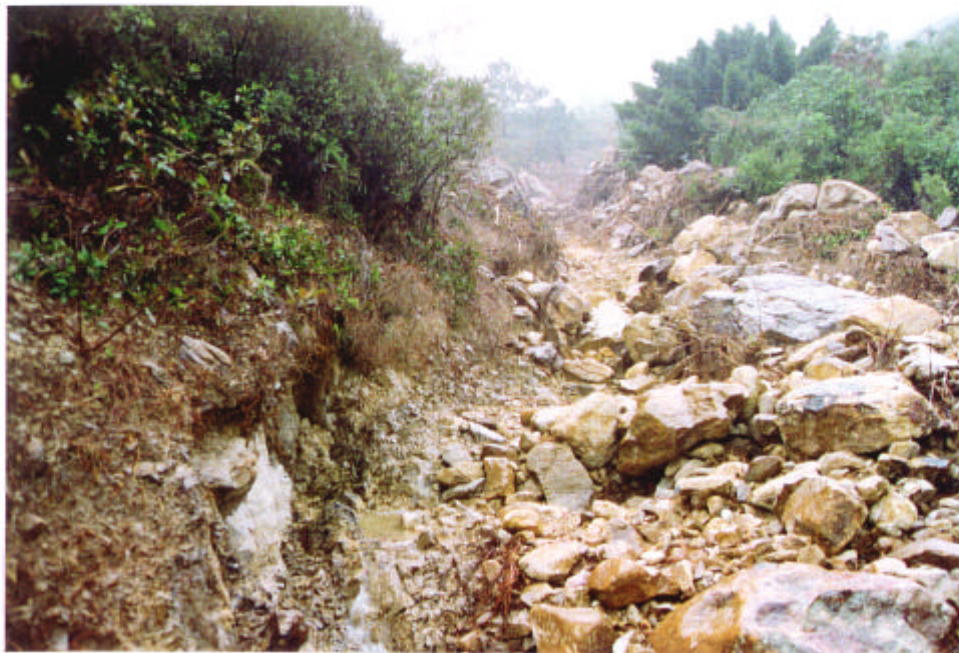
Negative No. EG 93/81/9

Plate 27 - Secondary Channel Eroded through the Substrate Bouldery Colluvium on Lower Slopes within the Trail of Landslide 5A/2

channel confinement. However subsequent re-mobilisation of the debris, possibly caused by a surge in the rainfall runoff, and further channel confinement downslope (Plate 27) resulted in an additional deposition fan on an 8° slope.

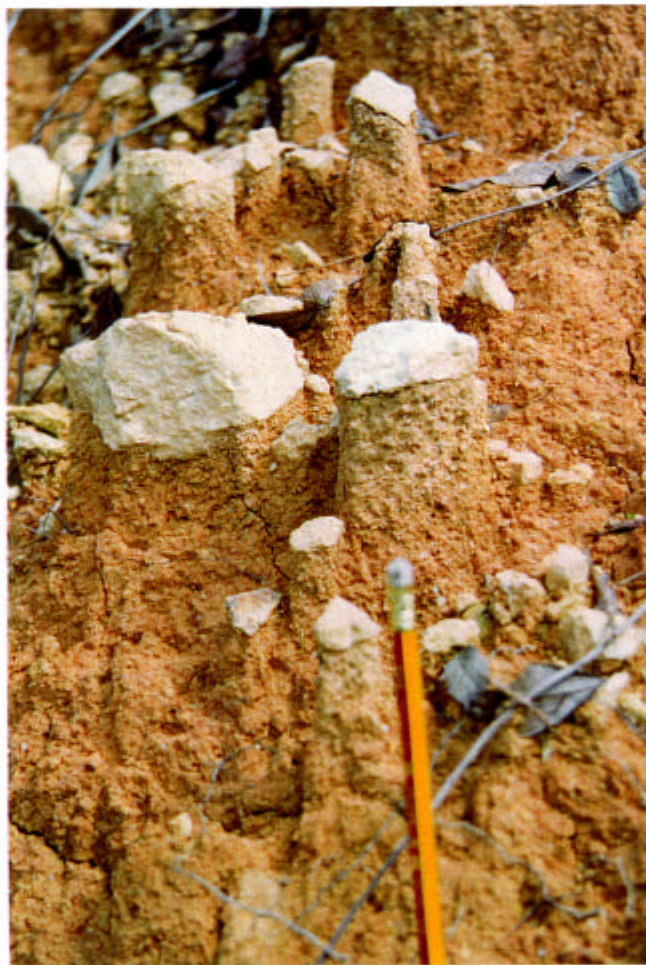
Negative No. EG 93/78/23

Plate 28 - Erosion of sand/silt matrix around Gravel-Sized Rock Fragments in exposed Colluvium Deposit caused by Intense Rainfall

The relationship between rainfall and landslides primarily from man made slopes, in Hong Kong has previously been studied by Brand et al (1984) and the salient aspects have recently been summarised by Premchitt (1991). The vast majority of landslides in Hong Kong are generally shallow and caused by heavy rainfall over a relatively short time period ("intense rainfall") and antecedent rainfall is not considered to be a significant contributory factor. It is considered that intense rainfall will produce erosion of susceptible materials that are exposed or have little surface protection, e.g. recent main scarps and a number of examples of this erosive power have been observed in the study area (Plate 28).
