| project | ASSESSMENT OF GEOLOGICAL FEATURES<br>RELATED TO RECENT LANDSLIDES IN<br>VOLCANIC ROCKS OF HONG KONG<br>PHASE 2A: CHAI WAN | | |
| drawing title | MAP No. 1<br>AERIAL PHOTOGRAPH<br>INTERPRETATION | | |
| drawing no. | GS-SP/11-SE-D/758 | scale | 1:5 000 |

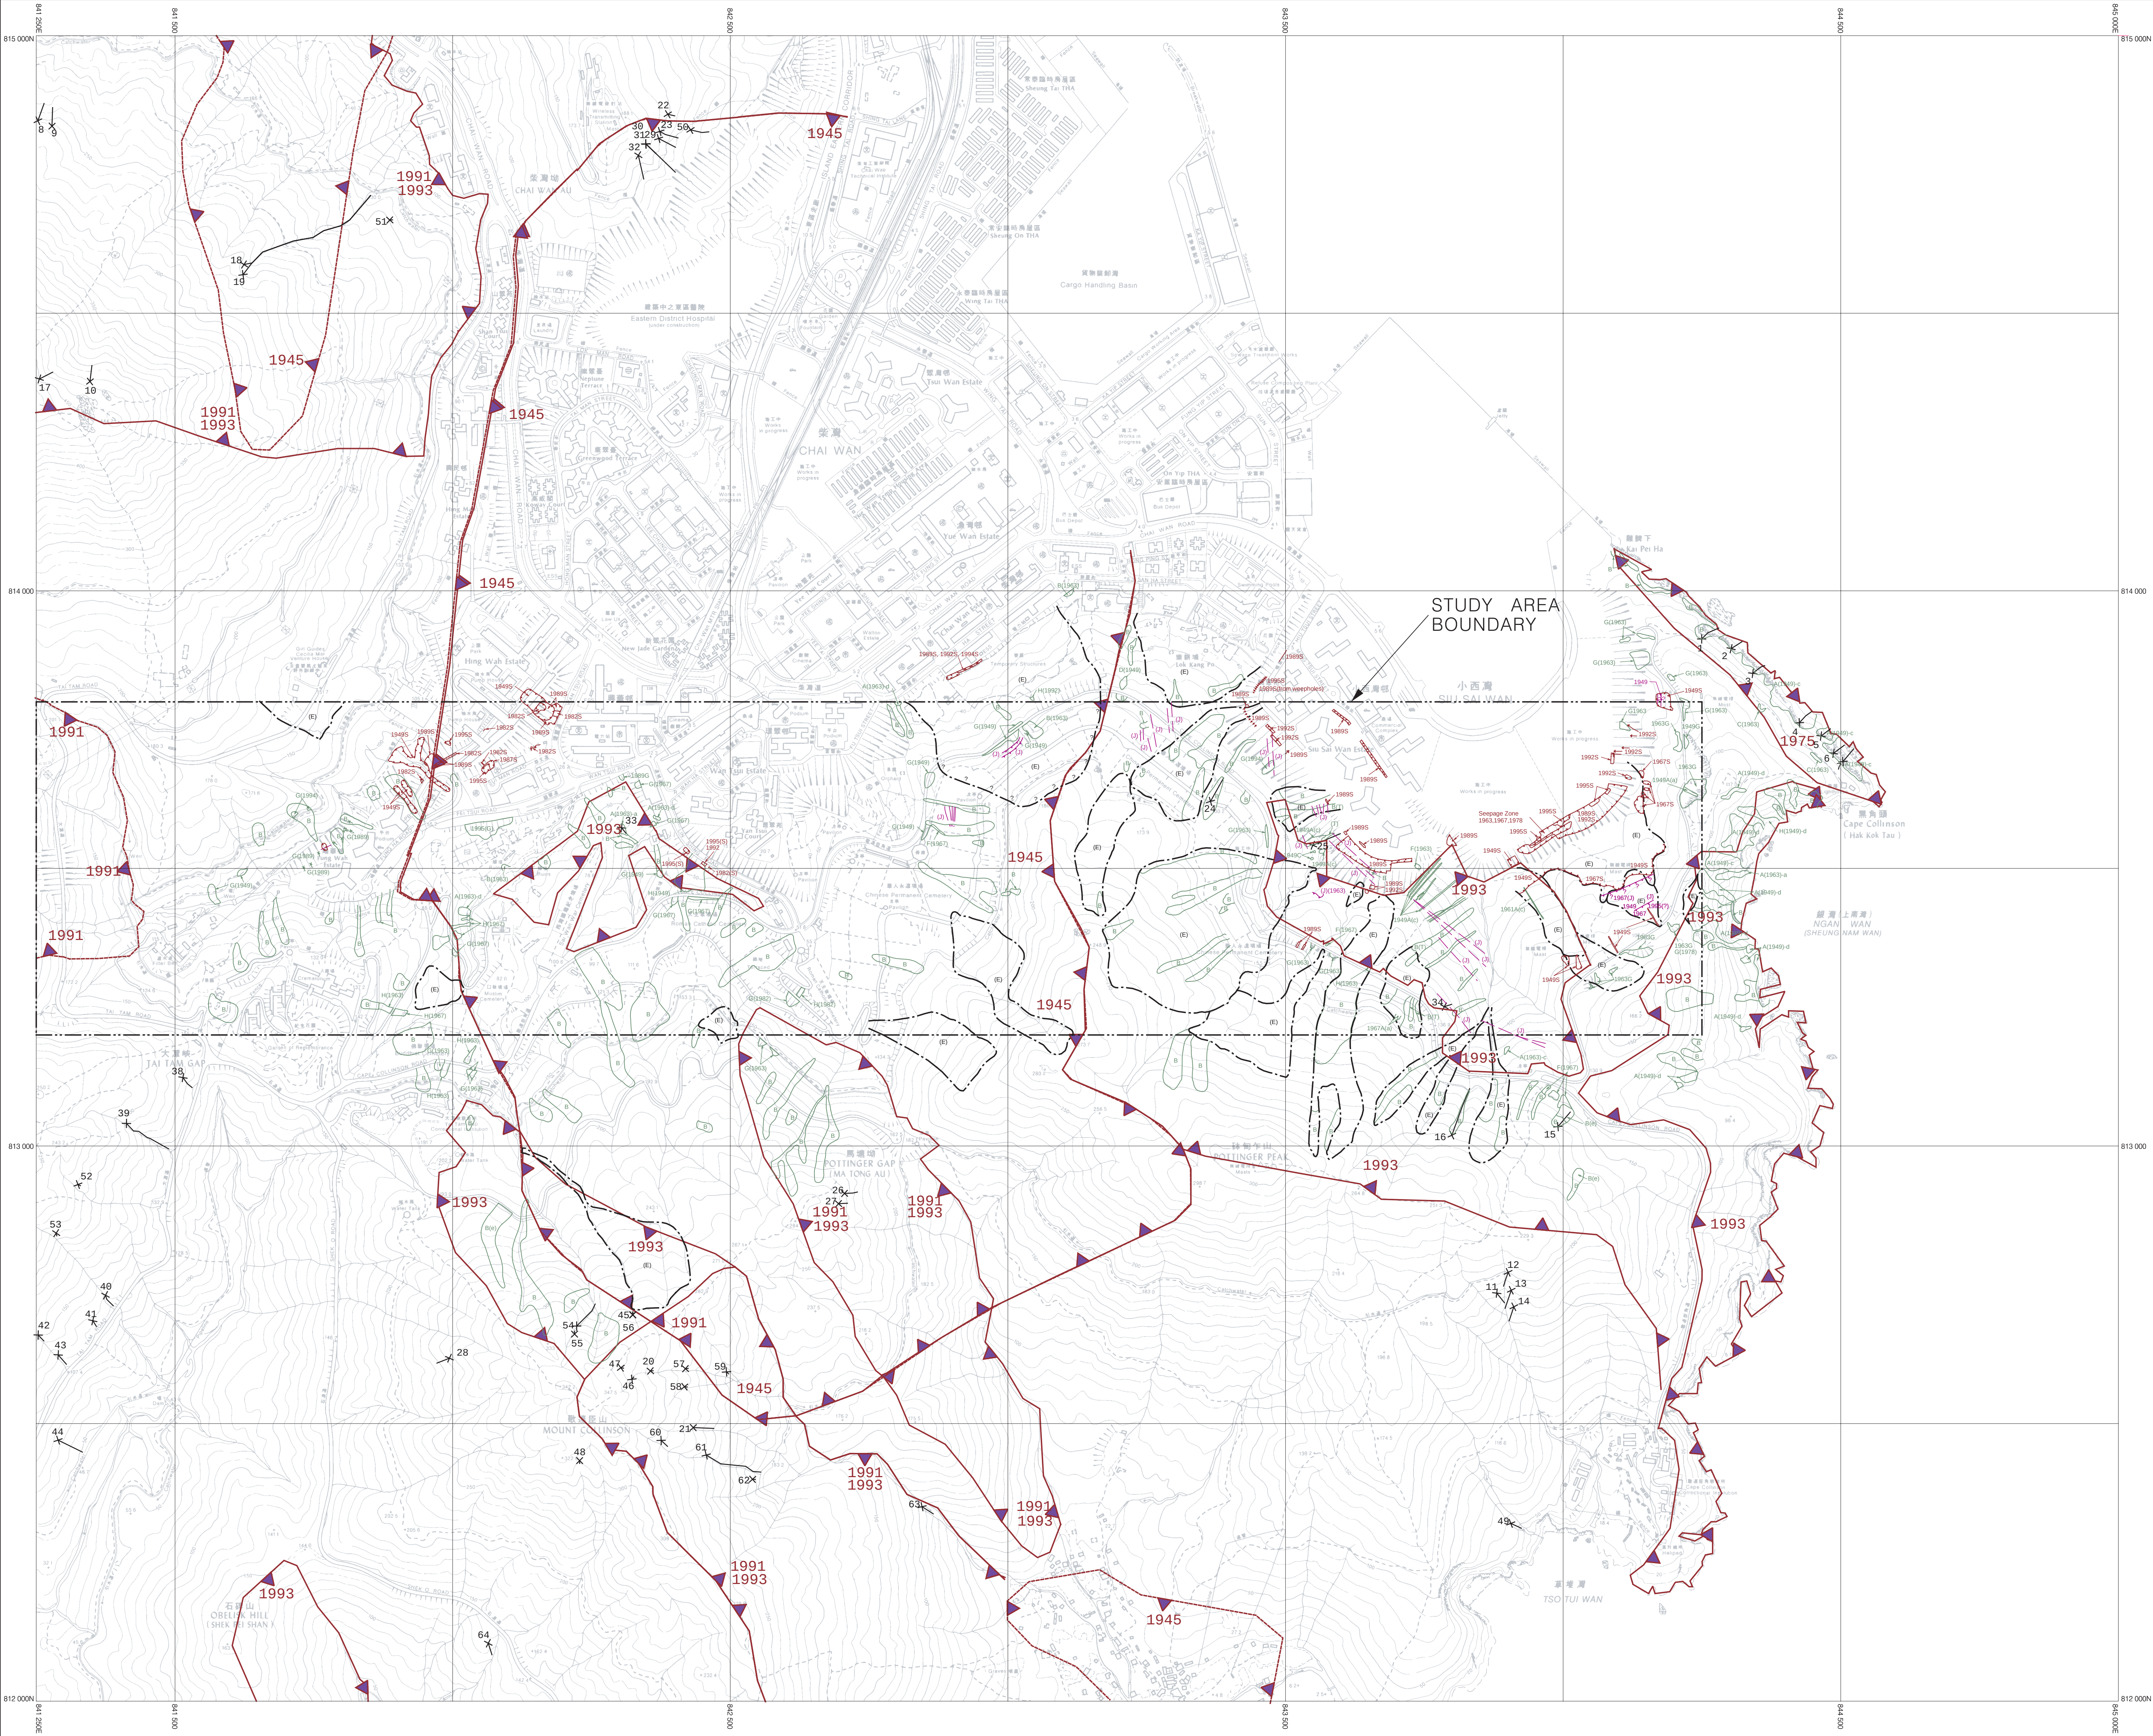
Landslide Scar: A - natural slope relict feature with obvious head scarp  
B - natural slope relict feature with no obvious head scarp  
C - landslide scar within, or impinging on, a cut slope  
D - landslide scar within, or impinging on, a fill slope  
F - fresh landslide scar in natural slope, bare of vegetation  
G - fresh landslide scar in cut slope, bare of vegetation  
H - fresh landslide scar in fill slope, bare of vegetation

The year of aerial photograph coverage on which recurring observations are first identified is shown in brackets. Other years refer to observations made on specific sets of aerial photographs.

Additional symbols record the vegetation cover occurring on natural terrain landslides. The four classes used are:  
a - totally bare of vegetation  
b - partially bare of vegetation  
c - completely covered in grass  
d - covered in shrubs and/or trees
