APPENDIX D

ASSESSMENT OF THE PHASE 1 FIELD TRIAL RESULTS

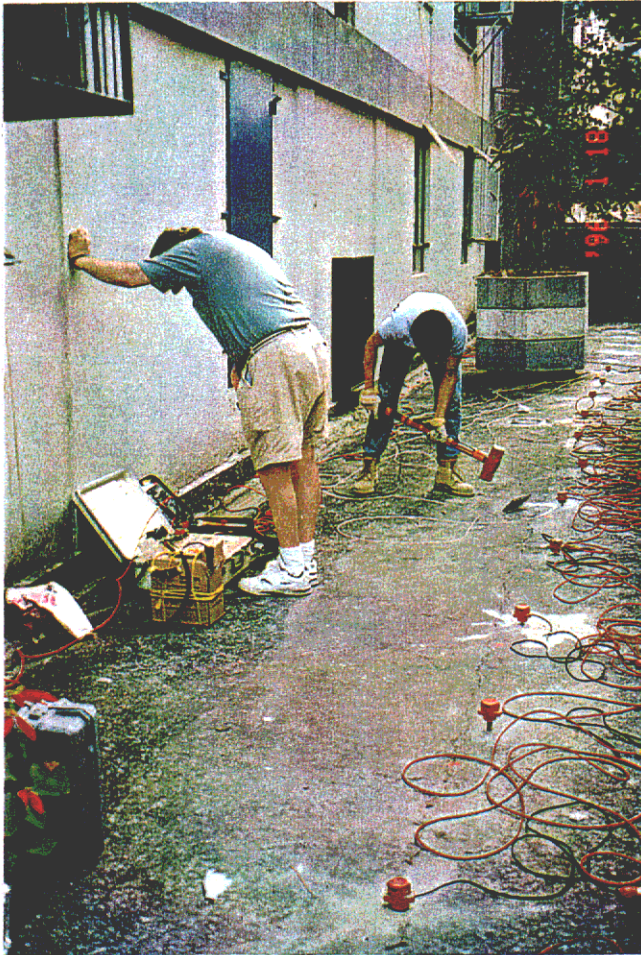
Plate D1 - 6 kg sledge hammer being used at Site A (TA04) as energy source for high resolution seismic reflection. Contractor Golder Associates. (EG96/28/21)

The method was practised by three of the six contractors (see Appendix C). The equipment and set up used in the field by the three companies were very similar. A 2-6 kg sledge hammer was used as the power source (Plate D1). At Sites A, B and C spike geophones were inserted into pre-drilled holes (Plate D2). Along the vertical slope and wall traverses, geophones with flat surfaces were used by GSC to allow attachment using rapid hardening glue (Plate D3). This appeared to work reasonably well unless the surface was rough as in the case of the shotcrete along TA01 or some of the masonry blocks. In such cases a smooth area was prepared first. IGGE used plaster of paris to couple the geophones to hard surface cover (Plate D4). The geophone spacing used was 1m by GA, 0.5m to 1m by GSC and 0.25m to 0.7m by IGGE. Typically hammer blows were repeated 3-6 times at the source for stacking of seismic traces to enhance signals. The source location was moved along the traverse lines at predetermined intervals and the seismic data were recorded in separate data files. Notch and corner filters were sometimes applied during the field collection of data. Filters were normally applied in the data analysis.

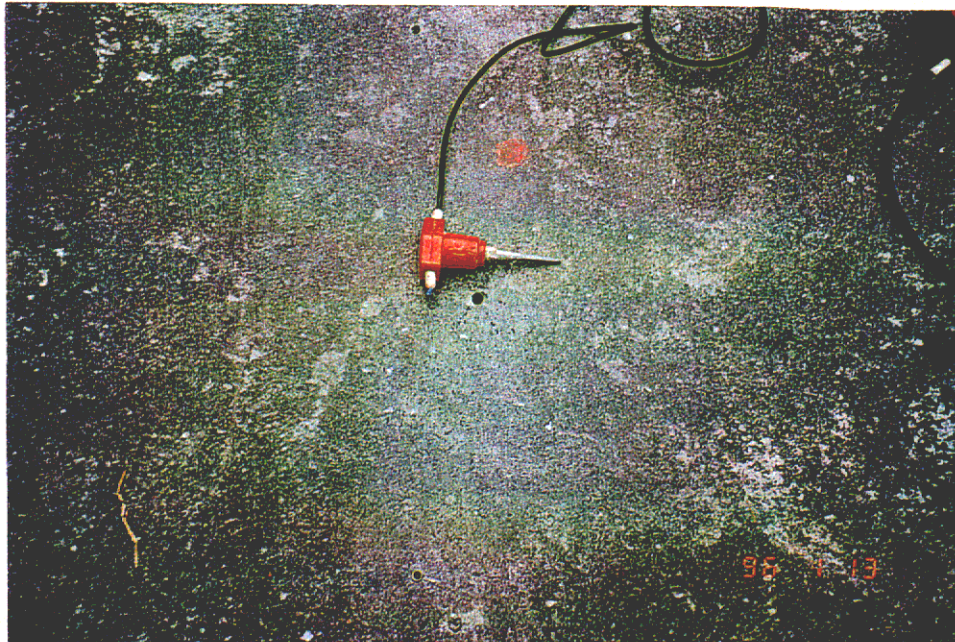
Plate D2 - Spiked geophone adjacent to pre-drilled hole prior to high resolution seismic reflection survey at Site A. Contractor Guandong South China EGTD Co. (EG96/07/20)

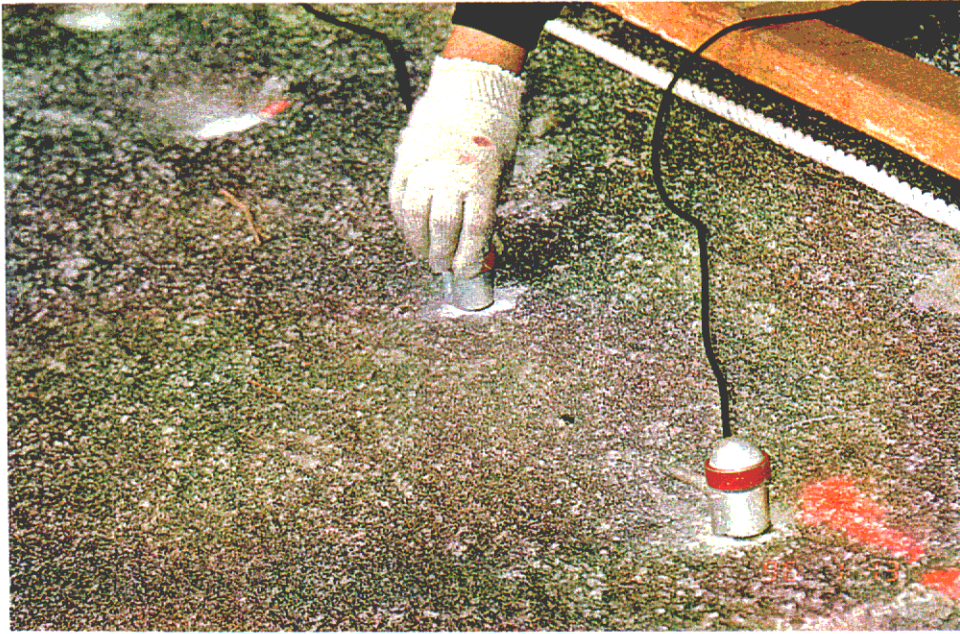
Plate D3 - 65Hz geophone being fixed to shotcrete slope surface during high resolution seismic reflection survey at Site A (TA01). Contractor Guandong South China EGTD Co. (EG96/08/23)

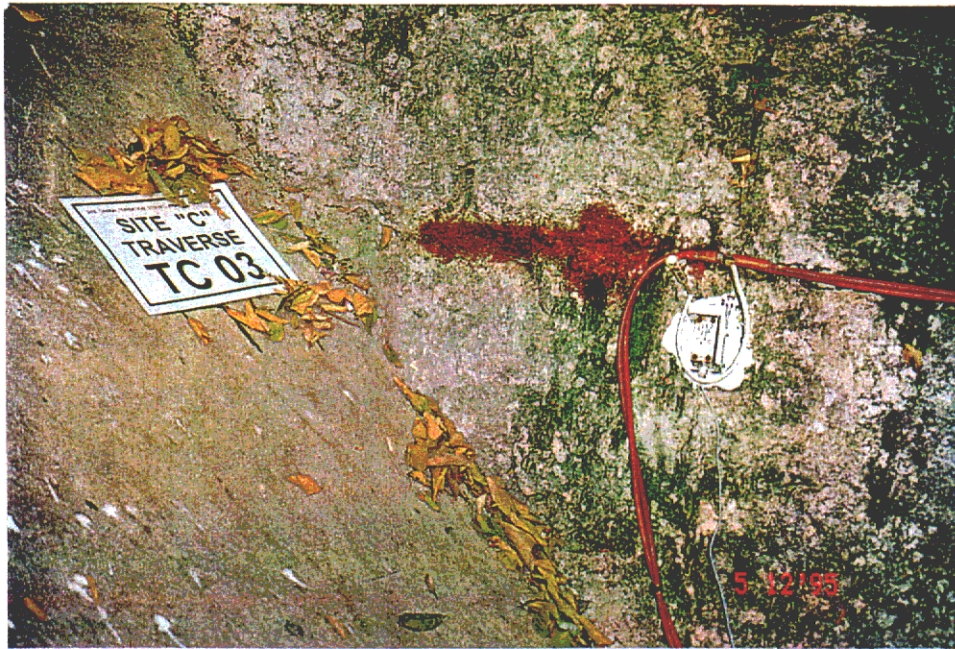
Plate D5 - Metravib CSH05 Piezoelectric accelerometer attached to masonry wall with plaster of Paris at Site C (TC03) during SASW survey. Contractor Bachy Soletanche. (EG95/143/14)

SASW was carried out by five of the six contractors, each using different equipment (see Appendix A). Piezoelectric accelerometers coupled to hard surface protection using plaster of paris and spiked magnetic pads were used by BS and MW (Plates D5 and D6). Both IGGE and GSC used geophones coupled by inserting the spiked end into pre-drilled holes or with plaster of paris (Plates D7 and D8). GA used low-frequency geophones and seismic accelerometers (Plate D9). They coupled the geophones and accelerometers to the surface by various methods depending on site conditions. Hammers of various sizes were used as the power source. Small light hammers were used to generate high frequency waves and heavier sledge hammers were used to generate lower frequency waves (Plates D10 & D11). Typically the hammer blow was repeated 4 to 5 times at the source for stacking to enhance the signals. The site procedures were fairly consistent apart from GSC who used a multiple geophone array to collect the field data (Plate D12). The other contractors used either two or four geophones in a common receiver mid-point array (Plate D13). In this array the geophones spacing is doubled after each test about a common mid-point. Hammer blows were made at either end of the geophone spread.

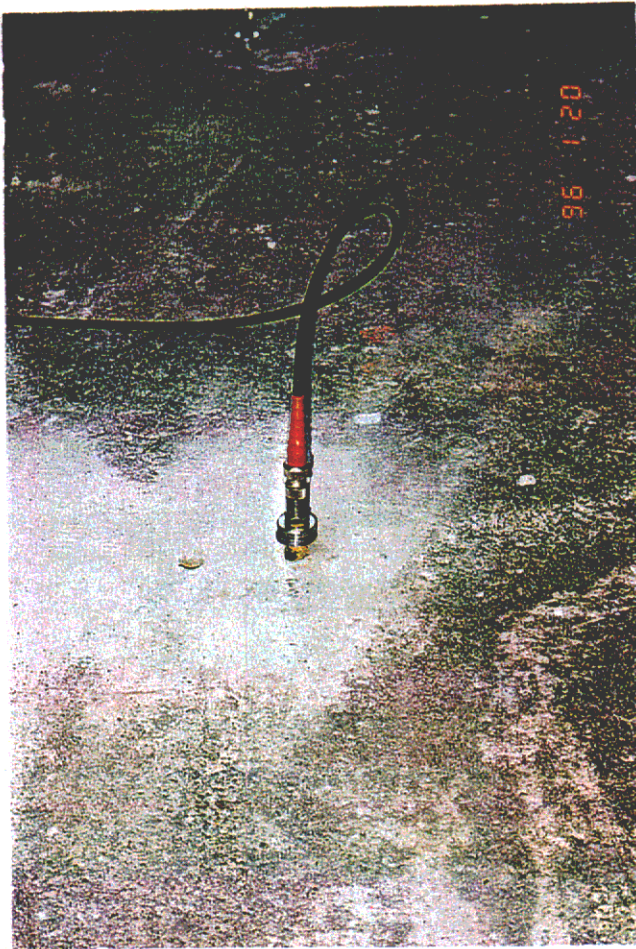
Plate D6 - Bruel & Kjaer piezoelectric transducer coupled to the concrete slab through a spiked magnetic mandrel during a SASW survey at Site A (TA04). Contractor Meinhardt Works. (EG96/33/13)

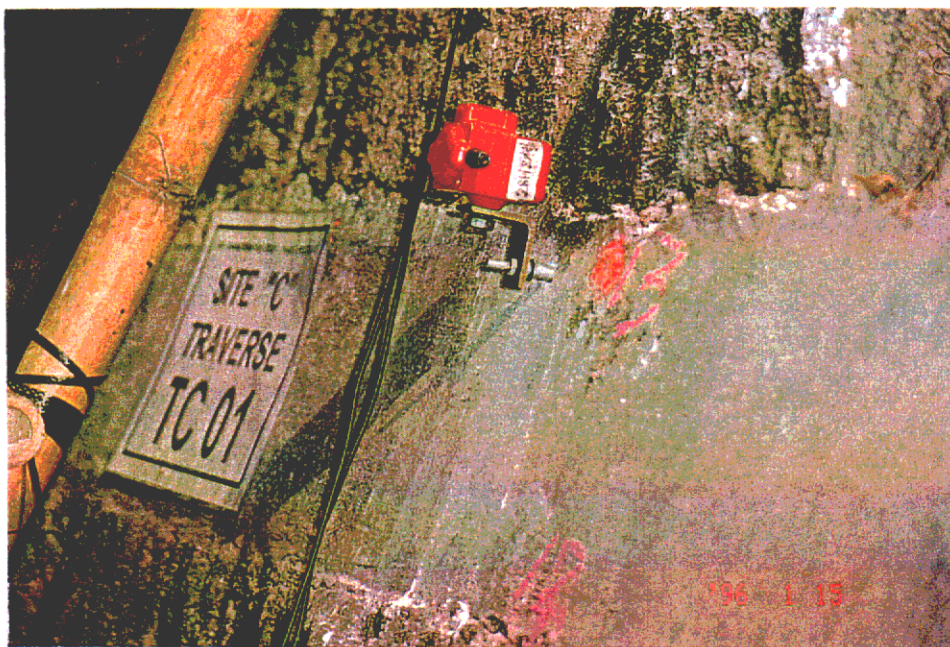
Plate D7 - SASW geophone inserted into pre-drilled hole along the masonry wall tie beam at Site C (TC01). Contractor Institute of Geophysical and Geochemical Exploration. (EG96/14/7)

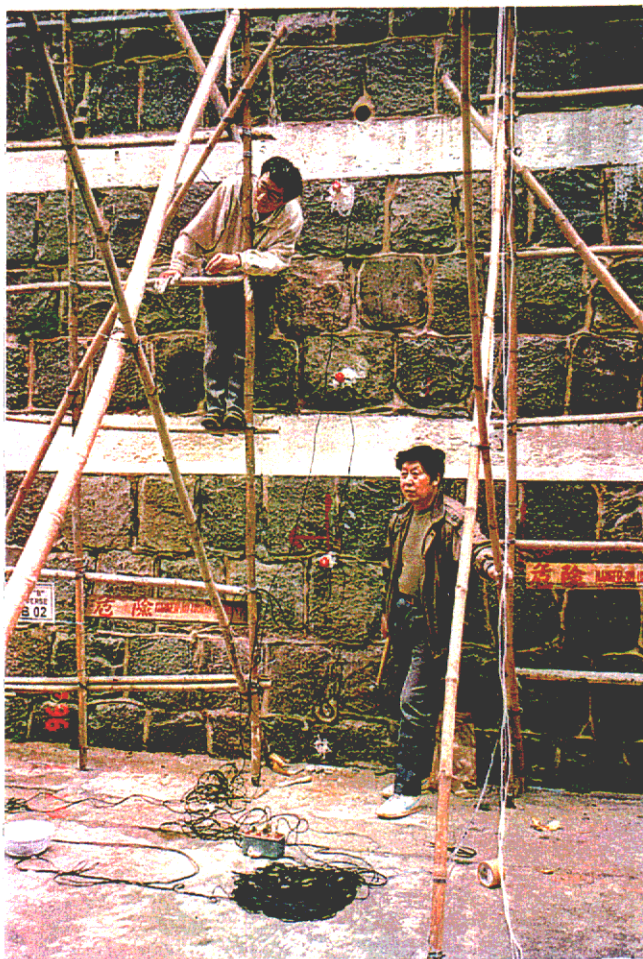
Plate D8 - Plaster of Paris being used to fix 10Hz geophones to masonry wall at Site B (TB02) during SASW survey. Contractor Institute of Geophysical and Geochemical Exploration. (EG96/27/20)

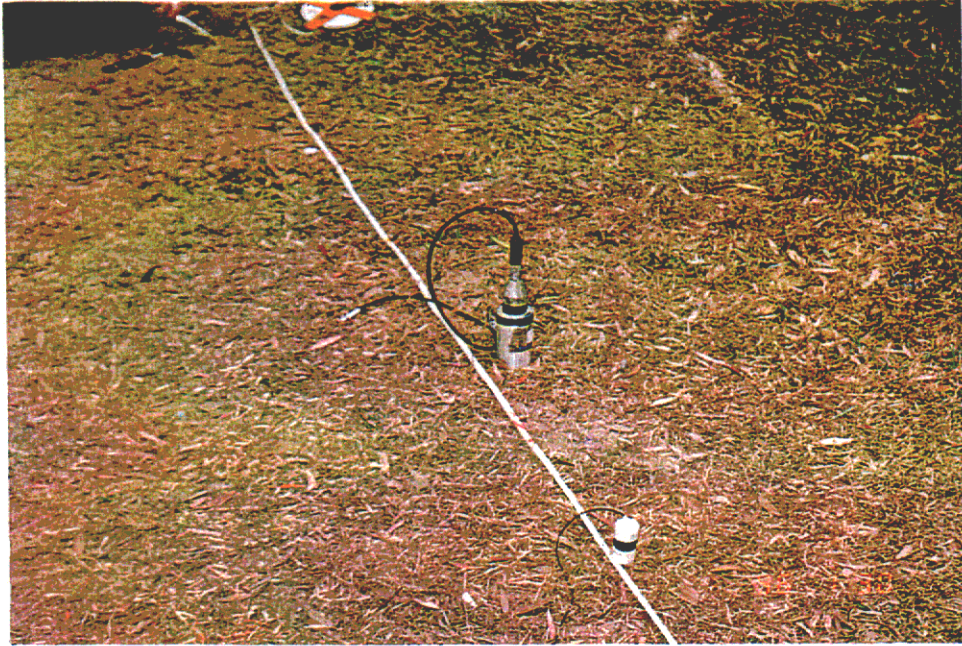
Plate D9 - Low frequency 1Hz geophone used to record long wavelength surface waves during SASW survey at Site D (TD01). Contractor Golder Associates. (EG96/45/6)

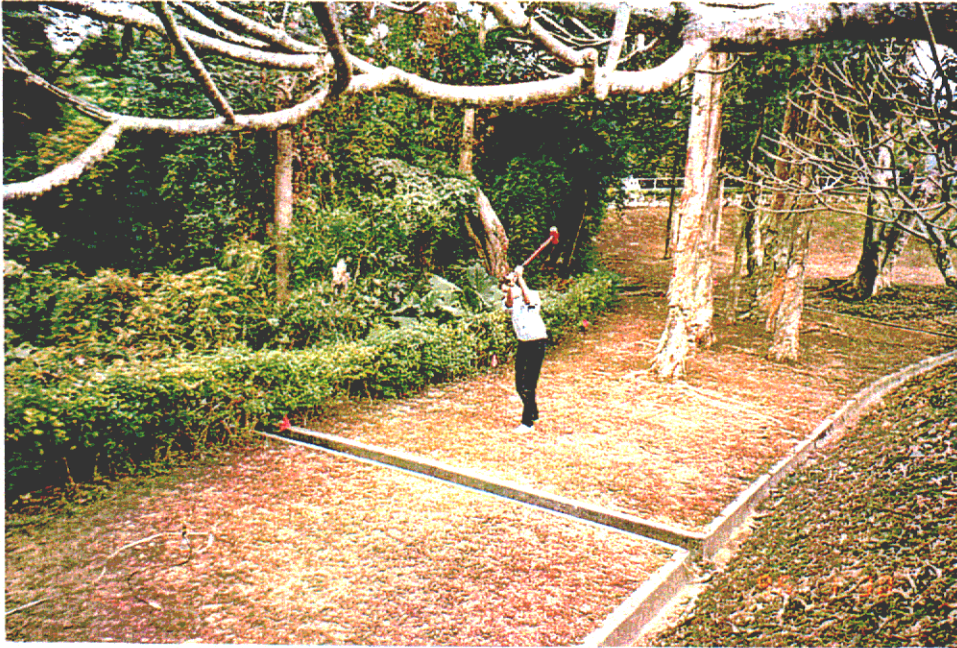
Plate D11 - 6kg sledge hammer being used at Site D (TD01) to produce low frequency surface waves during SASW survey. Contractor Golder Associates. (EG96/45/9)

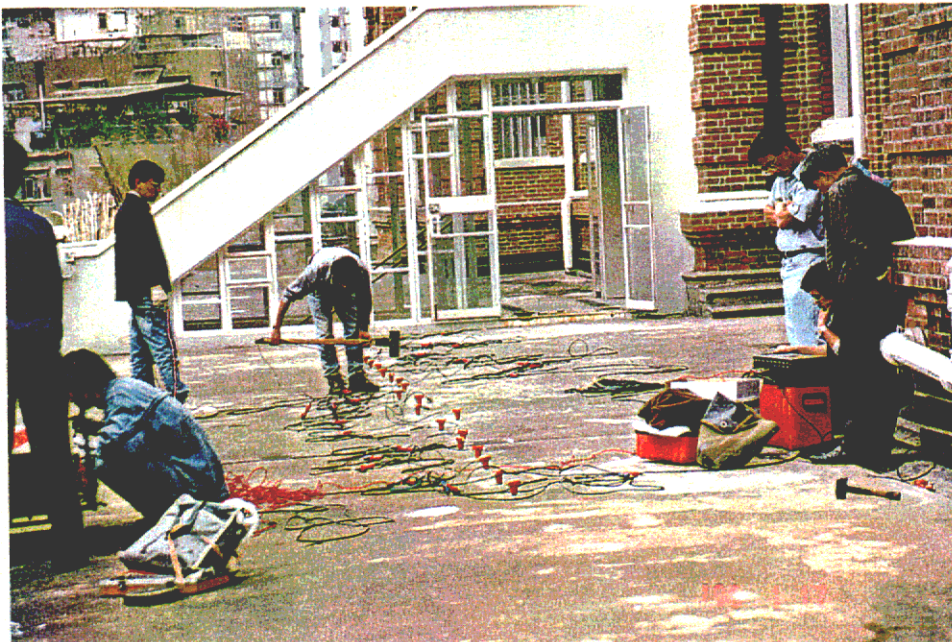
Plate D12 - SASW survey in progress with a multiple geophone array at Site B (TB04). Contractor Guandong South China EGT Co. (EG96/23/22)

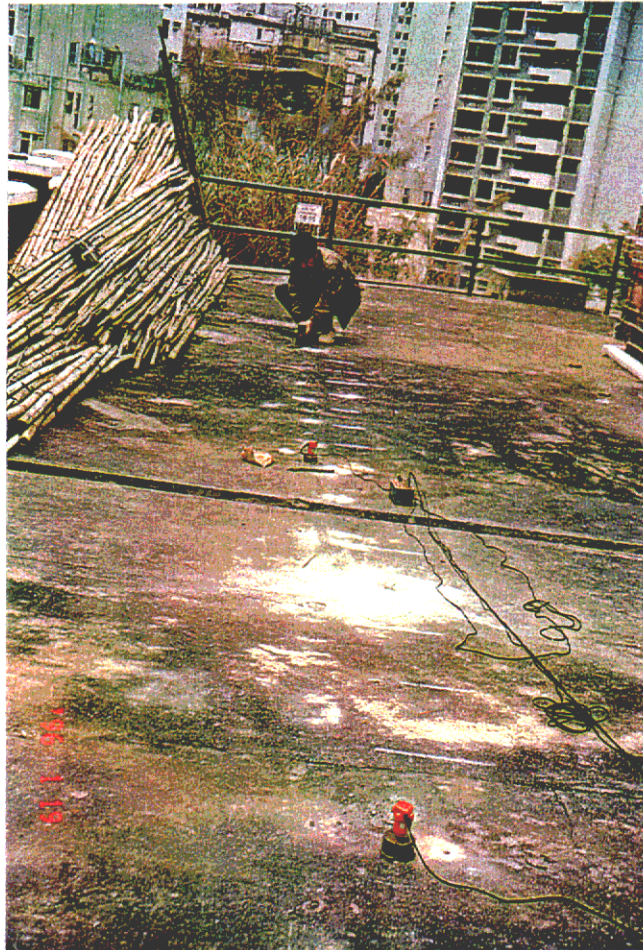
Plate D13 - Common mid-point receiver array being used for SASW survey at Site B (TB05). Sounding point is mid-way between the two geophones. Contractor Institute of Geophysical and Geochemical Exploration. (EG96/26/24)

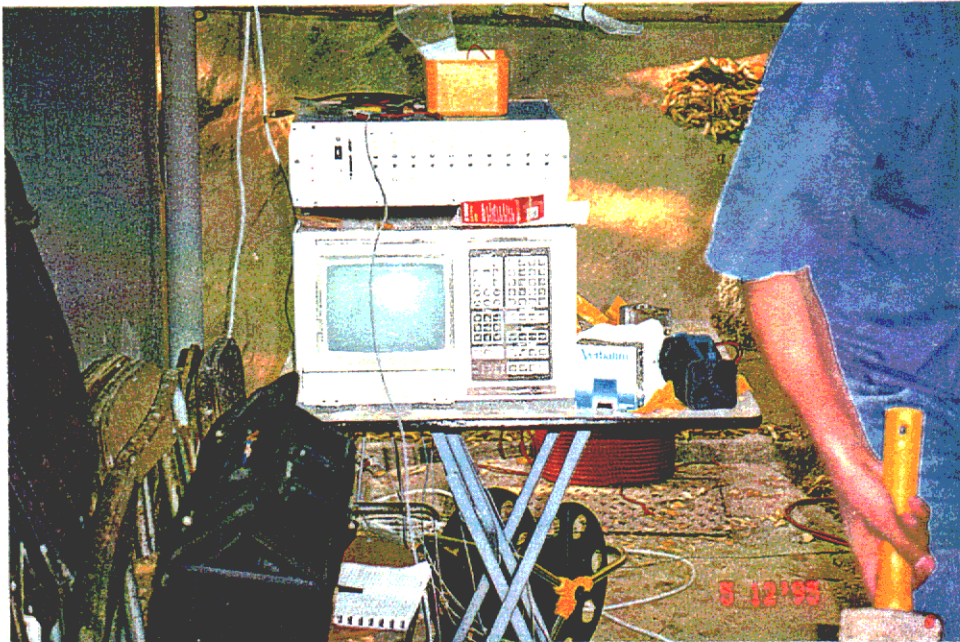
Plate D14 - Metravib RAIO seismograph and Scientific - Atlanta Spectral Dynamics SD380 Signal Analyser used for SASW survey. Contractor Bachy Soletanche. (EG95/144/13)

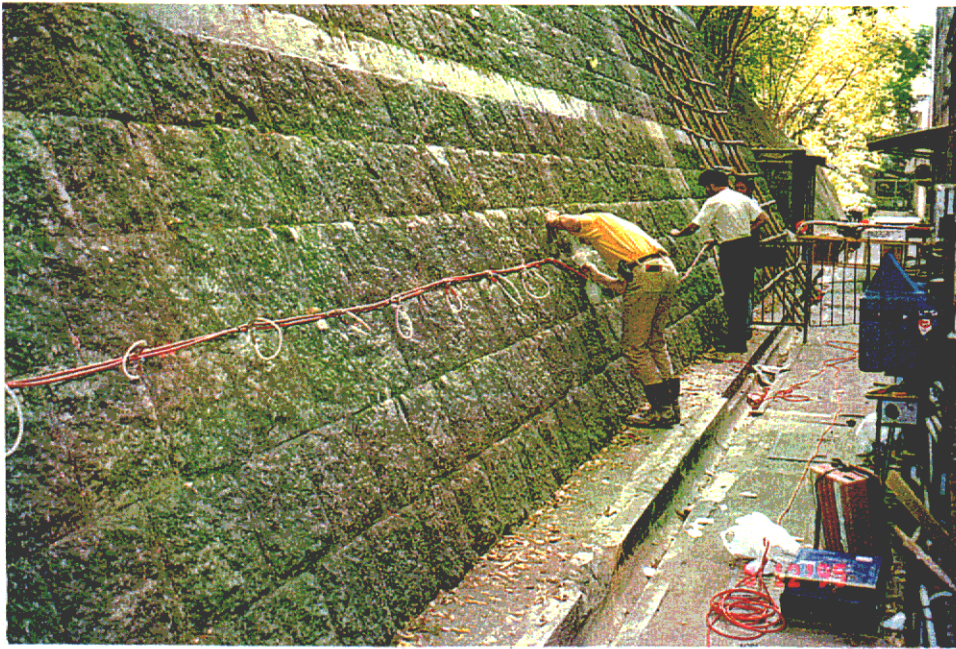
Plate D17 - Multi-takeout cable being attached to electrodes during resistivity imaging survey at Site C (TC03). This system allows each electrode to be identified so that surveys with different electrode spacing can be made automatically. Contractor Bachy Soletanche. (EG95/143/13)

The method was practised by five of the contractors (see Appendix C). The dipole-dipole array configuration was used by most of the companies, except IGGE who used a tripolar configuration and GA, who employed dipole-dipole at one site and the Wenner configuration at others. Electrode spacing between 1m and 2m were generally used. BS drilled and inserted "Hilti" bolts into hard surface protection at calculated distances, which were used as electrodes (Plate D15). Most other contractors used steel pins inserted into pre-drilled holes through surface protection so that they could make direct contact with the soil beneath (Plate D16). Multi-conductor cables with takeouts for electrode connections which enabled current to be cycled to particular pairs of electrodes helped to minimise the time required for the electrode deployment (Plate D17).

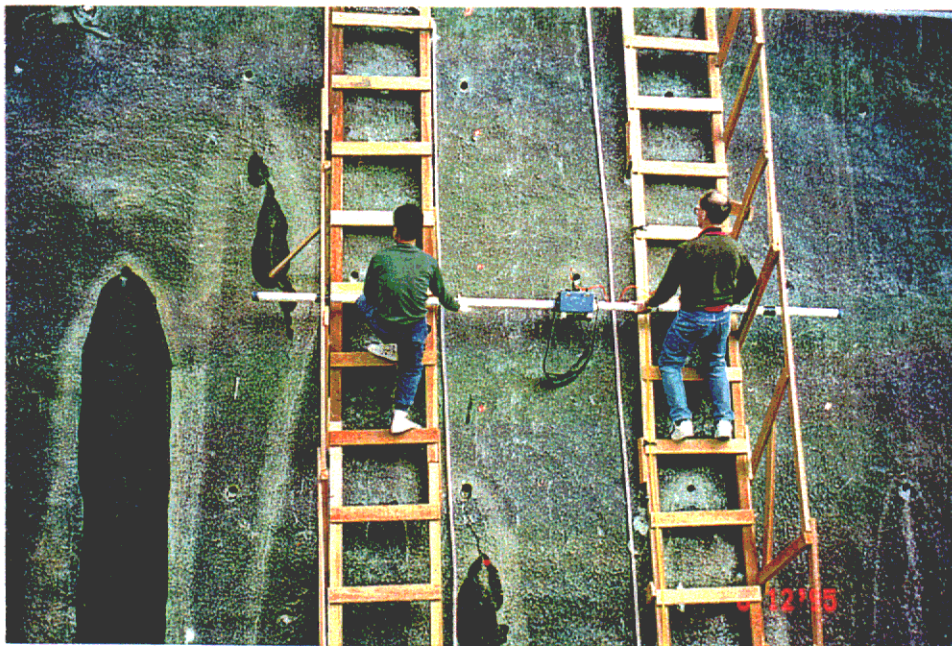
Plate D22 - Geonics EM31 conductivity meter being used at Site A (TA01). Two-man job to carry out the survey up the slope at the site. Contractor Fugro Geotechnical Services (HK) Ltd. (EG95/156/17)

Four of the contractors tested the frequency-domain electromagnetic method (see Appendix C). Each used equipment manufactured by Geonics, either the EM 31-D or the smaller EM38 (Plates D22 & D23). They both measure quadrature and in-phase components of the electromagnetic field produced by induced eddy currents. The sampling depth of the EM 31-D and the EM38 is about 5.5m and 1.5m respectively and is related to the induction coil spacing. In the field, readings were taken at 1m intervals along each traverse. At Site D, the survey made by GA was on a 1m grid over the platform area (Plate 24). Data loggers were used on site to collect the raw data.

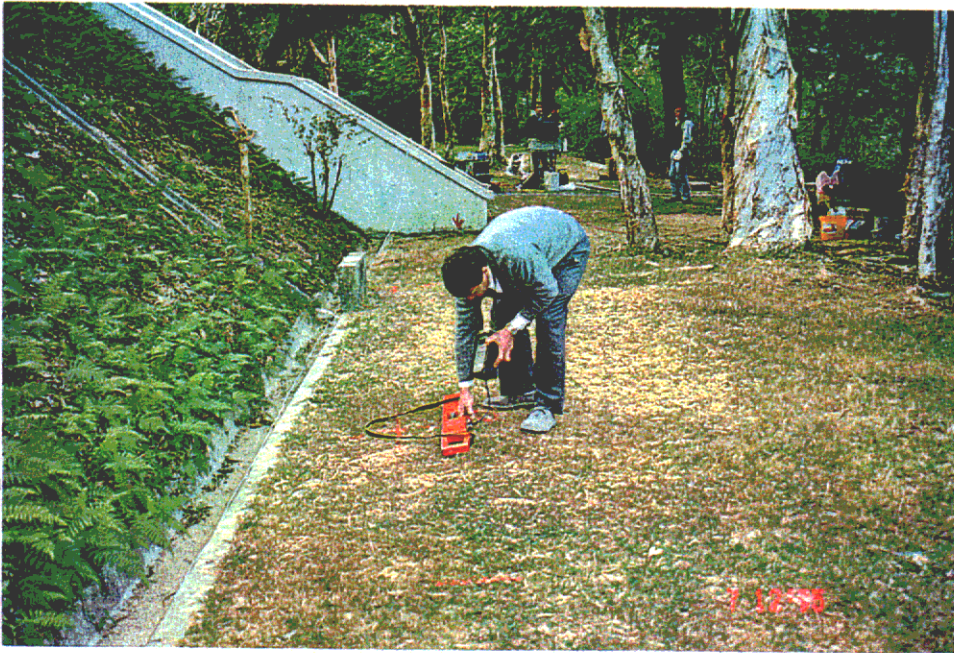
Plate D23 - Geonics EM38 conductivity meter being used at Site D (TD01).
Contractor Bachy Soletanche. (EG95/155/19)

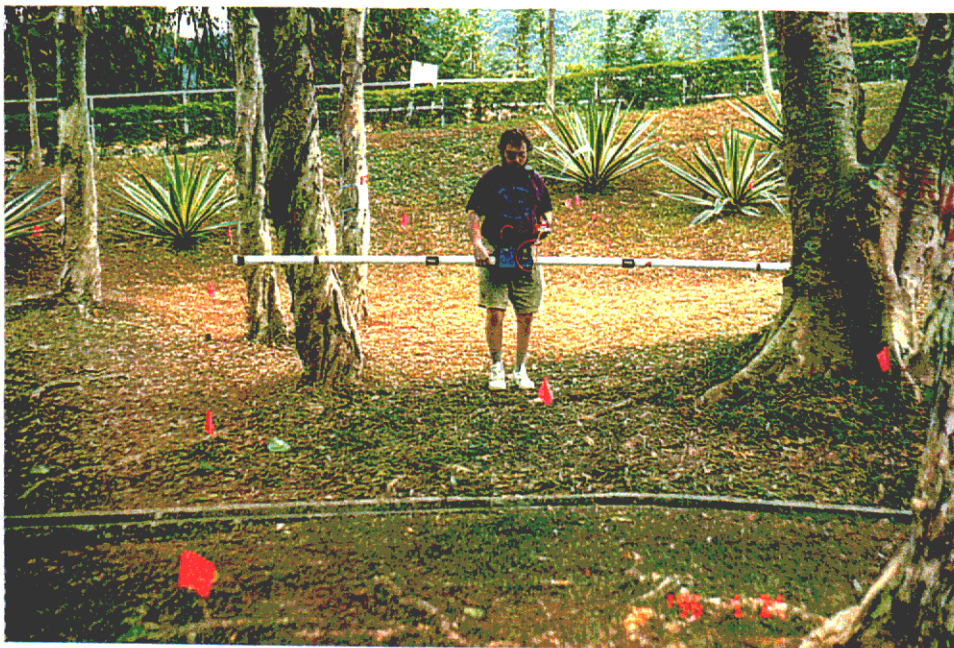
Plate D24 - Geonics EM-31 being used for FDEM survey of fill slope platform
at Site D. Red flags define the 1m grid used to carry out the survey.
Contractor Golder Associates. (EG96/39/4)

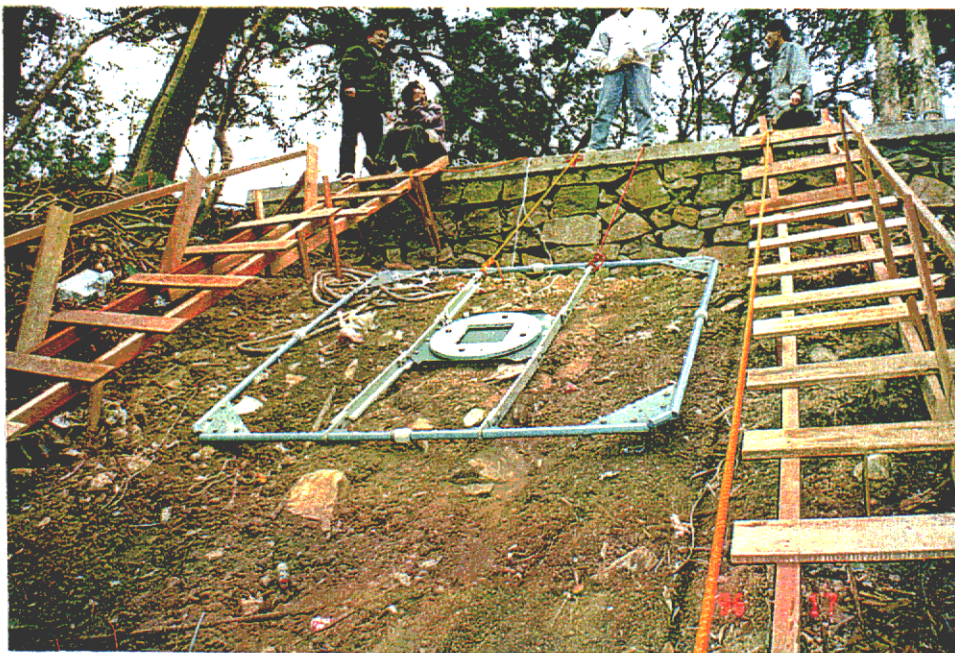
Plate D25 - Crone Geophysics & Exploration Ltd. digital pulse TDEM system being lowered down fill slope at Site D (TD02). Contractor Institute of Geophysical and Geochemical Exploration. (EG96/17/21)

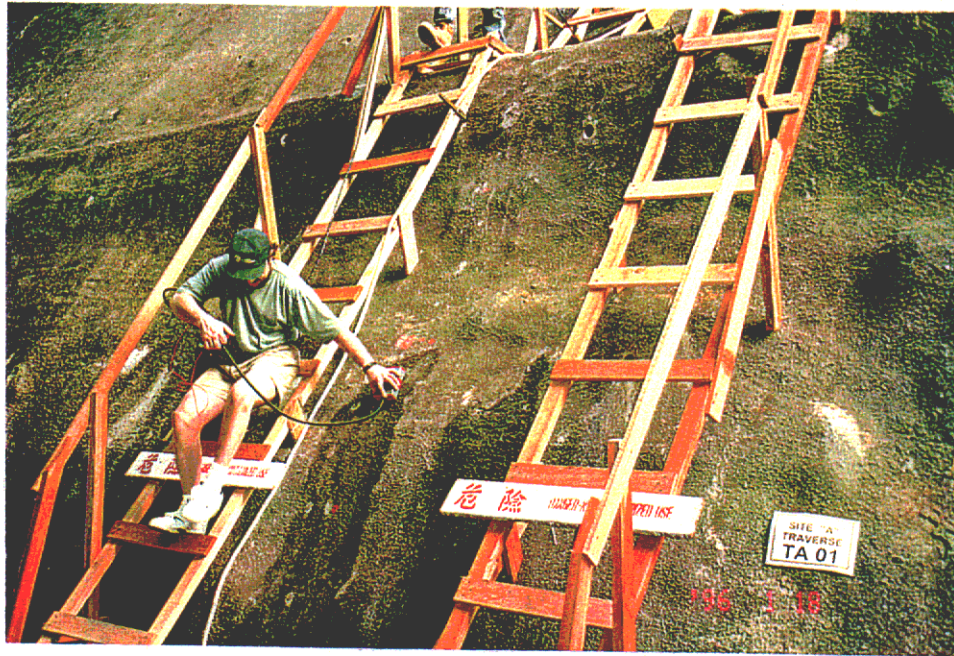
Plate D27 - 1GHz GSSI antenna being used to penetrate mesh reinforced shotcrete at Site A (TA01) - Contractor Golder Associates. (EG96/28/9)

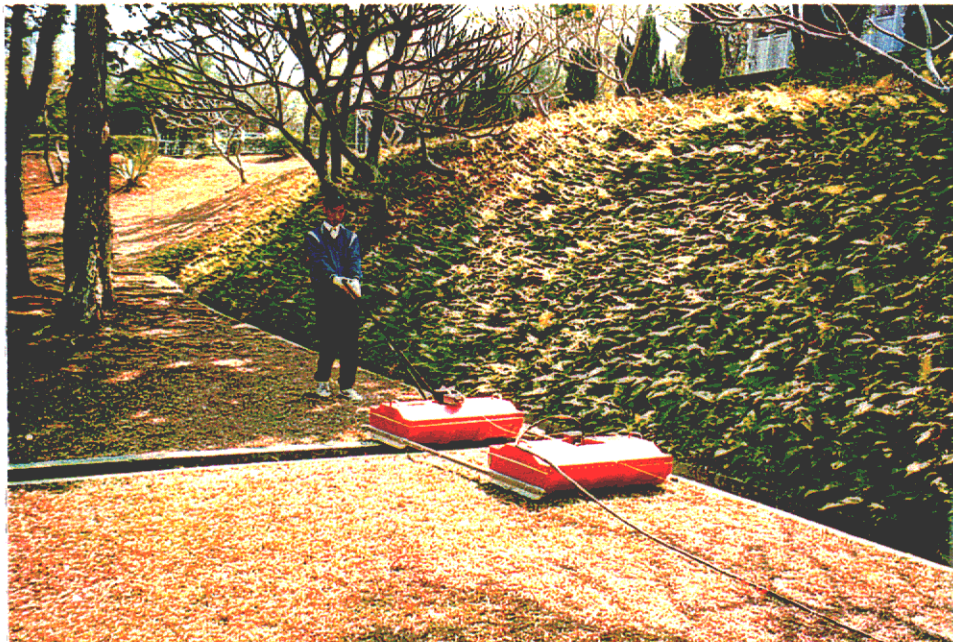
Plate D28 - GSSI 100MHz bistatic antenna being used in GPR survey at Site D (TD01). Contractor Guandong South China EGTD Co. (EG96/02/16)

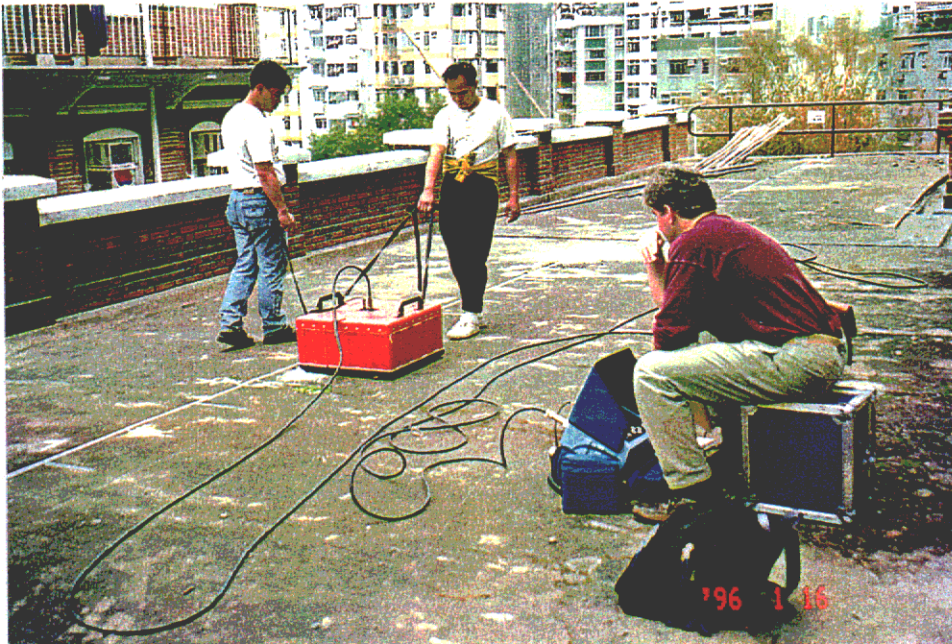
Plate D29 - GSSI 200MHz monostatic antenna being pulled along platform above the masonry wall at Site B (TB05) during GPR survey. Contractor Meinhardt Works. (EG96/12/8)

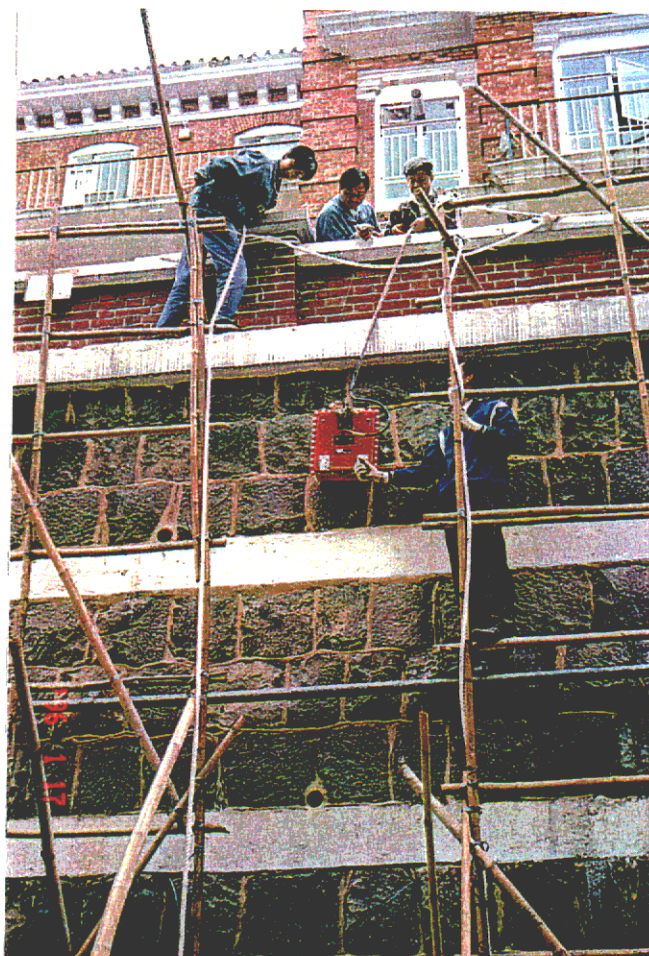
Plate D32 - GSSI 500MHz monostatic antenna being lowered down vertical masonry wall on a rope at Site B (TB02). Contractor Guangdong South China EGTD Co. (EG96/20/24)

The antennas were pulled along horizontal surfaces and either lowered or pulled up the sub-vertical and vertical structures using ropes attached to the antennas (Plate D32). MW and IGGE both used survey wheels which provide encoded distance information automatically on the radargram (Plate D33). The other contractors recorded manually electronic fiducial distance markers onto the radargram, generally at 1m intervals. It was noted that the teams from BS, MW and GA repeated traverses more than once, making adjustments to the gain

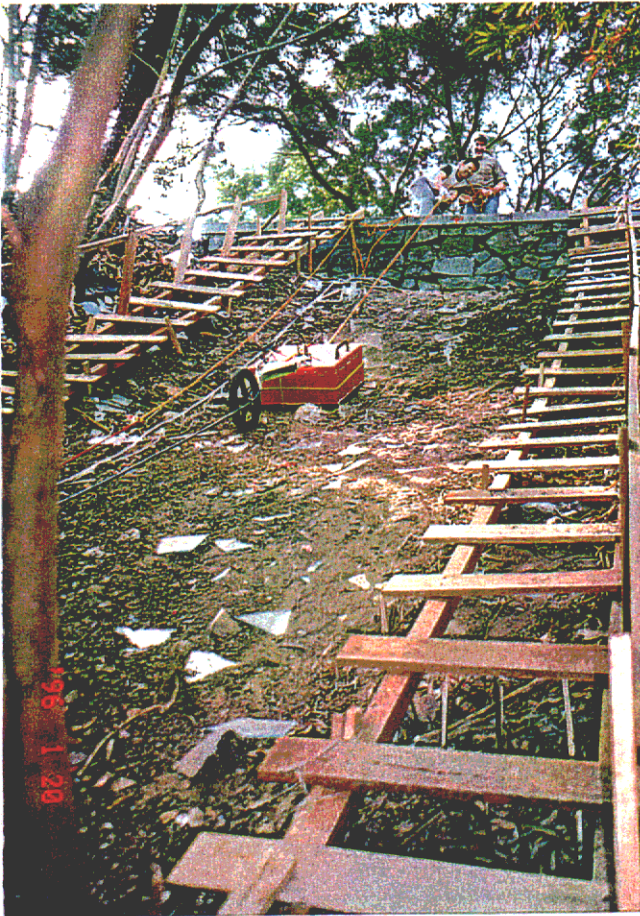
Plate D33 - GSSI 200MHz monostatic antenna being pulled up fill slope at Site D (TD02) during GPR survey. Note survey wheel attached which automatically encodes the radargram with a distance measurement. Contractor Meinhardt Works. (EG96/30/17)

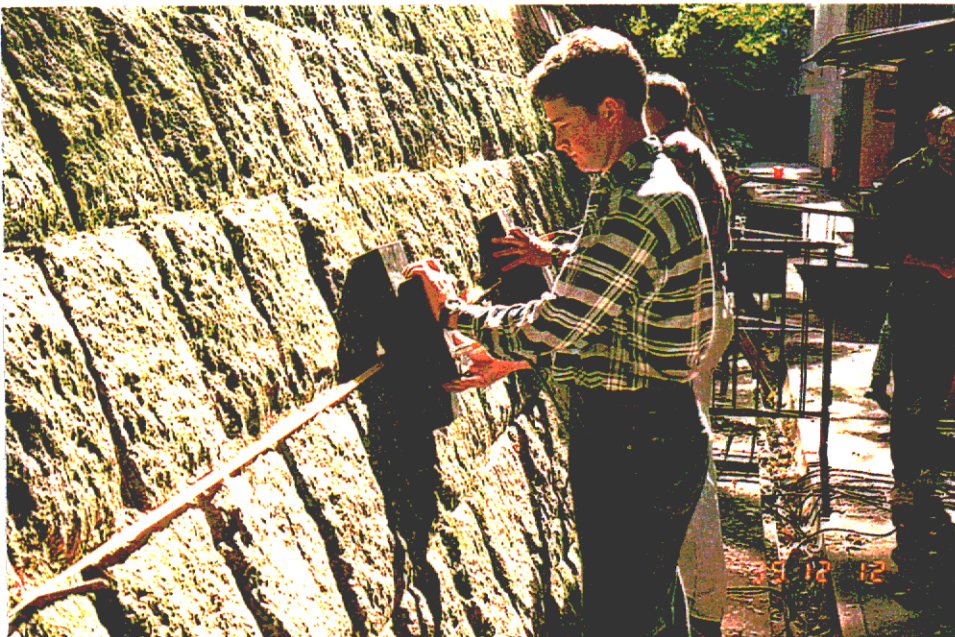
Plate D34 - Sensors & Software Inc. PulsEKKO 1000 System 225MHz antenna's being used in a Common Depth Point (CDP) GPR survey for masonry wall velocity determination at Site C (TC03). Contractor Fugro Geotechnical Services (HK) Ltd. (EG95/165/20)

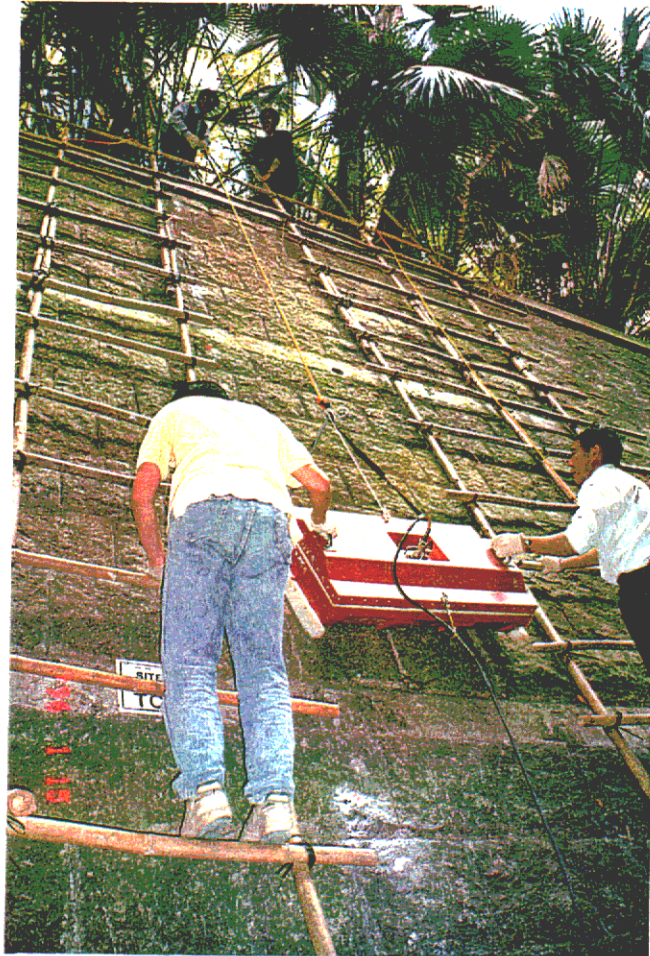
Plate D35 - GSSI 100MHz antenna being lowered down masonry wall at Site C (TC02). Note three men required to manhandle the large antenna to ensure proper contact with the wall. Contractor Institute of Geophysical and Geochemical Exploration. (EG96/11/8)

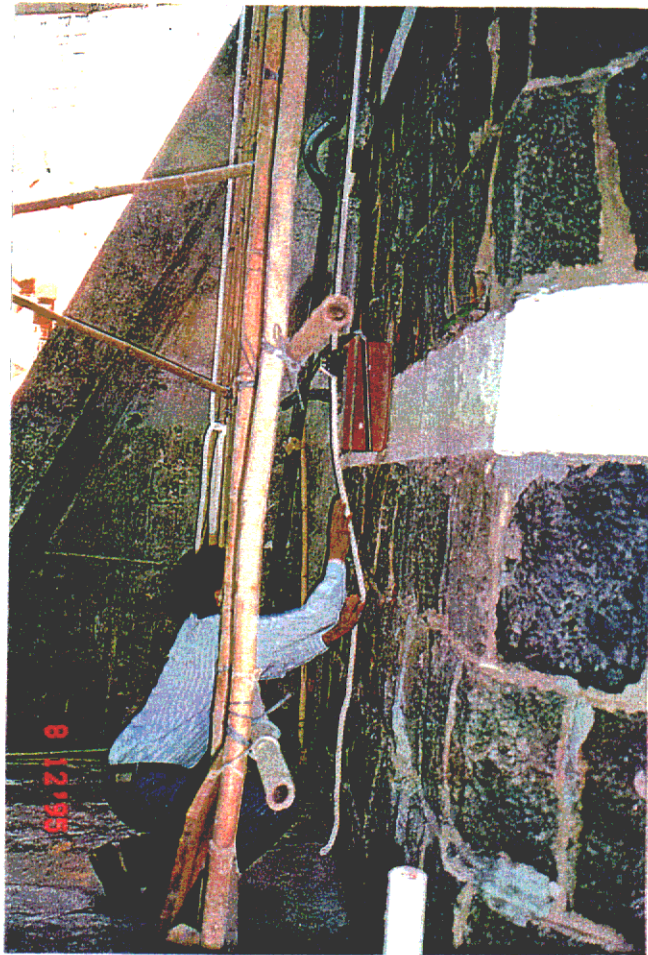
Plate D36 - SIR 2 System 500MHz monostatic antenna being held against masonry wall at Site B (TB01) during ground penetrating radar survey. Contractor Bachy Soletanche. (EG95/158/12)

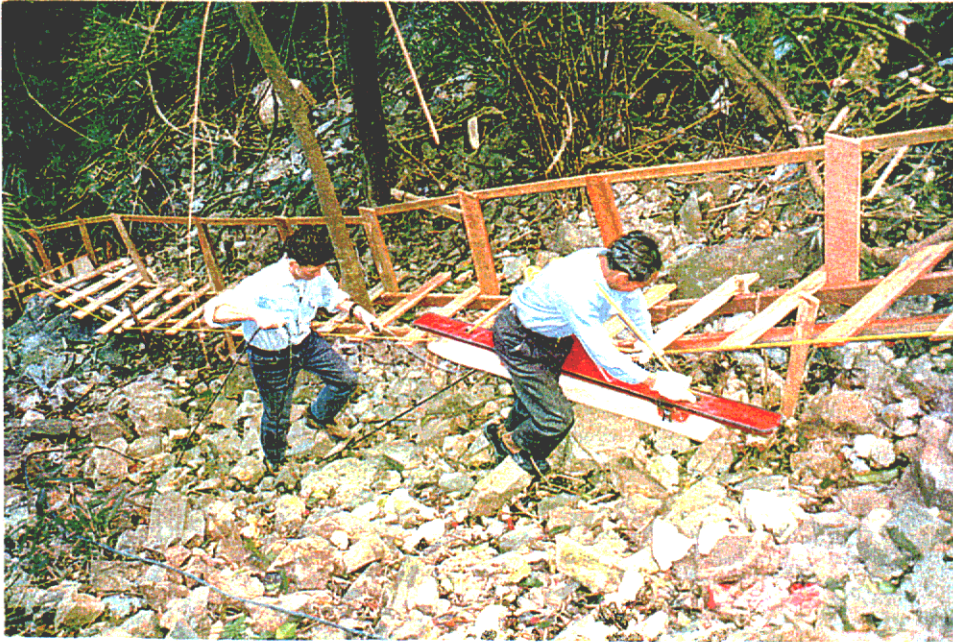
Plate D37 - Radarteam - Sweden A - Model subecho 40 - monostatic 35MHz non-contact antenna being used during GPR survey at Site D (TD02). This non-contact antenna has obvious advantages over the contact type of antenna in rough ground conditions. Contractor Fugro Geotechnical Services (HK) Ltd. (EG95/172/18)
