SITE CHARACTERISATION STUDY - PHASES 1 AND 2

GEO REPORT No. 71

**GEOTECHNICAL ENGINEERING OFFICE
CIVIL ENGINEERING DEPARTMENT
THE GOVERNMENT OF THE HONG KONG
SPECIAL ADMINISTRATIVE REGION**

**This report was originally produced in November 1997
as GEO Special Project Report No. SPR 8/97**

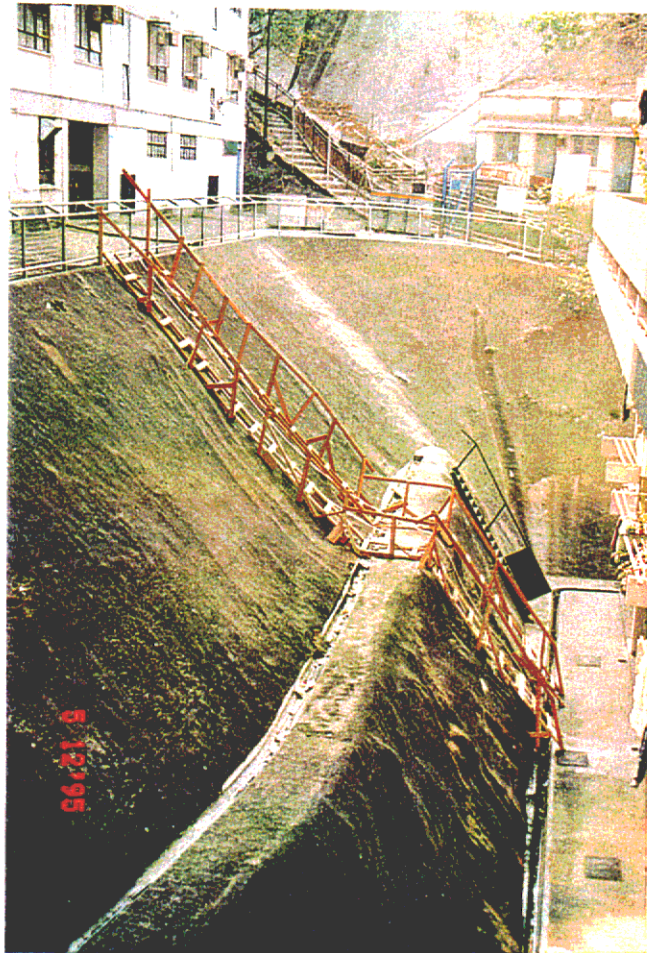
Plate 1 - Trial Site A - View looking south west at shotcreted section of slope.
Note zones of seepage from weepholes adjacent to the access ladder.
(EG95/143/1)

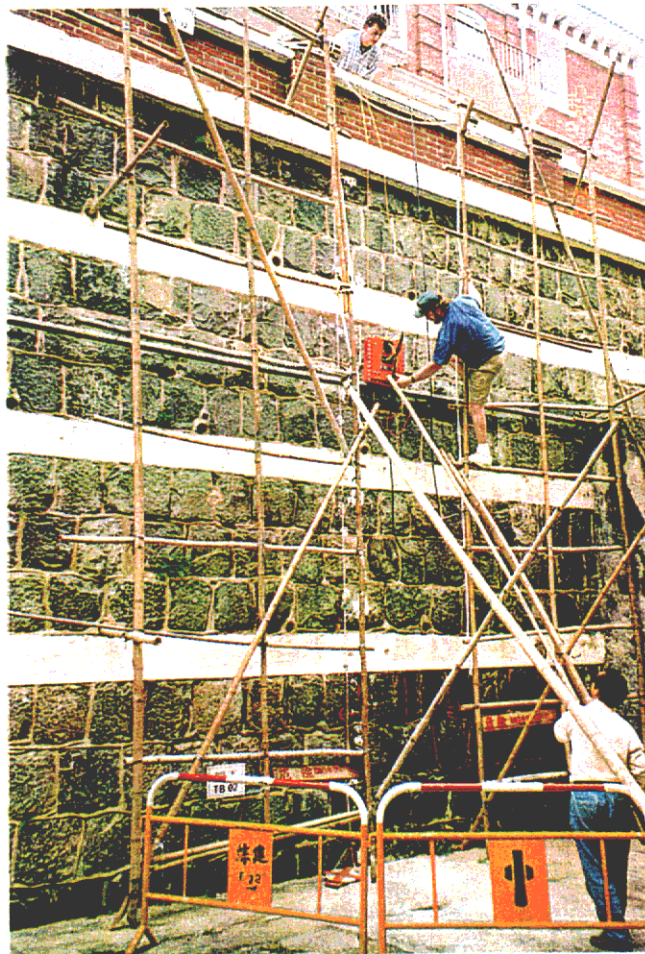
Plate 2 - Trial Site B - View looking west at dressed masonry wall with horizontal tie beams picked out in white. (EG96/46/10A)

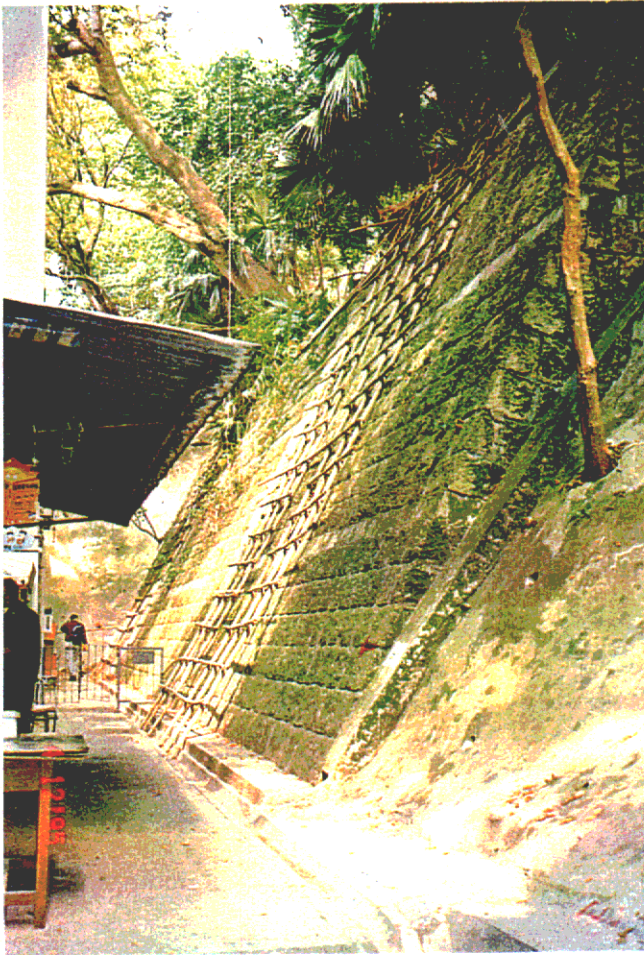
Plate 3 - Trial Site C - View looking
north west along dressed
masonry wall.
(EG95/142/20)

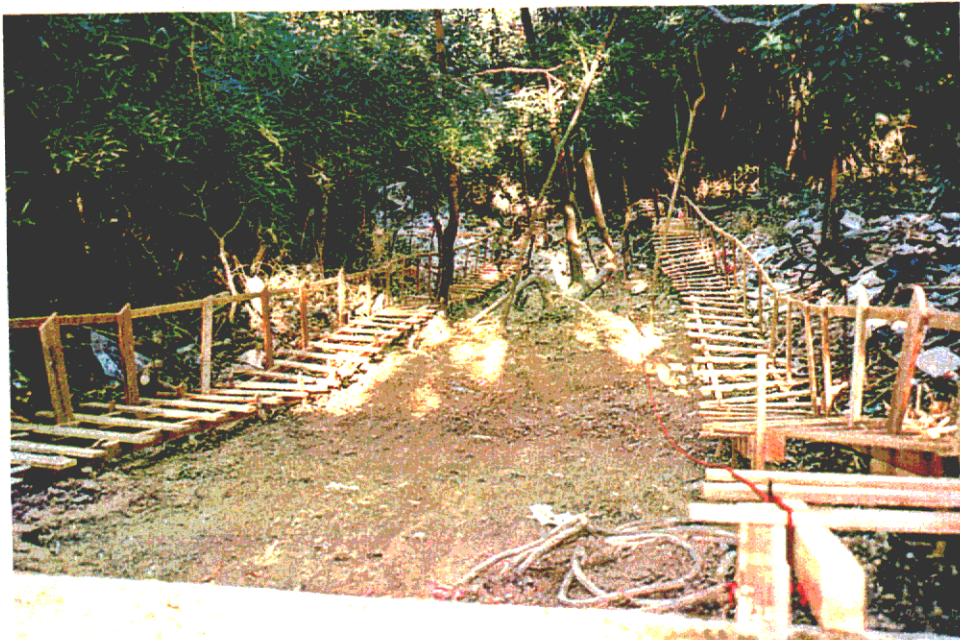
Plate 4 - Trial Site D - View looking north east down slope along traverse TD02.
Note access ladders either side of traverse. (EG95/150/10)

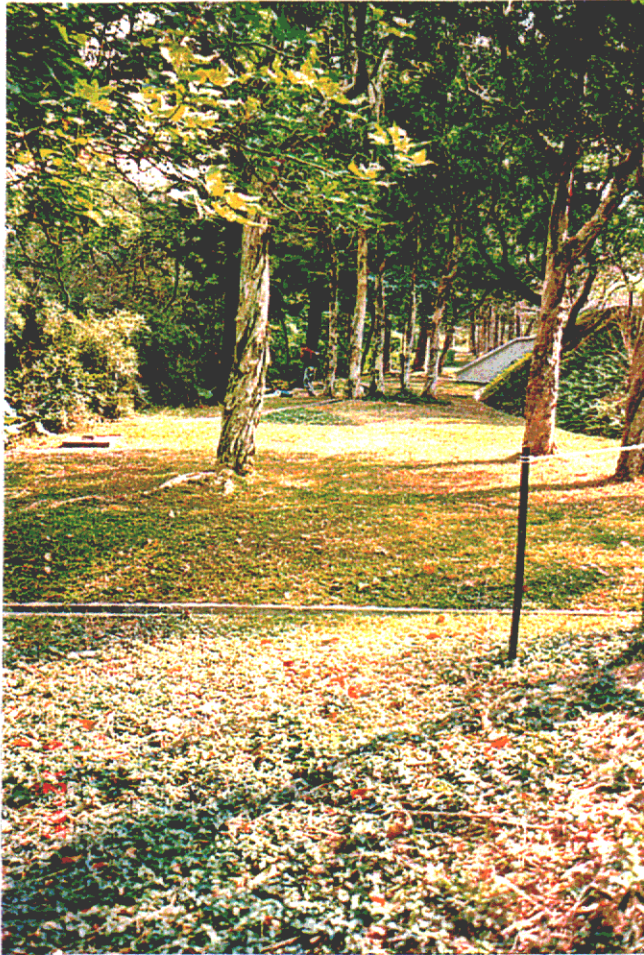
Plate 5 - Trial Site D - View looking north east along traverse TD01 located on the fill platform at the top of the slope. (EG95/142/15)

Site D is a 16m-high north-facing, fill slope with an average inclination of 37° (Plate 4). It is located on the northern side of the Cape Collinson Crematorium (Figure 10). At the crest of the slope is a 80m-long, 9m to 15m wide platform covered with grass and trees (Plate 5). The surface of the fill slope is covered with dense vegetation of mainly shrubs and small trees. The surface materials at the top half of the slope consist of very loose fill with an abundance of broken glass. The lower part of the slope surface is composed of cobble and boulder-sized angular fragments of rock fill. Geophysical trials were made along two traverses TD01 and TD02 (Figure 10).

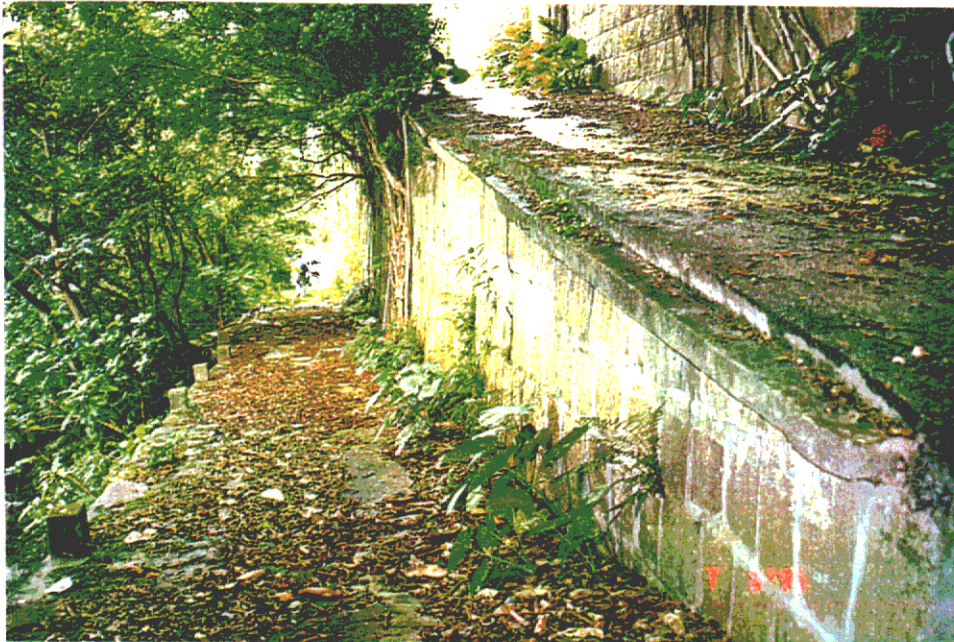
Plate 6 - Trial Site E - View looking east towards Stubbs Road from the lower end of the dressed masonry wall. (EG96/68/9)

Site E is a 62m long dressed block masonry wall which reduces in height from 11m in the east to 0m in the west and is inclined at about 80° (Plate 6). It forms part of the retaining wall and cut slope complex which supports the building platform for Stubbs Villa located to the south of the wall (Figure 12). At the toe and crest of the wall is a 3.5m to 4m wide ramp which accesses Stubbs Road to the east. The masonry wall facing is composed of bonded, square (450 by 450mm), slightly decomposed granite blocks. The mortar bonding between each block was in poor condition at the time of the trials, showing signs of spalling, erosion and weathering, and was friable in places.

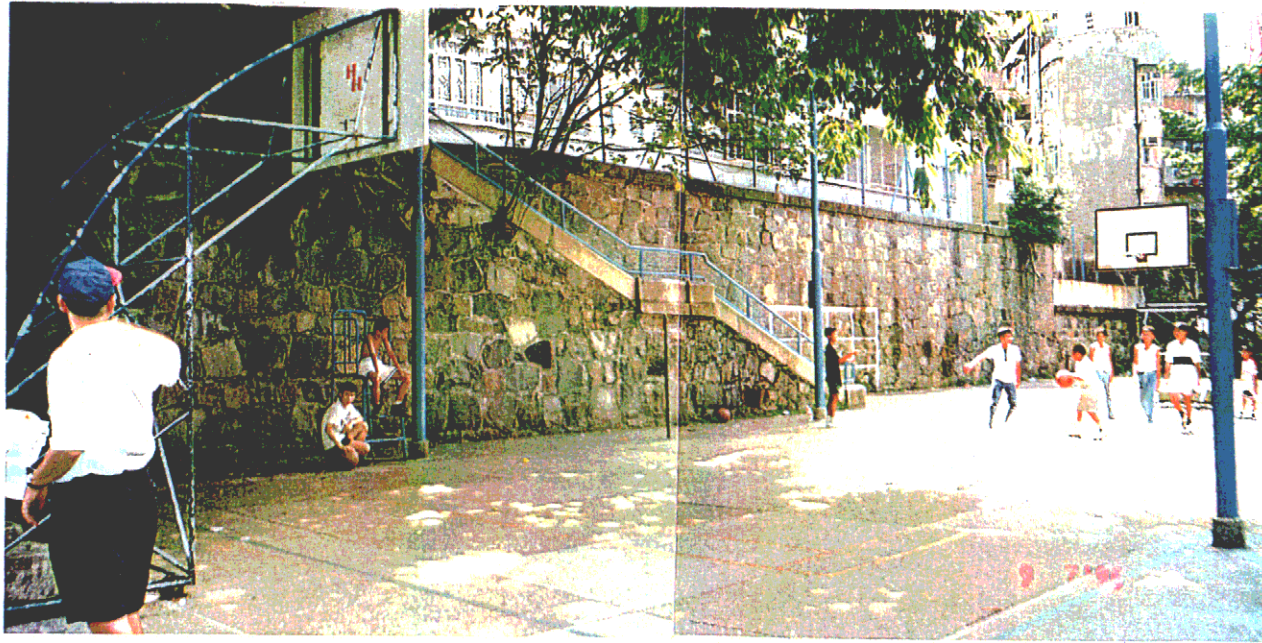
Plate 7 - Trial Site F - View from playground of tied random rubble wall. (EG96/62/6,7)

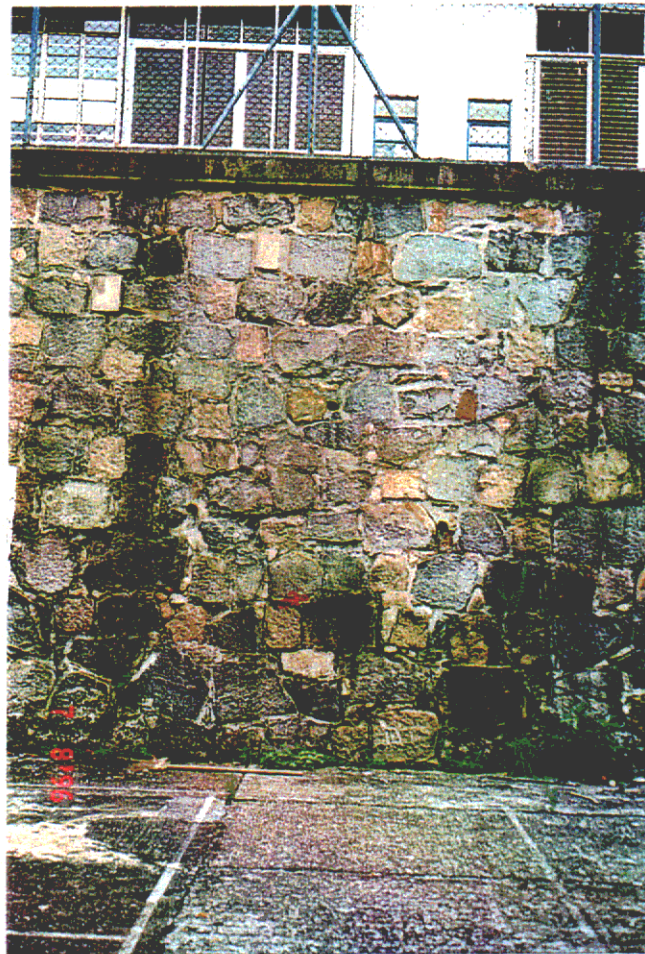
Plate 8 - Trial Site F - Granite headers in tied masonry wall. (EG96/69/21)

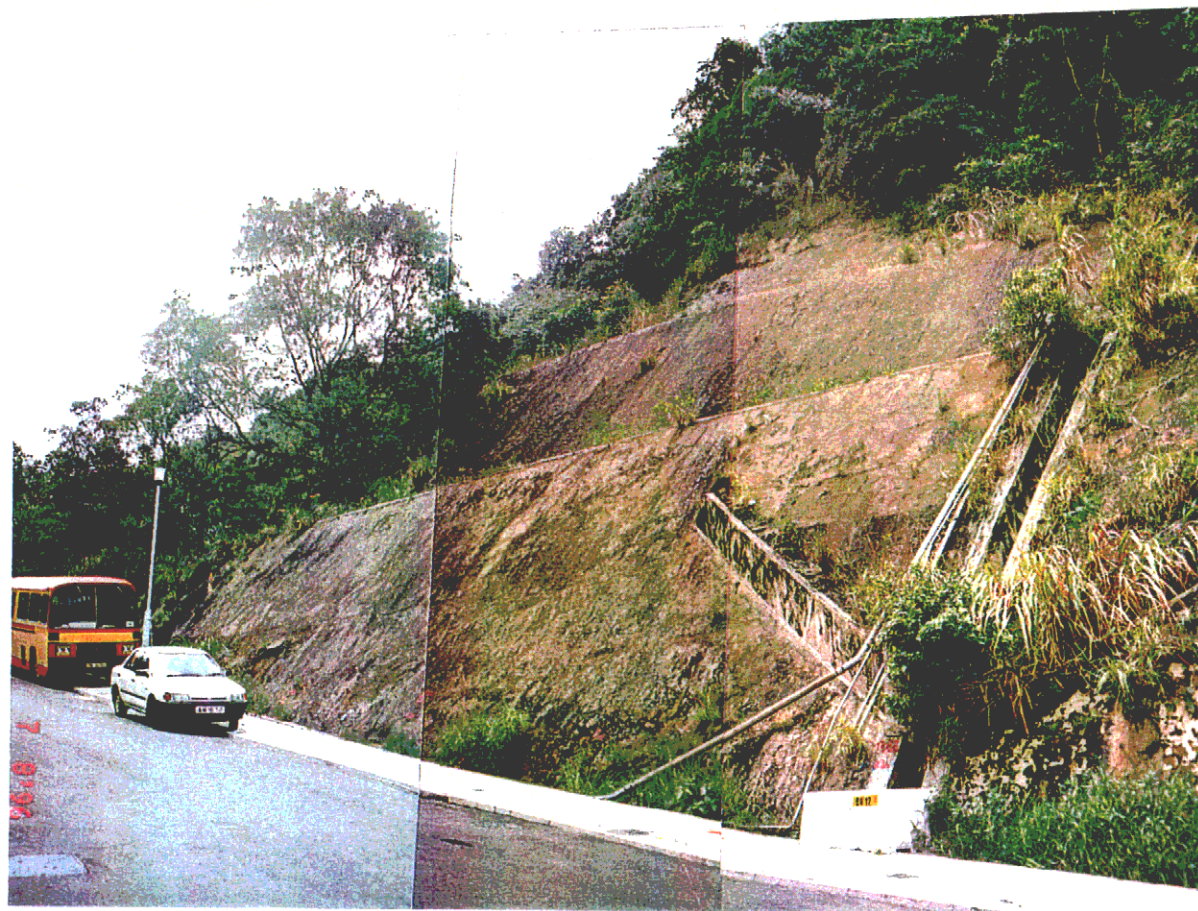
Plate 9 - Trial Site G - View of cut slope looking south east. Note single corestone protruding from slope face close to white motor car. (EG96/68/13,14,15)

Site G is a north-east facing, 20m high, 55° road-side cut soil slope (Plate 9) adjacent to Blue Pool Road (Figure 14). The slope is 40m wide at road level and has two 1.2m wide berms at +144mPD and +149.5mPD. Blue Pool Road falls from south east to north west from about +140.6mPD to +136.1mPD along the length of the slope. The slope is covered with chunam which at the time of the trials was cracked and spalled in several places. Prior to the field trials the site had vegetation growing through the chunam mostly at the south eastern end. In the spalled areas the exposed slope forming material was extremely weak, medium-pinkish brown, coarse-grained completely decomposed granite. The slope is bounded to the south by a vegetated natural slope. Surface drainage is provided by a series of 300mm U-channels along the toe and on each berm which feed into 300mm and 450mm wide stepped channel running along the north western boundary of the slope. A 250mm-wide inclined drainage channel with weepholes drains into the catch-pit at the base of the slope at the north-western end. A Towngas utility box is located at the north western end of the slope on the first berm and a series of pipes run down the slope from the box into the pavement at the toe (Figure 14). A metallic pipe filled with concrete protrudes from the lower slope at the south-eastern end (Figure 14). Further north-west of the pipe is a rock outcrop of moderately decomposed granite which protrudes through the chunam.

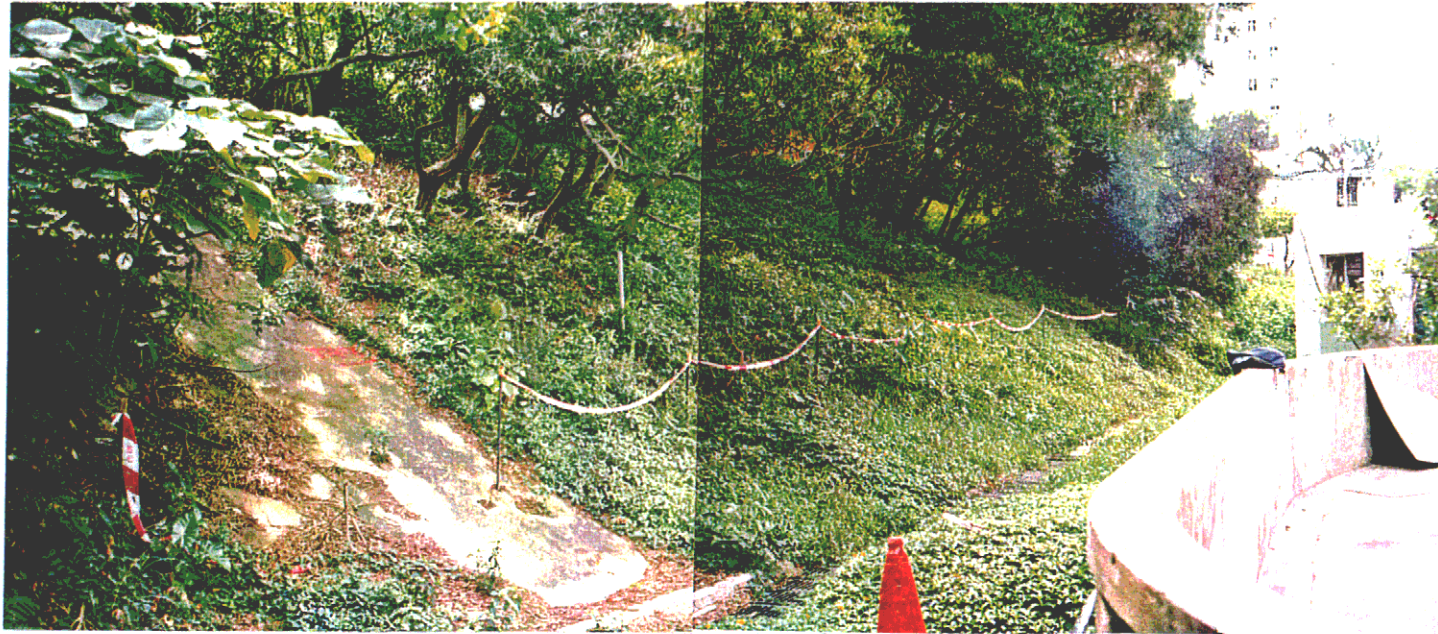
Plate 10 - Trial Site H - View looking south east at fill slope. (EG96/70/23,24)

Site H is situated in the north part of Choi Wan Estate, Kowloon. It is bounded by a small playground with a small carpark to the east, Clear Water Bay Road to the south, St. Joseph Primary School and a small shed to the west, and slope 11NE-A/F79 to the north (Figure 15). The slope has a maximum height of 7m, is 31m long and inclined at 26° (Plate 10). Prior to the field trials the slope was thickly vegetated with trees and small shrubs. A metal fence runs along the crest of the slope separating it from the playground. A 900mm-wide concrete drainage channel runs along the toe the slope and is covered by a concrete and cast iron grating over its full length. A 250mm U-channel is located at the crest of the slope. A twin 1650mm-diameter culvert and a 450mm diameter sewer pipe passes the slope to the east and are located about 6m to 7m below ground level (Figure 15).

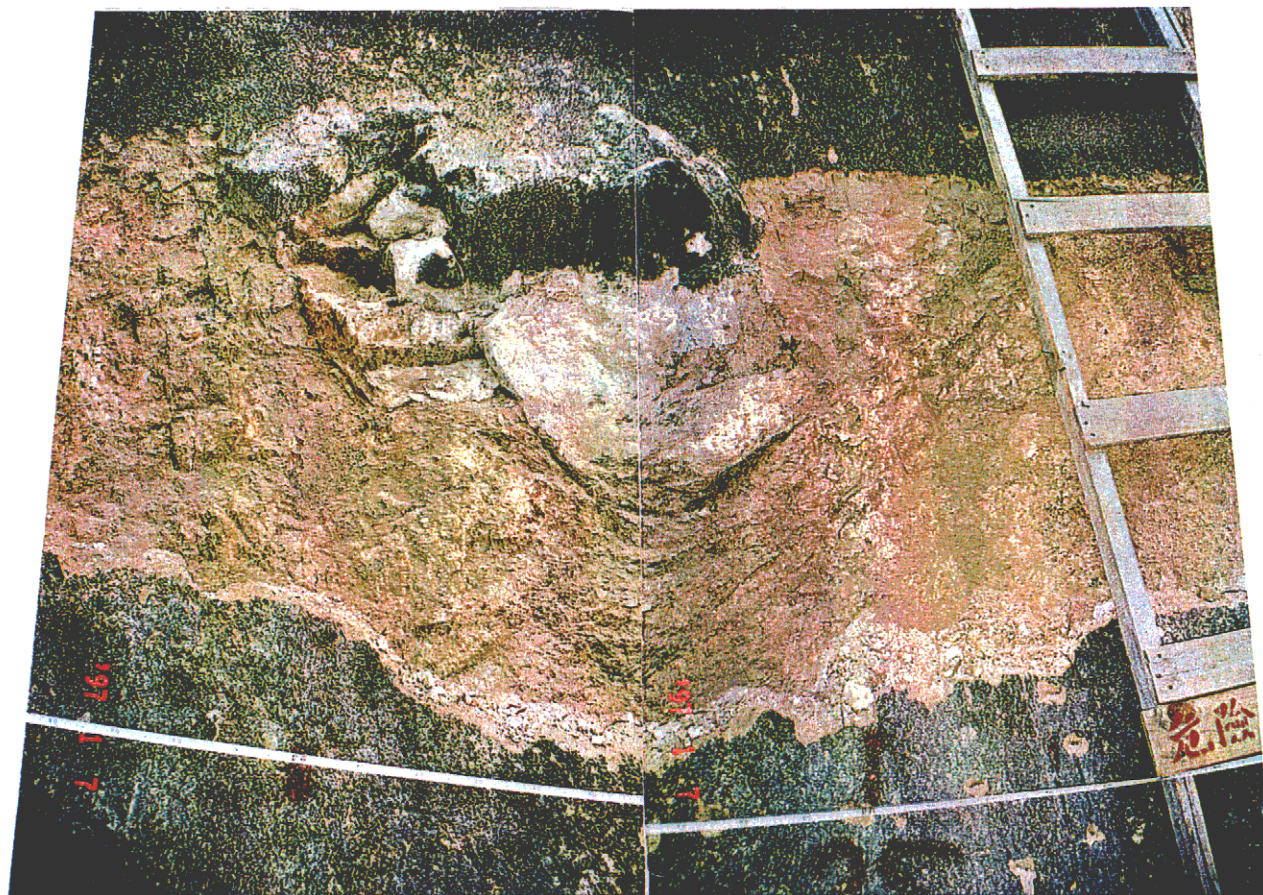
Plate 12 - Corestone of moderately decomposed granite exposed along chunam strip CSG1 at Site G.
(EG97/03/4,5)

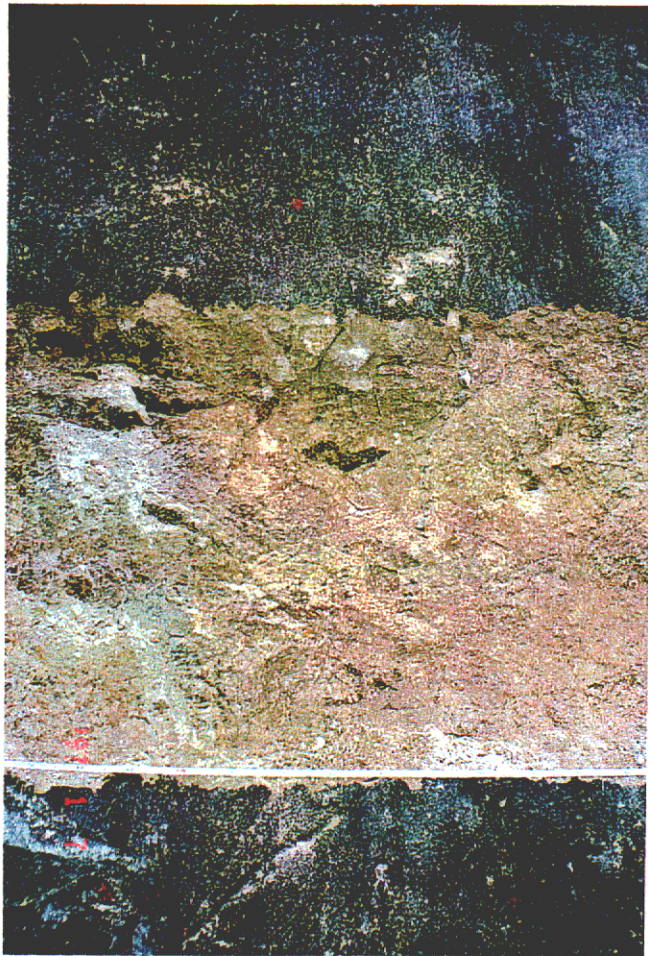
Plate 13 - Thin quartz vein within completely decomposed granite along chunam strip CSG1 at Site G. (Eg97/11/23)
