HONG KONG RAINFALL AND LANDSLIDES IN 1997

GEO REPORT No. 97

**GEOTECHNICAL ENGINEERING OFFICE
CIVIL ENGINEERING DEPARTMENT
THE GOVERNMENT OF THE HONG KONG
SPECIAL ADMINISTRATIVE REGION**

SECTION 1: HONG KONG RAINFALL AND LANDSLIDES IN 1997

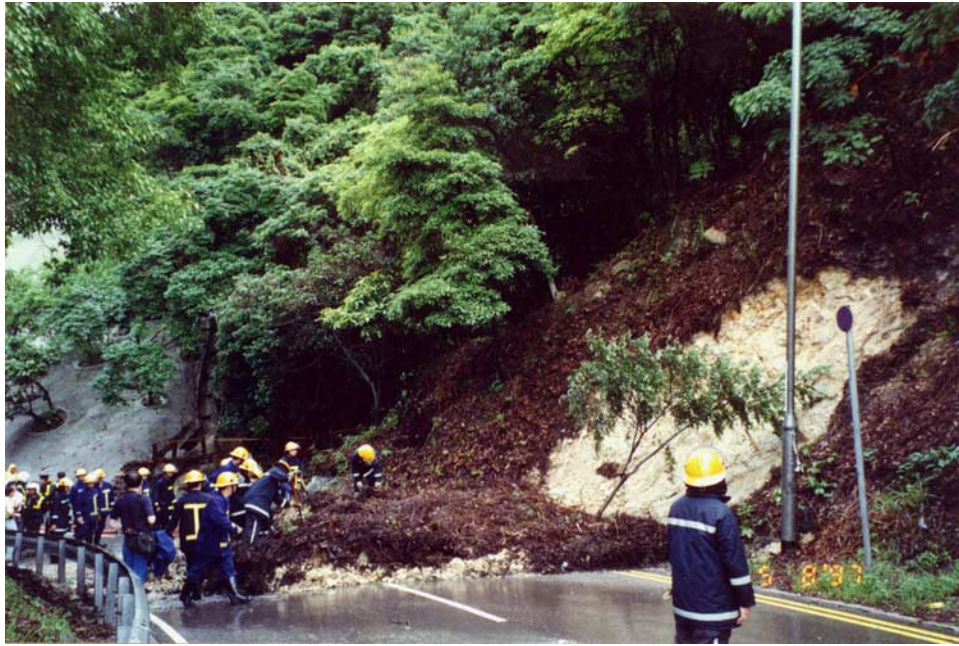
Plate 1 - Clear Water Bay Road near Ta Ku Ling, Sai Kung
(Incident ME 97/5/3)

A soil cut slope failure (Slope No. 11-NE-B/C143) occurred on the morning of 8 May 1997 at Clear Water Bay Road near Ta Ku Ling, Sai Kung. Prior to failure, the 5 m high cut slope was covered by poor vegetation and had a slope angle of about 70°. The failure scar was about 4 m high and failure volume was 20 to 30 m³. The travel angle was estimated to be 30° as measured from the crest of the failure to the distal end of the landslide debris. The landslide debris accumulated at the toe of the cut slope and resulted in the closure of one lane of Clear Water Bay Road.

The cut slope failure was probably triggered by the infiltration of intense rainfall into unlined surface channels and the bare surface on the slope crest. Insufficient drainage maintenance was considered a contributing factor to the failure.

Description : A soil cut slope failure resulting in the closure of one lane of Clear Water Bay Road.

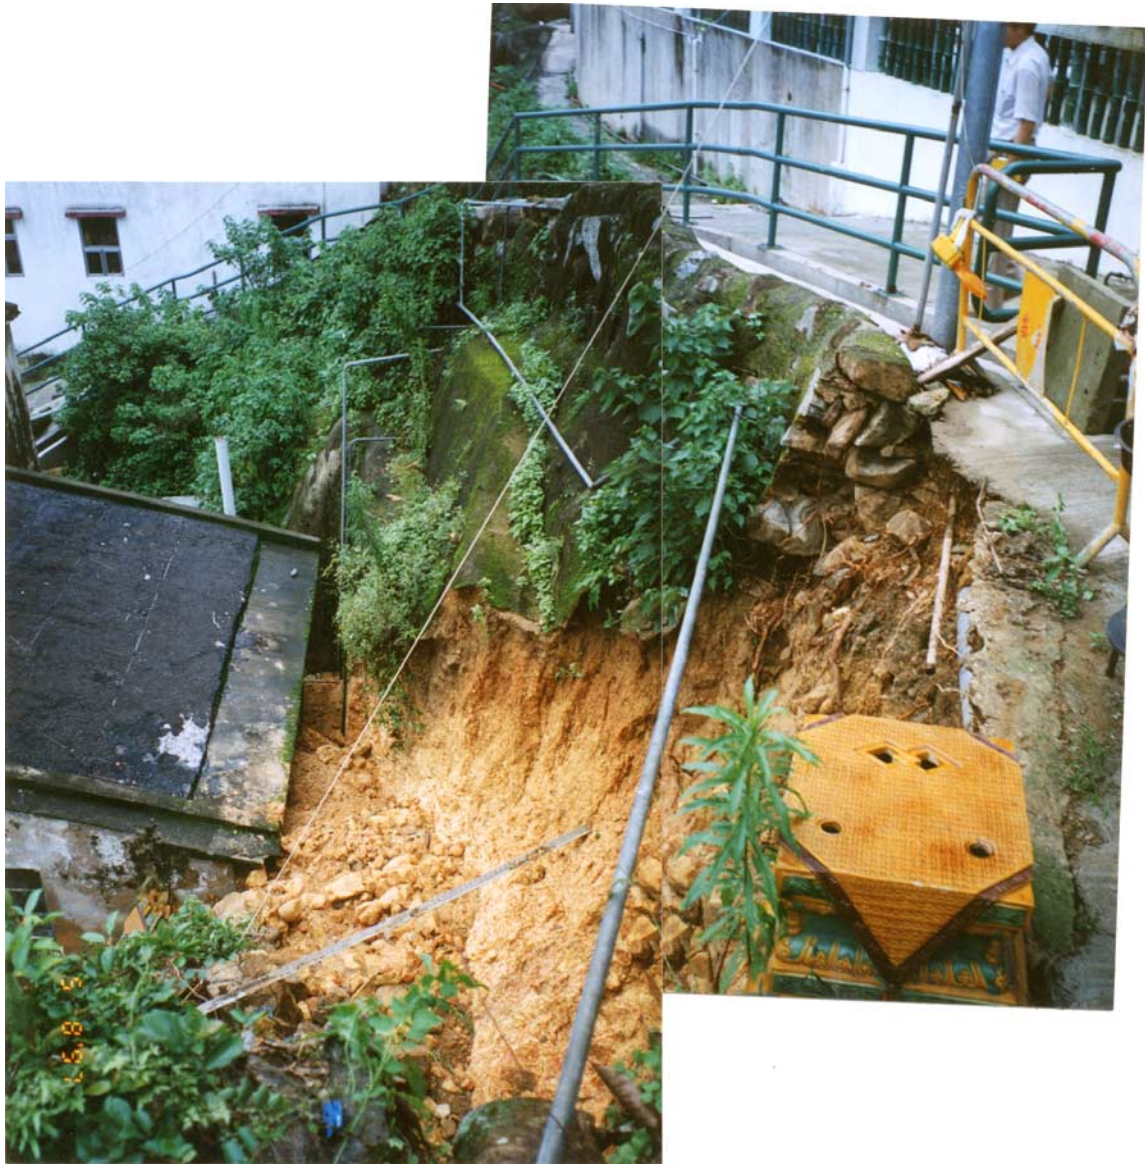
Plate 2 - House Nos. 47 and 48 Hiu Po Path, Sheung Sze Wan, Sai Kung
(Incident ME 97/5/7)

On the morning of 8 May 1997, a soil cut slope failure occurred adjacent to house Nos. 47 & 48 Hiu Po Path, Sheung Sze Wan, Sai Kung. The cut slope was about 8 to 10 m high and covered by chunam before the failure. The volume of the failure was estimated to be about 30 m³. The landslide debris accumulated at the rear area of house No.47 and some debris from this landslide travelled down to house No.48, resulting in the evacuation of house No.47, affecting house No.48 and causing the closure of a pedestrian pavement.

The failure at Sheung Sze Wan was probably triggered by the infiltration of intense rainfall into a poorly maintained chunam surface and overflow of rainfall runoff from surface channels at the crest of the slope.

Description : A soil cut slope failure resulting in the evacuation of No. 47
Hiu Po Path, Sheung Sze Wan.

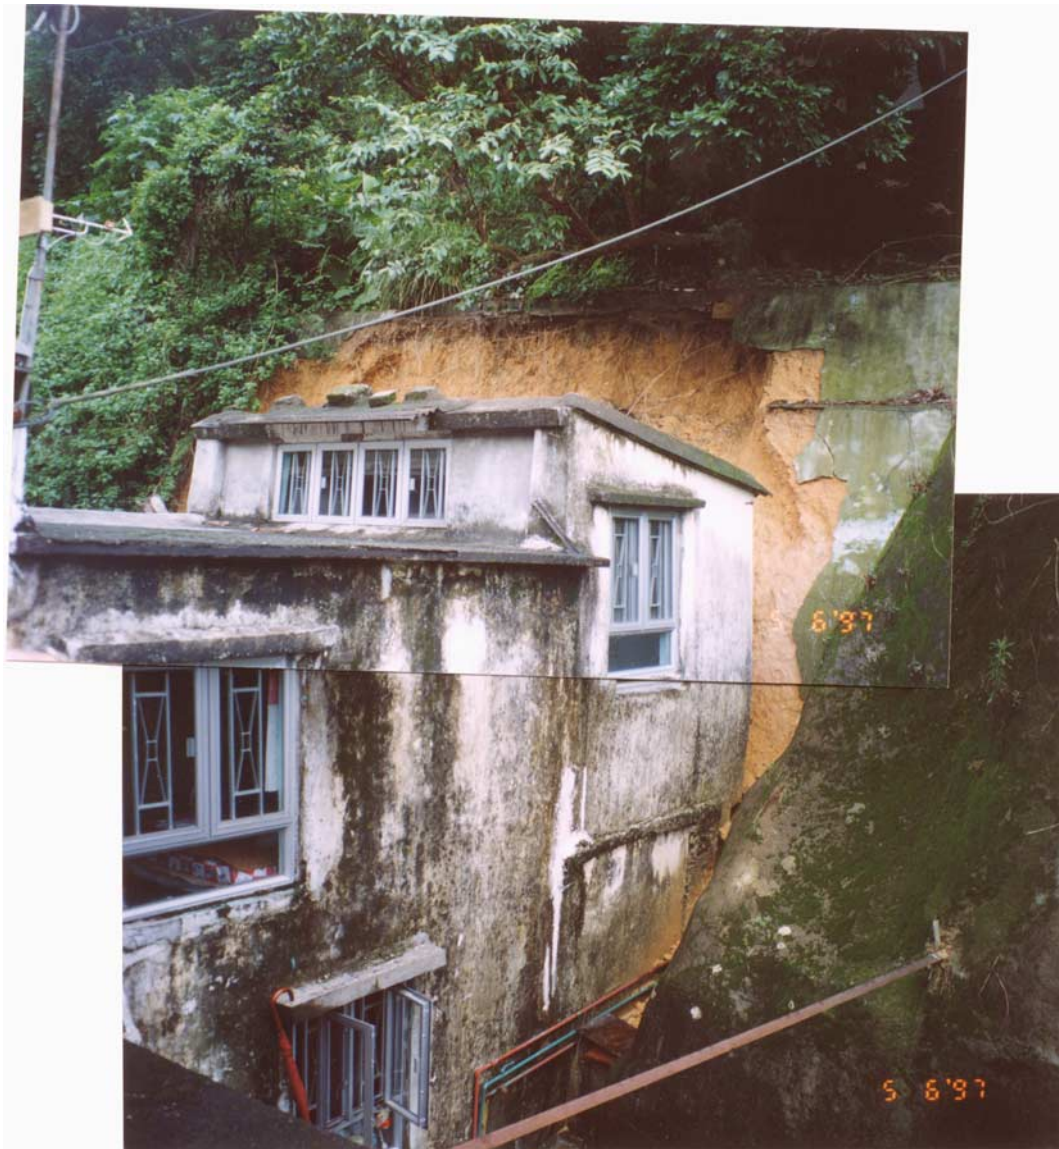
Plate 3 - House Nos. 4 and 5 Pak Shek Wo Sun Tsuen, Clear Water Bay Road,
Sai Kung (Incident ME 97/6/13)

At 10:00 a.m. on 4 June 1997, a soil cut slope failure occurred on slope No.11NE-B/C405 at Pak Shek Wo Sun Tsuen, Clear Water Bay, Sai Kung. Prior to failure, the 8 m high cut slope was covered by chunam and had a slope angle of 60°. The failure scar was about 5 m wide and 6 m high. The volume of the failure was estimated to be about 20 m³. The landslide debris toed against a wall of a two-storey building located behind house Nos.4 and 5, which were evacuated.

The failure was probably triggered by the infiltration of intense rainfall exacerbated by insufficient surface drainage due to the blockage of channel drains at the slope crest.

Description : A soil cut slope failure which resulted in the evacuation of
two houses, Nos. 4 and 5 Pak Shek Wo Sun Tsuen.

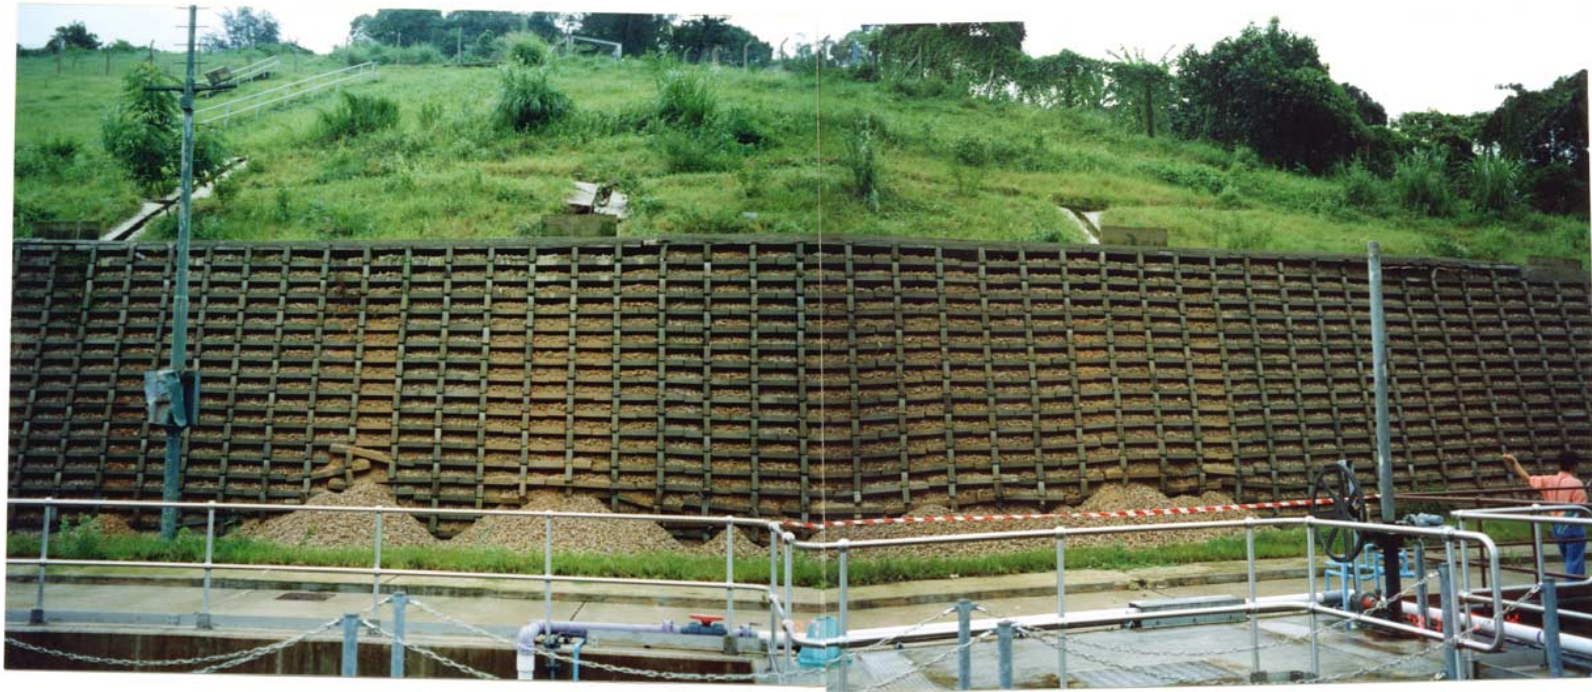
Plate 4 - Pak Kong Water Treatment Plant, Sai Kung (Incident ME 97/7/15)

A soil cut slope failure (Slope No.8SW-C/C175) occurred at 8:30 a.m. on 4 July 1997 at Pak Kong Water Treatment Plant, Sai Kung. The soil cut slope with berms was 30 m high, comprising a 7.5 m high slope with a gradient of 80° at the toe, with the remaining upper slope having a gradient of about 26°. The near-vertical 7.5 m high slope at the toe was retained by a crib wall and the remaining upper slope was covered by moderate vegetation with surface drainage channels. Surface subsidence was observed on the slope berms with

extensive tension cracks, concrete slab cracks and drainage channel cracks. Significant cracking and bulging were noted on the crib wall concrete members associated with backfill materials emerging from the toe of the crib wall. The volume of the unstable mass was estimated to be about 100 m³.

The failure was probably triggered by intense rainfall associated with a rise in perched groundwater levels and possibly the presence of adverse geological conditions.

Description : A soil cut slope failure resulting in structural distress on a crib wall and backfill materials emerged from the toe of the crib wall.

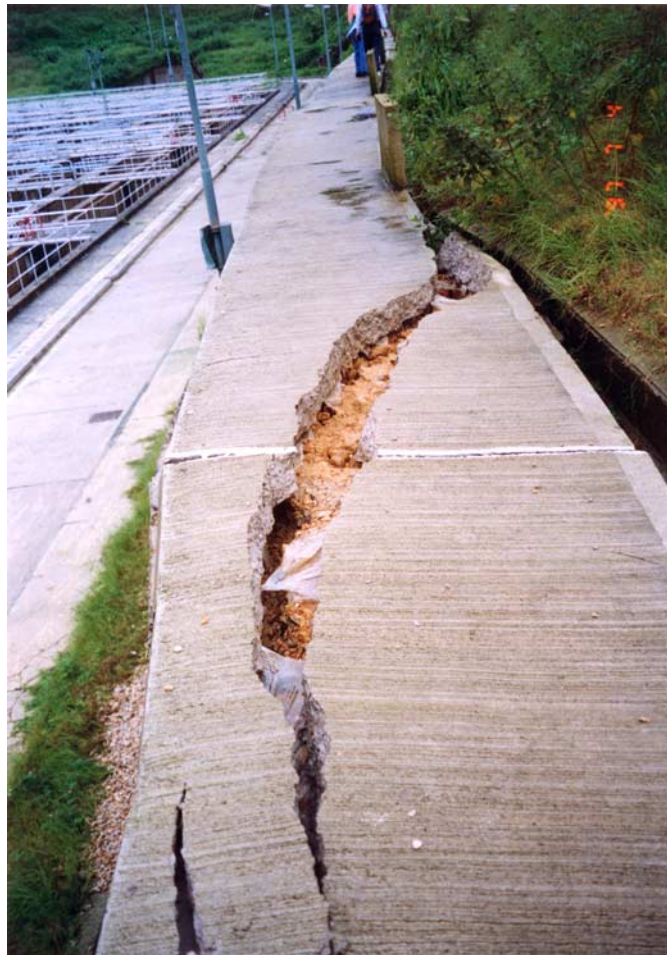
Plate 5 - Pak Kong Water Treatment Plant, Sai Kung
(Incident ME 97/7/15)

Description : Concrete slab cracks on top of the crib wall.

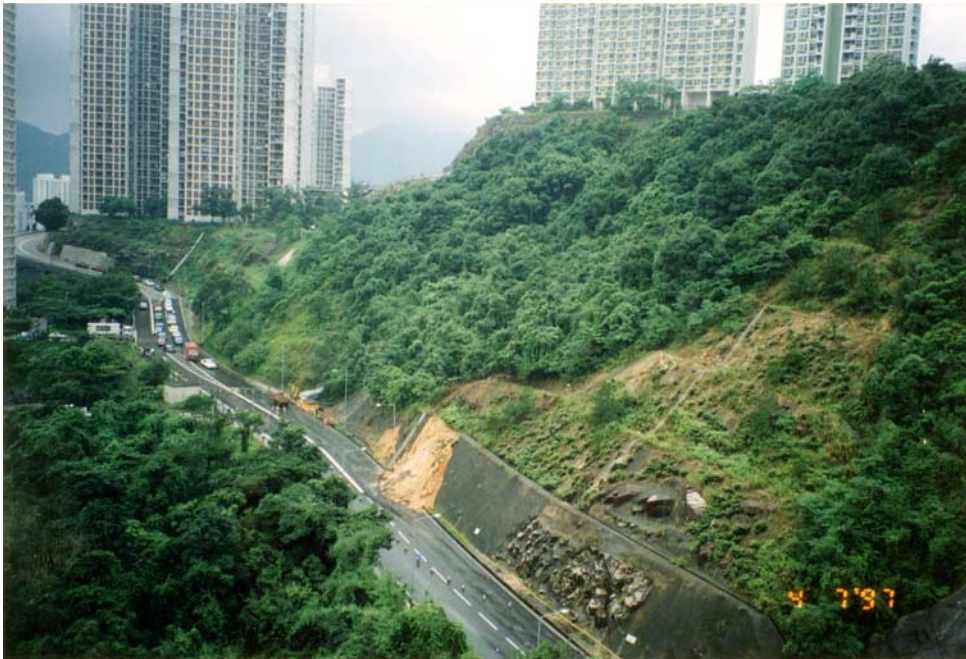
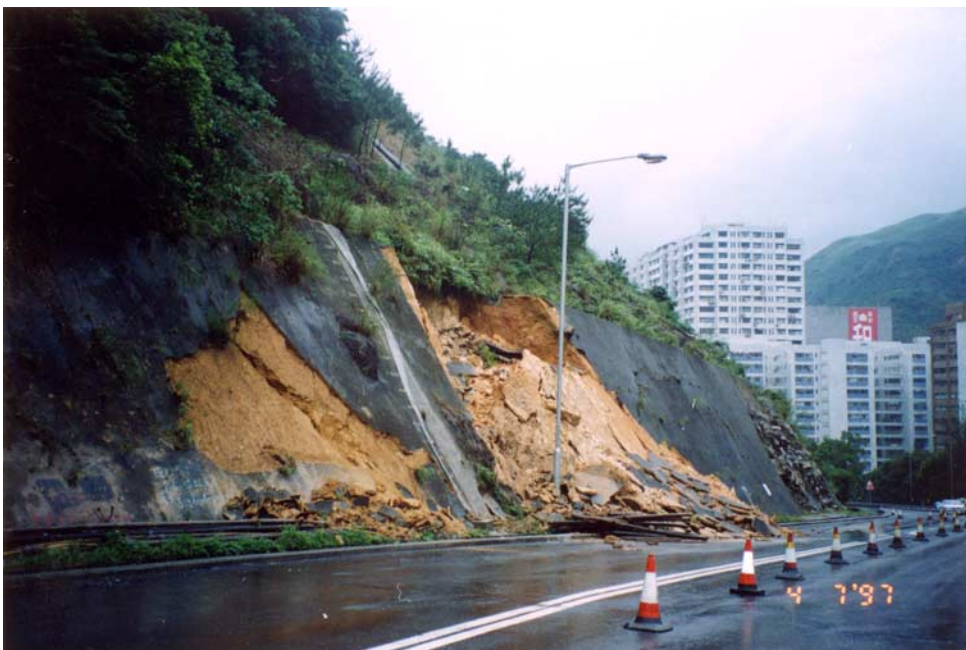
Plates 6 & 7 - Opposite to a Pumping Station at Sui Wo Road, Fo Tan (Incident ME 97/7/17)

A soil cut slope failure (Slope No.7SE-A/C2) occurred at 7:45 a.m. on 4 July 1997 opposite to a pumping station at Sui Wo Road, Fo Tan. The slope was about 47 m high. The lower 7 m of the slope was covered by chunam, while the remaining upper slope was covered by poor vegetation. The failure scarp was about 4 m high with a failure volume of about 44 m³. This failure resulted in the blockage of one lane of Sui Wo Road.

The landslide was probably triggered by infiltration following intense rainfall associated with a rise in groundwater level. Insufficient drainage maintenance was also considered a contributing factor to the failure.

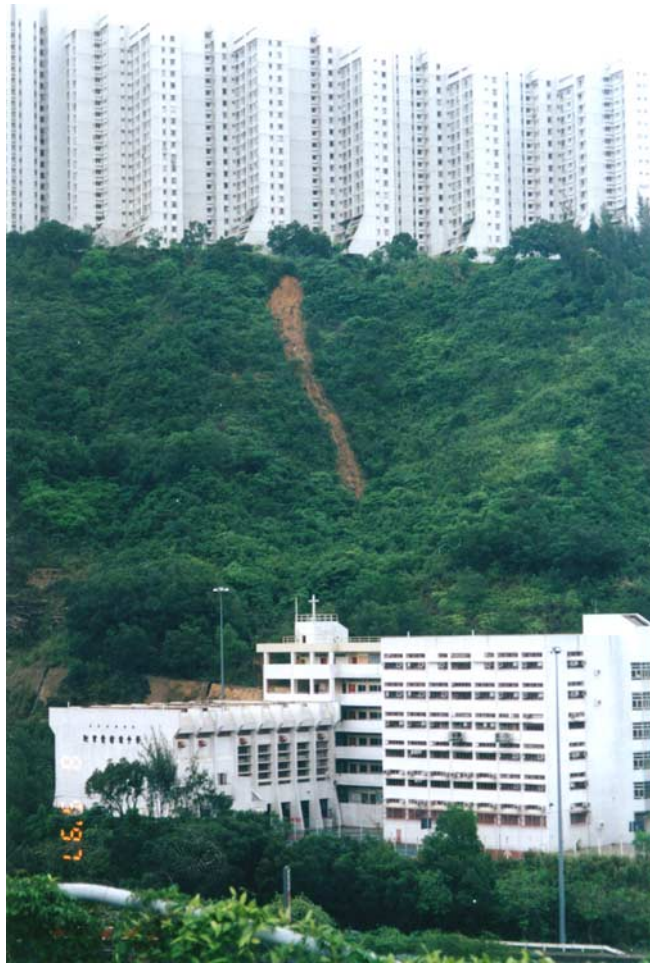
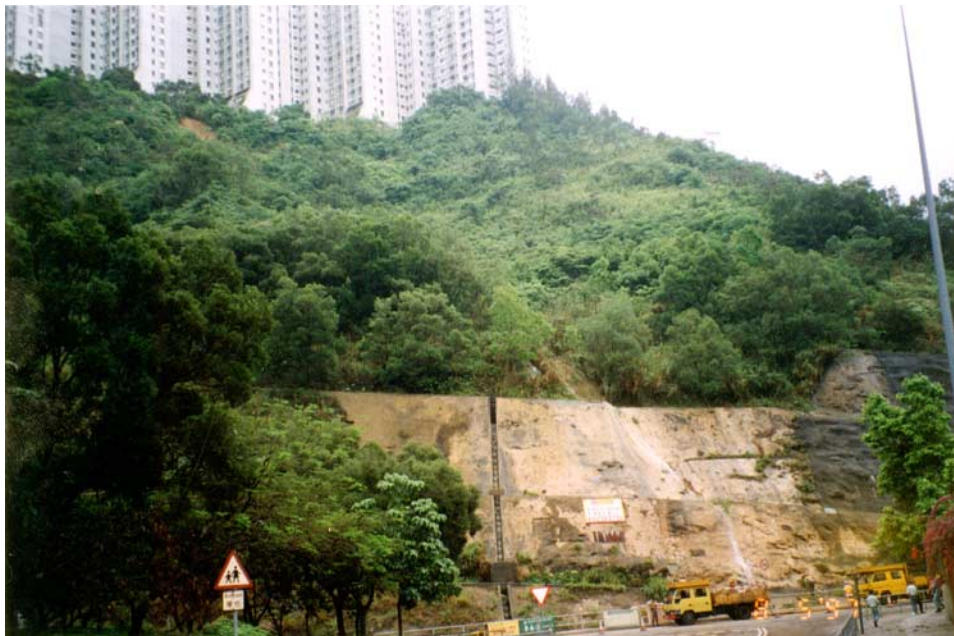
Plates 8 & 9 - Behind Blocks 3 and 4 Wonderland Villas, Kwai Chung (Incident MW 97/5/1)

A major natural slope failure occurred between 10:00 a.m. and 10:30 a.m. on 8 May 1997 at the crest of a natural hillside below Wonderland Villas, Kwai Chung. The landslide scar was about 16.5 m long and 8 m wide, with an average depth of less than 1 m and a maximum depth of 1.5 m. The landslide debris entered a drainage line, in which it was washed downstream over a roadside cut slope (No. 11NW-A/C33) and onto Wah King Hill Road. The estimated failure volume was about 80 m³. Landslide debris travelled about 200 m downslope onto Wah King Hill Road and partly blocked the southbound lane. The failure caused superficial damage to a roadside cut slope (No. 11NW-A/C33) and disruption to traffic on Wah King Hill Road.

This landslide was probably triggered by intense short duration rainfall immediately before the failure. The probable cause of the failure was the build up of a transient water table above a less weathered zone at the base of the detachment scar.

Description : A natural slope failure behind Wonderland Villas.

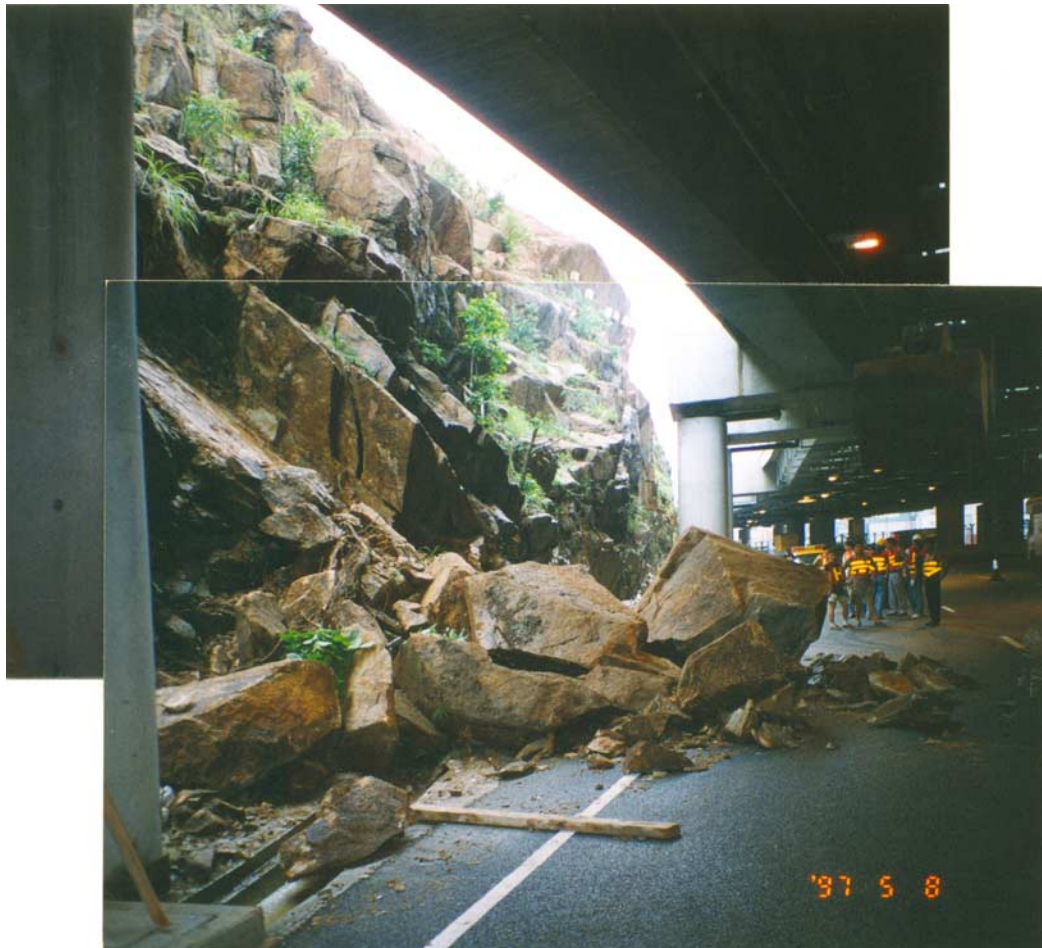
Plate 10 - Opposite to Container Terminal No. 2, Kwai Chung
(Incident MW 97/5/6)

A rockfall failure occurred at 11:00 a.m. on 8 May 1997, and affected the lower rock slope portion of Slope No.11NW-A/C79 adjacent to Kwai Chung Road. The base of the failure was about 1 m above the road level. The failure was 5 m long, 3 m wide and 1.5 m deep with an estimated volume of about 23 m³. The debris comprised several large angular blocks and numerous small angular blocks and boulders. The debris was deposited on the verge and partially blocked the inside lane of the Kowloon-bound carriageway of Kwai Chung Road.

The failure was probably triggered by the infiltration of water during severe rainstorms into the rock slope via high-angle discontinuities, with resulting development of critical water pressures that destabilized the rock mass.

Description : A rock fall failure which resulted in the blockage of one lane of Kwai Chung Road at the underpass of Kwai Chung Viaduct.

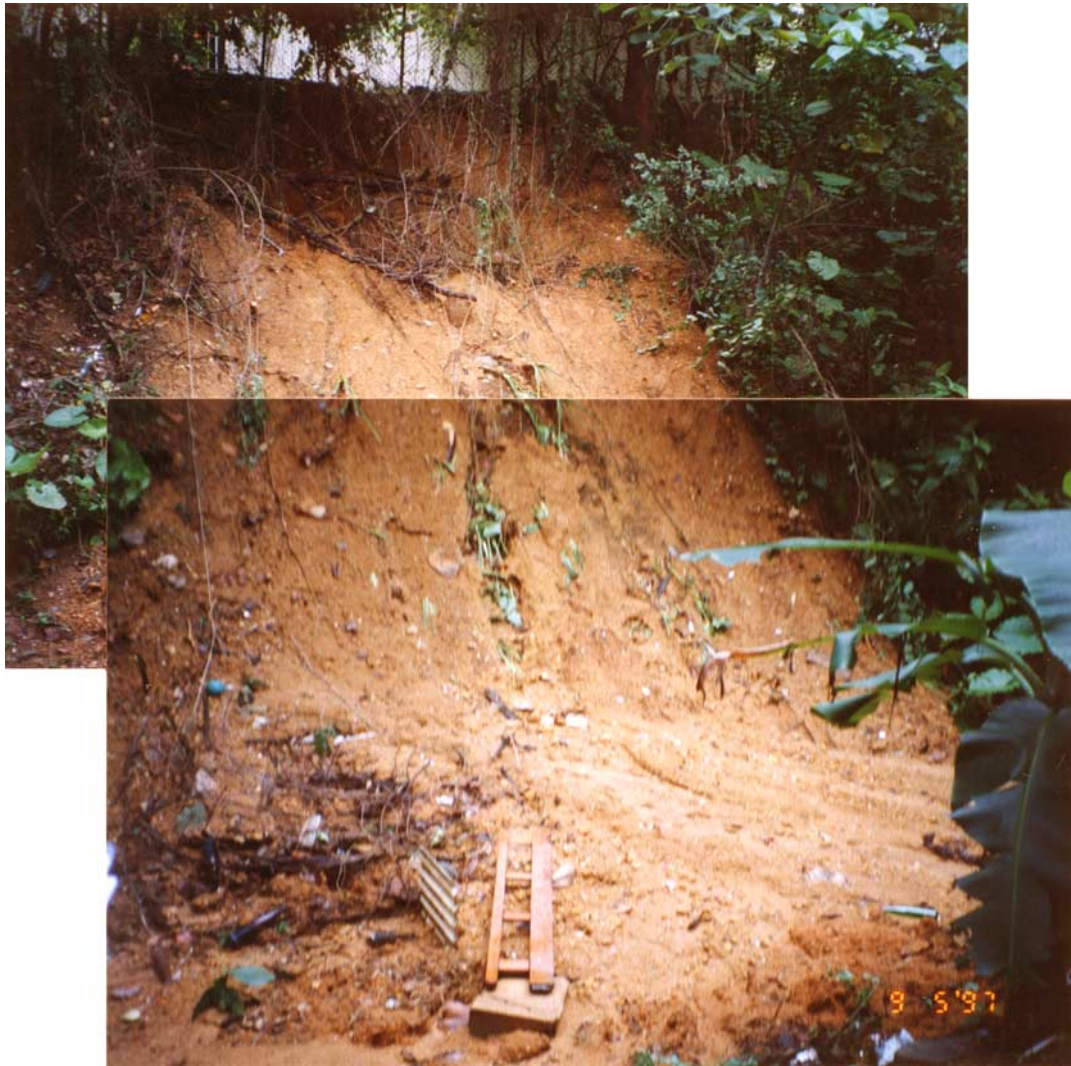
Plate 11 - Glorious Praise Christian Centre, Kwai Chung
(Incident MW 97/5/18)

A fill slope failure was reported at 10:00 a.m. on 8 May 1997 on a slope between Kwai Chung Public School (KCPS) and the Glorious Praise Christian Centre (GPCC), Kwok Shui Road, Kwai Chung. The failure was up to 5.8 m long, 4.9 m wide and 0.8 m deep. The failure volume was about 20 m³. Debris from the landslide accumulated at the toe of the slope adjacent to the GPCC. The landslide also undermined part of a fill platform of KCPS at the crest of the slope.

The failure was probably triggered by intense short duration rainfall causing stormwater infiltration at the crest of the slope and runoff from the edge of the platform onto the unsurfaced slope below, due to the partial blockage of a U-channel and a discharge point above the crest of the slope.

Description : A fill slope failure which undermined part of a fill platform
of Kwai Chung Public School at crest of slope.

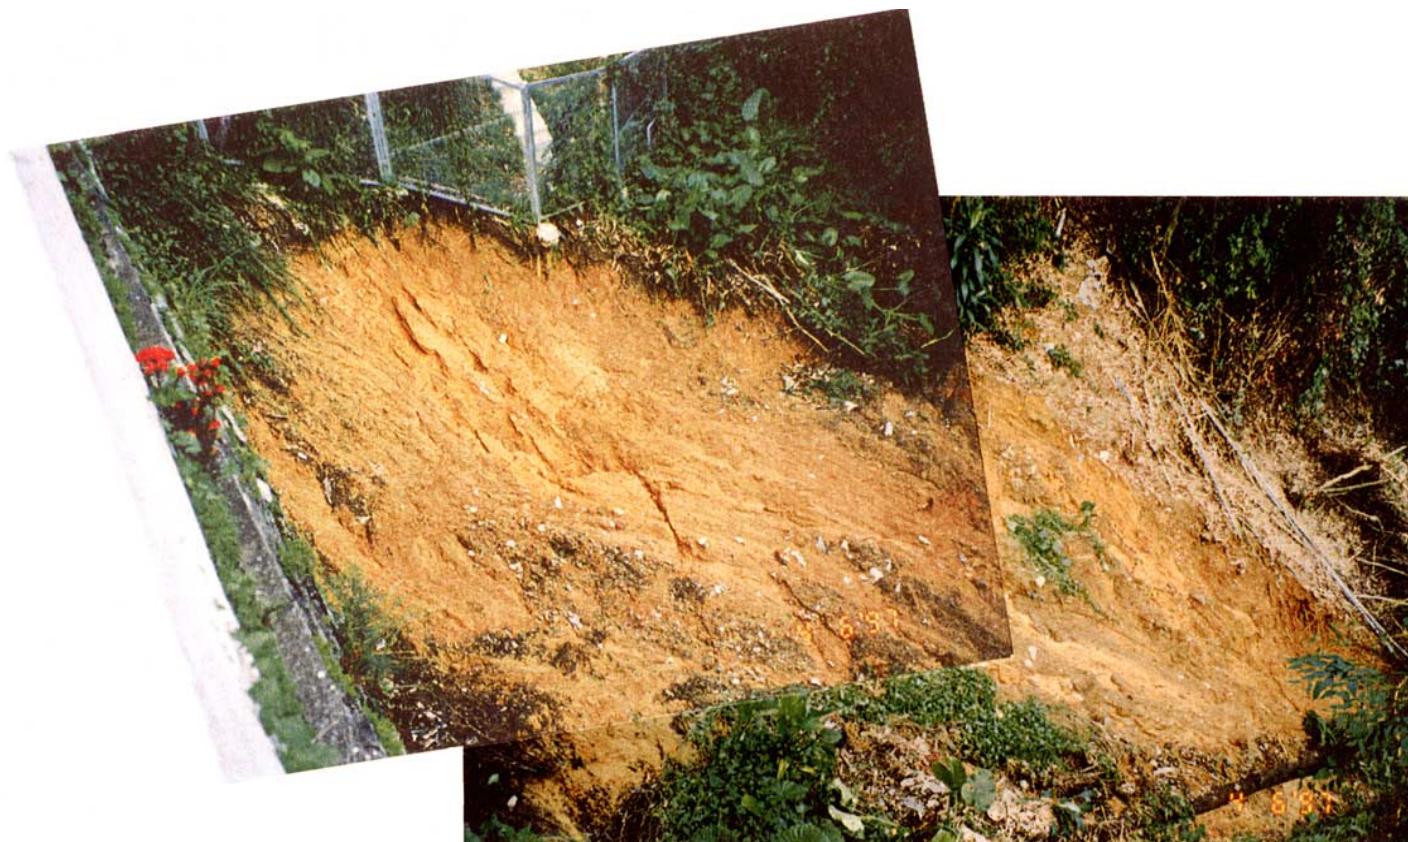
Plate 12 - 19-23 Sha Tin Heights Road, Sha Tin (Incident MW 97/6/12)

heavily-vegetated hillside to the south of Sha Tin Heights Road, Sha Tin. The landslide occurred below the western block of Happy View House (No.21 Sha Tin Heights Road) near the crest of the hillside. The main scarp was about 20 m long and 15 m wide, with an average depth of about 1.5 m. The volume of failed materials was estimated to be about 150 m³. The travel angle of the landslide debris, measured from the crest of the failure to the distal end of the debris, was about 28°. Debris from the landslide travelled down a natural gully line and inundated the garden area of No.9 Woodcrest Hill at the mouth of the gully. Considerable signs of distress were observed immediately upslope of the retaining wall (No.7SW-DR2), together with a tilted guardhouse and cracks in the adjacent hardstanding area and within a wall around Albert Villa.

The landslide was probably caused primarily by infiltration of intense rainfall immediately before the landslide, together with possible prolonged leakage from the drainage channels in the area.

Description : Looking northeast across the main scarp of a major natural terrain landslide.

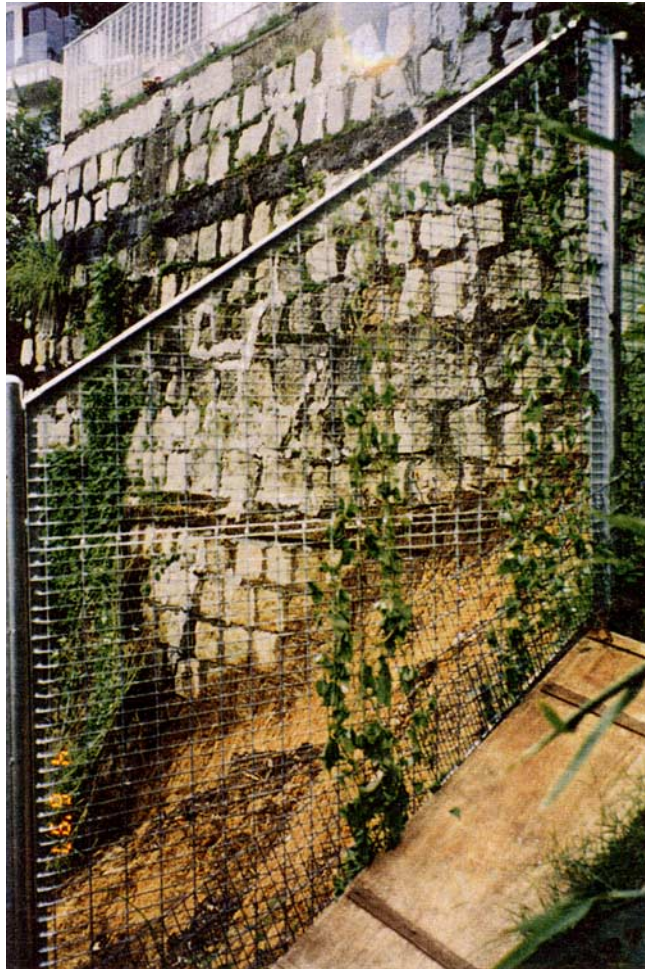
Plate 13 - 19-23 Sha Tin Heights Road, Sha Tin
(Incident MW 97/6/12)

Description : Signs of distress on the retaining wall.

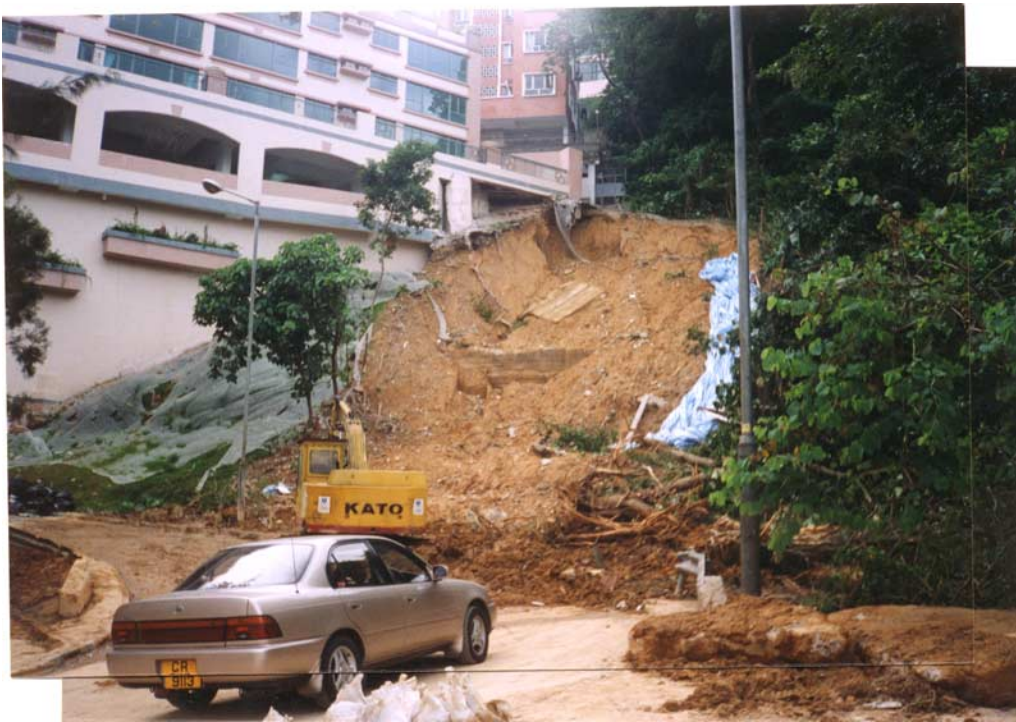
Plate 14 - Chung Shan Terrace , Lai King Hill Road, Kwai Chung
(Incident MW 97/6/15)

A major fill slope failure occurred at 7:15 a.m. on 4 June 1997 at Chung Shan Terrace, Kwai Chung. The incident involved the failure of an unregistered fill body and resulted in the collapse of a buried retaining wall. The landslide was 15 m long, 18 m wide and an average of 3 m deep. The estimated volume of landslide debris was 450 m³. The height of the main scarp varied from about 2 m in its eastern part adjacent to a U-channel, to about 4 m in the northern corner where a podium of the Green Regency development was slightly undermined. The travel angle of the landslide was 18° as measured from the crest to the distal end of the debris. The landslide ran out about 45 m from the toe of the slope, mostly over the gently inclined and lower part of the Chung Shan Terrace access road. Landslide debris from the landslide completely blocked Lai King Hill road and an access road to Chung Shan Terrace. A car travelling on the access road was carried by the landslide debris to the far side of Lai King Hill Road.

The landslide at Chung Shan Terrace was probably triggered by the intense rainfall immediately before the failure. Probable contributory factors include: (a) the loose nature of the fill which was susceptible to collapse and liquefaction, (b) leakage of a combined stormwater and foulwater drainage system at Crawford Court, (c) the absence of surface protection to the fill which allowed infiltration, and (d) the existence of a buried retaining wall which restricted water flow.

Description : A major fill slope failure which resulted in the collapse of a buried retaining wall, blocking of Lai King Hill Road and an access road to Chung Shan Terrace.

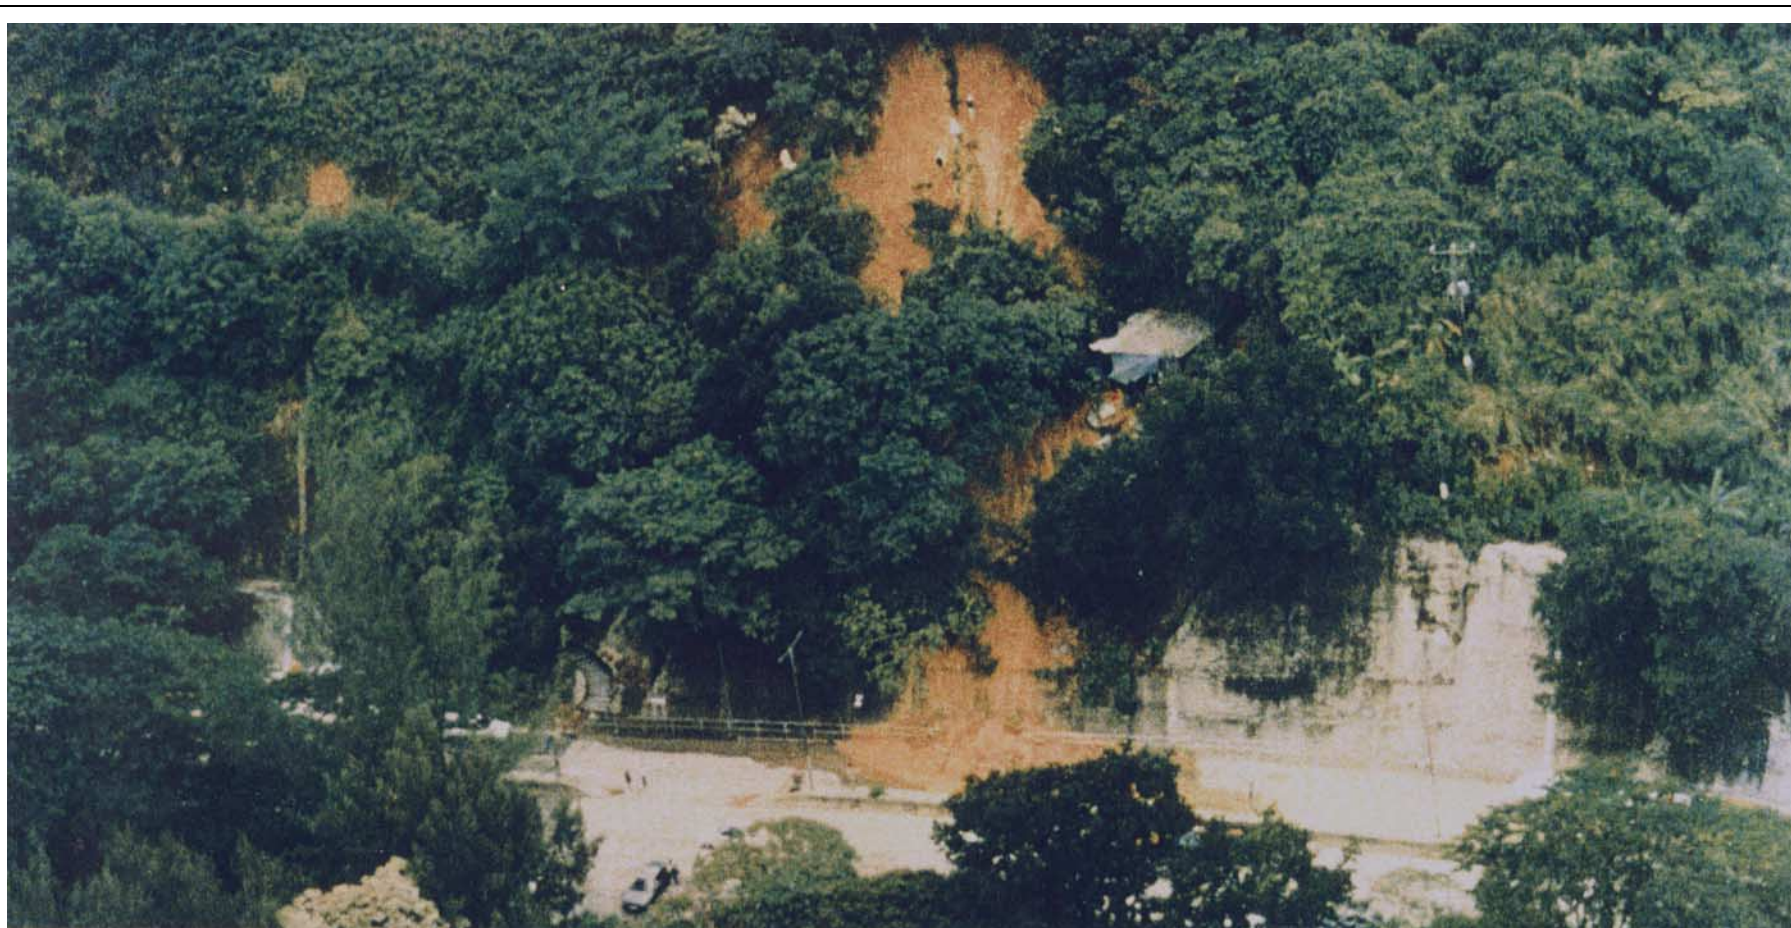
Plate 15 - Hut No. 26 Kau Wa Keng Upper Village, New Territories (Incident MW 97/6/16)

The main part of the northern landslide involved Slope No.11NW-A/C416 and a significant portion of the hillside above. A subsidiary part of the northern landslide affected the southern end of Slope No.11NW-A/C415. The landslide released an estimated 360 m³ of landslide debris. About 280 m³ originated from the main scar which was about 10 m long and 12 m wide. The remaining debris came from the subsidiary scar, about 5 m long and 8 m wide. The average vertical depth of the failure was about 2 m to 2.5 m. The travel angle of the landslide debris was about 30°. The northern landslide resulted in one fatality, five injuries and damage to a squatter hut. Some debris from this landslide was washed downslope and blocked two lanes of Castle Peak Road. The southeastern landslide occurred on the same cut slope (Slope No.11NW-A/C416) and involved about 25 m³ of debris over a scar width of 6 m. Significant seepage was observed over the slip surface within the northern part of the main scar. The southeastern landslide occurred closer to the damaged squatter hut and also damaged two ancillary structures.

These landslides were probably caused by an increase in groundwater pressure in the weathered granite hillside following very heavy rainfall, coupled with adverse hydrogeological conditions.

Description : An aerial view of a major soil cut slope failure resulting in one fatality, five injuries, damaged to a squatter hut and the blockage of a footpath and two lanes of Castle Peak Road.

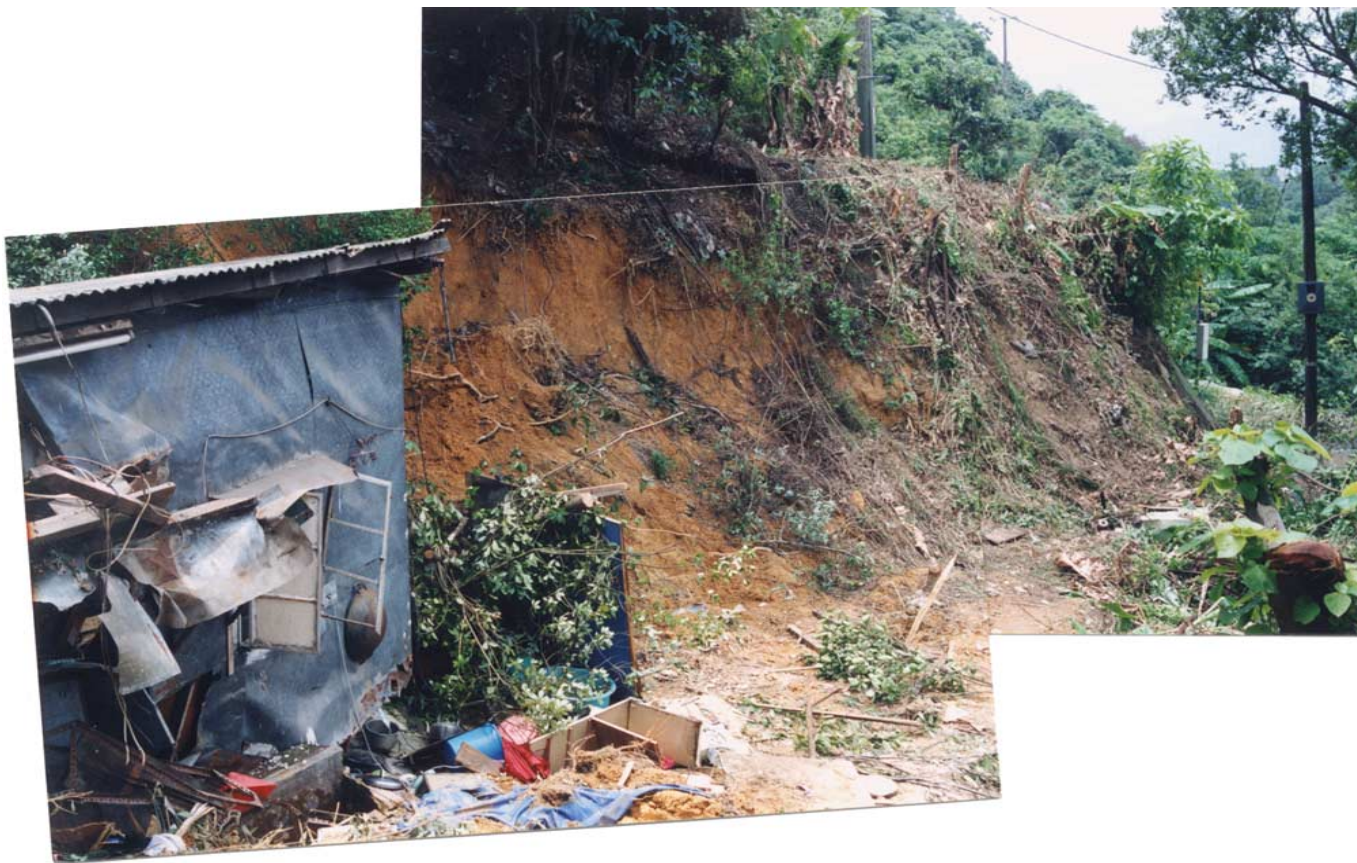
Plate 16 - Hut No. 26 Kau Wa Keng Upper Village, New Territories (Incident MW 97/6/16)

Description : A close view of a squatter hut damaged by the northern landslide.

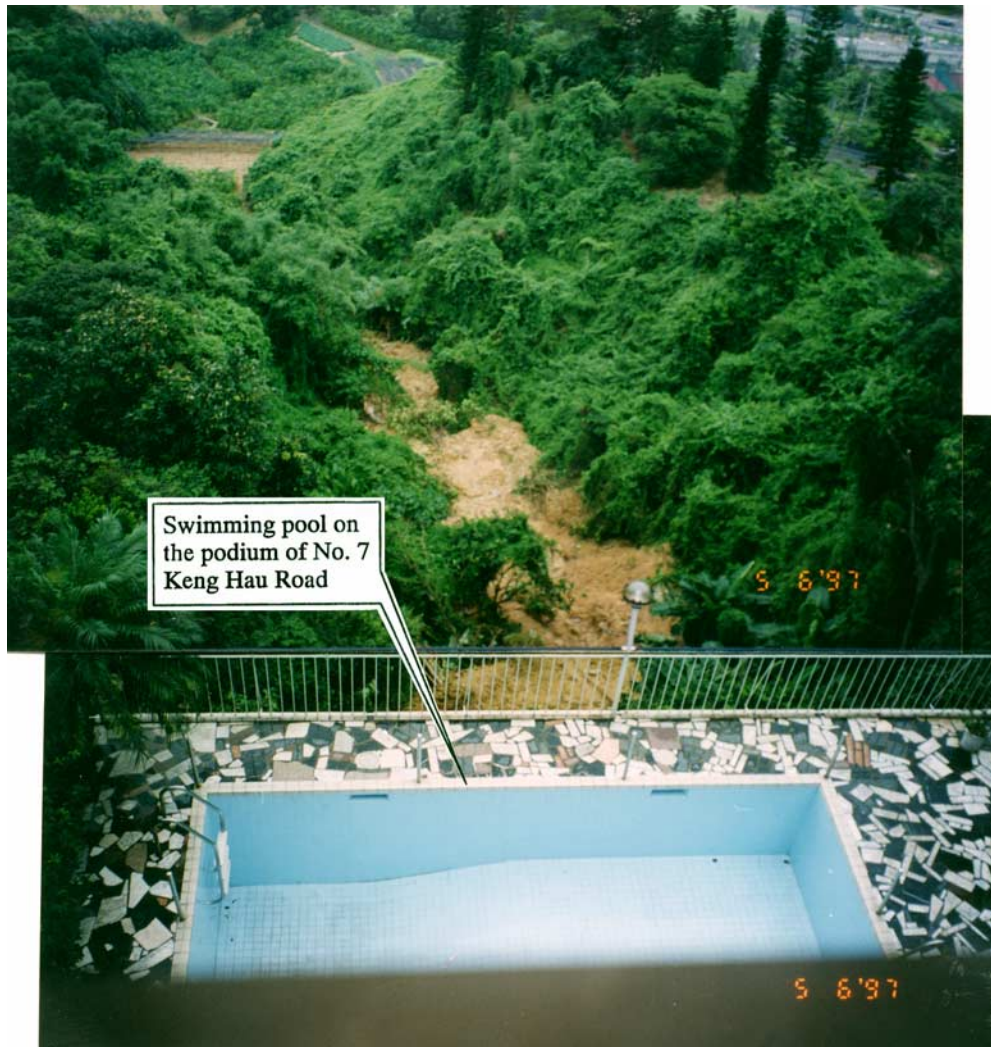
Plate 17 - No. 7 Keng Hau Road, Sha Tin (Incident MW 97/6/22)

On the morning of 4 June 1997, a major soil cut slope failure (No.7SW-D/C700) occurred immediately to the east of No.7 Keng Hau Road, Sha Tin. The detached failure surface was about 10 m to 12 m wide extending from the original toe of the cut slope to the eastern wall of the building podium. The maximum depth of failure was between 1.5 m and 2 m. The estimated volume of failure was 150 m³. The travel angle of the landslide debris was 19°. Some debris travelled down a natural gully and ran out onto a cultivated low-lying area. The failure resulted in the destruction of part of a terrace garden, and partly undermined the podium of No.7 Keng Hau Road.

infiltration of surface water into the steep soil cut slope and development of high pore water pressures. The poor condition of the slope surface may have been a contributory factor in the failure.

Description : A soil cut slope failure which destroyed a terraced garden area and partly undermined the podium of No. 7 Keng Hau Road.

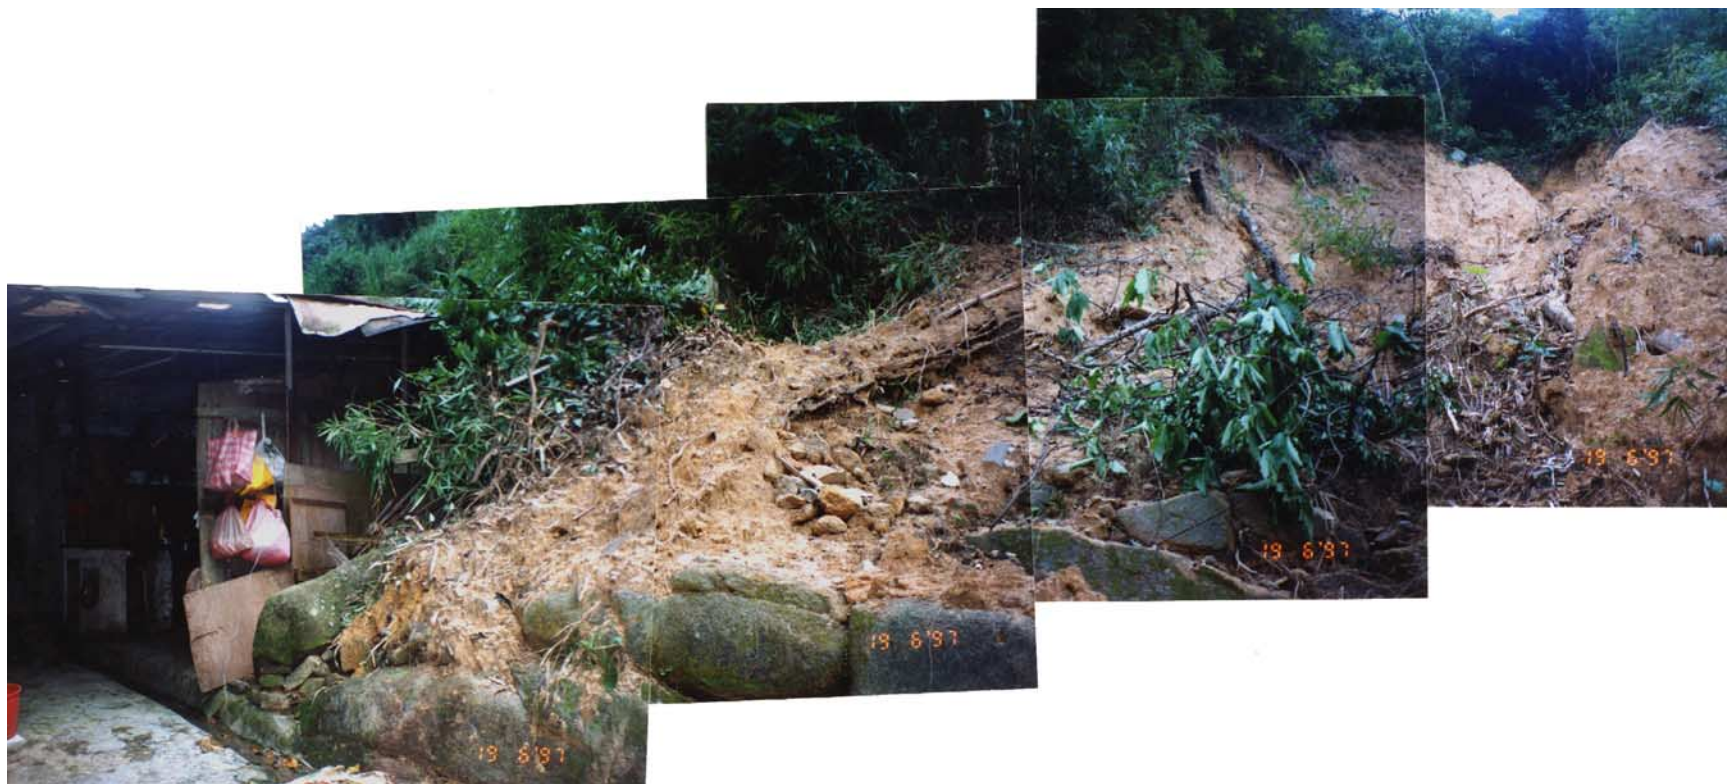
Plate 18 - Kau Wah Keng San Tsuen, Lai Chi Kok (Incident MW 97/6/56)

A major fill slope failure occurred at 7:00 a.m. on 4 June 1997 near No.139C Kau Wah Keng San Tsuen, Lai Chi Kok. Prior to failure, the slope was bare with no vegetation cover. The failure was 35 m long, 11 m wide and 4 m deep. The failure volume was about 500 m³. An initial failure most likely occurred at the front of the fill slope where the gradient was steep, followed by a washout caused by surface water flow from an ephemeral stream. The travel angle of the initial landslide debris was slightly in excess of 30°. The failure resulted in the permanent evacuation of house No.139C.

The landslide was probably triggered by intense short duration rainfall. Probable contributory factors include: (a) the concentrated discharge of surface water, (b) the rapid saturation of soil layers by concentrated infiltration of surface water, (c) ponding of water on a level area in the upper part of the fill slope, and (d) the development of transient groundwater pressures.

Description : A major fill slope failure which resulted in the permanent evacuation of a house.
