HONG KONG RAINFALL AND LANDSLIDES IN 1997

GEO REPORT No. 97

**GEOTECHNICAL ENGINEERING OFFICE
CIVIL ENGINEERING DEPARTMENT
THE GOVERNMENT OF THE HONG KONG
SPECIAL ADMINISTRATIVE REGION**

SECTION 1: HONG KONG RAINFALL AND LANDSLIDES IN 1997

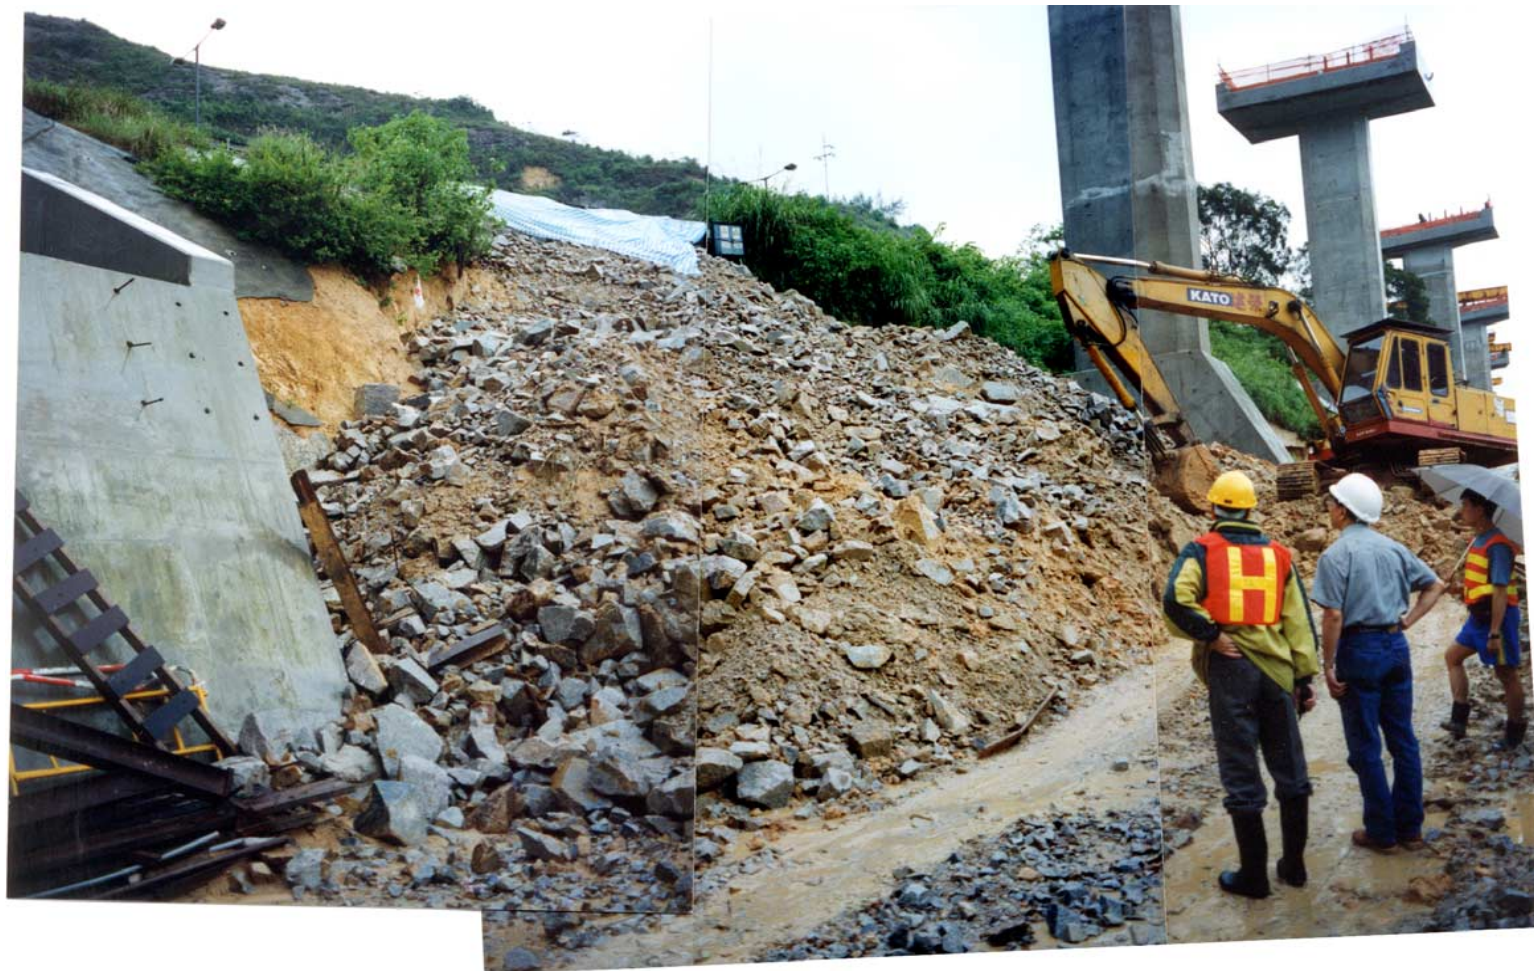
Plate 19 - Tuen Mun Road near Ting Kau (Incident MW 97/7/11)

Description : A major fill slope failure resulting in the blockage of an access road and the closure of two lanes of Tuen Mun Road.

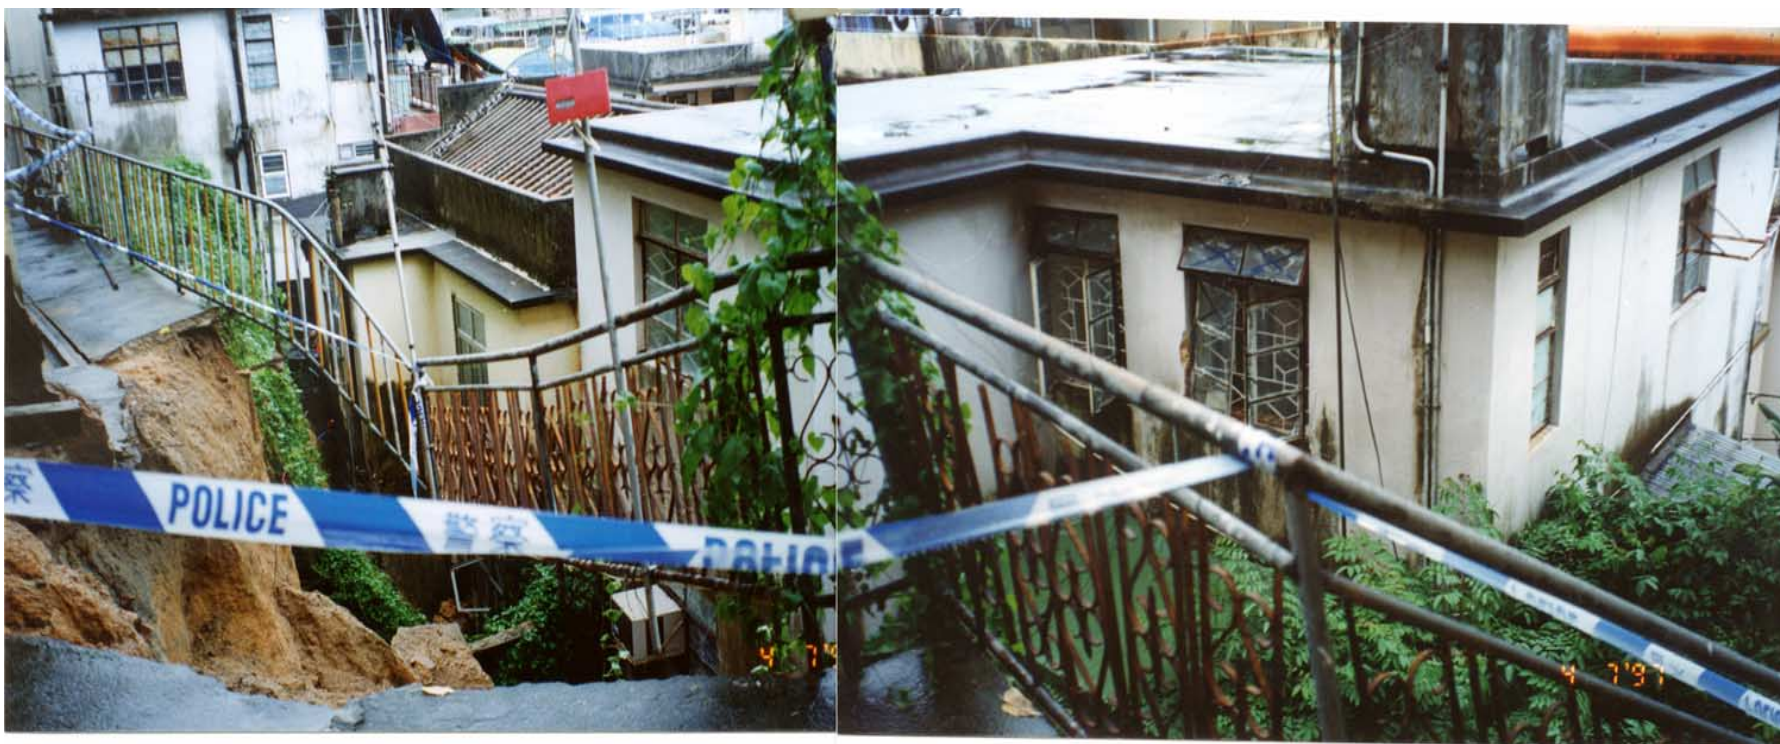
Description : A major soil/rock cut slope failure which resulted in the evacuation of three houses and the closure of a pedestrian footpath.
