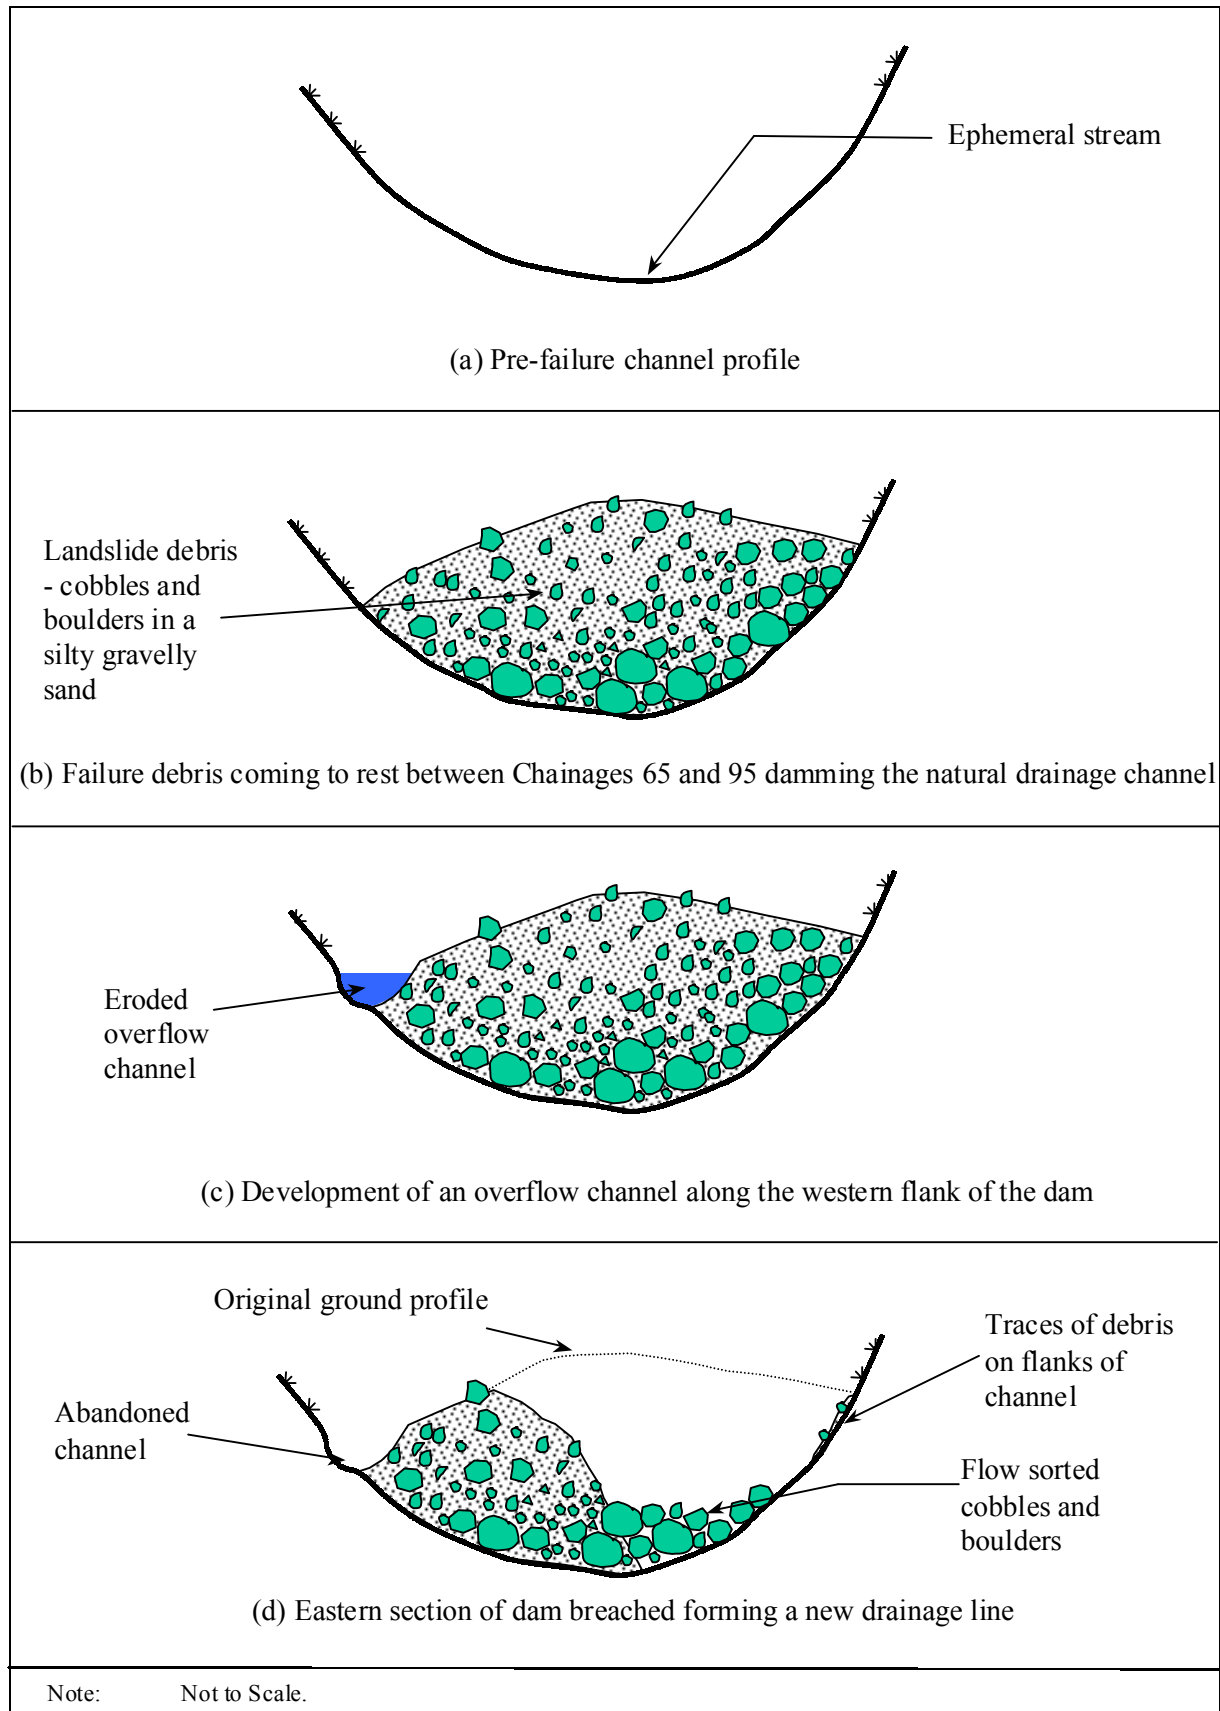
Figure 16 - Schematic Representation Showing the Inferred Development of a Possible Debris Dam located below Landslide B

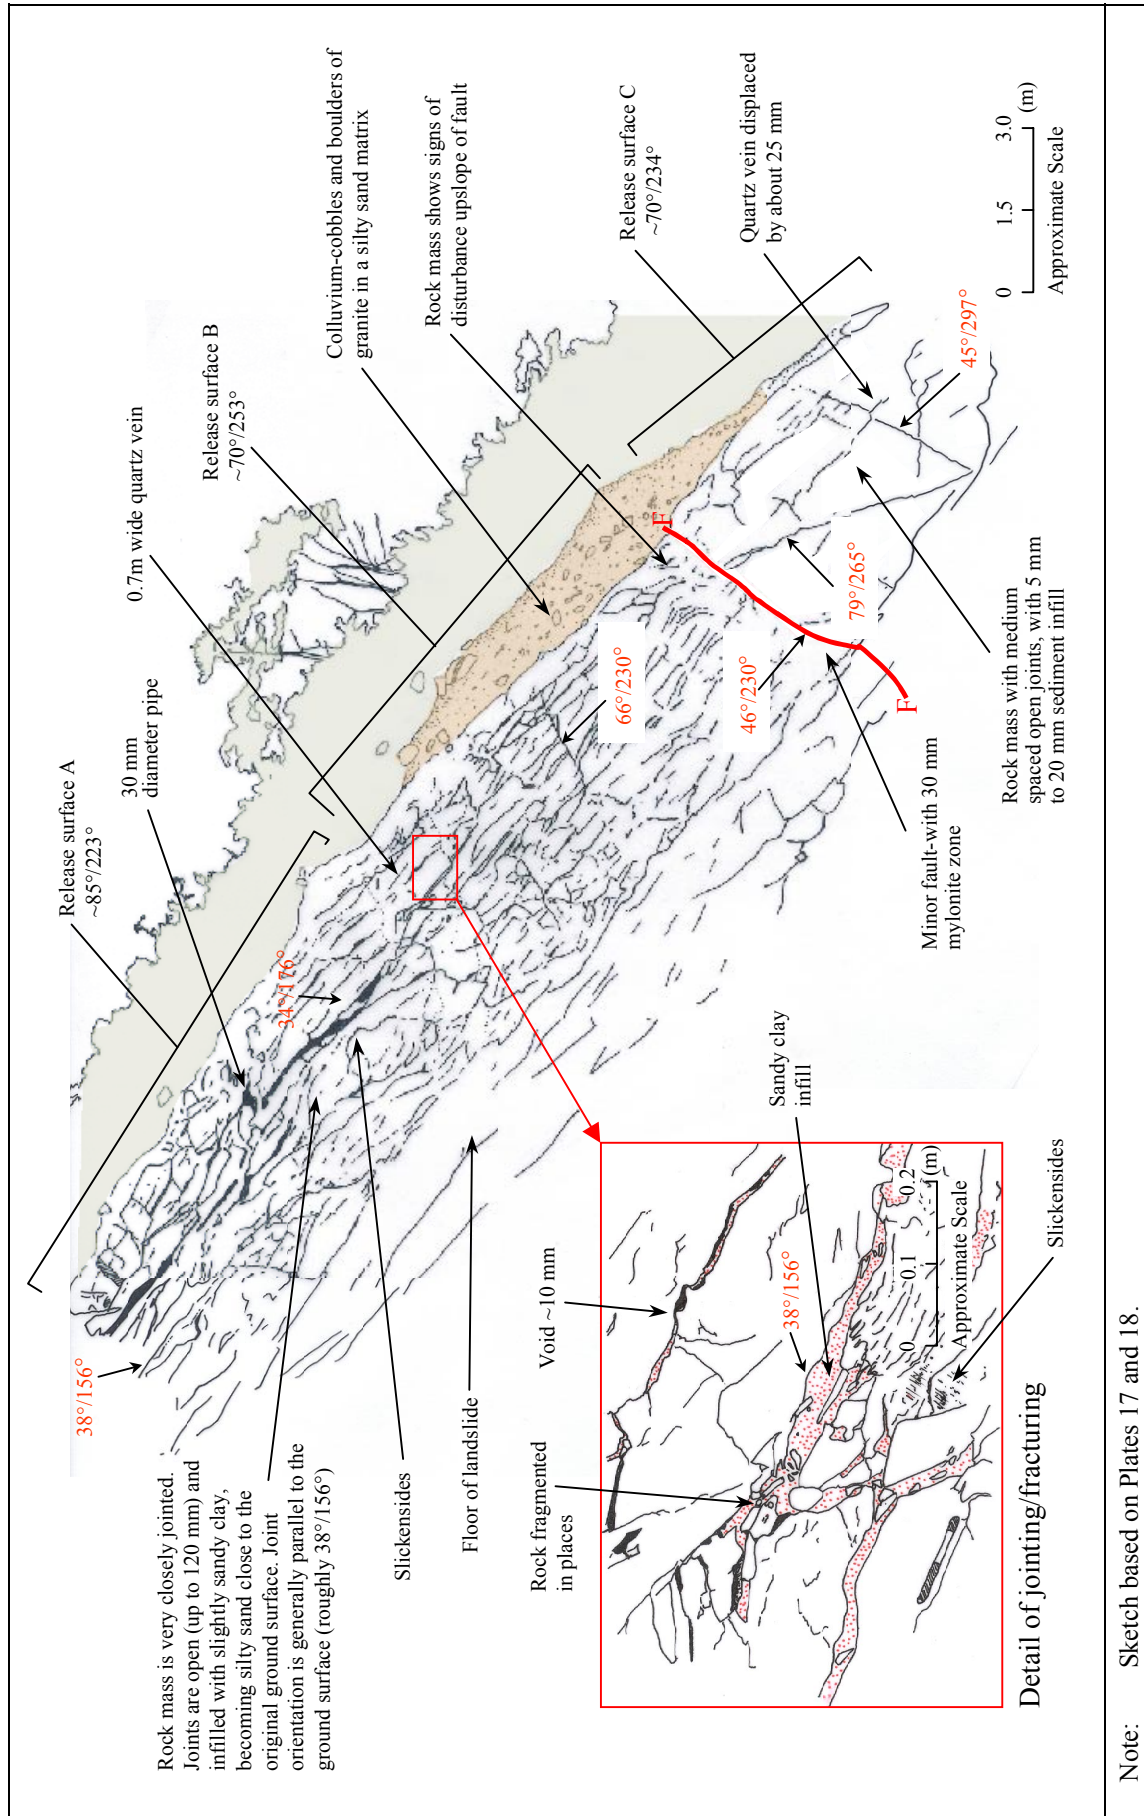
Figure 18 - Sketch of the Eastern Main Scarp

Note: Sketch based on Plates 17 and 18.

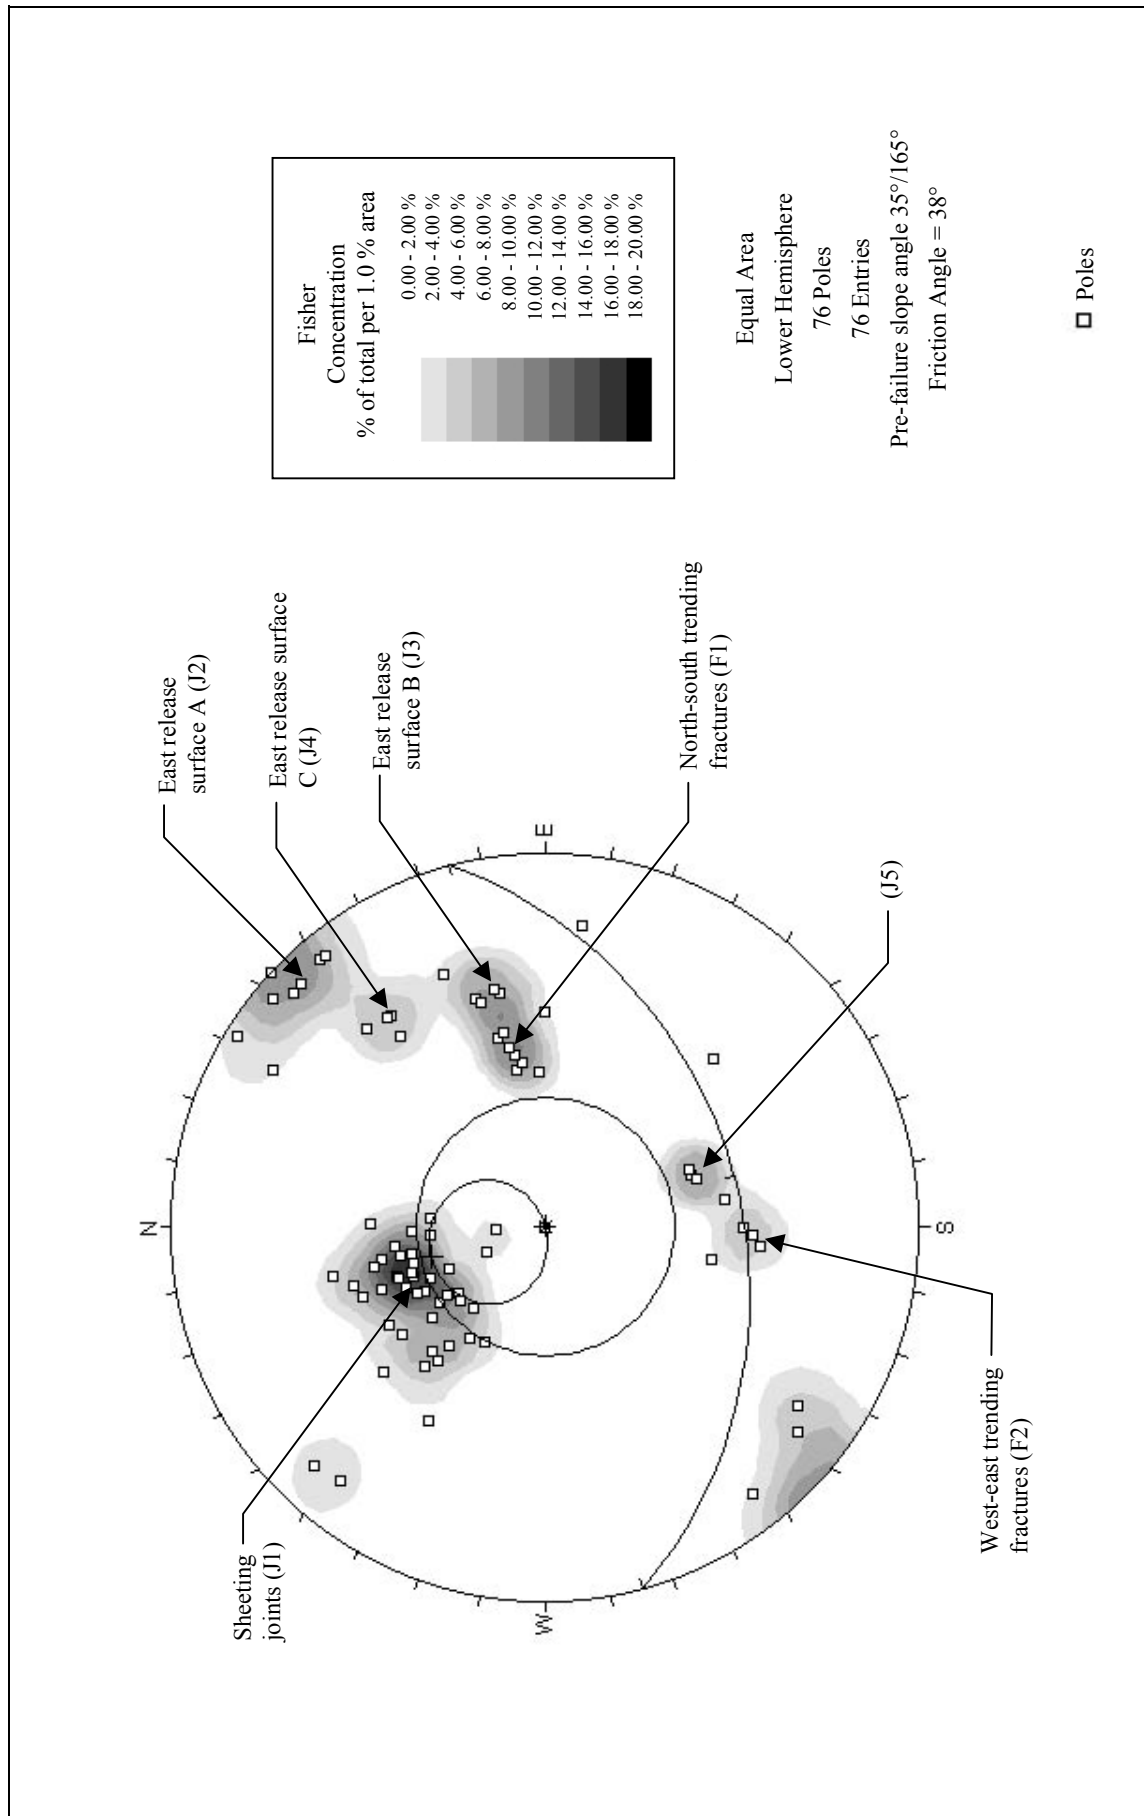
Figure 19 - Stereoplot of the Measured Orientations of Discontinuities at Landslide B

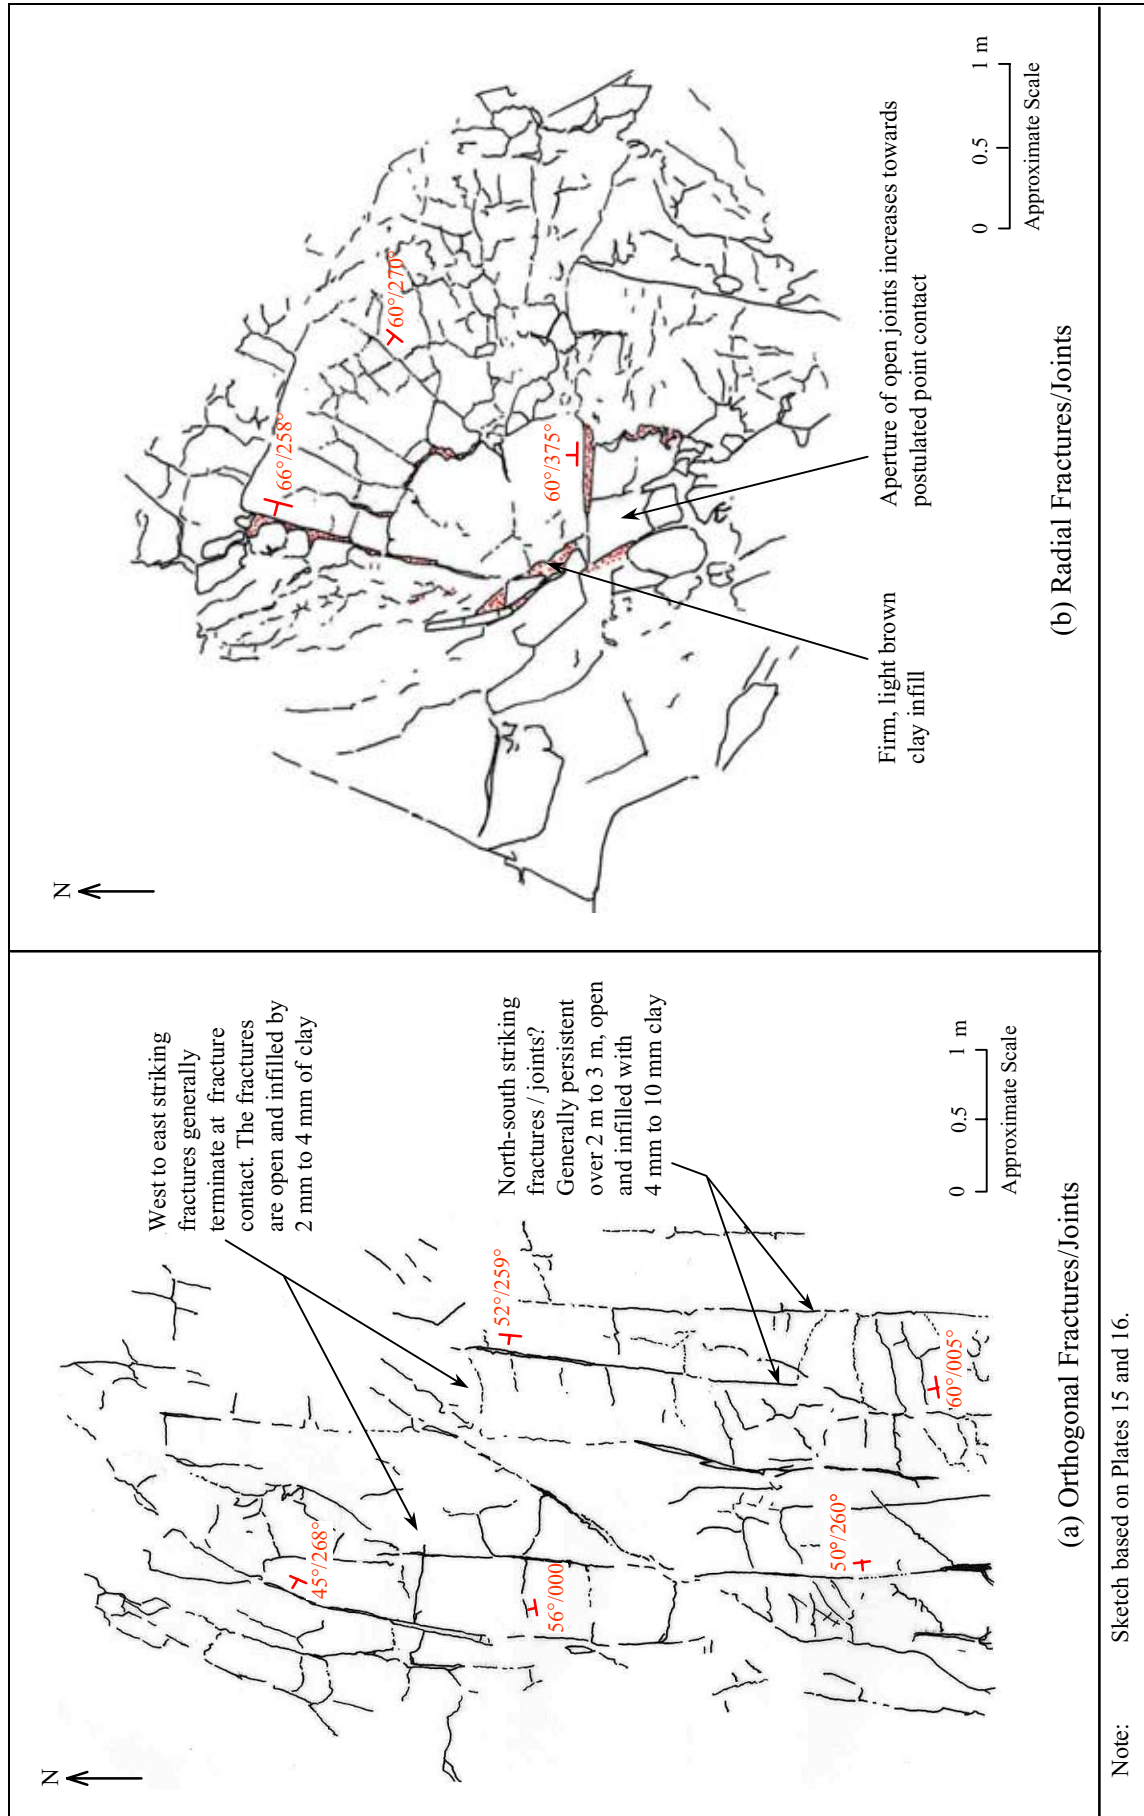
Figure 21 - Sketch Plan of Fractures/Joints on Floor of Landslide B

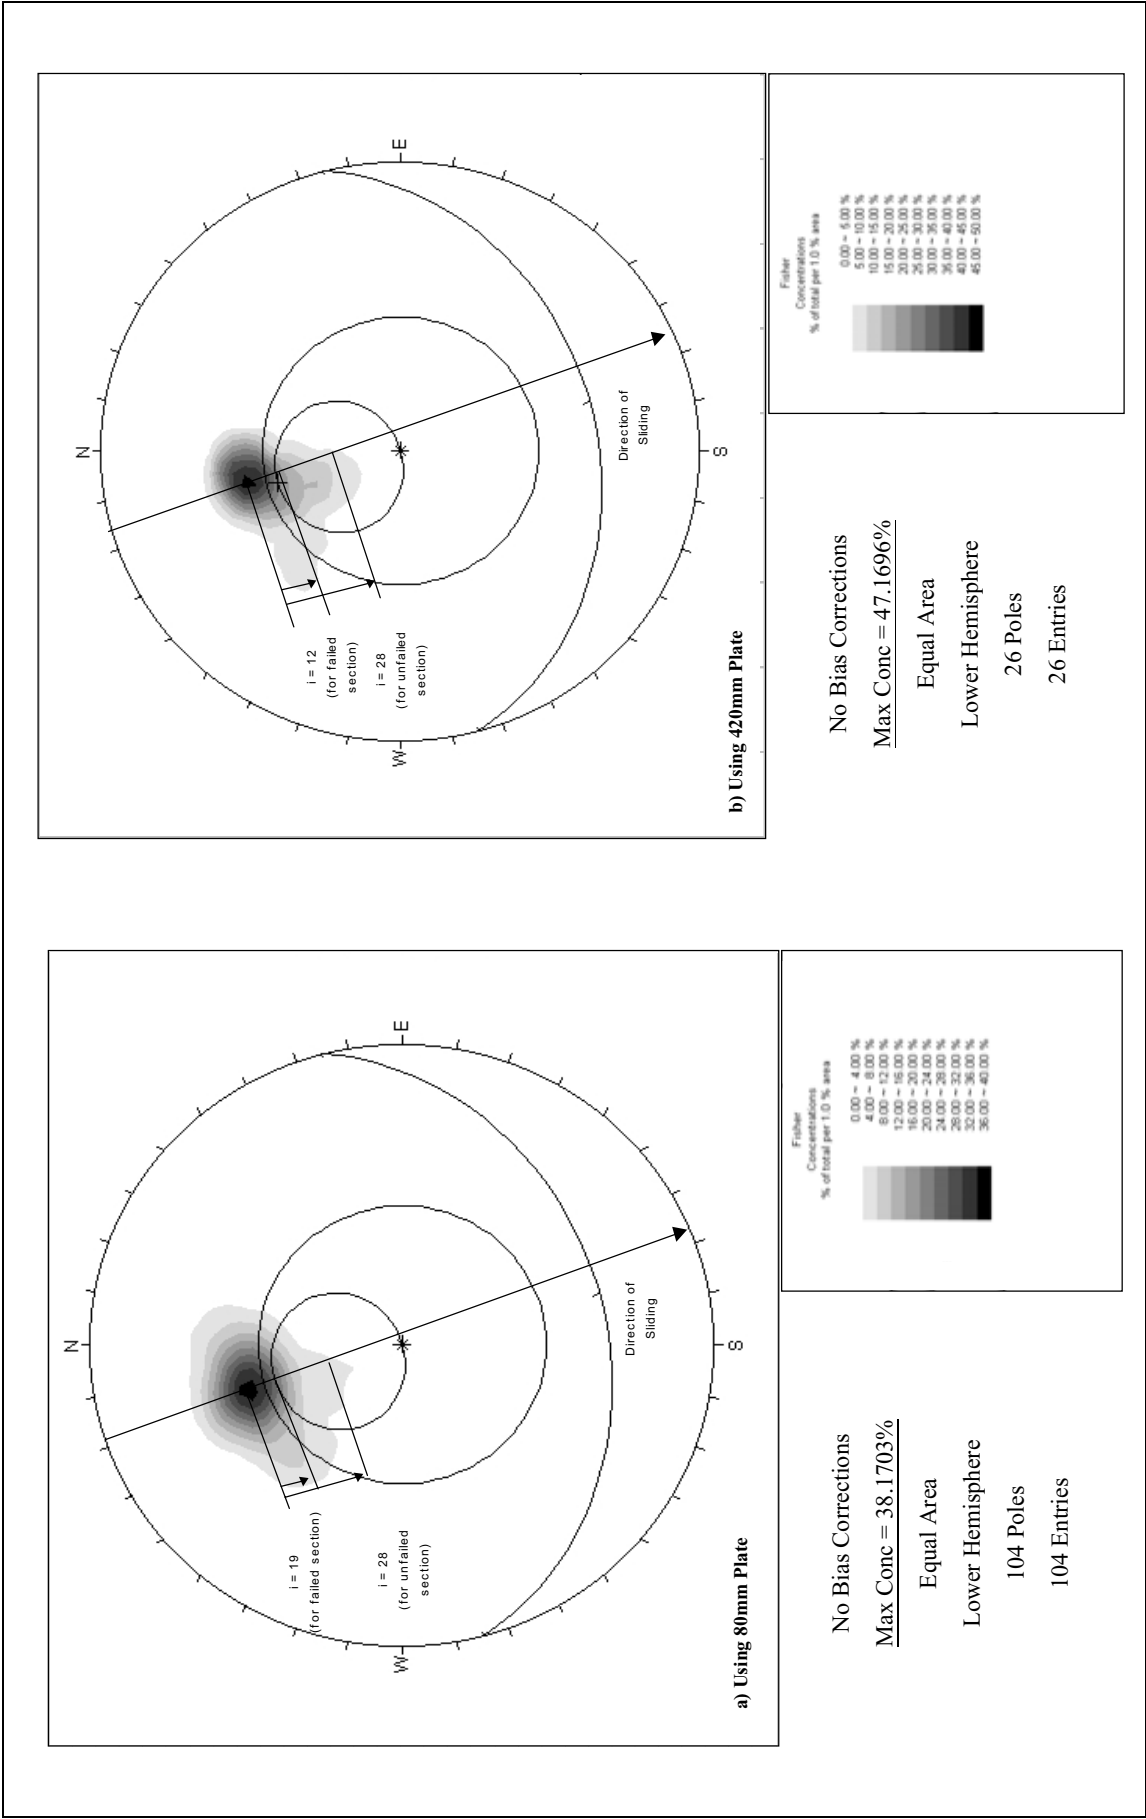
Figure 22 - Stereoplots of Main Release Surface, Landslide B

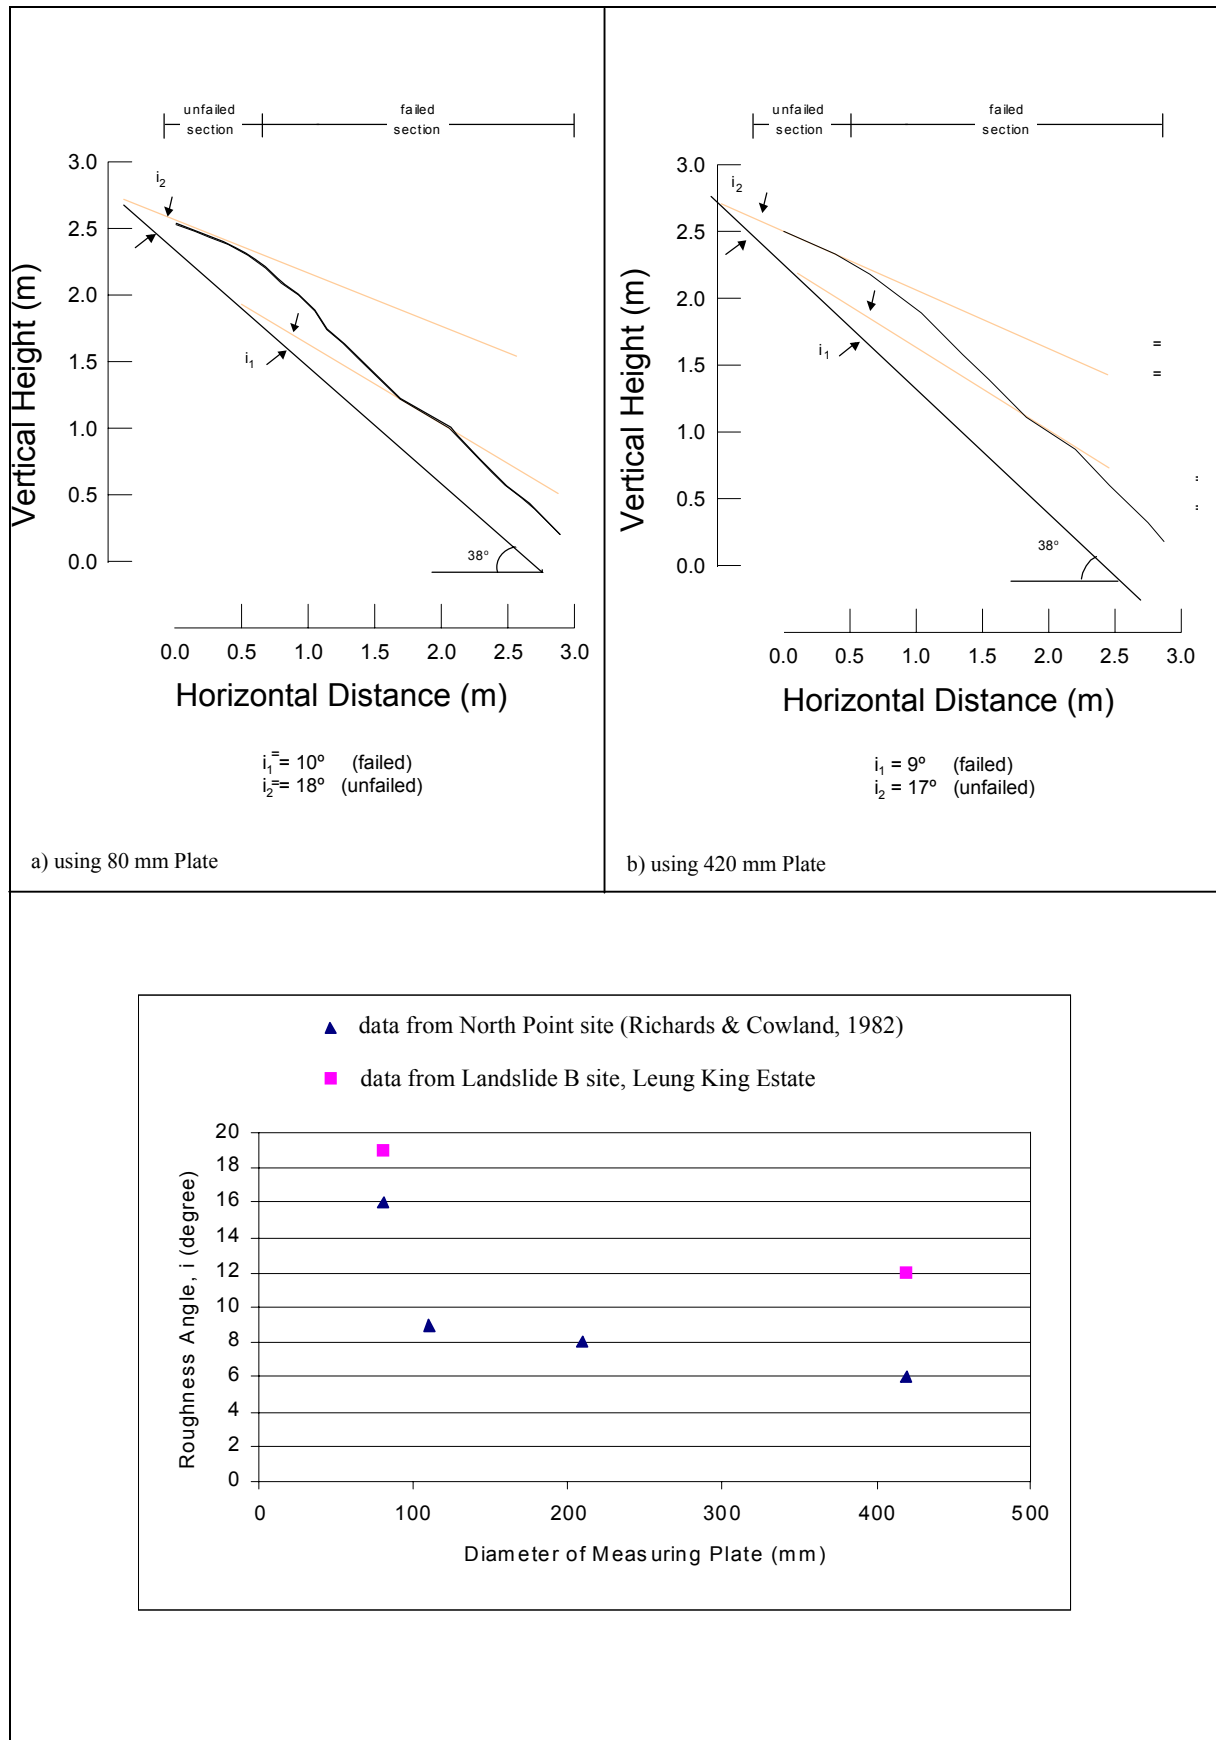
Figure 23 - Profile of Main Release Surface, Landslide B

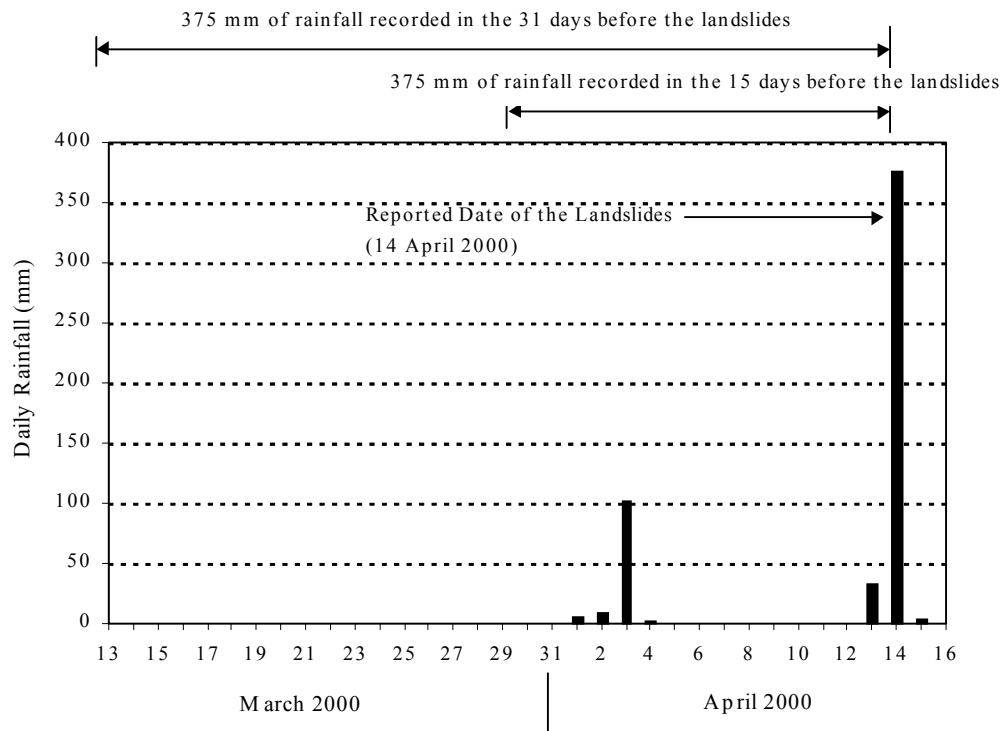
Figure 24 - Rainfall Recorded at GEO Raingauge No. N07

(a) Daily Rainfall Recorded between 13 March and 16 April 2000

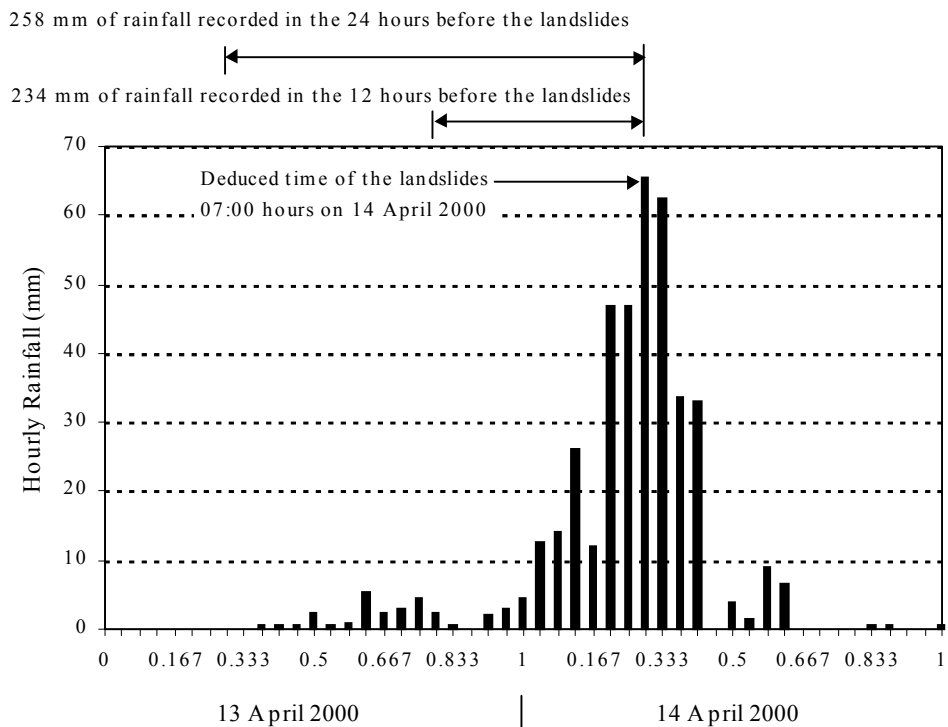
(b) Hourly Rainfall Recorded between 00:00 hour on 13 April and 24:00 hours on 14 April 2000

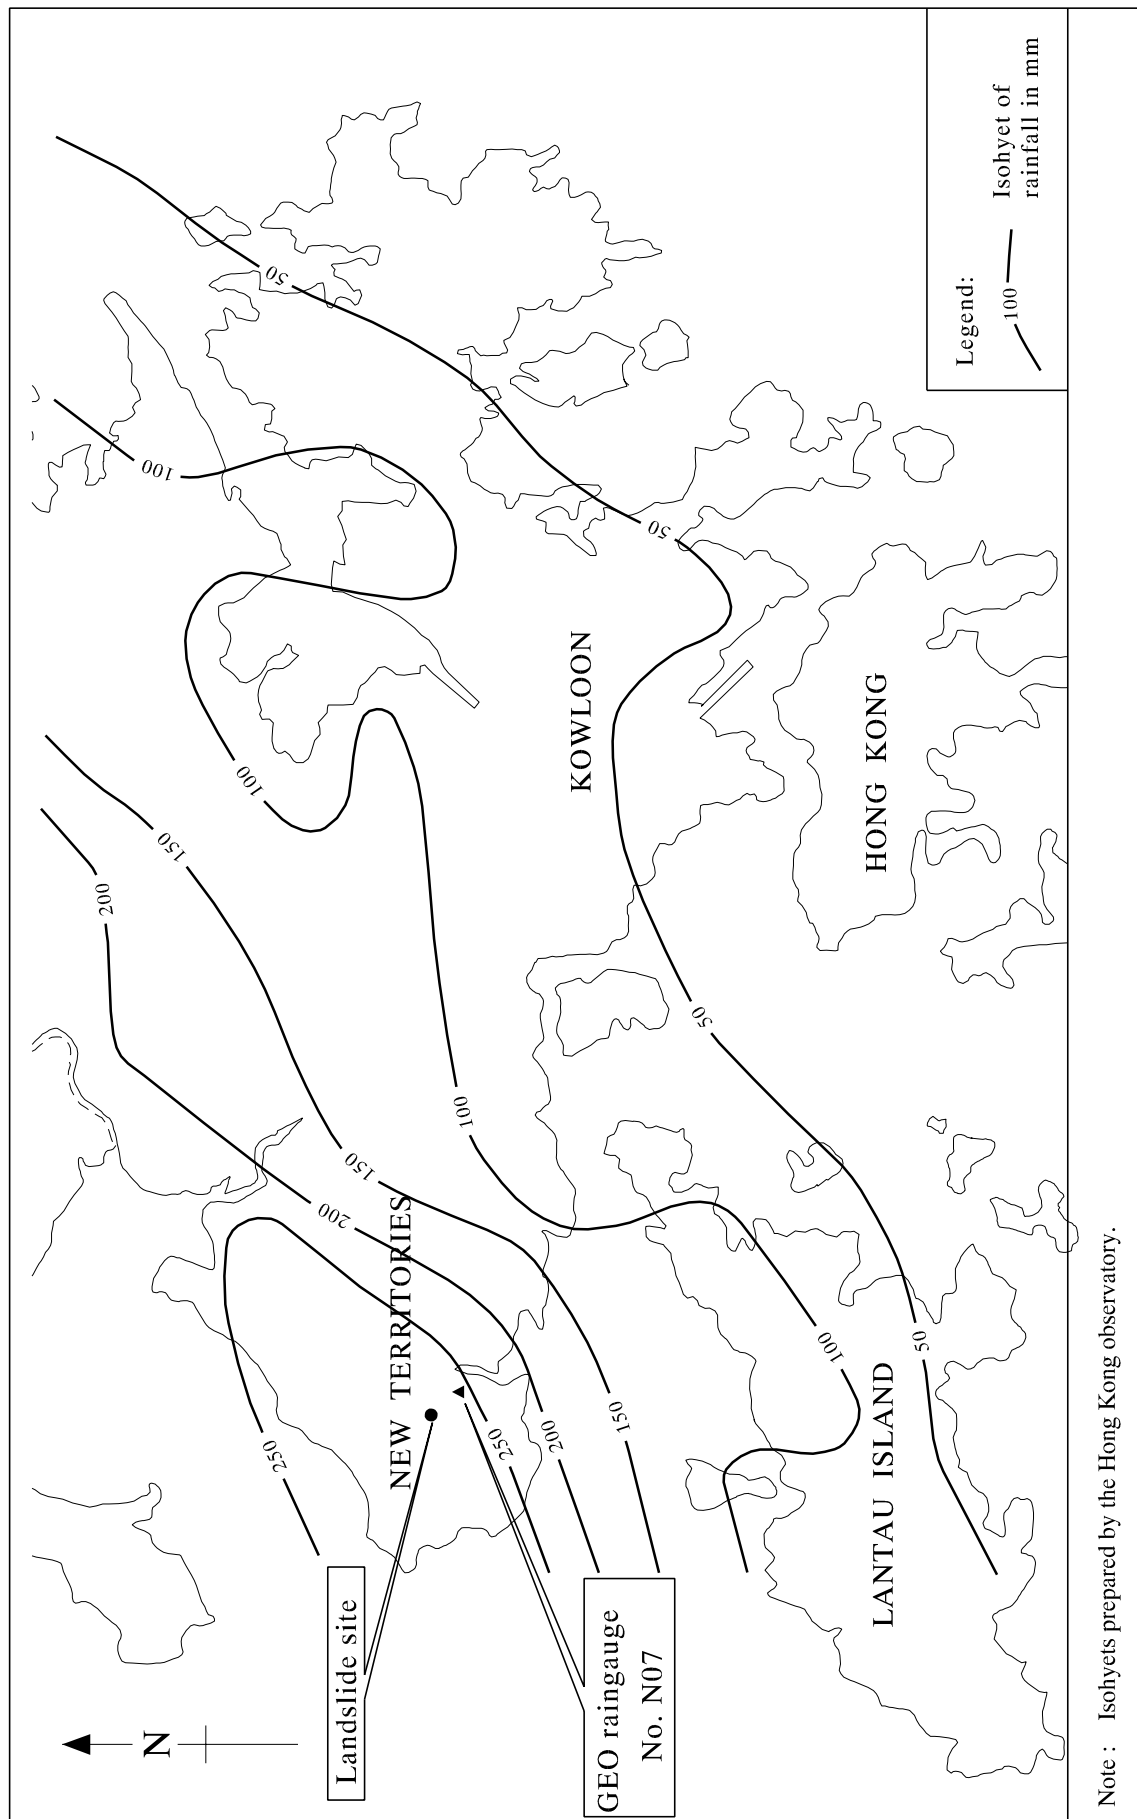
Figure 25 - Rainfall Distribution between 07:00 hours on 13 April and 07:00 hours on 14 April 2000

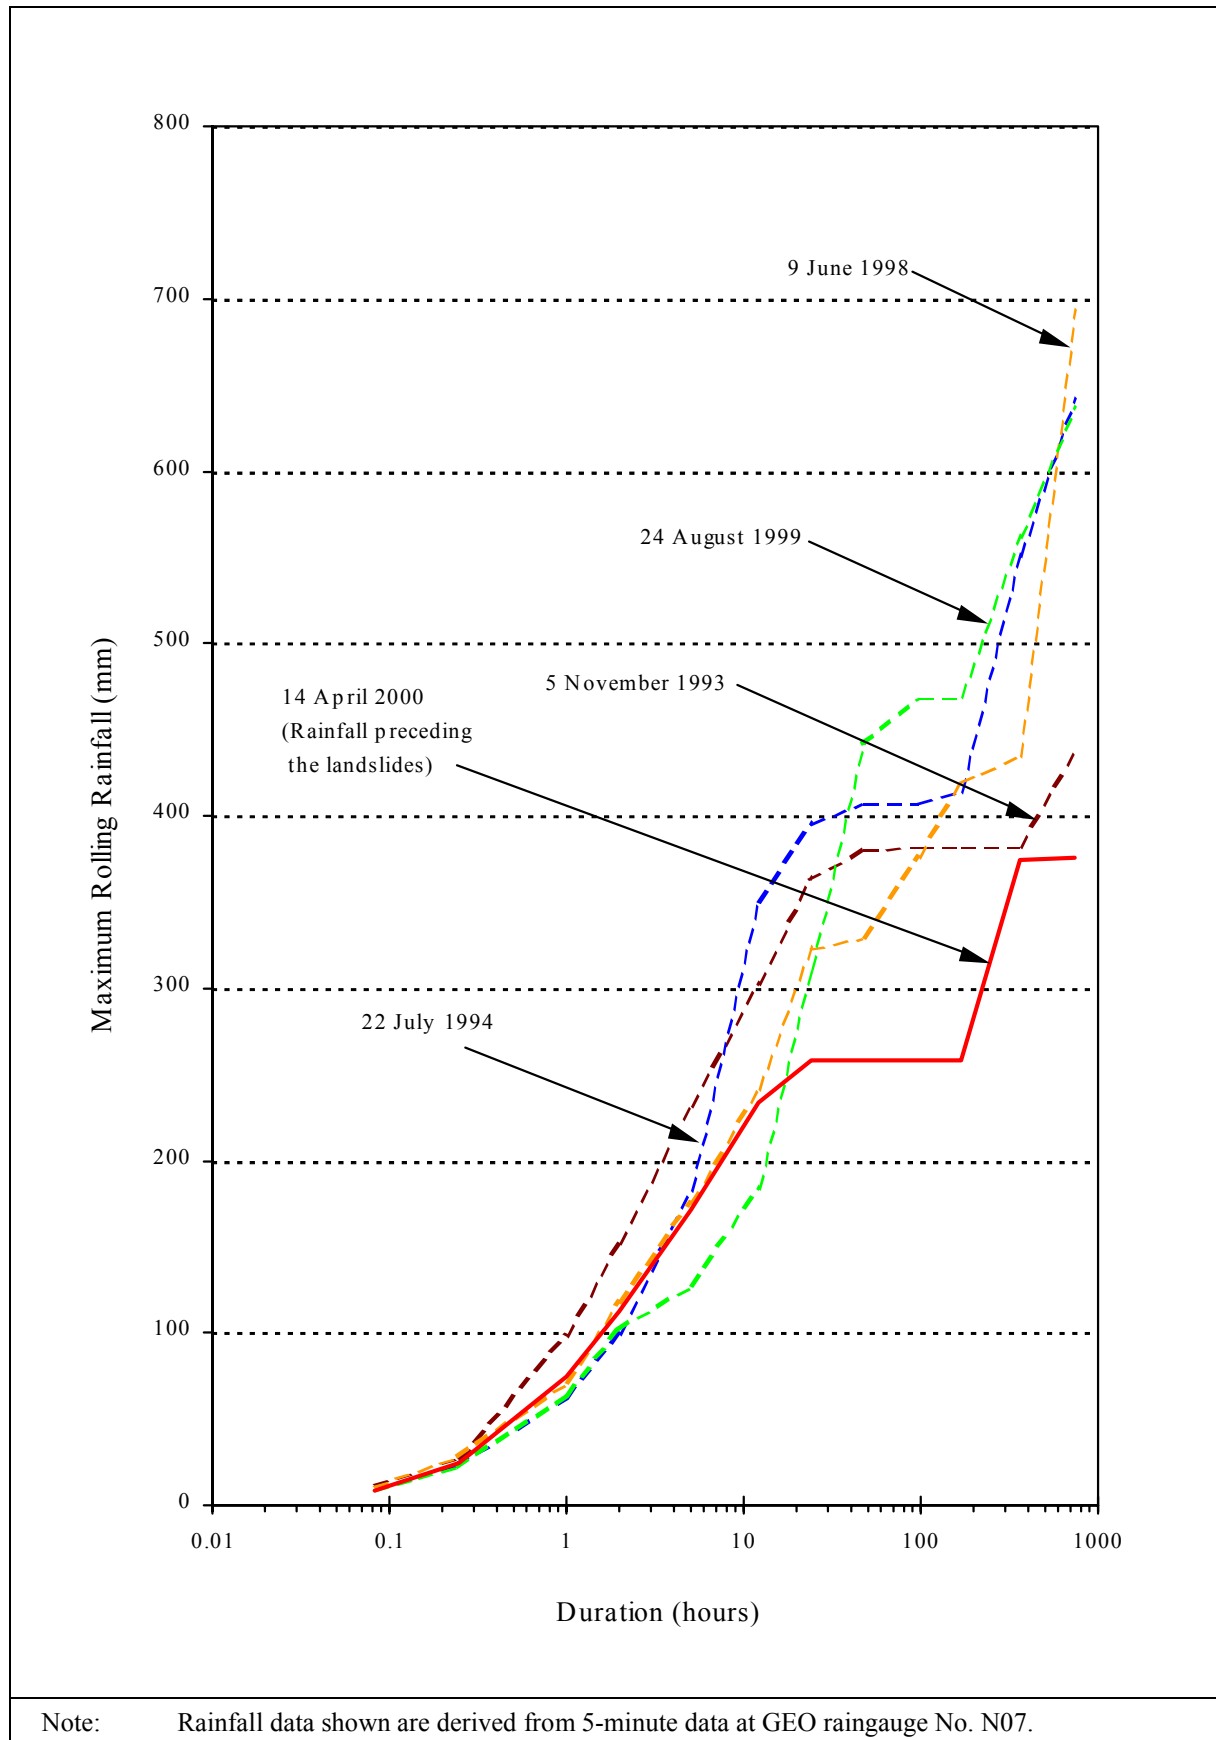
Figure 26 - Maximum Rainfall Preceding the Landslides of 14 April 2000 at Raingauge No. N07
