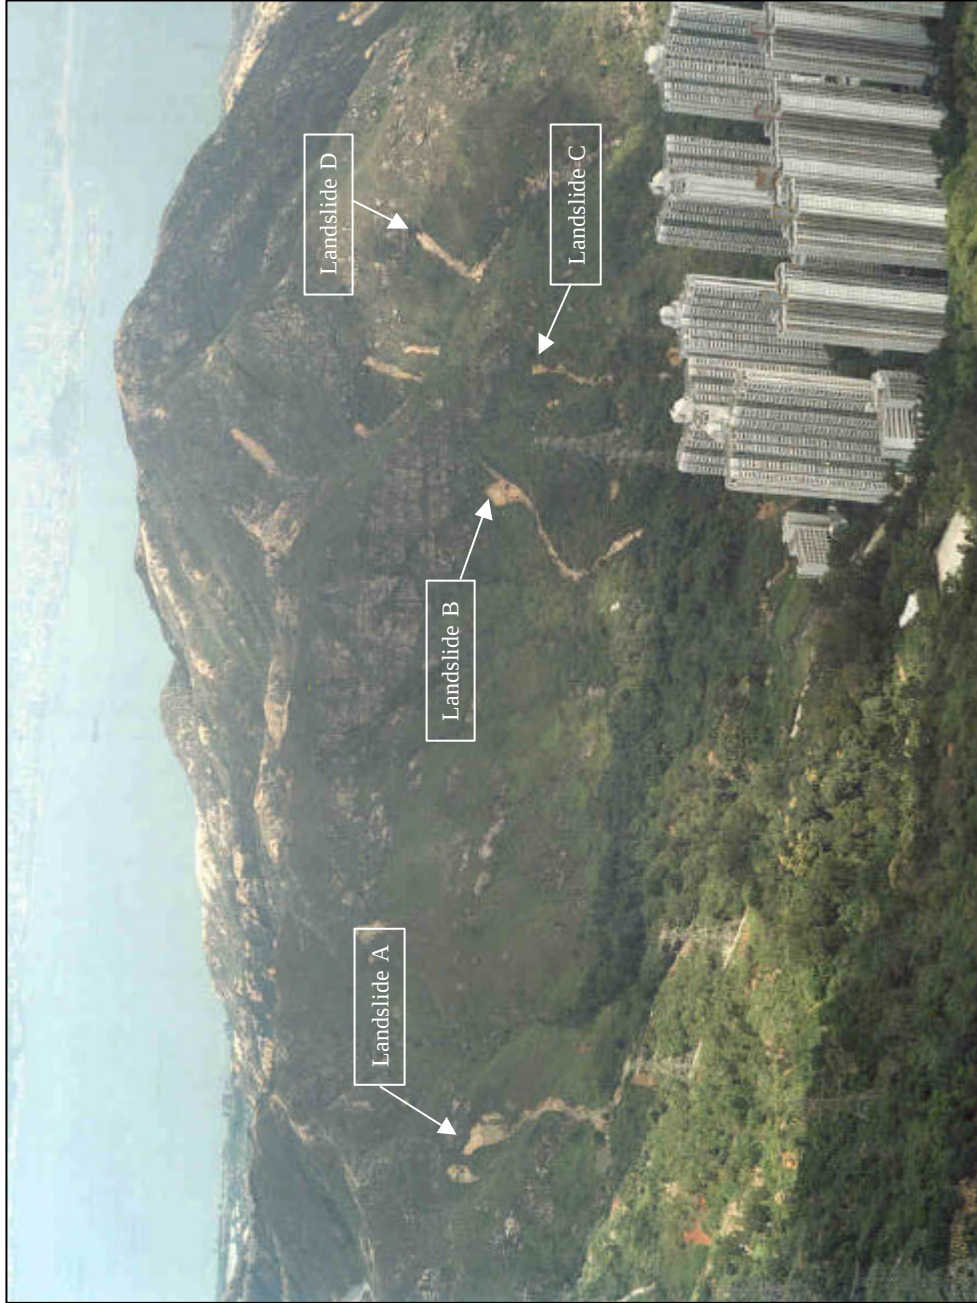
Plate 1 - Oblique Aerial View of the Study Area  
(Photograph taken on 30 June 2000)

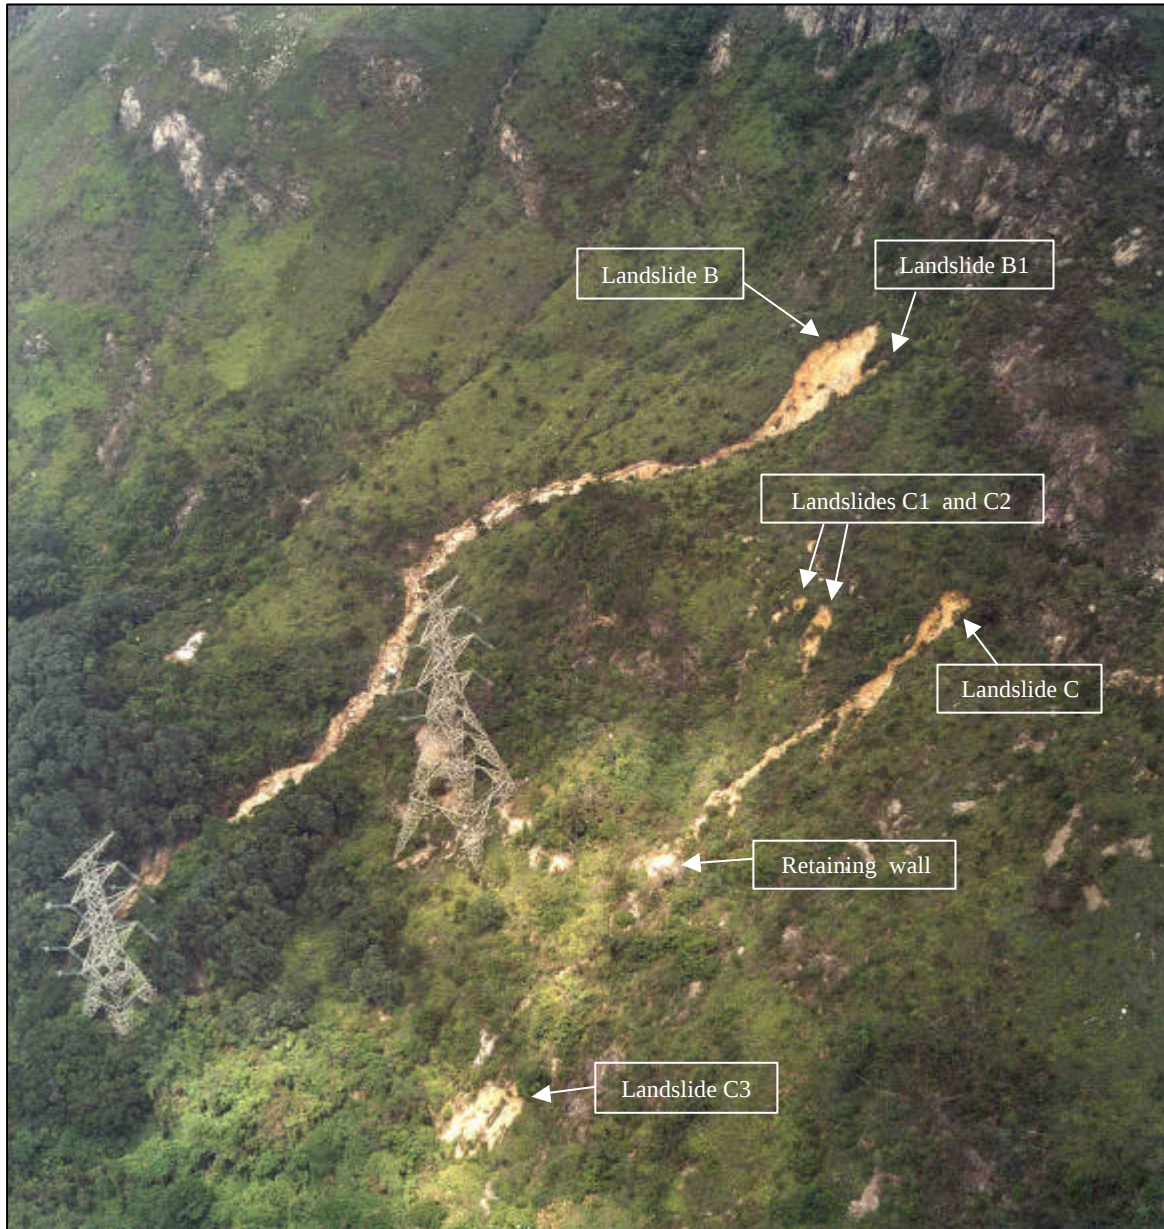
Plate 2 - Oblique Aerial View of Landslides B and C  
(Photograph taken on 30 June 2000)

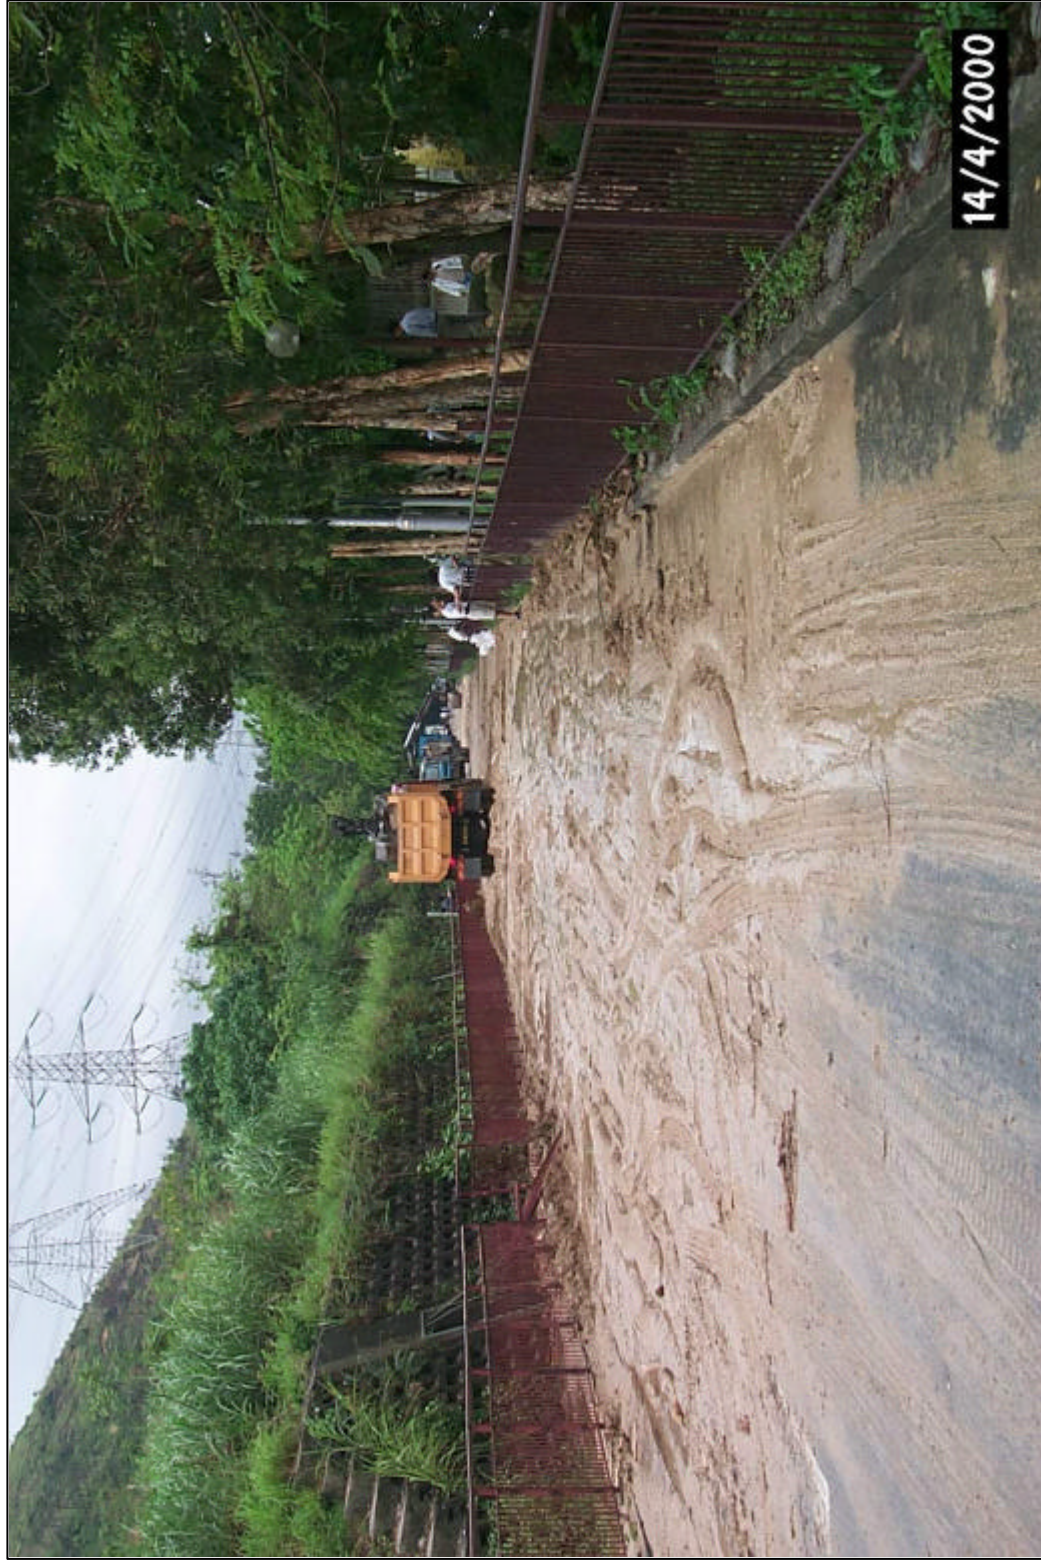
Plate 3 - View of the Alluvial Outwash Debris on the Leung King Estate Perimeter Road  
(Photograph taken by MCA on 14 April 2000)

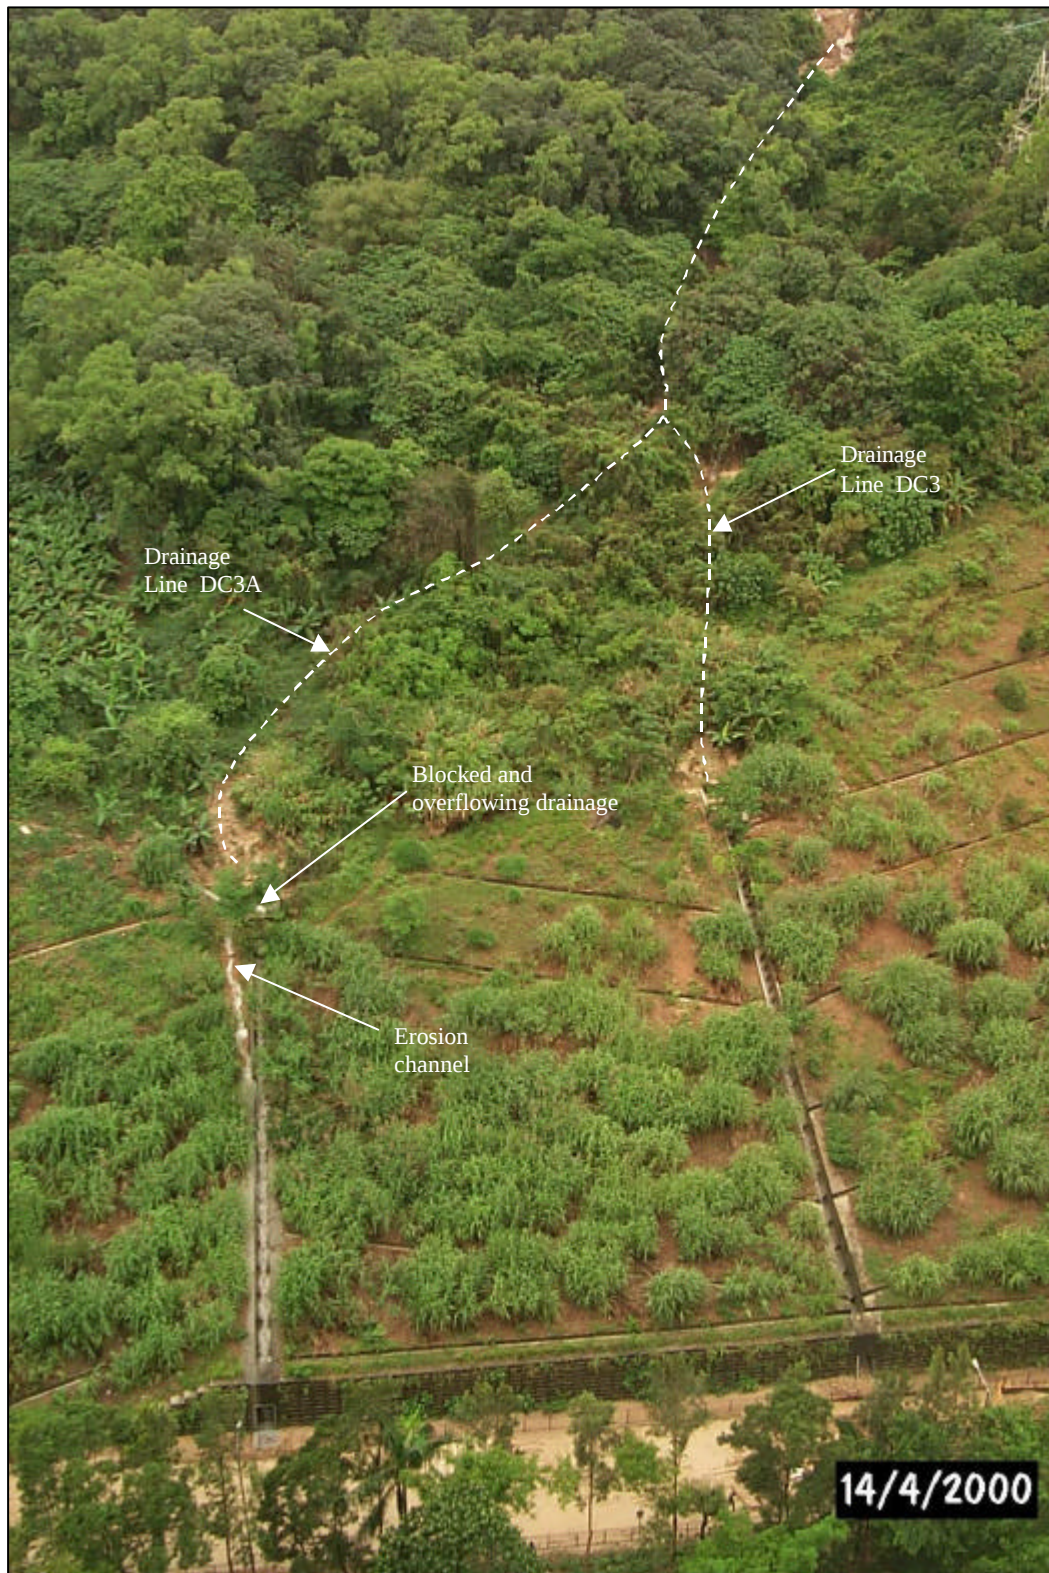
Plate 4 - View of the Blocked and Overflowing Slope Drainage  
Below the Source Area of Landslide B  
(Photograph taken by MCA on 14 April 2000)

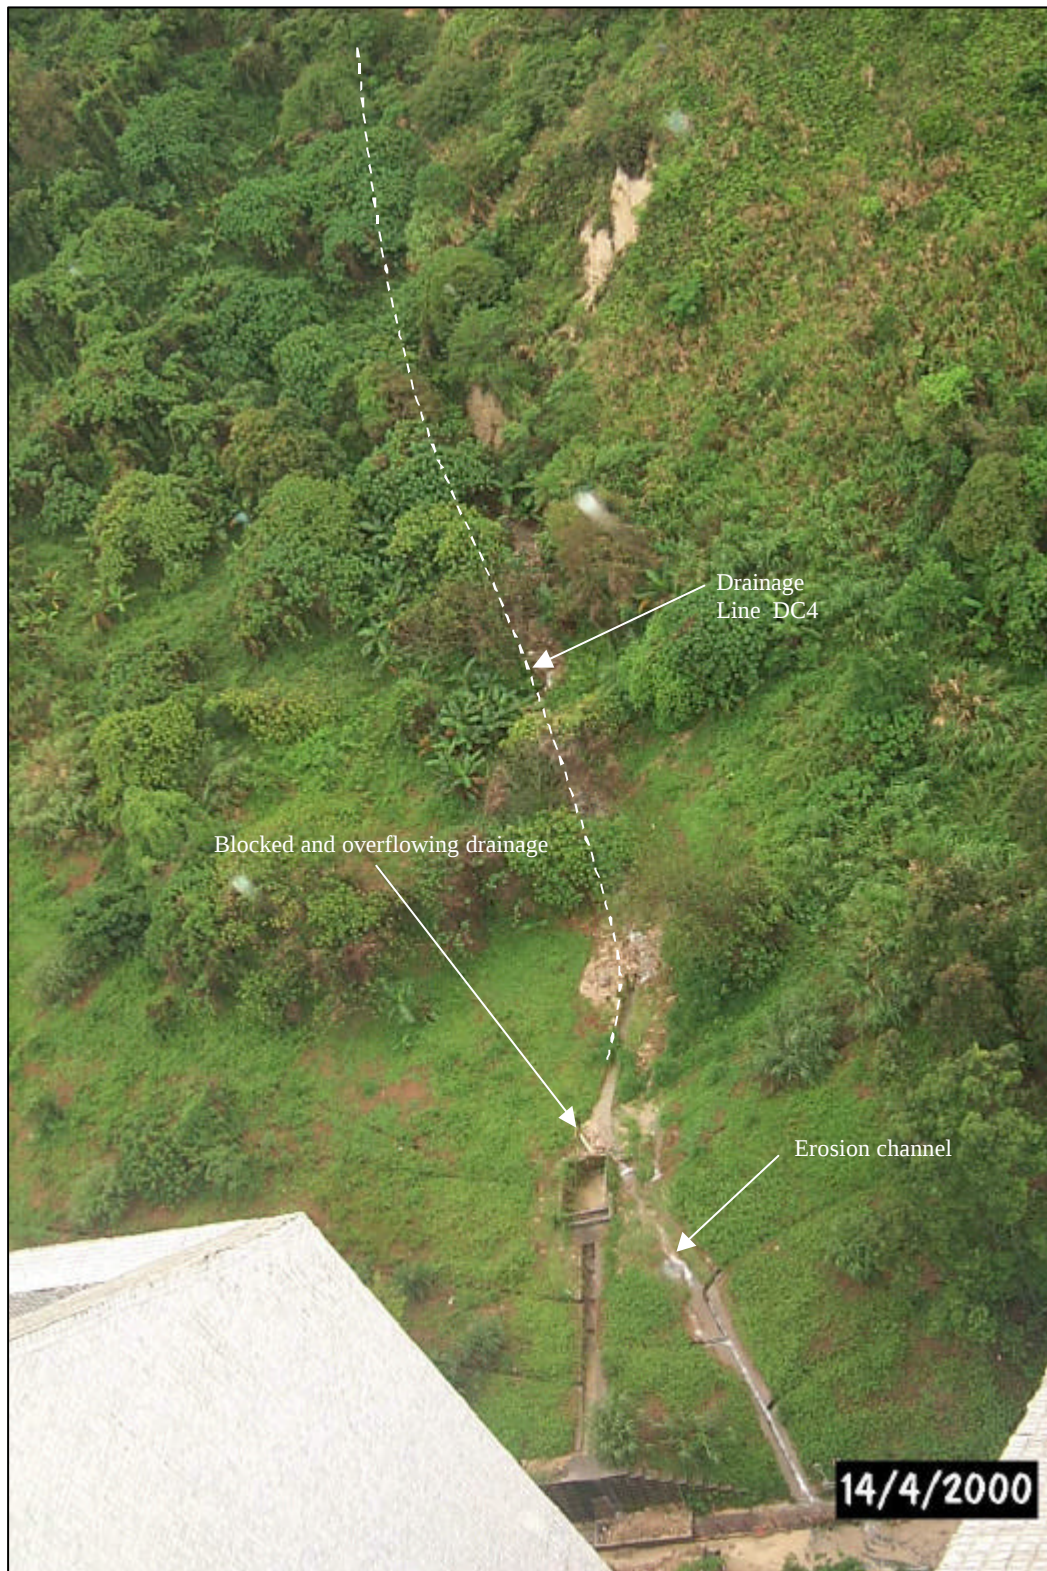
Plate 5 - View of the Blocked and Overflowing Slope Drainage  
Below the Source Area Landslide C  
(Photograph taken by MCA on 14 April 2000)

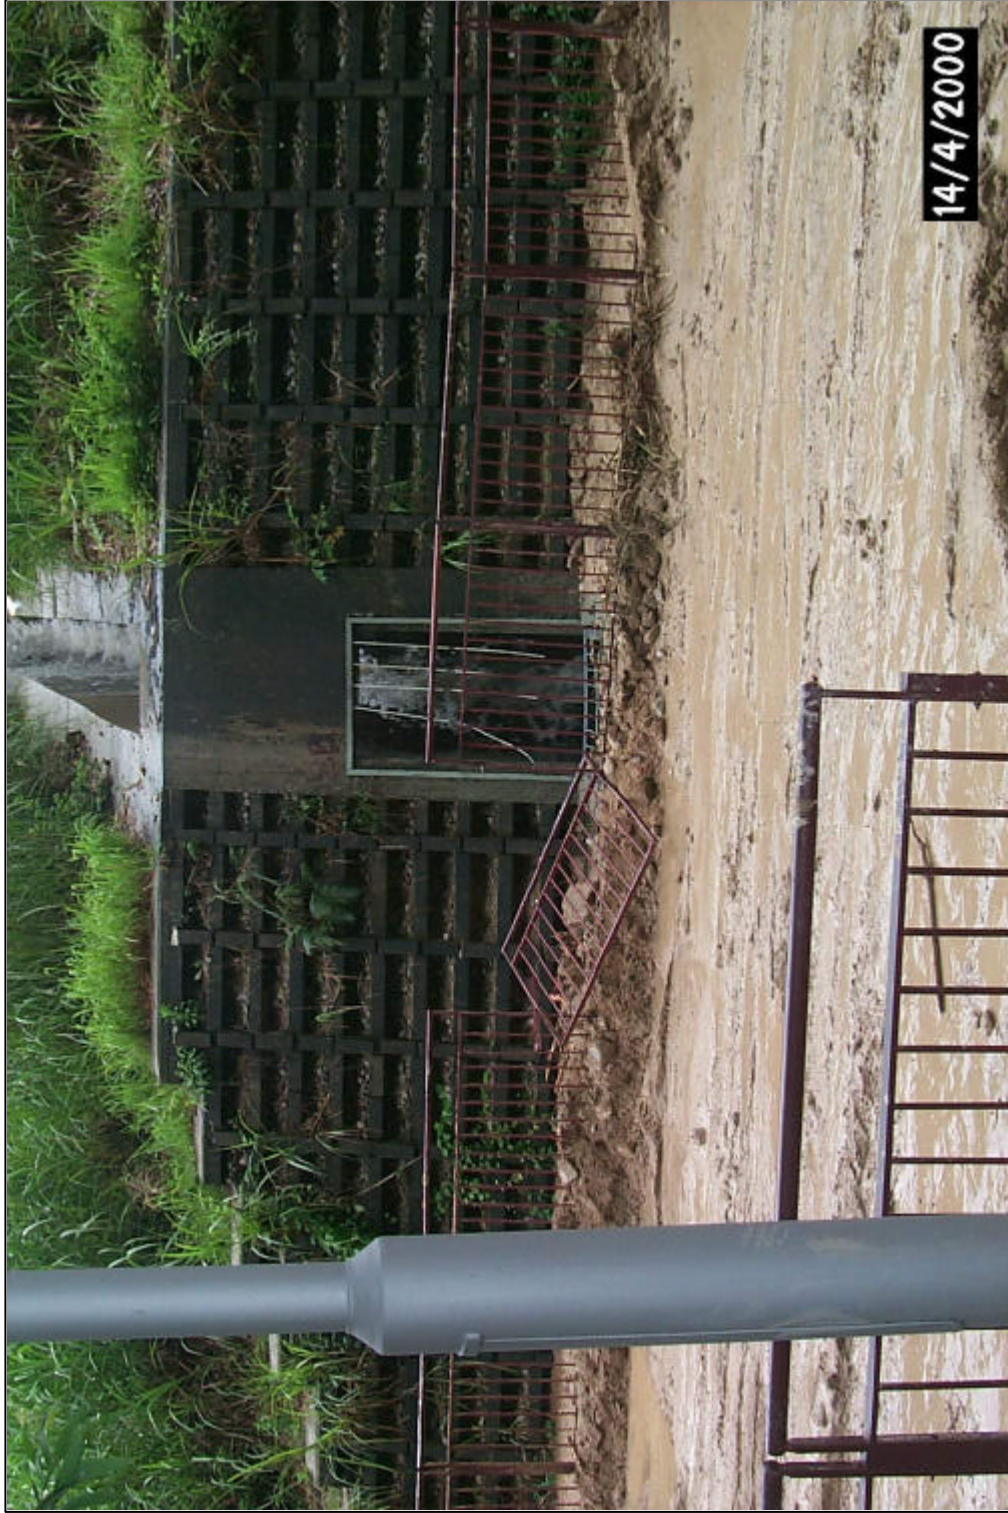
Plate 6 - View of the Alluvial Outwash Debris and Damaged Pedestrian Railing Below Drainage Line DC3  
(Photograph taken by MCA on 14 April 2000)

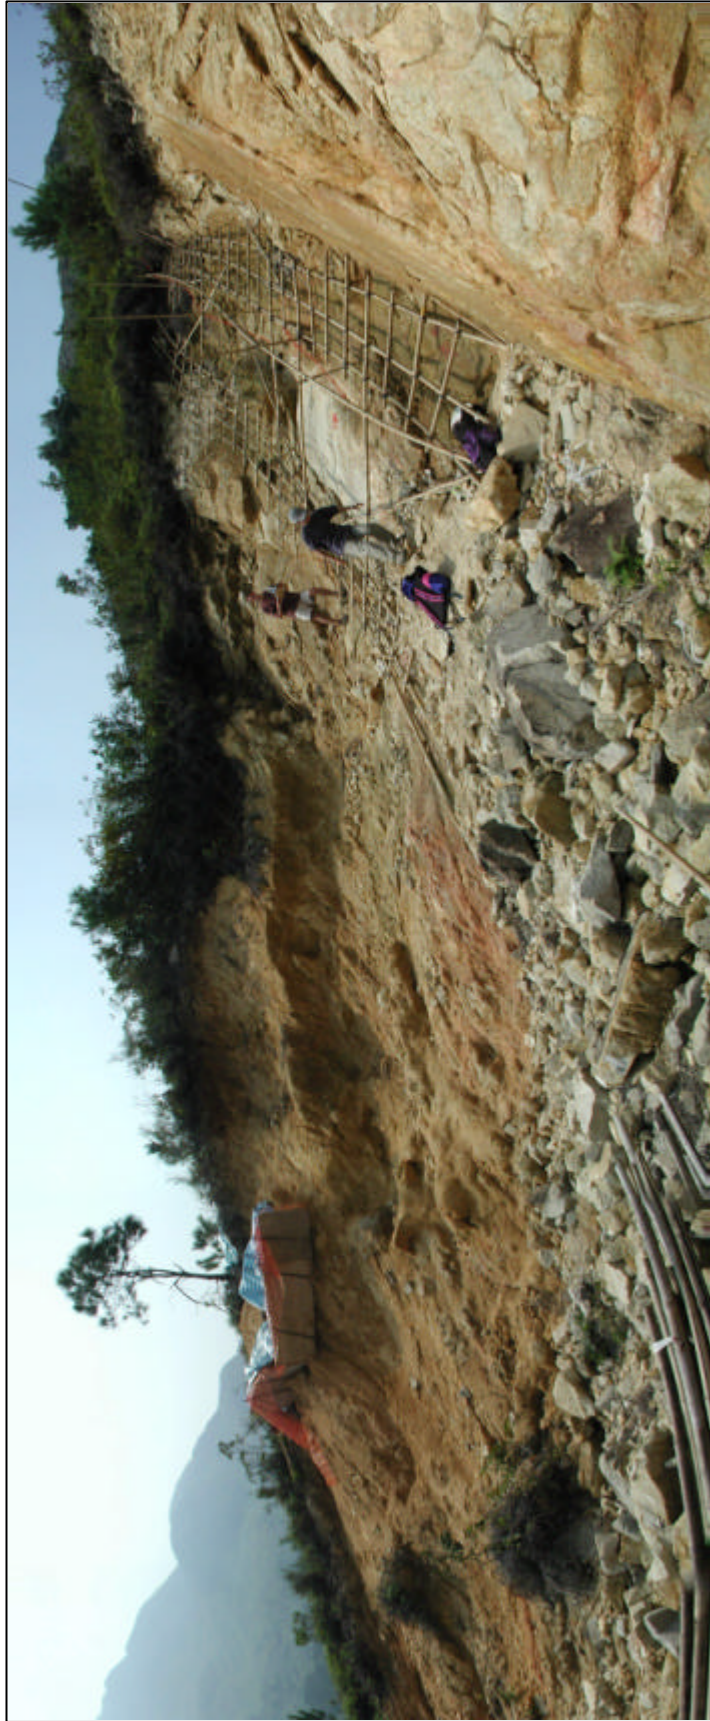
Plate 7 - Panoramic View of the Western Flank of Landslide B  
(Photograph taken on 24 October 2000)

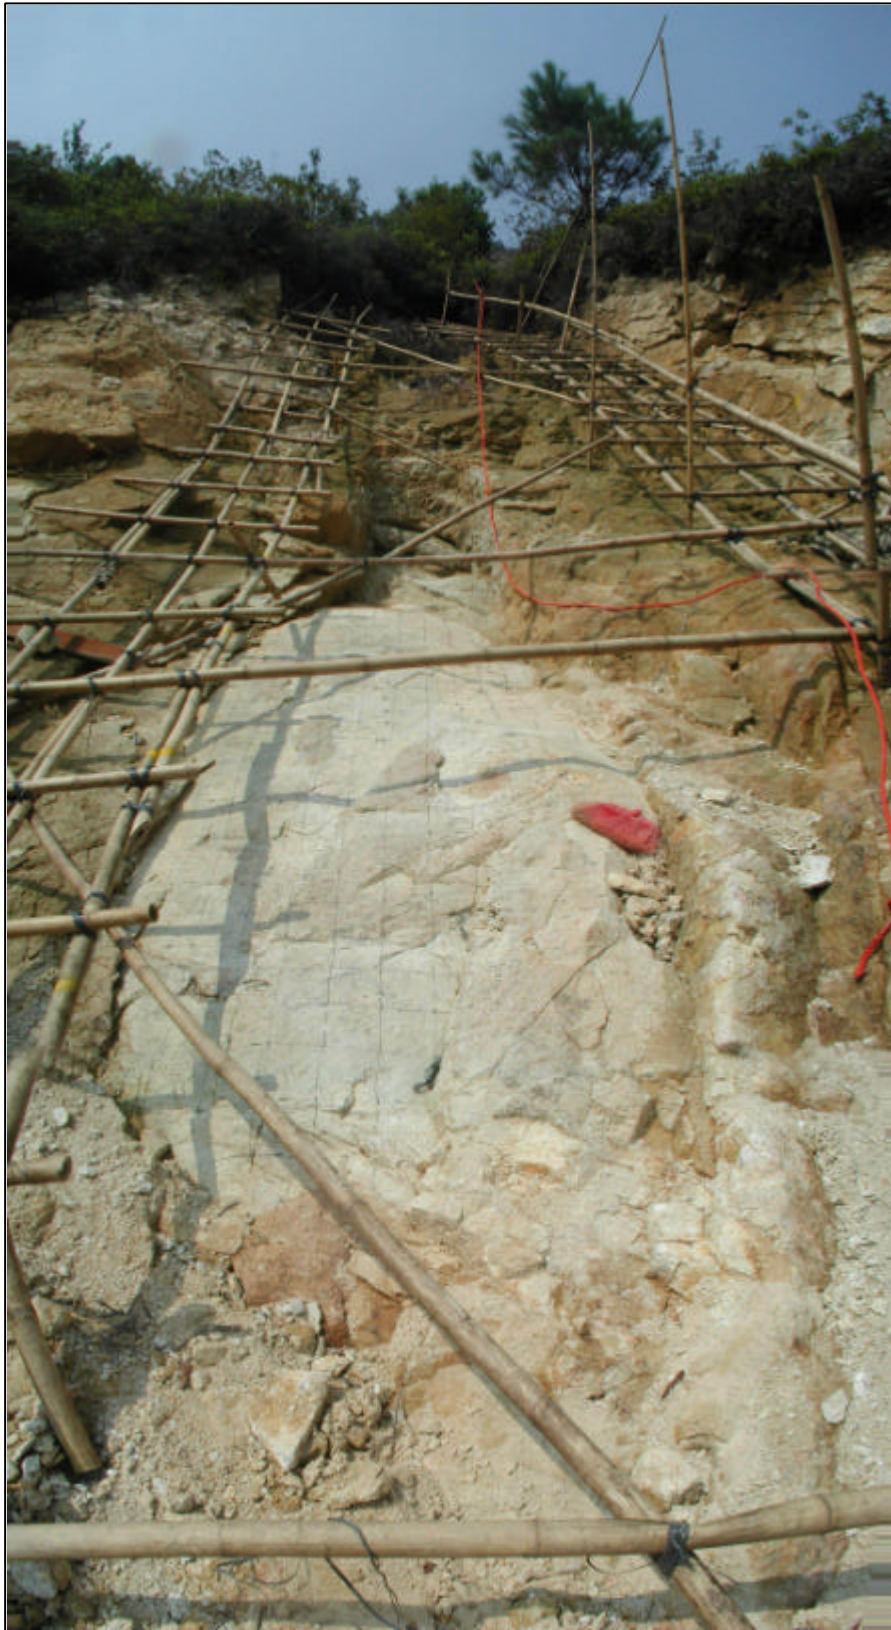
Plate 8 - View of the Floor of Landslide B  
(Photograph taken on 24 October 2000)

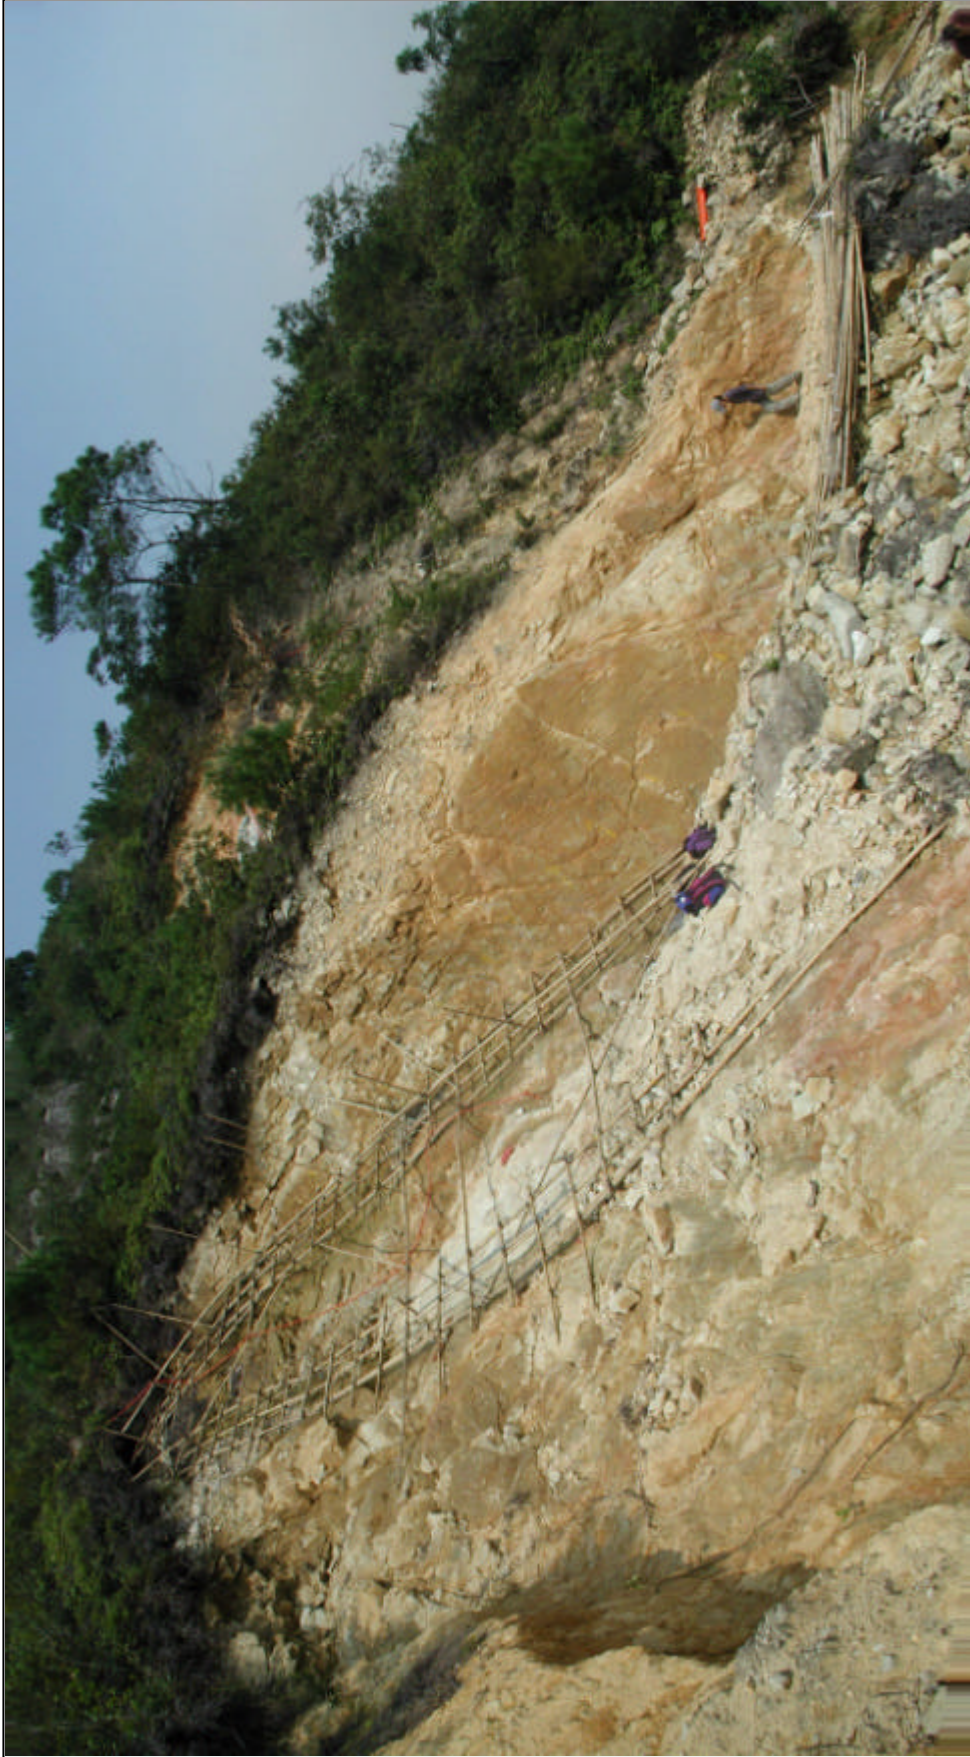
Plate 9 - Panoramic View of the Eastern Flank of Landslide B  
(Photograph taken on 24 October 2000)

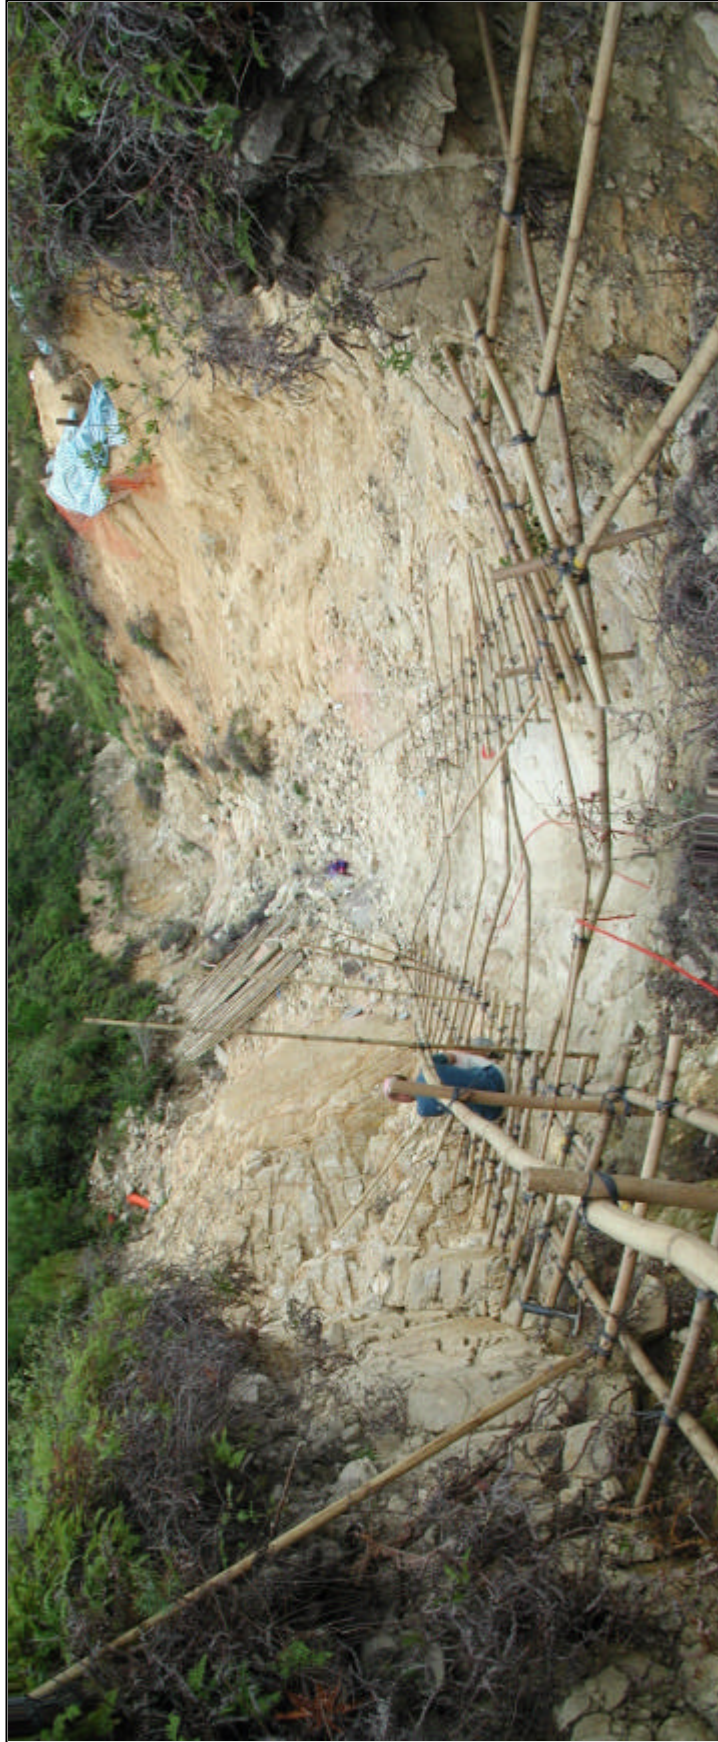
Plate 10 - Panoramic View Looking Down from the Crown of Landslide B  
(Photograph taken on 12 October 2000)

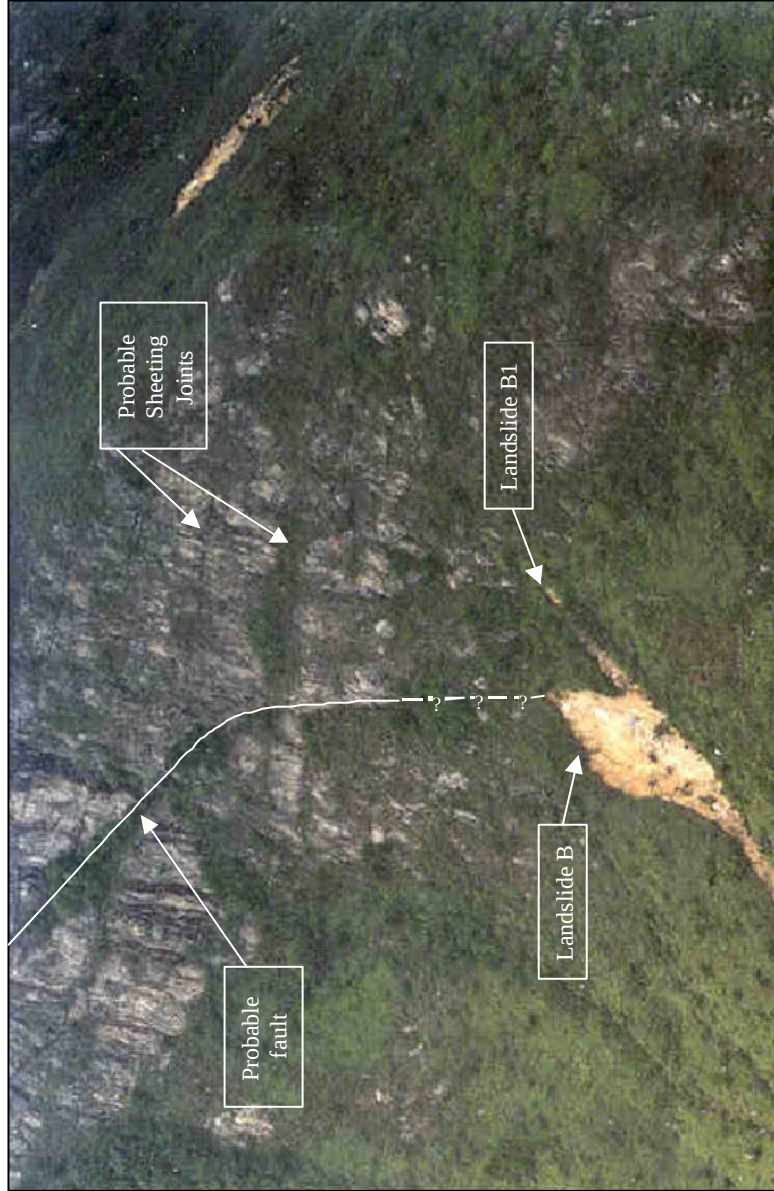
Plate 11 - Oblique Aerial View of the Exposed Granite Cliff above Landslide B  
(Photograph taken on 30 June 2000)

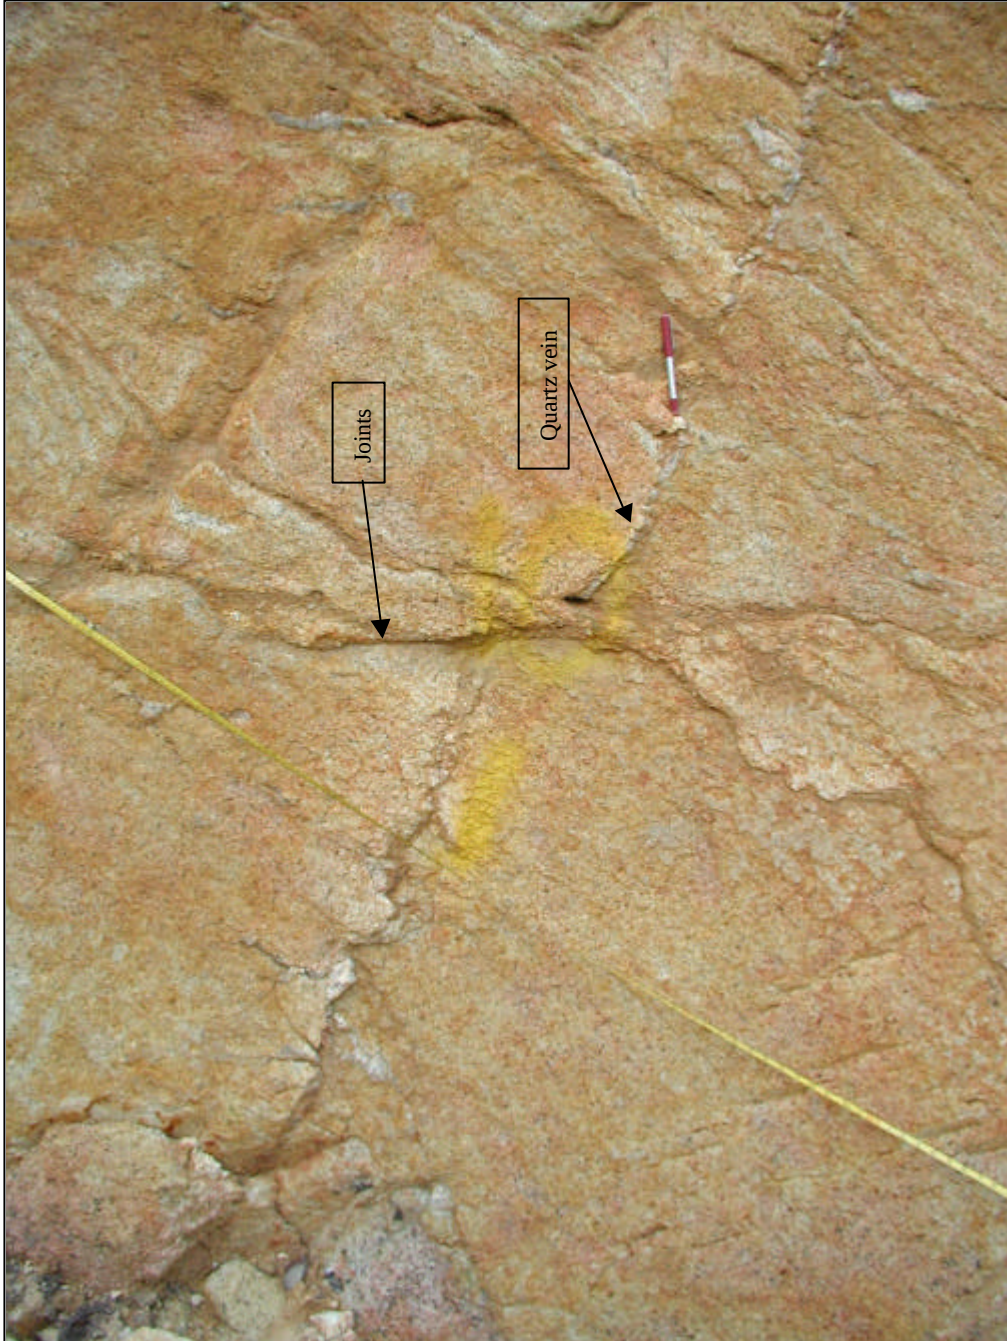
Plate 12 - Detail of Quartz Vein Offset by a Joint on the Eastern Flank of Landslide B  
(Photograph taken on 24 October 2000)

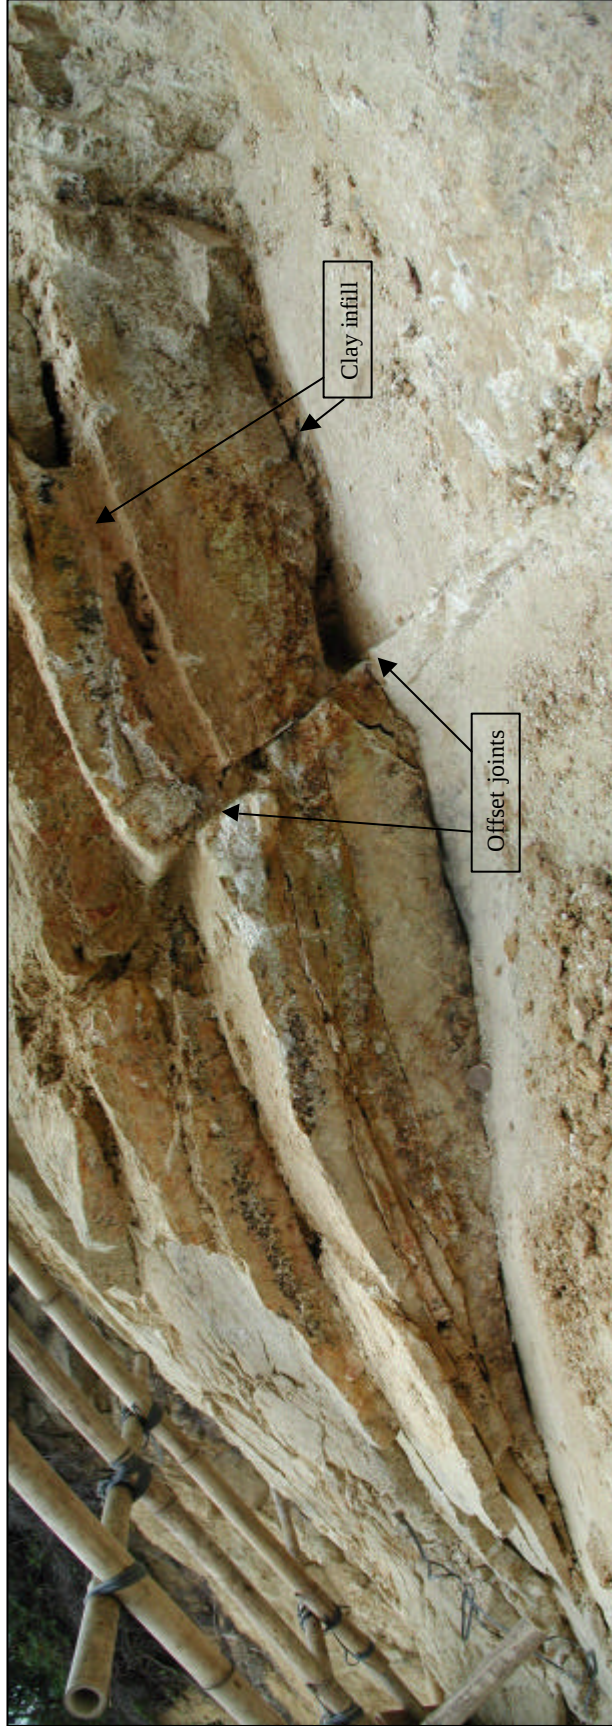
Plate 13 - Detail of West Face of Trial Trench LKTT1. Note Offset Joints and Clay Infills (Figure 20)  
(Photograph taken on 12 October 2000)

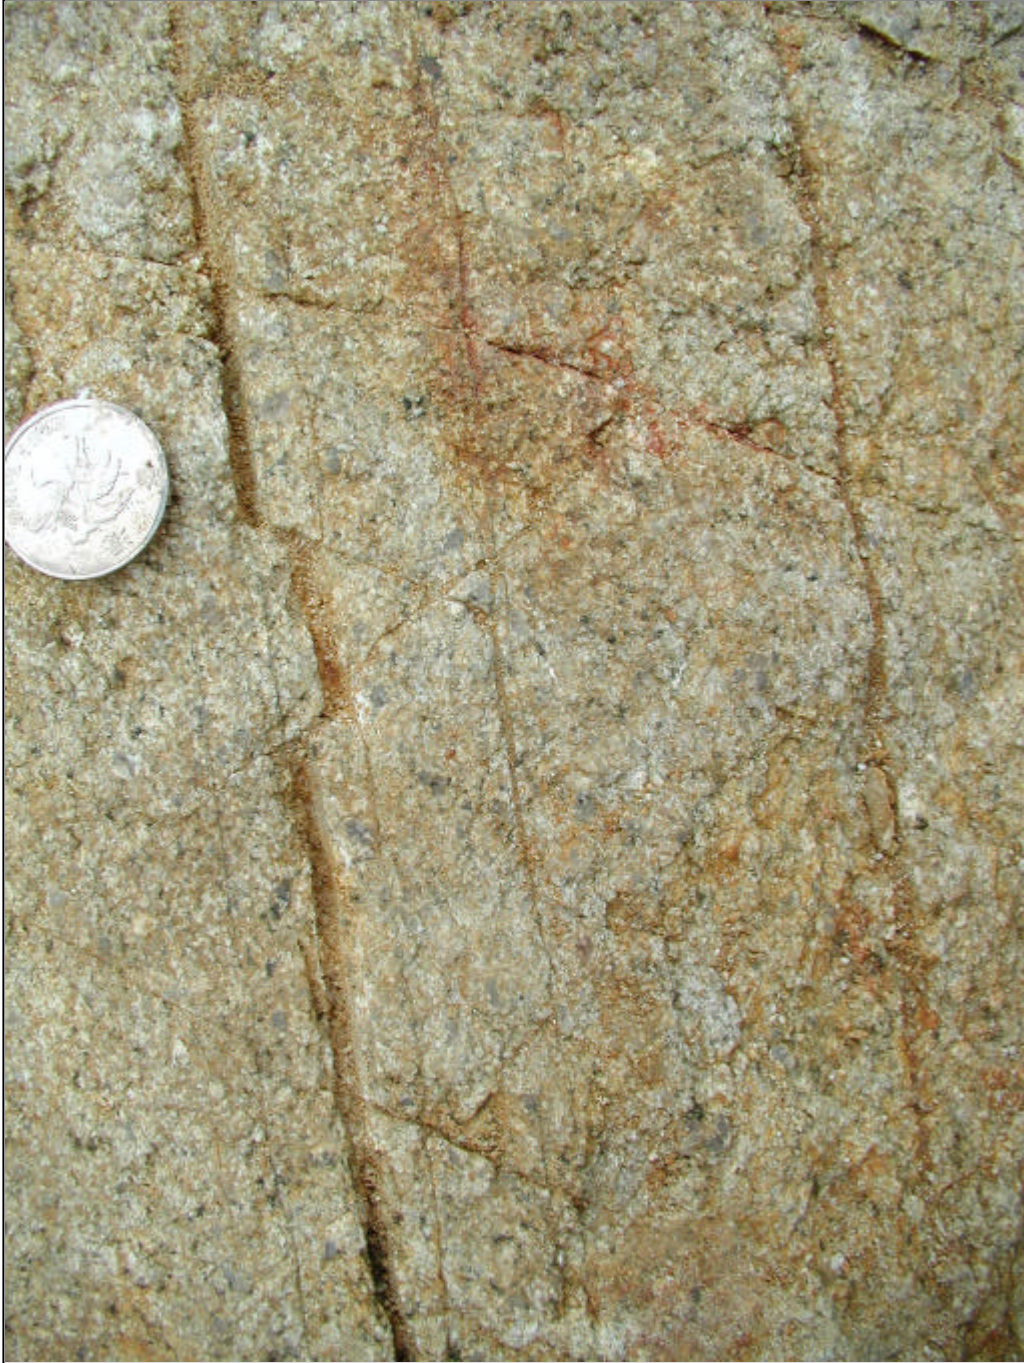
Plate 14 - Detail of Offset Clay Infilled Joint on the Floor of Landslide B  
(Photograph taken on 12 October 2000)

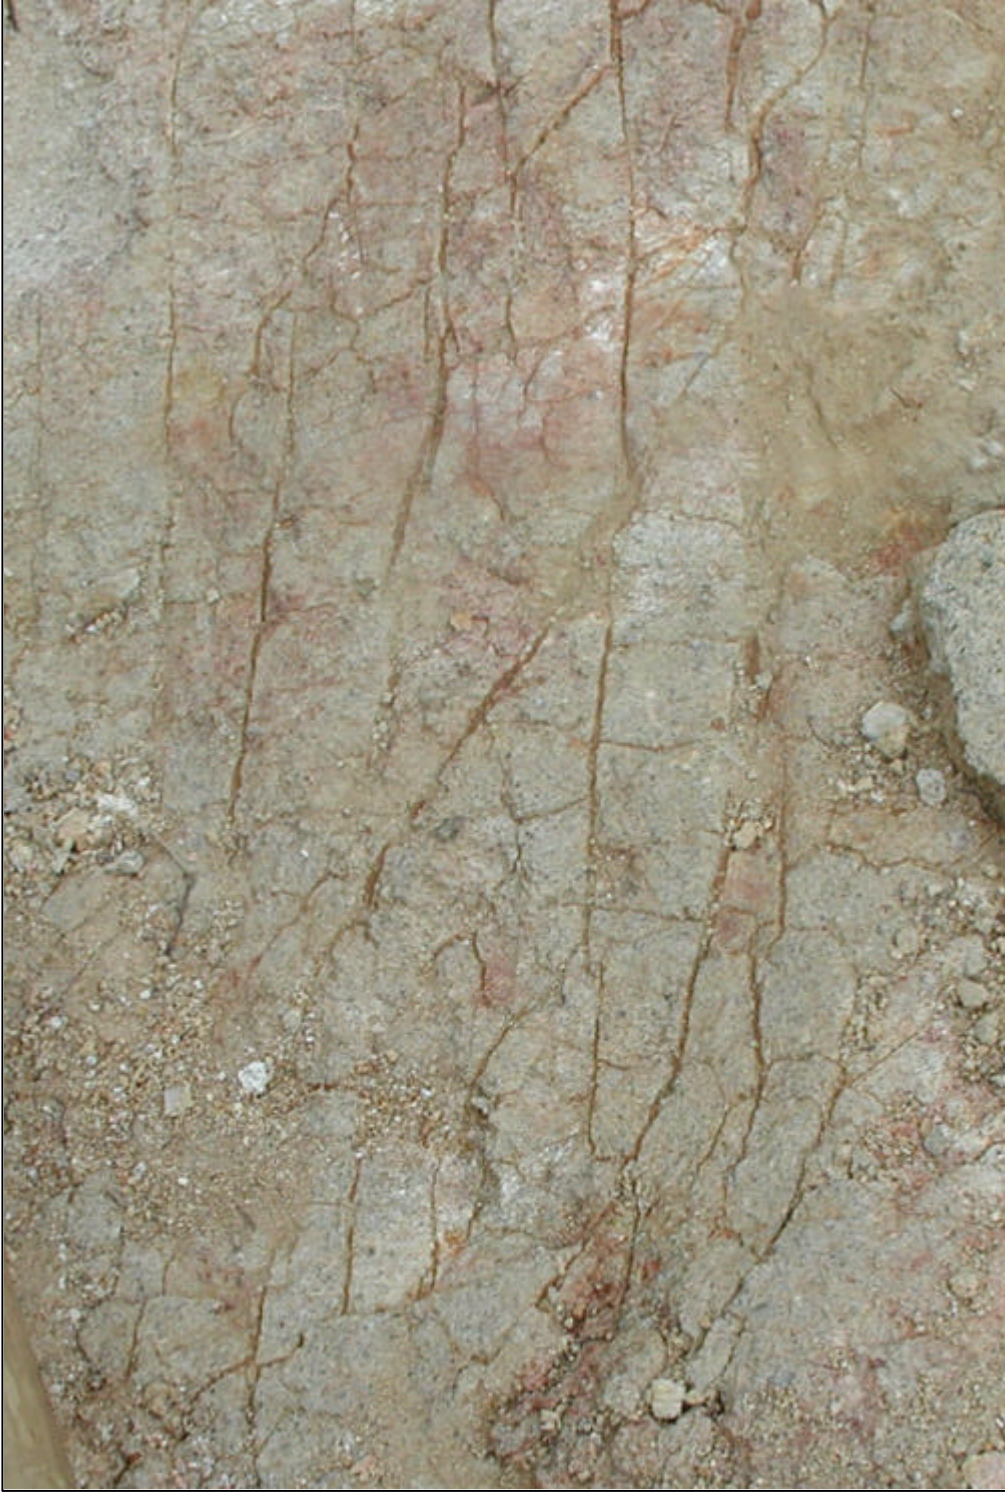
Plate 15 - Detail of Fractures Forming an Orthogonal Pattern on the Floor of Landslide B  
(Photograph taken on 12 October 2000)

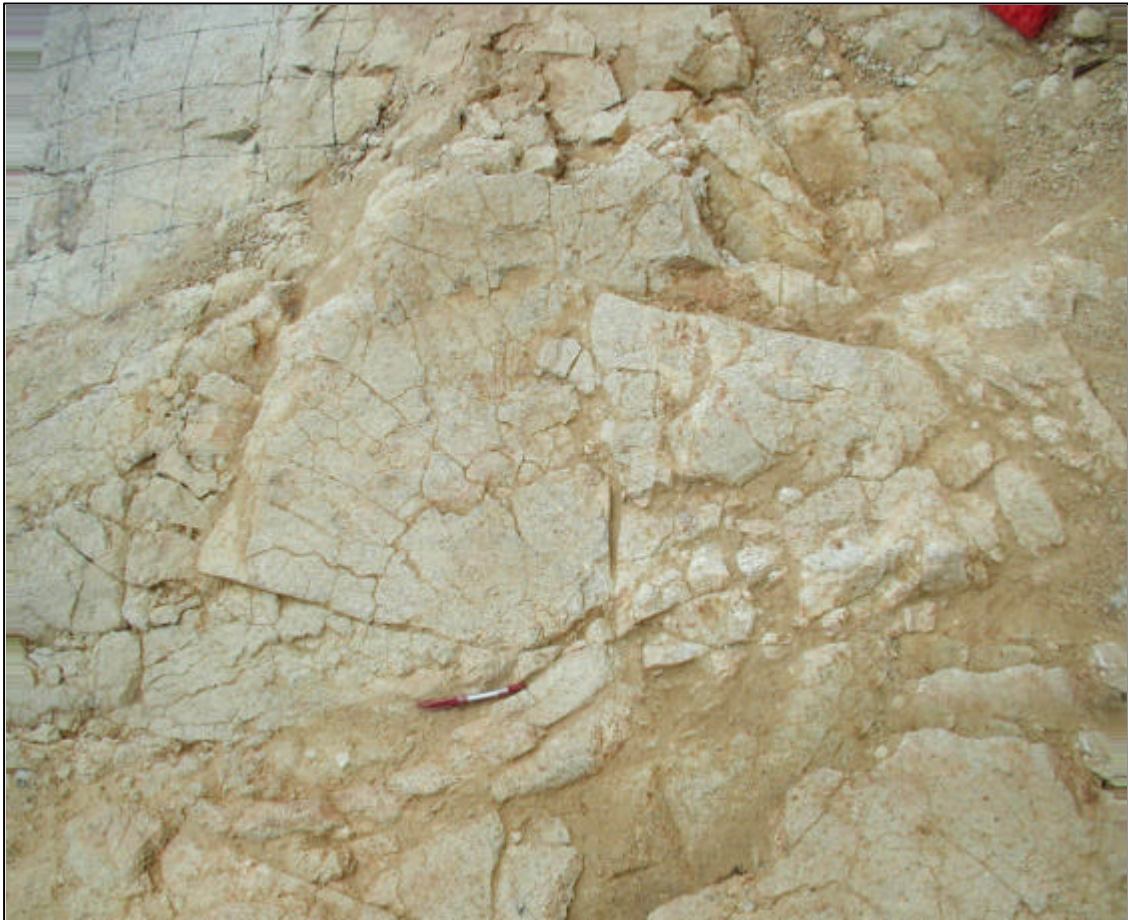
Plate 16 - Detail of Partially Radial Fractures on the Floor of Landslide B  
(Photograph taken on 5 July 2000)
