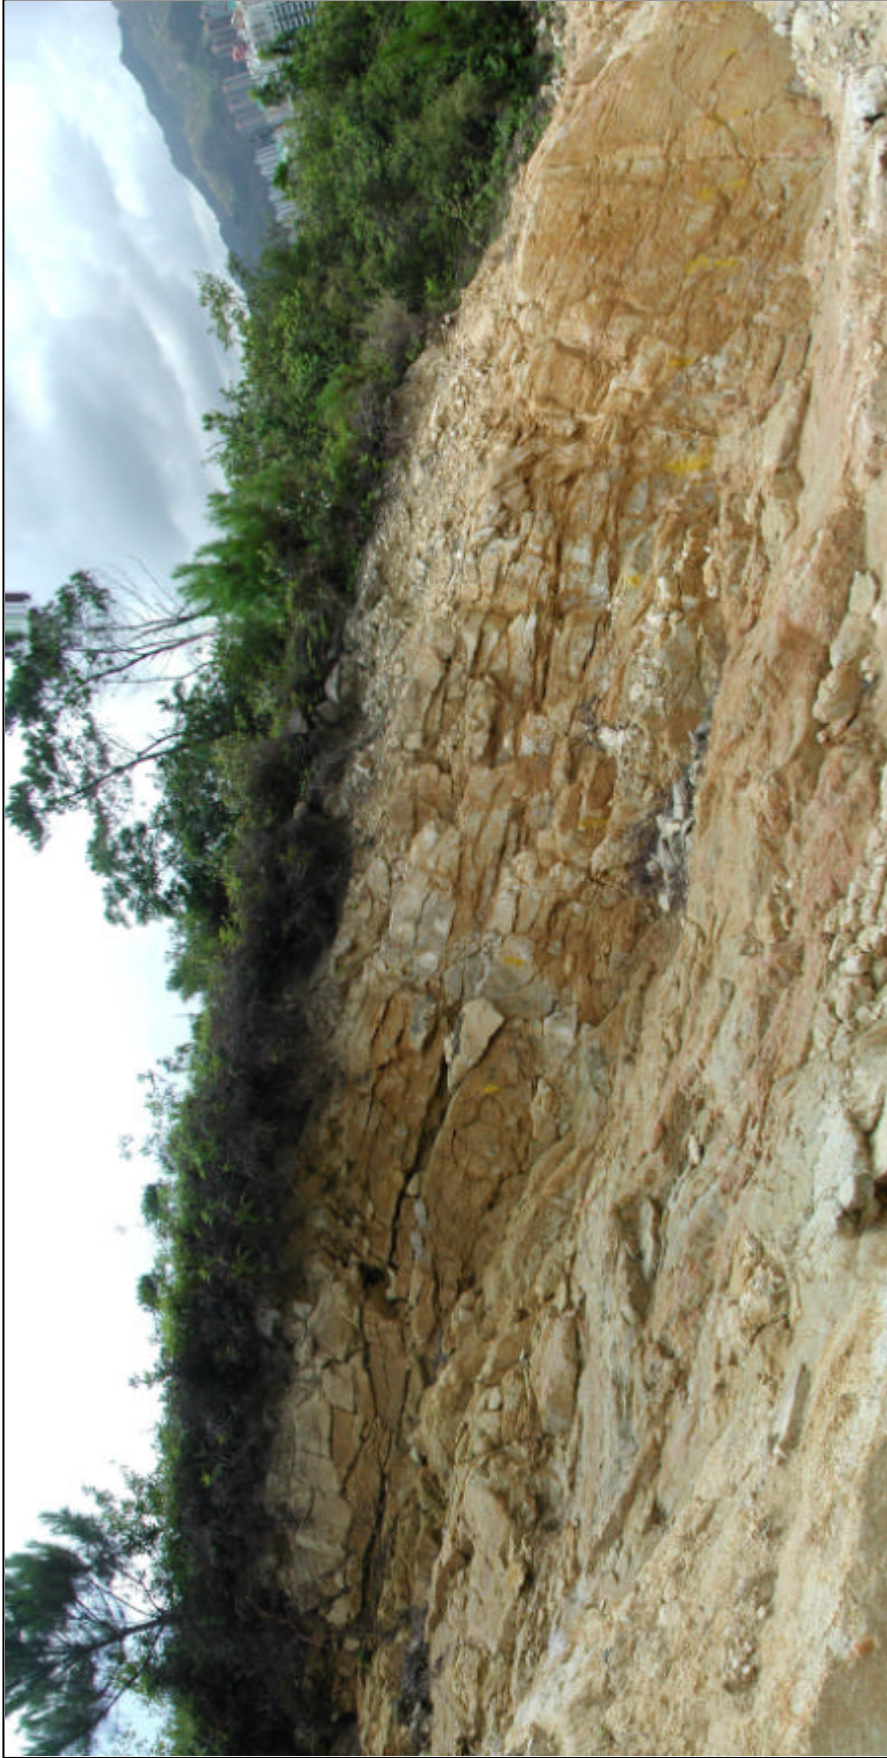
Plate 17 - Panoramic View of Eastern Release Surface of Landslide B. Note Open and Sediment-infilled Joints  
(Photograph taken on 14 July 2000)

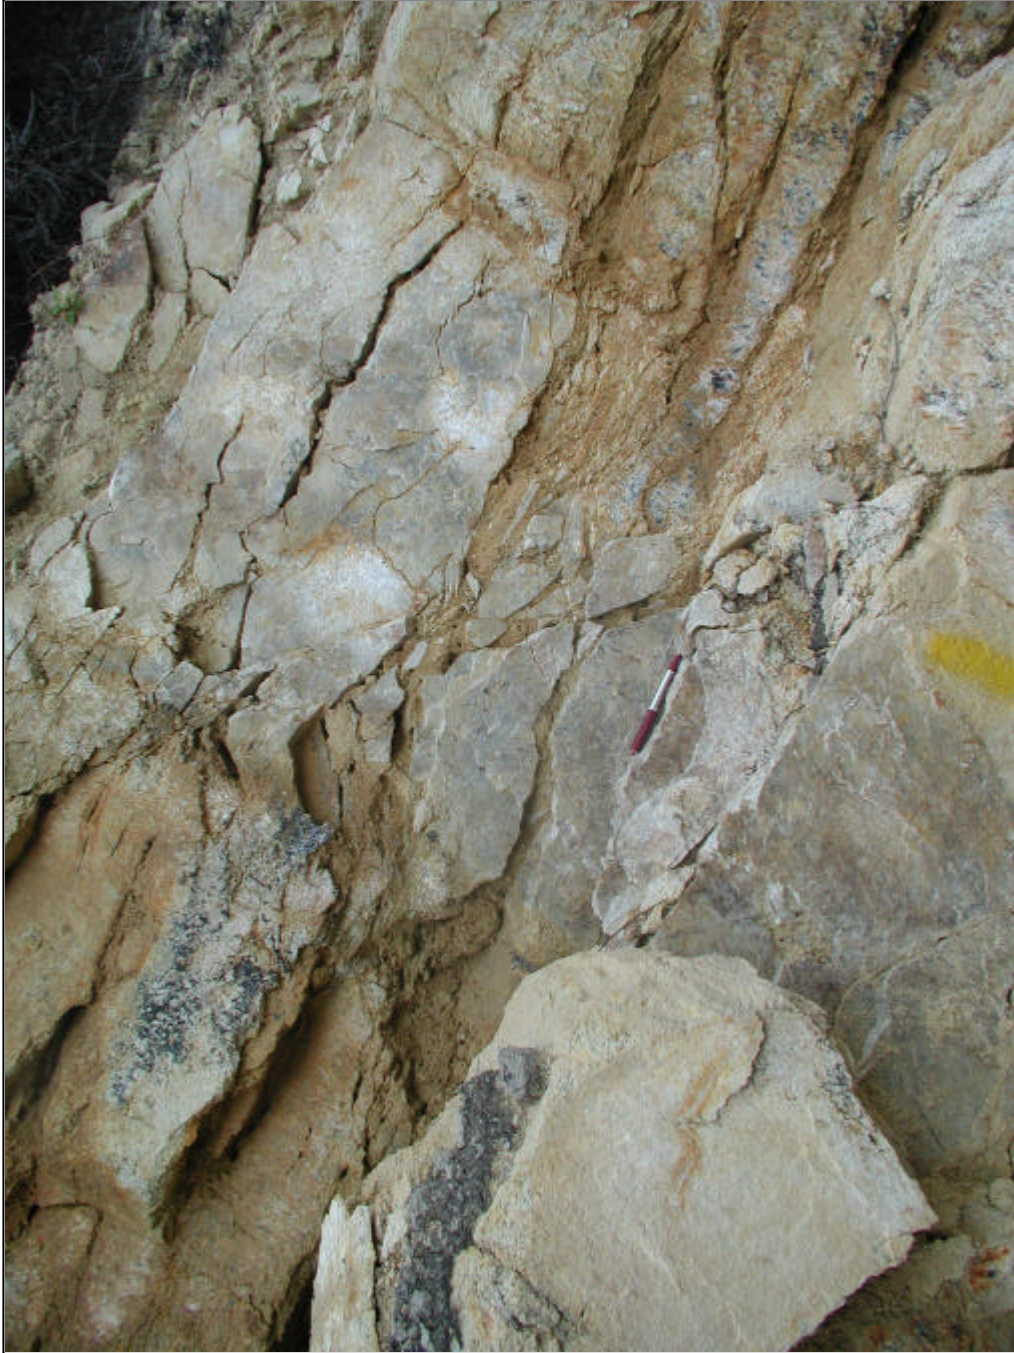
Plate 18 - Detail of Open and Sediment-infilled Joints Exposed on the Eastern Release Surface  
(Photograph taken on 14 July 2000)

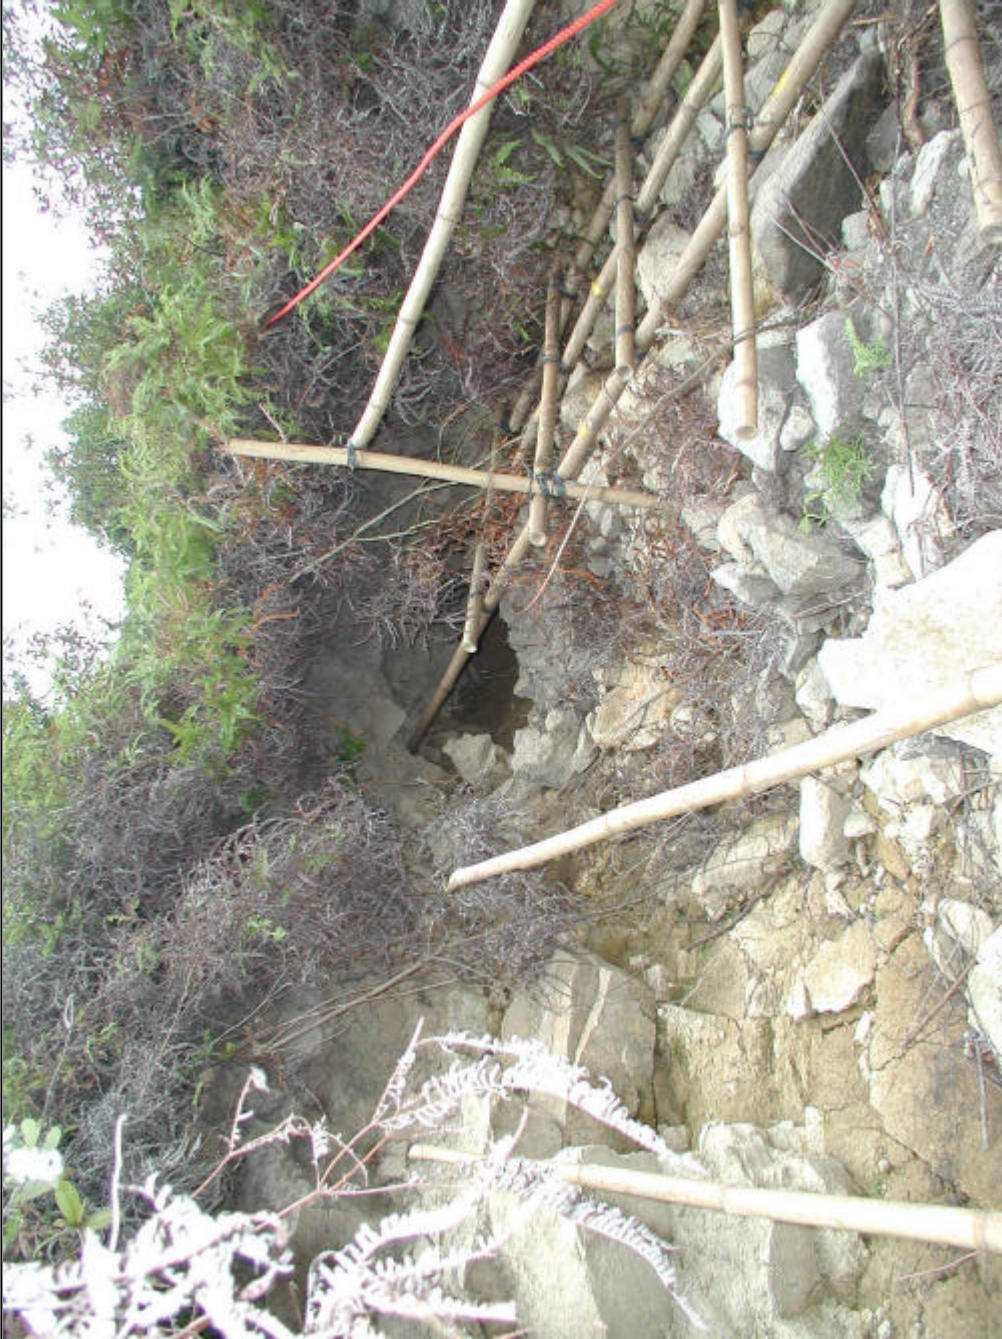
Plate 19 - Detail of Crown of Landslide B  
(Photograph taken on 10 October 2000)

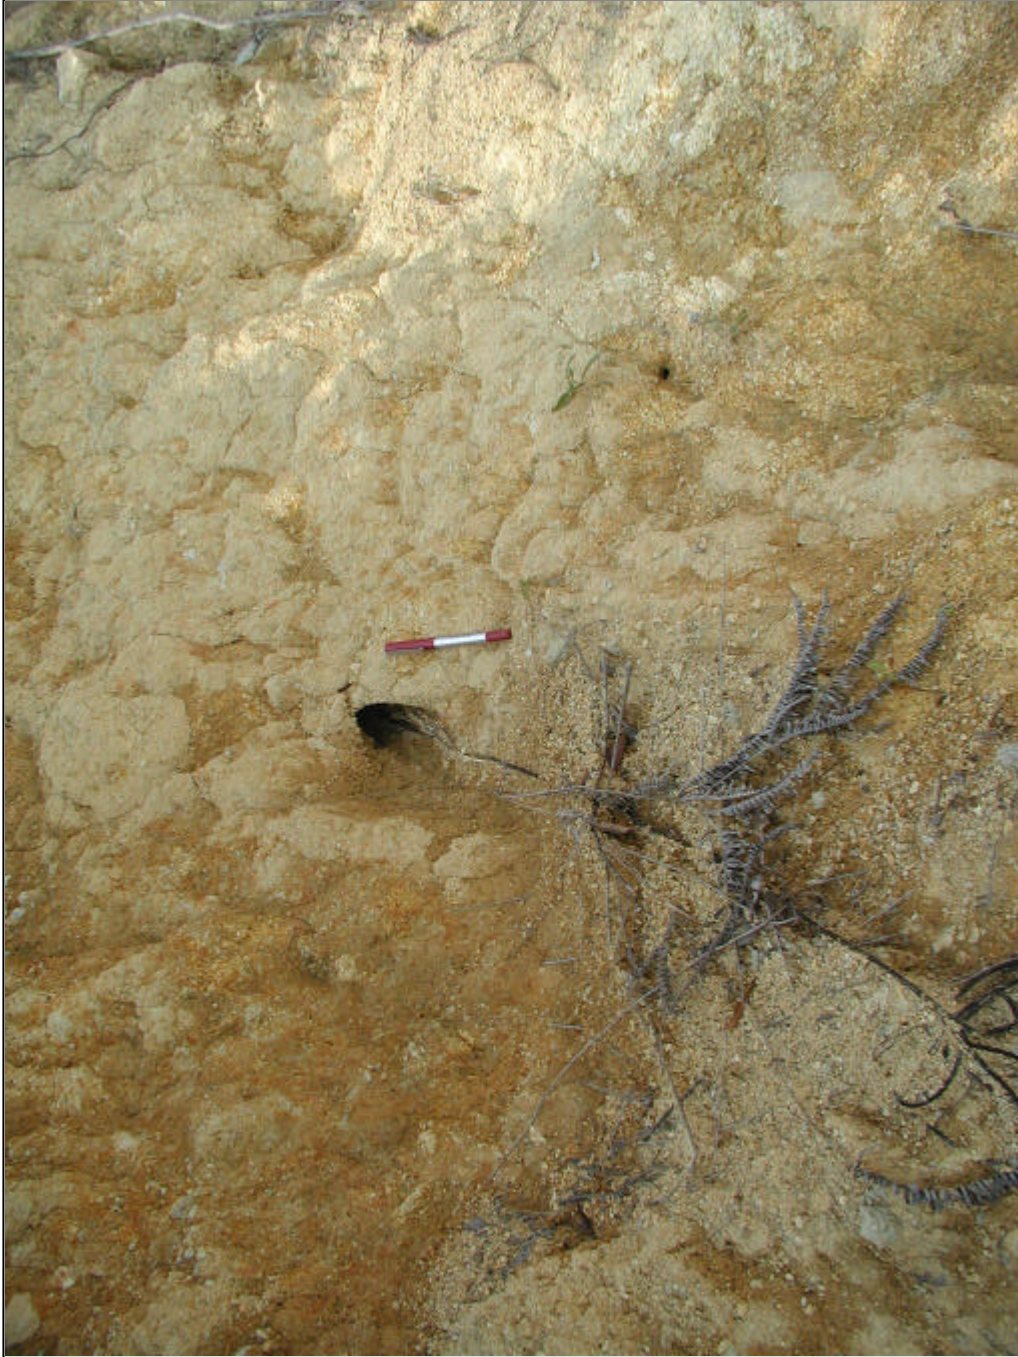
Plate 20 - Erosion Pipe Located on the Western Flank of Landslide B  
(Photograph taken on 24 October 2000)

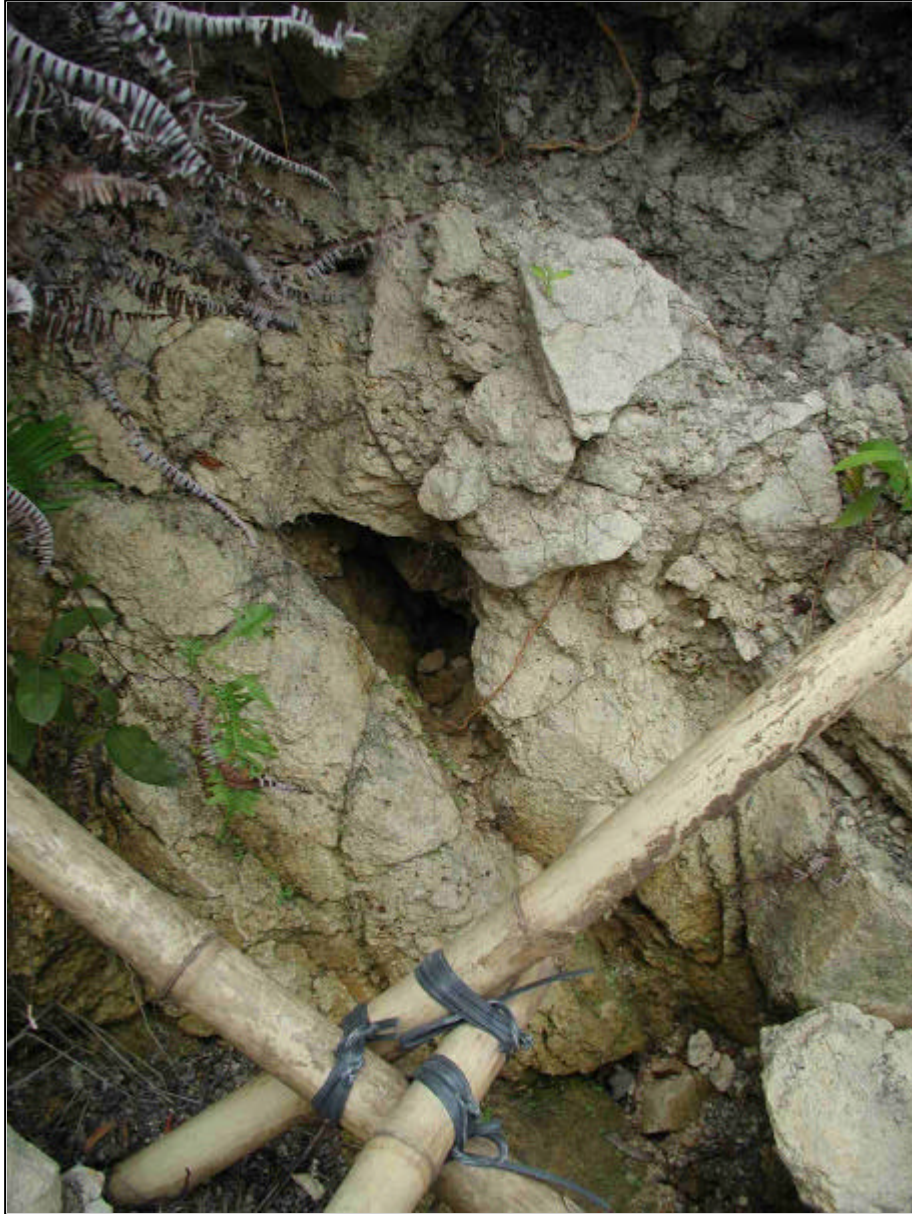
Plate 21 - Erosion Pipe Located Below the Crown of Landslide B  
(Photograph taken on 12 October 2000)

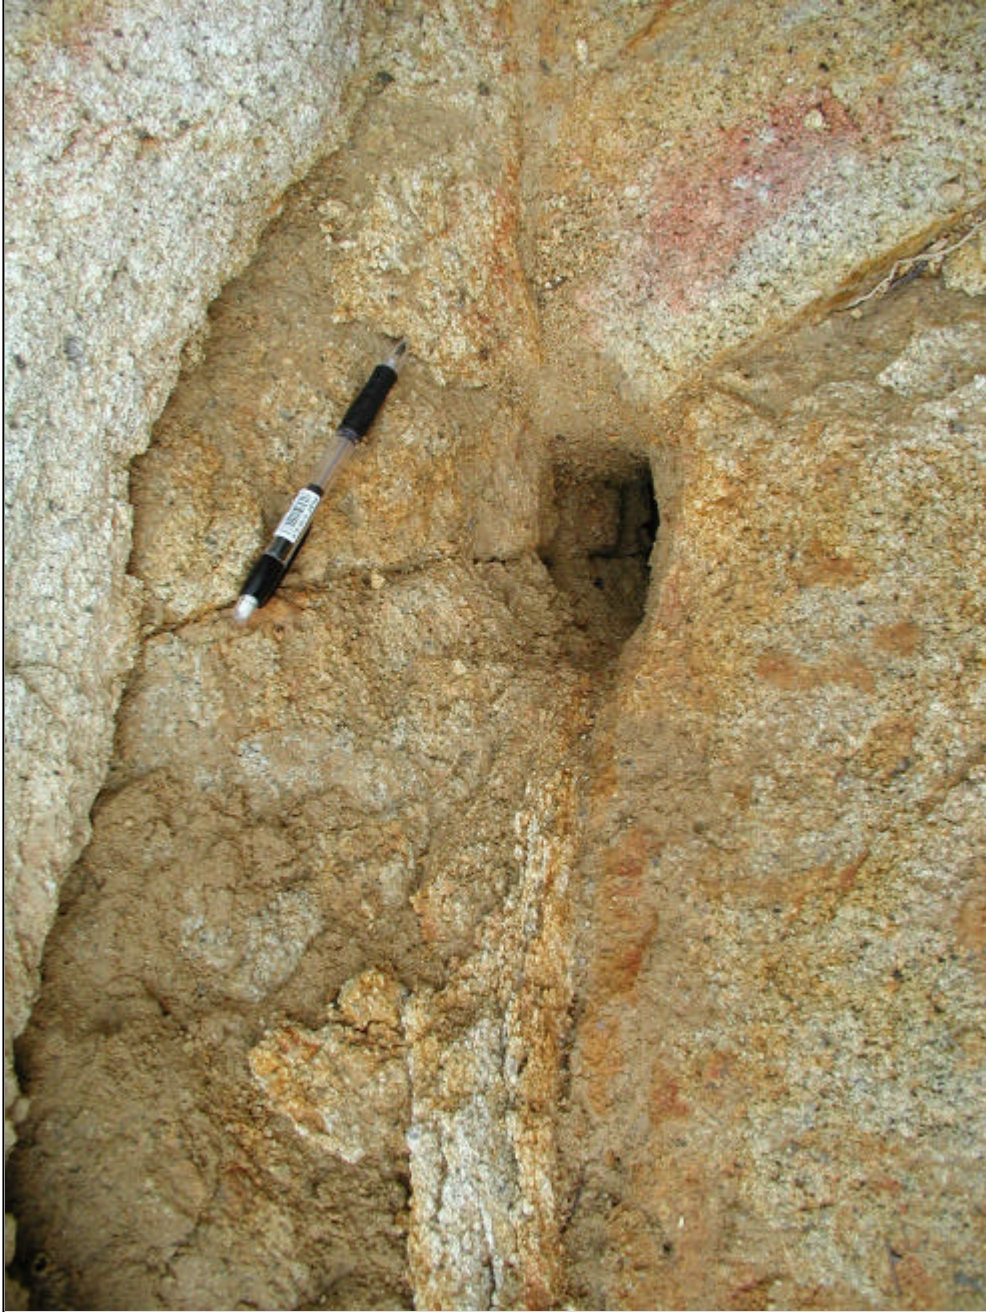
Plate 22 - Erosion Pipe Located at the Intersection of Two Joints  
within Highly Decomposed Granite on the Floor of Landslide B  
(Photograph taken on 4 July 2000)

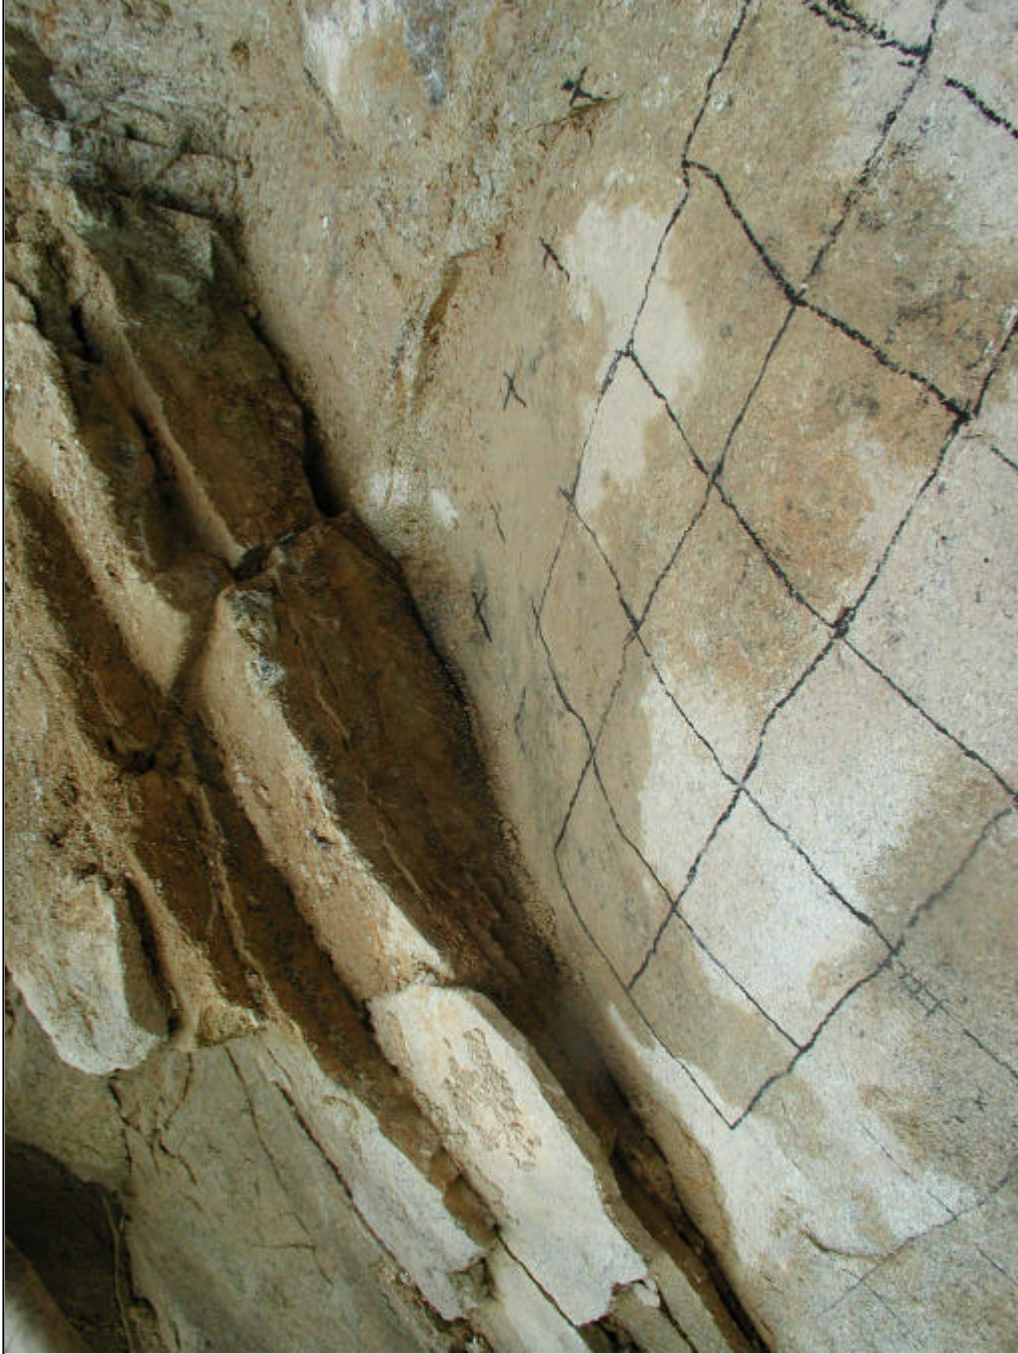
Plate 23 - Detail of Minor Seepage from Sheetting Joint Exposed on the Floor of Landslide B  
(Photograph taken on 28 October 2000)

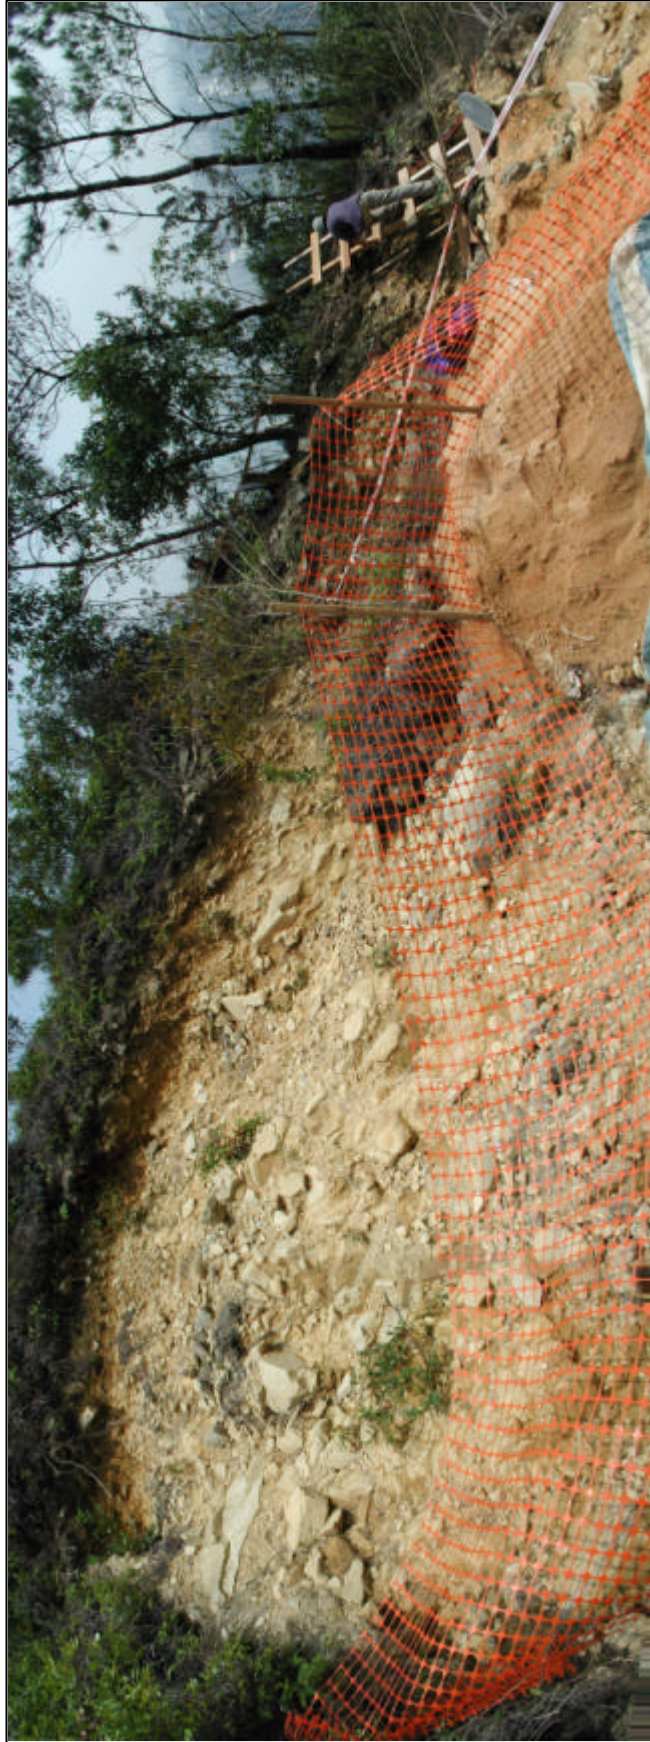
Plate 24 - Main Scarp of Landslide B1  
(Photograph taken on 24 October 2000)

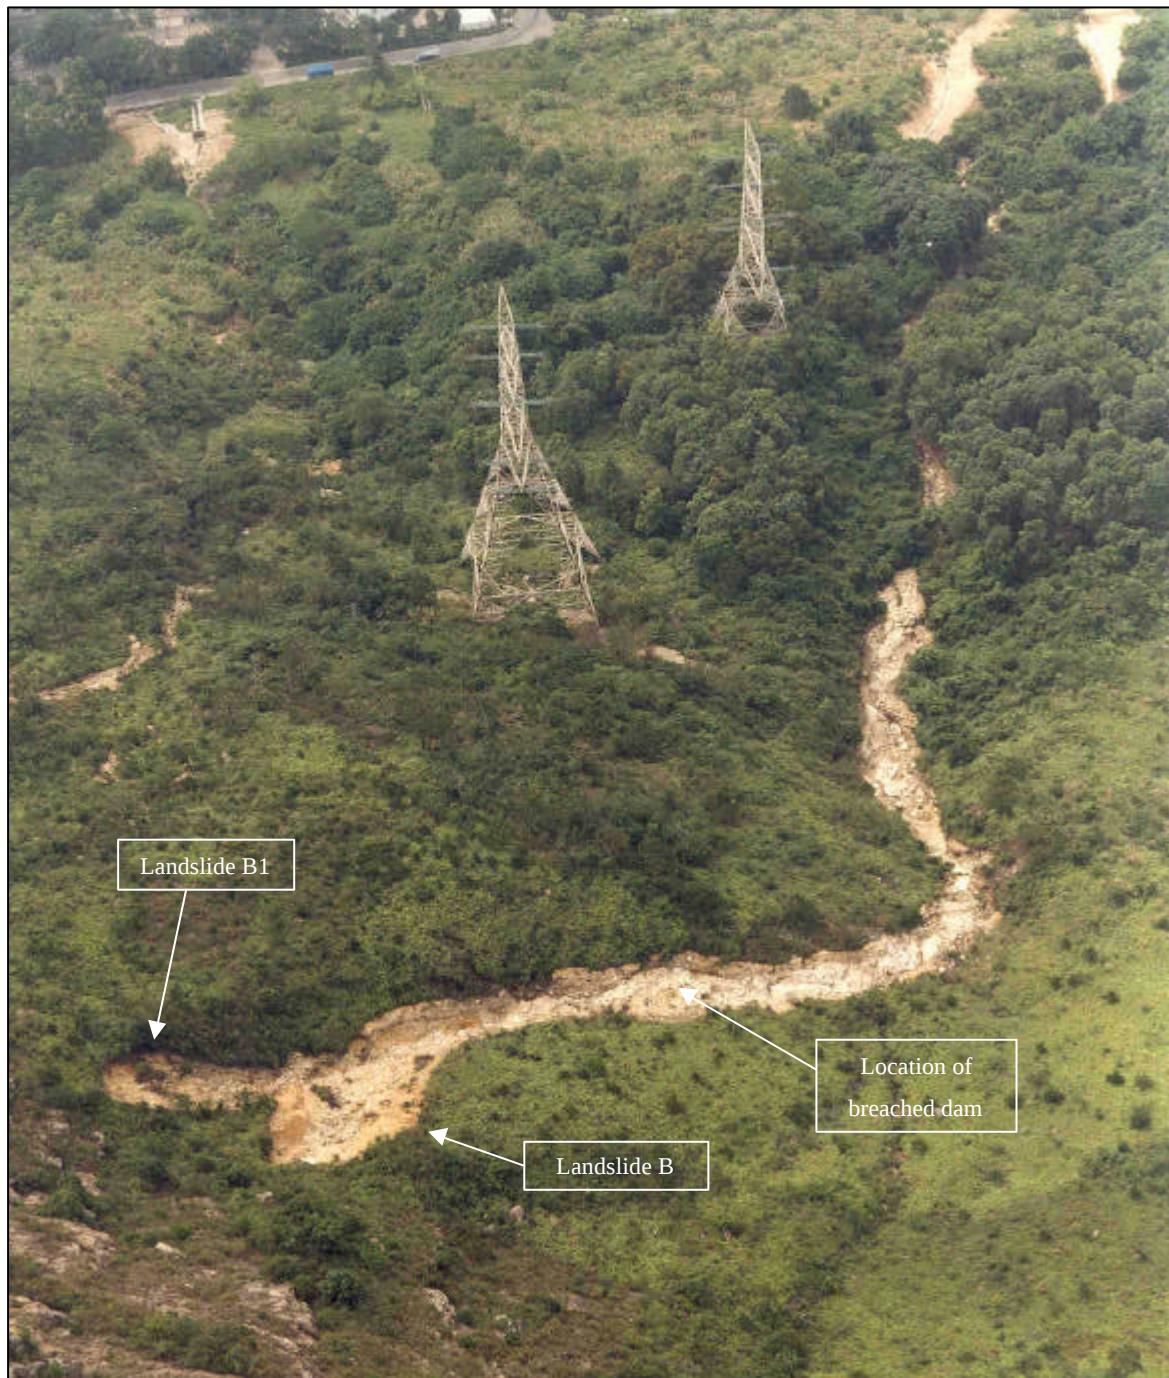
Plate 25 - Oblique Aerial View of the Upper Section of the Debris Trail Below Landslide B  
(Photograph taken on 30 June 2000)

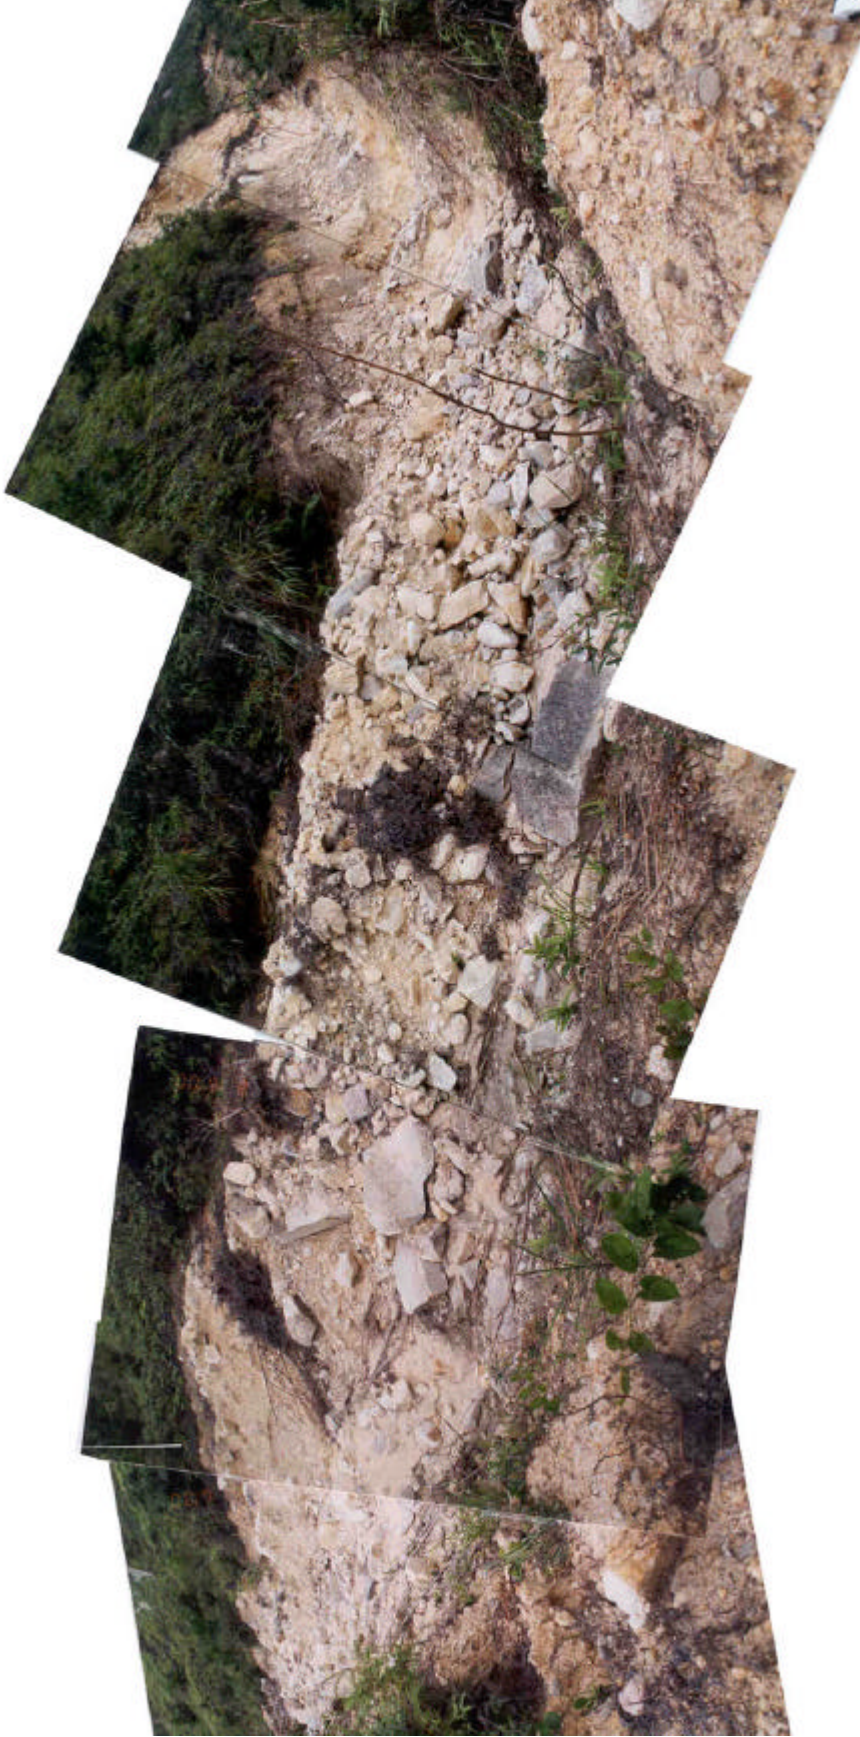
Plate 26 - Possible Breached Dam Below Landslide B Between Chainages 65 and 95  
(Photograph taken on 8 June 2000)

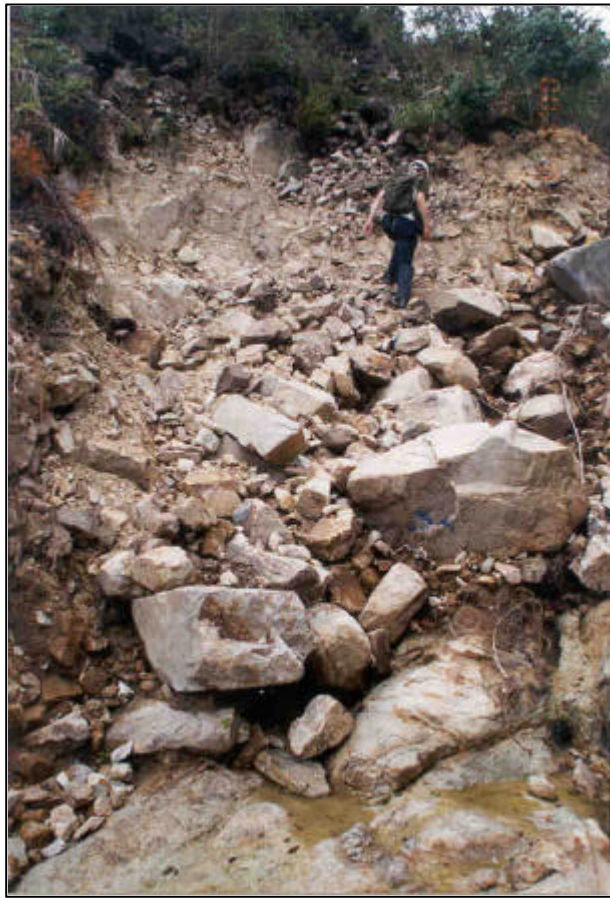
Plate 27 - View of a Minor Failure on Western Flank of  
Drainage Line at Chainage 140  
(Photograph taken on 8 June 2000)

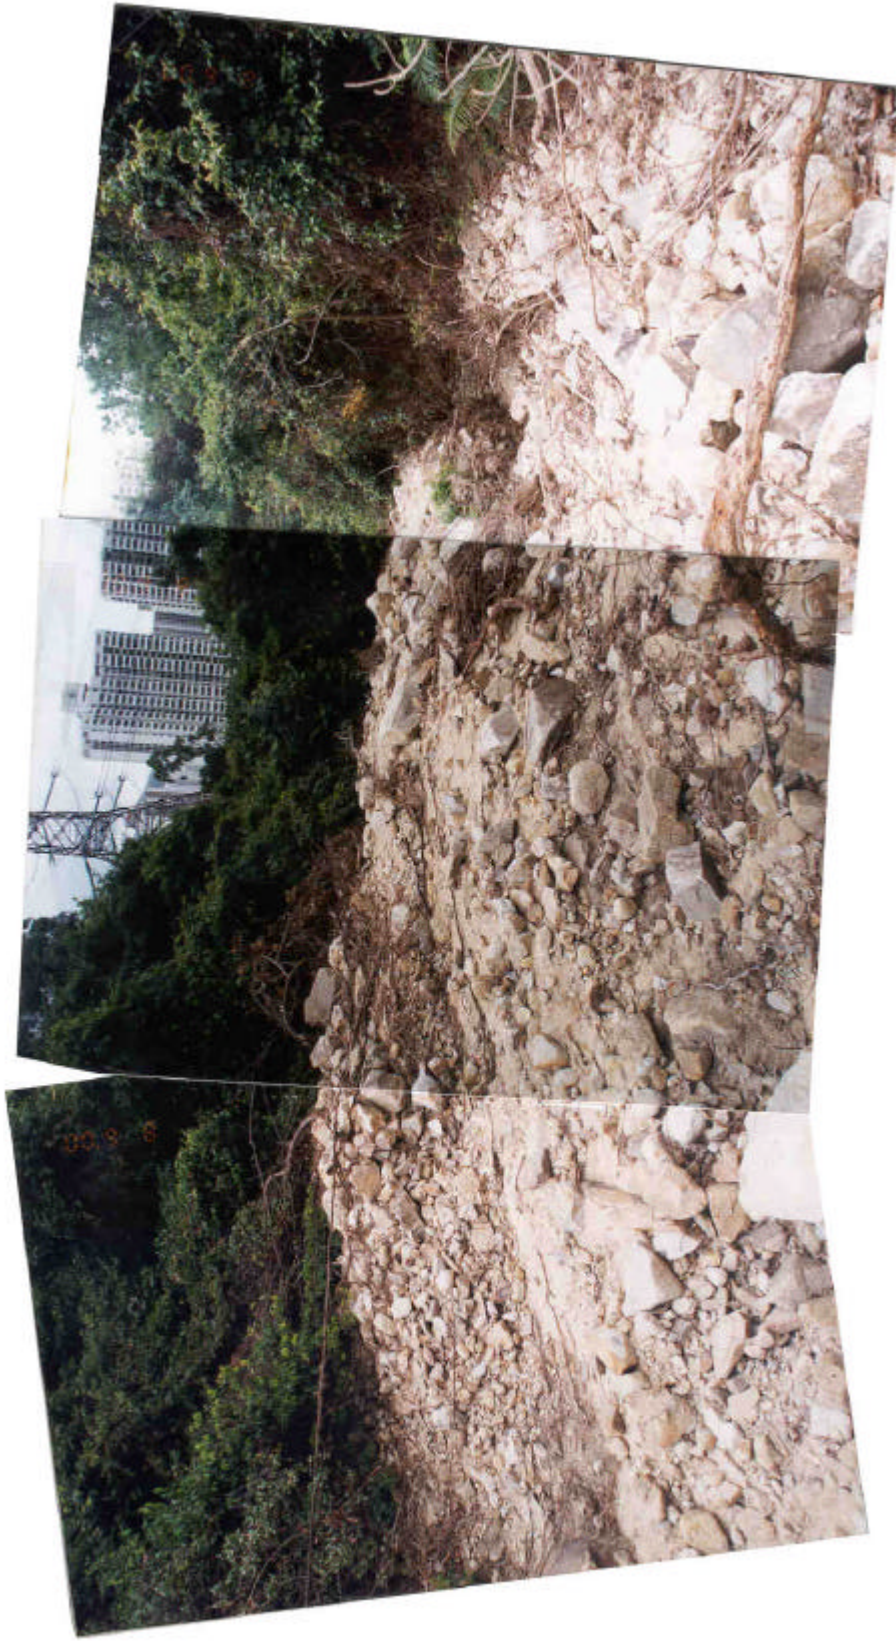
Plate 28 - View of Debris Lobe Located between Chainages 210 and 240  
(Photograph taken on 8 June 2000)

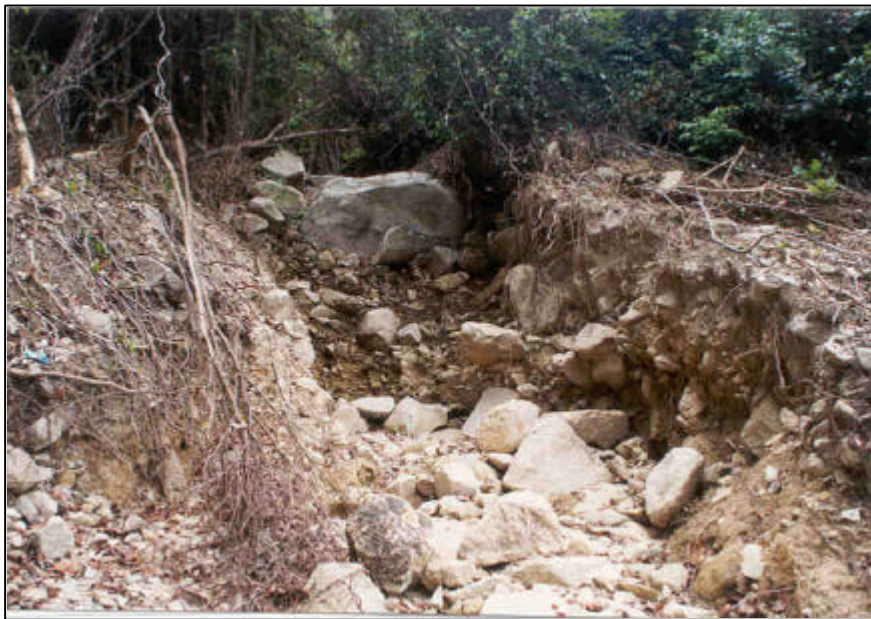
Plate 29 - View of Eroded Channel within the Colluvium Substrate  
(Note the 2 m Diameter Boulder at Chainage 250.  
Photograph taken on 6 June 2000)

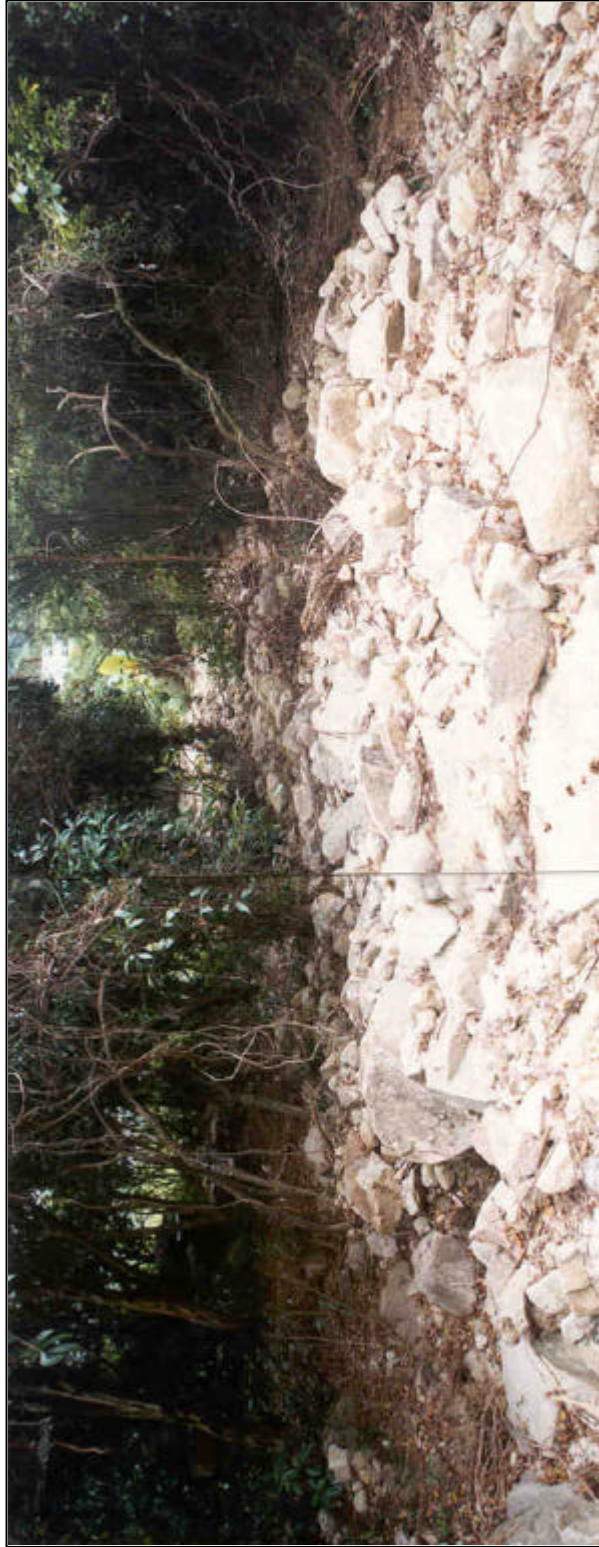
Plate 30 - View of the Distal End of the Debris Lobe Covering the Gently Inclined Slope between Chainages 310 and 360  
(Photograph taken on 6 June 2000)

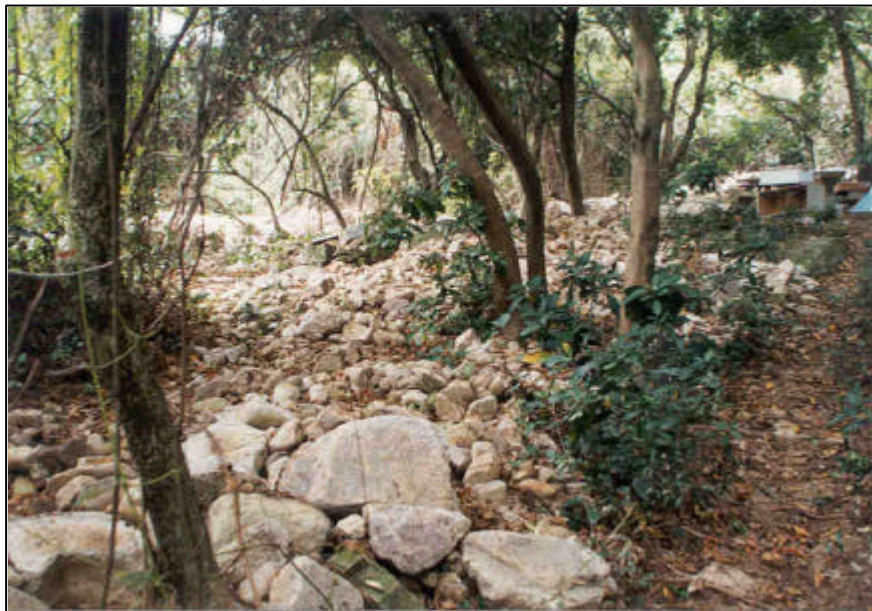
Plate 31 - View of the Sheet Deposit of Sorted Debris  
at the Distal End of the Debris Trail at Chainage 365  
(Photograph taken on 6 June 2000)

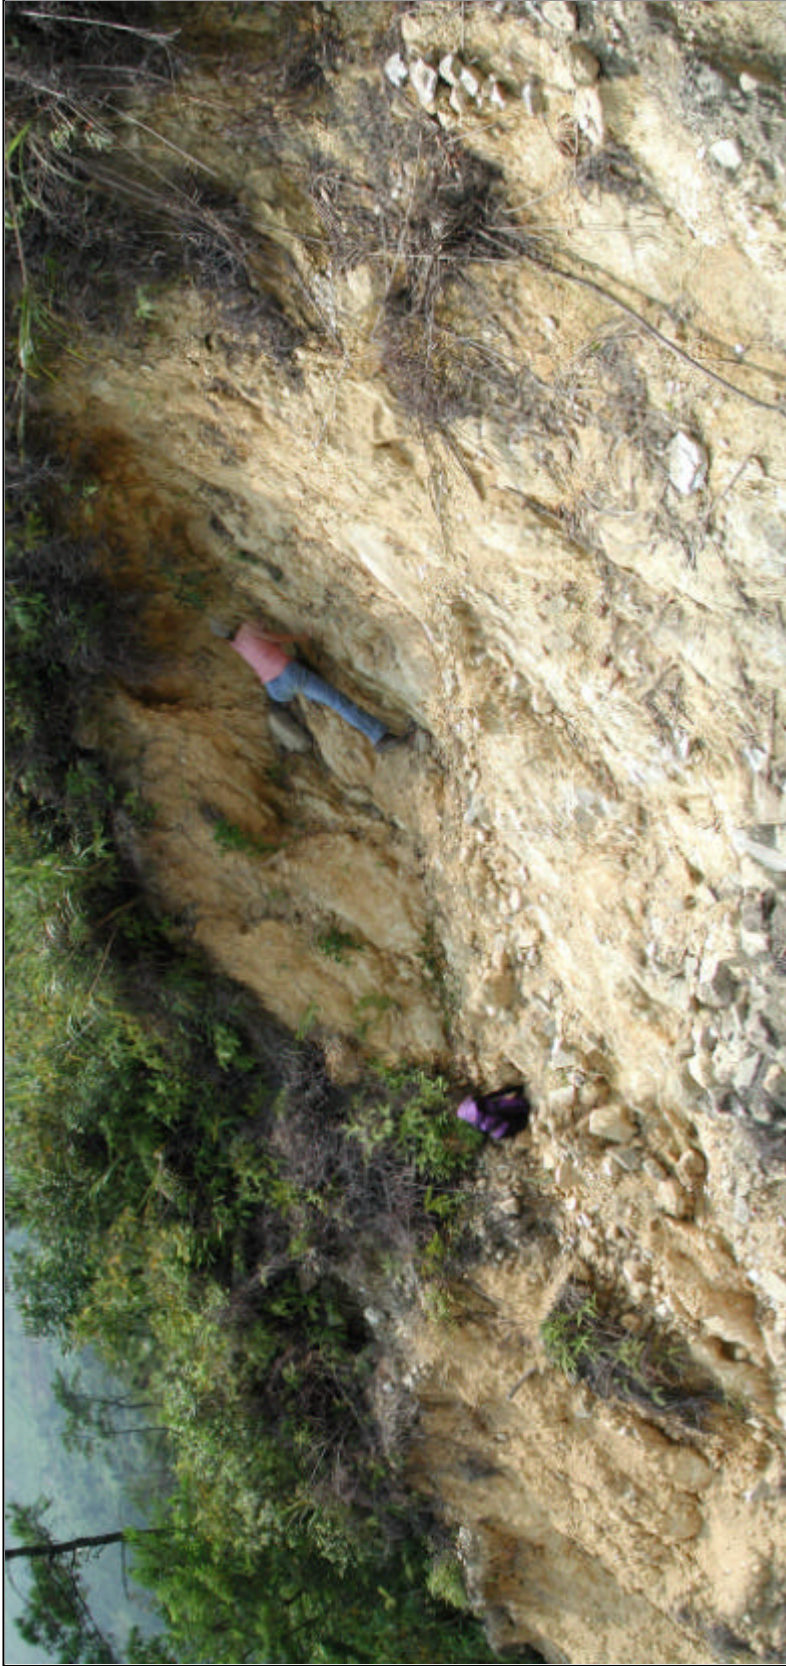
Plate 32 - View of the Western Flank of Landslide C  
(Photograph taken on 18 September 2000)

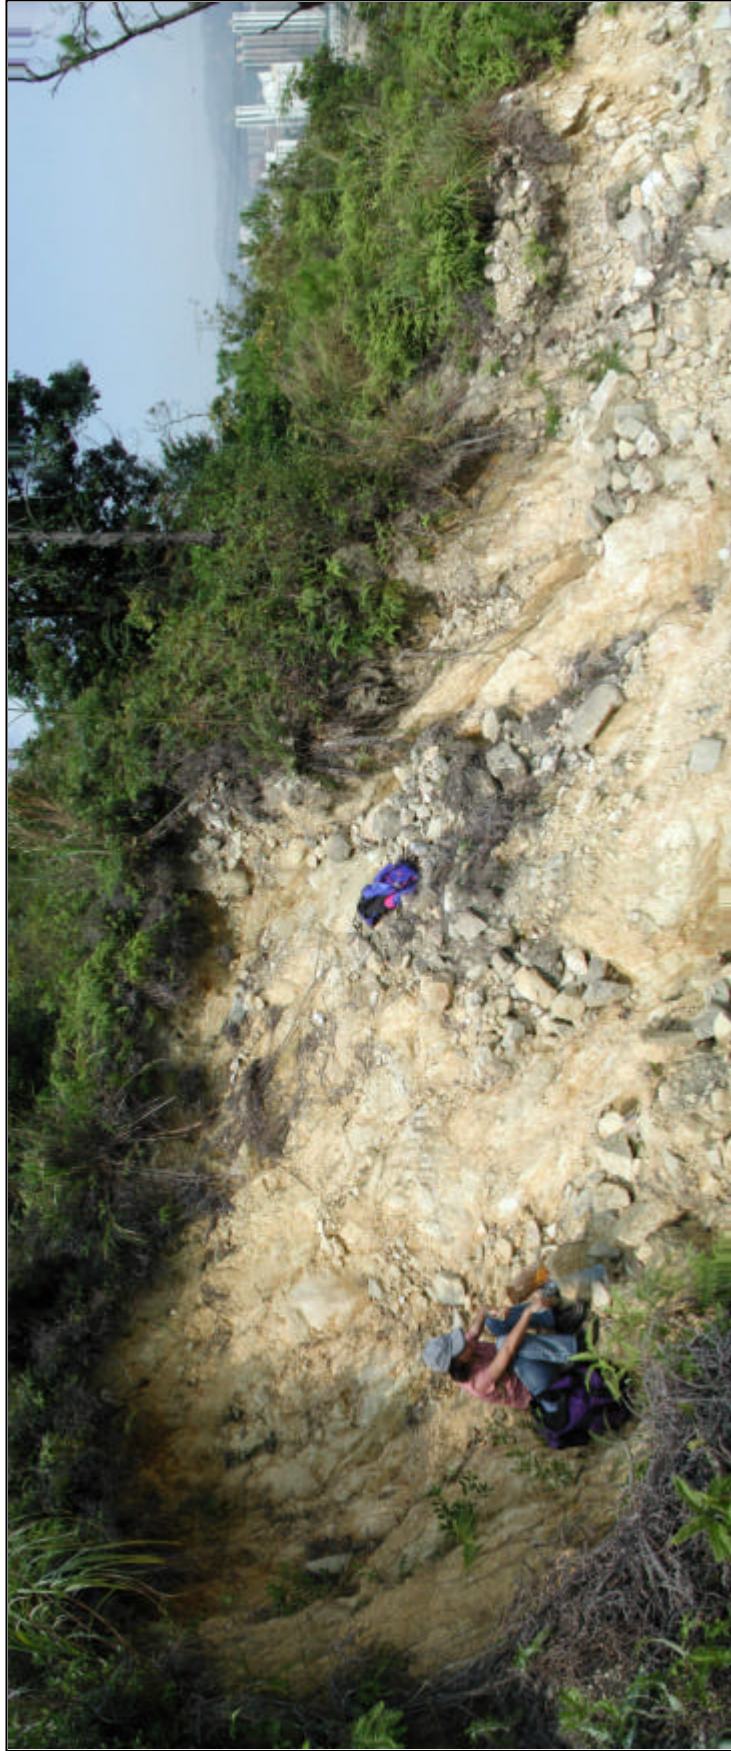
Plate 33 - View of the Eastern Flank of Landslide C  
(Photograph taken on 18 September 2000)

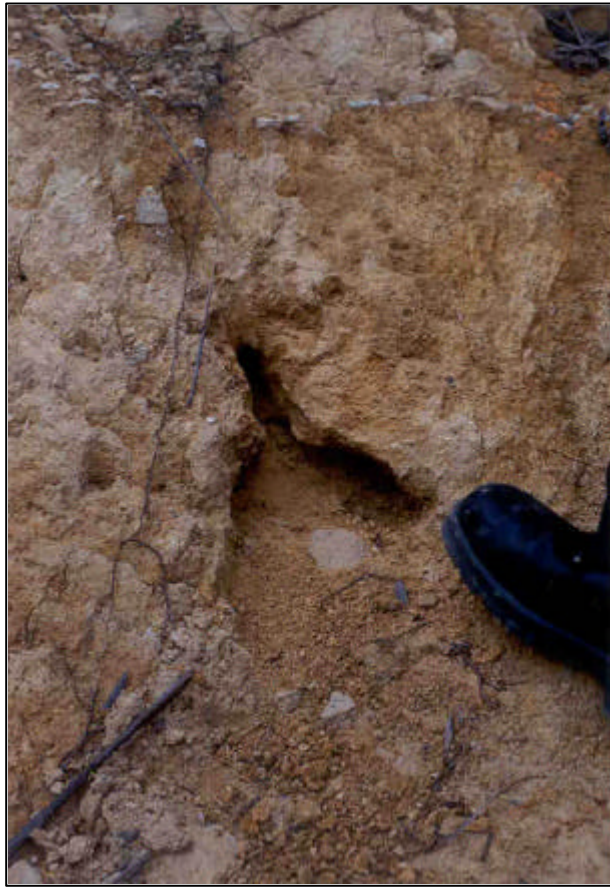
Plate 34 - Erosion Pipe with V-shaped Washout Feature Below  
(Photograph taken on 9 June 2000)

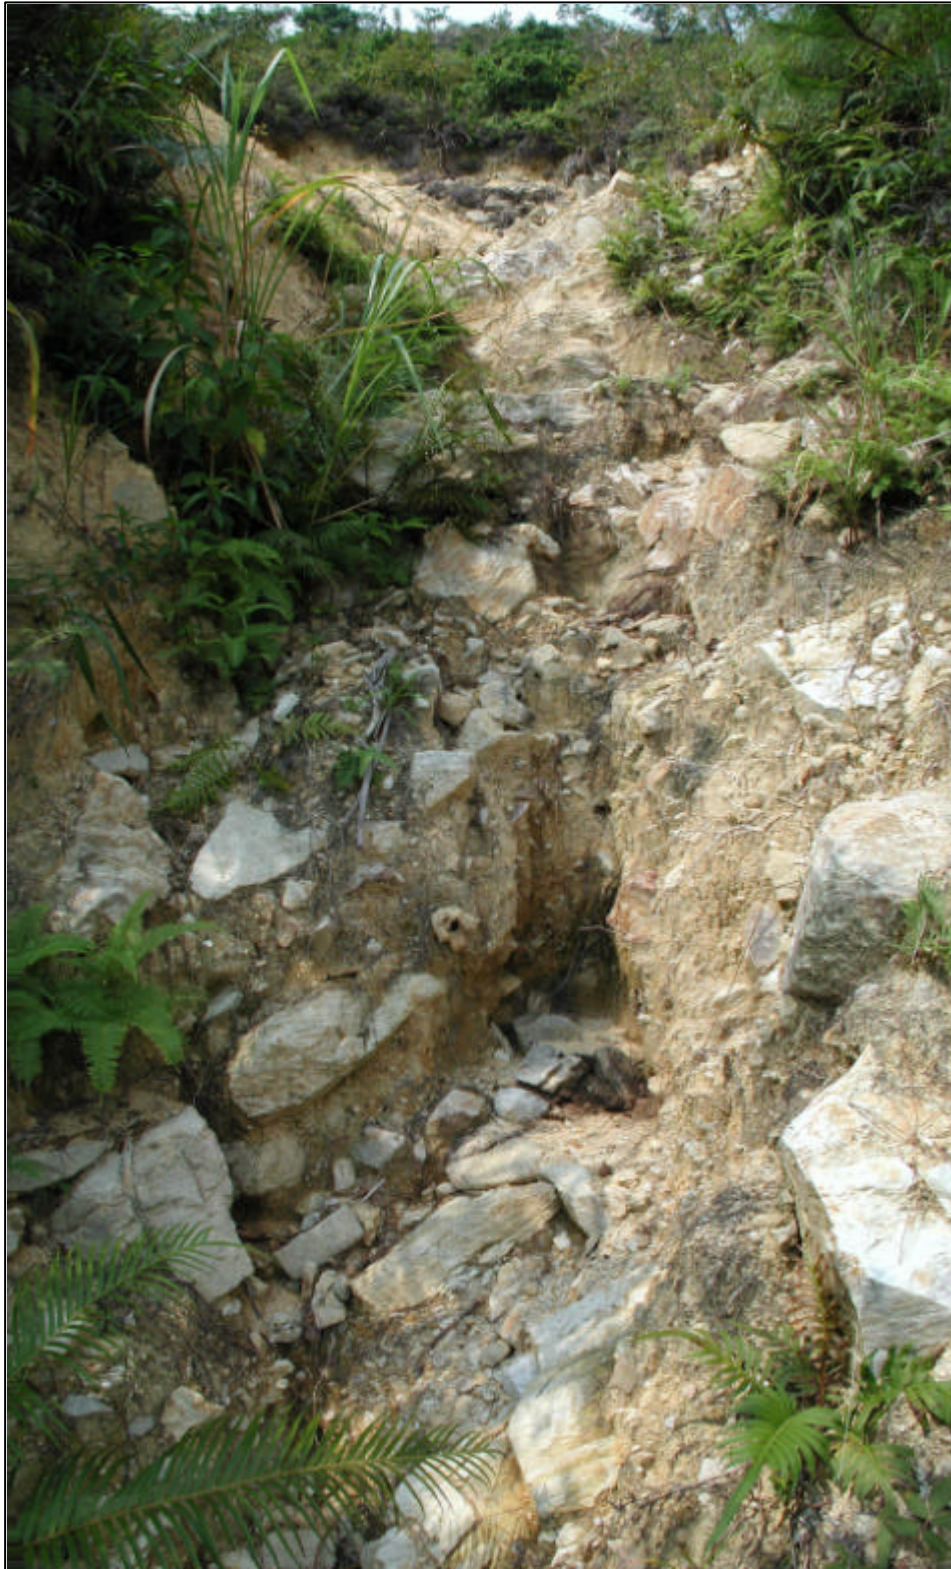
Plate 35 - View of Eroded Channel within Mining Waste Located  
Directly Below the Source Area of Landslide C  
(Photograph taken on 18 September 2000)
