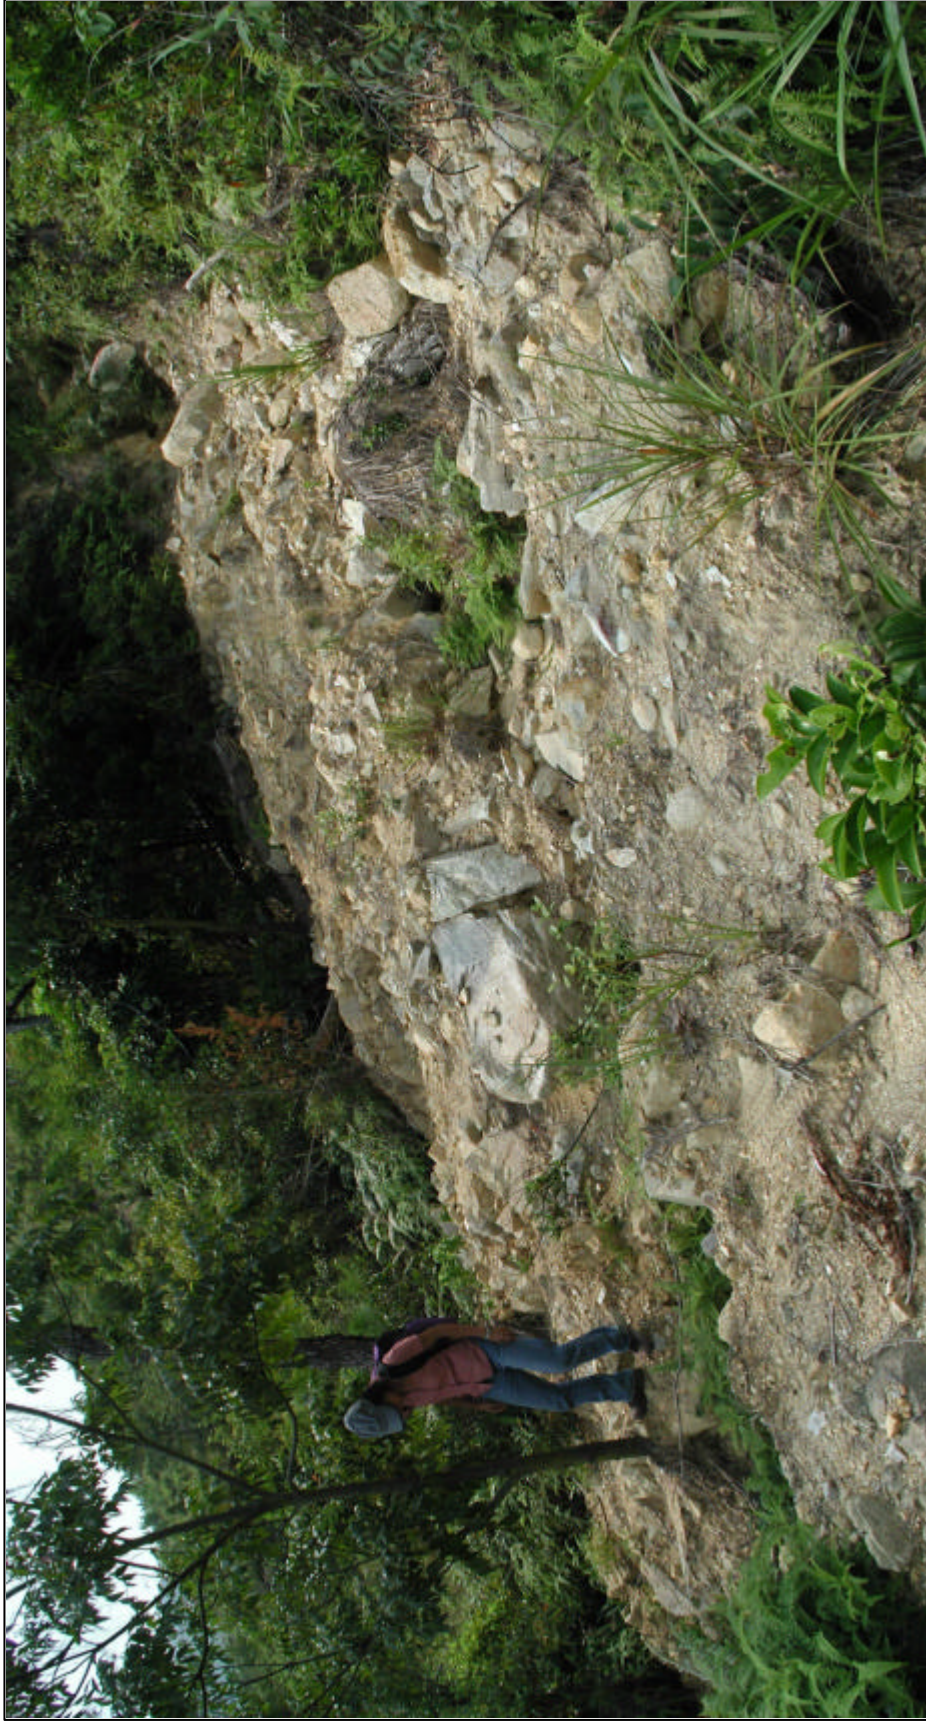
Plate 36 - View of Debris Lobe Below Landslide C between Chainages 45 and 60  
(Photograph taken on 18 September 2000)

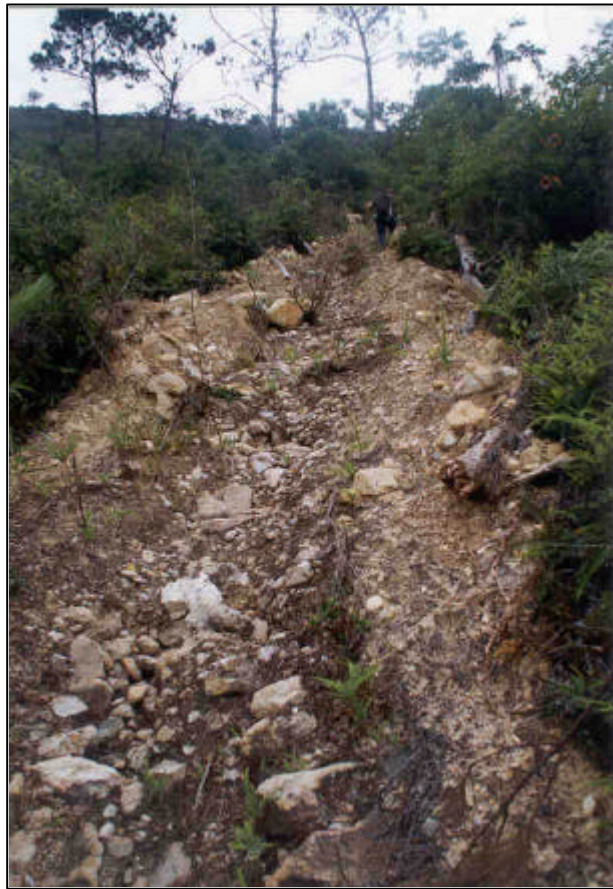
Plate 37 - View of Debris Trail above Chainage 100.  
(Note Parallel Debris Lobes Flanking Eroded Channel.  
Photograph taken on 9 June 2000)

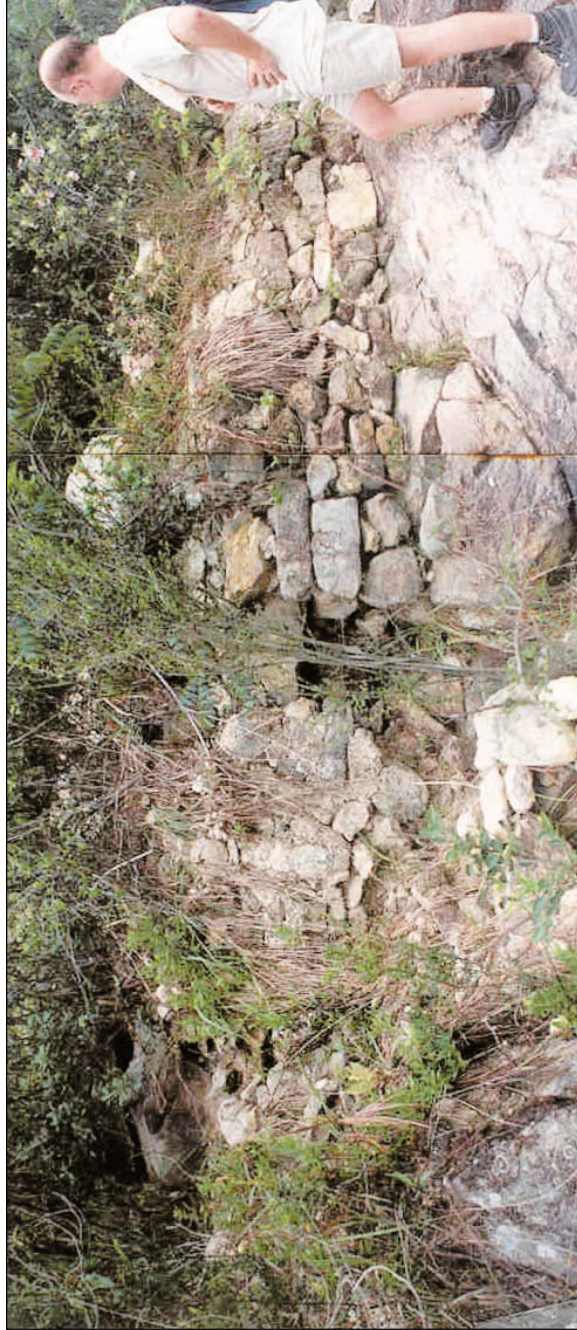
Plate 38 - View of Random Rubble Retaining Wall at Chainage 106  
(Photograph taken on 9 June 2000)

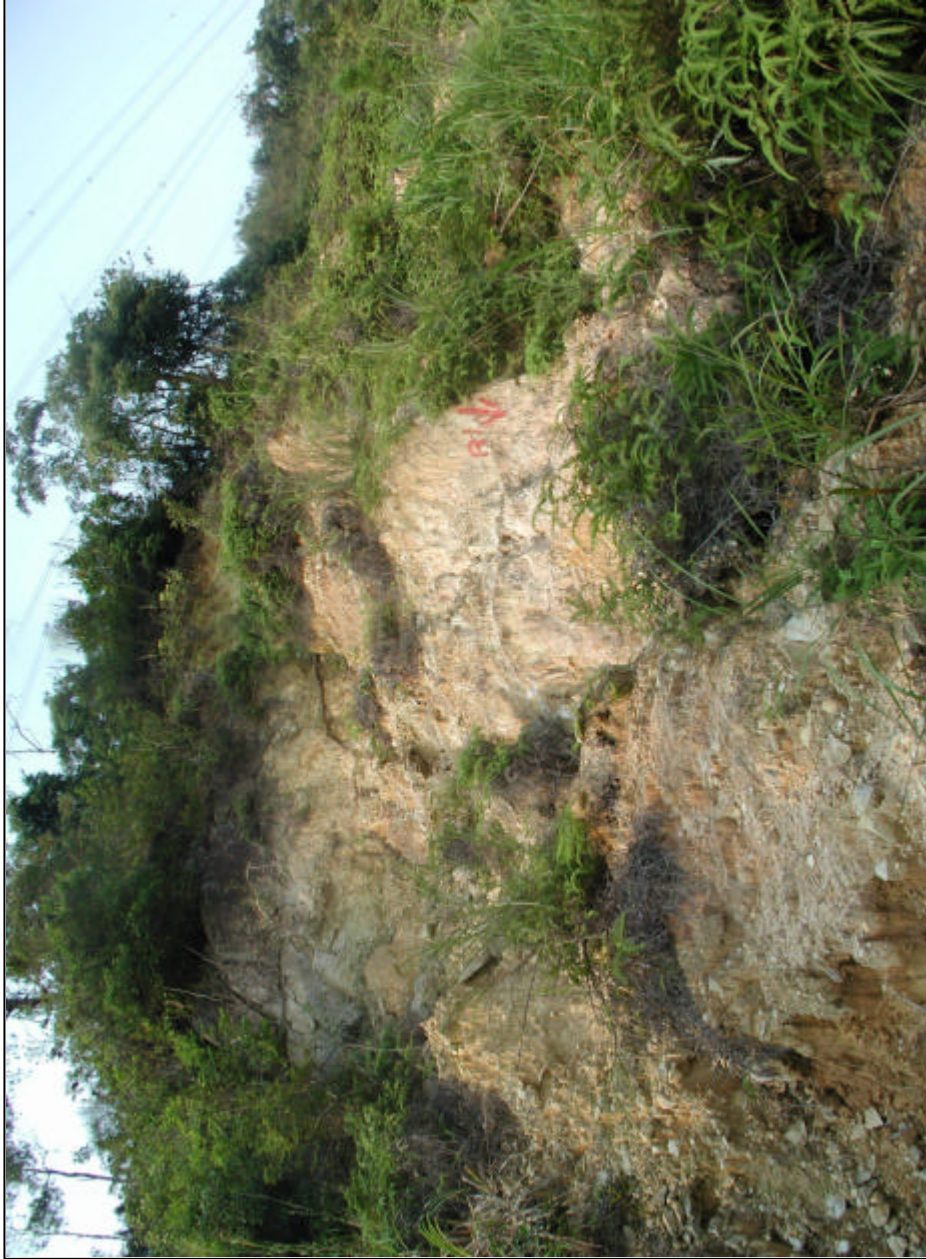
Plate 39 - General View of Landslide C3  
(Photograph taken on 24 October 2000)

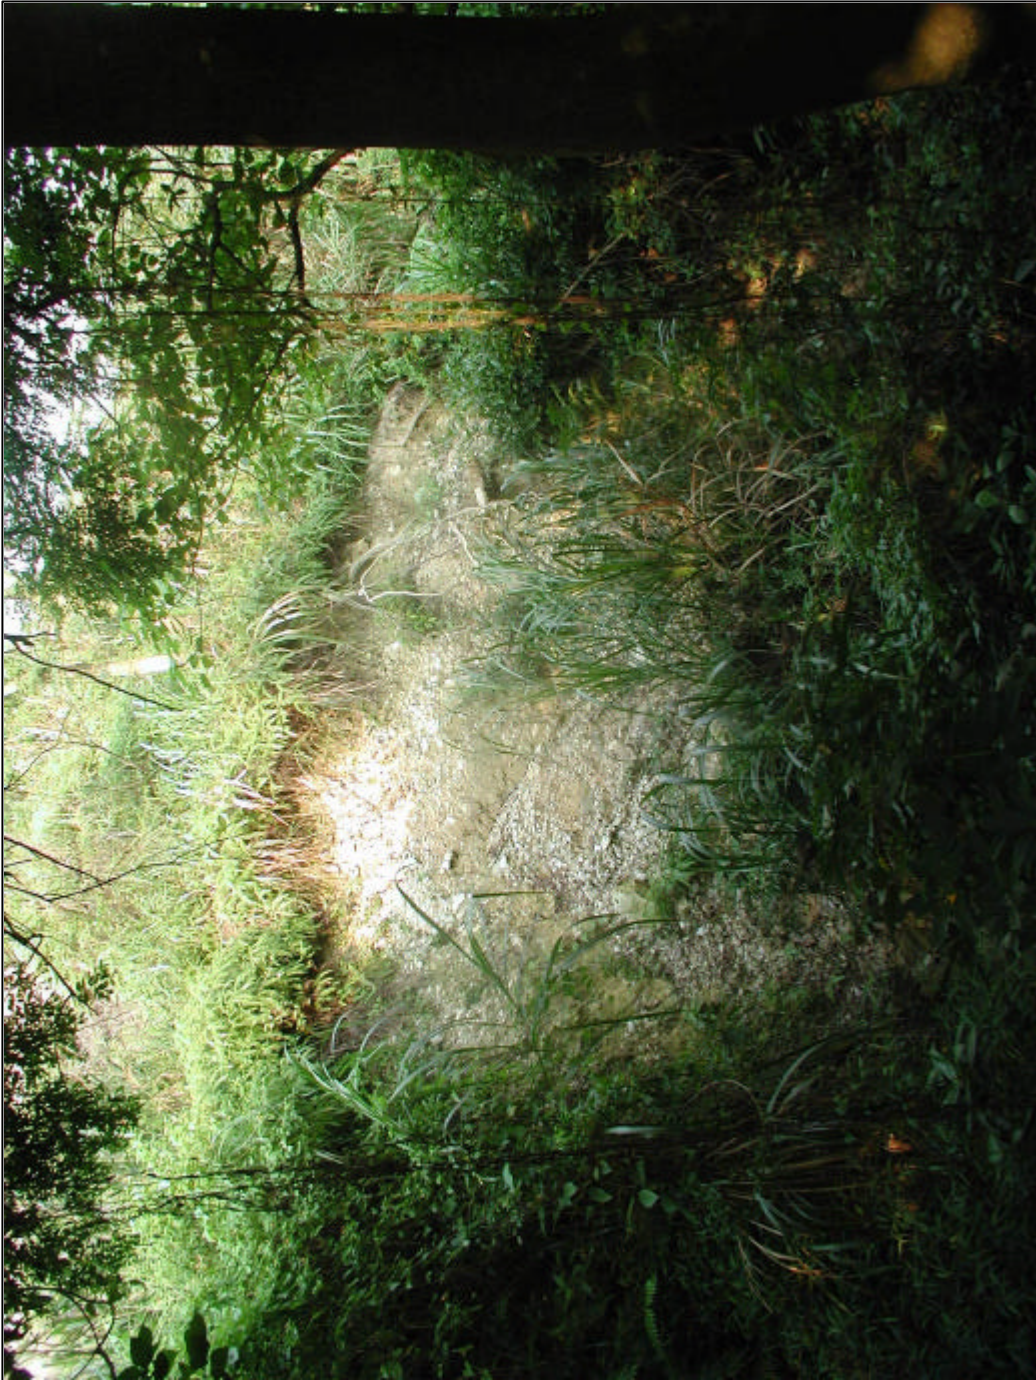
Plate 40 - General View of Landslide C4  
(Photograph taken on 24 October 2000)

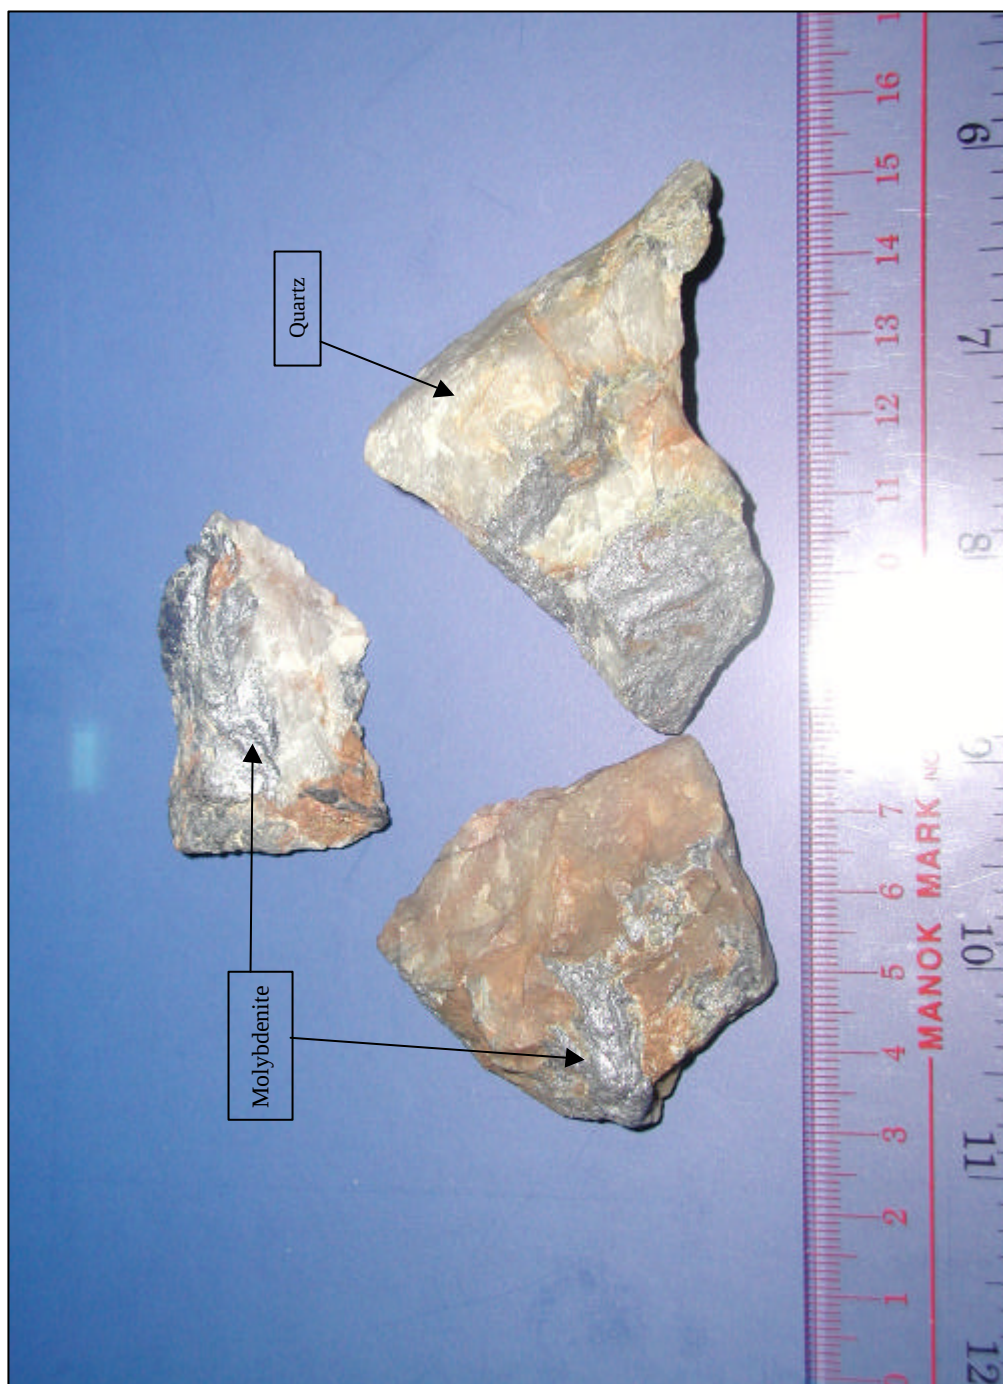
Plate 41 - Samples of Molybdenite and Quartz Found within the Mining Waste Below Landslide C  
(Photograph taken on 24 October 2000)

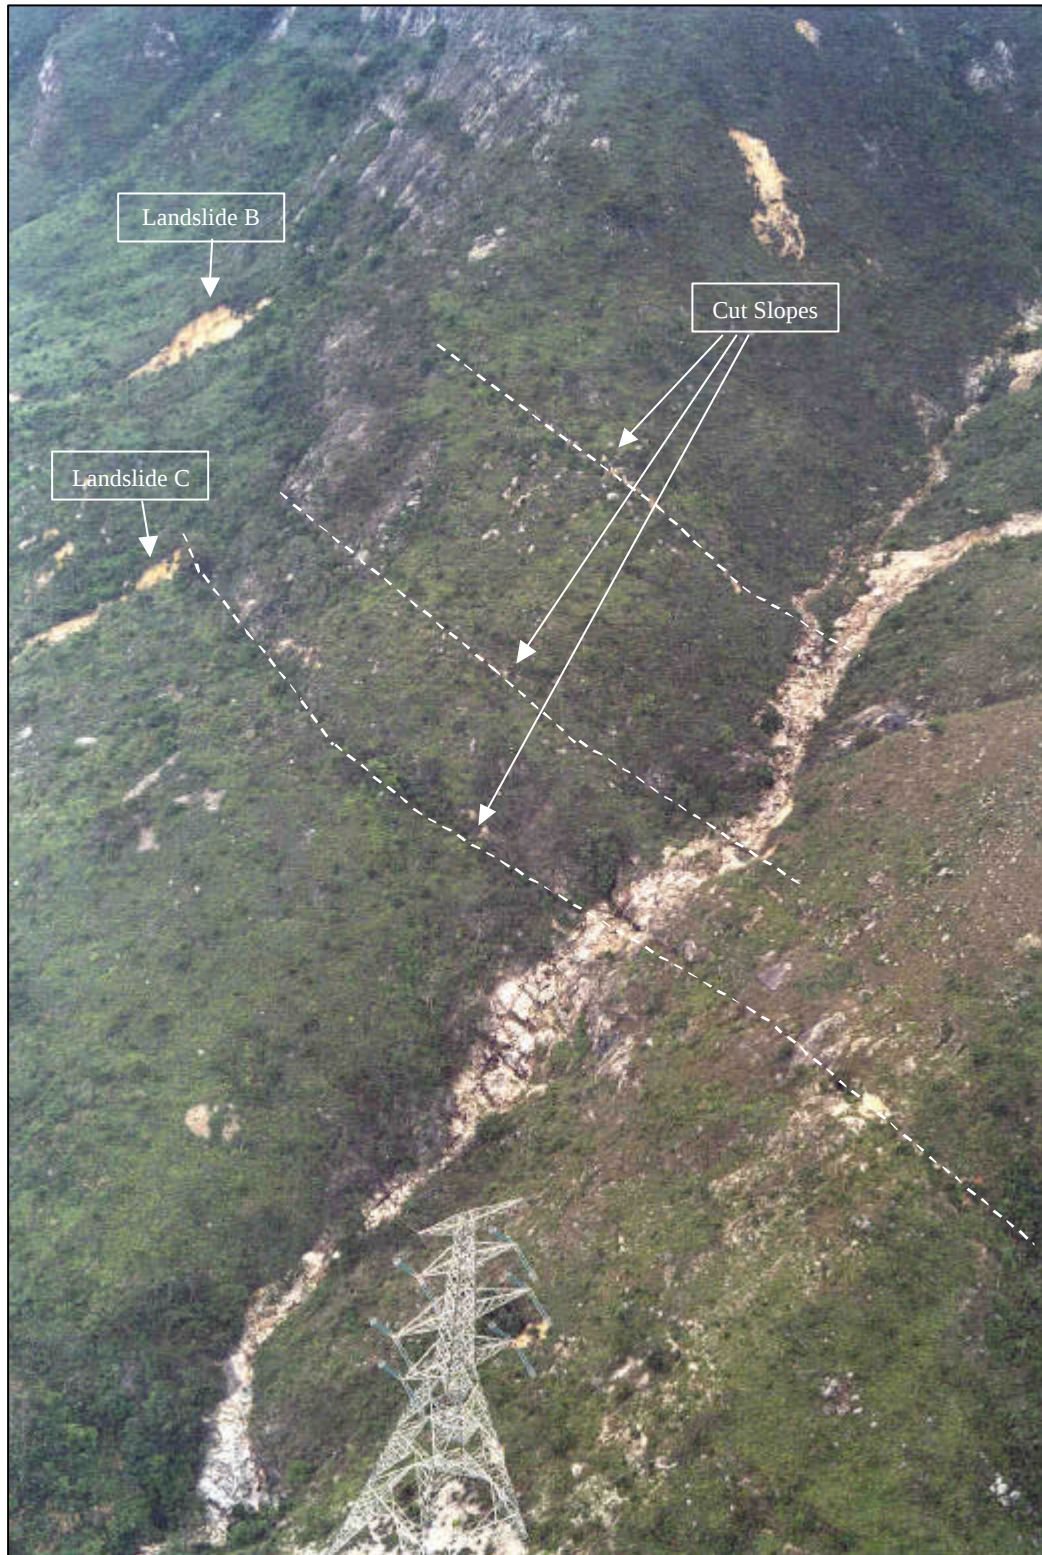
Plate 42 - Oblique Aerial View Showing the Cut Slopes Formed  
During the Mining Works before 1945  
(Photograph taken on 30 June 2000)

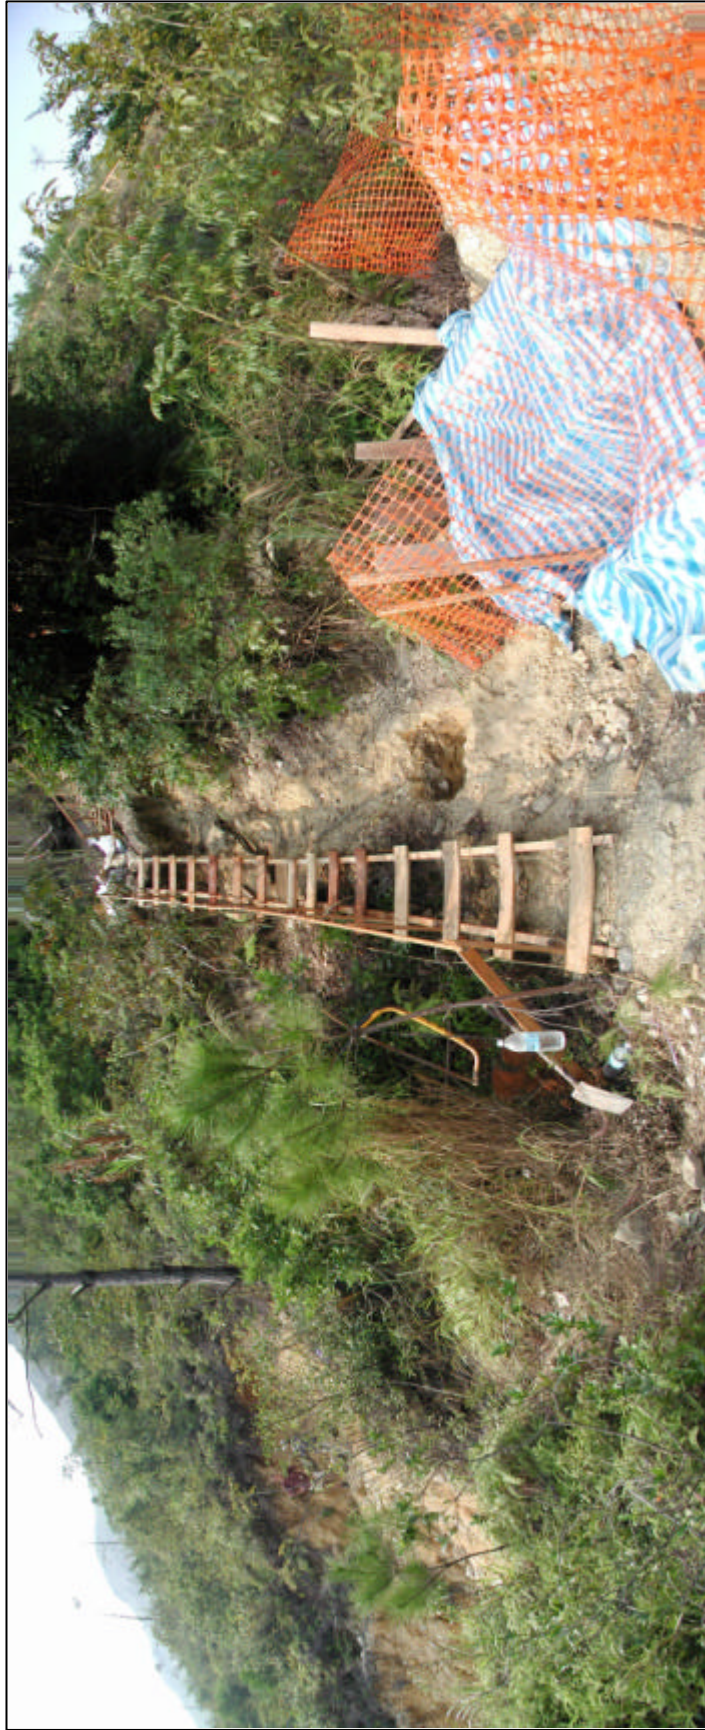
Plate 43 - Panoramic View of the Mining Cut Slope to the East of Landslide C  
(Note Landslide C on the Left, Slope Strip LKSS4 in the Centre and Trial Pit LKTP6 on the Right.  
Photograph taken on 24 October 2000)

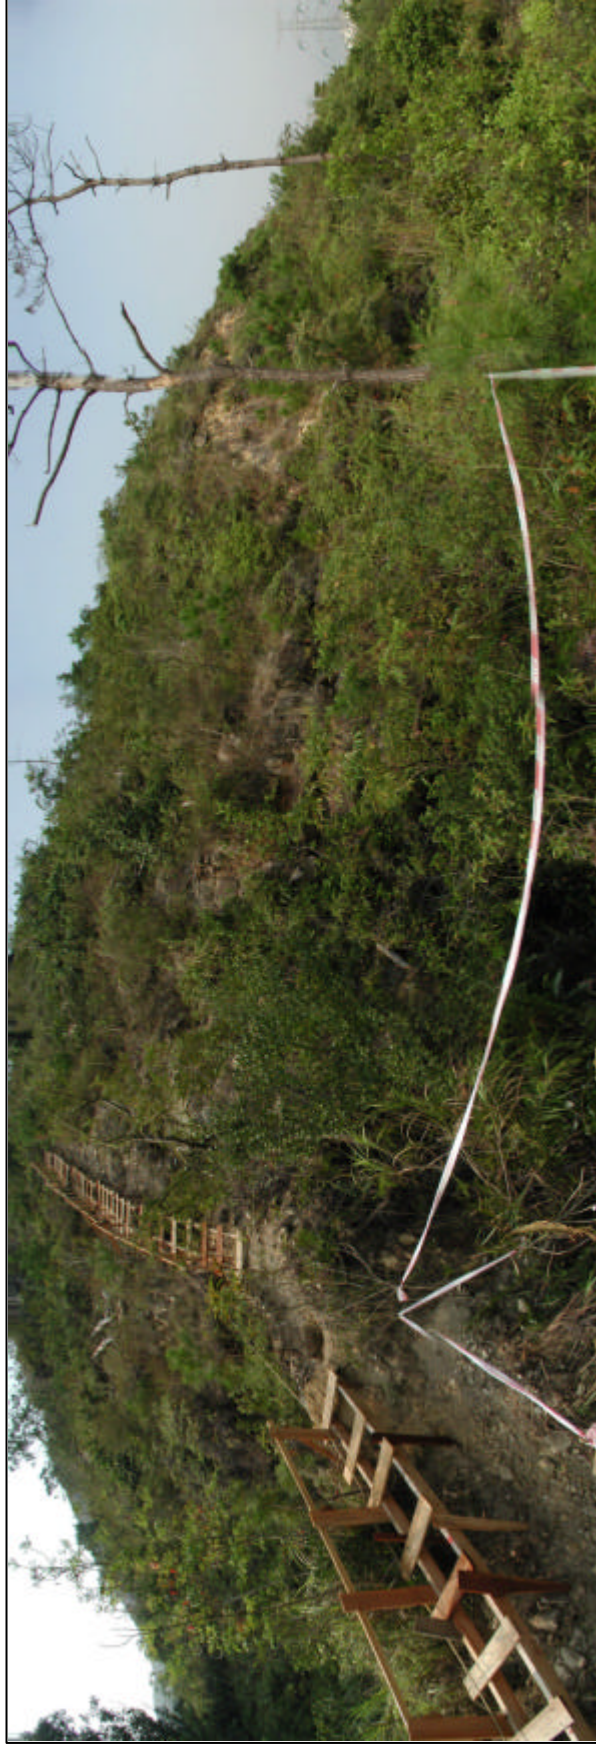
Plate 44 - Panoramic View of the Mining Cut Slope About 30 m to the East of Landslide C  
(Note Slope Strip LKSS5 and Mining Excavation in the Foreground.  
Photograph taken on 24 October 2000)
