**REPORT ON THE
INVESTIGATION OF
KAOLIN-RICH ZONES
IN WEATHERED ROCKS
IN HONG KONG**

GEO REPORT No. 132

**GEOTECHNICAL ENGINEERING OFFICE
CIVIL ENGINEERING DEPARTMENT
THE GOVERNMENT OF THE HONG KONG
SPECIAL ADMINISTRATIVE REGION**

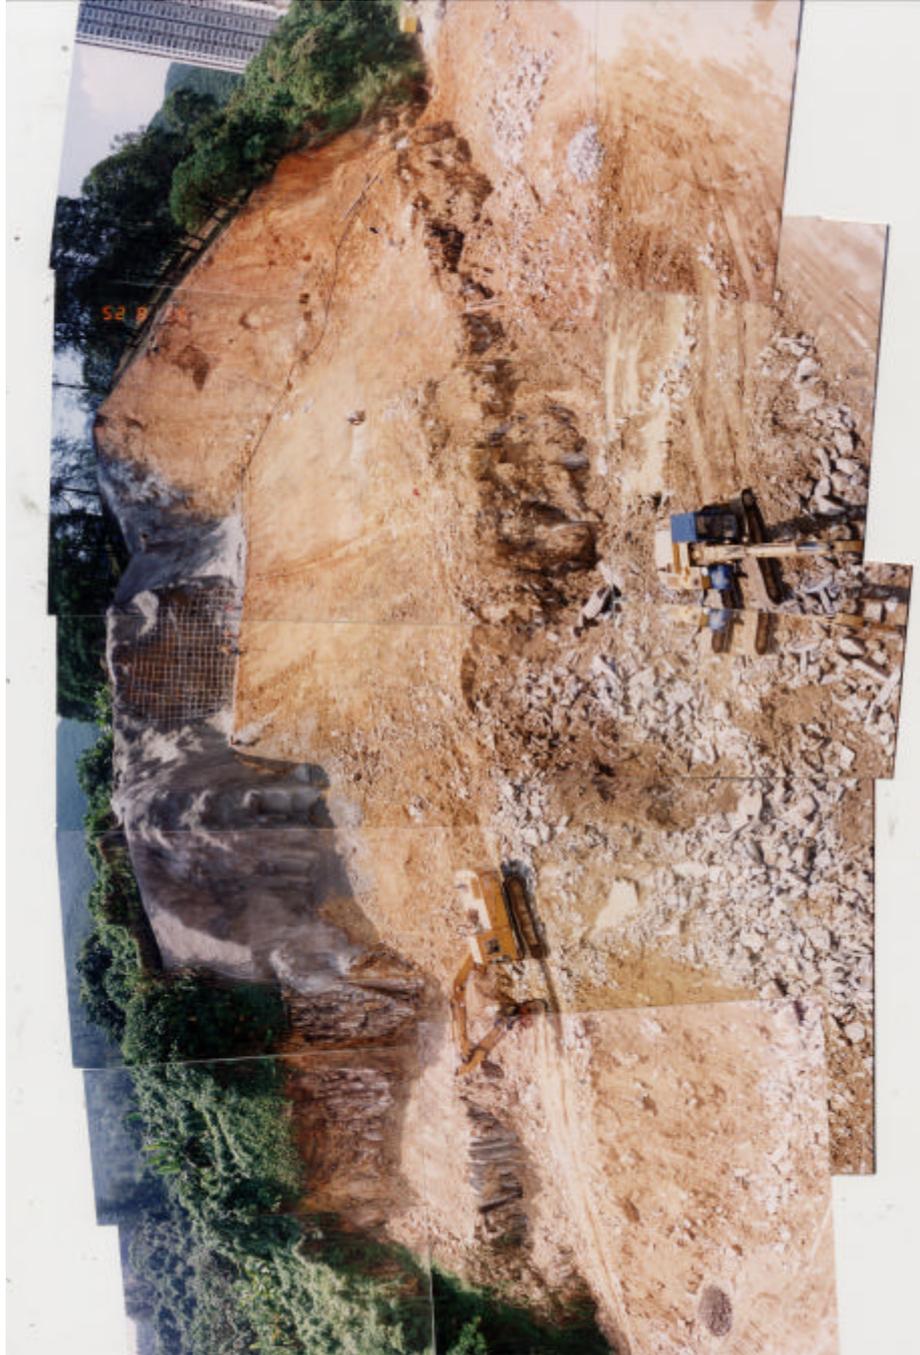
Plate 1 - Fei Tsui Road Landslide, August 13, 1995 (Shown Schematically in Figure 5)

On 13 August, 1995, two large landslides that were land influenced by kaolin-rich zones occurred in Hong Kong. The first (Plate 1), at Fei Tsui Road in Chai Wan, released about 14 000 m³ of debris and resulted in one fatality. The second (Plate 2), at Shum Wan Road near Aberdeen, had a volume of 26 000 m³ and caused two fatalities. Following the landslides, the Geotechnical Engineering Office (GEO) carried out a series of studies to improve understanding of the origin, distribution and characteristics of kaolin-rich zones in weathered rocks, which may adversely affect slope stability. The studies were completed in 2001 and have been separately documented in reports published by the GEO.

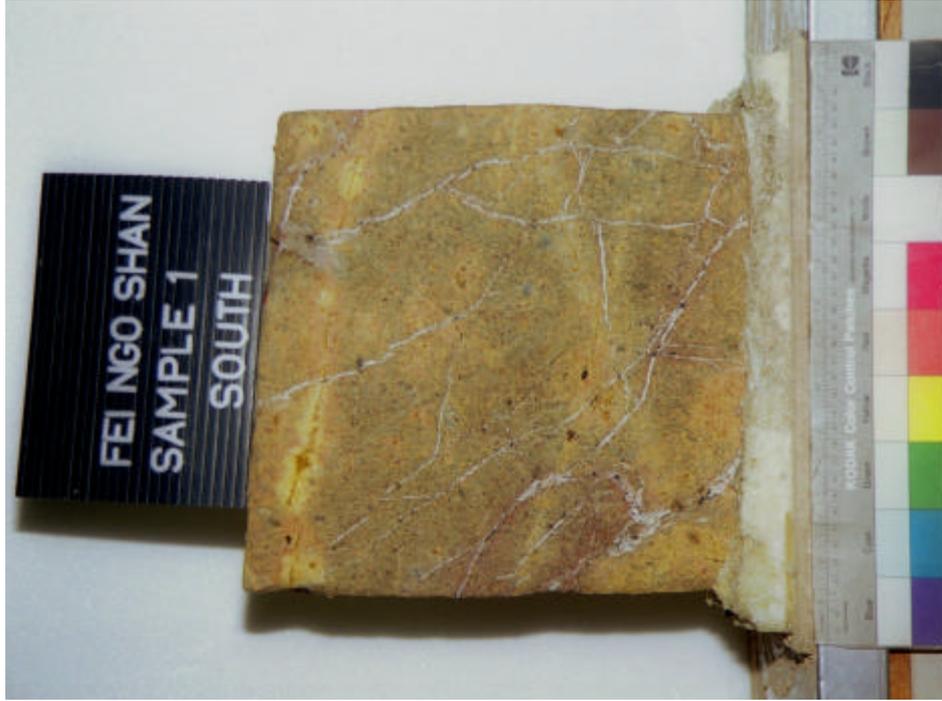
Plate 6 (a) - Southern Face of Block Sample S1, Fei Ngo Shan Completely Decomposed Fine Ash Tuff. Note Box-work Structure of White Veins

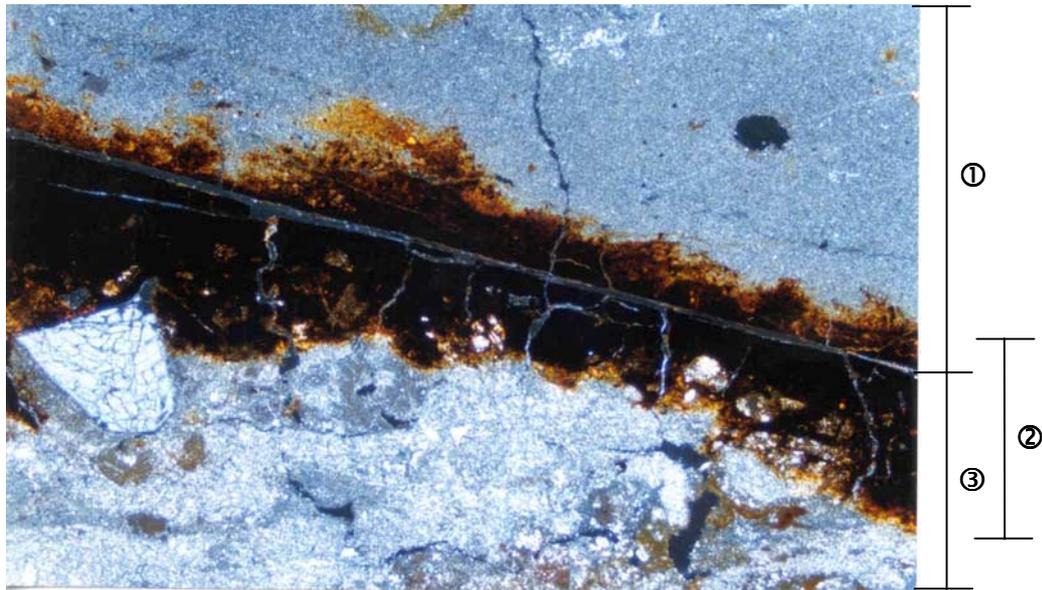
Plate 7 (a) - Optical Micrograph of Thin Section from SSR-D1, Sai Sha Road. Intense Manganese Oxide Staining ② of Ultrafine Kaolin ① and Kaolinised Tuff ③ along Shear Plane. Width of View 6.35 mm (after CSIRO, 2000)

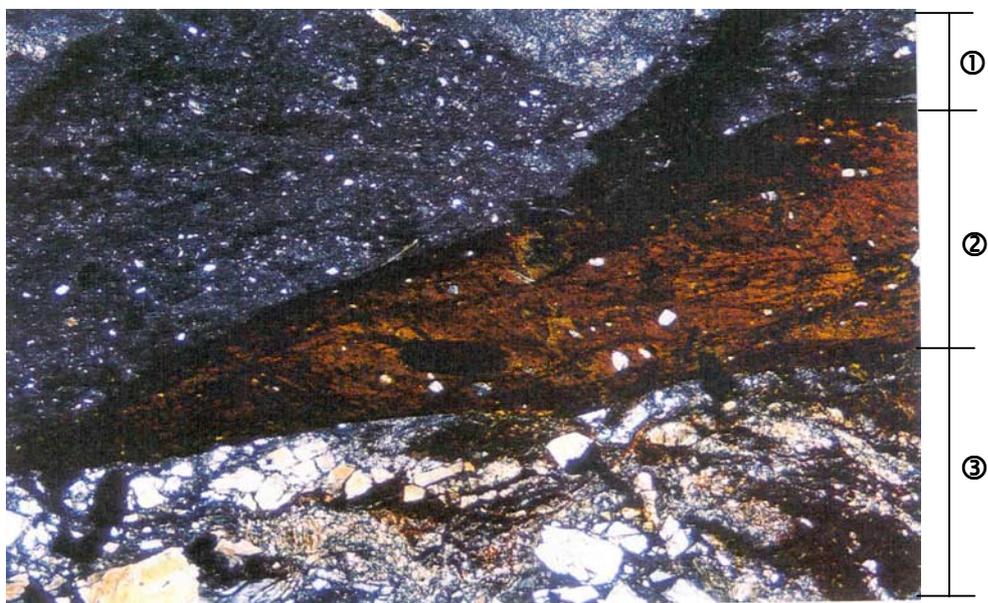
Plate 7 (b) - Optical Micrograph of Thin Section from S2, Shek Kip Mei, Manganese Oxide Stained Foliated Kaolin ② at Base of White Kaolin Infill ① overlying Brecciated Granite ③. Width of View 6.35 mm (after CSIRO, 2000)

suggesting that the manganese was a constraint to further halloysite development and as a result, kaolinite formed. This interpretation was supported by the manganese oxide staining having been constrained to the immediate zone of shearing (Plate 7b) (CSIRO, 2000).

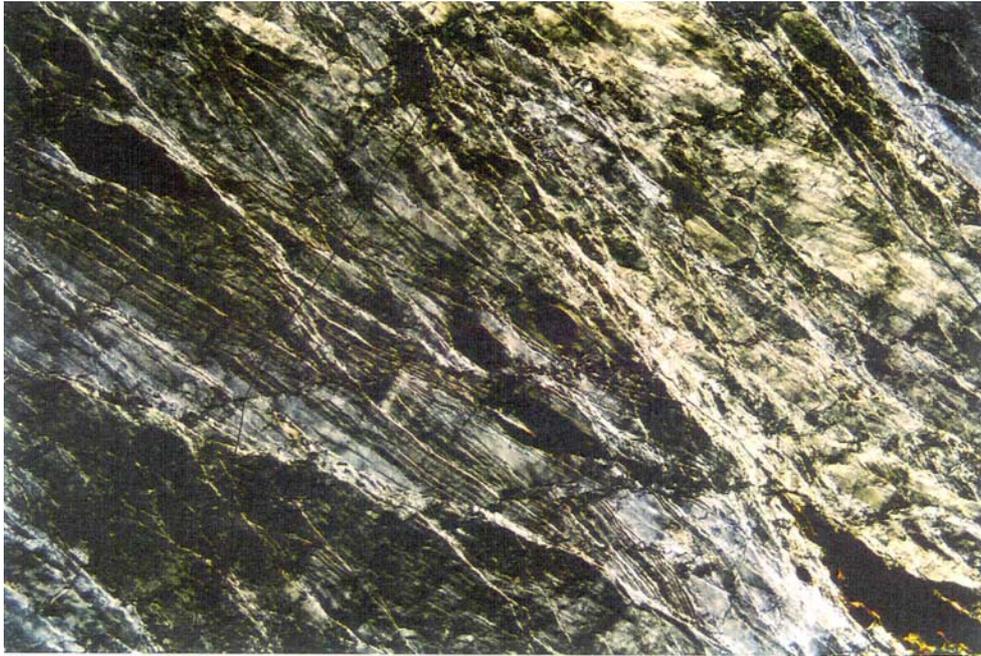
Plate 8 (c) - Optical Micrograph of Thin Section from S12, Shum Wan Road.
Complex Shear Foliation and Brecciation. Width of View
6.35 mm (after CSIRO, 2000)

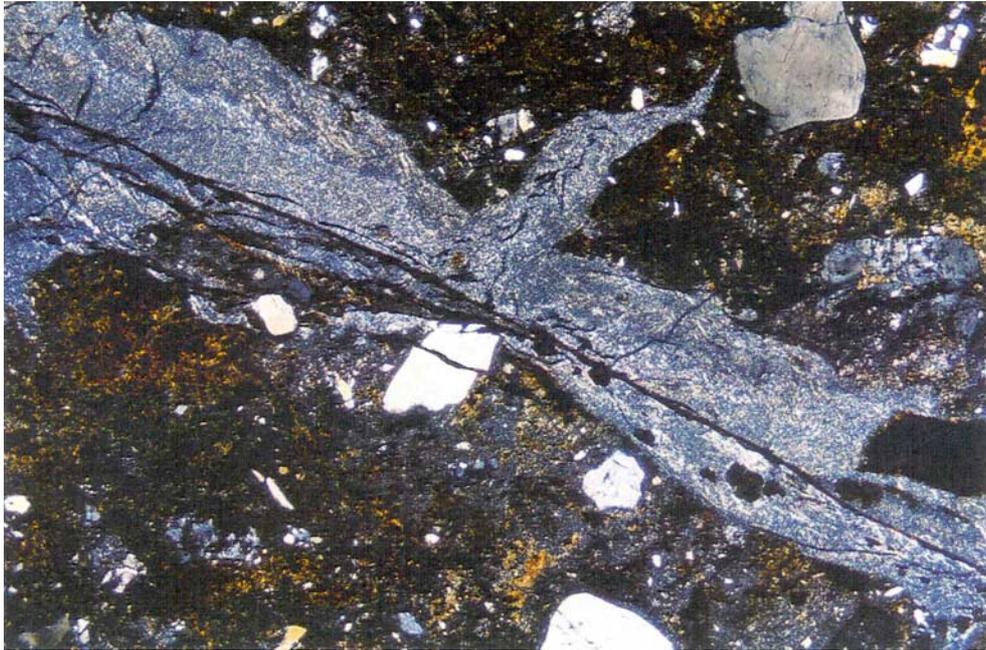
Plate 8 (e) - Optical Micrograph of Thin Section from S1, Fei Ngo Shan. Shear Deformation through Kaolin Infill. Width of View 6.35 mm (after CSRIO, 1999)

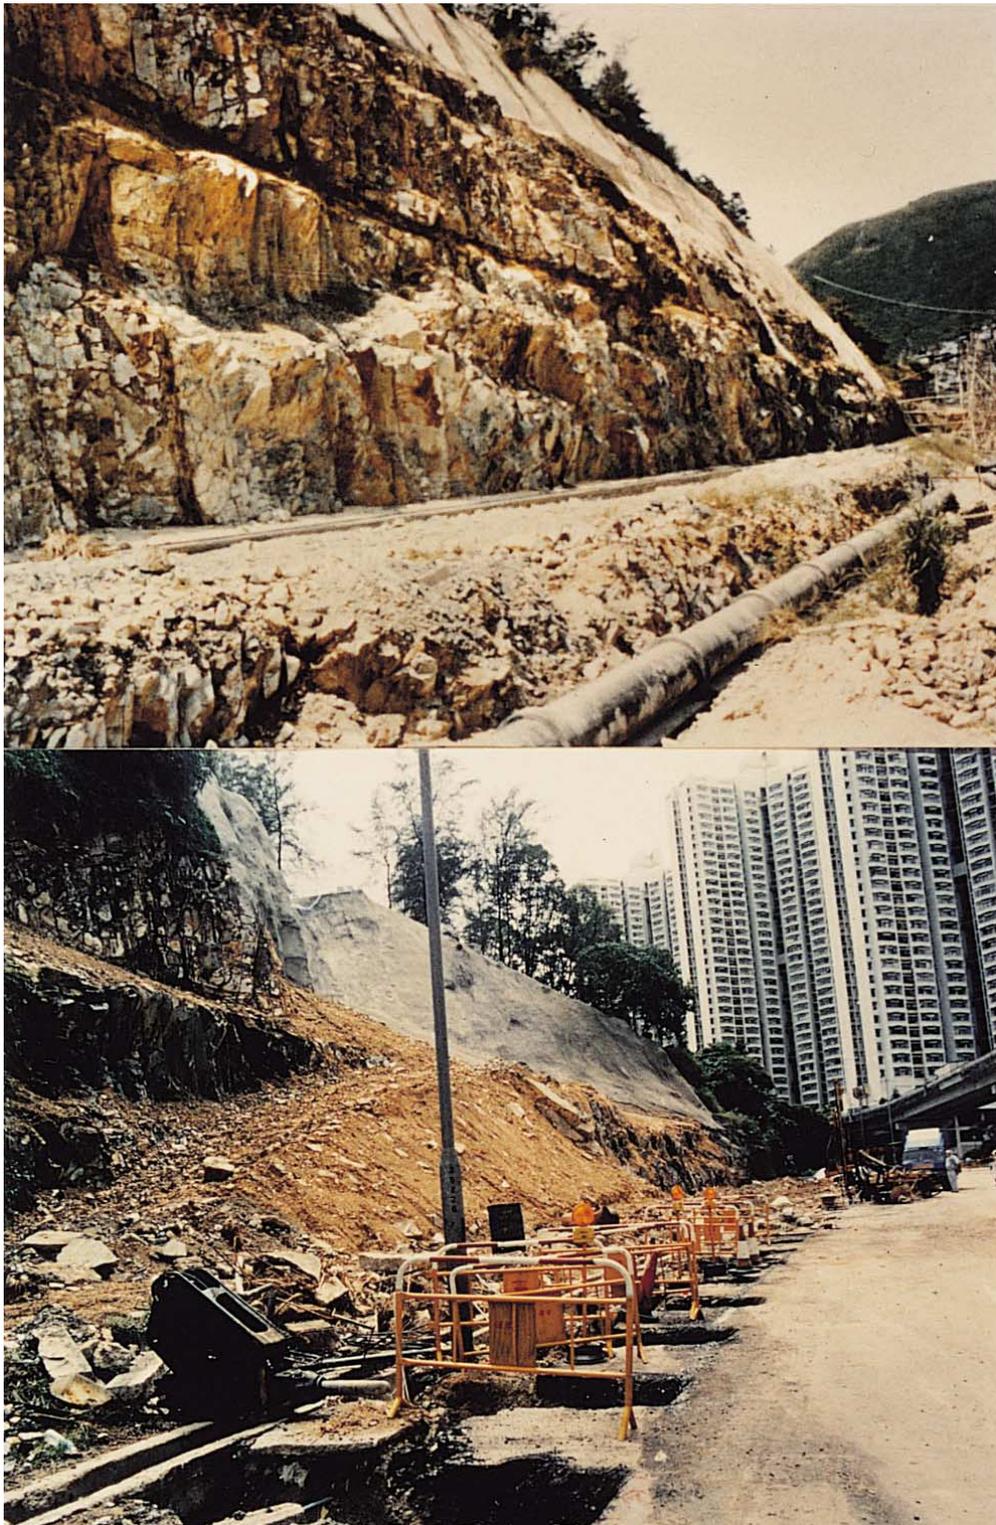
Plate 10 - Views Southwest towards Cut Slope at Fei Tsui Road in 1977 (above) and in 1995 after Failure (below). The Dark Band in Mid-slope in 1977 Is the Kaolin-rich Layer that Influenced Failure in 1995; in 1997, Chunam Covered Soil, but Rock (Fine Ash Tuff of the Che Kwu Shan Formation) Was Unprotected (after Kirk et al., 1997)

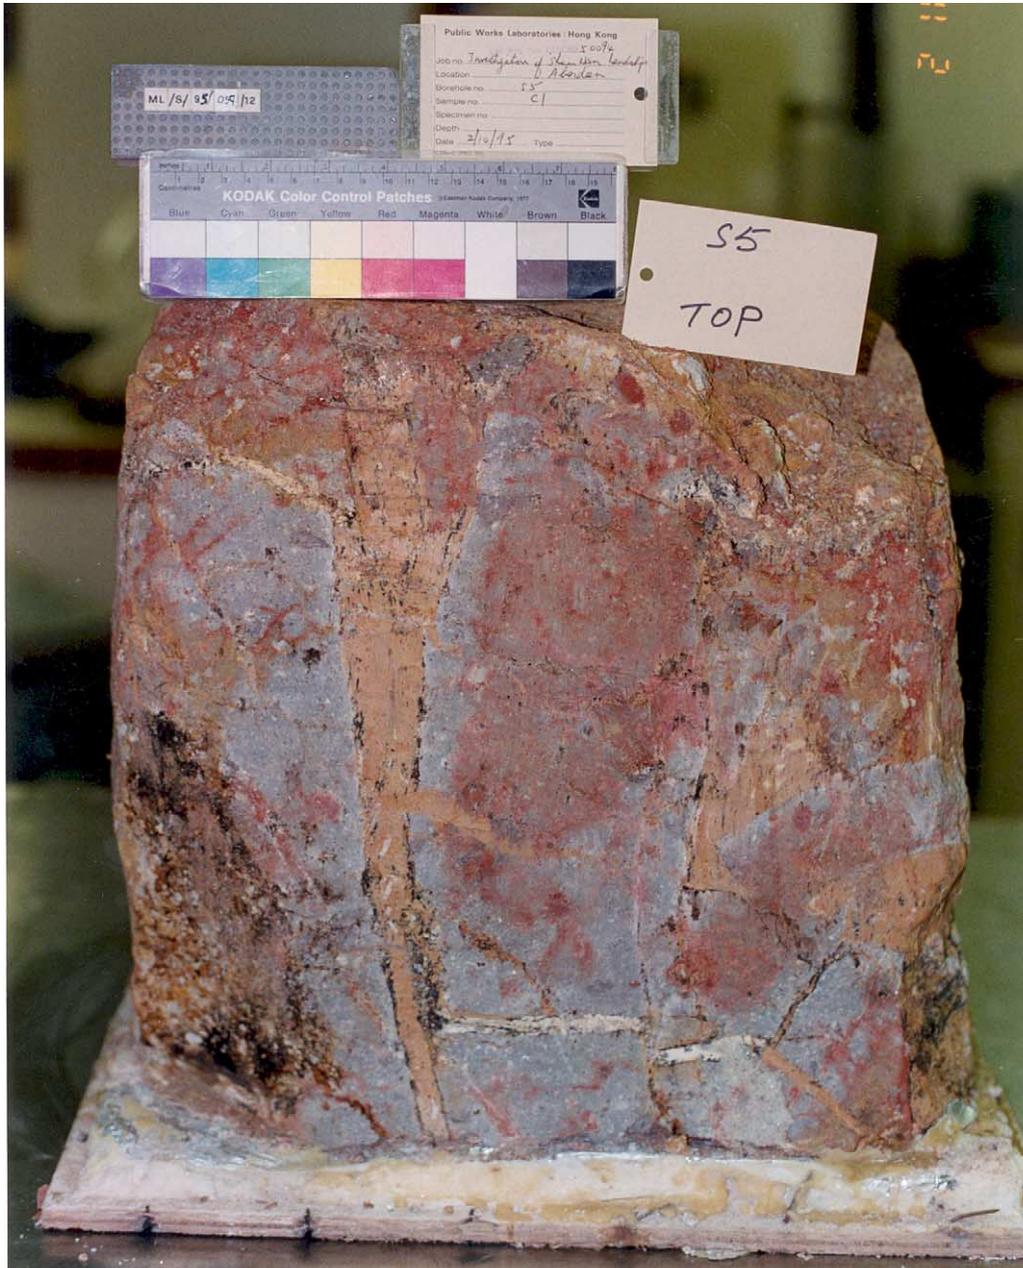
Plate 11 - Block Sample from the Shum Wan Road Landslide (1995),
Showing Two Types of Kaolin Infill (Buff and White) of
Relict Joints and Displacement of Some Previously
Kaolin-infilled Joints

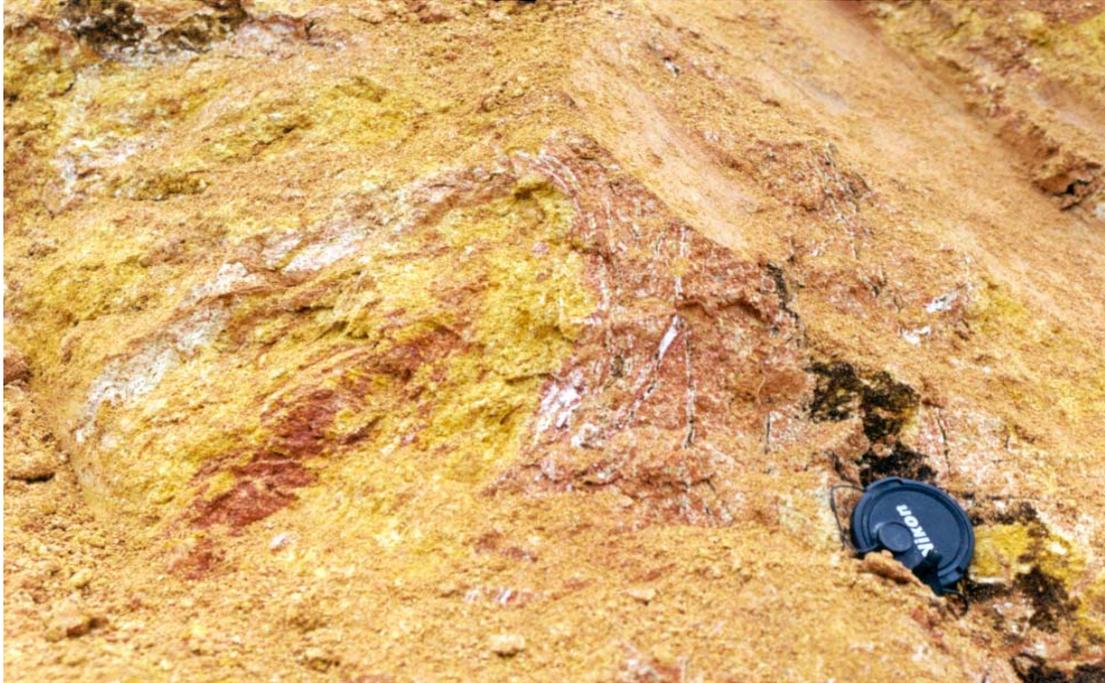
Plate 12 - Concentric Distribution of Kaolin Infills around Relict Corestone, Sai Sha Road Landslide Site (1998)

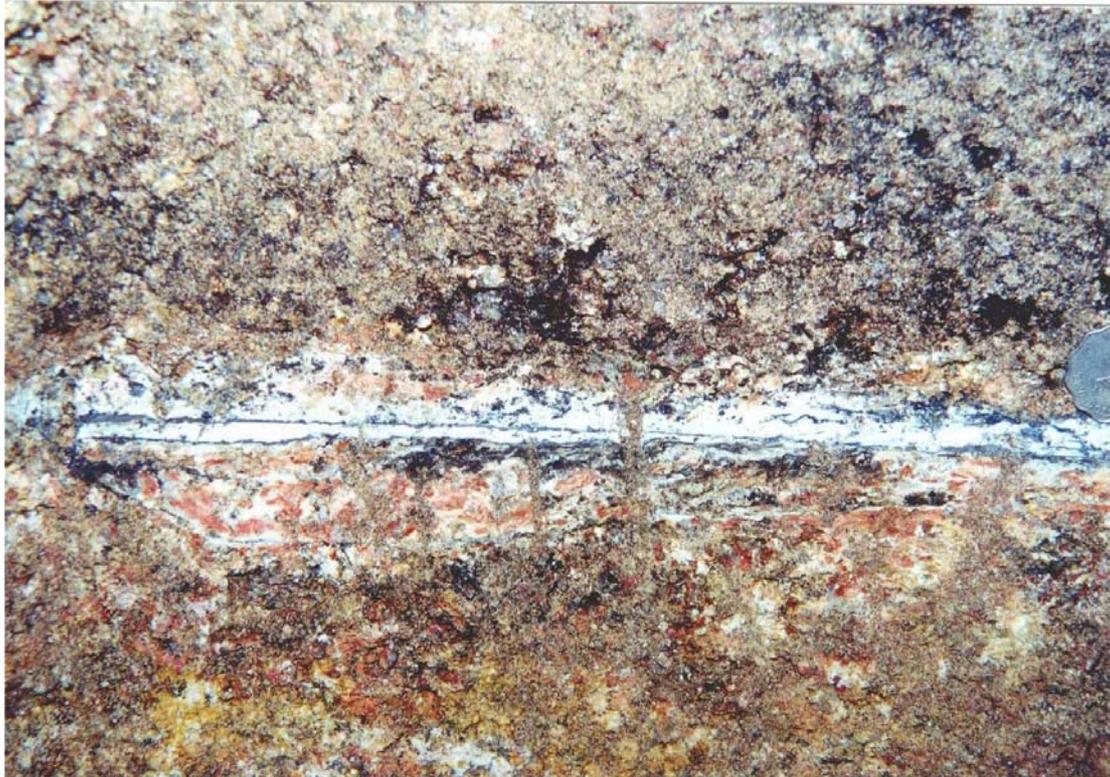
Plate 15 - Close-up of Feature Shown in Plate 14 - the Dark, Planar, Horizontal Feature within the White Kaolin Infill Is the Surface(s) of Rupture of the 1999 Landslide

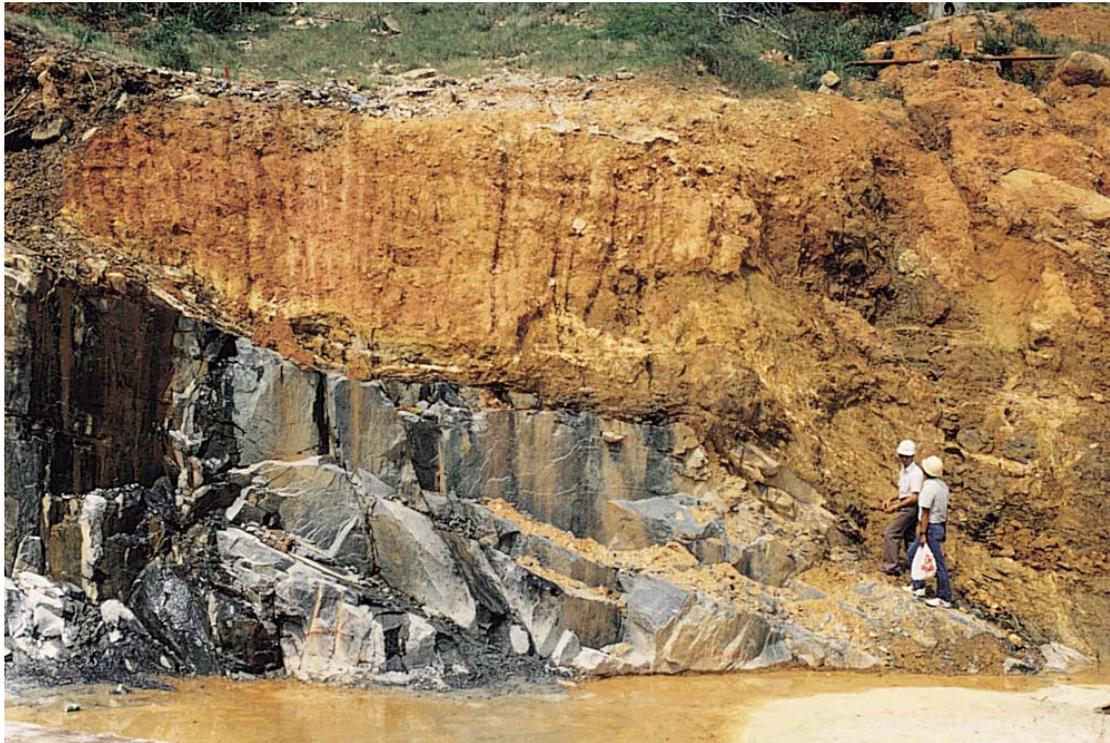
Plate 17 - Siu Sai Wan Estate during Site Formation (Precise Location Uncertain)
Showing Probable Kaolin Distributed Immediately above the Interface
between PW90/100 Rock Mass below and PW0/30 Rock Mass above

Kaolin-rich zones at Siu Sai Wan Estate (Campbell & Koor, 1998), where the cut slopes are currently being upgraded, were observed near a relatively planar rock mass weathering zone interface between the PW0/30 and PW90/100 rock mass weathering zones (Plate 16). Such zones often occur preferentially at, or immediately above, the interface. Kaolin is common within joints in the PW0/30 rock mass above the weathering zone interface, and particularly those subparallel to the interface. However, significant kaolin infills were not observed more than two metres below the interface in any of the extensive

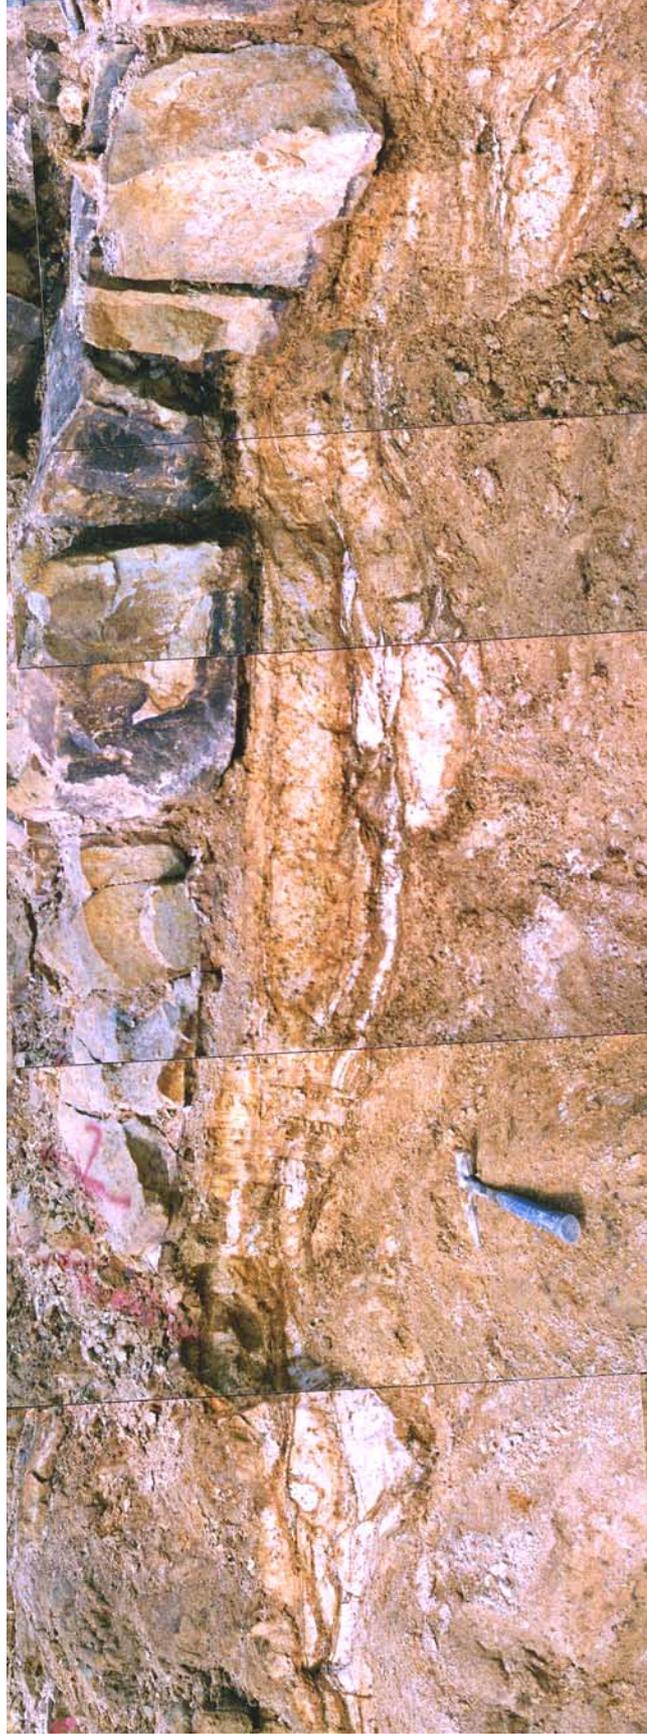
Plate 18 - Kaolin beneath Coreslab on West Side of Tiu Keng Leng Estate, during Site Formation (1999)

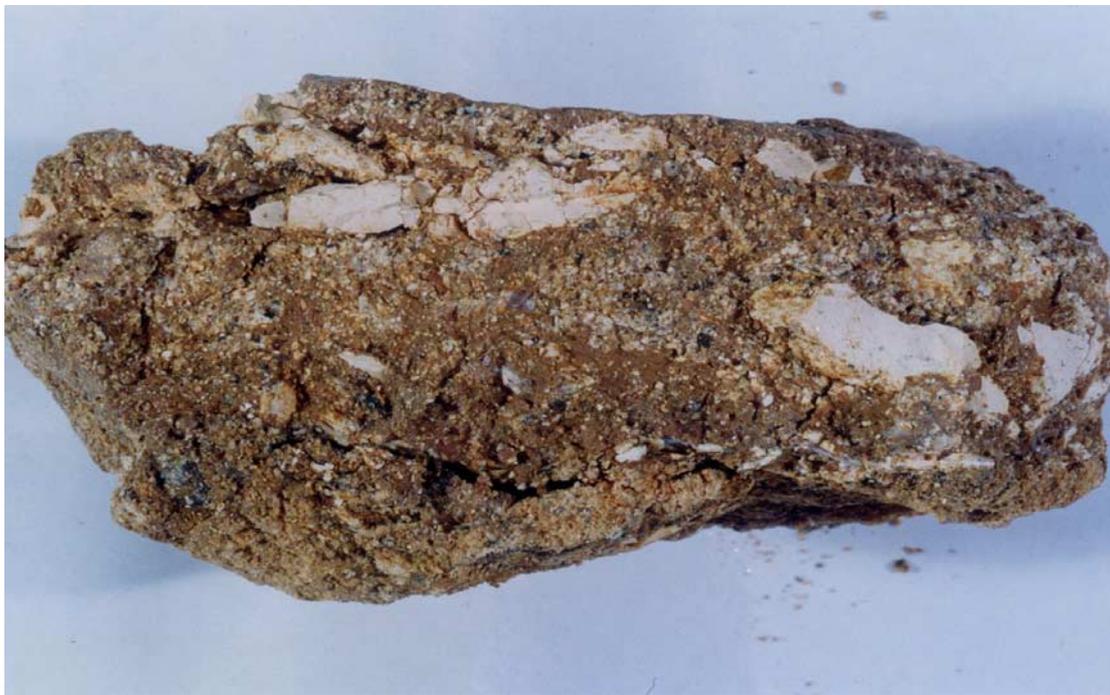
Plate 19 - Sedimentary Breccia with Kaolin Clasts, Extracted from Joint Infill,
West Side of Tiu Keng Leng Estate, during Site Formation (1999)
