# **Guidelines for Natural Terrain Hazard Studies**

**GEO Report No. 138  
(Second Edition)**

**Geotechnical Engineering Office  
Civil Engineering and Development Department  
The Government of the Hong Kong  
Special Administrative Region**

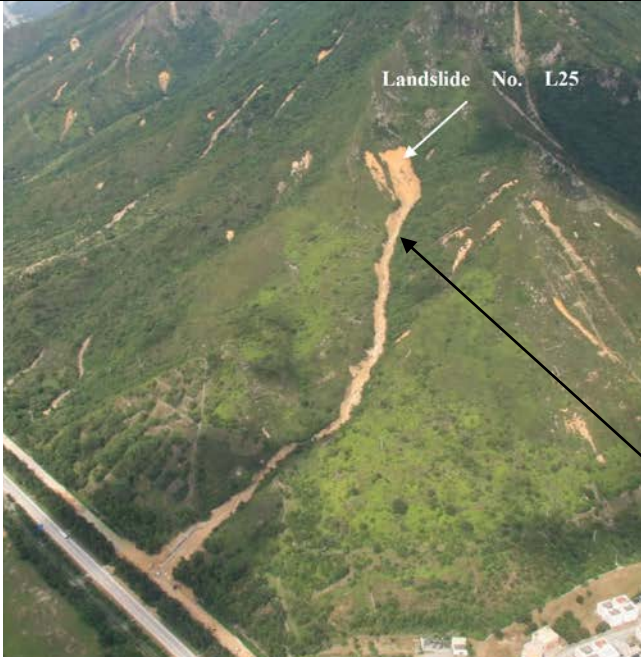
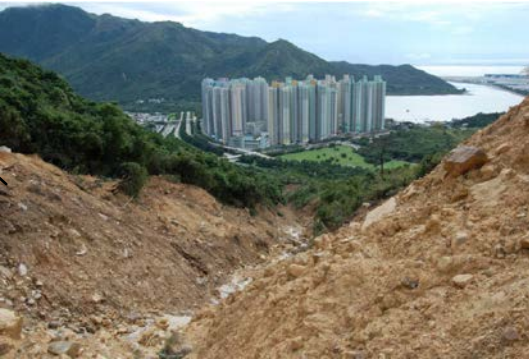
</div> <div style="display: flex; justify-content: space-around; margin-top: 10px;"> <div style="text-align: center;"> <p>General View of Landslide No. L25</p> </div> <div style="text-align: center;"> <p>View down Drainage Line below the Landslide Source</p> </div> </div>	
Date	7 June 2008
Landslide Type	Channelised debris flow
Volume of Landslide Debris Involved	3,500 m <sup>3</sup>
Consequence	The debris blocked the westbound lanes of Yu Tung Road.
Key Observations	<p>The severe 7 June 2008 rainstorm triggered 19 landslides on the hillside above Yu Tung Road. The largest landslide was Landslide No. L25 (see the plates above). This landslide scar was spatially extensive (32m wide by 50m long). The failure involved a large area of bouldery deposits within a topographical depression. This may have influenced the extent of the landslide. The debris flow was very mobile and appeared to be more “watery” than those commonly observed in Hong Kong, probably due to the large catchment size and presence of tributaries. Field observations from the debris flow indicated that the entrainment mainly involved loose materials previously perched on the drainage line. The amount of perched material present along a drainage line is dynamic and may change significantly after a rainstorm.</p>

**Figure C.1.6    2008 Yu Tung Road Landslide**

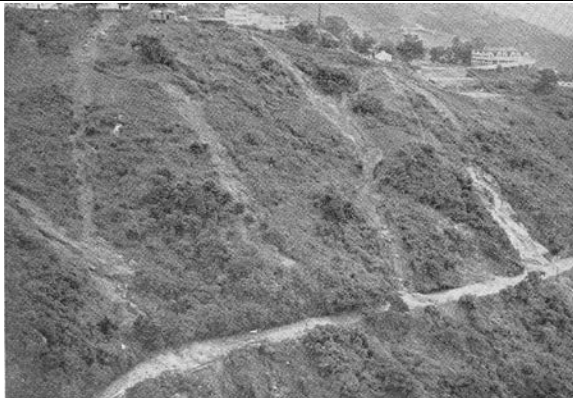
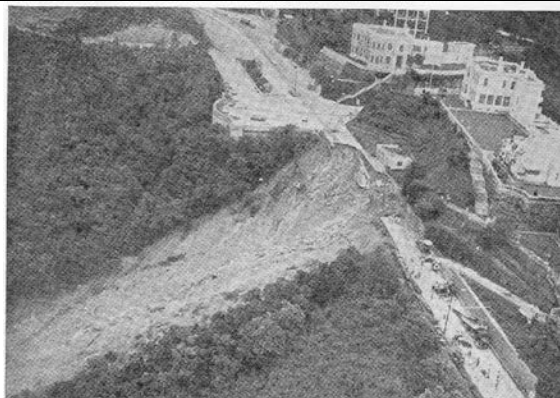
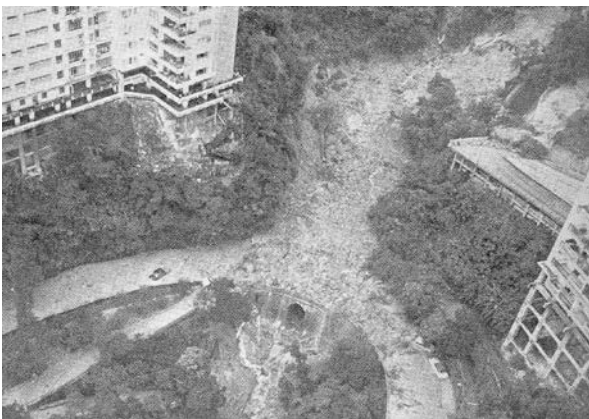
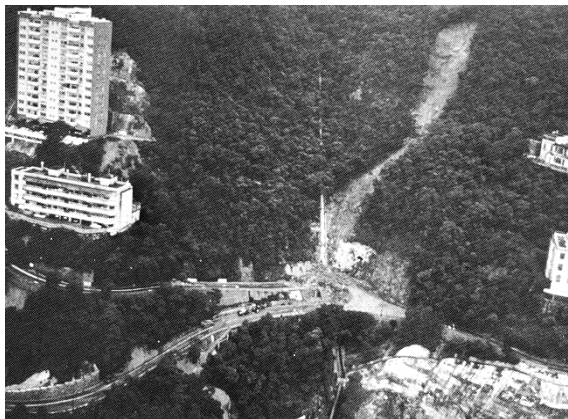
Glenealy	Magazine Gap Road
Year	1966
Location	Hong Kong Island
Normalized 24-hour rainfall	10-25%
Number of Natural Terrain Landslide	A total of 180 ENTLI landslides over 45 km <sup>2</sup> of natural terrain.
Consequence	The available records suggest that the rainstorm resulted in 64 fatalities, 29 people injured, 2,672 people homeless, 8,561 people temporarily evacuated and 407 houses damaged. (Exact figures for consequence solely related to natural terrain landslides are not clear.)
Key Observations	It can be envisaged that more serious consequences can be caused by a similar rainfall event as the area affected is now more densely developed than in 1966.
Reference	Chen, T.Y. (1969). Supplement to Meteorological Results 1966 - The Severe Rainstorms in Hong Kong during June 1966. Royal Observatory, Hong Kong.

**Figure C.1.8 Widespread Natural Terrain Landslides in 1966**

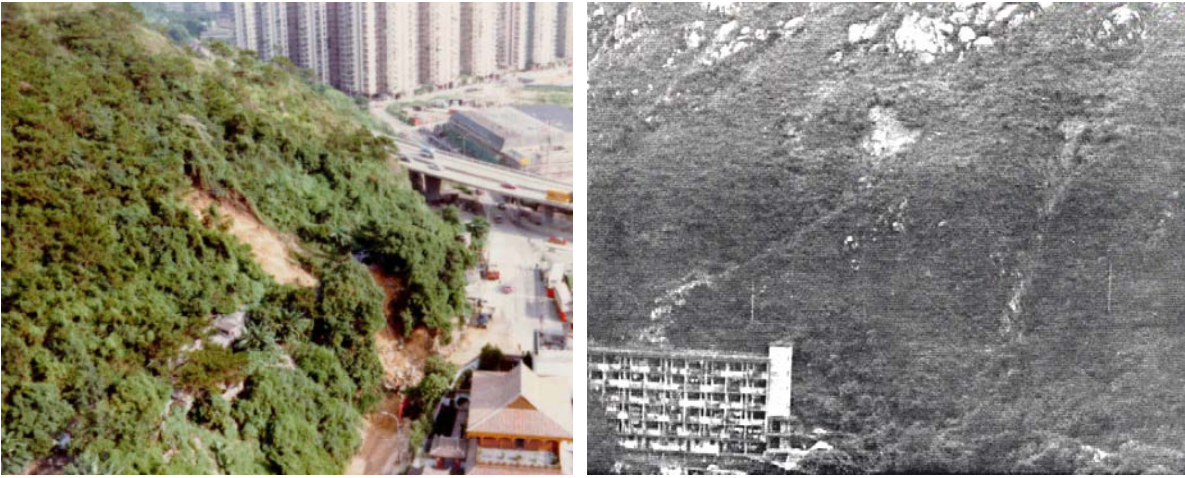
<div style="display: flex; justify-content: space-around; margin-top: 5px;"> <span>(a) Landslide in Kau Wah Keng</span> <span>(b) Landslides in Sham Tseng San Tsuen</span> </div>	
Year	1982
Location	Hong Kong
Normalized 24-hour rainfall	5-25%
Number of Natural Terrain Landslide	A total of 1,800 ENTLI landslides over the natural terrain of Hong Kong.
Consequence	Nine natural terrain landslide related fatalities were reported and most of which were in squatter areas.
Key Observations	<p>In May and August 1982, Hong Kong was hit by two heavy rainstorms. Plate (a) shows a 200 m<sup>3</sup> natural terrain landslide, which killed two people in Kau Wah Keng, Lai Chi Kok. Plate (b) shows a cluster of 1982 natural terrain landslides on the hillside overlooking Sham Tseng San Tsuen, where further cluster of landslides occurred in 1999. One of the 1999 landslides developed into a debris flow and resulted in one fatality and injury to 13 people (see Figure C.1.3).</p> <p>Hong Kong was less densely developed in 1982 and since then more developments have taken place closer to steep hillsides.</p>

**Figure C.1.9 Widespread Natural Terrain Landslides in 1982**

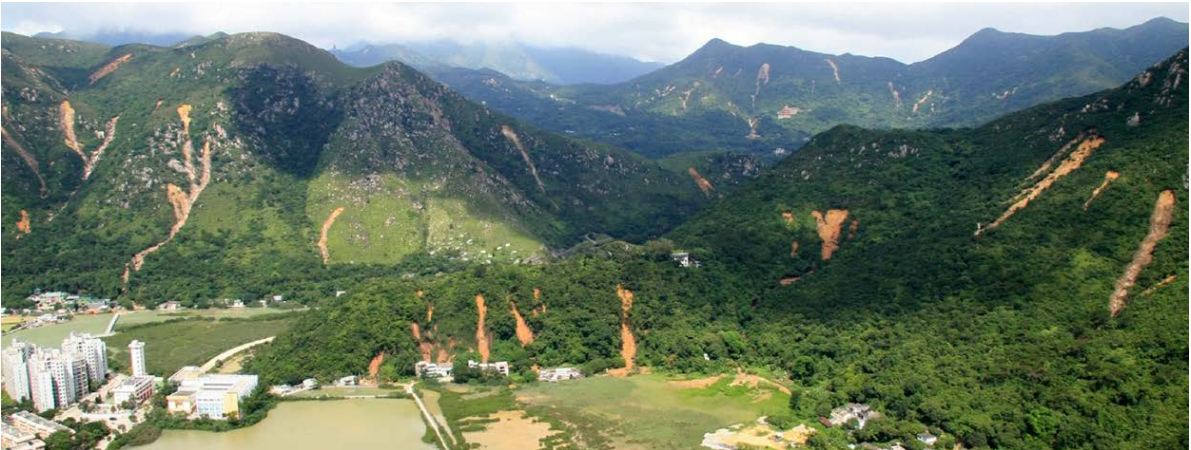
Landslides Occurring in Lantau Island during the 7 June 2008 Rainstorm	
Year	2008
Location	Lantau Island
Normalized 24-hour rainfall	20-30%
Number of Natural Terrain Landslide	Over 2,400 landslides on the natural terrain of Lantau Island.
Consequence	These failures blocked several key road links that provided the sole access to rural communities and resulted in emergency evacuation of over 25 village houses. The highway to the airport was also closed for about 16 hours (see Figure C.1.7).
Key Observations	<p>The intense rainfall on the 7 June 2008 was one of the most notable storms to have occurred in Hong Kong for several decades. The most intense portion of the storm was focused over the western part of Lantau Island and resulted in over 1,000 landslides in that area, including numerous debris flows. Had the rainstorm hit other more densely populated parts of Hong Kong, it is anticipated that the subsequent landslides could have resulted in much more significant consequences.</p> <p>A regional-scale Natural Terrain Hazard Review for an area of some 18.5 km<sup>2</sup> was undertaken in response to this widespread landslide event with the purpose of identifying landslide risk within natural hillside catchments and prioritising the implementation of more detailed hazard studies and mitigation works.</p>

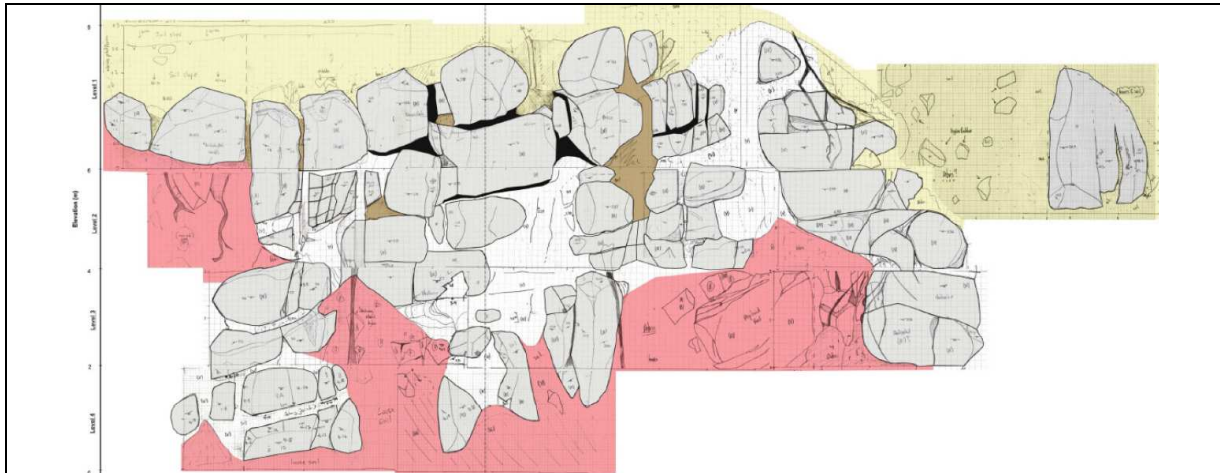
**Figure D.5.3 Engineering Geological Map of Corestone Complex (FSWJV, 2012a)**

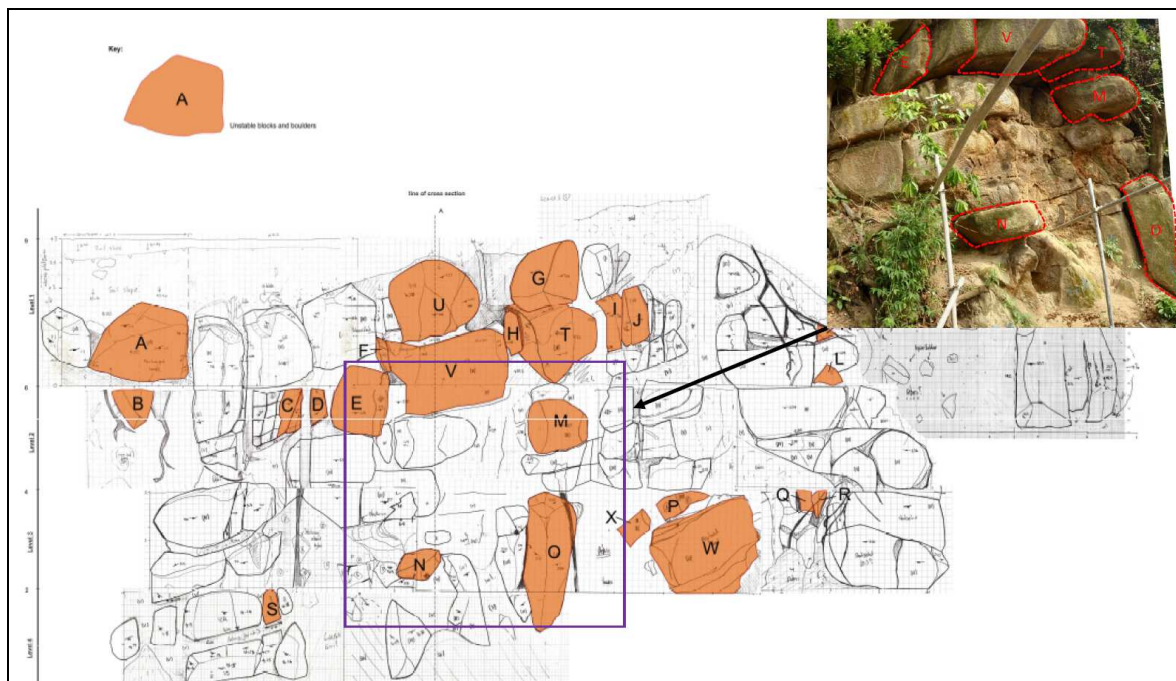
**Figure D.5.4 Identification of Potentially Unstable Corestones (FSWJV, 2012a)**

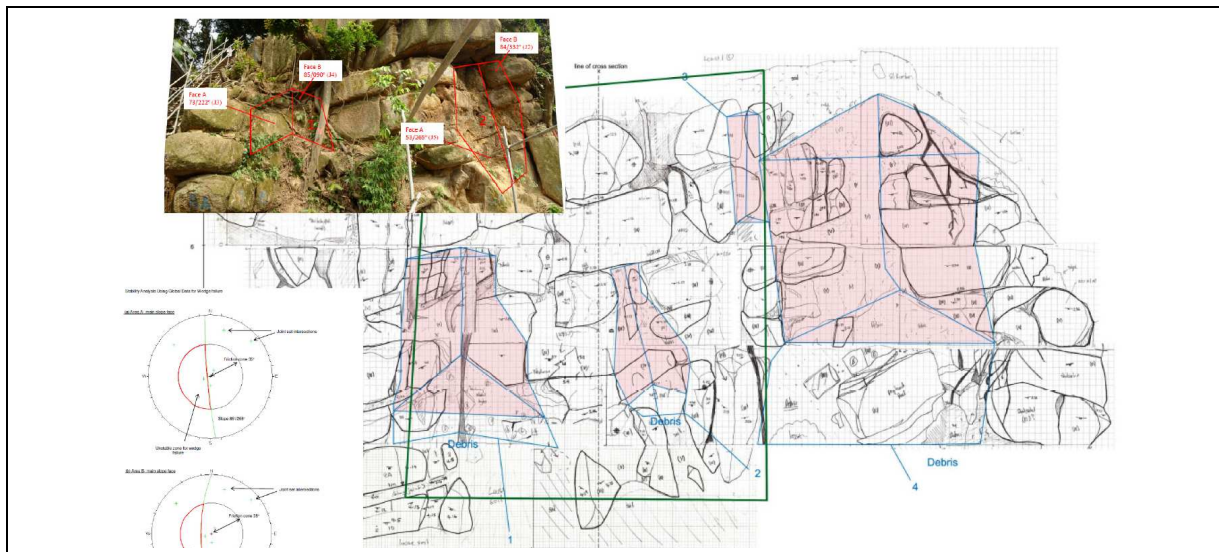
**Figure D.5.5 Evaluation of Larger Scale Instability of Corestone Complex (FSWJV, 2012a)**
