# **TUNG CHUNG EAST NATURAL TERRAIN STUDY AREA GROUND MOVEMENT AND GROUNDWATER MONITORING EQUIPMENT AND PRELIMINARY RESULTS**

**GEO REPORT No. 142**

**N.C. Evans & J.S. Lam**

**GEOTECHNICAL ENGINEERING OFFICE  
CIVIL ENGINEERING DEPARTMENT  
THE GOVERNMENT OF THE HONG KONG  
SPECIAL ADMINISTRATIVE REGION**

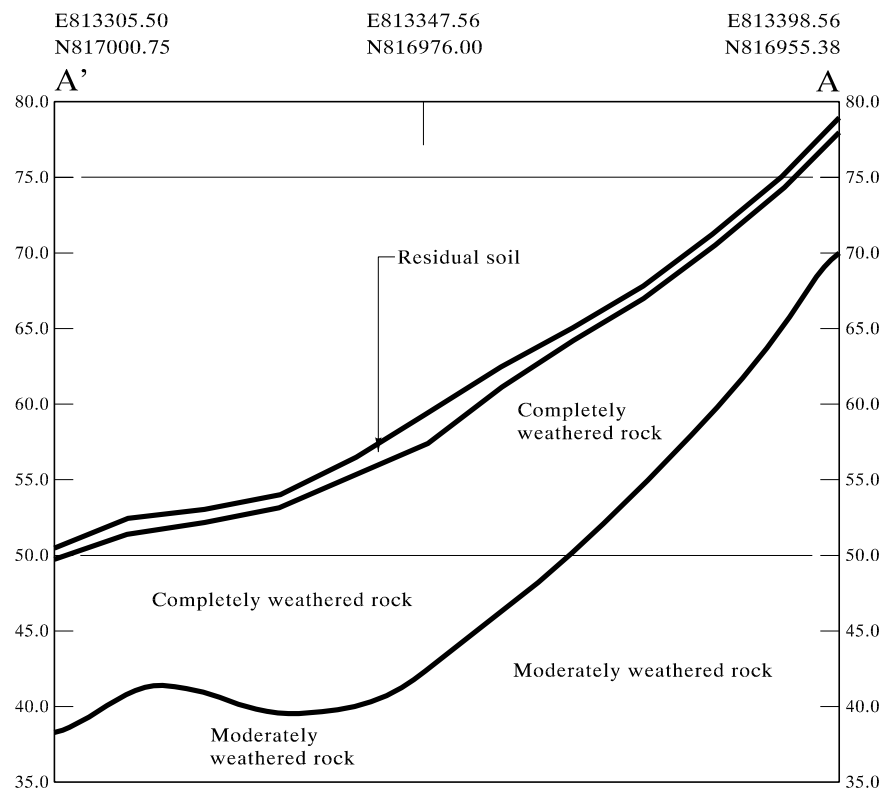
Figure 4 - Seismic Profile A'-A

Horizontal scale 1:500  
Vertical scale 1:250

Note: After EGS (1999).

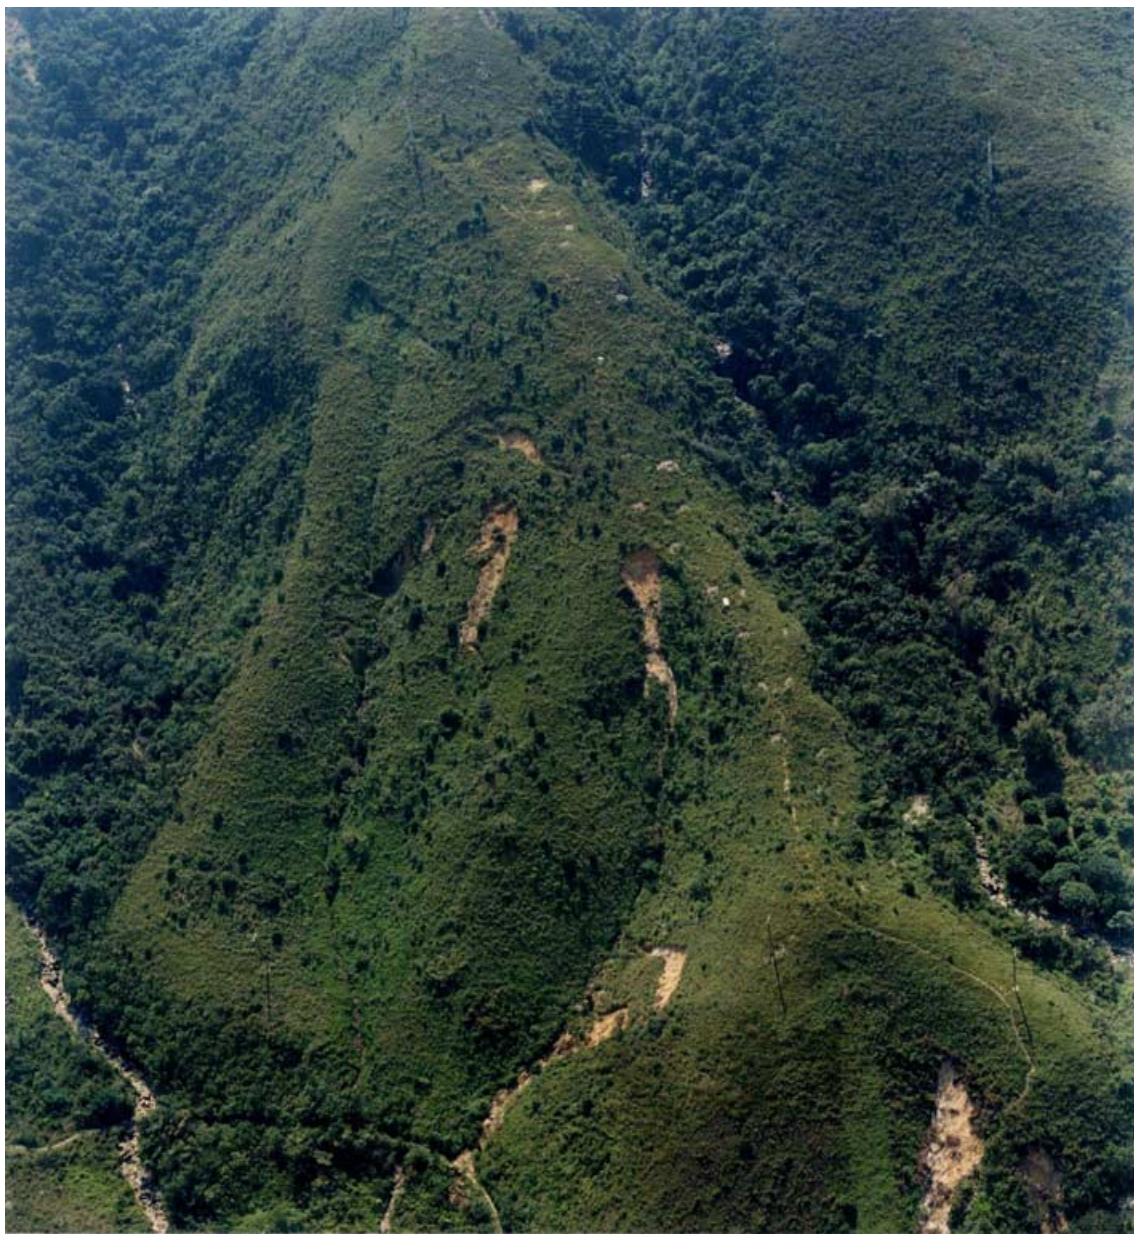
Plate 1 - PS 1027-S Overview of the Site, 24 September 1999

The natural terrain in the study area was first investigated as part of a larger area under Consultancy Agreement No. CE 42/98 (Halcrow Asia Ltd, 2000), which developed and evaluated methods of hazard and risk assessment. Although site work under CE 42/98 ended in the summer of 1999, Special Projects Division continued to monitor the site at Tung Chung East because movement was observed after heavy rainfall associated with Typhoon Sam (20-23 August 1999). Fresh shallow slab-slide type movement and longer run-out debris avalanches occurred within an area approximately 100 m by 100 m. A site visit by staff of SP Division the following week confirmed this movement, and signs of previous similar movements were also noted. Plate 1 is an overview of the site at this time.

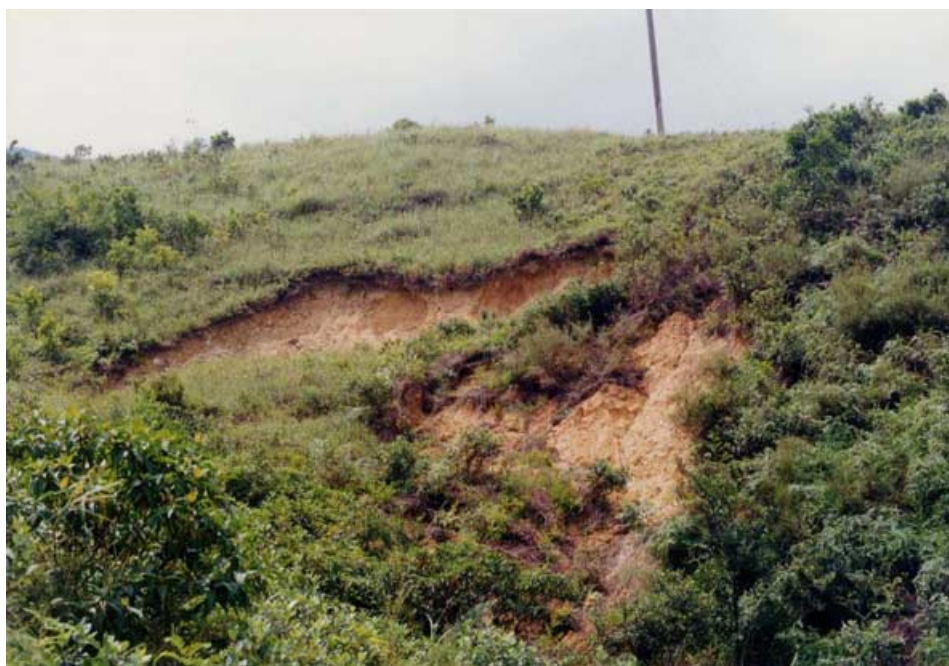
Plate 2 - SP 99027/13 Area 1, September 1999

Investigation in this area has been focussed on the slip identified as area (1). Plate 2 shows the backscarp of this failure. Trial pit TP1 and portable sampler hole A6 were sunk in the failed mass and found colluvium to 2.6 m and 3.1 m respectively. It was not clear whether there was a single failure plane at the base of the colluvium, or multiple failures within it. It is also not clear whether the colluvium involved in the failure derived entirely from the recent movements or, possibly more likely, also resulted from gradual infilling of the gully. Grade V tuff is exposed in the backscarp (which is up to about 2 m high) beneath thin colluvium. Degraded scarps up to about 0.5 m in height are visible upslope, indicating earlier movement.

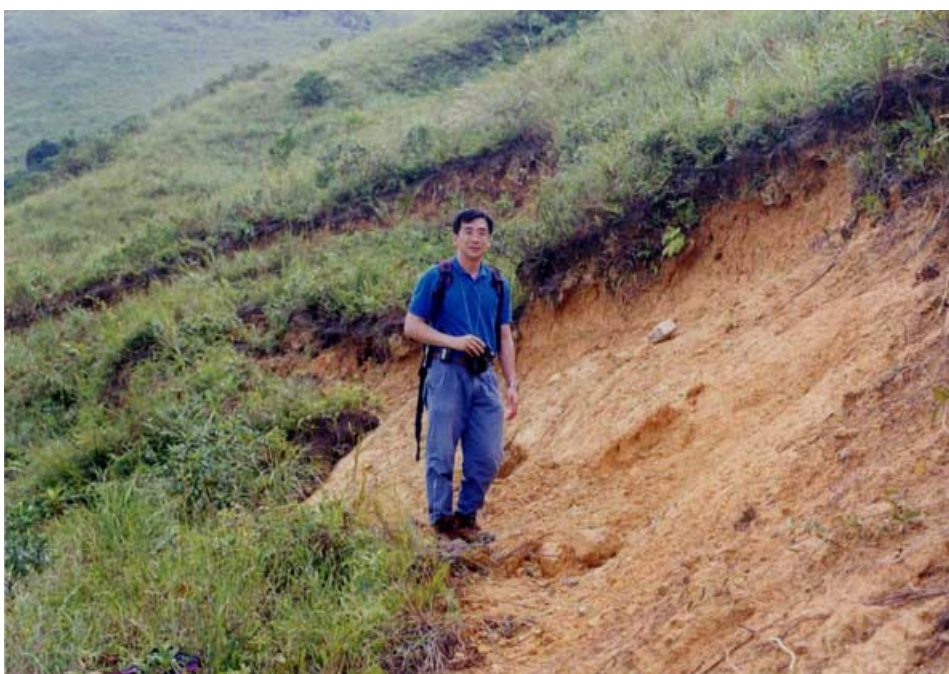
Plate 3 - SP 99027/06 Area 2, September 1999

In the eastern half of the site a large area of the gently concave slope appears to be subject to slab-slide type failure of limited mobility, with the failed material remaining on the slope. The area affected slopes at 25°-35°, with a regolith thickness of about 3 m to 6 m. The failed area contains many minor scarps and tension cracks. The unstable area is identified on Figure 20 as area (2) and has been instrumented. The back scarps are about 1 m high and expose thin colluvium over Grade V tuff. Degraded minor scarps are again visible upslope. Plate 3 shows part of the recent backscarp.

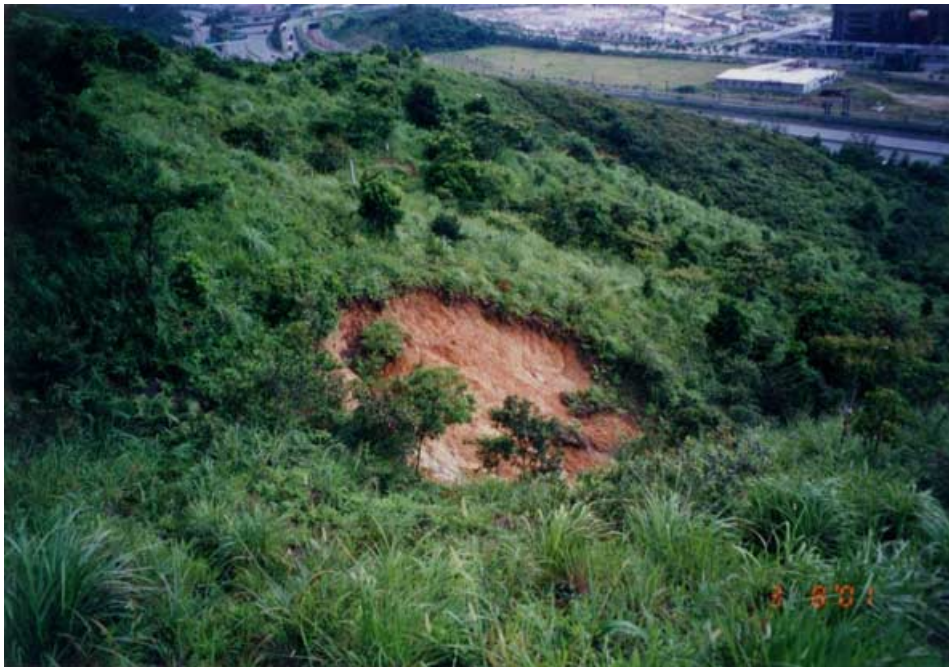
Plate 4 - SP 0103522 Minor Failure, July 2001

- (i) Before 1963 (data unknown); a variety of movement types, ranging from minor surface failures to possible slab-slide low-mobility events.
- (ii) Between November 1984 and December 1986; one slump-type high mobility failure, and possible reactivation of the area of low-mobility slab-slides.
- (iii) Between April 1992 and 11 November 1992; three minor high-mobility surface failures.
- (iv) Between 22 and 27 August 1999 (Typhoon Sam); moderate-sized high-mobility slump type failures, and major reactivation of the area of low-mobility slab-sliding (see Plates 1, 2 and 3).
- (v) Between 6 and 8 July 2001; one minor surface failure (see Plate 4).

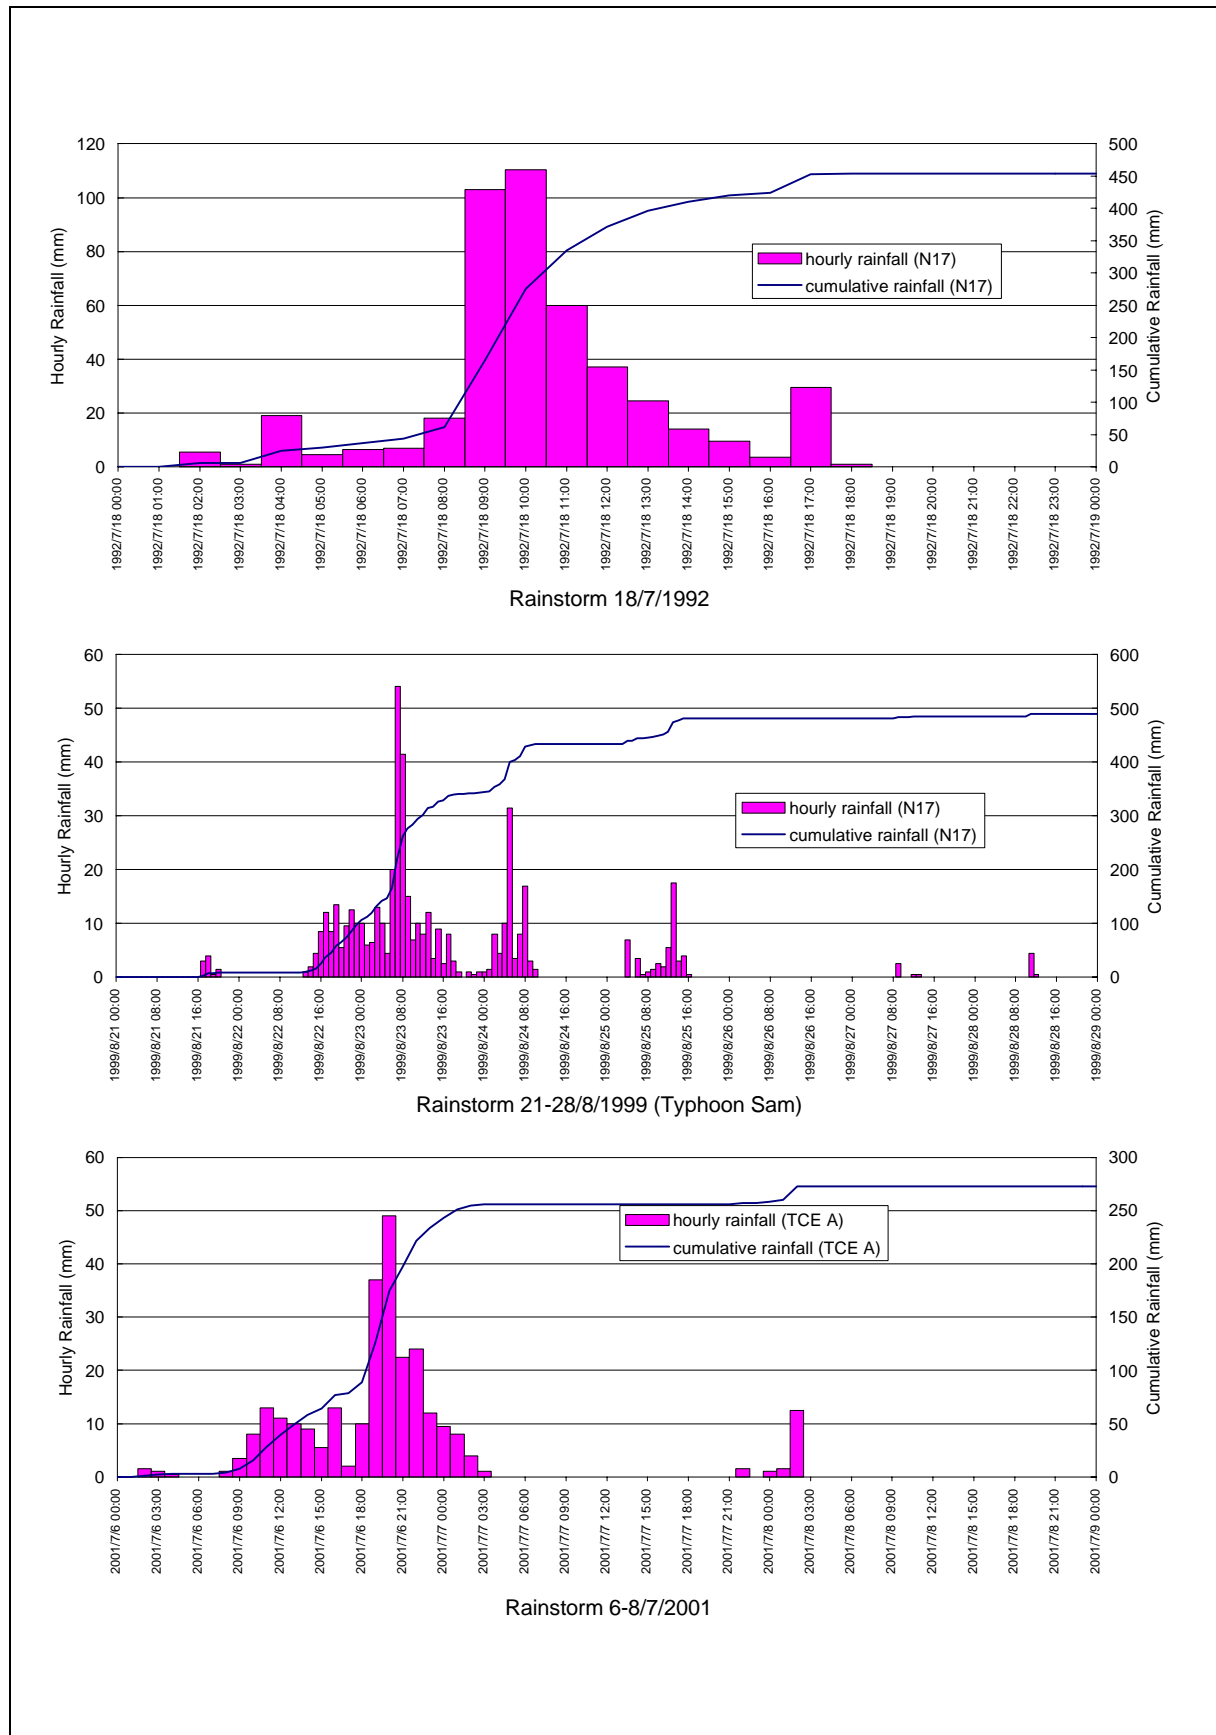
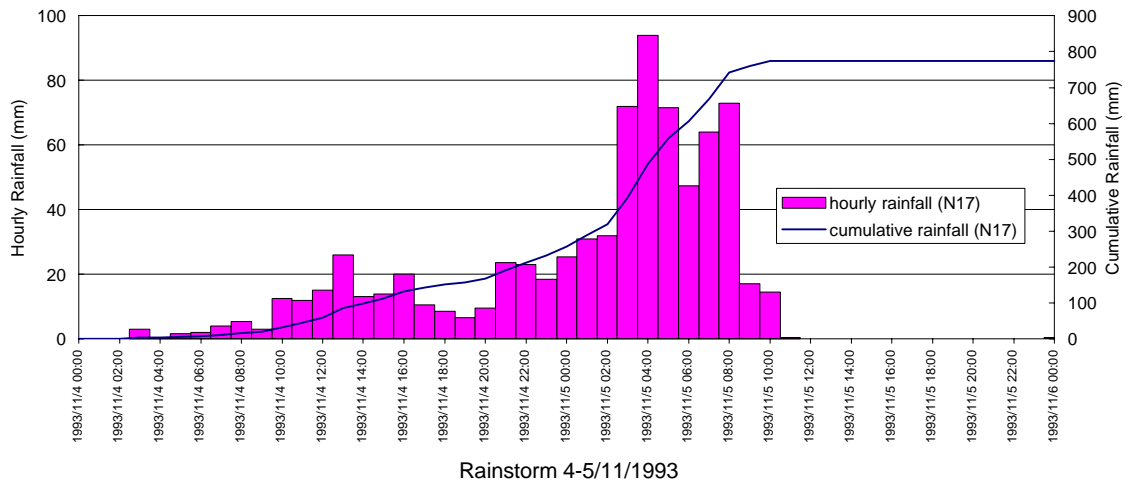
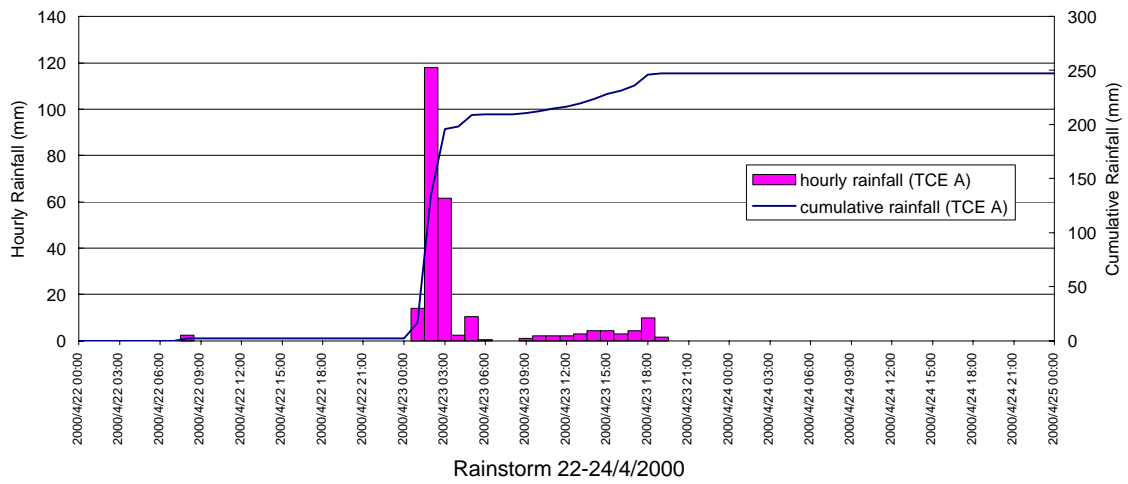
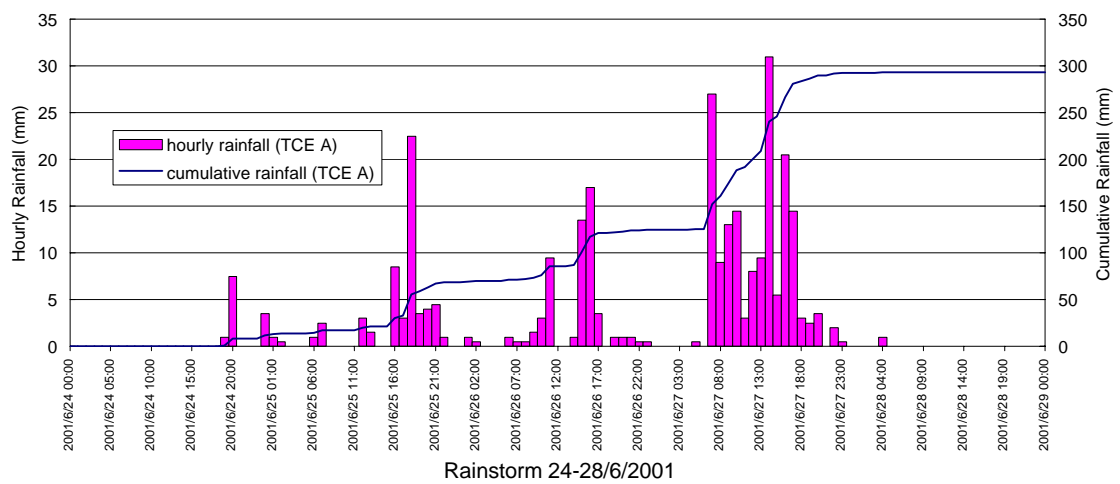
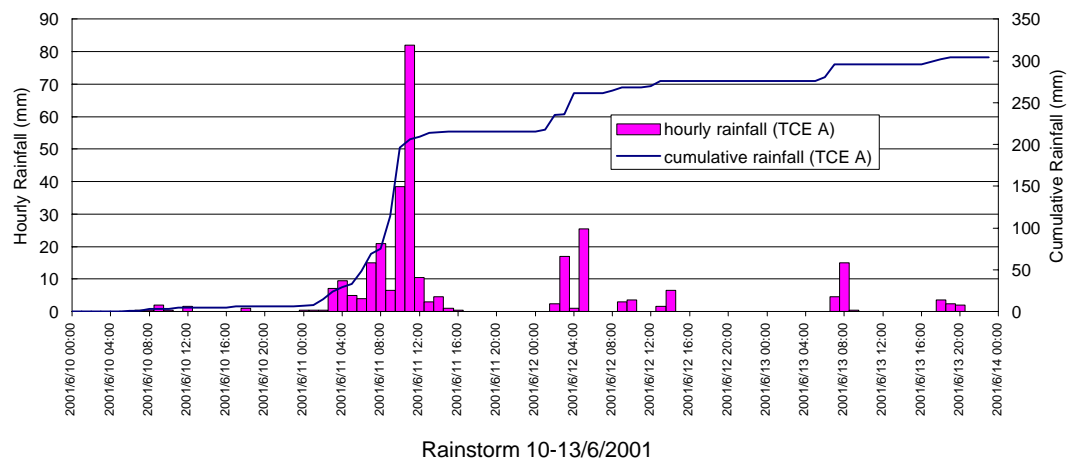
Figure C1 - Rainstorm Profiles (Sheet 1 of 3)

Table 3 shows a selection of rainfall data from these storms, also from all other major storms known to have affected the site since 1992. Plots of the rainfall profiles are in Appendix C. Note particularly the storm of 4-6 November 1993 which was extremely severe but which did not apparently cause any movement at the site. Note also that prior to April 2000 the rainfall parameters are taken from raingauge N17, which is located about 3 km to the southwest of the site. There is therefore some uncertainty over the actual rainfall at the site for the storms before this date.

All the three rainstorms associated with failures are typified by an initial period of moderate intensity rainfall (averaging between 7.5 and 9 mm/hr) contributing between 60 and 150 mm. This initial rainfall was then followed immediately by more intense rainfall (40 mm per hour or more) contributing between 90 and 330 mm.

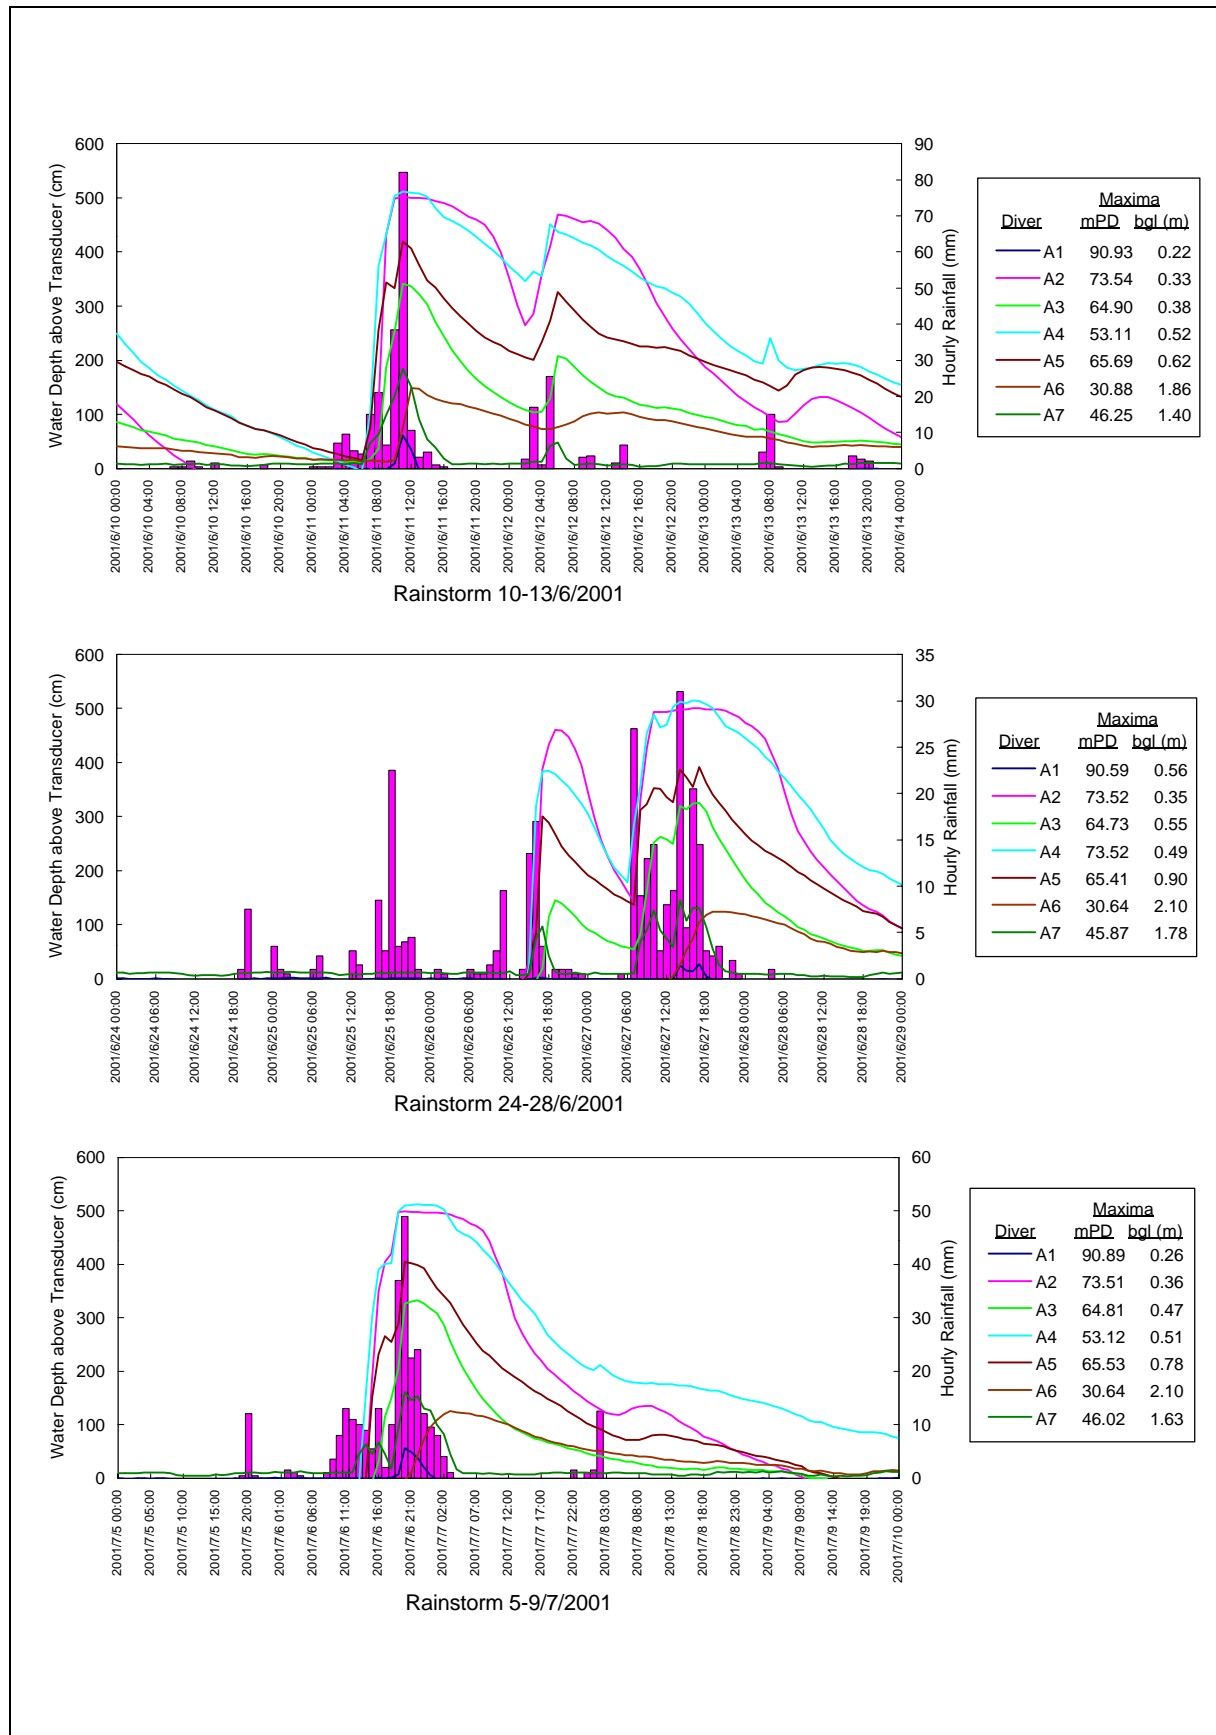
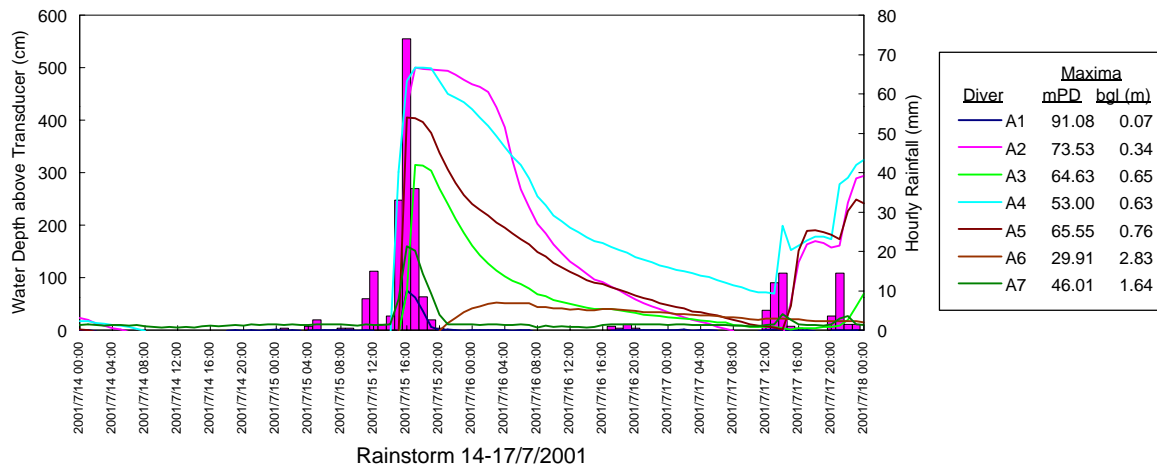
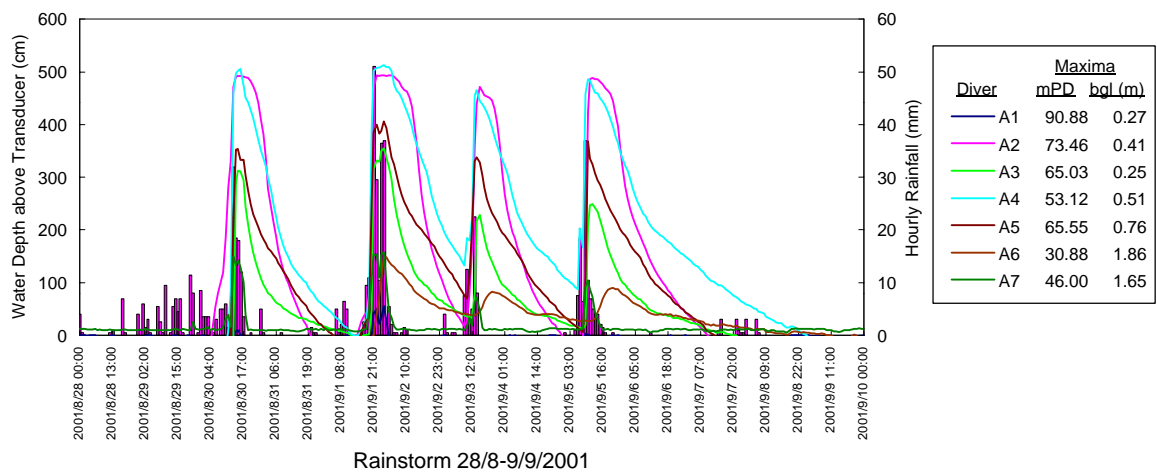
Figure C2 - Groundwater Response Measured by Divers During Rainstorms (Sheet 1 of 2)

The rainstorm of 24-28 June 2001 produced peak levels noticeably above the general trend. It is interesting to note that this storm was a little unusual in that it produced almost 300 mm of rain in 24 hours, but the intensity never exceeded about 30 mm/hour. Hence the relative infiltration could be expected to be quite high when compared with higher intensity rainfall.

Peak water levels were generally reached between 10 and 15 hours after cessation of significant rainfall (14 to 18 hours after peak hourly intensity). The storm of 10-13 June 2001 was an exception, with peak values 30 hours after cessation of significant rainfall, and 33 hours after peak hourly rainfall. It should be noted that this was the first significant storm of 2001, with low estimated base flows prior to the event. There are no data from TRL 129 for the first (only) storm of 2000, so a comparison cannot be made.

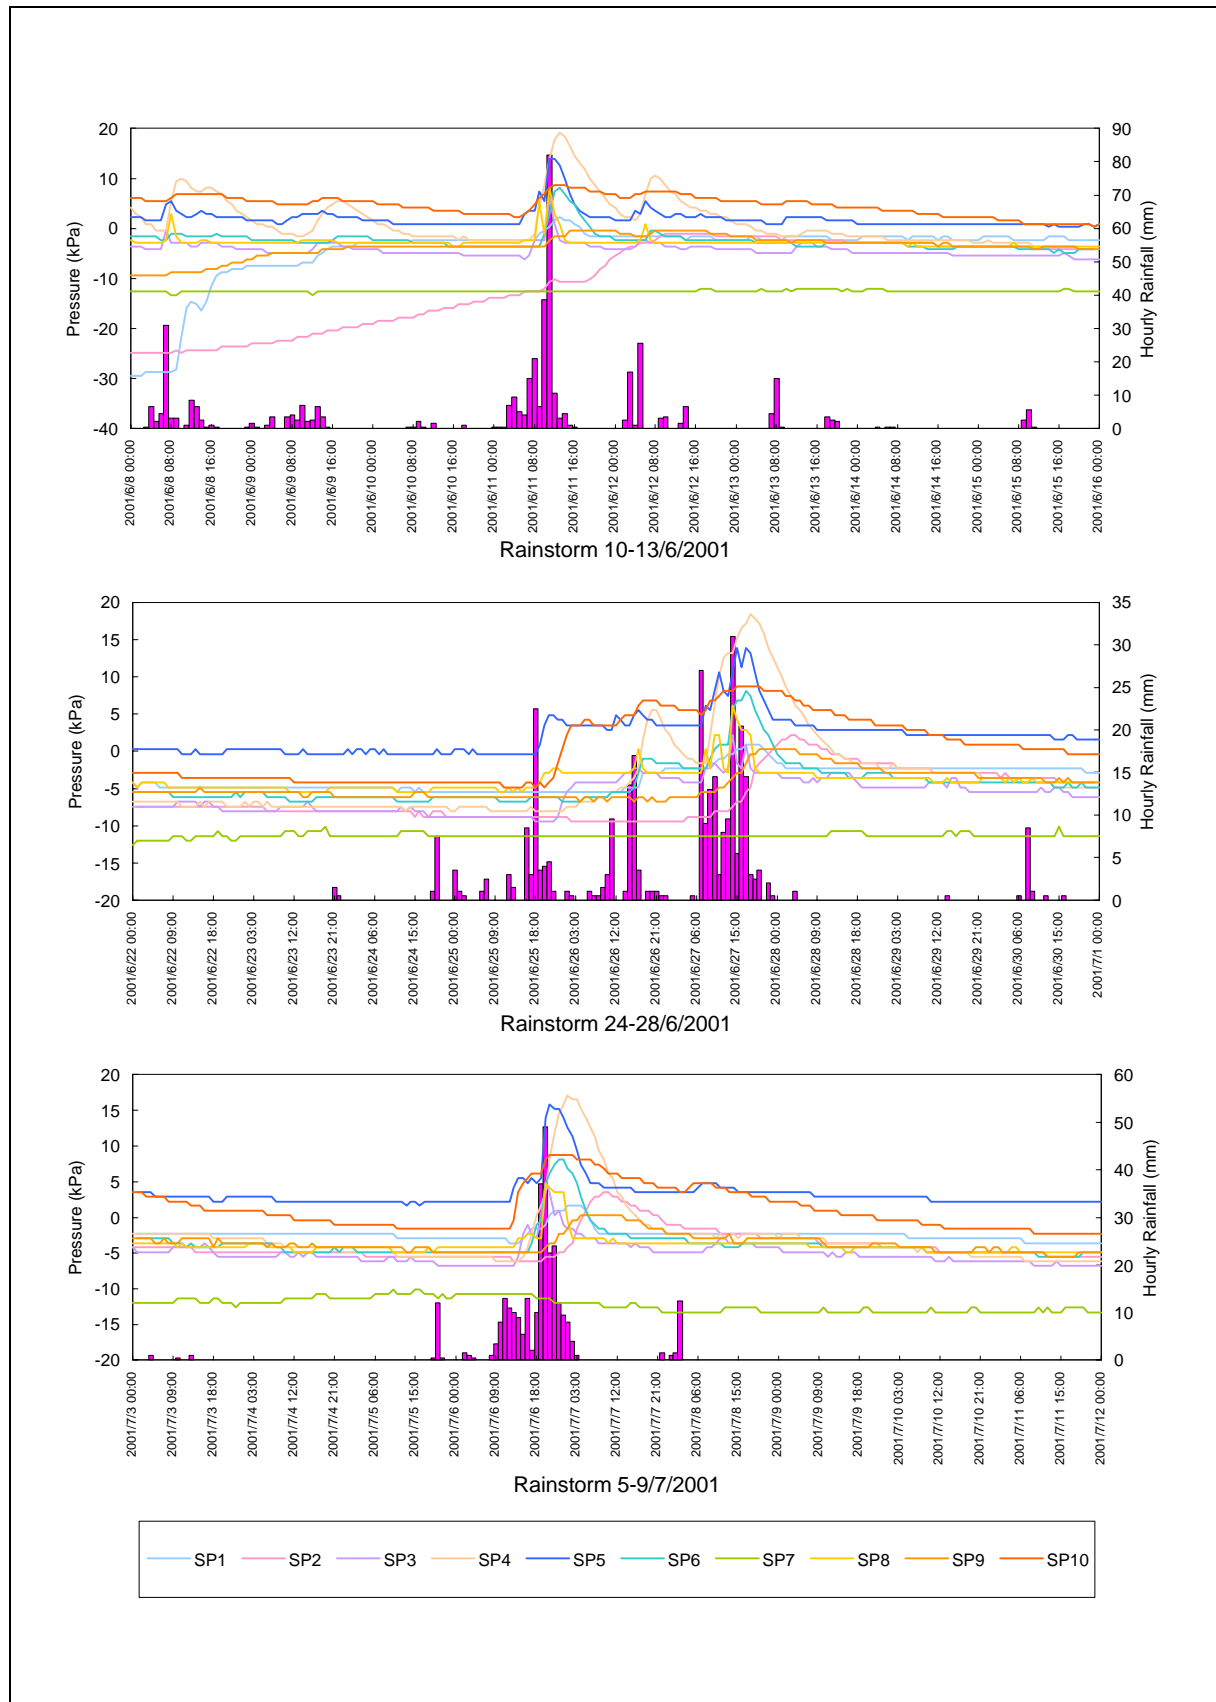
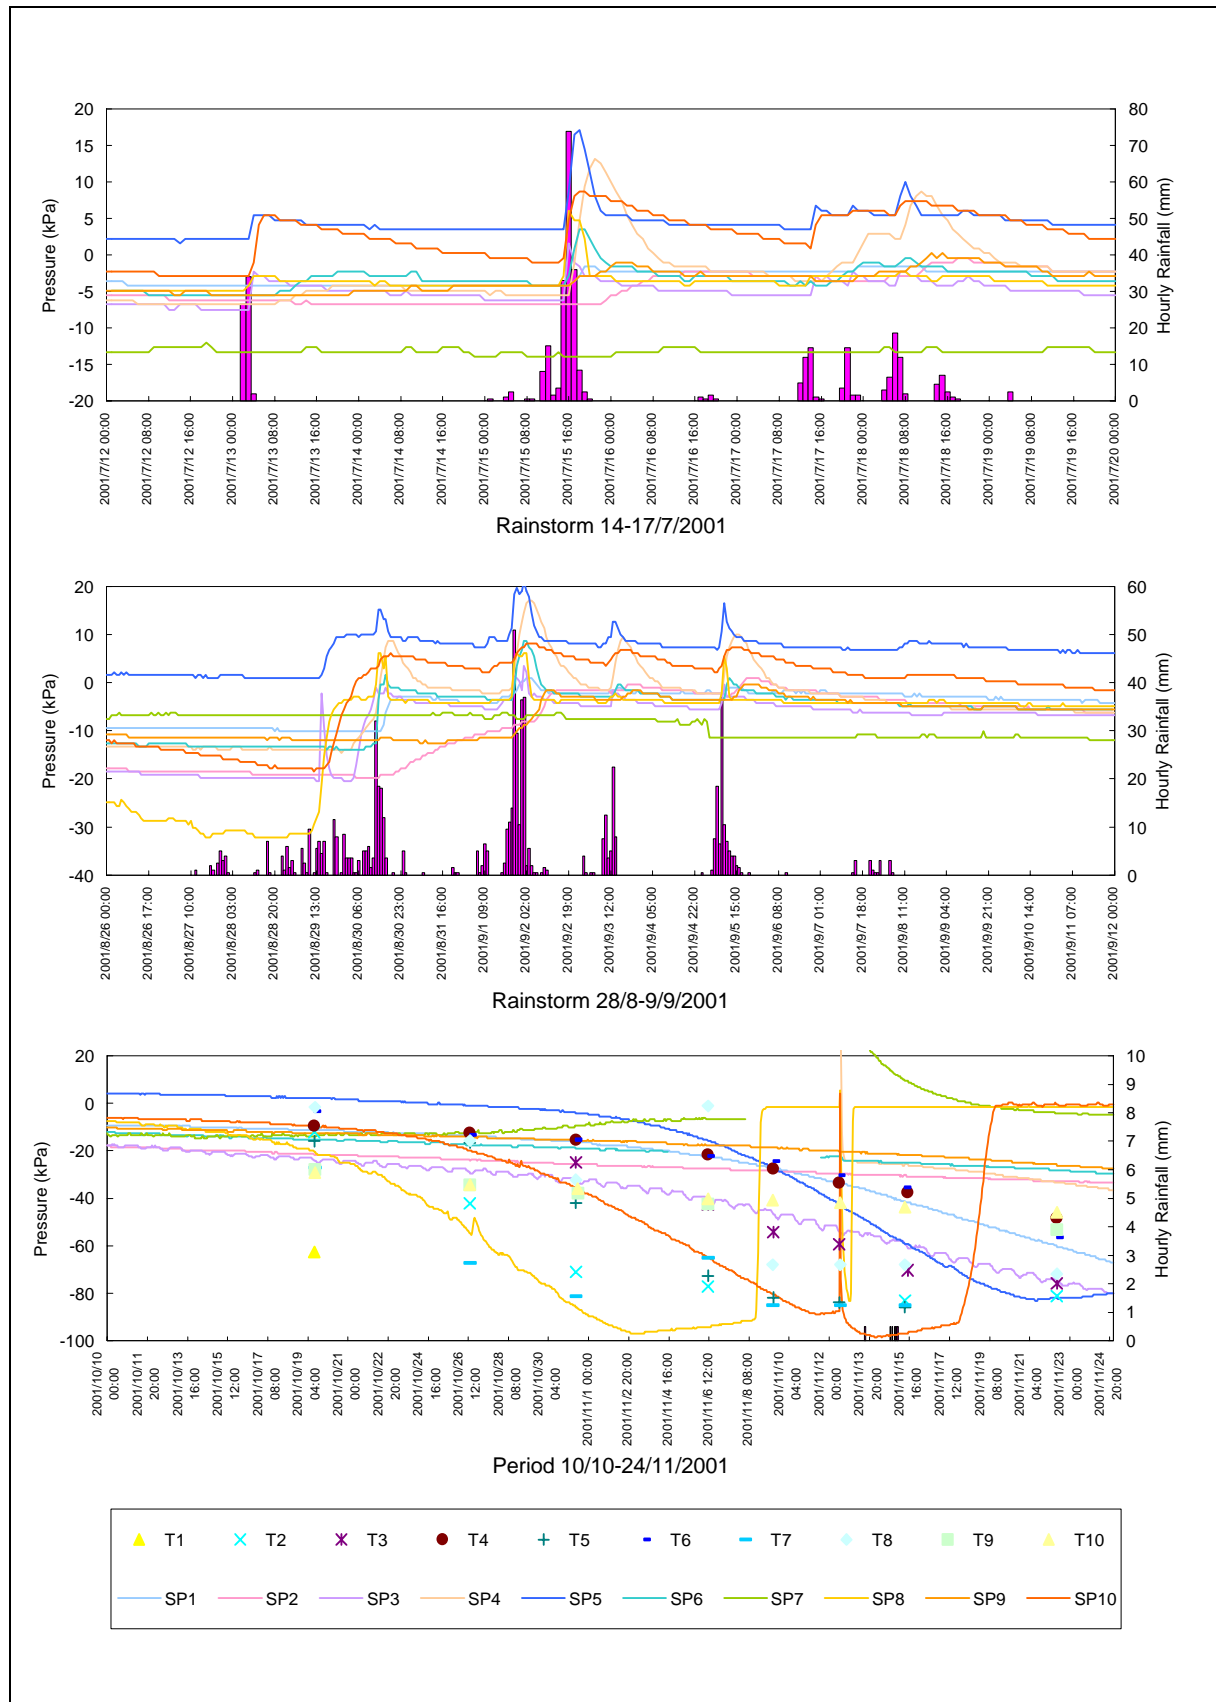
Figure C3 - Rainfall Profile and Pore Pressures Measured by Shallow Piezometers During Rainstorms (Sheet 1 of 2)

As a general observation it should be noted that at shallow depths (about 1 m) pore pressures during rainstorms occasionally approach, or even exceed, full hydrostatic. This suggests that seepage pressures and/or a degree of confinement are present, in addition to complete, or almost complete, saturation of the surface layer. This observation is in agreement with possible observation of flowing (artesian) standpipe piezometers after Typhoon Sam (see Section 7.2.3).
