Detailed Study of the 1 September 2001 Debris Flow on the Natural Hillside Above Lei Pui Street

The Debris Flow Scar Materials and Mass Balance

drawing no. **DRAWING NO. 1** scale 1:250

office
 LANDSLIP INVESTIGATION DIVISION
 GEOTECHNICAL ENGINEERING OFFICE

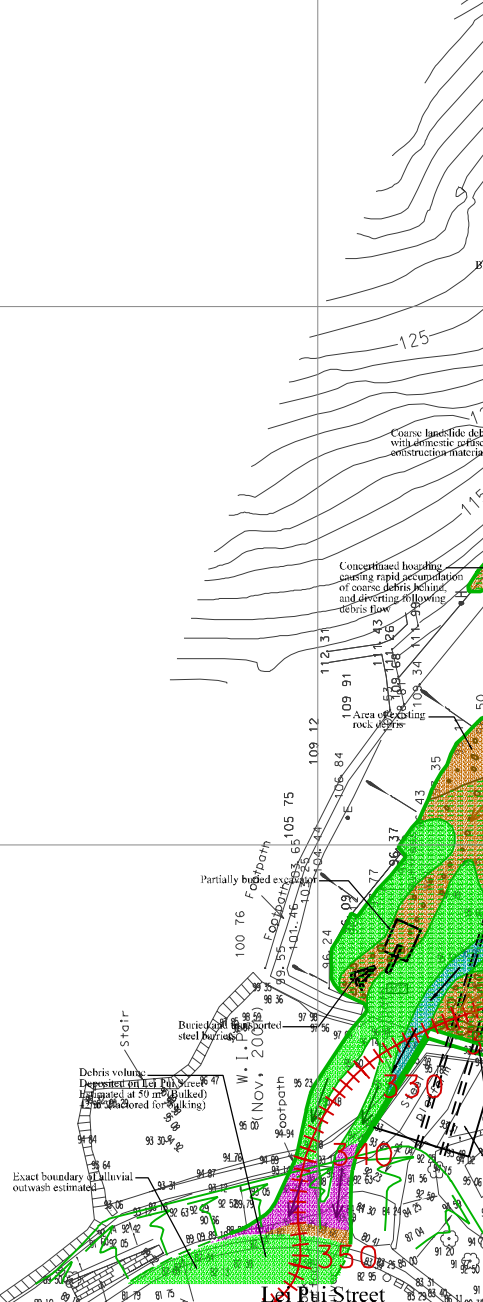
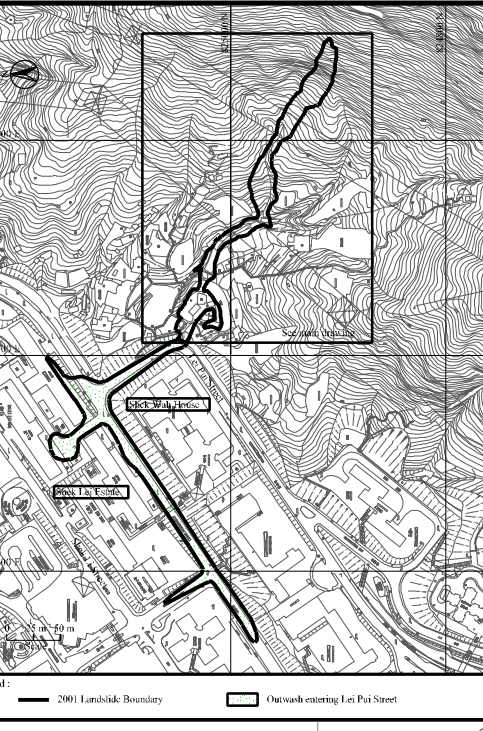
Landslide Mass Balance Summary

Source and Debris Trail

Chargeage (m)	Slope angle (°)	Deposition (m³)	Material Deposited	Material Eroded (m³)	MT Eroded
Source (0-24)	42	1	MT 6	250	MT 1, 3 & 4
Cliff (24-40)	58	0	-	5	-
Main Zone of Erosion (40-128)	33	37	MT 5 & 6	455	-
Squatter Platform (128-148)	8	15	MT 5 & 6	20	MT 1
Rock Slope (148-168)	35	1	MT 5 & 6	5	MT 1 + Fill
Squatter Platform (168-185)	12	35	MT 5 & 6	10	MT 1 & 3
Zone of Accumulation (185-270)	6	105	MT 5 & 6	1	MT 1
Quarry (270-325)	2	530	MT 5, 6 & 7	0	-
Lei Pui Street	-	50	MT 7	0	-
Total Volume		774		746
