# **ASSESSMENT OF LANDSLIDE RISK OF NATURAL HILLSIDES IN HONG KONG**

**GEO REPORT No. 191**

**GEOTECHNICAL ENGINEERING OFFICE  
CIVIL ENGINEERING AND DEVELOPMENT DEPARTMENT  
THE GOVERNMENT OF THE HONG KONG  
SPECIAL ADMINISTRATIVE REGION**

**This report was originally produced in July 2004  
as GEO Special Project Report No. SPR 5/2004**

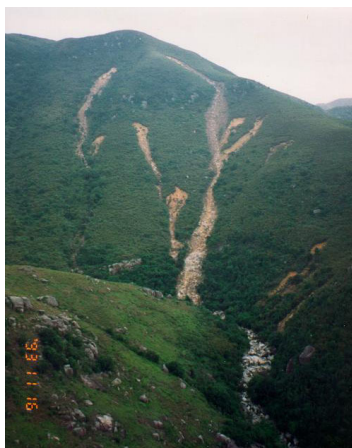
Plate (a) - Natural terrain landslides

The Natural Terrain Landslide Inventory (NTLI) was compiled by the GEO from interpretation of high level aerial photographs. Plate (a) shows some typical natural terrain landslides in Hong Kong. The location of each identified natural terrain landslide crown was recorded and the centre-line of the debris trail was marked with a line (Plate (b)). Up to the year 2000, the NTLI has catalogued some 30,000 landslides, about 19,000 and 11,000 of which are considered recent and relict landslides respectively. Recent landslides in the NTLI refer to those that occurred within the aerial photograph coverage. On aerial photographs, recent landslides appear in light tone and are bare of vegetation. Relict landslides in the NTLI refer to scars which still have a well-defined main scarp and on which vegetation has re-established.

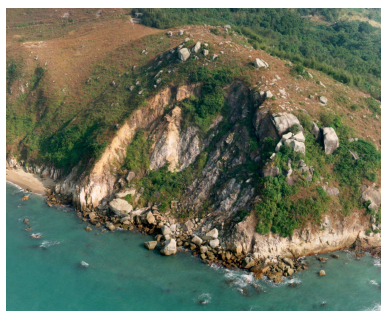
Plate (a) - Large coastal landslide on Lamma Island

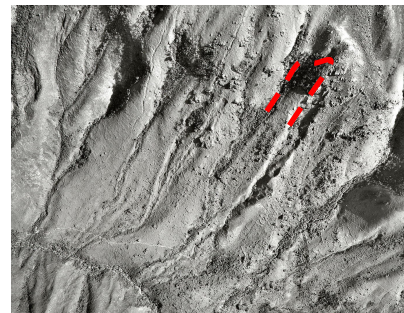
Plate (c) - 1963 aerial photograph showing a large relict landslide near the existing Tung Chung Road

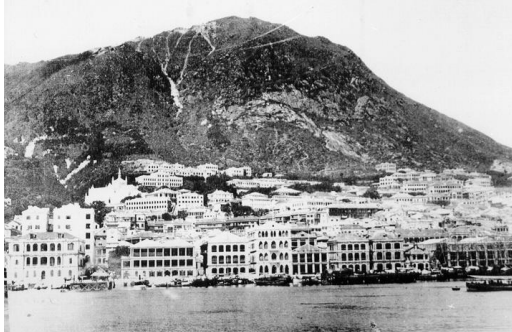
Plate (a) - Landslide debris trails on Hong Kong Island in the 19th Century

Little information is available on natural terrain landslides in Hong Kong before the early 1900s, although landslide activities are evident from some old photographs. Long debris trails are visible in Plate (a), which shows the western part of Hong Kong Island in the 19th Century. Plate (b) shows a big fallen boulder, which killed 5 people in Pokfulam in 1924.

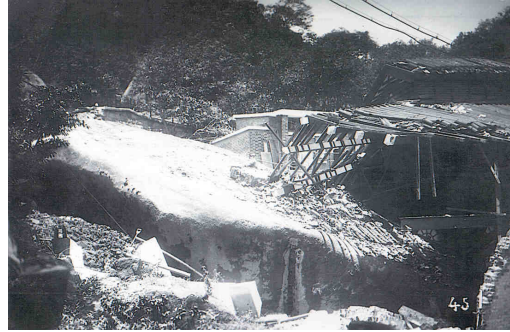
Plate (b) - Fallen boulder in Pokfulam in 1924

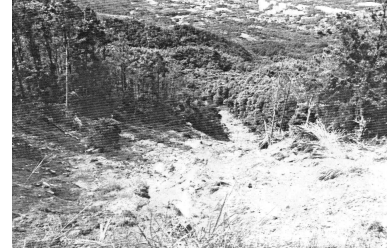
Plate (c) - Long-runout debris flow near Route Twisk

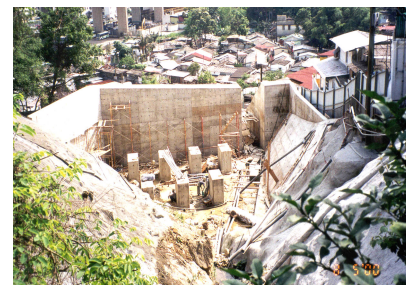
A check dam (Plate (d)) with a debris retention volume of 1,400 m<sup>3</sup> was constructed to protect the village from future debris flows.

Plate (d) - Check dam constructed to protect the village from future debris flows

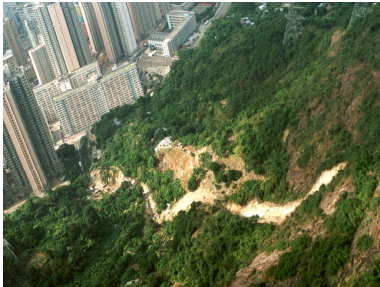
Plate (a) - Debris flow at Shek Lei Hill

In September 2001, a debris flow with a volume of about 800 m<sup>3</sup> occurred at Shek Lei Hill above Lei Pui Street, Kwai Chung (Plate (a)). The landslide developed into a channelized debris flow down a drainage line and demolished two squatter structures (Plate (b)). The four occupants of the structures left their houses two hours before the debris flow, after being alerted by the unusual barking of their dogs and running of muddy water in the ephemeral drainage line. Part of the debris reached Lei Pui Street, which is the sole vehicular access to Shek Lei Estate. Lei Pui Street was closed for three days after the debris flow.

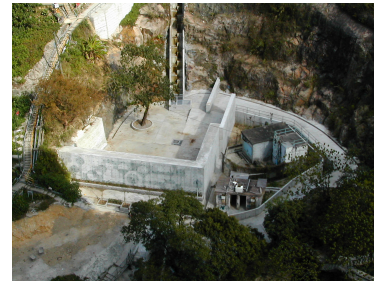
Plate (c) - Check dam constructed after the debris flow

After the event, a check dam was constructed at the toe of the hillside as an emergency protective measure (Plate(c)). In line with the 'react-to-known-hazard' principle, a natural terrain hazard study was being undertaken on the hillside in 2003.

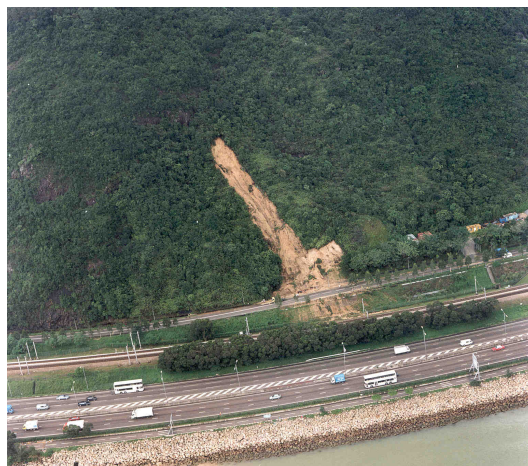
Plate (a) - Natural terrain landslide near KCRC University Station, Shatin

A 200 m<sup>3</sup> natural terrain landslide occurred in 1999 with debris deposited close to the KCRC track near University Station (Plate (a)). This 'near-miss' case could have resulted in serious consequence in case of more mobile debris or larger scale failure.

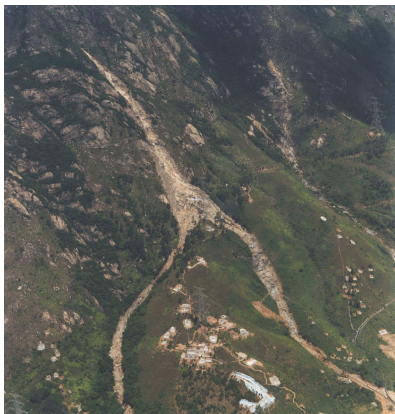
Plate (a) - The 2000 Tsing Shan debris flows

About 120 natural terrain landslides occurred in the east-facing hillside of the Tsing Shan in the April 2000 rainstorm. A 1,600 m<sup>3</sup> bifurcated debris flow (Plate (a)) took place in the catchment next to that of the 1990 debris flow (Box 2). The 2000 debris flows started with a 150 m<sup>3</sup> landslide at the source, and involved significant entrainment along the channelized debris flow path (Plate (b)). An electricity pylon (Plate (b)) was damaged in the event. The debris affected an extensive foothill area, including a construction site and the golf-course at the toe of the hillside, an access road that runs from the construction site to Lung Mun Road (Plate (c)), and the Light Rail at Lung Mun Road (Plate (d)). It is fortunate that the debris flows have not resulted in any casualties. However, the economic loss and disruption to the community were still severe.

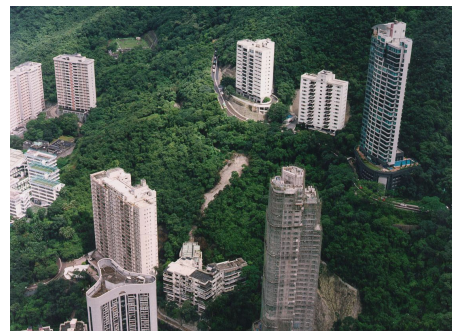
Plate (a) - A 20 m<sup>3</sup> landslide below Bowen Road in 1998

A small landslide occurred on a hillside below Bowen Road (Plate (a)) in 1998. The debris had a volume of about 20 m<sup>3</sup> only, but it directly hit the building below the hillside and resulted in some damage. Given the close proximity of the building to the hillside, the consequence of the failure could have been more serious if the landslide was of larger volume. Post-landslide investigation undertaken by the GEO found that discharge of water into the hillside from a leaked water main along the edge of Bowen Road probably contributed to triggering the landslide. The case illustrates that in Hong Kong's urban setting, even a relatively small-size hillside landslide could be damaging to facilities close to the steep hillside. Also, the stability of natural hillsides may also be affected by man-made influences, such as discharge of surface water and leakage of water-carrying services.

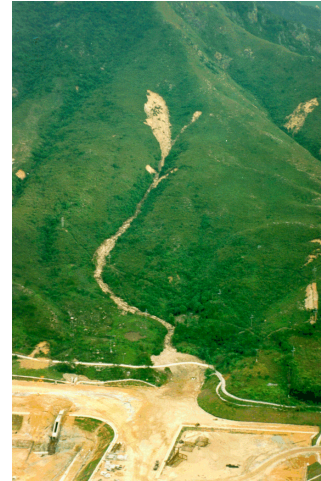
Plate (d) - A debris flow near the present Tung Chung New Town

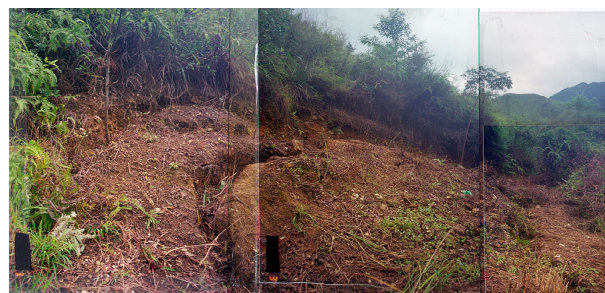
Extensive cracking at the hillside behind Burma Lines Camp at Fanling was found in 1997, and it was estimated that the distressed zone had a total volume of about 2,000 m<sup>3</sup> (Plates (a) and (b)). Although the registered cut slope at the toe of the hillside meets current standards, the natural terrain instability problem is found to be difficult to fix. As a result, four existing Government quarters buildings at the toe of the hillside were permanently evacuated.

Plate (b) - Tension cracks on the hillside

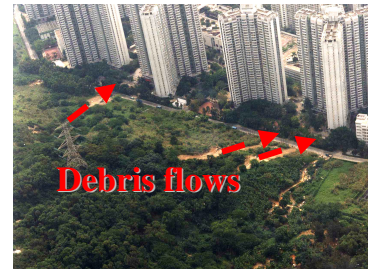
Plate (c) - Debris flows reached the access road to the housing estate

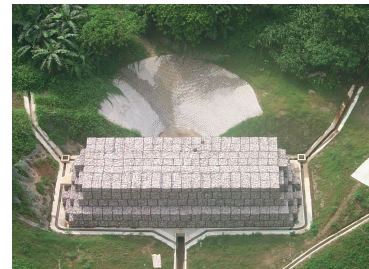
Plate (d) - Debris-resisting barrier with  $600 \text{ m}^3$  design debris retention volume

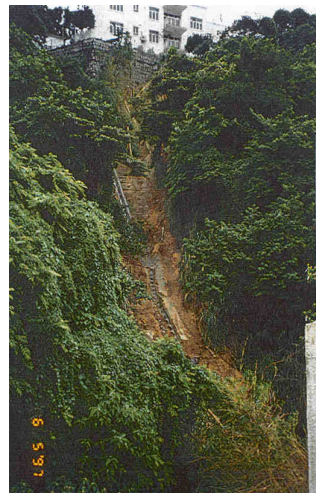
Plate (b) - Debris flow in 1997

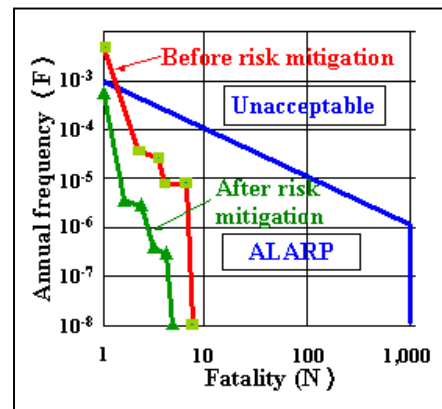
Plate (c) - Societal risk of natural terrain landslides before and after provision of risk mitigation measures

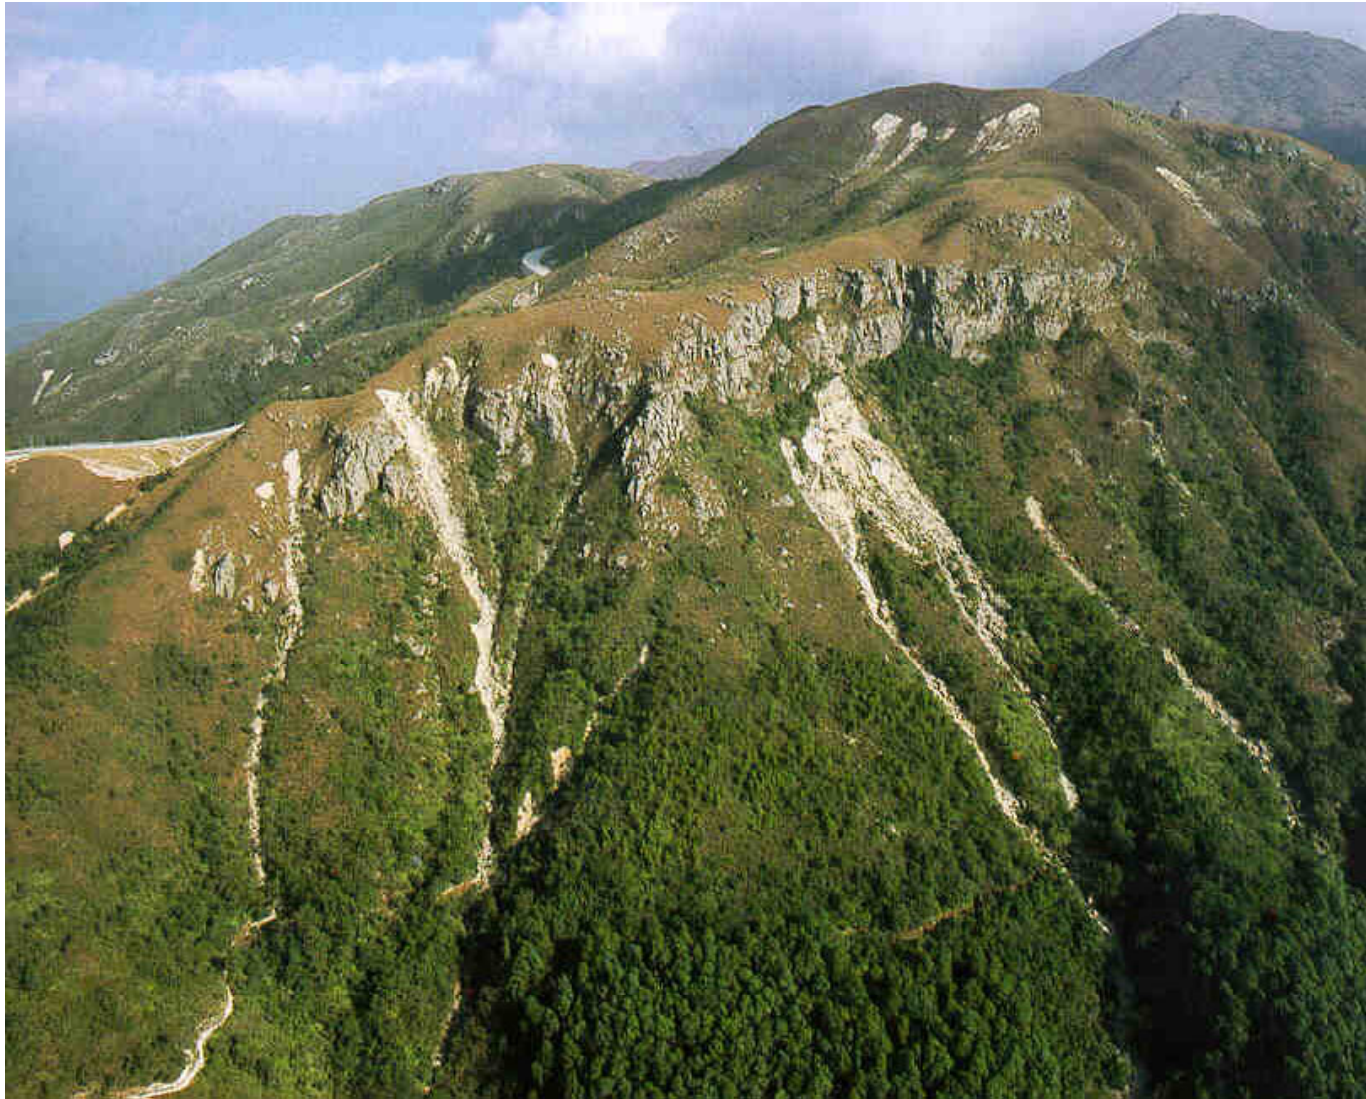
Figure 3 - Rain-induced Shallow Natural Terrain Landslides

Natural terrain landslides in Hong Kong arise typically from rain-induced shallow failures of the surface mantle of the hillside (Figure 3). The materials that fail at the source areas of the landslides may include top-soil, colluvium and weathered rock (Figure 4). Most of the landslides are of several hundred cubic meters in volume, but some have developed into massive, mobile debris flows with devastating destructive power. Falls of individual boulders from natural terrain into developed areas are also reported from time to time (Figure 5).

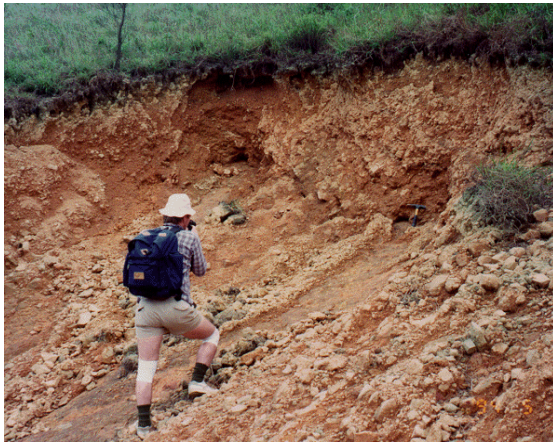
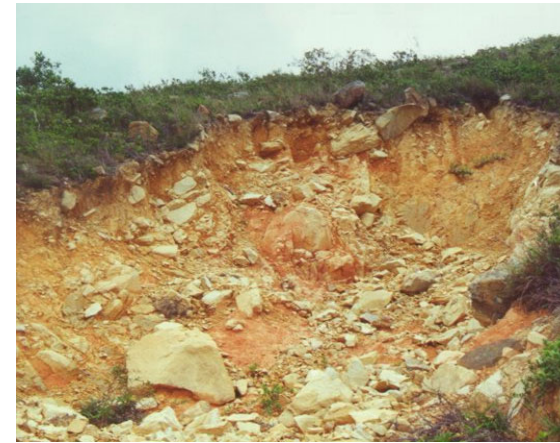
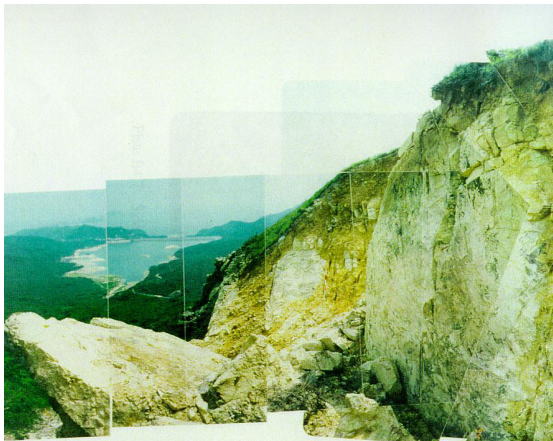
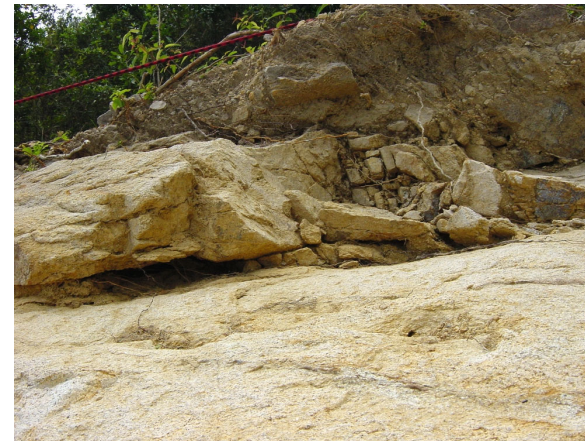
Figure 4 - Failure Types at the Source of Natural Terrain Landslides

(a) Landslide in colluvium, above the interface with weathered rock

(b) Landslide in weathered rock

(c) Landslide due to rock toppling failure

(d) Landslide along joint planes in weathered rock

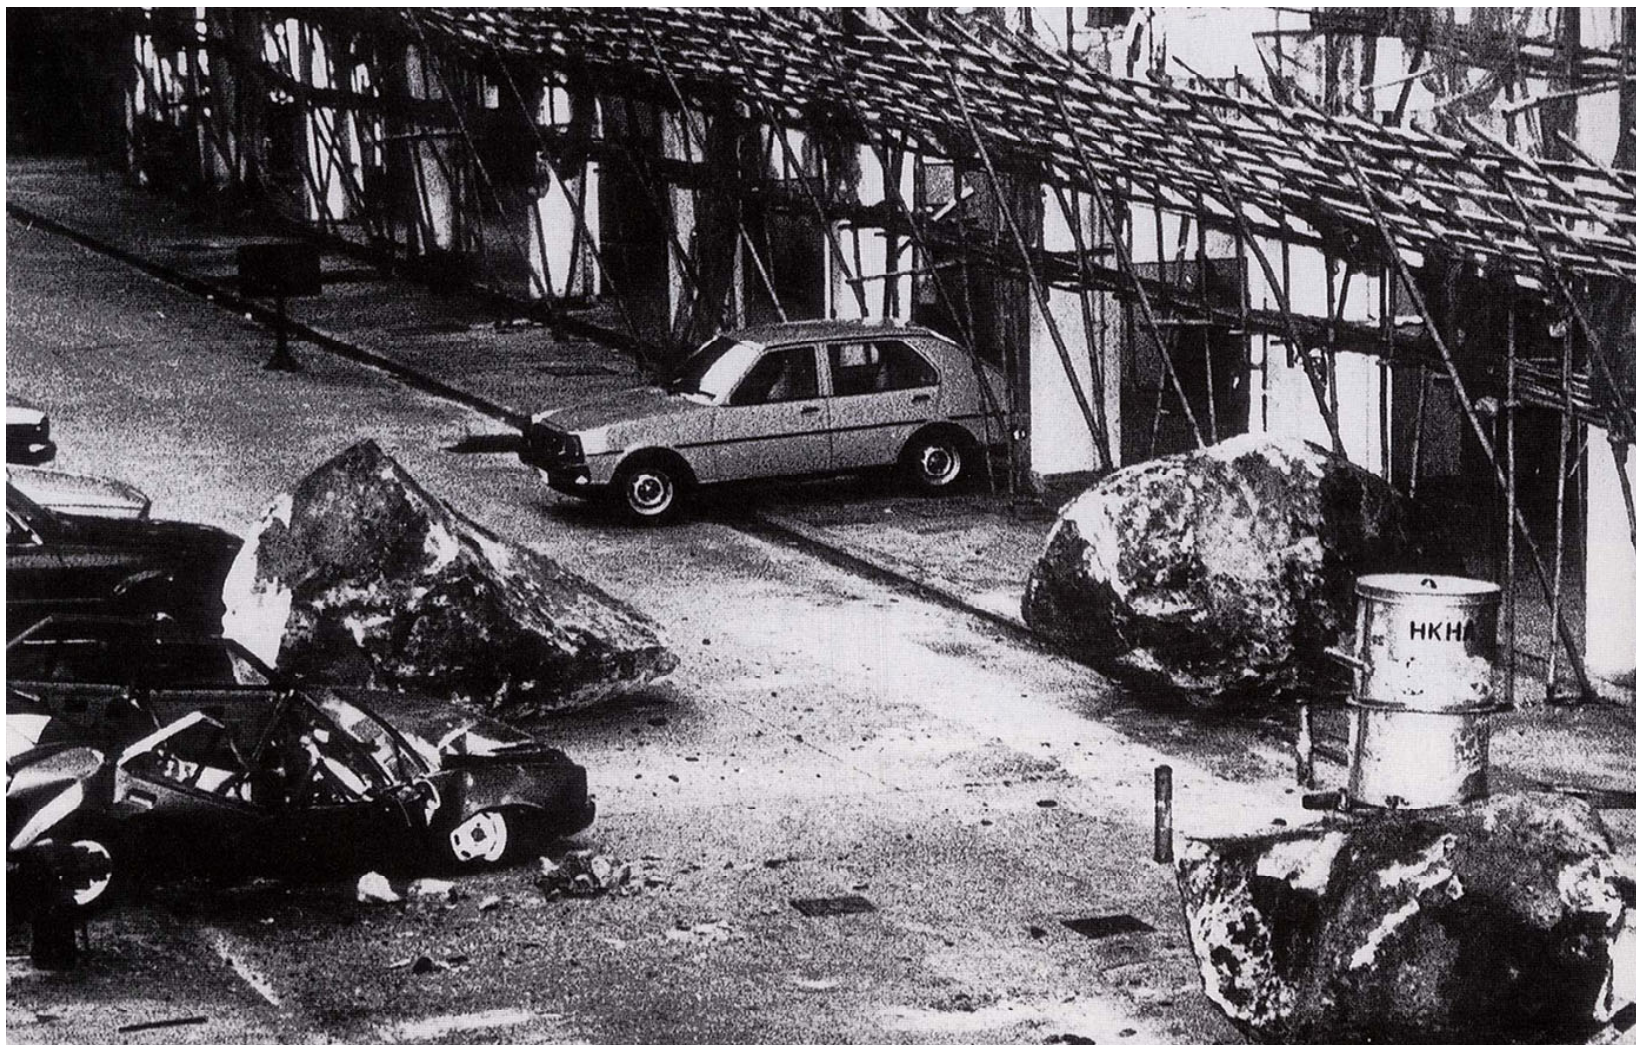
Figure 5 - Fall of Boulders at Kennedy Town Police Quarters in 1986

Note: Vehicles were severely damaged. Fortunately, there were no casualties.

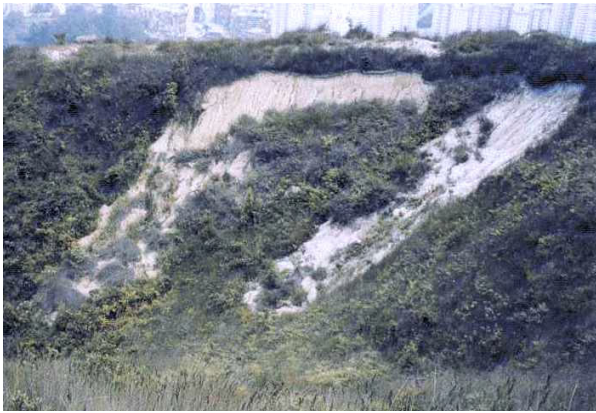
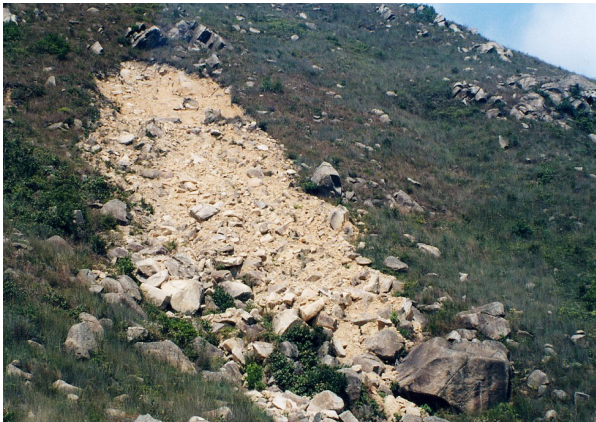
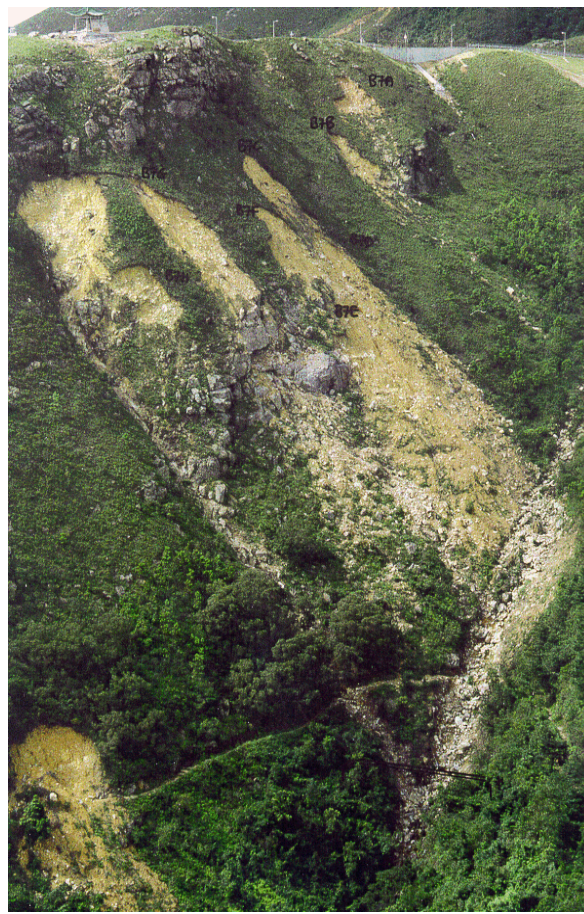
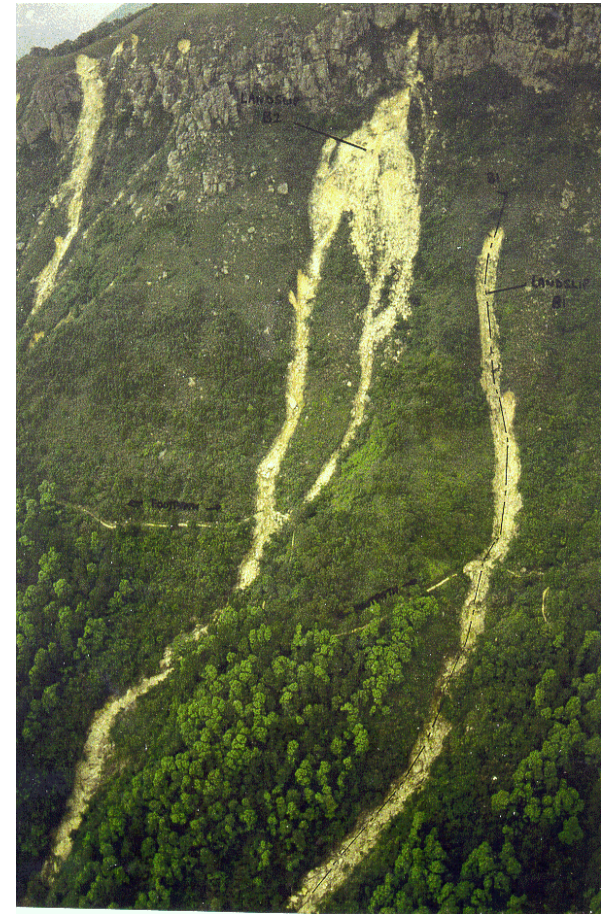
Figure 6 - Different Mechanisms of Debris Movement

(a) Debris slide

(b) Debris avalanche

(c) Change in mechanism from debris avalanche to debris flow

(d) Debris flow

- Where the hillside is relatively planar, the debris may slide down the hillside as an intact slab and result in an open slope debris slide (Figure 6(a)). If disintegration occurs during debris movement, the landslide becomes an open slope debris avalanche (Figure 6(b)).
- A channelized debris flow would occur if the debris enters into an incised drainage line that governs the alignment of the debris flow path (Figures 6(c) & (d)). Where loose materials are present in the drainage line, entrainment of the loose materials may occur and this could significantly escalate the debris volume and mobility (Box 2).
- Where the drainage line or depression in topography is more subtle, the mechanism becomes a mixed debris avalanche-and-flow, which is intermediate between an open slope landslide and a channelized debris flow.

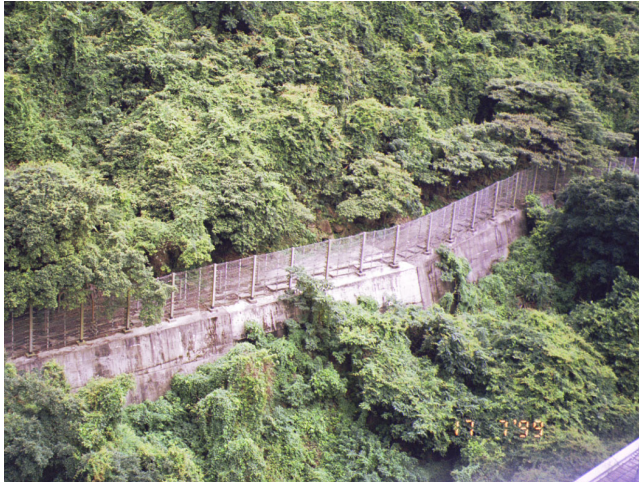
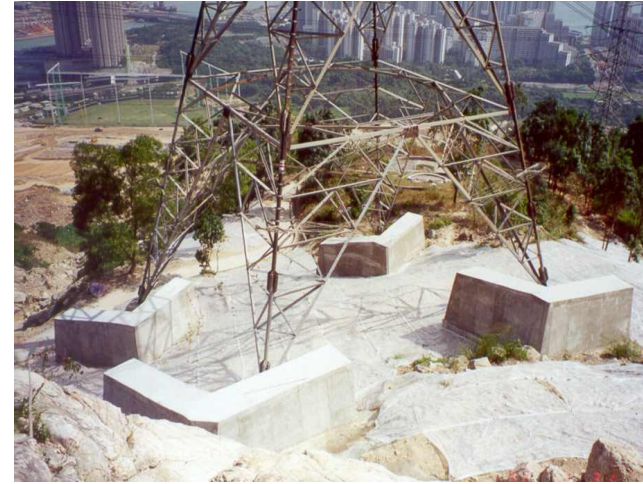
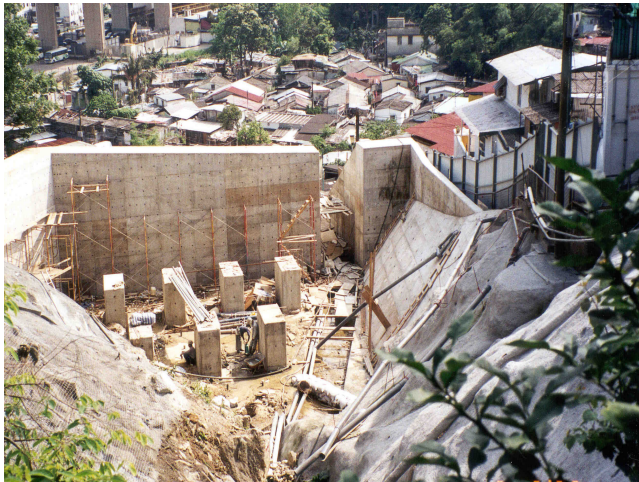
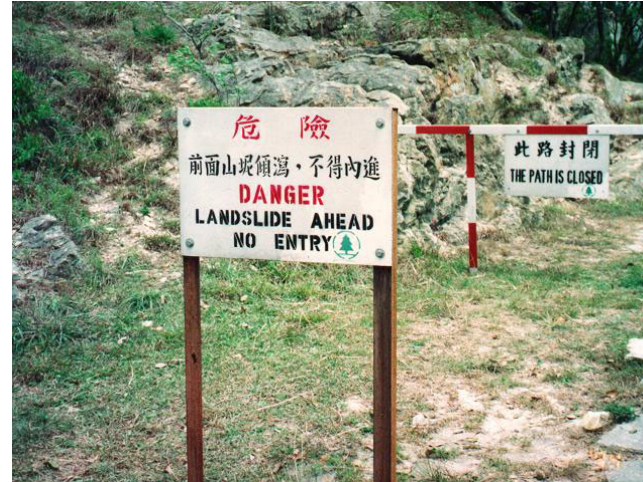
Figure 11 - Typical Natural Terrain Landslide Risk Mitigation Measures

(a) Boulder/debris fence

(b) Protective barrier

(c) Check dam

(d) Provision of buffer zone

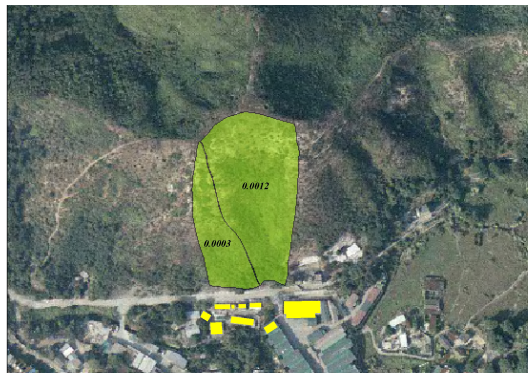
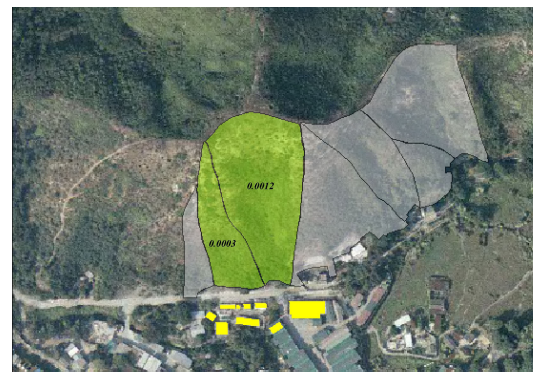
Historical NTLI  
Catchments in Inventory

Full Catchments  
in Pat Heung Area

Historical NTLI Catchments in Inventory	Full Catchments in Pat Heung Area
Results from Global QRA	0.0015 (building data validated)	-
	0.0024 (building data not validated)	0.0029 (building data not validated)
Results from Site-specific QRA (OAP, 2003)	-	0.0016 (building data validated)

(a) PLL for Building Structures in Pat Heung Area (in Fam Kam Road Region)

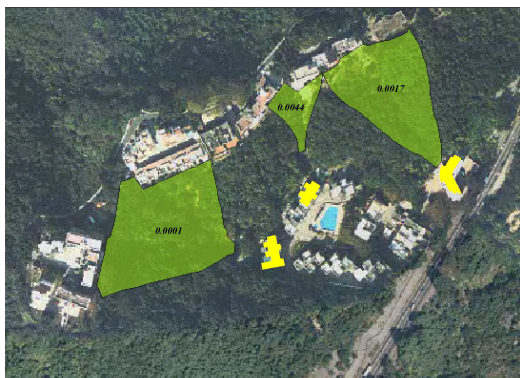
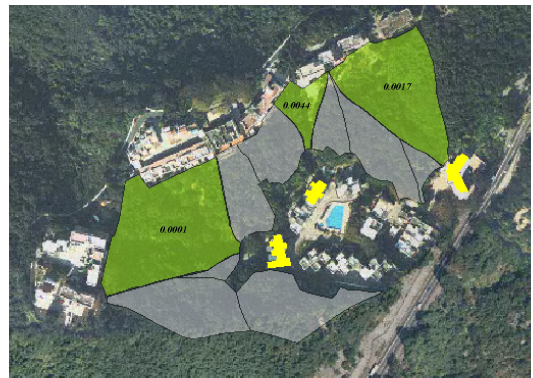
Historical NTLI  
Catchments in Inventory

Full Catchments  
in Shatin Heights Area

Historical NTLI Catchments in Inventory	Full Catchments in Shatin Heights Area
Results from Global QRA	0.0062 (building data validated)	-
	0.0066 (building data not validated)	0.0096 (building data not validated)
Results from Site-specific QRA (Fugro Maunsell Scott Wilson Joint Venture, 2001)	-	0.0057 (building data validated)

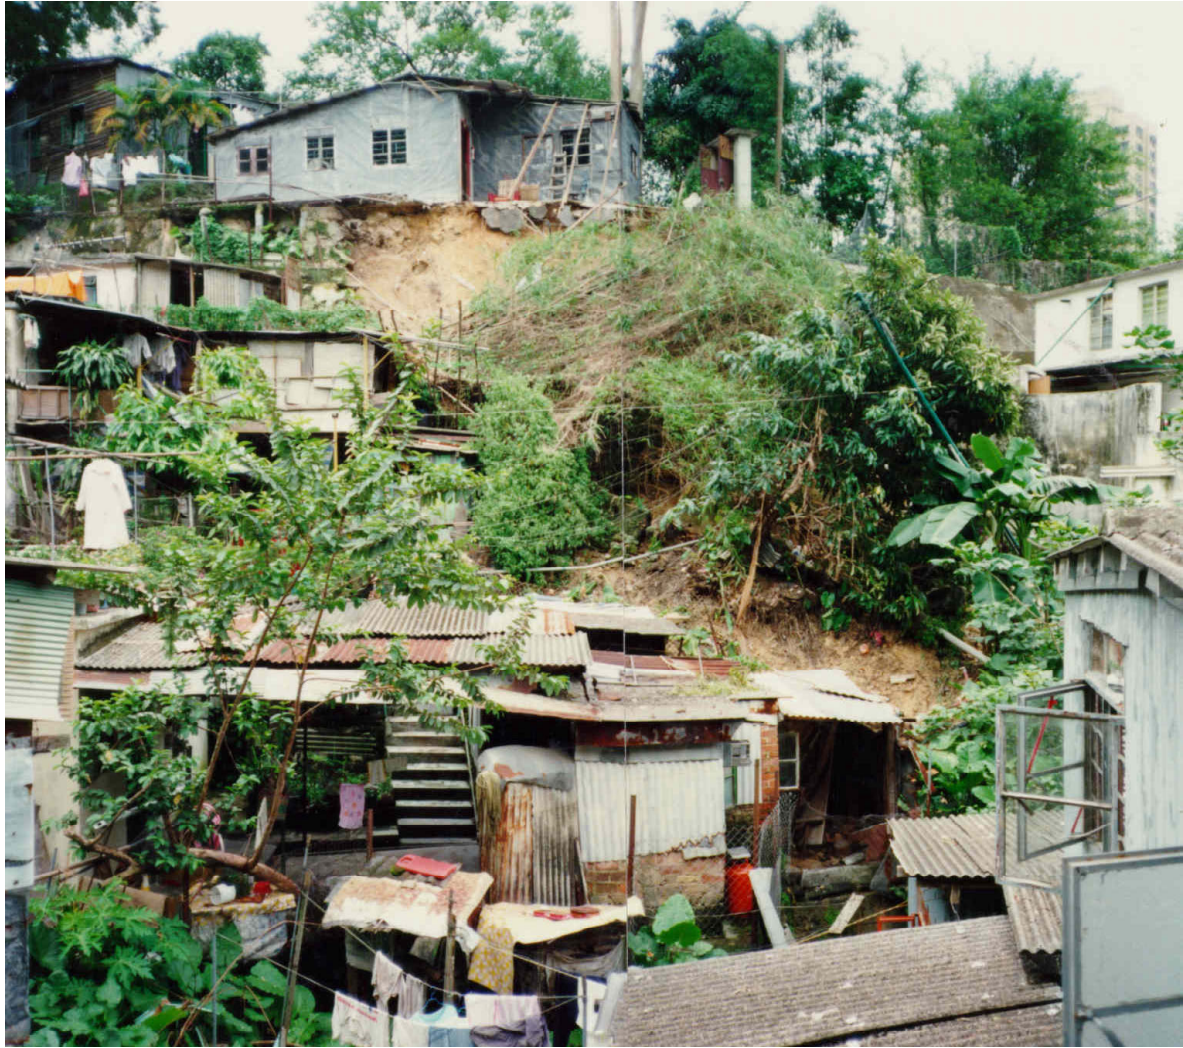
Figure 24 - Local, Small-scale Landslides on Disturbed Hillside

Most of the hillsides within or in the vicinity of the Development Lines could have been disturbed or modified by man-made activities, e.g. local cutting and filling of different extent. They form a specific type of hillside problem, and landslide incidents on such hillsides are reported to the GEO from time to time. As the local cutting and filling do not result in a sizeable man-made slope features, they would not be registered in the Catalogue of Slopes and hence their potential risk is also not considered in the global QRA on registered man-made slopes (Lo & Cheung, 2004). Where the landslide is principally confined to the local cut and fill, the scale of failure is small and it would normally not result in any serious consequences unless it directly affects some vulnerable facilities, e.g. flimsy structures (Figure 24). However, where the landslide involves a significant portion of the hillside, the consequence and hence the risk of landslide would escalate as the debris volume increases (Figure 25). The landslide risk from these hillsides has not yet been quantified, and further work on assessing the potential scale of the problem is being carried out by the GEO.

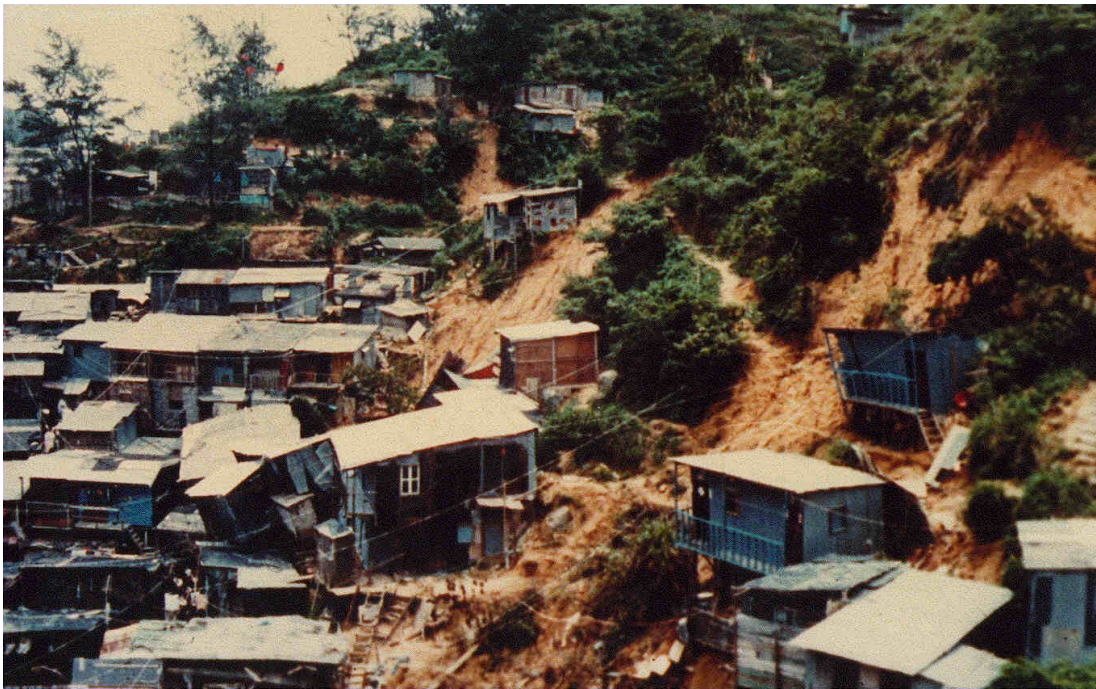
(a) Landslide covering a large area, where small cuttings and pockets of fill materials are present

1 Photograph/Sketch of failure relative to buildings, roads etc		2 Inspected by Mark Swales (HAP) Michael Lee (HAP)		3 Failure Number MW 97/6/56			
		4 Ownership Government land		5 Lot: No. N/A			
		6 Location No. 139c Kau Wa Keng San Tsuen, Kowloon (831890 E) (823118 N)		7 Active Construction Site: Yes (No)			
		Date and Time		10 File No.			
		8 Failure: 4/6/97 07:00		9 Inspected: 23/6/97 14:30		GCMW 2/E2 197	
Retaining Wall	Natural	Cut	Fill	Chunam/Concrete	Grass	Trees/Bushes	Stone Pitching
11	12 ✓	13	14 ✓	20	21	22 ✓	23
Possible Cause				Rainfall in preceding Range No. N04			
Ground Water	Infiltration	Pipe Failure	Excavation	15 days mm	1 day mm	1 hour mm	
30	31 ✓	32	33	40 296	41 263	42 128.5	
Material				60 Remaining Danger			
D.V.	D.G.	Soil	Rock	Colluvium	widening may affect houses adjacent to No. 137.		
50	51 ✓	52 ✓	53	54			
70 Description of Failure Fill slope (25m long, 11m wide and 4m deep) failed due to heavy rain and infiltration in the slope from surface runoff in stream course.				71 Joint controlled		80 Back Analysis Yes/No
