TRIAL APPLICATION OF THERMAL INFRA-RED IMAGE AND SEISMIC SYMPATHETIC VIBRATION TECHNIQUES FOR SLOPE INVESTIGATION

GEO REPORT No. 199

T.H.H. Hui & H.W. Sun

**GEOTECHNICAL ENGINEERING OFFICE
CIVIL ENGINEERING AND DEVELOPMENT DEPARTMENT
THE GOVERNMENT OF THE HONG KONG
SPECIAL ADMINISTRATIVE REGION**

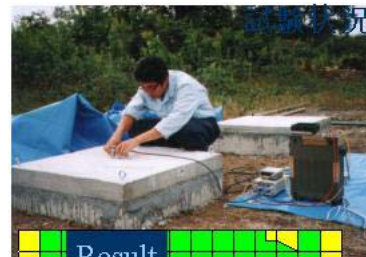
Model Experiment

Analysis by the
grid of 5cm×5cm

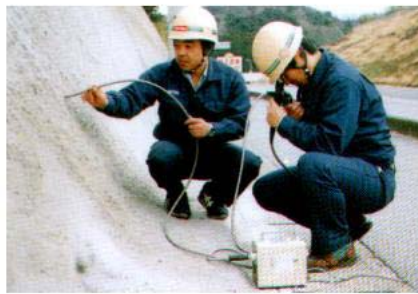
Confirmation by Fiber Scope

Minimum effect to the
structure of shotcrete
