Geotechnical Area  
Studies Programme

GASP Report XII

# Territory of Hong Kong

Geotechnical Control Office  
Civil Engineering Services Department  
Hong Kong

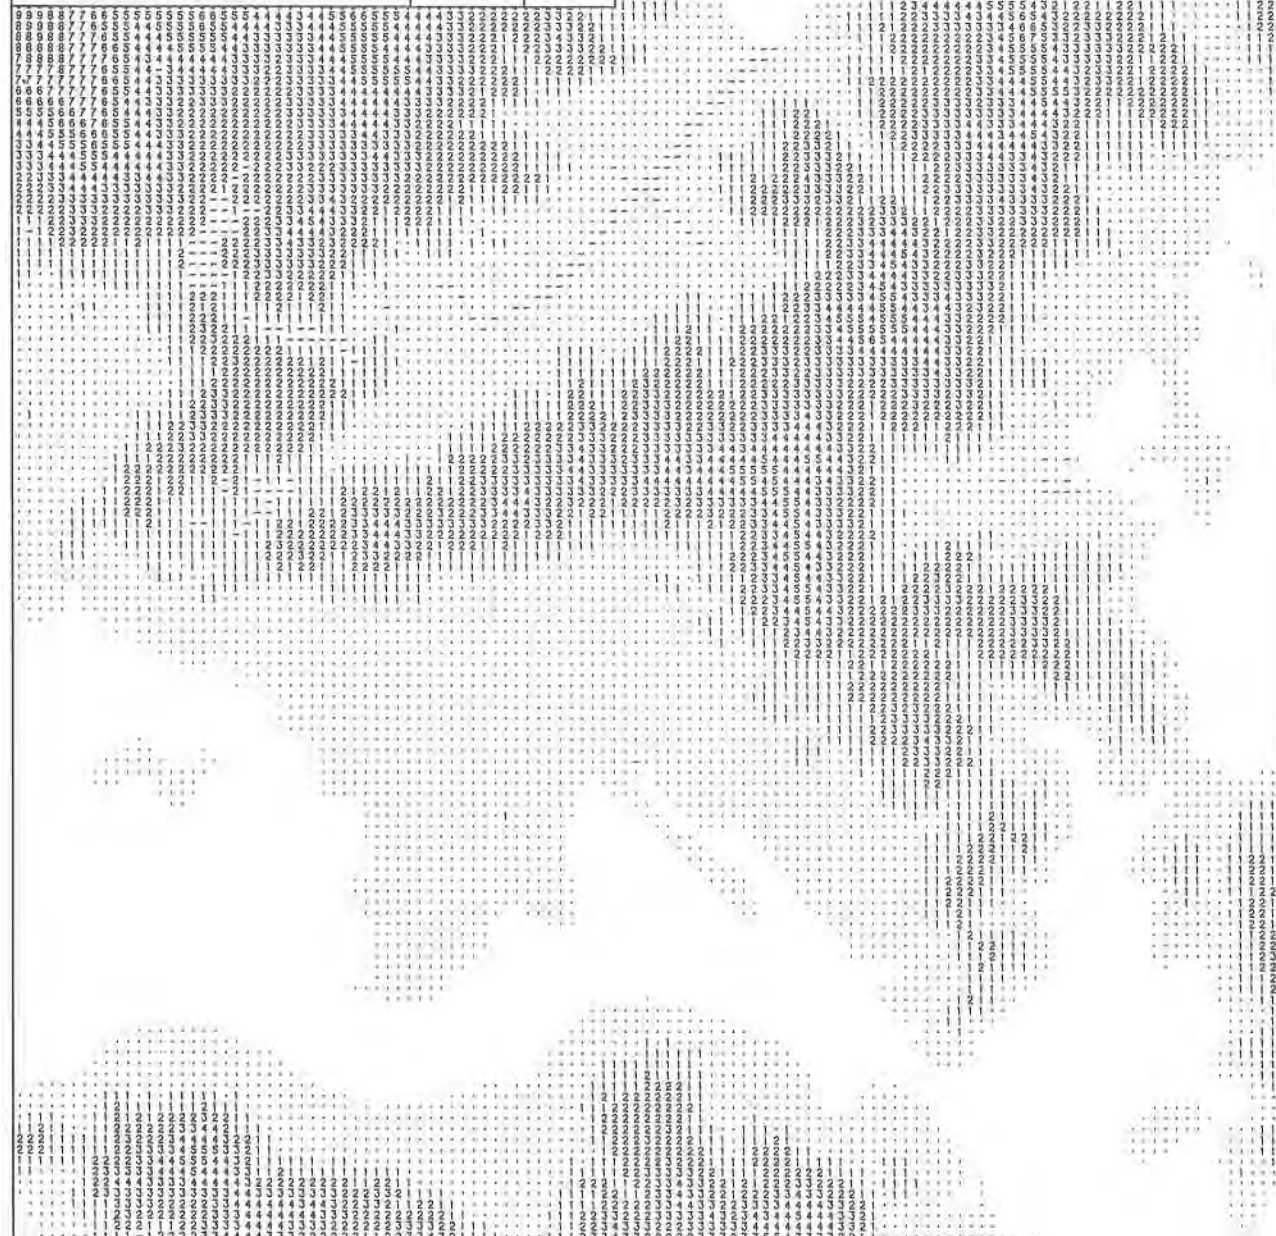
Scale 1:100 000	Example of the GEOTECs Relief Map	Fig. 8
--------------------	-----------------------------------	--------

SYMBOL	DESCRIPTION	AREA (HECTARES)	PERCENT
*	TERRAIN < 100 METRES	52 327	48.0
1	TERRAIN 100 - 199 METRES	23 047	21.1
2	TERRAIN 200 - 299 METRES	14 420	13.2
3	TERRAIN 300 - 399 METRES	7 418	6.8
4	TERRAIN 400 - 499 METRES	3 580	3.3
5	TERRAIN 500 - 599 METRES	1 369	1.3
6	TERRAIN 600 - 699 METRES	649	0.6
7	TERRAIN 700 - 799 METRES	329	0.3
8	TERRAIN 800 - 899 METRES	105	0.1
9	TERRAIN > 900 METRES	20	< 0.1
~	STREAMS, CHANNELS, RESERVOIRS AND PONDS	5 764	5.3
TOTALS :		109 029	100.0

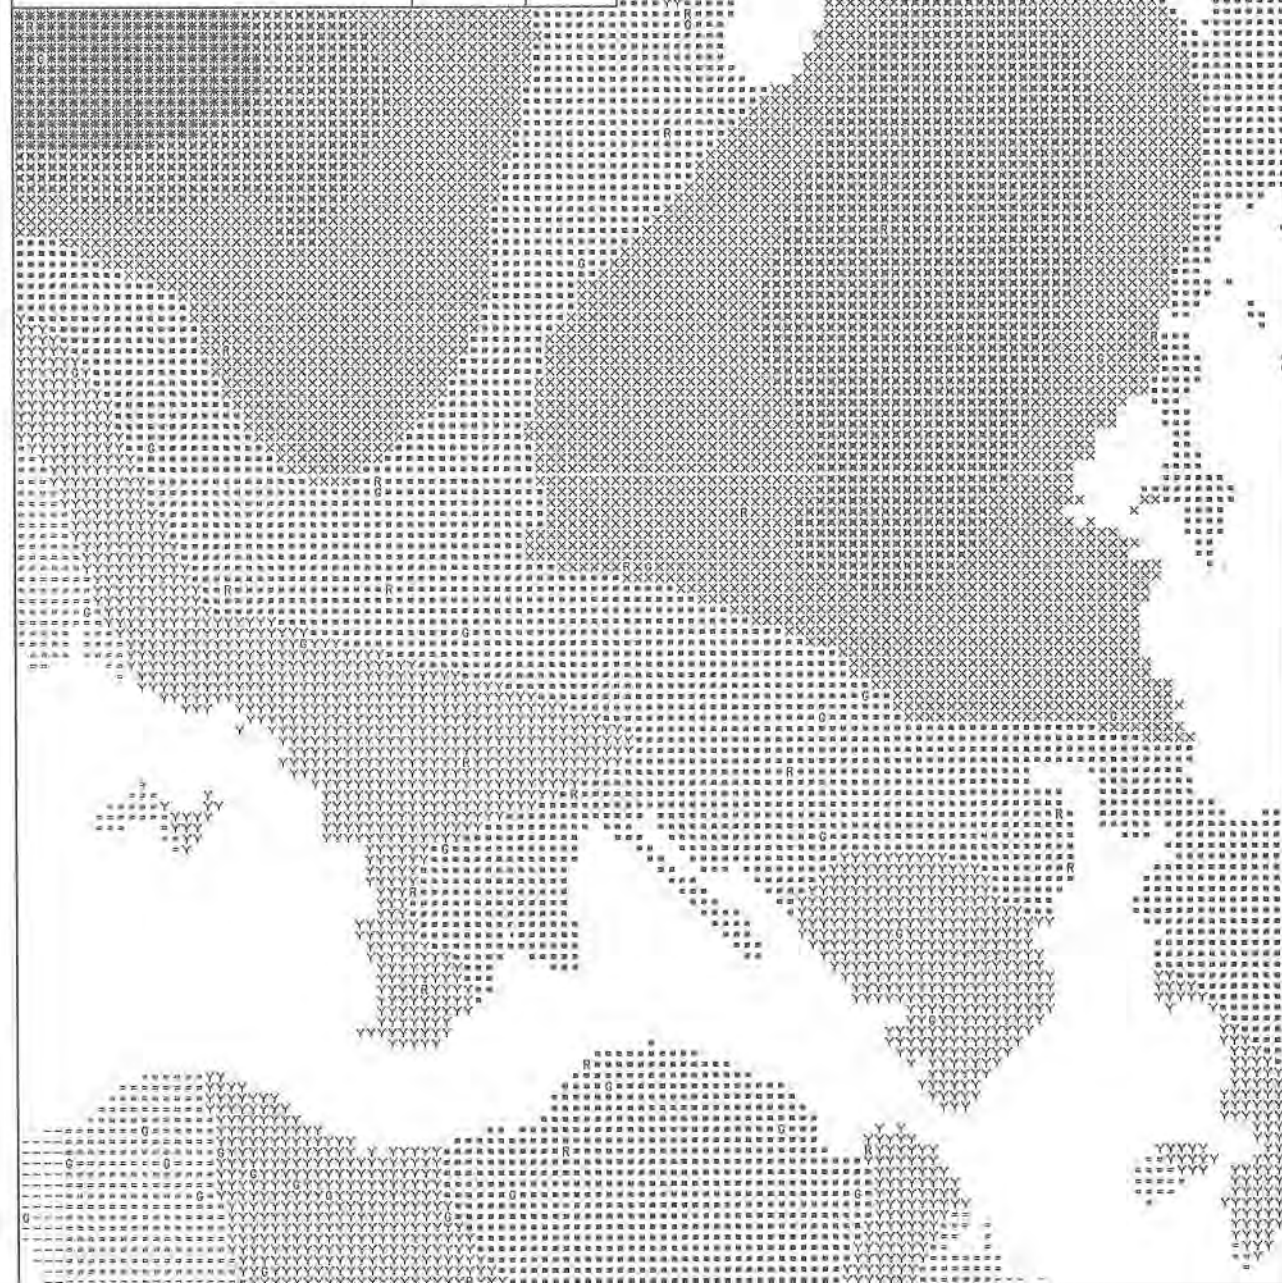
Example of the GEOTEC S Rainfall Map

SYMBOL	DESCRIPTION	AREA (HECTARES)	PERCENT
.	1 300 - 1 699 mm RAINFALL	6 331	5.5
—	1 700 - 1 899 mm RAINFALL	12 823	11.8
=	1 900 - 2 099 mm RAINFALL	22 794	20.9
Y	2 100 - 2 299 mm RAINFALL	25 276	23.2
≡	2 300 - 2 499 mm RAINFALL	26 700	26.3
X	2 500 - 2 699 mm RAINFALL	8 120	7.4
⋈	2 700 - 2 899 mm RAINFALL	3 867	3.5
*	> 2 900 mm RAINFALL	824	0.8
R	ROYAL OBSERVATORY RAINGAUGE NETWORK	200	0.2
G	GEOTECHNICAL CONTROL OFFICE RAINGAUGE NETWORK	94	< 0.1
TOTALS :		108 029	100.0

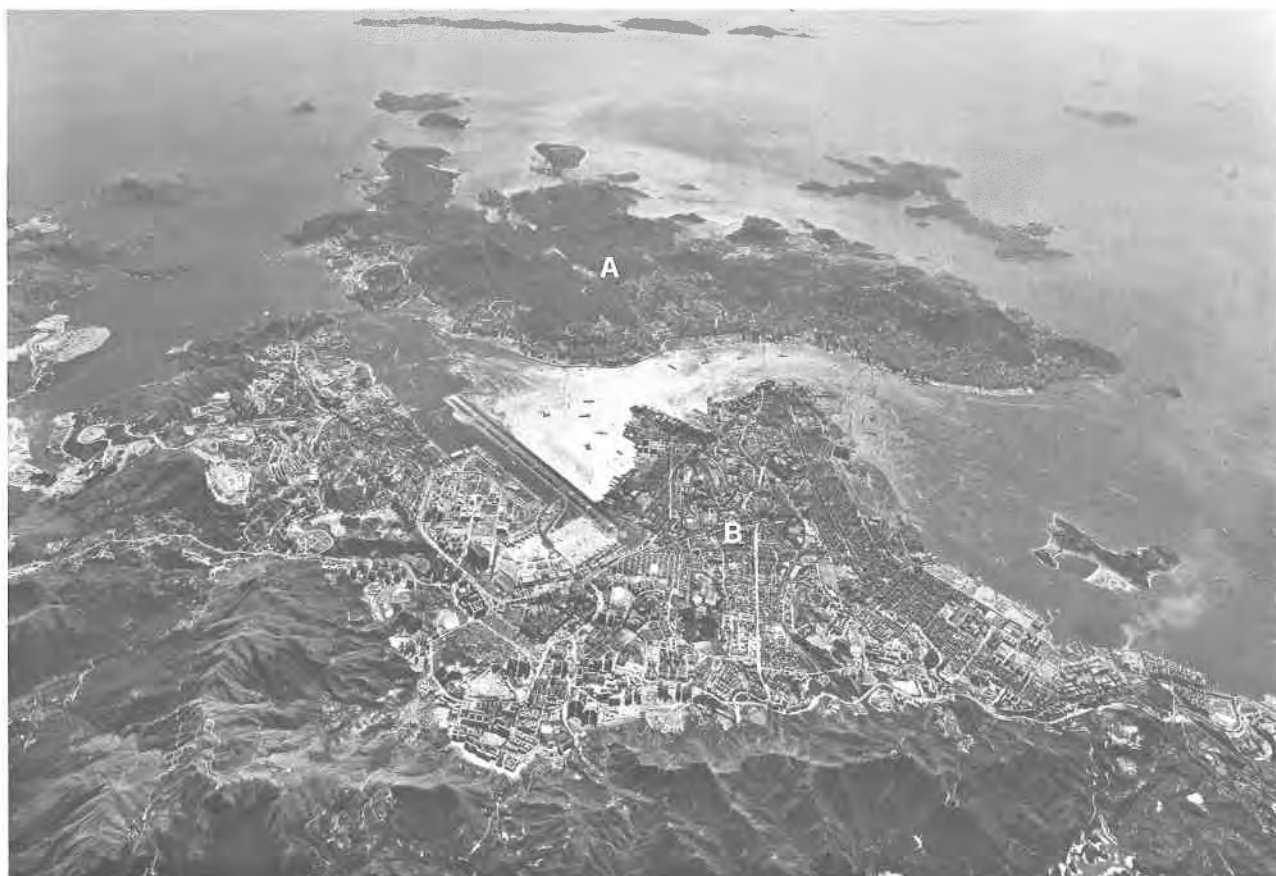
**Plate 1.** *High Oblique Aerial Photograph Looking South across Kowloon towards Hong Kong Island in 1987.* This Plate shows the historical focus of development within the Territory. Hong Kong Island is shown at A, and the area generally referred to as Kowloon at B. Almost 70% of the Territory's population of 5.6 million (1985 Census) live within the Kowloon area and along the northern shore of Hong Kong Island. The rapid development of the seven New Towns has significantly increased the proportion of the population in the New Territories over the last decade. In 1987, approximately 1.83 million lived in the New Town areas (Government of Hong Kong, 1988). Traditionally however, the harbour foreshores have been the subject of reclamation to meet the demands for development. There is approximately 1 600 ha of reclamation fringing Victoria Harbour. The rate of reclamation has dramatically accelerated since the mid-1960's, and it is estimated that this now represents some 24% of the developed terrain within the Territory. Development has been forced to encroach on the Harbour because of severe limitations on the availability of undeveloped usable land. The developed areas are generally bounded on the landward side by steep, rugged terrain. In the Territory, some 70% of the terrain is steeper than 15° in slope gradient, 45% is affected by high to extreme geotechnical limitations and there is evidence of landslips and slope instability on 22% of the total landmass. Superimposed on this geotechnically-problematical terrain is an annual rainfall in the order of 2 250 mm, mostly occurring as intense rainstorms during the period May to September. As an example, in a single rainstorm during June 1983, some 263 landslips were reported in the Hong Kong Island and Kowloon areas alone. This storm produced the most intense 5hr rainfall (274.4 mm) since June 1966. Some of the disastrous effects of the 1966 rainstorms are depicted in Plates 58 to 87. It is within this context of steep terrain, high rainfall and intense demand for rapid expansion that development has occurred within the Territory. The approximate position of the camera when this photograph was taken is depicted on the map at Figure 1. Compare this Plate with Plate 51, taken from a similar position in 1979. (5.1.1987/A08547).

The Territory of Hong Kong consists of a large, irregularly-shaped peninsula extending from the southeastern coast of Guangdong Province of the People's Republic of China, into the South China Sea. Large marine embayments exist on either side of the Territory, with the Pearl (Zhujiang) River estuary to the west, and Mirs Bay to the east (Figure 1). Each of these creates significantly different natural environmental conditions. Within the mainland area of the Territory, several smaller peninsulas occur, separated by narrow, moderately deep inlets, e.g. the Sai Kung Peninsula, split from the northeastern parts of the Territory by Tolo Channel. Many of the approximately 230 offshore islands represent extensions of the hill ranges of the mainland, with the largest being Lantau and Hong Kong Islands. The area traditionally known as 'Hong Kong' is centred on the magnificent natural harbour, and comprises the undulating hills of the Kowloon Peninsula and the northern shore of Hong Kong Island. Plates 1 to 8 provide a general impression of the nature of the terrain and intensity of development within the Territory. The Kowloon and Hong Kong Island areas are shown in high level oblique aerial photographs in Plates 1 and 2.

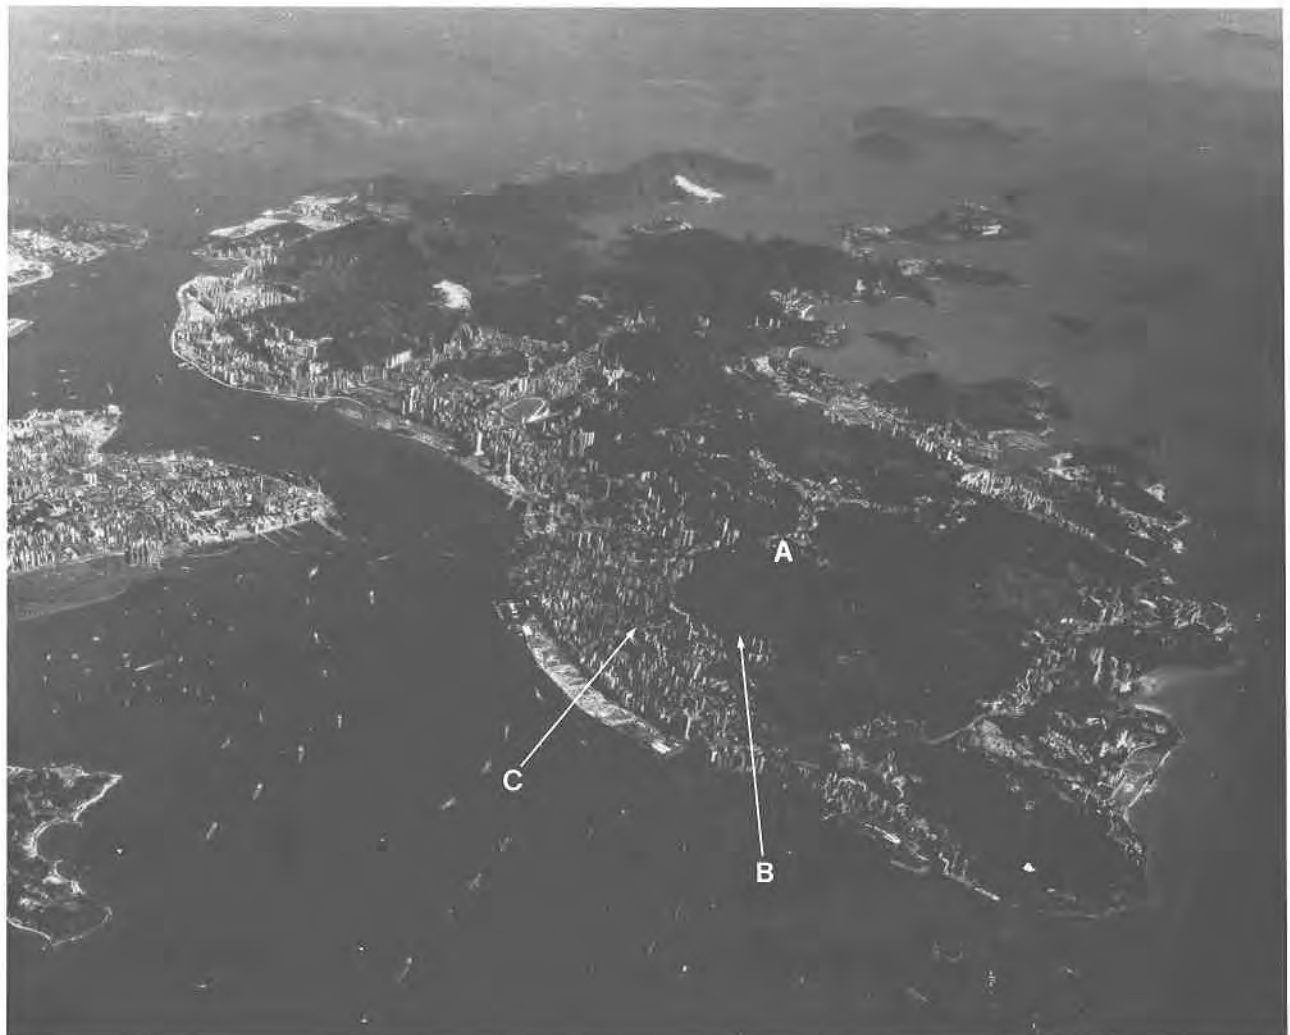
**Plate 2.** *High Oblique Aerial Photograph Looking Southeast across Hong Kong Island in 1985.* This Plate highlights the intensive development along the coastal areas of Hong Kong Island. The central core of the Island is composed of steep terrain, with Victoria Peak rising to an elevation of 554m (A). There are large tracts of undeveloped land which are allocated as Country Park and water storage catchment. Disastrous slope failures have occurred in a number of locations on Hong Kong Island. Probably the most significant are associated with the intensively developed Mid-levels District, where much of the terrain is in the 15–30° slope range. During the period 1979 to 1983, the Mid-levels area was the subject of intensive geotechnical investigation. The sites of the Po Shan (Kotewall) Road Landslip in 1972, and the Po Hing Fong Landslip in 1925, are shown at B and C respectively. The camera position for this photograph is shown on the map at Figure 1. (4.10.85/A02895).

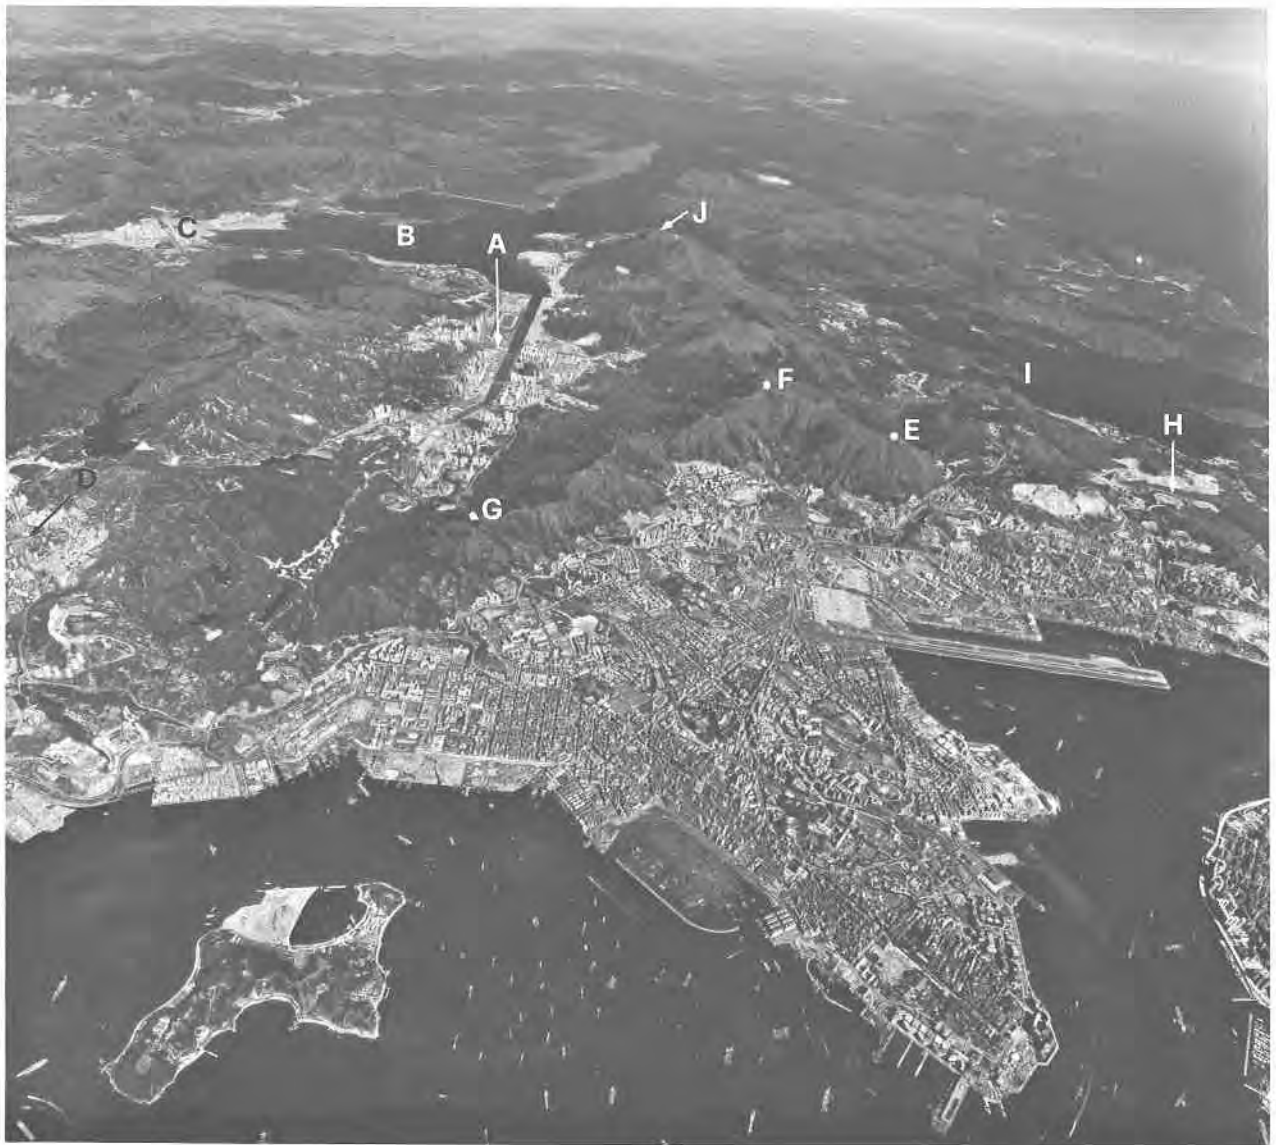
**Plate 3.** *High Oblique Aerial Photograph Looking Northeast across the Kowloon Peninsula towards Sha Tin and Tolo Harbour in 1987.* This Plate highlights the intensive development of the low-lying Kowloon Peninsula. Many of the granitic hills on the peninsula were removed for reclamation during the early years of the Territory. Sha Tin (A) is one of seven New Town development areas and its population is estimated to rise from a 1987 level of 460 000 to 750 000 by 1995. Tolo Harbour and Tai Po New Town are shown at B and C respectively. The areas of intensive development in Sha Tin, Tsuen Wan (D) and Kowloon are constrained by the steep, mountainous terrain which forms the Kowloon Hills. Fei Ngo Shan (602m), Tate's Cairn (577 m), and Beacon Hill (452 m) are at E, F and G respectively. Large areas of the footslope terrain below the Kowloon Hills have been the subject of considerable geotechnical investigation as part of the public housing programme. Detailed terrain classification mapping has been completed on these areas within the GASP District Stage 1 Studies. Site formation for the Junk Bay New Town is evident at H, and large areas of undeveloped terrain are apparent around Port Shelter (I). The highest peak in the eastern part of the Territory is Ma On Shan (J) with an elevation of 702m. The camera position for this photograph is shown on the map at Figure 1. (5.1.1987/A08574).

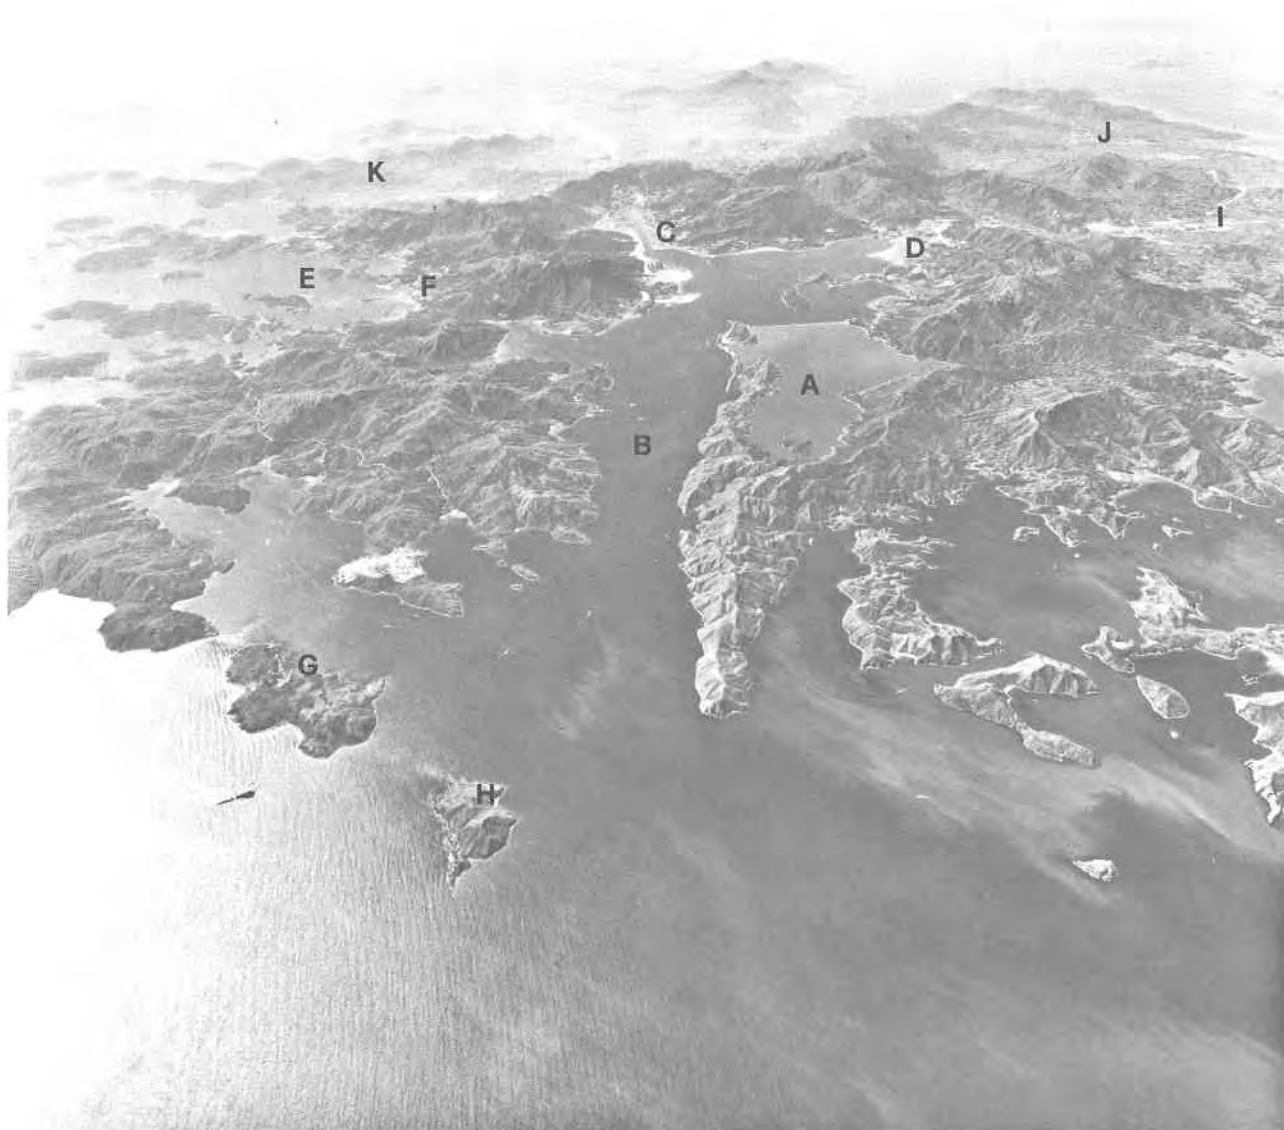
**Plate 5.** *High Oblique Aerial Photograph Looking Southeast across the Plover Cove Reservoir and Tolo Channel towards Sha Tin and Tai Po in 1987.* This Plate provides a very unusual view of the Territory from the east. Plover Cove Reservoir is at A, Tolo Channel at B, Sha Tin at C and Tai Po at D. Much of the terrain in this sector is designated as Country Park and water catchment. Port Shelter is at E, the town of Sai Kung at F, and Tap Mun Chau and Port Island are at G and H respectively. The Fanling Sheung Shui New Town is at I, Yuen Long (J) is some 40 km away and Hong Kong Island (30 km distant) is at K. The camera position for this photograph is shown on the map at Figure 1. (5.1.1987/A08496).

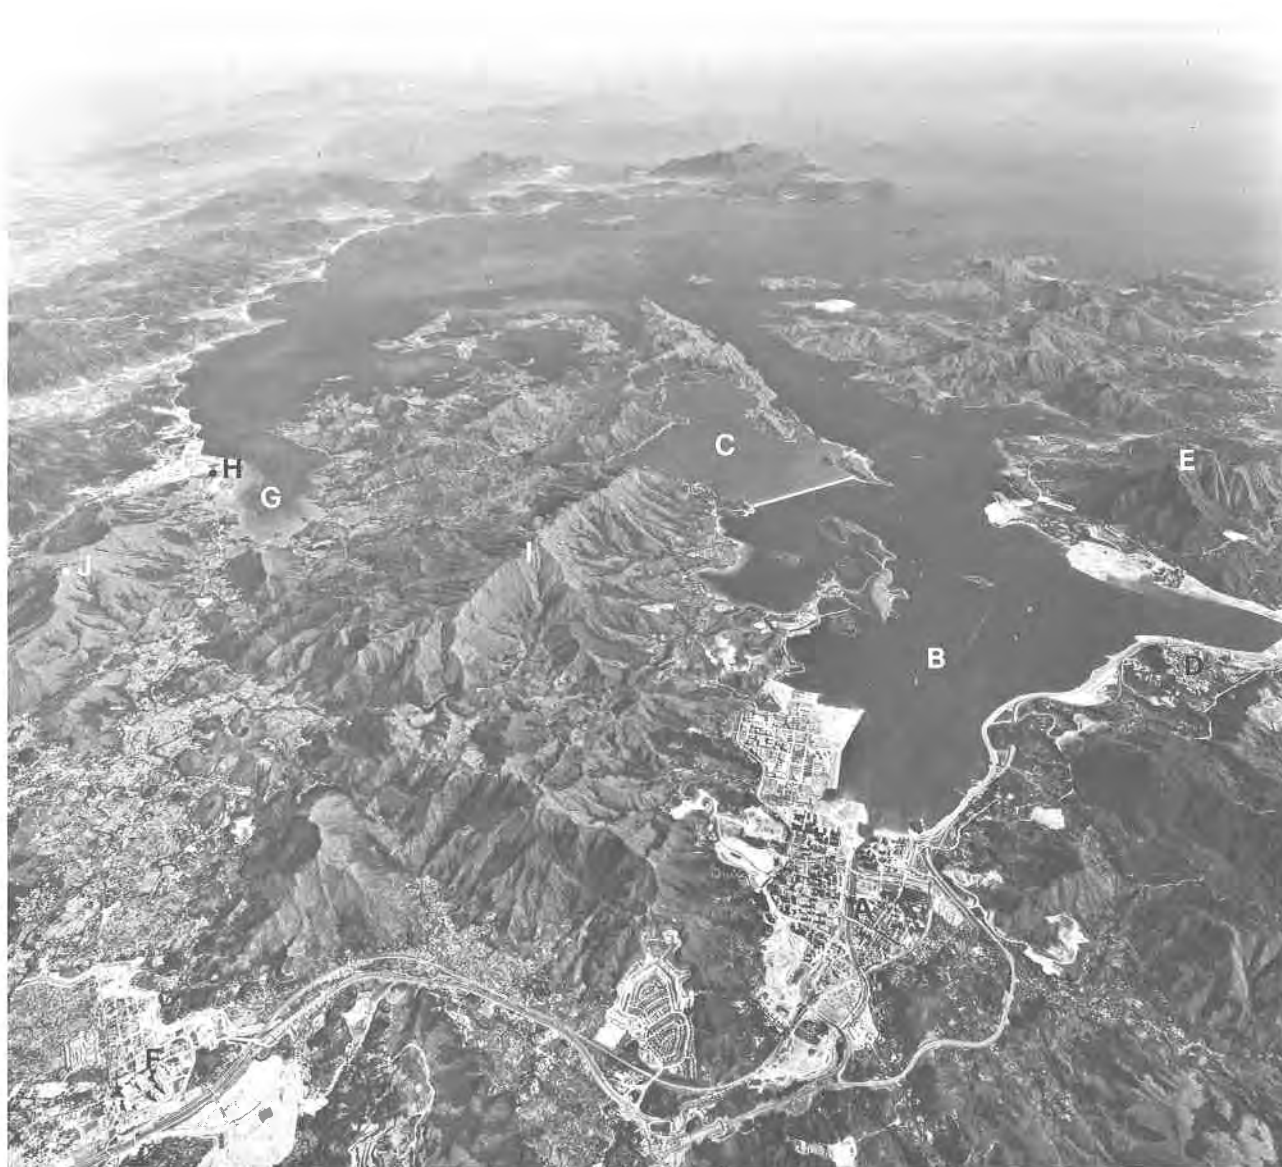
**Plate 6.** *High Oblique Aerial Photograph Looking East across Tai Po towards the Plover Cove Reservoir and Tolo Harbour in 1987.* This Plate, viewed from the west of Tai Po (A), looks across Tolo Harbour (B) towards the Plover Cove Reservoir (C). A large area of the foreshore has been reclaimed for the construction of Tai Po New Town (Plates 49 & 50). The Chinese University of Hong Kong is located at D, with Ma On Shan (702 m) at E. Fanling is at F, Starling Inlet at G and Sha Tau Kok at H. The Pat Sin Range forms the east-west striking ridge at I, with a maximum elevation of 511 m. Robin's Nest (492 m) at J, is slightly lower. The camera position for this photograph is shown on the map at Figure 1. (5.1.1987/A08535).

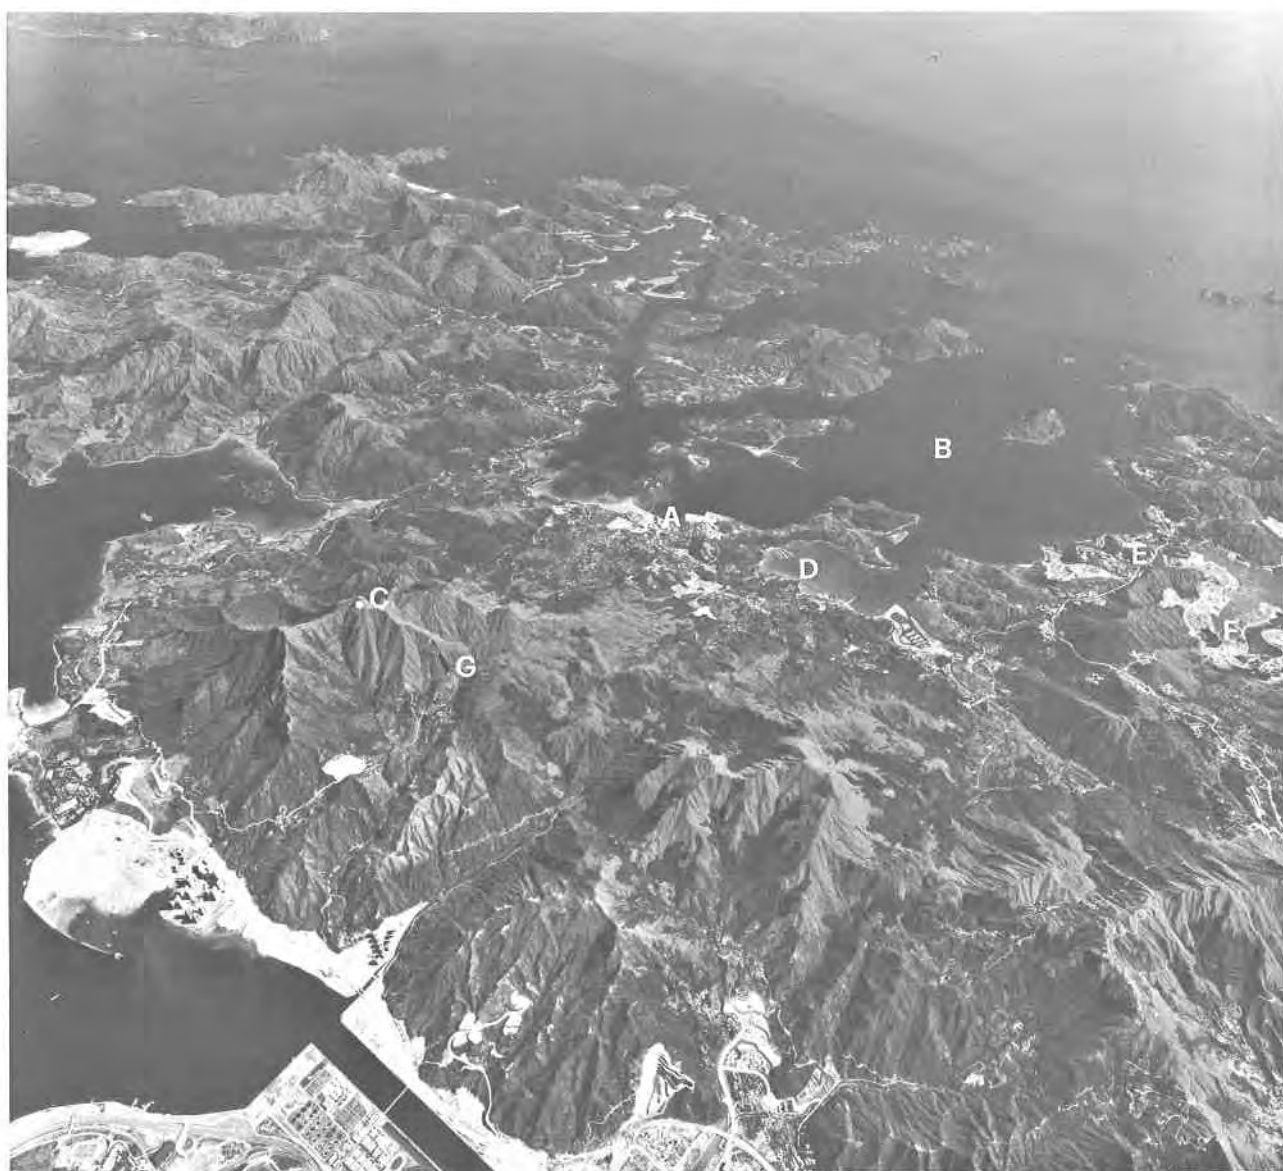
*Plate 7. High Oblique Aerial Photograph Looking Northeast across Ma On Shan towards Sai Kung and Port Shelter in 1987. This Plate, taken from above the Sha Tin valley, looks across the Ma On Shan Country Park toward Sai Kung (A) and Port Shelter (B). Ma On Shan (702 m) is at C, Hebe Haven at D, the Clear Water Bay Peninsula at E, and site formation works for the Junk Bay New Town at F. The largest area of slope failure in the Territory, associated with the old mine site at Ma On Shan, is at G (Plate 128). The camera position for this photograph is shown on the map at Figure 1. (5.1.1987/A08544).*

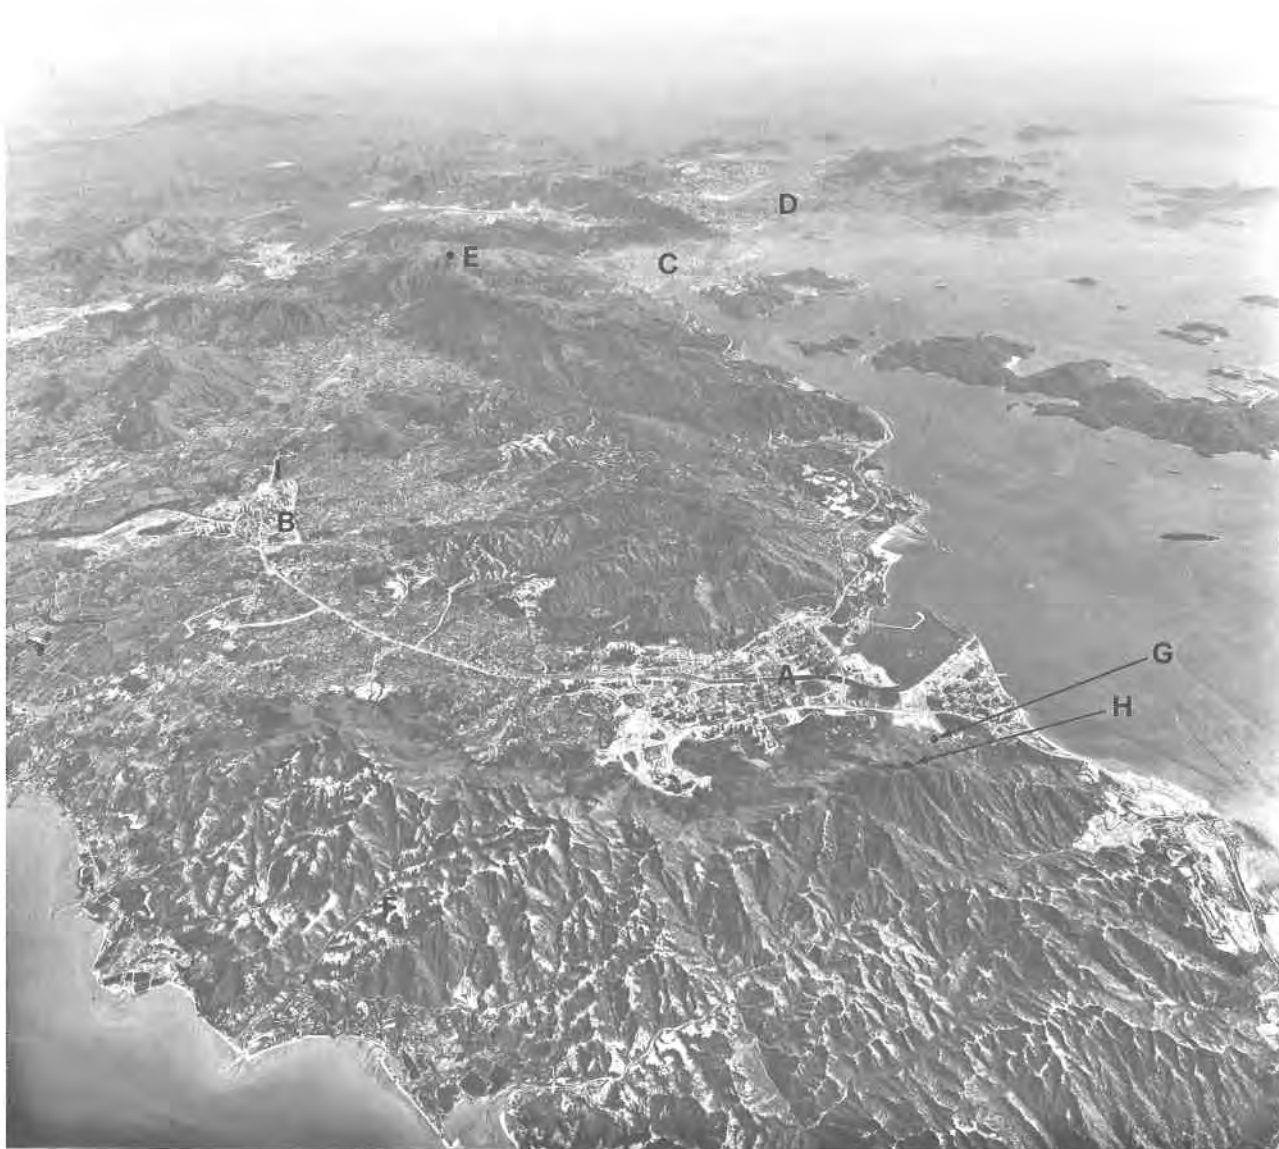
**Plate 8.** *High Oblique Aerial Photograph Looking East across the Tuen Mun and Yuen Long Districts towards Tsuen Wan and Kowloon in 1987.* This Plate views the Territory from above Black Point in the far west. Tuen Mun is at A, Yuen Long at B, Tsuen Wan at C and Kowloon (30 km away) at D. The highest point in the Territory is some 25 km away at Tai Mo Shan (975 m, at E). Much of the hilly granitic terrain occurring in the west of the Territory is affected by erosion which is indicated by the bright tones on the hillcrests and ridgelines (e.g. at F). Major geotechnical problems arose during the development of the footslope terrain at G, below Castle Peak (583 m, at H) (Plates 120–124 & 126). Further geotechnical issues arose following confirmation of areas of cavernous marble beneath parts of the Yuen Long plain (I) during the remapping of the geology of the District. The camera position for this photograph is shown on the map at Figure 1. (5.1.1987/A08473).

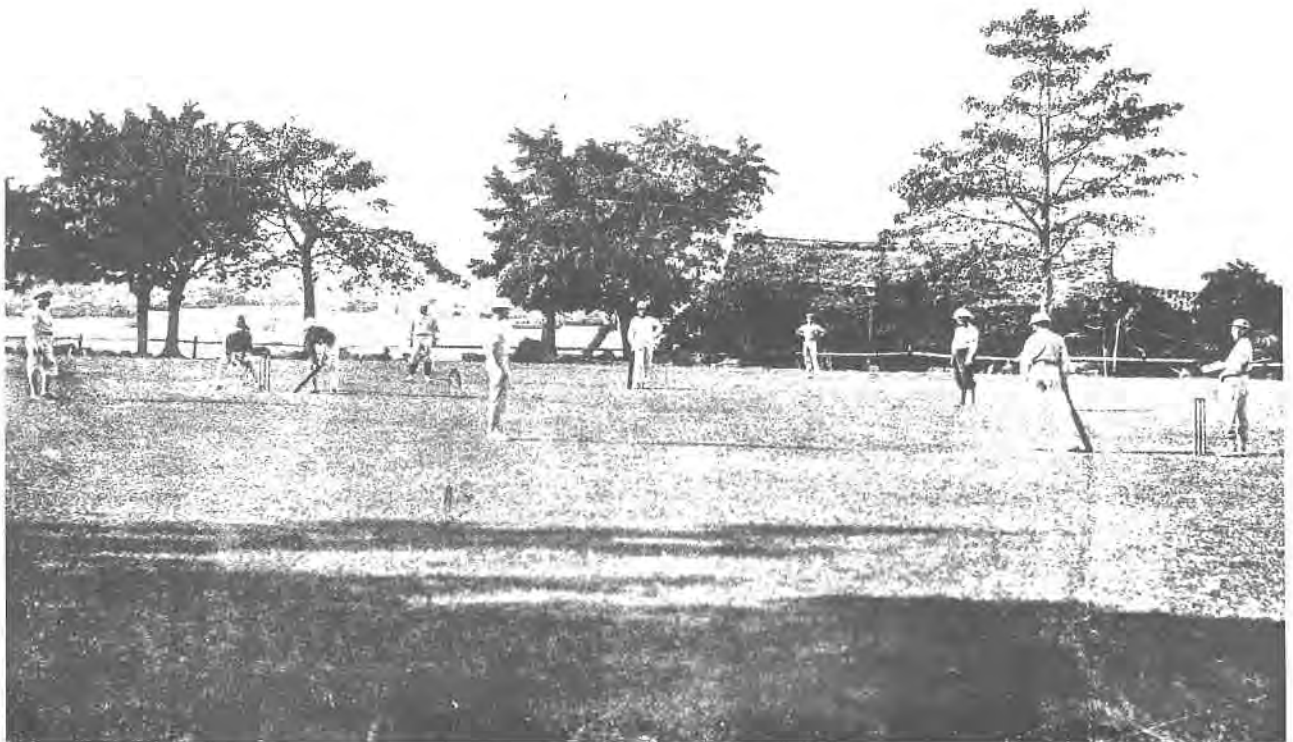
**Plate 10.** *Reclamation on the Northern Shore of Hong Kong Island in 1860.* From the earliest times in the Territory, reclamation was used to assist in the formation of level ground. The site of the Garrison Parade ground, near Murray Barracks, was also used for recreational activities. (PRO 1/14/378).

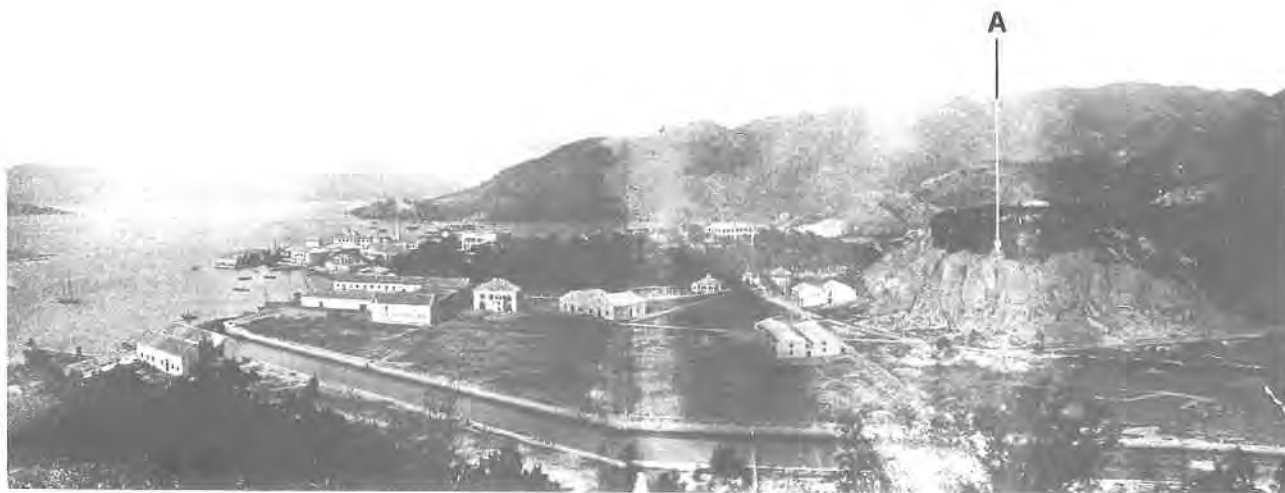
Plate 15. *Bowrington Canal and Leighton Hill from Morrison Hill, circa 1868.* The severely eroded granitic slopes of Leighton Hill (A) is probably associated with excavation for the nearby reclamation. At the time, this area was known as East Point. (PRO 1/8/211).

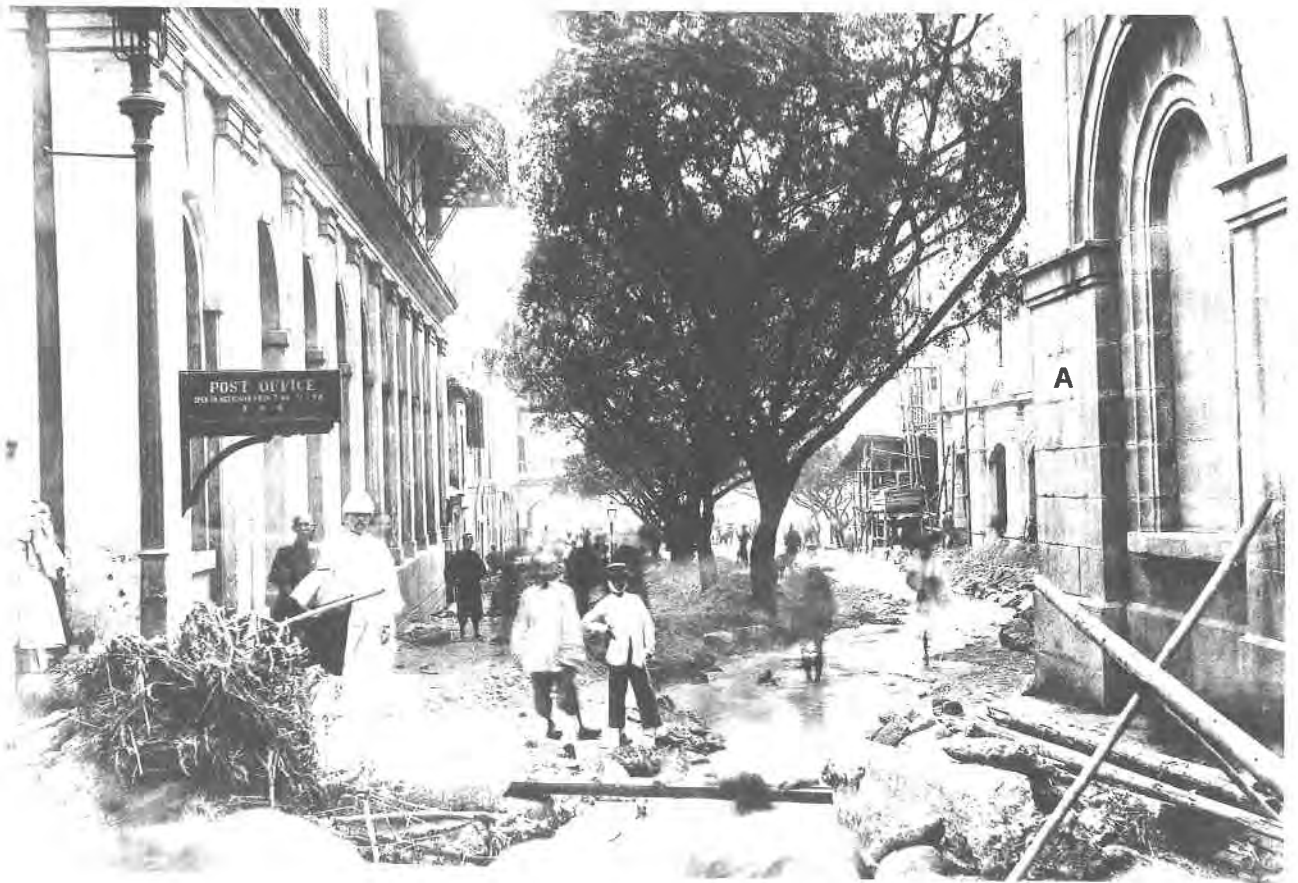
*Plate 19. Flood Damage and Debris in Pedder Street, circa 1879.* This view was taken looking north along Pedder Street towards the harbour following a severe rainstorm. The old Clock Tower evident at A was demolished in the early years of this century. This Plate is reproduced with the permission of the Museum of History, Urban Council (P68.31).

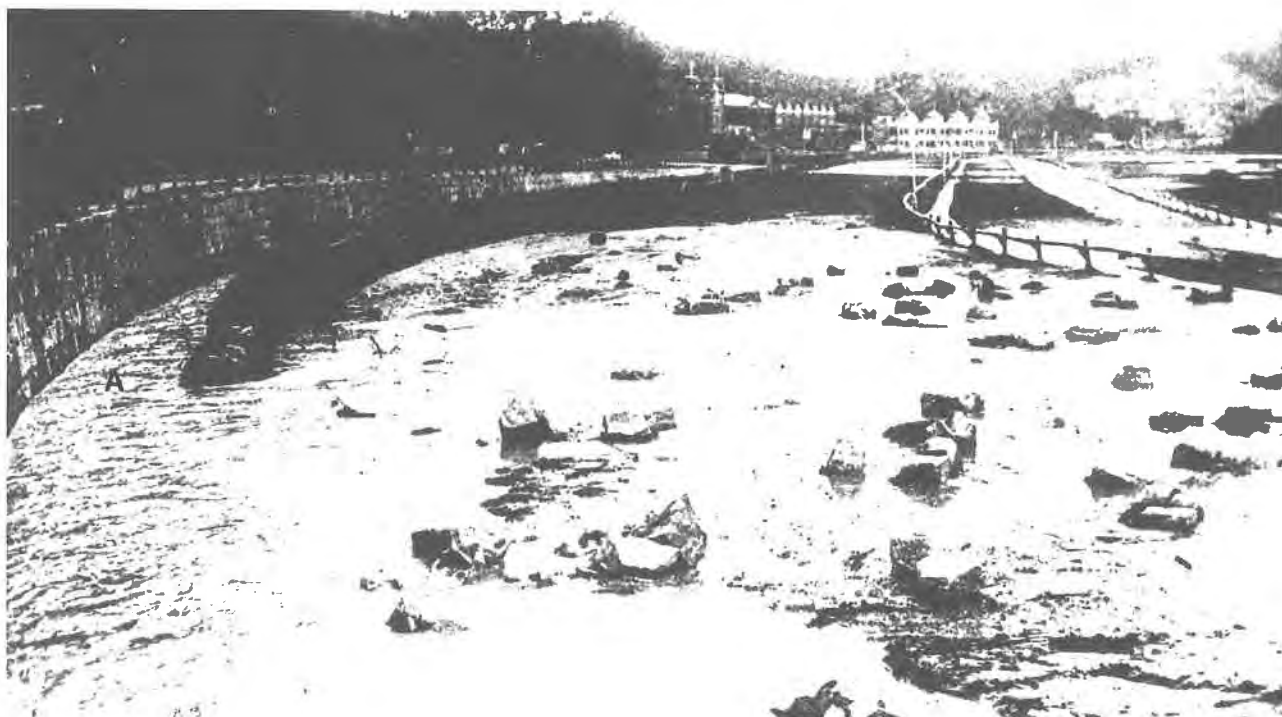
**Plate 27.** *Floodwaters on the Western Side of Happy Valley in 1923.* Rock and boulder debris has been washed downslope from the cemetery and the drainage nullah at A has overflowed. (PRO 1/4/94).

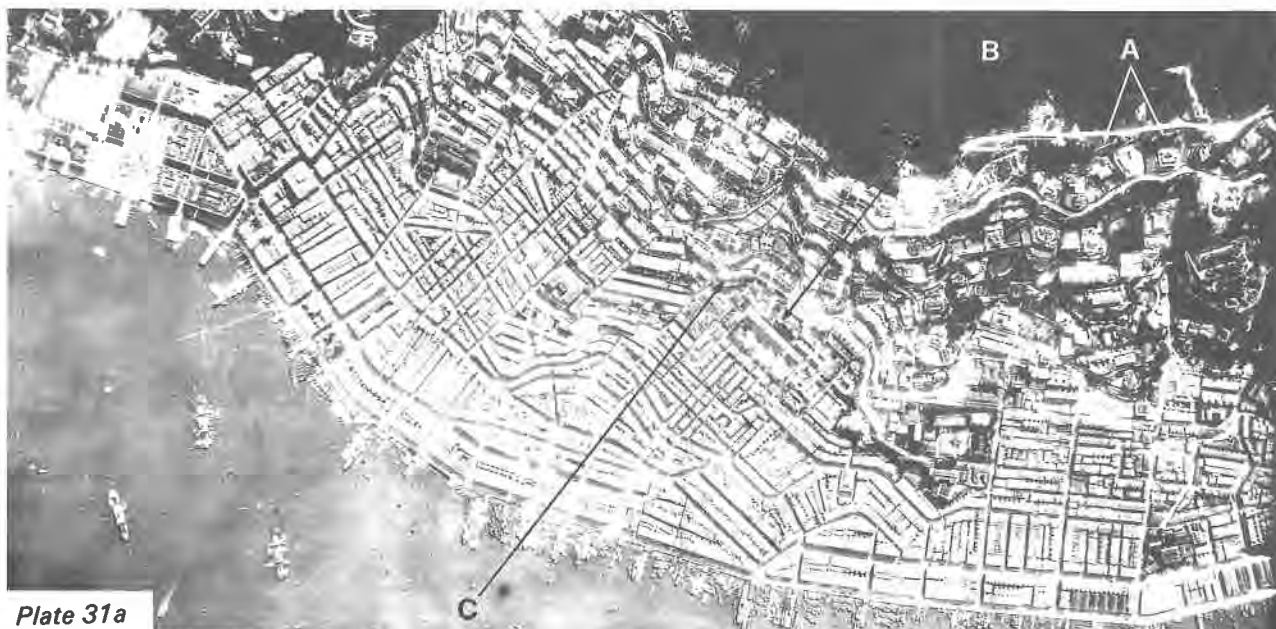
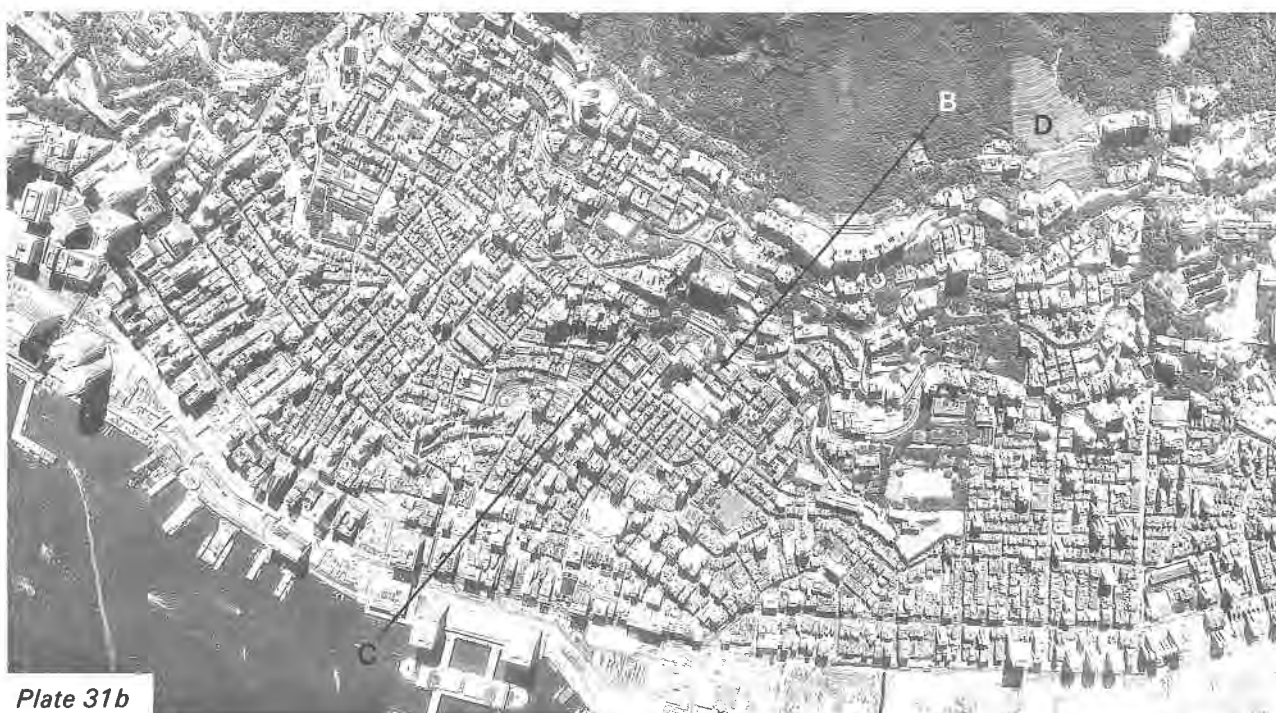
*Plate 31. Comparative Aerial Photographs of the Central and Mid-levels Area on Hong Kong Island in 1924 and 1958.* Plate 31a illustrates the intensity of development on 12.11.1924. The waterfront is approximately in the position of Connaught Road. There is evidence of fill slopes (A) on Po Shan Road in the area affected by the landslide in 1972 (cf Plate 101b). The aerial photographs taken in 1924 are the earliest known vertical aerial photographs of the Territory. They were taken by a small group from the Fleet Air Arm operating off HMS Pegasus, in Hong Kong waters from early November 1924 to January 1925. Further information on these old photographs is given in Section 8.2.4. Plate 31b illustrates the amount of reclamation in the intervening 60 years. The remedial works to the Po Shan Road landslide are indicated at D. A number of other major landslips have occurred in the area, in particular the failure at Po Hing Fong (B) at about 9.30 a.m. on 17.7.1925, and of the retaining wall at Caine Lane (C) in August 1976. Newspaper reports in 1925 estimated that in excess of 200 fatalities resulted from the Po Hing Fong landslide. The Po Hing Fong failure occurred during a period of heavy rainfall. Apparently three masonry retaining walls situated one above the other collapsed and demolished a row of seven 3-storey houses. This disaster, and the resulting Coroner's Inquiry, were widely reported in the Press at the time. The Caine Lane retaining wall failure on 25.8.1976 caused the evacuation of some 400 people (cf Plate 116). (12.11.1924/H19/9 and 4.10.1985/A02620).
