Geotechnical Area  
Studies Programme

GASP Report XII

# Territory of Hong Kong

Geotechnical Control Office  
Civil Engineering Services Department  
Hong Kong

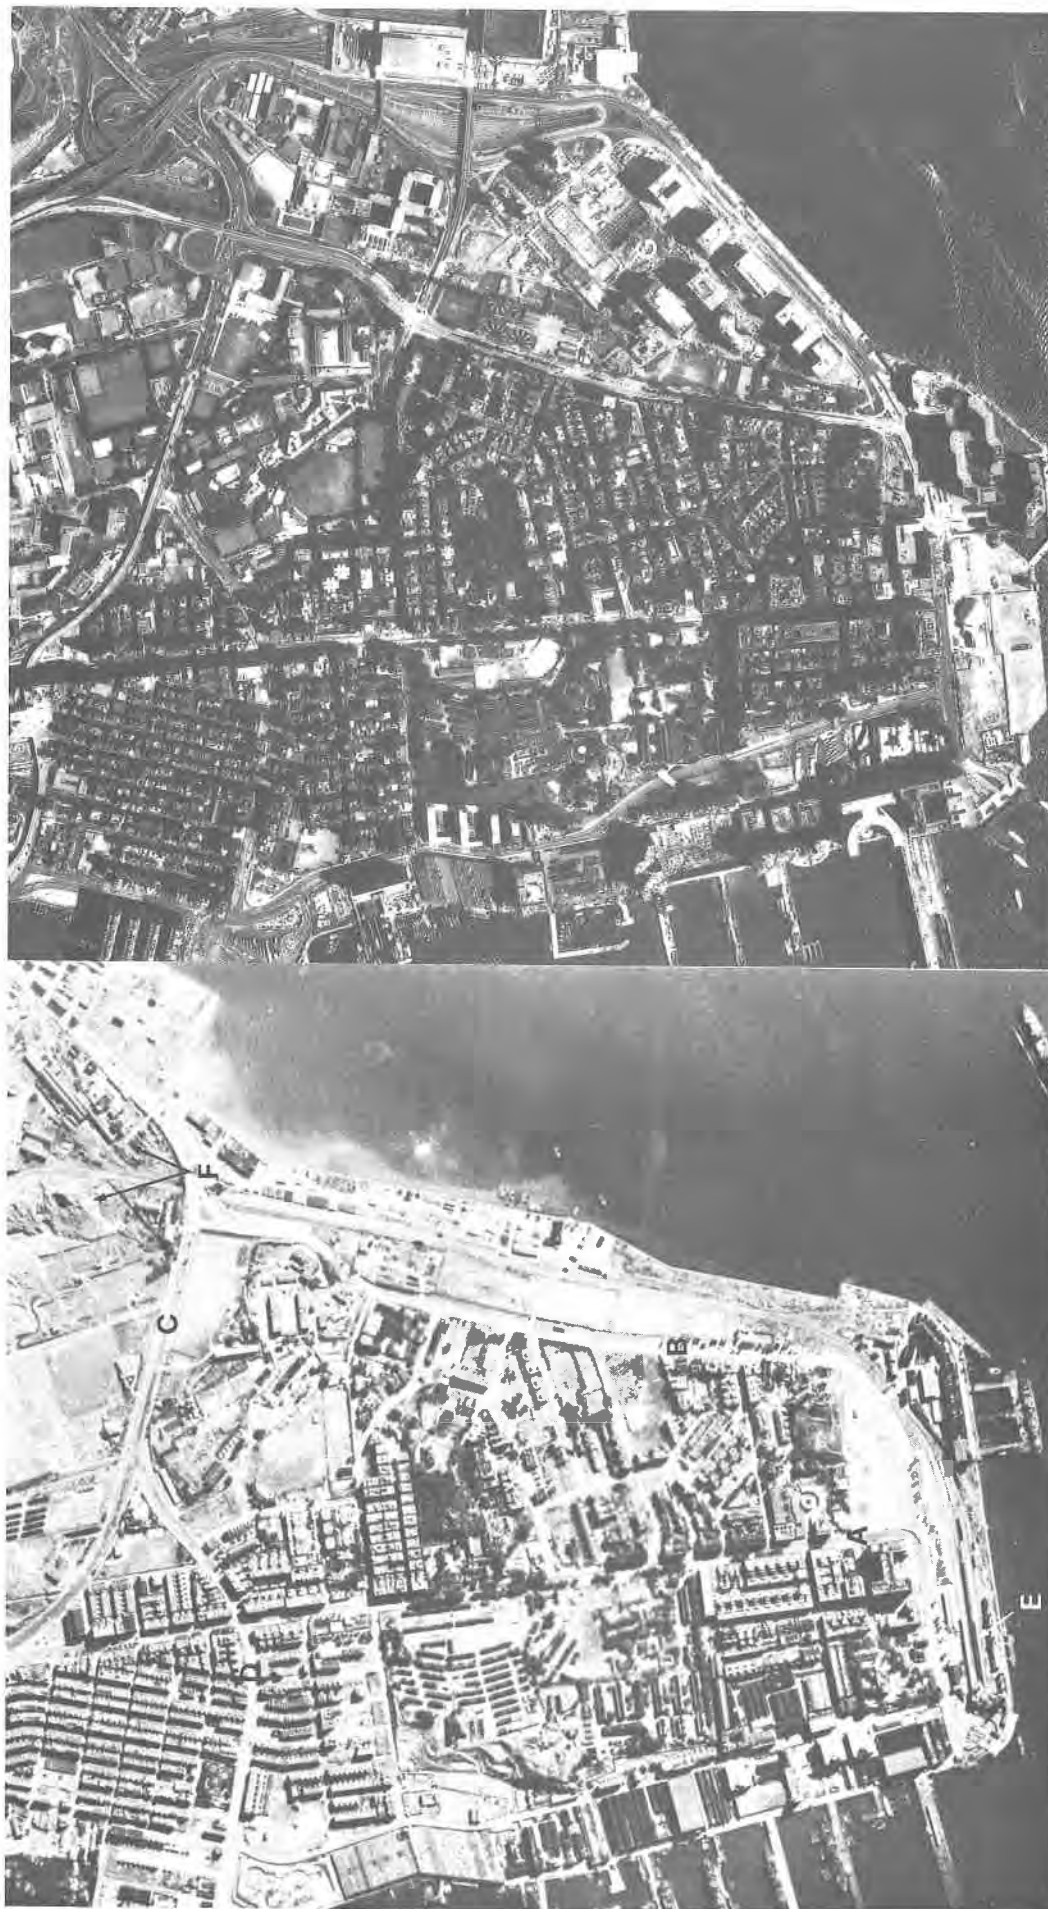
Plate 34. *Comparative Aerial Photographs of the Tsim Sha Tsui Area in 1945 and 1980.* The location of Nathan Road (A), Chatham Road (B), Gascoigne Road (C), Jordan Road (D) and the Kowloon-Canton Railway Terminal (E) are indicated on the 1945 photograph. Hilly, severely eroded granitic terrain is apparent in the vicinity of Wiley Road and the Ho Man Tin area in 1945 (F). By comparison, the area in 1980 has been extensively redeveloped, and a large area (G) to the east of Chatham Road has been reclaimed from the harbour. (11.11.1945/3025 and 28.11.1980/33441).

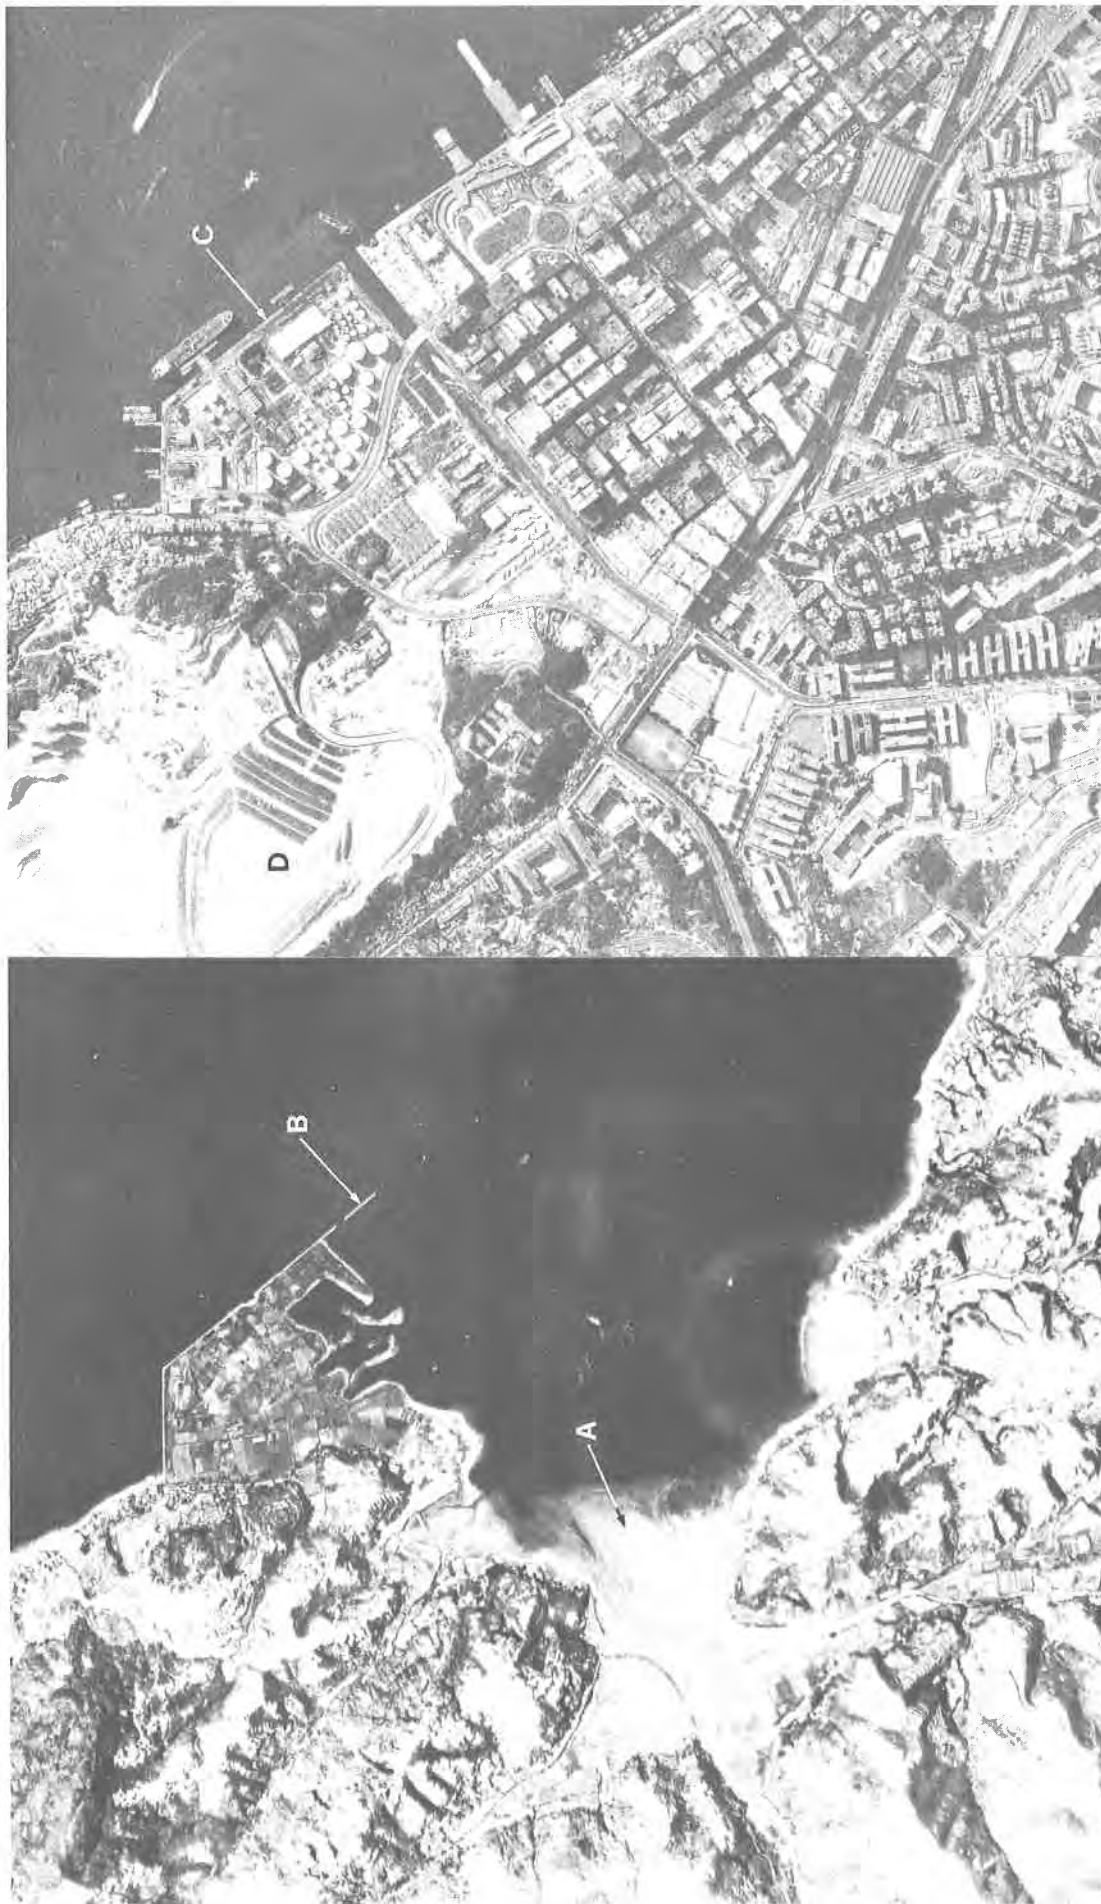
Plate 35. Comparative Aerial Photographs of the Kwun Tong and Sai Tso Wan Area in 1945 and 1983. Note the severe erosion on the granitic terrain, sediment plumes in the bay (A) and the line of the sea wall (B) in the 1945 photograph. By 1983, the bay has been reclaimed and intensively developed up to the line of reclamation evident in 1945 (C). The Sai Tso Wan Landfill is shown at D. (10.11.1945/681-5/4146 and 24.1.1983/47140).

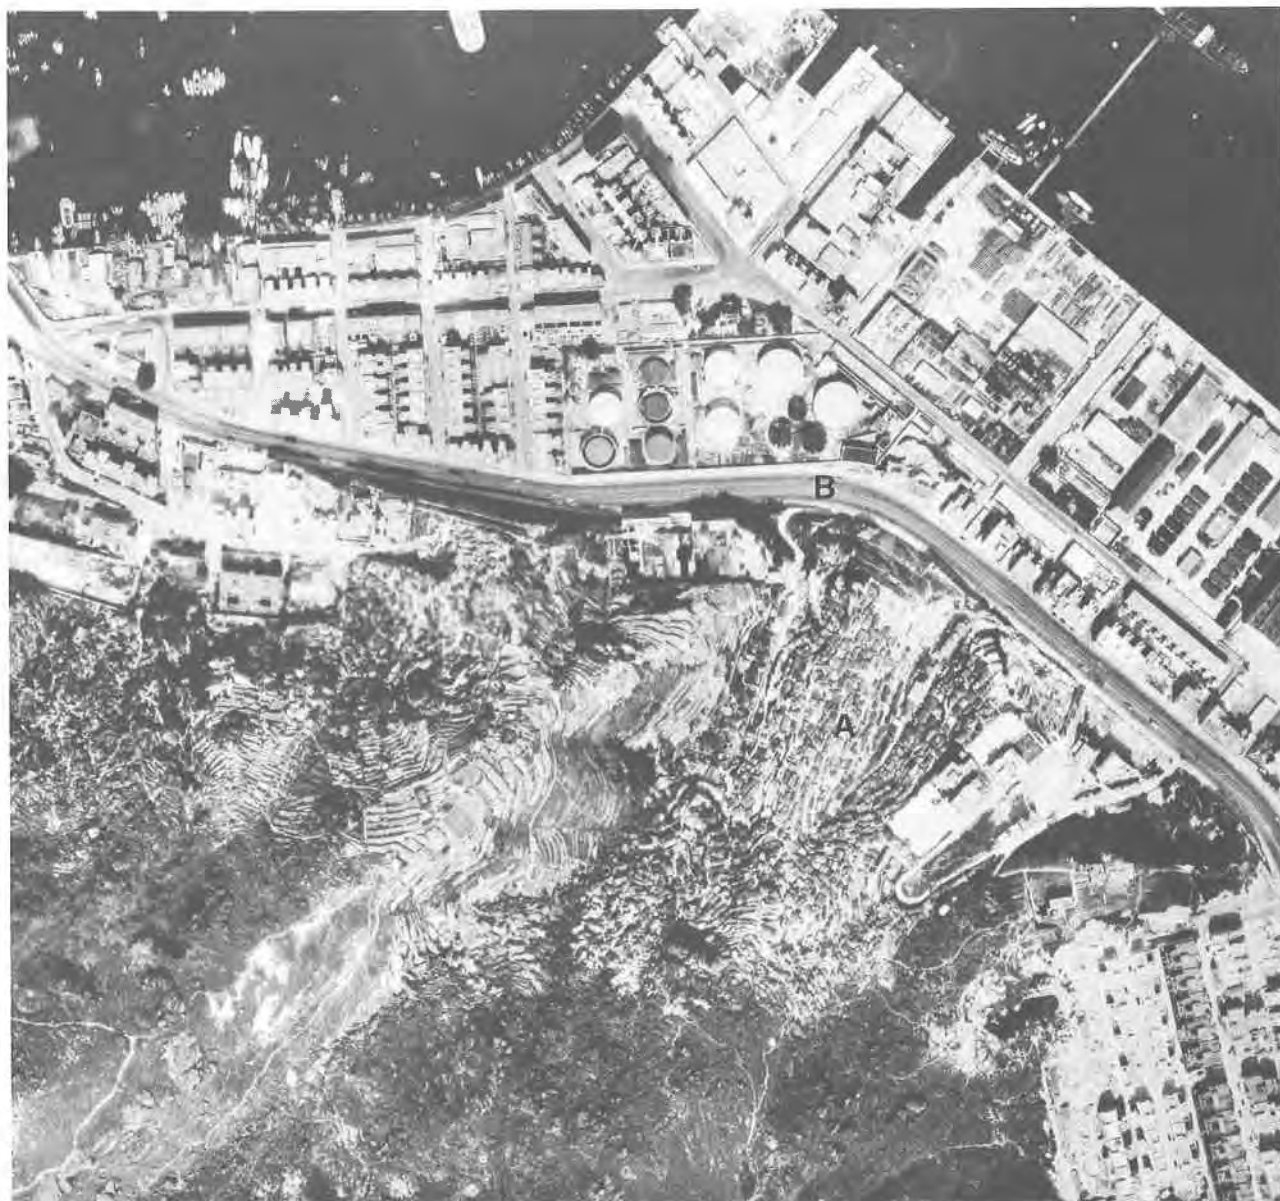
*Plate 37. North Point in 1949.* The extensive, orderly pattern of squatter development (A) on the granitic terrain on the eastern side of King's Road (B) is quite evident. (8.5.1949/81A/128/6027).

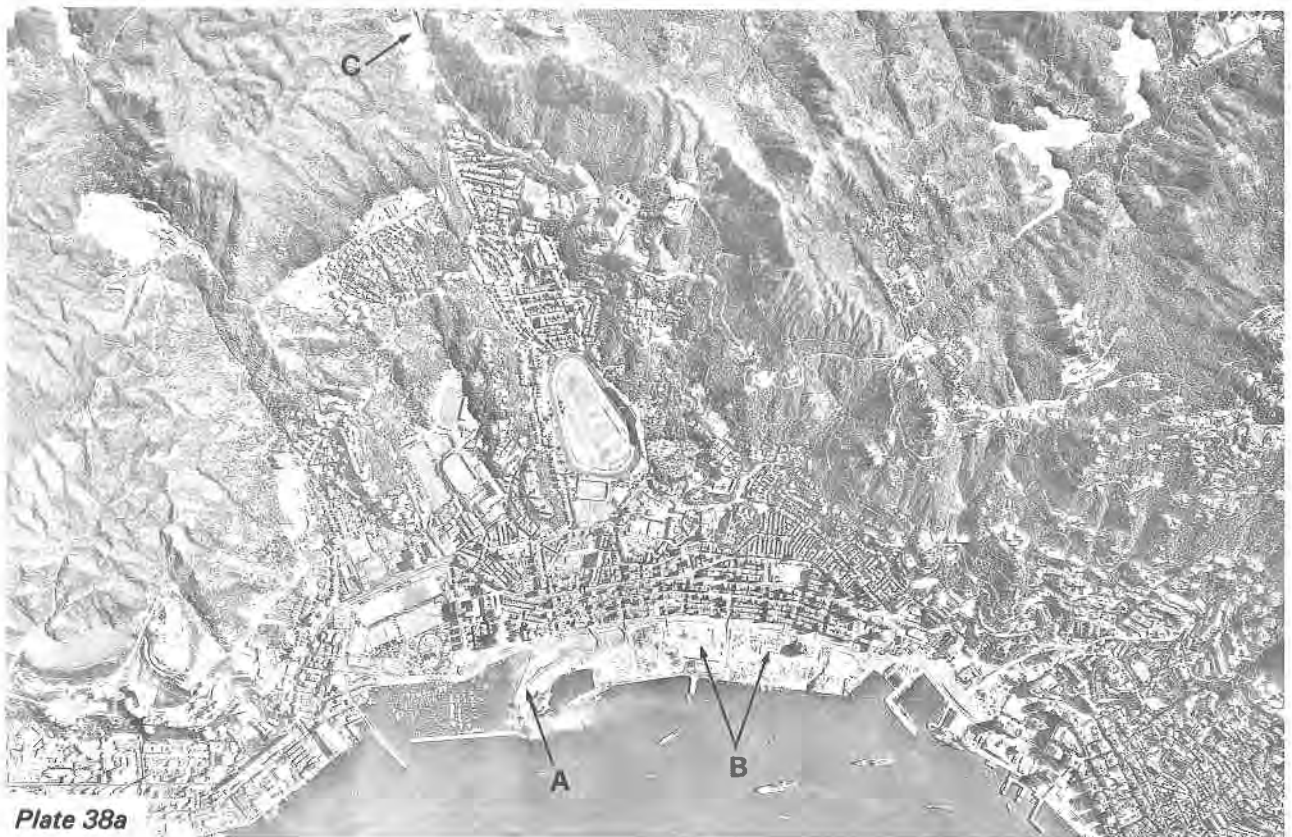
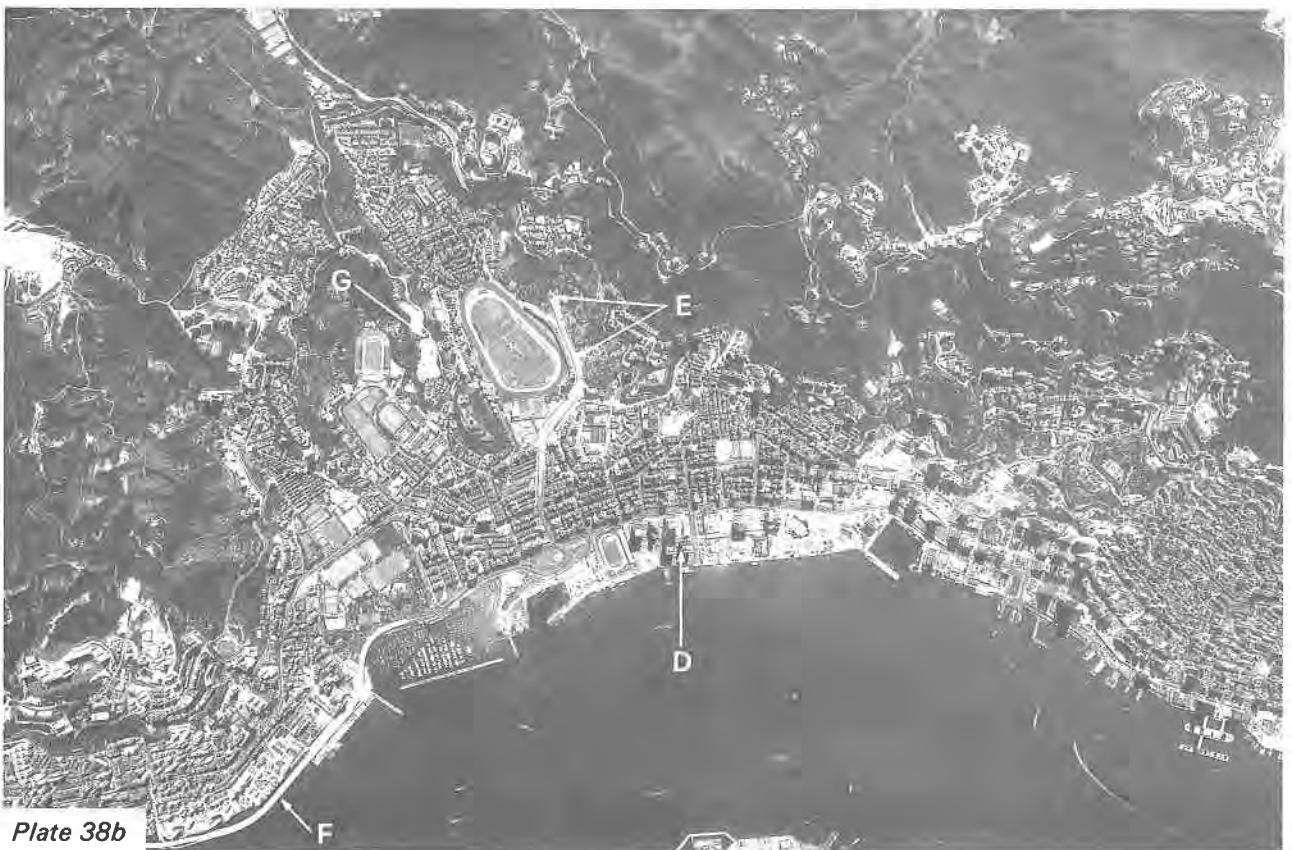
**Plate 38. Comparative Aerial Photographs of North Point, Causeway Bay, Happy Valley and Wan Chai in 1972 and 1985.** Plate 38a shows the state of development in 1972. The areas of reclamation associated with the Cross Harbour Tunnel entrance and development of Wan Chai are evident at A and B respectively. Major earthworks are in progress for the relocation of the Hong Kong Cricket Club from Chater Road to Wong Nai Chung Gap (C). Significant changes have occurred in the intervening 13 years as Plate 38b illustrates: multi-storey tower blocks on the Wan Chai reclamation (D); the completion of the Aberdeen Tunnel and associated infrastructure (E); construction of the Island Eastern Corridor (F); and extensive development along the Broadwood Road area (G). An oblique view of the area is presented in Plate 43. (3 10 1972/2305 and 4 10.1985/A02618).

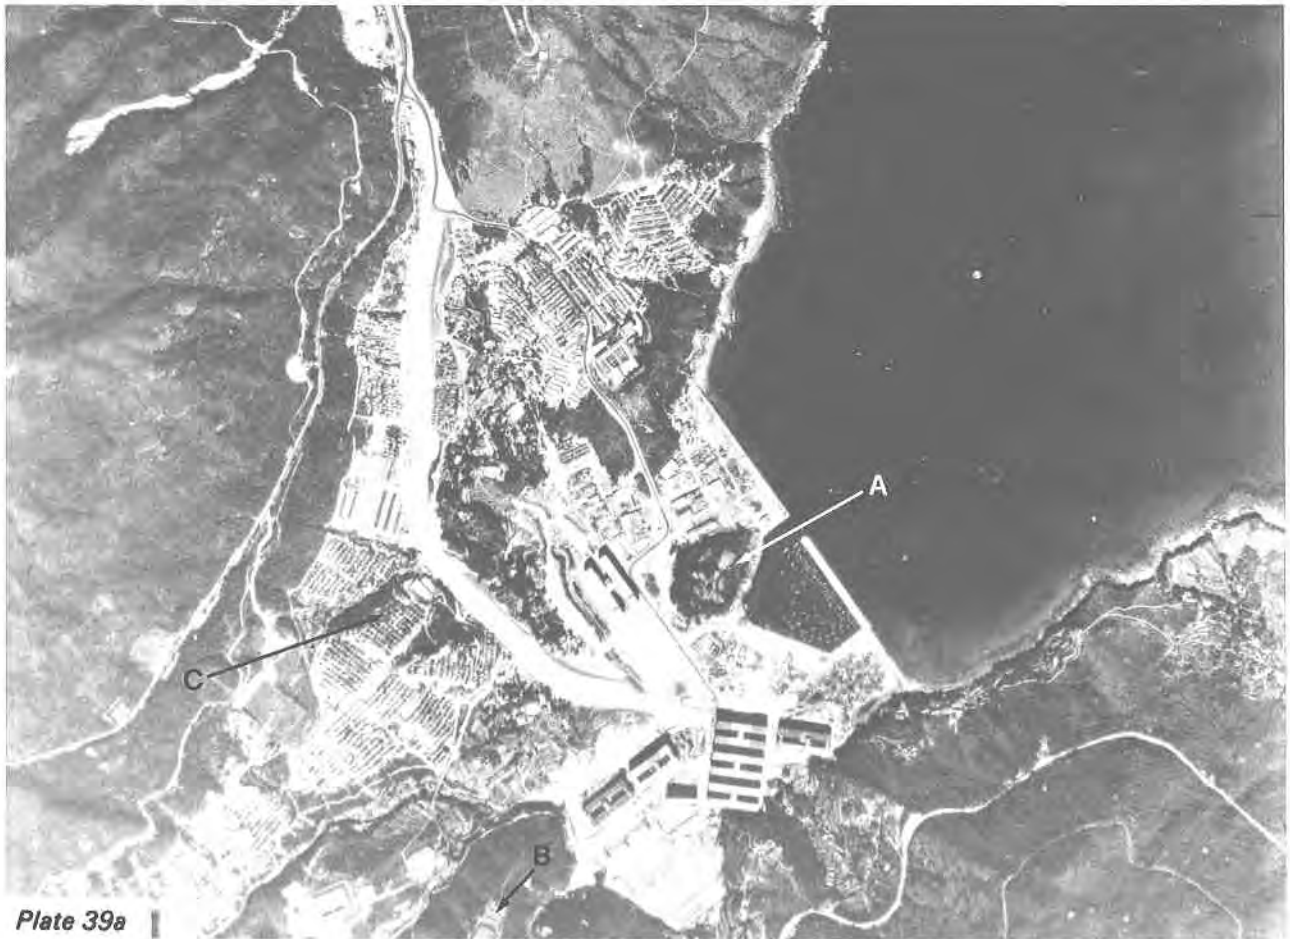
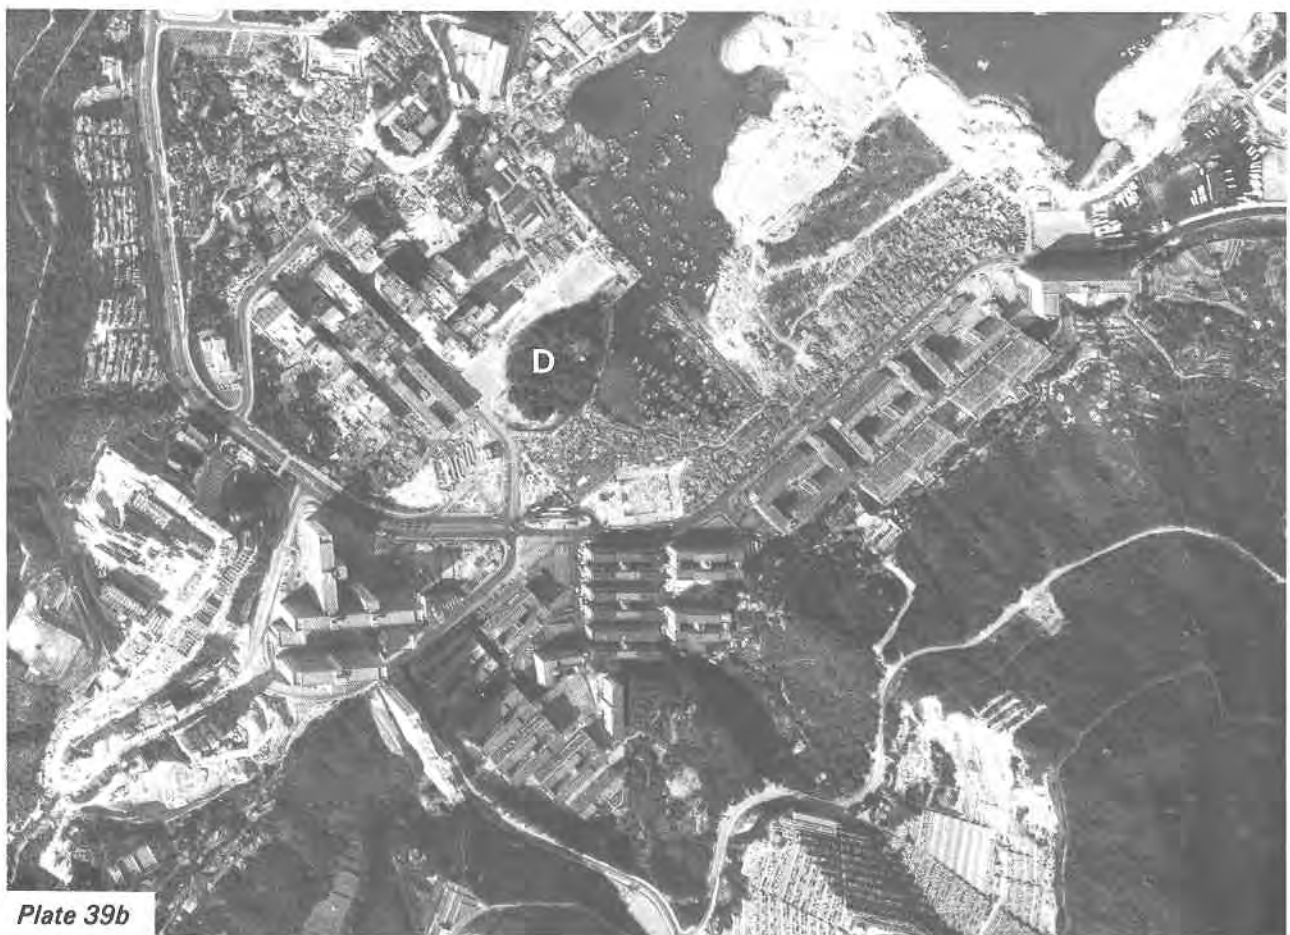
**Plate 39c**

**Plate 39.** *Comparative Aerial Photographs of the Chai Wan Area in 1961, 1973 and 1985.* In 1961, the first housing estate blocks are being constructed and some reclamation is evident in the bay. The island is clearly evident at A, the War Cemetery at B, and the Licensed Areas at C. By 1973, extensive reclamation is apparent, although the island is still discernable at D. In 1985, there has been further reclamation, the infrastructure for the Mass Transit Railway (MTR) is in place (E) and only a small portion of the island remains (F). This area is featured in the Insets at Figures A8a to A14b in Appendix A, which are used to demonstrate the GASP terrain classification mapping system. (17.1.1961/F43-81A/0119, 24.10.1973/5460, 4.10.1985/A02615).

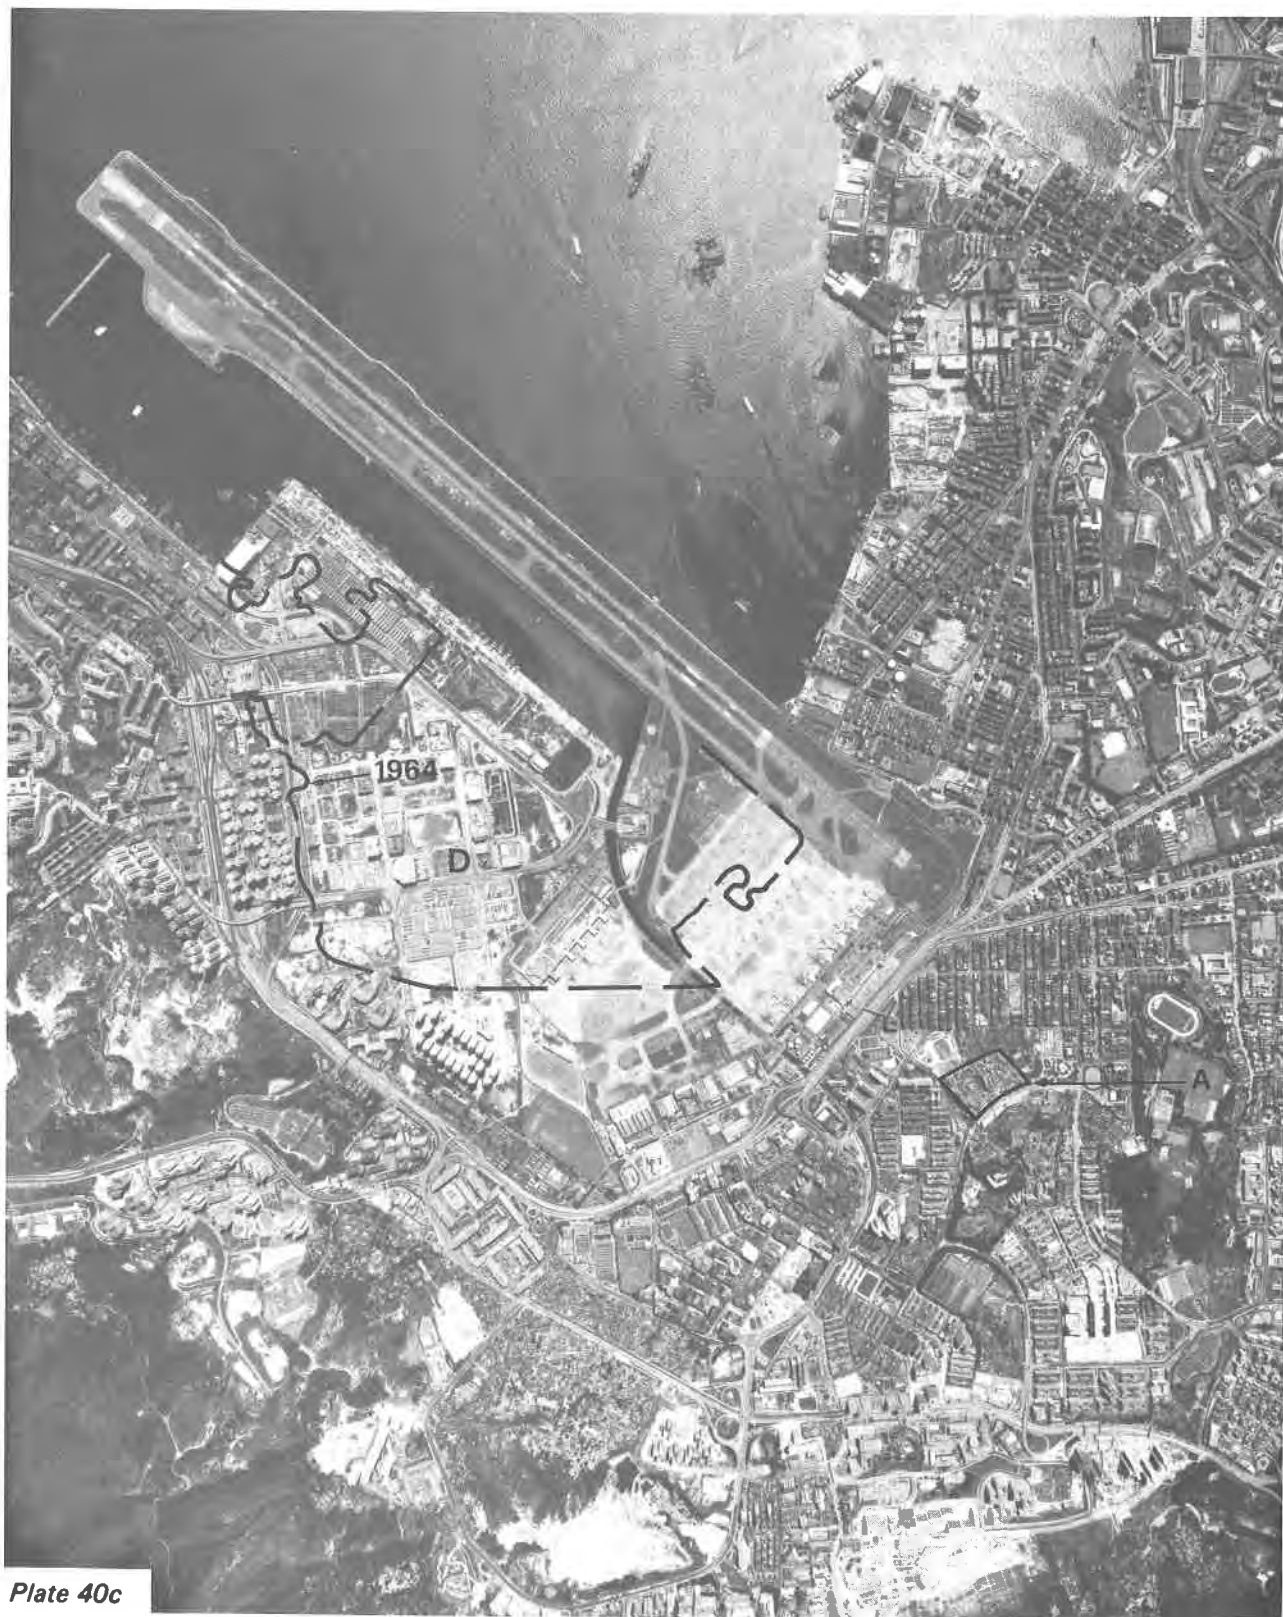
Plate 40b

**Plate 40.** *Comparative Aerial Photographs of the Kai Tak Area in 1954, 1964 and 1985.* In 1954, the dual runway system is evident on an area of general reclamation. The Kowloon 'Walled City' is highlighted at A on each photograph. By 1964, the old runway configuration has been superseded by the current '130-310' layout which extends some 2 500 m into the harbour. In addition, substantial reclamation has occurred in the Kowloon Bay (B) and To Kwa Wan areas (C), immediately to the east and west of the new runway respectively. The 'Walled City' has developed since 1954 into the multi-storied conglomeration of structures apparent in 1985. By 1985, further reclamation is evident to the east of the runway (D). (18.11.1954/18A/552/0108, 1964/2606, 4.10.1985/A02661).

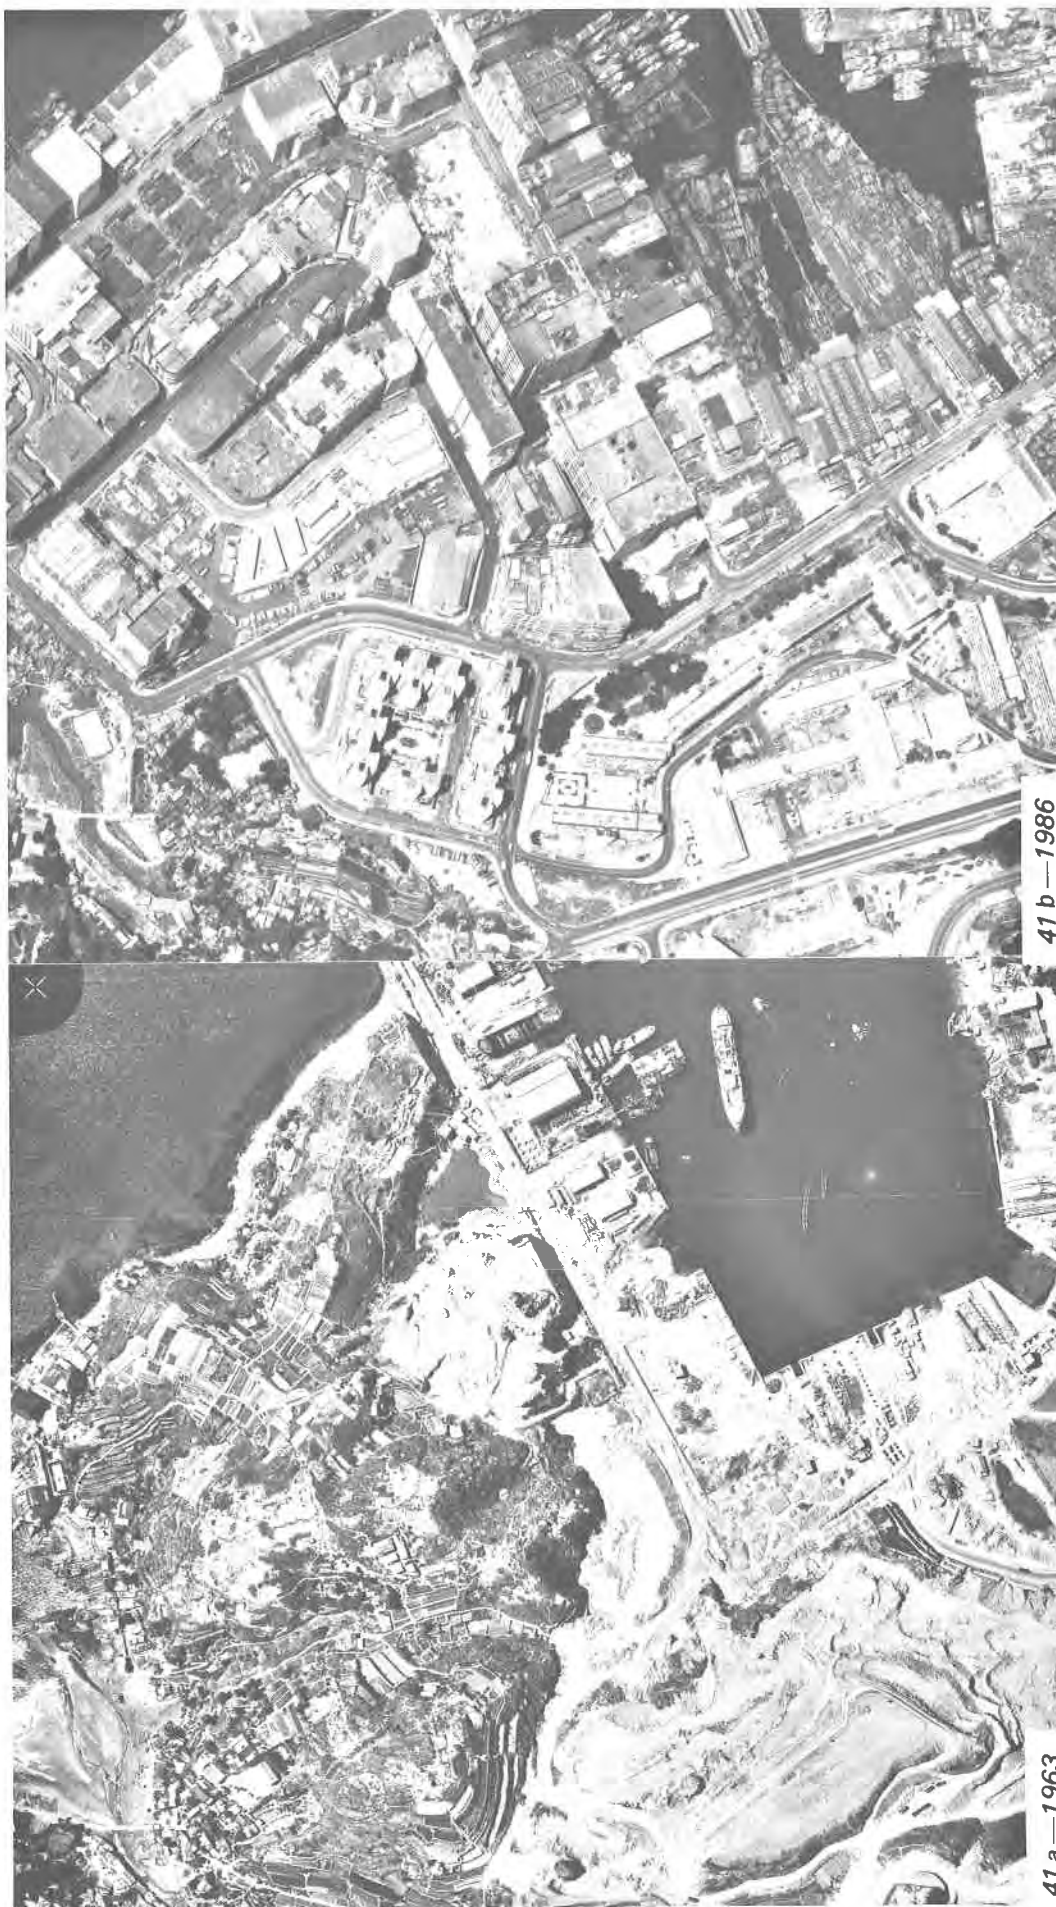
Plate 41. Comparative Aerial Photographs of the Lei Yue Mun Area in 1963 and 1986. Extensive reclamation and site formation has occurred around the bay. (1963/6085 and 3.3.1986/A04261).

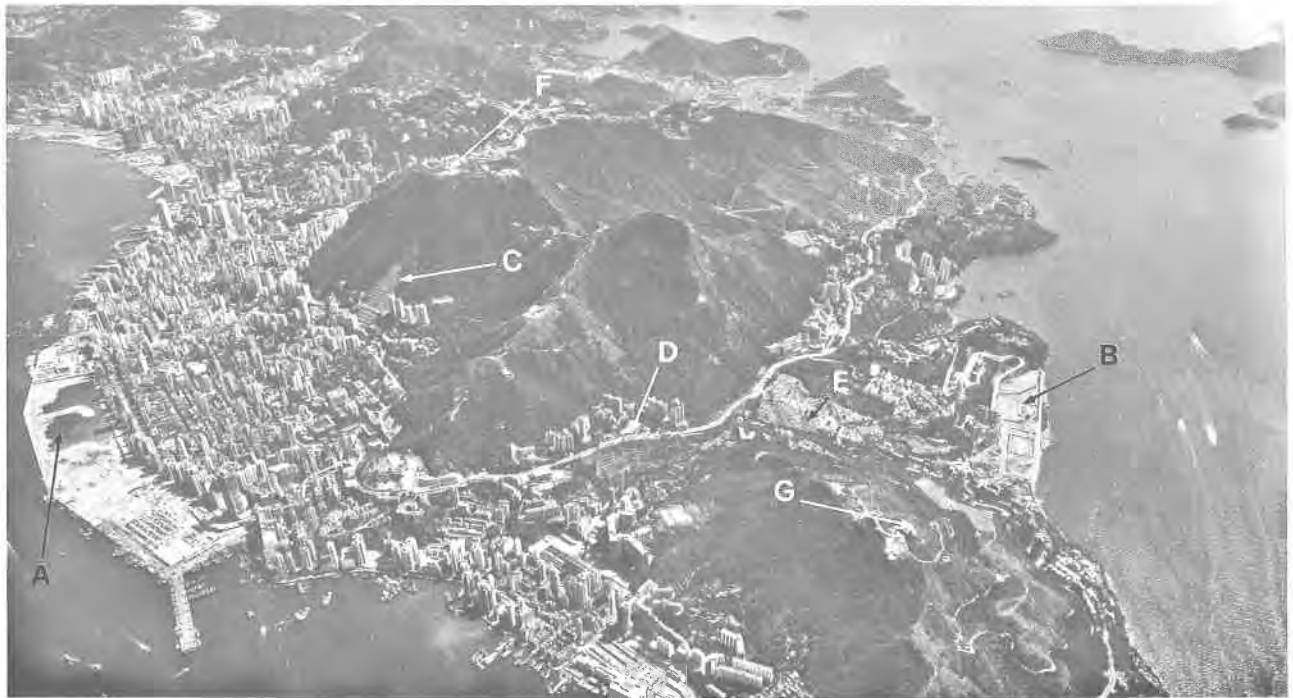
**Plate 42.** *High Oblique Aerial Photograph Looking East across Hong Kong Island in 1983.* This photograph offers a similar perspective to that in Plate 2, which was taken 2 years later. Large areas of reclamation are underway along the harbour foreshores (A) and at Sandy Bay (B). A number of features of geotechnical significance are evident. The location of the Po Shan Road Landslip is at C (Plates 94 to 106), the site of a large reconstructed fill slope on Pok Fu Lam Road at D (Plate 165), and the site of the landslide in Pok Fu Lam Cemetery is at E (Plate 136). Victoria Peak is at F and Mt Davis at G. (11.2.1983/48137).

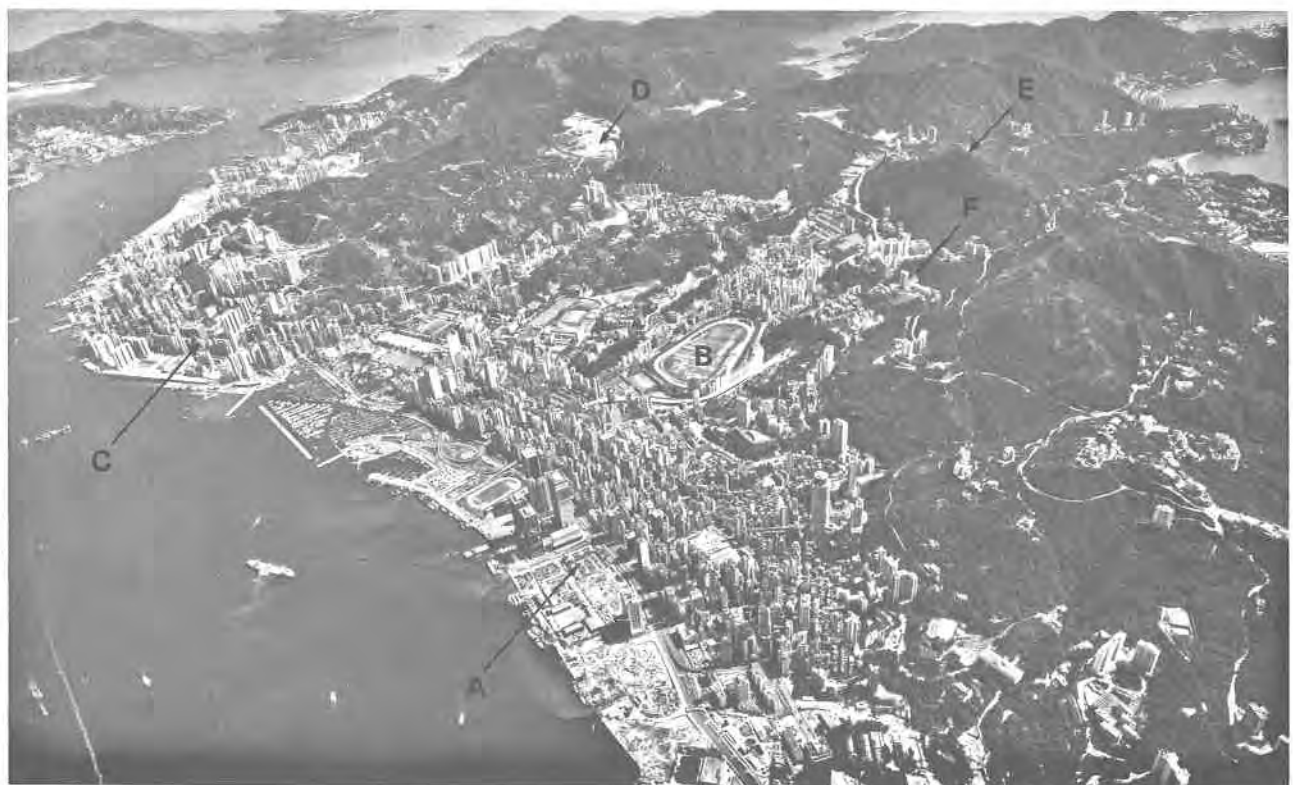
**Plate 43.** *Oblique Aerial Photograph of the Wan Chai, Happy Valley and North Point Areas in 1983.* The Wan Chai, Happy Valley and North Point areas are at A, B and C respectively. Mt Butler Quarry is at D, Mt Nicholson is at E, the location of the 1966 landslide at Victoria Flats (Plates 81 to 85) is at F. Plate 38 compares the degree of development of this area between 1972 and 1985. (17.2.1983/48137).

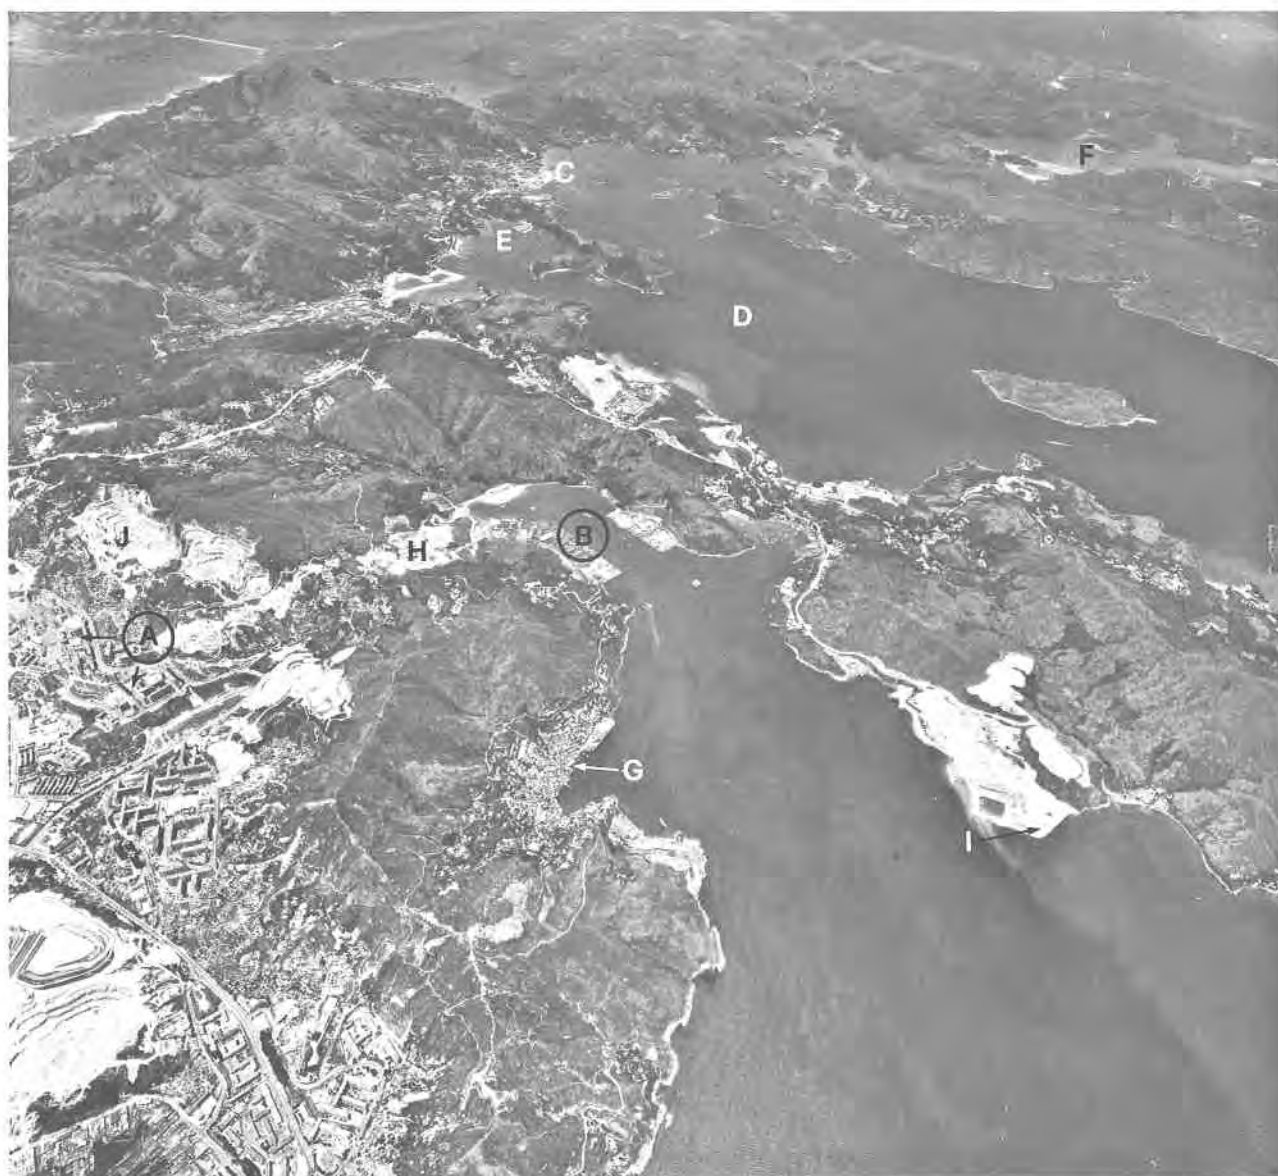
**Plate 44.** *High Oblique Aerial Photograph of the Eastern Kowloon and Junk Bay Areas in 1983.* The public housing estates in eastern Kowloon and the general area of the Junk Bay redevelopment are highlighted at A and B respectively. Sai Kung is at C, Port Shelter at D and Hebe Haven at E. The High Island Reservoir is at F and Rennie's Mill is at G. The Junk Bay Tunnel exits at H, and the location of the Junk Bay landfill failure is at I (Plates 159 & 160). The Anderson Road Quarries are at J (Plates 211 & 217). Most of the undeveloped terrain in the area is Country Park. (16.5.1983/48777).

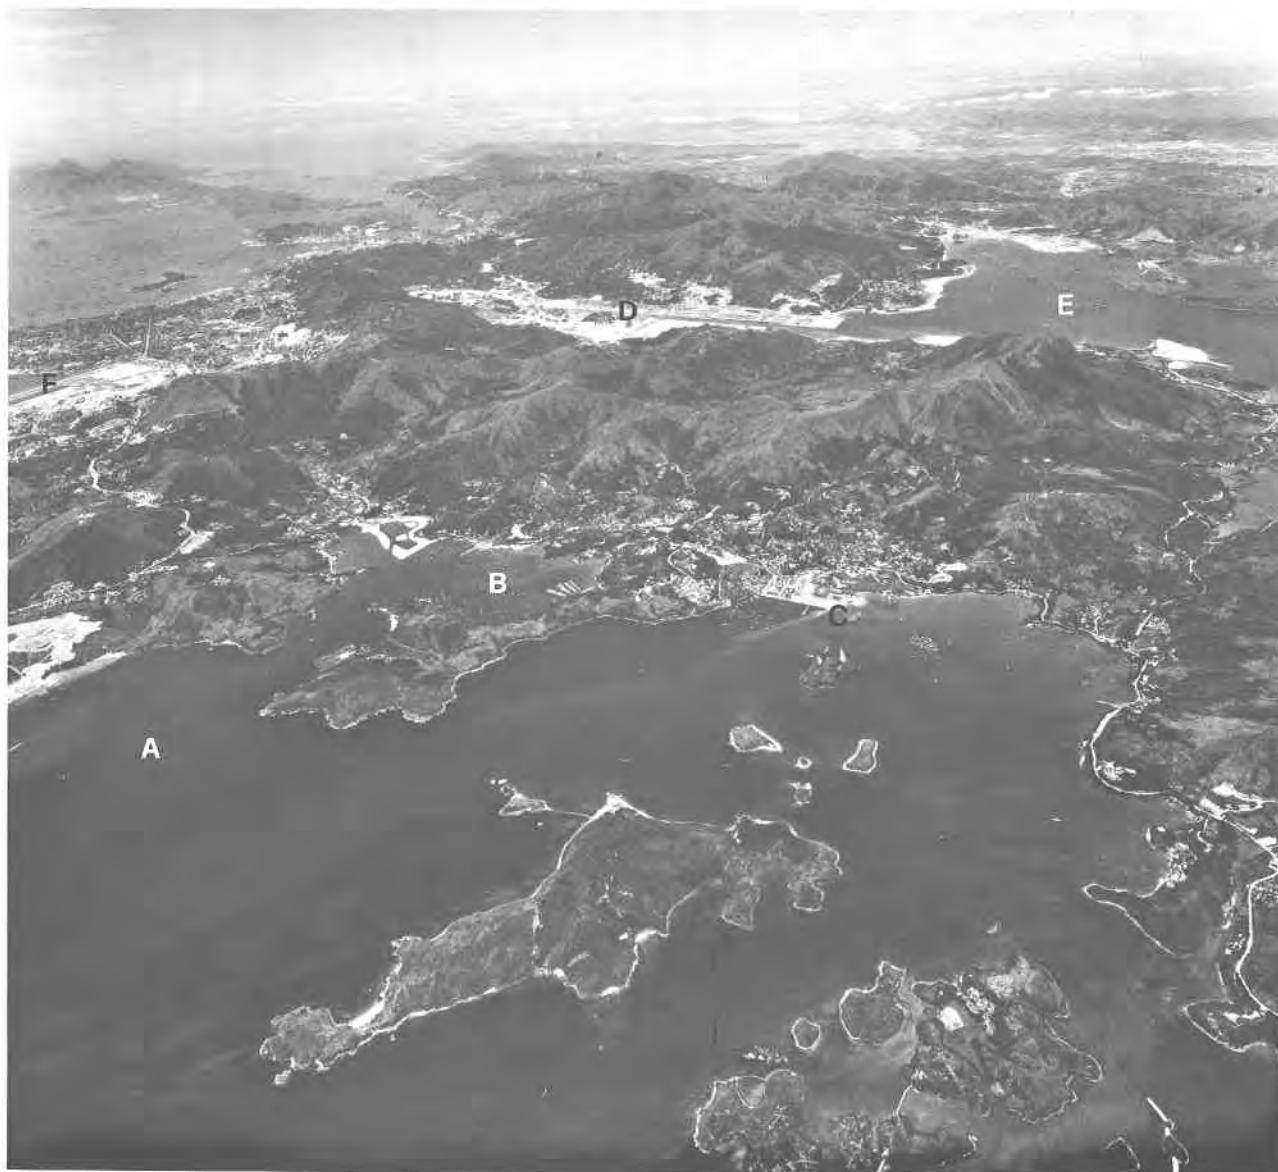
**Plate 45.** *High Oblique Aerial Photograph Looking West across Port Shelter towards Sha Tin and Tolo Harbour in 1983.* This photograph provides a southwesterly view across Port Shelter (A), Hebe Haven (B) and Sai Kung (C). Sha Tin New Town is at D and Tolo Harbour at E. Kai Tak runway is at F. (16.5.1983/48622).

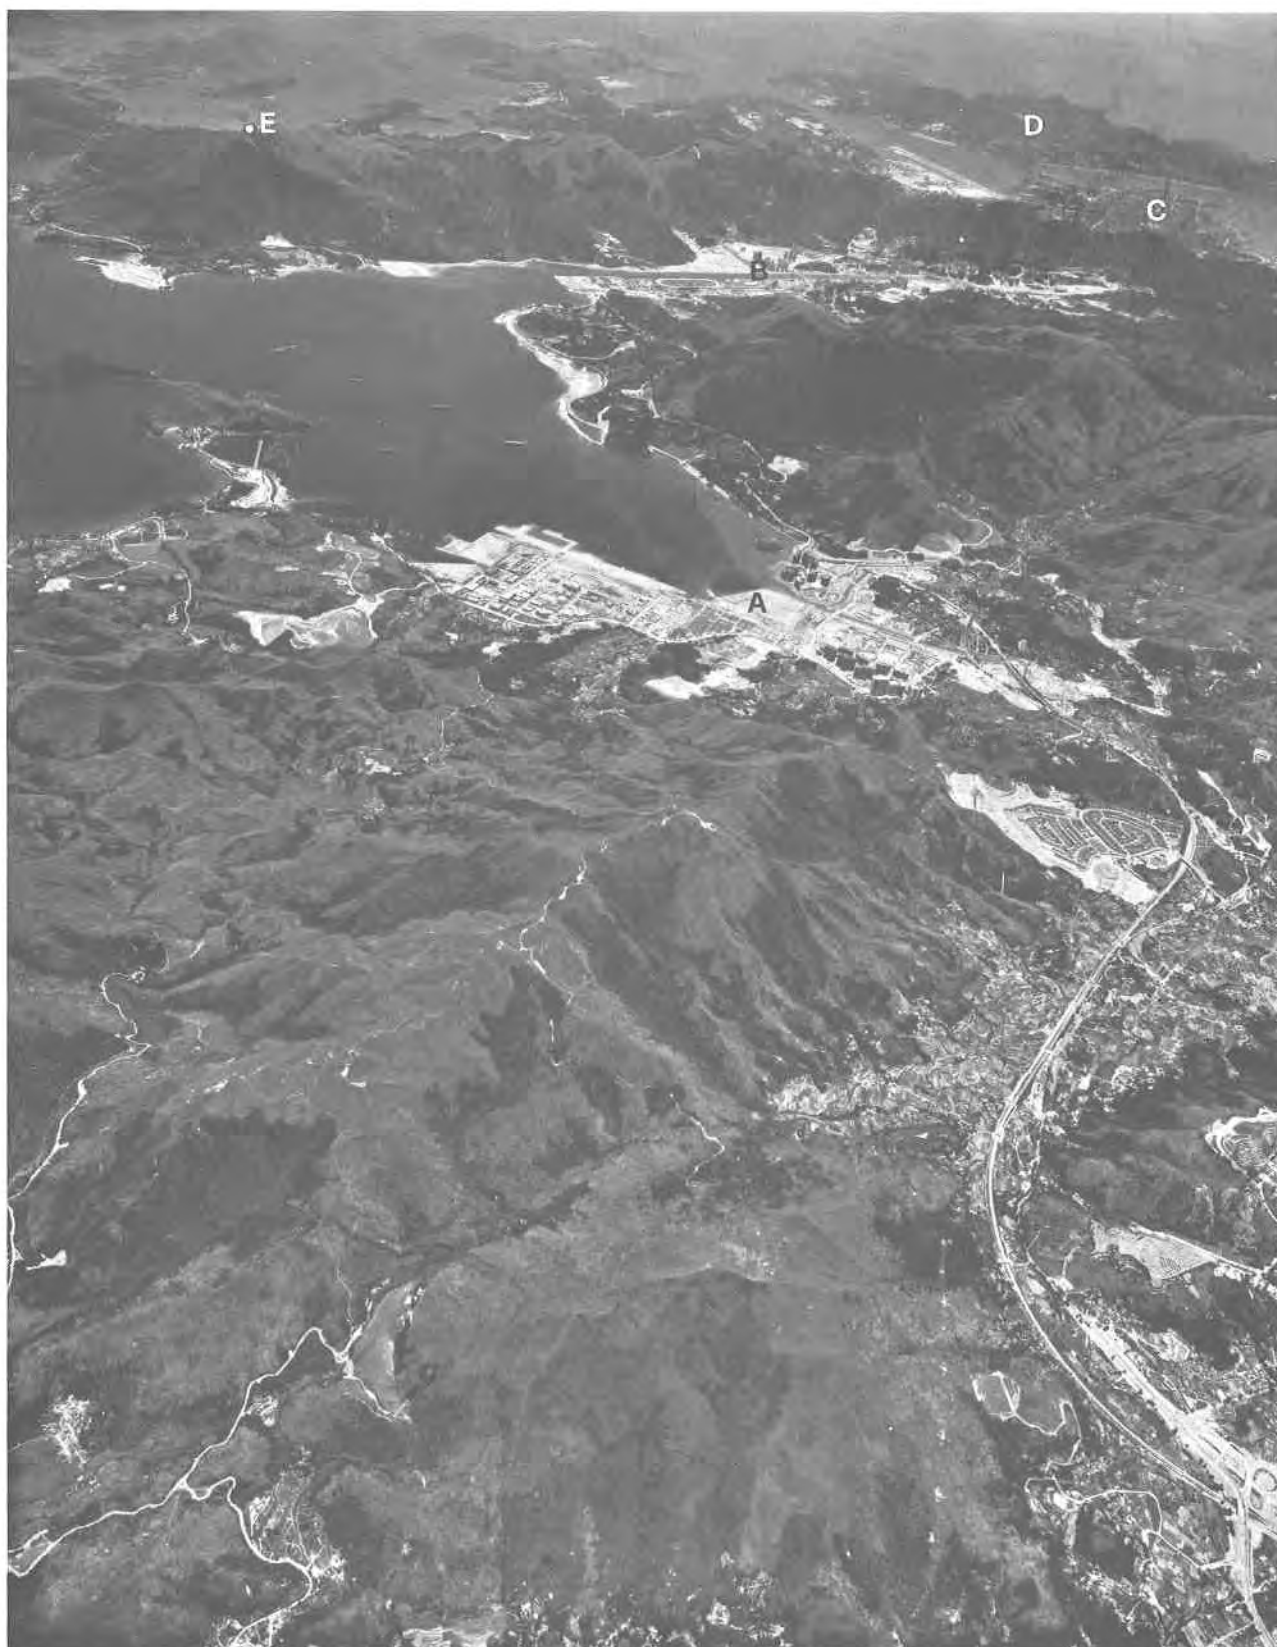
**Plate 46.** *High Oblique Aerial Photograph Looking Southeast across Tai Po towards Sha Tin in 1983.* This photograph views Tai Po (A) and Sha Tin (B) from the north. Kowloon and Hong Kong Island are at C and D respectively. Ma On Shan (E) is the highest peak in the area, with an elevation of 702 m. The current population of Tai Po is about 150 000 and this is expected to increase to some 290 000 by the mid-1990's. In comparison, Sha Tin has absorbed approximately 460 000 people since development commenced some 15 years ago, and its population is likely to reach 750 000 by 1995. Development is encroaching onto the steeper terrain along the valley footslopes. Compare this with Plates 49 & 50. (16.5.1983/48639).
