Geotechnical Area  
Studies Programme

GASP Report XII

# Territory of Hong Kong

Geotechnical Control Office  
Civil Engineering Services Department  
Hong Kong

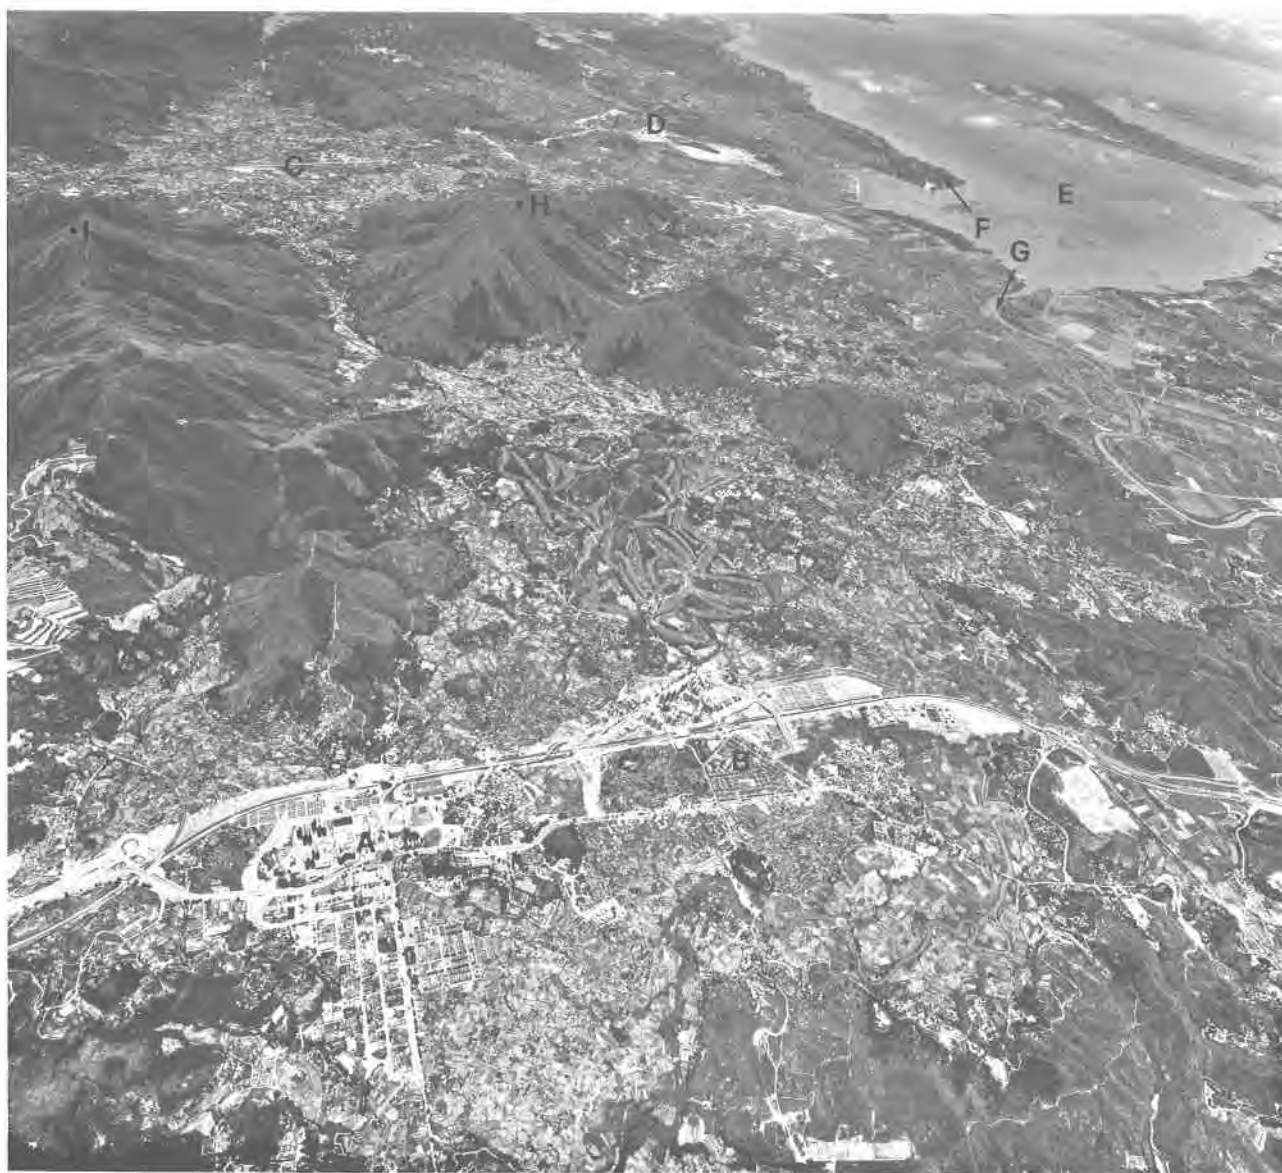
**Plate 47.** *High Oblique Aerial Photograph Looking Southwest towards Deep Bay in 1983.* Fanling is evident at A, Sheung Shui at B, Sek Kong airfield at C and Yuen Long at D. The population of Fanling New Town is about 110 000 and is expected to double by 1995. Yuen Long New Town is expected to increase from its current population of 111 000 to 180 000 during the same period. Deep Bay is at E, Tsim Bei Tsui at F and the Shum Chun River is at G. The peaks of Kai Keung Leng (572 m) and Tai To Yan (560 m) are at H and I respectively. (16.5.1983/48640).

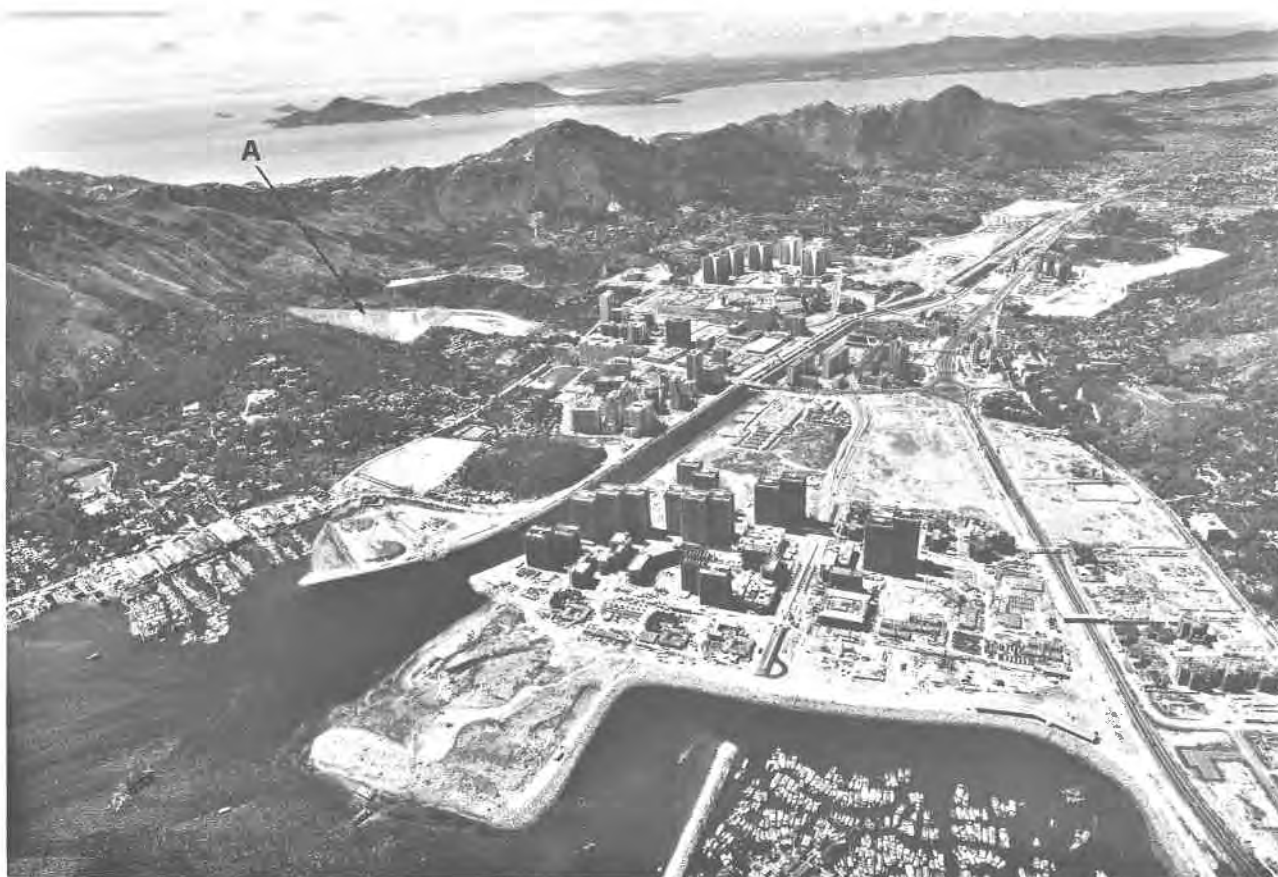
**Plate 48.** *Oblique Aerial Photograph Looking North across Tuen Mun towards Deep Bay in 1980.* The population of the Tuen Mun area is about 300 000 and is expected to increase to 500 000 by 1995. The rapid expansion of the Tuen Mun New Town area has created considerable pressure for development on the steeper terrain flanking the valley. Many of the natural landforms in the area show evidence of previous slope instability; this is especially apparent on the footslopes. Geotechnical problems have occurred in a number of borrow areas. Tuen Mun Borrow Area 8 is evident at A; instability associated with this area is shown in Plate 126. (13.6.1980/30699).

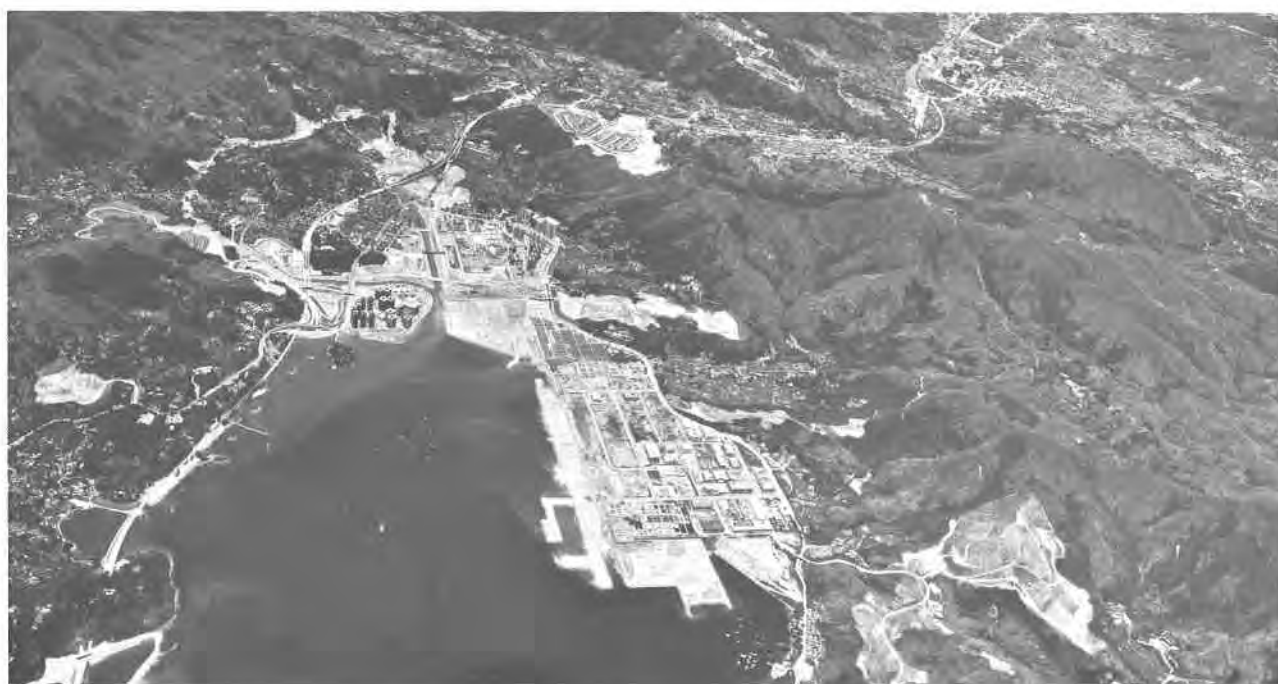
**Plate 49.** *High Oblique Aerial Photograph Looking Northwest across Tai Po in 1983.* Compare the extent of reclamation with that of only 5 years earlier, shown in Plate 50. (16.5.1983/48631).

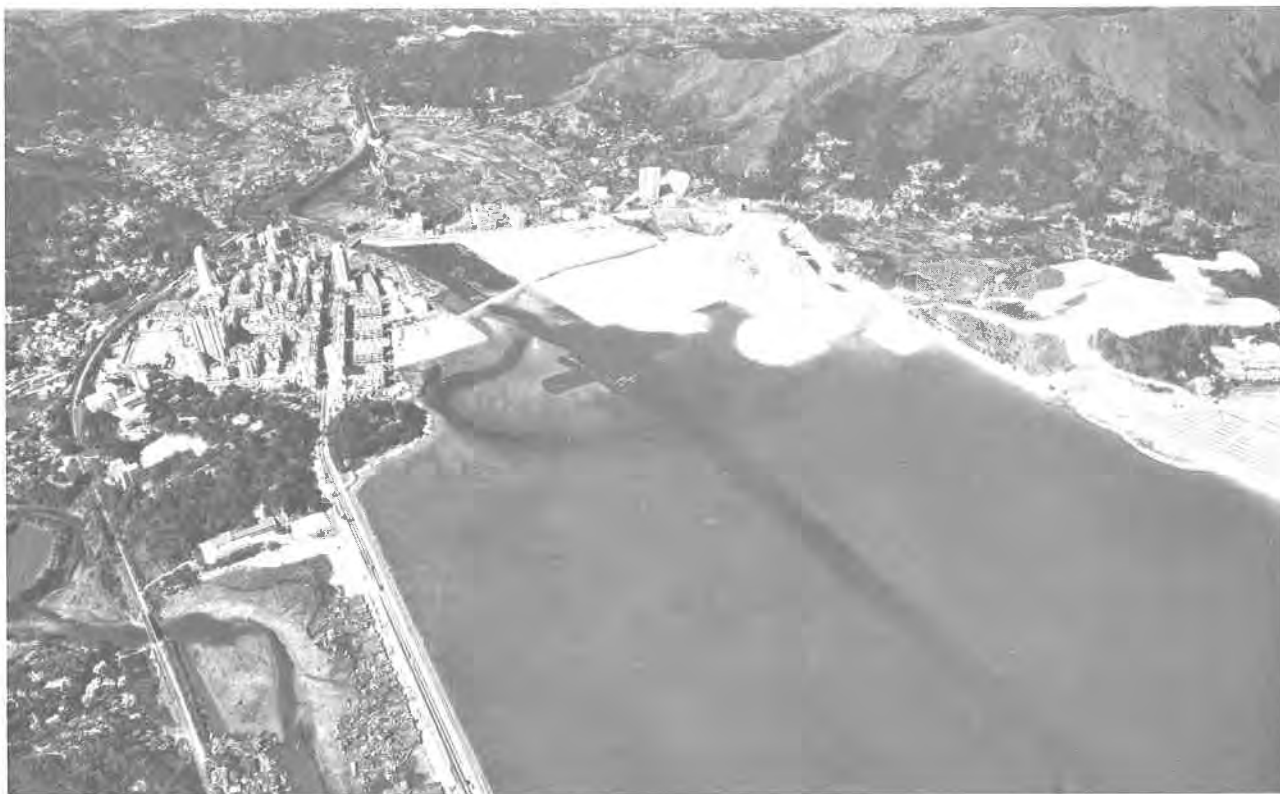
**Plate 50.** *Oblique Aerial Photograph Looking Northwest across Tai Po in 1978. Compare the extent of reclamation with that shown in Plate 49. (24.1.1978/21062).*

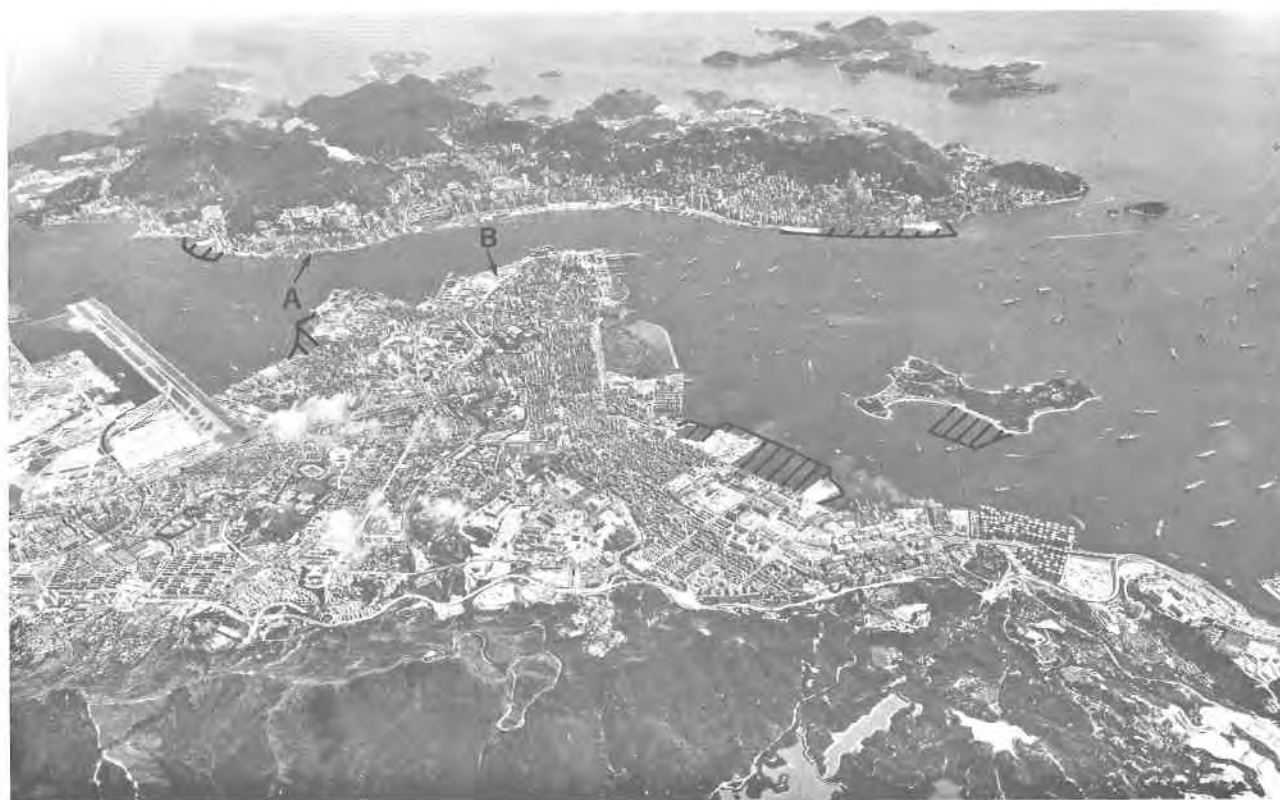
**Plate 51.** *High Oblique Aerial Photograph Looking South across Kowloon towards Hong Kong Island in 1979. Compare this with Plate 1, which was taken in 1987. In the intervening 8 years, a considerable area of the harbour has been reclaimed (hatched). In addition, construction of the East Island Corridor along the southern shore of the harbour from Shau Kei Wan to North Point (A) has not commenced, and only vacant reclaimed land is evident in Tsim Sha Tsui East area (B). (4.7.1979/25851).*

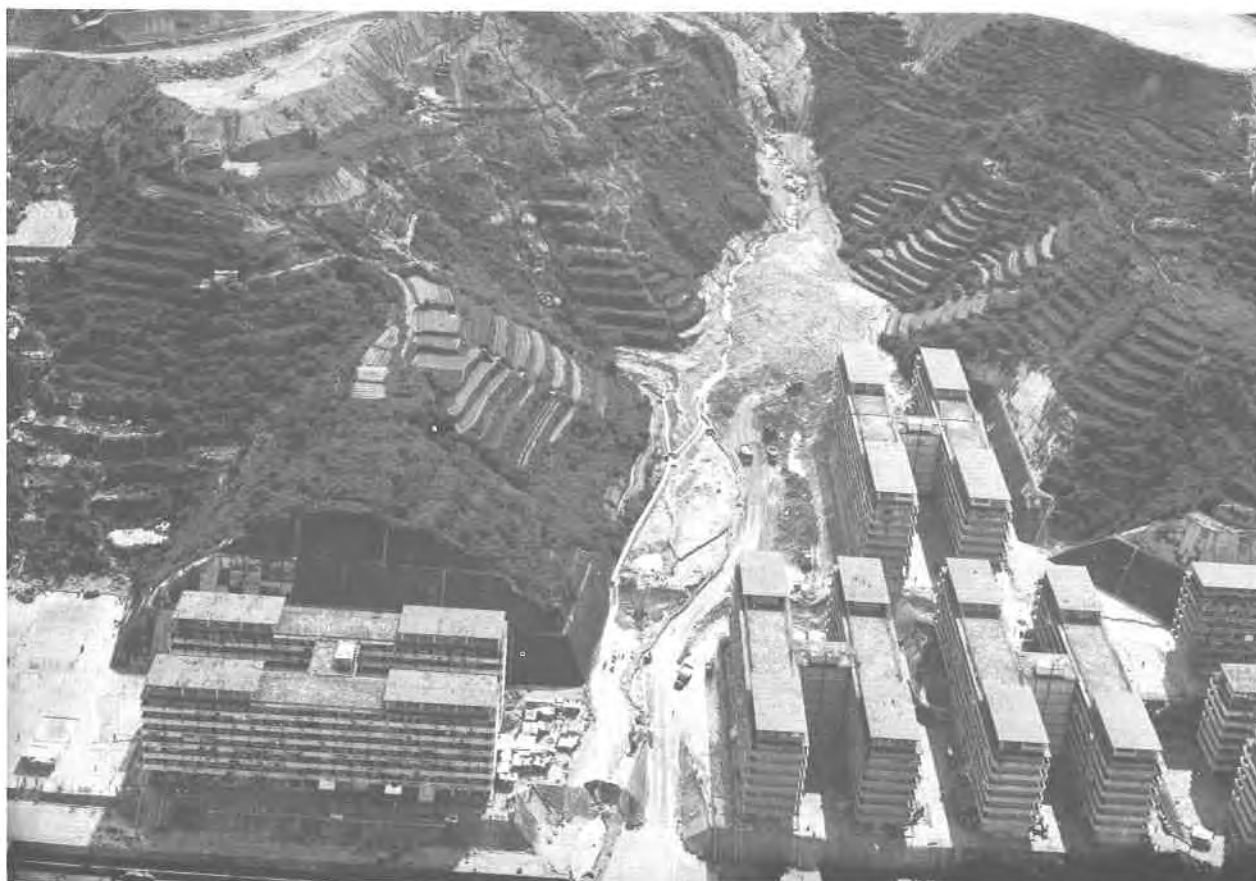
**Plate 52.** *Oblique Aerial Photograph Looking Northeast towards the Landslip at Tsui Ping Road Estate in 1964.* Hong Kong was badly hit by Typhoon Ida in August 1964. Two landslips occurred on a fill slope under construction on terrain upslope of Tsui Ping Road in the Kwun Tong area of Kowloon. The first landslip was early in the morning of 10.8.1964, after intense rainfall the previous day. Reports indicate that a mud avalanche flowed down the valley and deposited up to 3m of debris in an area approximately 90m by 70m in a resettlement estate. Surprisingly, only three people were listed missing, and no other injuries were reported. Six days later, at the same location during heavy rain on 16.8.1964, a second smaller landslip occurred shortly after 3.30 p.m. The Royal Observatory recorded a 24 hr rainfall of 2.86 inches (72.6 mm) for 16.8.1964. Five injuries were recorded, and hundreds were evacuated from their homes in the Kwun Tong Estate. In this Plate, taken approximately 2 weeks after the second landslip, trucks are evident removing debris from around the housing blocks. (ISD/30.8.1964/3276/1).

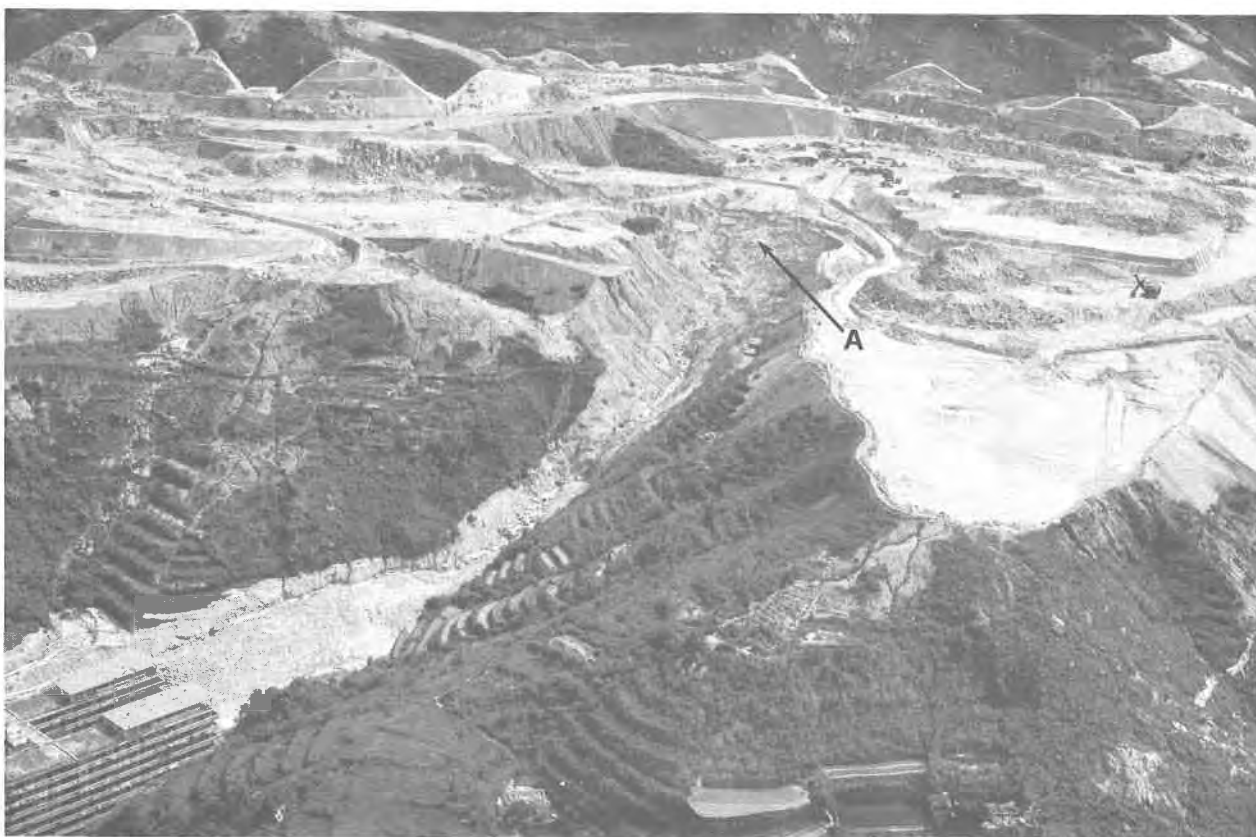
**Plate 54.** *Oblique Aerial Photograph of the Landslip near Tsui Ping Road Estate in 1964. The source of the failure is clearly evident at A. (ISD/30.8.1964/3276/6).*

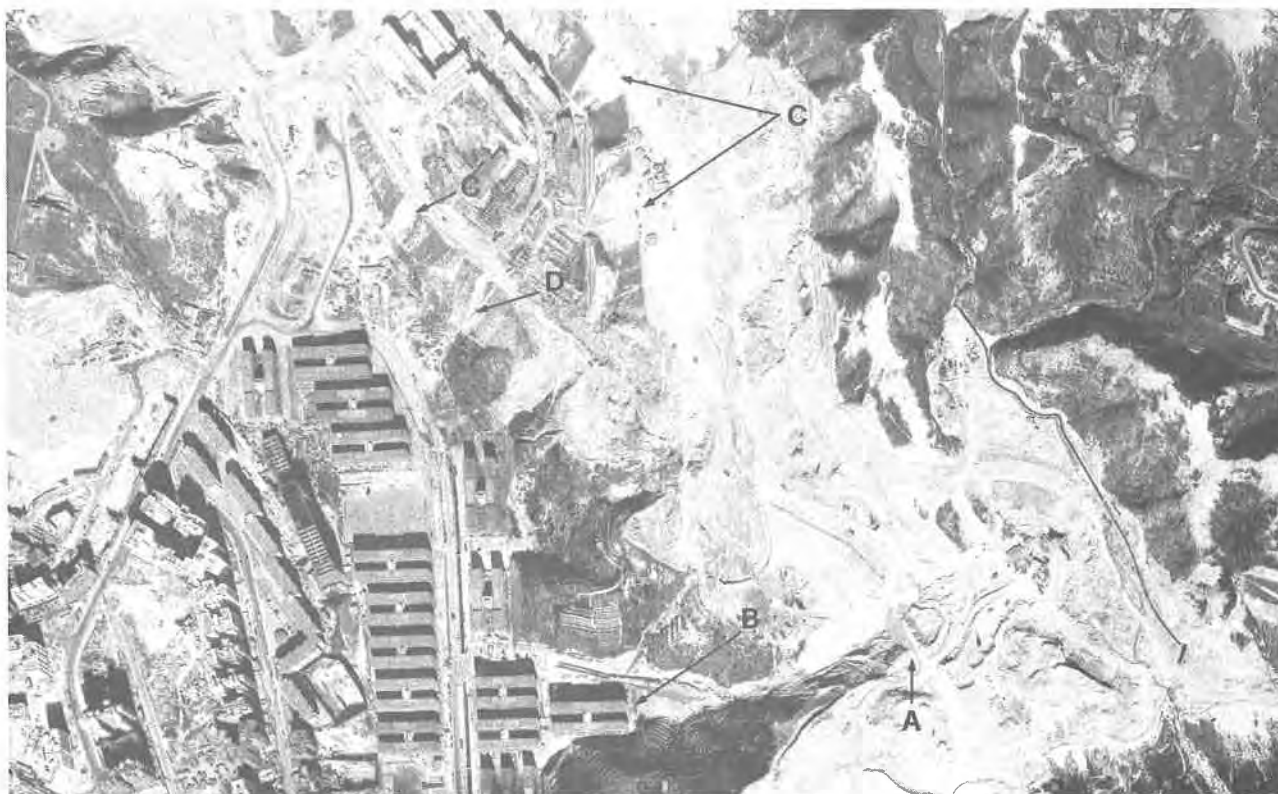
**Plate 55.** *Enlargement to Accompany Stereopair of the Tsui Ping Road Area in 1964.* This Plate accompanies Plate 56. Remedial works to the failure site are evident at A and debris is being removed from around the housing blocks at B. Landslips are evident to the north on newly formed slopes in the Sau Mau Ping Area (C), and a large gully is apparent on the fill slope at the site of the 1972 landslide (D). Compare this with Plates 107, 109 and 115. (13.12.1964/2539).

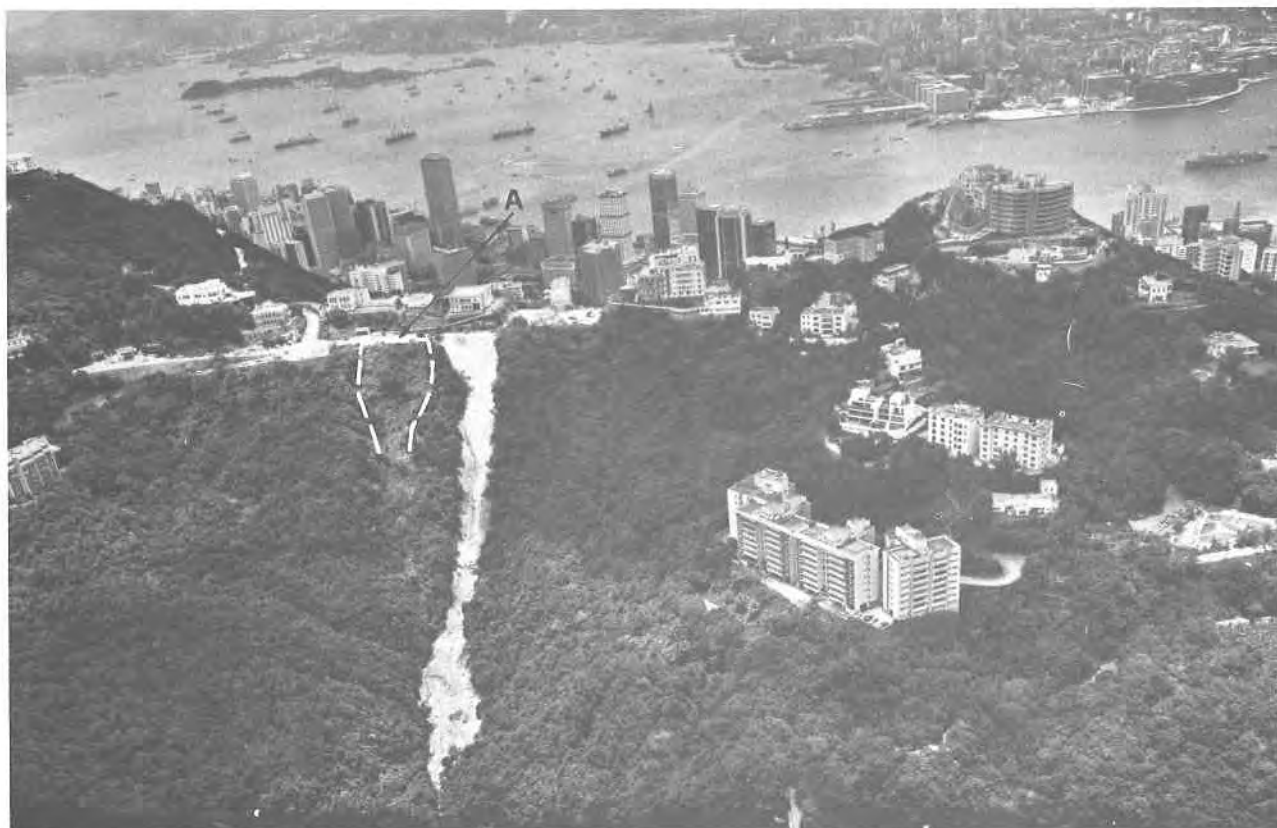
**Plate 57.** *Oblique Aerial Photograph of Landslip on Peak Road in 1983.* The area at A failed in 1966 and the incident is highlighted in Plate 58. Plate 153 provides a view of the 1983 failure from the carriageway. (21.6.1983/49230).

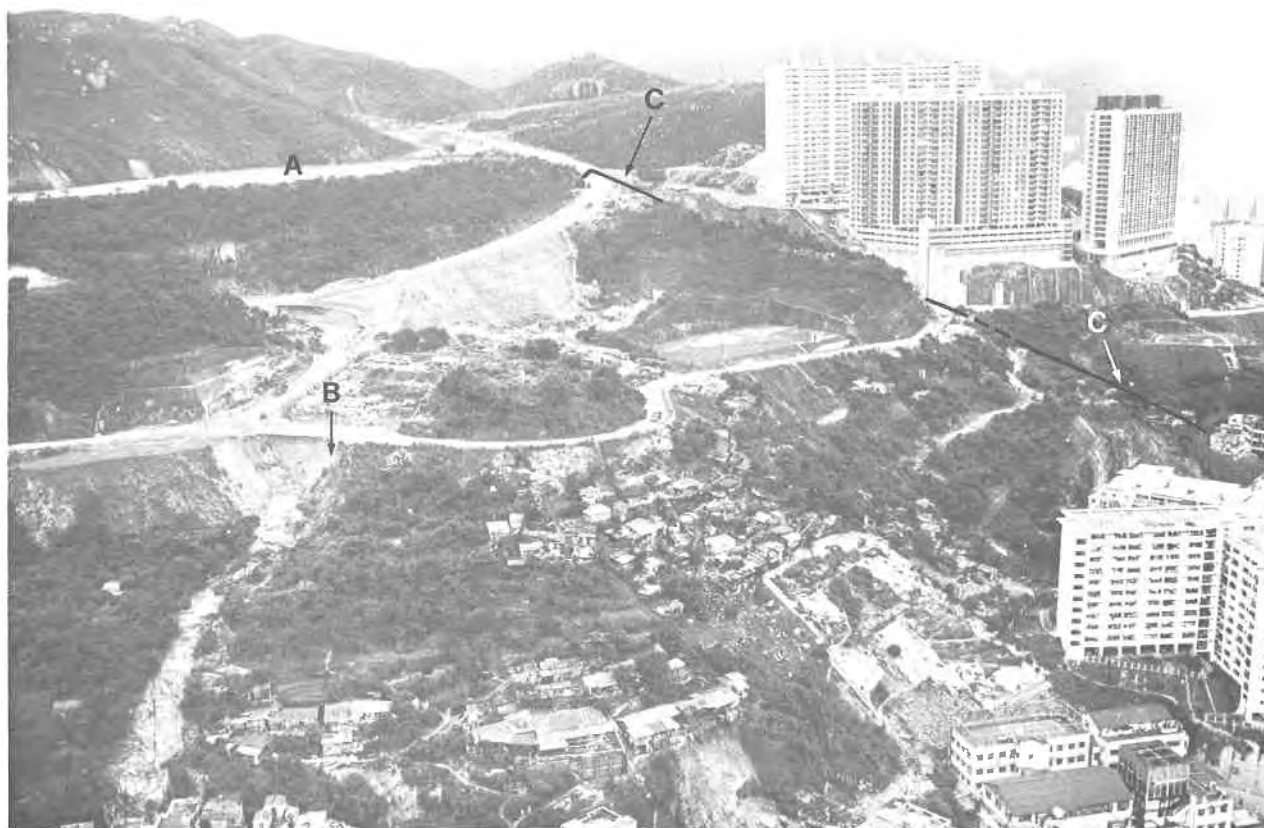
**Plate 60.** *Oblique Aerial Photograph of Braemar Reservoir in 1966.* Overflow from the Reservoir (A) caused serious flooding and damage evident in Plates 62–63 and 65–67. A large washout is evident on Tin Hau Temple Road (B). The severe damage in the Ming Yuen Street–King's Road area was caused by stormwater runoff which flowed along the natural stream course indicated in the western portion of the area (C). (Reproduced from Chen (1969), ISD/3982/275).

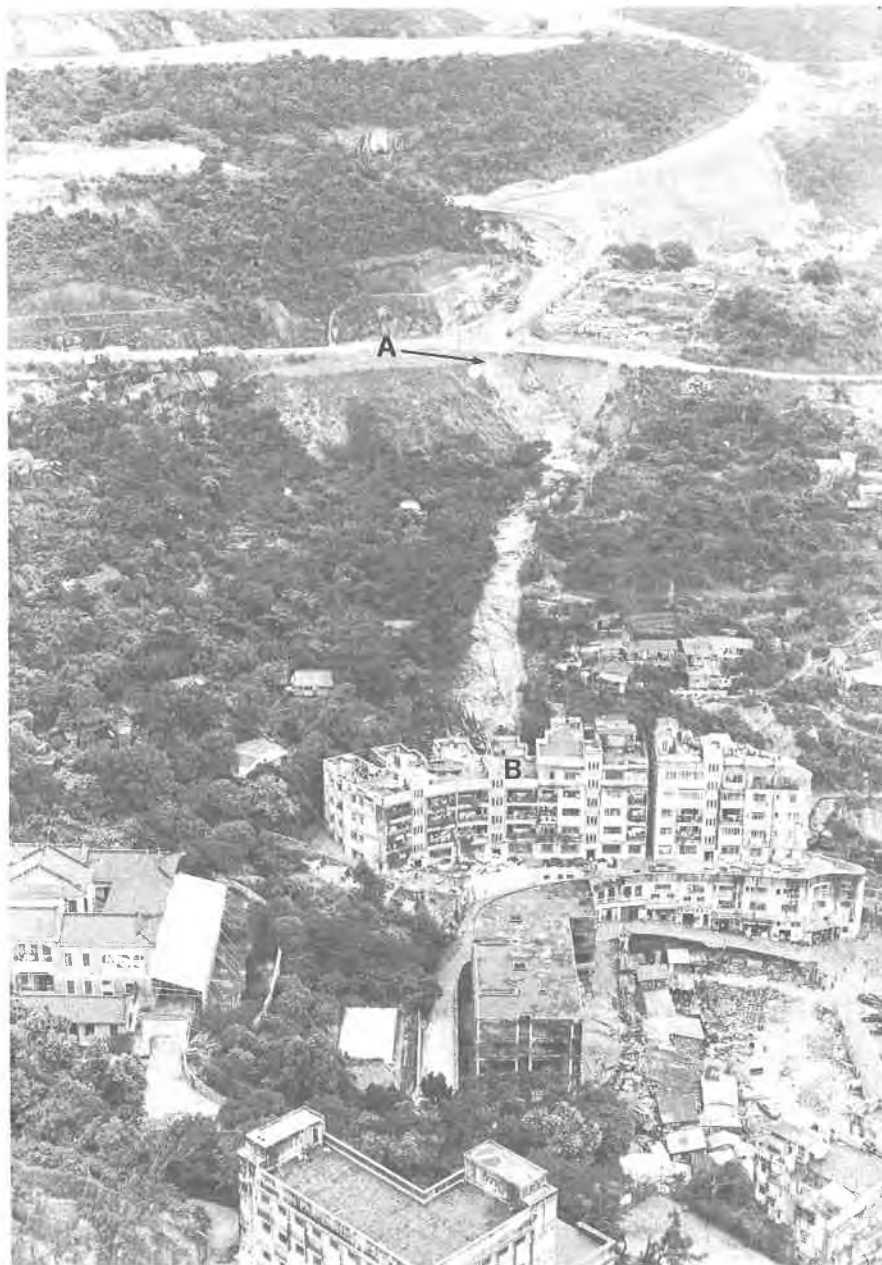
*Plate 61. Oblique Aerial Photograph of Washouts on Braemar Reservoir Road and Tin Hau Temple Road in 1966. A large washout is evident at the intersection of Tin Hau Temple Road and Braemar Reservoir Road (A). The multi-storey development at B is near Kai Yuen Street. (Reproduced from Chen (1969), ISD/3982/318).*

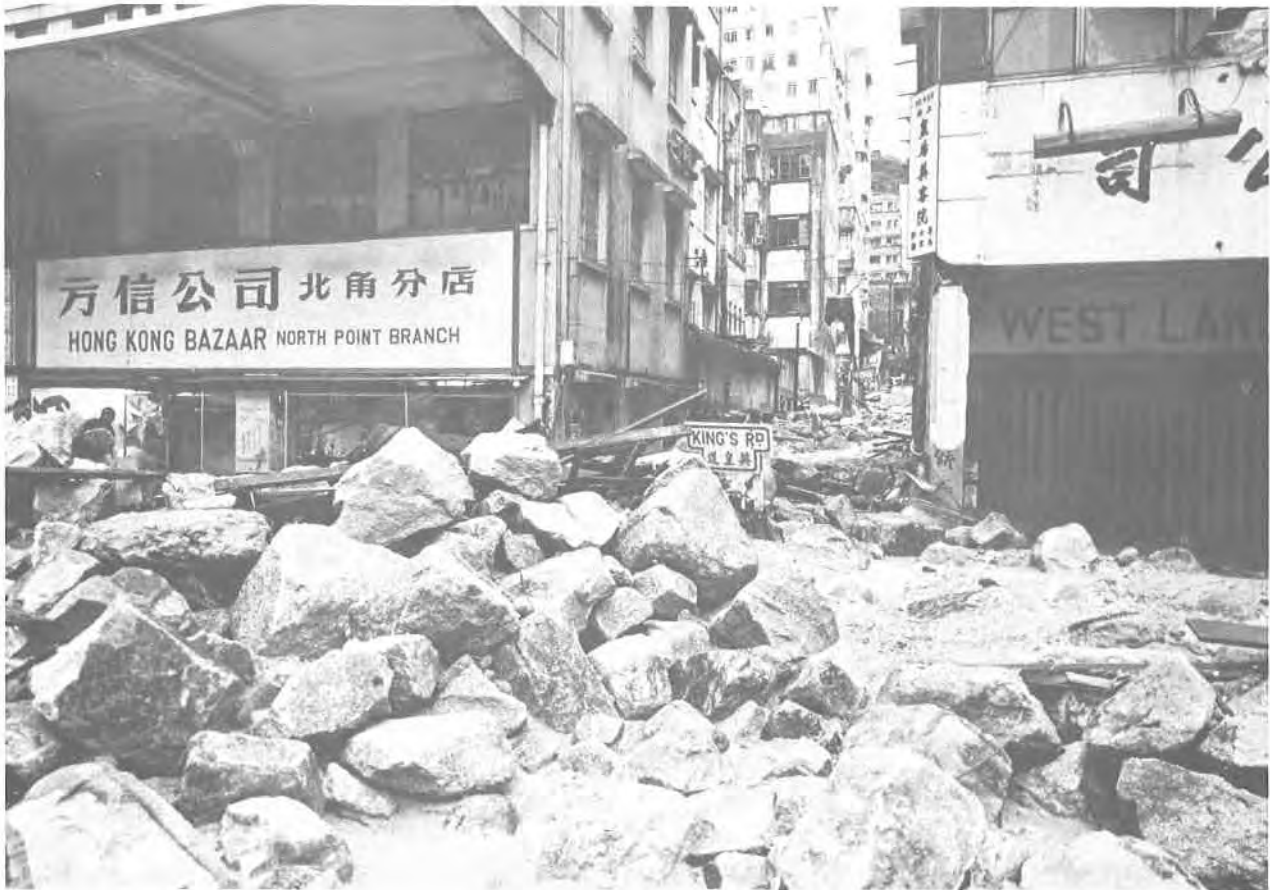
Plate 62. *Rocks and Debris in King's Road in 1966.* (Reproduced from Chen (1969), ISD/3982/104).

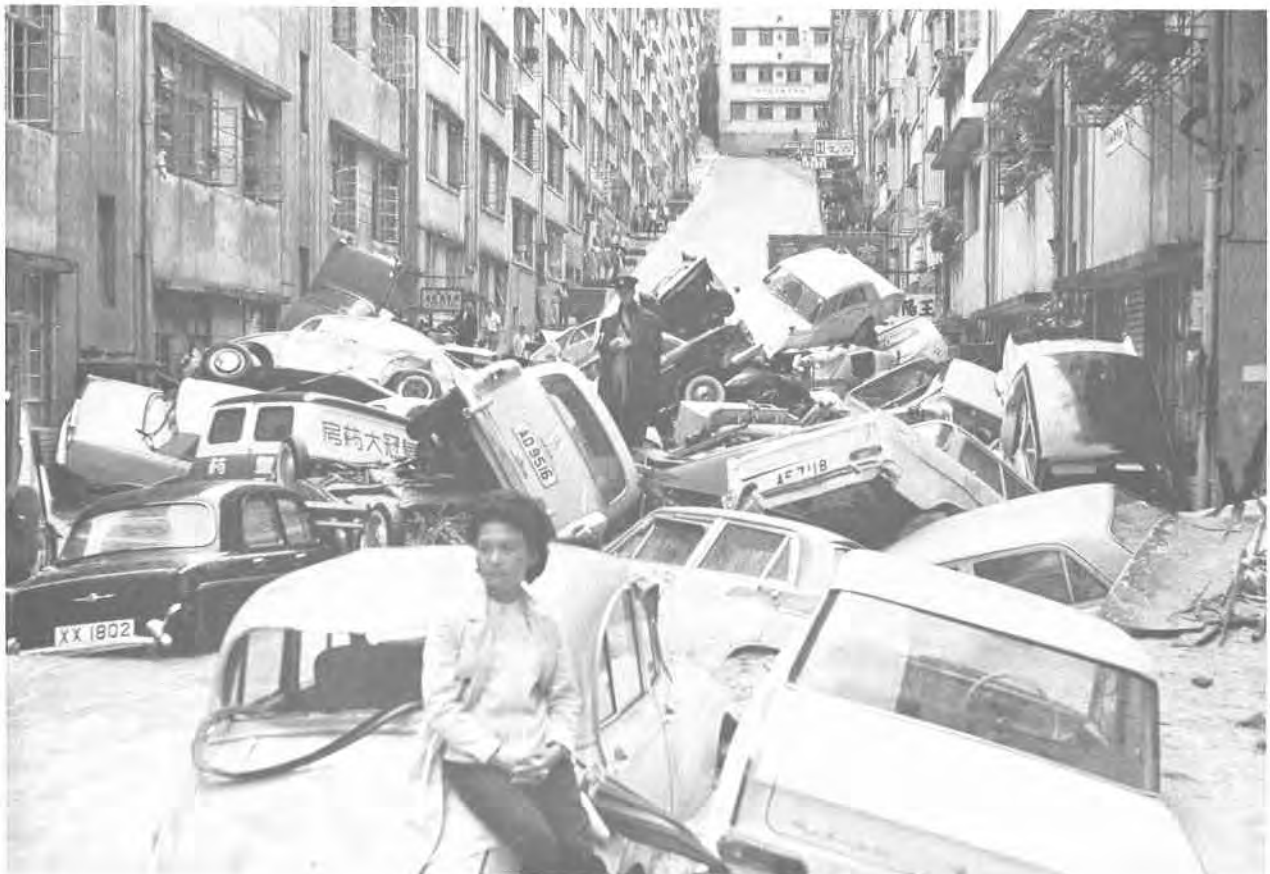
Plate 63. *Wrecked Vehicles in Ming Yuen Street in 1966.* (Reproduced from Chen (1969), ISD/3982/60).

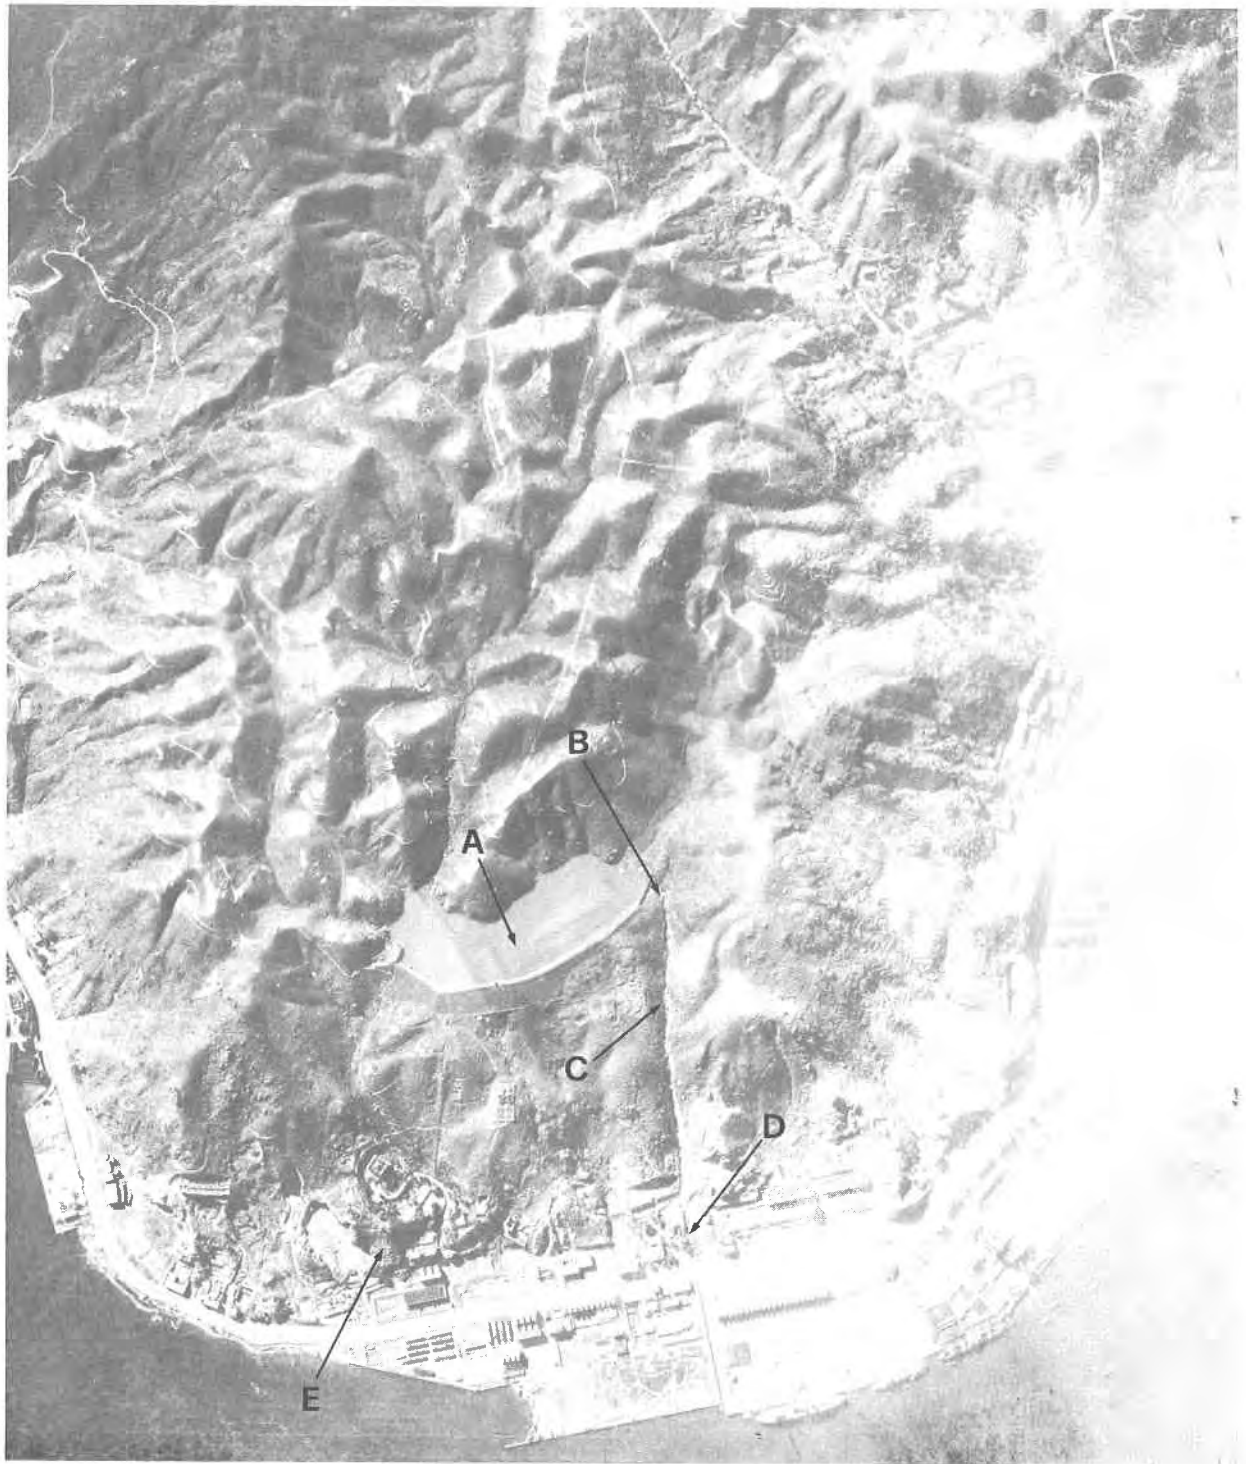
**Plate 64.** *Aerial Photograph of the Braemar Reservoir and North Point in 1945.* This photograph dramatically illustrates the intimate relationship between the natural drainage course and Ming Yuen Street, some 21 years before the 1966 rainstorms. The results of these rainstorms are seen in Plates 61–63 and 65–67. The Reservoir is shown at A, the spillway at B, and the natural stream course at C. Ming Yuen Street is located (D) directly downslope of the main drainage line leading from the Reservoir spillway. The perspective seen in Plate 61 is shown by the arrow at E. (11.11.1945/681/6/4034).

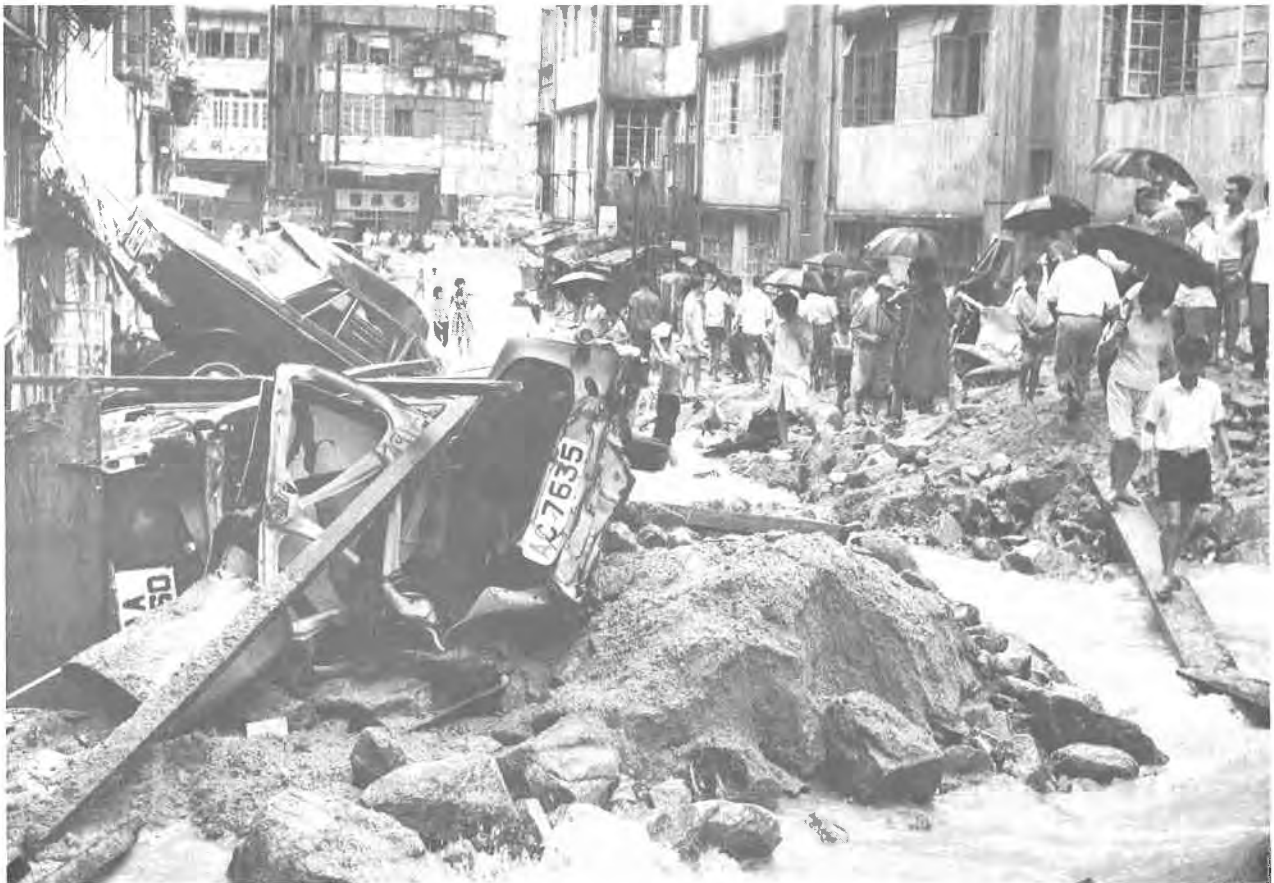
**Plate 65.** *Debris in Ming Yuen Street in 1966.* (Reproduced from Chen (1969), ISD/3982/222).

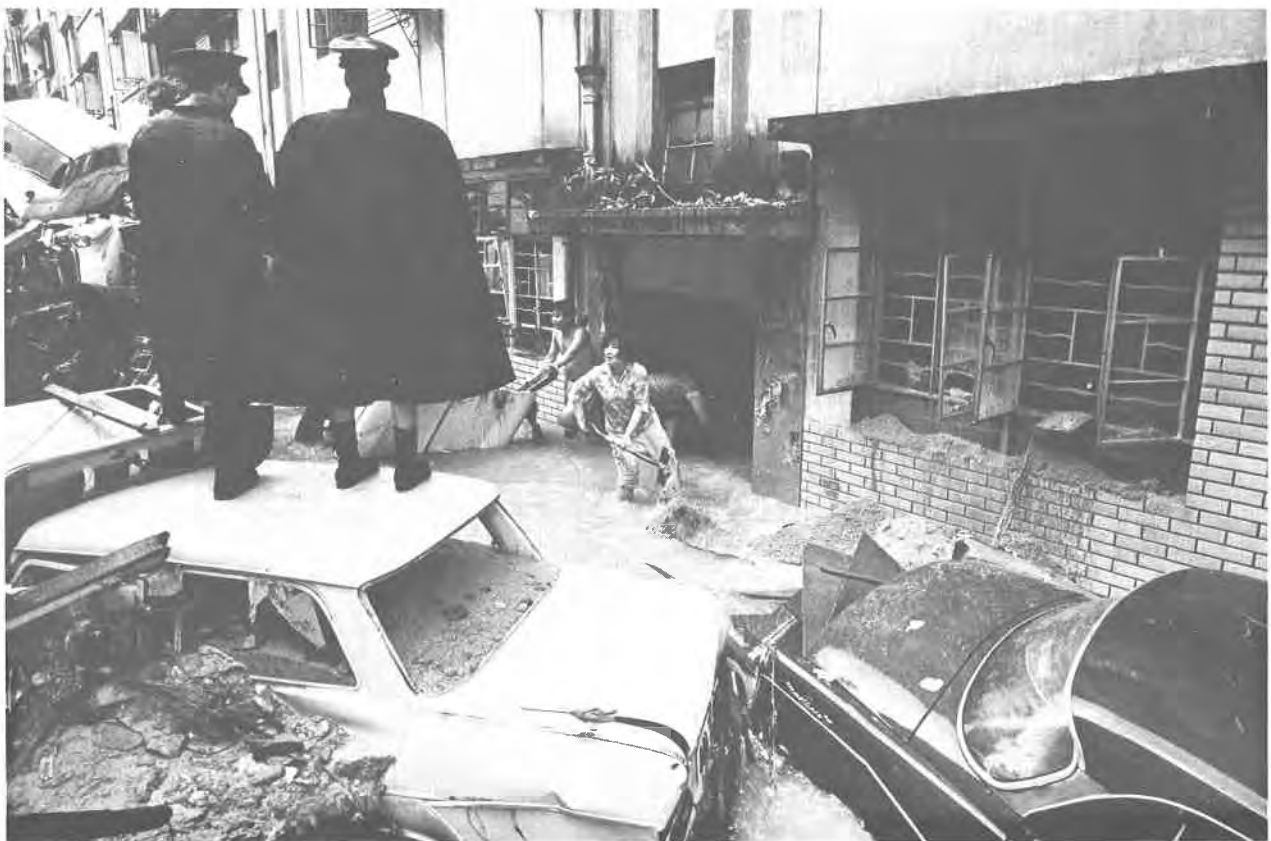
**Plate 66.** *Flooding and Debris in Ming Yuen Street in 1966.* (Reproduced from Chen (1969), ISD/3984/91).

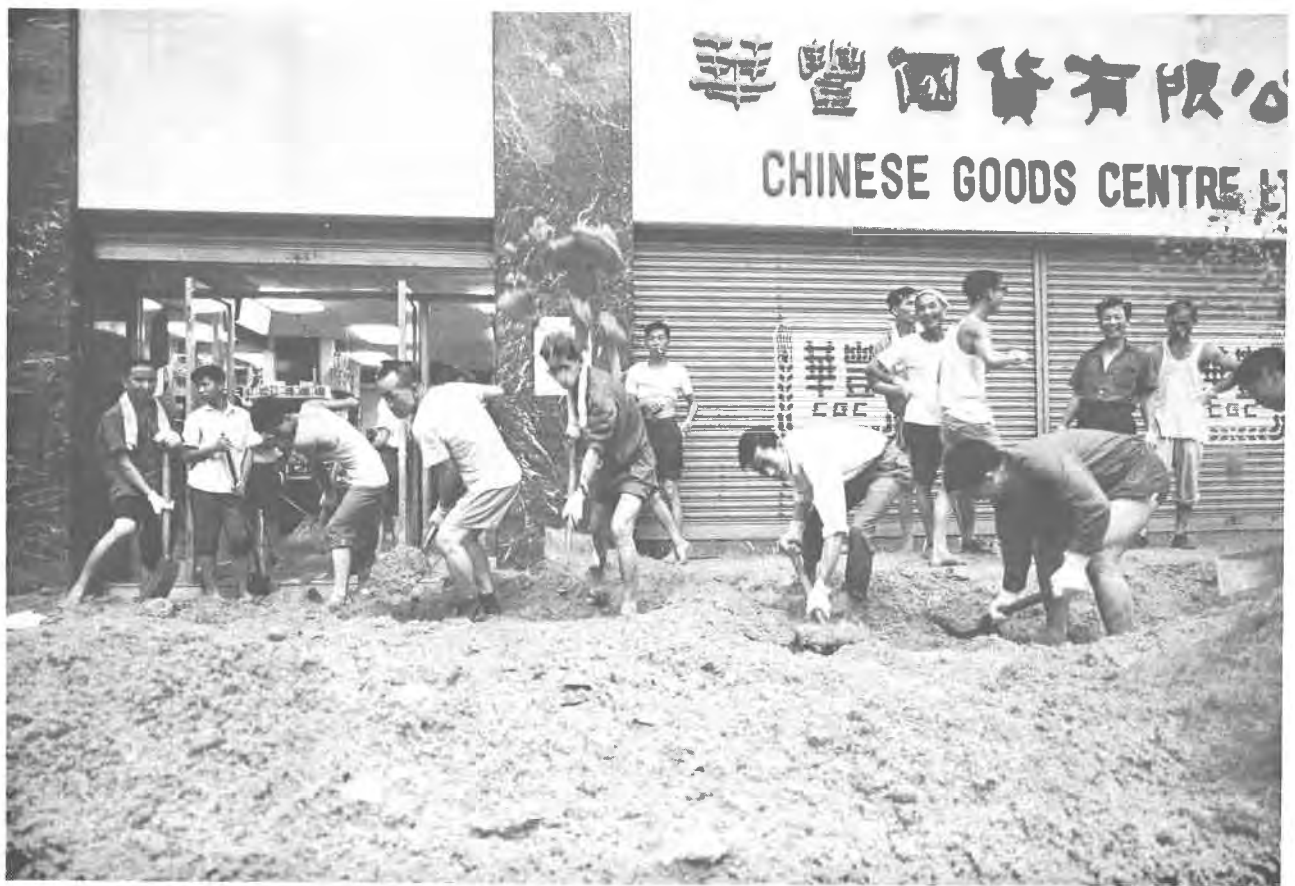
Plate 67. *Clearing of Debris on King's Road in 1966.* (Reproduced from Chen (1969), ISD/3982/114).

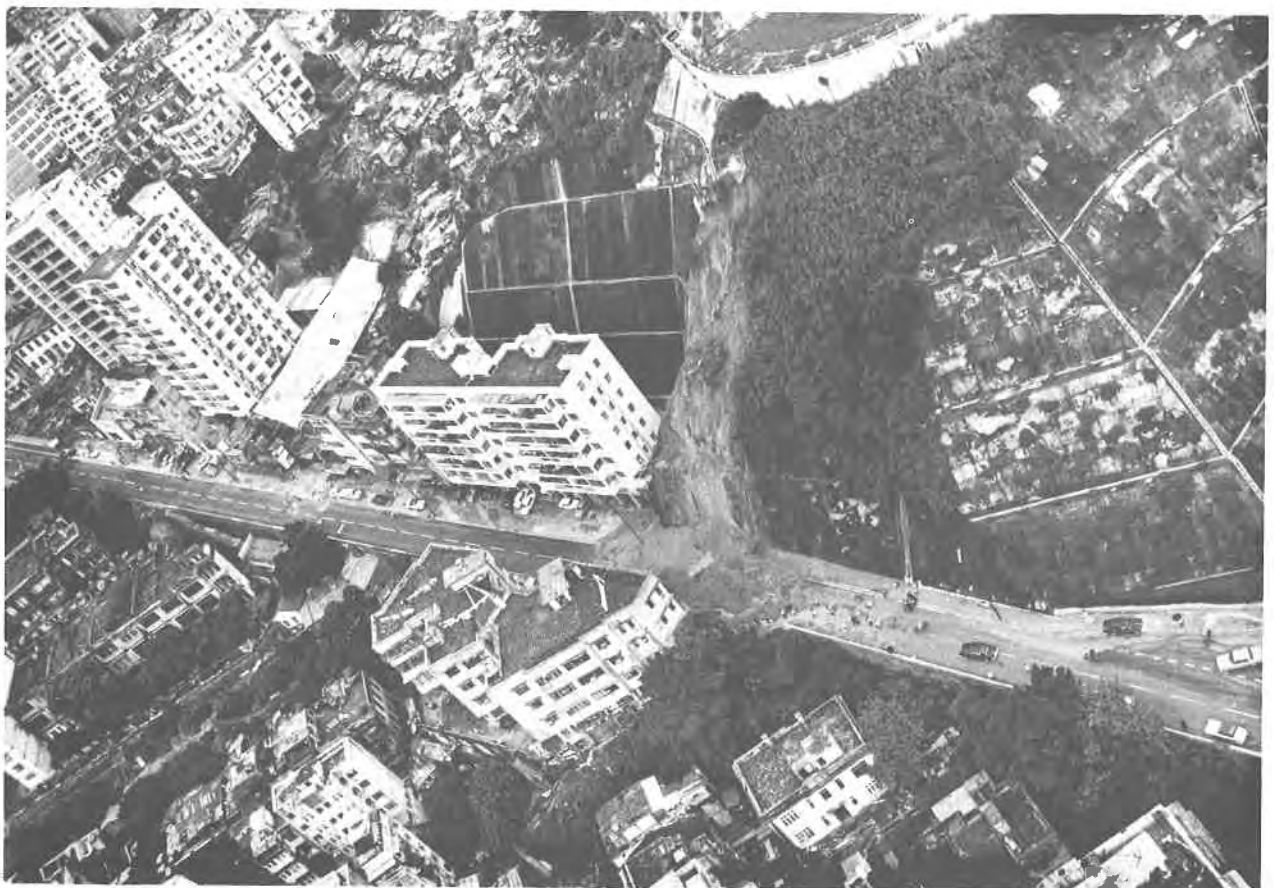
Plate 68. *Large Landslip on Tai Hang Road in 1966.* (Reproduced from Chen (1969), ISD/3982/262).
