Geotechnical Area  
Studies Programme

GASP Report XII

# Territory of Hong Kong

Geotechnical Control Office  
Civil Engineering Services Department  
Hong Kong

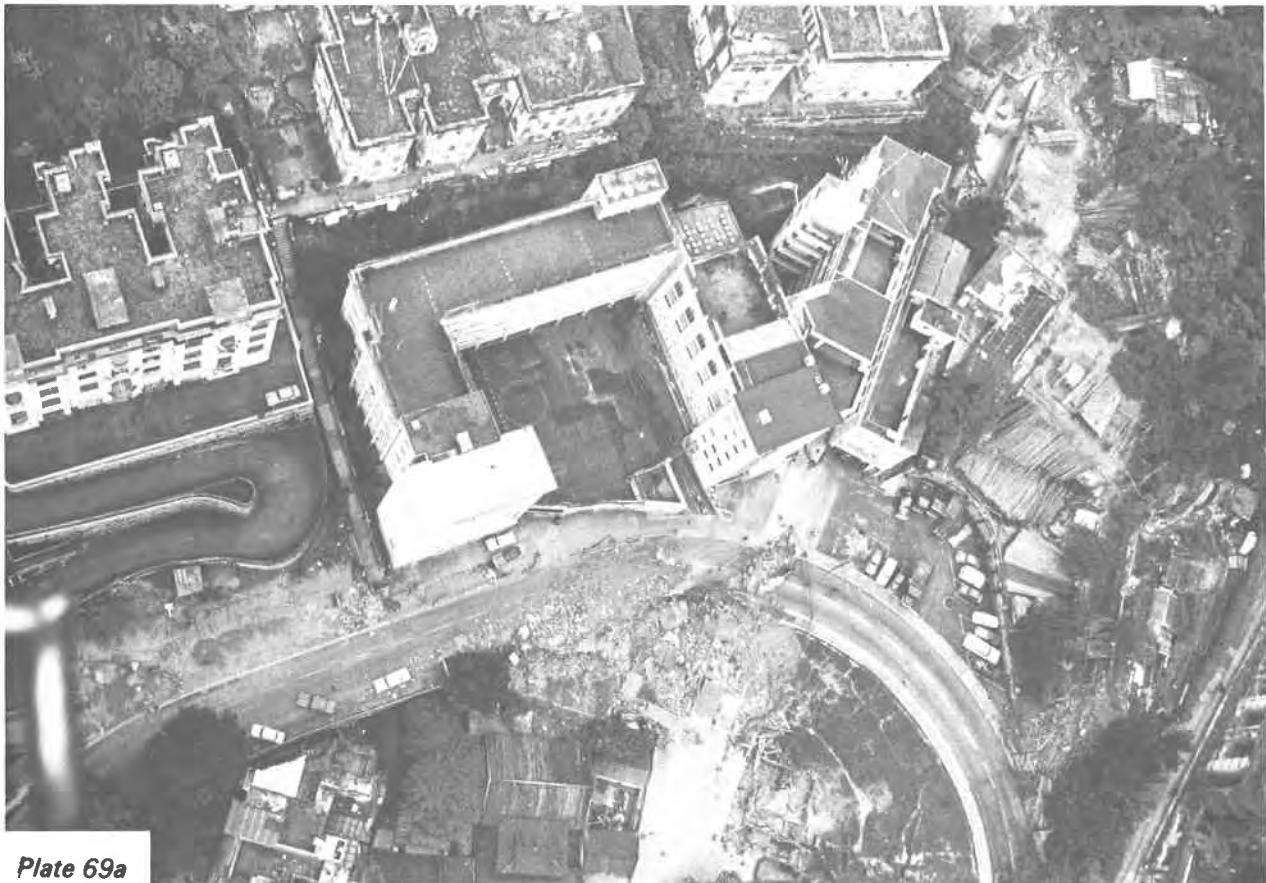
**Plate 69.** *Washout at Junction of Kennedy Road and Stone Nullah Lane in 1949 and 1966.* Plate 69a shows the washout caused by the rupture of a culvert. Damage from this washout is evident in Plates 70 and 71 (reproduced from Chen (1969), ISD/3982/266). Plate 69b shows the uncovered drainage nullah (A) in 1949. The location of the blowout is shown at B. (8.5.1949/81A/128/6121).

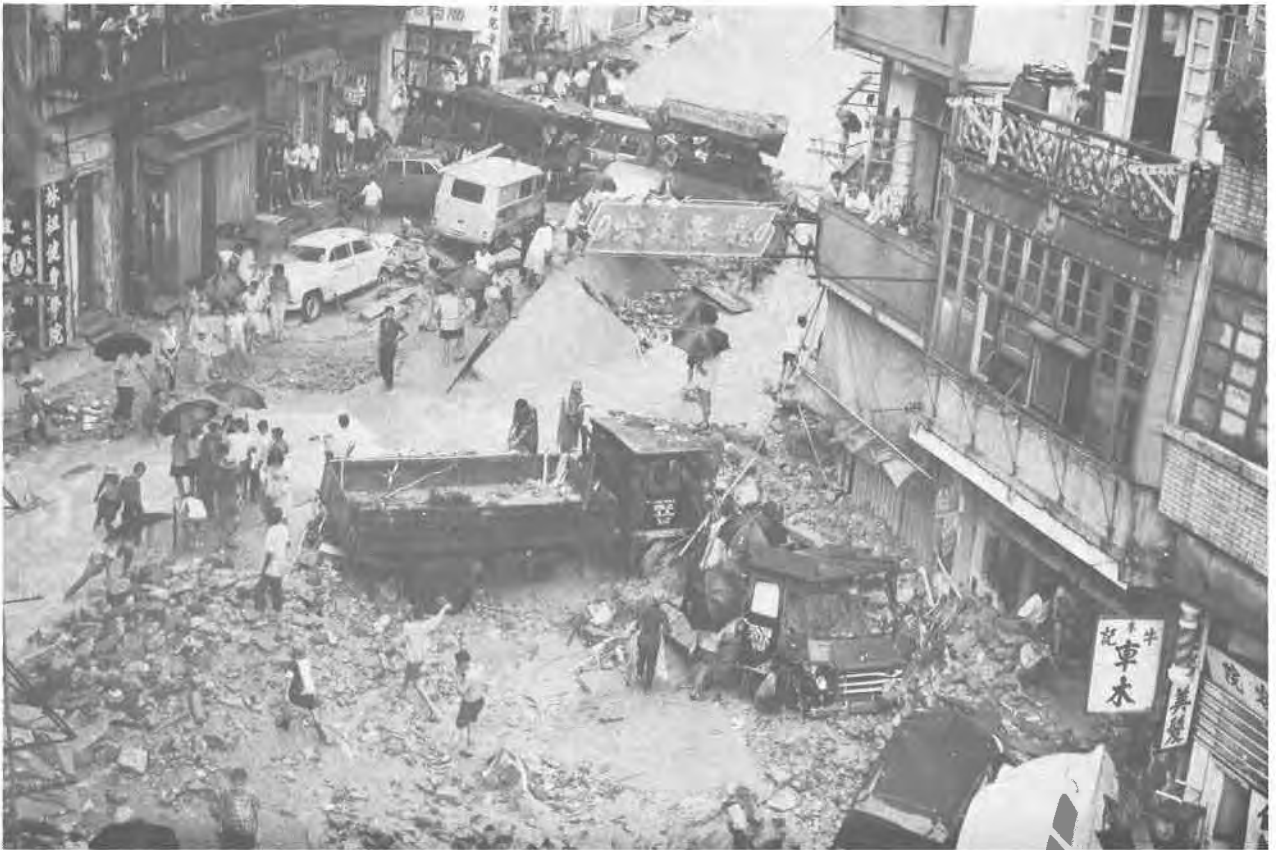
**Plate 70.** *Damage Caused by Debris and Flooding in Stone Nullah Lane in 1966.* (Reproduced from Chen (1969), ISD/3982/194).

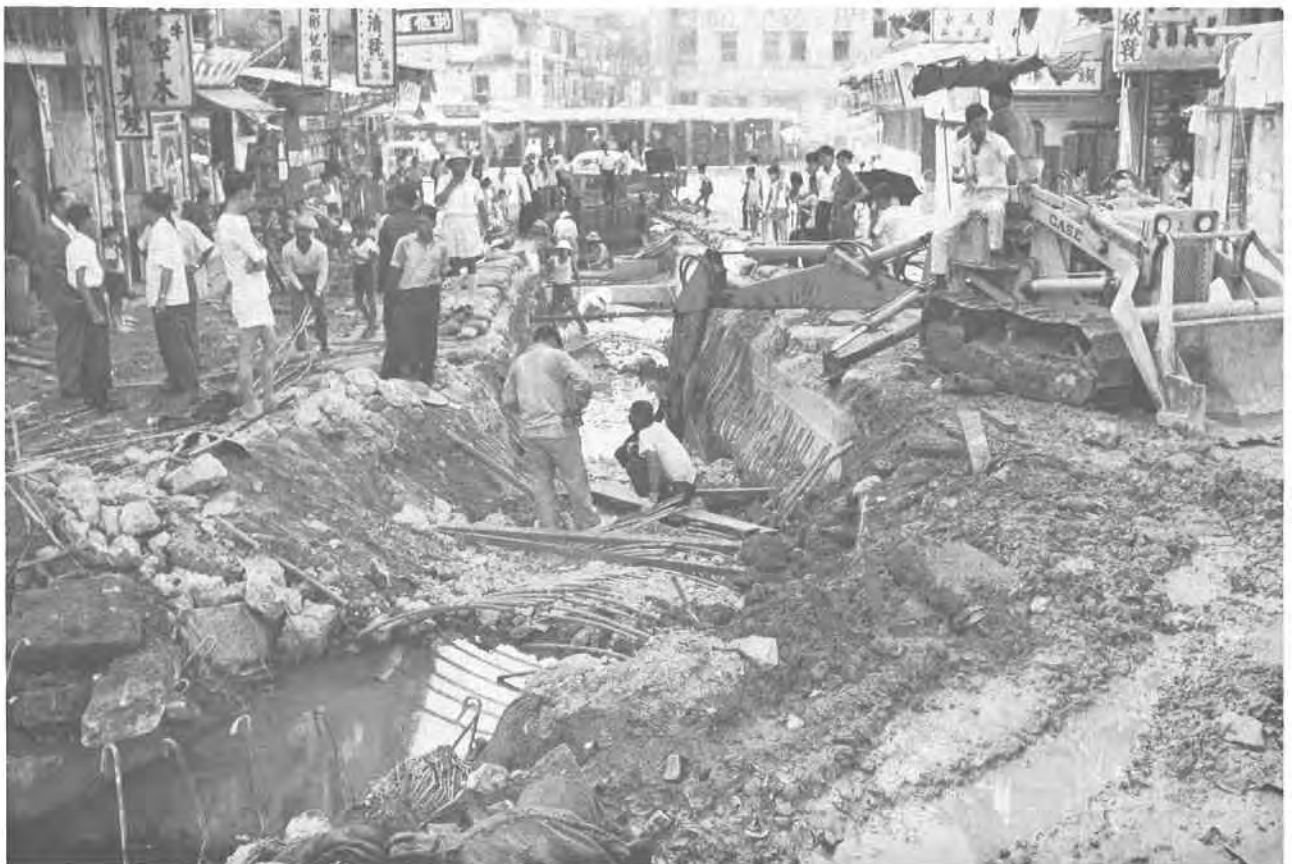
**Plate 71.** *Damage to Drainage Culvert in Stone Nullah Lane in 1966.* The concrete road slabs were washed away by floodwaters. (Reproduced from Chen (1969), ISD/3982/426).

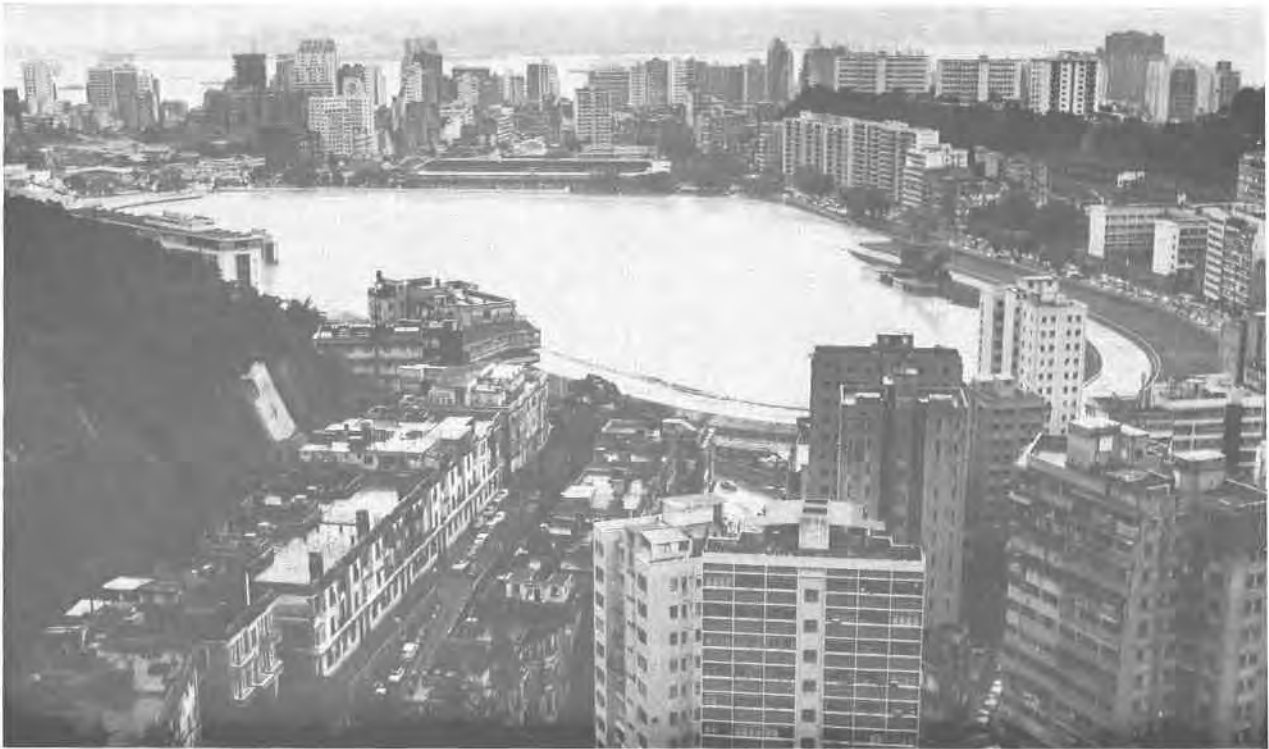
**Plate 72.** *Flooding in Happy Valley in 1966.* The race course is inundated by floodwaters following torrential rains. (Reproduced from Chen (1969), ISD/3982/172).

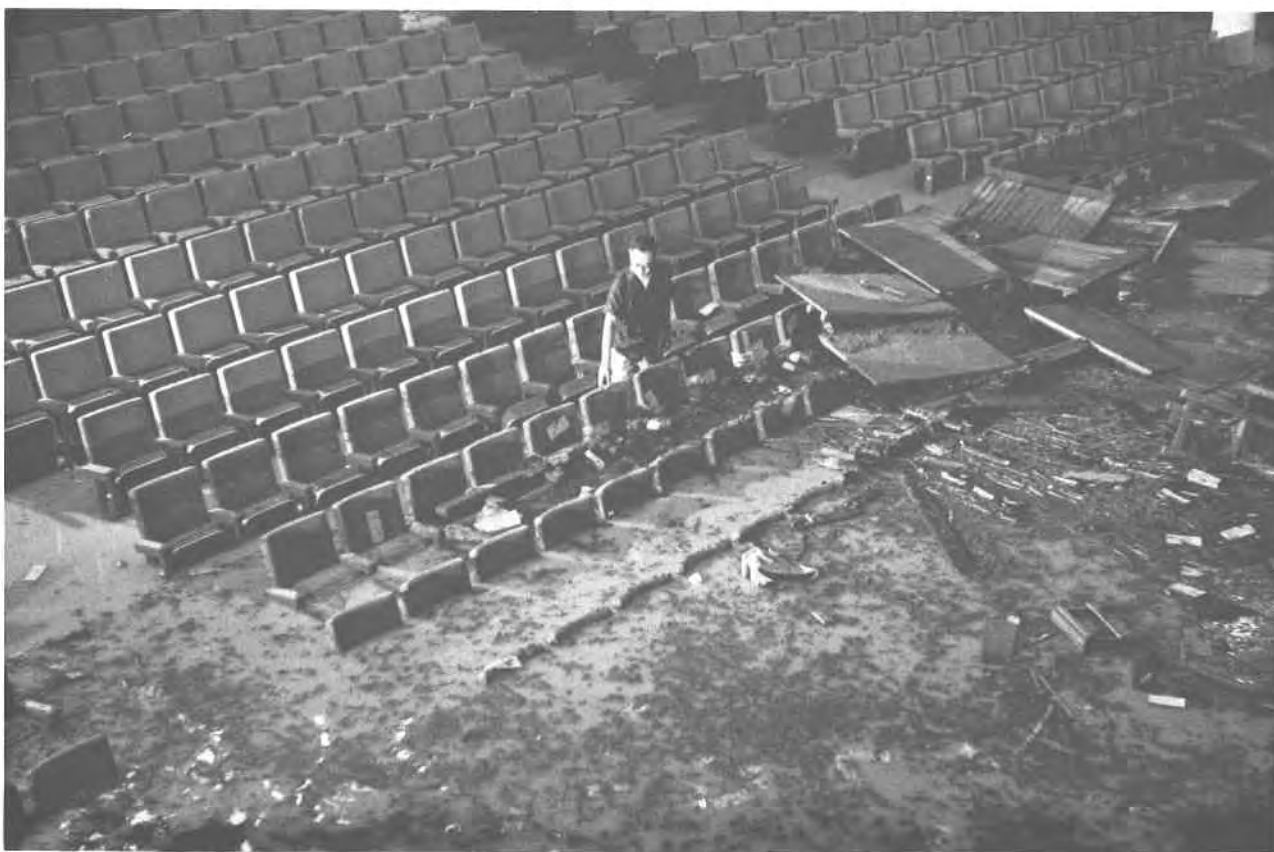
**Plate 75.** *Floodwaters in the City Hall Concert Hall in 1966.* It was reported that an eel weighing one catty was caught in the Hall. (Reproduced from Chen (1969), ISD/3982/1).

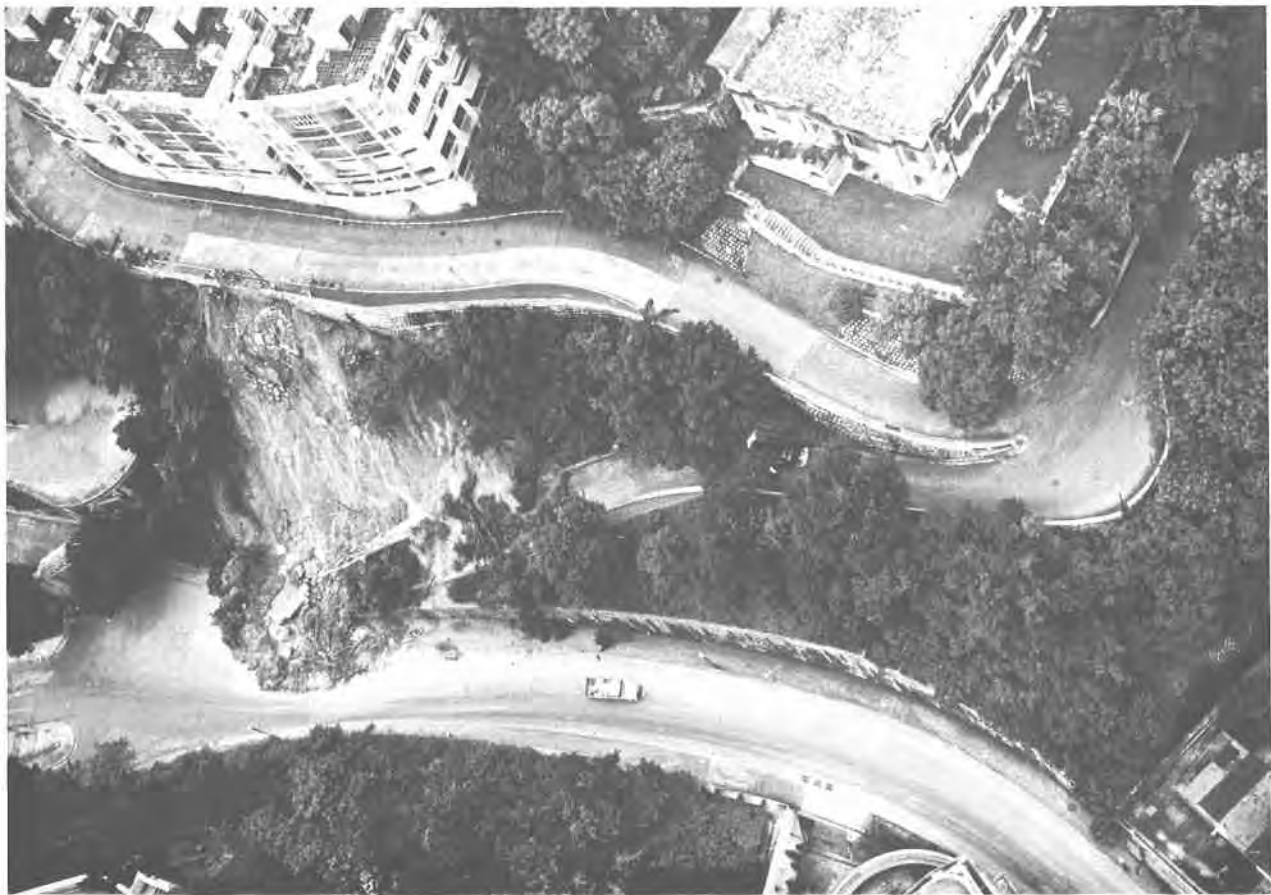
**Plate 76.** *Oblique Aerial Photograph of a Landslip at the Junction of Broadwood and Link Roads in 1966. (Reproduced from Chen (1969), ISD/3982/265).*

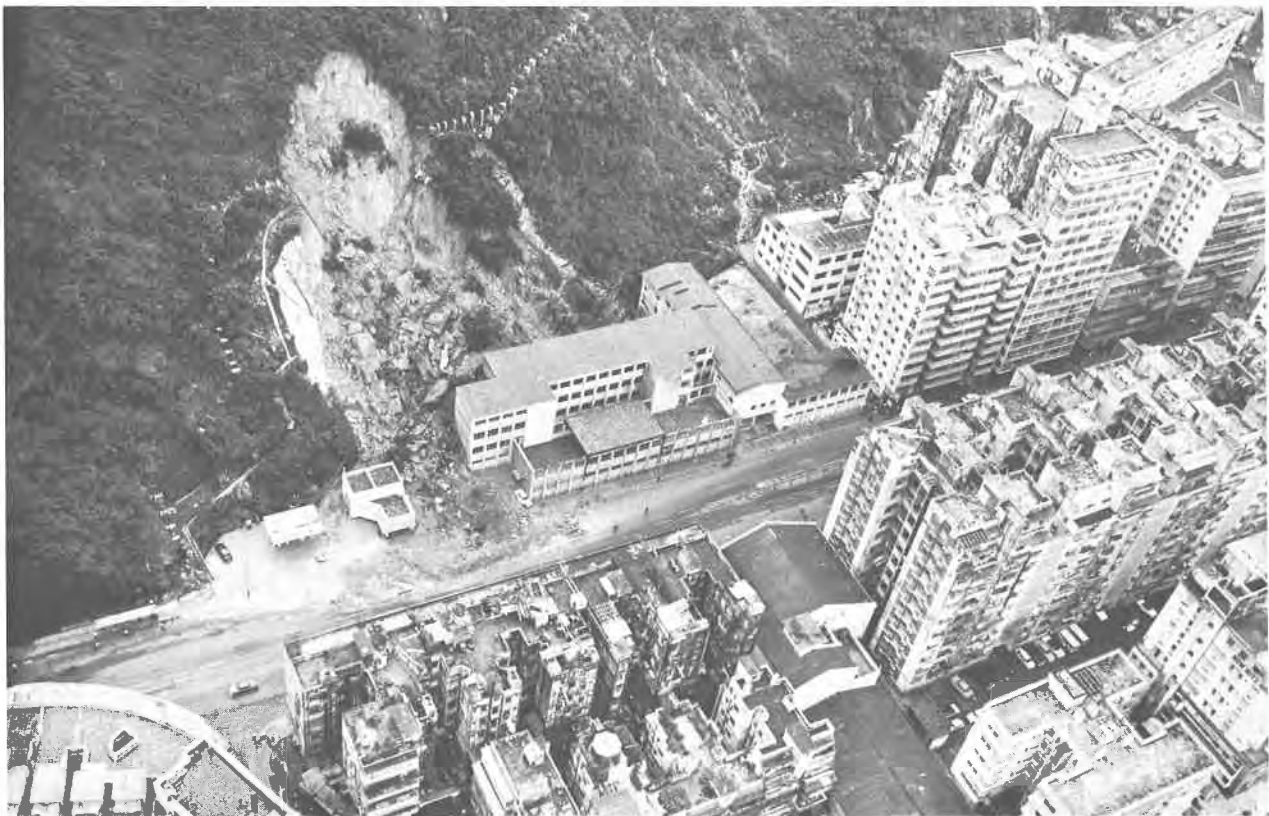
**Plate 77.** *Oblique Aerial Photograph of a Landslip behind the North Point Government School in 1966. (Reproduced from Chen (1969), ISD/3982/373).*

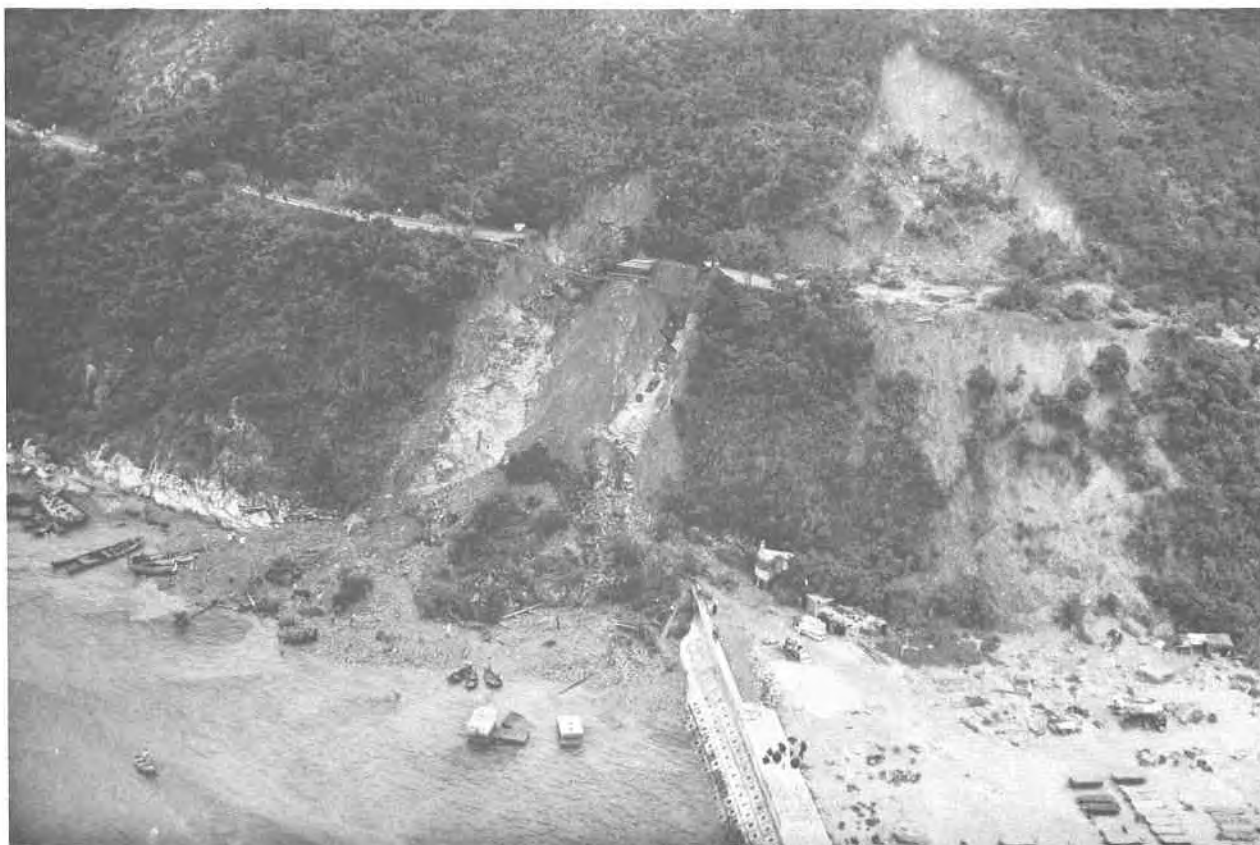
**Plate 78.** *Oblique Aerial Photography of Landslips on Shek Pai Wan Road on Ap Lei Chau in 1966.* (Reproduced from Chen (1969), ISD/3982/329).

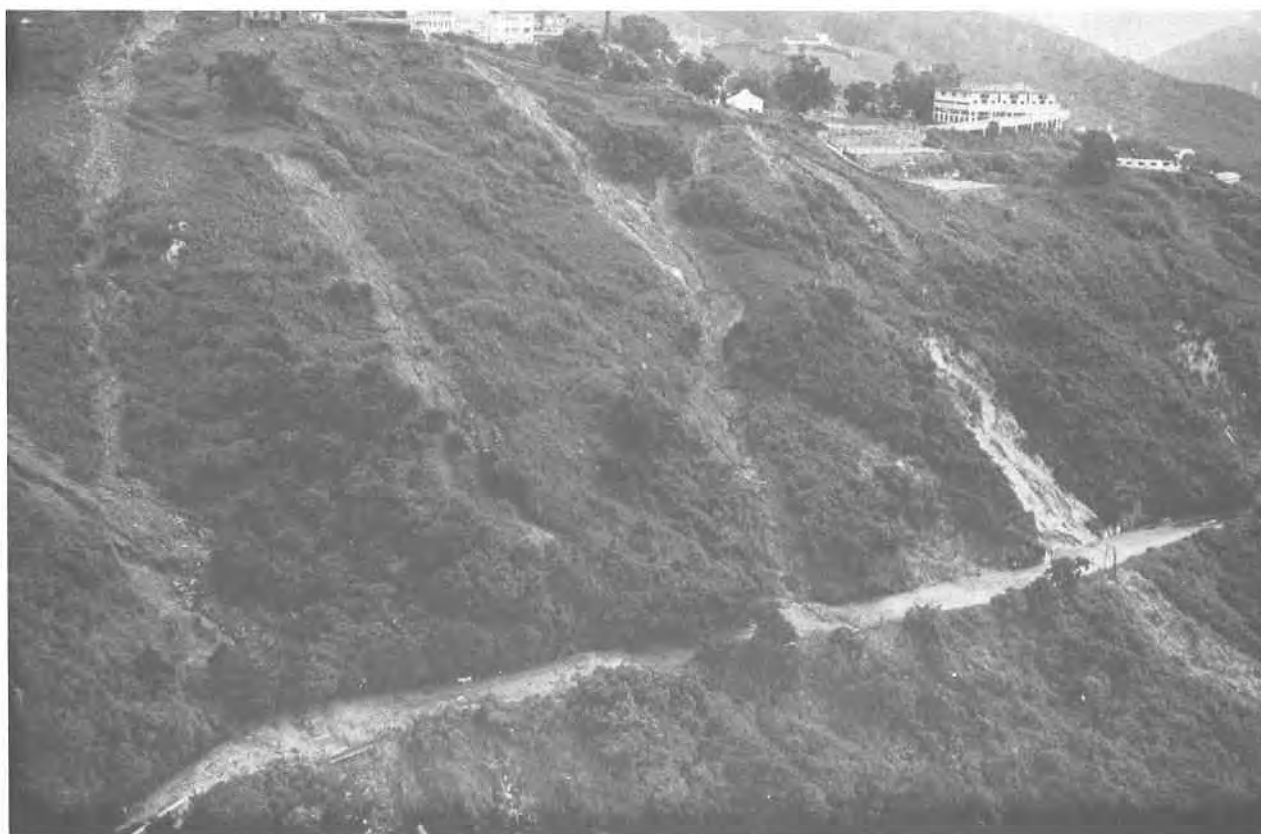
**Plate 79.** *Oblique Aerial Photograph of Landslips above Victoria Road in Pok Fu Lam in 1966.* It was reported that a total of 29 landslips and 18 washouts occurred along Victoria Road during the period of storm activity following 10.6.1966. (Reproduced from Chen (1969), ISD/3982/382).

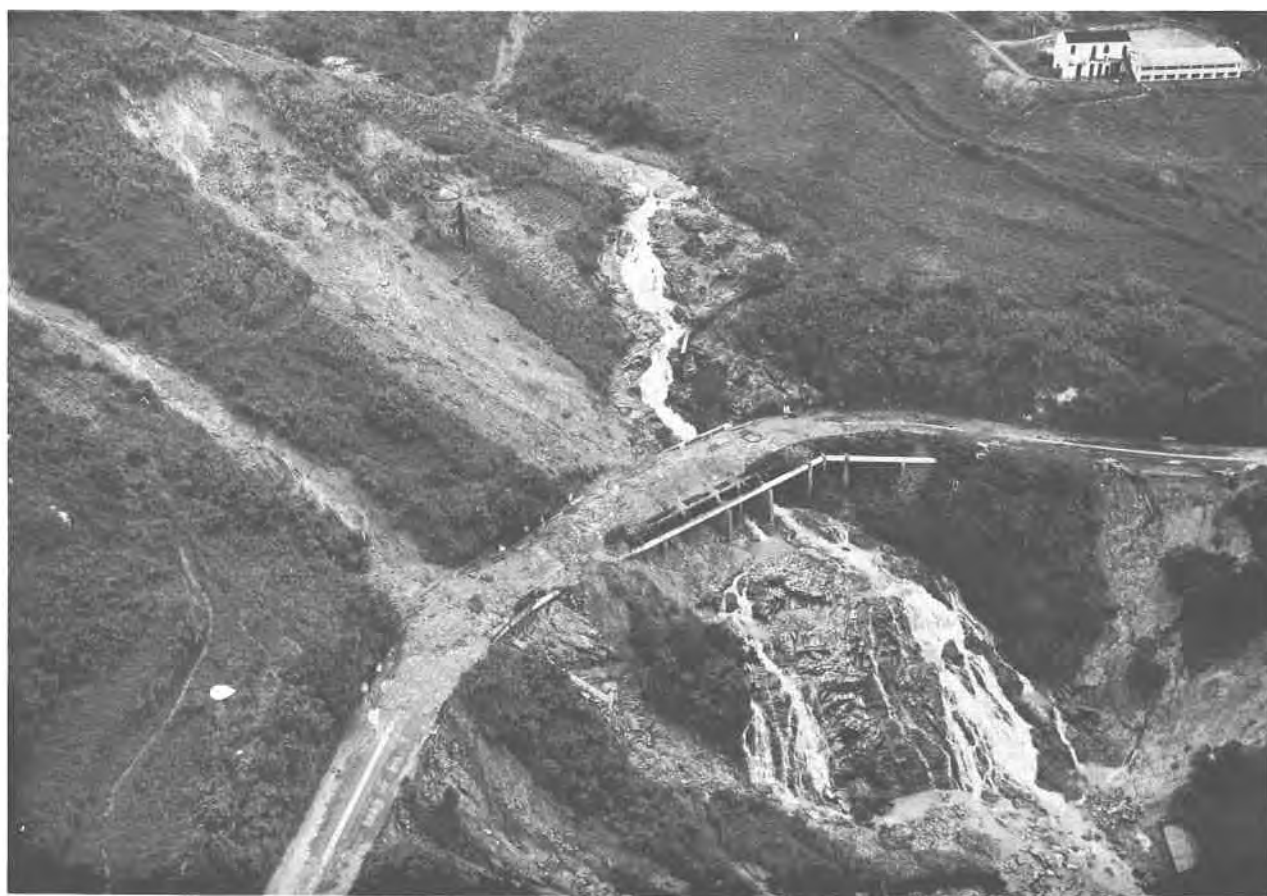
*Plate 80. Oblique Aerial Photograph of Landslips above Victoria Road in Pok Fu Lam in 1966. (Reproduced from Chen (1969), ISD/3982/384).*

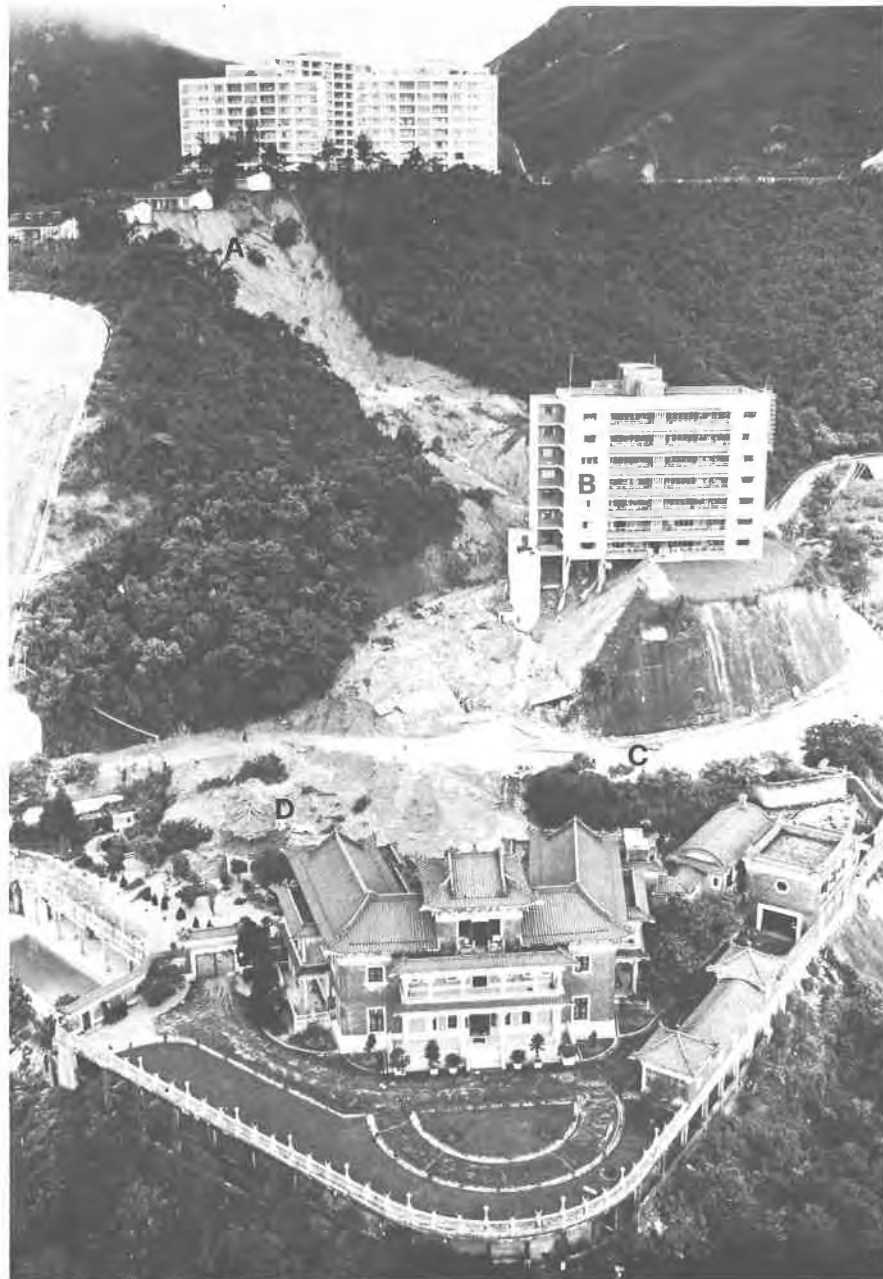
**Plate 81.** *Landslip below Mt Nicholson Bungalows in 1966.* Failure (A) of portion of a fill slope, forming part of the platform for the Mt Nicholson Bungalows, resulted in a large landslip which damaged Victoria Heights (B) and flowed across Stubbs Road (C) into a neighbouring garden (D). The Assistant Director of Education was fatally injured in the landslip. (Reproduced from Chen (1969), ISD/3982/284).

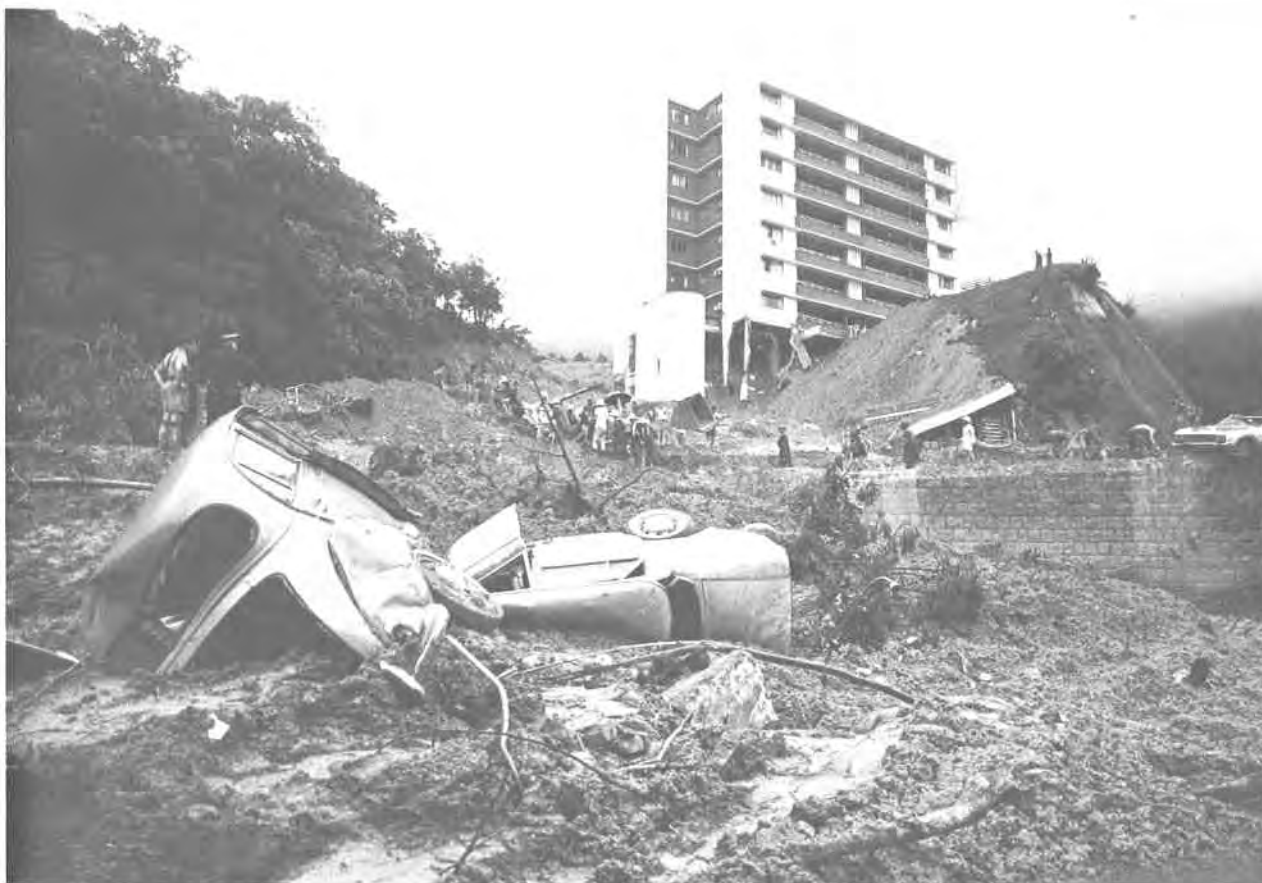
**Plate 82.** *Damage caused by the Mt Nicholson Landslip in 1966.* (Reproduced from Chen (1969), ISD/3982/136).

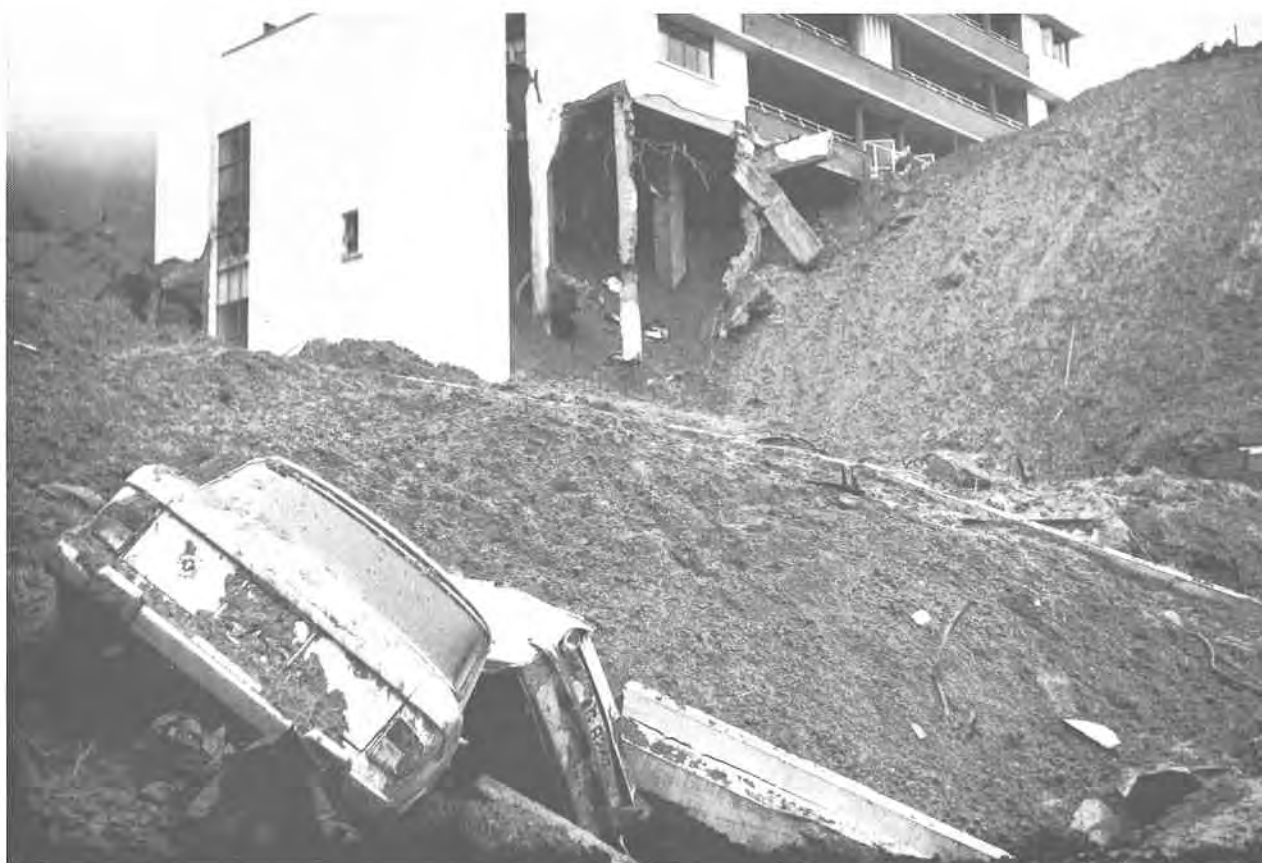
**Plate 83.** *Damage to Victoria Heights Flats in 1966.* (Reproduced from Chen (1969), ISD/3982/160).

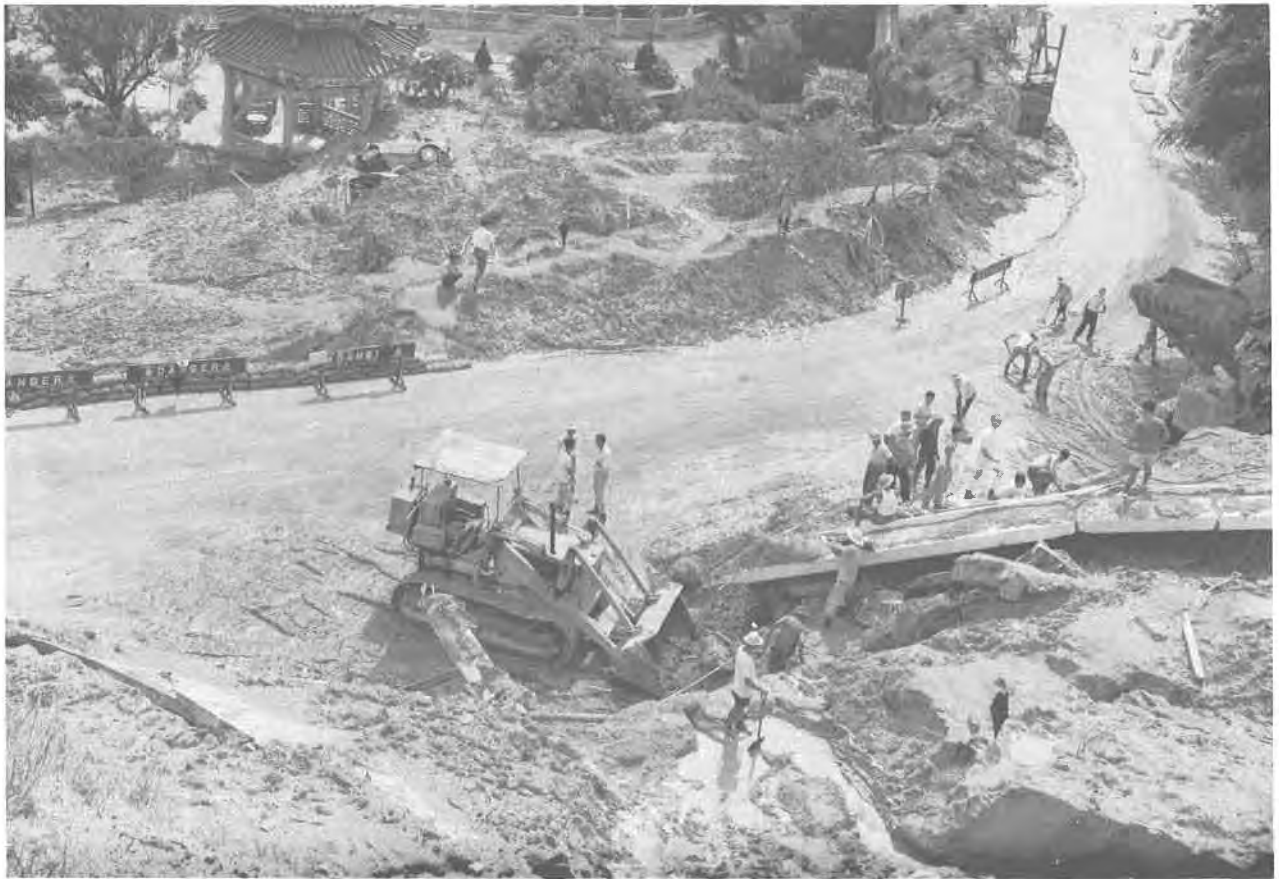
**Plate 84.** *Clearing of Landslip Debris from Stubbs Road in 1966. Clearance work following the Mt Nicholson failure. (Reproduced from Chen (1969), ISD/3982/415).*

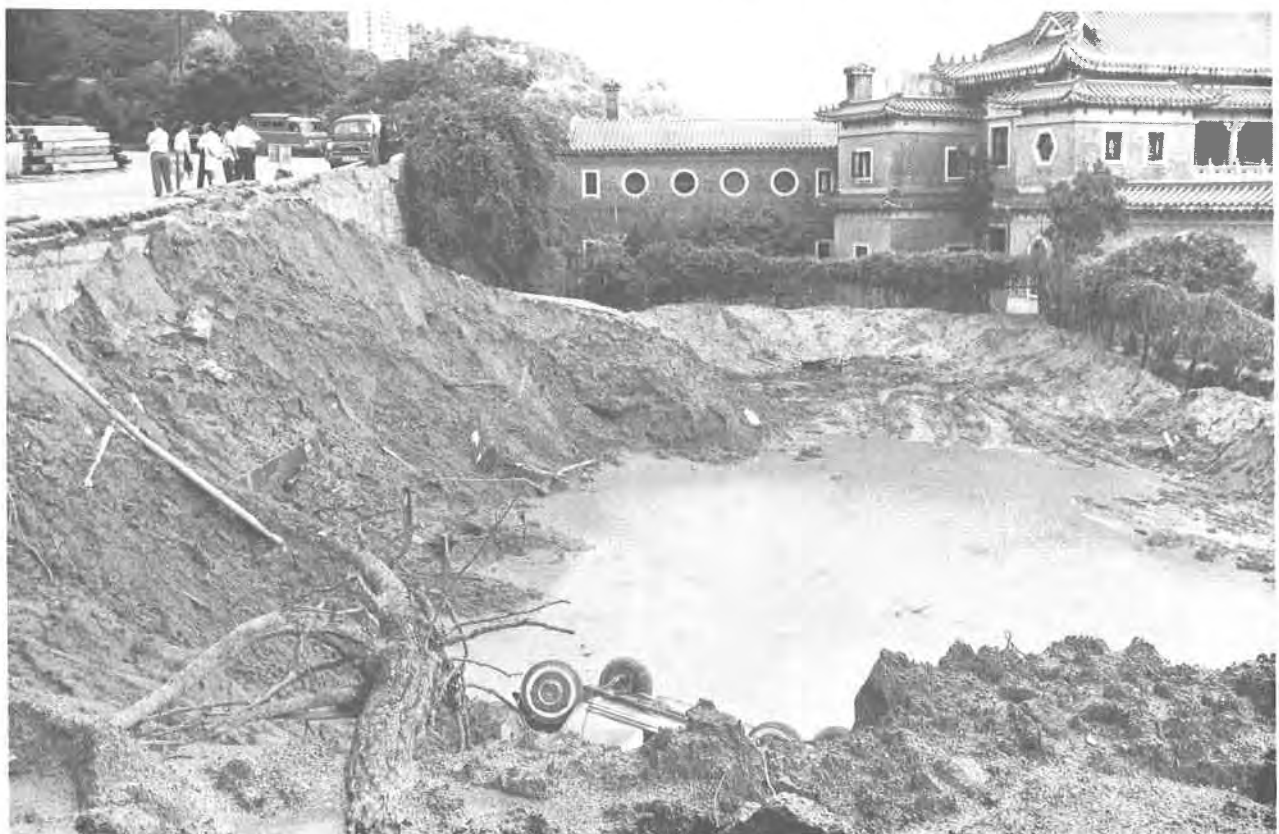
**Plate 85.** *Landslip Debris in Garden below Victoria Heights in 1966. (Reproduced from Chen (1969), ISD/3982/449).*

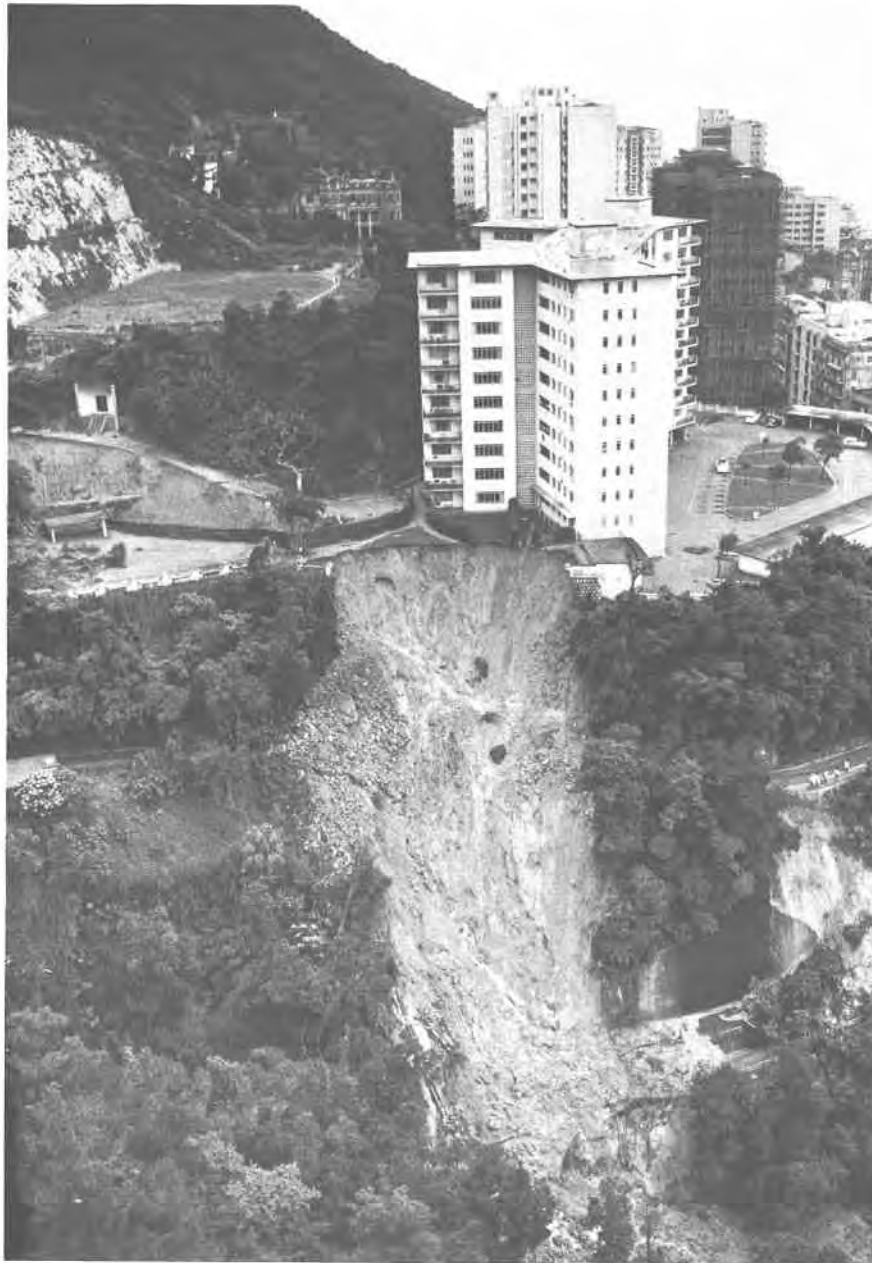
*Plate 86. Landslip near Chater Hall in 1966. A section of May Road (Hornsey Road) was destroyed by this landslide, Plate 87 reveals the effects of the debris on the downslope terrain. A newspaper report at the time noted that the residents of Chater Hall were being accommodated at the Mandarin and Hilton Hotels 'at special rates'. (Reproduced from Chen (1969), ISD/3982/8).*

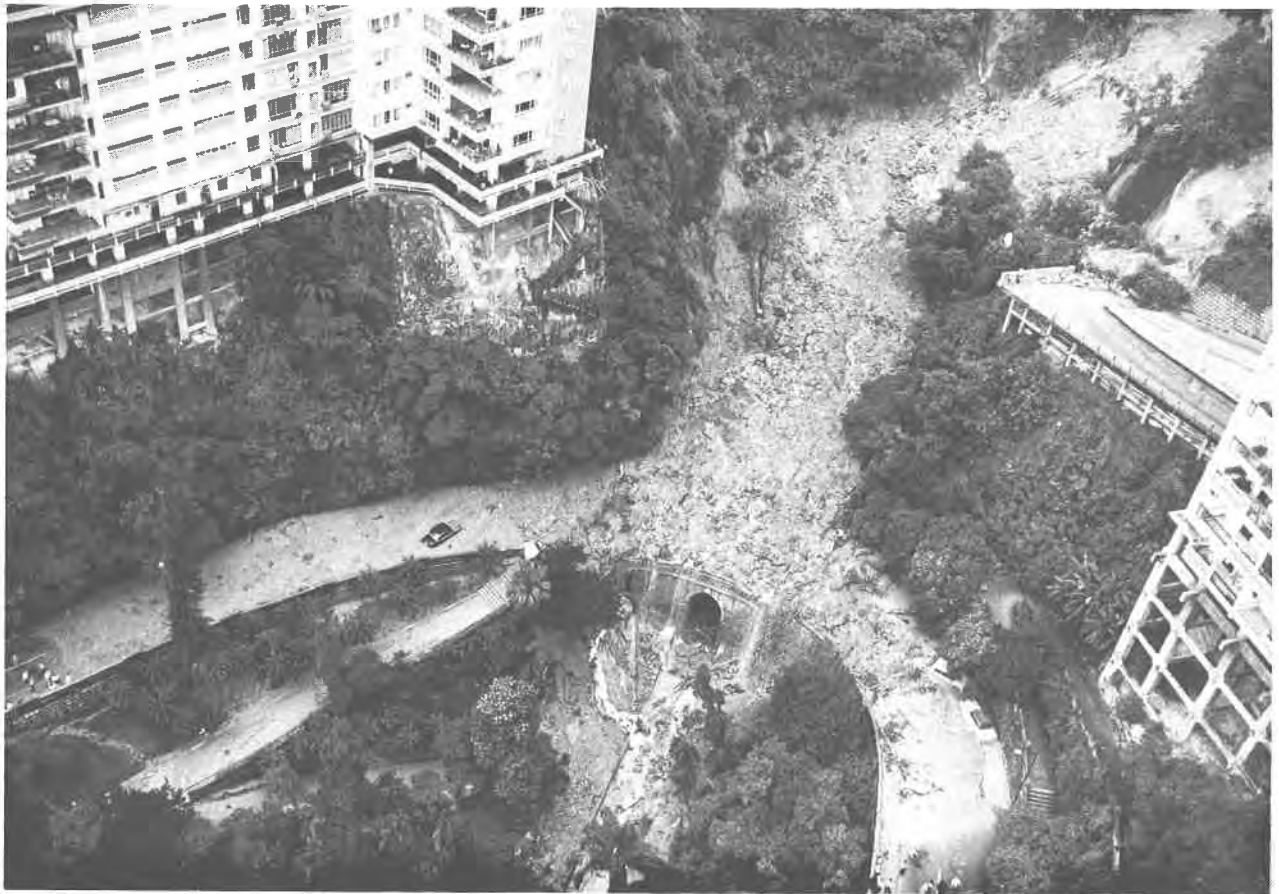
*Plate 87. Landslip on Robinson Road in the Upper Glenealy Area in 1966. This was the result of the landslide near Chater Hall shown in Plate 86. (Reproduced from Chen (1969), ISD/3982/320).*

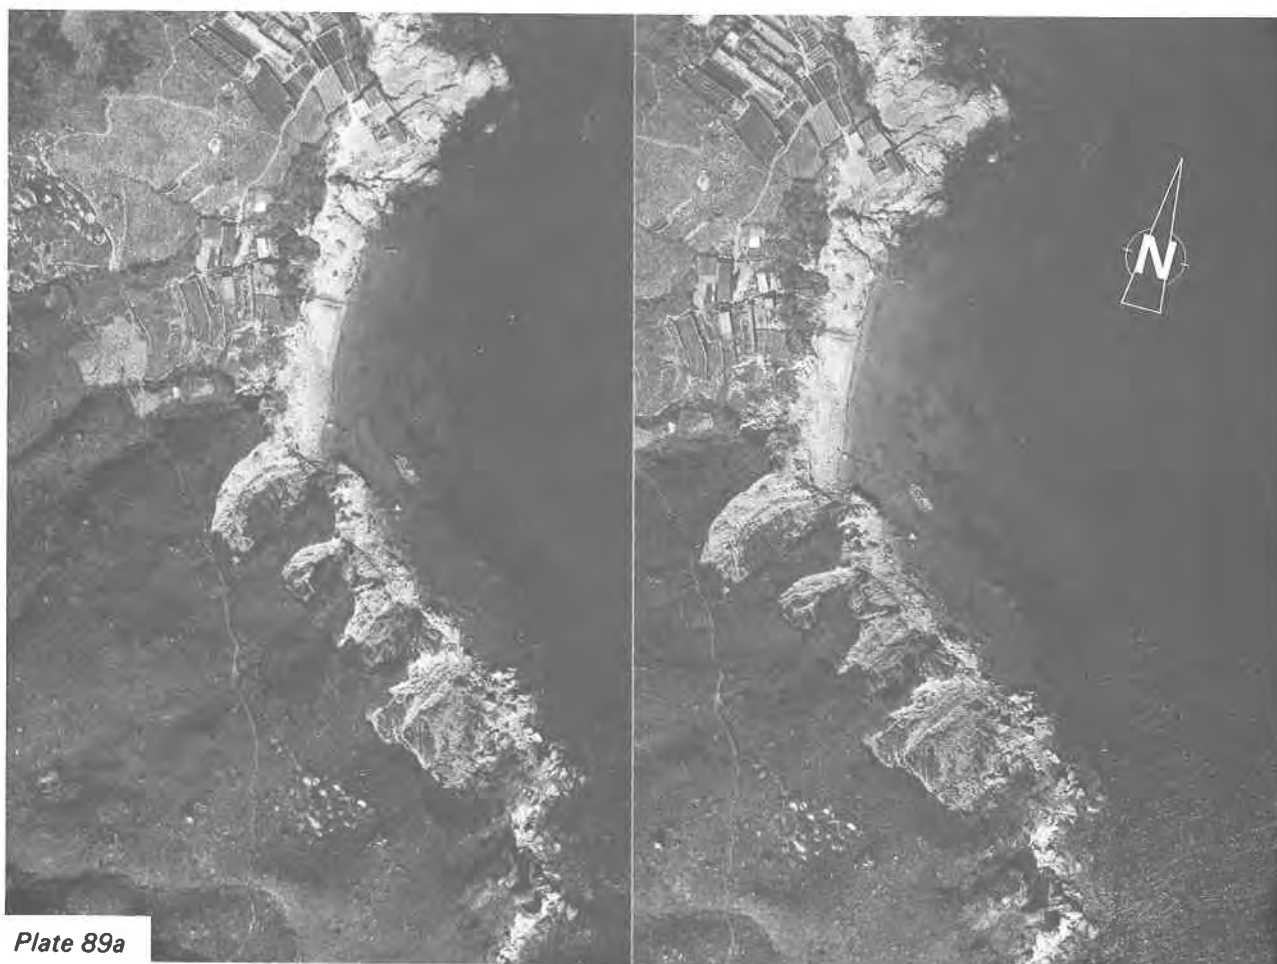
**Plate 88.** *Enlargements of Aerial Photographs of Landslips at Ap Lei Chau in 1963 and 1969.* Plate 88a, taken in 1963, is an enlargement of part of the stereopair at Plate 89a. Three areas of instability are evident at A, B and C. Area B appears to consist of two landslips (E and F) which are joined by an upslope tension crack to form a larger area of mass movement. Plate 88b, taken in 1969, is an enlargement of part of the stereopair at Plate 89b. The landslips evident on the coastal terrain in 1963 have clearly worsened by 1969. The areas of instability at A and B have enlarged quite dramatically with considerable upslope progression. The lower portions of landslips E and F have merged. The approximate extent of the failures in 1969 is shown by the dashed line in Plate 88a. (1963/7497 and 1969/1730).

Plate 89. *Stereopairs of Aerial Photographs of Landslips at Ap Lei Chau in 1963 and 1969.* Plate 89a in 1963, shows the extent of landslips on the coastal terrain, Plate 89b in 1969, reveals that the landslips have increased in size. Plate 88 presents enlargements of the area and highlights the change in extent of the unstable area during the intervening 6 years. (1963/7497-98 and 1969/1729-30).

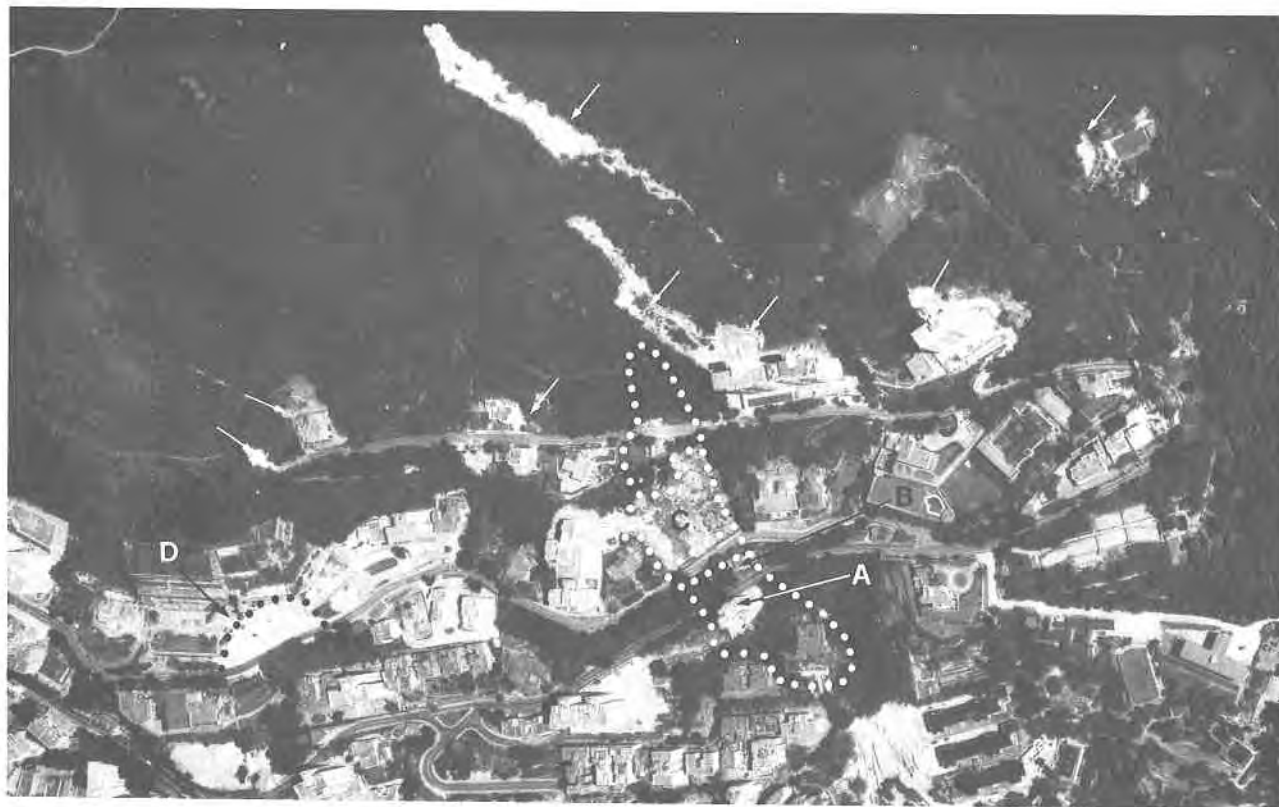
*Plate 93. Enlargement of Aerial Photograph of Landslips in the Mid-levels Area in 1967. The major landslips are arrowed. The general extent of the Po Shan Road landslip in 1972 (Plates 94 to 100) is shown, and the location of Kotewall Court is indicated at A, and the house at 11 Kotewall Road at B. Both these structures were destroyed during the major Po Shan Landslip at about 9.00 p.m. on 18.6.1972. A large cut platform is evident at C, and seepage is also apparent across the platform. Remedial measures appear to be underway on the site of the retaining wall failure in 1966 (D), which is shown in Plate 73. This Plate accompanies Plate 92. (1967/5606).*
