Geotechnical Area  
Studies Programme

GASP Report XII

# Territory of Hong Kong

Geotechnical Control Office  
Civil Engineering Services Department  
Hong Kong

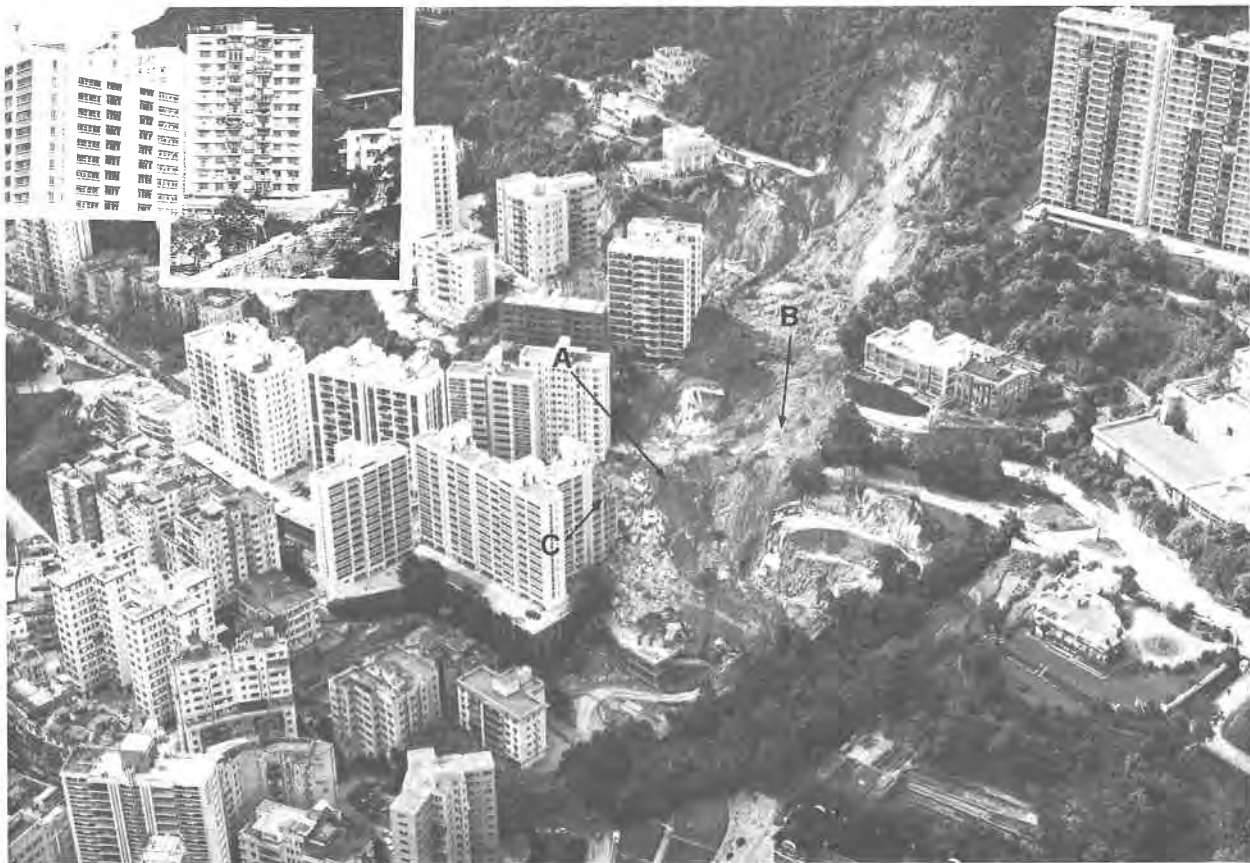
**Plate 94.** *Oblique Aerial Photograph of the Po Shan Road Landslip in the Mid-levels Area in 1972.* On 18.6.1972, a large landslide occurred in the Mid-levels of Hong Kong Island. A multistorey residential building (Kotewall Court) collapsed during the failure. There were 67 fatalities and twenty injuries in this incident. The landslide occurred between 8.50 and 8.55 p.m., after three days of abnormally heavy rainfall. Part of the hillside above a cut slope failed and the debris descended across Conduit Road, and then to Kotewall Road. A witness indicated that the major landslide took only seven to ten seconds (Government of Hong Kong, 1972b). This landslide also destroyed a four-storey house which was evacuated following slope movement some 4 hours before the major landslide. The location of Kotewall Court and the House are shown at A and B respectively, and on Plate 93. Damage to the upper stories of Greenview Gardens is evident at C. Kotewall Court collapsed onto Greenview Gardens, which was unoccupied at the time. The top of the landslide was at an elevation of approximately 230m and the toe of the debris reached 110 m, a vertical fall of some 120 m (Lo, 1978). The horizontal distance was approximately 255 m. (21.6.1972/ISD/8264/5). The inset in the top left hand corner shows Kotewall Court and the House at 11 Kotewall Road before the disaster. The actual date of the photograph is unknown, but it is likely that this photograph was taken only a matter of weeks before the failure. Scaffolding is evident on Greenview Gardens. (6729/72).

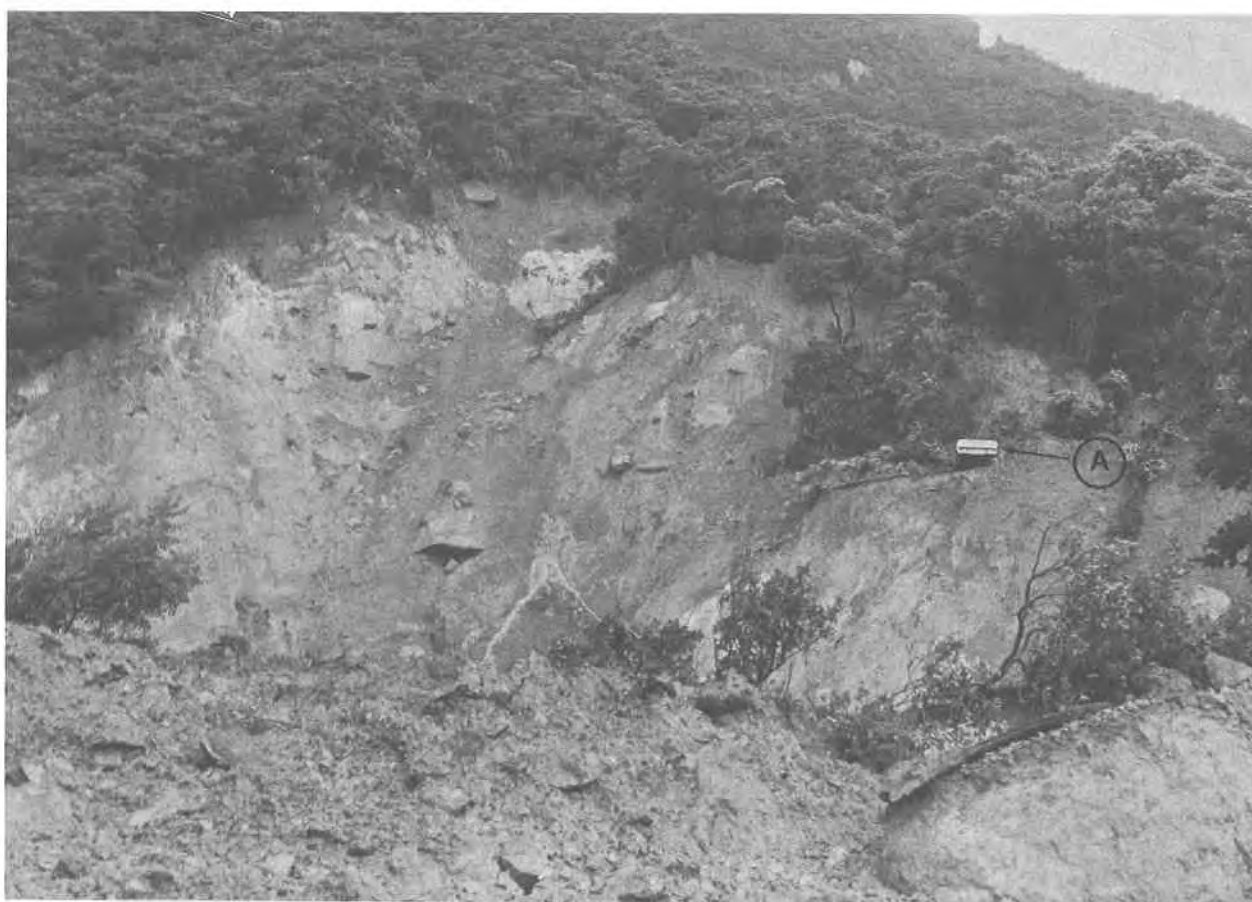
*Plate 95. Backscar of the Po Shan Road Landslip in 1972. Part of a vehicle is evident (A). This vehicle was probably parked on Po Shan Road at the time of the landslip, but has come to rest some 5m below the level of the road. (19.6.1972/ISD/8257/1).*

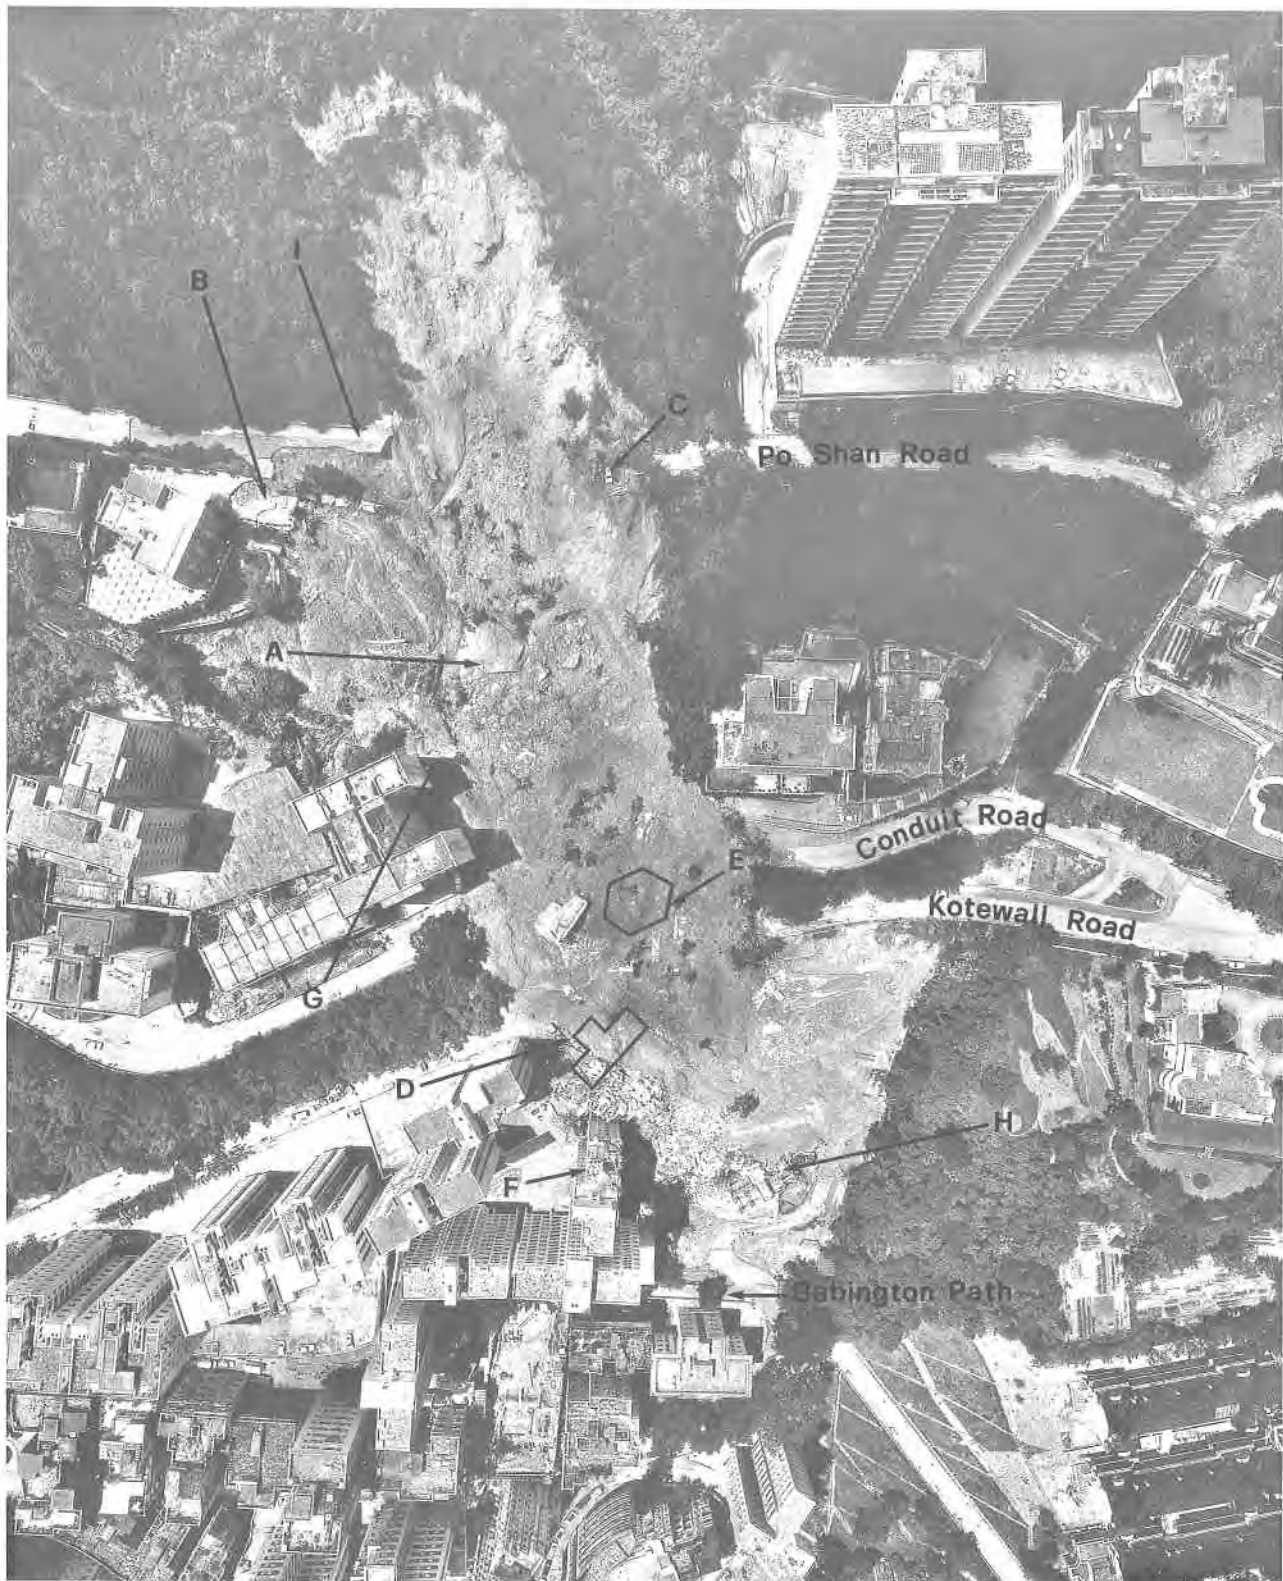
**Plate 96.** *Large Scale Aerial Photograph of the Po Shan Road Landslip in 1972.* Note the large block of rock, probably of volcanic origin at (A), the failure of the lawn and garage at 21 Po Shan Road (B), the vehicle below Po Shan Road (C), the location of Kotewall Court (D), the location of the four storey private dwelling at 11 Kotewall Road (E), the damaged portion of Greenview Gardens (F), debris around Skyline Mansions (G), and the debris around a structure under construction (H). The residents of 11 Kotewall Road (E) were evacuated following a landslip at about 5.00 p.m. on 18.6.1972, some 4 hours before the major failure. The building was apparently buried up to the 2nd Floor by landslip debris after the 5.00 p.m. failure, and the occupants escaped without injury. (Government of Hong Kong, 1972b). The boulder on Po Shan Road referred to in Plate 99 is at I. (20.6.1972/1650).

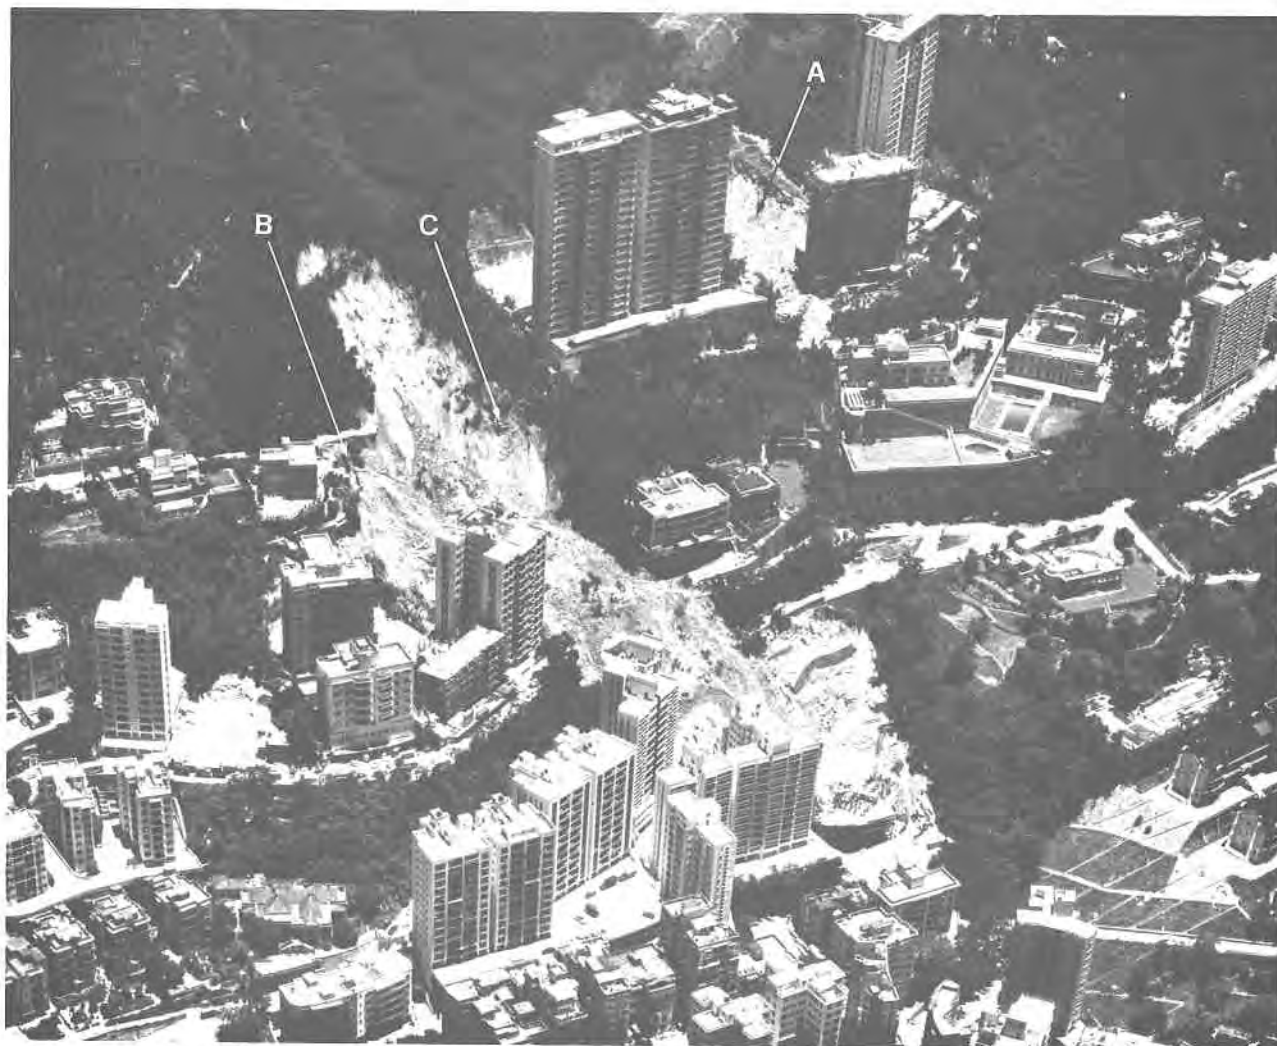
*Plate 97. Oblique Aerial Photograph of the Po Shan Road Landslip Site in 1972.* The plate provides a perspective of the disaster site from the northeast, some 6 days after the landslide. Note the large landslide behind the partially constructed Hamilton Court (A); the lawn and garage area at 21 Po Shan Road have collapsed (B); compare this with the photographs in Plate 94. The vehicle is still evident (C). The landslide on the slope behind Hamilton Court occurred on the morning of 16.6.1972, some 2 days before the major incident and blocked Po Shan Road (Government of Hong Kong, 1972b). (24.6.1972/1805).

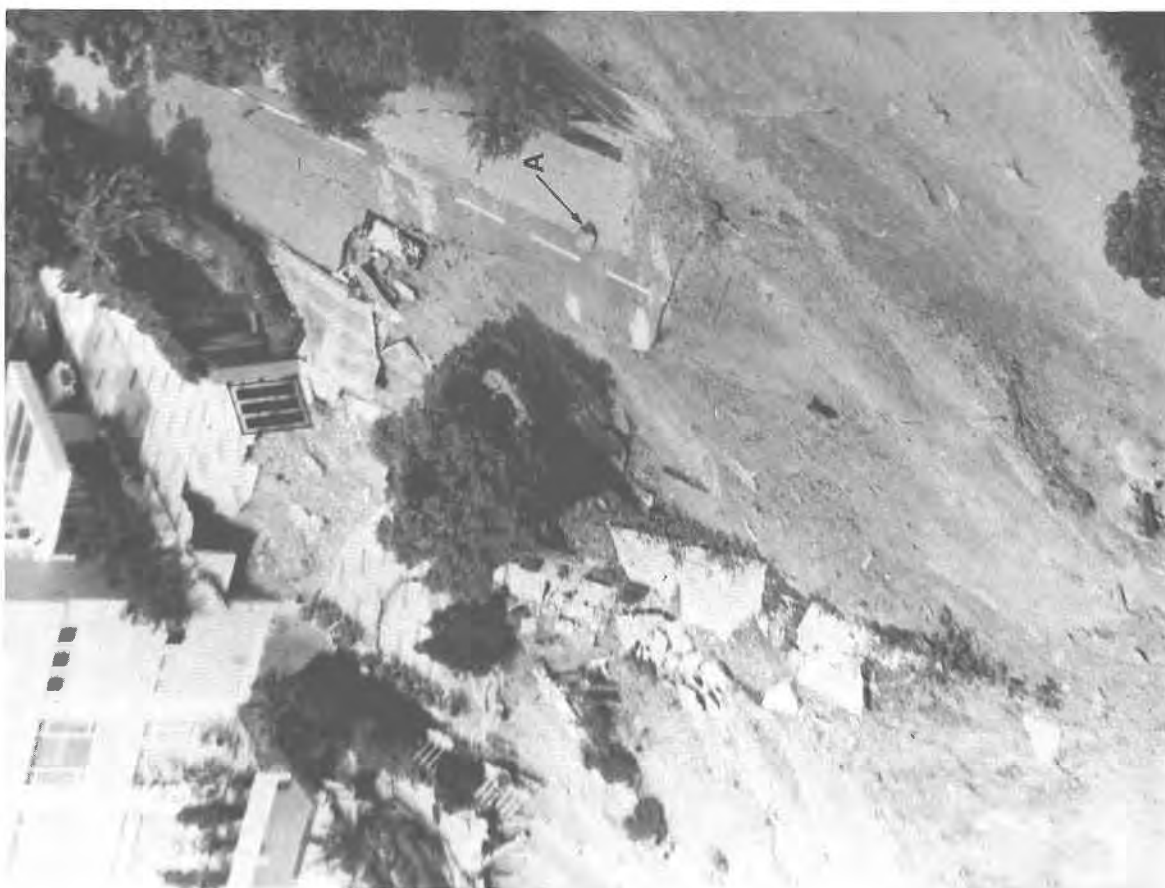
**Plate 99.**

**Damage to Lawn and Garage Area at 21 Po Shan Road in 1972.**  
The boulder at A is evident in Plates 96 and 98. This photograph, probably taken on 26.6.72, highlights the damage caused on the eastern side of the Po Shan Road Landslip. (ISD 8371/7)

This photograph records the major distress evident on Po Shan Road prior to the Po Shan Road landslip on the evening of 18.6.1972. Apparently, cracks had developed in the middle of the carriageway between 8 & 21 Po Shan Road by noon on 16.6.1972 (Government of Hong Kong, 1972b). This photograph was probably taken after the partial failure of the cut slope of IL 2260, at about 10 a.m. on 17.6.1972. This resulted in the settlement, by approximately 2m, of half of the carriageway, and the garage and adjoining garden terrace of 21 Po Shan Road. The residents of the house were advised to evacuate on the 17.6.1972. Further settlement of this area probably occurred during the evening of the 17.6.1972 (Government of Hong Kong, 1972b). Compare this with Plate 99 taken sometime after the major landslip. (ISD/8371/1)

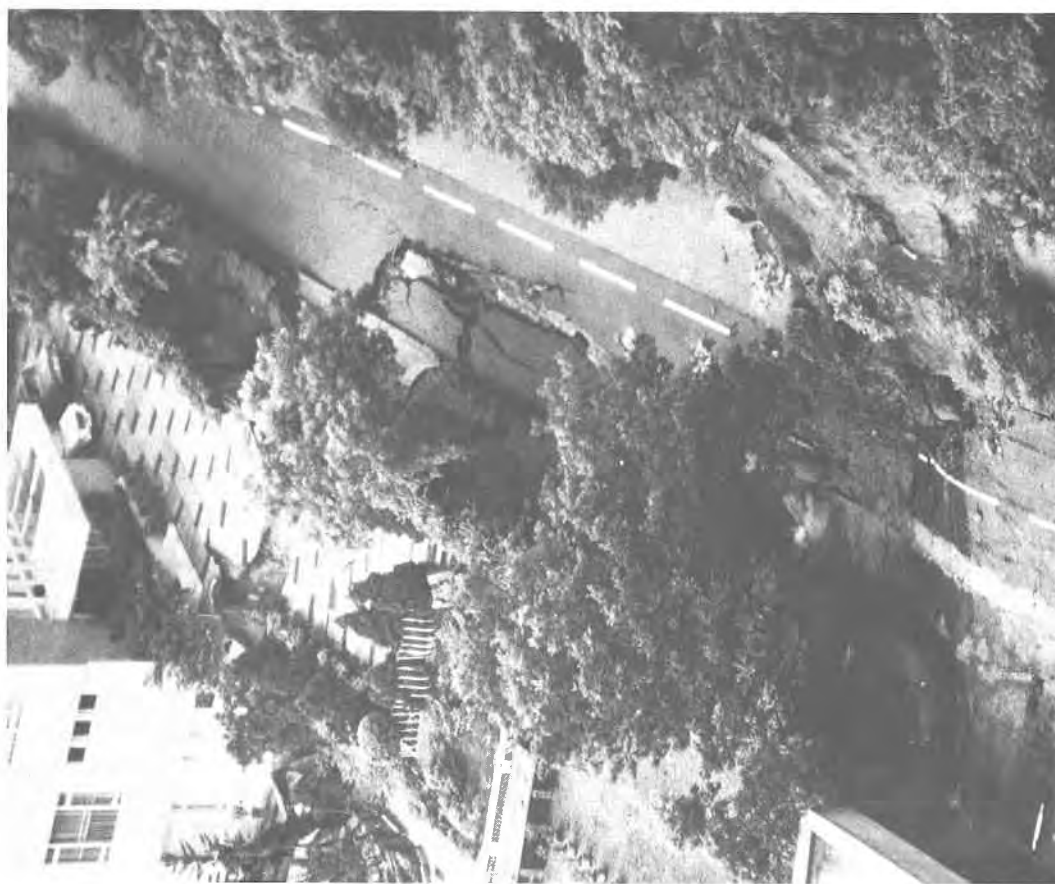
**Plate 100. Distress Evident on the Lawn and Garage Area of 21 Po Shan Road prior to the Landslip in 1972.**

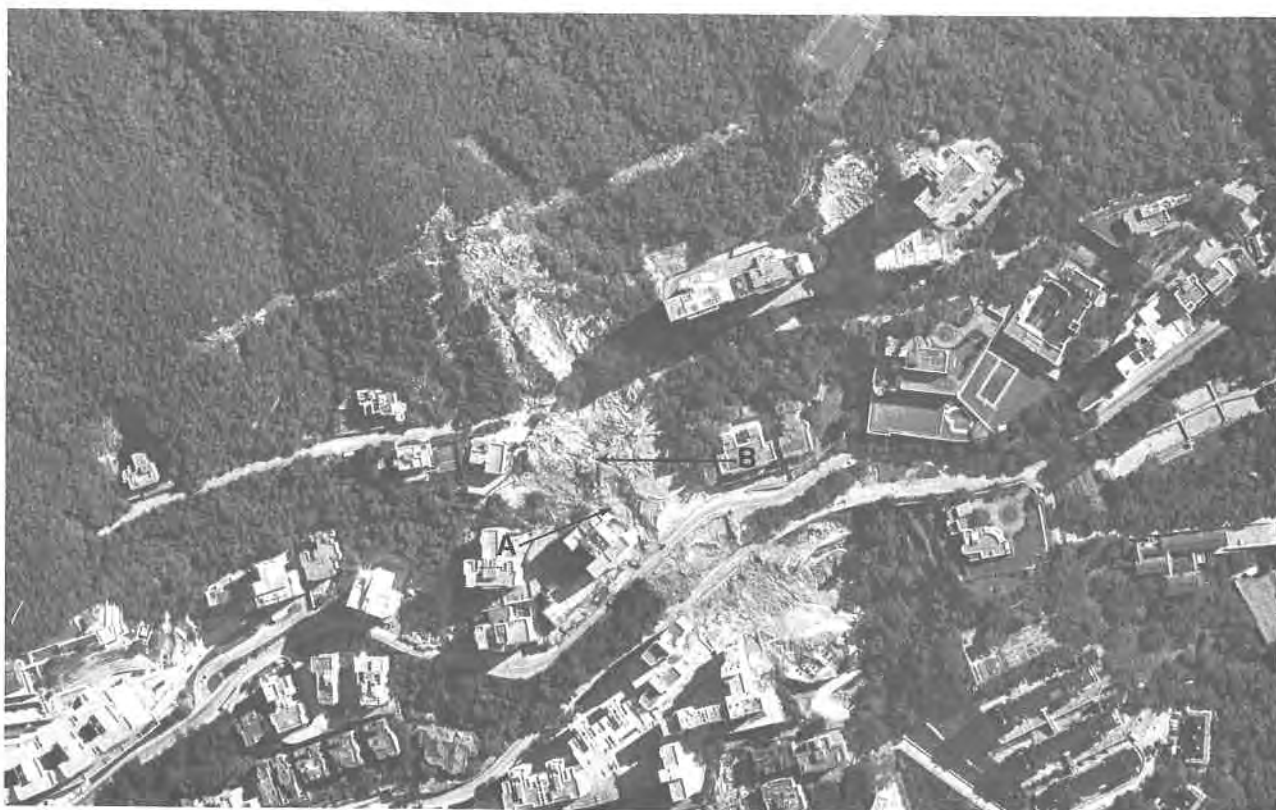
**Plate 102.** *Site of the Po Shan Road Landslip in October 1972.* This plate shows the state of remedial works to the site some 3.5 months after the landslip. Access has been cleared across Conduit and Kotewall Roads. Clearing operations are still being carried out, and preliminary slope works appear to be underway. Debris has been removed from around Skyline Mansions (A), and the large boulder evident at A in Plate 96 has been removed (B). (3.10.1972/2303).

**Plate 103.** *Stereopair of Aerial Photographs of the Po Shan Road Landslip Site in October 1972.* This Plate accompanies Plate 102. (3.10.1972/2303-4).

**Plate 104.** *Oblique Aerial Photograph of the Po Shan Road Landslip Site in November 1972.* This photograph was taken some 9.5 months after the failure; compare this with Plates 102 and 103. An access track to the upper portions of the landslide scar is apparent, and clearance work has progressed on the lower slopes. The damage to the upper storeys of Greenview Gardens (Plates 94 and 96) appears to have been repaired (A). (3.11.1972/2363).

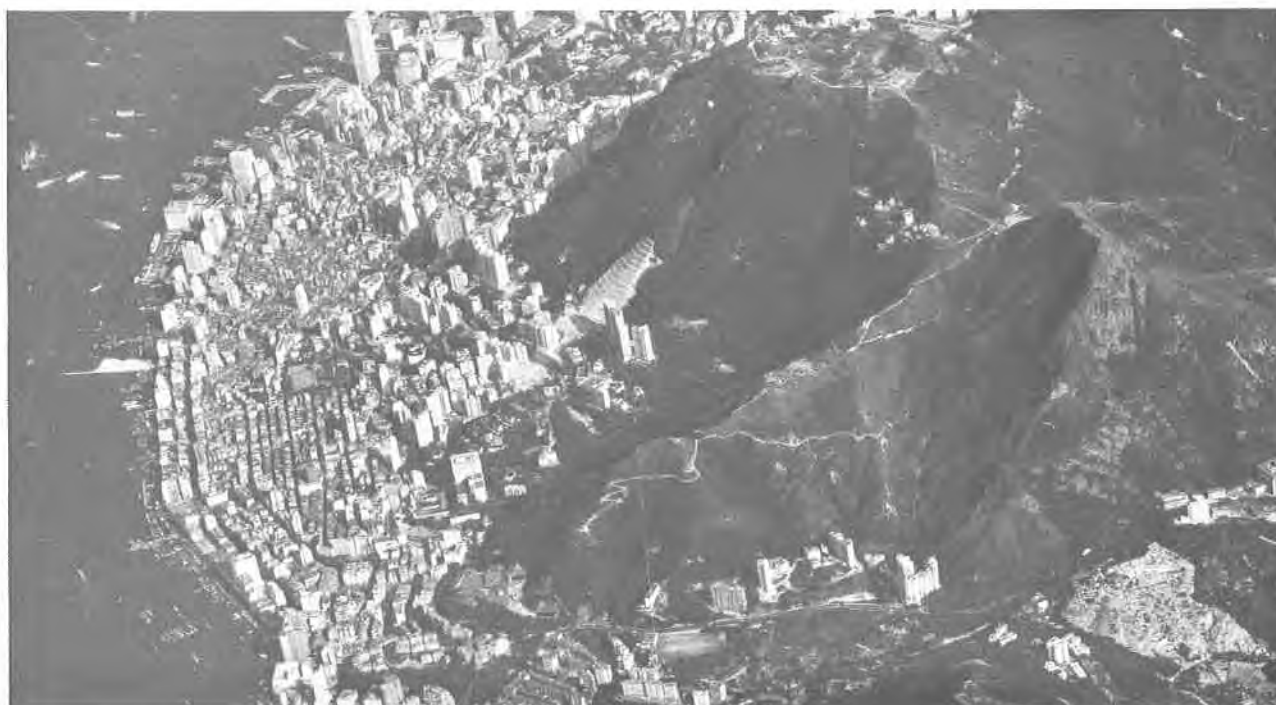
**Plate 105.** *Oblique Aerial Photograph of Remedial Works to the Po Shan Road Landslip Site in October 1973.* Reinstatement of the middle to upper portions of the landslide scar above Po Shan Road is clearly visible. Much of the slope is grassed, and surface drainage has been installed. Po Shan Road has been reinstated. (24.10.1973/5466).

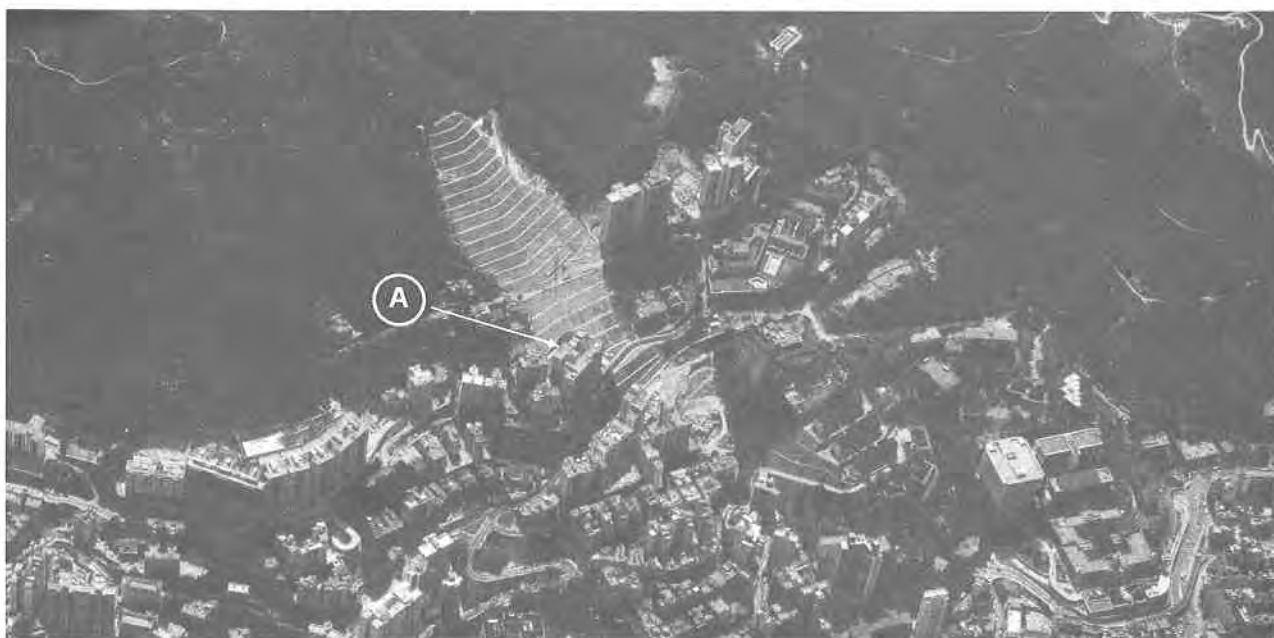
**Plate 106.** *Oblique Aerial Photograph of Remedial Works to the Po Shan Road Landslip Site in February 1974.* Reinstatement appears to be complete, with a large retaining wall behind Skyline Mansions (A). The new alignment of Conduit Road has been completed. Plate 117 shows the area in 1980. (28.2.1974/8264).

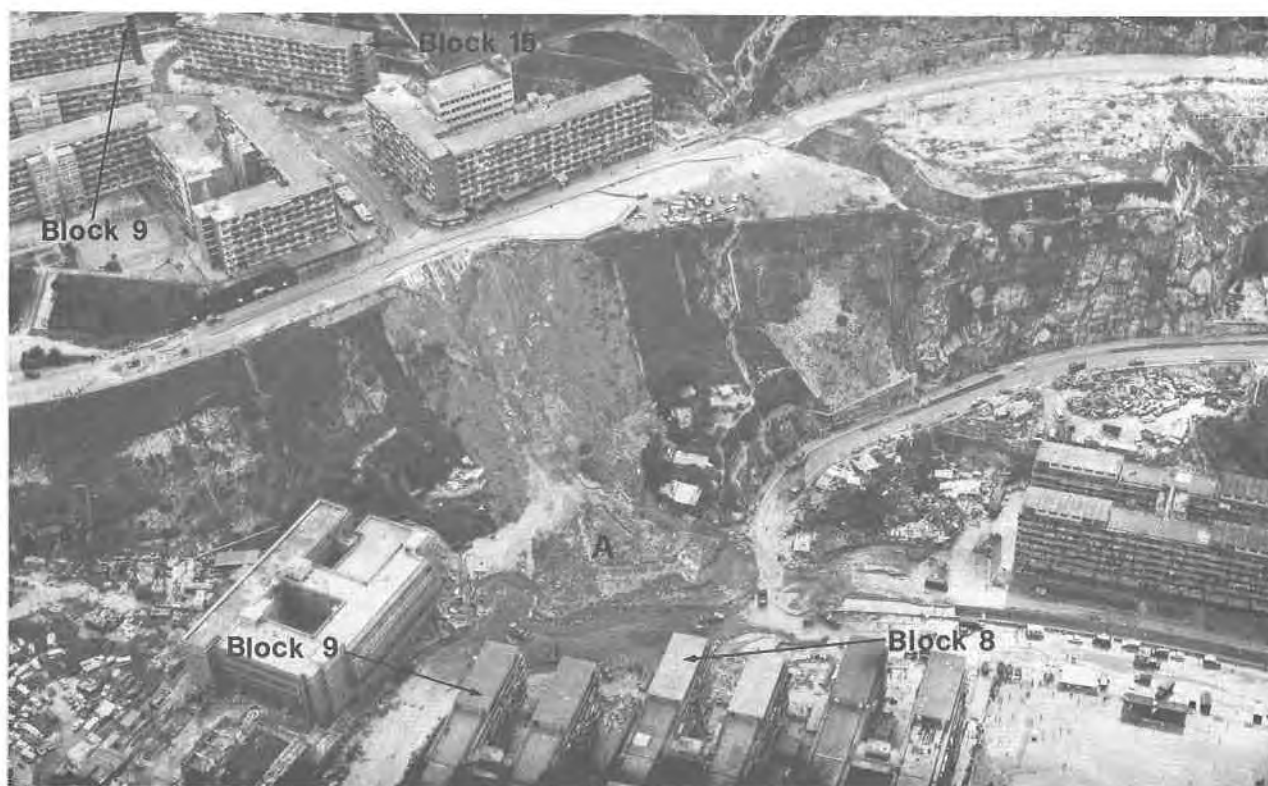
**Plate 107.** *Oblique Aerial Photograph of Sau Mau Ping Landslip Site in 1972.* On the afternoon of 18.6.1972, between 1.10 and 1.24 p.m., a massive landslide occurred on a fill slope between Hiu Kwong Street and Tsui Ping Road in Sau Mau Ping, Kowloon. This landslide followed some 6 weeks of continuous rainfall, culminating in 3 days of intense rain. The Royal Observatory recorded a total rainfall of 652.3 mm during the period 16–18.6.1972. This shallow failure took the form of a high velocity flowslide, and was probably due to 'liquefaction' caused by the super-saturation of uncompacted fill material. A large number of huts (A) were buried by mud, with 71 killed and 60 injured. The locations of Blocks 9 and 15 affected by landslips in 1976 are also shown. Compare this with Plate 111. Plates 108 and 109 provide further coverage of the 1972 failure. (ISD/21.6.1972/8264/11).

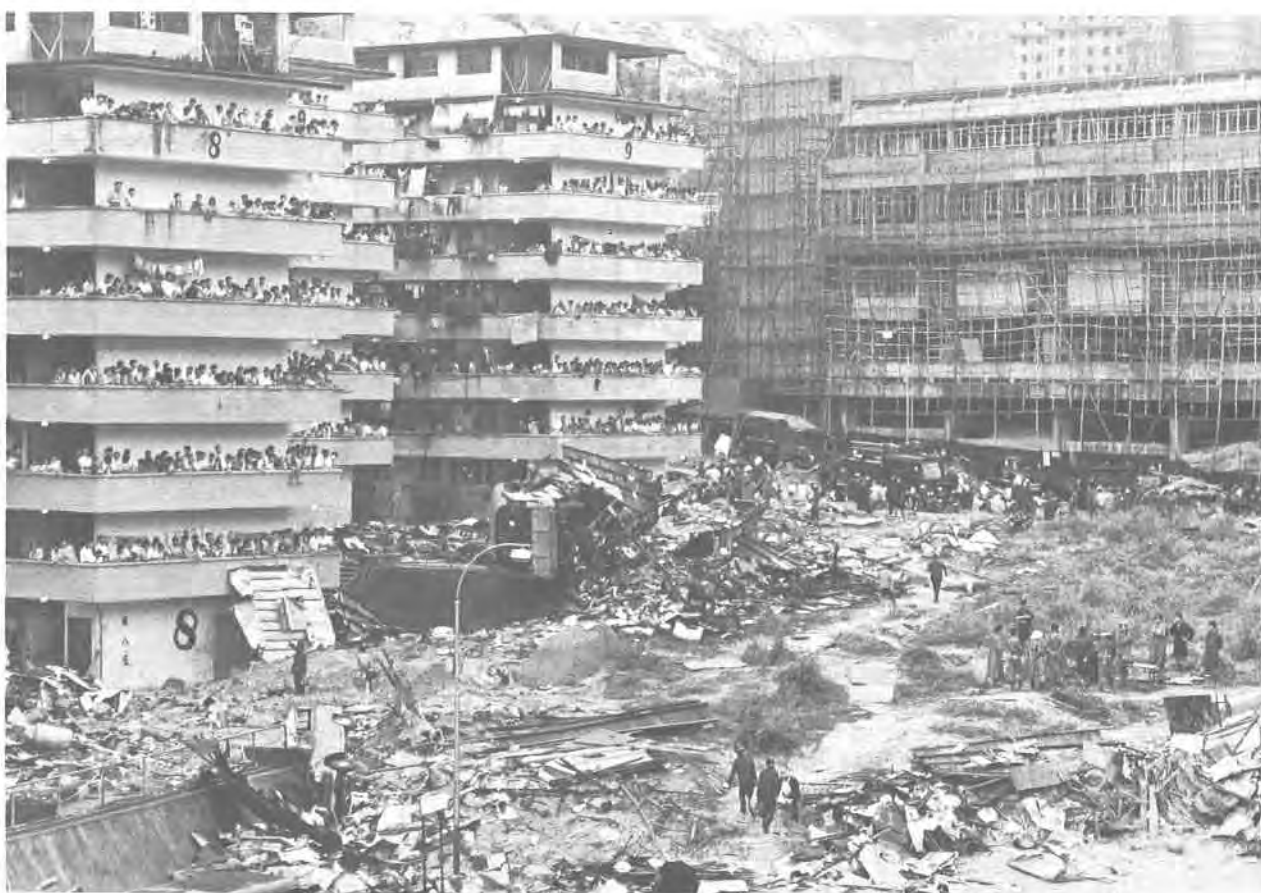
*Plate 108. Landslip Debris at Sau Mau Ping in 1972. Debris is evident near Blocks 8 and 9 in Tsui Ping Road on 18.6.1972. The debris blocked Tsui Ping Road and Hui Ming Street. (ISD/18.6.1972/8255/32).*

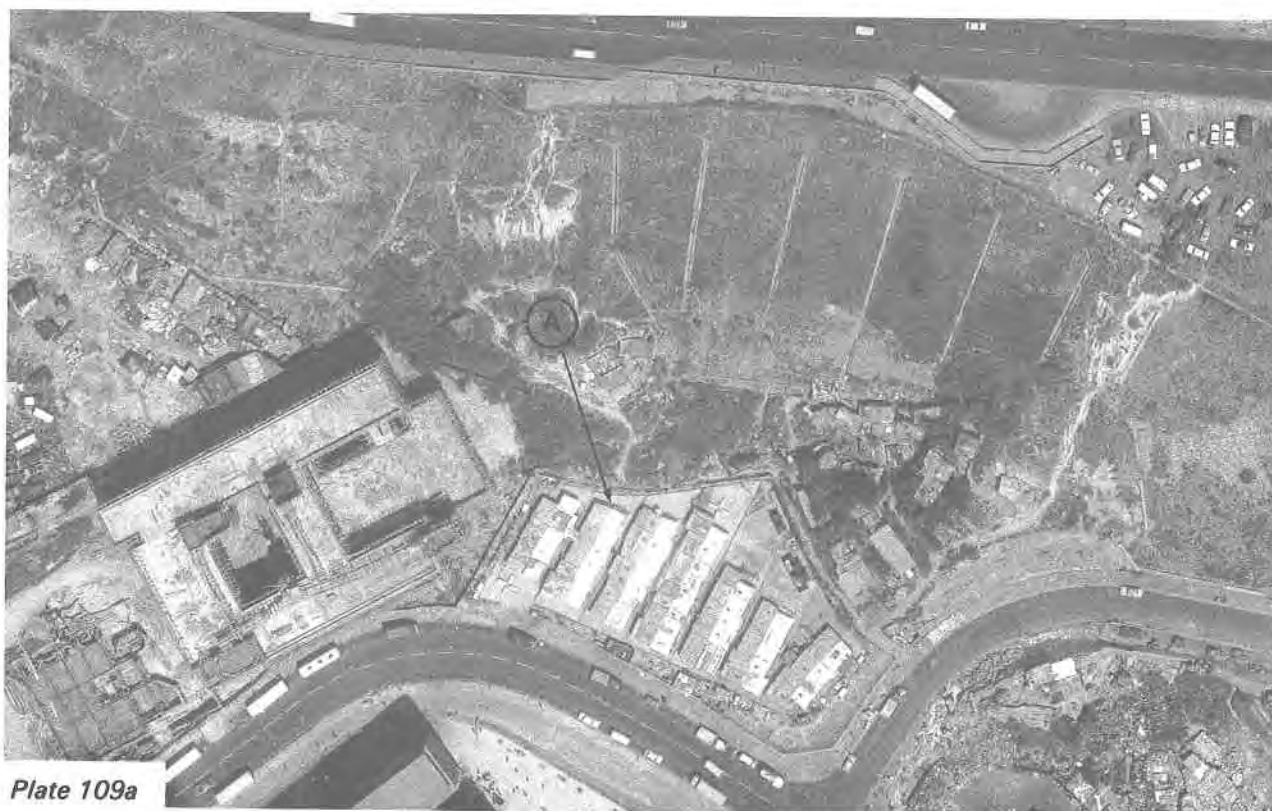
Plate 109. *Comparison of the Sau Mau Ping Area before and after the 1972 Landslip.* Plate 109a shows the location of the Licensed Housing Area (A) near Tsui Ping Road prior to the landslide on 18.6.1972. Plate 109b, taken following the failure, shows the extent of damage. All the huts in the Licensed Area were destroyed. Compare this with Plate 107, which presents a view of the disaster scene 3 days after the landslide. Plate 115 shows the 1976 landslips and the remedial works to the 1972 landslide. (1972/30 & 31).

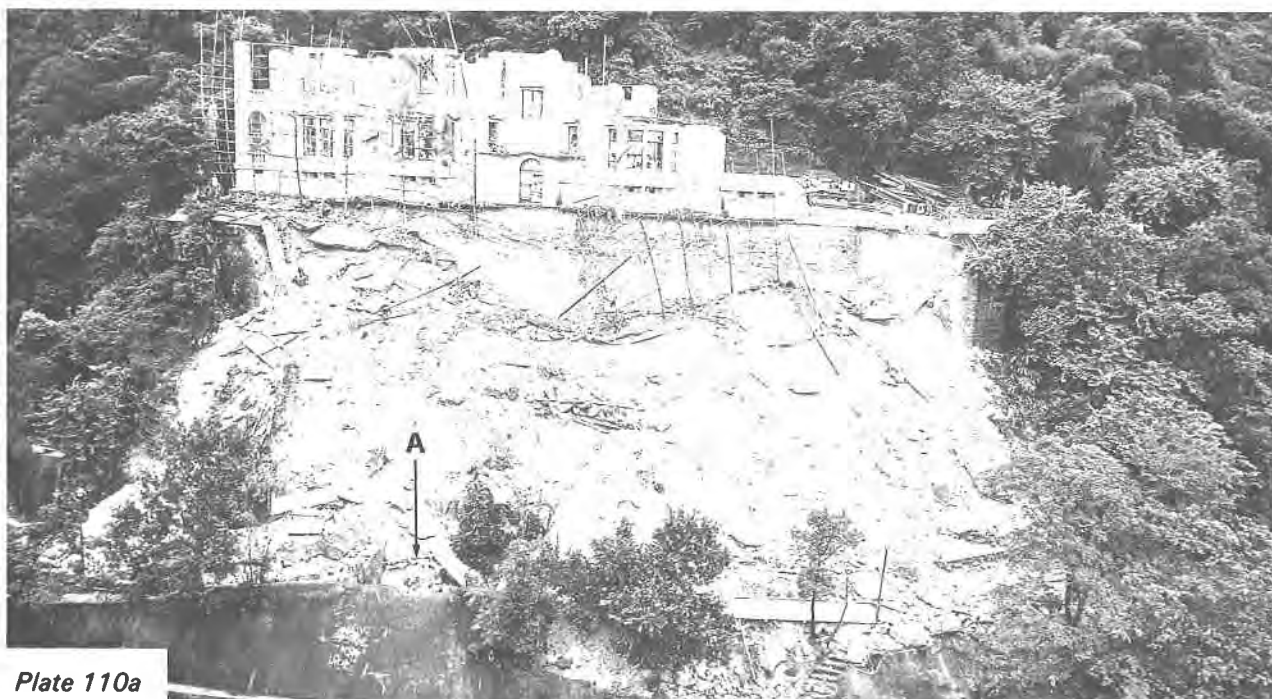
**Plate 110a**

**Plate 110.** *Landslip at Thorpe Manor in 1973.* A retaining wall and fill slope in front of 1 May Road (Thorpe Manor) failed on 2.9.1973, following an intense rainstorm. According to newspaper reports at the time, there were two failures during the 30 minute period between 2.00 and 2.30 p.m. The Director of Public Works and the Principal Government Building Surveyor witnessed the second of the failures. Plate 110a shows the extent of the failure and the effect on the grounds of Thorpe Manor, whilst Plate 110b shows its dramatic position above a high-rise residential block. This failure, which occurred only a little over a year after the Po Shan (Kotewall) Road landslide disaster, received headline coverage in the daily press. At the time of the incident, Thorpe Manor was under demolition and collapsed scaffolding is evident on parts of the site. Debris from the failure severed May Road (located at A) and extended down a 40–50m cut slope onto the platform behind Grenville House. There were no injuries, but some 40 flats on the lower floors of this 12-storey residential block were evacuated for a period of several weeks. (ISD/OA/98/1973 and ISD/16A/98/1973).

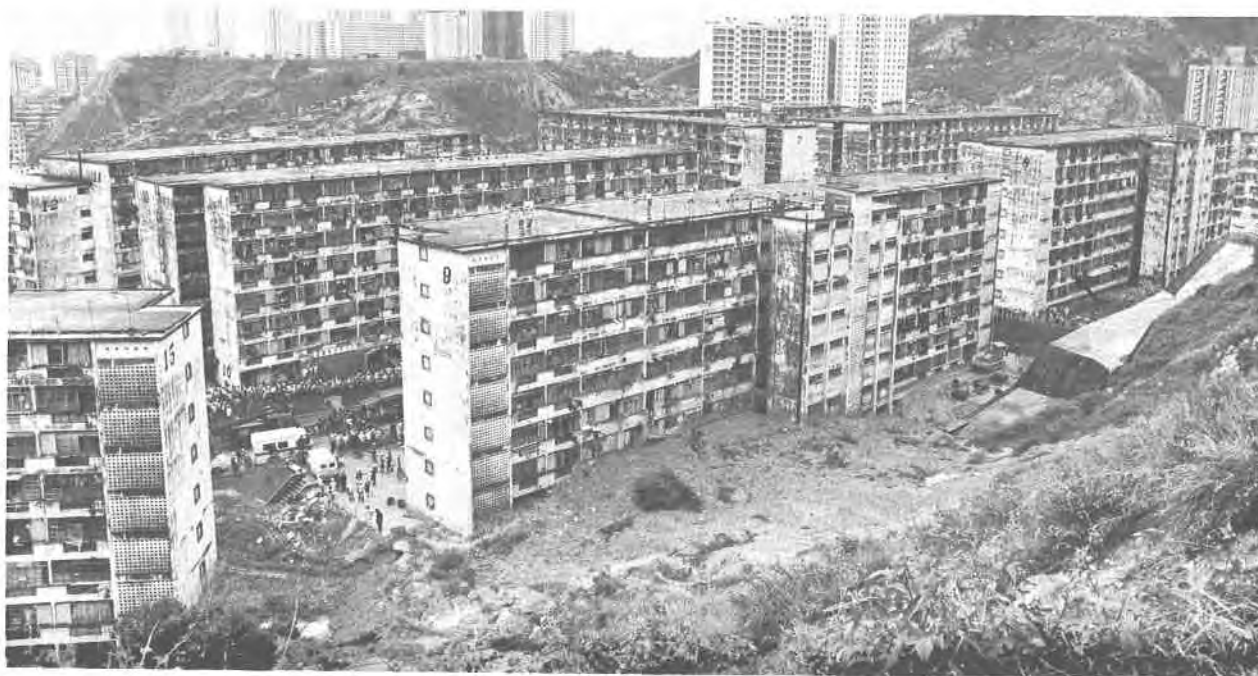
**Plate 111. Landslip at Sau Mau Ping in 1976.** Some four years after the 1972 landslip (Plates 107 to 109), a further three landslips occurred on the fill slopes above Sau Lai Street. The embankment adjoining Block 9, Sau Mau Ping Estate collapsed at 10.12 a.m. on 25.8.1976. The landslip debris buried most of the ground floor of the residential estate building below the slope. As a result, there were 18 killed and 24 injured. This landslip occurred following intense rainfall on 25–26.8.1976. The Royal Observatory recorded more than 545 mm of rainfall in the 2 day period. The failure was very similar to the 1972 Sau Mau Ping landslip, involving the 'liquefaction' of uncompacted fill. The location of Block 9 in relation to the 1972 landslip is shown in Plate 107. Plates 55 and 56, taken at the time of site formation, provide an interesting comparison with the location of the 1972 and 1976 failures highlighted in Plate 115. (ISD/25.8.1976/ 14949/76).

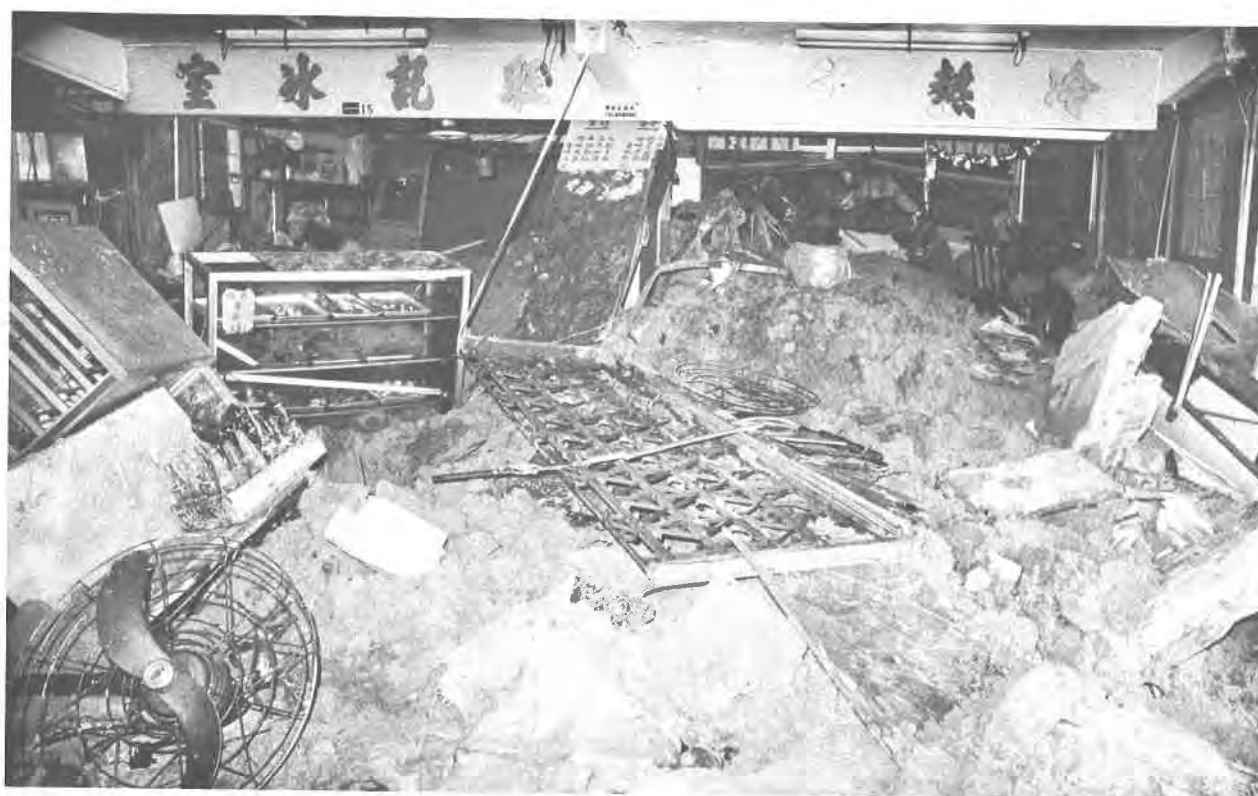
**Plate 112. Damage to a Coffee Shop on the Ground Floor of Block 9 in Sau Mau Ping Estate in 1976.** Mud and debris resulting from the landslip on 25.8.1976 filled this Coffee Shop in Block 9. (ISD/25.8.1976/14949/13).

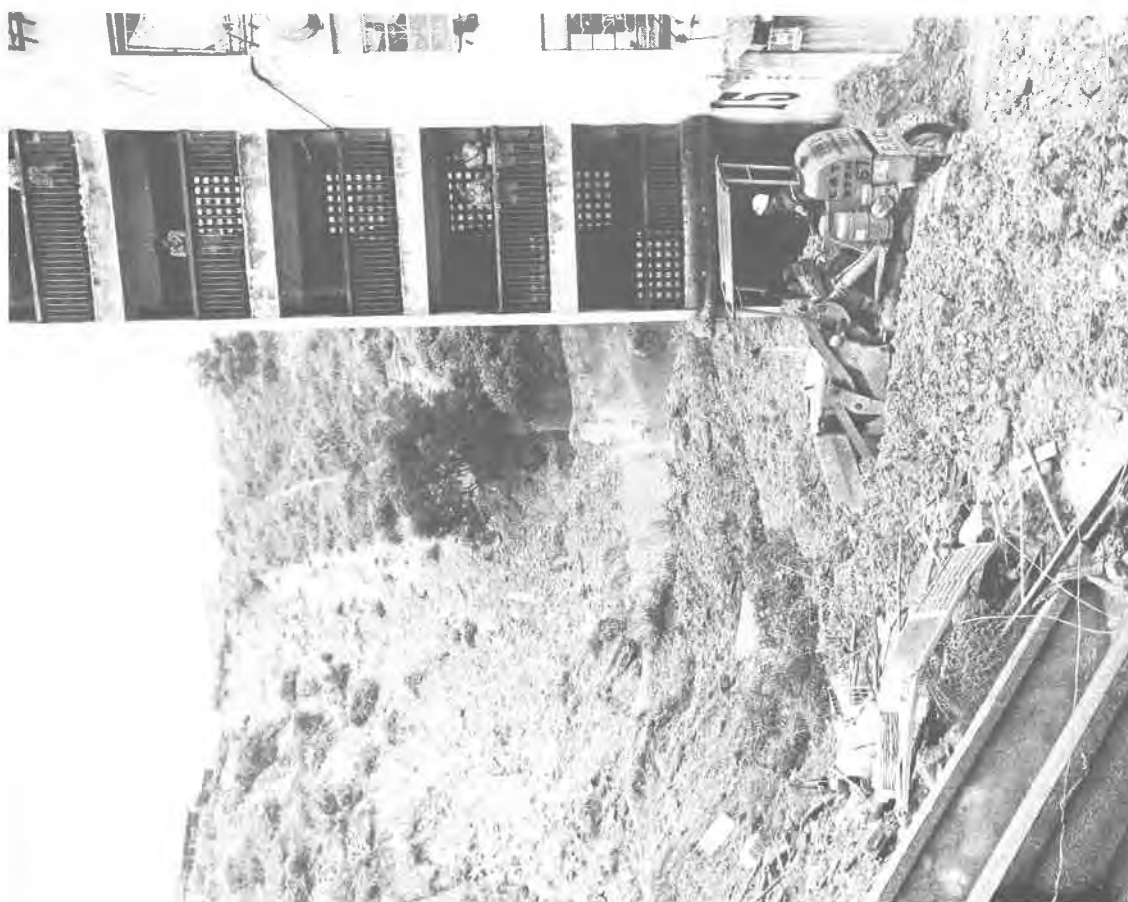
**Plate 114.** Debris near Block 15 in Sau Mau Ping Estate in 1976. Landslip debris is being cleared from the vicinity of Block 15 following the landslip on 25.8.1976. Compare this with Plates 107, 111 and 115. (ISD/25.8.1976/14949/118).

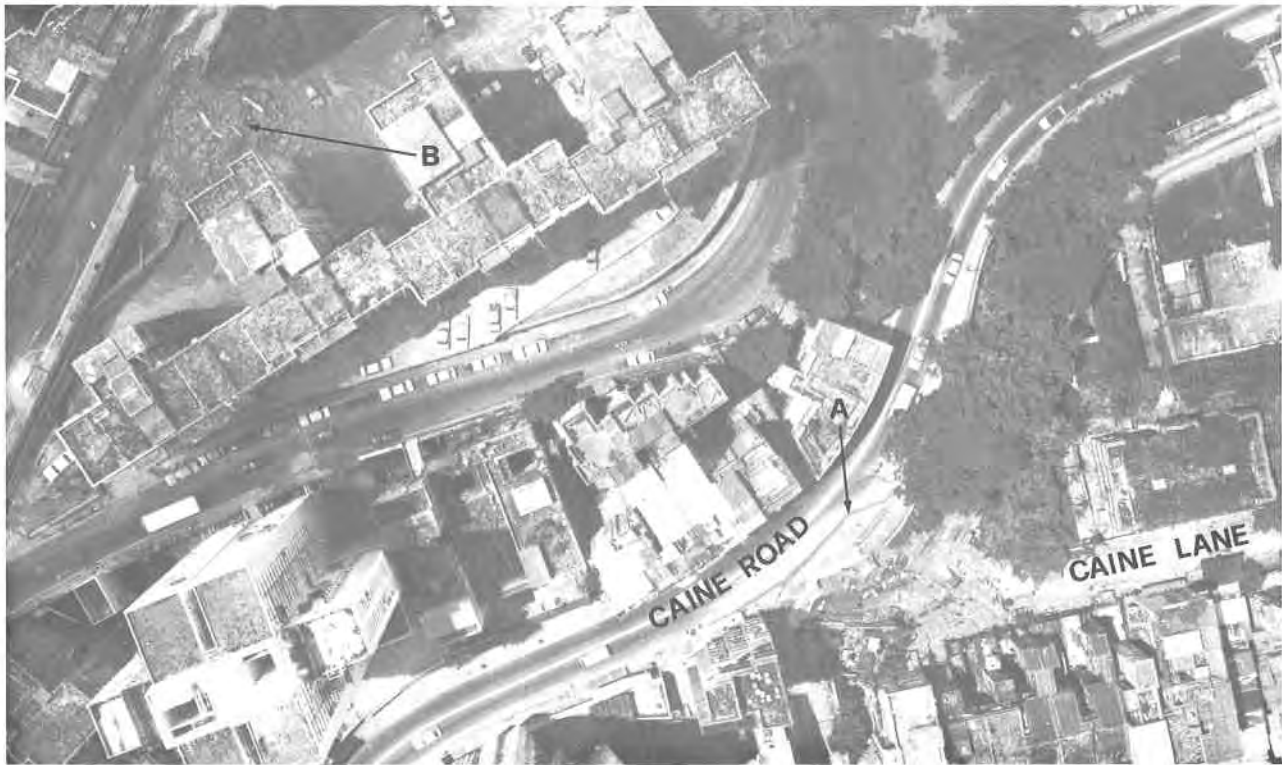
**Plate 116.** *Aerial Photograph of the Caine Lane Retaining Wall Failure in 1976.* The retaining wall between Caine Lane and Caine Road, in the Mid-levels District, collapsed on 25.8.1976. The failure (A) occurred at an elevation of approximately 70mPD. Three old masonry retaining walls supported Caine Road and Caine Lane, the lowest of which failed. Some 400 people were evacuated following this failure. Another retaining wall failure (B) occurred on the same day in Castle Road, collapsing onto the grounds of Merry Terrace. The wall was some 10m high and the failed portion was some 18m in length, at about 95mPD. (26.8.1976/15085).

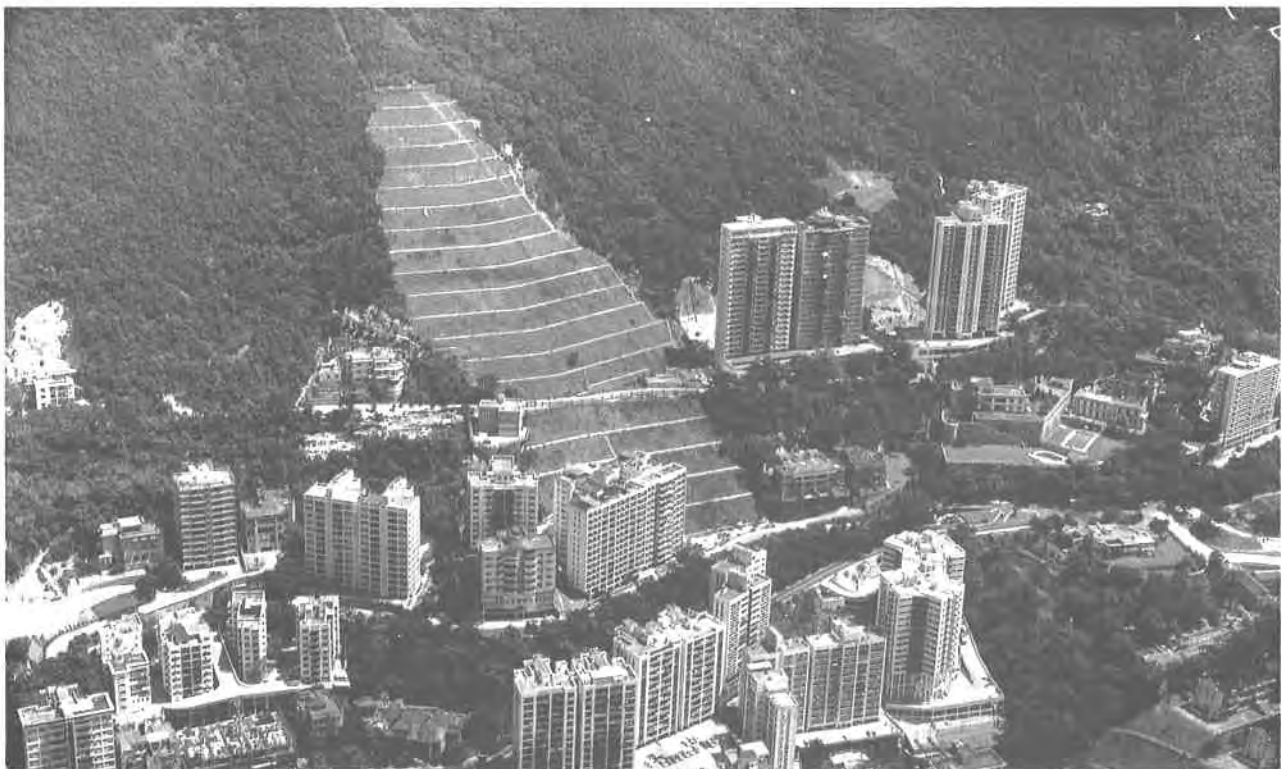
**Plate 117.** *Oblique Aerial Photograph of the Po Shan Road Landslip Site in 1980.* Considerable development has occurred on the adjacent terrain since 1972. Plates 92 to 106 provide a site history during the period before and after the failure. (GCO/OAP/1980/ PS132-9A).
