Geotechnical Area  
Studies Programme

GASP Report XII

# Territory of Hong Kong

Geotechnical Control Office  
Civil Engineering Services Department  
Hong Kong

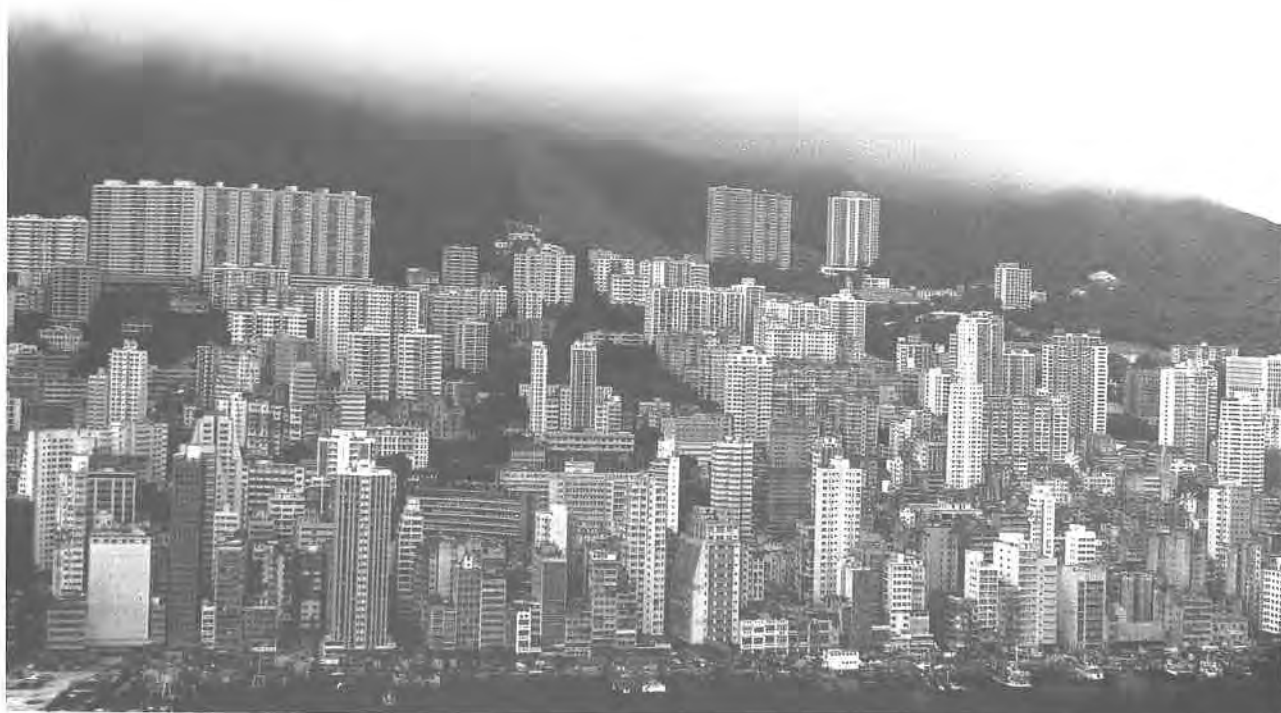
**Plate 118.** *Oblique Aerial Photograph of the Lower to Mid-levels Area of Hong Kong Island in 1979.* The photograph illustrates the intensity of multistorey development within the area. The Moratorium on Building Development, imposed in May 1979, affected much of the mid to upper areas of the developed terrain. The Moratorium restricted development in the area whilst intensive geotechnical investigations were completed. (GCO/OAP/1979/PS37-7).

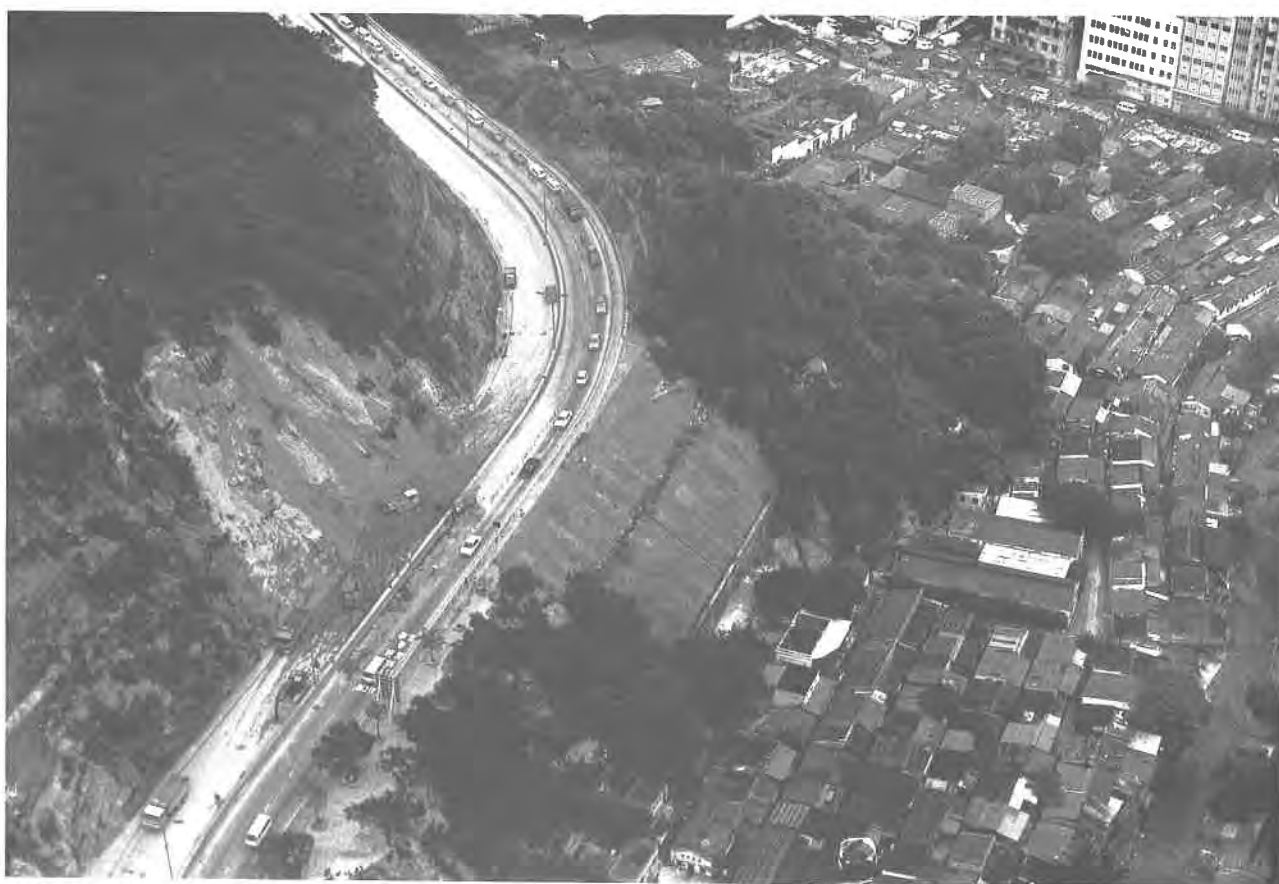
**Plate 119.** *Oblique Aerial Photograph of Landslip on Ching Cheung Road in 1982.* This photograph shows the disruption of the east bound carriageway above Wai Man Tsuen in Butterfly Valley. The landslide resulted from the failure of a large cut slope. (GCO/OAP/PS336-12A).

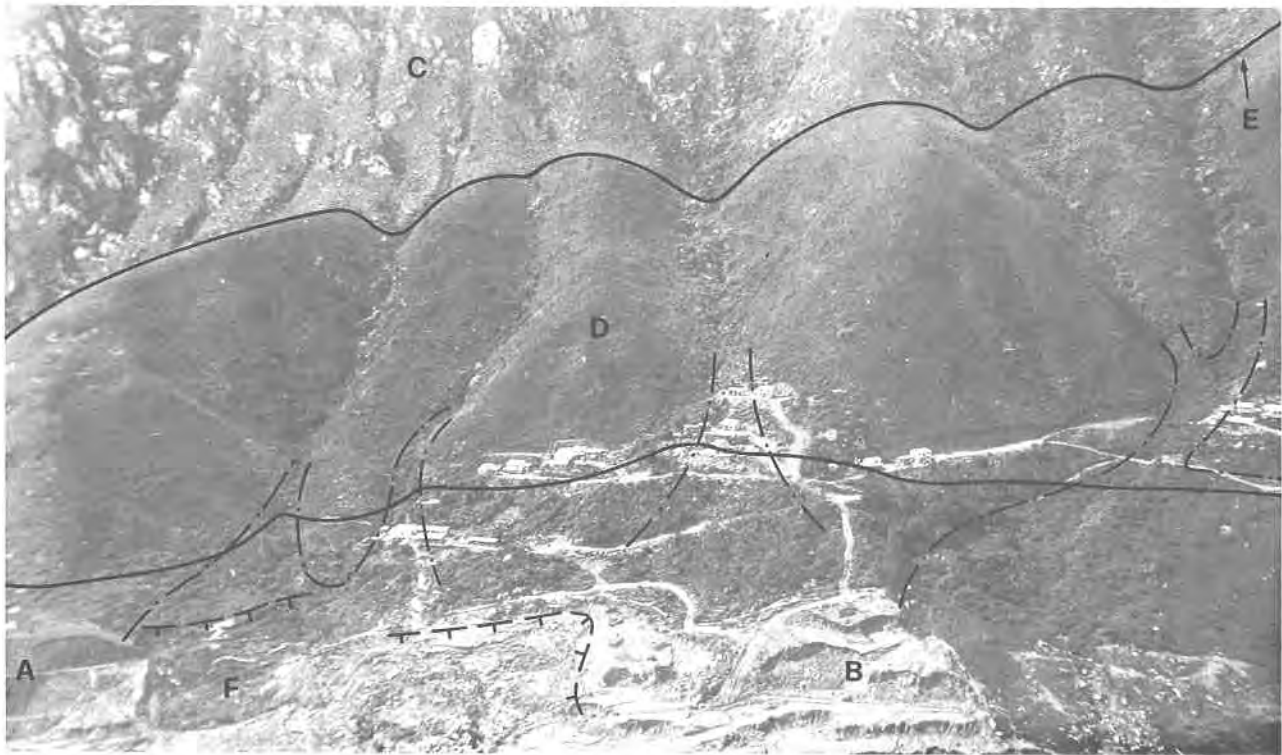
**Plate 120.** *Oblique Aerial Photograph of Tuen Mun Borrow Area 19 in 1978.* On the eastern slopes below Tsing Shan (Castle Peak), several areas of instability are associated with decomposed volcanic (A) and colluvial terrain (B). The upper slopes are formed of well-jointed granite (C) and decomposed metasediments (D), separated by a near-vertical fault (E). This Plate demonstrates the significance of the natural drainage pattern on instability. The zone of instability marked at F (shown in Plate 121) is within an area that receives discharge from the upper slopes. Numerous tension cracks are visible within the area. This view is to the west across the borrow area on 28.9.1978. The stereotriplet at Plate 122 shows the general nature of the terrain prior to development. (GCO/OAP/1978/PS9-1).

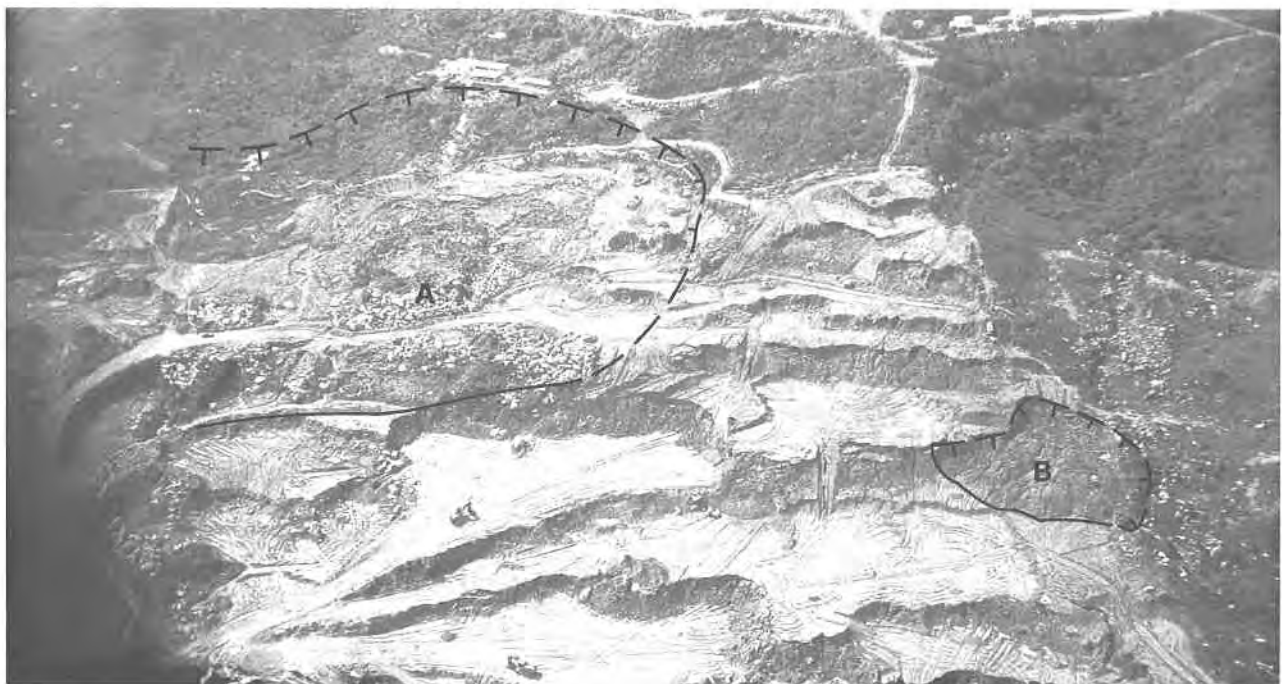
**Plate 121.** *Oblique Aerial Photograph of Progress on Site Formation for Tuen Mun Borrow Area 19 in 1978.* This photograph illustrates the state of extensive cutting of the footslope terrain in Area 19 on 28.9.1978. The general area of instability is indicated at A, whilst a smaller failure is at B. (GCO/OAP/1978/PS9-2).

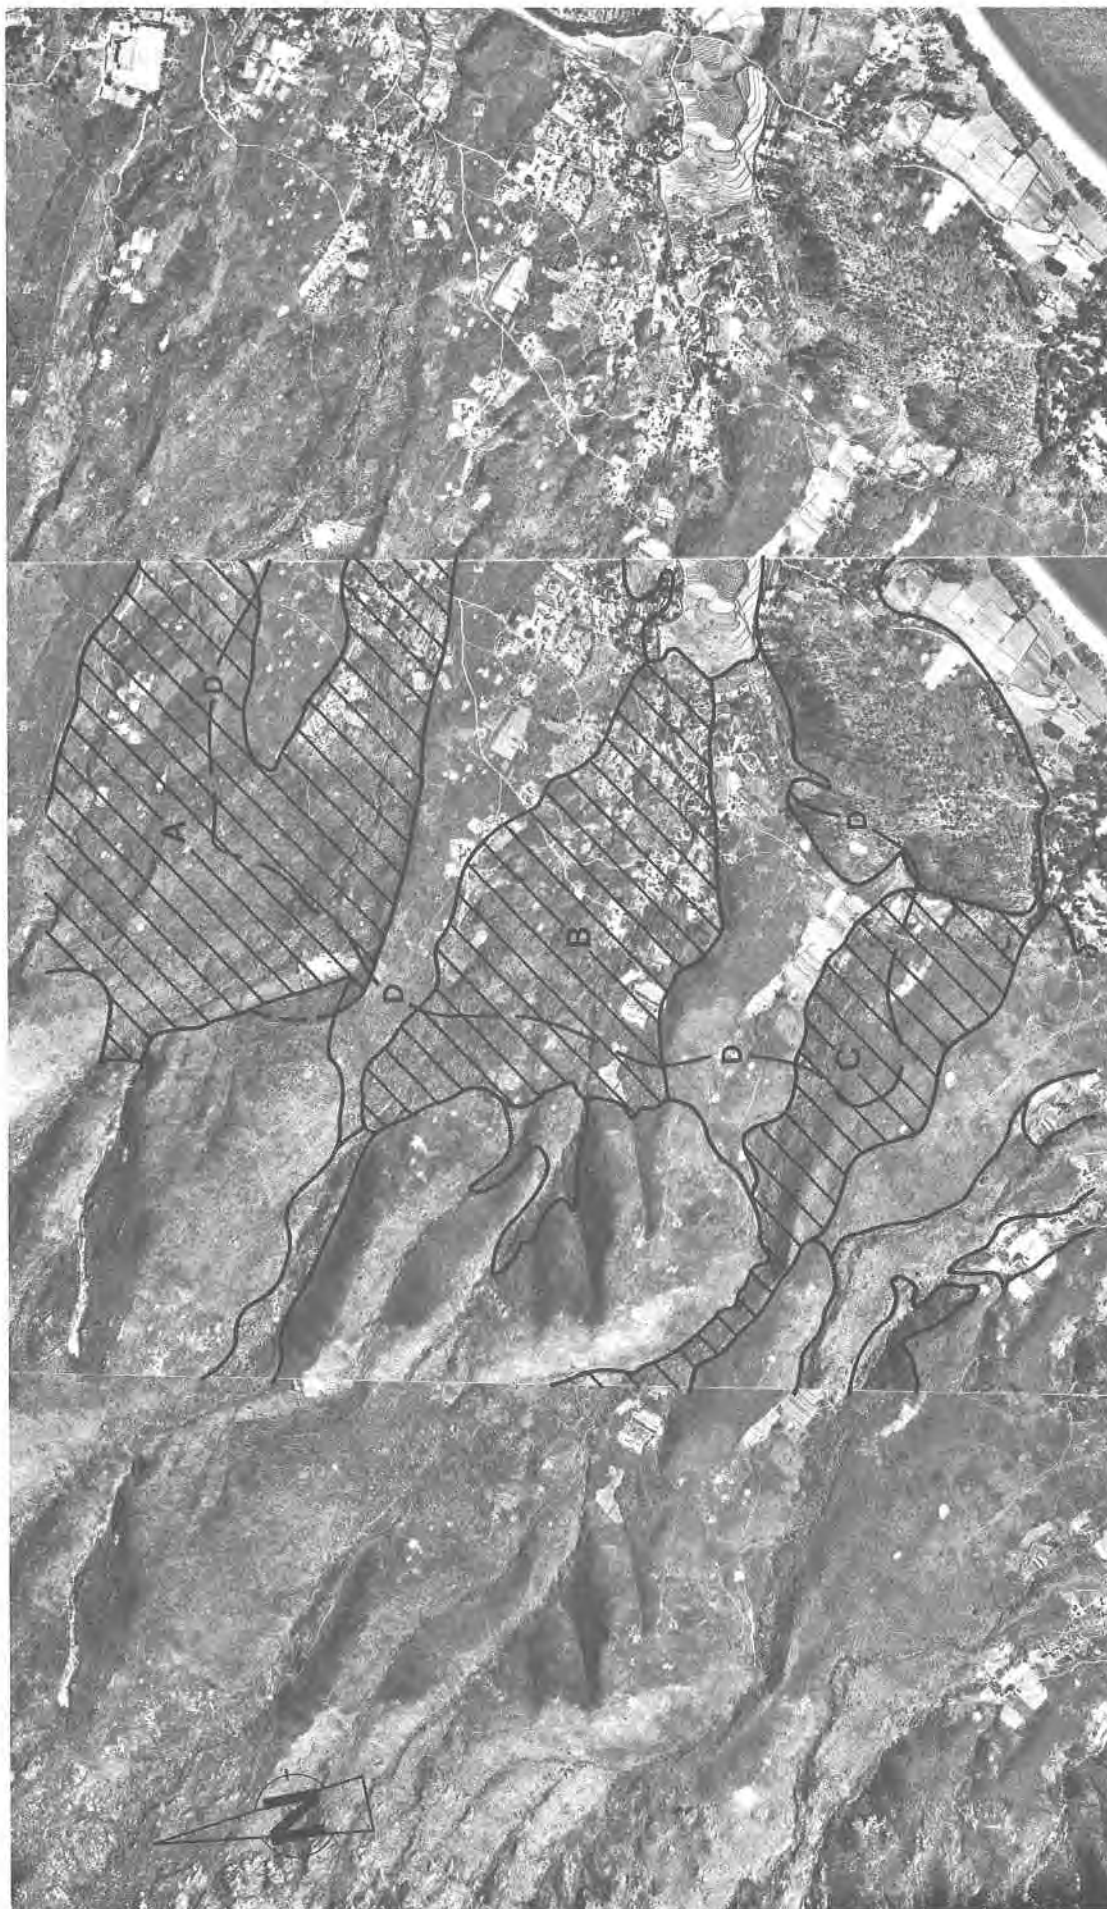
Plate 122. Stereotriple of Aerial Photographs of the Footslopes of Tsing Shan (Castle Peak) in 1963. The plate shows the terrain in Tuen Mun Borrow Area 19 on 29.1.1963, some 15 years prior to development. There is considerable evidence of instability reflected in the disposition of the colluvium which covers the footslope terrain. Three areas of instability, associated with the footslope terrain, are indicated at A, B and C. These areas are characterised by hummocky and irregular terrain. These areas coincide with zones of surface runoff from the major drainage lines leading from Castle Peak. The general extent of Borrow Area 19 is shown at D. Plates 120, 121, 123 and 124 show the terrain within this area following site formation works. (1963/6111-2).

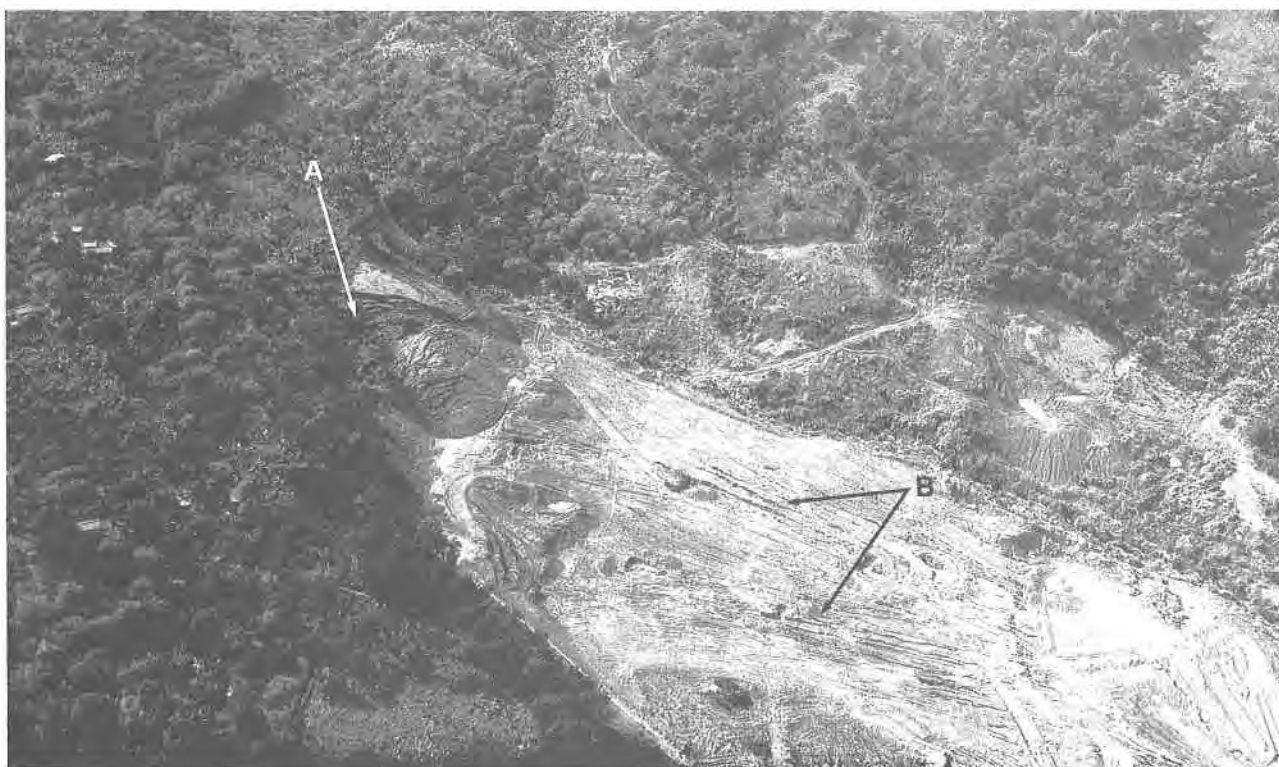
**Plate 126.** *Oblique Aerial Photograph of Landslip in Tuen Mun Borrow Area 8 in 1978.* A small landslide (A) occurred during site formation on deeply weathered volcanoclastic rocks. Severe erosion and soil tunnelling are also generally evident on the cut slope at B. Unlike Borrow Area 19 (Plates 120–124), colluvial deposits did not blanket the site prior to construction (GCO/OAP/1978/PS3–9).

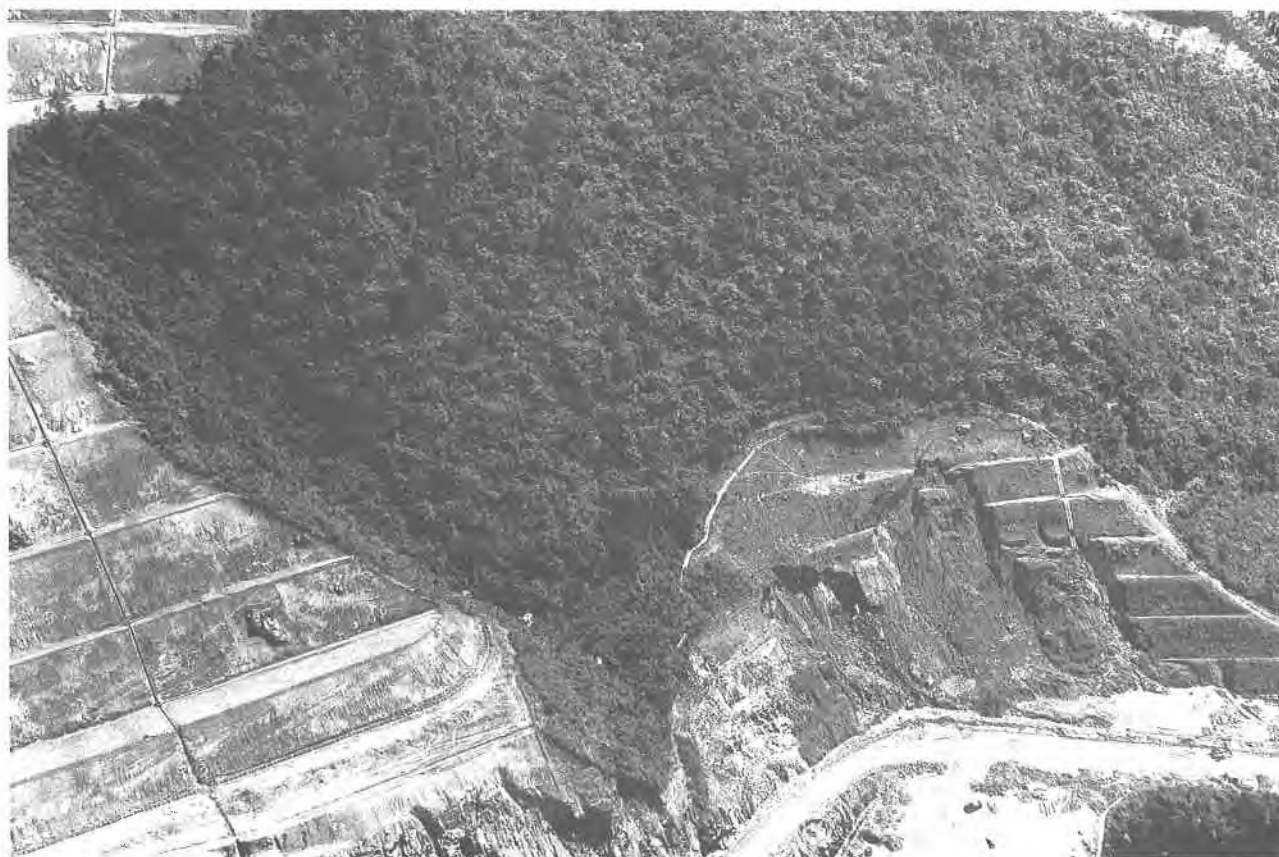
**Plate 127.** *Oblique Aerial Photograph of Landslip at Kau Tau in 1979.* Failure of a cut slope occurred in a borrow area near the Chinese University of Hong Kong. (GCO/OAP/1979/PS52–17).

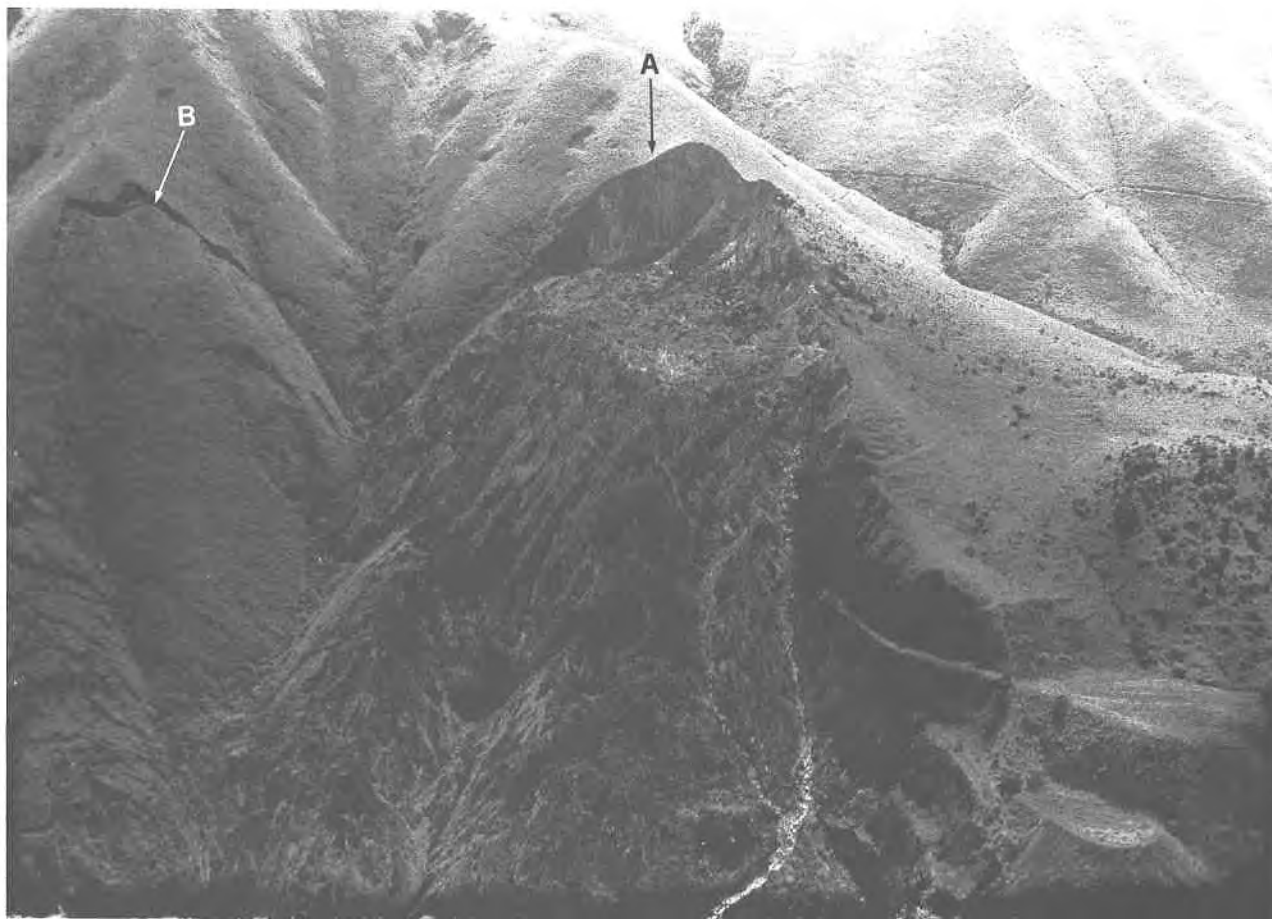
**Plate 128.** *Oblique Aerial Photograph of Landslip at Ma On Shan Mine Site in 1979.* The landslide associated with old mine workings at Ma On Shan is easily the largest area of instability within the Territory. Taken in 1979, this photograph shows the unstable mine workings, and the extensive system of tension cracks on the south-facing natural hillside. Instability was first apparent in 1954 in the area indicated at A. Evidence of the first incidence of the large tension cracks on the south-facing slope (B) was apparent in aerial photographs taken in 1969, and by 1973 they were clearly defined. The tension cracks have enlarged since 1973. Extensive underground operations associated with mining occurred between 1953 and 1976, and tunnels and shafts were constructed beneath the site. The Ma On Shan Mine has a long history of development commencing in 1906, when the first licence was issued to the Hong Kong Iron Mining Company. In 1934, the New Territories Iron Mining Company was granted a Crown Lease for 50 years. In 1940, South China Iron Smelters Limited took over with the intention of building a blast furnace on the sea-front. From 1942 to 1944, the mine was operated sporadically by the Japanese and employed about 1 500 workers. As there was no mechanical transport, the ore was carried by coolies to the seashore (Davis, 1961). In 1949, the Mutual Trust Company assumed the mining rights and in 1953 the Nittetsu Mining Company of Japan joined the Mutual Trust Company to operate the mine. In that year, the change-over from open cast to underground mining began and by 1959, all mining was underground. The mine ceased operations in 1976 (Addison, 1986). (GCO/OAP/1979/PS55-8).

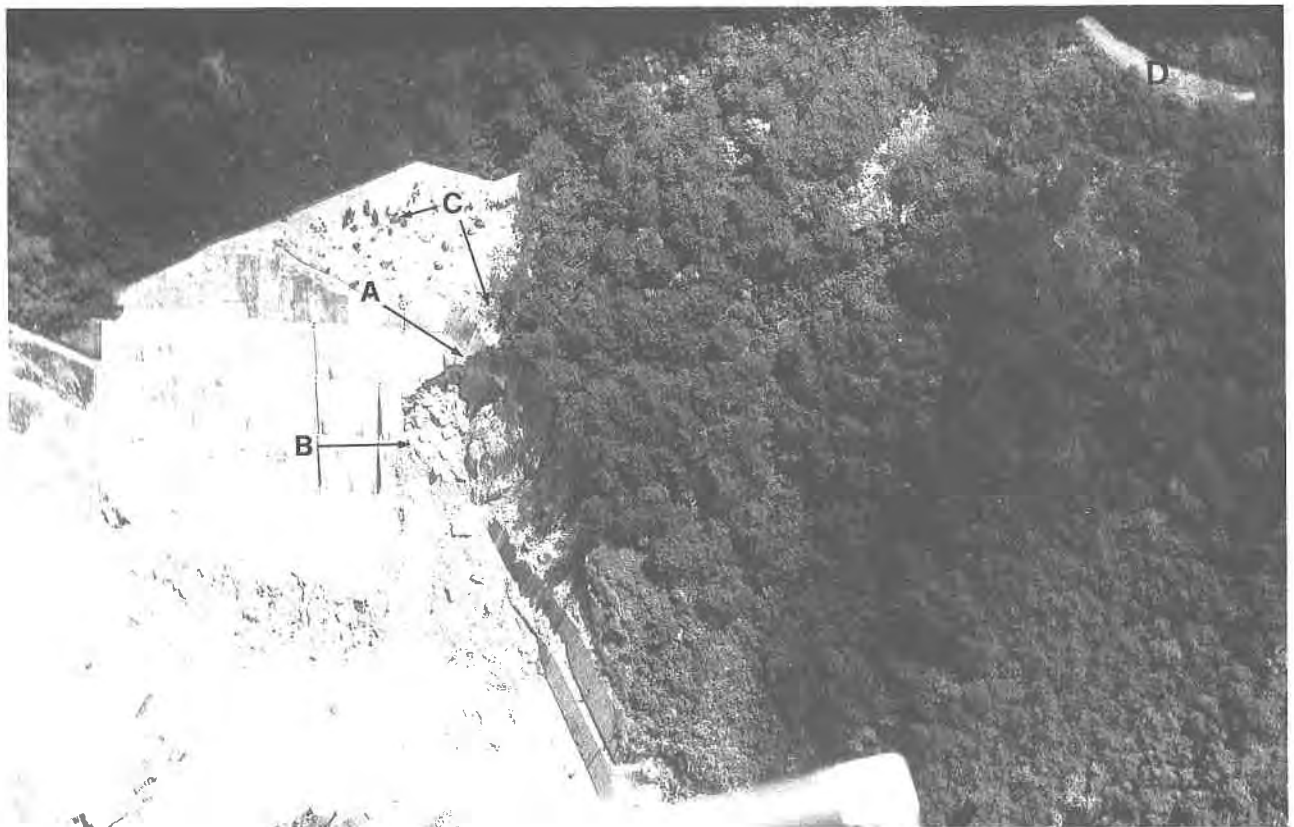
**Plate 130.** *Oblique Aerial Photograph of Landslip at Ngau Chi Wan in 1979.* Failure at A, of a cut slope, during site formation, in decomposed granite (B) and colluvium (C) is evident on a natural drainage line. A portion of Jats Incline is evident at D. (GCO/OAP 1979/PS55-23).

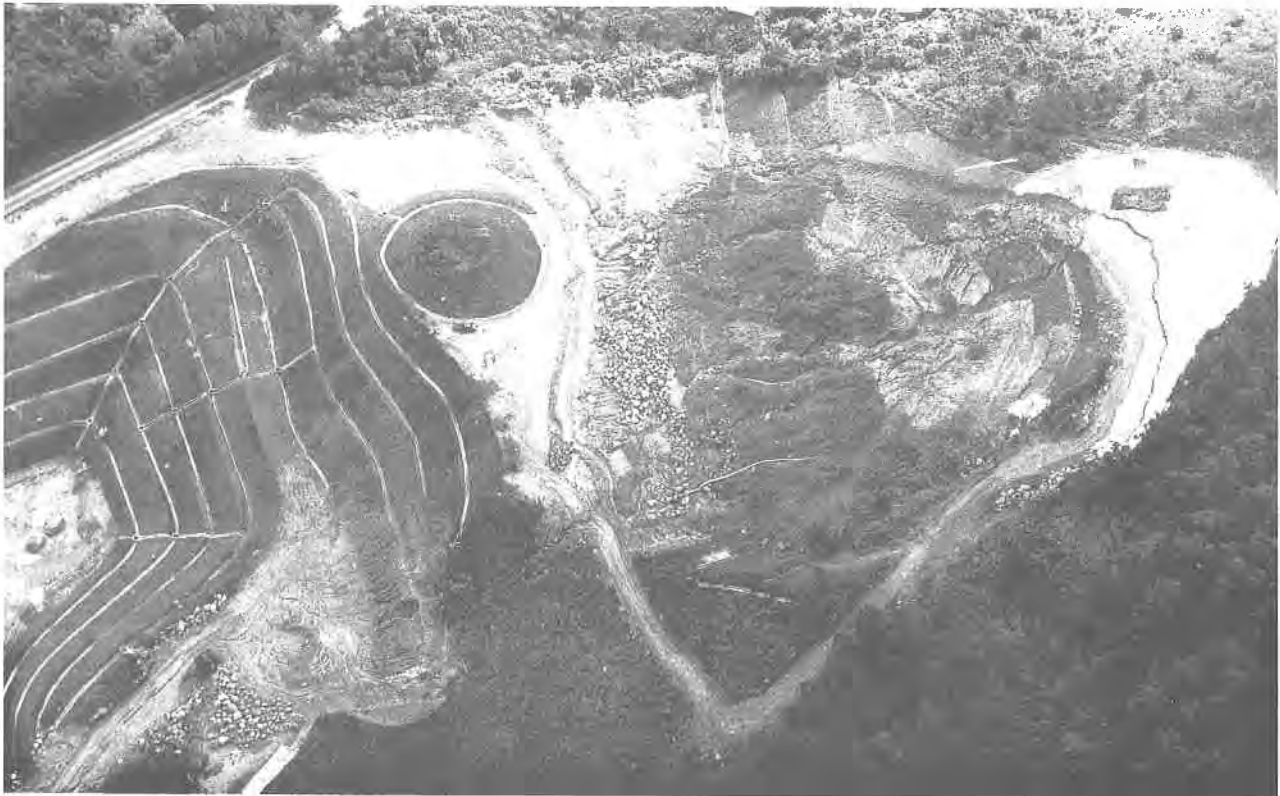
**Plate 131.** *Oblique Aerial Photograph of a Landslip near Kwun Yam Shan in July 1979.* A landslide occurred during site formation for a large development near Kadoorie Farm. This photograph was taken during July 1979. Compare this with Plate 132, which was taken some 3 months later in October 1979. (GCO/OAP/1979/PS51-20A).

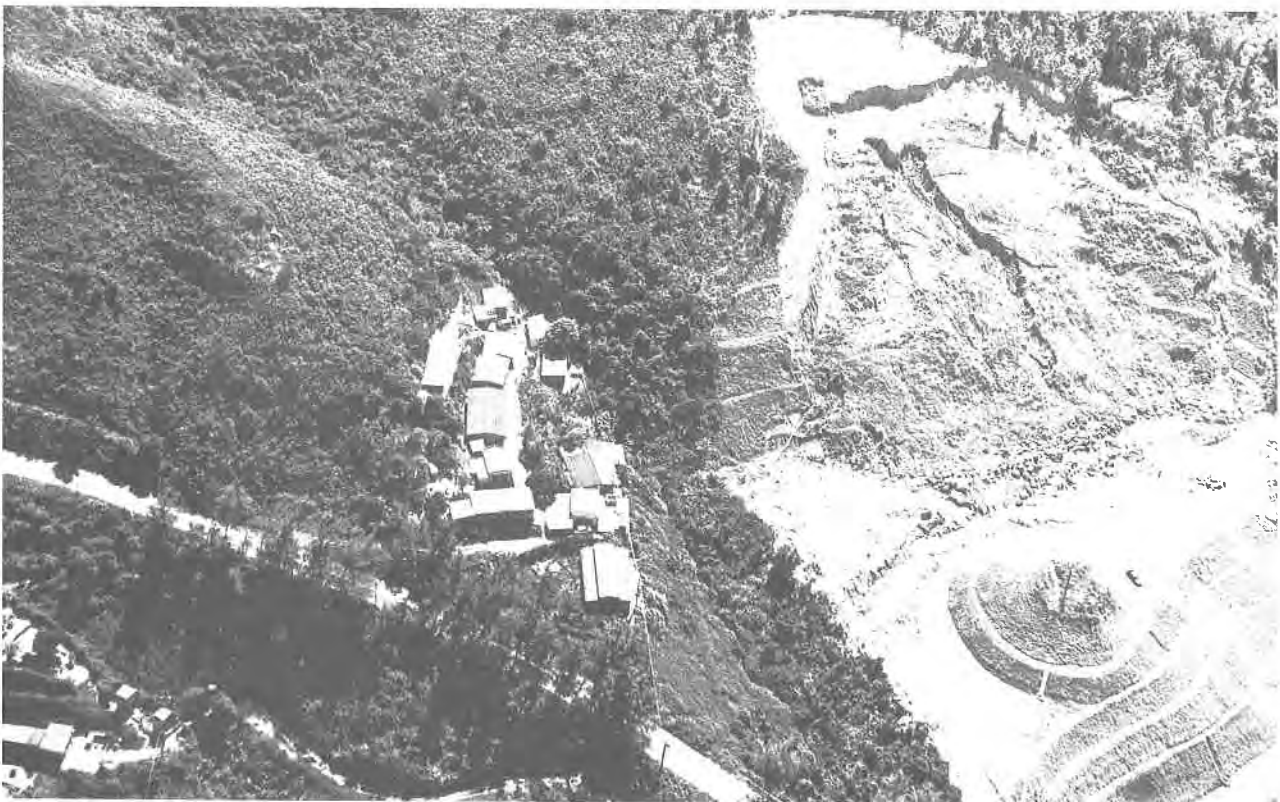
**Plate 132.** *Oblique Aerial Photograph of a Landslip near Kwun Yam Shan in October 1979.* The site is viewed from the northwest, and the landslide is evident on a formed cut slope. Lam Kam Road is in the foreground. Compare this with Plate 131 taken some 3 months earlier. (GCO/OAP/1979/PS78-31).

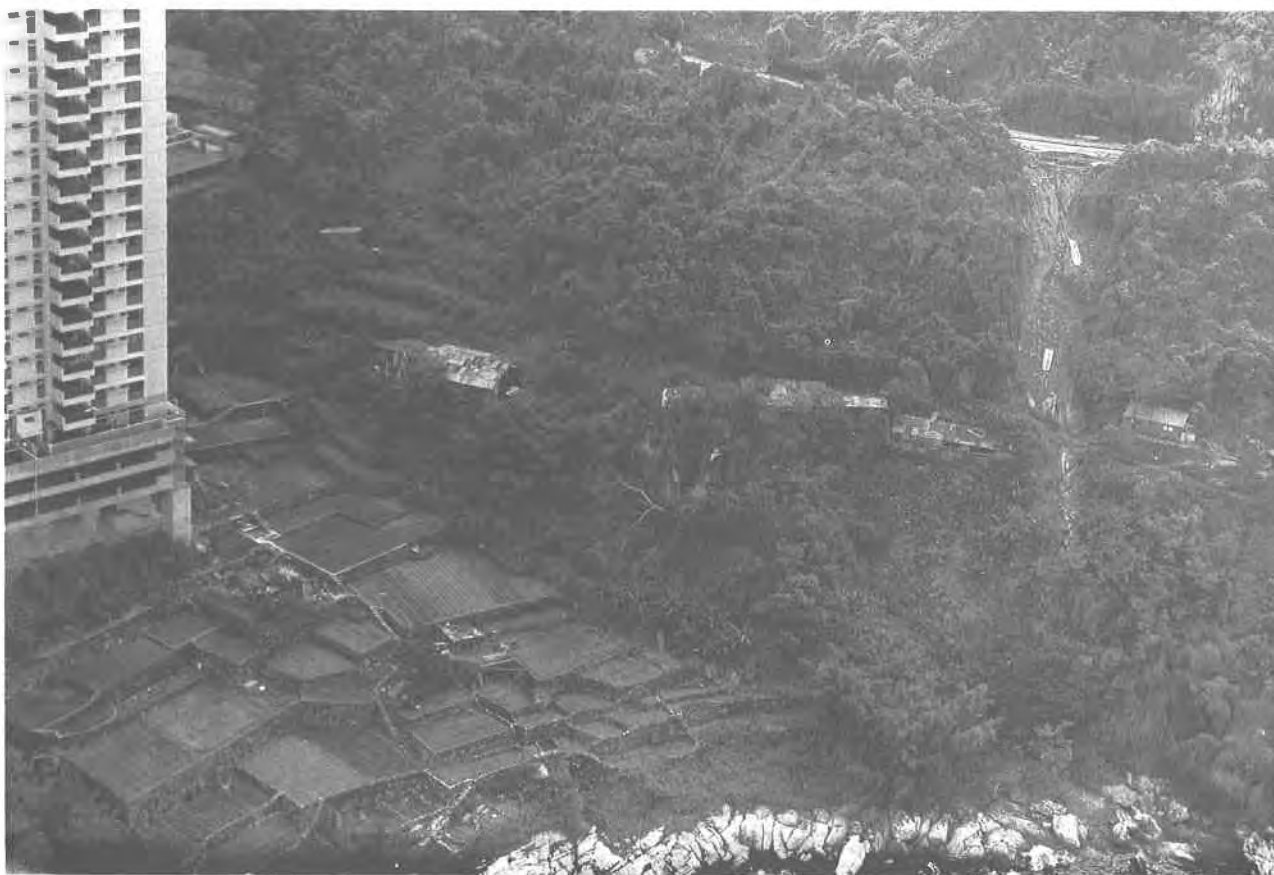
**Plate 133.** *Oblique Aerial Photograph of a Landslip below Victoria Road in 1979.* This landslide occurred during Typhoon Hope in September 1979 and affected huts in a mid-slope position near Baguio Villa. (GCO/OAP/1979/PS75-6A).

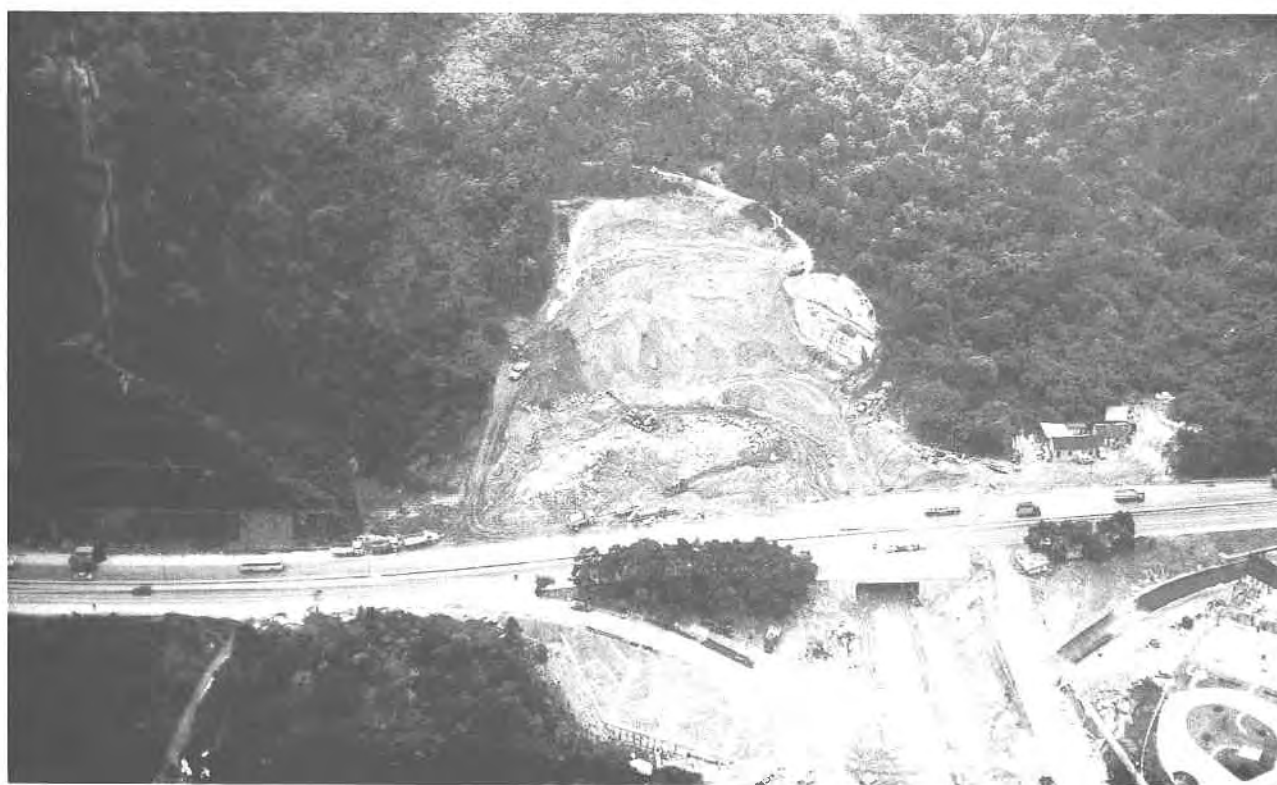
**Plate 134.** *Oblique Aerial Photograph of Remedial Works to Landslip Site near World Wide Gardens in Sha Tin in 1979.* This photograph, taken in 1979, shows remedial works on the site of a landslide which occurred during Severe Tropical Storm Agnes in July 1978. (GCO/OAP/1979/PS19-12).

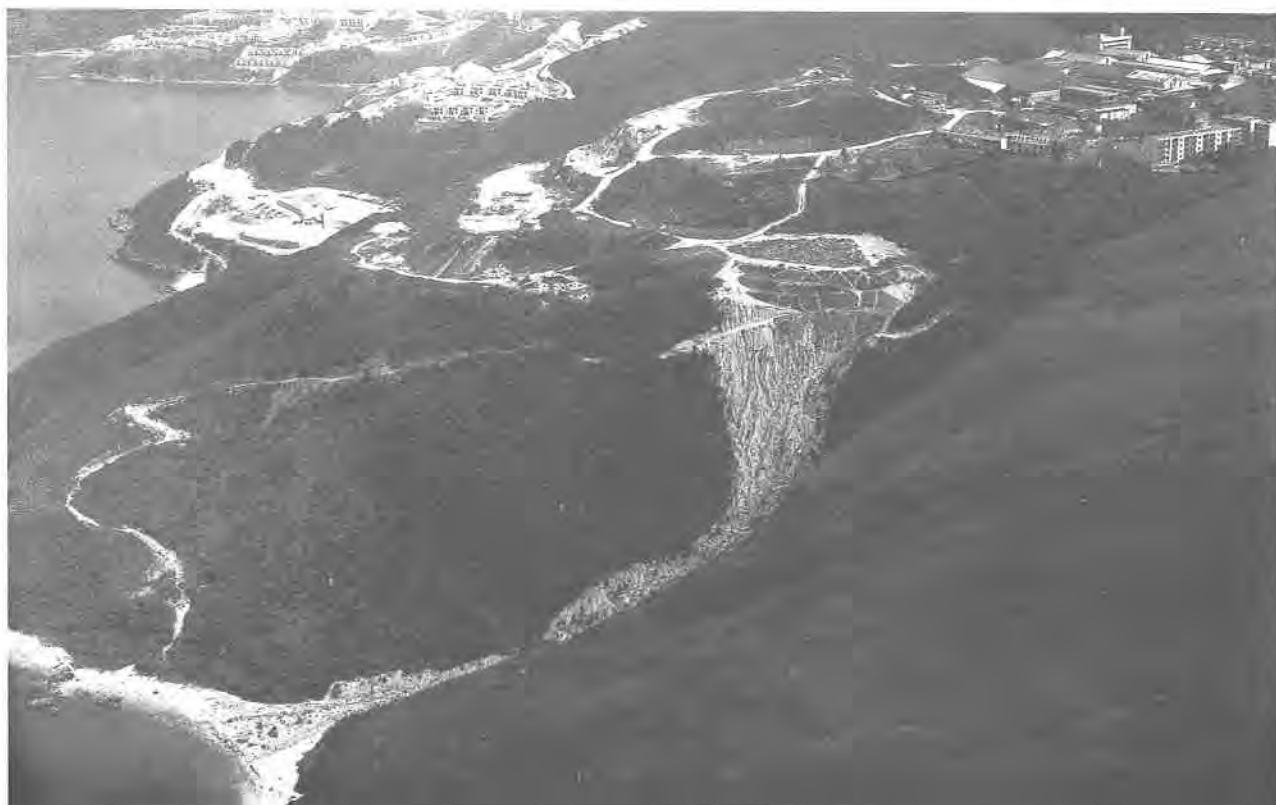
**Plate 135.** *Oblique Aerial Photograph of a Severely Eroded Fill Slope in the Silverstrand Area in 1980. Severe gully and sheet erosion is evident on this large fill slope on the Clear Water Bay Peninsula. (GCO/OAP/1980/PS134-1).*

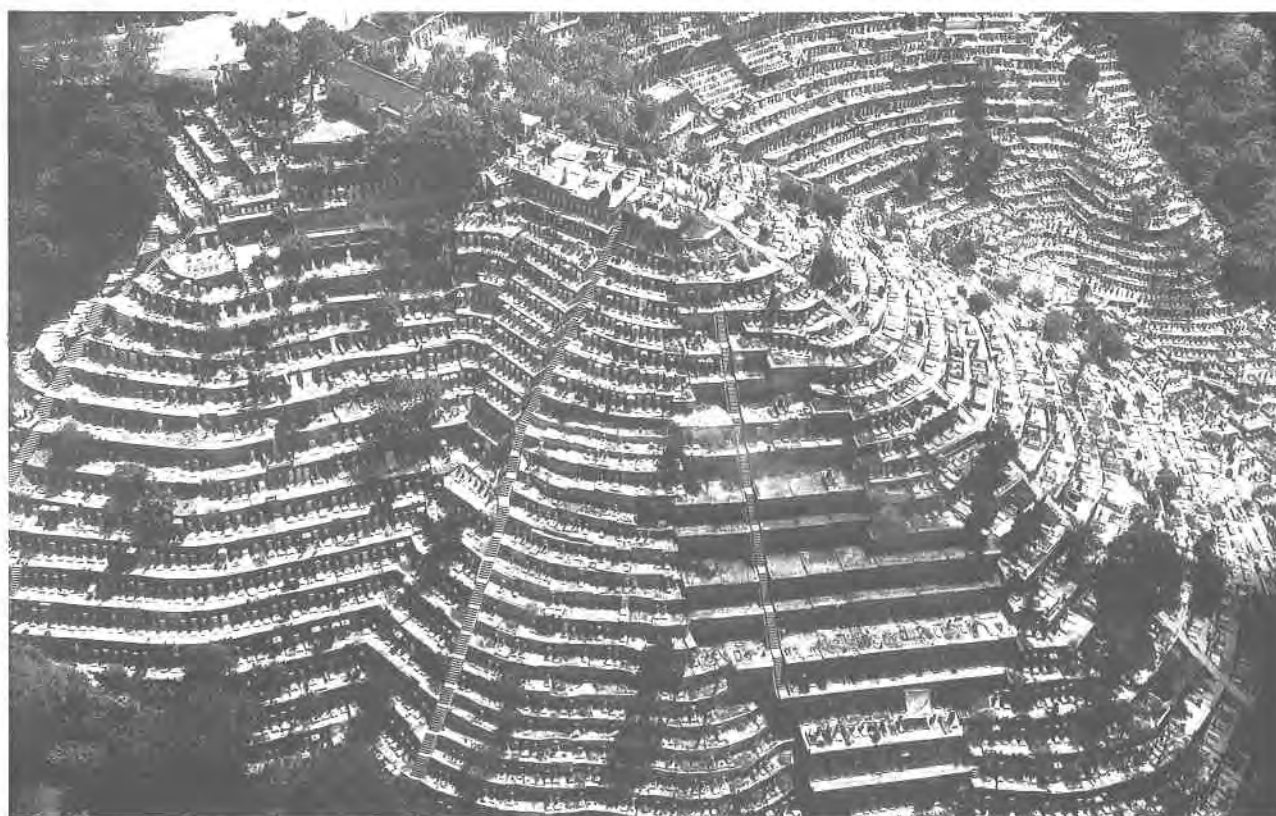
**Plate 136.** *Oblique Aerial Photograph of Remedial Works to a Landslip in the Cemetery at Pok Fu Lam in 1981. A landslide resulted in the exhumation of more than 500 grave sites and illustrates in a dramatic manner, that it is not always possible to 'rest-in-peace' from the dangers of slope failure. (GCO/OAP/ 1981/PS230-2A)*

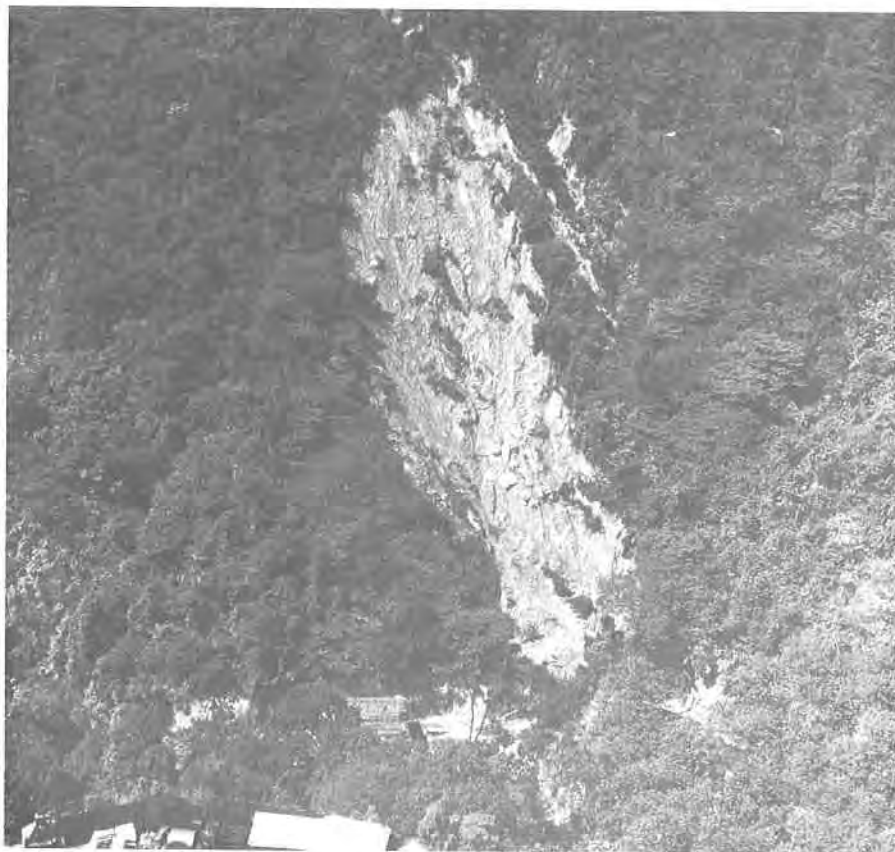
*Plate 138. Oblique Aerial Photograph of Landslip near the Crow's Nest in 1981. This landslide occurred on natural granitic terrain in the vicinity of Beacon Hill, and is also shown in Plate 137. (GCO/OAP/1981/PS232-12).*

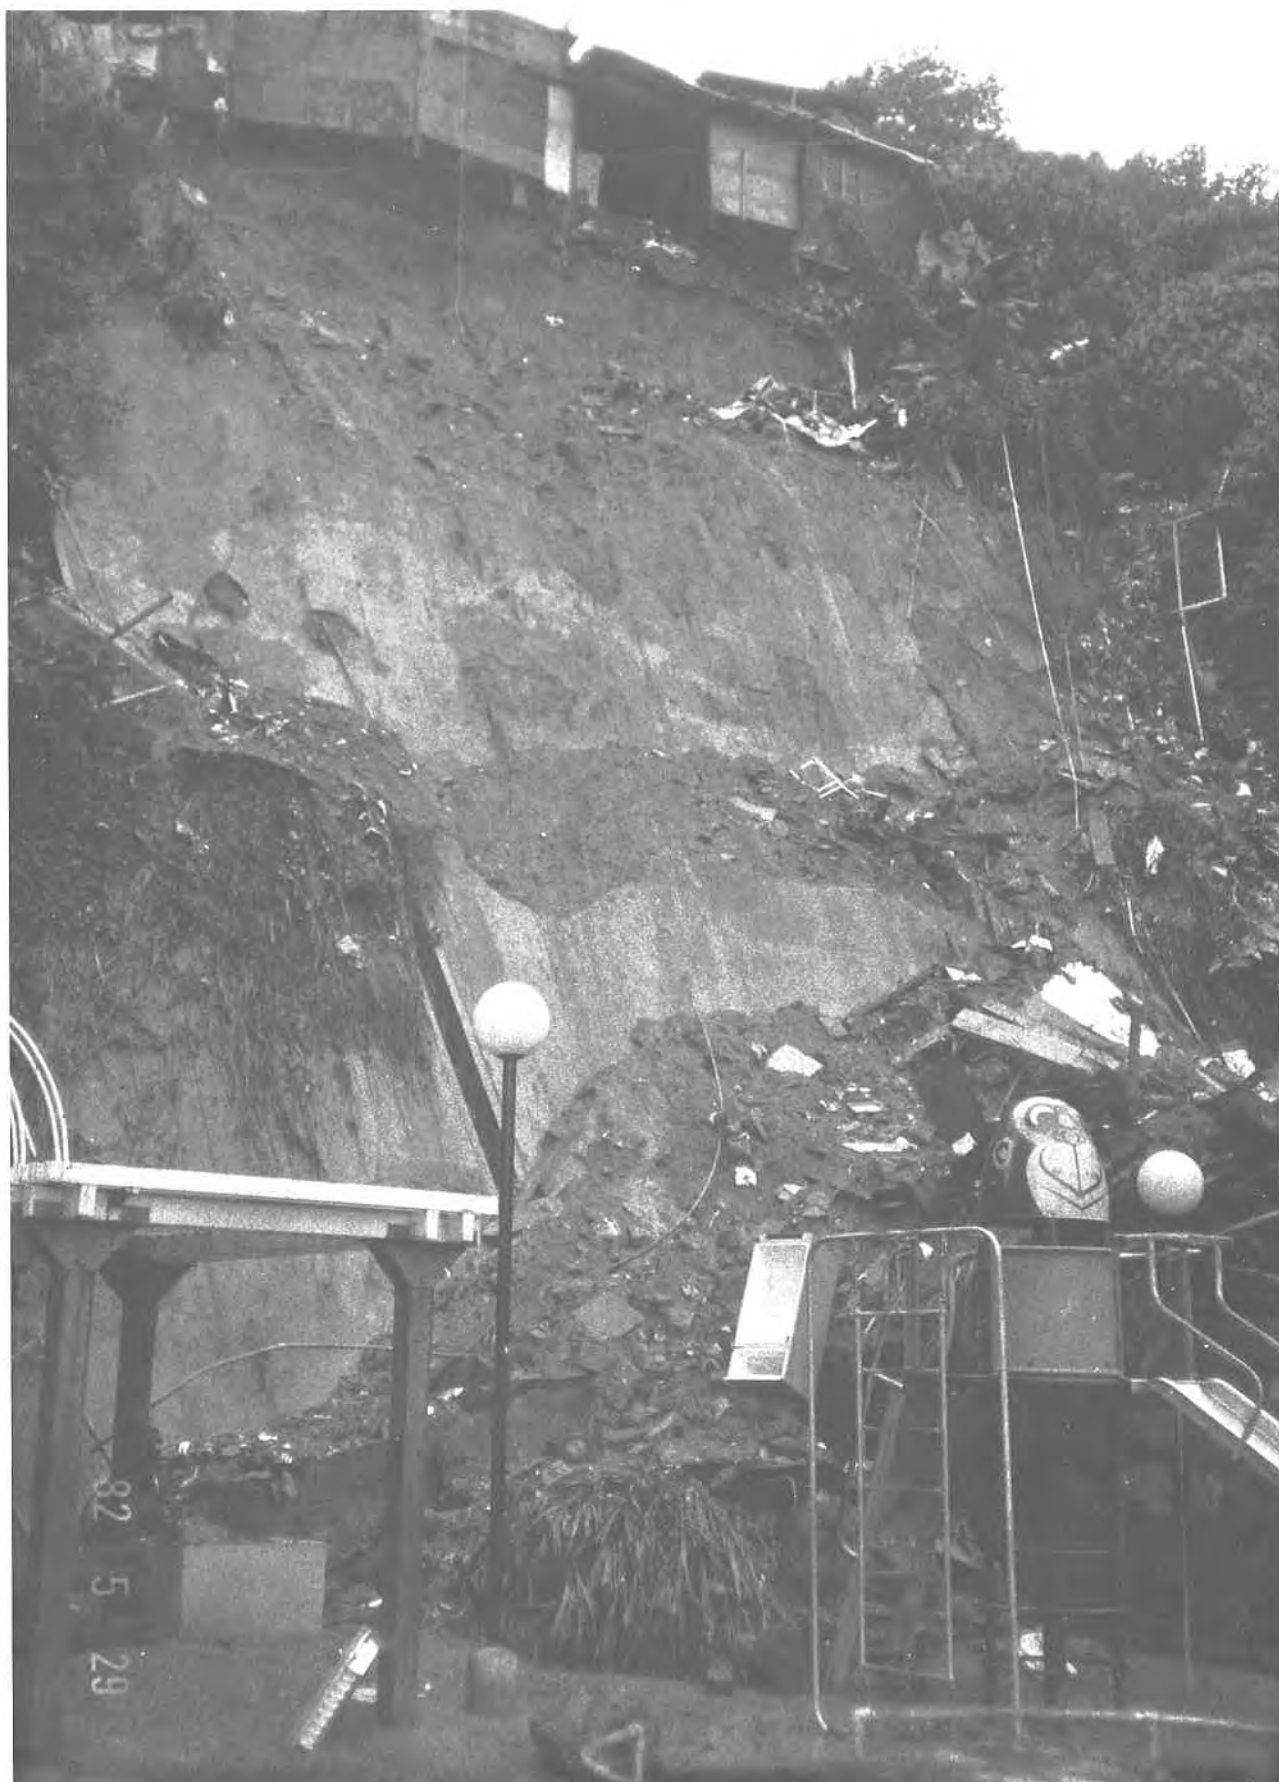
*Plate 139. Landslip at Tsin Shui Ma Tau in 1982.* The landslide is viewed from the playground at the base of the slope, and the precarious position of the undermined squatter huts is evident. An aerial view of the landslide is presented in Plate 140. (GCO/ES/1982/206819).

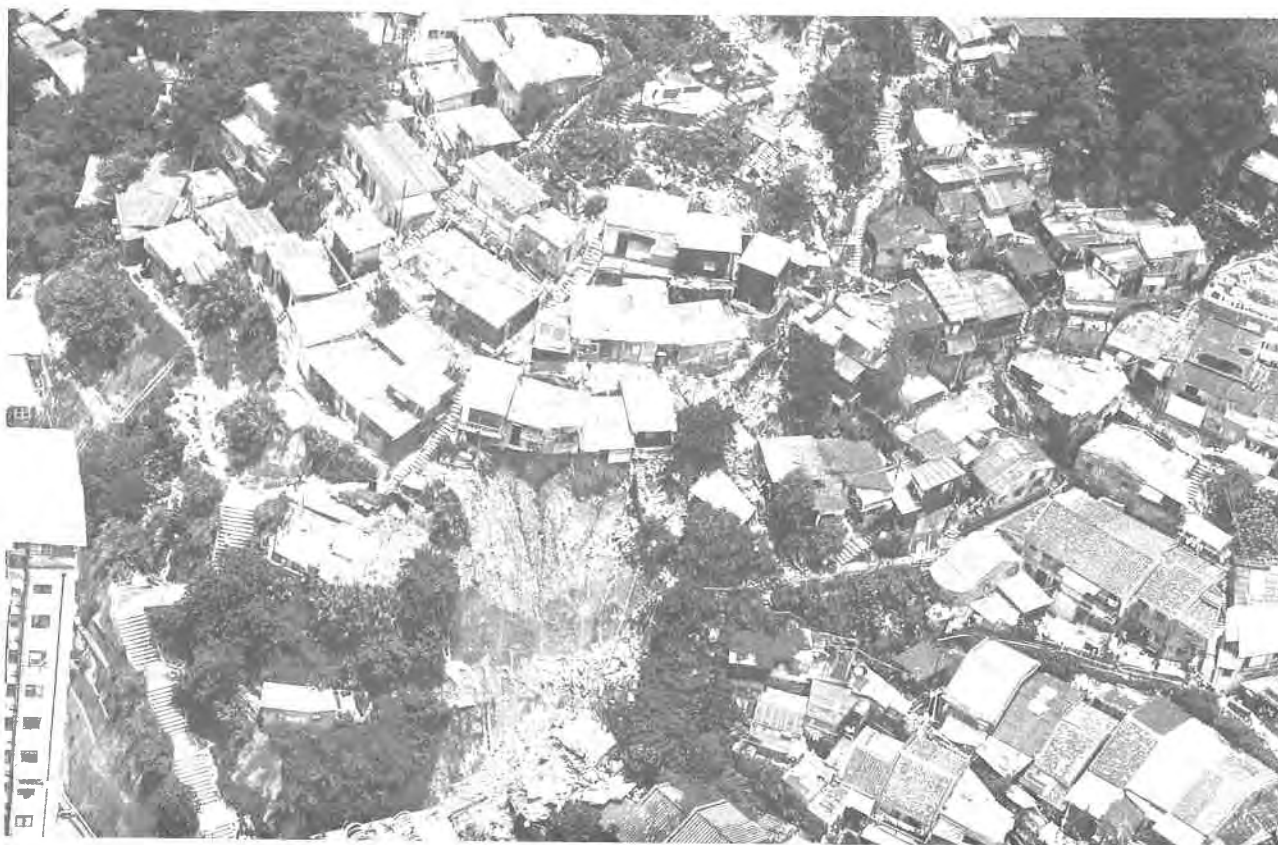
*Plate 140. Oblique Aerial Photograph of Landslip at Tsin Shui Ma Tau in 1982. Slope failure occurred on a cut slope and affected squatter huts at the crest of the slope and a portion of a children's playground. Plate 139 provides detail of the failure viewed from the playground at the base of the slope. (GCO/OAP/1982/PS297-9).*
