Geotechnical Area  
Studies Programme

GASP Report XII

# Territory of Hong Kong

Geotechnical Control Office  
Civil Engineering Services Department  
Hong Kong

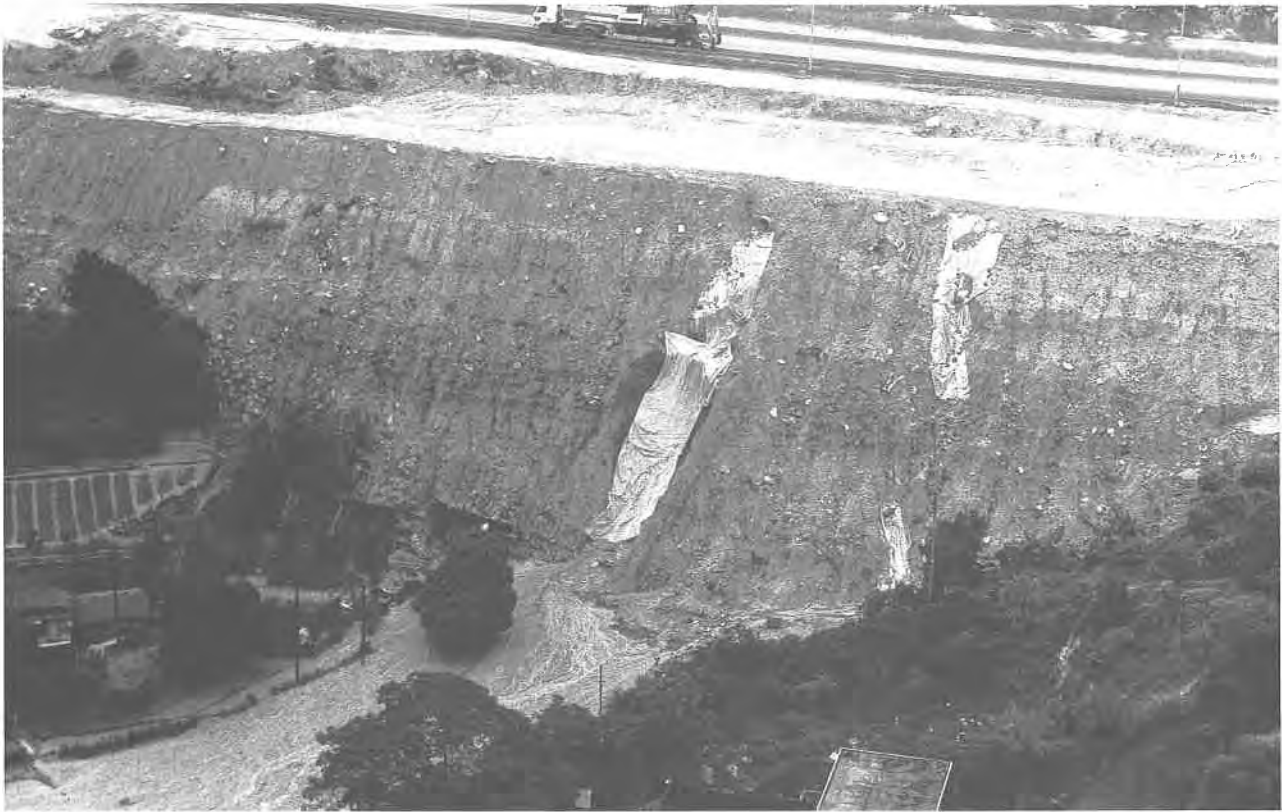
*Plate 142. Oblique Aerial Photograph of Erosion on a Fill Slope near Siu Lam San Tsuen in 1982. Severe erosion is evident on the road embankment, and a large area of sediment is apparent. (GCO/OAP/1982/PS275-12A).*

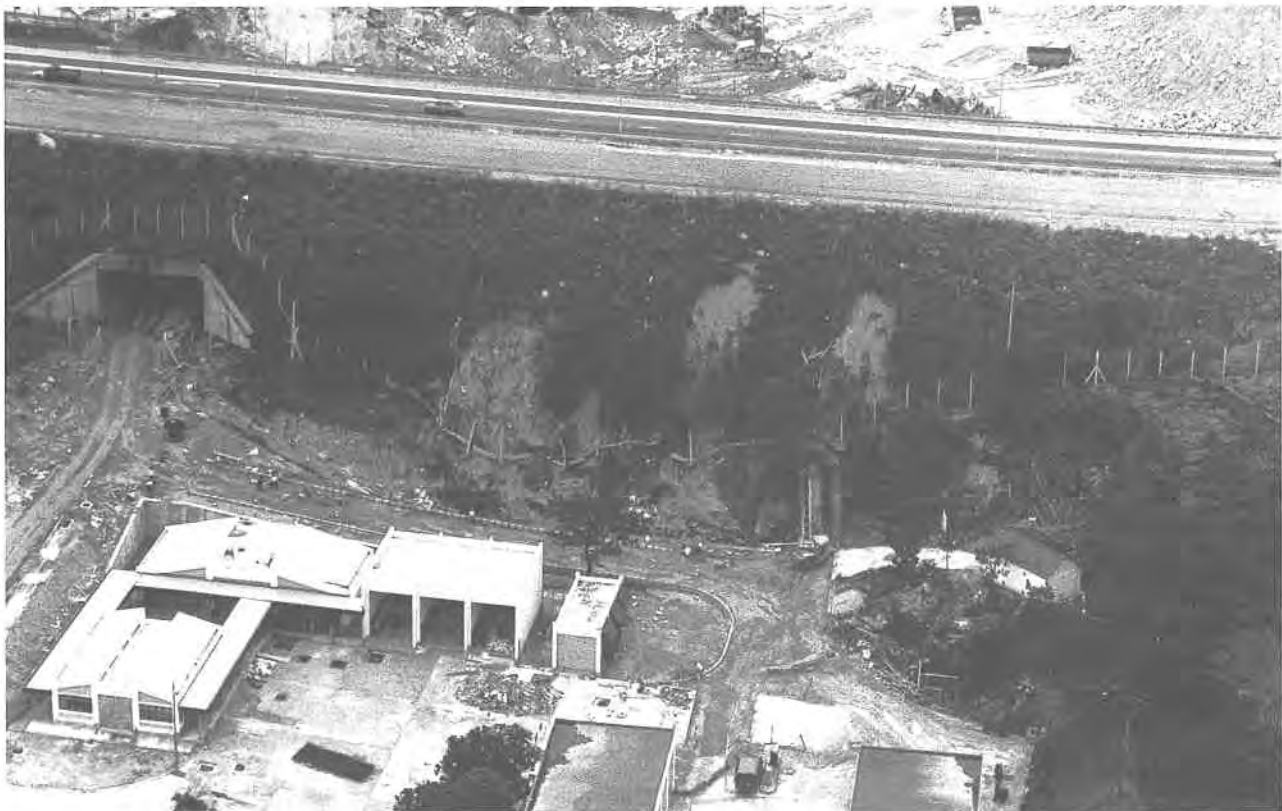
*Plate 143. Oblique Aerial Photograph of Landslips on a Road Embankment near Cafeteria Beach in 1982. Although these are relatively small failures, this type of incident has considerable impact in terms of maintenance costs for reinstatement and clearance of blocked access and drainage systems. (GCO/OAP/1982/PS275-5A).*

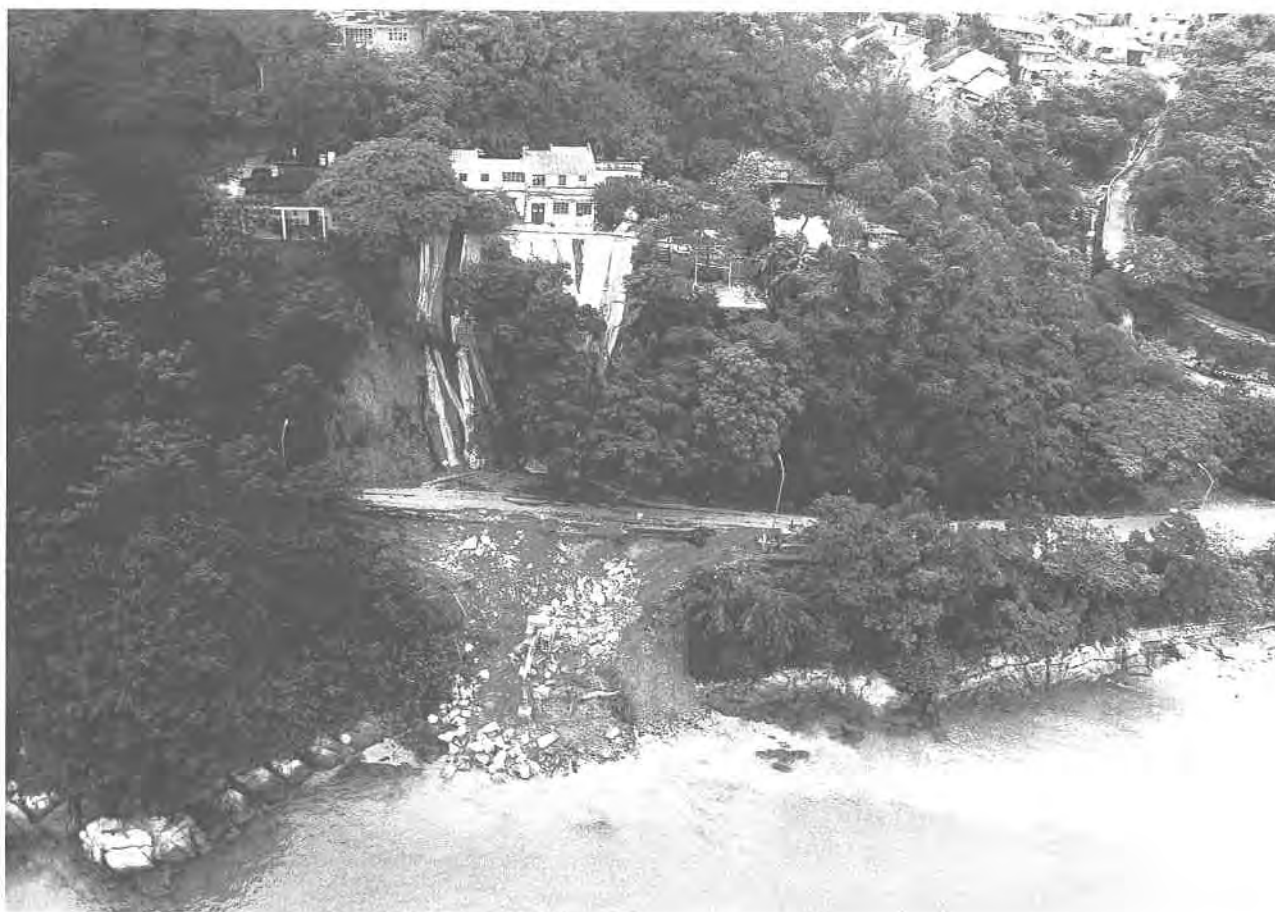
*Plate 144. Oblique Aerial Photograph of Landslips on Castle Peak Road in 1982.* During heavy rain on 29.5.82, a number of failures occurred in the vicinity of Lai Shum Villa off Castle Peak Road. These included three minor cut slope failures behind the Villa, one larger cut slope failure on Castle Peak Road, the subsidence of a 30 m by 30 m wide section of Castle Peak Road due to failure of a fill embankment, and the failure of the edge of a fill platform associated with the cracking of a masonry retaining wall. The interesting aspect of the Lai Shum Villa incidents is that six failures occurred in a very small area, on both cut and fill slopes. This could be attributed to extremely intense local rainfall, perhaps for only a few minutes during the storm. (GCO/OAP/1982/PS272-23).

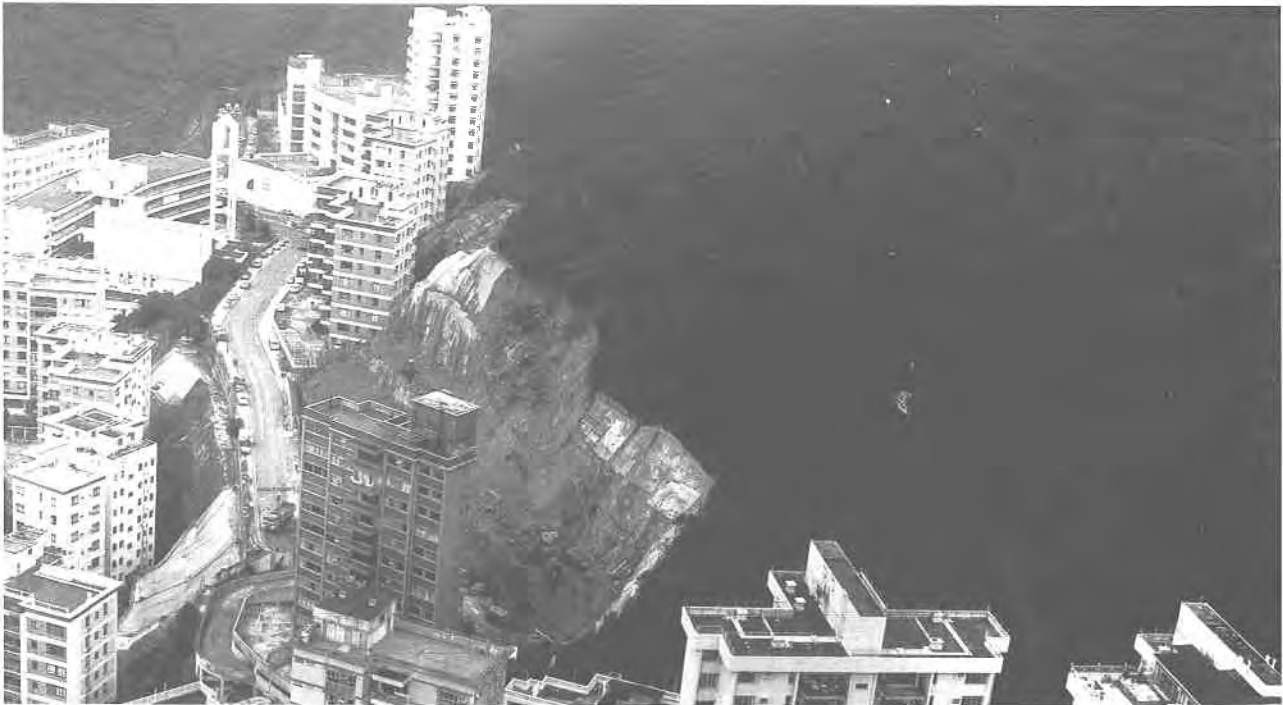
**Plate 145.** *Oblique Aerial Photograph of Landslip in South Bay Close in 1982.* The failure occurred in the upper 12 m of a slope under construction on 29.5.82, during heavy rain. More than 3 000 m<sup>3</sup> of debris was involved and affected much of the site for a multistorey residential block. The failure occurred along a pre-existing, persistent discontinuity some 700 mm thick in places. The infill material consisted of a 'gouge' of gravel sized fragments of volcanic rock in a silty matrix, with occasional bands and pockets of pink clay. After the failure, water flowed from the discontinuity at several points. Piezometers, read on a daily basis prior to the failure, did not confirm the existence of a perched water table. However, piezometer buckets were installed in existing standpipes after the failure, and readings taken during the August rainstorms in 1982 showed much higher water levels. The landslide occurred as a simple wedge failure along a pre-existing major discontinuity. (GCO/OAP/1982/PS286-8).

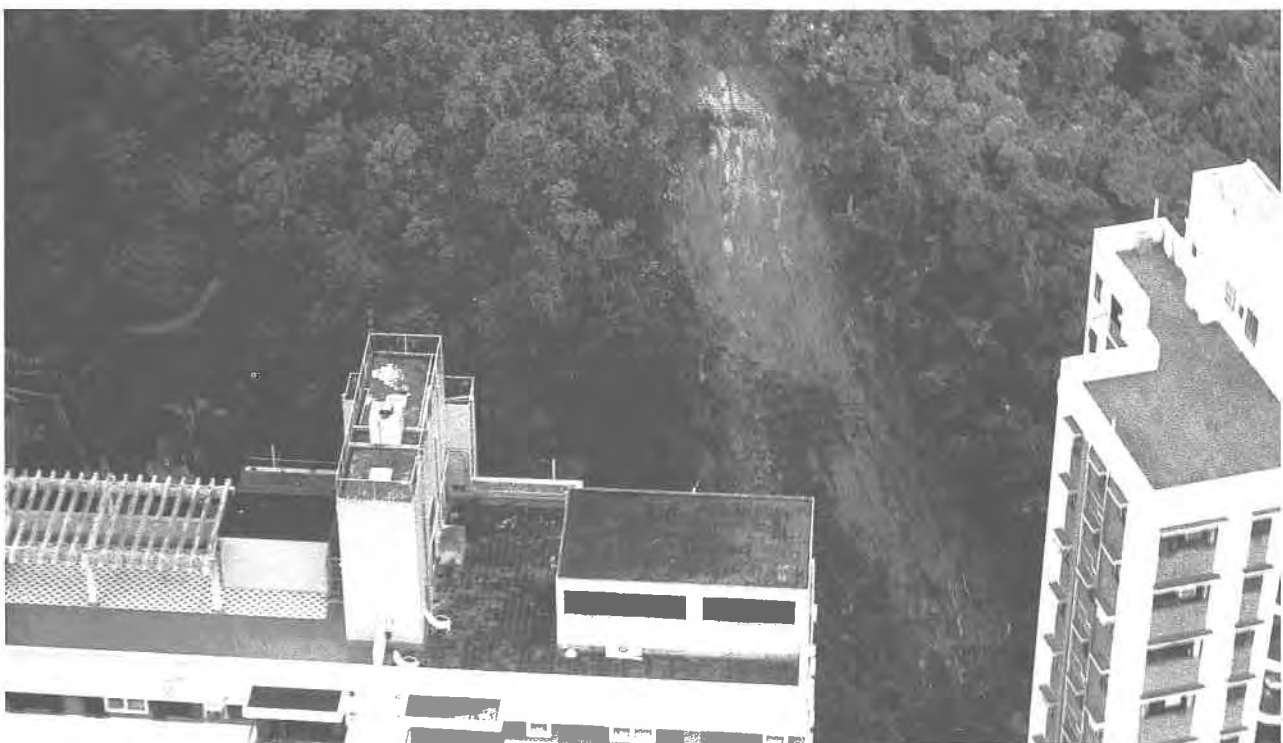
**Plate 146.** *Oblique Aerial Photograph of Landslip above Kennedy Road in 1982.* Failure occurred on the hilly terrain south of Wan Chai. (GCO/OAP/1982/PS260-23).

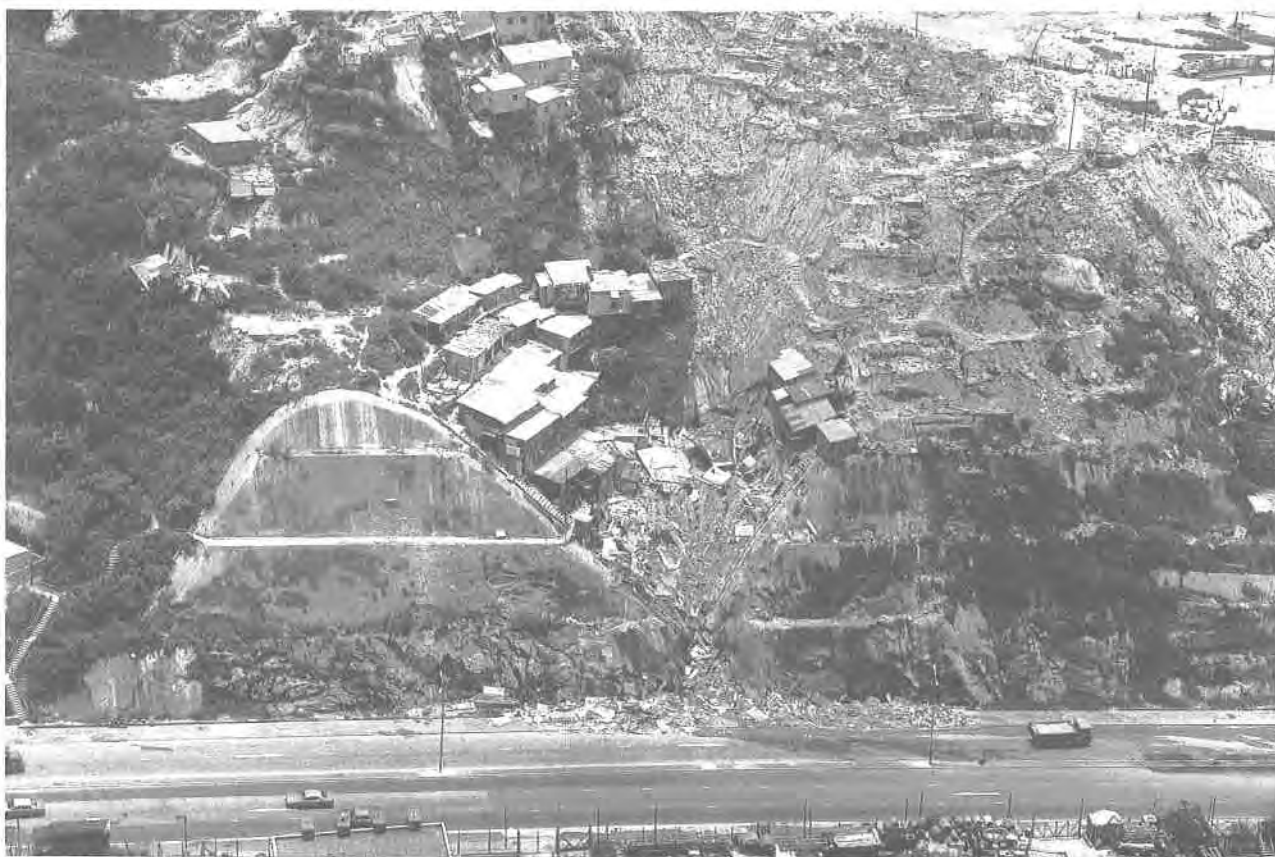
*Plate 147. Oblique Aerial Photograph of Landslip in a Squatter Area at Lam Tin in 1982. A number of huts were destroyed by this failure above Junk Bay Road. (GCO/OAP/1982/PS297-5).*

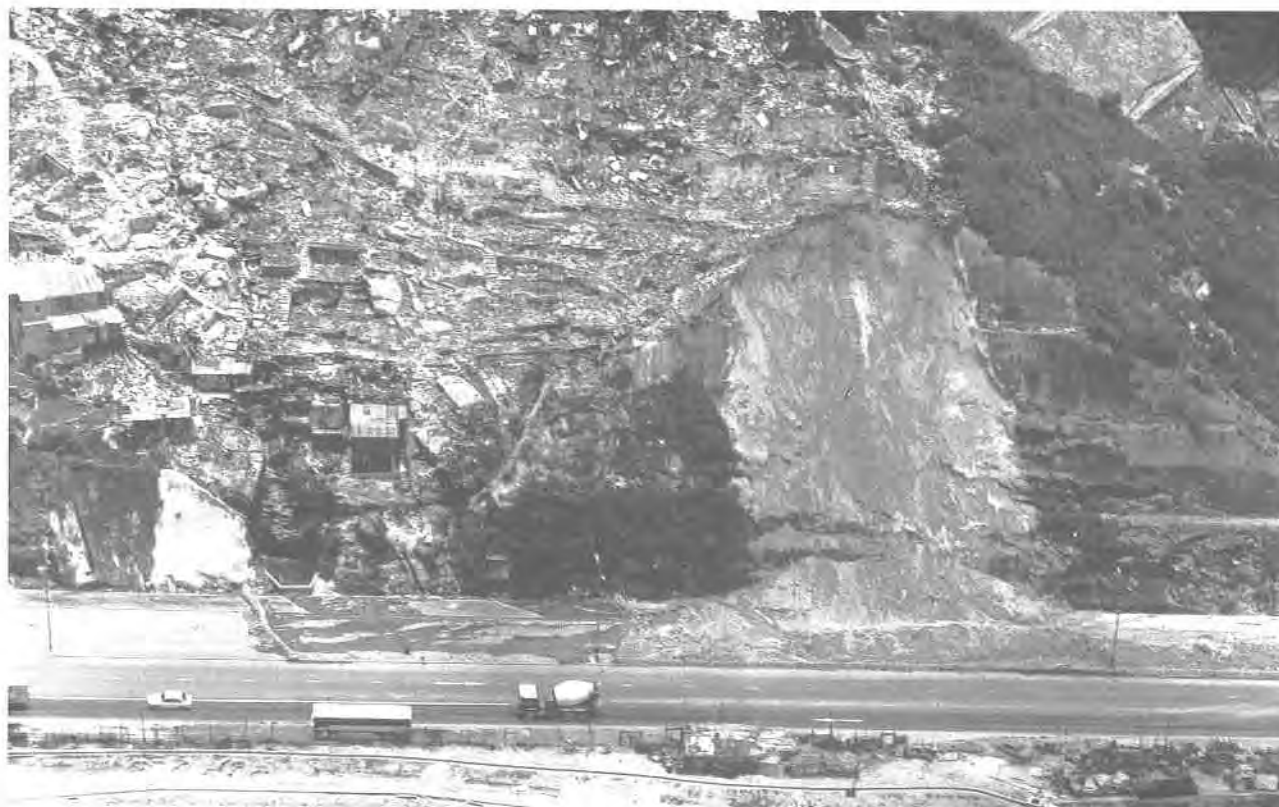
*Plate 148. Oblique Aerial Photograph of Landslip near a Squatter Area at Lam Tin in 1982. A large cut slope failure occurred on Junk Bay Road near the location of the landslip in Plate 147. The general area had been cleared of squatters at the time due to a fire earlier in the year. Some details of the slope failure are presented in Plate 149. (GCO/OAP/1982/PS297-5A).*

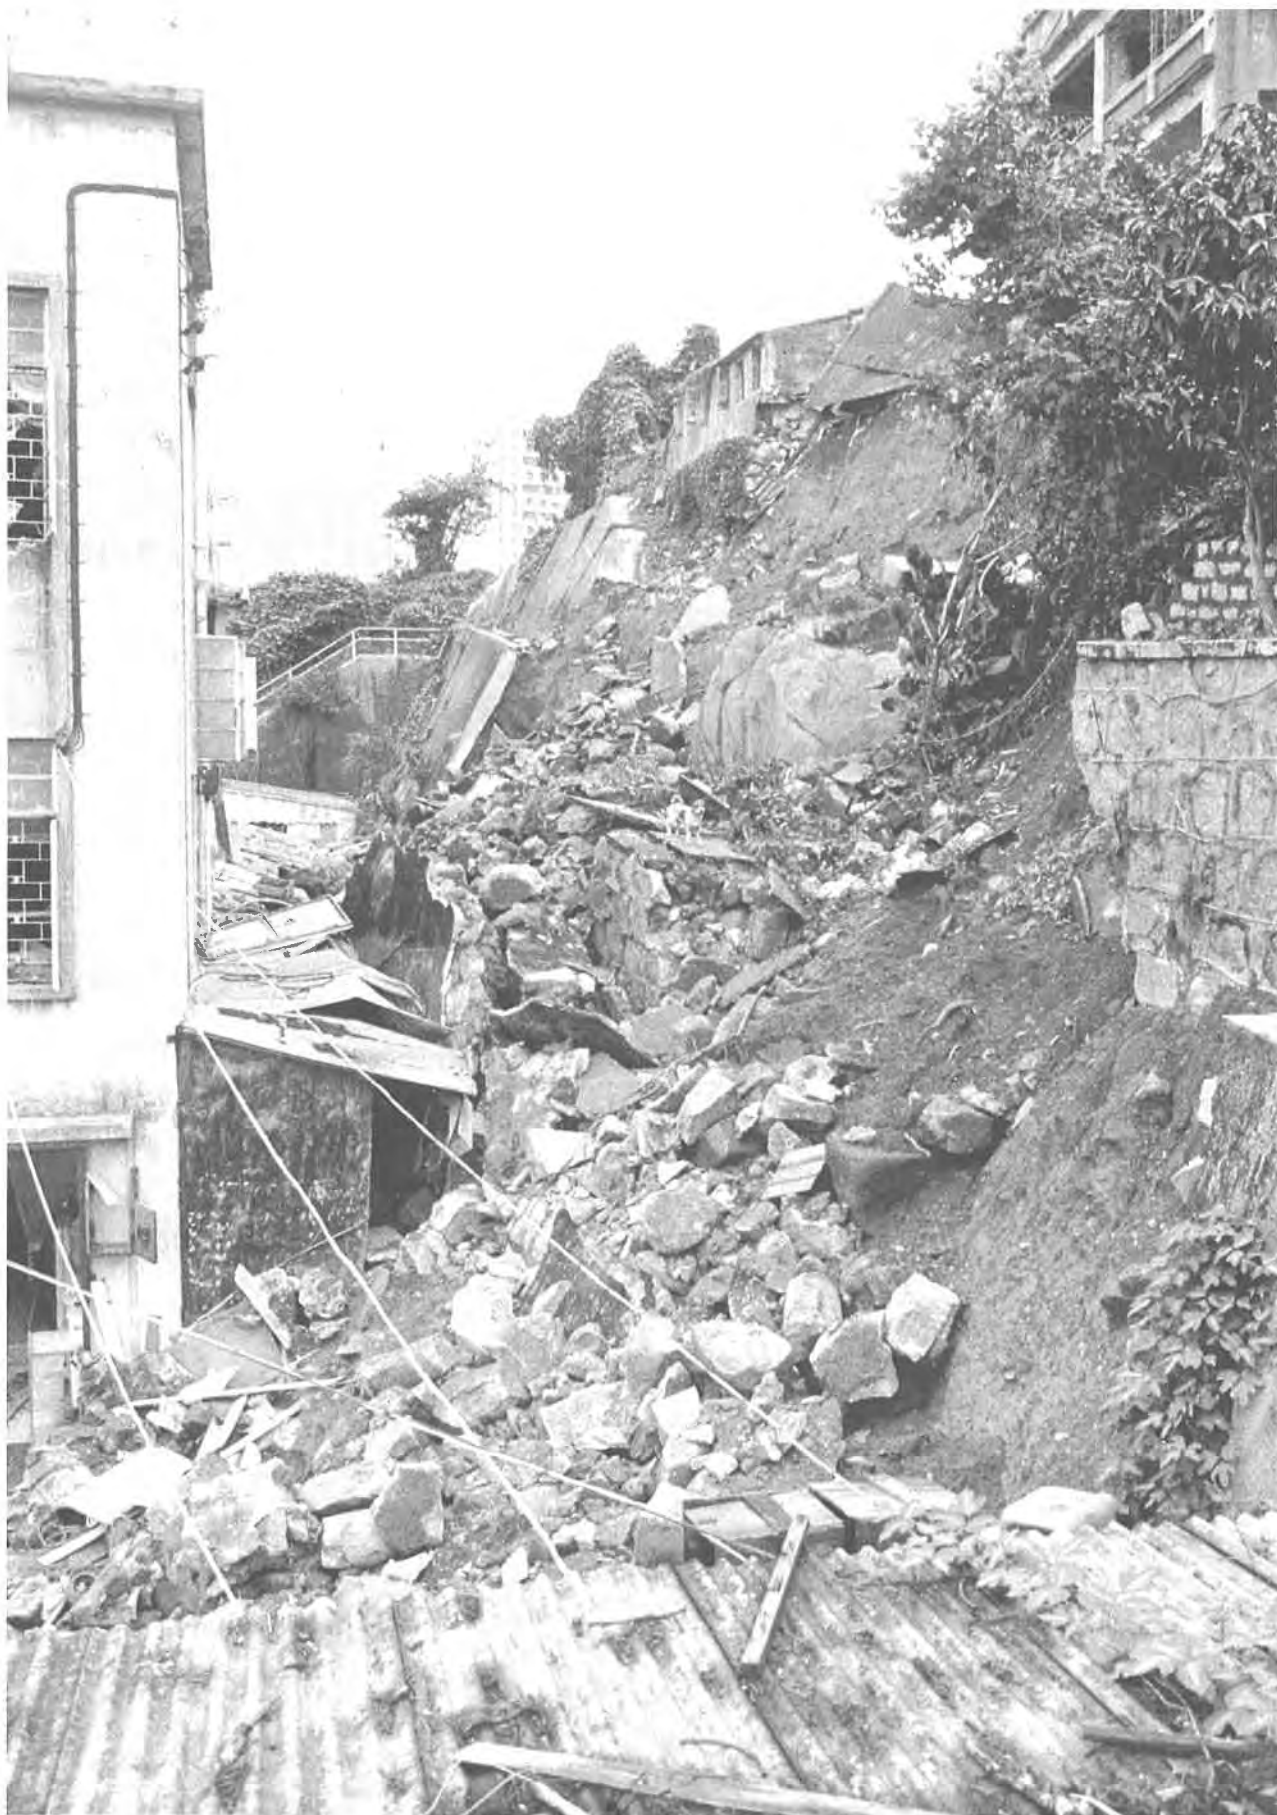
*Plate 150. Landslip at Wa On Terrace in 1982. Failure of a cut slope and retaining wall caused damage to this residential property in the Tsuen Wan district. (GCO/1982/19/70/82).*

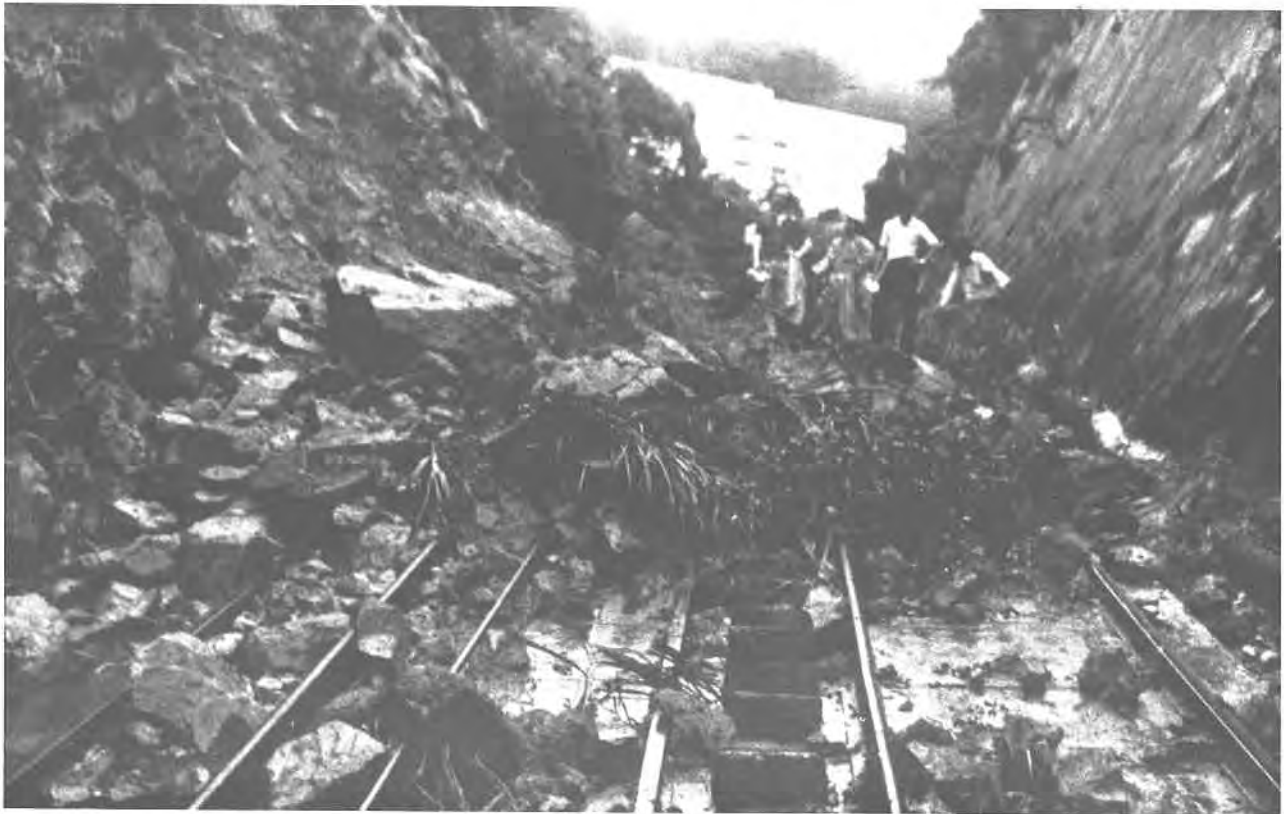
*Plate 151. Landslips on the Peak Tramway near May Road Station in 1982. This landslide severely disrupted tram services to the Peak. (GCO/ES/1982/216604).*

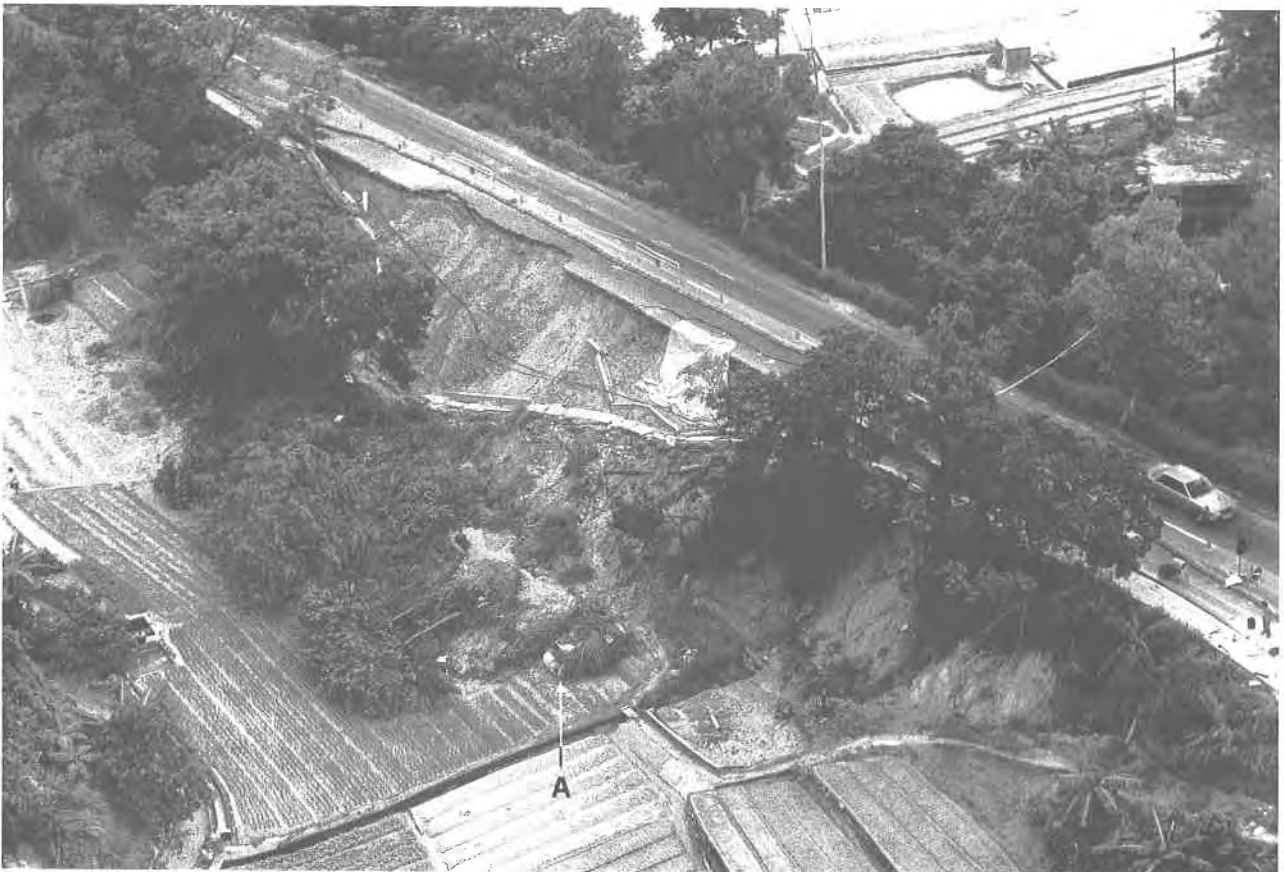
*Plate 152. Landslip on Road Embankment near Sui Wo Village in 1982. This landslide occurred near the 17.5 milestone on Castle Peak Road and damaged agricultural land. A vehicle, presumably parked on the carriageway at the time of failure, is evident at A. (GCO/OAP/1982/PS275-9A).*

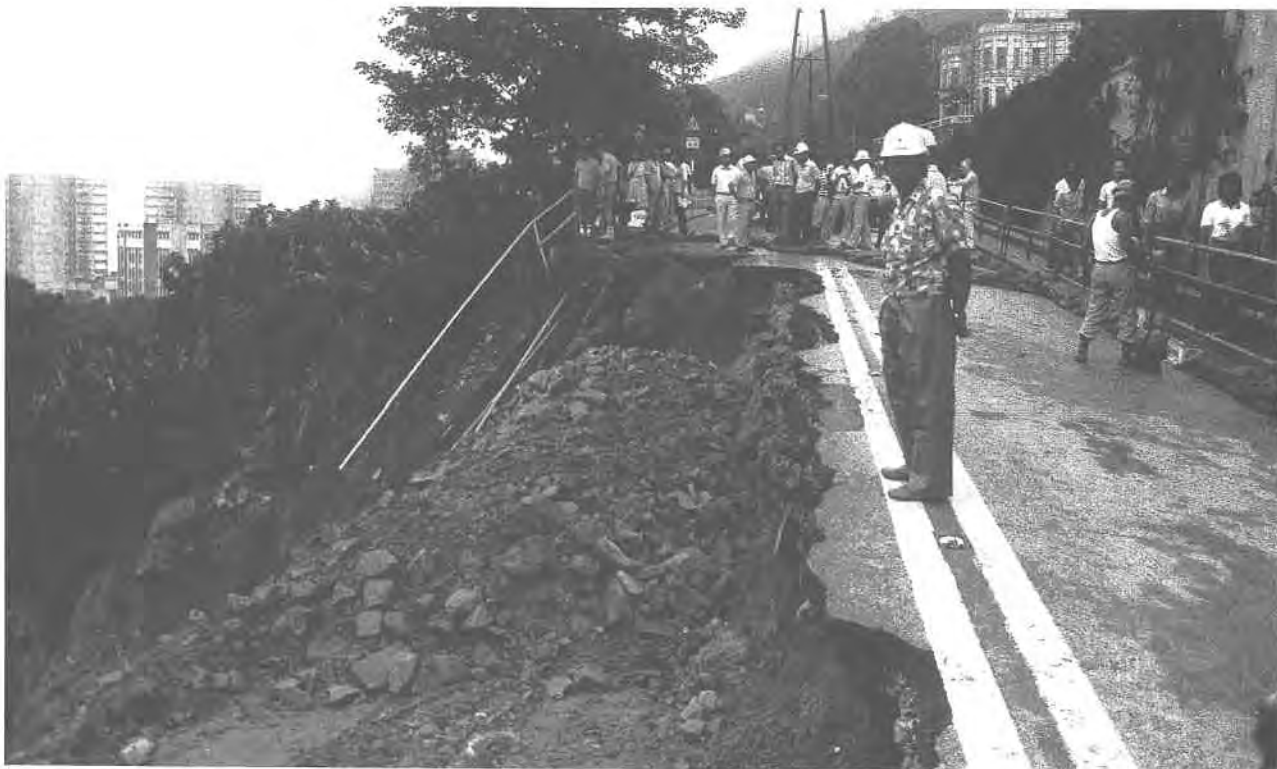
*Plate 153. Landslip on Peak Road in 1983.* This landslide severely damaged the westbound carriageway of Peak Road near the junction with Magazine Gap Road and resulted in the closure of the only access to The Peak for a week. An aerial view of site is given in Plate 57, and remedial works are shown at B in Plate 190. (GCO/1983/83/122/12A).

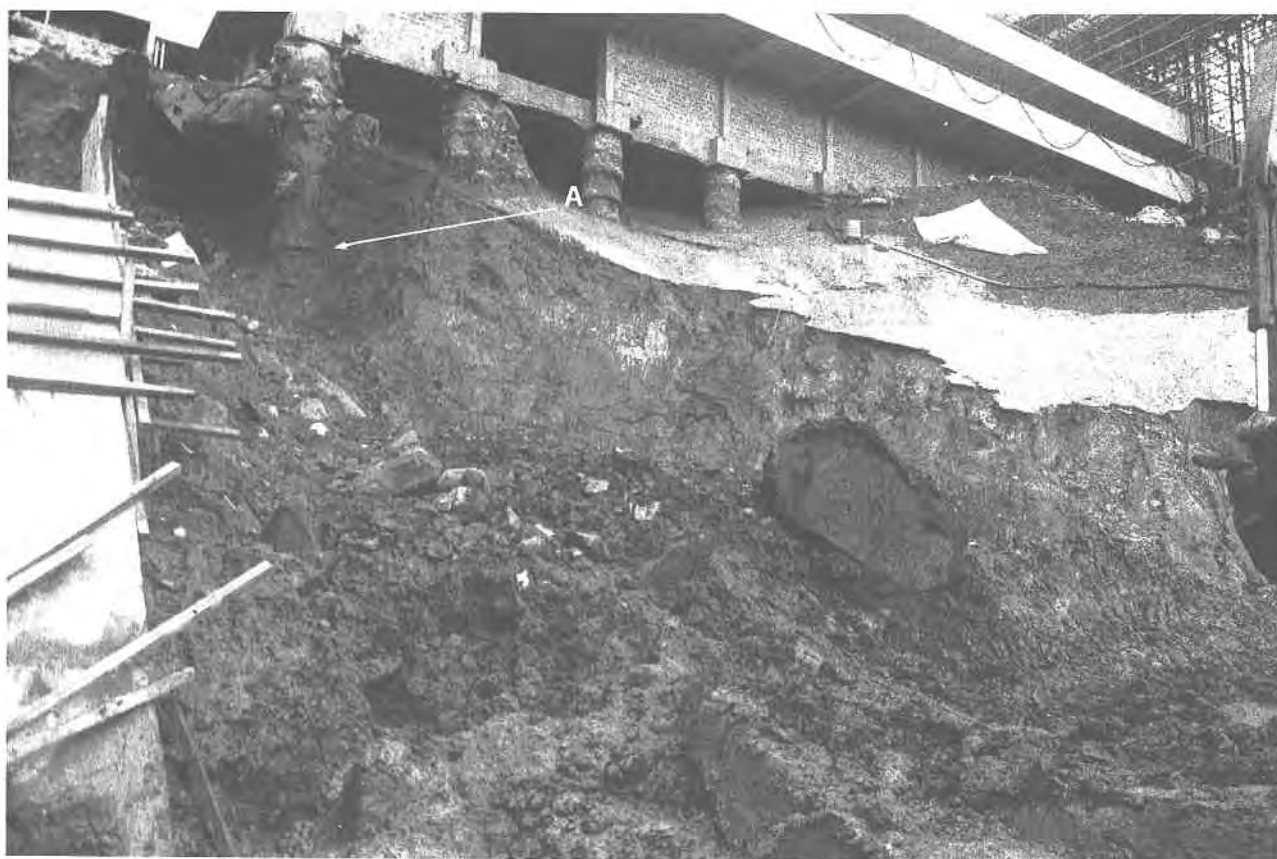
*Plate 154. Landslip at Hing Man Estate in 1983.* This landslide resulted from the failure of a colluvial slope beneath the car park podium of a housing estate under construction. Note the exposure of the foundations (A). Hing Man Estate is in the Chai Wan area. (GCO/1983/83/121/21).

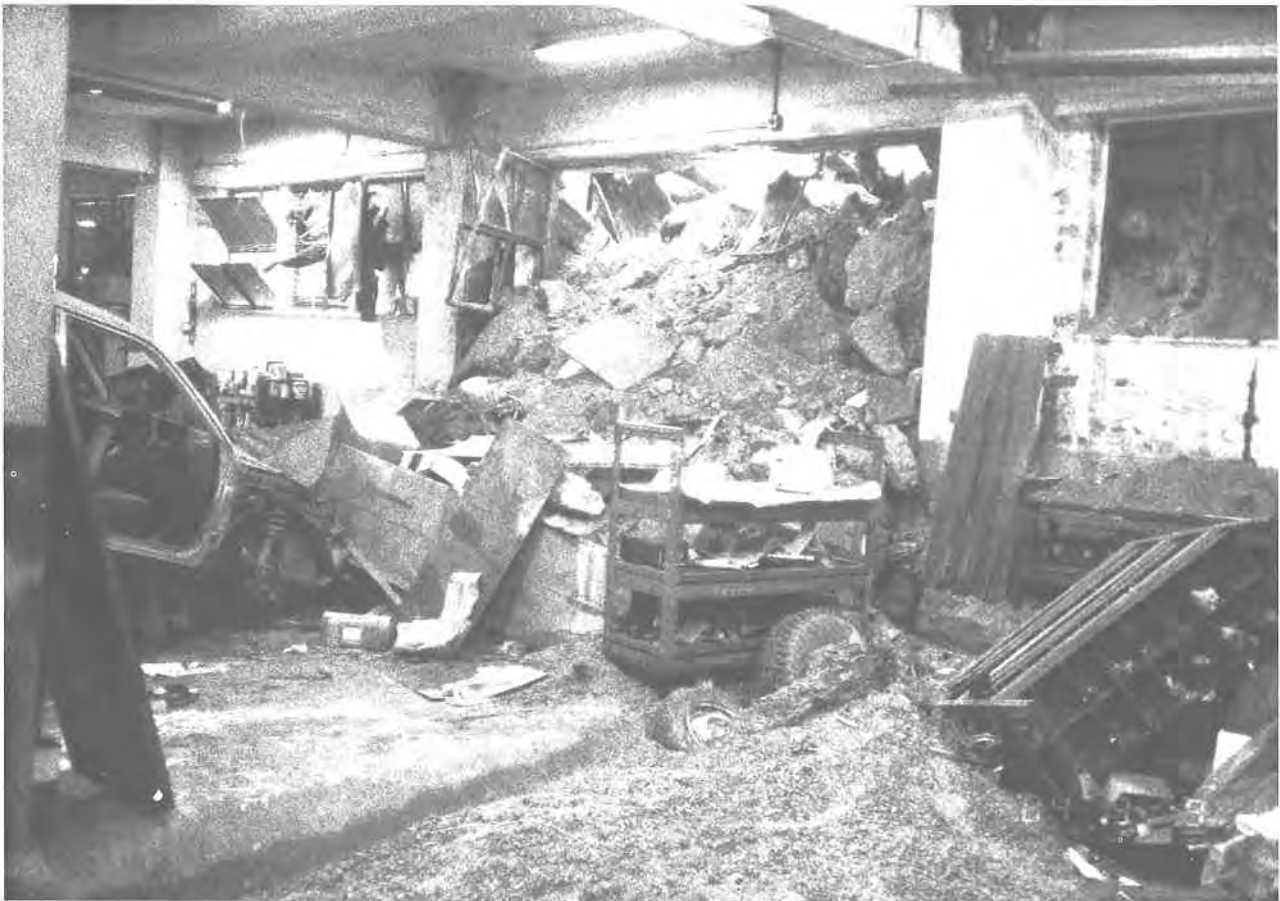
*Plate 158. Damage to Workshop at Tsat Tsz Mui Road in 1984. Failure of the cut slope, shown in Plate 157, resulted in damage to a workshop on the ground floor. (GCO/IE/1984/IE111/84/6A).*

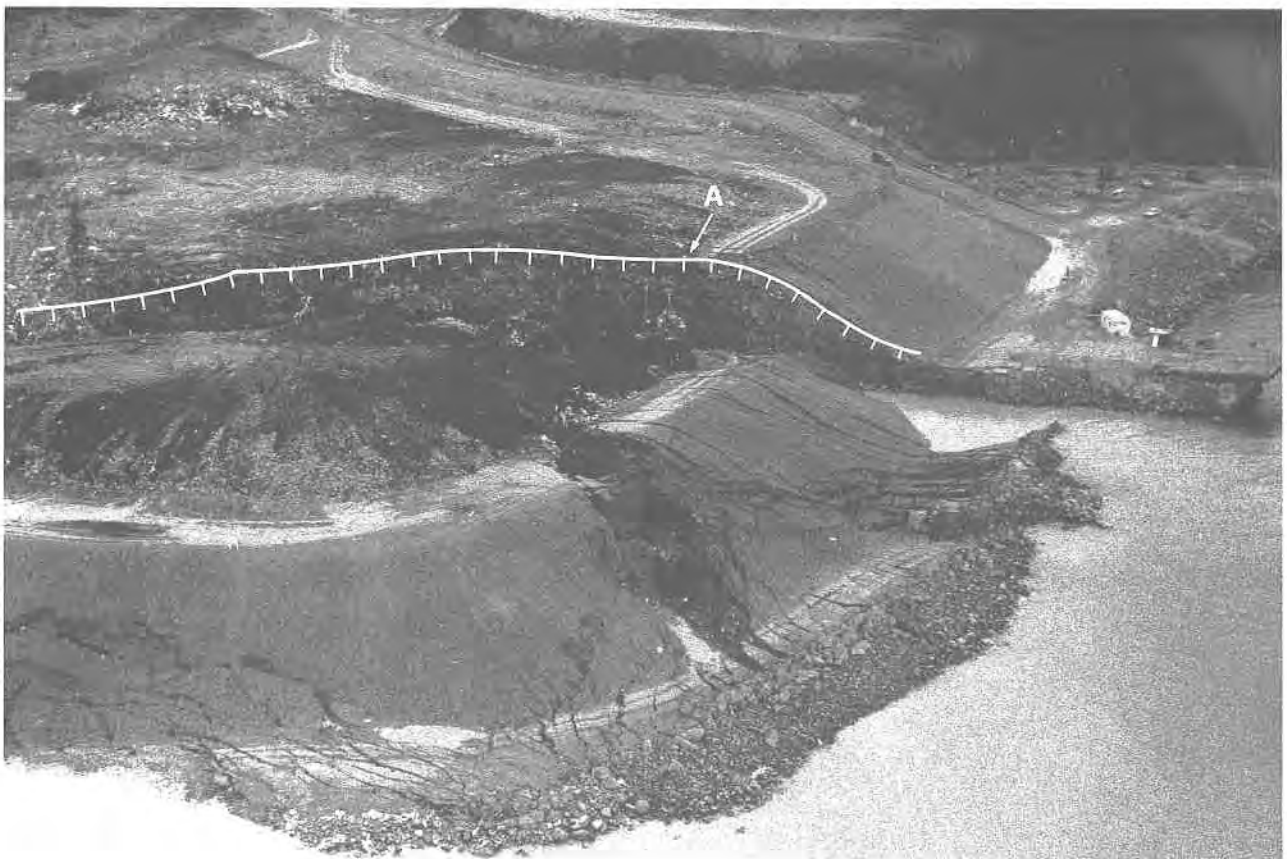
*Plate 160. Oblique Aerial Photograph of Failure of Landfill at Junk Bay in 1984.* This photograph views the site in an easterly direction. The multiple sets of tension cracks are clearly evident. The major line of failure is indicated at A. (GCO/MW/1984/64/84/15).

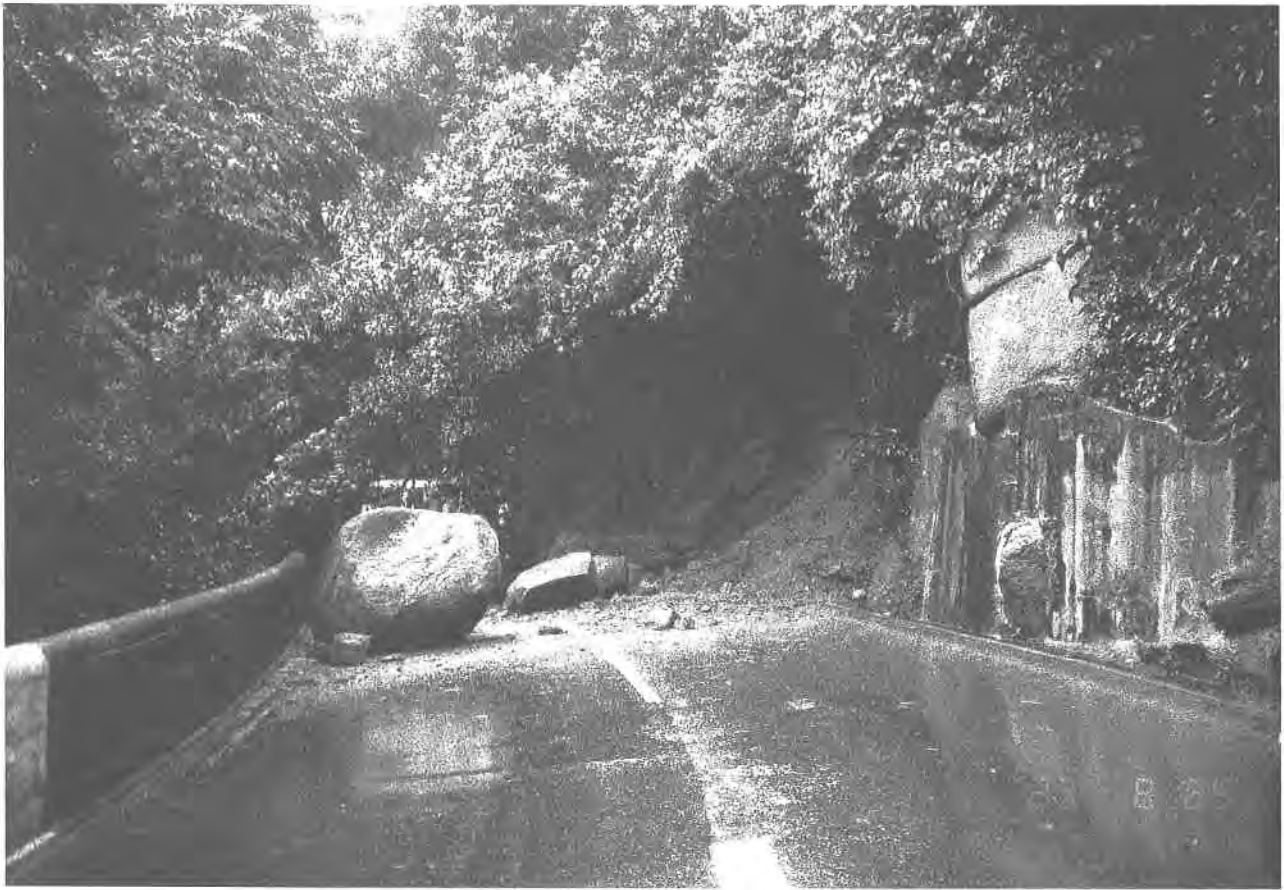
*Plate 161. Landslip on Stubbs Road in 1985. A landslip and rockfall near 34 Stubbs Road resulted in disruption of road traffic. (GCO/IW/1985/IW85/267/0).*

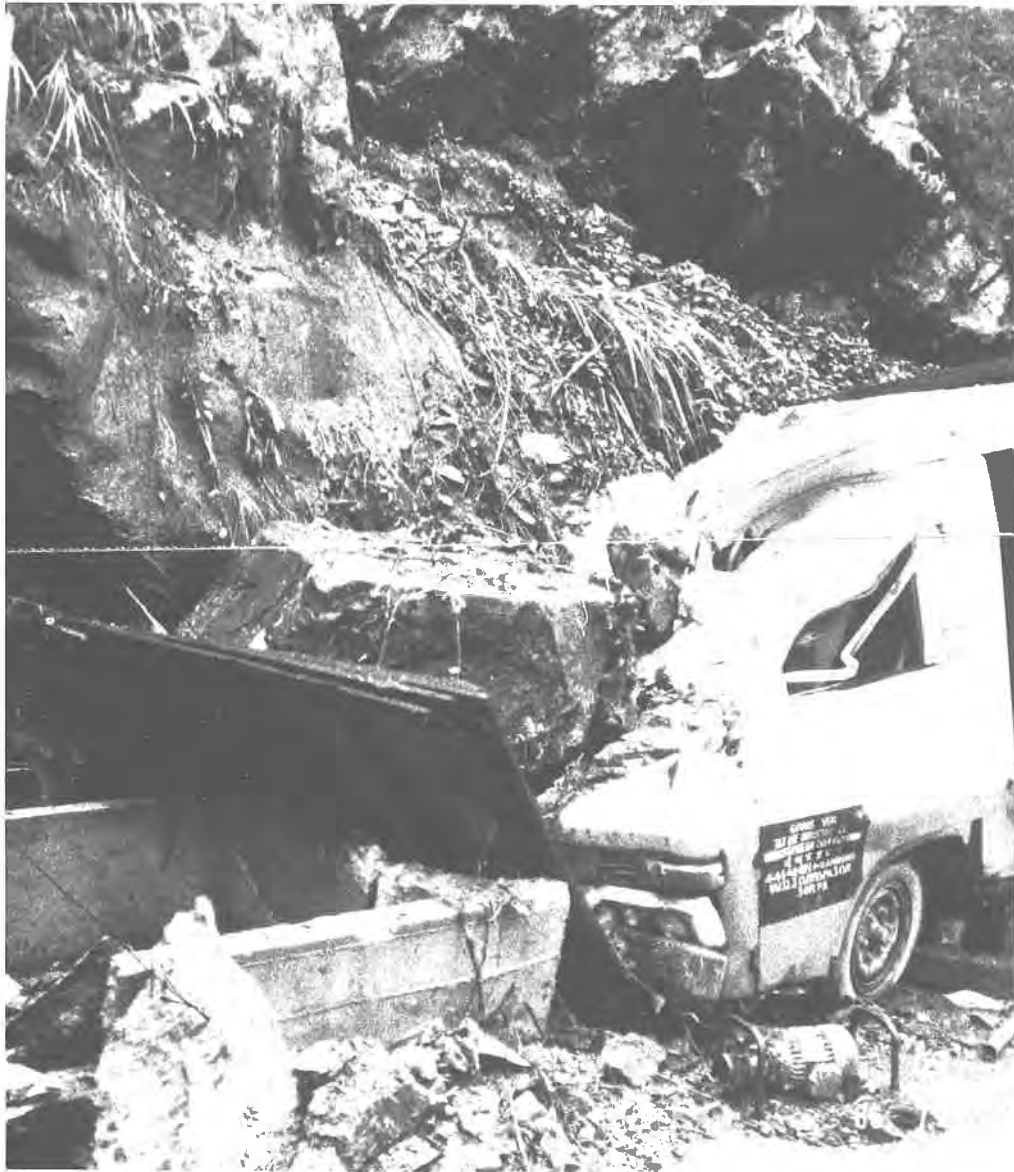
*Plate 162. Rockfall at Wo Yi Hop Road in 1986. This incident occurred on a construction site at Tsuen Wan. The light goods vehicle did little damage to the boulder. (GCO/HQ/1986/HQ8603015).*

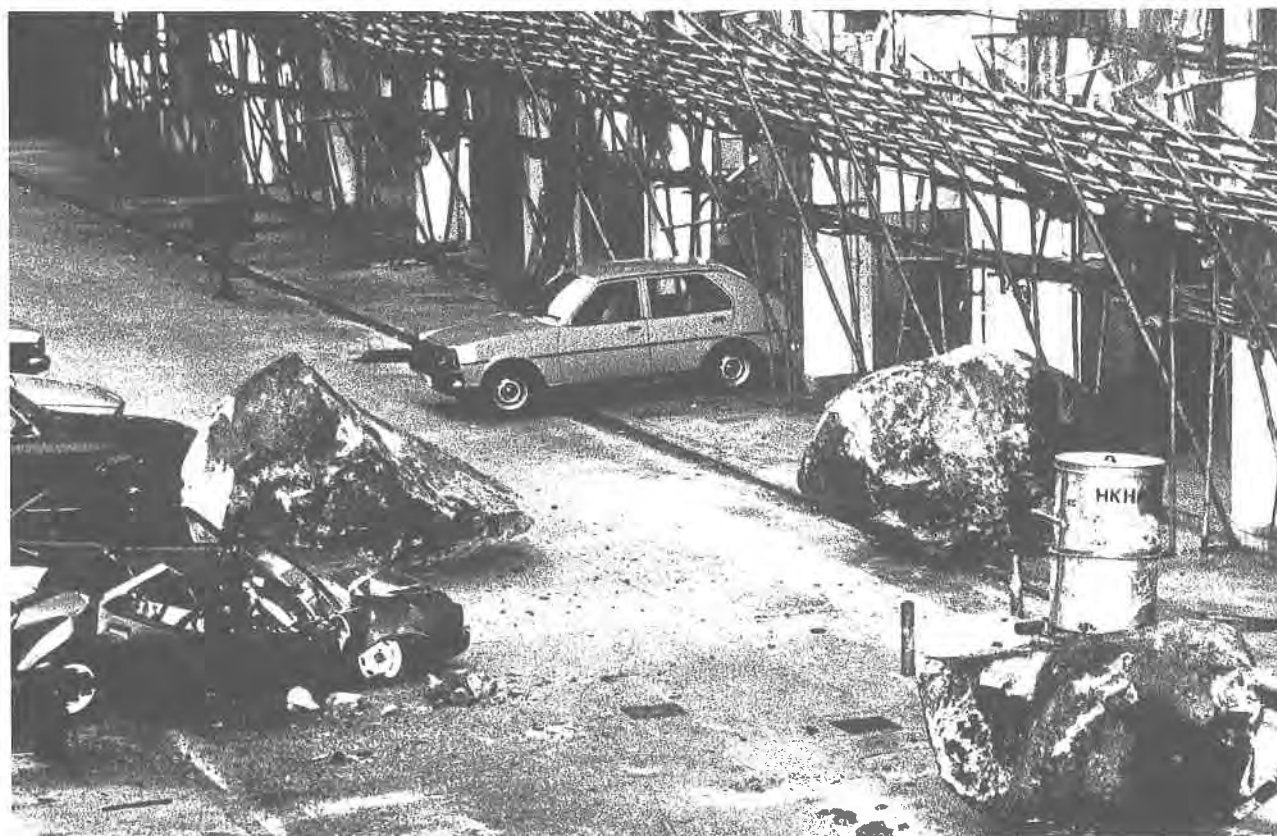
**Plate 164.** *Rockfall at Kennedy Town Police Quarters in 1986.* Parked vehicles were severely damaged as a result of this rockfall at Kai Wai Man Road. Fortunately there were no injuries associated with the incident. This photograph was reproduced from the South China Morning Post of 15.7.1986. (GCO/SP/1986/SP 8701832).

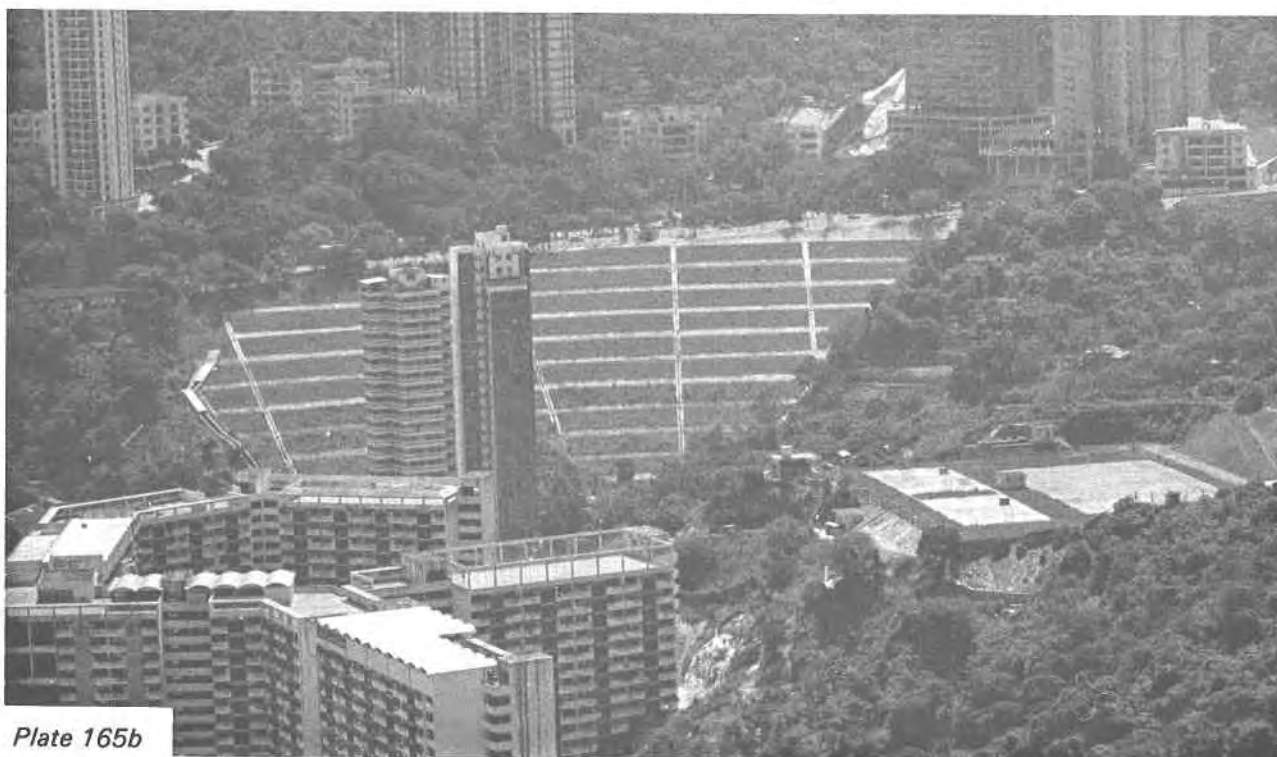
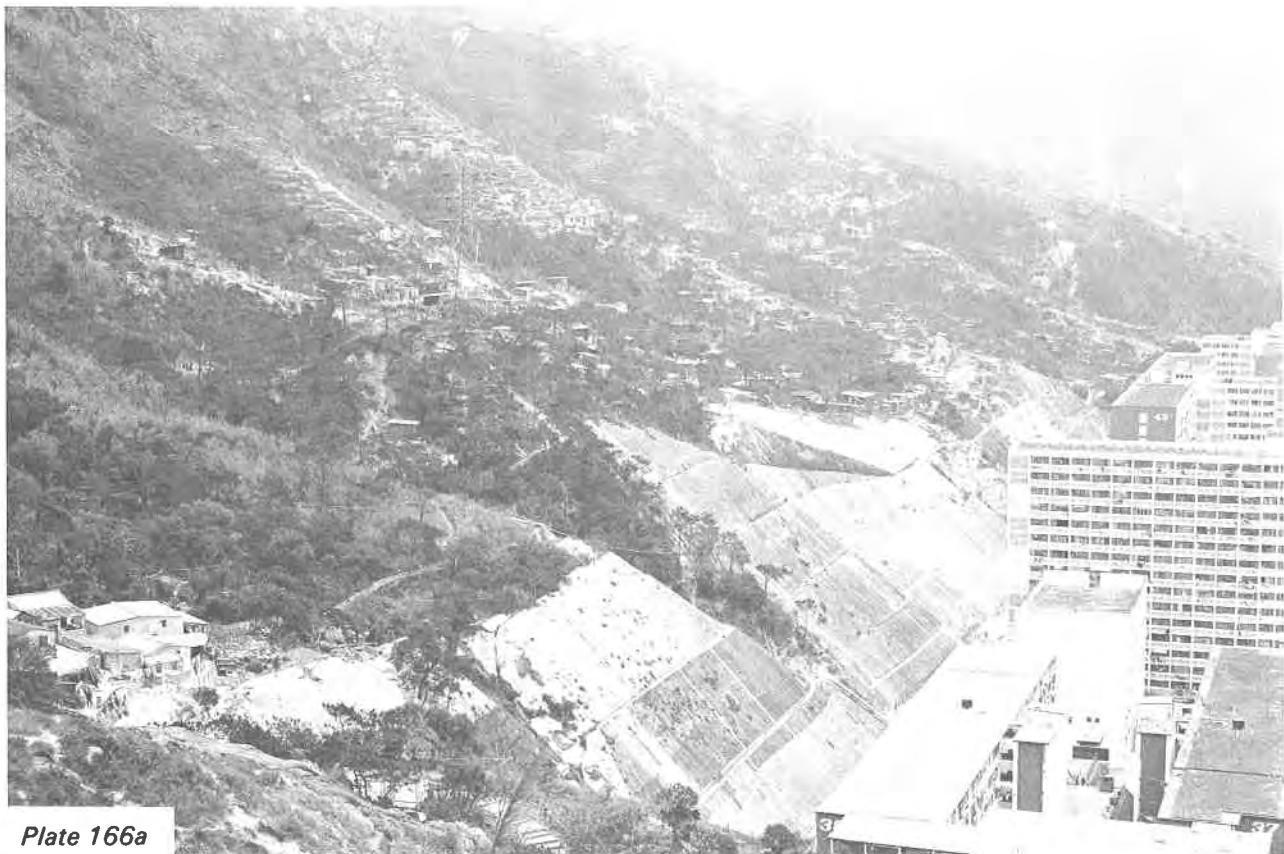
Plate 165. *Oblique Aerial Photograph of Slope Stabilization on Pok Fu Lam Road in 1978 and 1979.* The Pok Fu Lam dump site was reconstructed during 1978 and 1979 as part of the Landslip Preventive Measures (LPM) Programme. The site on Pok Fu Lam Road and another dump site at Mt Davis were recompacted in a contract worth some \$14 million. Plate 165a shows the 50 m high by 200 m wide slope on 28.9.1978. Information on some of the early LPM sites is given in Bowler & Phillipson (1982). Plate 165b shows the slope some 7 months later. (GCO/OAP/1978/PS4-29A & 1979/PS11-7).
